(12) **United States Patent**
Lee et al.

(10) **Patent No.:** **US 7,445,377 B2**
(45) **Date of Patent:** **Nov. 4, 2008**

(54) **NONDESTRUCTIVE RESIDENTIAL INSPECTION METHOD AND APPARATUS**

This invention provides an apparatus for nondestructive residential inspection and various methods for using a thermal imaging apparatus coupled to inspect exterior residential components, interior residential components, a pitched roof and basement of a residential building and the electrical system of a residential building.

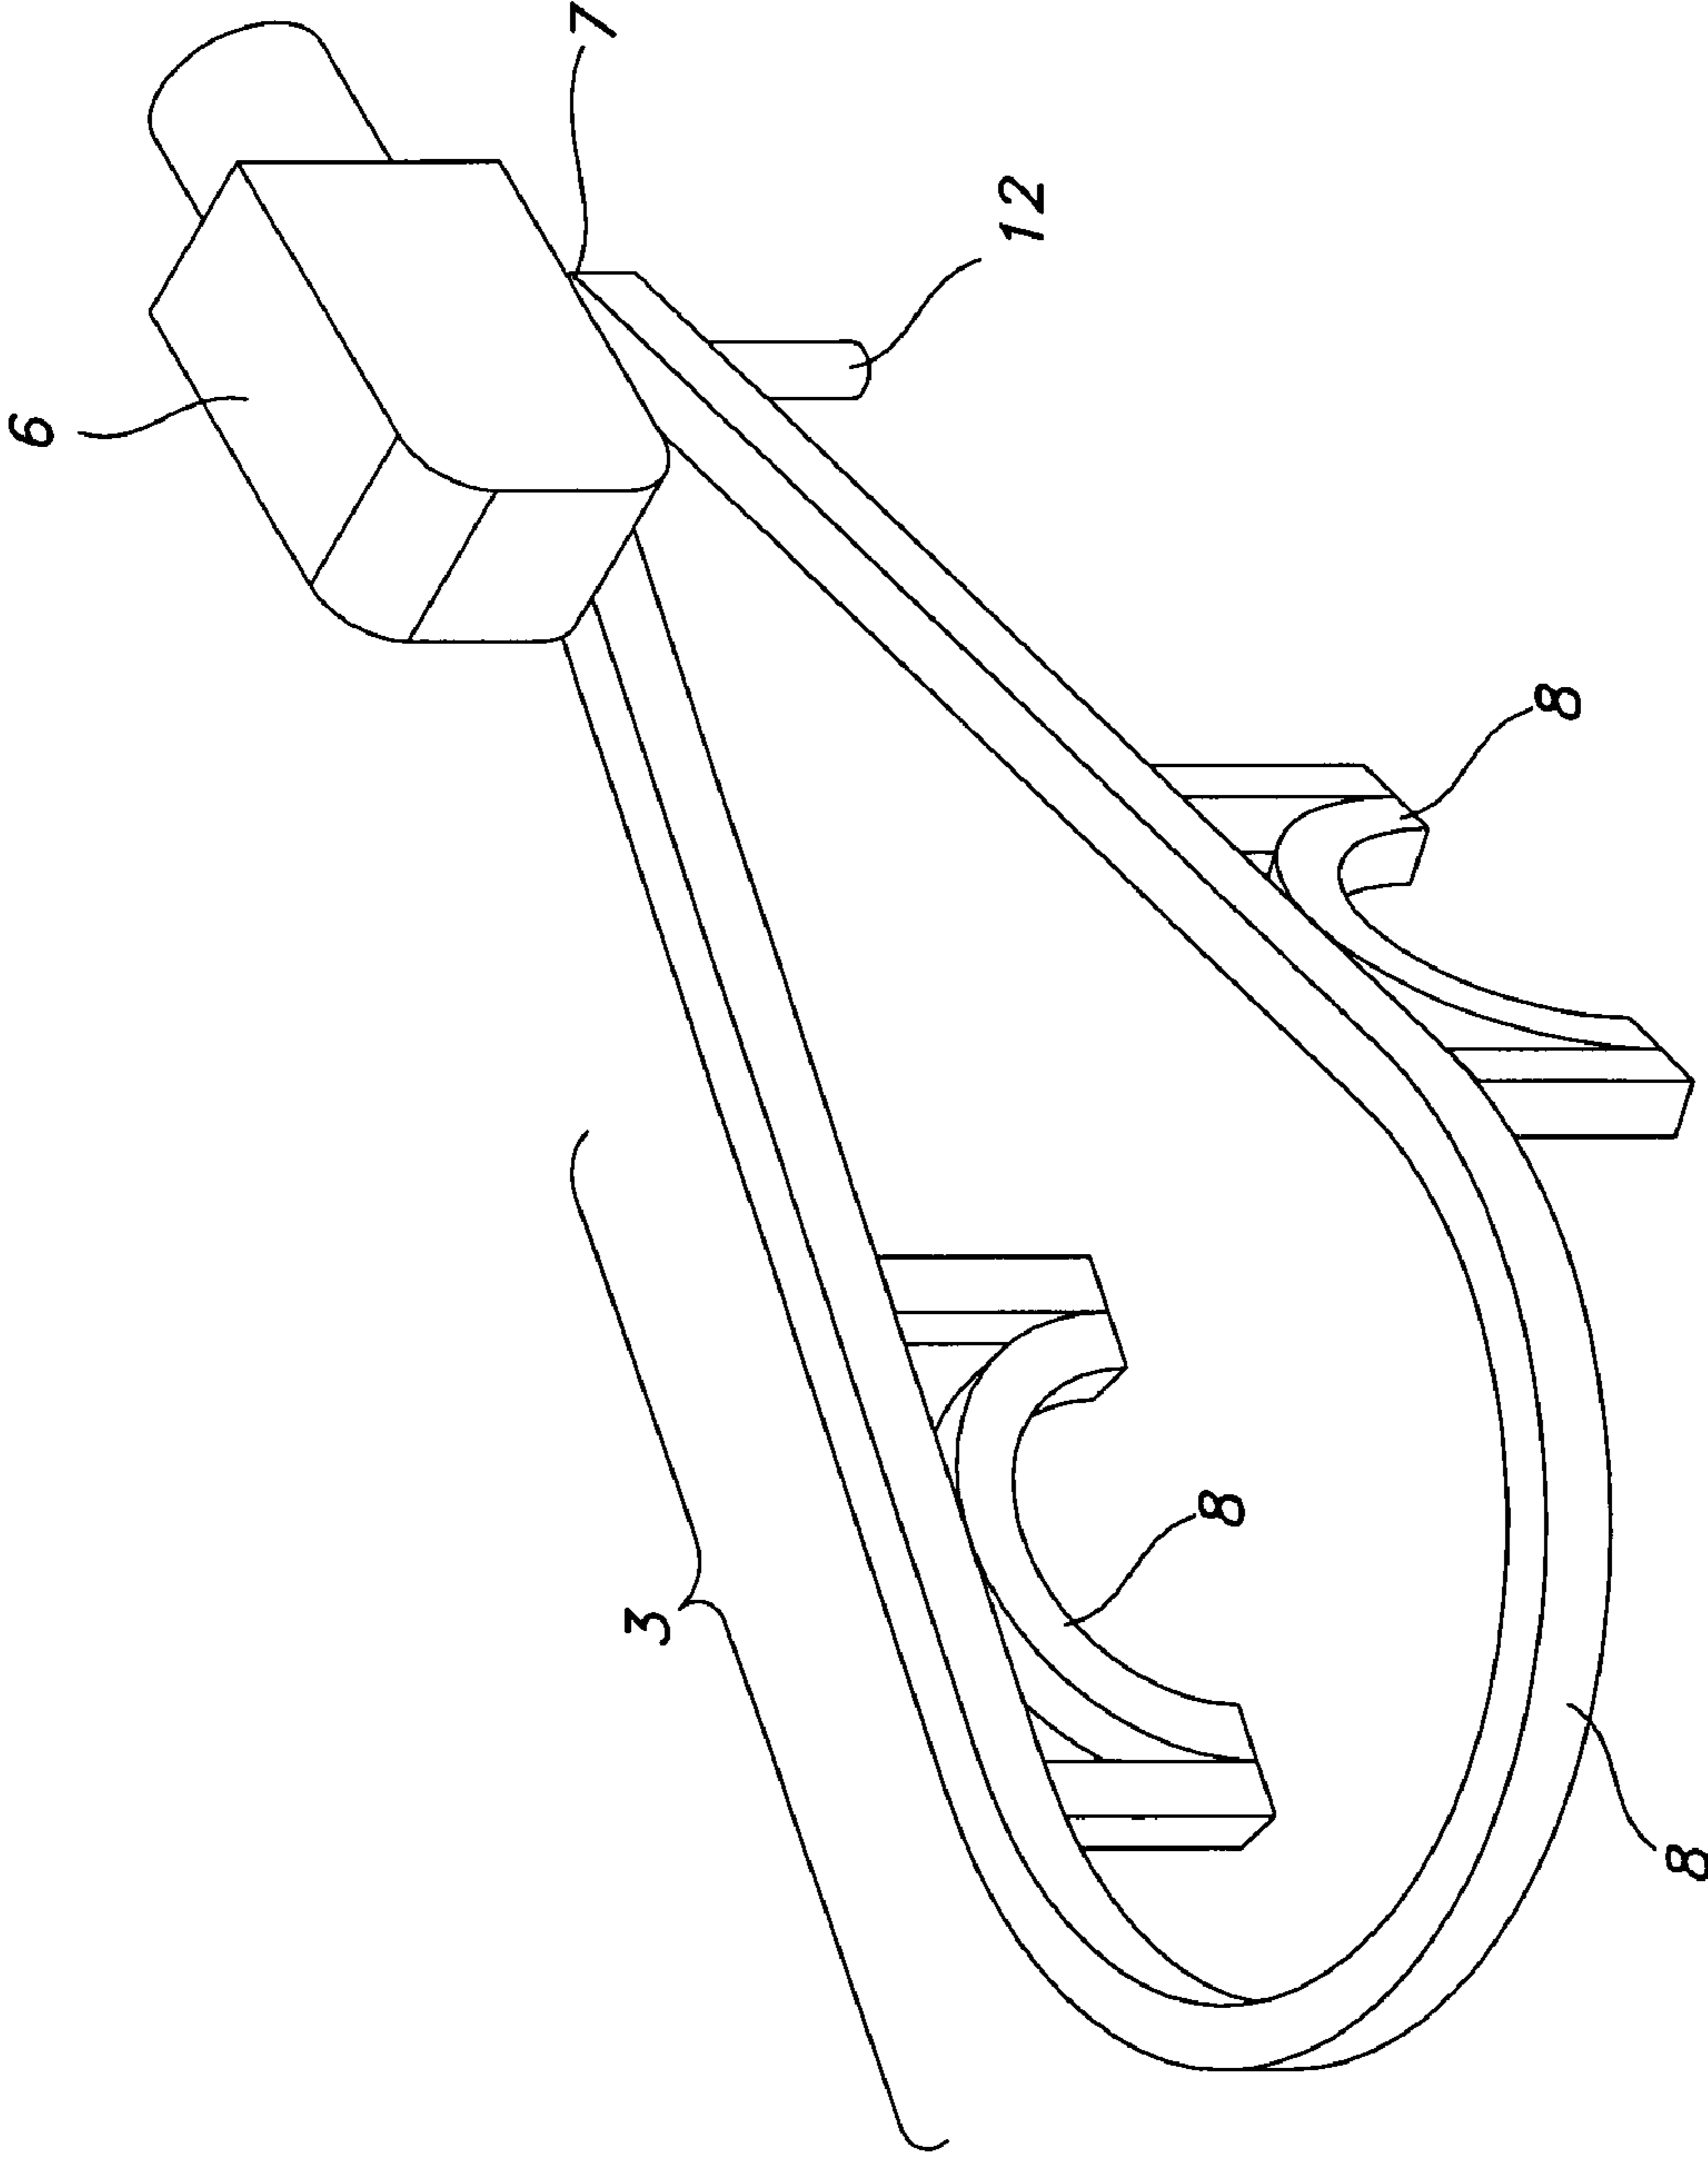
FIG. 3 is a schematic illustration of an alternate embodiment of the apparatus.

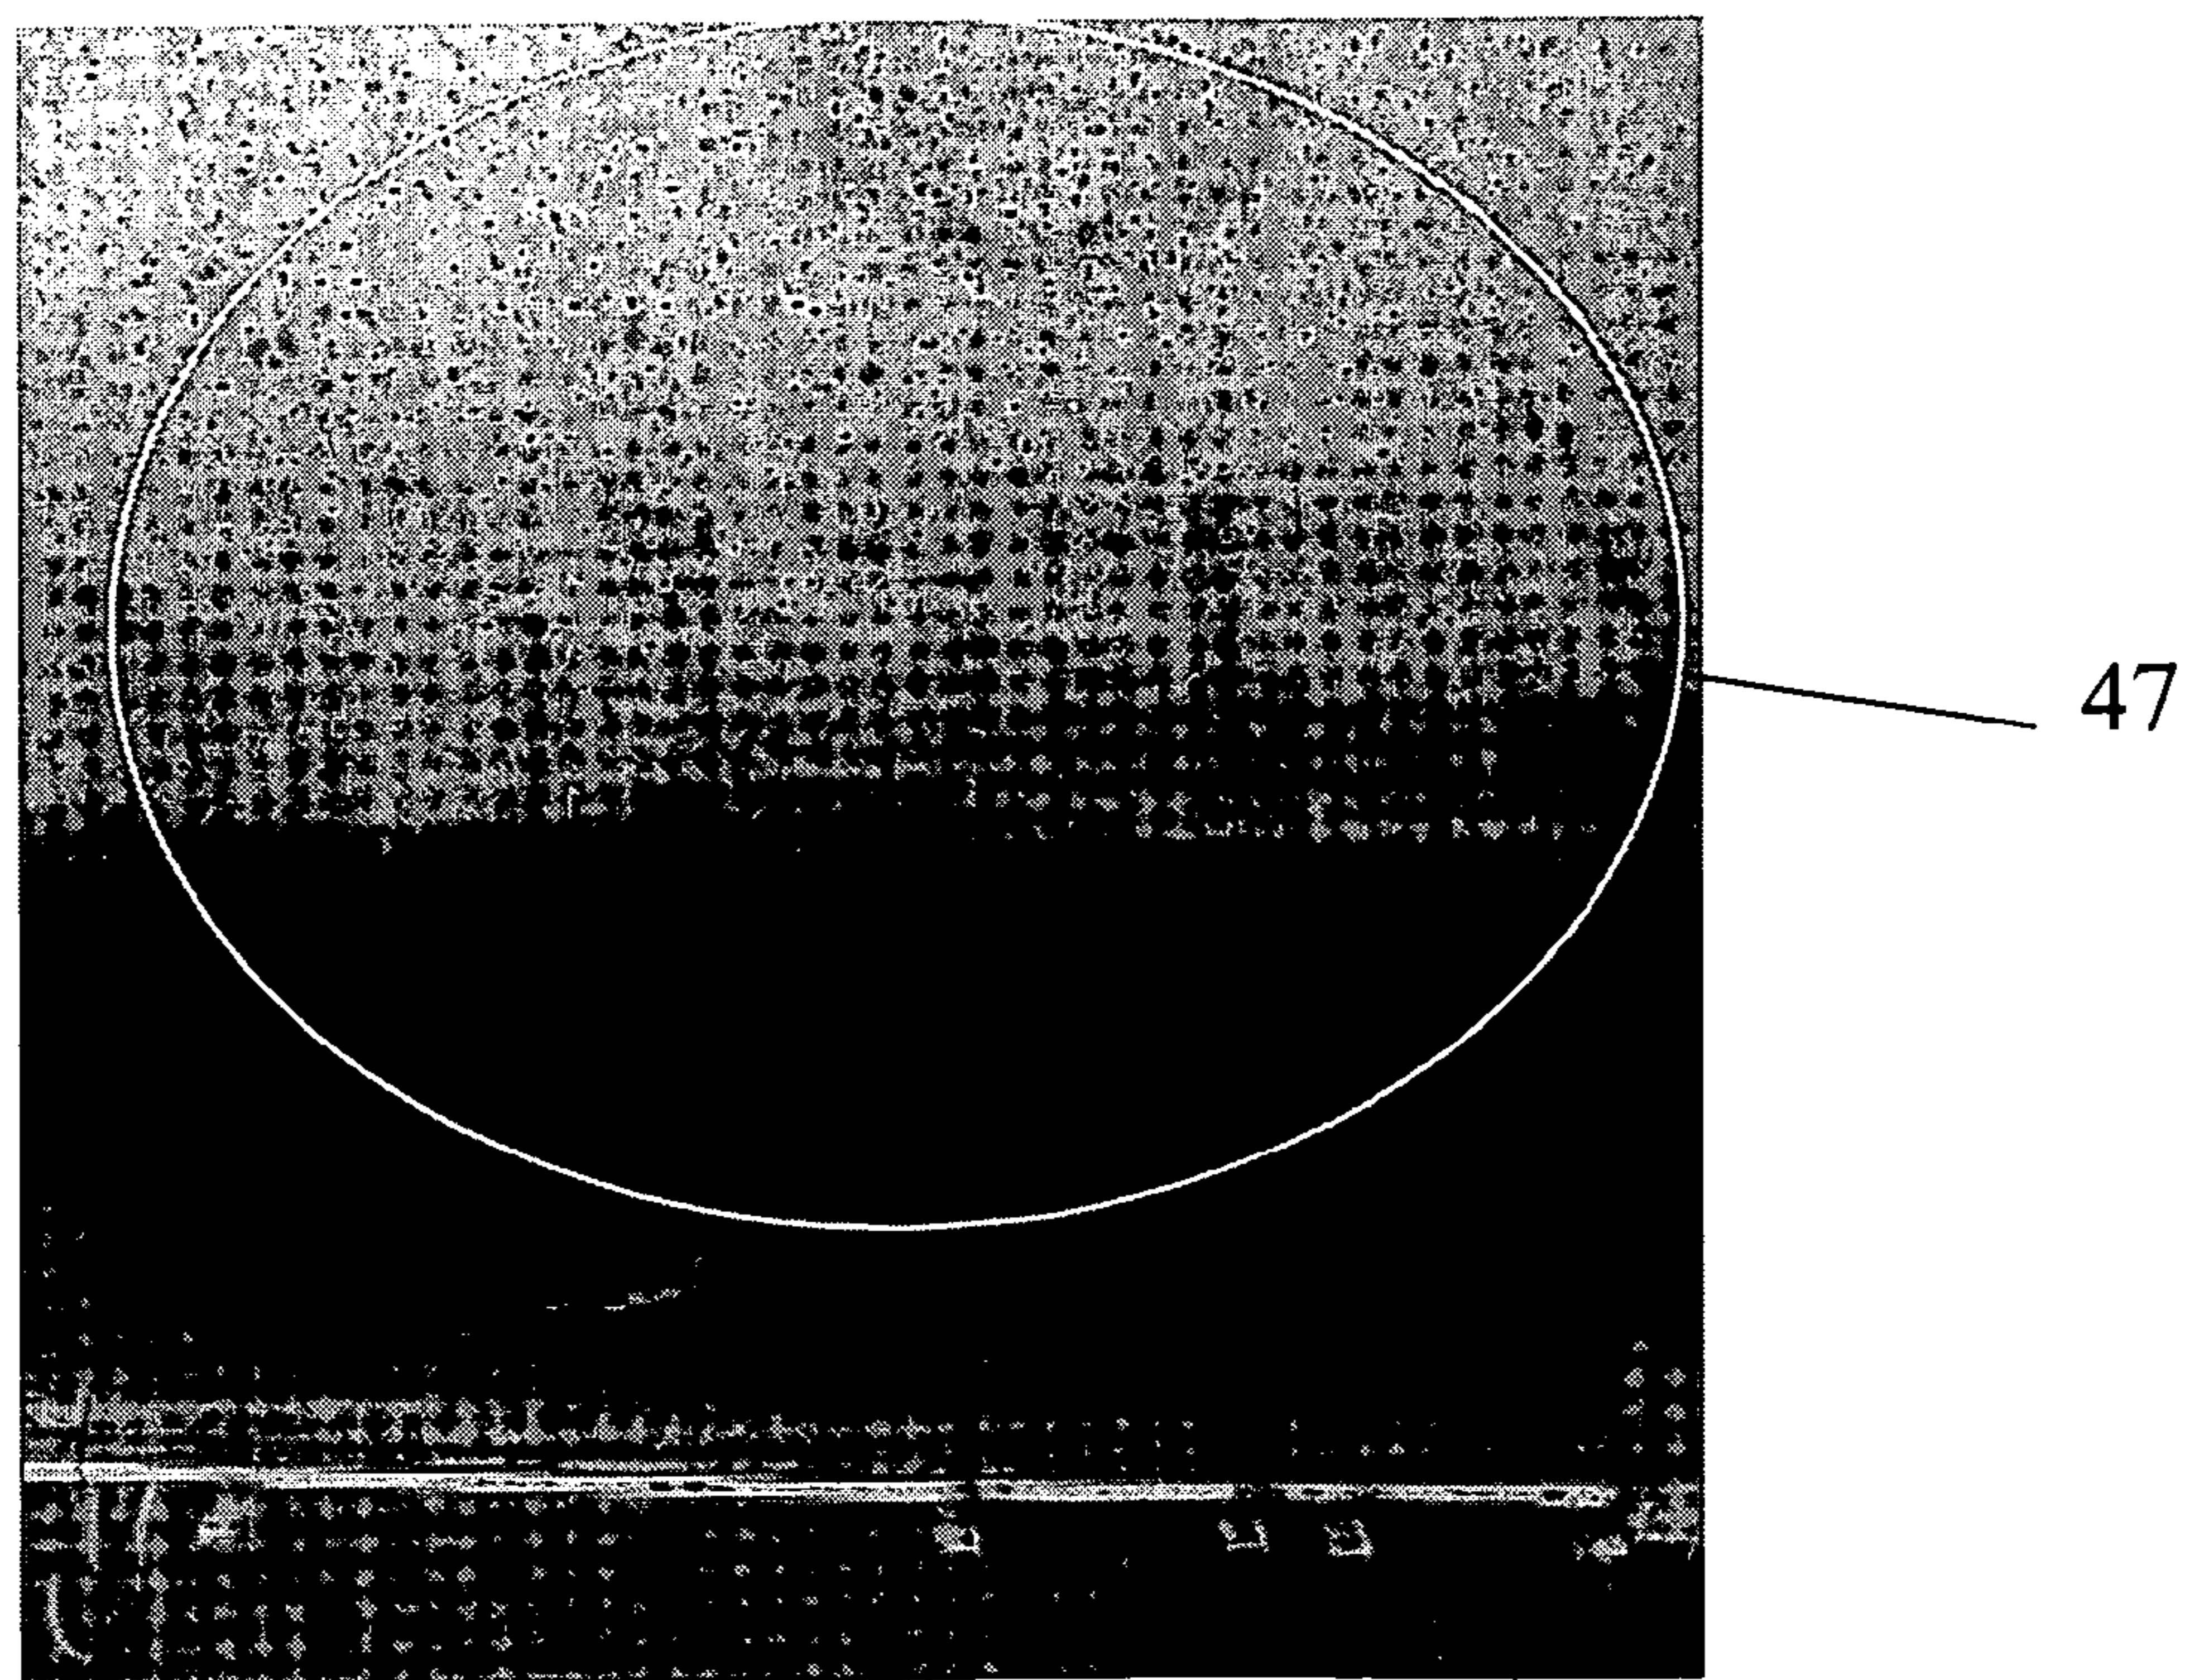
Condensation can also occur on interior ceiling surface as shown in FIGS. 21A and 21B. FIG. 21A was taken 4 feet away from the ceiling. The anomaly 47 is indicative of moisture on the ceiling. The temperature profile shown in FIG. 21B was taken 15 feet away from the same ceiling shown in FIG. 21A. The anomaly 48 is indicative of moisture in the ceiling.
