(10) **Patent No.:** **US 7,445,377 B2**  
(45) **Date of Patent:** **Nov. 4, 2008**

(54) **NONDESTRUCTIVE RESIDENTIAL INSPECTION METHOD AND APPARATUS**

(57) **ABSTRACT**

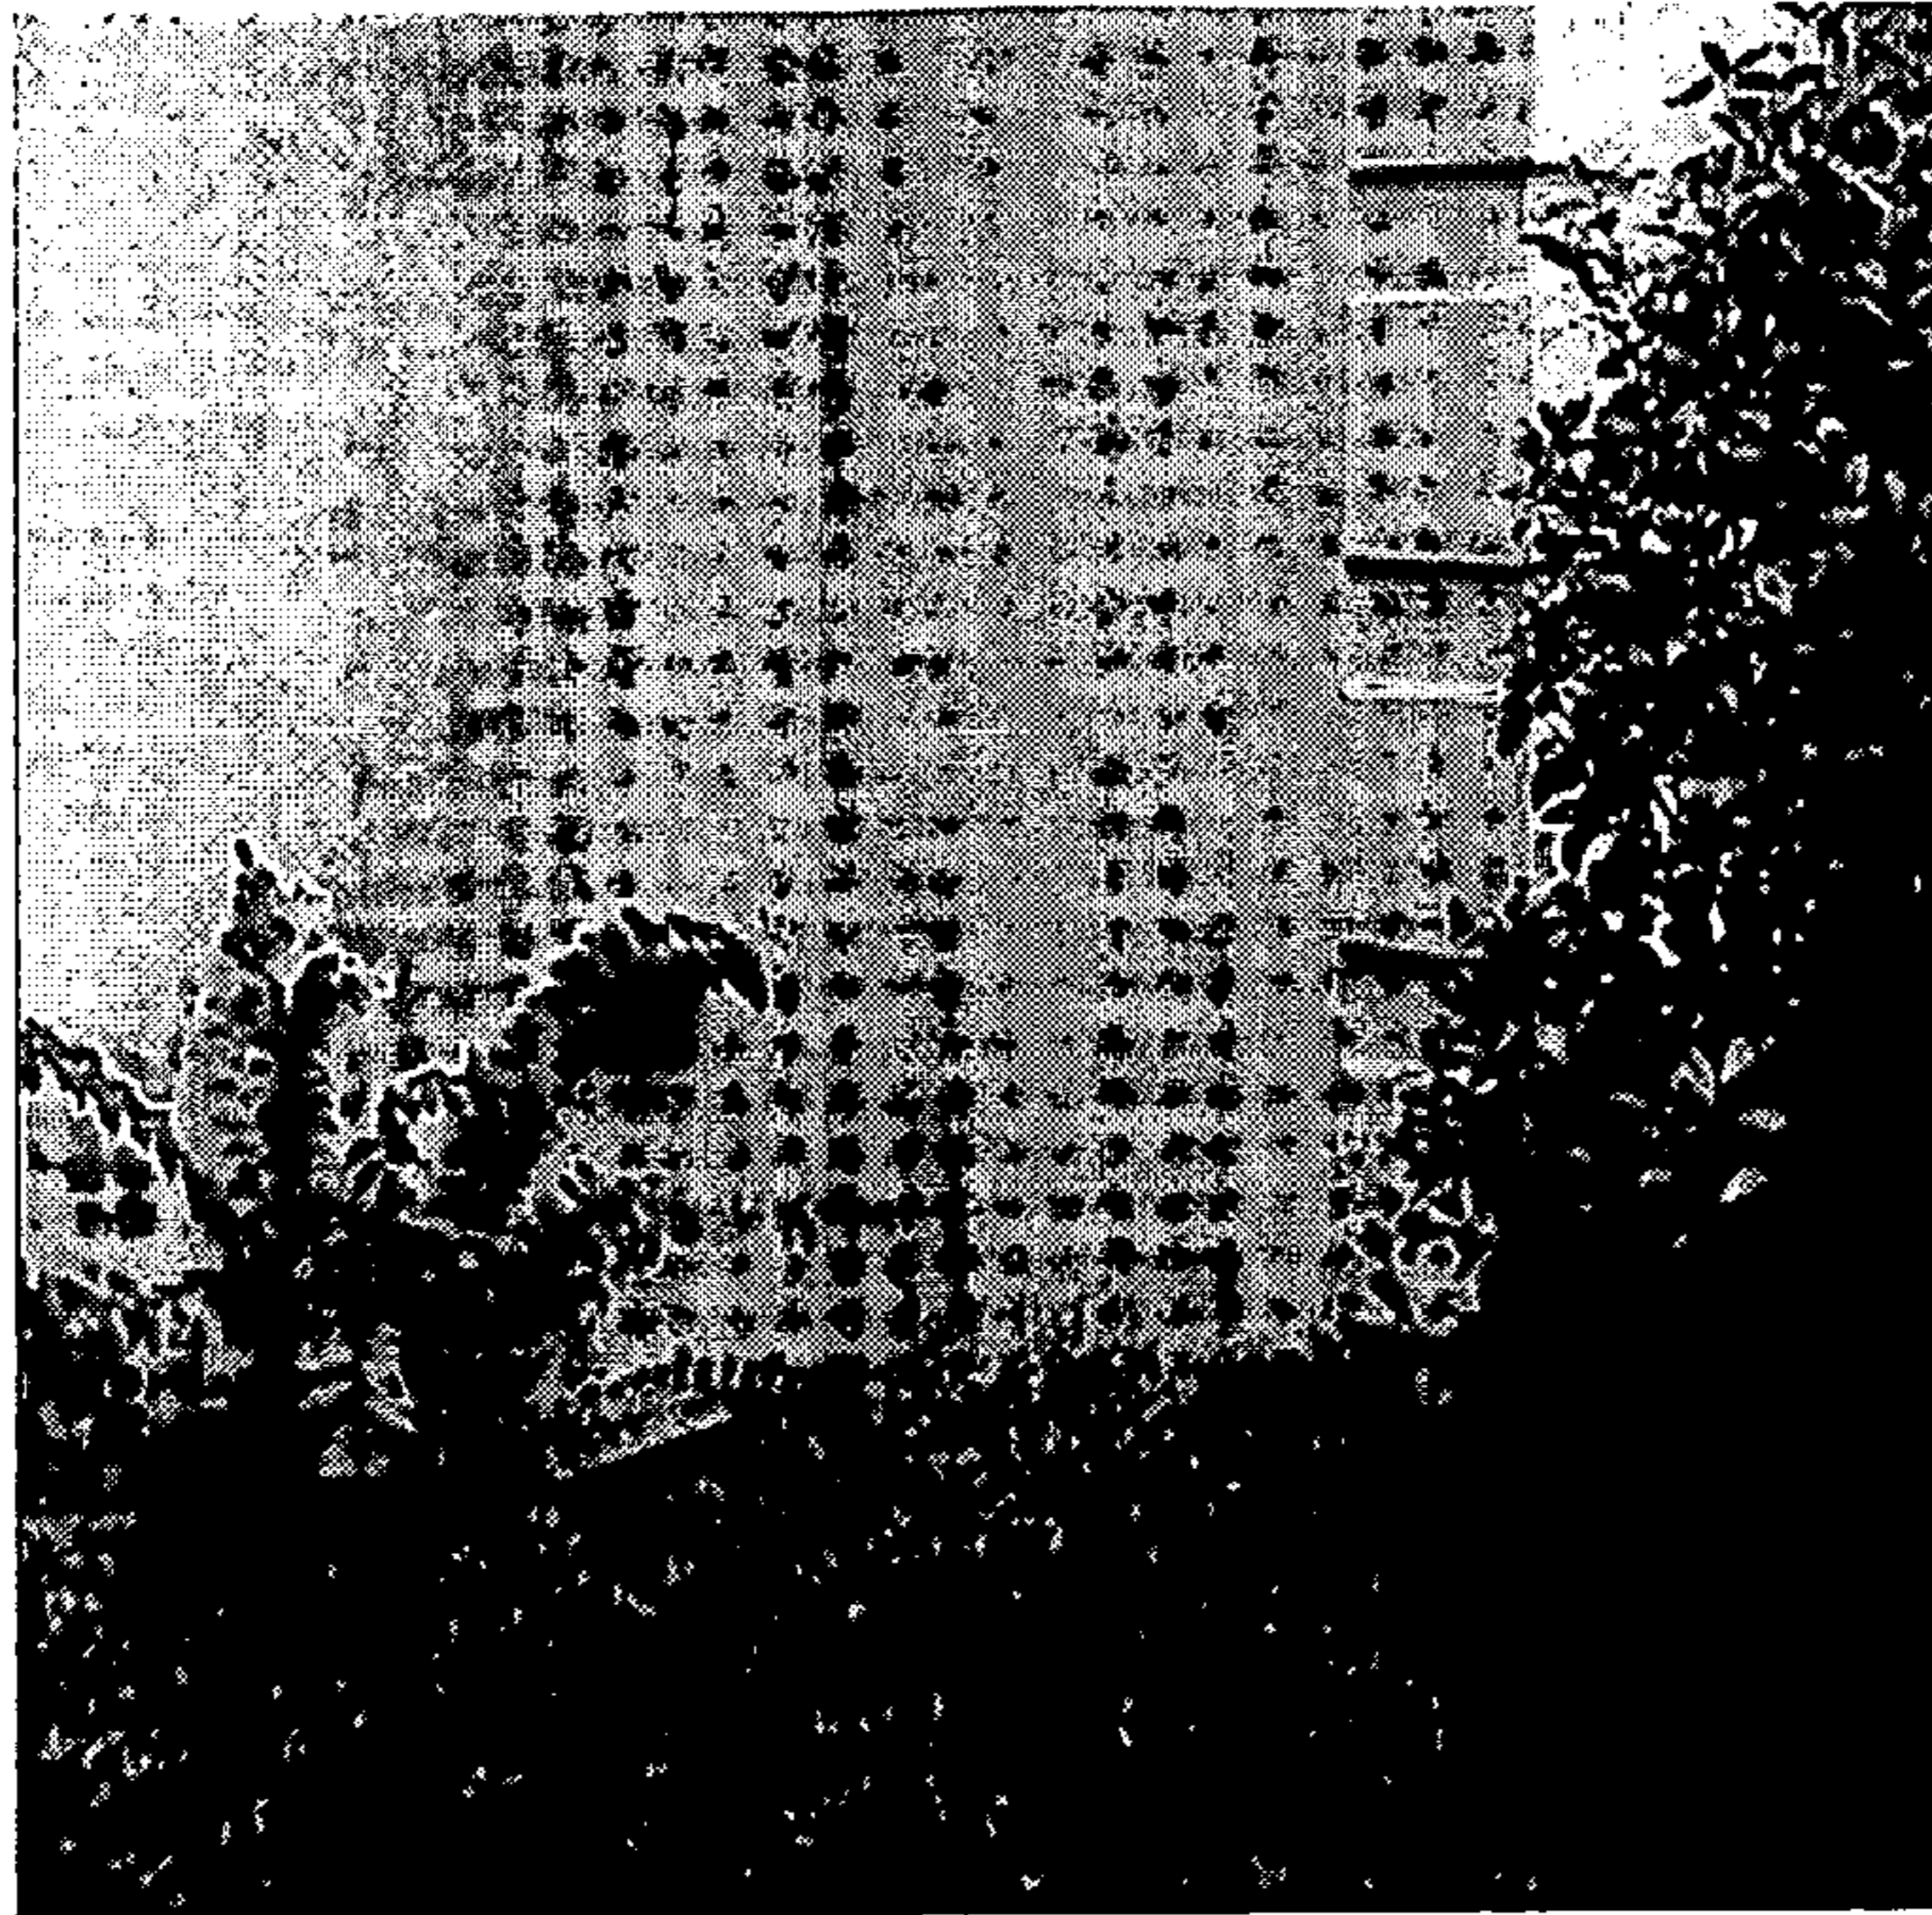
FIG. 4A is a visual photograph of an EIFS wall.

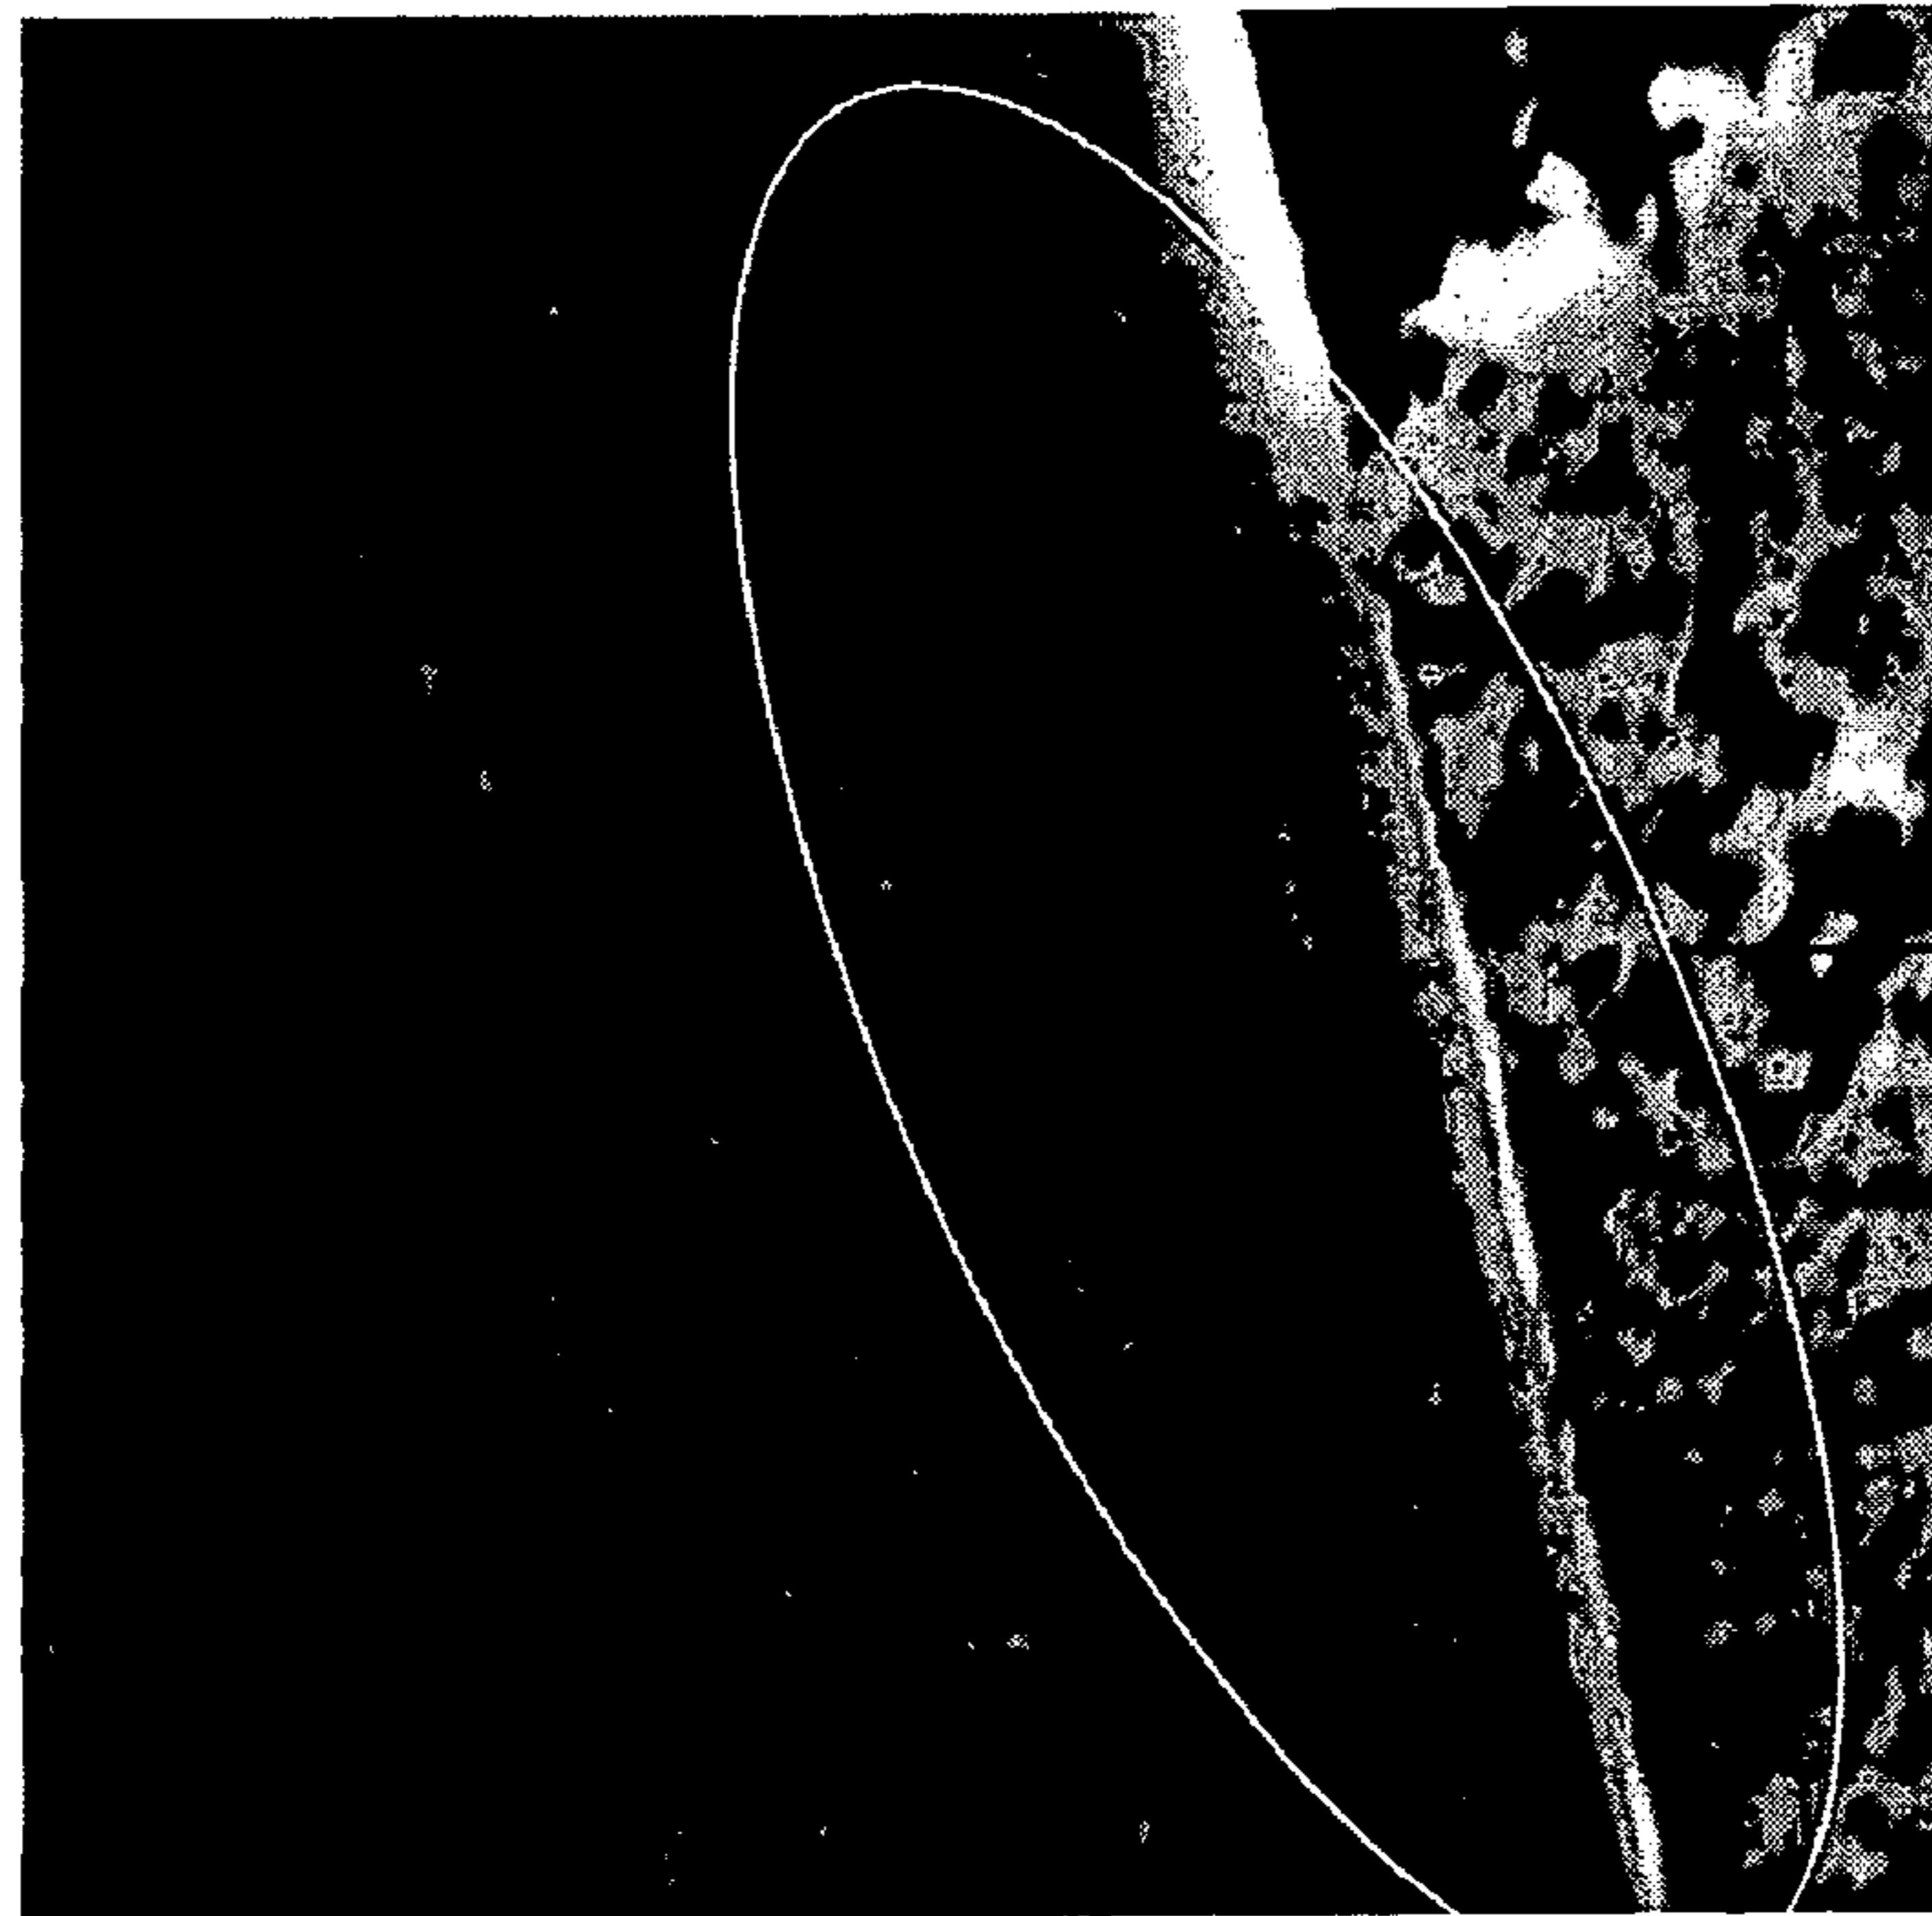
FIG. 5A

In FIGS. 5A, and 5B, temperature profiles, taken when moisture is allowed to evaporate shows anomalies as dark spots 21 and 23 under the vinyl siding. This moisture is not visible to the human eye. These anomalies 21 and 23 are indicative of the presence of moisture under the vinyl siding.

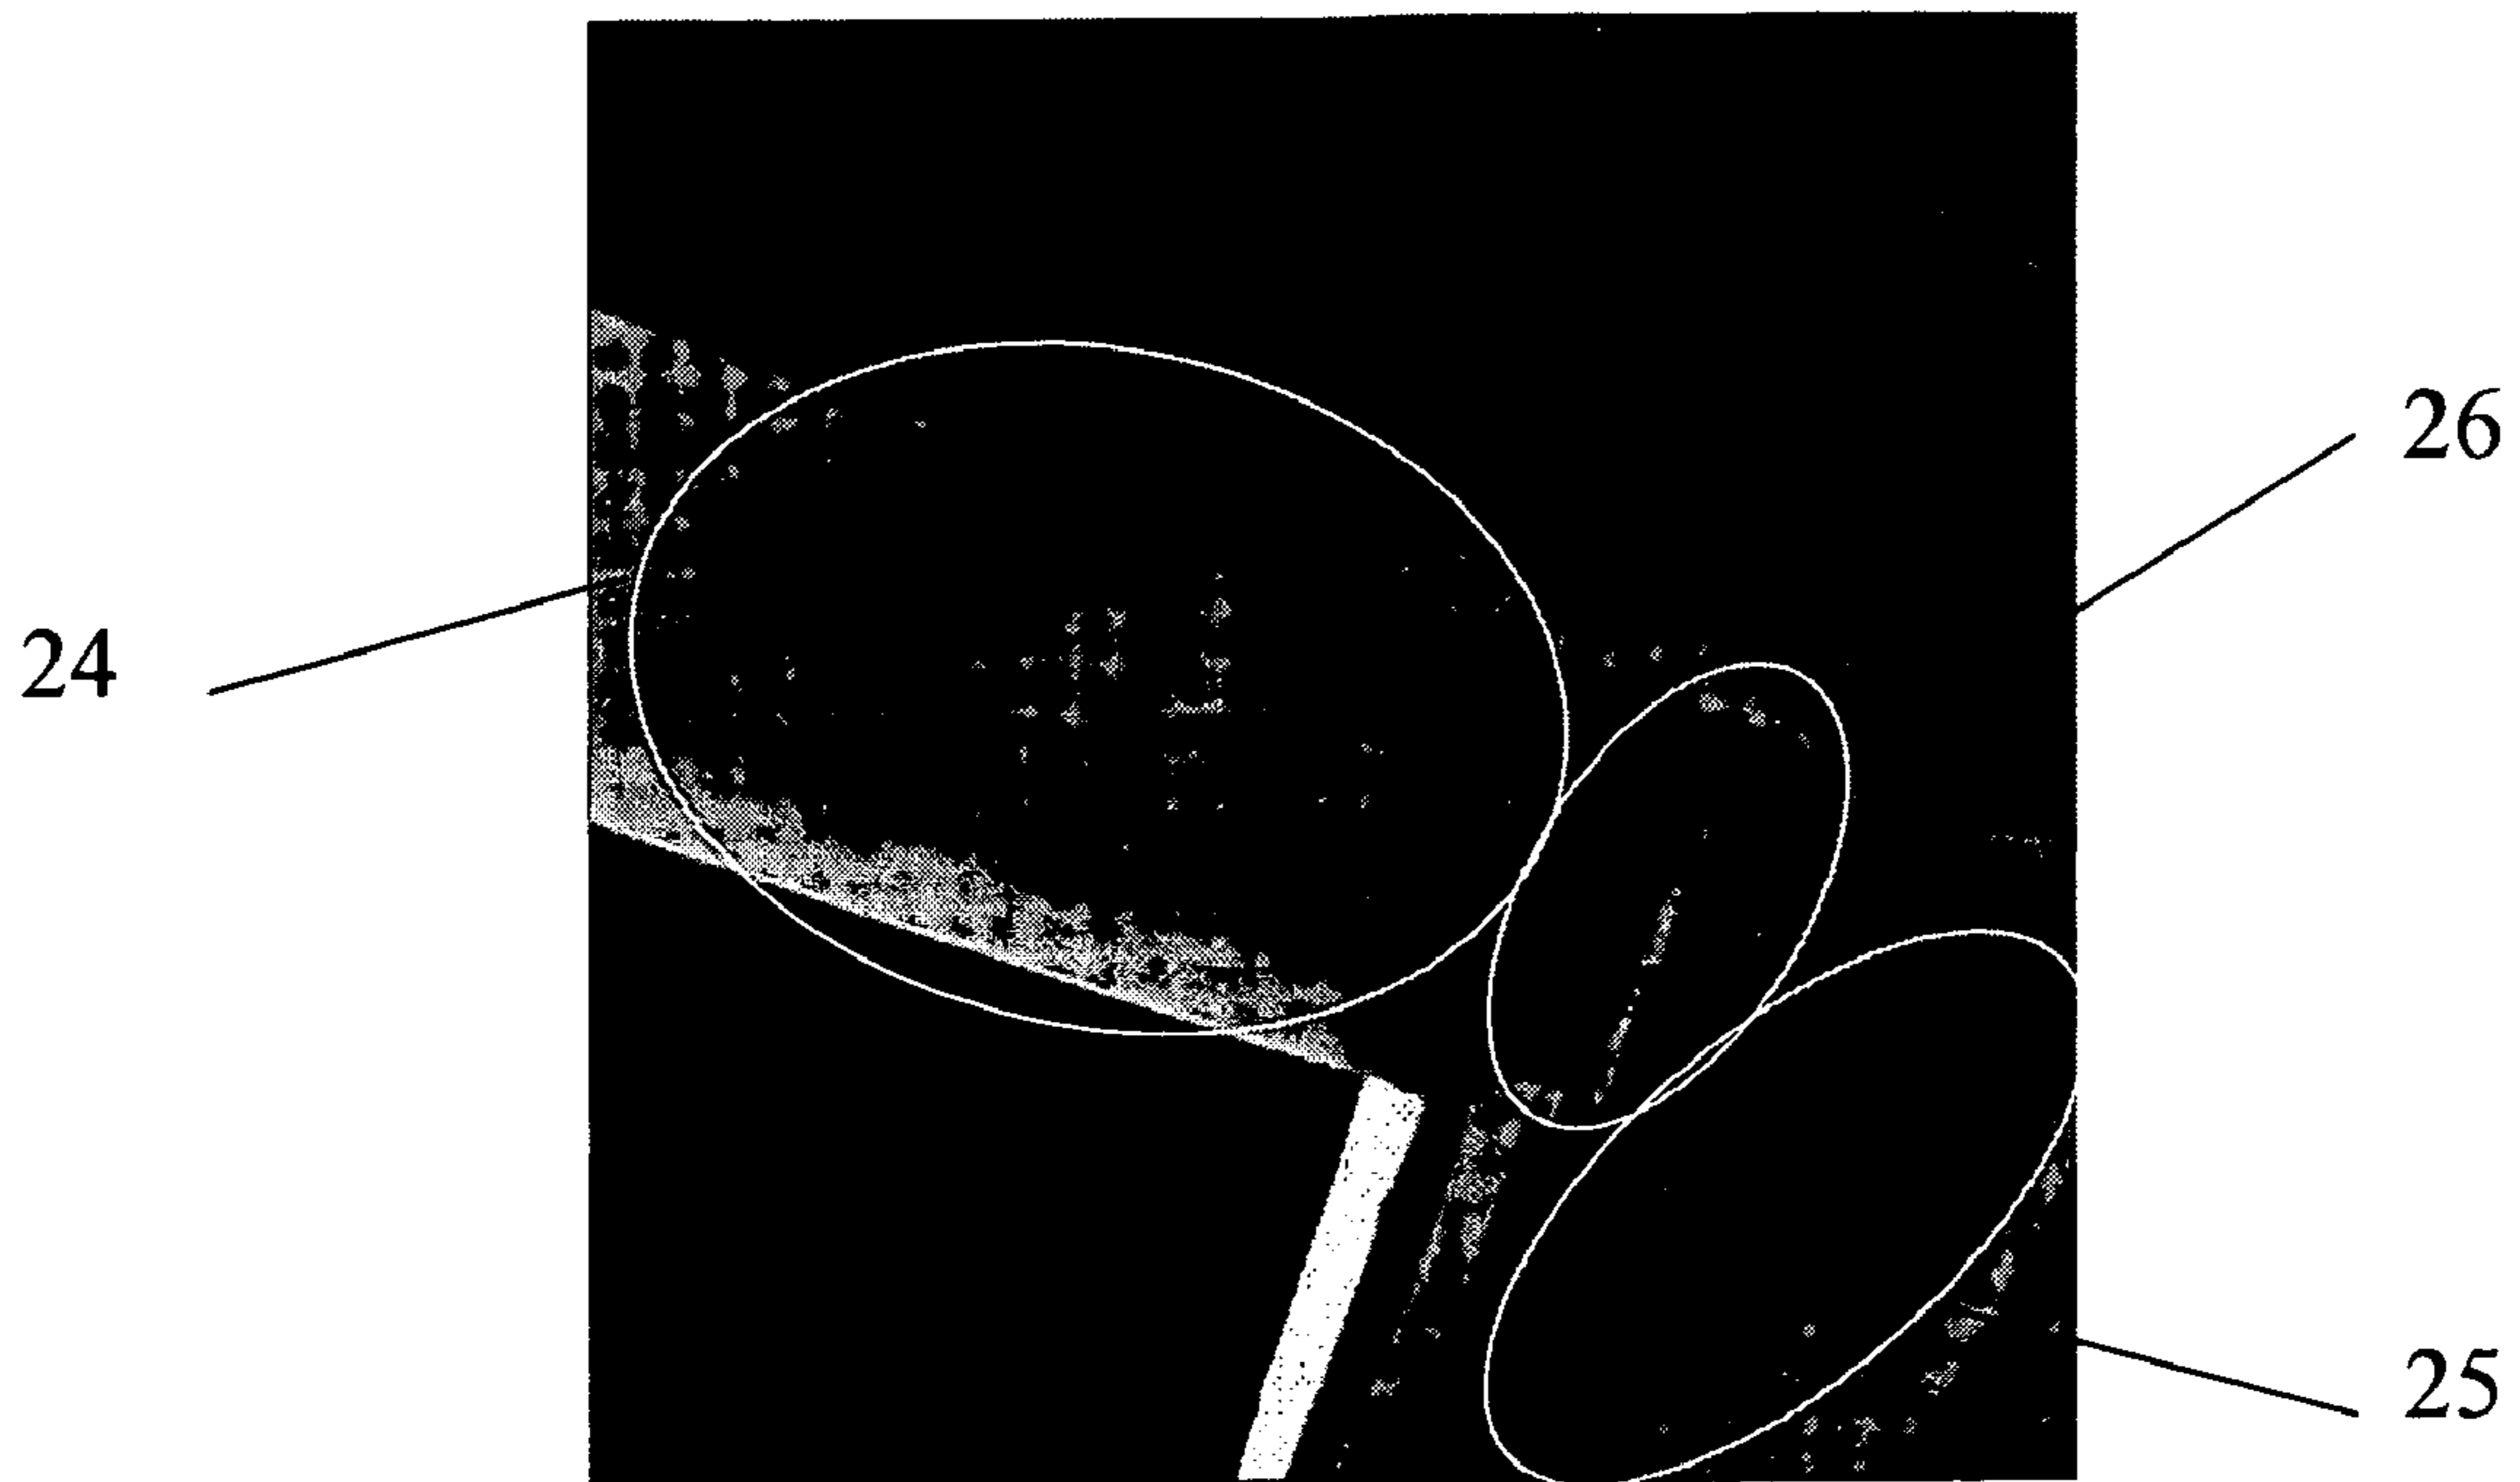
FIG. 6

Now referring to FIG. 6, a temperature profile, taken in the morning after sunrise of an eave shows a number of anomalies. Anomaly 24 and 25 are indicative of current structural deformations due to past infiltration of water (dried) and anomaly 26 is indicative of the presence of moisture.

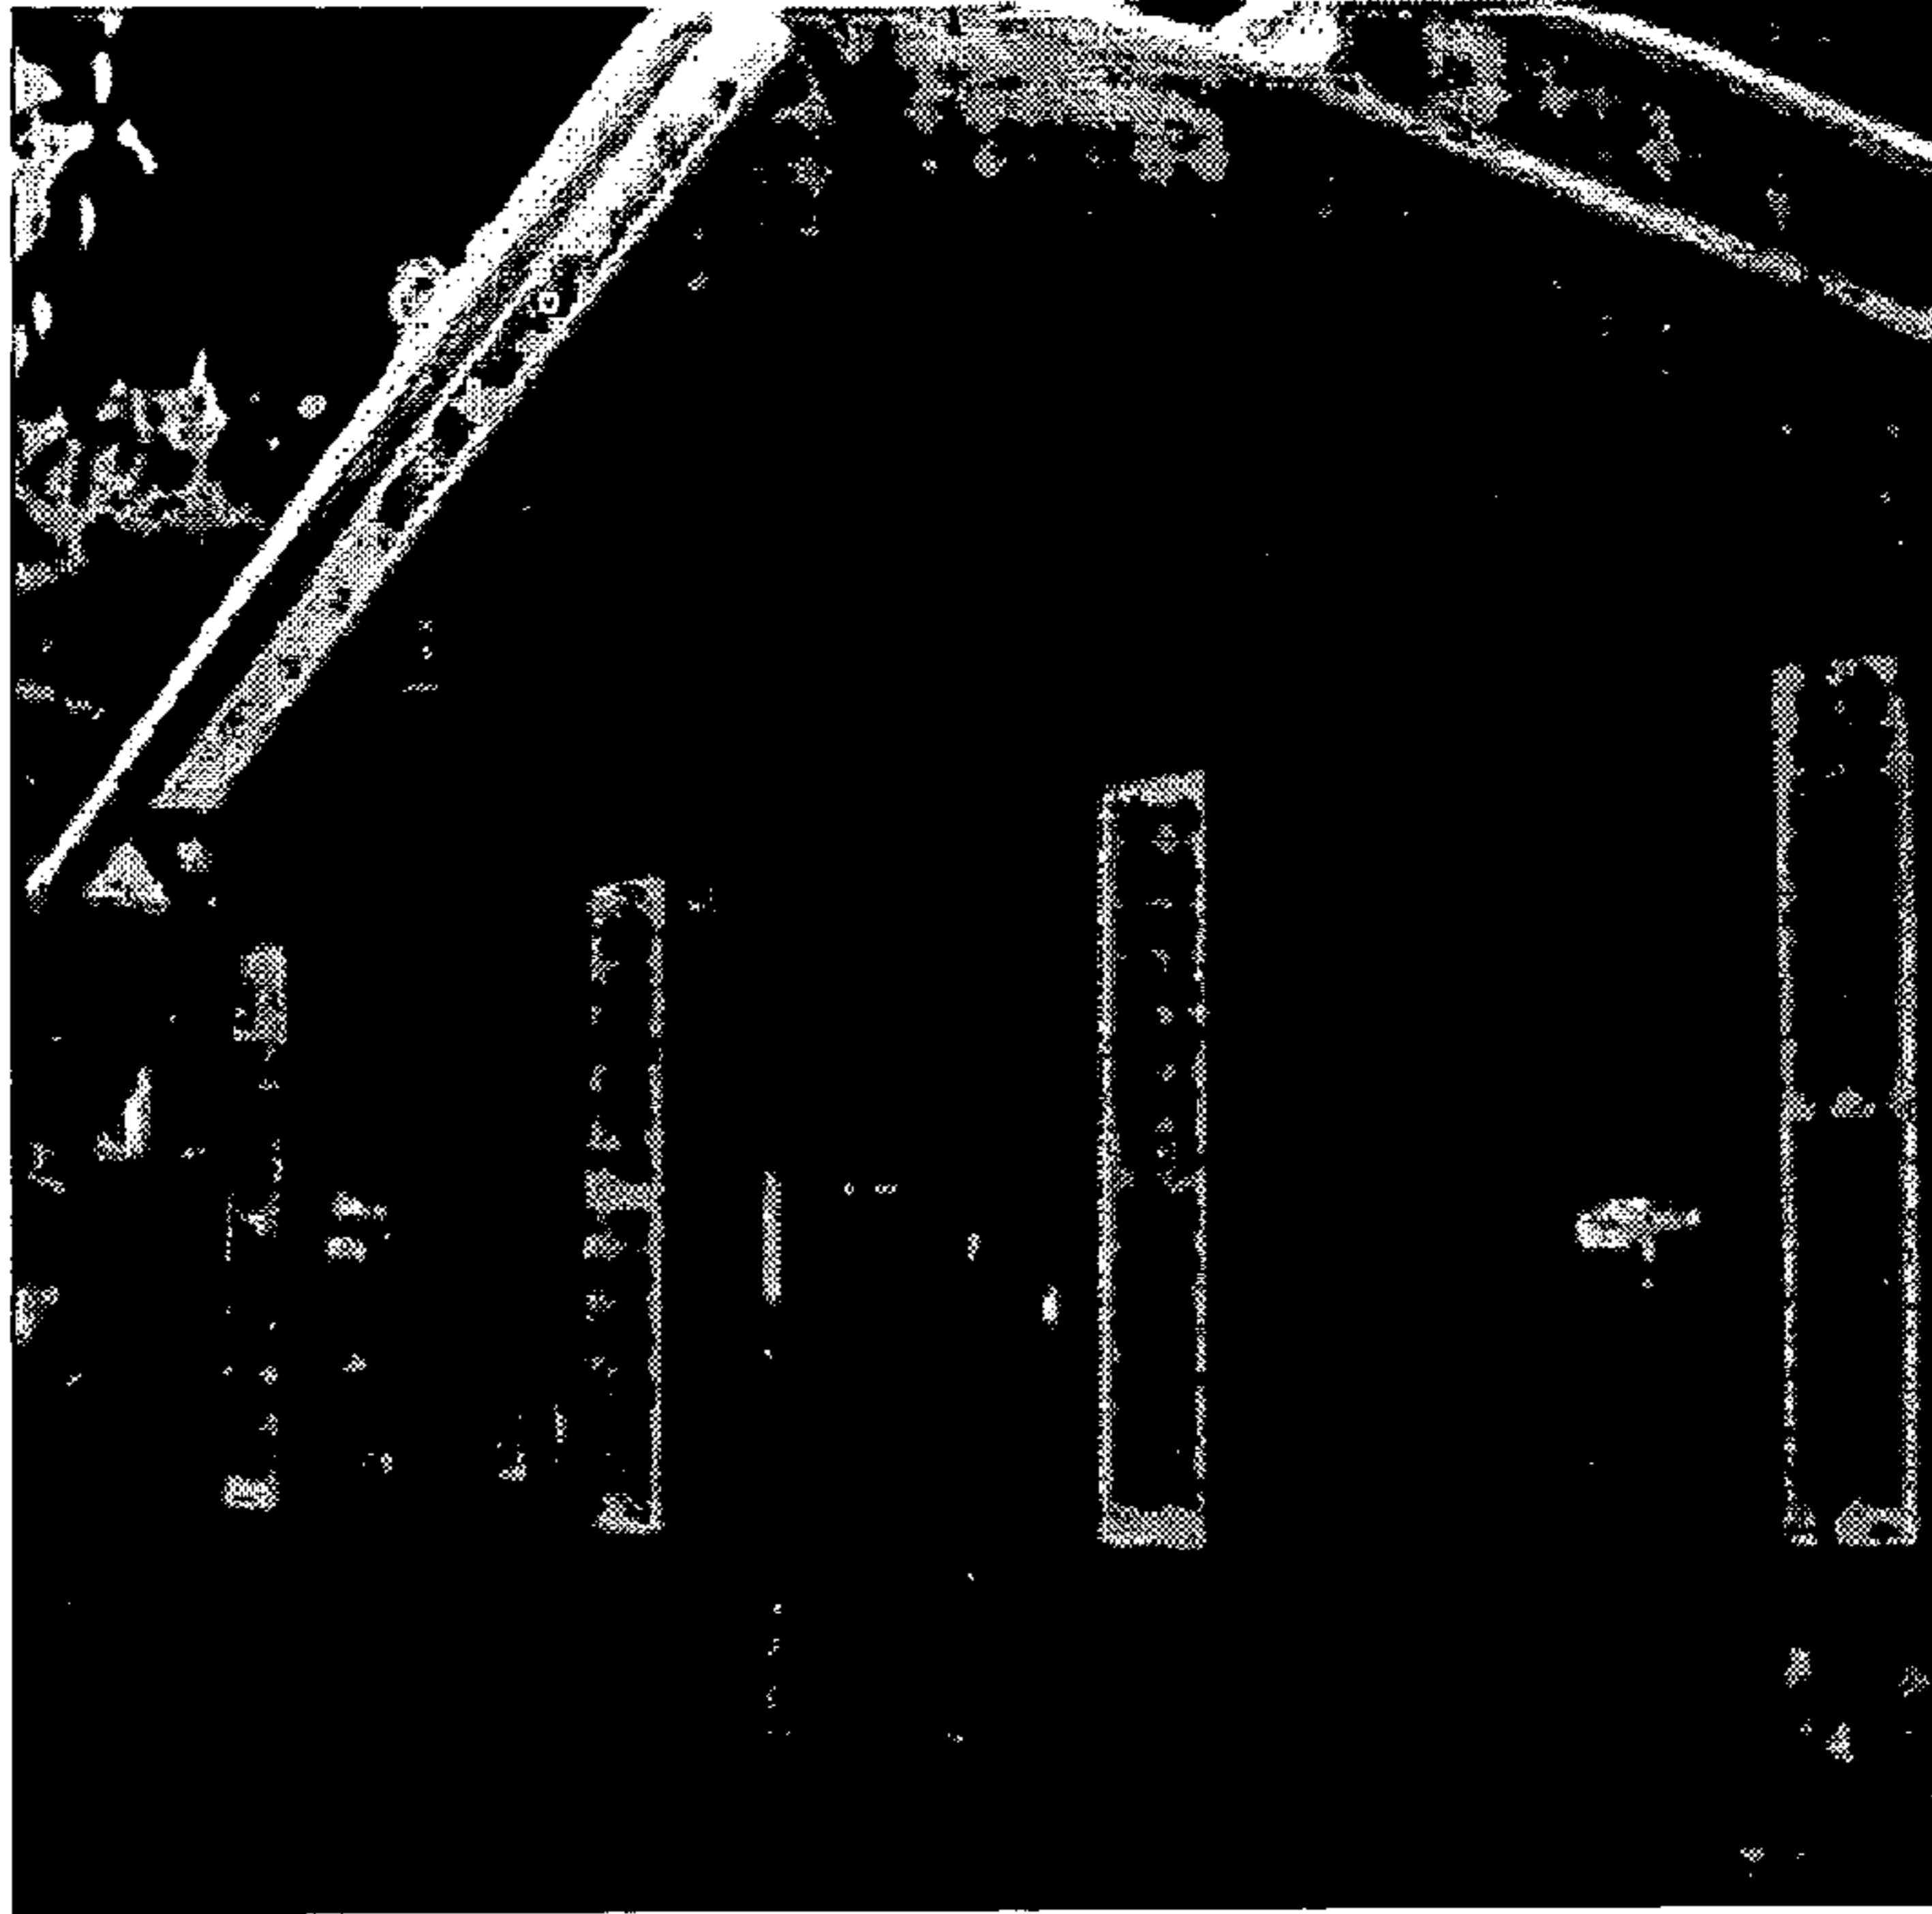
FIG. 8

FIGS. 8 and 9 show temperature profile taken at noon. In FIG. 8, no thermal anomalies are present, while in FIG. 9, a thermal anomaly 28 shows a cracked brick wall. This temperature profile shows as a thermal anomaly because moisture is in the crack in the wall.

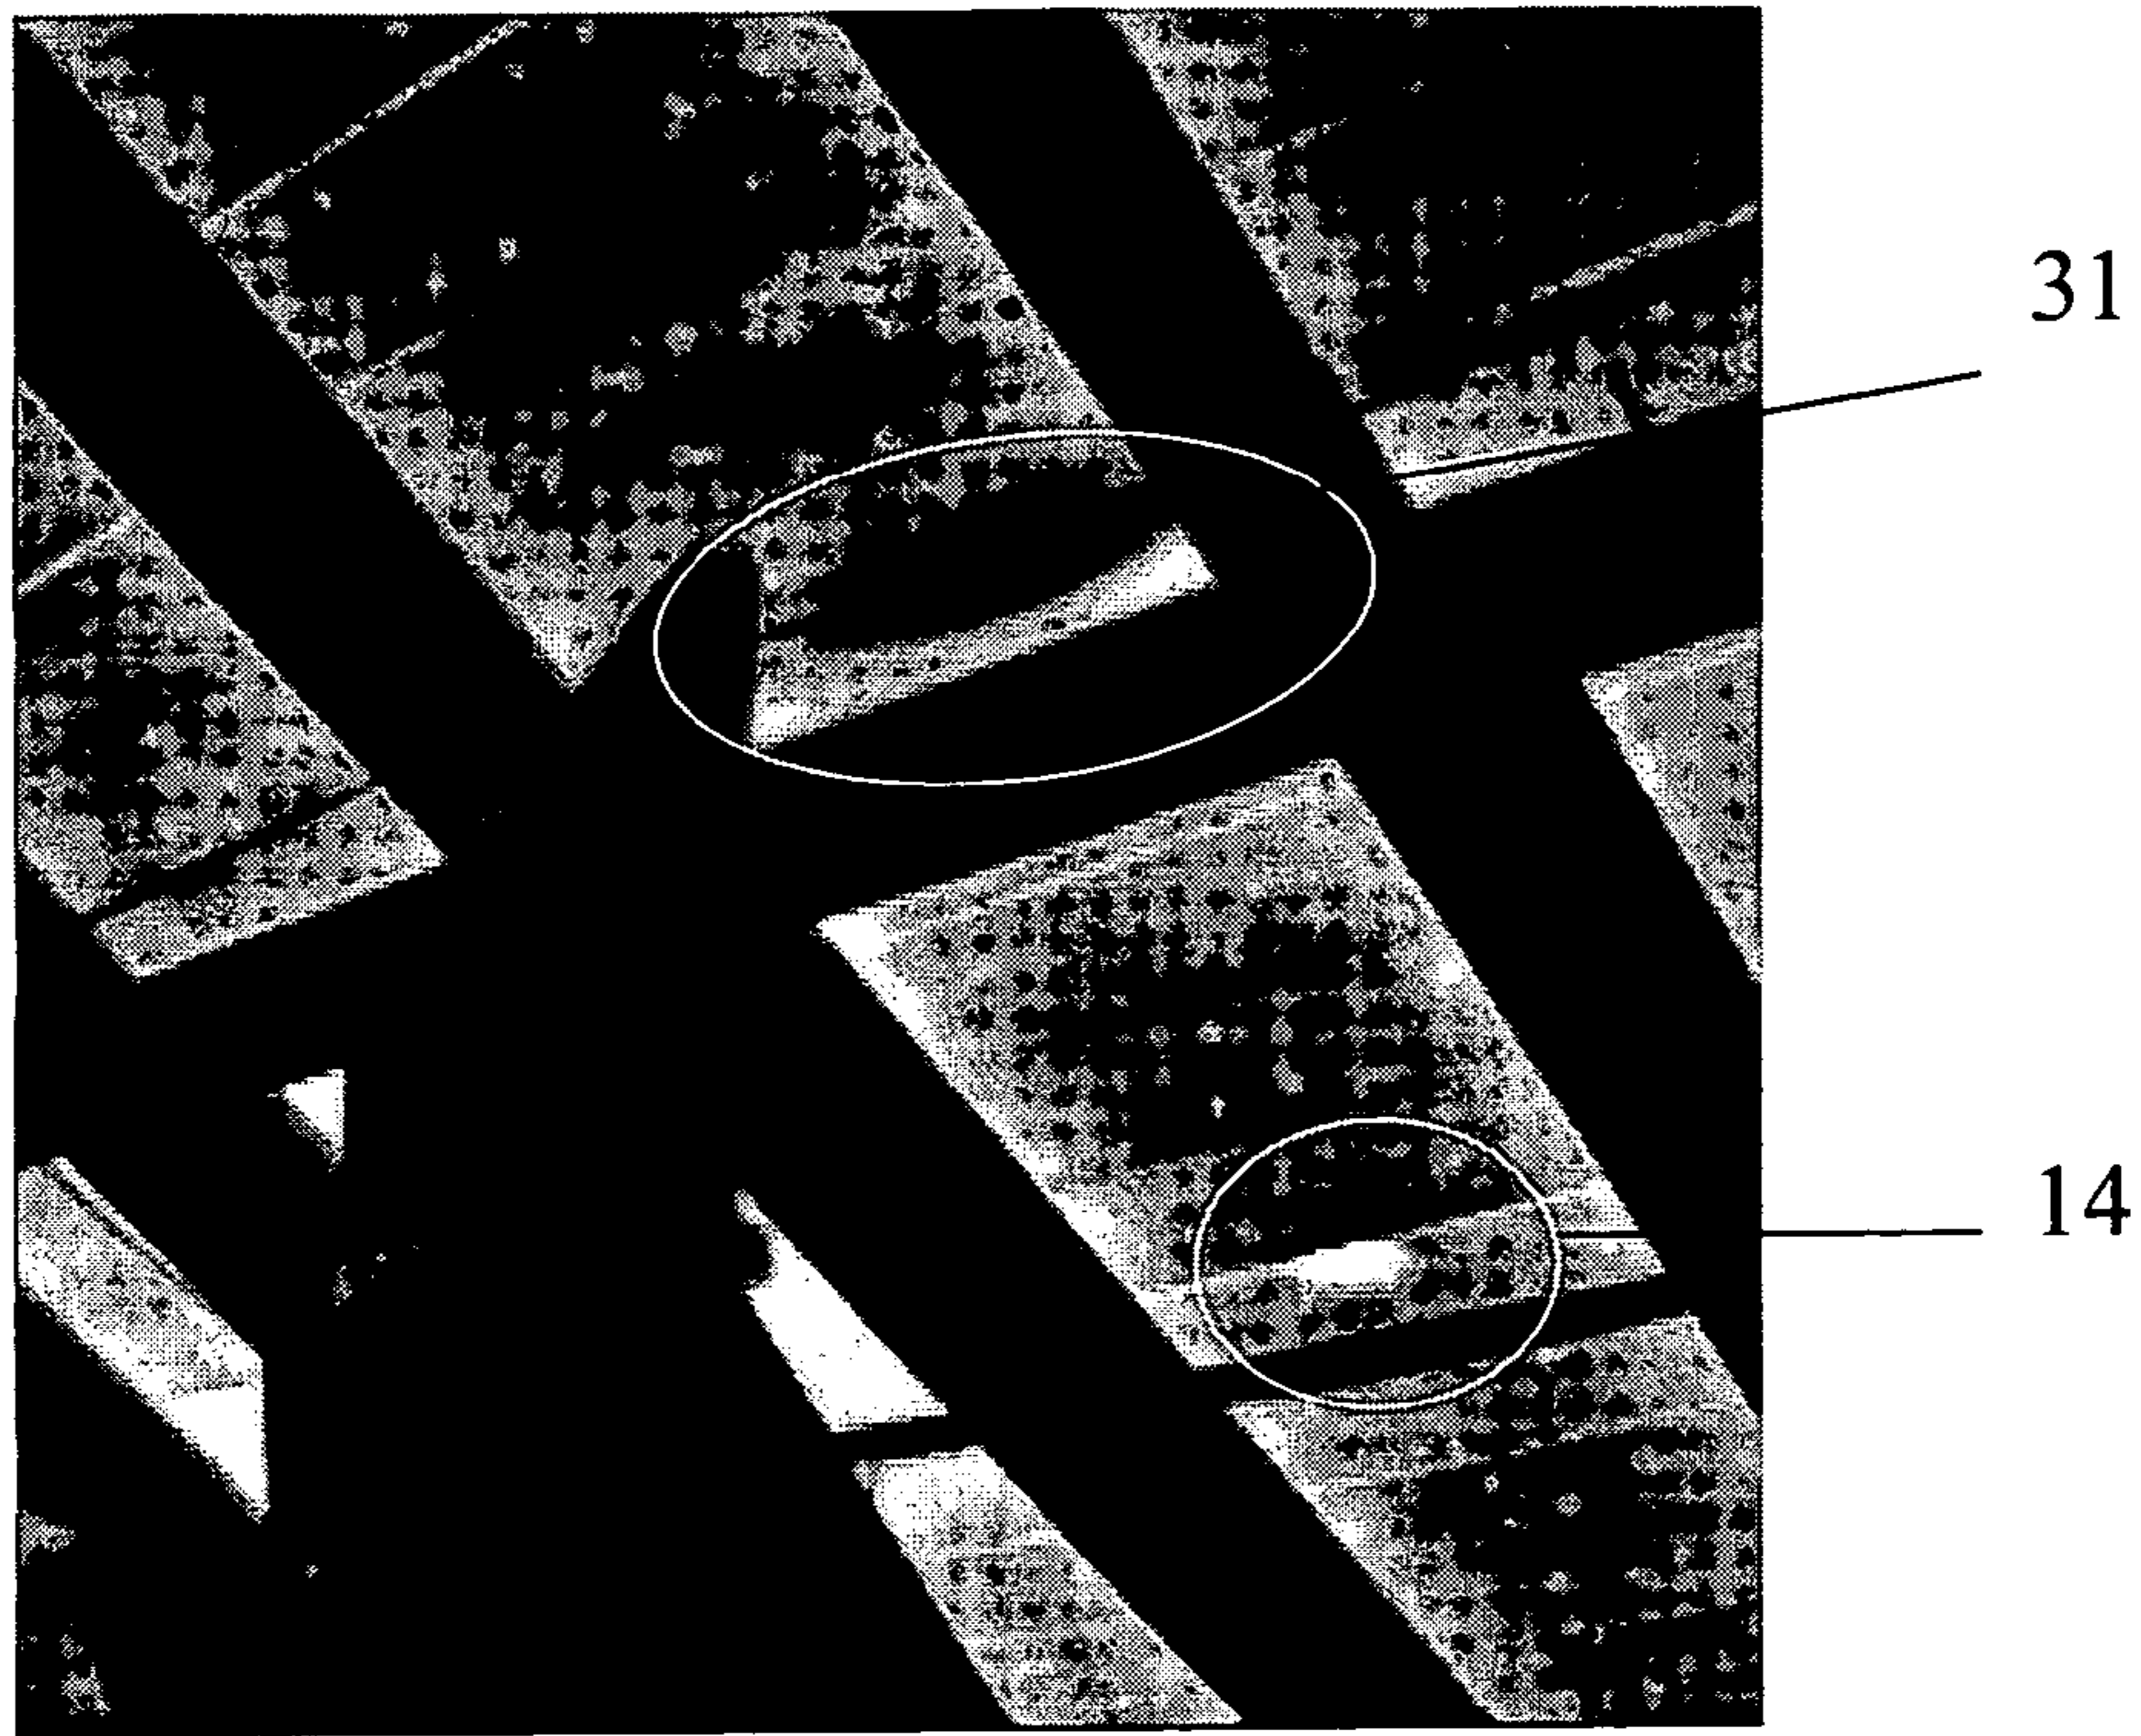
This invention can be applied to pitched roofs to inspect the condition of a residential roof. More specifically, in FIG. 10C the source of a leak can be traced by assessing the thermal anomaly 31. The leak can be followed from left to right to find the leak shown as the dark spot. Additionally, this method can also be used to detect structural deformation. The thermal anomaly shown as the white irregular spot 14 is indicative of a puncture in the roof decking material with the shingles covering over the puncture. This method can also be used to detect structural damage such as cracks. The temperature profile is recorded on a digital recording device 2.

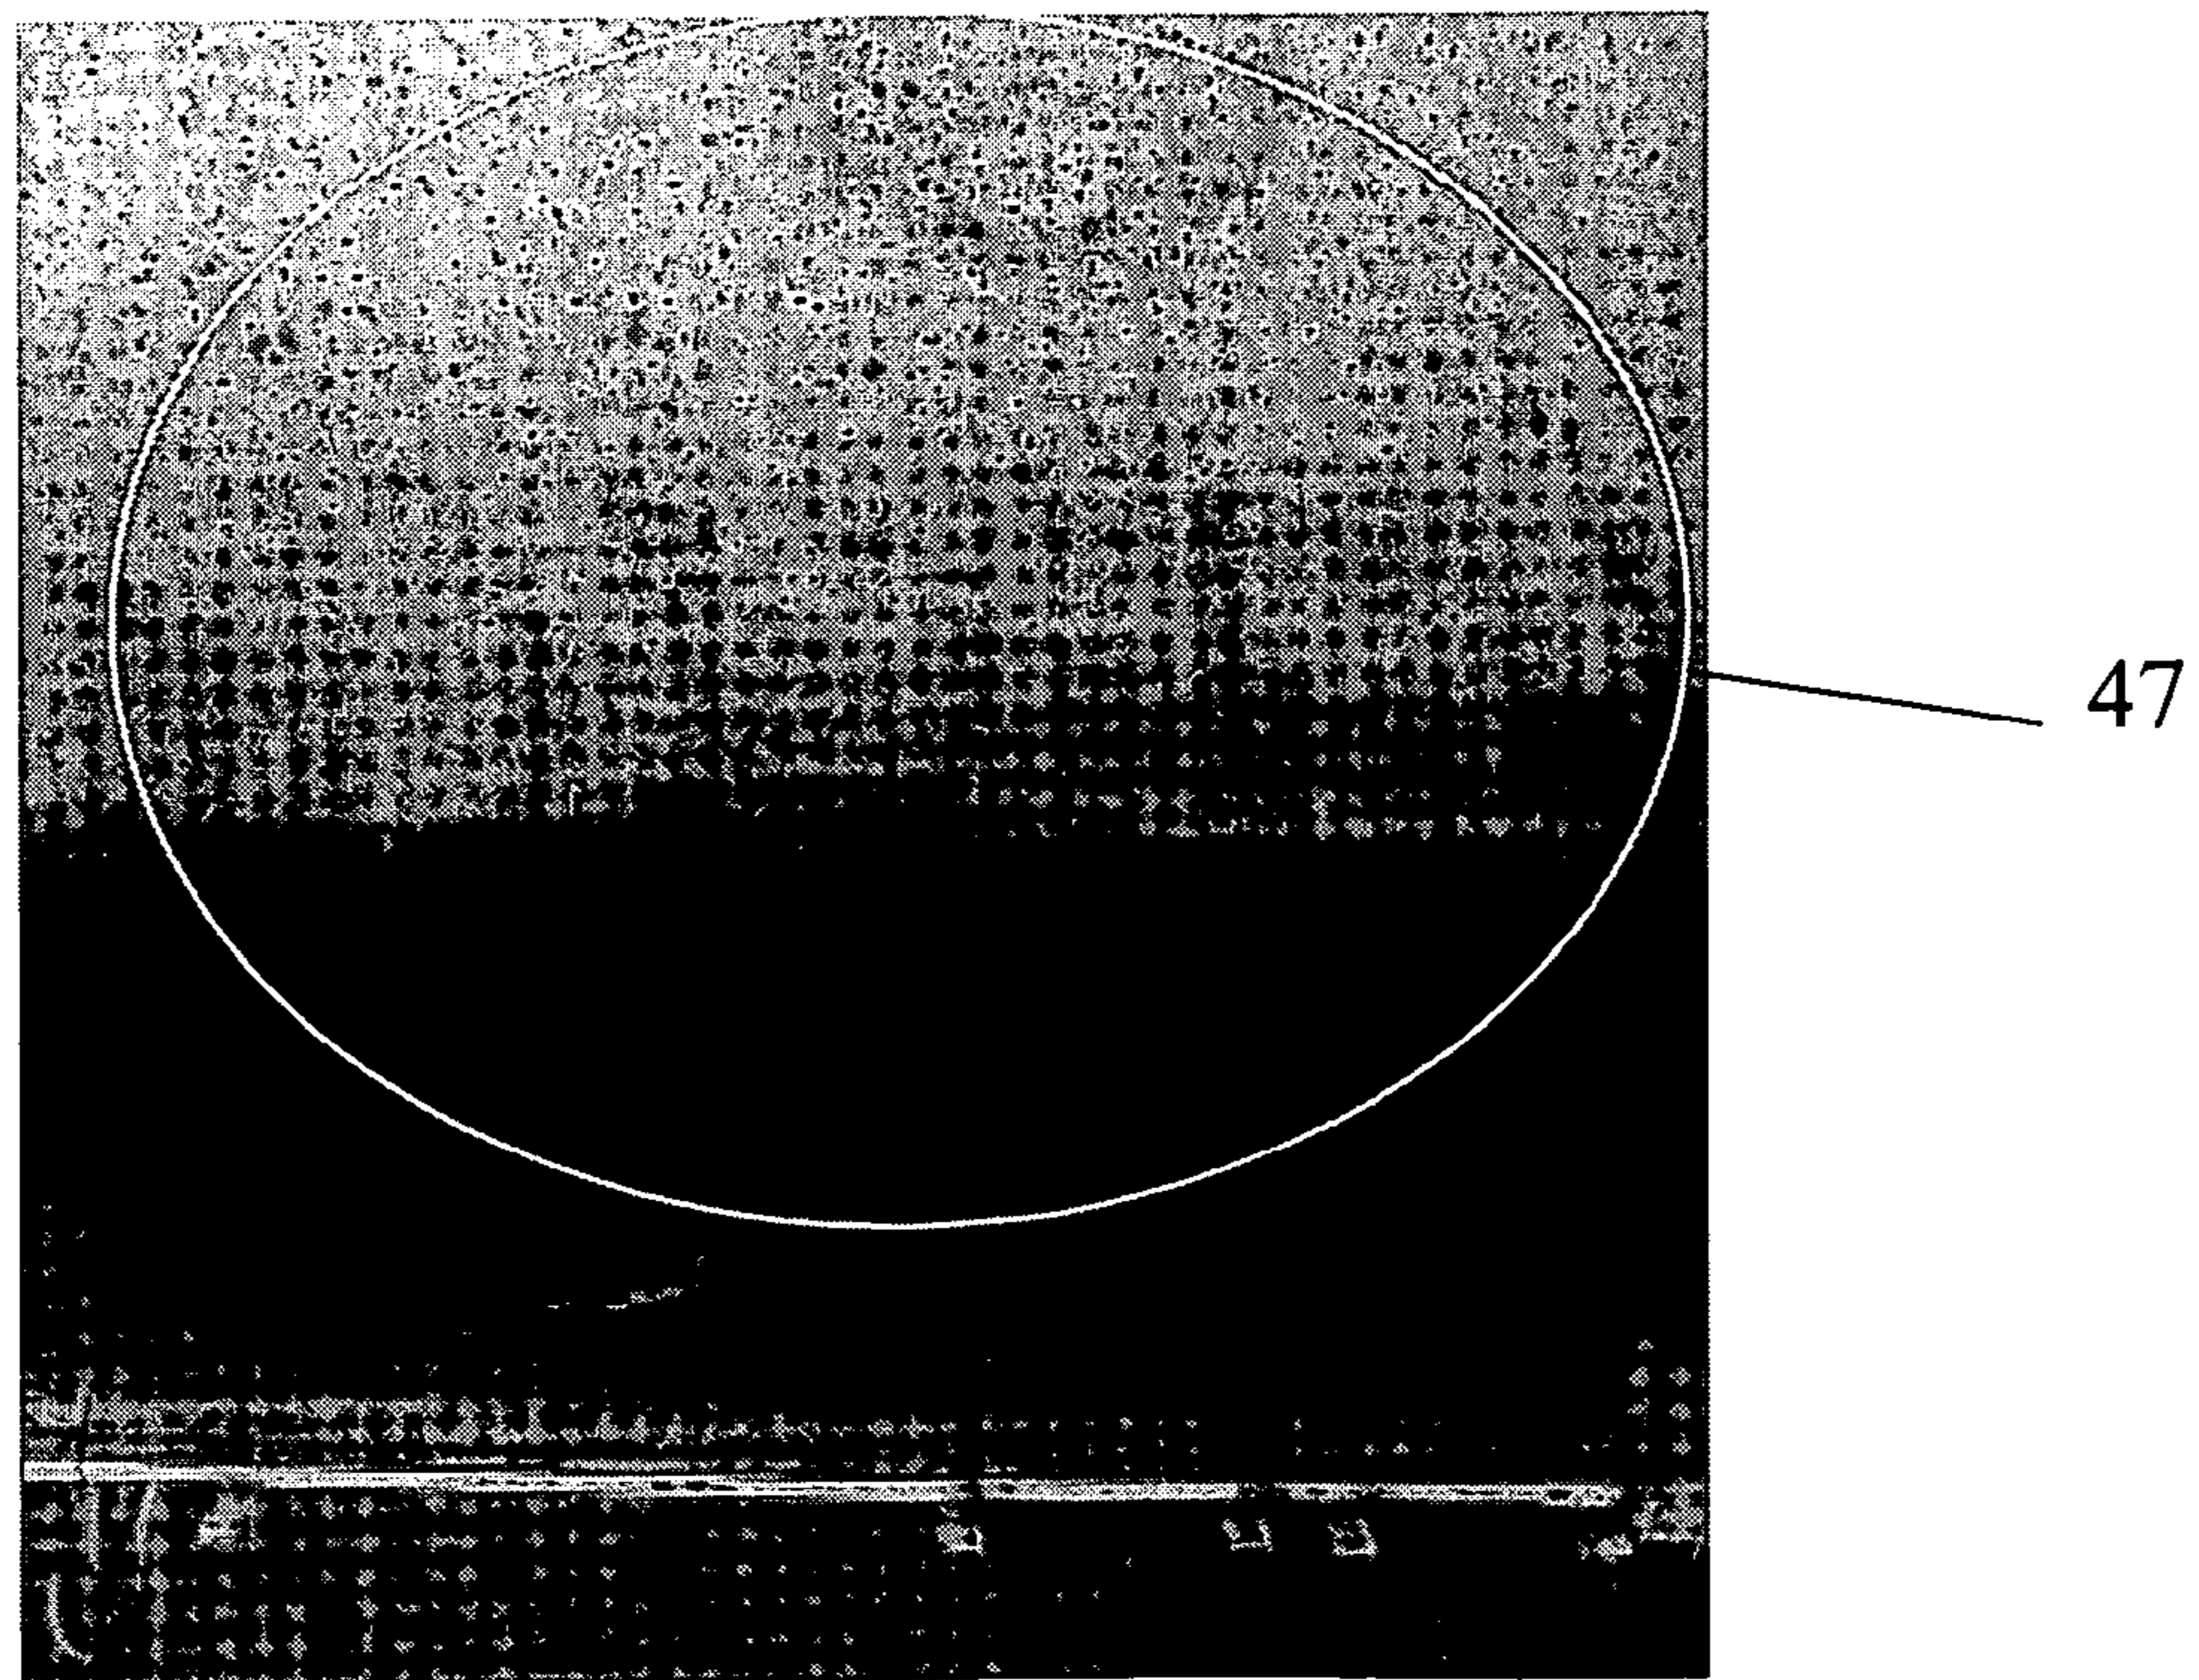
Condensation can also occur on interior ceiling surface as shown in FIGS. 21A and 21B. FIG. 21A was taken 4 feet away from the ceiling. The anomaly 47 is indicative of moisture on the ceiling. The temperature profile shown in FIG. 21B was taken 15 feet away from the same ceiling shown in FIG. 21A. The anomaly 48 is indicative of moisture in the ceiling.
