(10) **Patent No.:** **US 7,445,377 B2**  
(45) **Date of Patent:** **Nov. 4, 2008**

(54) **NONDESTRUCTIVE RESIDENTIAL INSPECTION METHOD AND APPARATUS**

(57) **ABSTRACT**

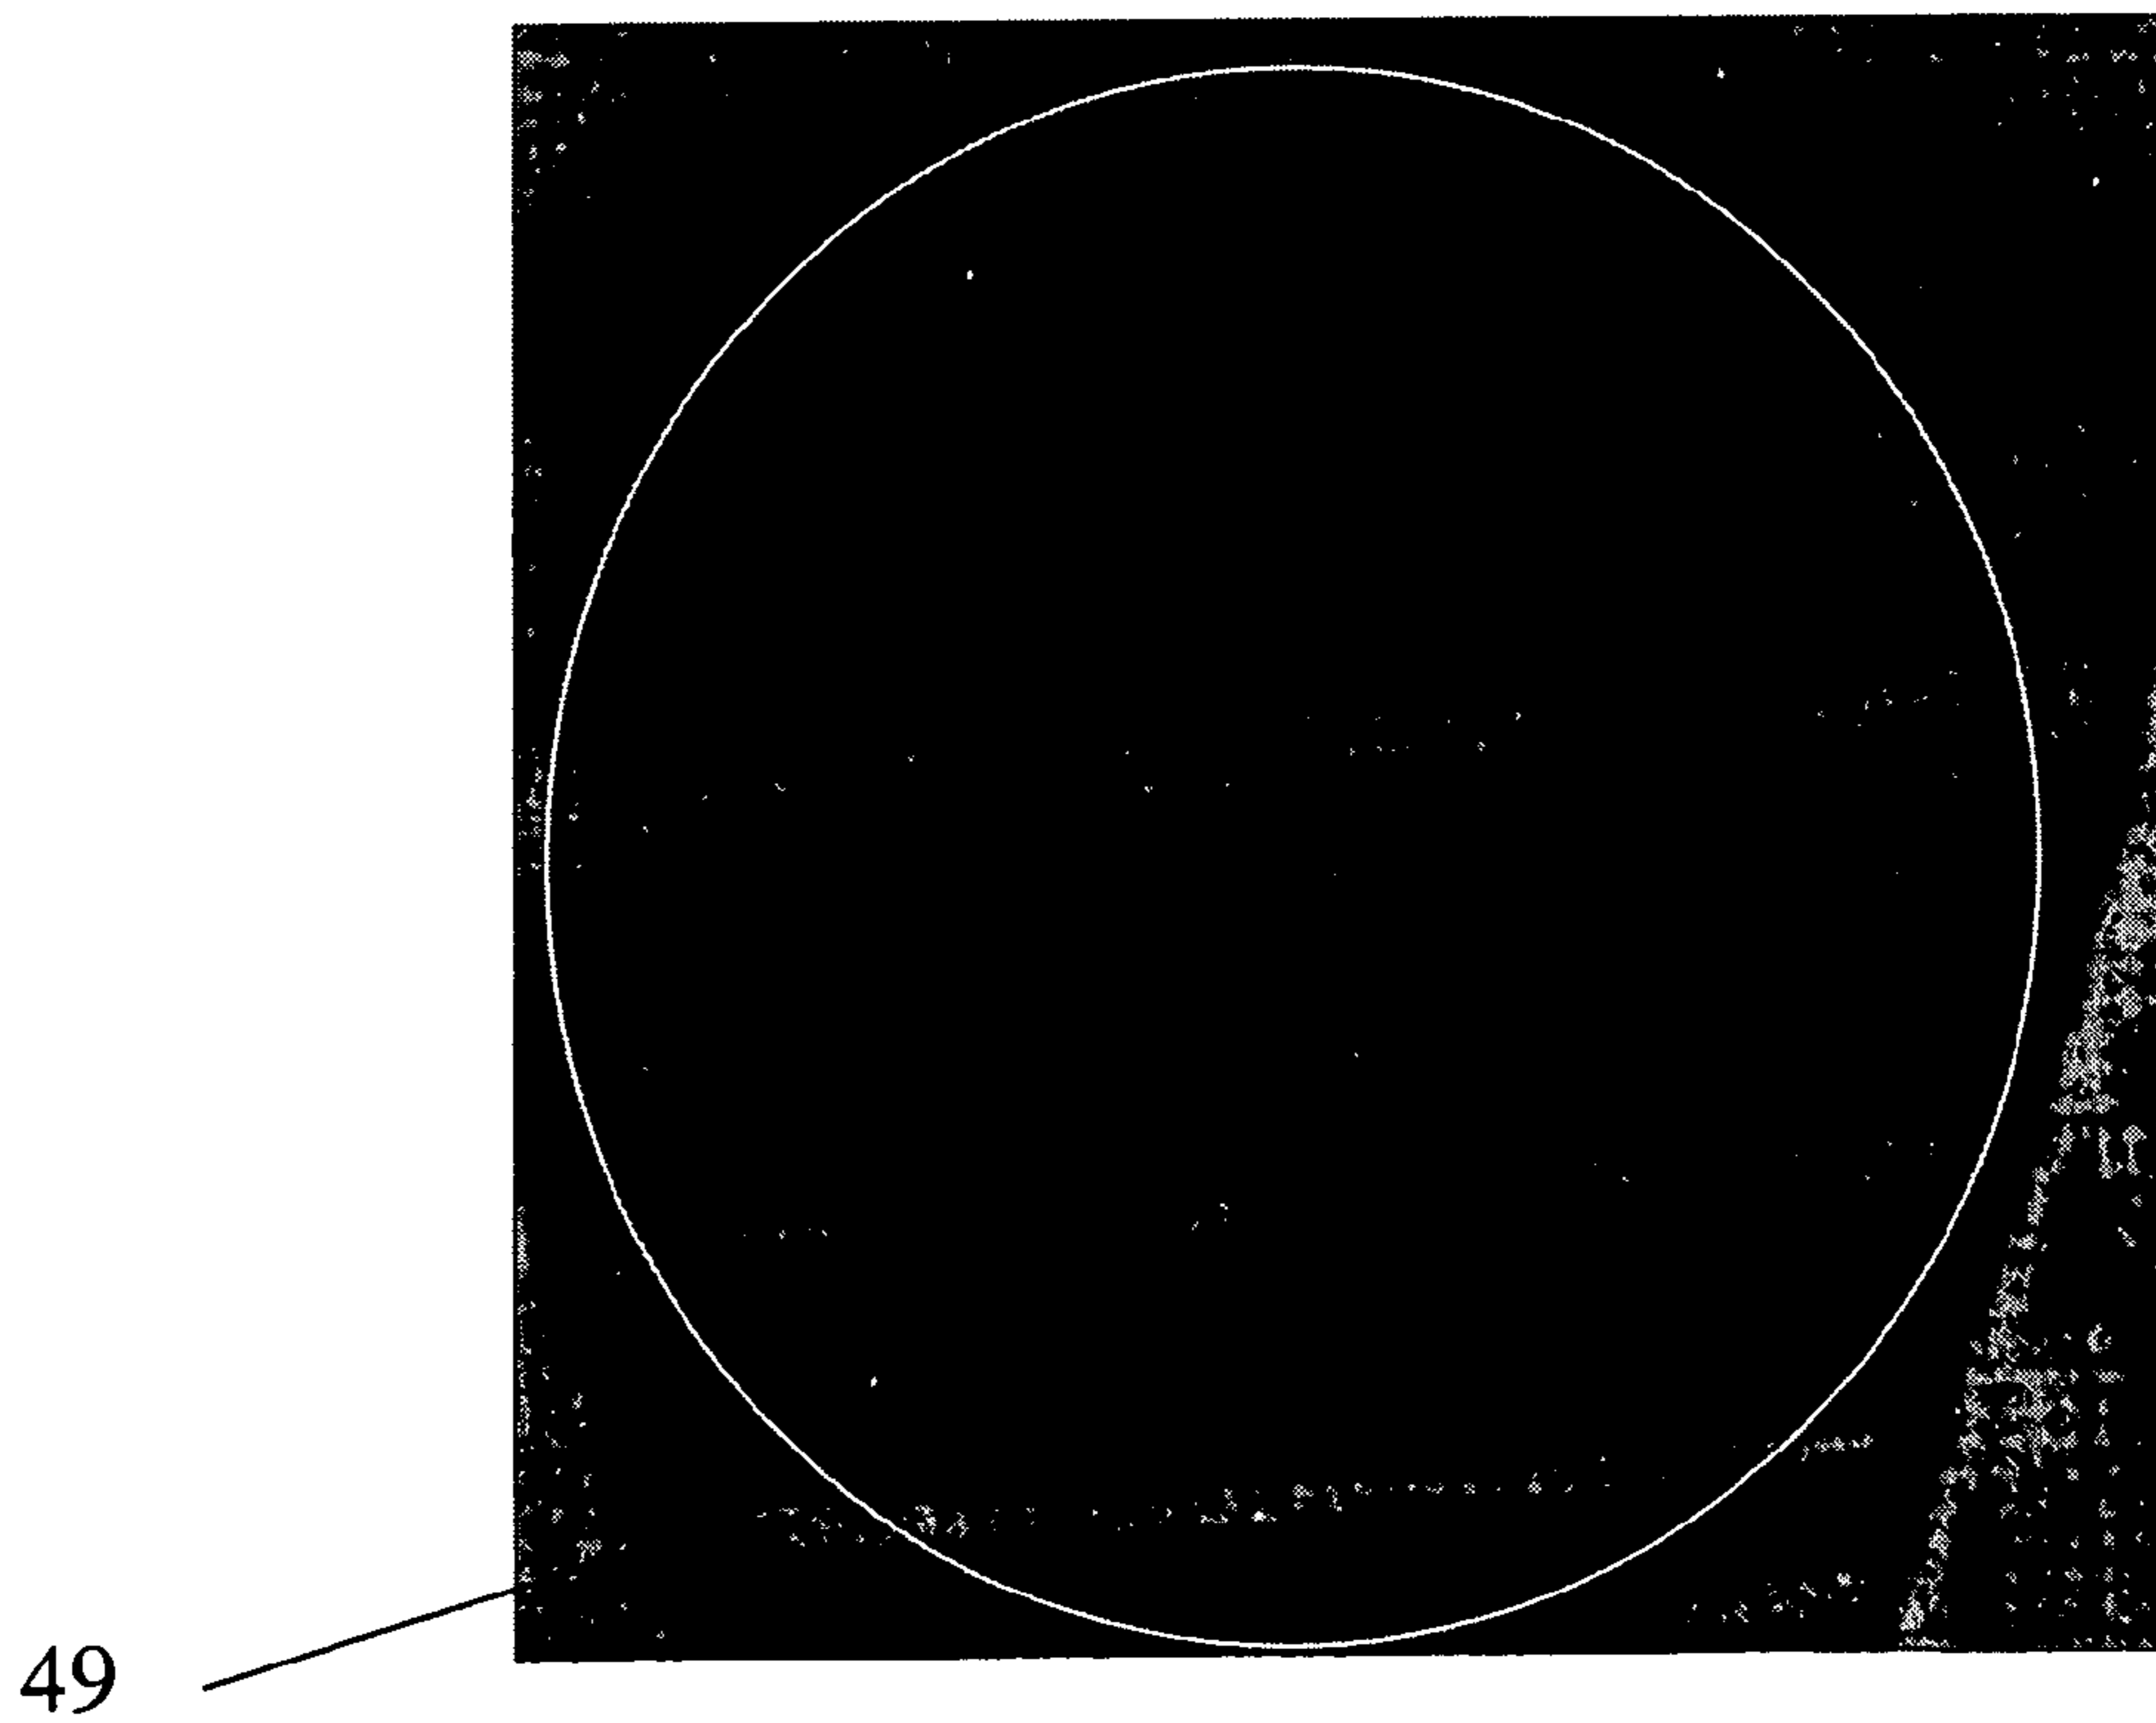
FIG. 21C

(4) Moisture in Air Duct—Additionally, FIGS. 21C and 21D show anomalies 49-51 which are indicative of moisture in an air duct. This happens most often when there is no insulation in that particular section of the ceiling due to poor workmanship or due to rodent activities plus the occupant of the house has the lifestyle of generating high level of moisture with inadequate ventilation during the winter season. The uninsulated ceiling is closer to the cold outdoor temperature. When the high level moisture indoor air comes in contact with the cold interior ceiling surface (the hotter the air, the higher it rises and more moisture it can hold), it will cook and condense. These types of condensation problems were often mistaken as roof leaks. This happens when there is insufficient insulation around the air duct and poor workmanship or aging insulation. Condensation accumulates in cold air (in summer) eventually dripping into the ceiling under the duct.

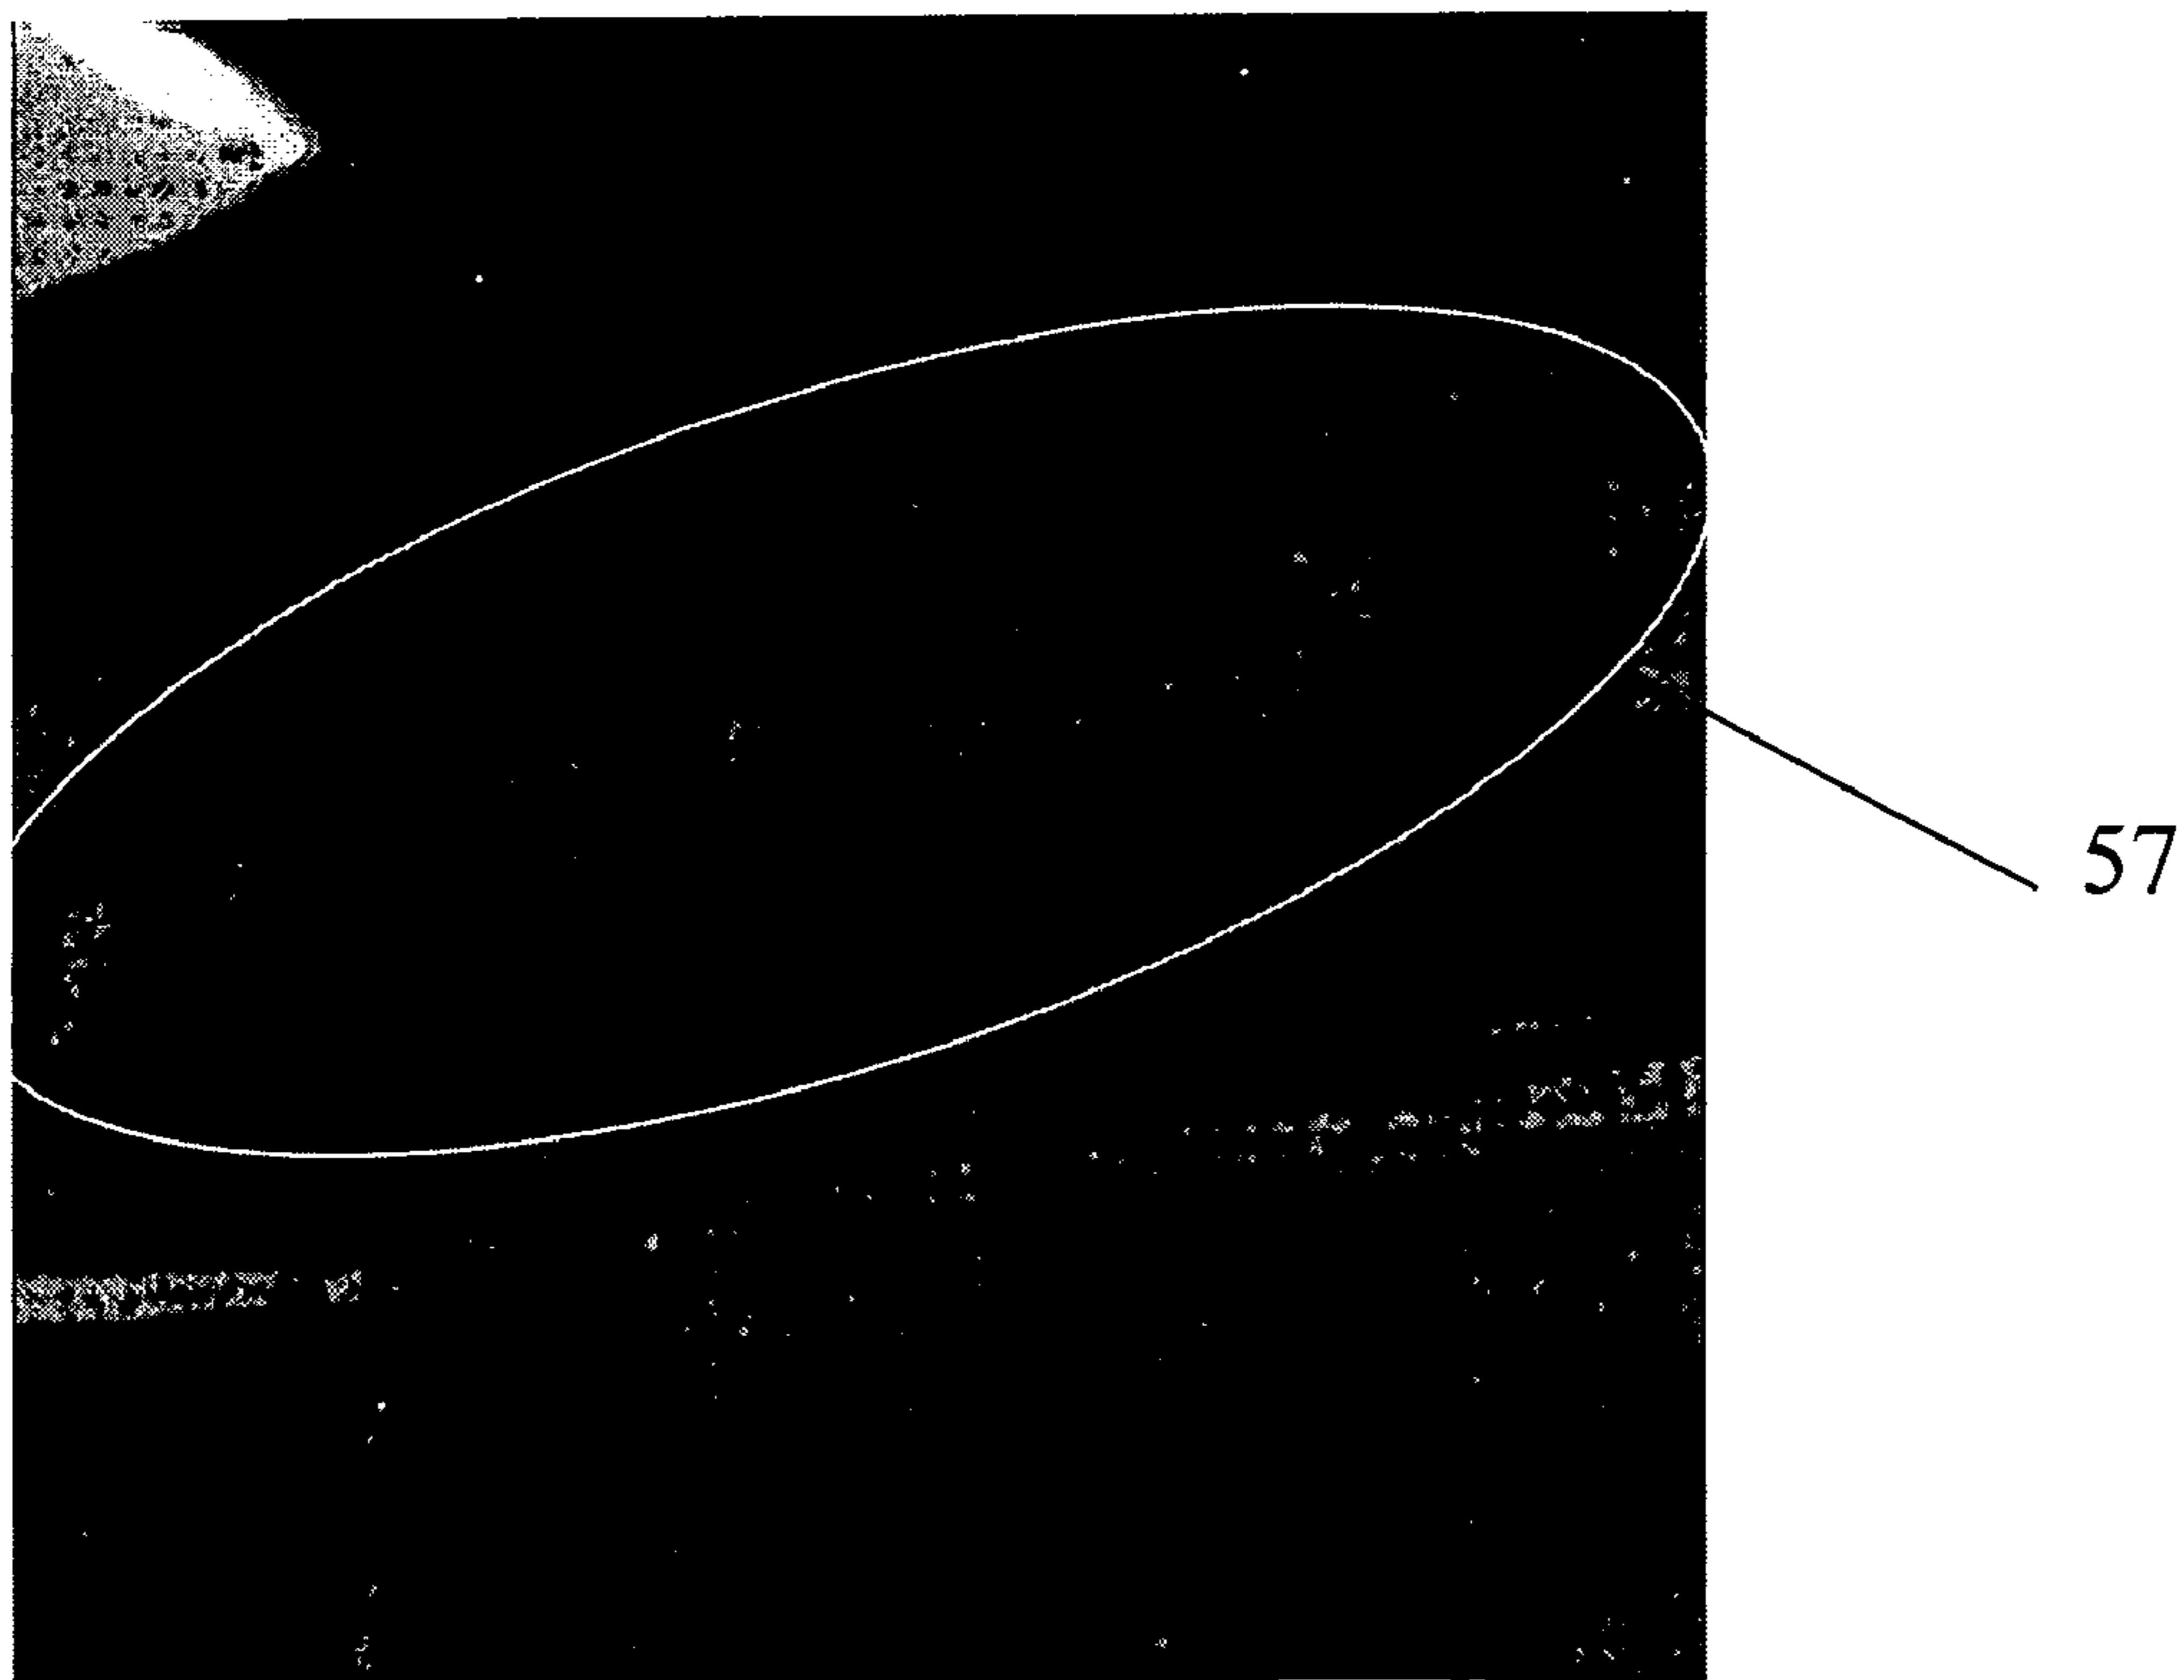
FIG. 28

(9) Air Duct Leakage—FIGS. 28 and 29 show a temperature profile indicative of air duct leakage. In these temperature profiles, the anomalies 57-59 are indicative of air leaking out of an air duct. The black is cold air leakage in the summer (in the winter it would be opposite).
