US 7,527,577 B2

(54) AUTOMATIC TRANSMISSION AND GEAR TRAIN

(57) ABSTRACT

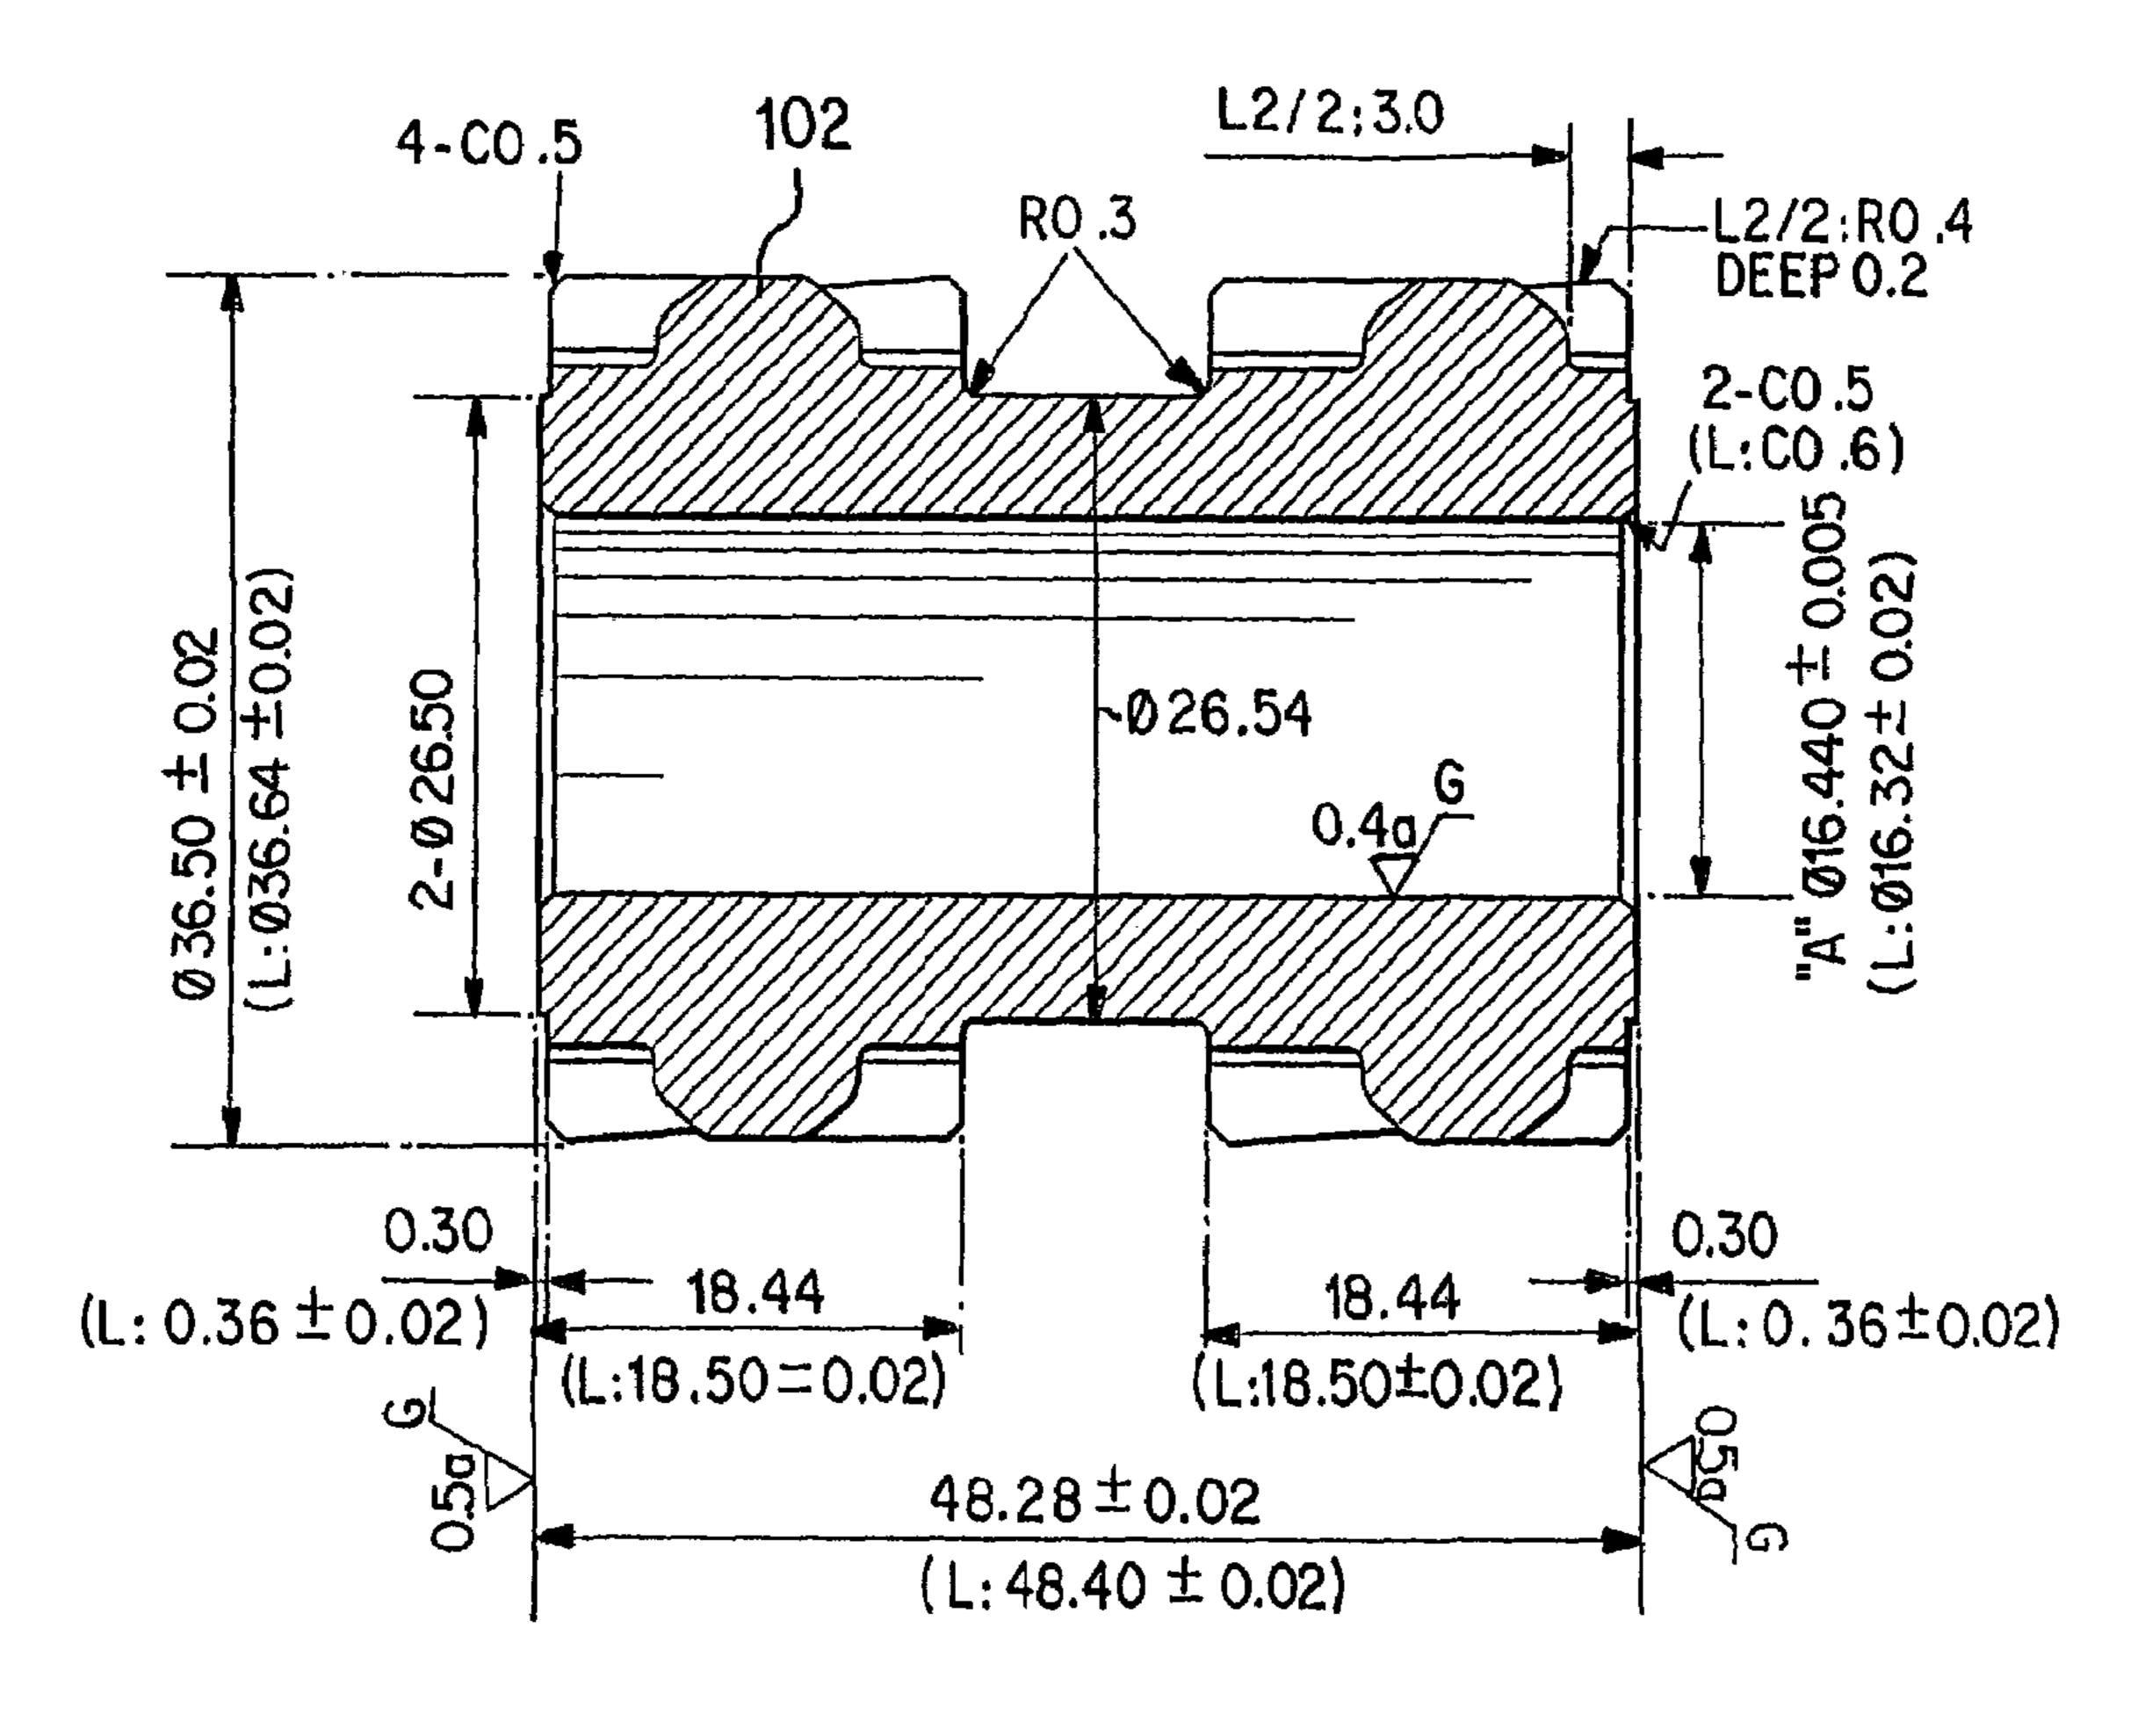
Fig. 1b

EXTERNAL INVOLUTE SPLINE DATA		
NUMBER OF TEETH	20	
NORMAL DIAMETRAL PITCH	17	
NORMAL PRESSURE ANGLE	18°	
HELIX ANGLE	18.08°	
HAND	RIGHT	
STANDARD PITCH DIAMETER	Ø 31.435	
MAJOR DIAMETER	Ø 36.50 ± 0.02	
MINOR DIAMETER	Ø 28.80 ± 0.05	
DIAMETER OF MEASURING PIN	Ø 3.0	
MEASUREMENT OVER 2 PINS	37.576 ± 0.035	
NORMAL CIRCULAR TOOTH THICKNESS	2.890 ± 0.018	
NORMAL TIP RADIUS	0.25	
NORMAL FILLET RADIUS	FULL	
TOTAL COMPOSITE TOLERANCE	0.038	
TOOTH TO TOOTH TOLERANCE	0.019	
MASTER GEAR NUMBER OF TEETH	40	
MASTER GEAR NORM. CIRC TOOTH THICKNESS	2.3470	
TEST RADIUS	16.862 ± 0.054	
CROWNING	0.03

FIGS. 1*a*-1*b* illustrate a compound pinion gear, with FIG. 1*a* showing the gear in perspective, FIG. 1*b* showing the gear in cross section, and FIG. 1*c* showing parameters.

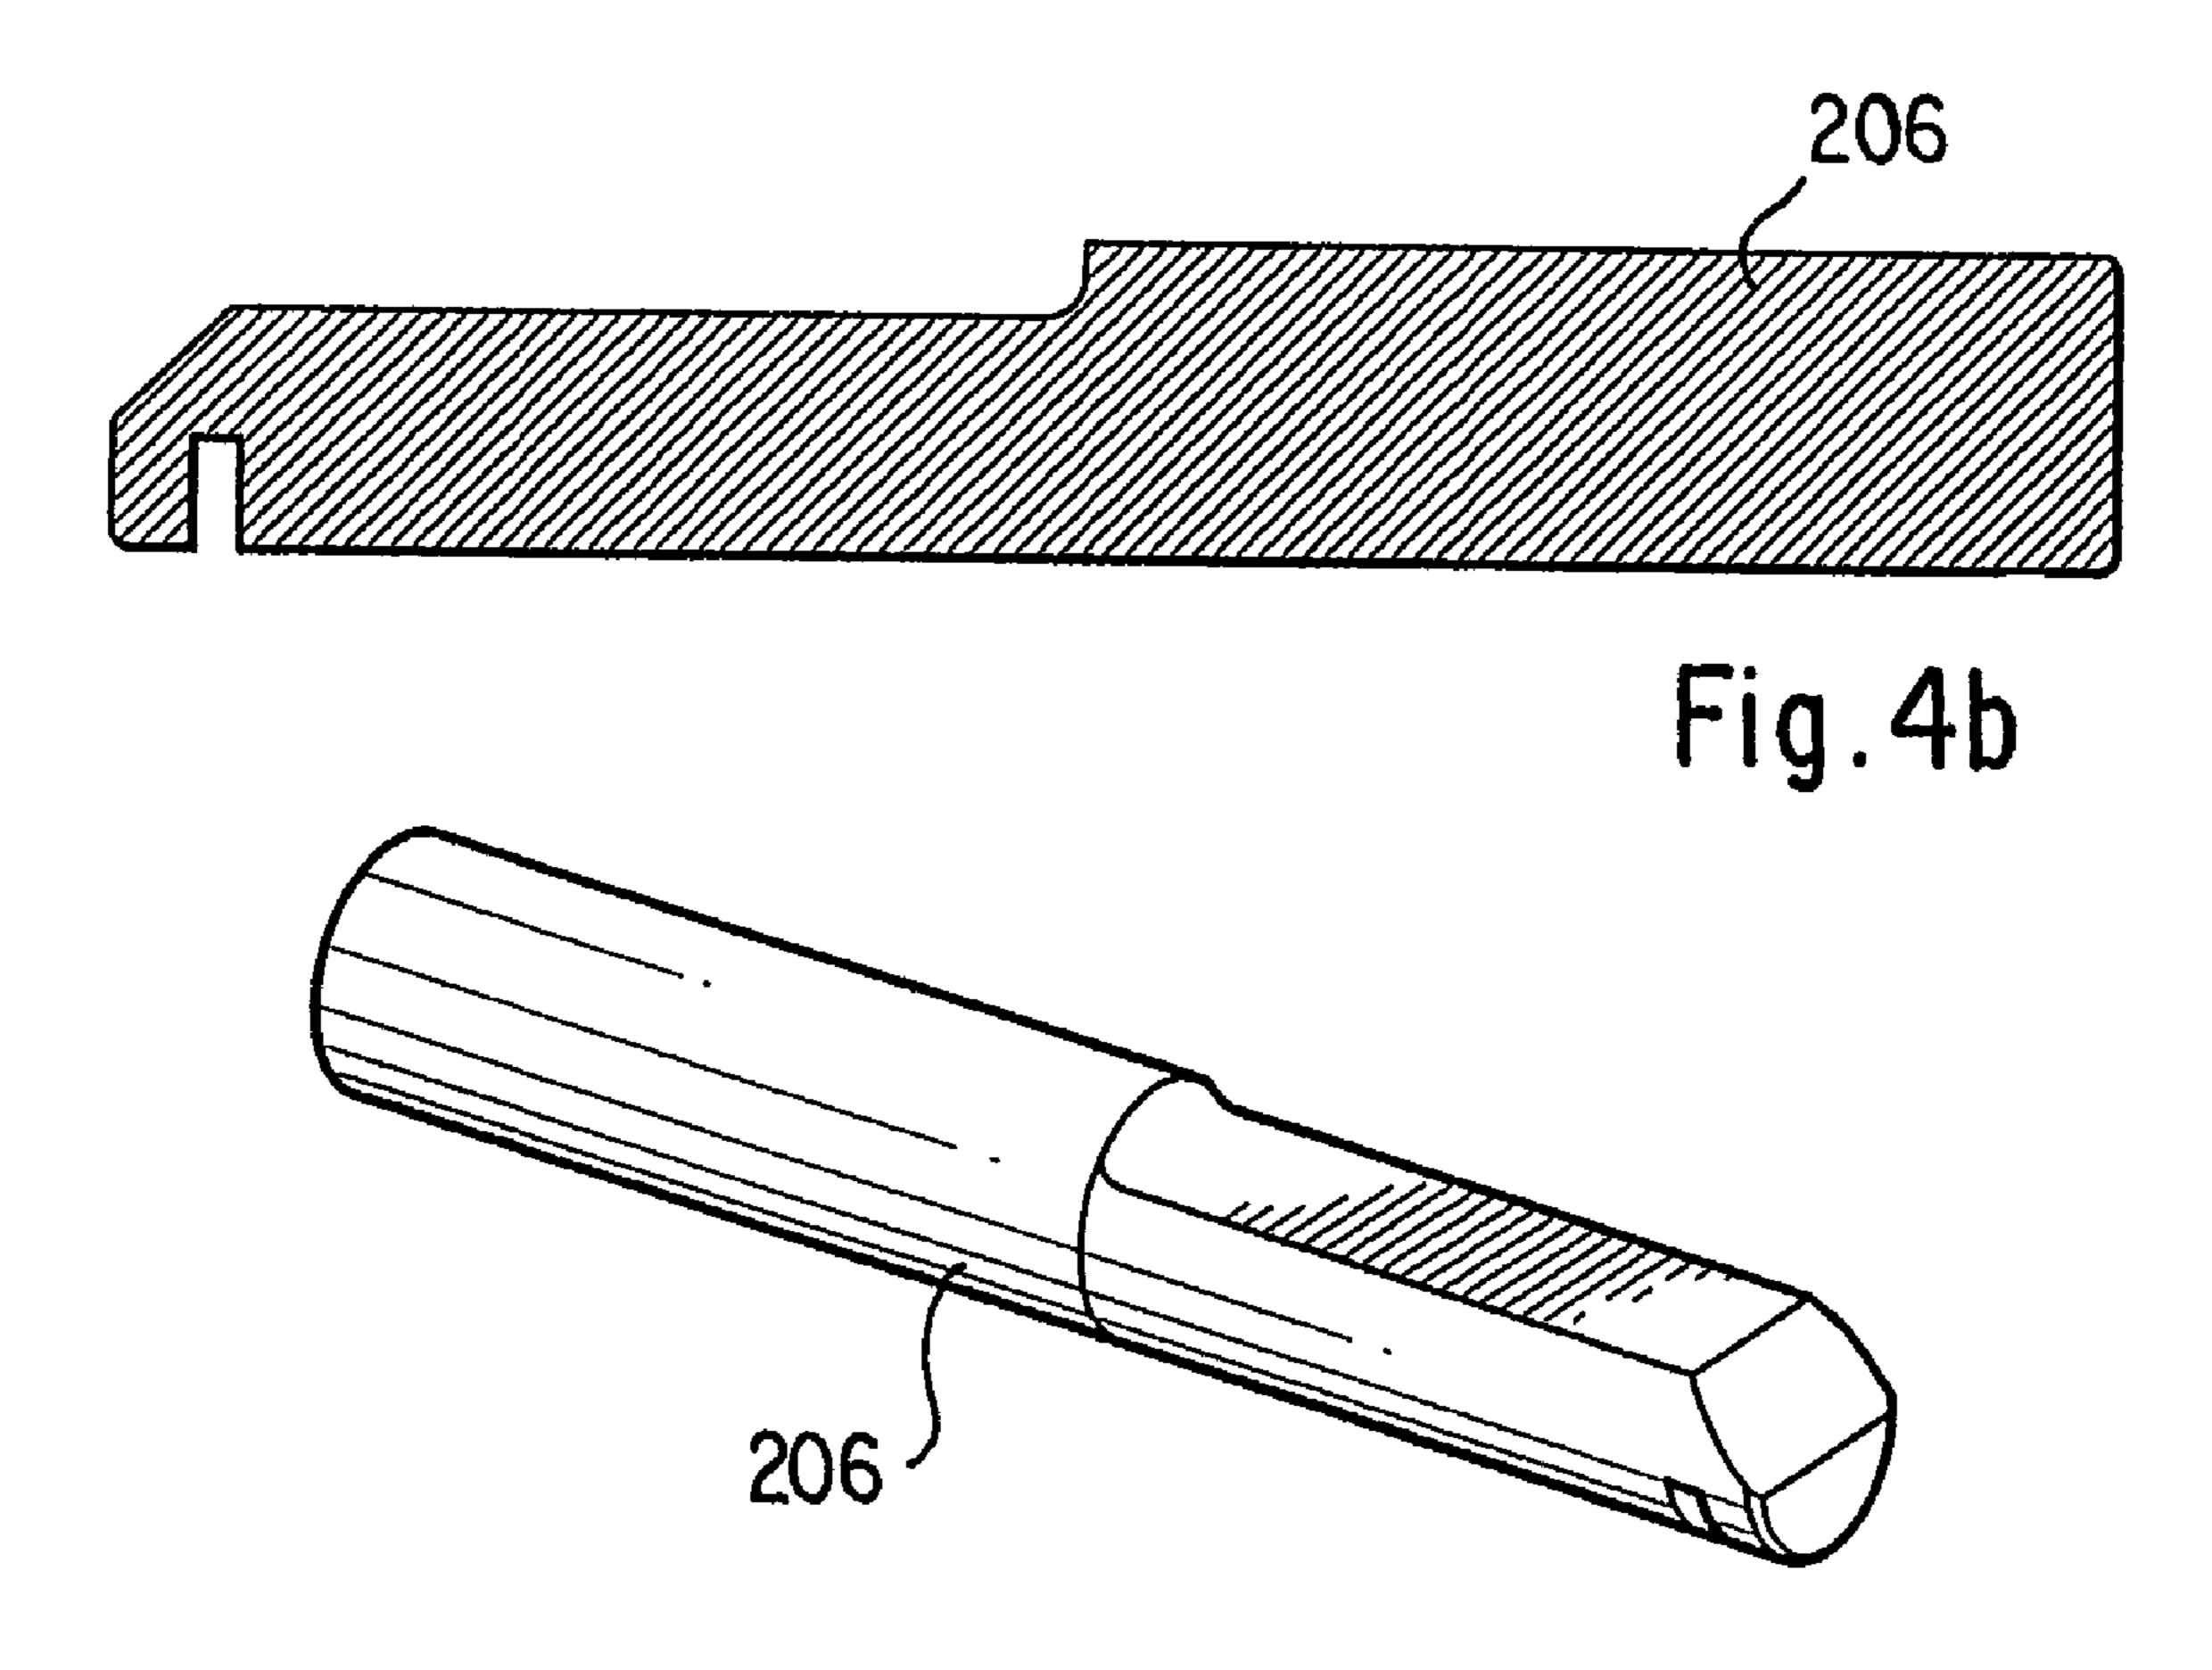
Fig. 4a

FIGS. 4a-4c illustrate a plain pinion pin, with FIG. 4a showing the pin in perspective, FIG. 4b showing the pin in cross section, and FIG. 4c showing the pin from one end.

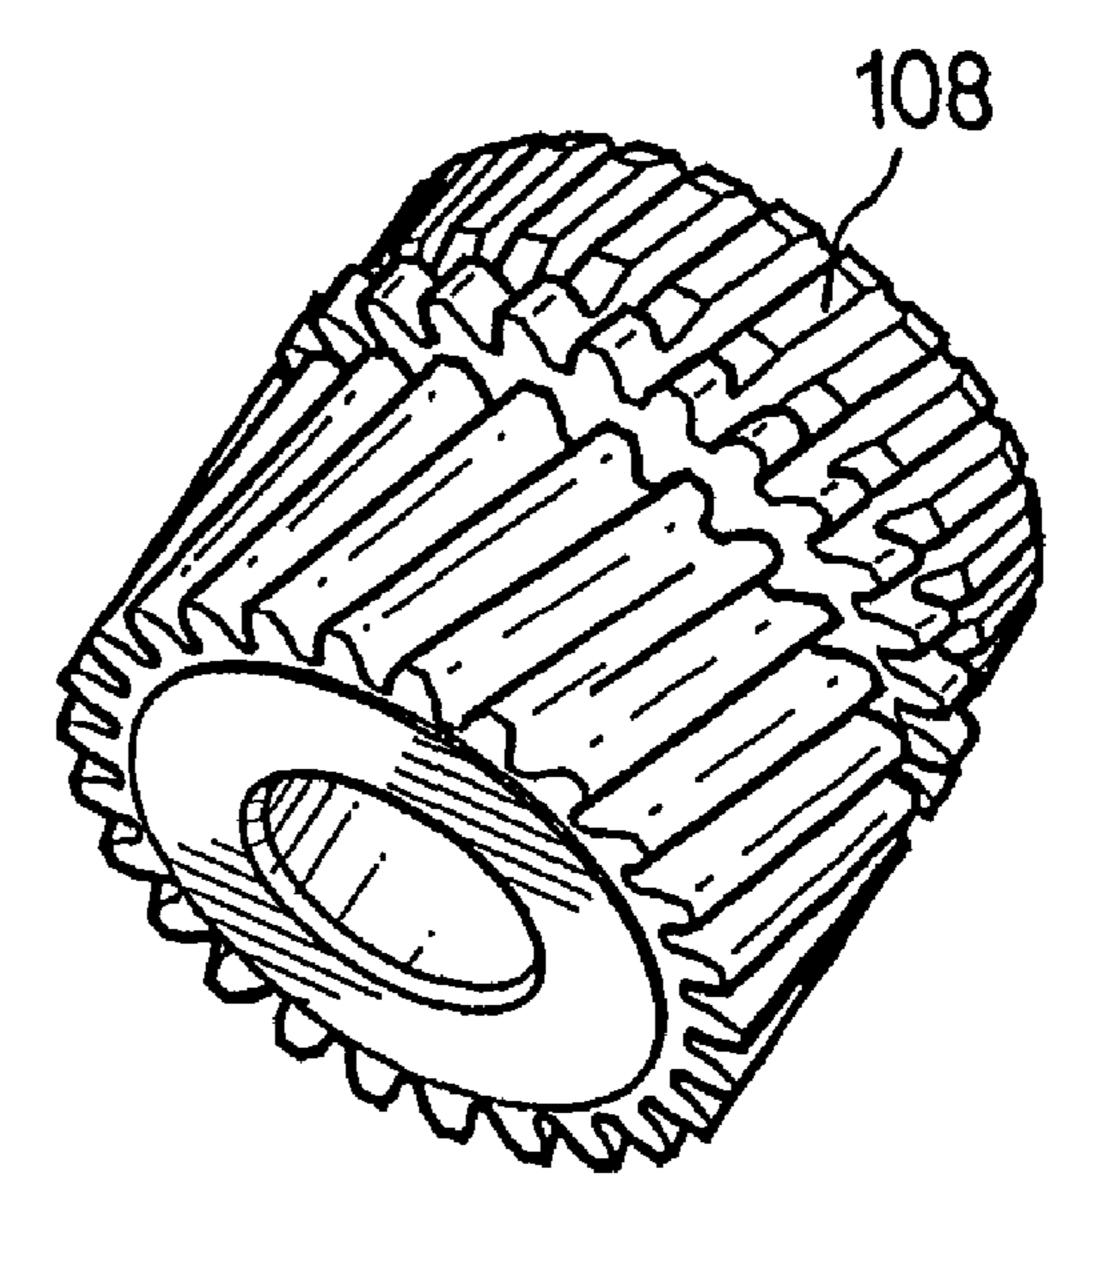
Fig. 8a

FIGS. 8*a*-8*d* are various views and parameters of a front sun gear.

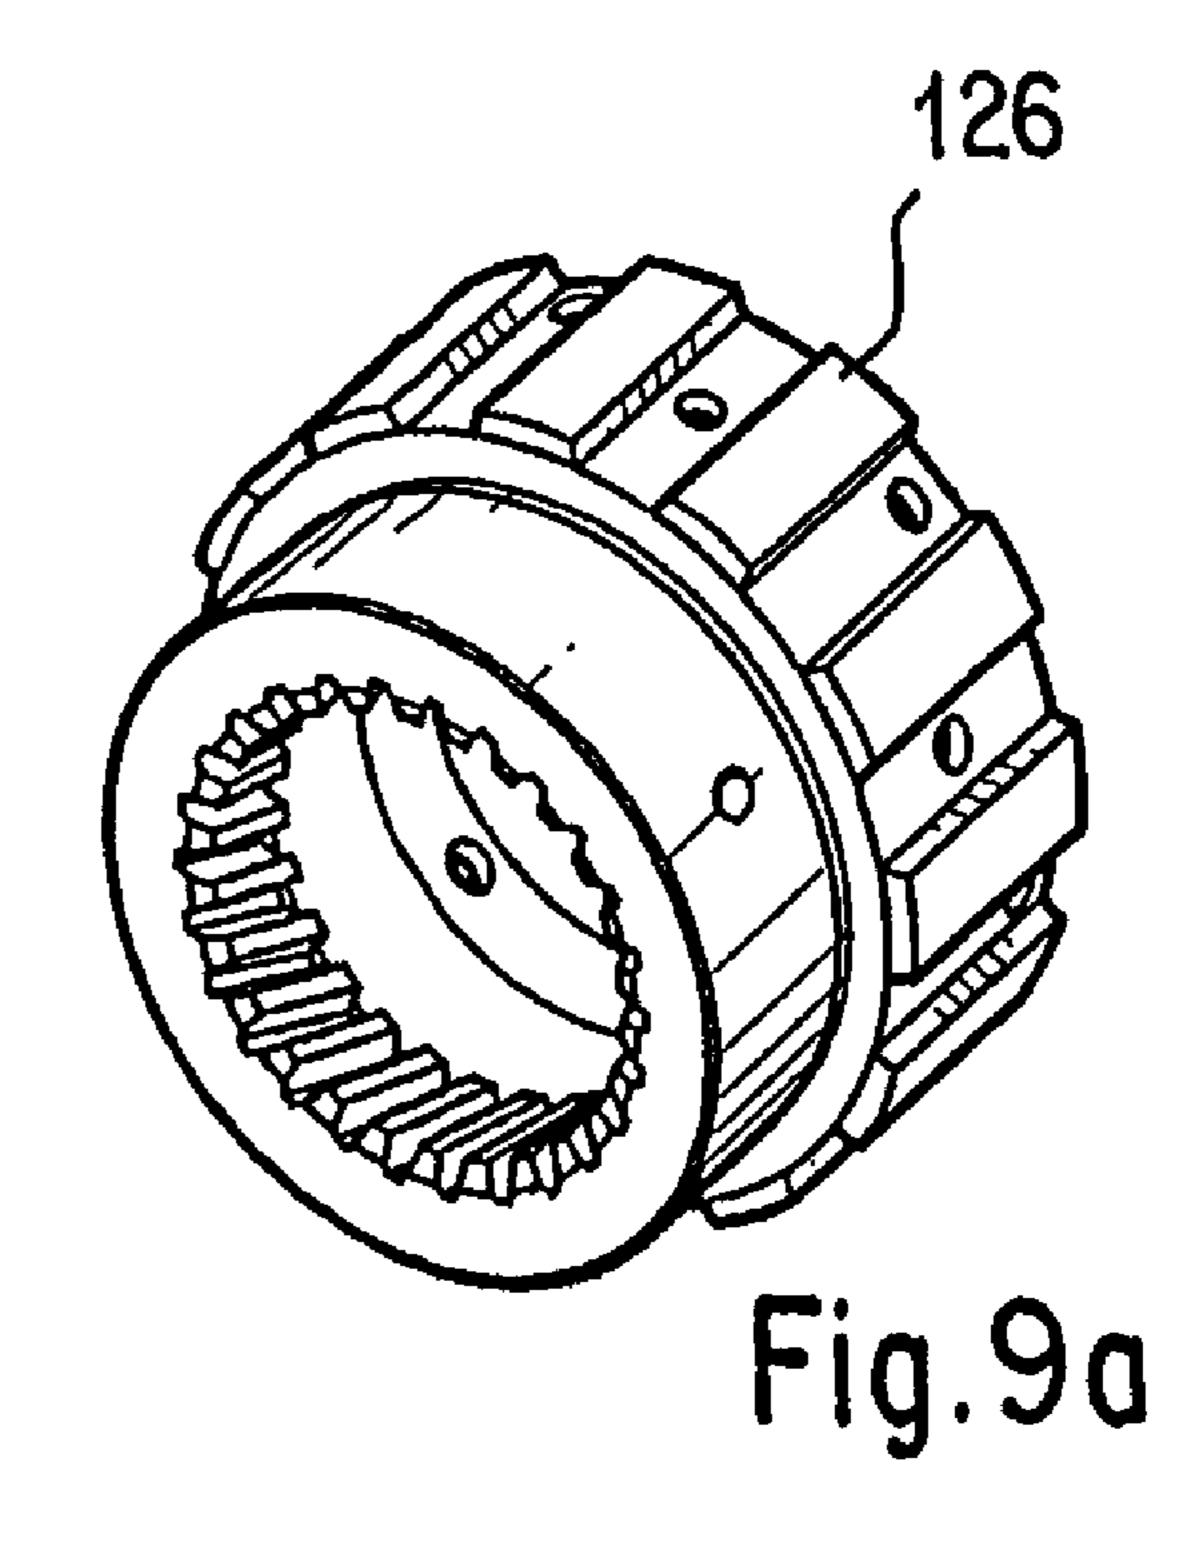
Fig.9d

GEAR DATA		
NUMBER OF TEETH	12	
MODULE	5.25	
PRESSURE ANGLE	20°	
HELIX ANGLE	SPUR	
HAND	SPUR	
TOOTH THICKNESS/ NUMBER OF TOOTH	W=41.6 ± 0.04/N=3	
MAJOR DIAMETER	Φ 70.45 ± 0.05	
MINOR DIAMETER	Φ 66.25 ± 0.05	
INTERNAL INVOLUTE SPLINE DATA		
NUMBER OF TEETH	26	
DIAMETRAL PITCH	17	
PRESSURE ANGLE	18°	
HELIX ANGLE	18.08°	
HAND	RIGHT	
MAJOR DIAMETER	Φ 42.66 ± 0.05	
MINOR DIAMETER	Ø 38.65 ± 0.05	
PIN DIAMETER	Ø 2.8	
MEASUREMENT BETWEEN PINS	37.65 ± 0.04

FIGS. 9*a*-9*d* are various views and parameters of a front sun gear hub.

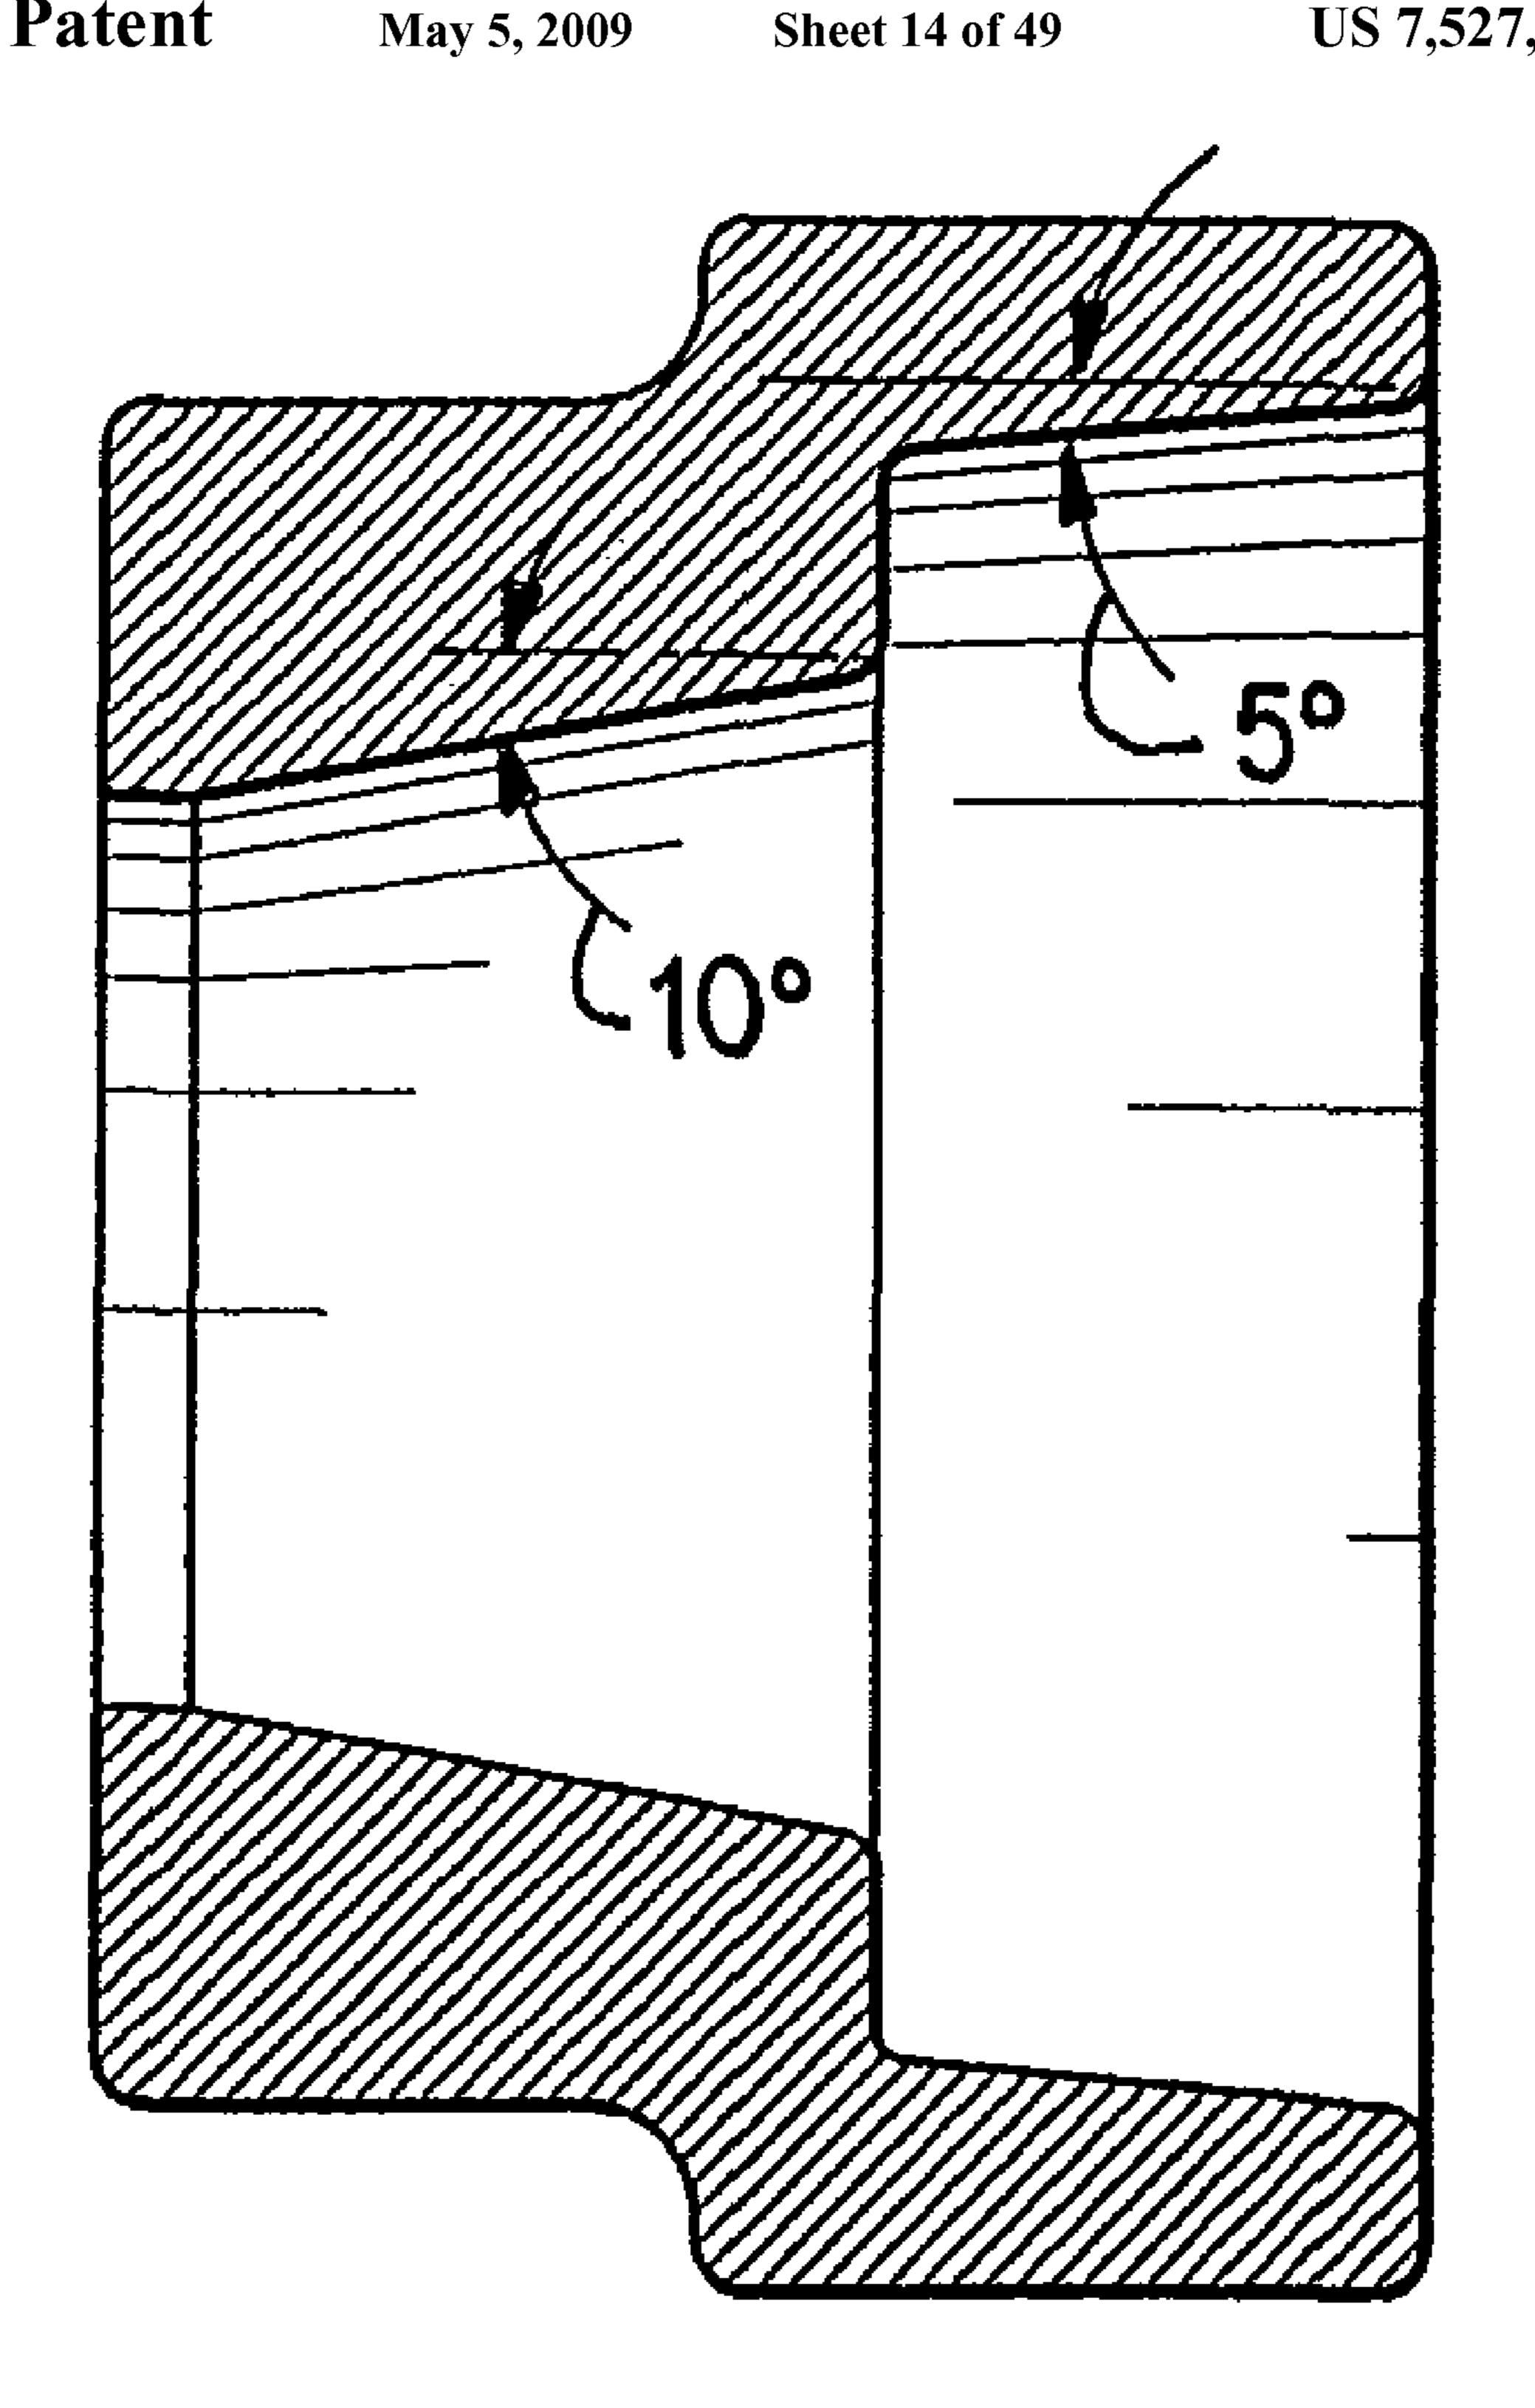
F1G.10

FIG. 10 illustrates front sun gear hub forging.

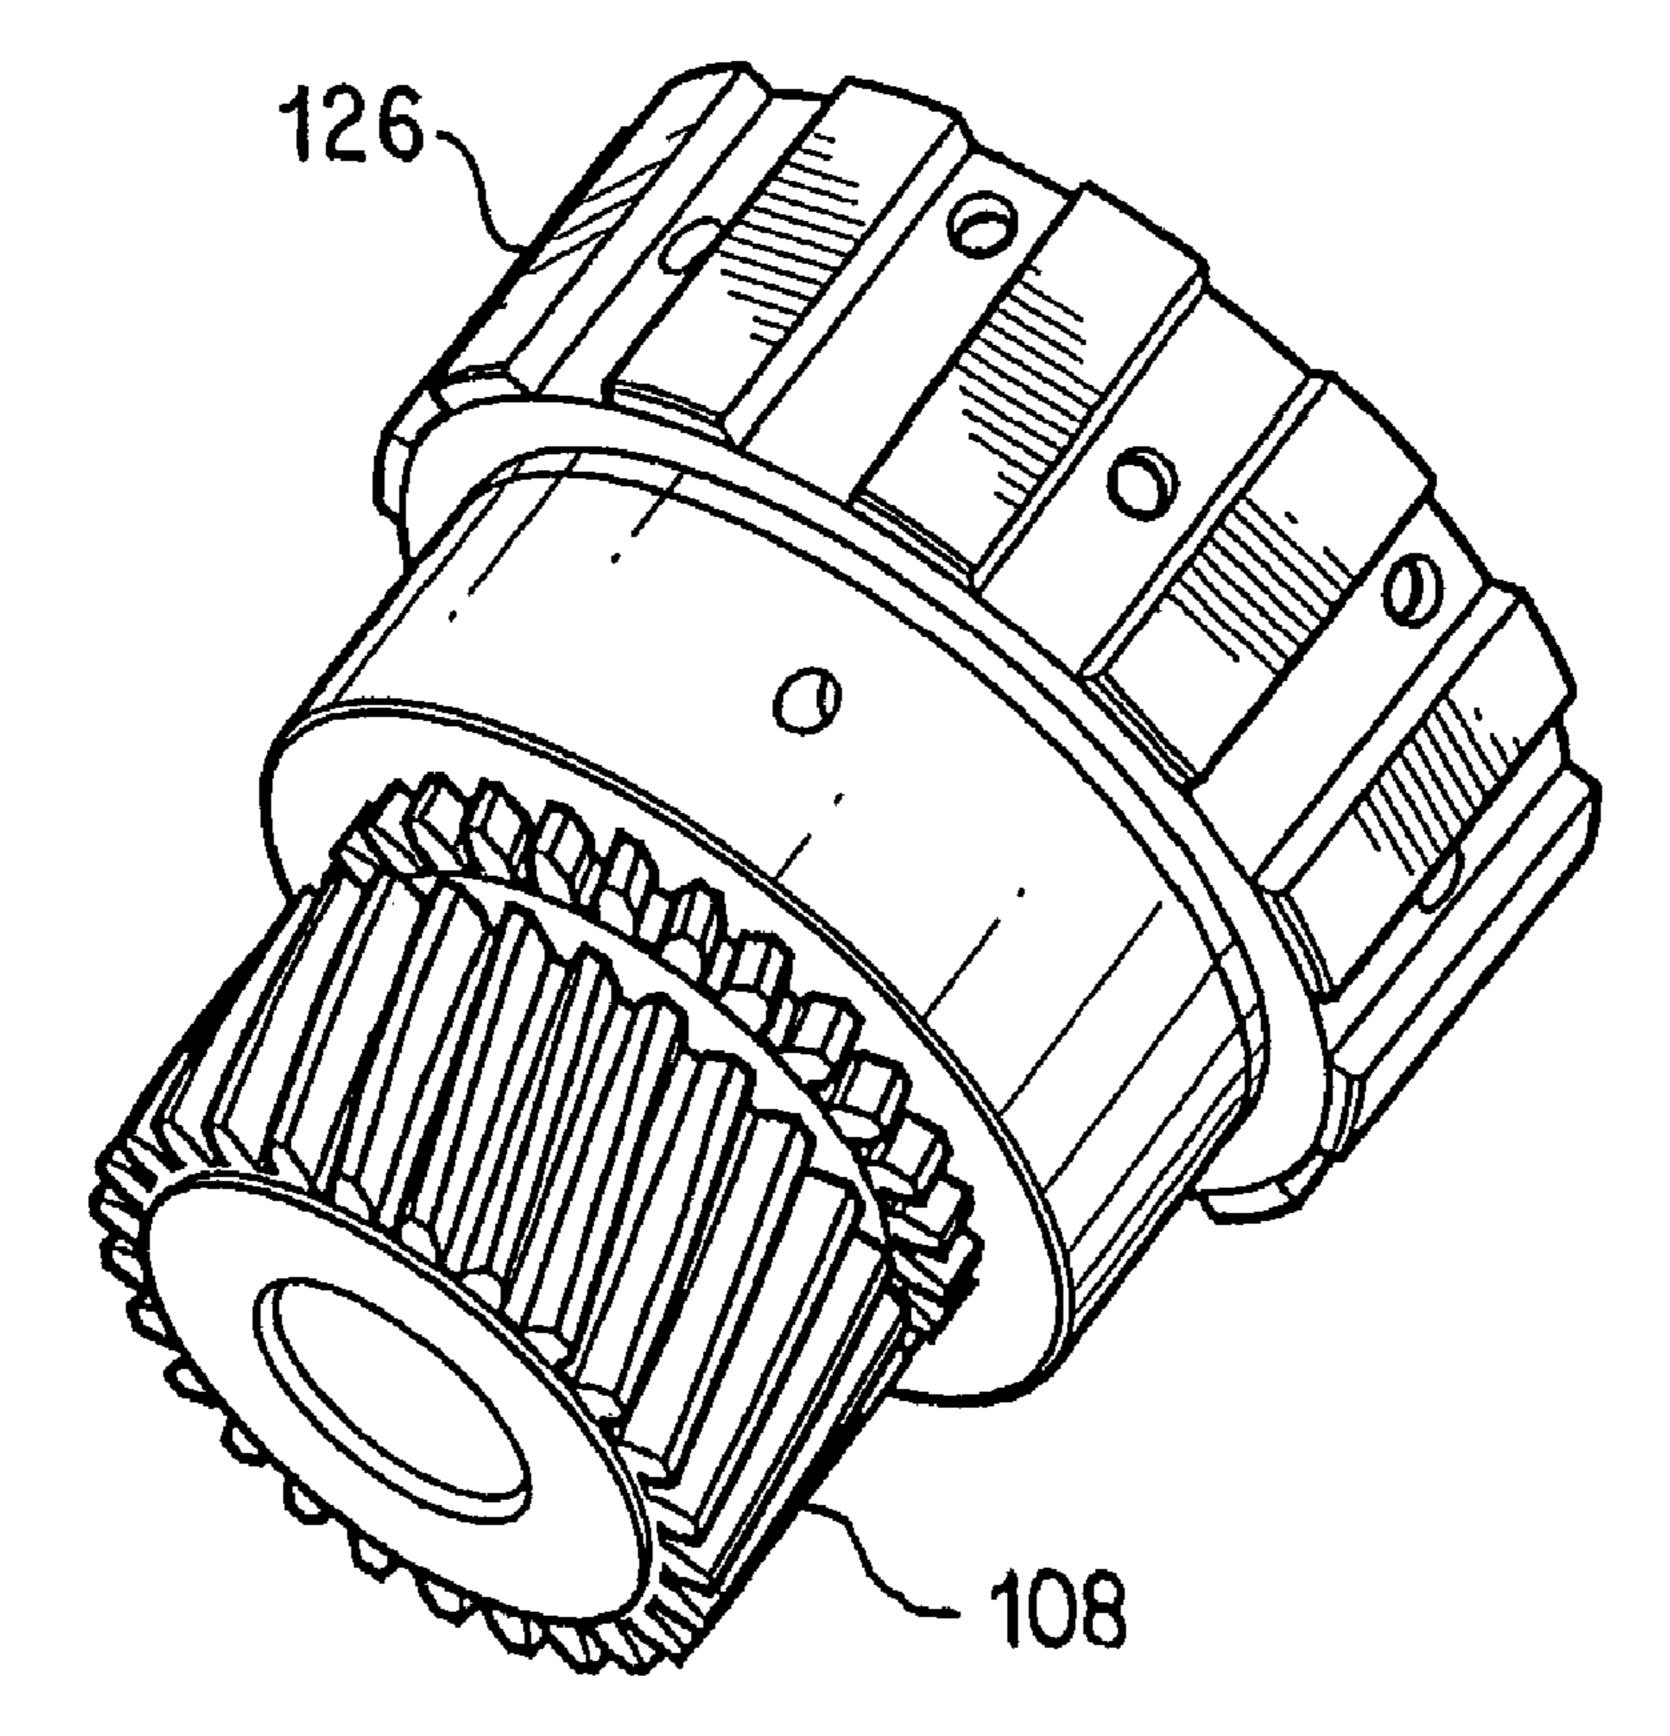
Fig.11a

FIGS. 11*a*-11*b* illustrate a sun gear and hub assembly.

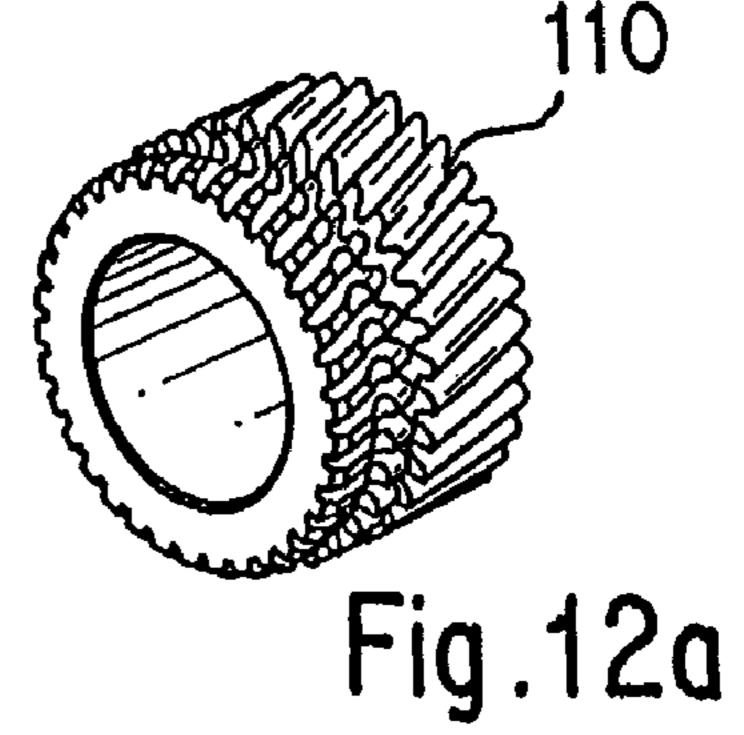
Fig. 12d

EXTERNAL INVOLUTE SPLINE DATA		
NUMBER OF TEETH	34	
NORMAL PRESSURE ANGLE	18°	
NORMAL DIAMETRAL PITCH	17	
HELIX ANGLE	18.08°	
HAND	LEFT	
STANDARD PITCH DIAMETER	Ø 53,44	
MAJOR DIAMETER	Φ 57.80 ± 0.02	
MINOR DIAMETER	φ 50.20 ± 0.05	
DIAMETER OF MEASURING PIN	Ф 3.0	
MEASUREMENT OVER 2 PINS	59.006 ± 0.042	
NORMAL CIRCULAR TOOTH THICKNESS	2.520 ± 0.018	
NORMAL TIP RADIUS	0.25	
NORMAL FILLET RADIUS	FULL	
TOTAL COMPOSITE TOLERANCE	0.038	
TOOTH TO TOOTH TOLERANCE	0.019	
MASTER GEAR NUMBER OF TEETH	40	
MASTER GEAR NORM. CIRC. TOOTH THICKNESS	2.3470	
TEST RADIUS	27.197 ± 0.067	
CROWNING	0.03

cross section, FIG. 12c showing a detail 12c of FIG. 12b, and FIG. 12d showing its parameters.

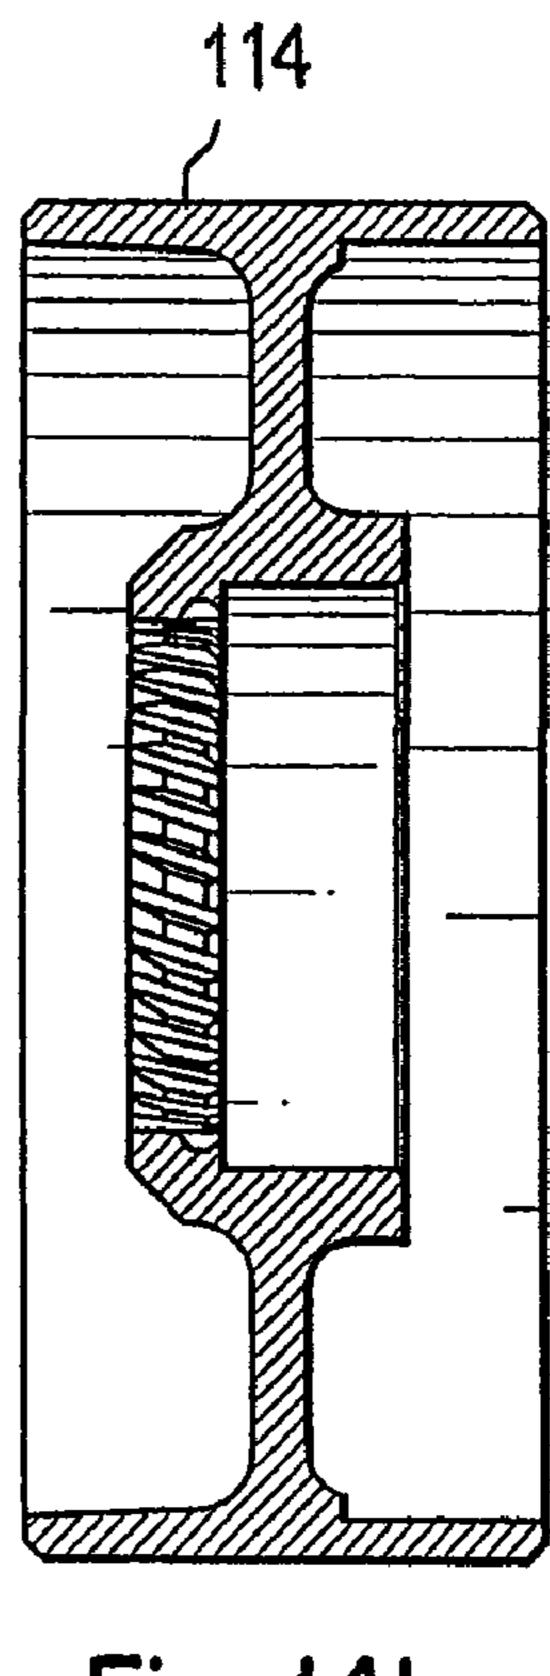
Fig. 14d

INNER GEAR DATA		
NUMBER OF TEETH	34	
DIAMETRAL PITCH	17	
PRESSURE ANGLE	18°	
HELIX ANGLE	18.08°	
HAND	LEFT	
MAJOR DIAMETER	Φ 55.51 ± 0.05	
MINOR DIAMETER	Φ 51.25 ± 0.05	
PIN DIAMETER	Ф 2.8	
MEASUREMENT BETWEEN PINS	49.04 ± 0.04

FIGS. 14*a*-14*d* illustrate a rear band drum and its parameters.
