US 7,527,577 B2

(54) AUTOMATIC TRANSMISSION AND GEAR TRAIN

(57) ABSTRACT

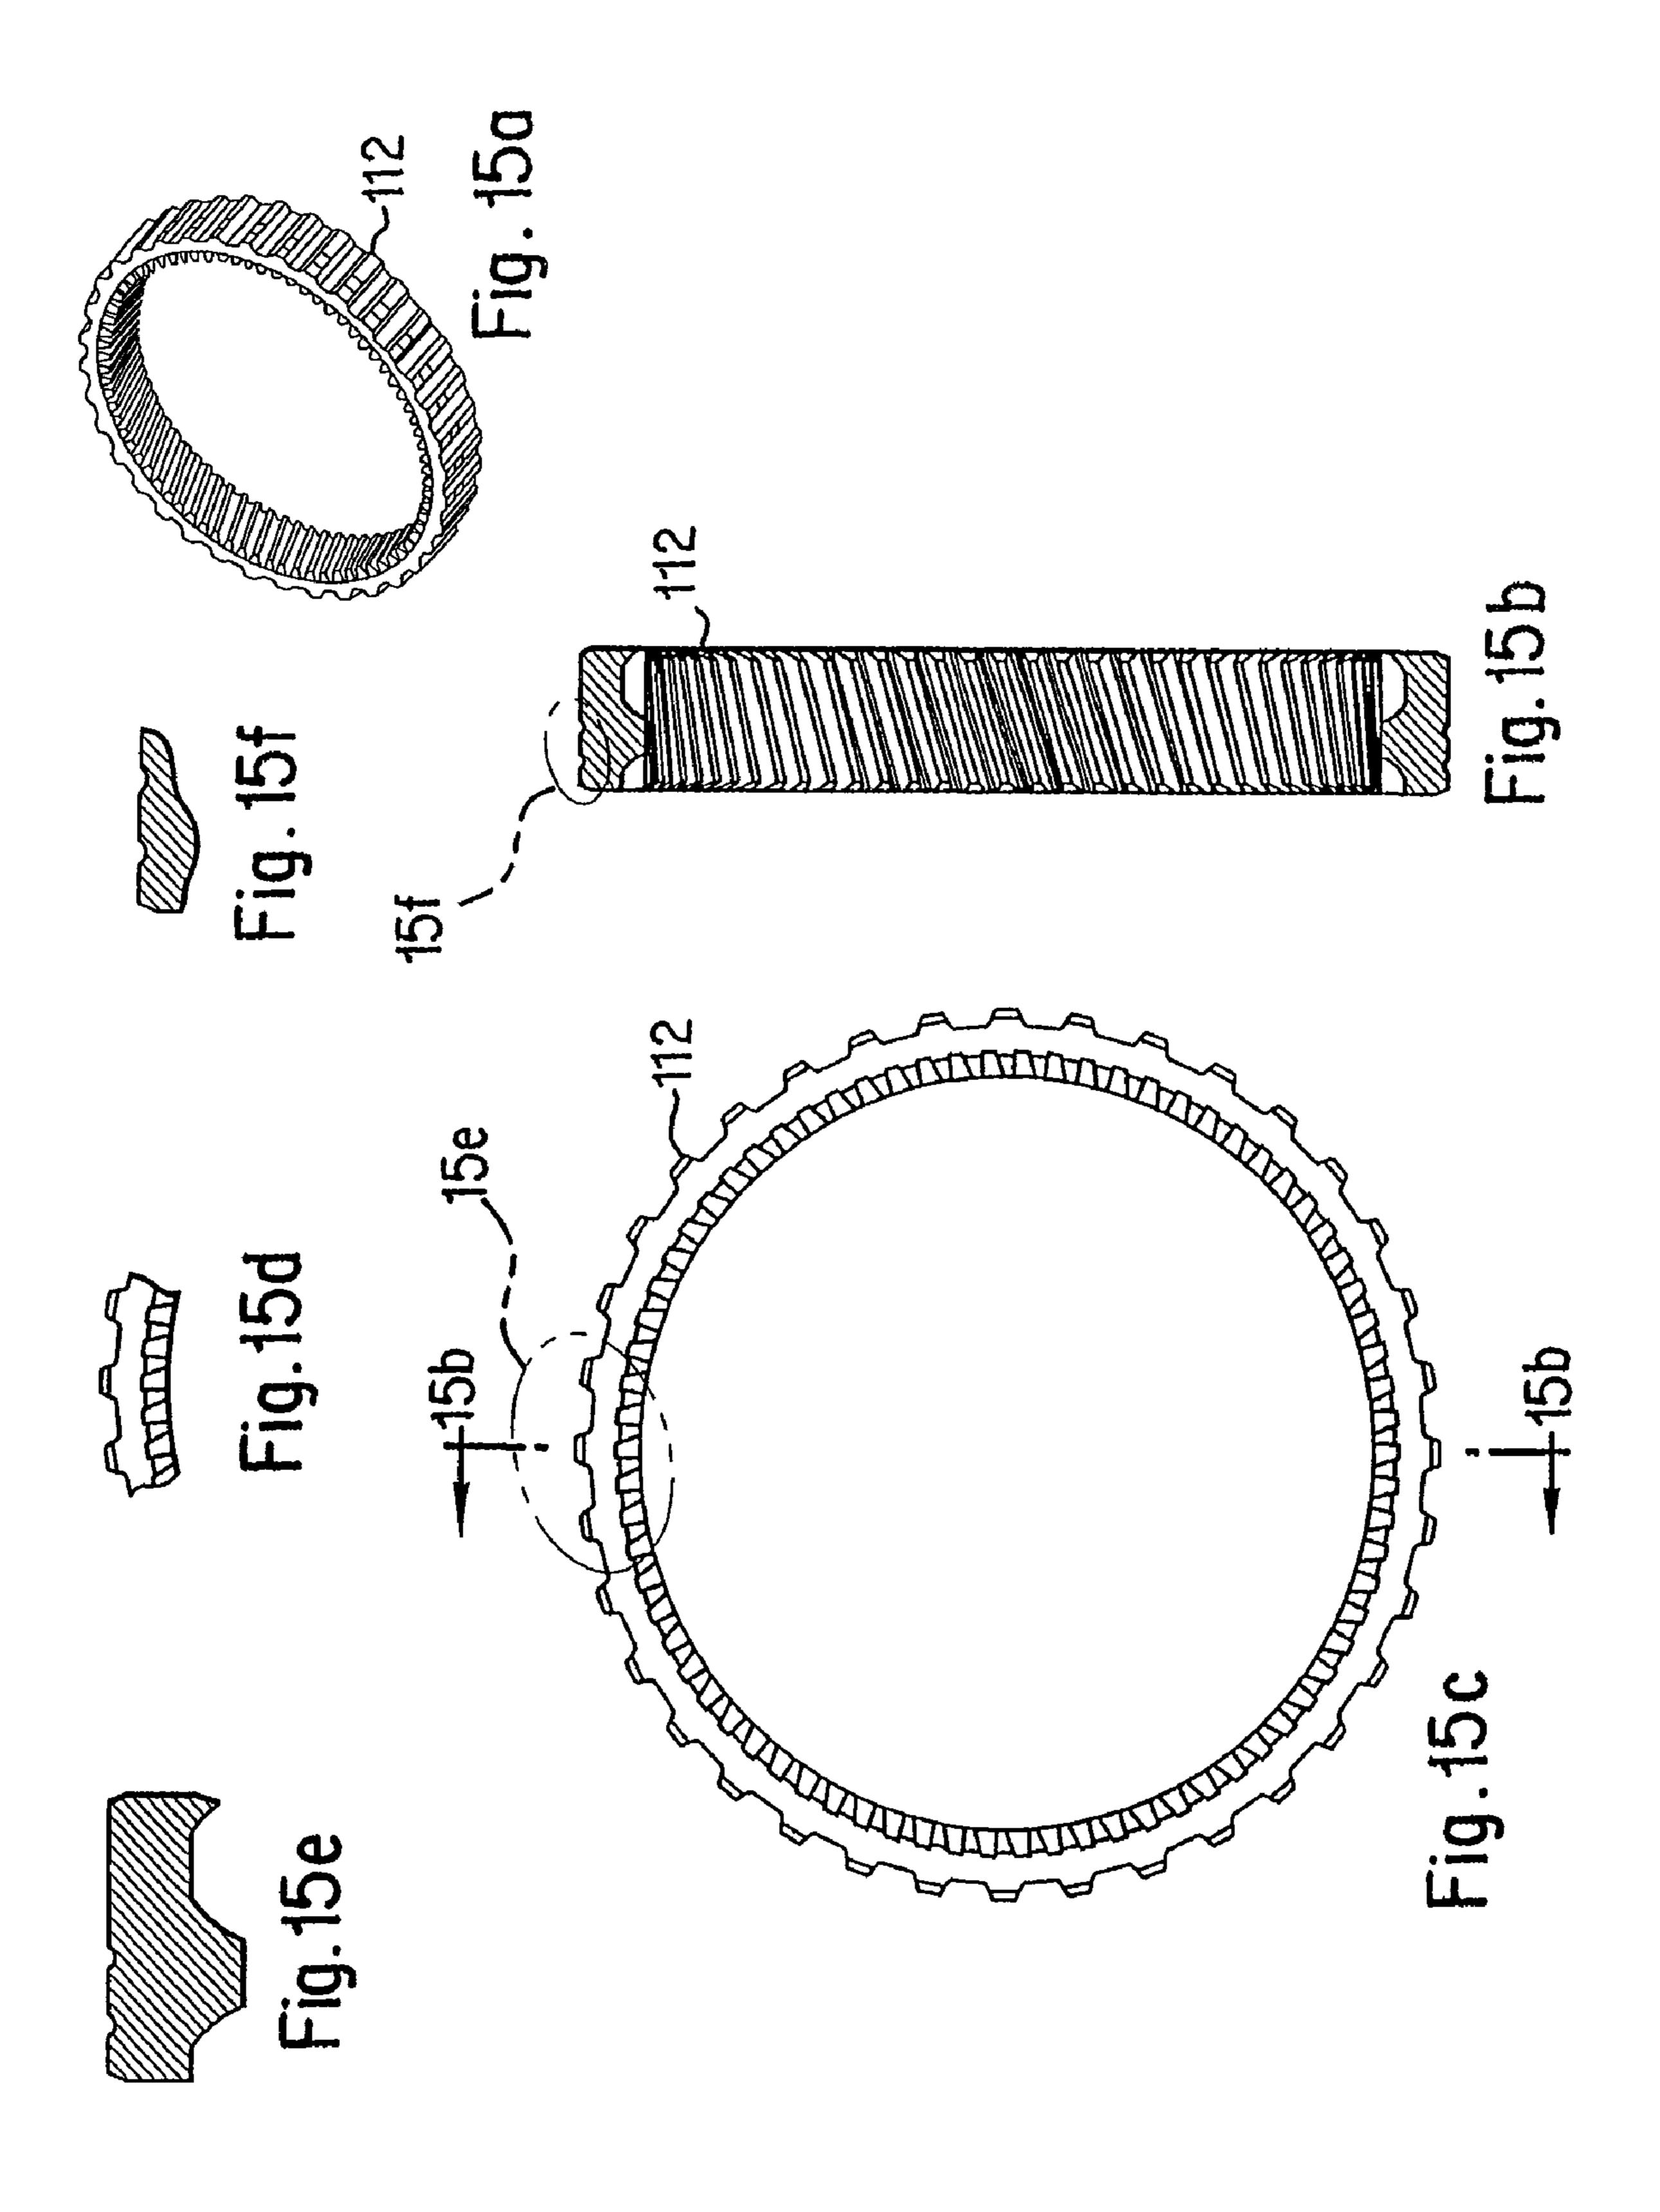
Fig. 15g

EXTERNAL SPLINE DATA	
NUMBER OF TEETH	36
MODULE	3.83245
PRESSURE ANGLE	24° 33′ 36″
MAJOR DIAMETER	Φ 130.070 ± 0.10
MINOR DIAMETER	ϕ 132.92 ± 0.10
INTERNAL GEAR DATA	
NUMBER OF TEETH	14
NORMAL DIAMETRAL PITCH	17
NORMAL PRESSURE ANGLE	18
HELIX ANGLE	18.08°
HAND	RIGHT
STANDARD PITCH DIAMETER	φ 116.310
MAJOR DIAMETER	Ø 125.0 ± 0.25
MINOR DIAMETER	Ø 116.99 ± 0.10
DIAMETER OF MEASURING PIN	Ф 3.0
MEASUREMENT OVER 2 PINS	116.000 ± 0.038
NORMAL CIRCULAR TOOTH THICKNESS	0.778 ± 0.015
NORMAL TIP RADIUS AT MAJOR DIAMETER	FULL
NORMAL FILLET RADIUS AT MINOR DIAMETER	0.15 MAX
TOTAL COMPOSITE TOLERANCE	0.177 (五)
TOOTH TO TOOTH TOLERANCE	0.063

FIGS. 15*a*-15*g* illustrate a ring gear and its parameters.

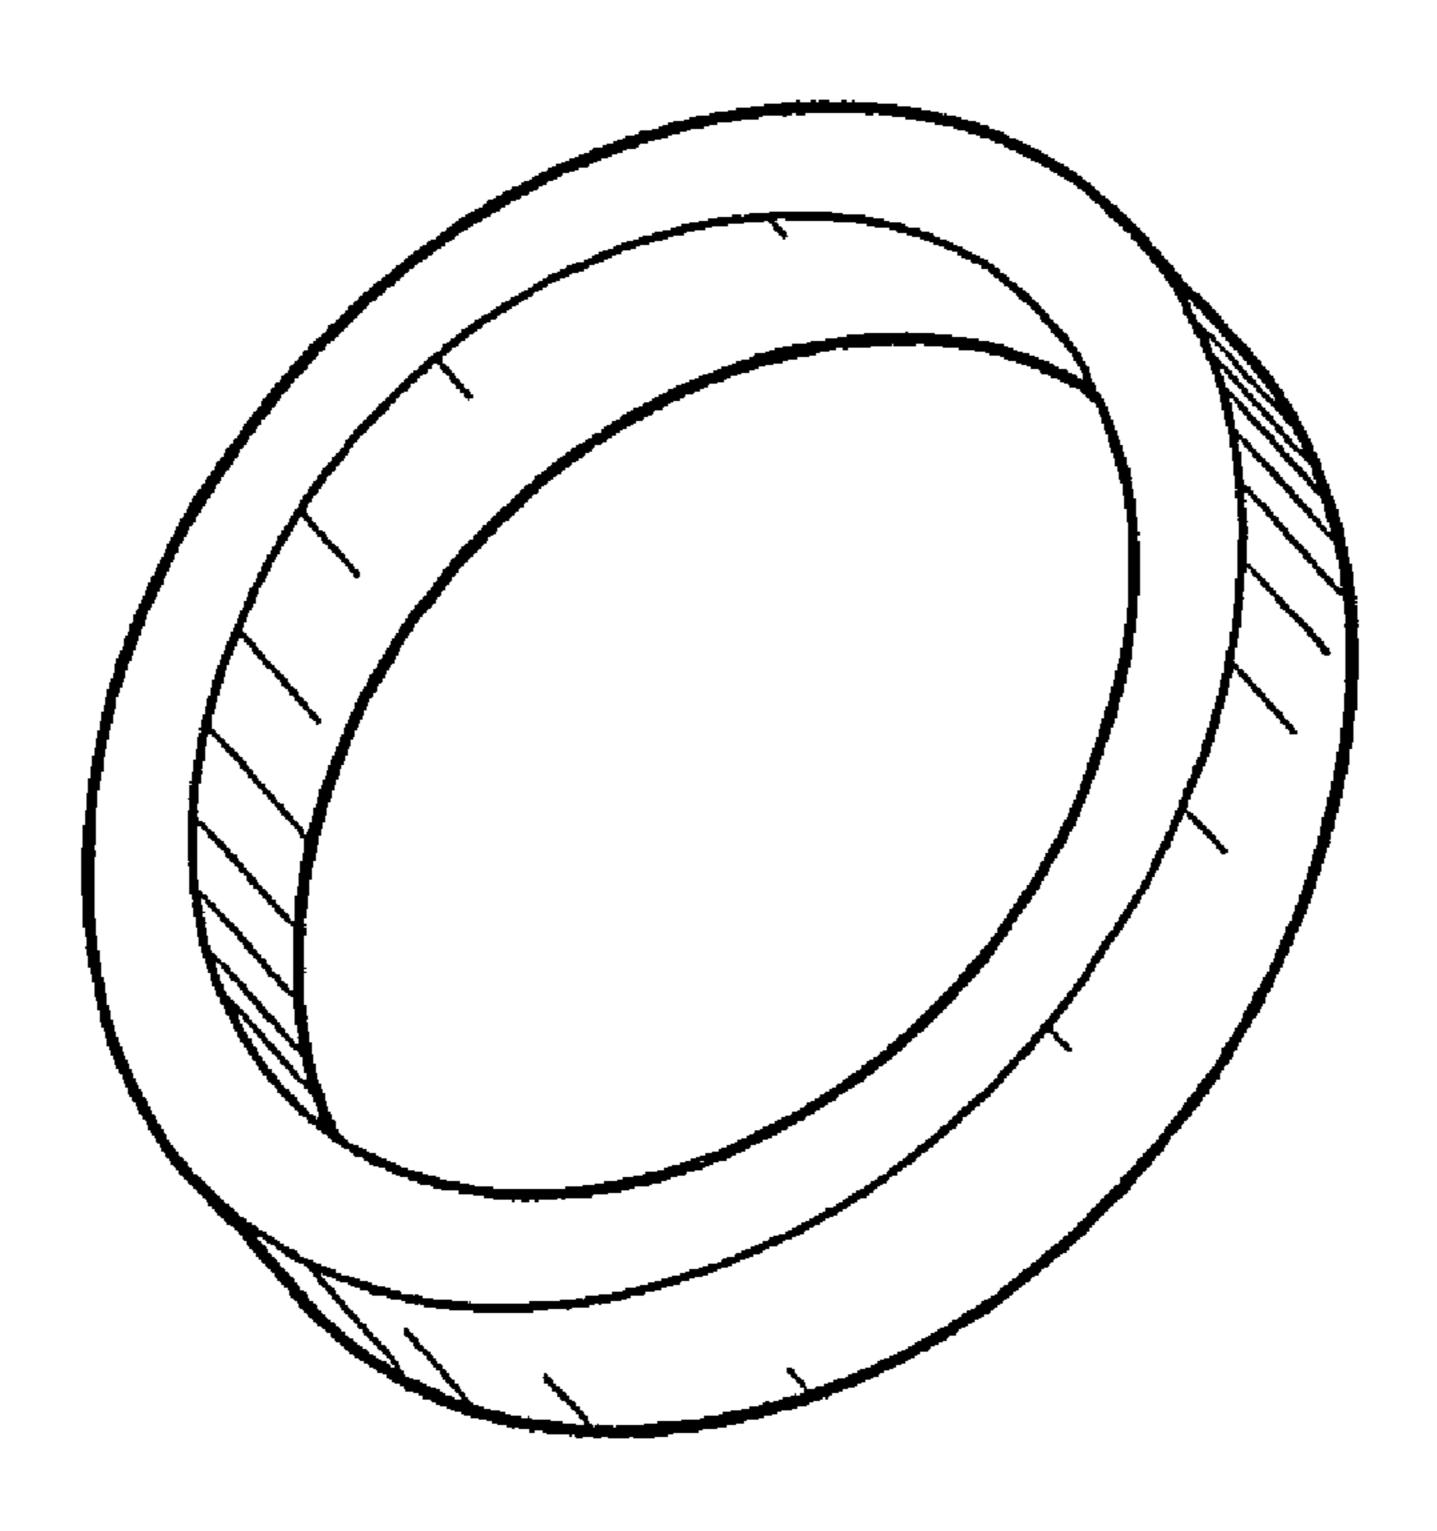
Fig. 16a

FIGS. 16a-16b illustrate a ring gear forging.

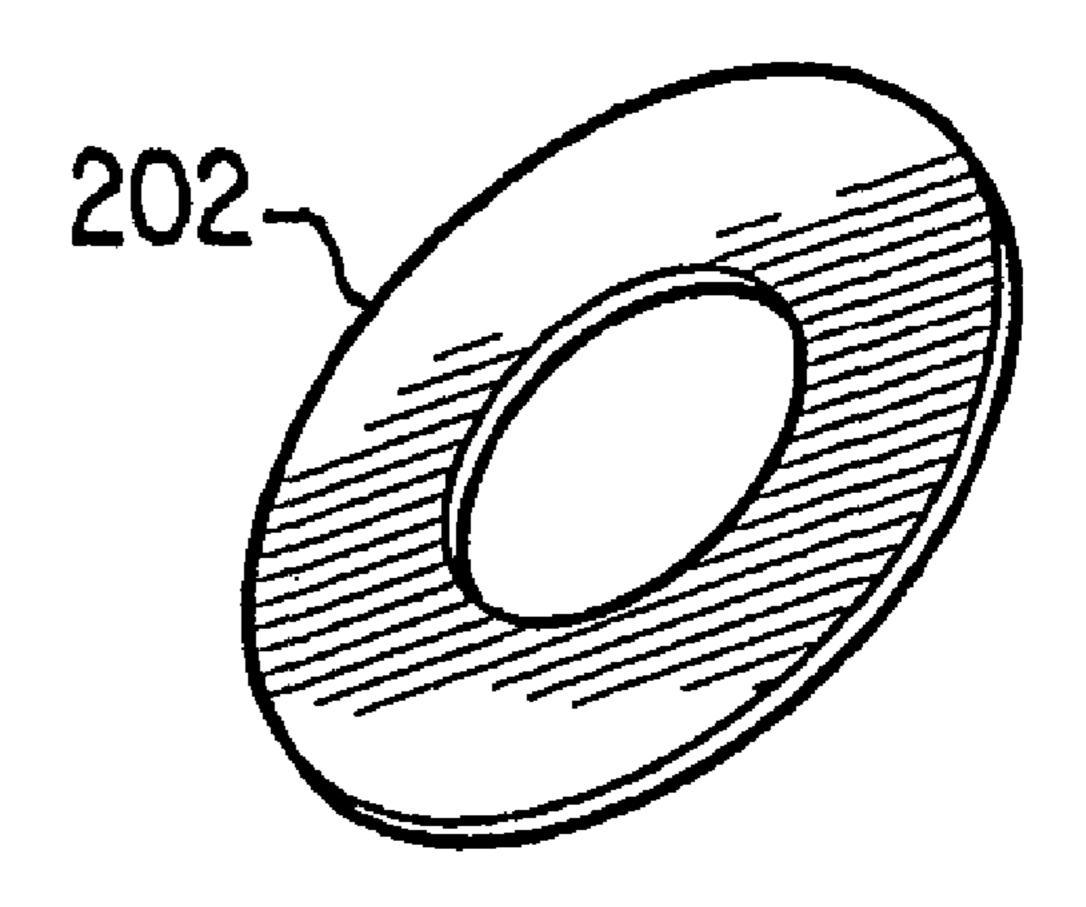
Fig. 18a

FIGS. **18***a***-18***c* illustrate a small washer.

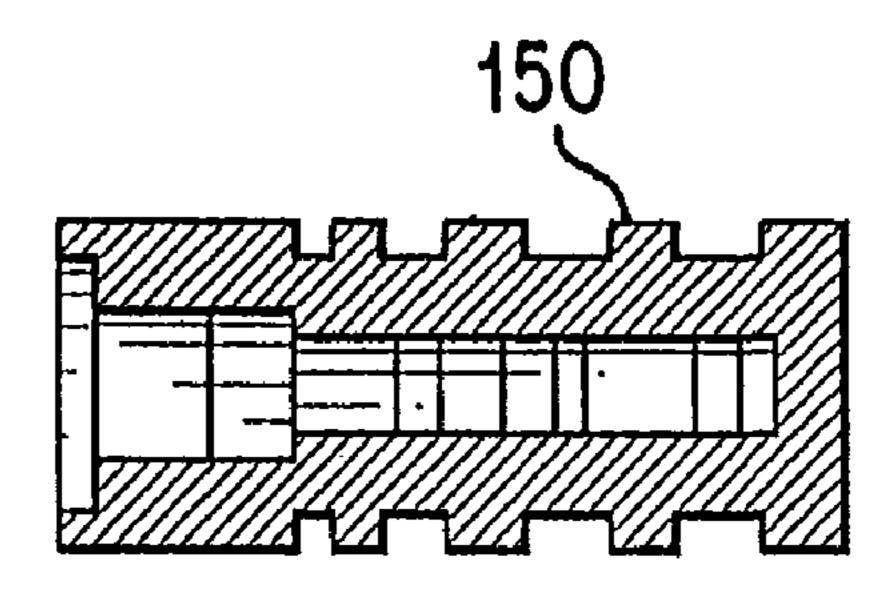
Fig. 30

If kept free of contamination the valve body will conceivably function indefinitely. However, when contamination occurs, some of the components will wear. The point of wear is the 2/3-boost sleeve 150, shown in FIG. 30, which is made of aluminum. The transmission of the instant invention has a new design boost sleeve installed in this position that is especially designed for this application. The geometry of the boost sleeve has been changed to allow more oil to react to the shifting lands of the shift valve. In so doing the valve is more sensitive and produces a more repeatable point of shift. The material from which the boost sleeve was made is still aluminum but the alloy is changed to 5056 in order to increase wear resistance and reduce the binding affects that small particles of metal create on the inner shift valve. The leading edges of the valve sleeve are very sharp by design and function as wipers to the valve spool in much the same way that any oil seal protects the inner parts of a mechanism form external dirt contamination. By increasing the valve sleeve's resistance to wear the sharp edges are maintained for a longer period of time during contamination. This new 2/3 shift valve spool will extend the life of the transmission even after metal contamination begins by keeping the small abrasive metal particles from getting between the valve and spool thus maintaining proper valve function.

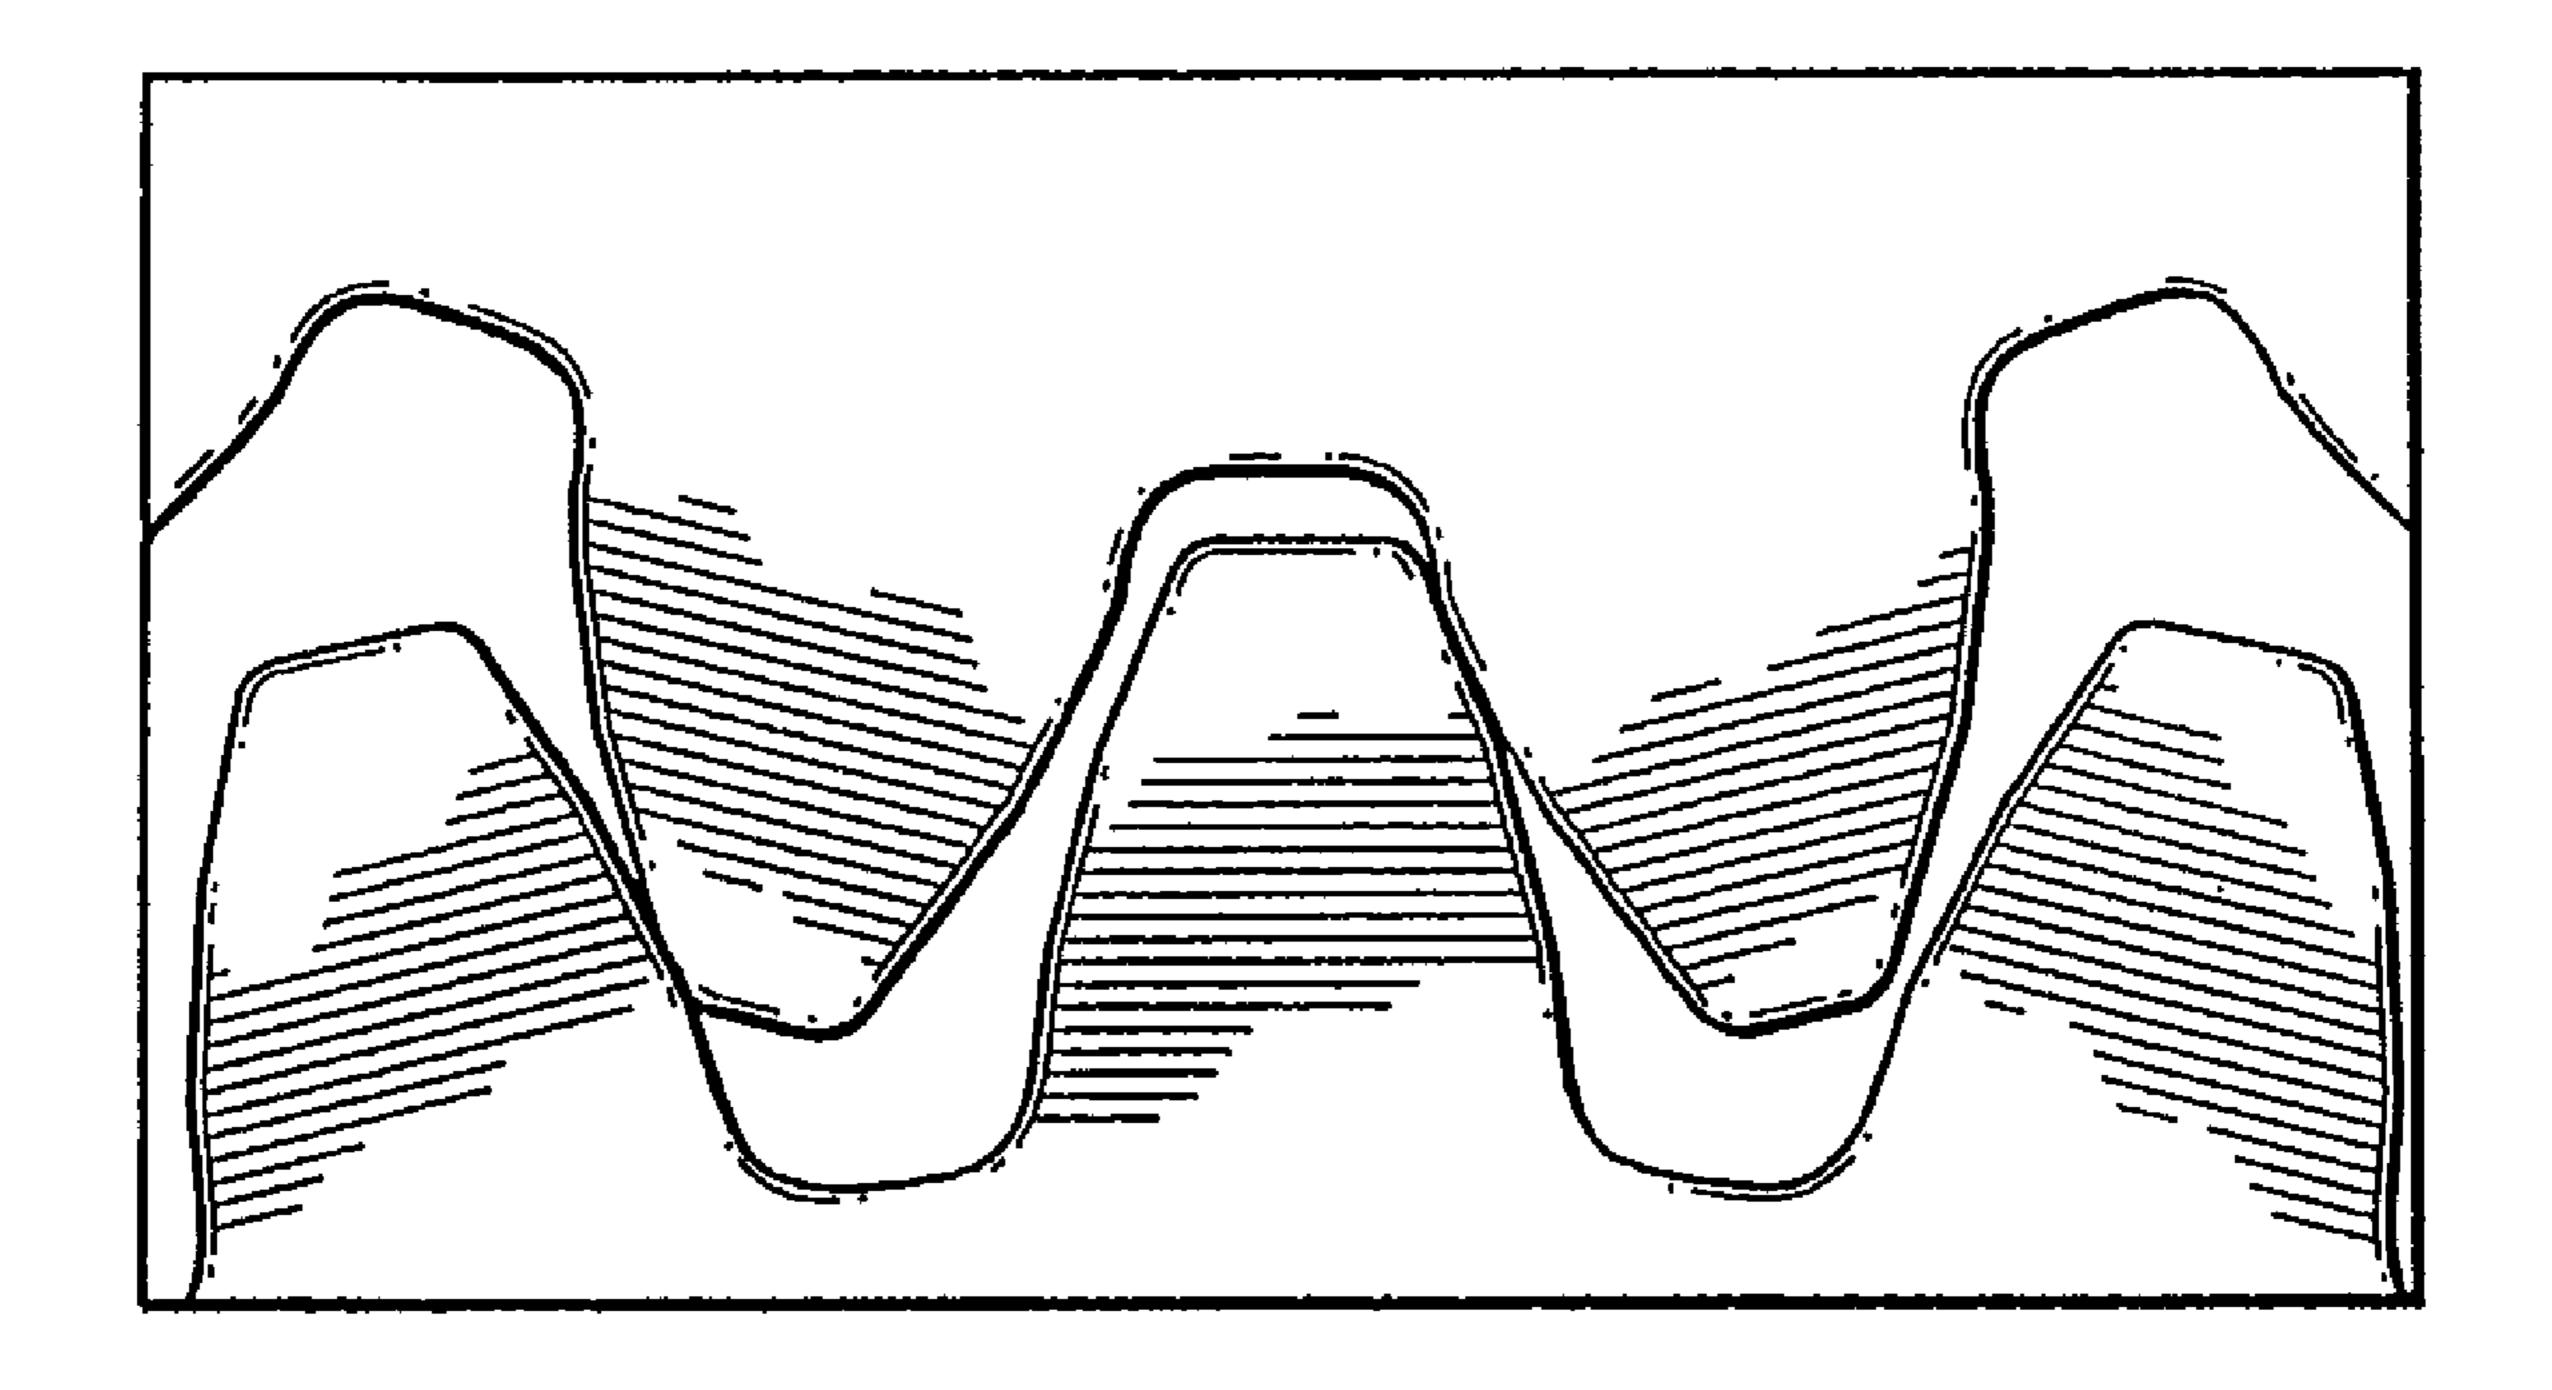
F1G.33

The new gear geometry is detailed in FIGS. 31-32. FIGS. 33-40 illustrate the initial and revised mesh conditions in each stage. Tables 2-4 show the initial and final I and J factors and the % improvement achieved. In each case, improvements to pitting resistance, and bending strength have been achieved by changing the designs to full fillet radii from sharp fillet radii, and by optimizing tooth proportions to provide more load sharing.

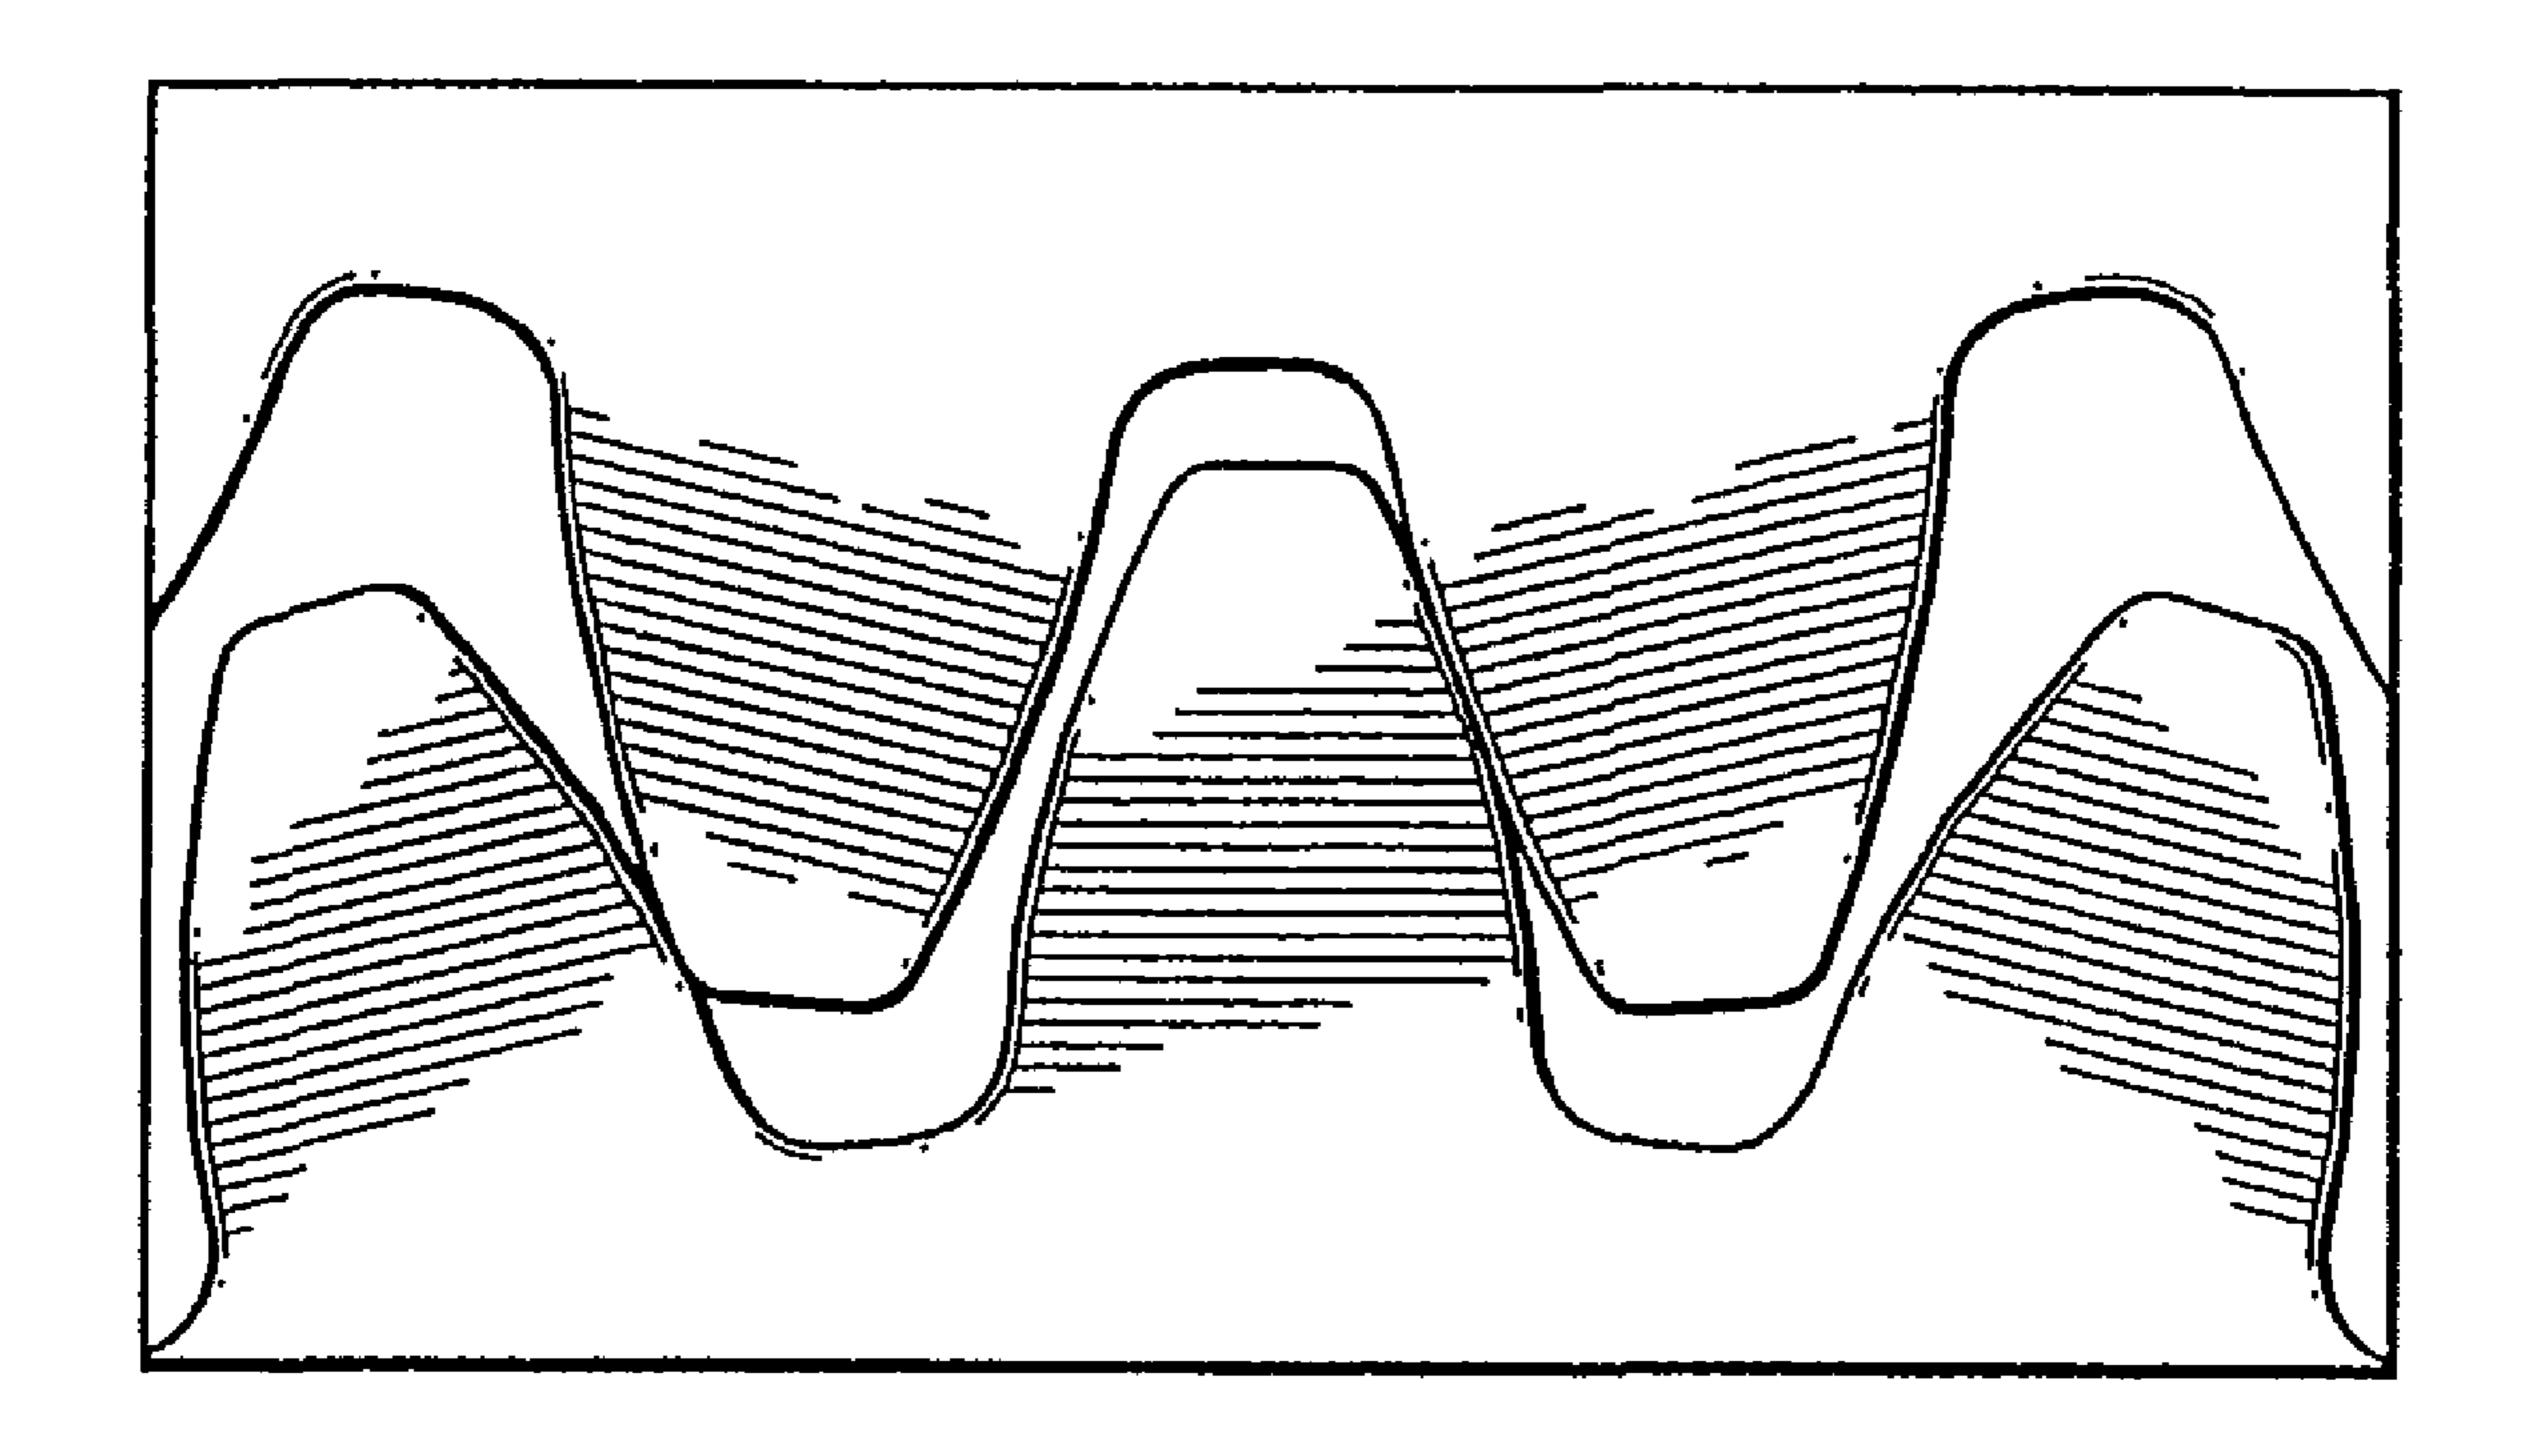
F1G.37

initial 34T to 20T design.

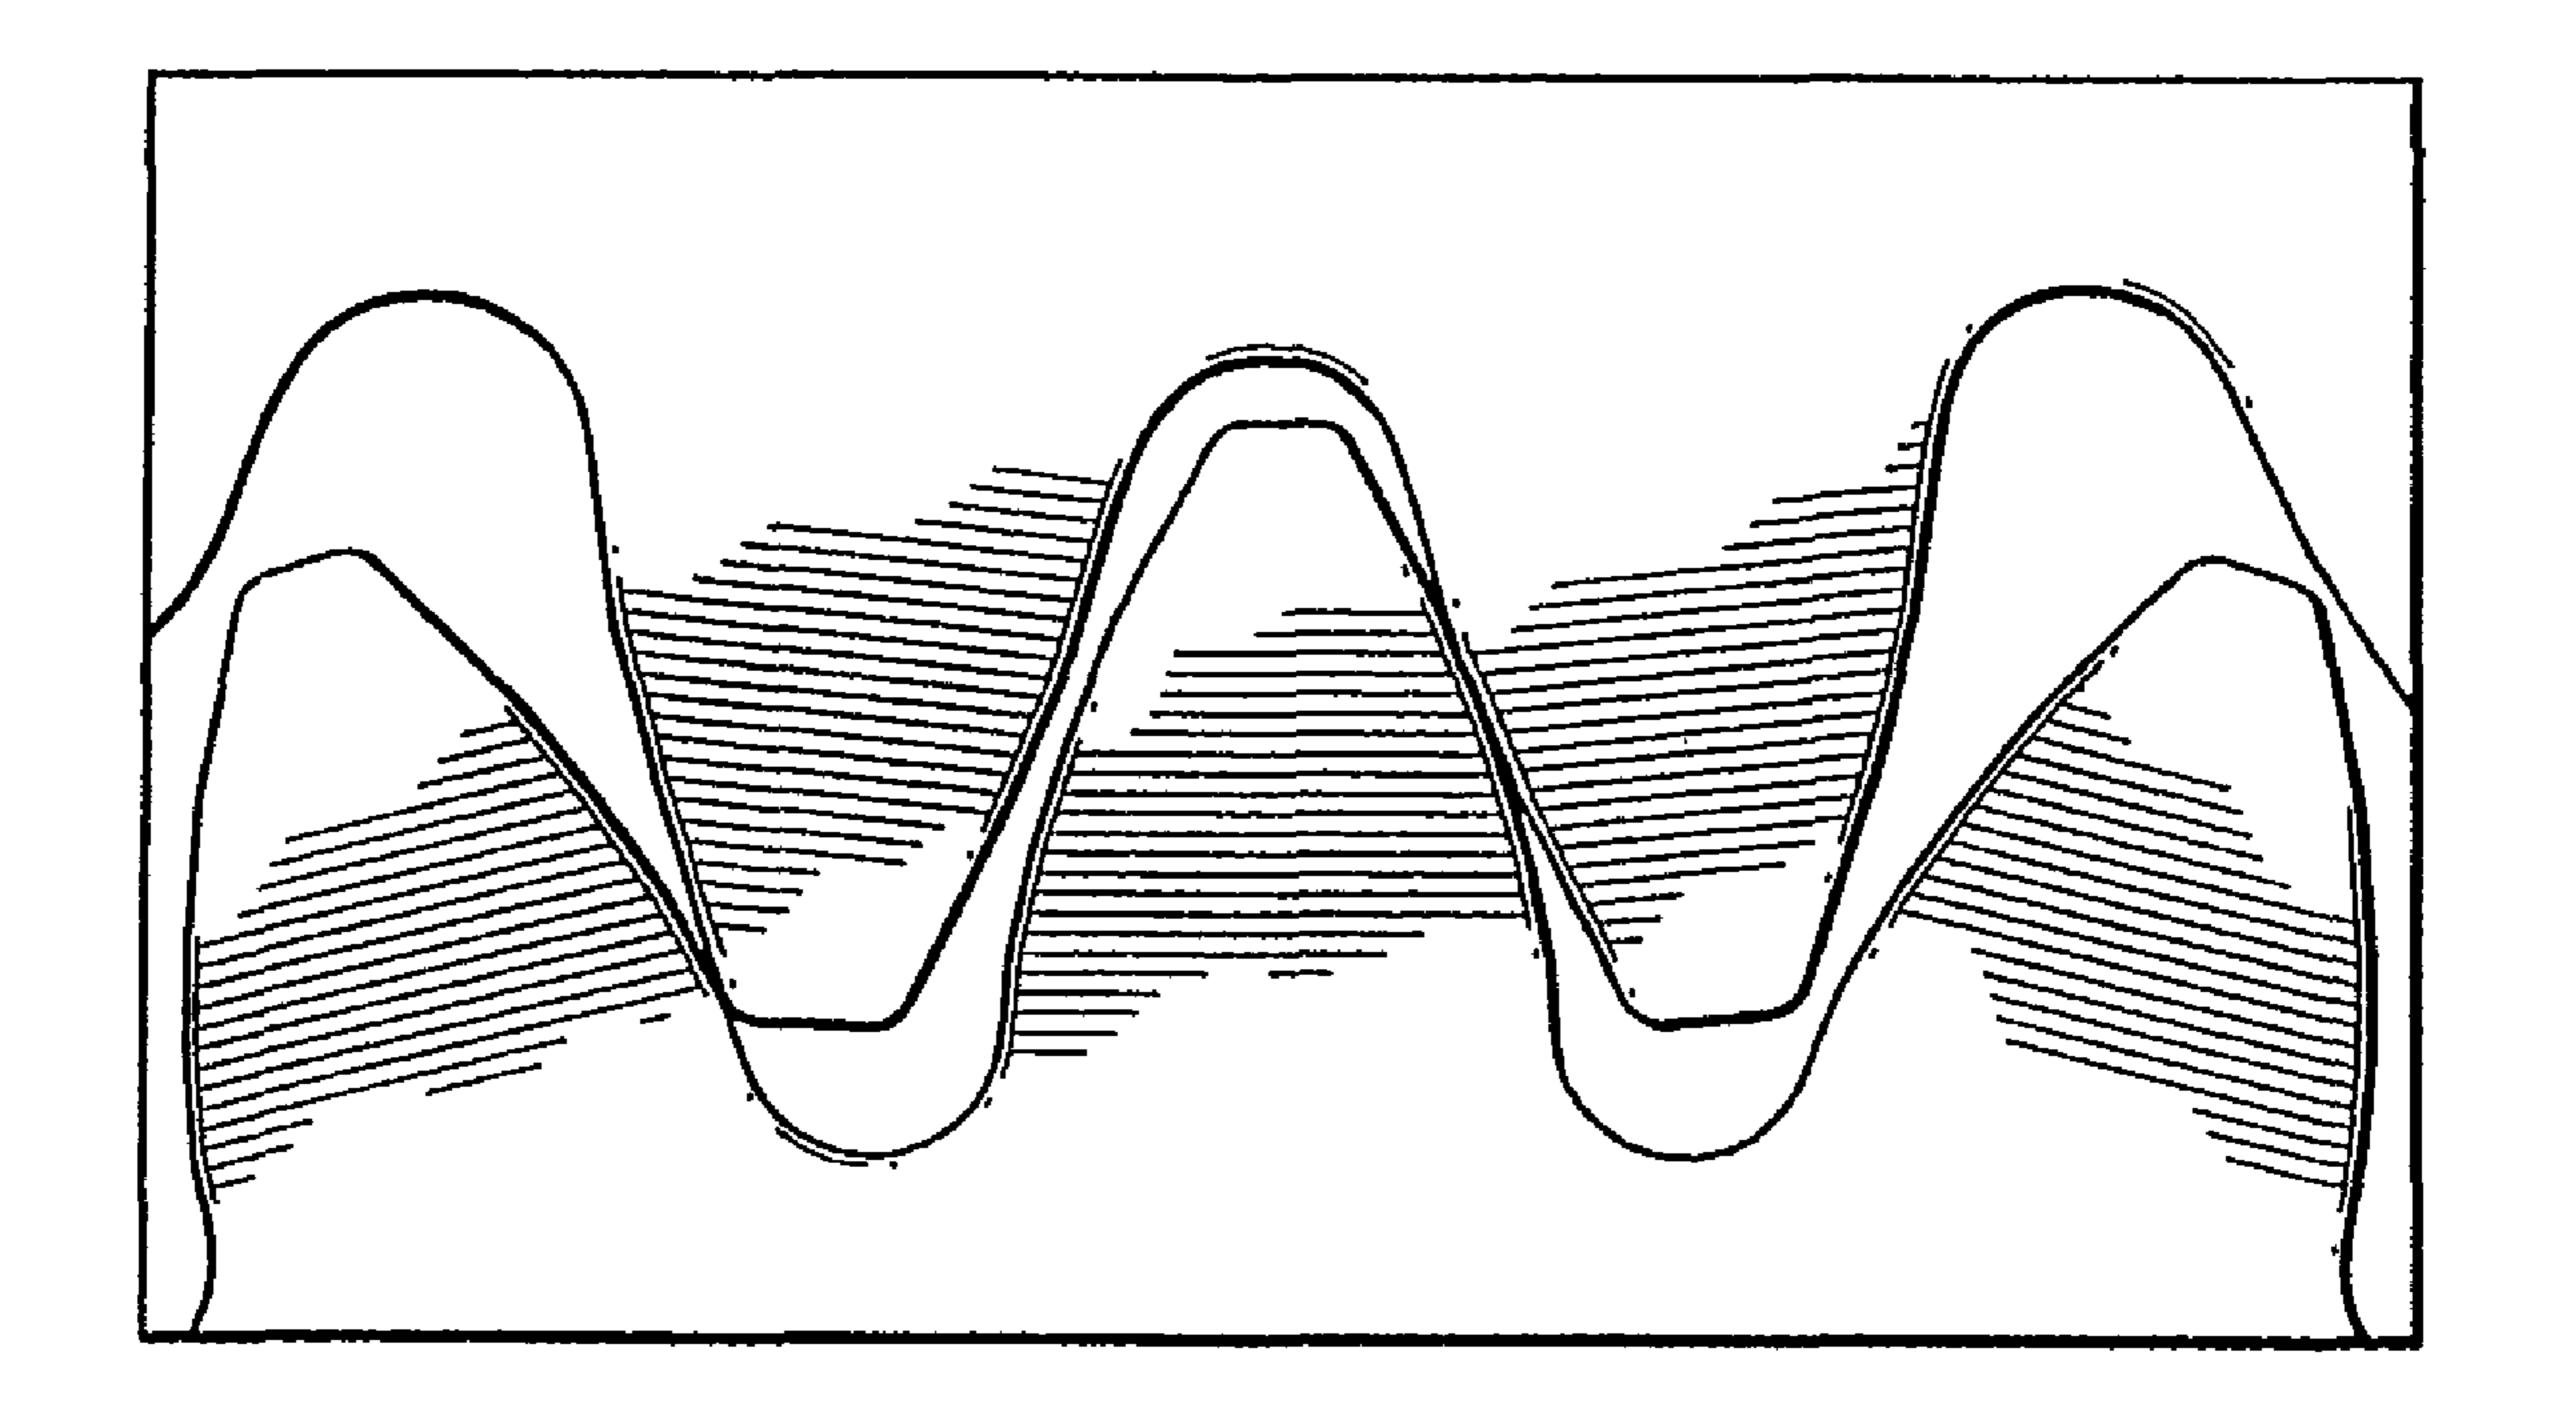
FIG. 38 illustrates a virt revised 34T to 20T design.

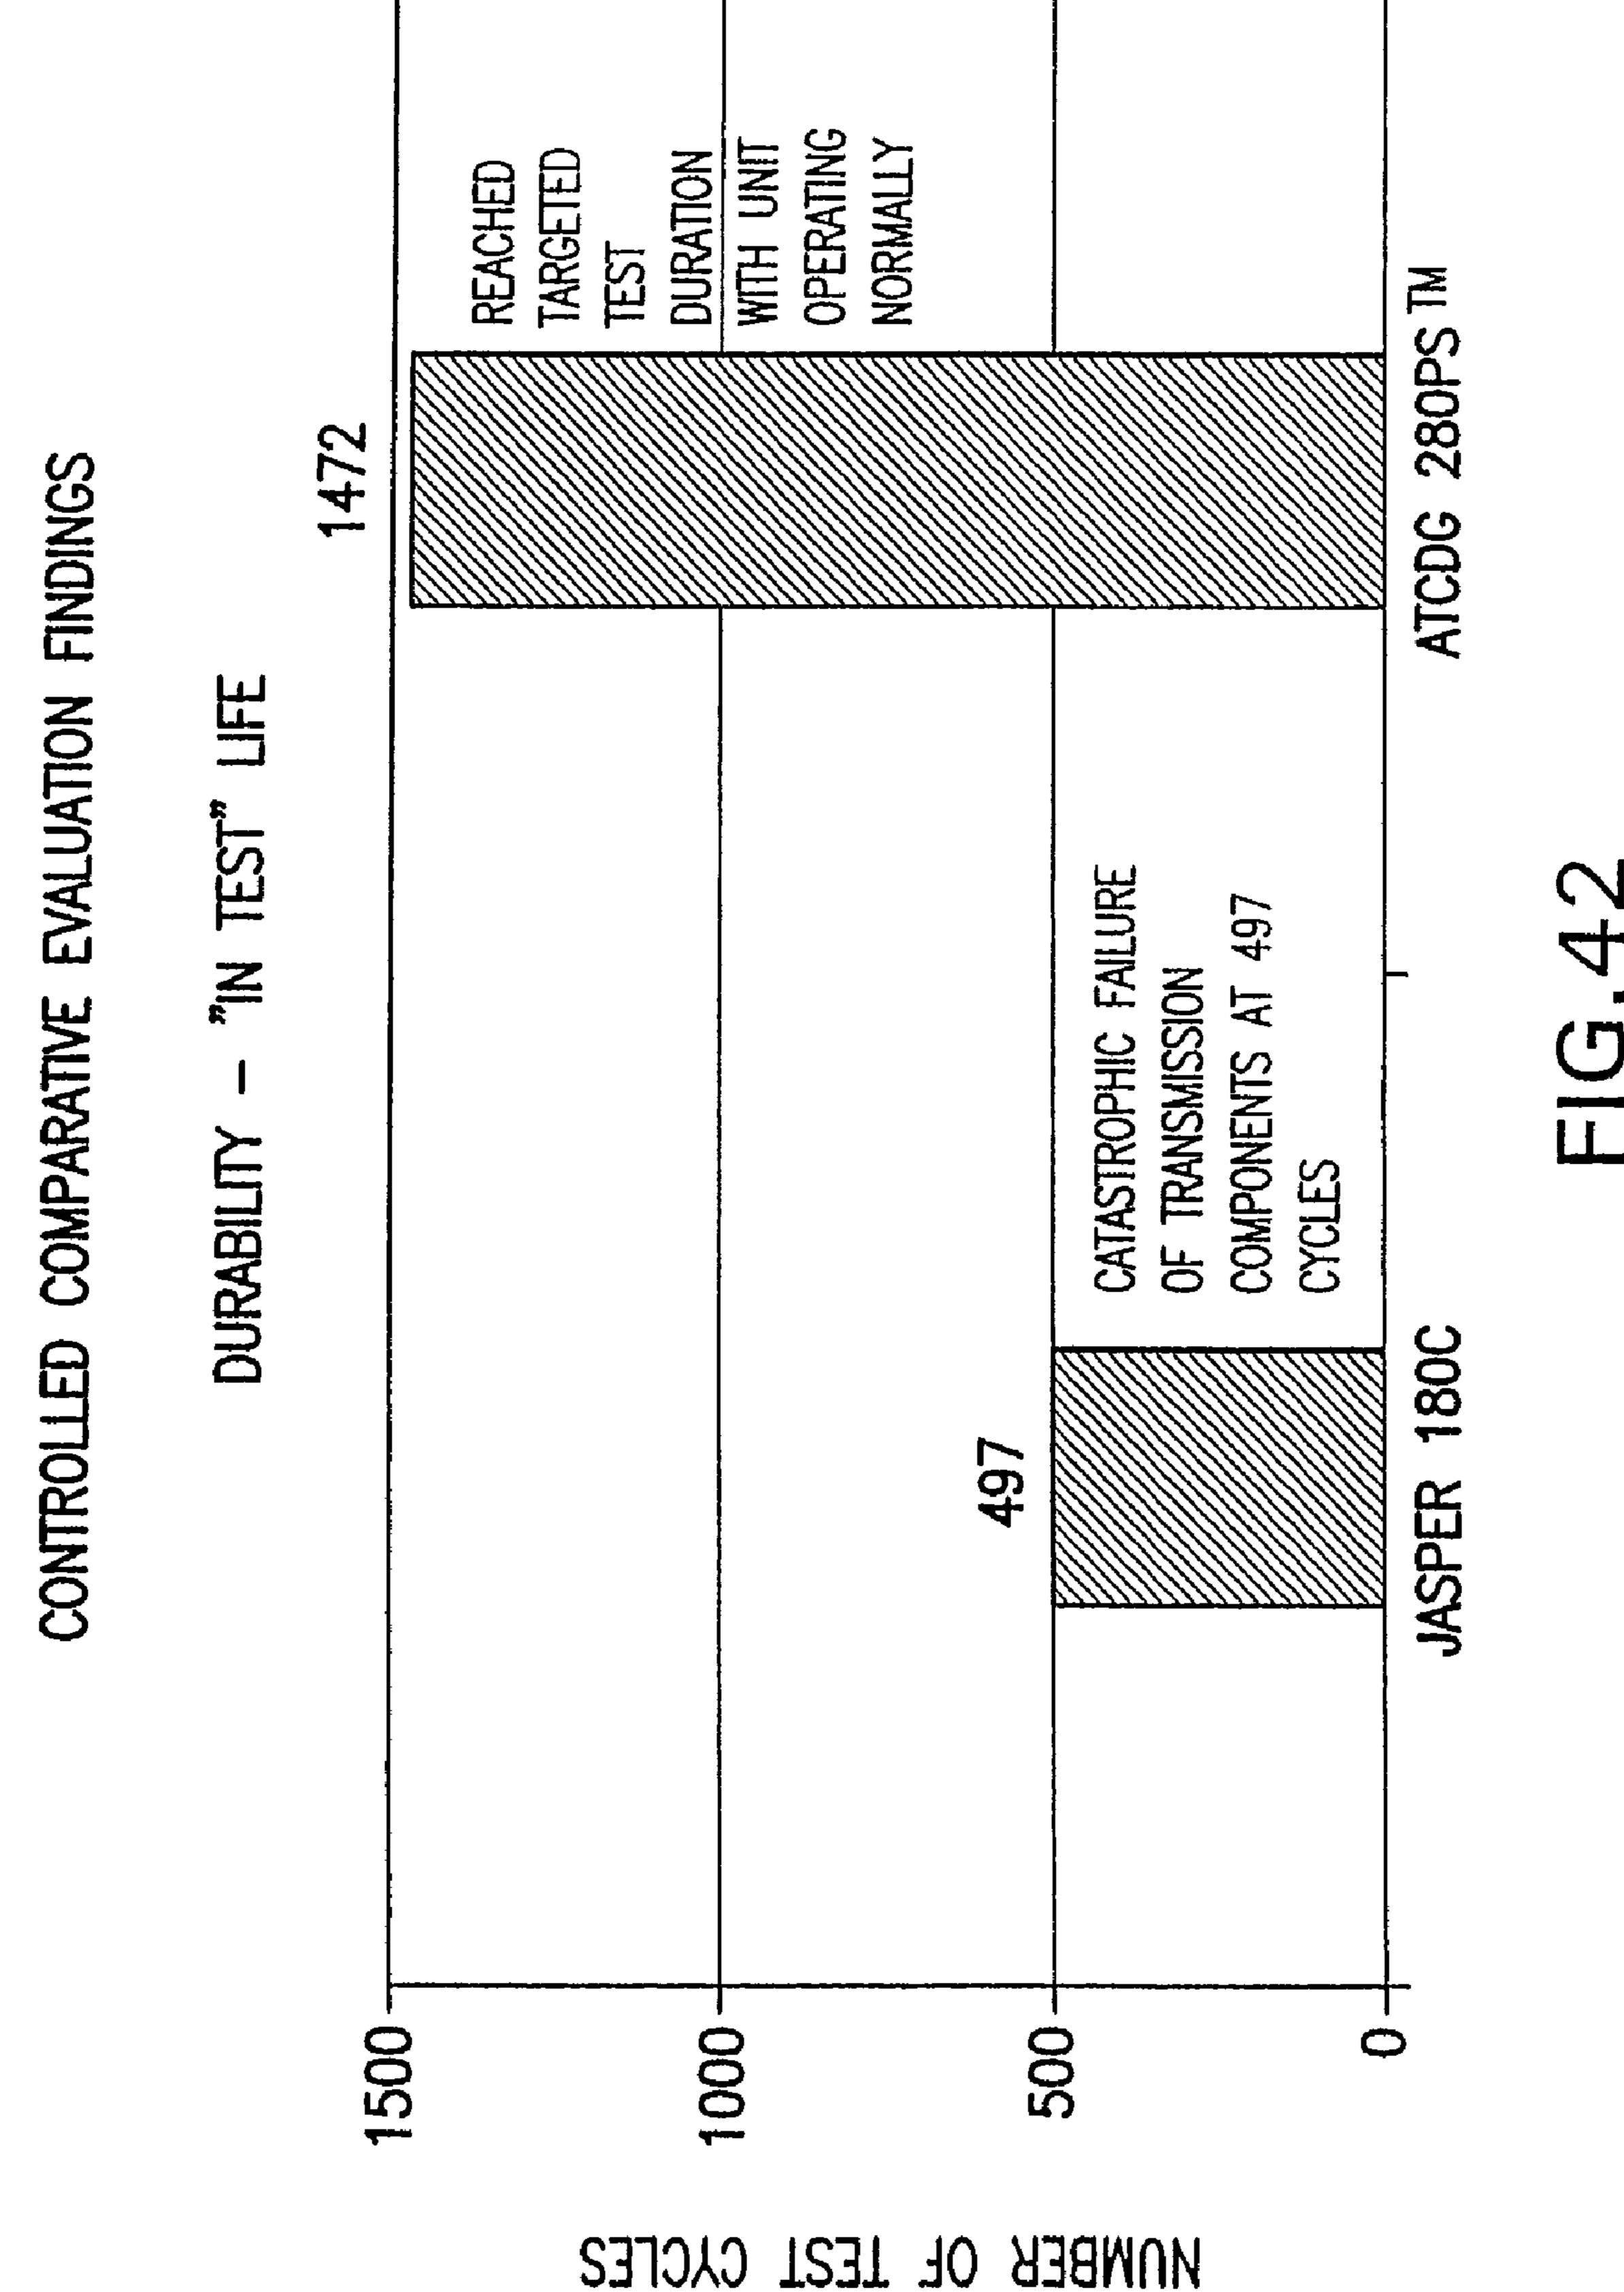
CONTROLLED COMPARATIVE EVALUATION FINDINGS

The 280PSTM operated normally through 1472 cycles, or three times the life of the 180C unit, which failed catastrophically at 497 cycles. At the time of its failure, the 180C unit had 75% more iron in the fluid (indicative of gear wear) and 375% more lead in the fluid (indicative of bearing wear) than the 280PSTM.
