# (12) United States Patent Lai

# (10) Patent No.: US 7,646,446 B2 (45) Date of Patent: Jan. 12, 2010

# (54) REPAIRING METHOD OF A THIN FILM TRANSISTOR ARRAY SUBSTRATE

A method for repairing a storage capacitor on gate or a storage capacitor on common line is described. A portion of each pixel electrode is disposed above a scan line or a common line. An upper electrode is disposed between the pixel electrode and the corresponding scan line or the common line. The pixel electrode and the upper electrode are electrically connected. A defective capacitor is formed when a particle/defect is produced between the upper electrode and the common line or the scan line. The method of repairing the defective capacitor includes removing a portion of the pixel electrode corresponding to the upper electrode of a defective storage capacitor and electrically isolating the upper electrode and the corresponding pixel electrode of the defective storage capacitor. The upper electrode and the scan line or the common line of the defective capacitor are welded together.

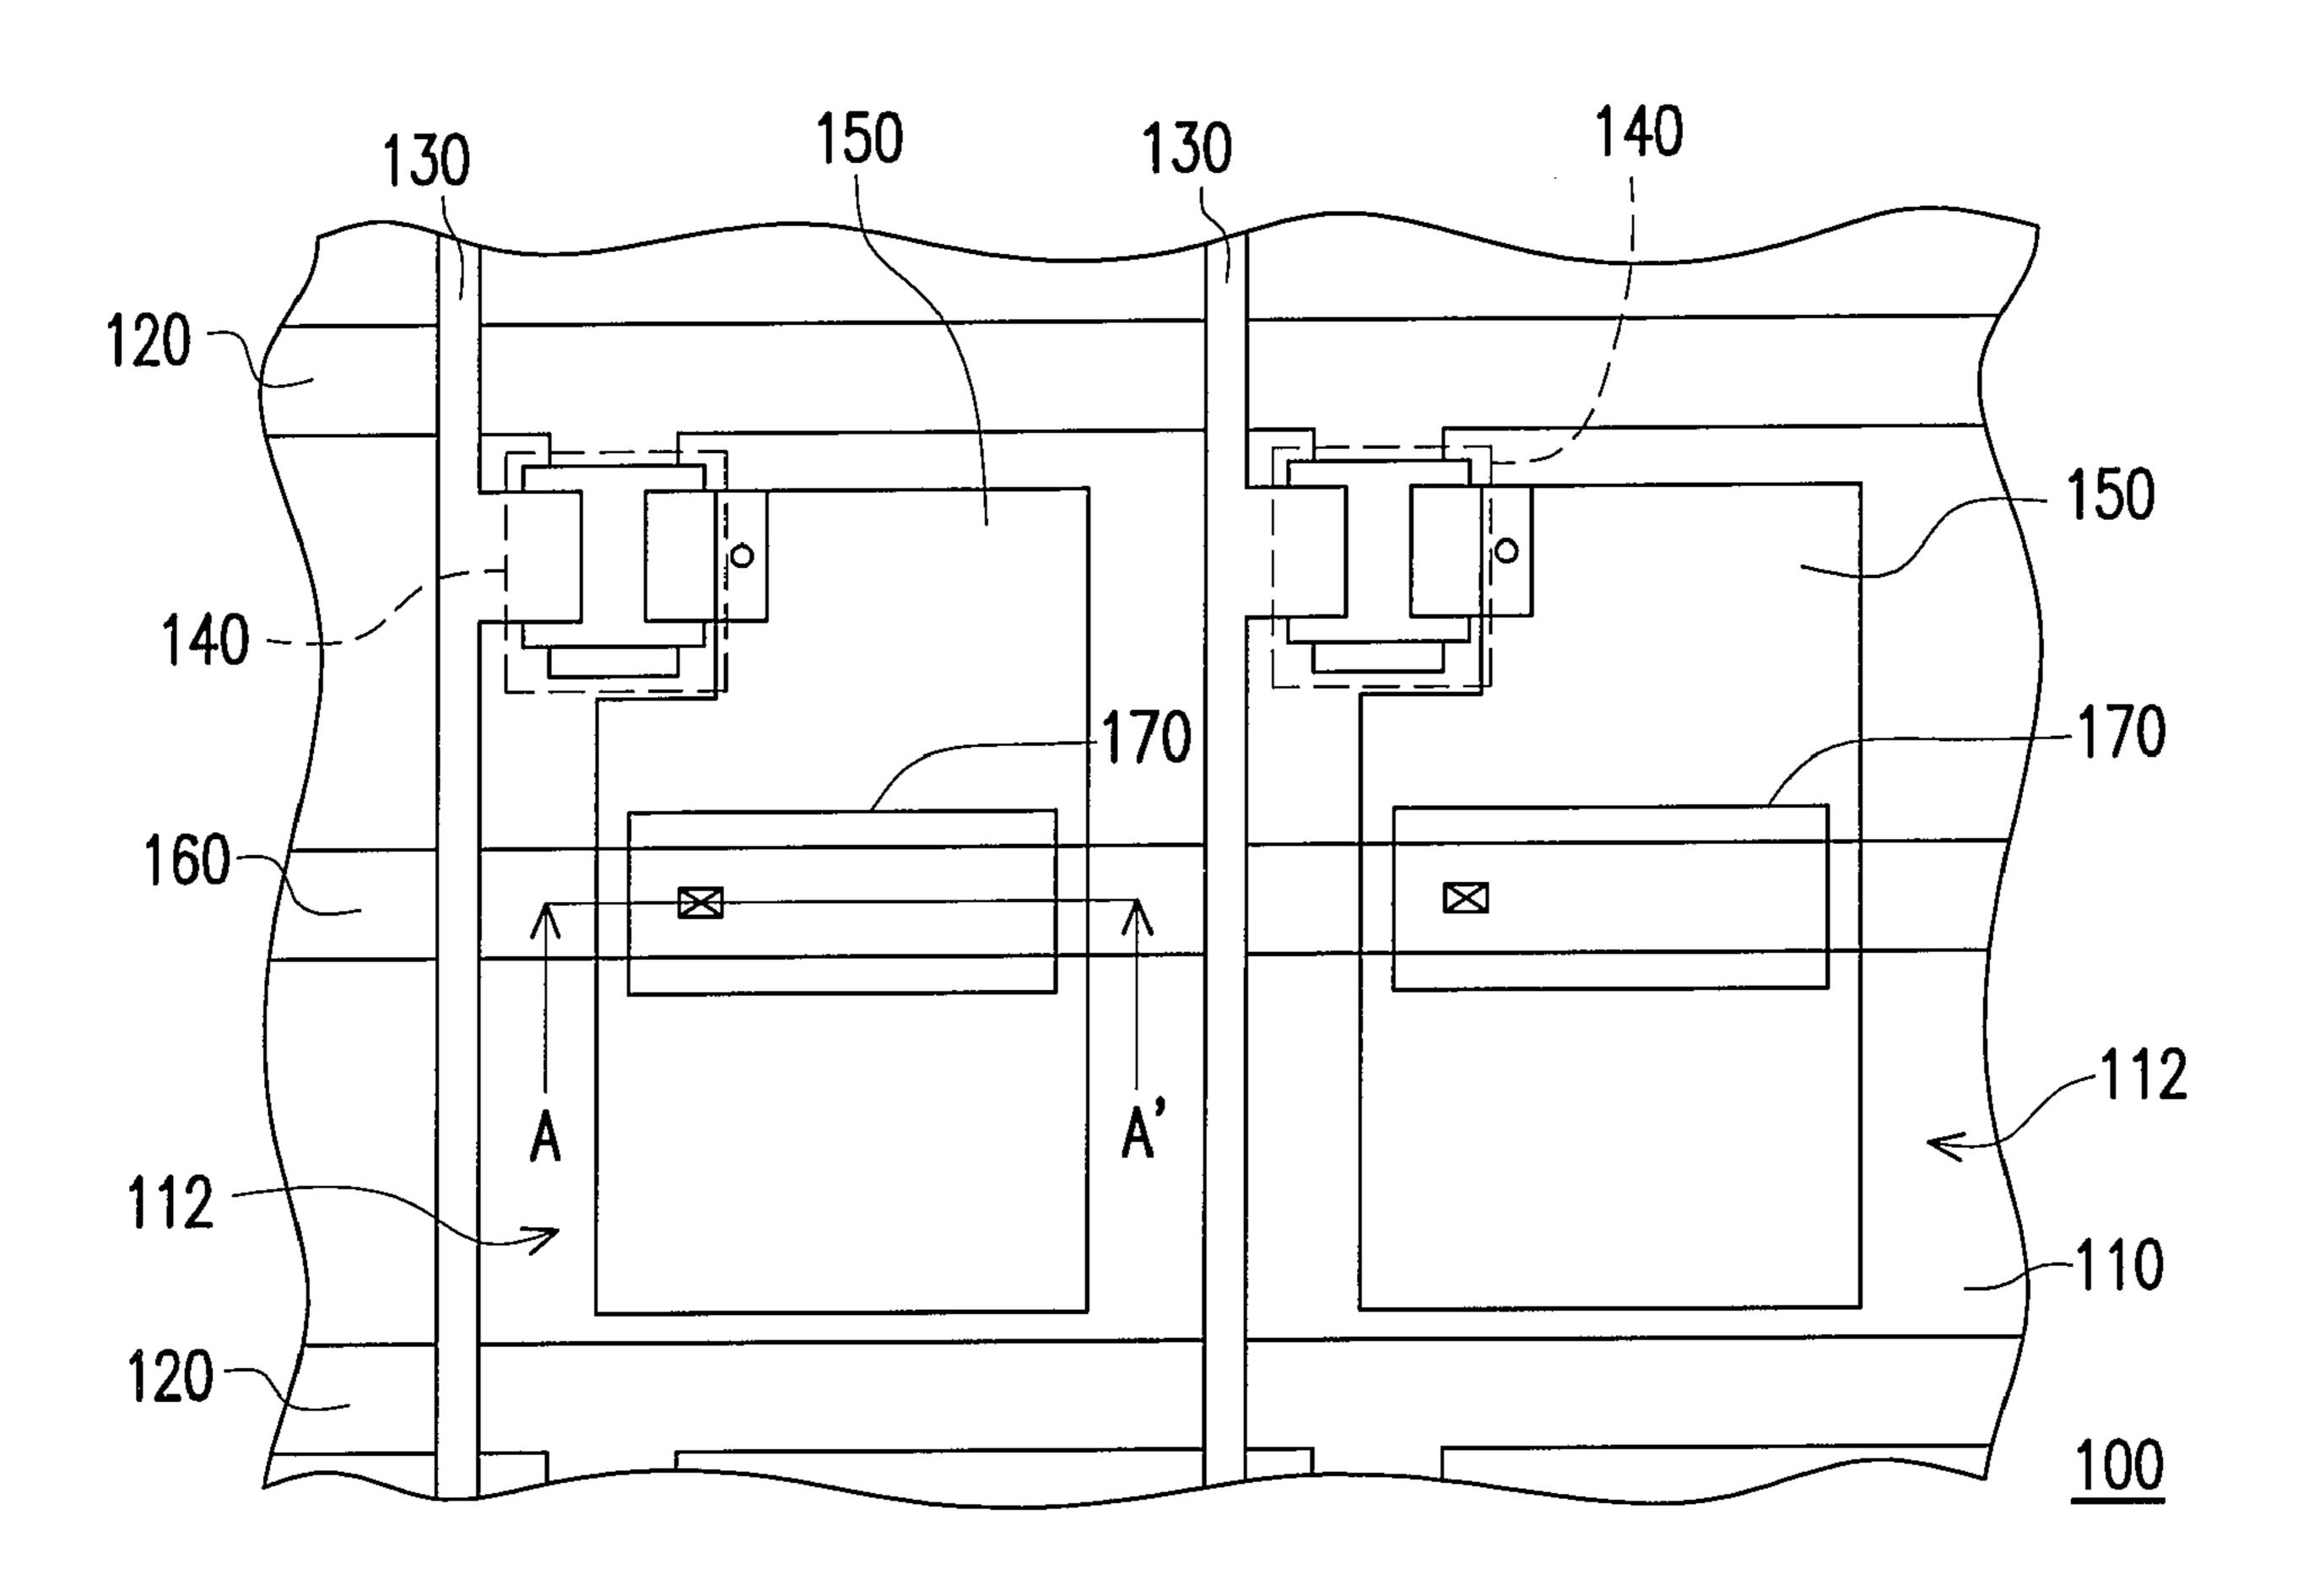
FIG. 1 (PRIOR ART)

FIG. 1 is a top view of a portion of a conventional thin film 65 transistor array substrate. FIG. 2 is a schematic cross-sectional view along line A-A' of the thin film transistor array

substrate in FIG. 1. As shown in FIGS. 1 and 2, a conventional thin film transistor array substrate 100 mainly comprises a substrate 110, a plurality of scan lines 120, a plurality of data lines 130, a plurality of thin film transistors 140, a plurality of pixel electrodes 150, a plurality of common lines 160 (only one is shown) and a plurality of upper electrode 170.

The scan lines 120 and the data lines 130 are disposed over the substrate 110 to define a plurality of pixel areas 112. Each thin film transistor 140 is disposed inside one of the pixel areas 112 and is driven by one of the scan lines 120 and data lines 130. Each pixel electrode 150 is also disposed inside one of the pixel areas 112 and is electrically connected to one of the thin film transistors 140. The common line 160 is disposed over the substrate 110 such that a portion of the pixel electrode 150 is above one of the common lines 160.

In addition, an upper electrode 170 is disposed between each pixel electrode 150 and one of the common lines 160. Furthermore, a dielectric layer 180 is disposed between the upper electrode 170 and the corresponding common line 160 for isolating the upper electrode 170 and the common line 160. Another dielectric layer 190 is also disposed between the upper electrode 170 and one of the pixel electrodes 150. The dielectric layer 190 has a contact 192 for connecting the upper electrode 170 and the corresponding pixel electrode 150 electrically together.

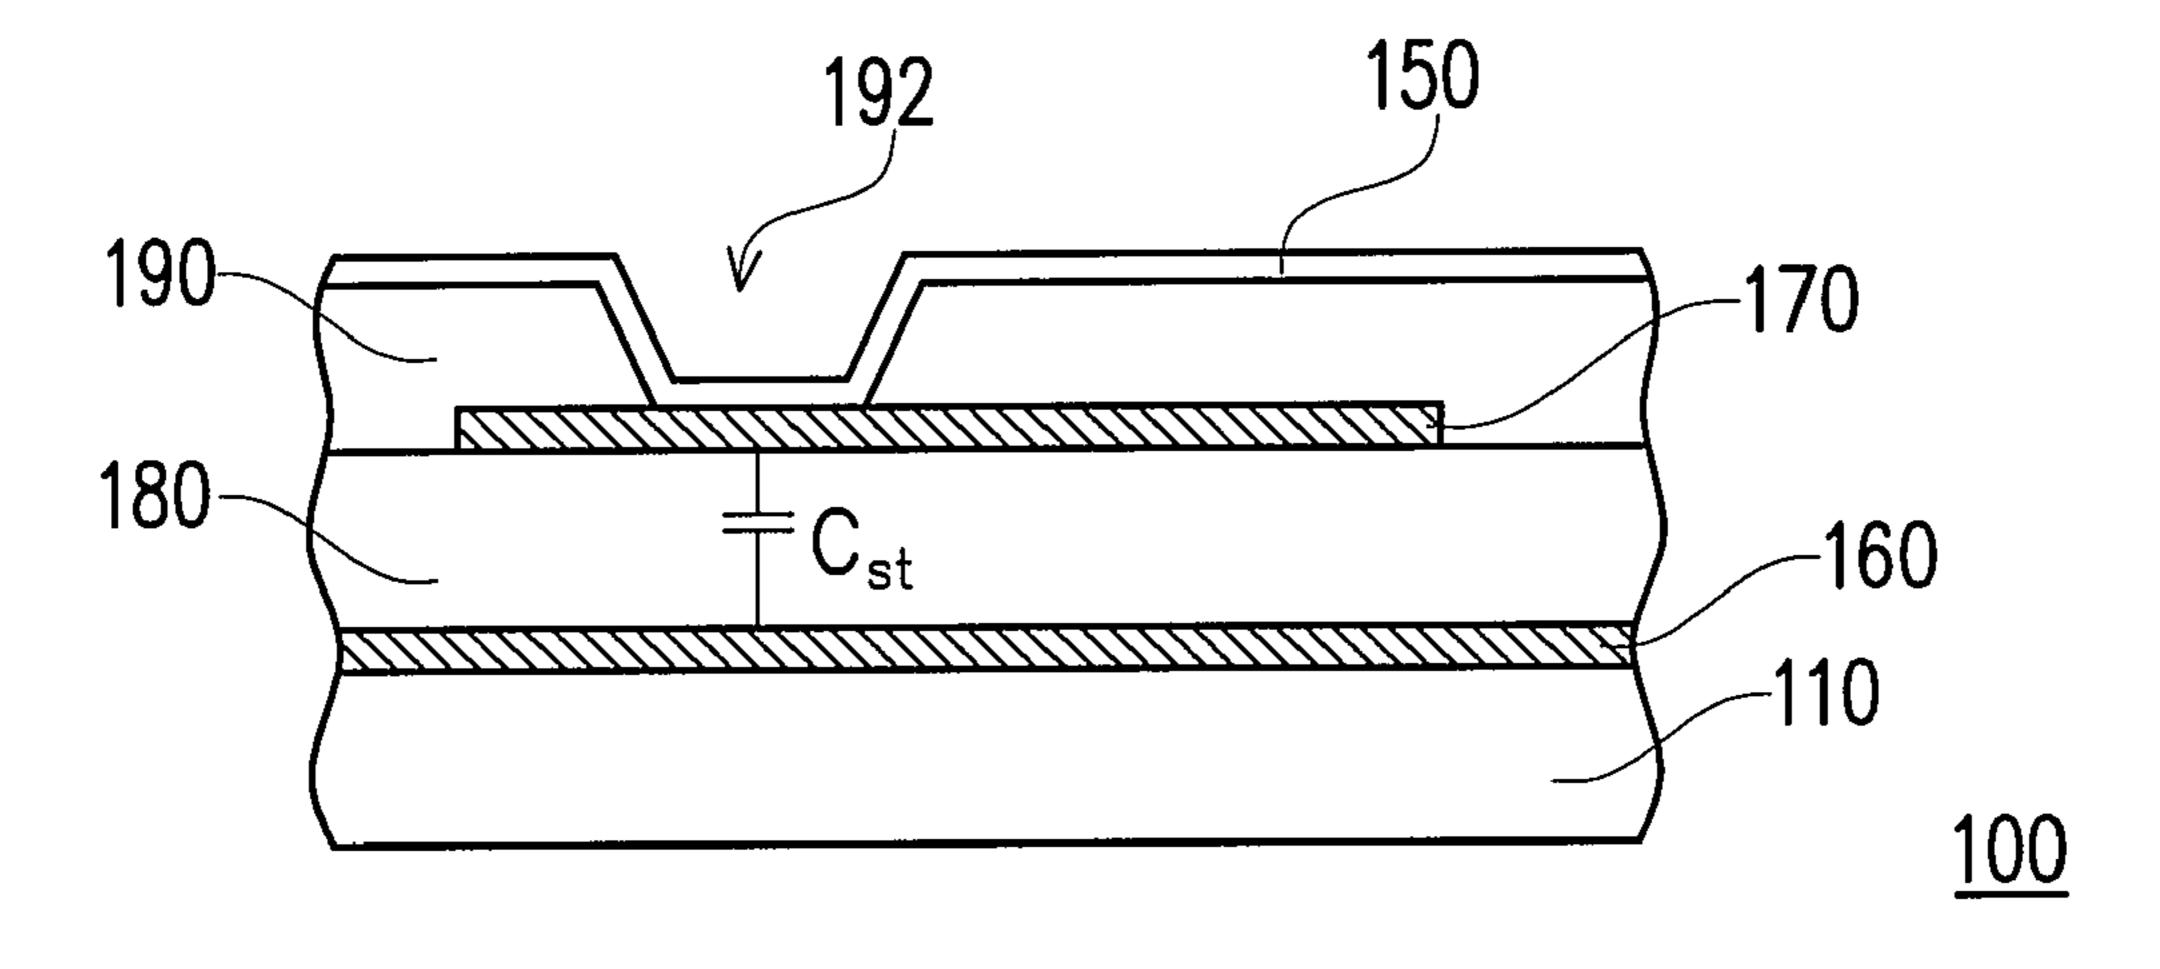
FIG. 2 (PRIOR ART)

As shown in FIG. 2, the upper electrode 170 and the corresponding common line 160 together form a storage capacitor (Cst) that smooth out the normal operation of various pixels within the thin film transistor liquid crystal display. However, any processing defect or other factors may lead to some particles falling into the dielectric layer 180 or trapped in the defects within the dielectric layer 180 and produce a leaky capacitor. Ultimately, the display quality of the pixel will be compromised.

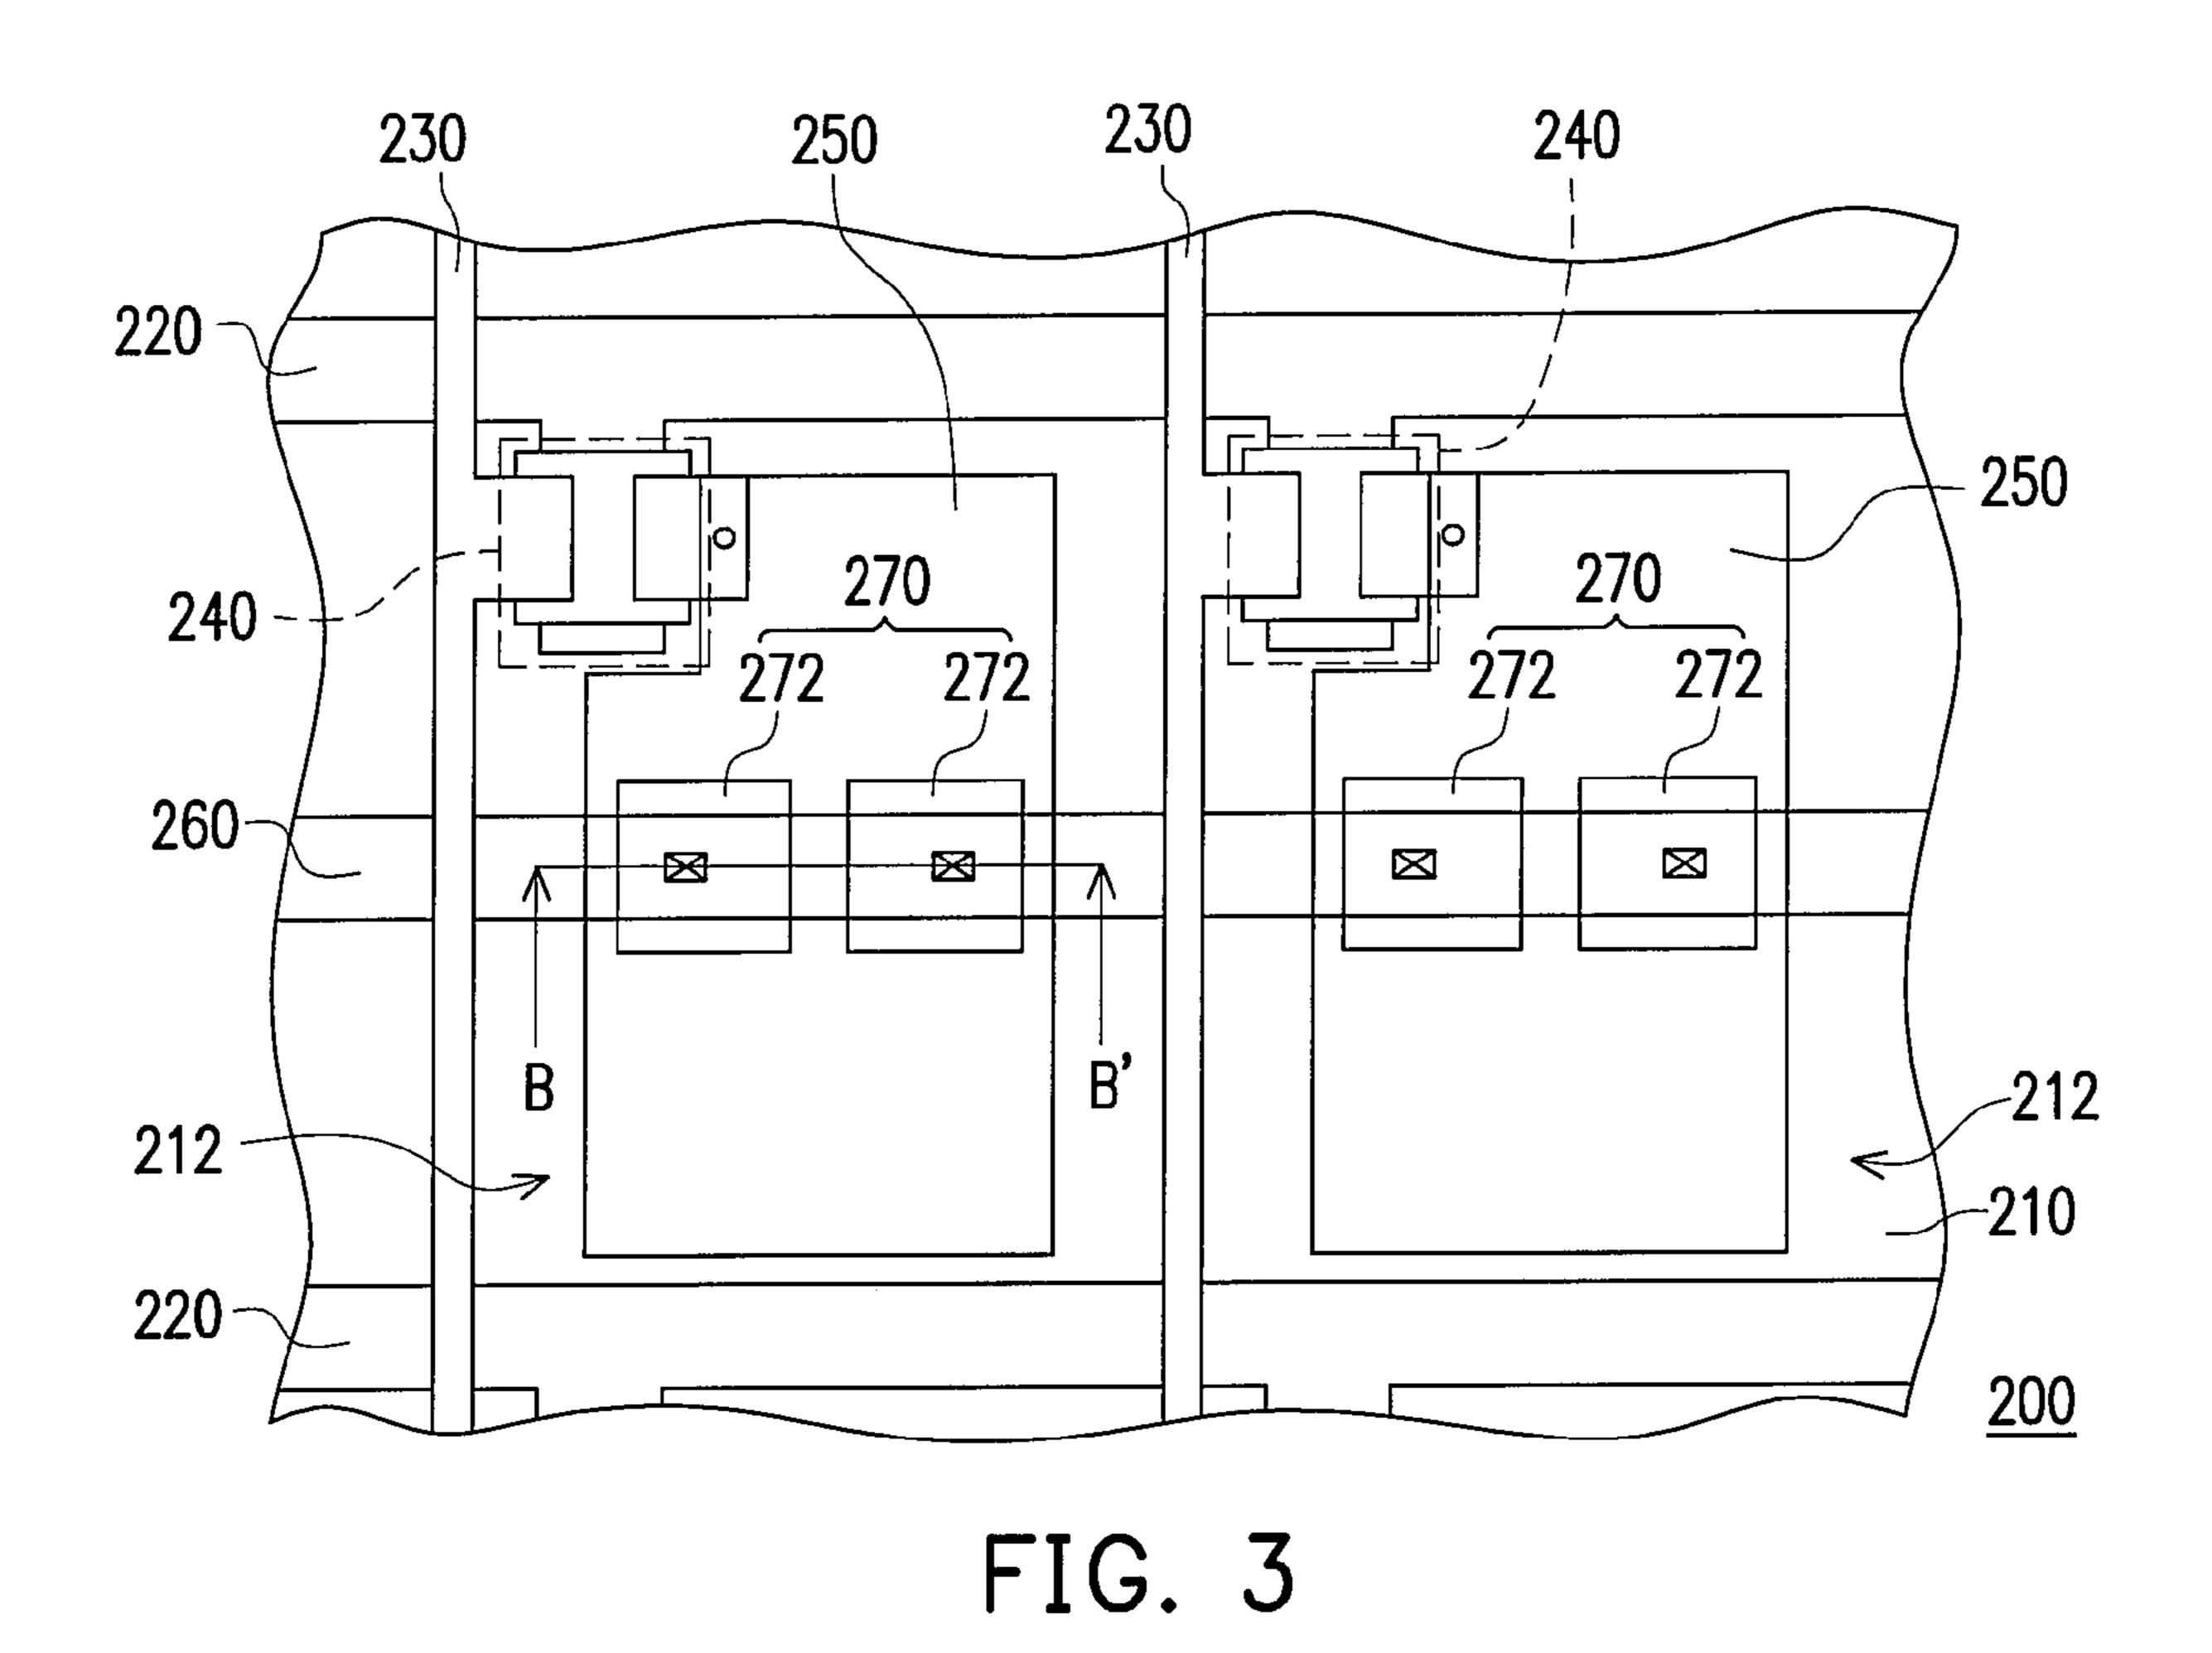
FIG. 3 is a top view of a thin film transistor array substrate according to one preferred embodiment of the present invention. FIG. 4 is a schematic cross-sectional view along line B-B' of the thin film transistor array substrate in FIG. 3. As shown in FIGS. 3 and 4, the thin film transistor array substrate 200 mainly comprises a substrate 210, a plurality of scan lines 220, a plurality of data lines 230, a plurality of thin film transistor 240, a plurality of pixel electrodes 250, a plurality of common lines 260 (only one is shown) and a patterned upper electrode 270.

The scan lines 220 and the data lines 230 are disposed over the substrate 210 to define a plurality of pixel areas 212. Each thin film transistors 240 is disposed inside one of the pixel areas 212 and driven by one of the scan lines 220 and one of the data lines 230. Each pixel electrode 250 is disposed inside one of the pixel areas 212 and electrically connected to one of the thin film transistors 240. The common line 260 is disposed over the substrate 210 such that a portion of each pixel electrode 250 is above one of the common lines 260.

The patterned upper electrode 270 is disposed between each pixel electrode 250 and the corresponding common line 260. A dielectric layer 280 is disposed between the patterned upper electrode 270 and the common line 260. Another dielectric layer 290 is disposed between the patterned upper electrode 270 and the pixel electrode 250. It should be noted that the patterned upper electrode 270 comprises a plurality of sub-upper electrodes 272 (only two of them are shown). A portion of each sub-upper electrode 272 is electrically connected to one of the pixel electrodes 250. For example, a contact 292 is formed in the dielectric layer 290 above each sub-upper electrode 272 so that each sub-upper electrode 272 is electrically connected to one of the pixel electrodes 250. Hence, the sub-upper electrode 272 and one of the common lines 260 together form a storage capacitor (Cst).

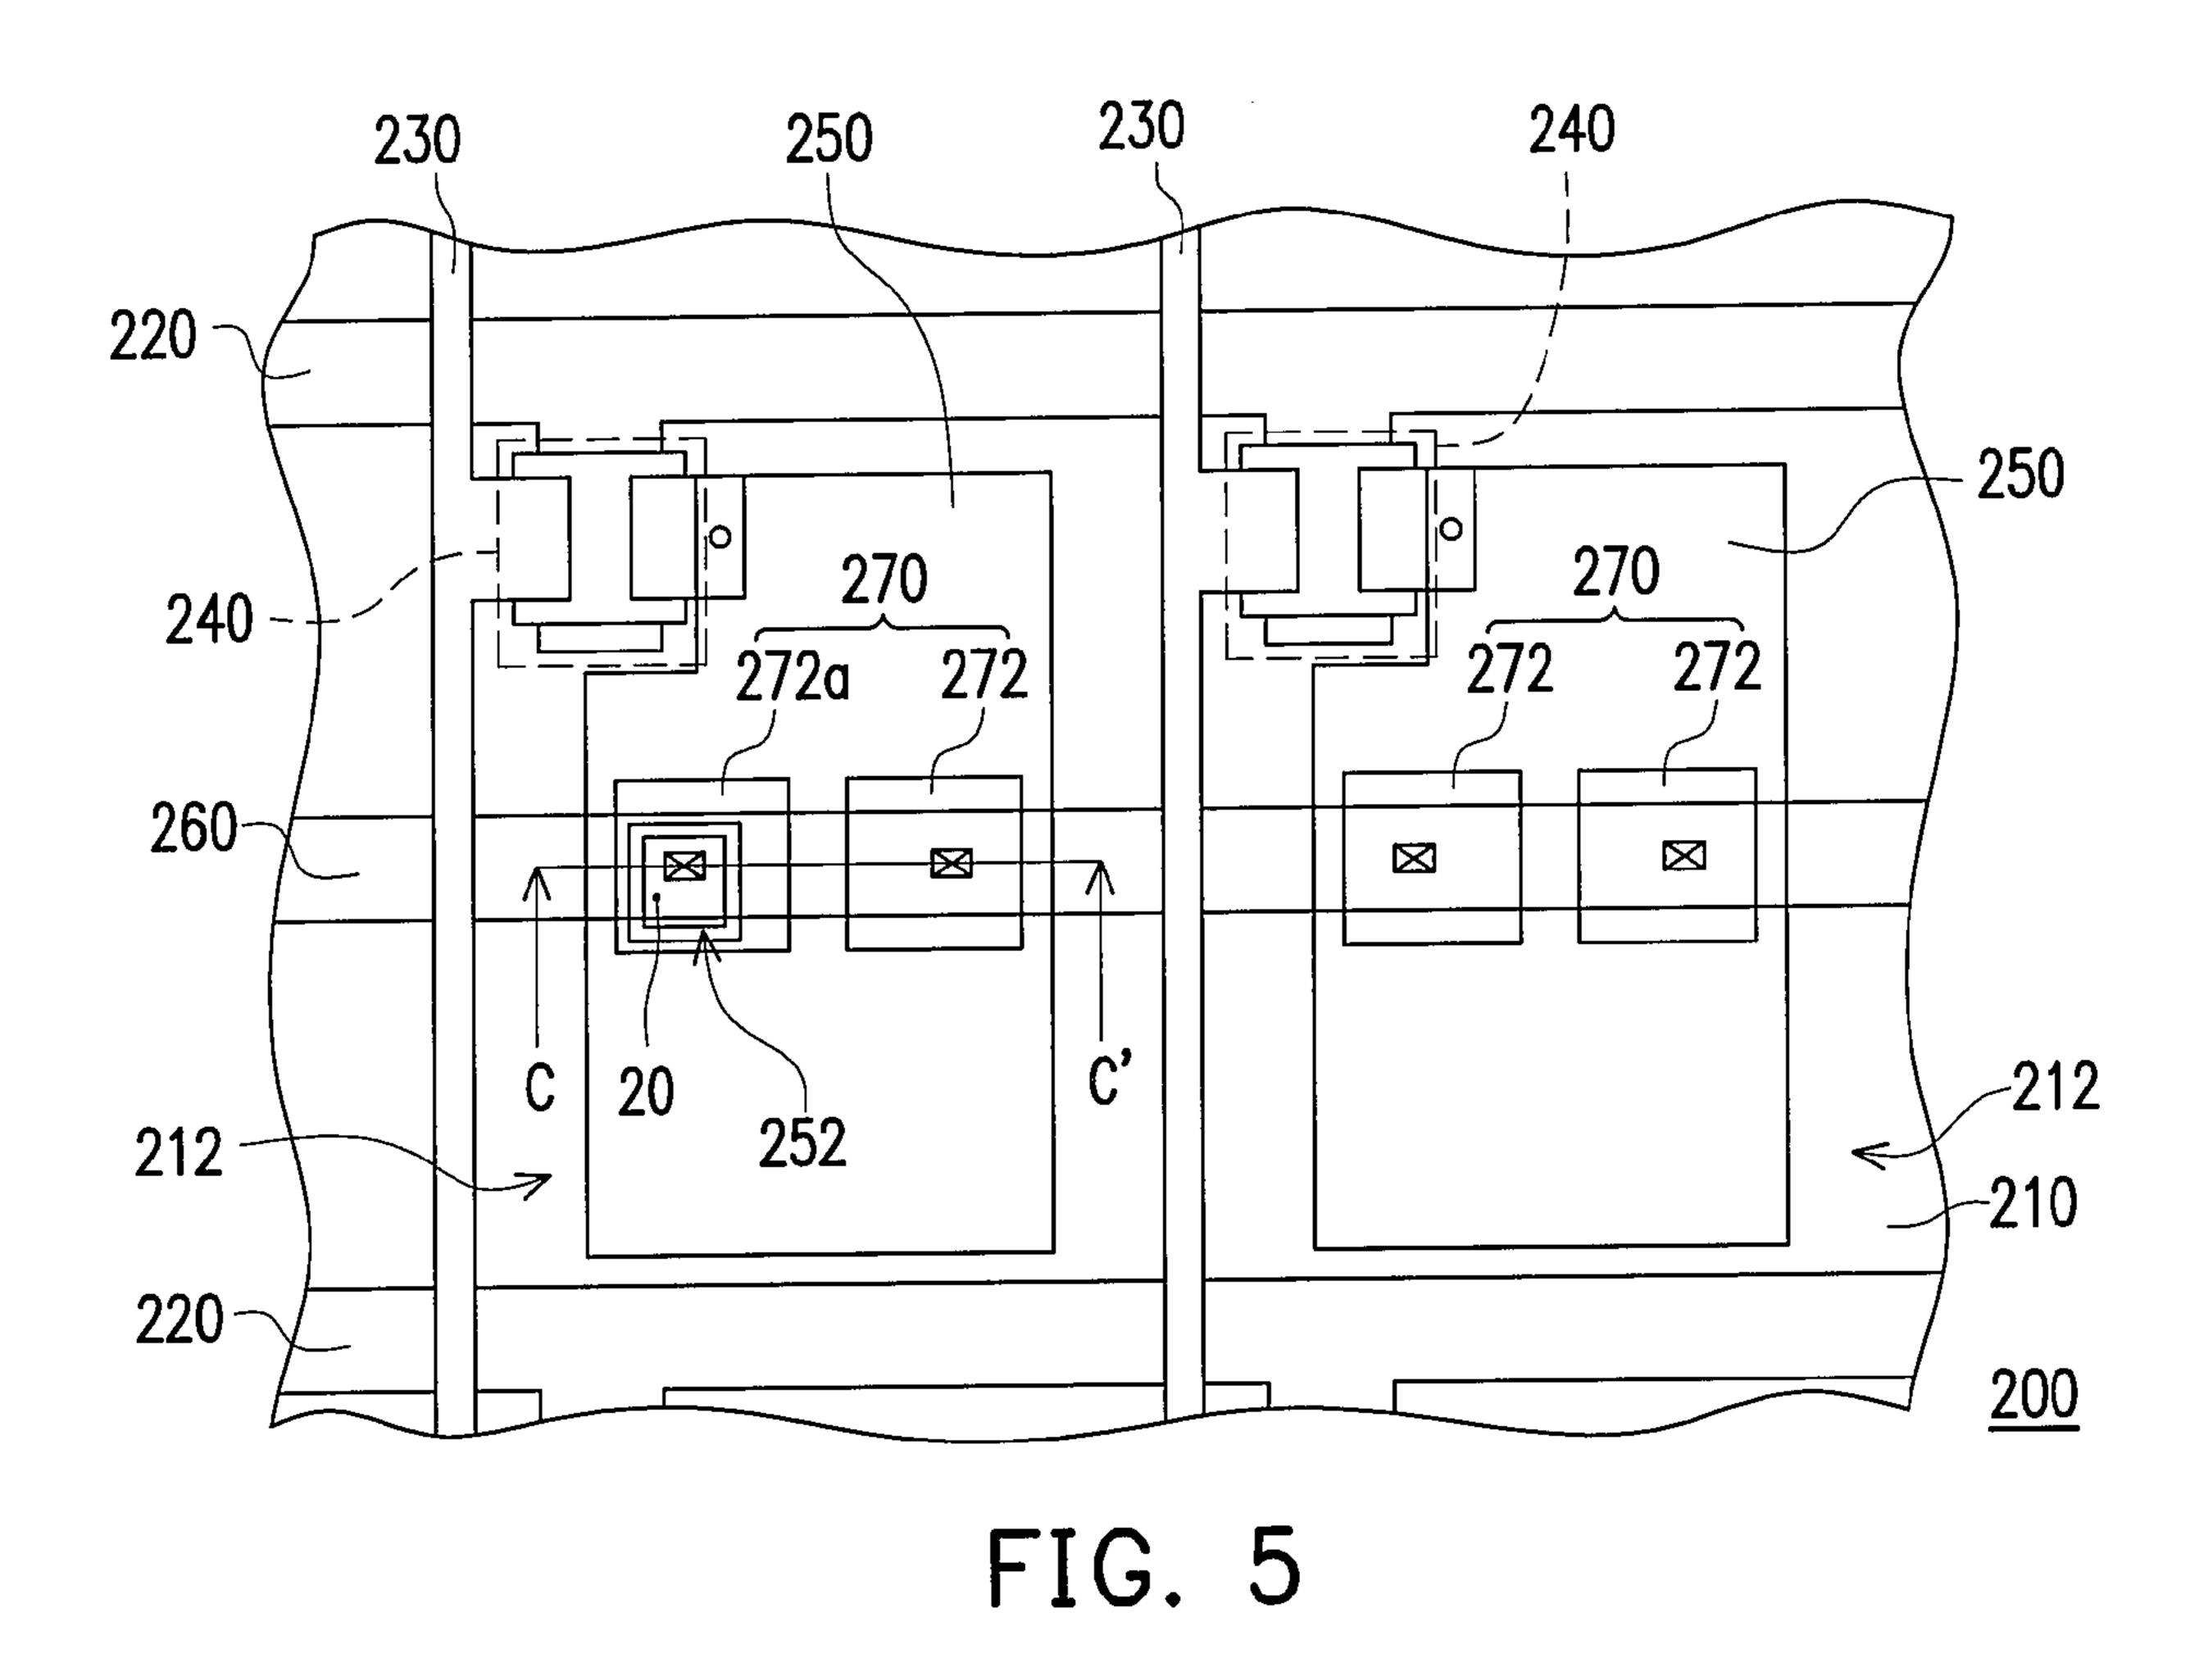
strate in FIG. 3 after performing a laser repairing operation. FIG. 6 is a schematic cross-sectional view along C-C' of the thin film transistor array substrate shown in FIG. 5. As shown in FIGS. 5 and 6, if there is a particle (or defect) in the material between one of the sub-upper electrodes 272 and one of the common lines 260, leakage between the sub-upper electrode 272a and the common line 260 may occur. Thus, the pixel may display abnormally and need a repair. The method of repairing the pixel includes removing a portion of the pixel electrode 250 corresponding to the sub-upper electrode 272a and the corresponding to the sub-upper electrode 272a and the corresponding pixel electrode 250 of the defective capacitor are electrically isolated.

In the present embodiment, a portion of the pixel electrode **250** above the sub-upper electrode **272***a* of the corresponding defective capacitor is removed to form an opening **252**. The method of removing a portion of the pixel electrode **250** includes laser ablation, for example. The opening **252** is located around the contact area between the sub-upper electrode **272***a* and the corresponding pixel electrode **250** of the defective capacitor (that is, around the contact **292**). By forming the opening **252**, the sub-upper electrode **272***a* and the corresponding pixel electrode **272***a* and the corresponding pixel electrode **250** of the defective capacitor

are electrically isolated. Since the repair causes no disruption to other sub-upper electrodes, the repaired pixel electrode **250** can function properly.

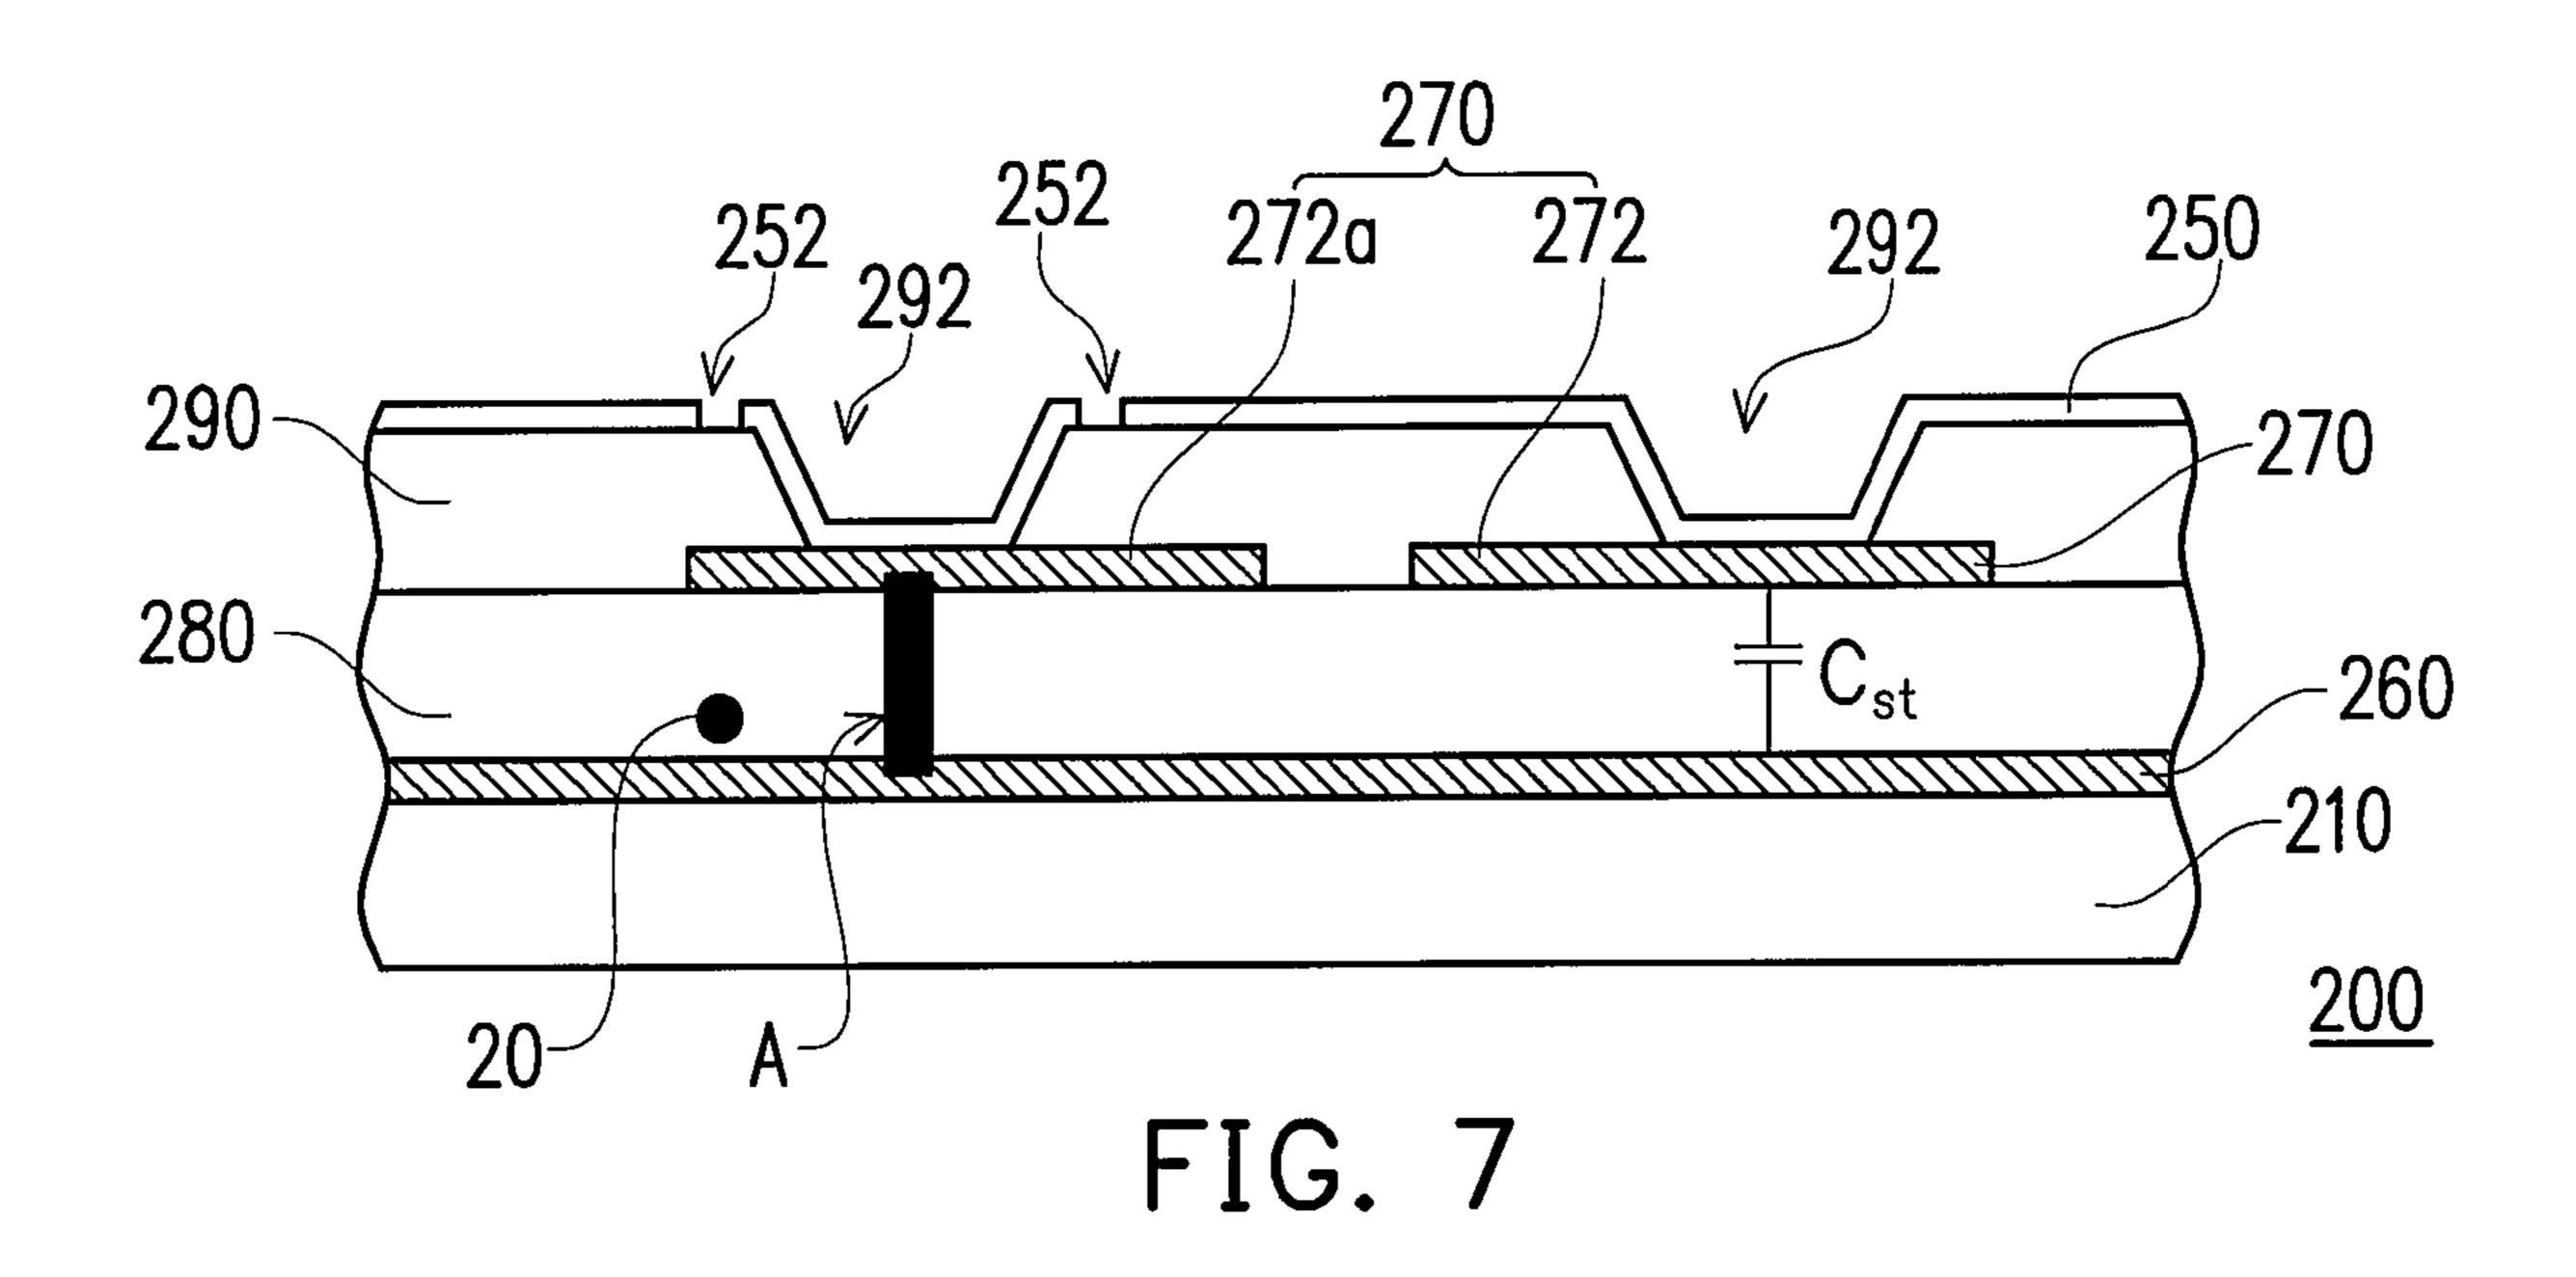
FIG. 7 is a schematic cross-sectional view showing the electrical connection between the common line and the subupper electrode in a defective capacitor for repairing a thin film transistor array substrate according to one preferred embodiment of the present invention. After removing a portion of the pixel electrode 250 corresponding to the sub-upper electrode 272a of the defective capacitor to isolate the subupper electrode 272a and the pixel electrode 250 electrically, the sub-upper electrode 272a and the corresponding common line **260** are welded together (labeled A). Hence, the subupper electrode 272a and the common line 260 of the defective capacitor are configured at the same potential to prevent any leakage via the particles (or defects). The sub-upper electrode 272a and the corresponding common line 260 are welded together by performing a laser welding process, for example.

In the present invention, the location at which the sub-upper electrode 272a and the corresponding common line 260 of the defective capacitor weld together is underneath the contact 292. However, anyone familiar with the technologies may choose other suitable locations convenient for welding the sub-upper electrode 272a and the corresponding common line 260 of the defective capacitor together.

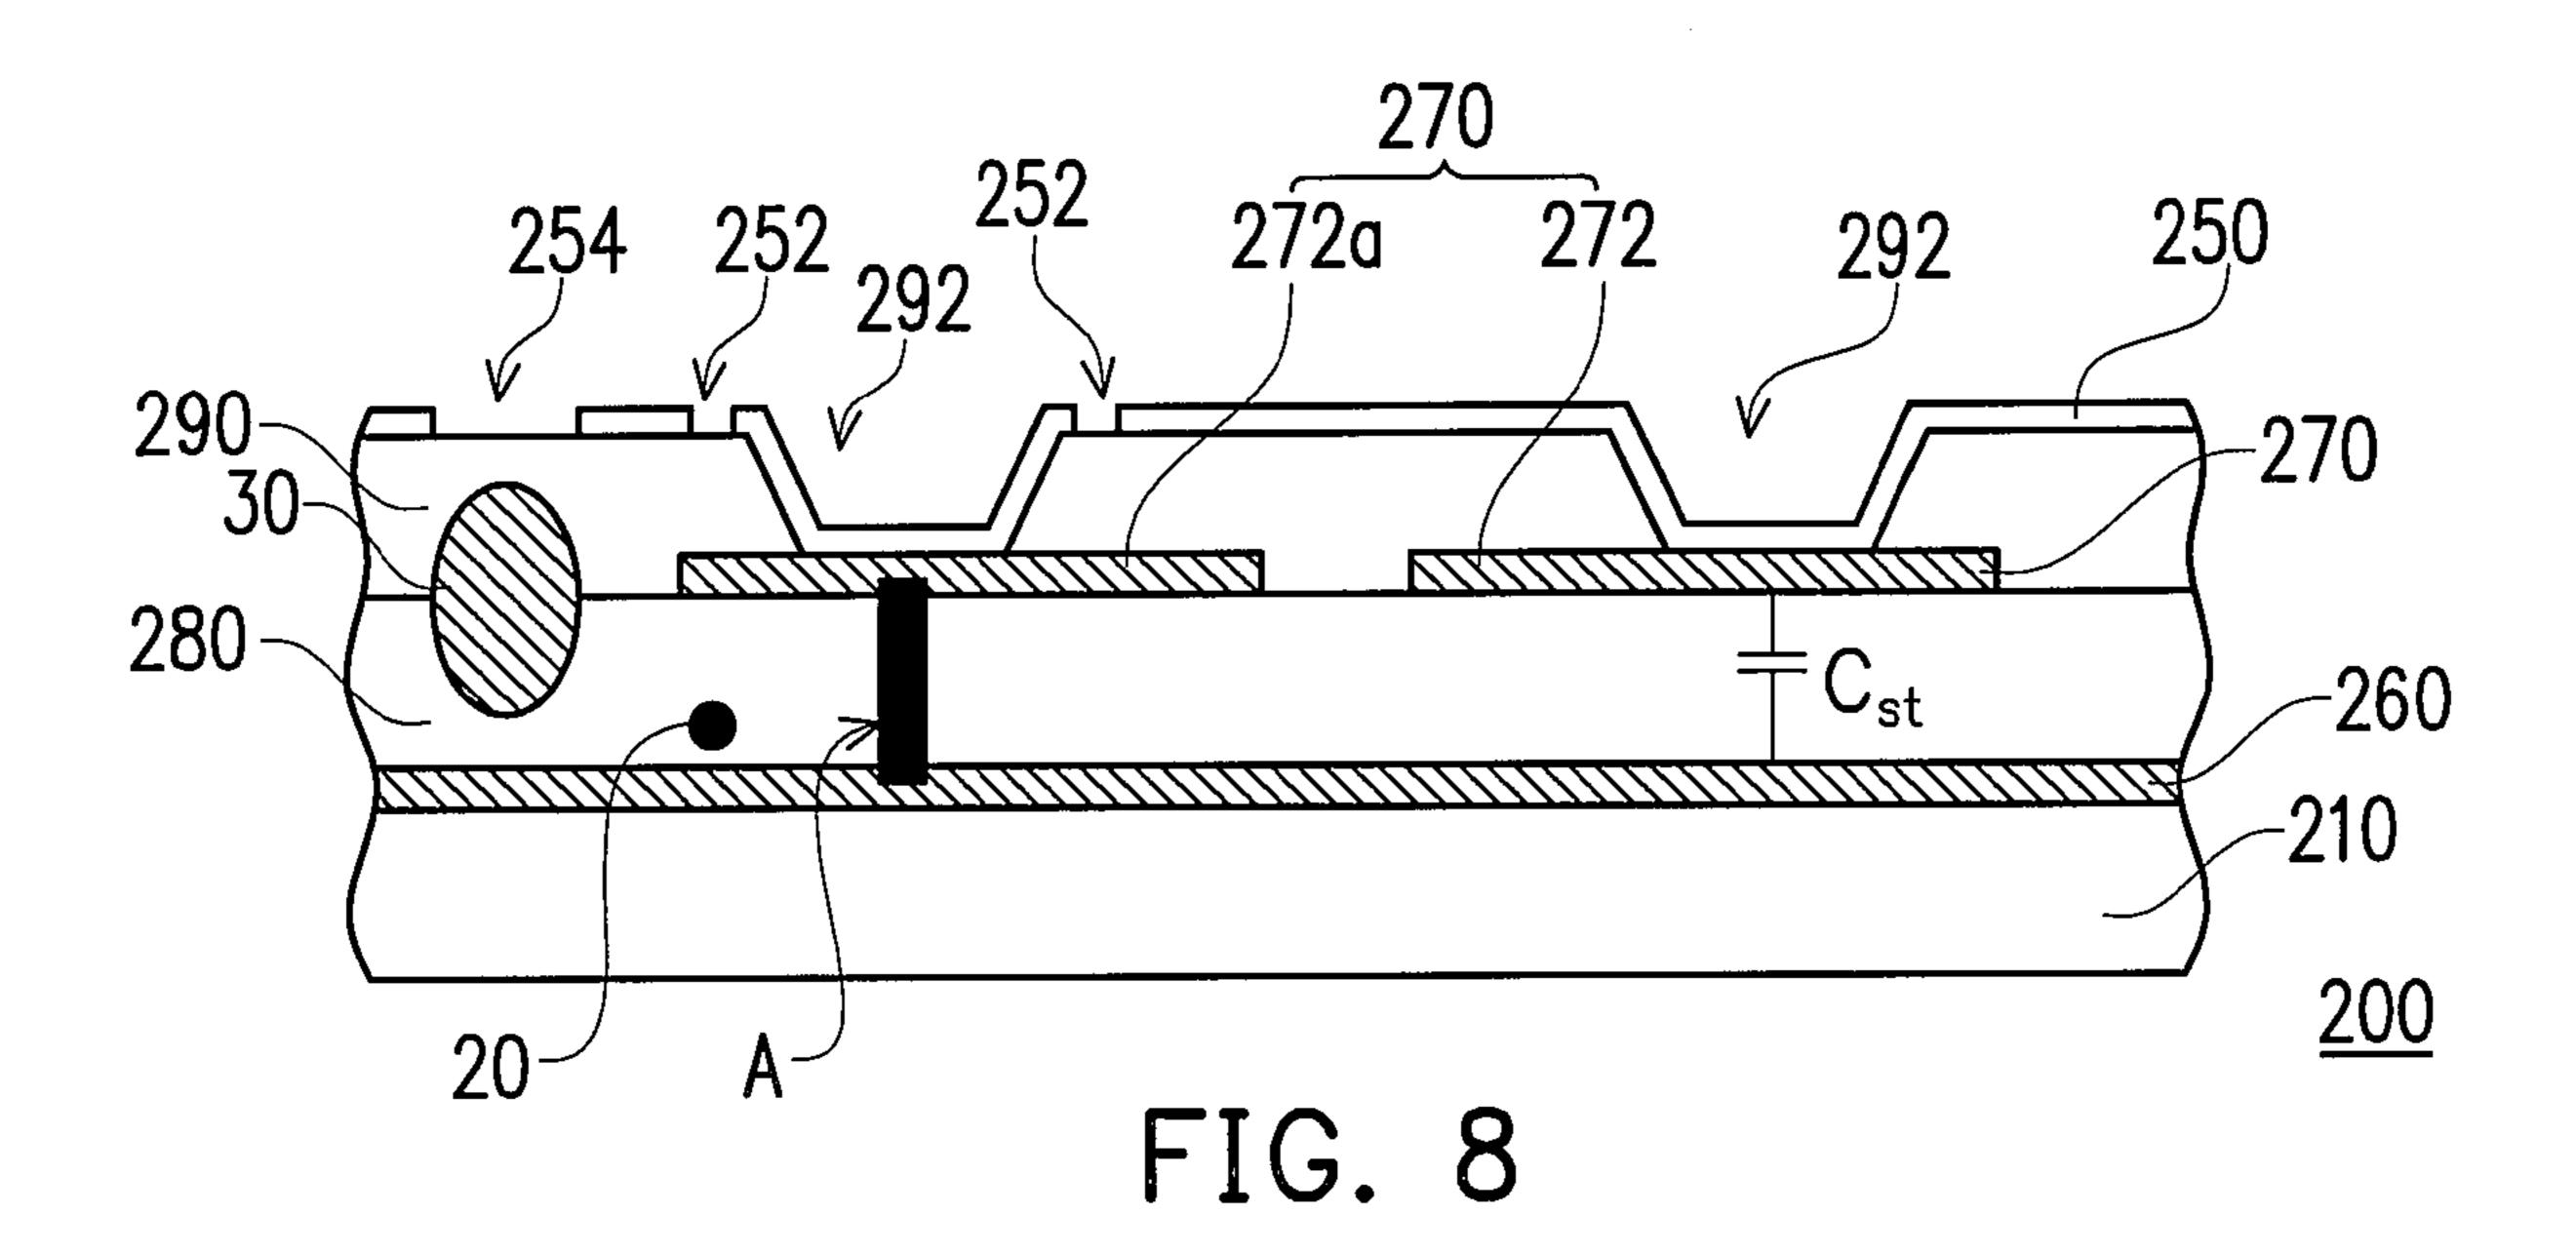
FIG. 8 is a schematic cross-sectional view showing the reparation of a thin film transistor array substrate when a particle is disposed between a pixel electrode and a common line. When a particle 30 (or a defect) is formed inside the layers between the pixel electrode and one of the common lines, the repairing method of the present invention also permits the removal of a portion of the pixel electrode 250 above the particle 30 (or defect). For example, a portion of the pixel electrode 250 is removed to form an opening 254 that exposes the particle 30 (or defect) using a laser beam.
