# (12) United States Patent Lai

# (10) Patent No.: US 7,646,446 B2 (45) Date of Patent: Jan. 12, 2010

# (54) REPAIRING METHOD OF A THIN FILM TRANSISTOR ARRAY SUBSTRATE

A method for repairing a storage capacitor on gate or a storage capacitor on common line is described. A portion of each pixel electrode is disposed above a scan line or a common line. An upper electrode is disposed between the pixel electrode and the corresponding scan line or the common line. The pixel electrode and the upper electrode are electrically connected. A defective capacitor is formed when a particle/defect is produced between the upper electrode and the common line or the scan line. The method of repairing the defective capacitor includes removing a portion of the pixel electrode corresponding to the upper electrode of a defective storage capacitor and electrically isolating the upper electrode and the corresponding pixel electrode of the defective storage capacitor. The upper electrode and the scan line or the common line of the defective capacitor are welded together.

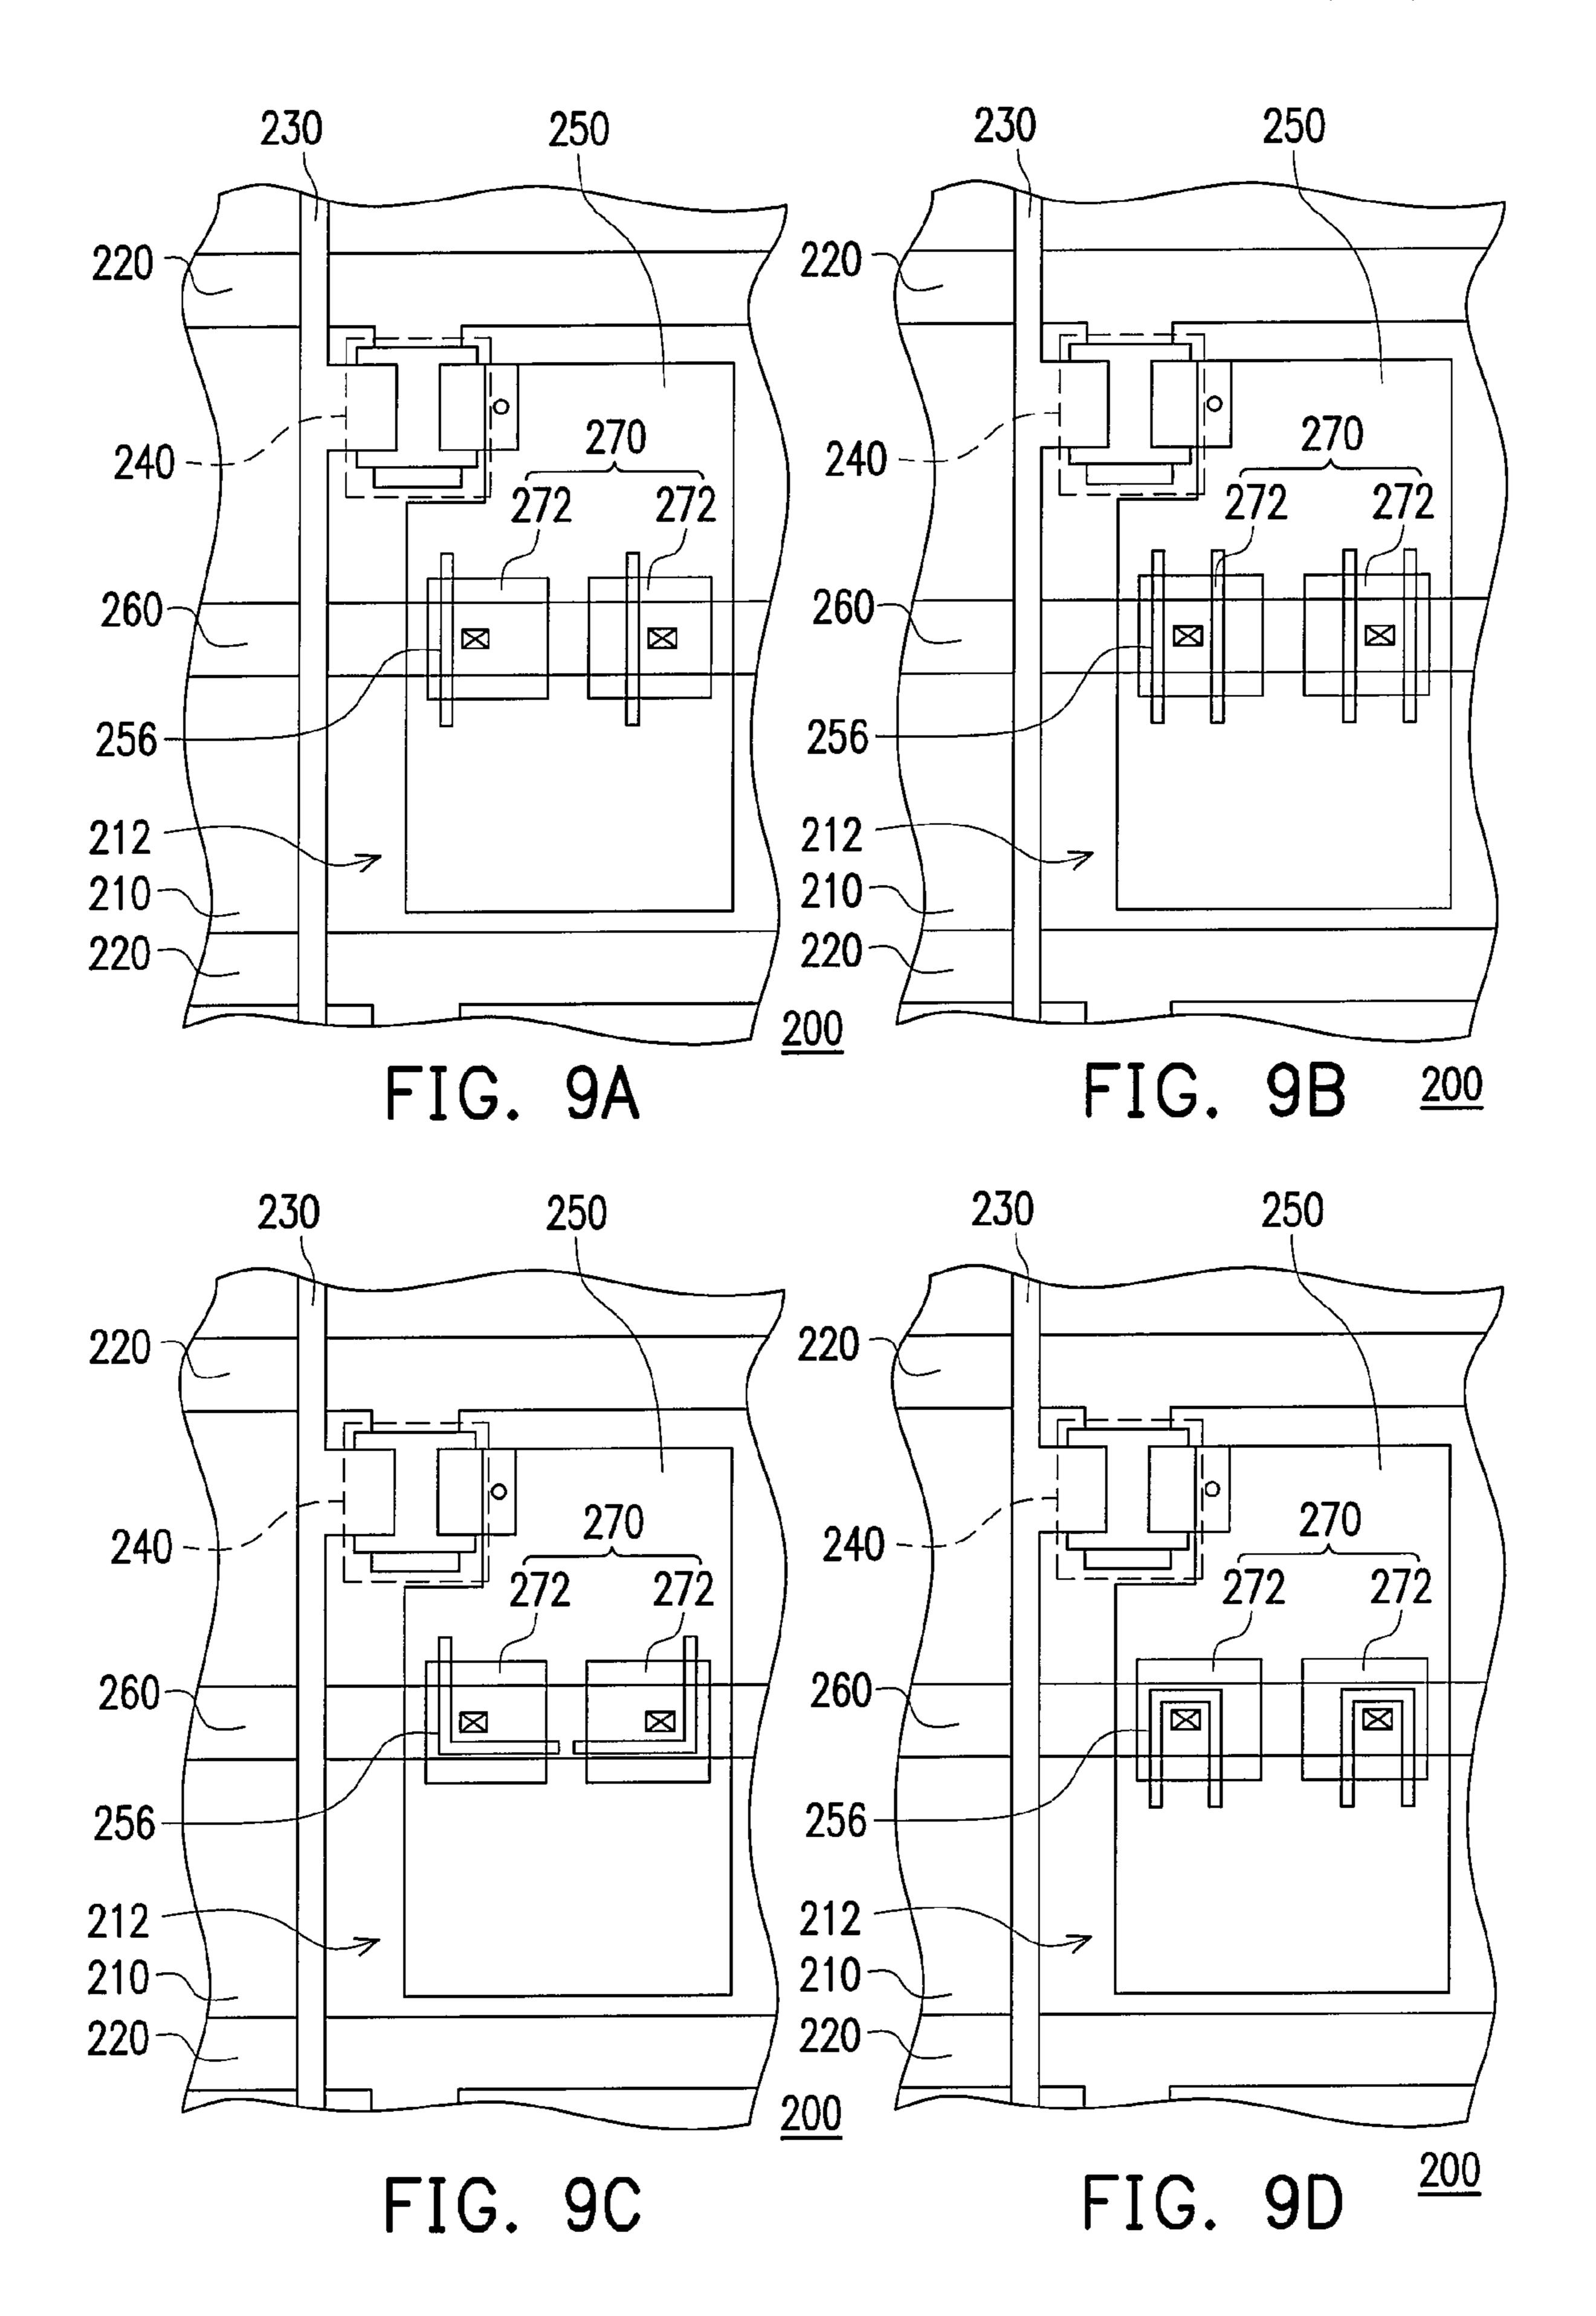
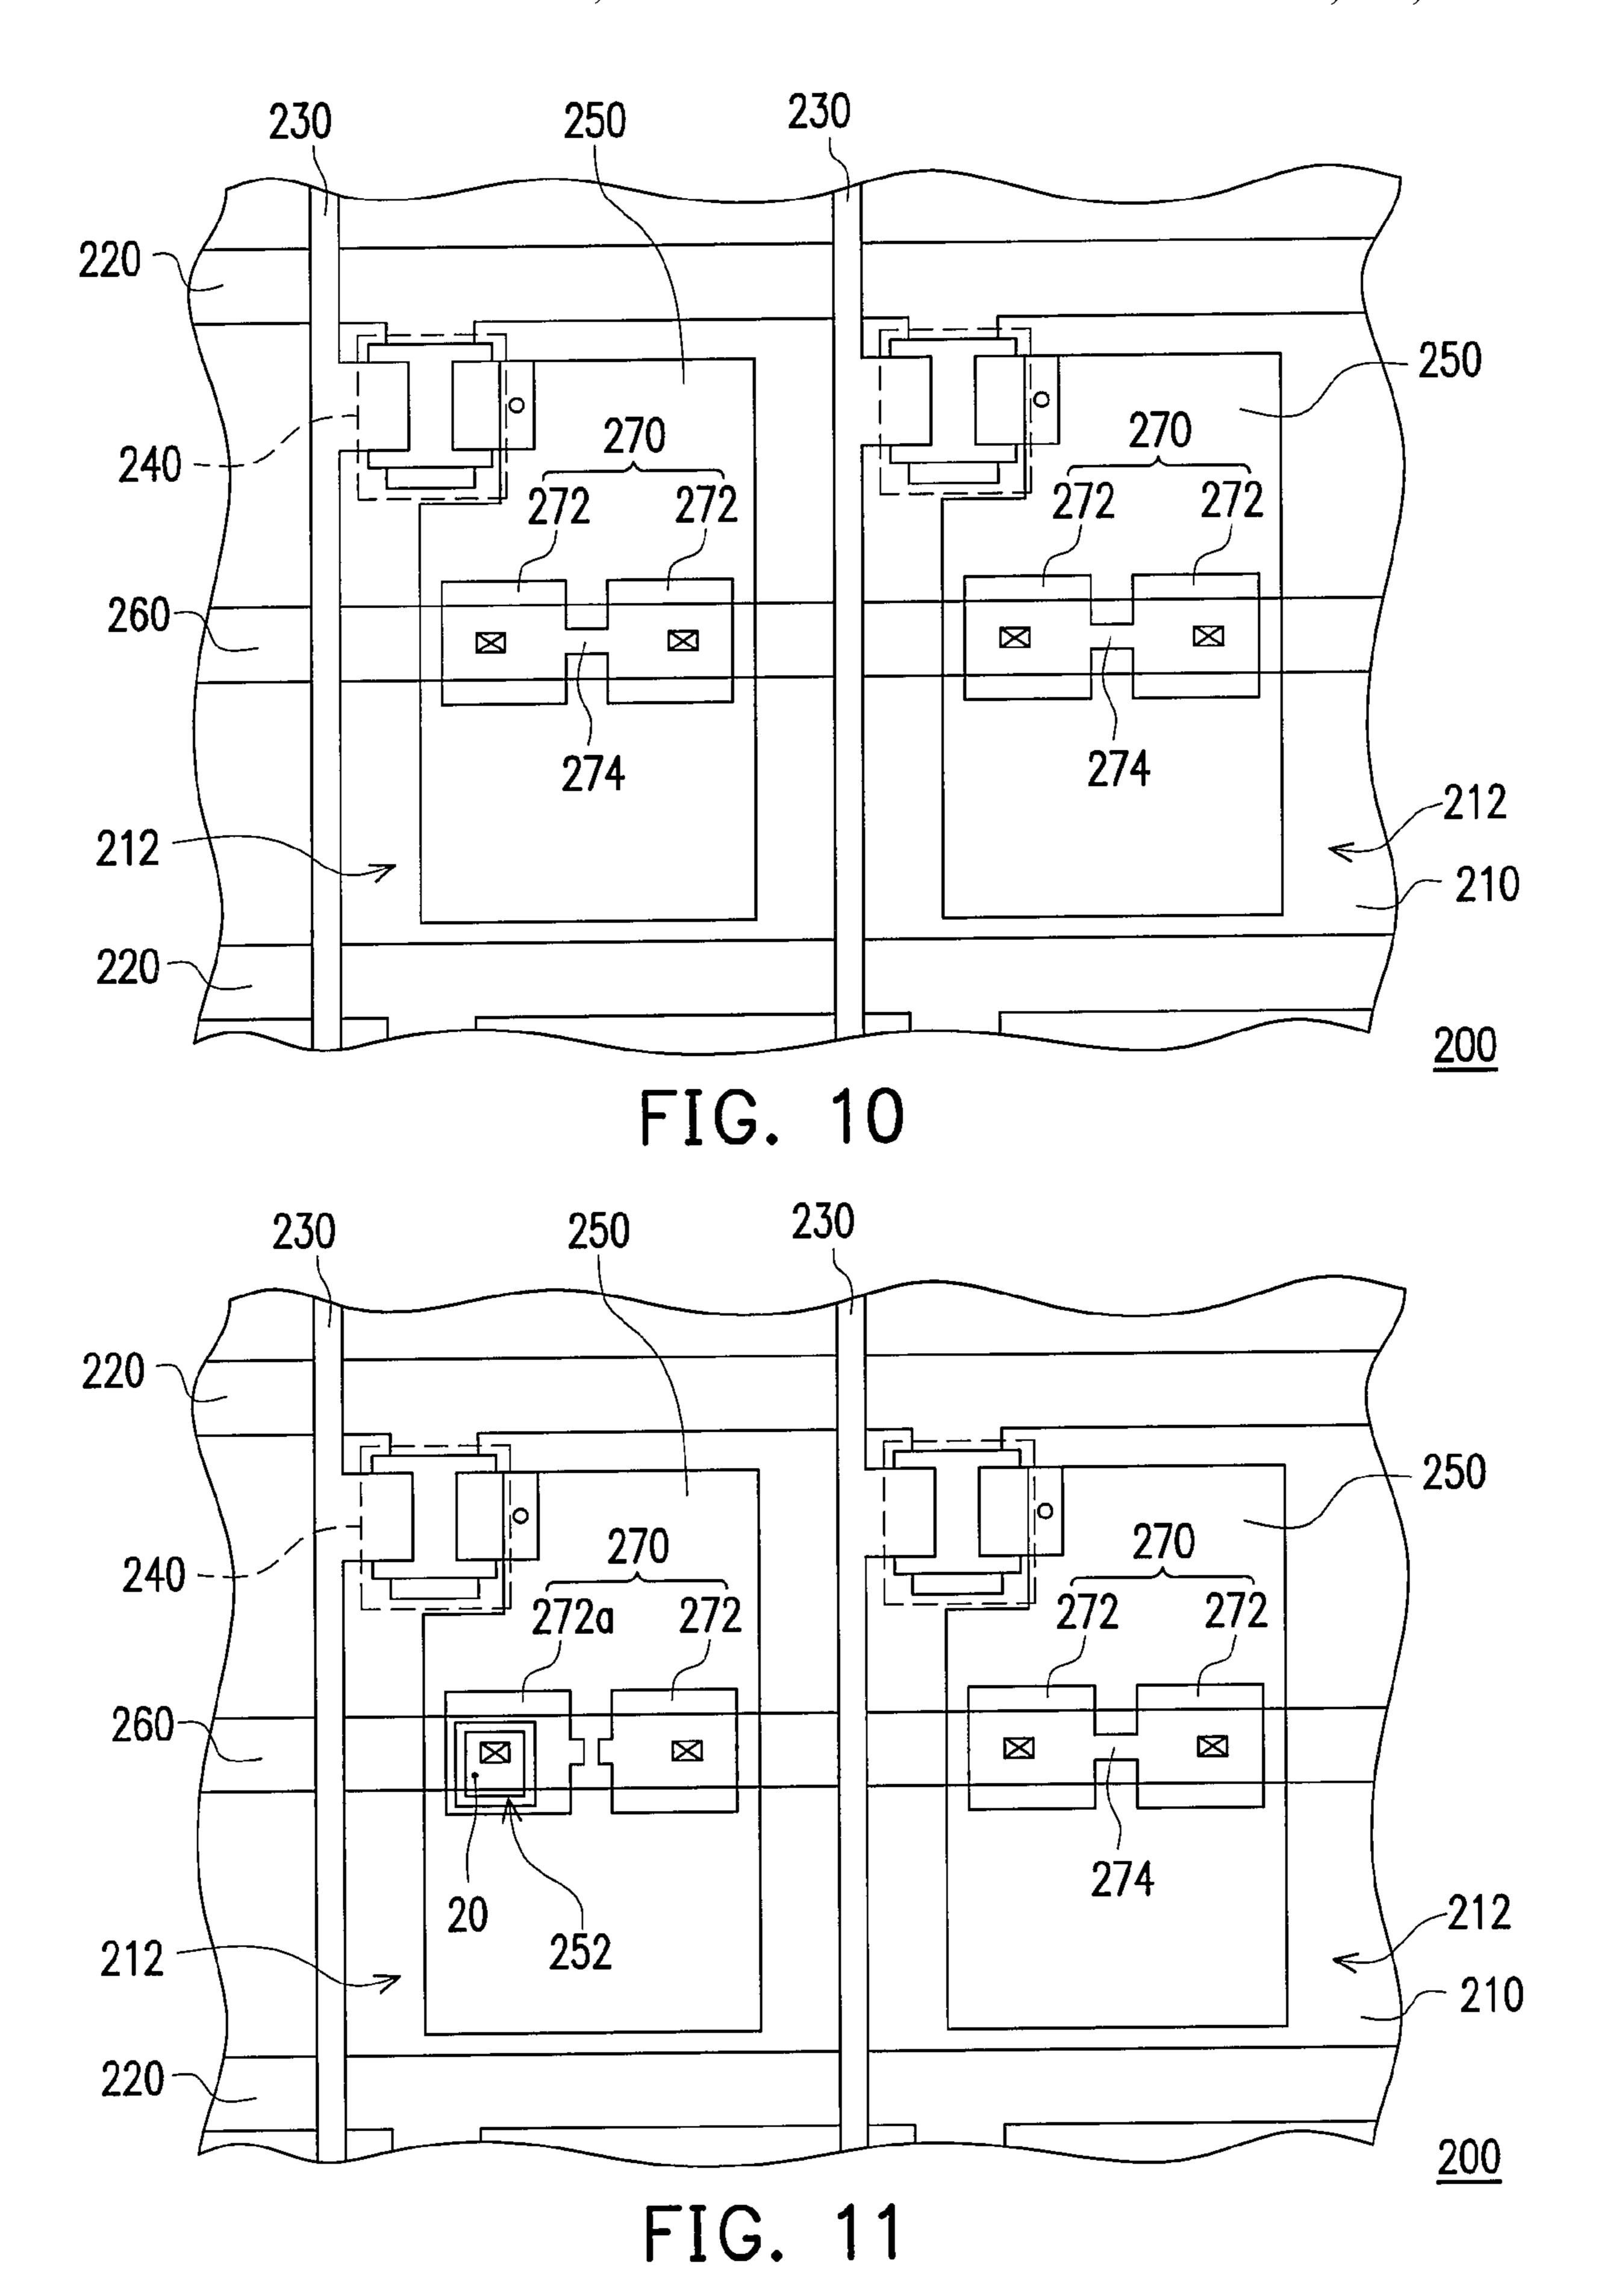
FIGS. 9A through 9D are top views showing different types of thin film transistor array substrates according to another preferred embodiment of the present invention. The  $_{40}$ thin film transistor array substrate of the present embodiment is mostly identical to the one shown in FIG. 3. One major difference is that one or more openings 256 are formed in each pixel electrode 250 when the pixel electrodes 250 are formed. The openings **256** are disposed around the contact 45 region between each sub contact pad 272 and one of the pixel electrodes 250. For example, a straight line opening 256 (shown in FIG. 9A), two straight line openings 256 (shown in FIG. 9B), an L-shaped opening (shown in FIG. 9C) or a U-shaped opening **256** (shown in FIG. **9**D) is formed over the 50 pixel electrode 250 corresponding to each sub contact pad 272. With an opening 256 formed over the every pixel electrode 250, a portion of any one pixel electrode 250 can be readily removed to connect the ends of the opening 256. Hence, an opening similar to the opening 252 that encircles 55 the contact **292** as shown in FIG. **5** can be produced when there is a particle (or defect) between a sub-upper electrode 272 and one of the common lines 260. In the present embodiment, the method of removing a portion of the pixel electrode 250 includes performing a laser ablation process.

As shown in FIGS. 9A through 9D, a portion of the opening 256 is disposed above the area occupied by the sub-upper electrode 272 while the remaining portion of the opening 256 is disposed outside the area occupied by the sub-upper electrode 272. In other words, the openings 256 also cover a 65 region outside the upper electrode 272 to simplify and speed the repairing operation. In addition, anyone familiar with the

technology may notice that there is no particular restriction on the dimension of each opening 256.

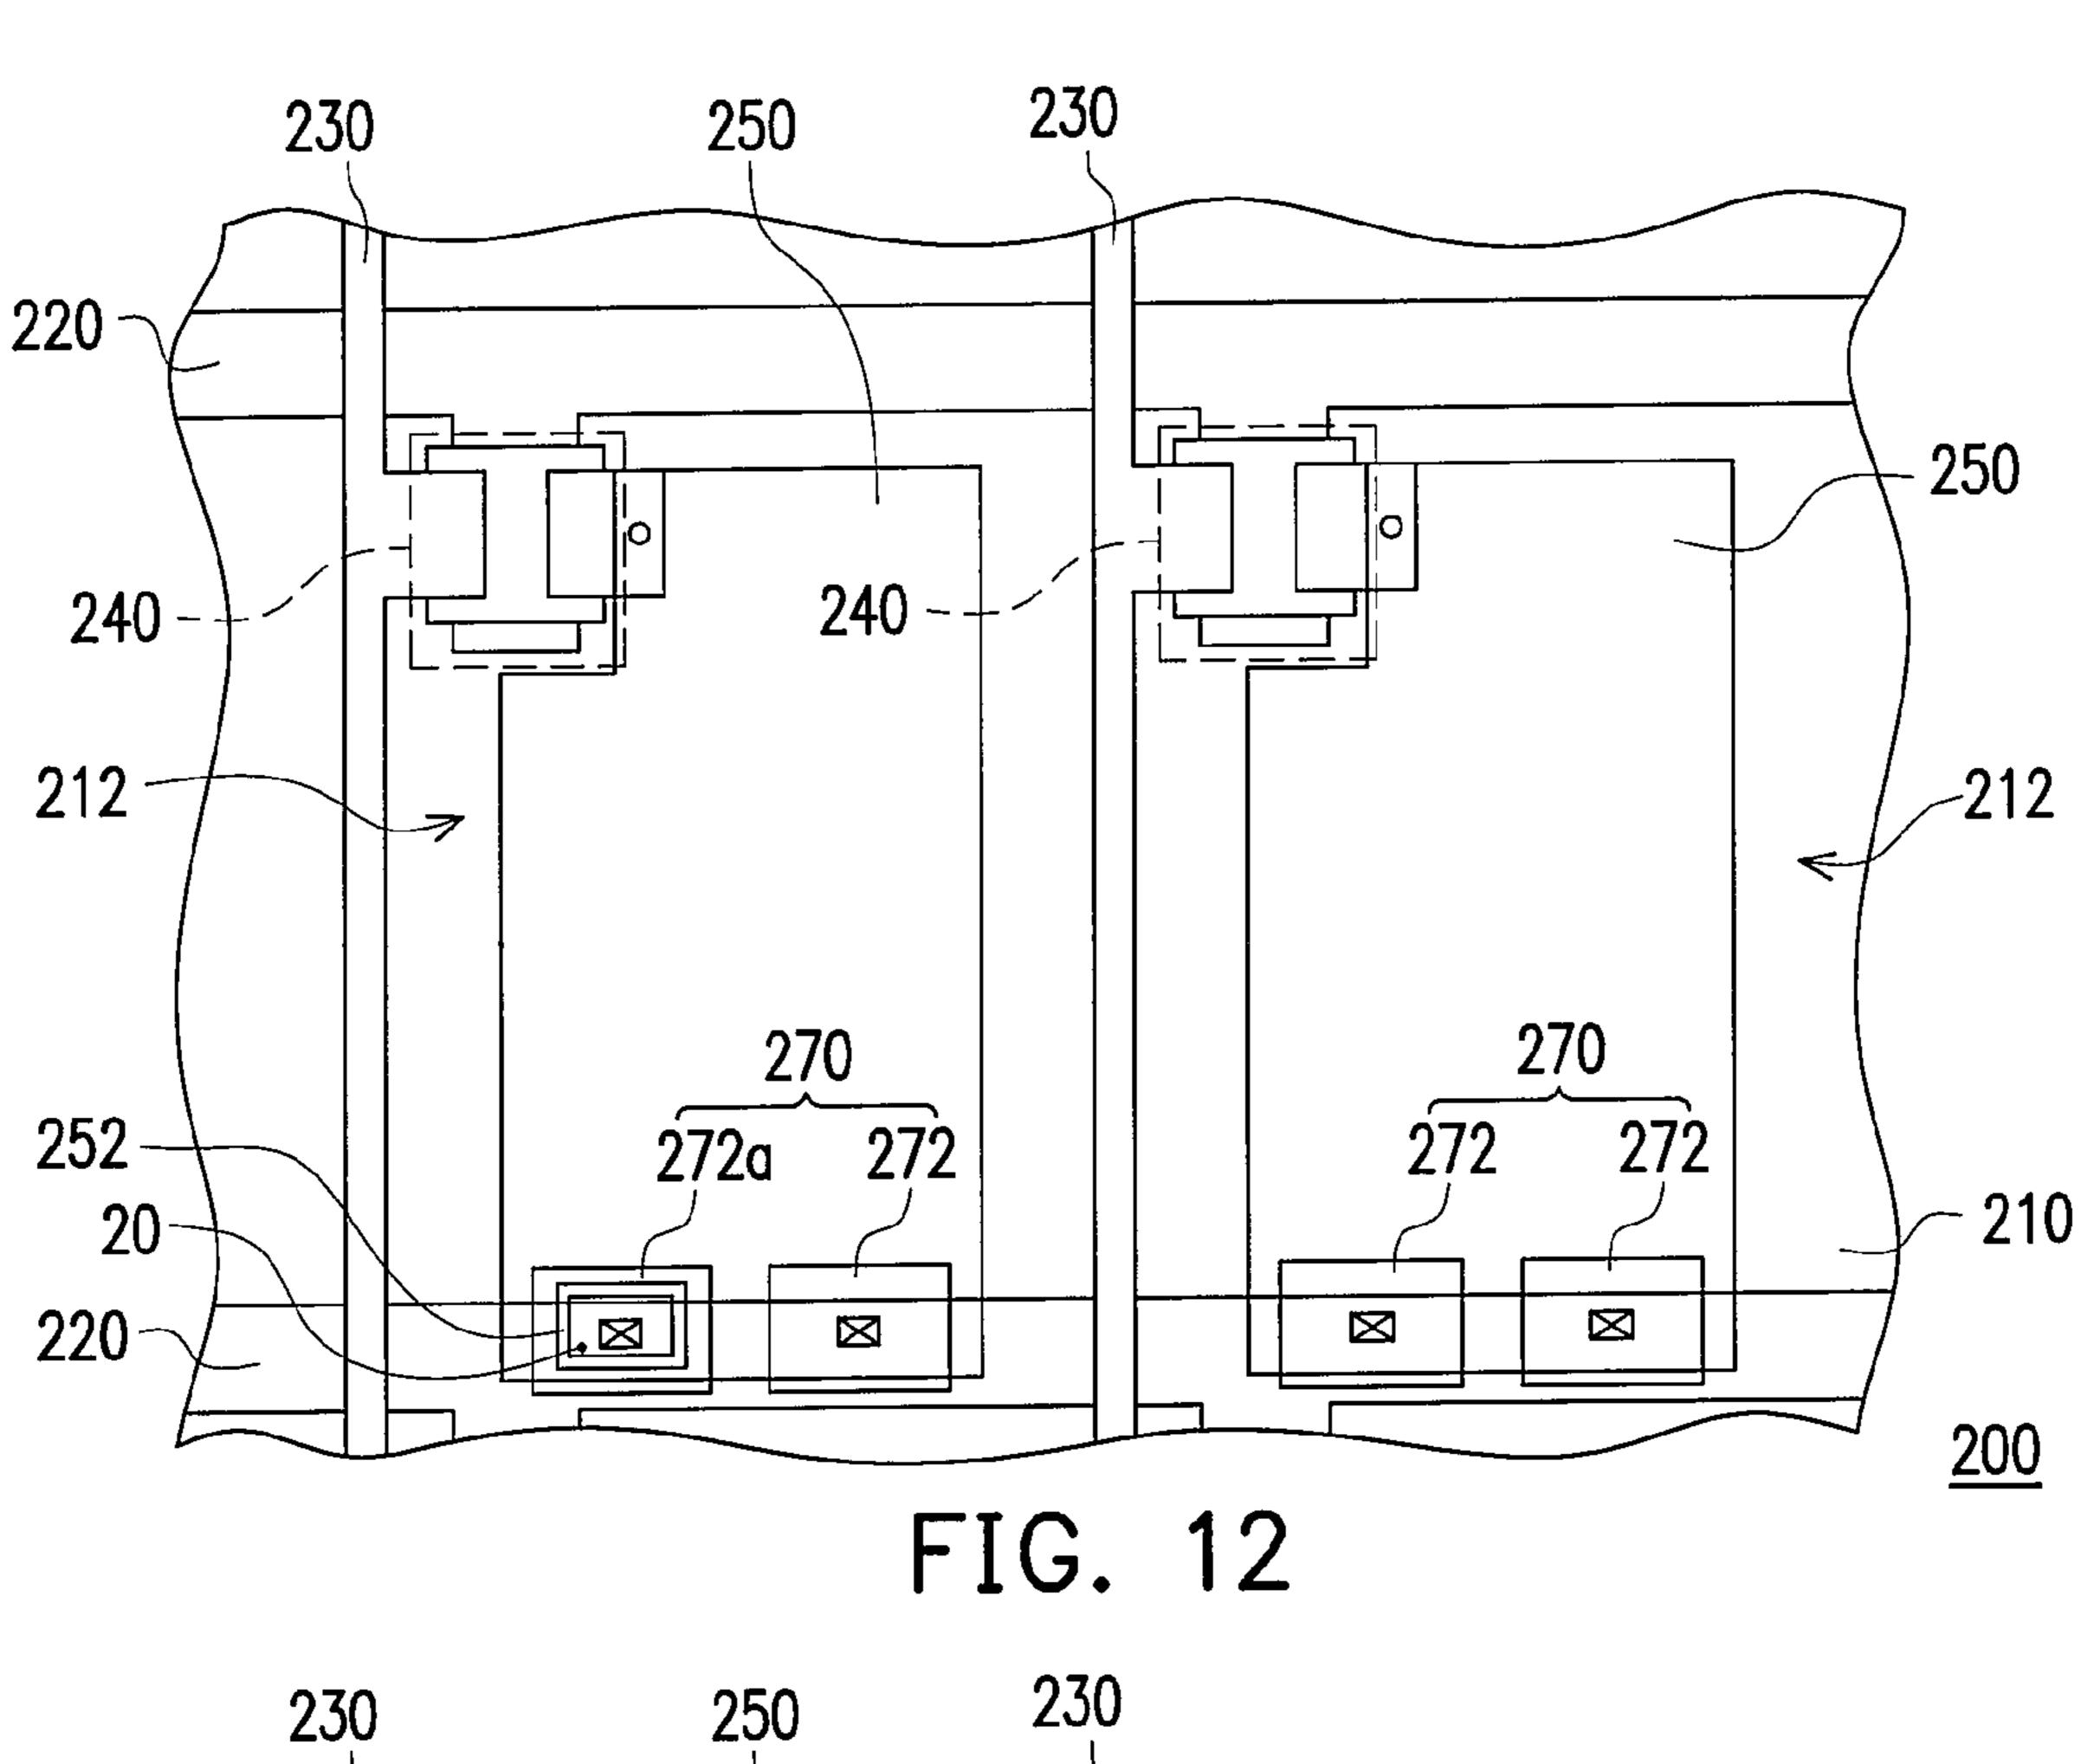
FIG. 10 is a top view of a thin film transistor array substrate according to another preferred embodiment of the present invention. FIG. 11 is a top view of the thin film transistor array substrate in FIG. 10 after a laser repairing operation. In the present embodiment, the thin film transistor array substrate has a structure mostly similar to the one shown in FIG. 3. One major difference of the present embodiment is that the sub-upper electrodes 272 underneath each pixel electrode 250 are mutually connected through a neck portion 274 that can be severed in a repair operation.

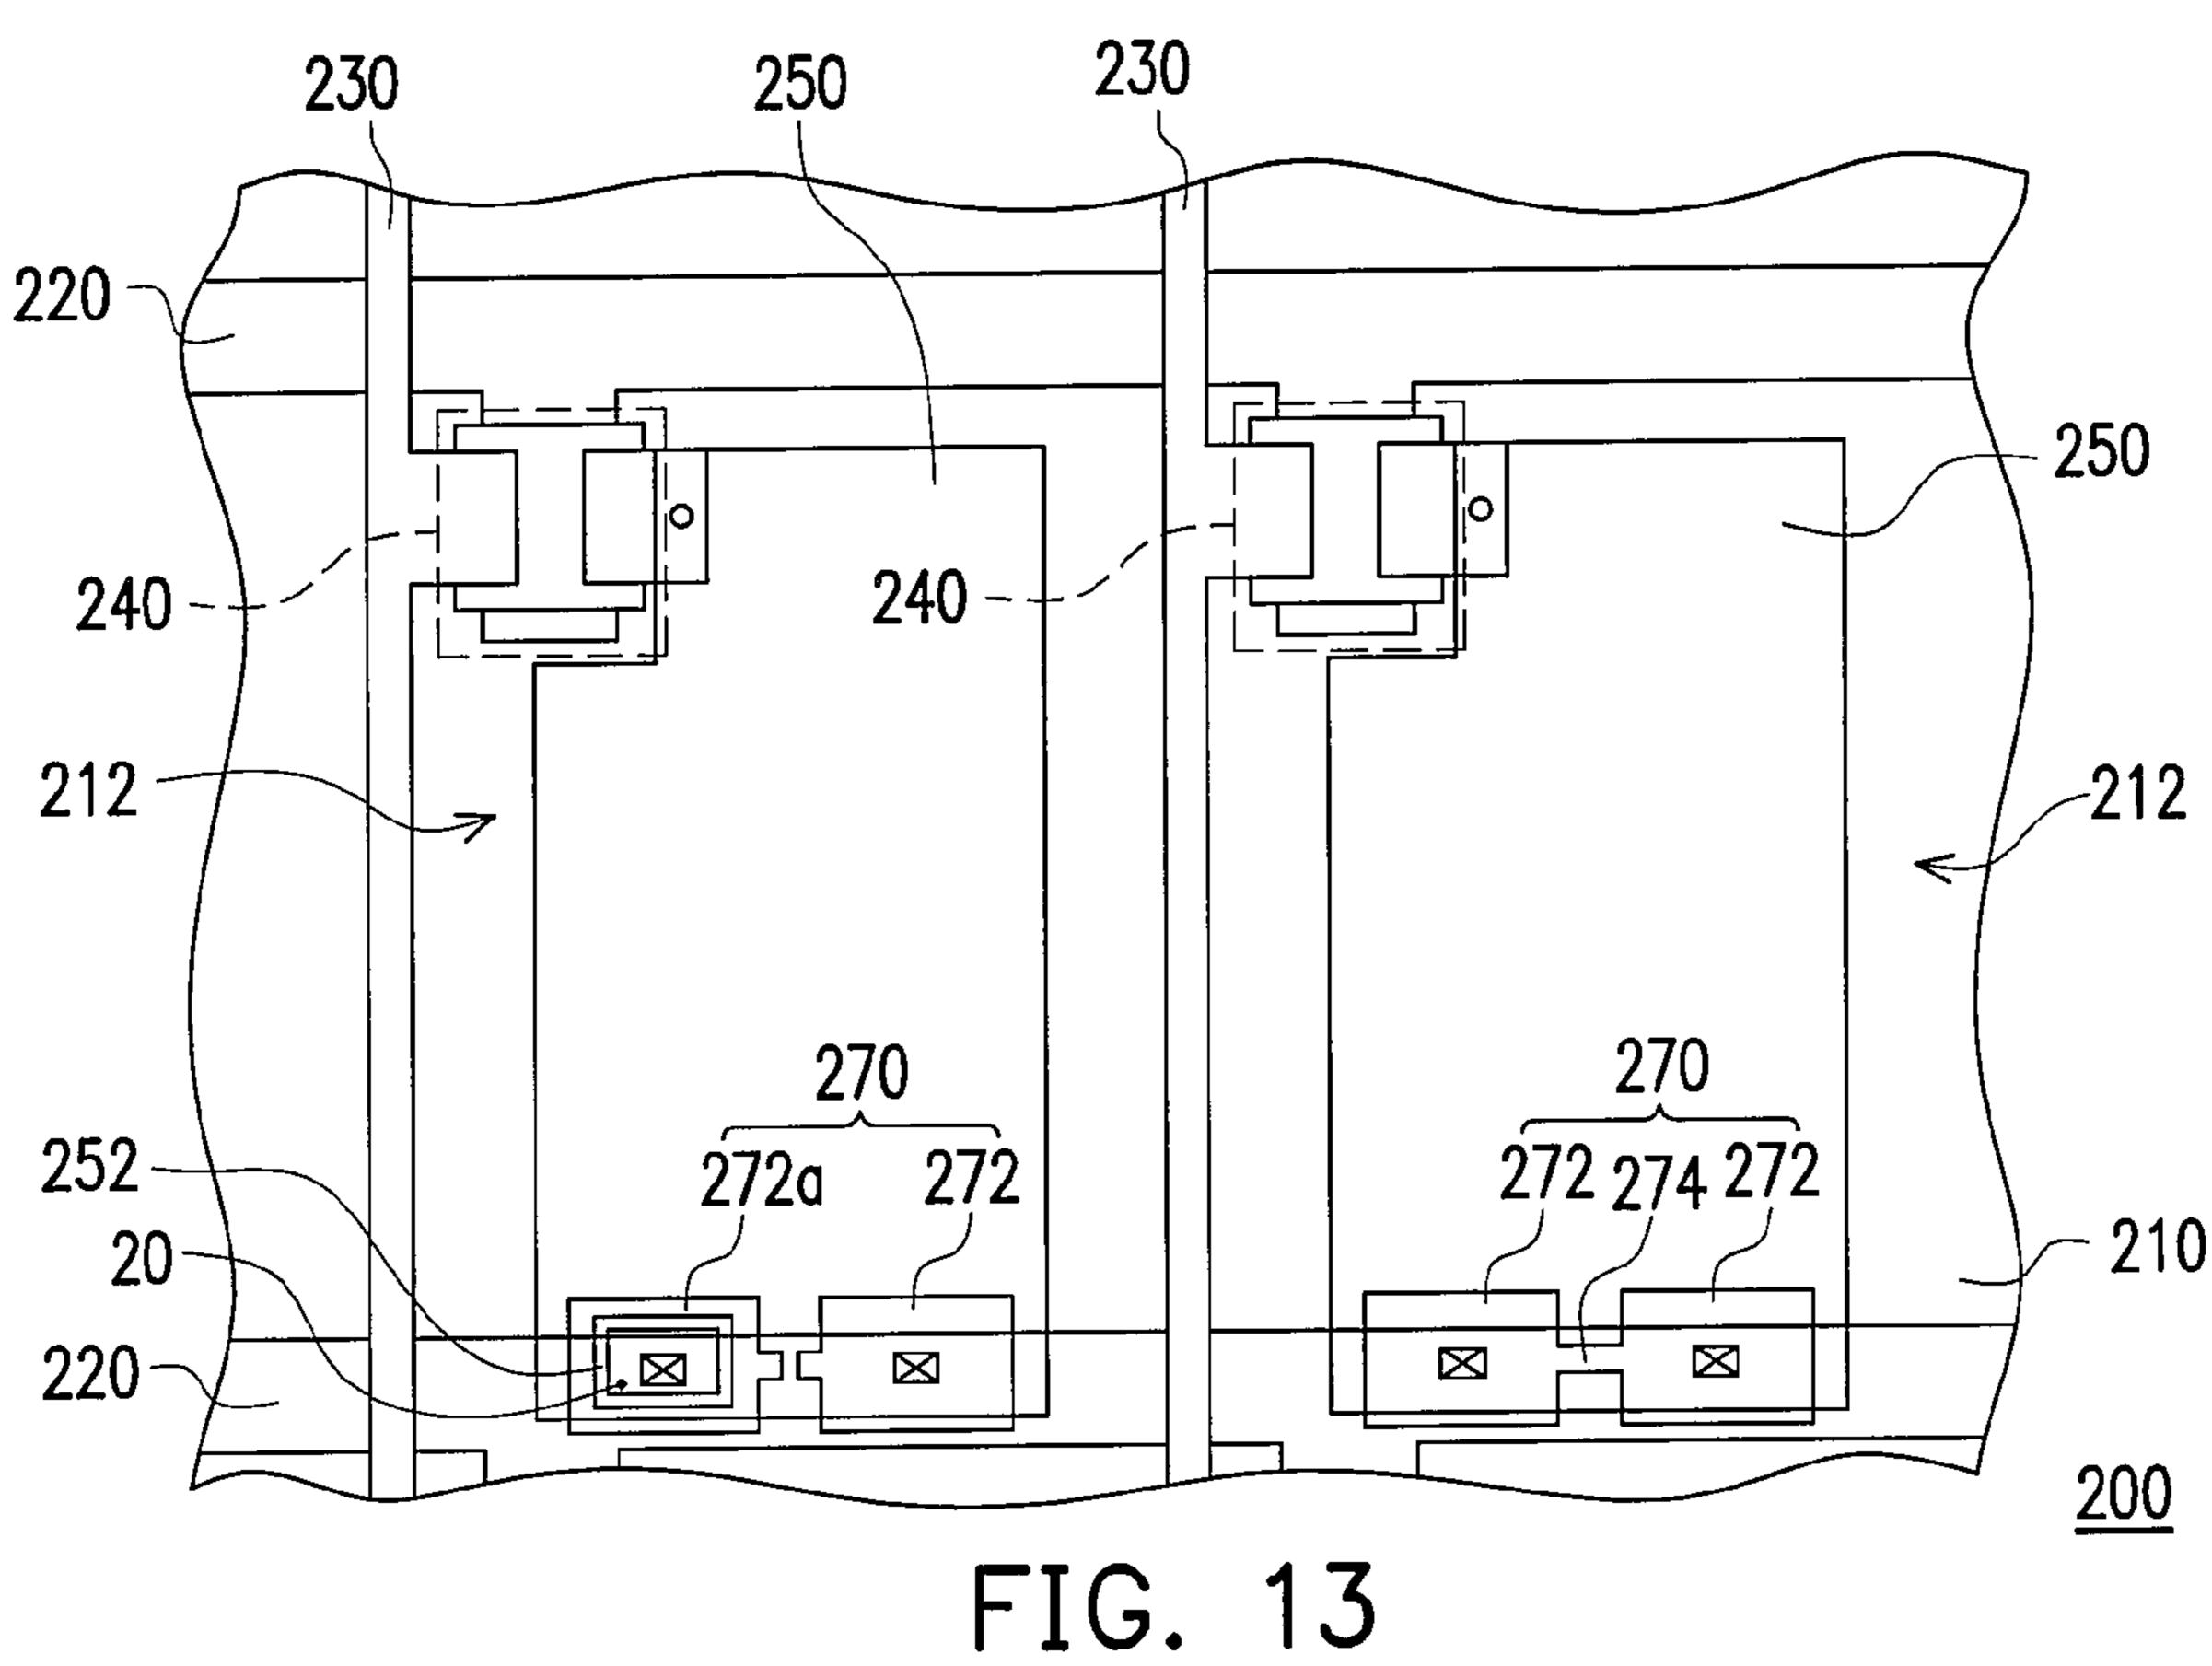
In the presence of a particle 20 (or defect) between one of the sub-upper electrode 270 and one of the common lines 260, a leakage between the sub-upper electrode 272a and the common line 260 may occur. To repair such defect, a portion of the pixel electrode 250 corresponding to the sub-upper electrode 272a of the defective capacitor is removed. Thereafter, the neck portion 274 connecting with the sub-upper electrode 272a of the defective capacitor 272a is cut so that the subupper electrode 272a and the corresponding pixel electrode 250 of the defective capacitor are electrically isolated. In the present embodiment, a portion of the pixel electrode 250 is removed to form an opening 252. The opening 252 is located 25 around the contact area between the sub-upper electrode 272a and the corresponding pixel electrode of the defective capacitor. Furthermore, the method of removing a portion of the pixel electrode 250 includes performing a laser ablation and the method of cutting the neck portion 274 includes performing a laser cutting operation. After cutting the neck portion 274 connecting the sub-upper electrode 272a of the defective capacitor, the sub-upper electrode 272a and the corresponding pixel electrode 250 are electrically isolated to achieve the goal of repairing a thin film transistor array substrate.

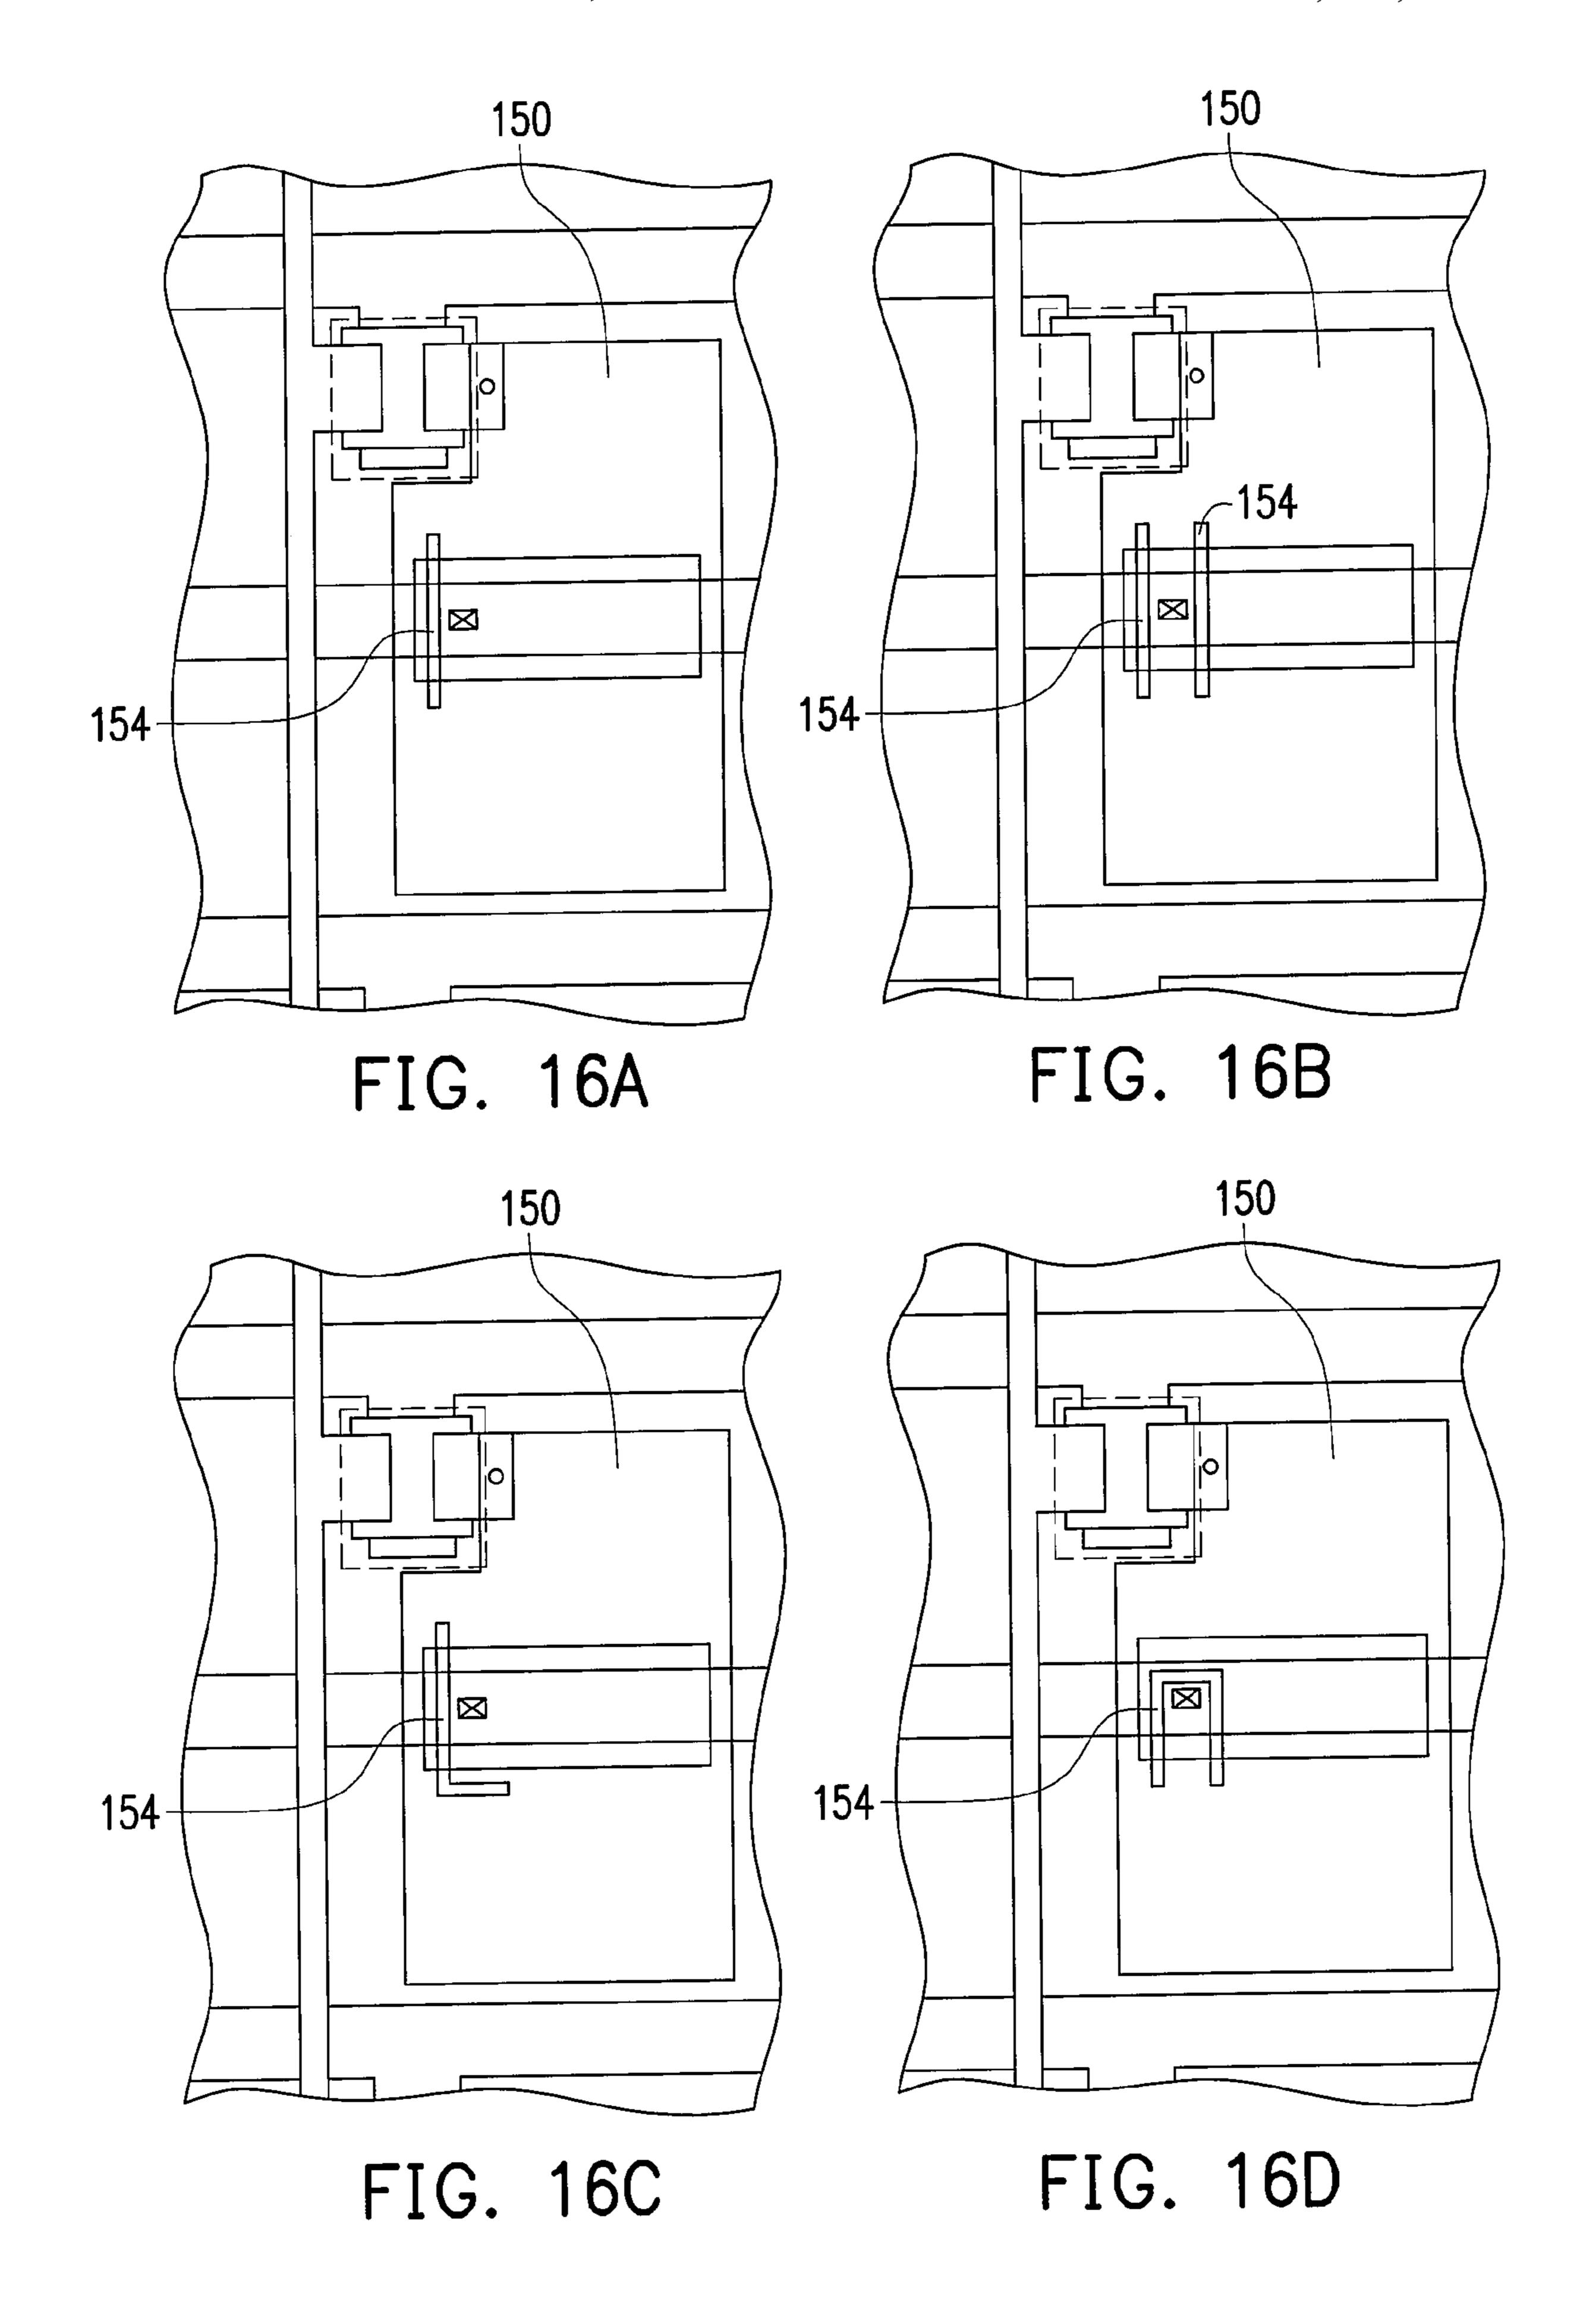
FIGS. 16A through 16D show the types of openings formed on the pixel electrode of a conventional thin film transistor array substrate. To simplify and speed up the repairing process, one or more openings 154 are also formed over the thin film transistor array substrate in the process of fabricating the pixel electrode 150. For example, a straight line opening 154 (as shown in FIG. 16A), a pair of straight line openings 154 (as shown in FIG. 16B), an L-shaped opening 154 (as shown in FIG. 16C) or a U-shaped opening 154 (as shown in FIG. 16D) are formed over the pixel electrode 150. Since the openings 154 are similar to the openings disclosed in FIGS. 9A through 9D, detailed description is omitted.

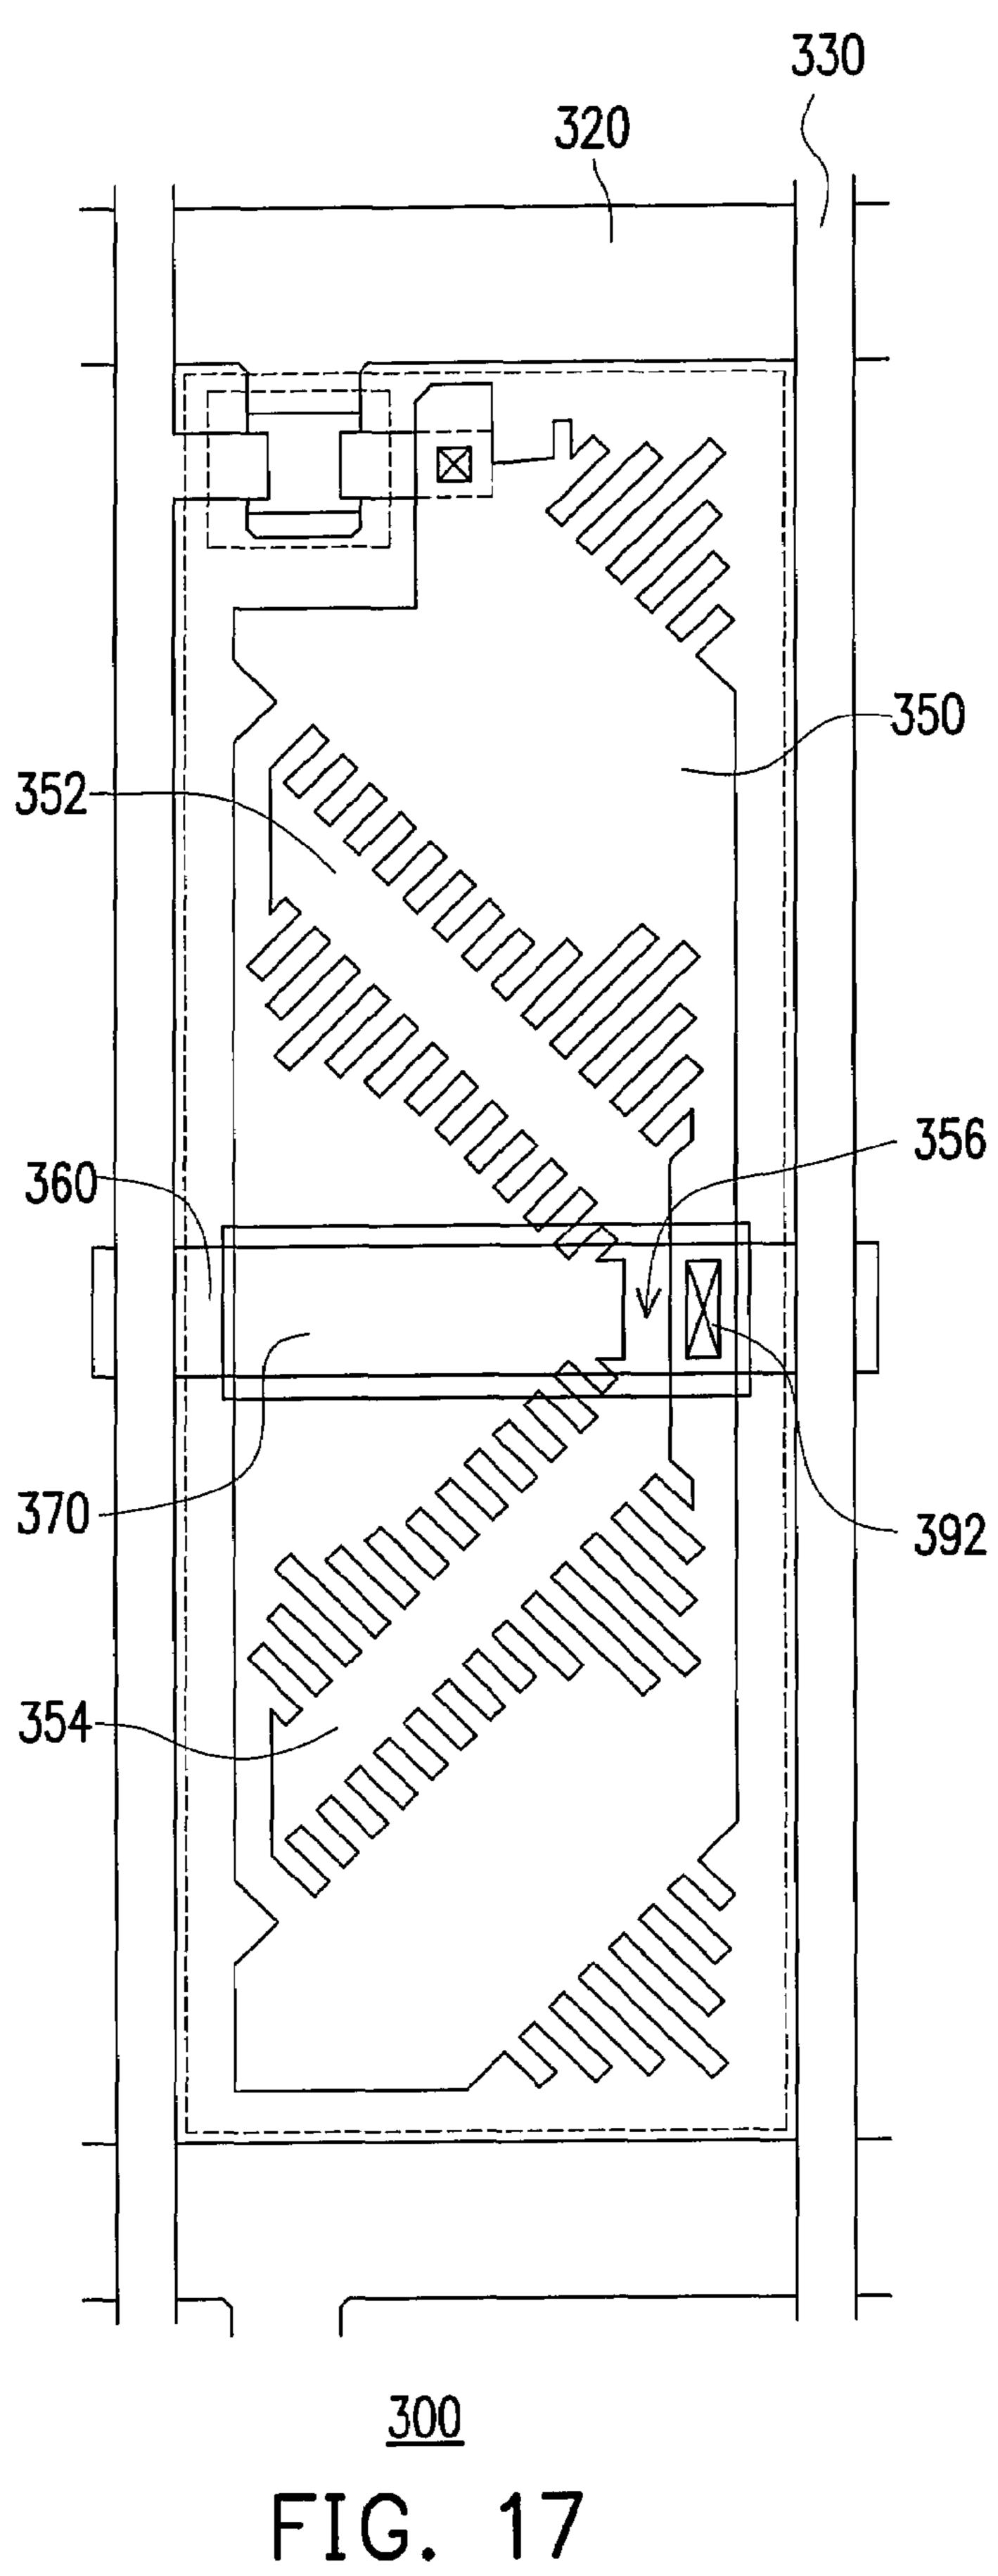
> FIG. 17 is a top view showing a thin film transistor array substrate applied to a multi-domain vertical alignment liquid crystal display (MVA-LCD) according to yet another preferred embodiment of the present invention. The thin film transistor array substrate 300 in the present embodiment has a structure very similar to the thin film transistor array substrate disclosed in FIG. 1. Hence, only the dissimilar portions are described in the following.

> The thin film transistor array substrate 300 has at least a first slit 352 and at last a second slit 354 disposed over each pixel electrode 350. The first slit 352 extends in a direction different from the second slit 354 and the direction of exten-

sion of the first and the second slit 352, 354 are different from the scan line 320, the data line 330 or the common line 360. In addition, a first slit 352 and one of the second slits 354 are connected together through a connecting area 356 when the first slits 352 and the second slits 354 are formed. The electrical contact area (the contact 392) between the upper electrode 370 and the corresponding pixel electrode 350 are adjacent to the connecting area 356 between the first and the second slit. Furthermore, the upper electrode 370 and the corresponding common line 360 are coupled to form a capacitor.
