# (12) United States Patent Lai

# (10) Patent No.: US 7,646,446 B2 (45) Date of Patent: Jan. 12, 2010

# (54) REPAIRING METHOD OF A THIN FILM TRANSISTOR ARRAY SUBSTRATE

A method for repairing a storage capacitor on gate or a storage capacitor on common line is described. A portion of each pixel electrode is disposed above a scan line or a common line. An upper electrode is disposed between the pixel electrode and the corresponding scan line or the common line. The pixel electrode and the upper electrode are electrically connected. A defective capacitor is formed when a particle/defect is produced between the upper electrode and the common line or the scan line. The method of repairing the defective capacitor includes removing a portion of the pixel electrode corresponding to the upper electrode of a defective storage capacitor and electrically isolating the upper electrode and the corresponding pixel electrode of the defective storage capacitor. The upper electrode and the scan line or the common line of the defective capacitor are welded together.

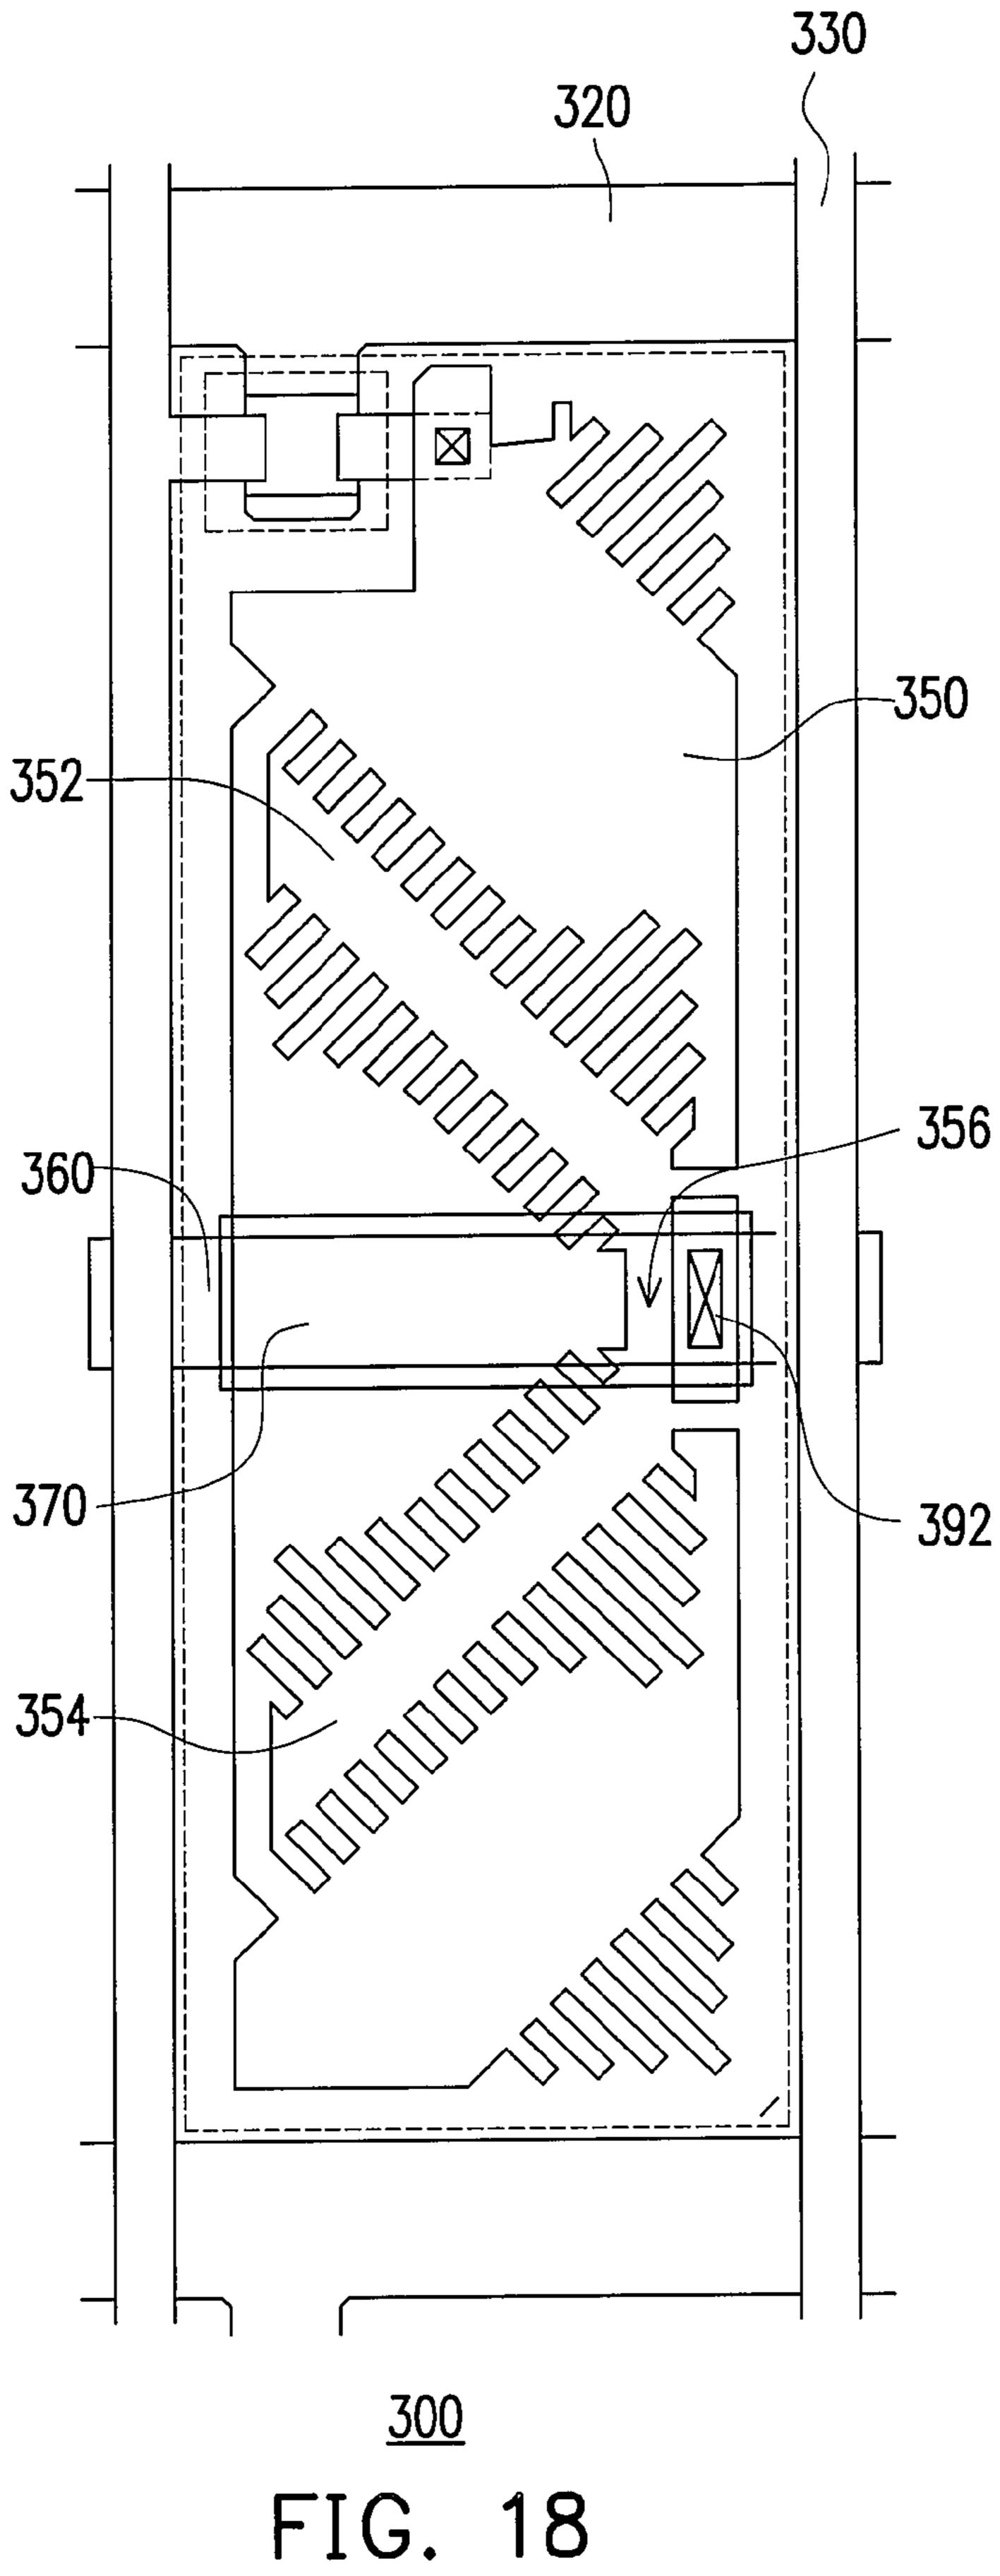
It should be noted a repair is required when a particle or defect is formed between the upper electrode 370 and one of the common lines 360 so that the upper electrode 370 and the common line 360 together form a defective capacitor. FIG. 18 is a top view of the thin film transistor array substrate of the MVA-LCD in FIG. 17 repaired according to the method of the present invention. The repairing method includes removing a portion of the pixel electrode **350** corresponding to the upper 20 electrode of the defective capacitor. In the present embodiment, the portion of the pixel electrode 350 to be removed is the area around the electrical contact (the contact 392) between the upper electrode 370 and the corresponding pixel electrode 350. Thus, the upper electrode 370 of the defective capacitor and the corresponding pixel electrode 350 are electrically isolated. In other words, by removing a small portion of the pixel electrode 350 (a small area around contact 392) covering the upper electrode 370, the upper electrode 370 and the corresponding pixel electrode 350 of the defective capacitor are electrically isolated. Since only a small portion of the pixel electrode 350 covering the upper electrode 370 is removed in the present embodiment, a large capacitance can be maintained after the repair operation.

Thereafter, the upper electrode 370 and the corresponding common line 360 of the defective capacitor are welded together so that the upper electrode 370 and the corresponding common line 360 of the defective capacitor are at the same potential. Obviously, whether to weld the upper electrode 370 and the common line 360 of the defective capacitor together can be determined by the amount of leakage in the defective capacitor.
