(10) **Patent No.:** **US 7,800,509 B2**
(45) **Date of Patent:** ***Sep. 21, 2010**

(54) **ROPEWAY WITH SENSORS AND METHOD**

A ropeway may include at least one cable. A first sensor and a second sensor may be provided. The second sensor may be located between the first sensor and the cable. Related methodology is also disclosed.

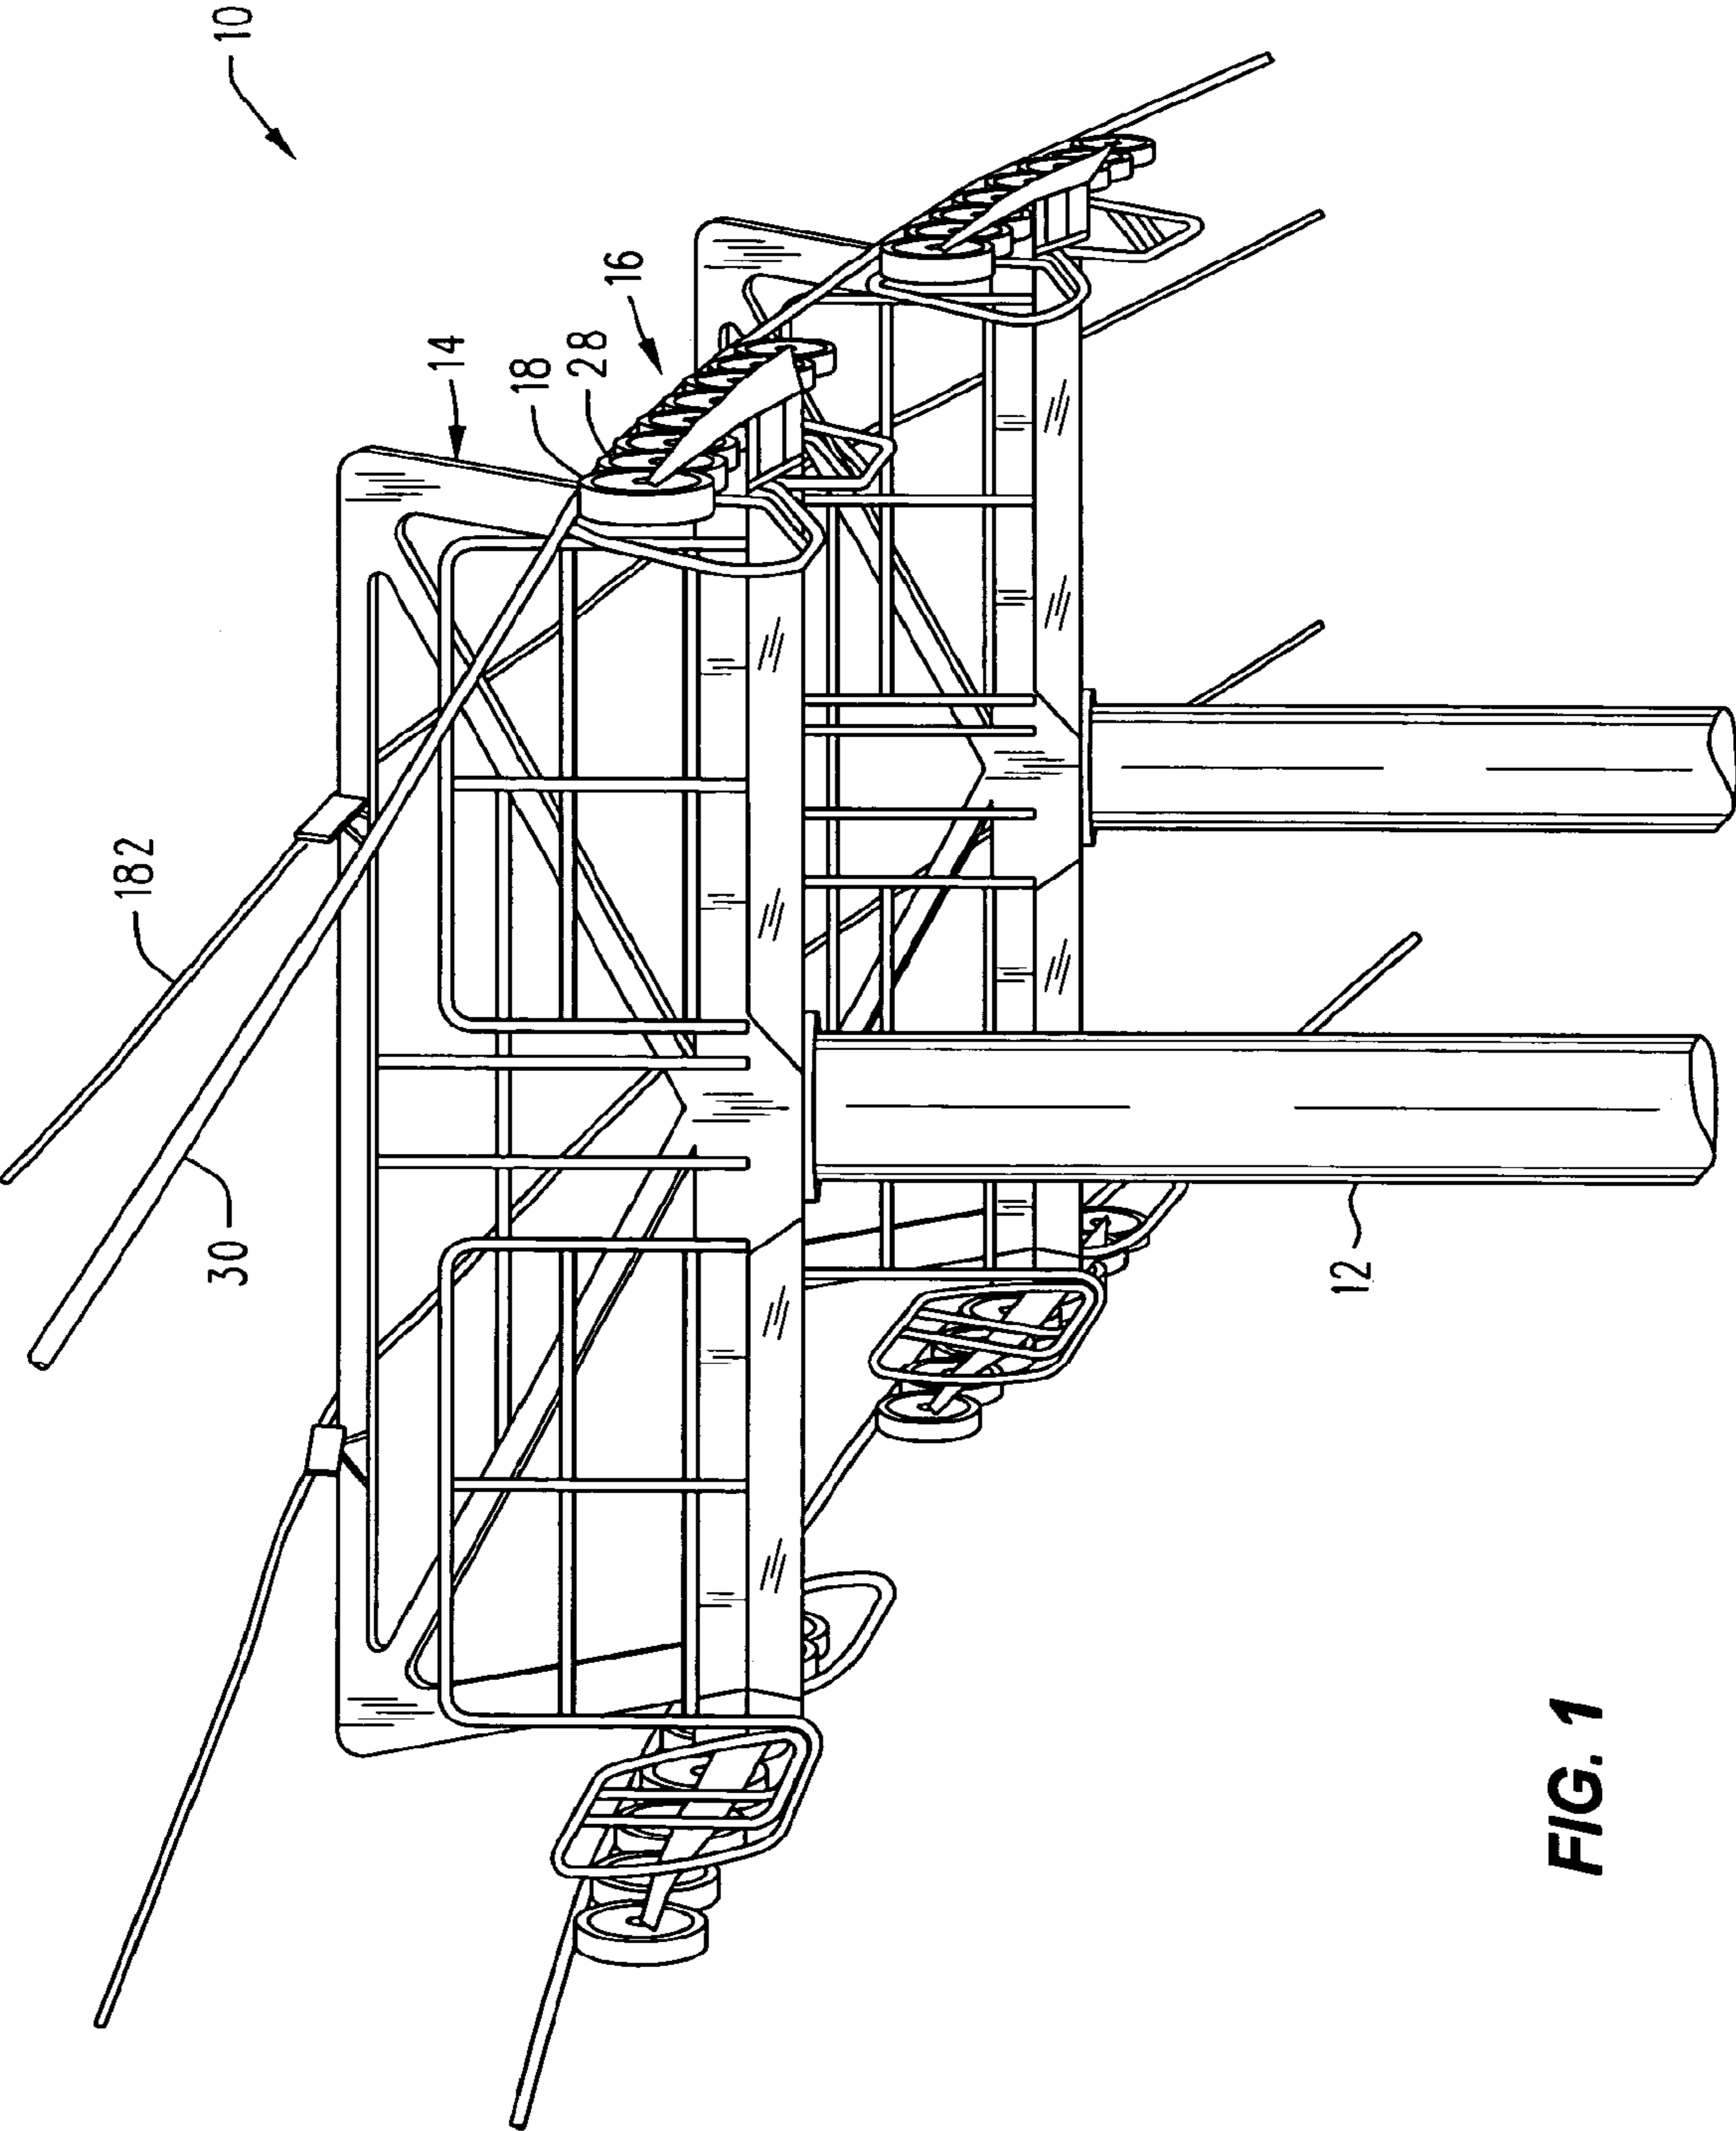
FIG. 1 is a perspective view of an exemplary type of aerial ropeway transportation system.

FIG. 1 shows one exemplary application for the damage indicator **100** (FIG. 4); this exemplary application is an aerial ropeway **10**. With reference to FIG. 1, the aerial ropeway **10** may include a plurality of support towers (e.g. support tower **12**) secured to earth at predetermined distances apart depending on application.

Each support tower, such as support tower **12**, may be provided with a crossbar member **14** and a plurality of sheaves **16**. The crossbar member **14** is somewhat rigidly attached to the support tower **12**. The plurality of sheaves **16** (e.g. individual sheaves **18** and **28**) are rotationally attached to the crossbar member **14**.

The aerial ropeway **10** may be further provided with a haul rope cable **30**. The haul rope cable **30** may be formed from any of a number of materials, however it is commonly manufactured from braided steel. The haul rope cable **30** may be supported by the plurality of sheaves **16** in a manner that allows the haul rope cable **30** to move relative to earth.

In one exemplary application illustrated in FIG. 1, the aerial ropeway **10** is operated to move objects from one location to another location. In order to move objects, the haul rope cable **30** moves with respect to the support tower **12**. The moving haul rope cable **30** is supported by the plurality of sheaves **16**.

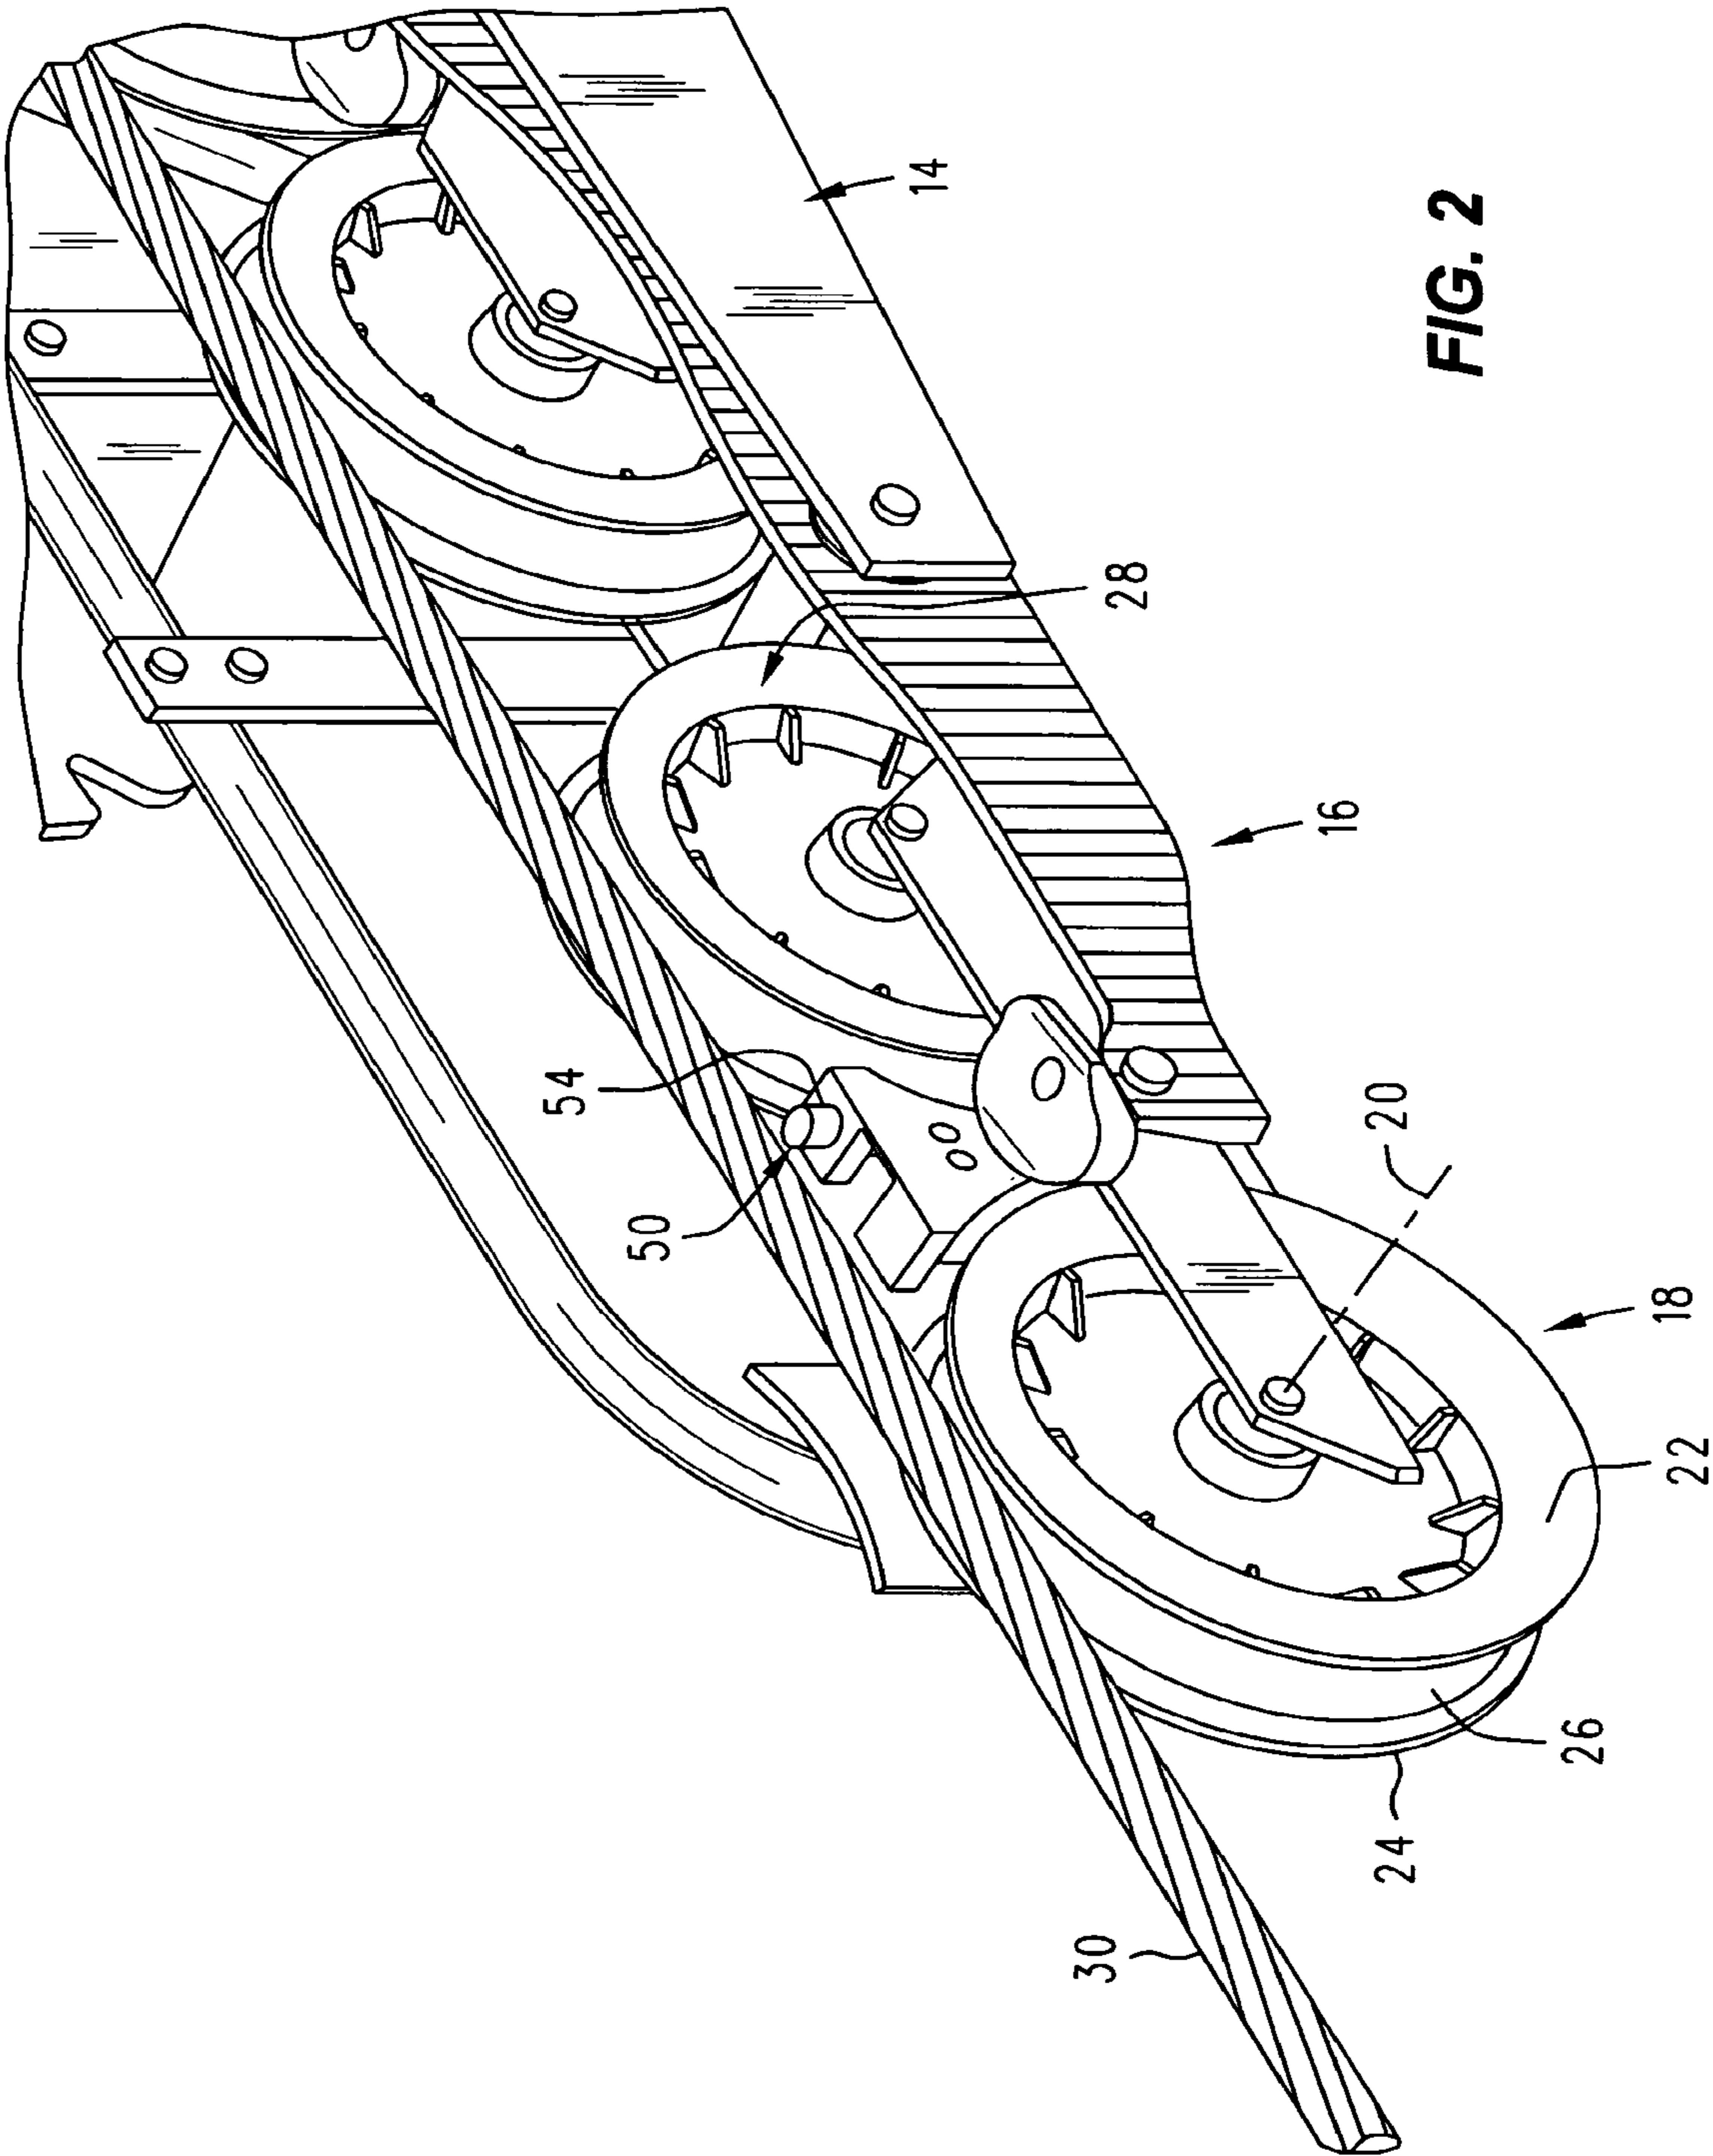
FIG. 2 is a perspective view of a plurality of sheaves of the aerial ropeway transportation system of FIG. 1.

FIG. 2 shows a magnified portion of the individual sheaves **18** and **28** attached to the crossbar member **14**. It should be noted that the plurality of sheaves **16** may be substantially similar to each other; therefore, the following description of individual sheave **18** is adequate for describing other sheaves (e.g. individual sheave **18**). With reference to FIG. 2, individual sheave **18** may be provided with a first axis **20**, a first face **22**, a second face **24** and a track **26**. The first and second faces **22**, **24** may take the form of circles formed parallel to and oppositely disposed from each other. The first axis **20** may be located at the center of the faces **22**, **24**. The track **26** may be formed as a semicircle and positioned **30** concentric to the first axis **20**. Furthermore, the semicircular configuration of the track **26** may accept the haul rope cable **30**.

With reference to FIG. 2, as individual sheave **18** supports the haul rope cable **30**, the sheave **18** rotates about the first axis **20**. In normal operating conditions, the first face **22**, the second face **24** and the track **26** of the sheave **18** support the haul rope cable **30**. Due to a variety of circumstances, the haul rope cable **30** may become misaligned and improperly supported by the sheave **18**. One such misalignment is the separation of the haul rope cable **30** from the track **26**. The cable positioning switch system **50** may sense this misalignment of the haul rope cable **30** and notify the cabinet **180** (FIG. 7). The cabinet **180** may invoke notification and/or take action accordingly.

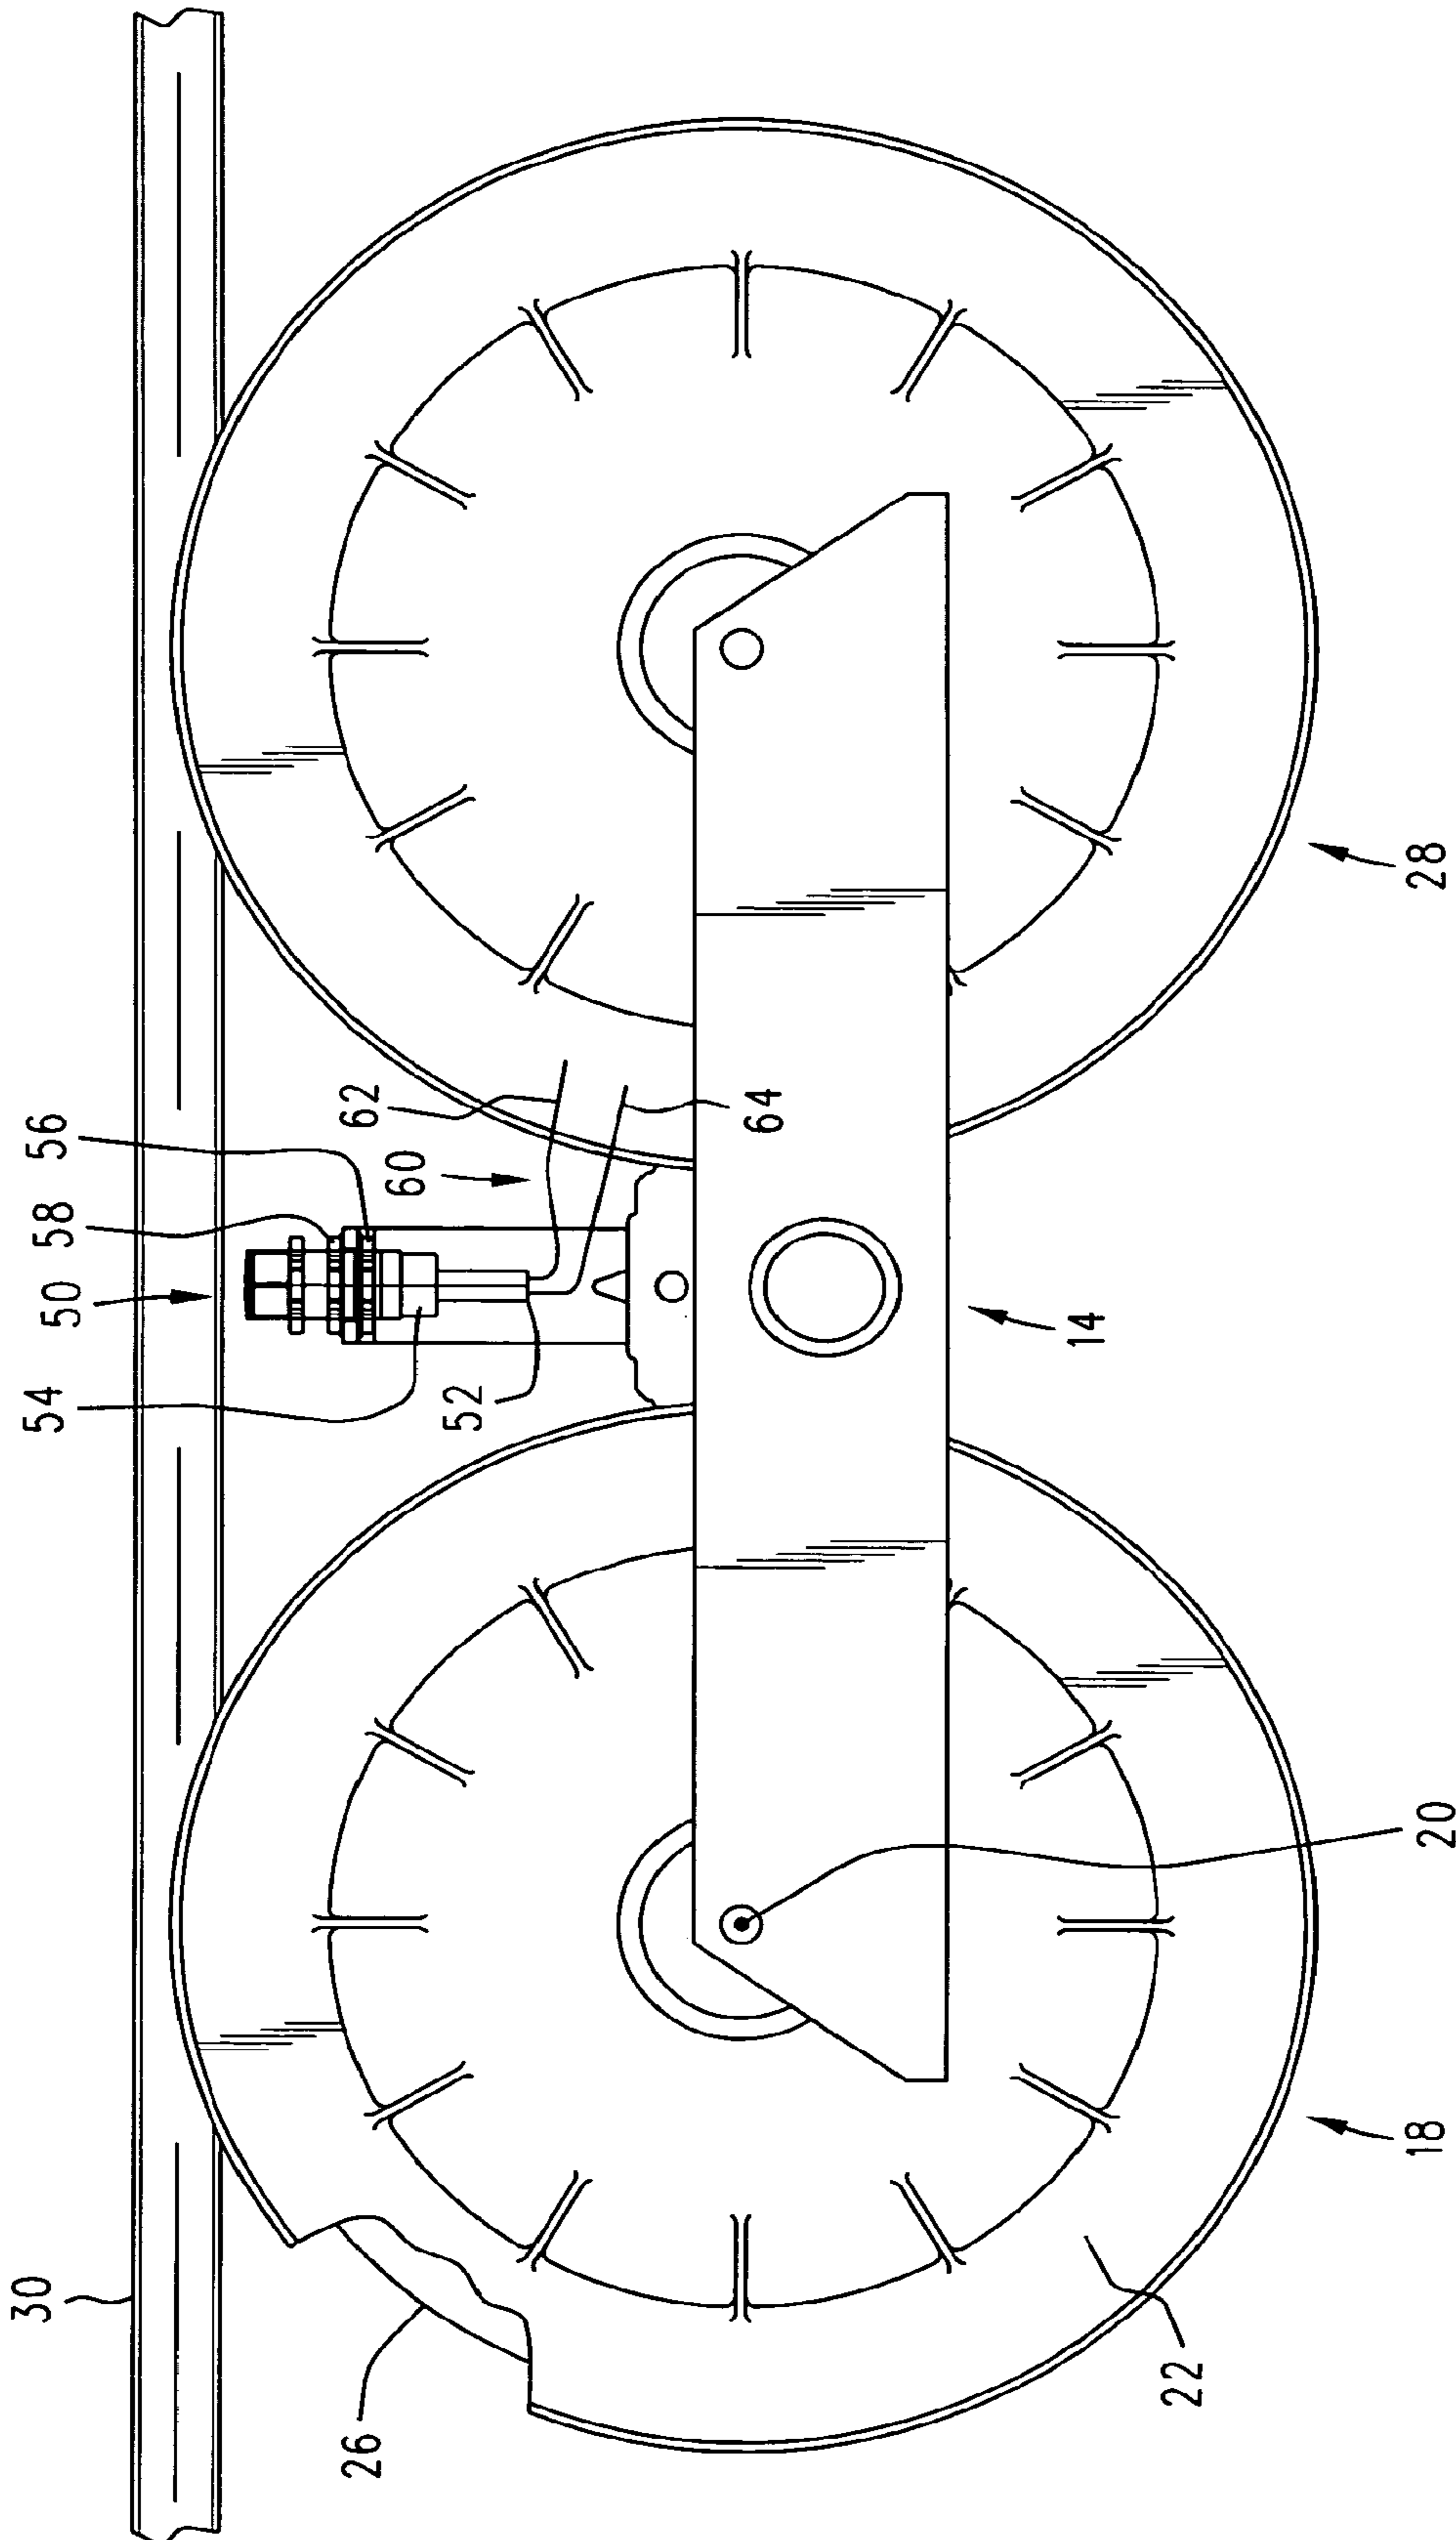
FIG. 3 is a side elevation view of the plurality of the sheaves of the aerial ropeway transportation system of FIG. 2.

FIG. 3 illustrates a side elevation view of the individual sheaves **18**, **28**. With reference to FIG. 3, the haul rope cable **30** contacts the plurality of sheaves **16** (e.g. individual sheave **18**). In particular, individual sheave **18** contacts the haul roped cable **30** at the track **26**.

With continued reference to FIG. 3, the aerial ropeway **10** may be provided with a cable positioning switch system **50**. The cable positioning switch system **50** may be provided with a mounting bracket **52**, a proximity sensor **54**, a first nut **56** and a second nut **58**. The mounting bracket **52** may be rigidly attached to the crossbar member **14**. The proximity sensor **54** may be adjustably affixed to the mounting bracket **52** with the nuts **56**, **58**.

With continued reference to FIG. 3, the location of the proximity sensor 54 renders it vulnerable to being damaged. One form of damage to the proximity sensor 54 is an impact (by objects such as, for example, ice, tools, ladders, brackets, etc.) to the proximity sensor 54. The previously-described internal components of the proximity sensor 54 are somewhat fragile. If these internal components are damaged by an impact, the proximity sensor 54 may send erroneous information about the location of the haul rope cable 30. In order to reduce the risk of sending erroneous information about the location of the haul rope cable 30, the present sensor damage indicator 100 may be incorporated into (or alternatively attached to) the proximity sensor 54.

With reference to FIG. 3, when the present damage indicator **100** is employed in the previously described situation, the damage to the proximity sensor **54** is reported to the cabinet **180** (via the damage indicator **100**). As previously described, when the damage indicator **100** receives an impact (for example, an impact from the haul rope cable **30**), the frangible conductor **170** (FIG. 6) is ruptured. The ruptured frangible conductor **170** is not able to transmit the indicator signal from the first end **172** to the second end **174**. The cabinet **180** may take action(s) to indicate this damage to the proximity sensor **54**. Therefore, use of the present damage indicator **100** improves proper operation of the aerial ropeway **10** by indicating impact to the proximity sensor **54**.

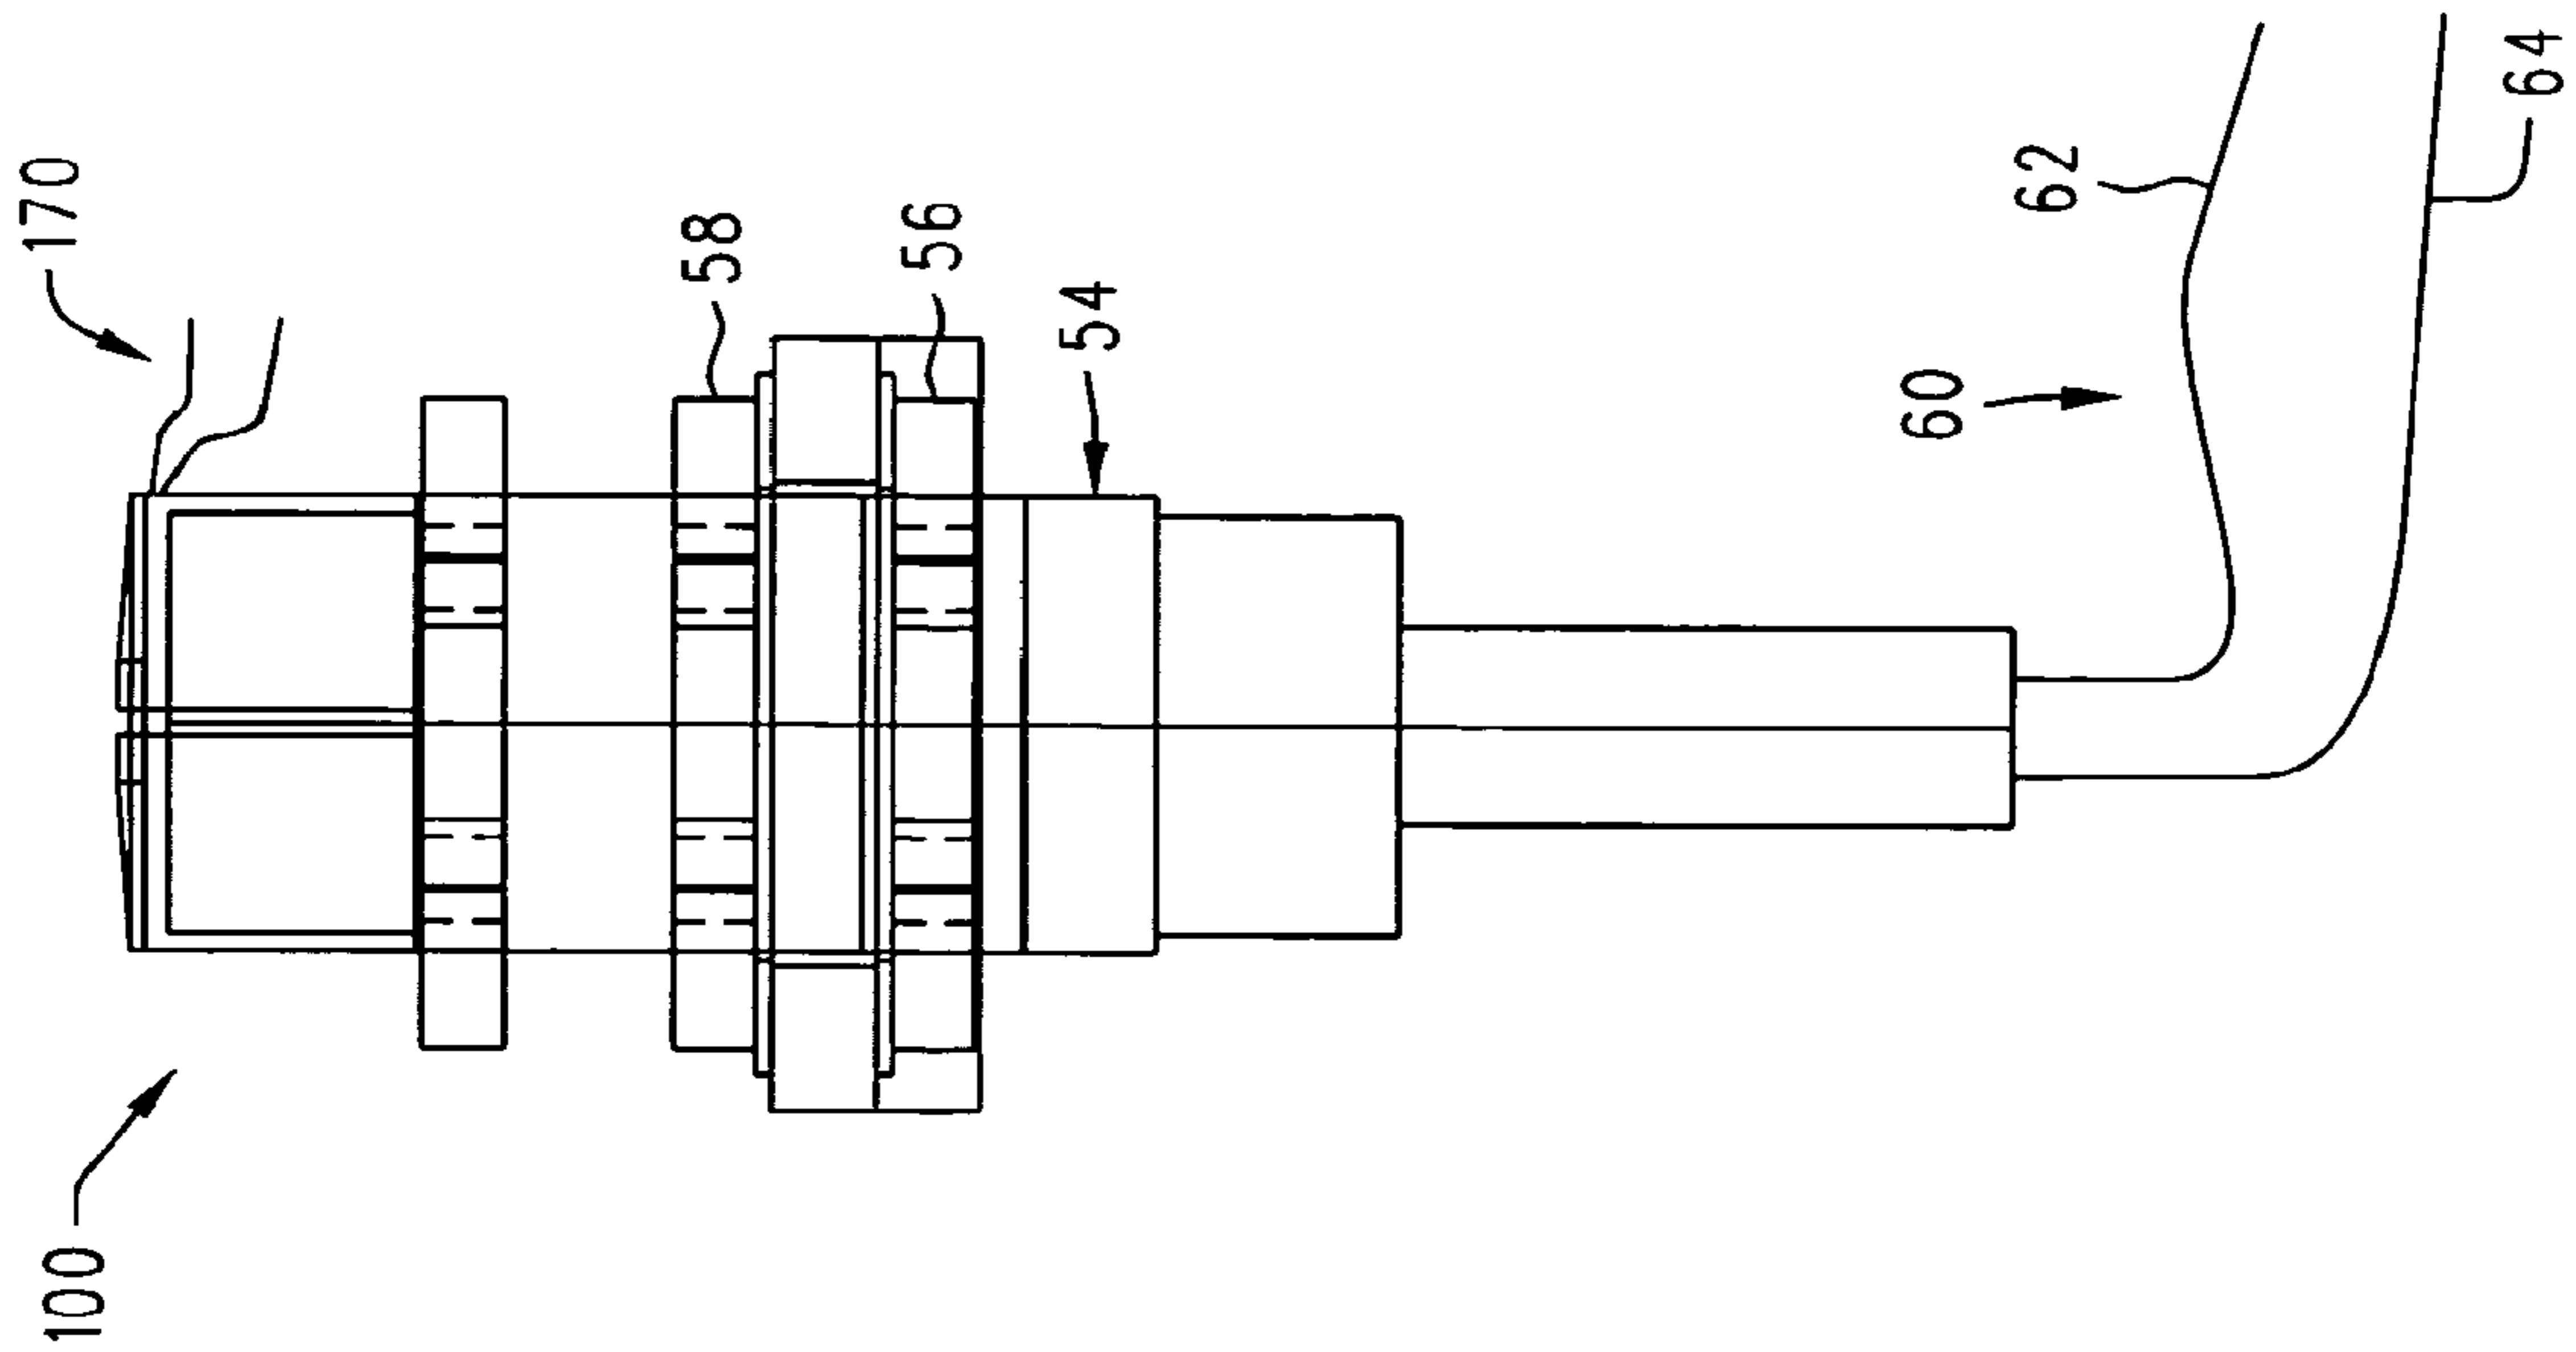
FIG. 4 is a side elevation view of an exemplary sensor provided with an exemplary damage indicator.

FIG. 4 illustrates a side elevation view of the proximity sensor 54. With reference to FIG. 4, the proximity sensor 54 is provided with electrical leads 60 such as first lead 62 and second lead 64. The illustrated embodiment shows a 2-wire configuration; it is to be understood that the present damage indicator 100 and methods associated therewith may be adapted to other types of fragile sensors. In a process that will be described later herein, the proximity sensor 54 may be mounted somewhat close to the haul rope cable 30 as illustrated in FIG. 3. With reference to FIG. 3, if the haul rope cable 30 moves from the track 26, the proximity sensor 54 generates a signal indicating this movement. In some cases, movement of the haul rope cable 30 may reduce operability of the aerial ropeway 10.

With reference to FIG. 4, the damage indicator 100 may be positioned on the proximity sensor 54. FIG. 5 illustrates a side elevation view of the damage indicator 100 of FIG. 4. With reference to FIG. 5, the damage indicator 100 may be provided with a top portion 102 and an oppositely disposed bottom portion 104. The bottom portion 104 may be formed as a threaded nut 106. The threaded nut 106 may be provided with a threaded portion 108 (FIG. 6) formed on the interior portion thereof. The threaded nut may also be provided with a flat-surfaced portion 110 formed on the exterior portion thereof.

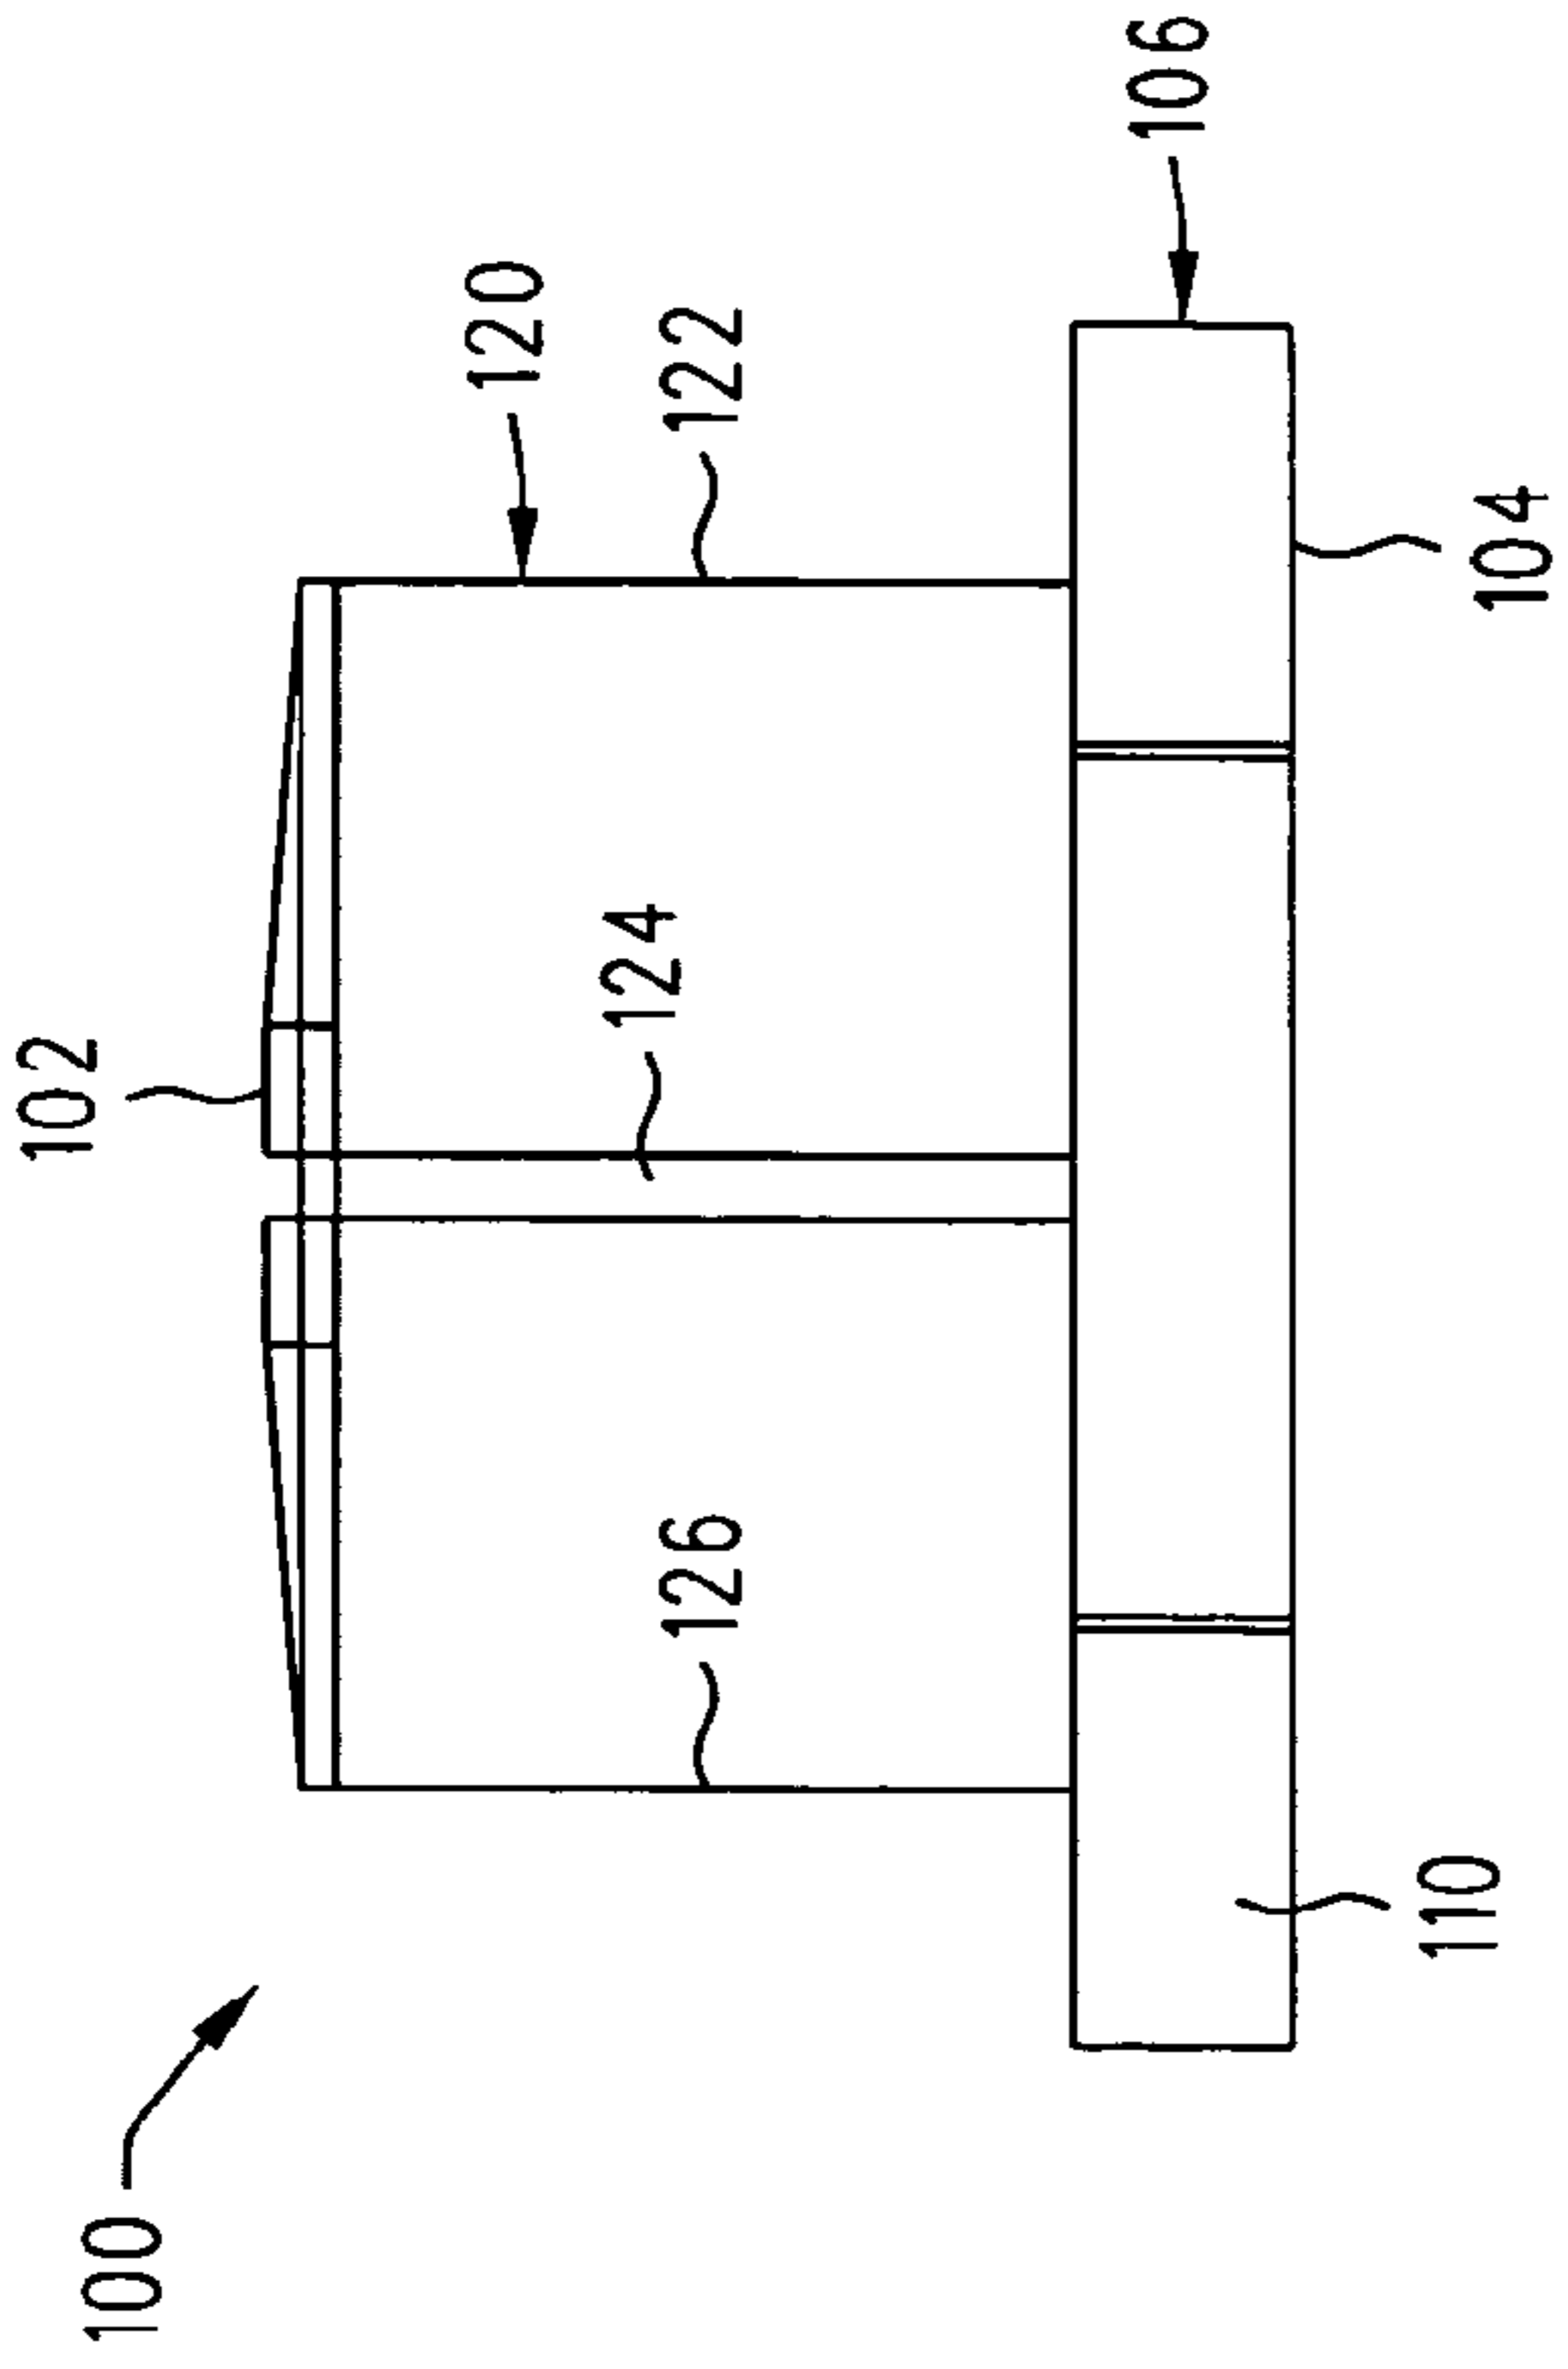
FIG. 5 is a side elevation view of the exemplary damage indicator of FIG. 4.
