(10) **Patent No.:** **US 7,800,509 B2**
(45) **Date of Patent:** ***Sep. 21, 2010**

(54) **ROPEWAY WITH SENSORS AND METHOD**

A ropeway may include at least one cable. A first sensor and a second sensor may be provided. The second sensor may be located between the first sensor and the cable. Related methodology is also disclosed.

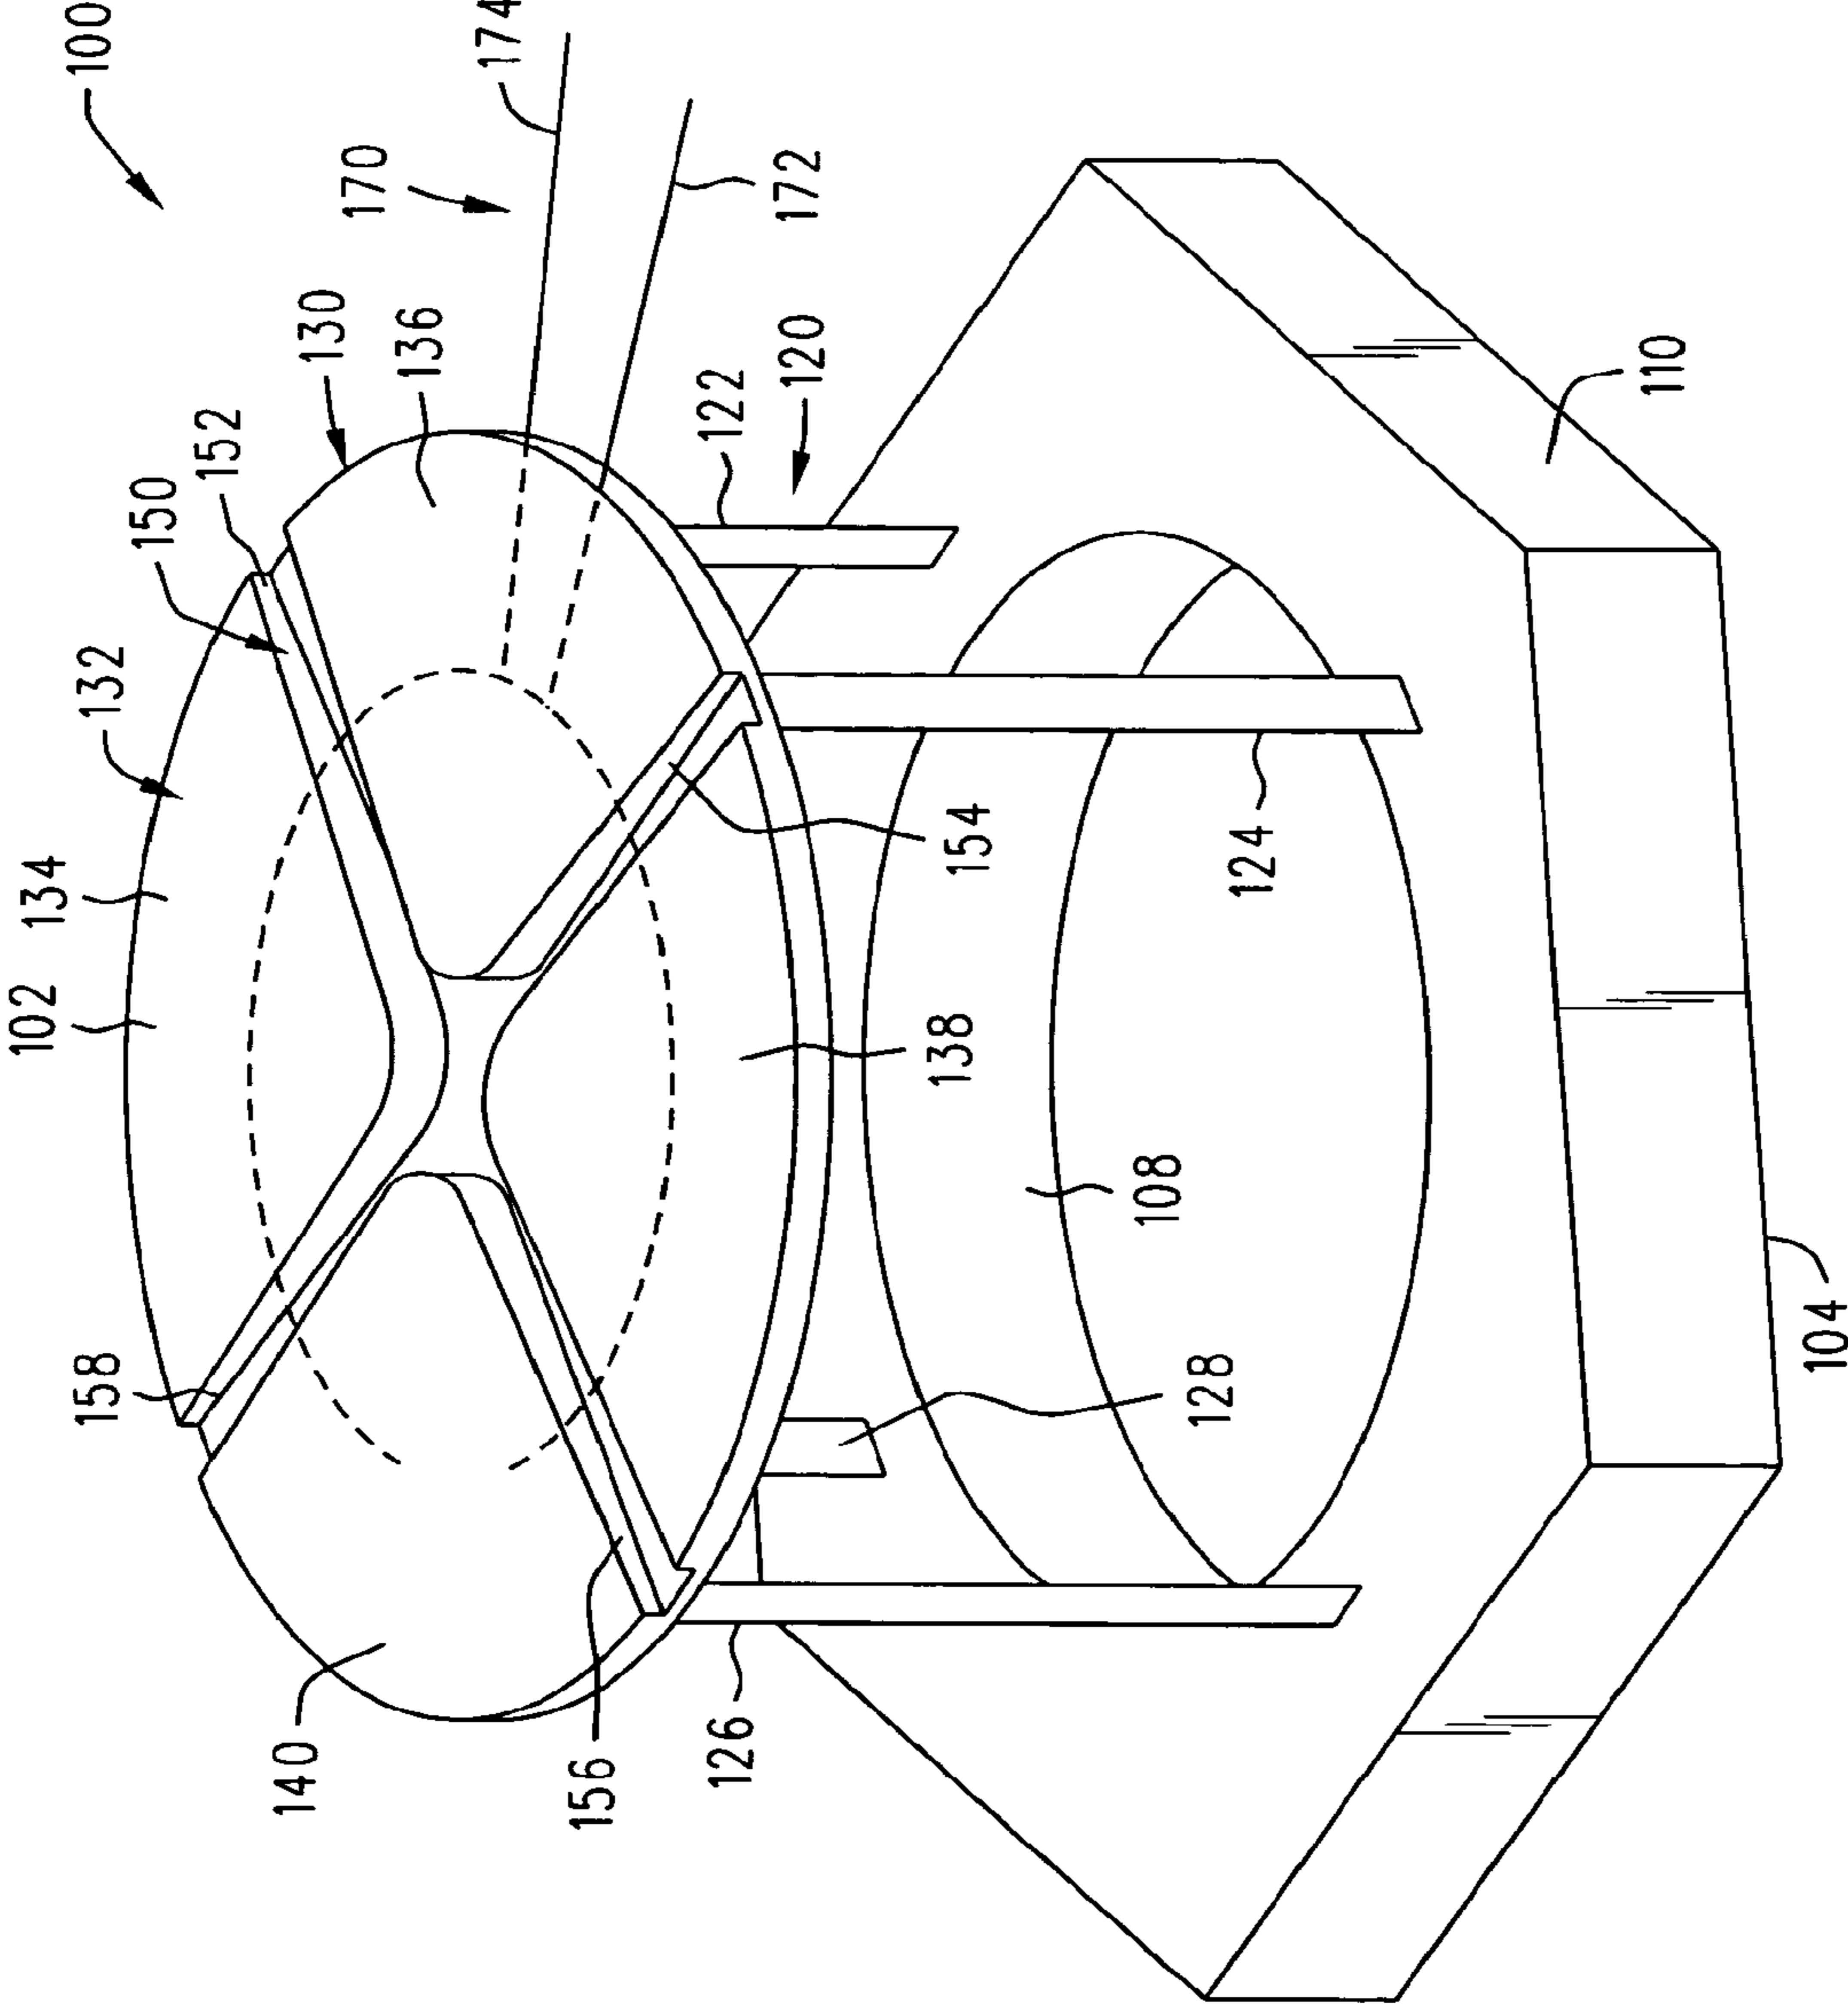
FIG. 6 is a perspective view of the exemplary damage indicator of FIG. 5.

FIG. 6 illustrates a perspective view of the damage indicator 100. With reference to FIG. 6, the damage indicator 100 may be further provided with a plurality of stanchions 120 such as first stanchion 122, second stanchion 124, third stanchion 126 and fourth stanchion 128. The stanchions 120 may protrude from the threaded nut 106 formed at the bottom portion 104 towards the top portion 102 as illustrated in FIG. 6.

With continued reference to FIG. 6, the damage indicator 100 may be provided with a plate 130. The plate 130 may be attached to (or integrally formed with) the stanchions 120. The plate 130 may be provided with a plurality of crush zones 132 such as first crush zone 134, second crush zone 136, third crush zone 138 and fourth crush zone 140. The plate 130 may be further provided with a plurality of frangible lines 150 such as first frangible line 152, second frangible line 154, third frangible line 156 and fourth frangible line 158. The first frangible line 152 may separate the first and second crush zones 134, 136. The second frangible line 154 may separate the second and third crush zones 136, 138. The third frangible line 156 may separate the third and fourth crush zones 138, 140. The fourth frangible line 158 may separate the fourth and first crush zones 140, 134. These frangible lines 150 may, for example, be areas where material is removed from the plate

With continued reference to FIG. 6, the damage indicator 100 may be further provided with a frangible conductor 170. This frangible conductor 170 may be composed of any conductor such as, for example, copper wire, conductor paths on printed circuit board, silver wire, metallic wire of any type, etc. In one exemplary embodiment, the frangible conductor 170 may be wire between 22 to 18 American Wire Gage (0.0253-0.0403 inches in diameter). The frangible conductor 170 may define a first end 172 and a second end 174. The frangible conductor 170 may be attached to (or integrally formed with) the plate 130 as illustrated, for example, in the exemplary pattern indicated by the dashed line in FIG. 6; It should be noted that as illustrated in FIG. 6, the frangible conductor 170 may overlap frangible portions of the damage indicator 100 (e.g. the frangible lines 150).

When the proximity sensor **54** is impacted, the plate **130** will rupture. This rupture may occur, for example, at the frangible lines **150**. This rupturing of the plate **130** causes the frangible conductor **170** to break (thereby disrupting the conductivity of the frangible conductor). Therefore, before the impact, an indicator signal may travel from the first end **172** to the second end **174** of the frangible conductor **170** (sometime referred to herein as a first condition of the damage indicator). After impact, the indicator signal cannot travel along the frangible conductor **170** (sometime referred to herein as a second condition of the damage indicator). This disruption of the indicator signal may be detected by the circuitry within the cabinet **180** (FIG. 7).

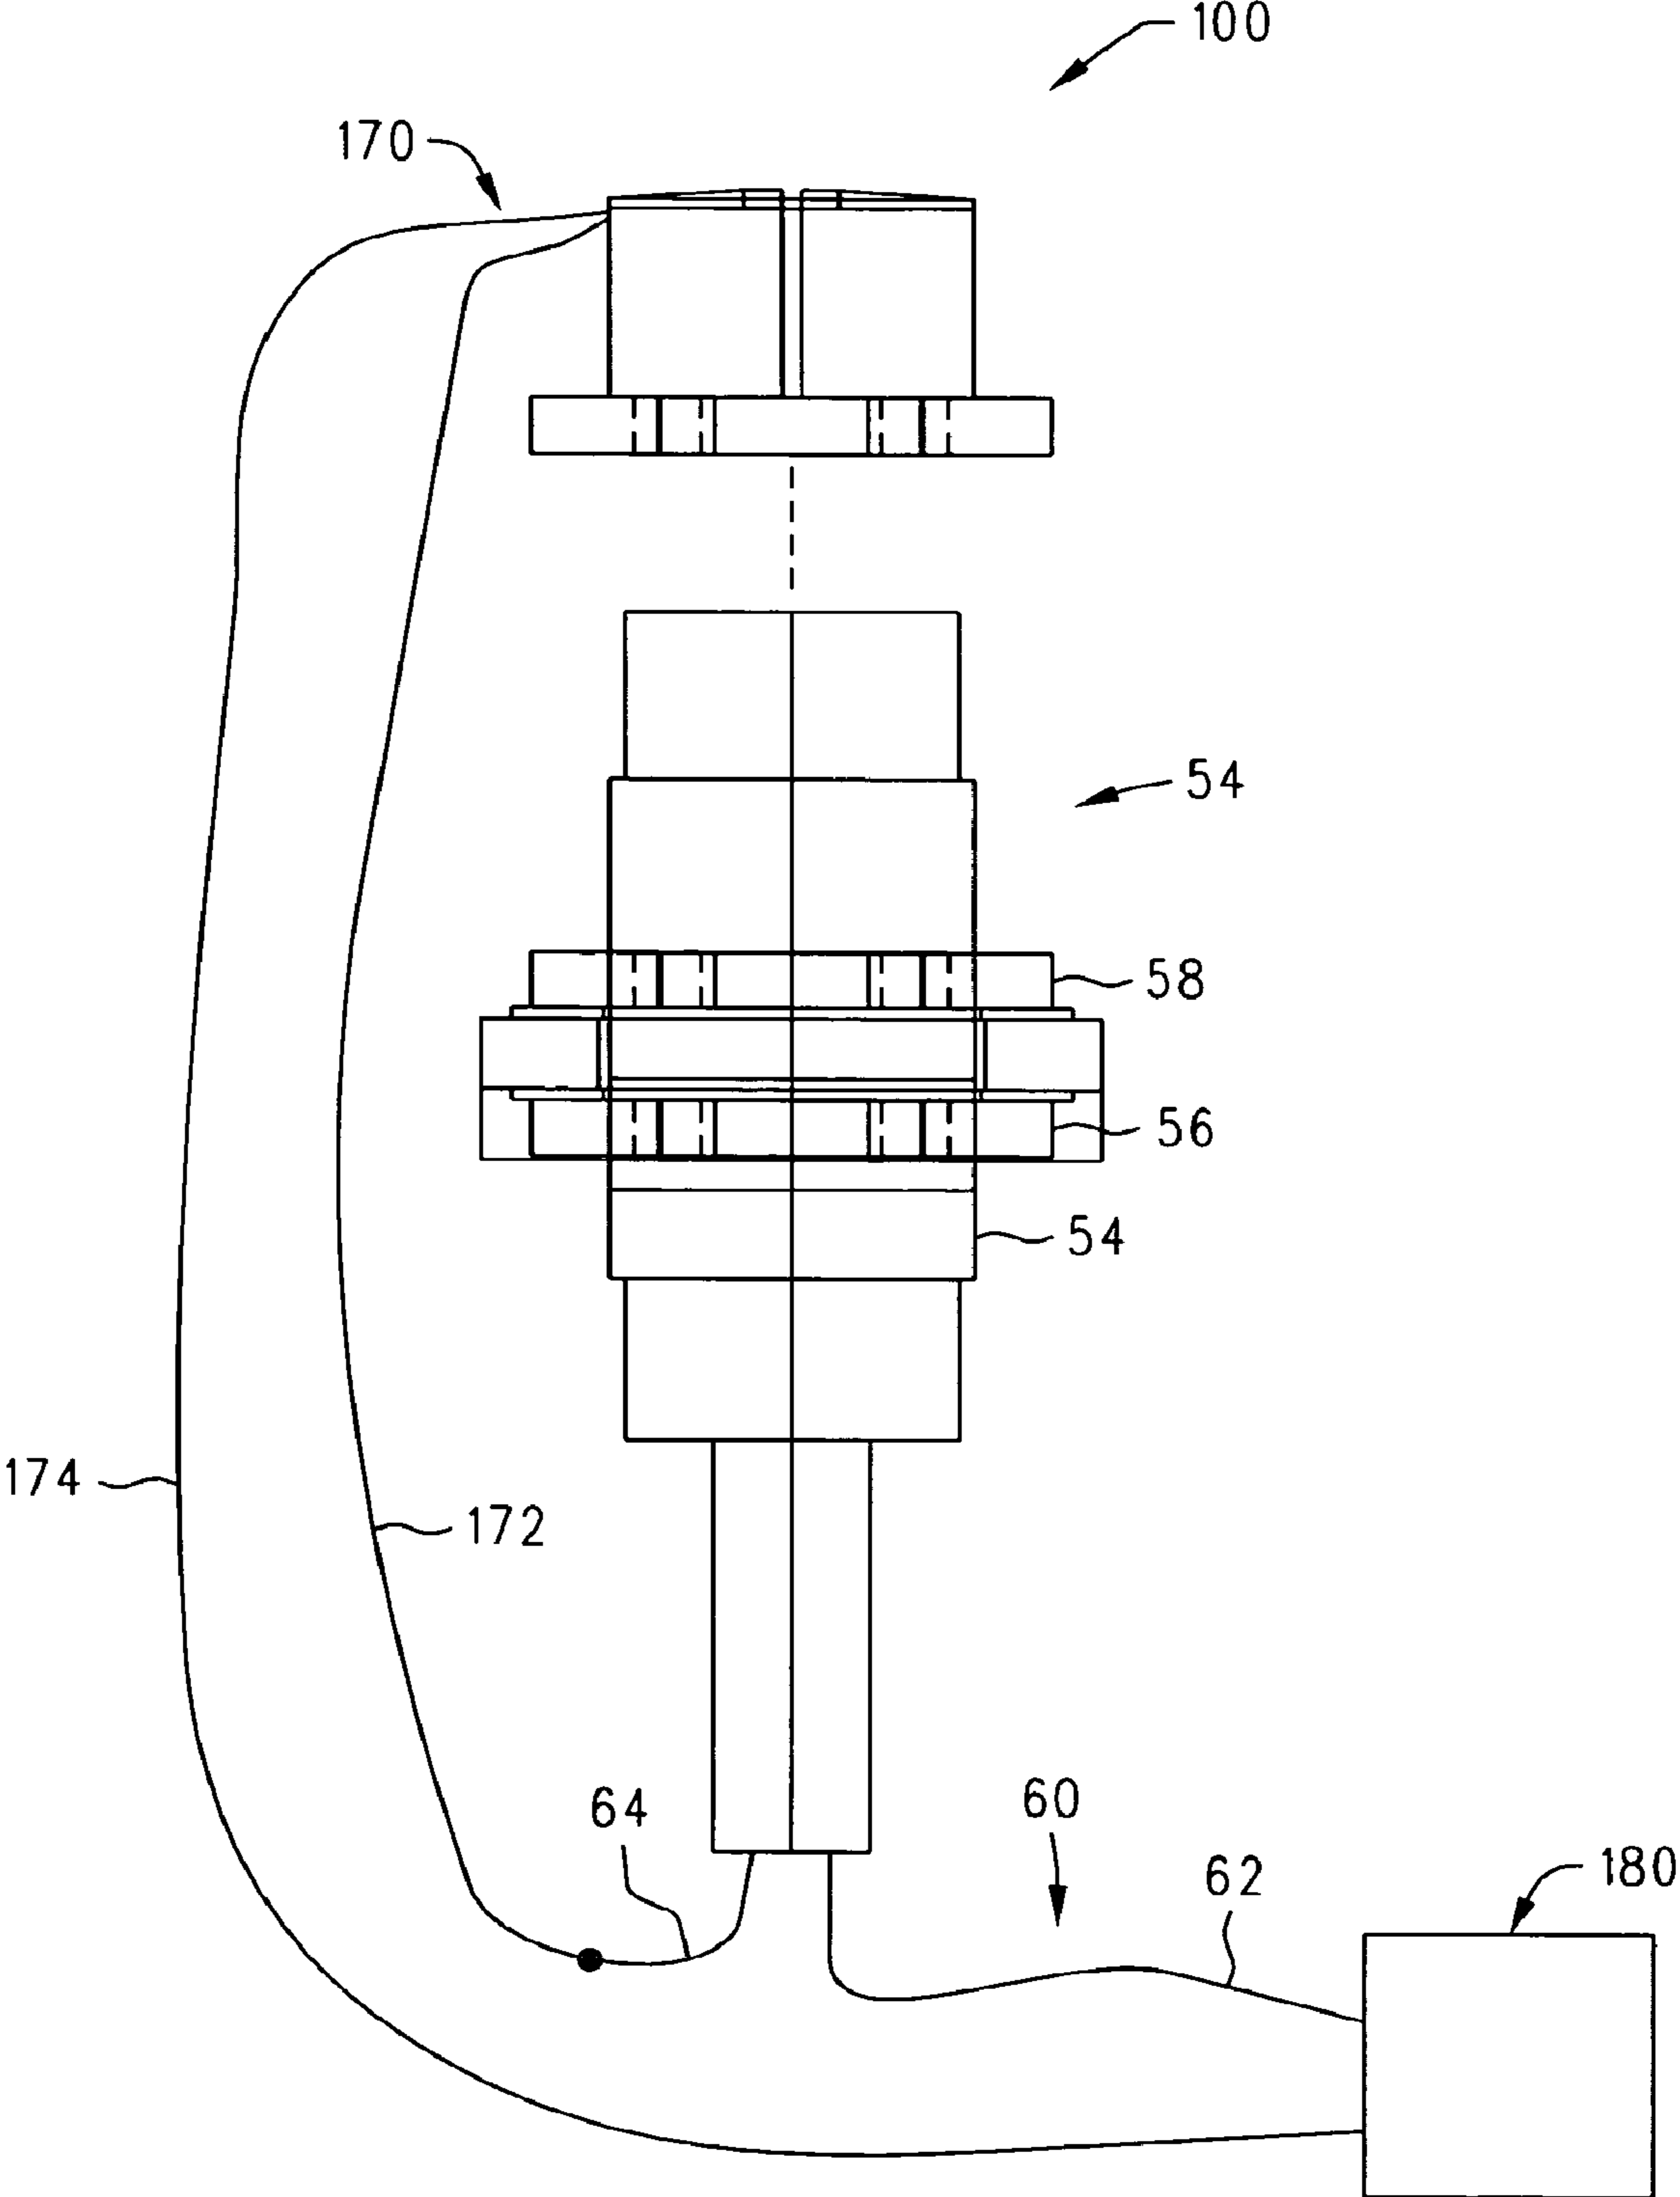
FIG. 7 is an exemplary wiring diagram for the exemplary sensor and exemplary damage indicator of FIG. 4.

With reference to FIG. 7, the aerial ropeway 10 (FIG. 1) may be further provided with a cabinet 180. The cabinet 180 may be provided with a high voltage side and a low voltage side. The high voltage side may include high-power components such as a main circuit breaker, a main contactor, a regenerative bridge, etc. The low voltage side may include low-power components that control and monitor all the functions of the aerial ropeway 10. Examples of low-power components include, but are not limited to, the cable positioning switch system 50 (FIG. 3), derailment detectors, stop buttons, end-track device safeties returns, anemometers, wind vanes, telephone and any other information transmission devices, are connected through these wires to the cabinet 180. These various low-power components may be connected to the cabinet 180 through wires located in a communication cable 182 (FIG. 1).

Having provided detailed descriptions of exemplary components of the present damage indicator 100, an exemplary assembly thereof will now be provided. FIG. 7 illustrates one exemplary assembly and wiring configuration for the damage indicator 100 and the proximity sensor 54. With reference to FIG. 7, the damage indicator 100 may be threadingly engaged to the proximity sensor 54. This engagement may occur by rotating the damage indicator 100 while contacting the proximity sensor 54 to cause the threaded portion 108 (FIG. 6) of the damage indicator 100 to capture the proximity sensor 54. The resulting combination of the damage indicator 100 and the proximity sensor 54 is illustrated in FIG. 4.

With continued reference to FIG. 7, after physically assembling the damage indicator 100 to the proximity sensor 54, the electrical components thereof may be attached. It should be noted that the following description of wiring is provided for illustrative purposes only and that other wiring approaches may be utilized (e.g. the proximity sensor 54 may be of the three-wire type, the damage indicator 100 may be direct-wired to the cabinet 180, etc.). The first lead 62 of the proximity sensor 54 may be electrically interfaced with the cabinet 180. The second lead 64 of the proximity sensor 54 may be electrically interfaced with the first end 172 of the frangible conductor 170. The second end 174 of the frangible conductor 170 may be electrically interfaced with the cabinet 180. It is to be understood that this electrical interfacing may occur through various electrical components such as, for example, bus bars, wires, the communications cable 182 (FIG. 1), etc.
