(10) **Patent No.:** **US 8,257,039 B2**
(45) **Date of Patent:** **Sep. 4, 2012**

(54) **GAS TURBINE ENGINE CASE WITH REPLACED FLANGE AND METHOD OF REPAIRING THE SAME USING COLD METAL TRANSFER**

(73) Assignee: **United Technologies Corporation**, Hartford, CT (US)

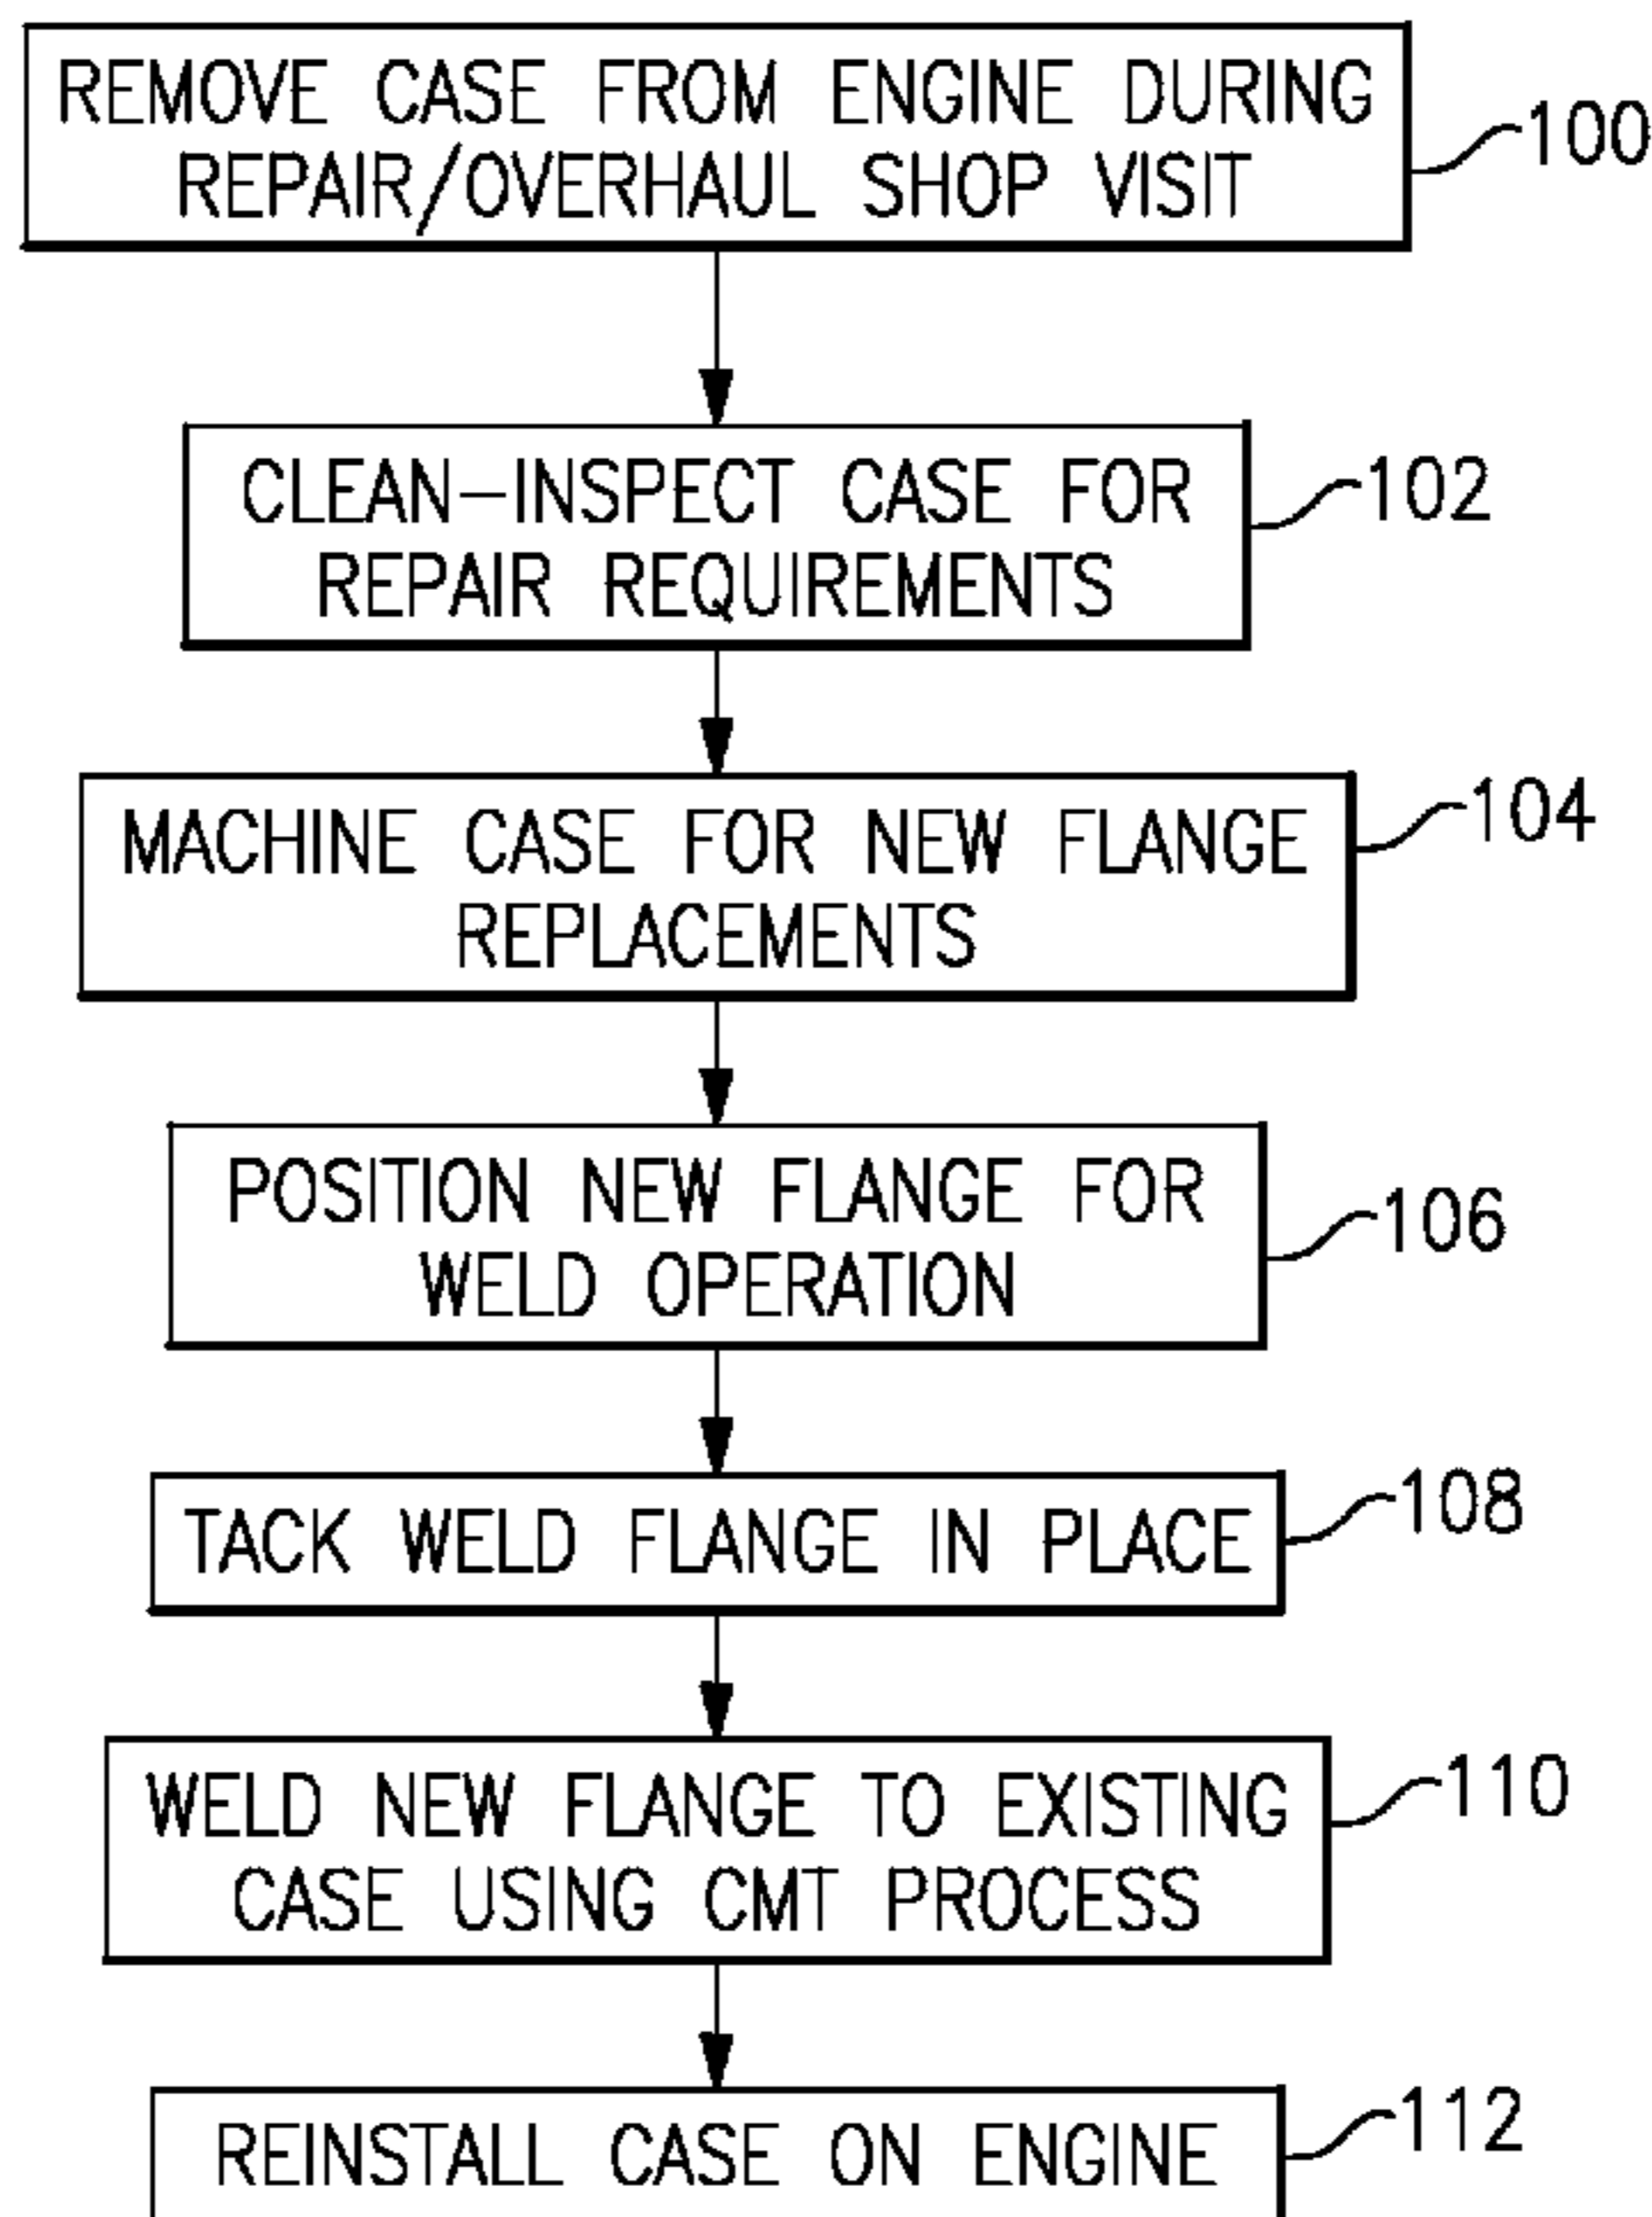
A gas turbine engine 10, such as a turbofan gas turbine engine, circumferentially disposed about an engine centerline, or axial centerline axis 12 is shown in FIG. 1. The engine 10 includes a fan 14, compressor sections 15 and 16, a combustion section 18 and a turbine 20. As is well known in the art, air compressed in the compressor 15, 16 is mixed with fuel and burned in the combustion section 18 and expanded in turbine 20. The turbine 20 includes rotors 22 and 24, which rotate in response to the expansion. The turbine 20 includes alternating rows of removable rotary airfoils or blades 26 and static airfoils or vanes 28. It should be understood that this schematic view is included to provide a basic understanding of the sections in a gas turbine engine, and is not to be limiting. This disclosure extends to all types of turbine engines for all types of applications.

The gas turbine engine 10 also includes an engine case surrounding internal engine components. The engine case is attached to adjacent housing parts at flanges at the end of the case. Over time, the engine case can wear at the flanges.

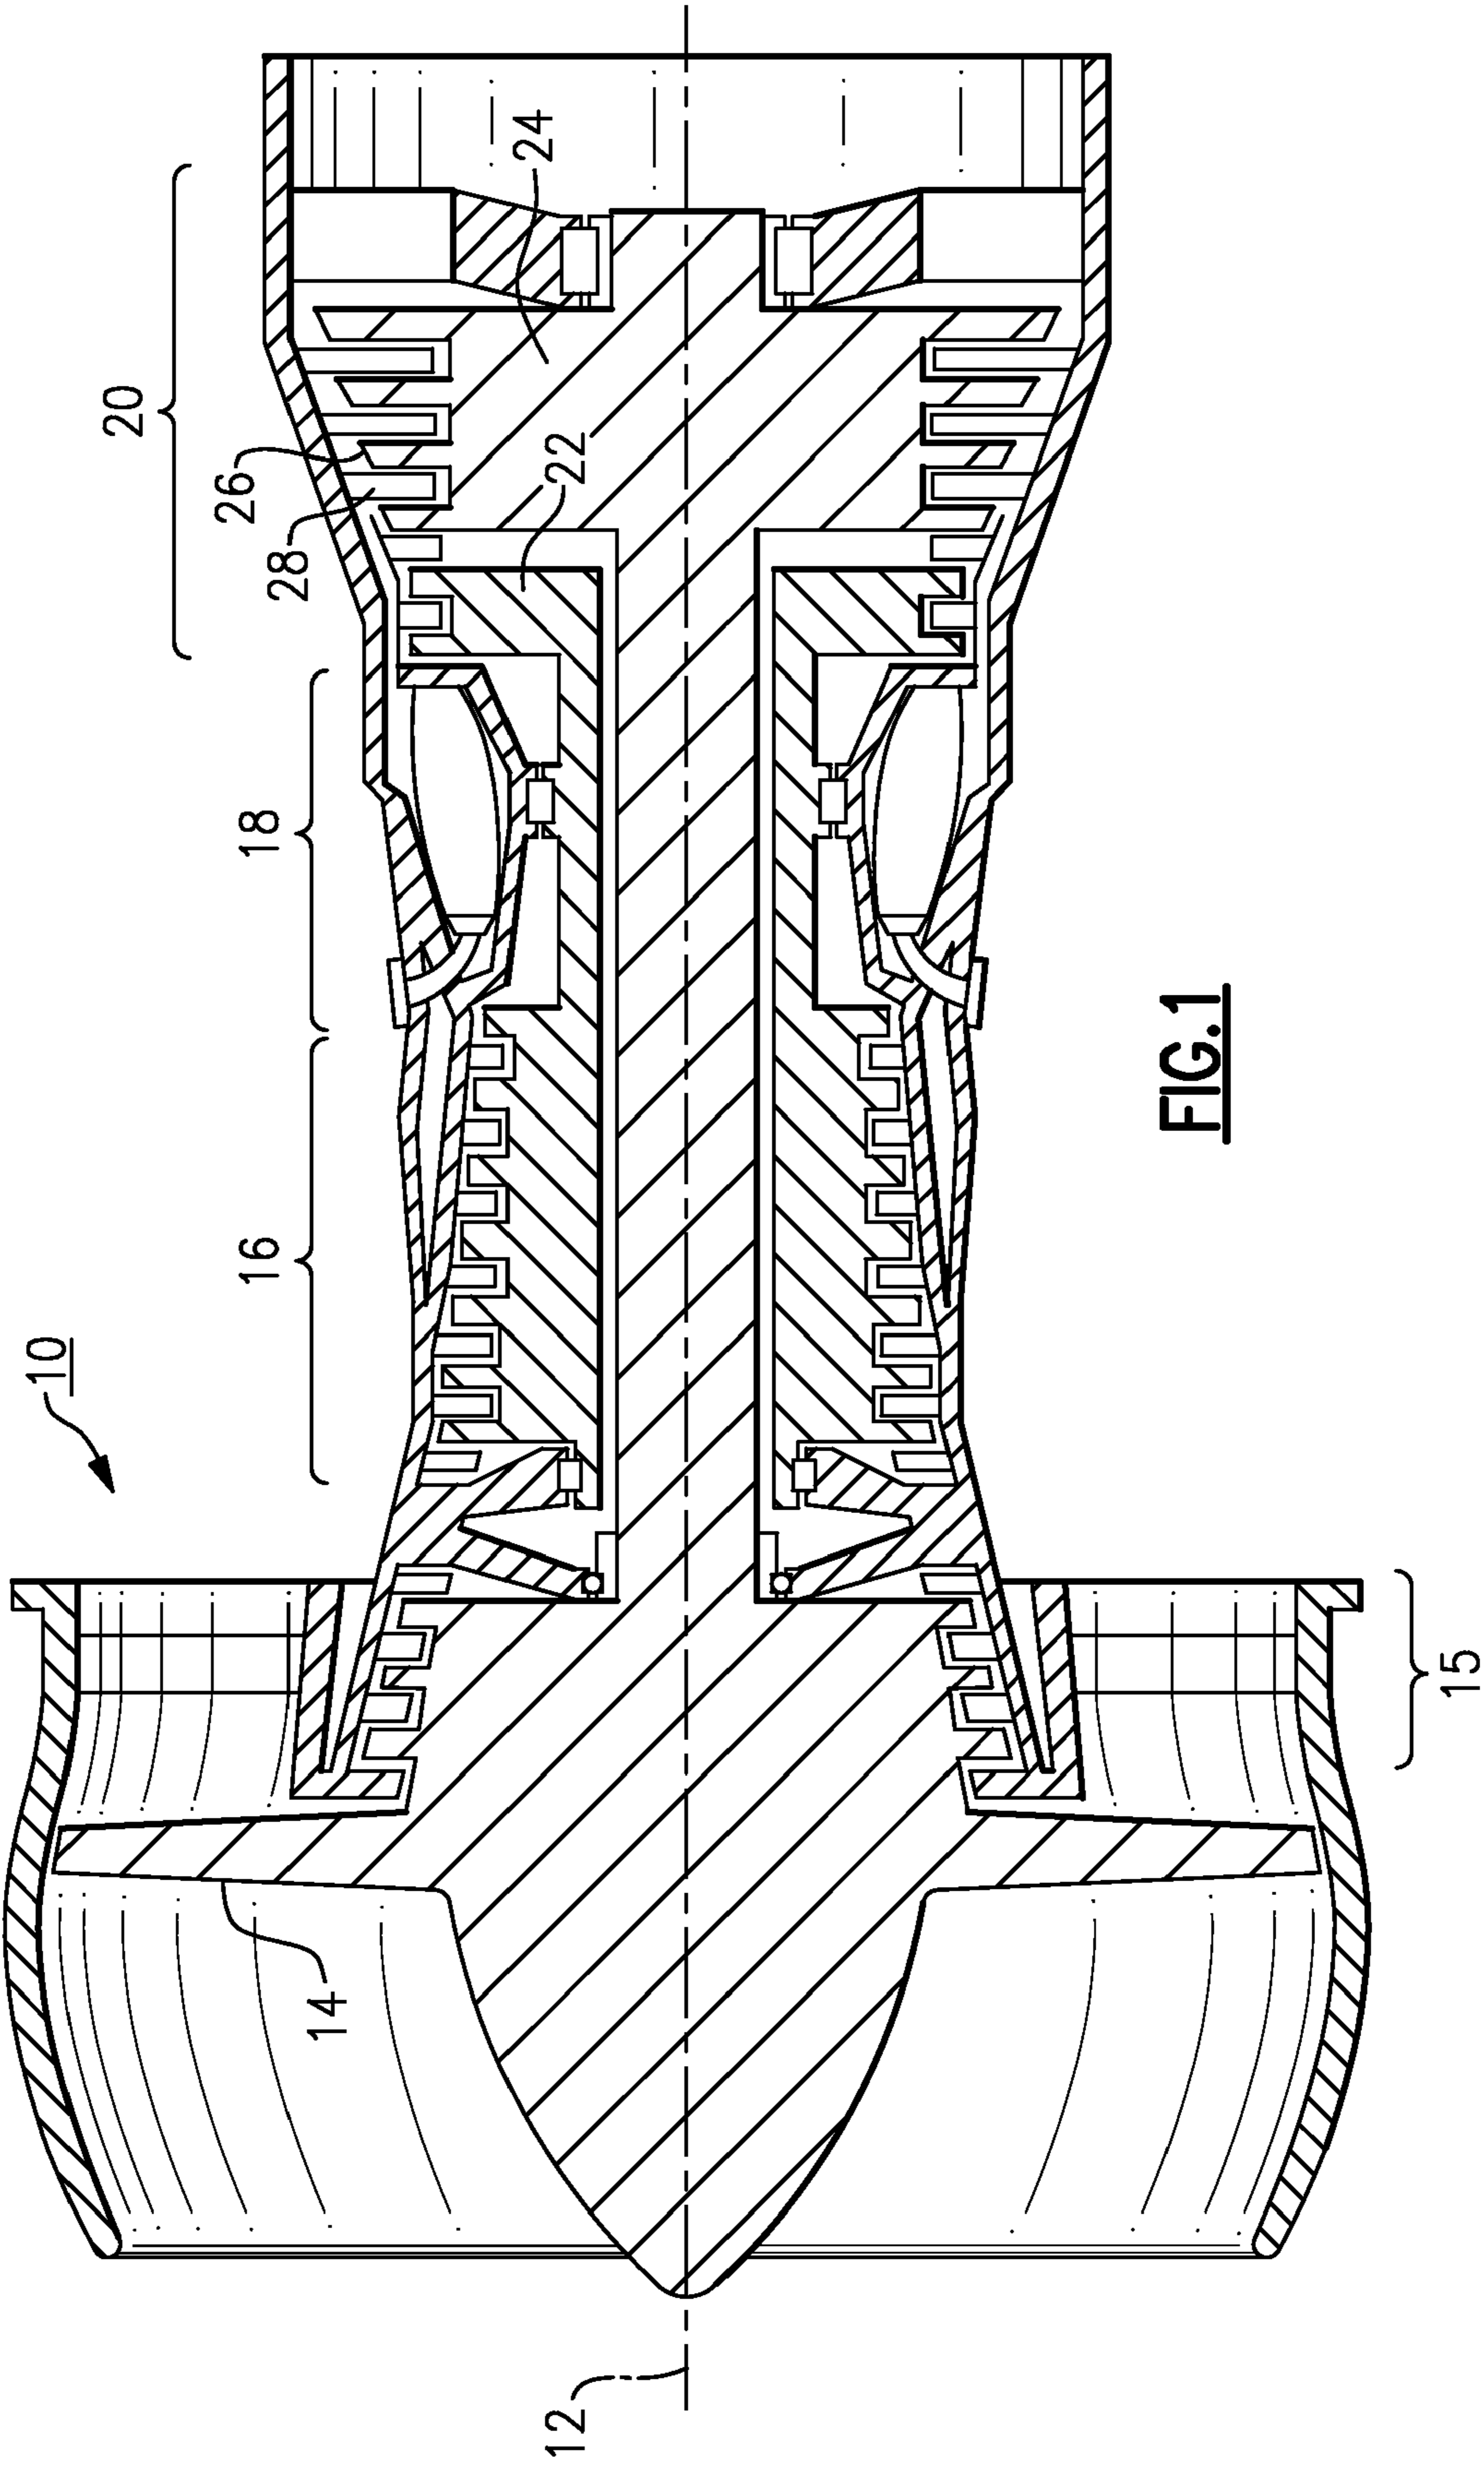
FIG.2A

FIG. 1 is a schematic view of a gas turbine engine.
FIG. 2A is a flow chart of an exemplary repair method.

FIG. 2A is a flow chart of a method of repairing a worn engine case 40 such as is shown in FIG. 2B. The initial step 100 is to removed the case 40 from the engine 10, for example, during a repair or overhaul shop visit. The case 40 is cleaned and inspected at step 102 for repair requirements. For example, as shown in FIG. 2B, a number of worn or damaged areas 44 may exist on a flange 42 of the engine case 40. These areas 44 may be identified for repair prior to the engine case 40 being reinstalled on the engine 10.

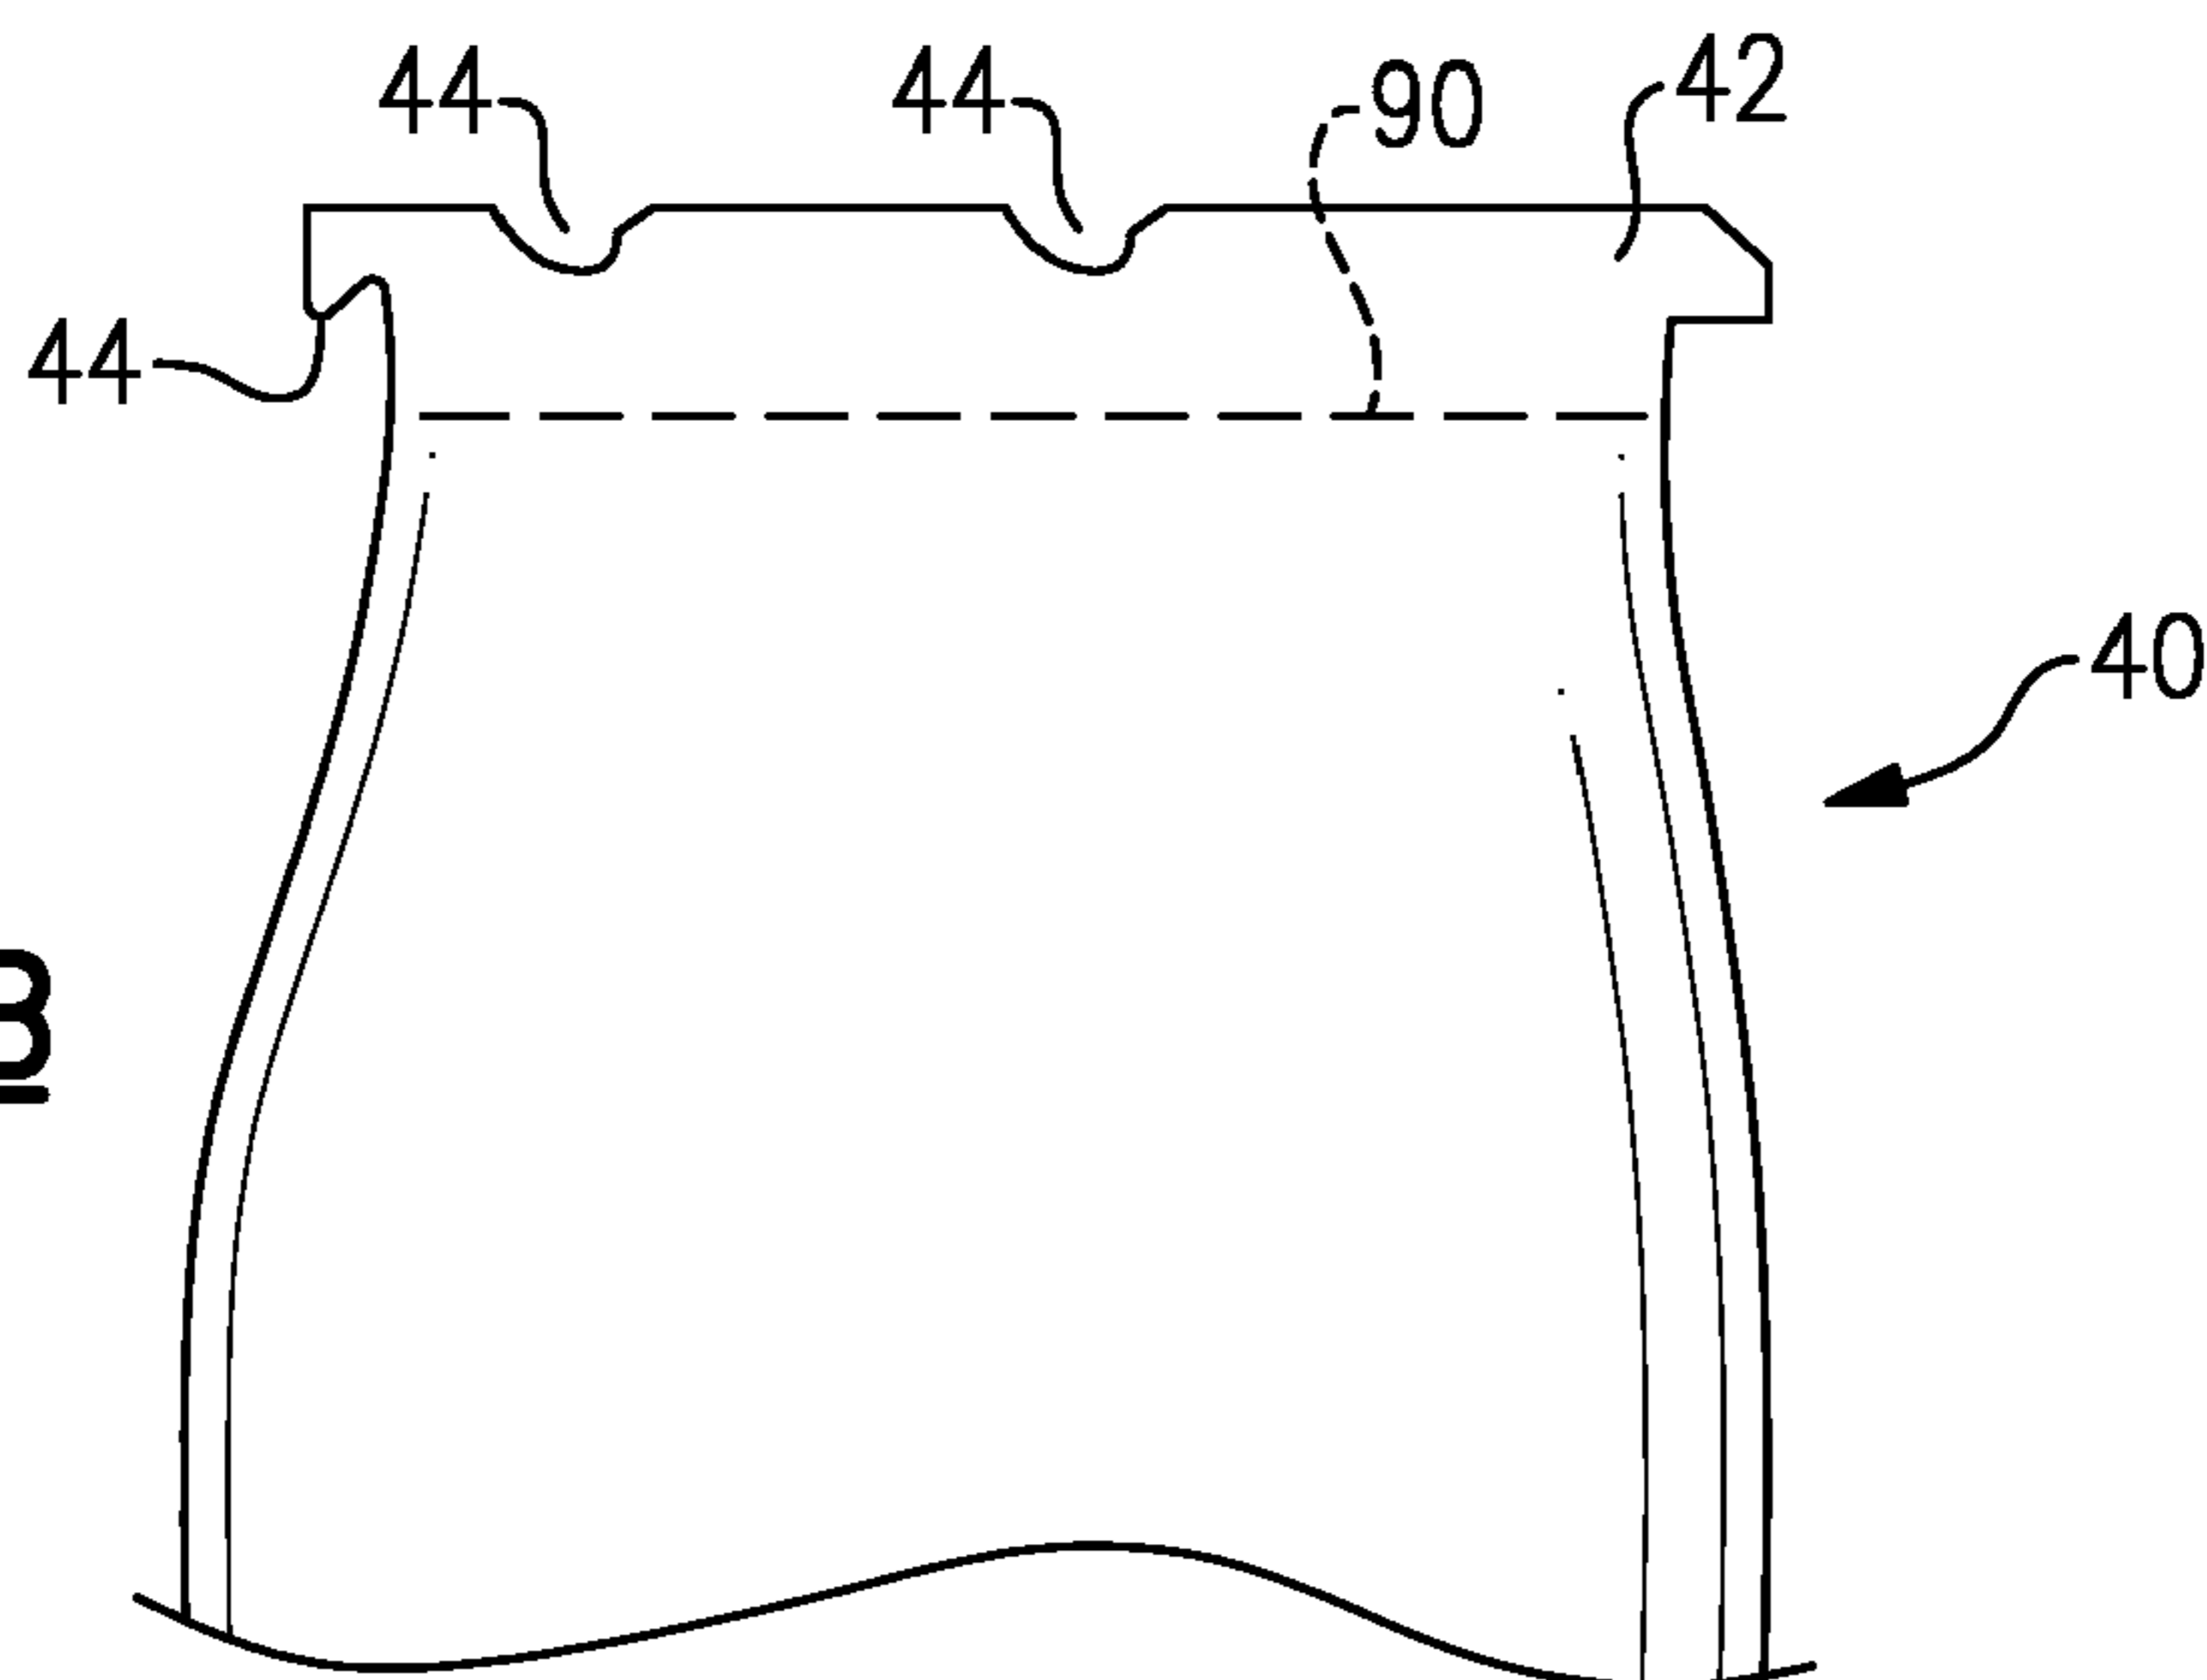
FIG. 3A shows a first step in a repair process.

An initial step 104 in the repair of the engine case 40 is to remove the existing flange 42 down to a substantially flat surface 46 as shown in FIG. 3A. This can be achieved by cutting down to dashed line 90 as shown in FIG. 2B. FIG. 3A shows the surface 46 as a substantially flat surface. A replacement flange 48 may then be utilized.

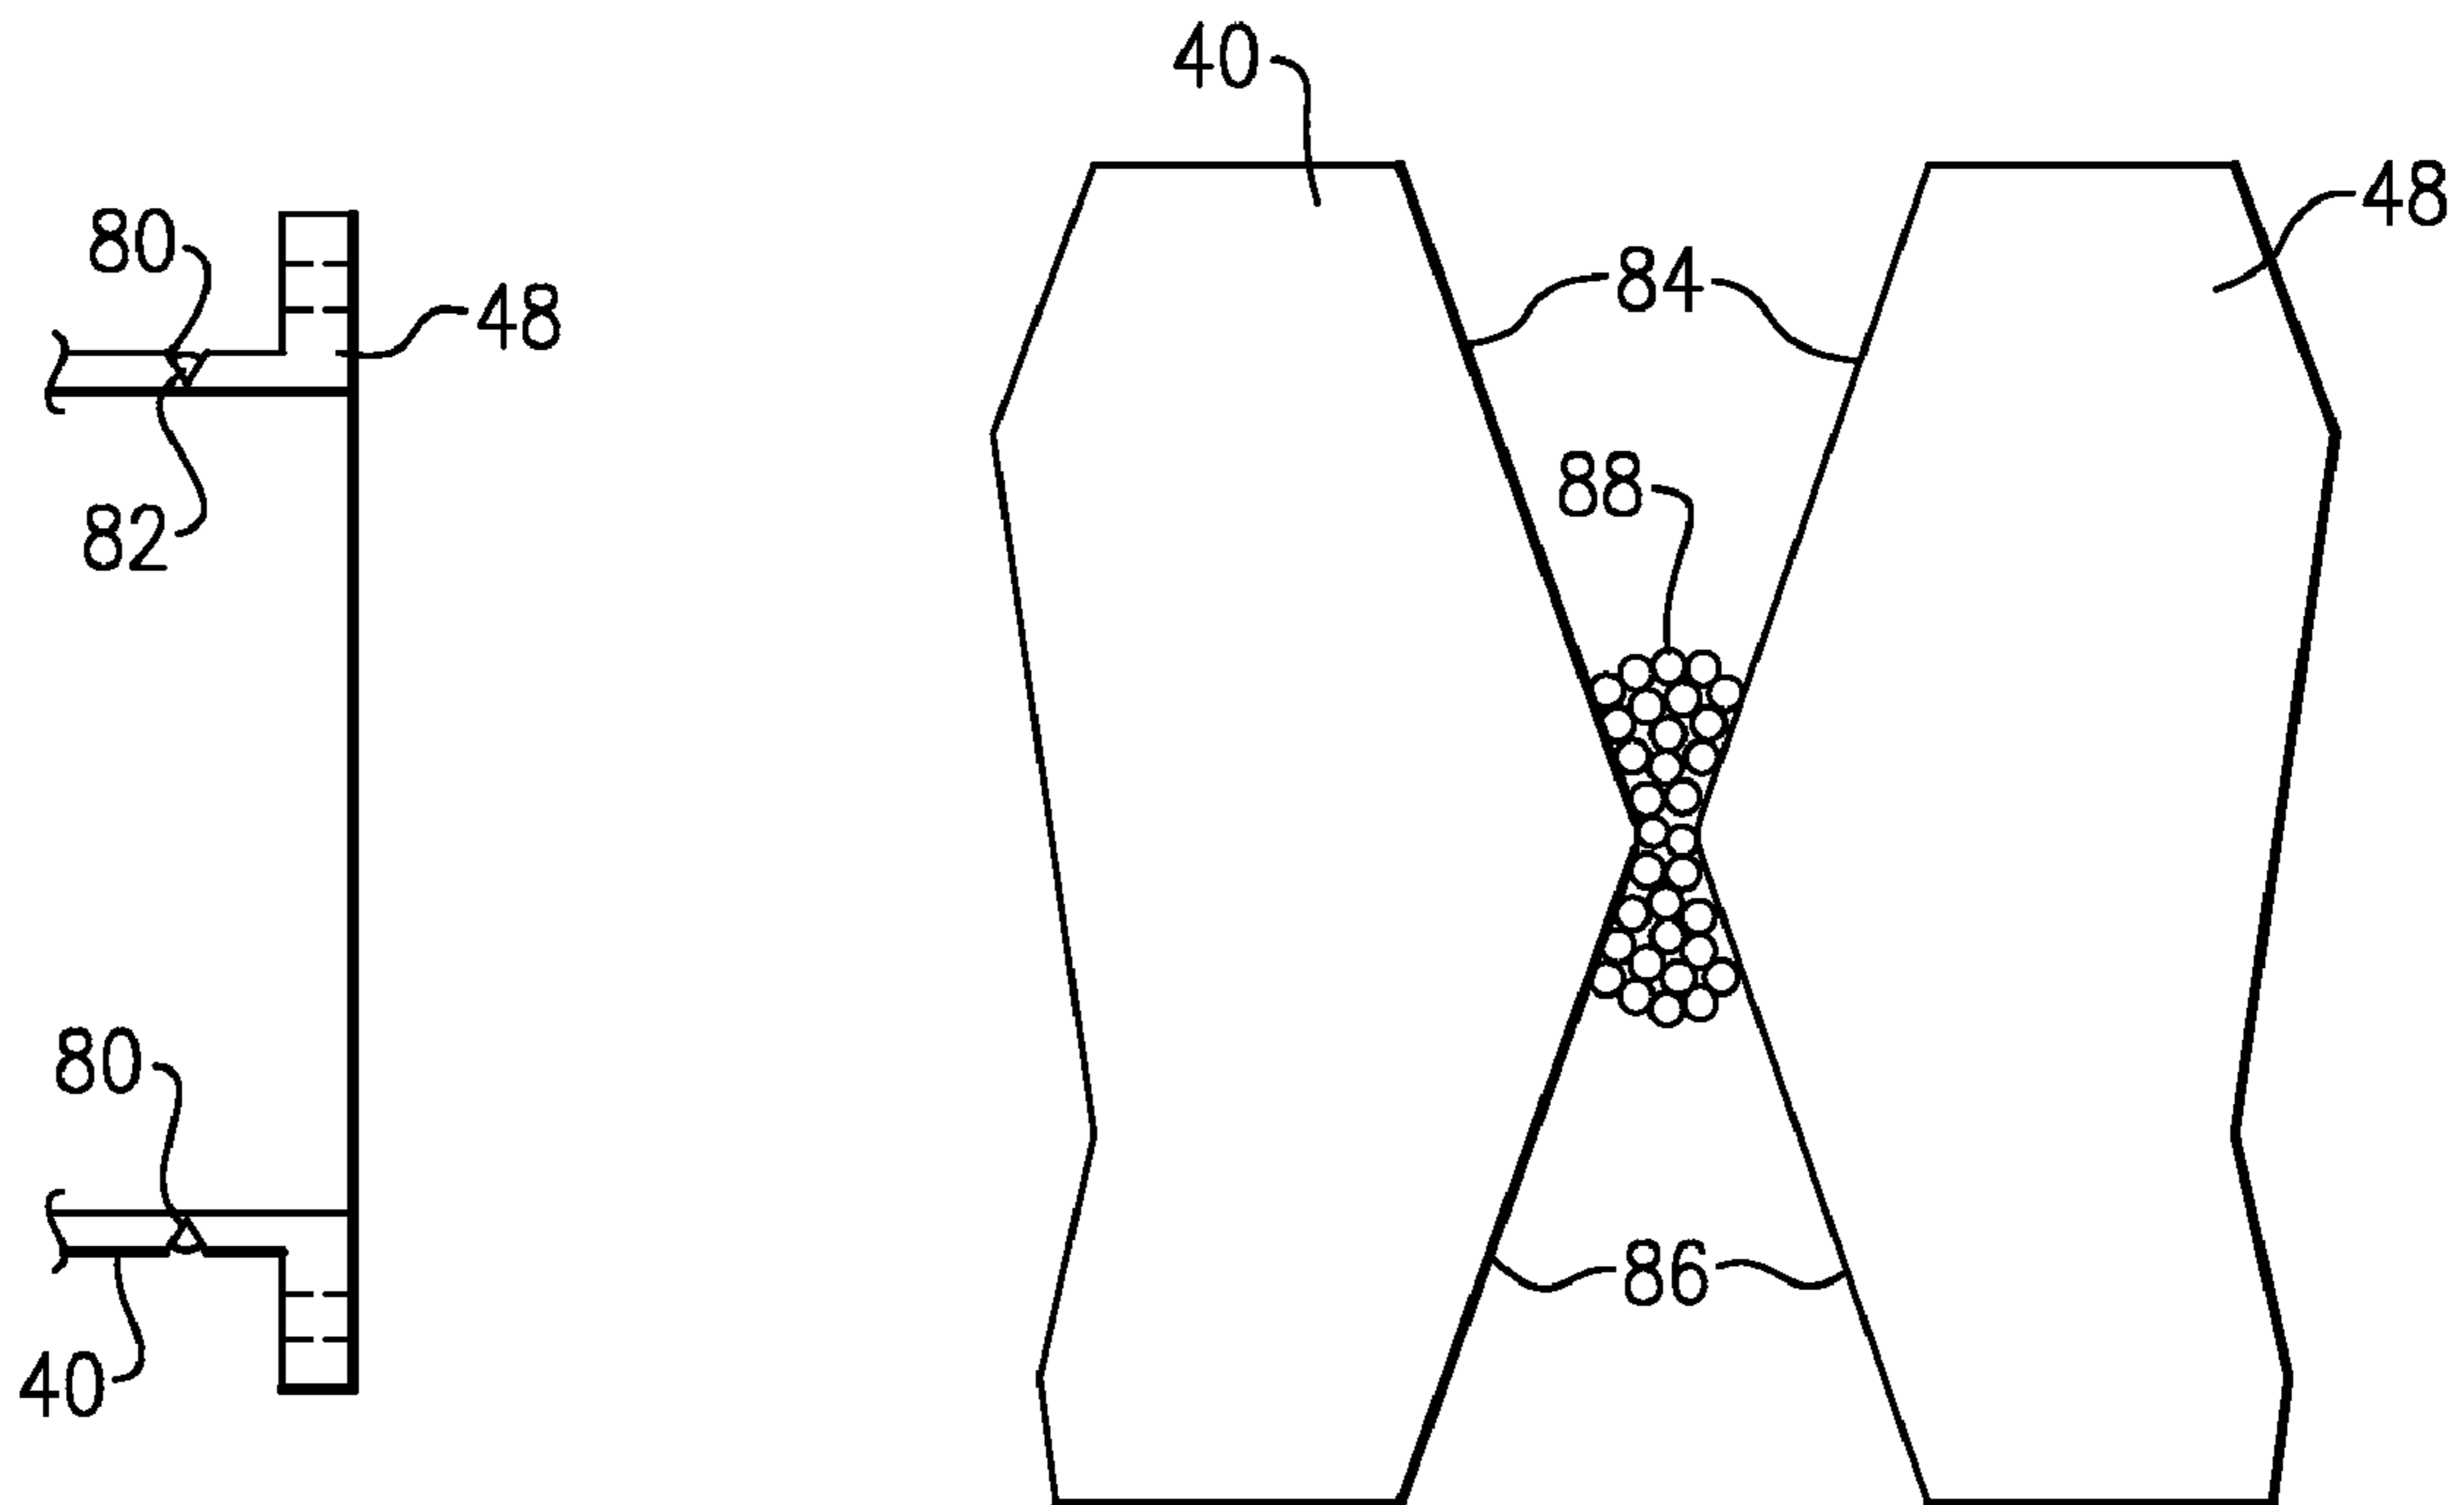
FIG.3C

FIG. 3C shows yet another alternative step.

FIG. 3C shows yet another preparation for the surface between the two components, engine case 40 and the replacement flange 48. As shown, an outer chamfer 84 and a radially inner chamfer 86 are formed on each of the components to hold the weld material 88. Again, the chamfer may be formed on only one of the two components, or may be formed on both.

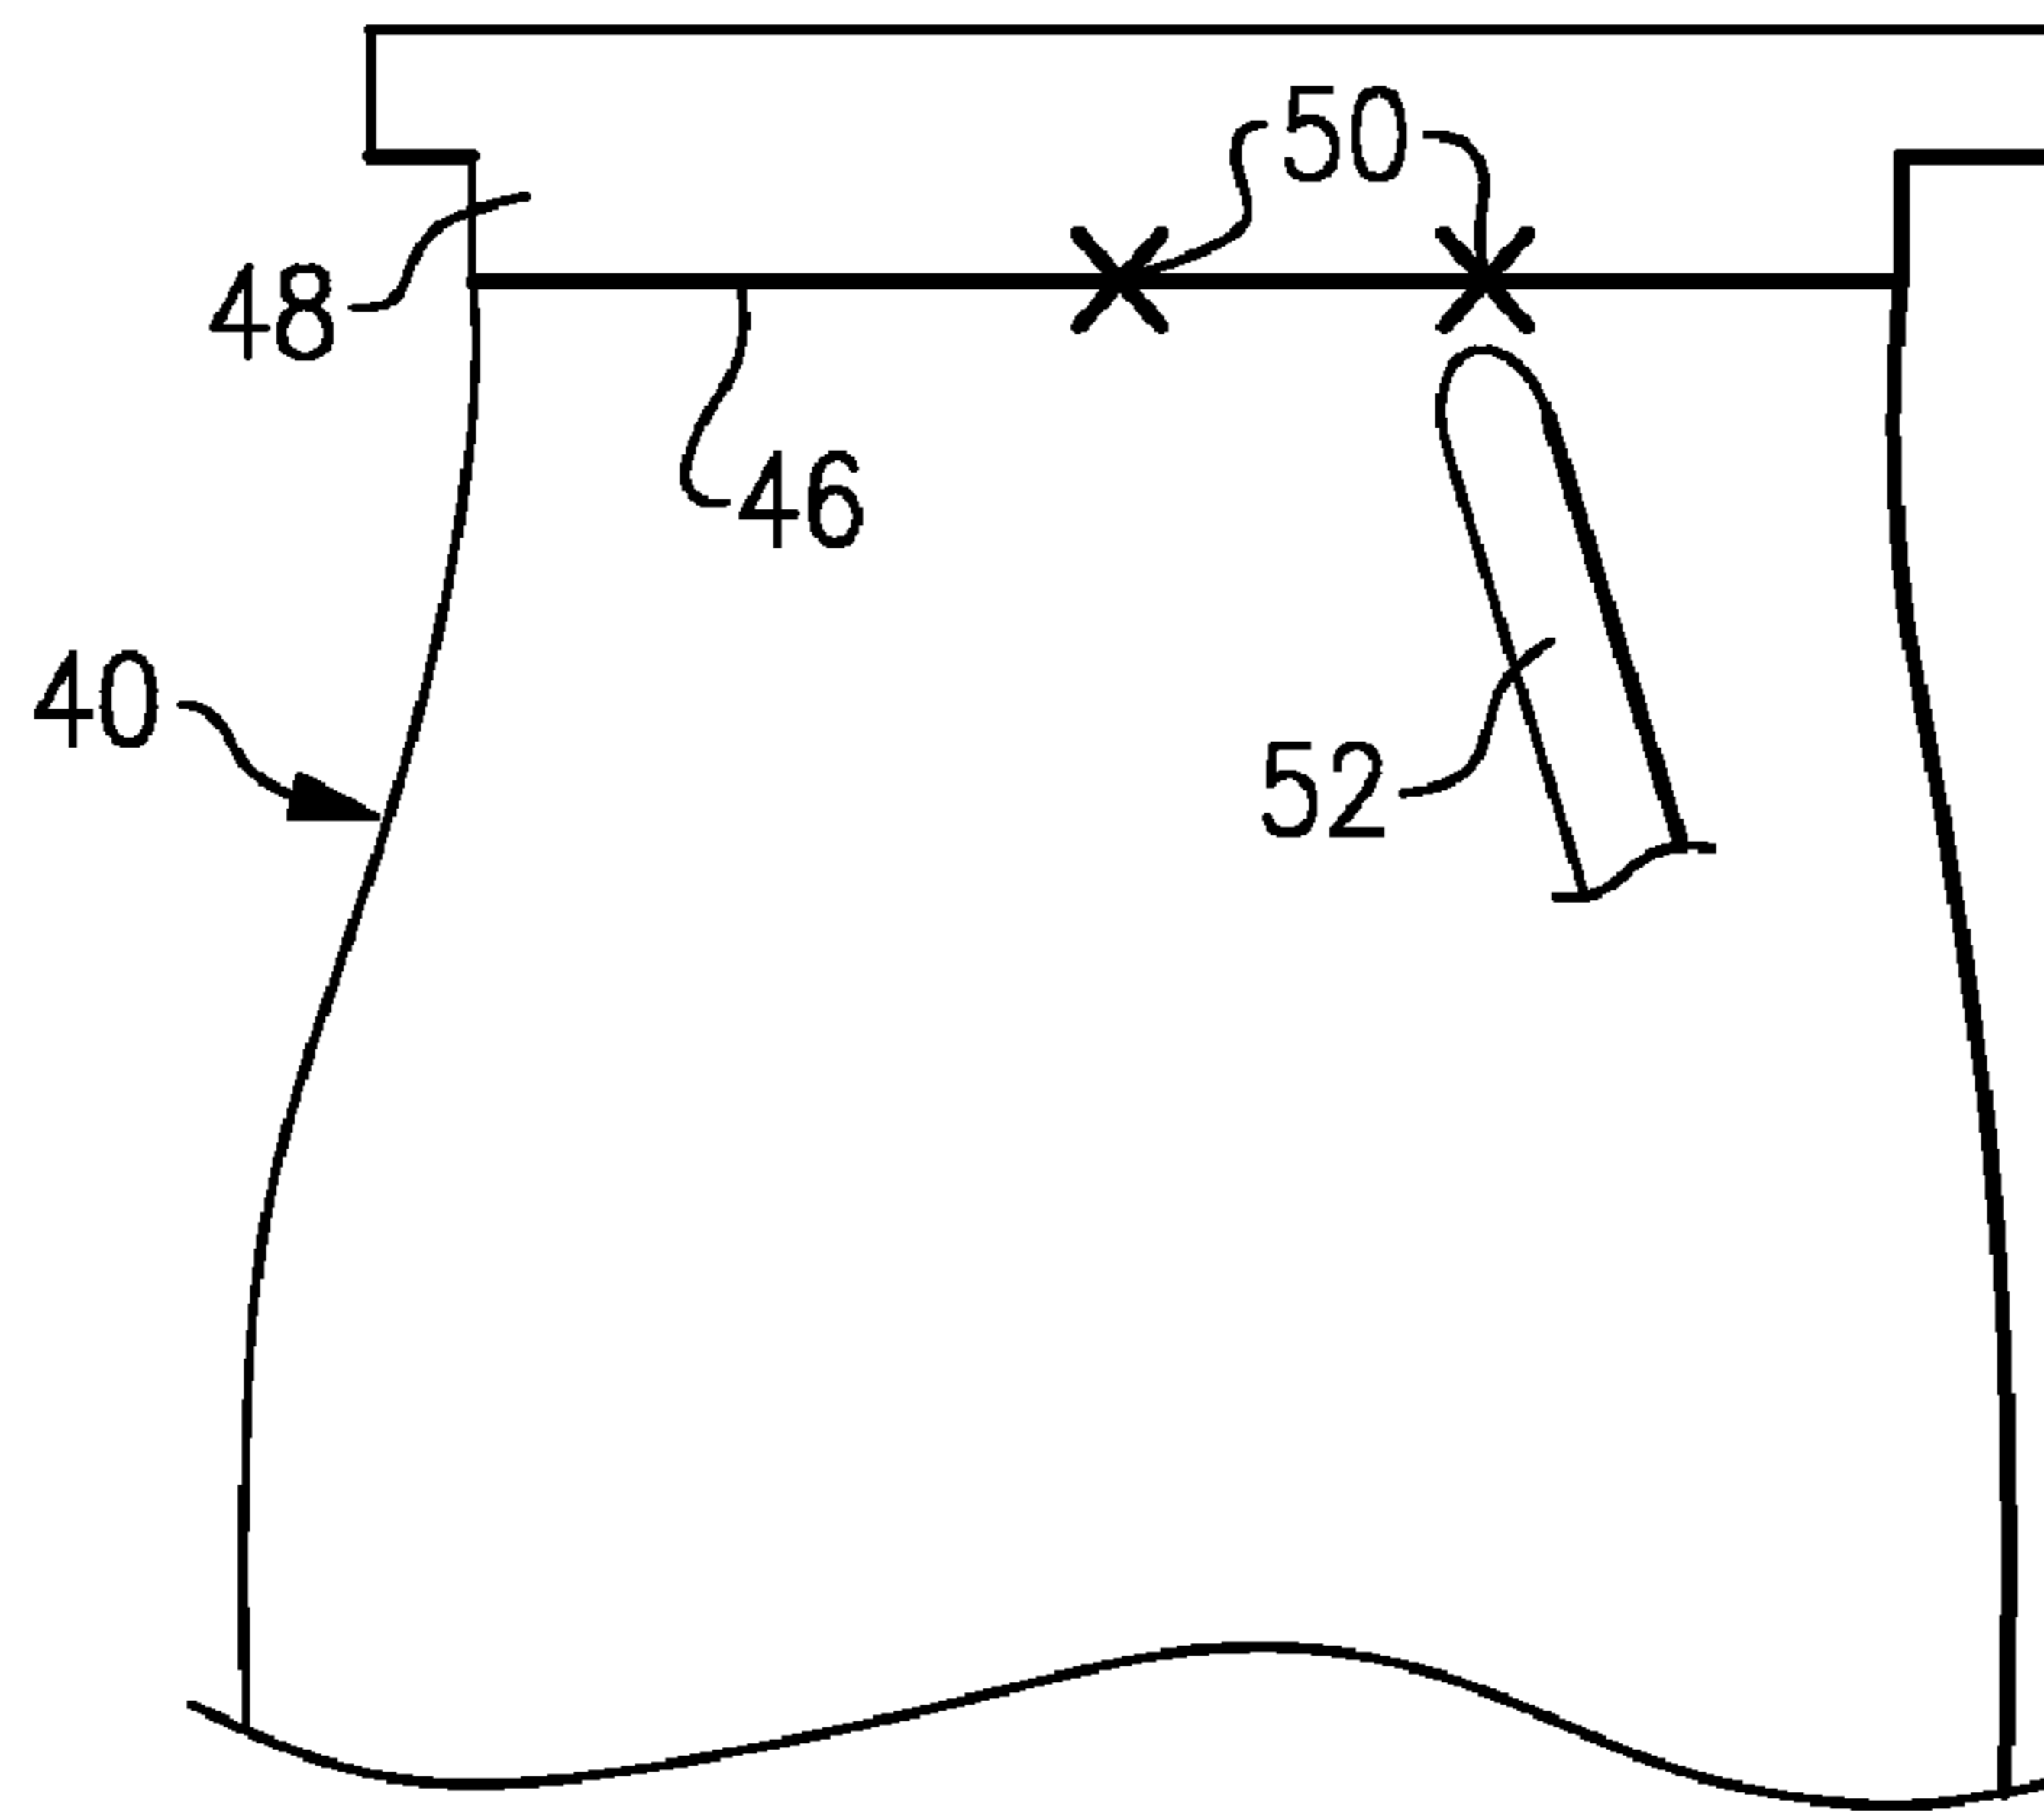
FIG.3D

FIG. 3D shows a subsequent step.

As shown in FIG. 3D, the replacement flange 48 is positioned on the surface 46 at step 106. A tack welding device 52

may then apply tack welds **50** to hold the replacement flange **48** on the surface **46** at step **108**.
