(10) **Patent No.:** **US 8,257,039 B2**
(45) **Date of Patent:** **Sep. 4, 2012**

(54) **GAS TURBINE ENGINE CASE WITH REPLACED FLANGE AND METHOD OF REPAIRING THE SAME USING COLD METAL TRANSFER**

(73) Assignee: **United Technologies Corporation**, Hartford, CT (US)

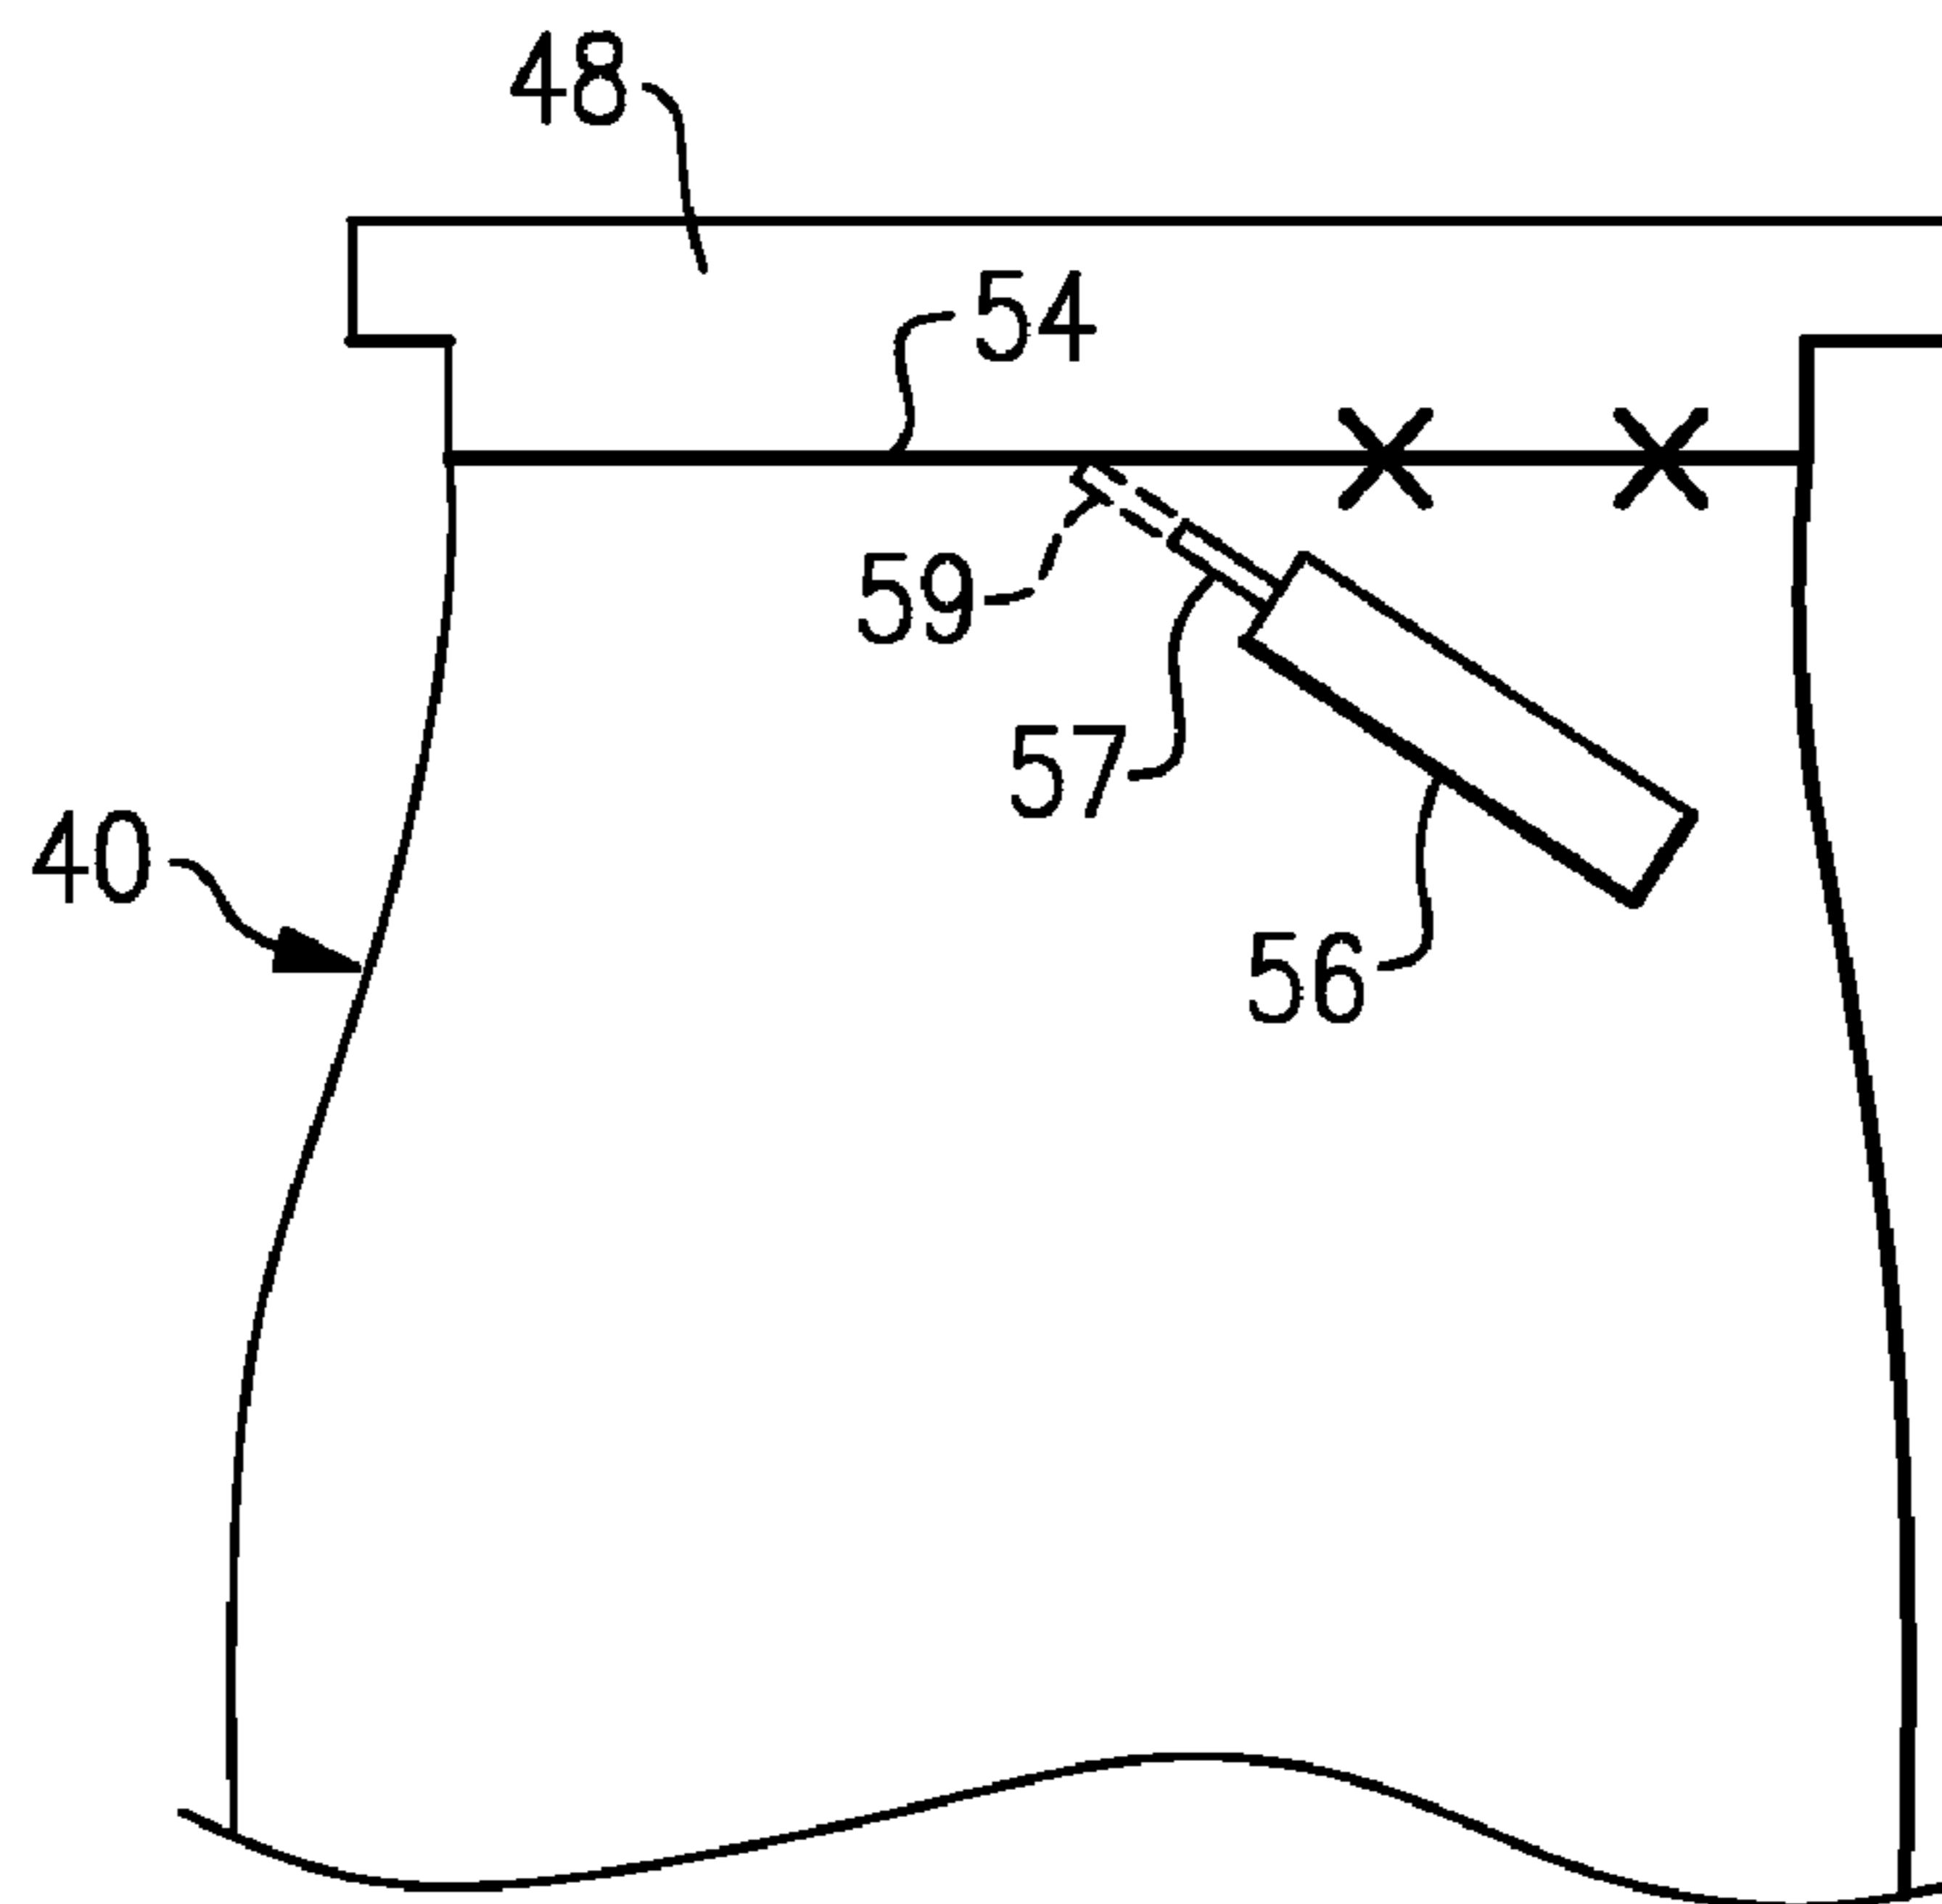
FIG.3E

FIG. 3E shows a final step in the repair process.

As shown in FIG. 3E, a final weld joint **54** may be applied along the surface **46** to secure the replacement flange **48** to the engine case **40** at step **110**. The engine case may now be 5
reinstalled on the engine at step **112**.

The welding equipment **56** may be a cold metal transfer welding equipment. Although cold metal transfer is known, the process has not been utilized for the replacement of a flange on an engine case as disclosed in the exemplary 10
embodiments. As mentioned above, CMT is a process having alternating hot and cold operation as a short circuit repeats with controlled movement of a weld wire **57**. As known, the wire may move towards and away from the surface as shown in phantom at **59**. Of course, this is a schematic view of the process.
