(10) **Patent No.:** **US 8,764,285 B2**
(45) **Date of Patent:** **Jul. 1, 2014**

(54) **NONDESTRUCTIVE RESIDENTIAL INSPECTION METHOD AND APPARATUS**

(73) Assignee: **Homesafe Inspection, Inc.**, Oxford, MS (US)

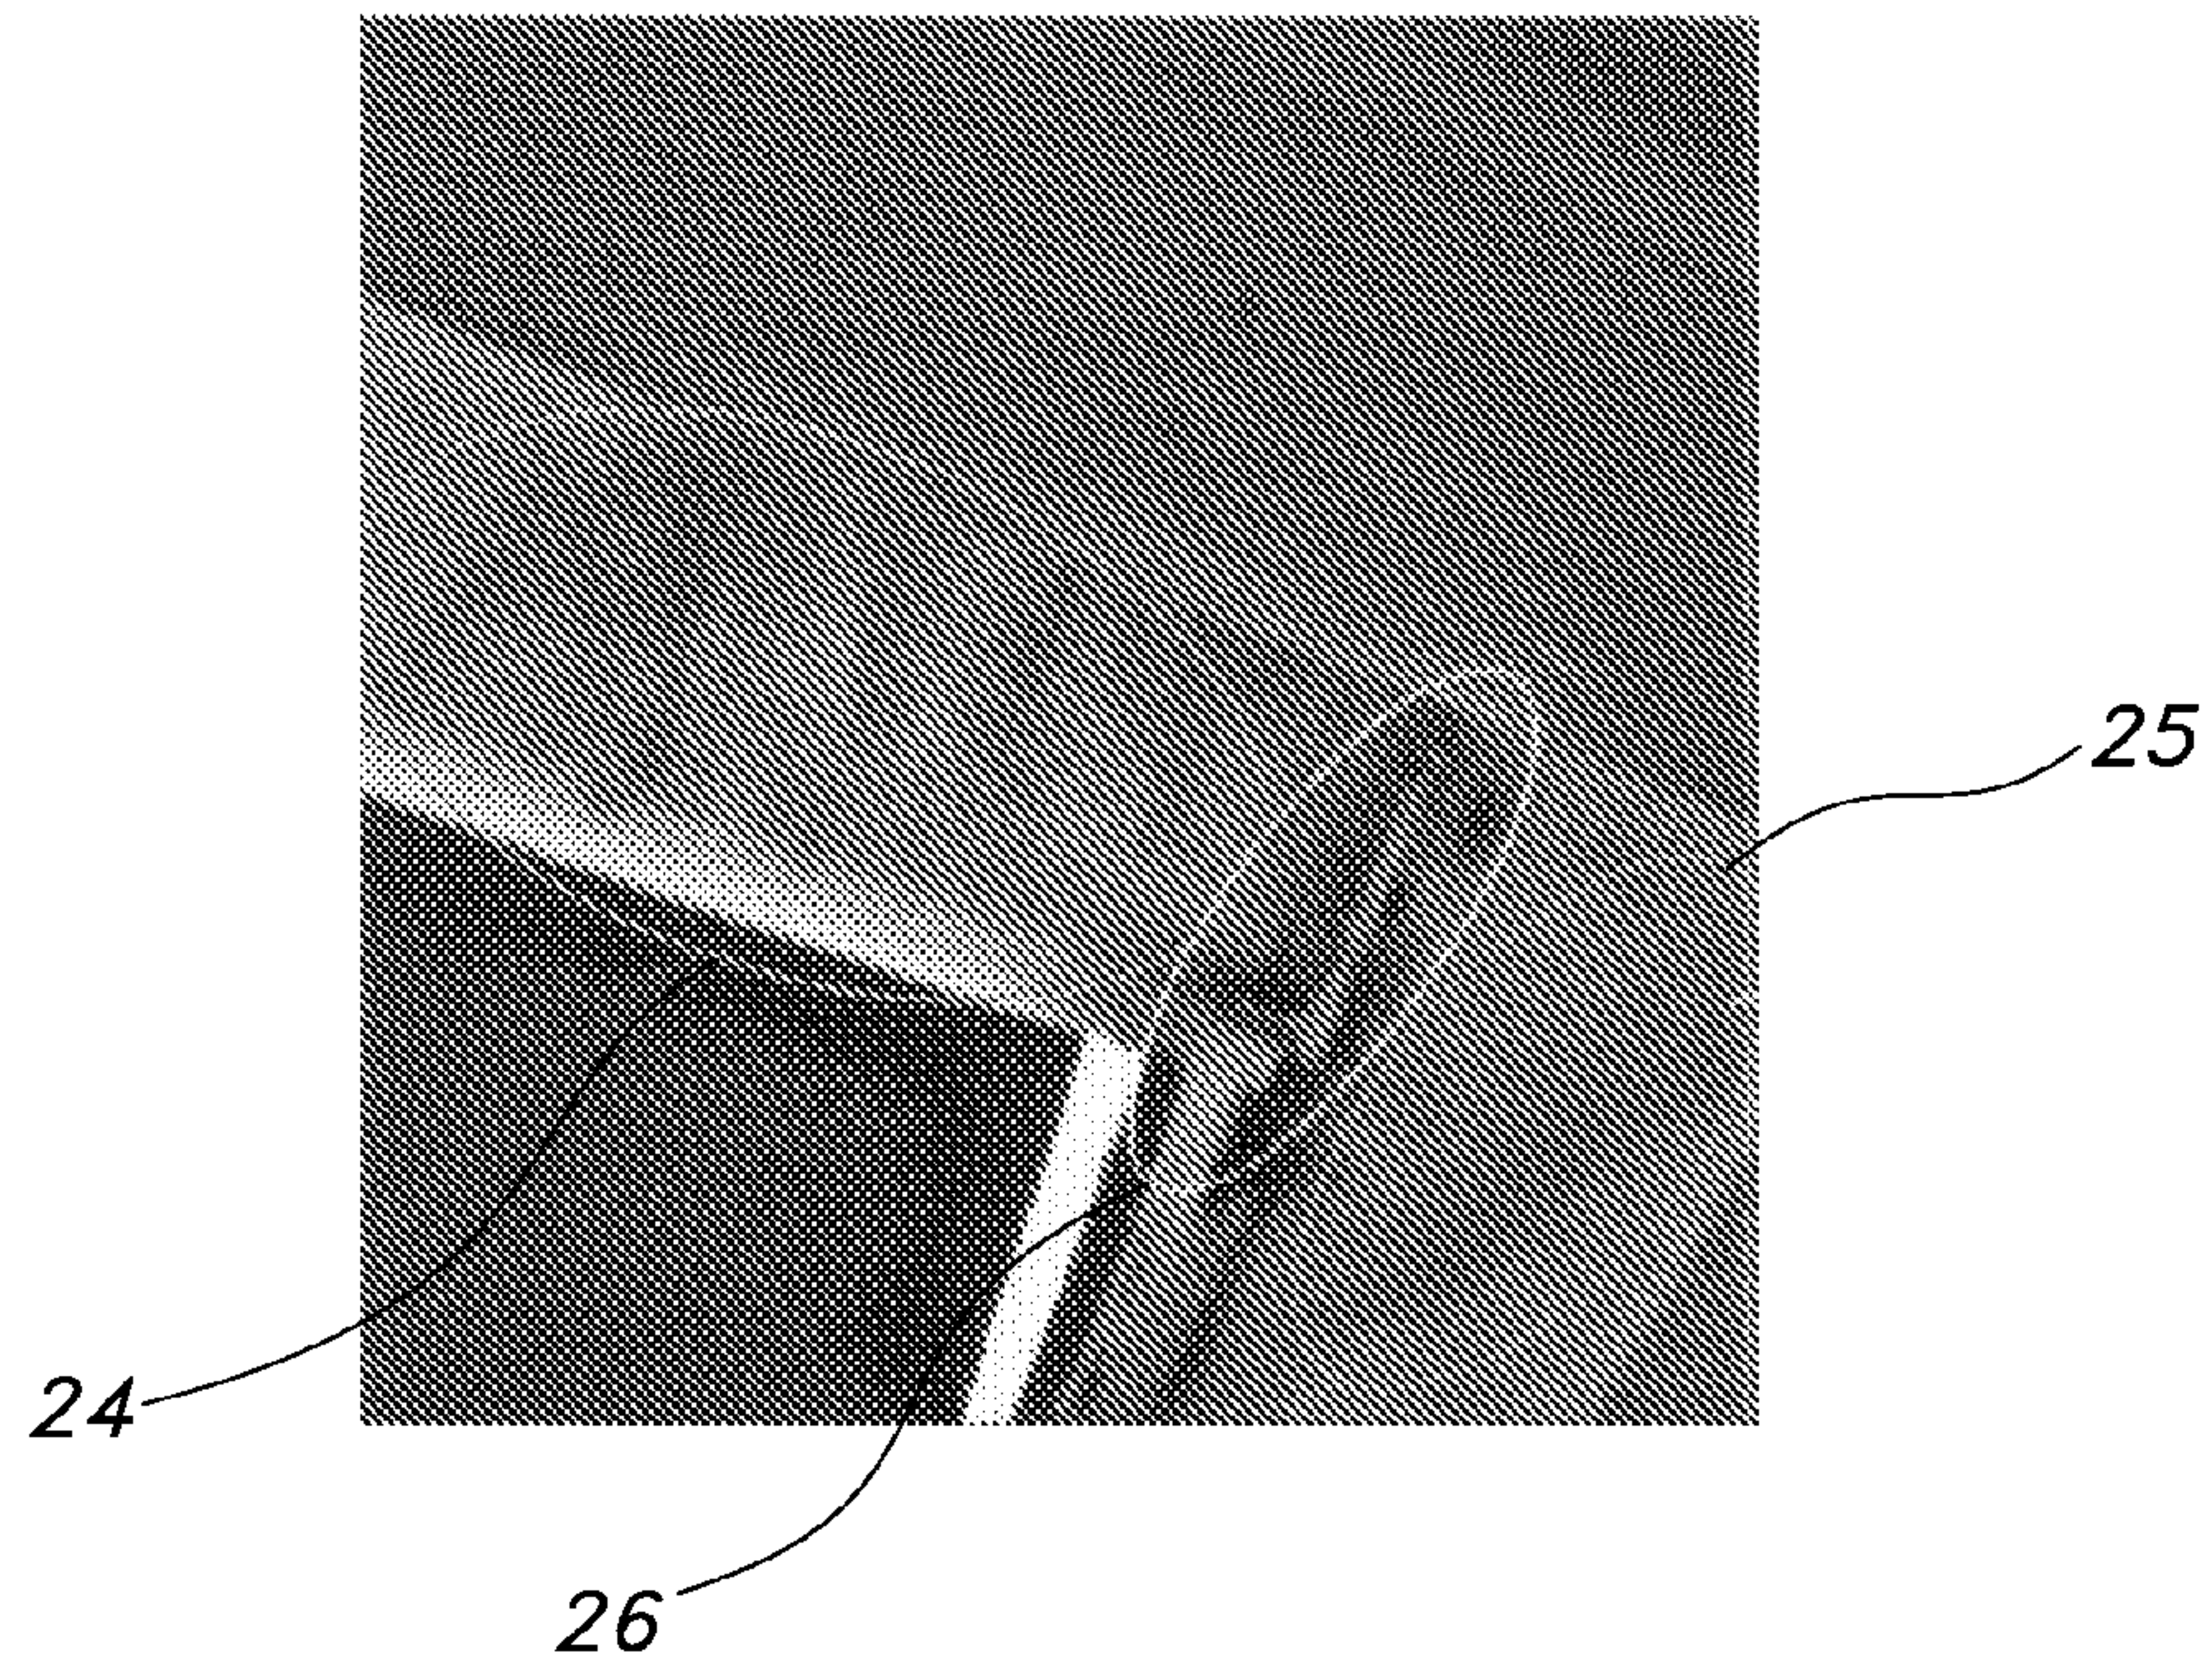
FIG. 6

Now referring to FIG. 6, a temperature profile, taken in the morning after sunrise of an eave shows a number of anomalies. Anomaly **24** and **25** are indicative of current structural deformations due to past infiltration of water (dried) and anomaly **26** is indicative of the presence of moisture.

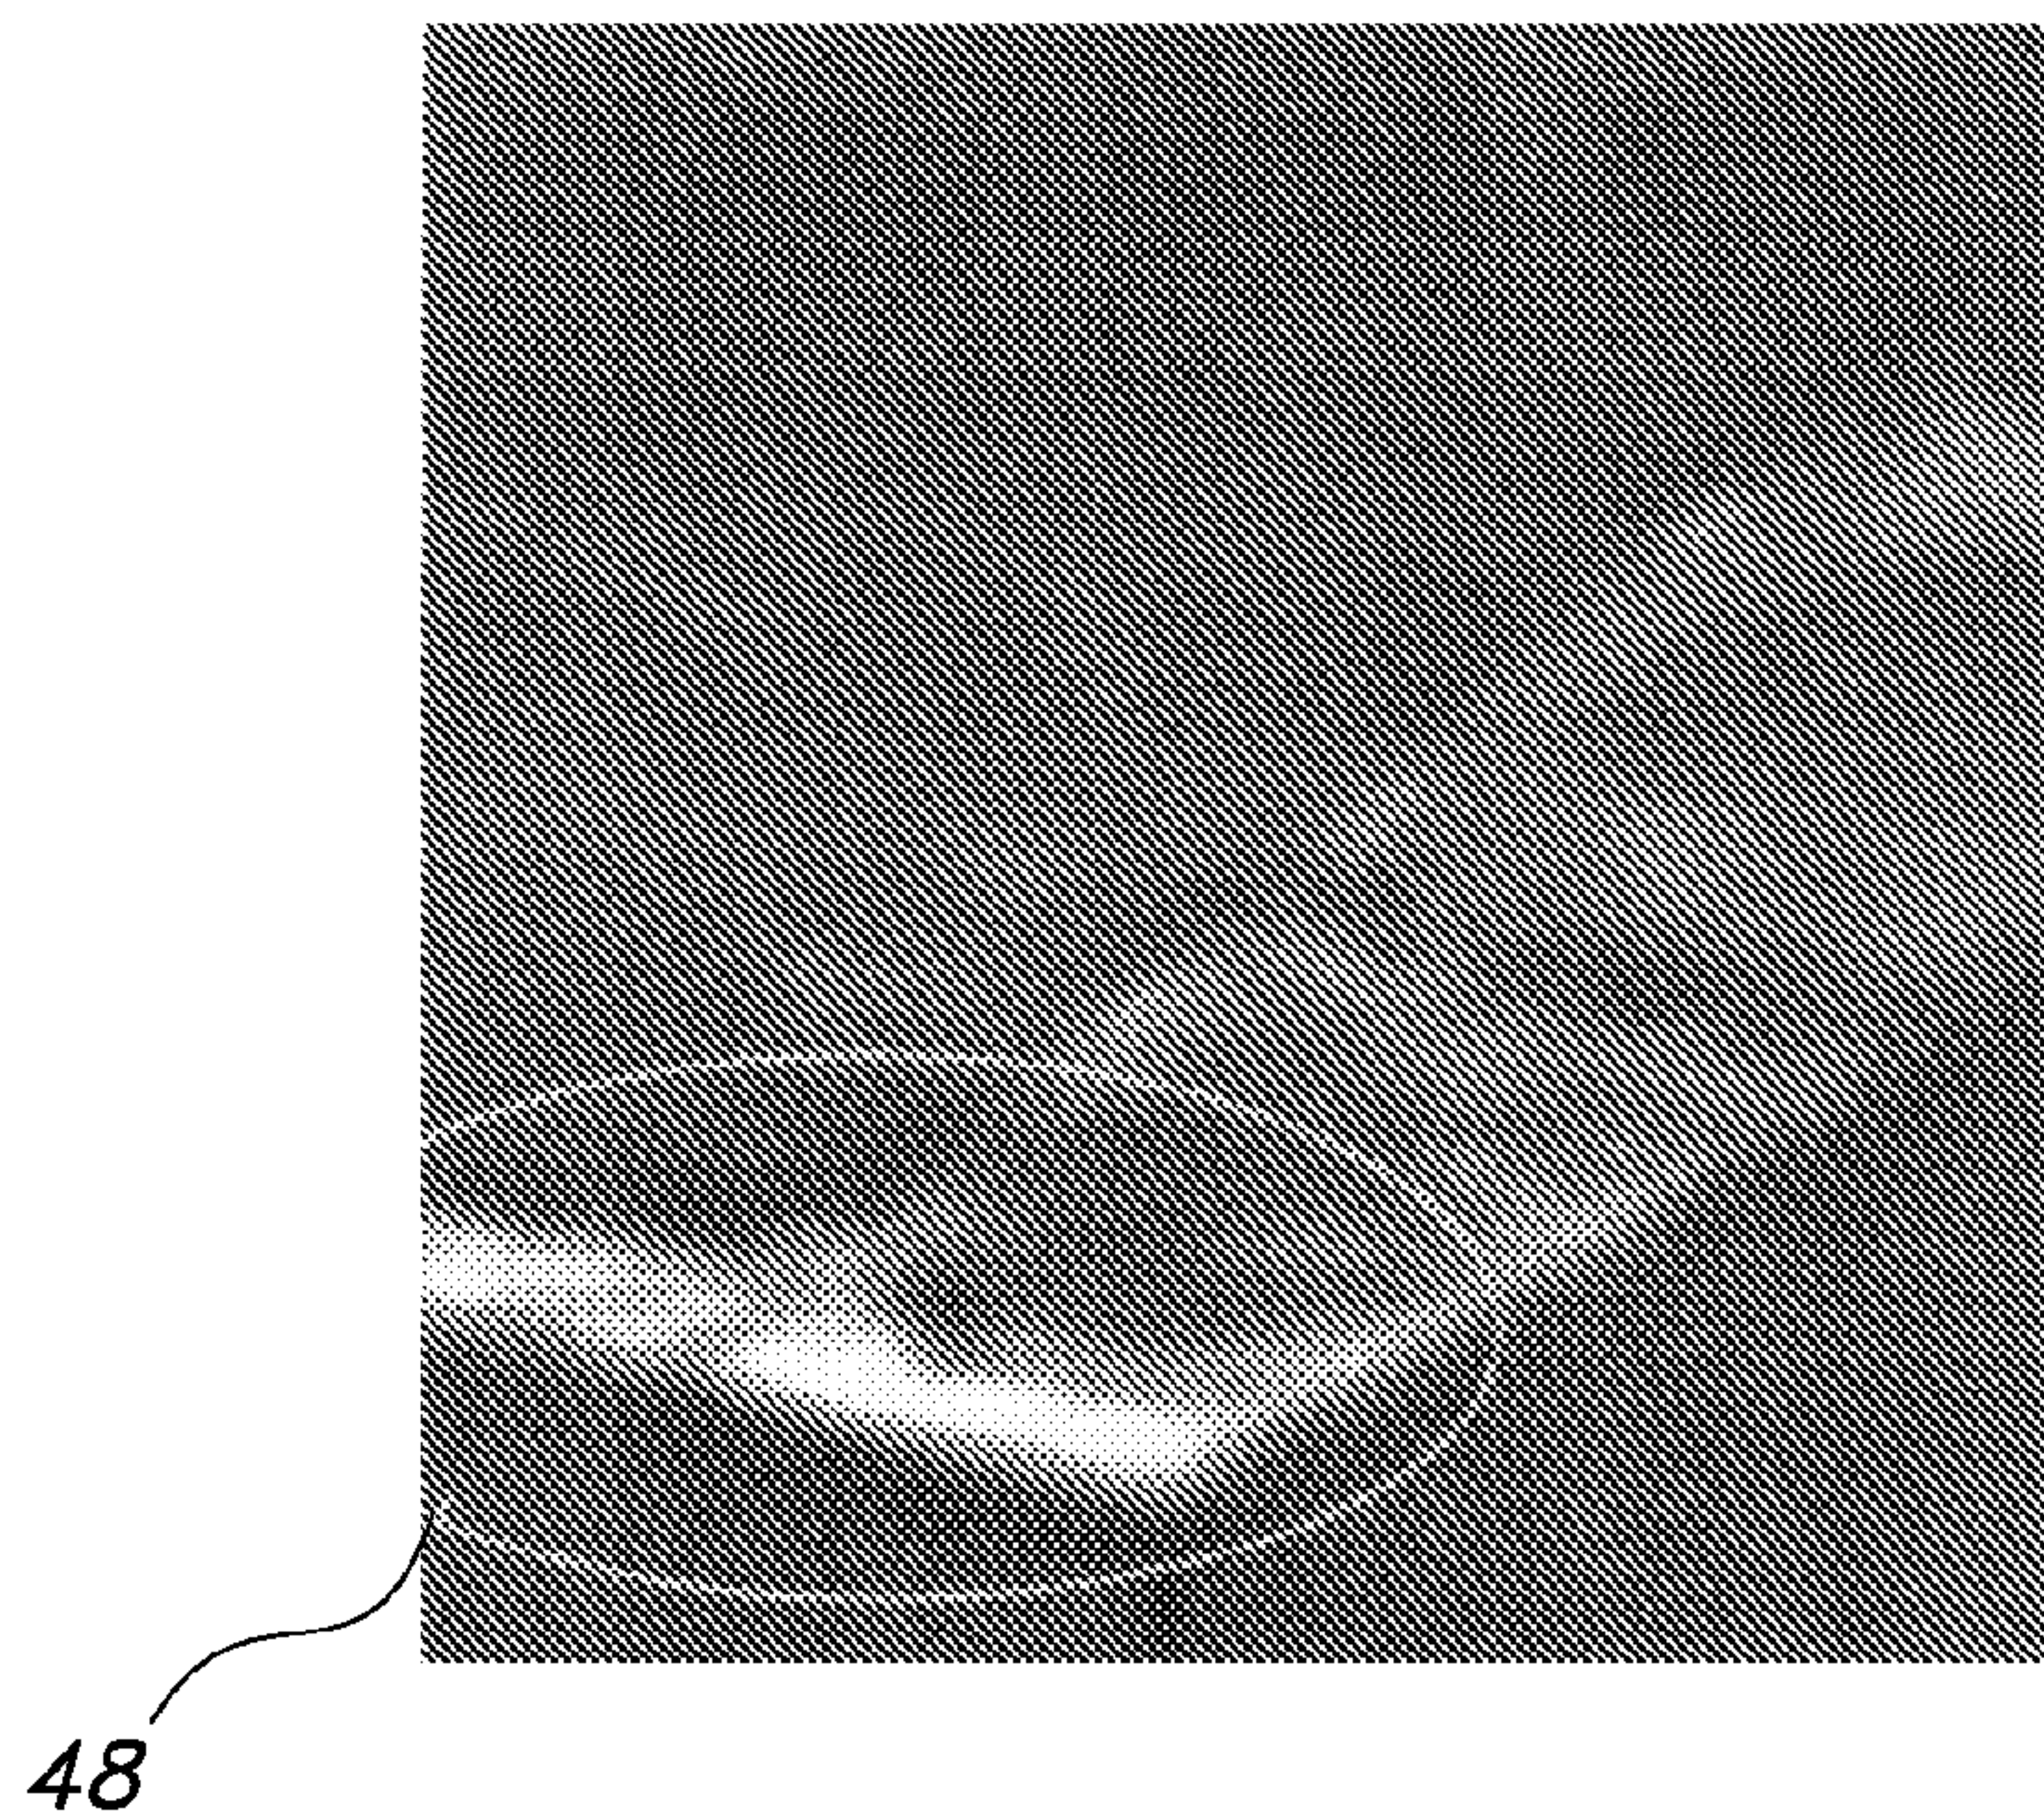
FIG. 21B

Condensation can also occur on interior ceiling surface as shown in FIGS. 21A and 21B. The temperature profile shown in FIG. 21A was shown in FIG. 21A was taken 4 feet away from the ceiling. The anomaly 47 is indicative of moisture on the ceiling. The temperature profile 21B was taken 15 feet away from the same ceiling shown in FIG. 21A. The anomaly 48 is indicative of moisture in the ceiling.

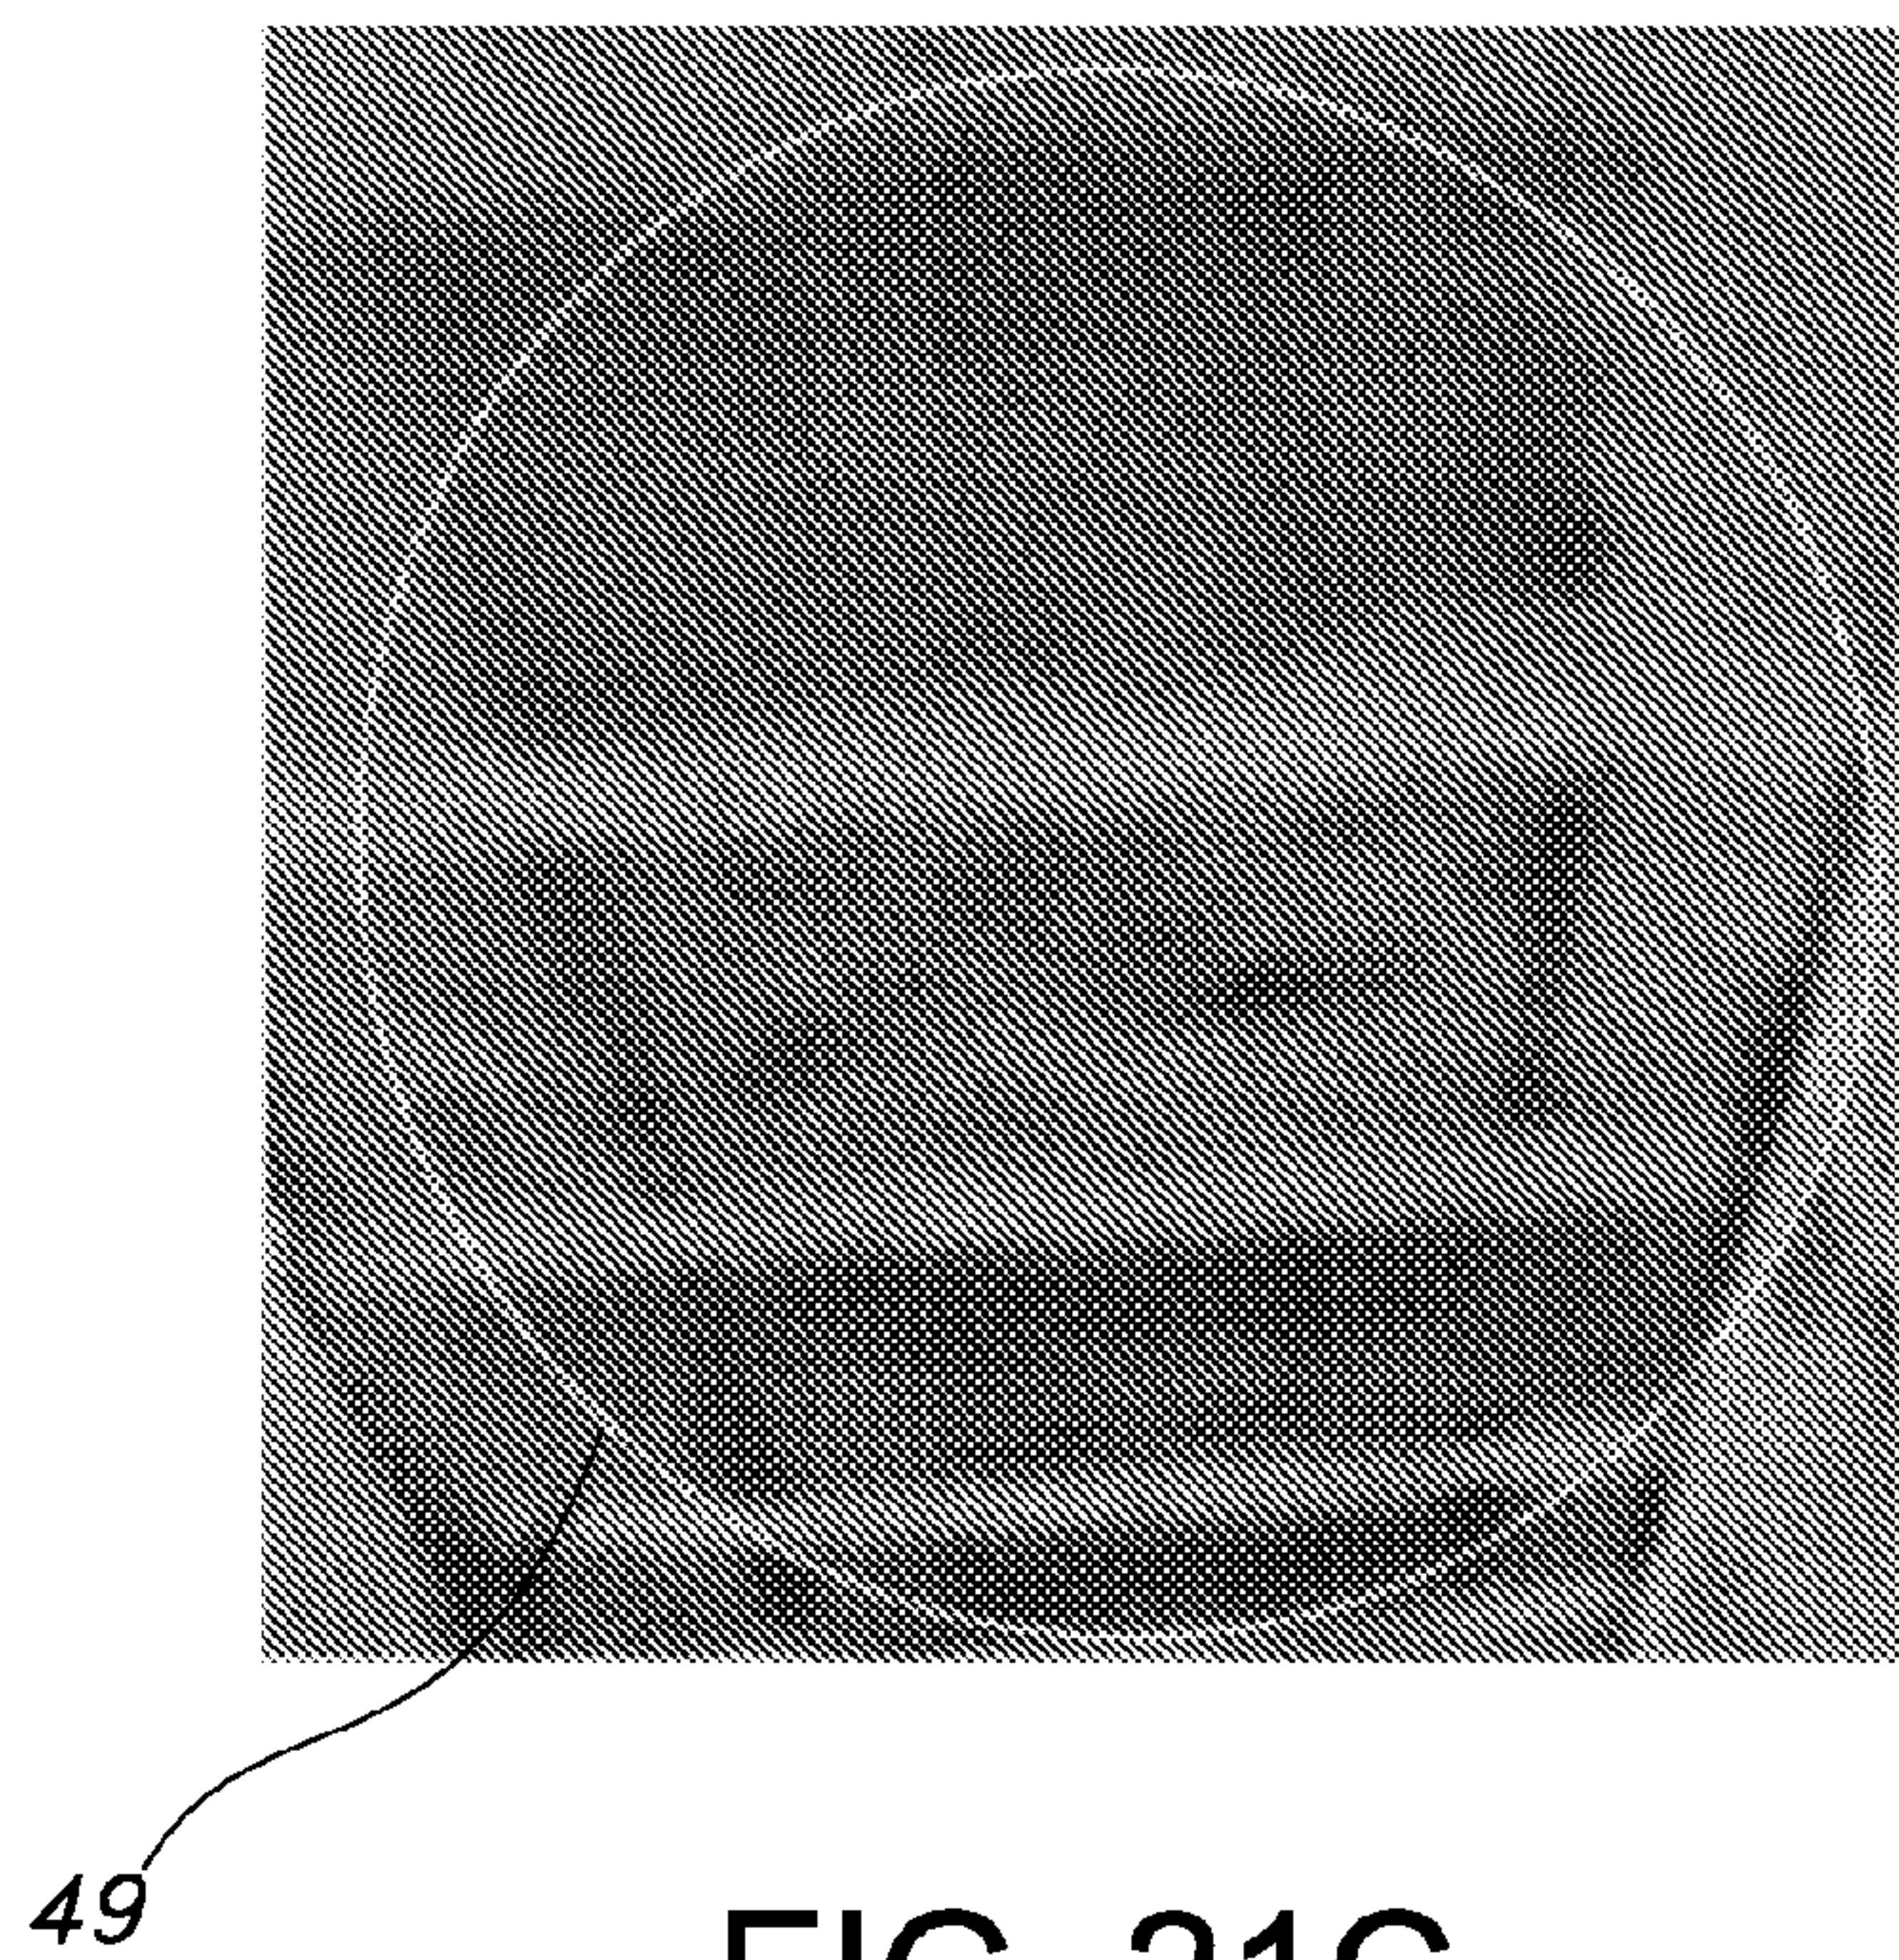
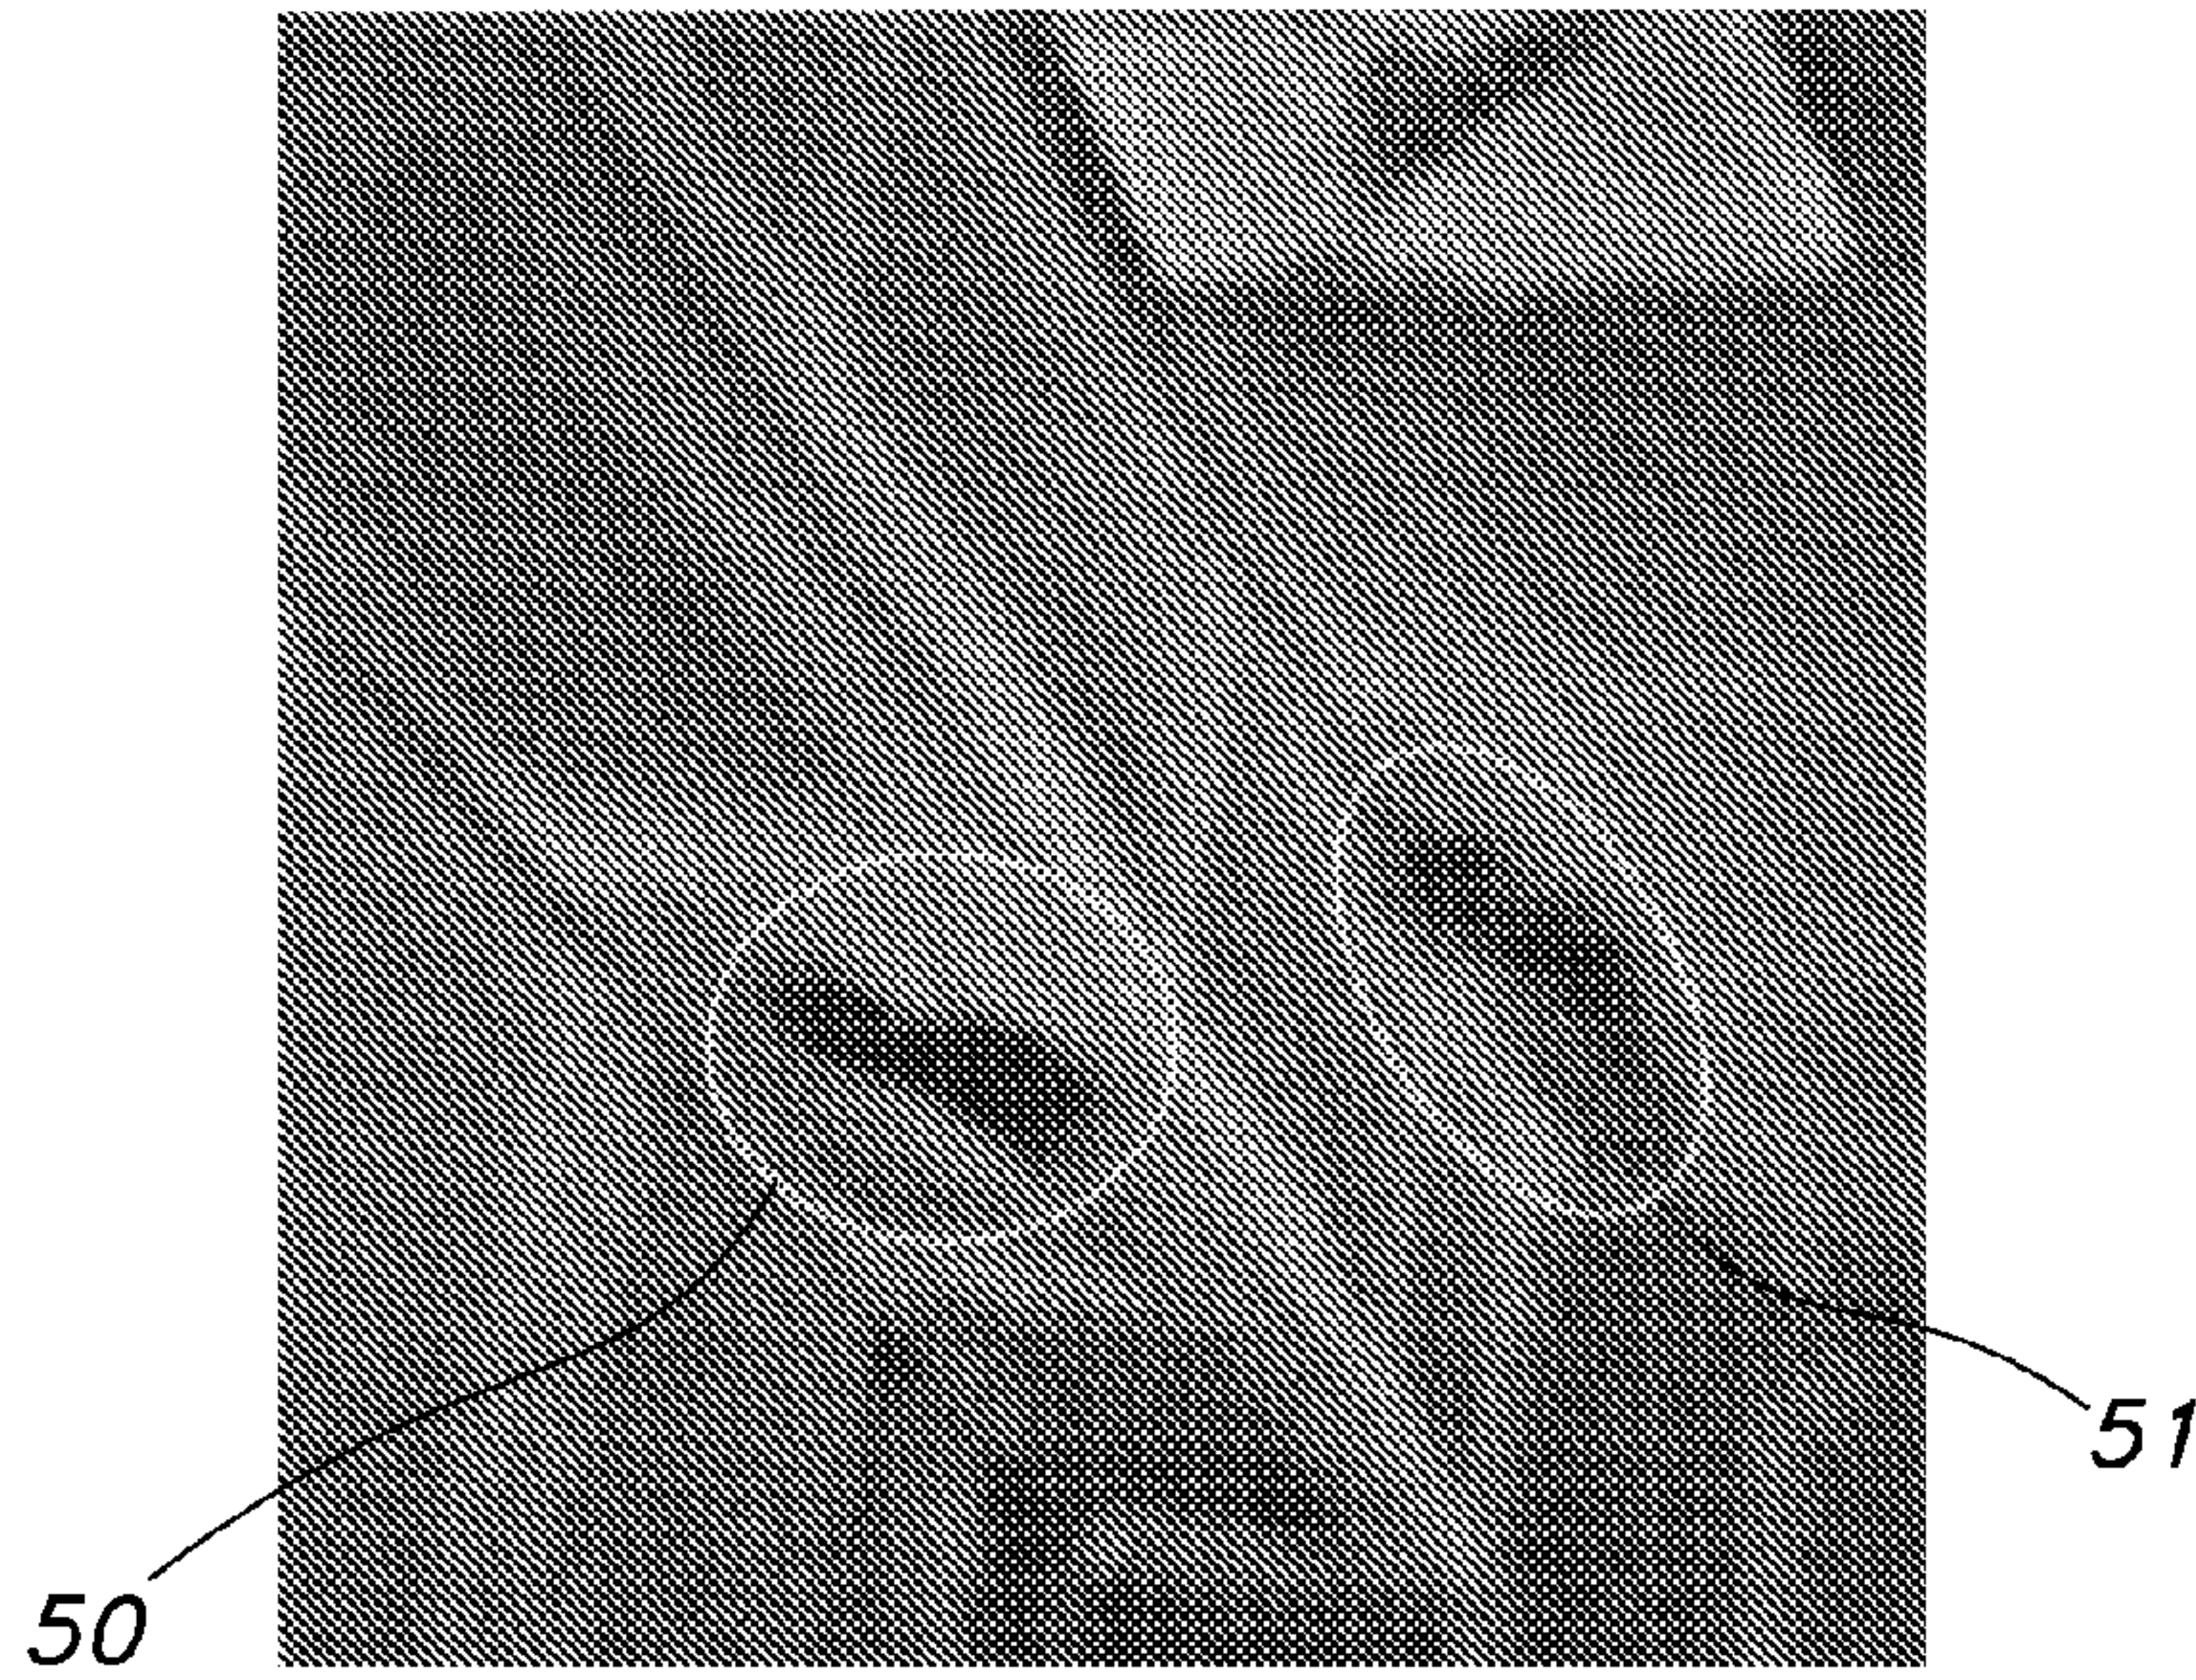
(4) Moisture in Air Duct—Additionally, FIGS. 21C and 21D show anomalies 49-51, which are indicative of moisture in an air duct. This happens most often when there is no insulation in that particular section of the ceiling due to poor workmanship or due to rodent activities plus the occupant of the house has the lifestyle of generating high level of moisture with inadequate ventilation during the winter season. The uninsulated ceiling is closer to the cold outdoor temperature. When the high level moisture indoor air come in contact with the cold interior ceiling surface (the hotter the air the higher it rises and more moisture it can hold), it will cool and condense. This type of condensation problems were often mistaken as roof leaks. This happens when there is insufficient insulation around the air duct and poor workmanship or aging insulation Condensation accumulates in cold air (in summer) eventually dripping into the ceiling under the duct.

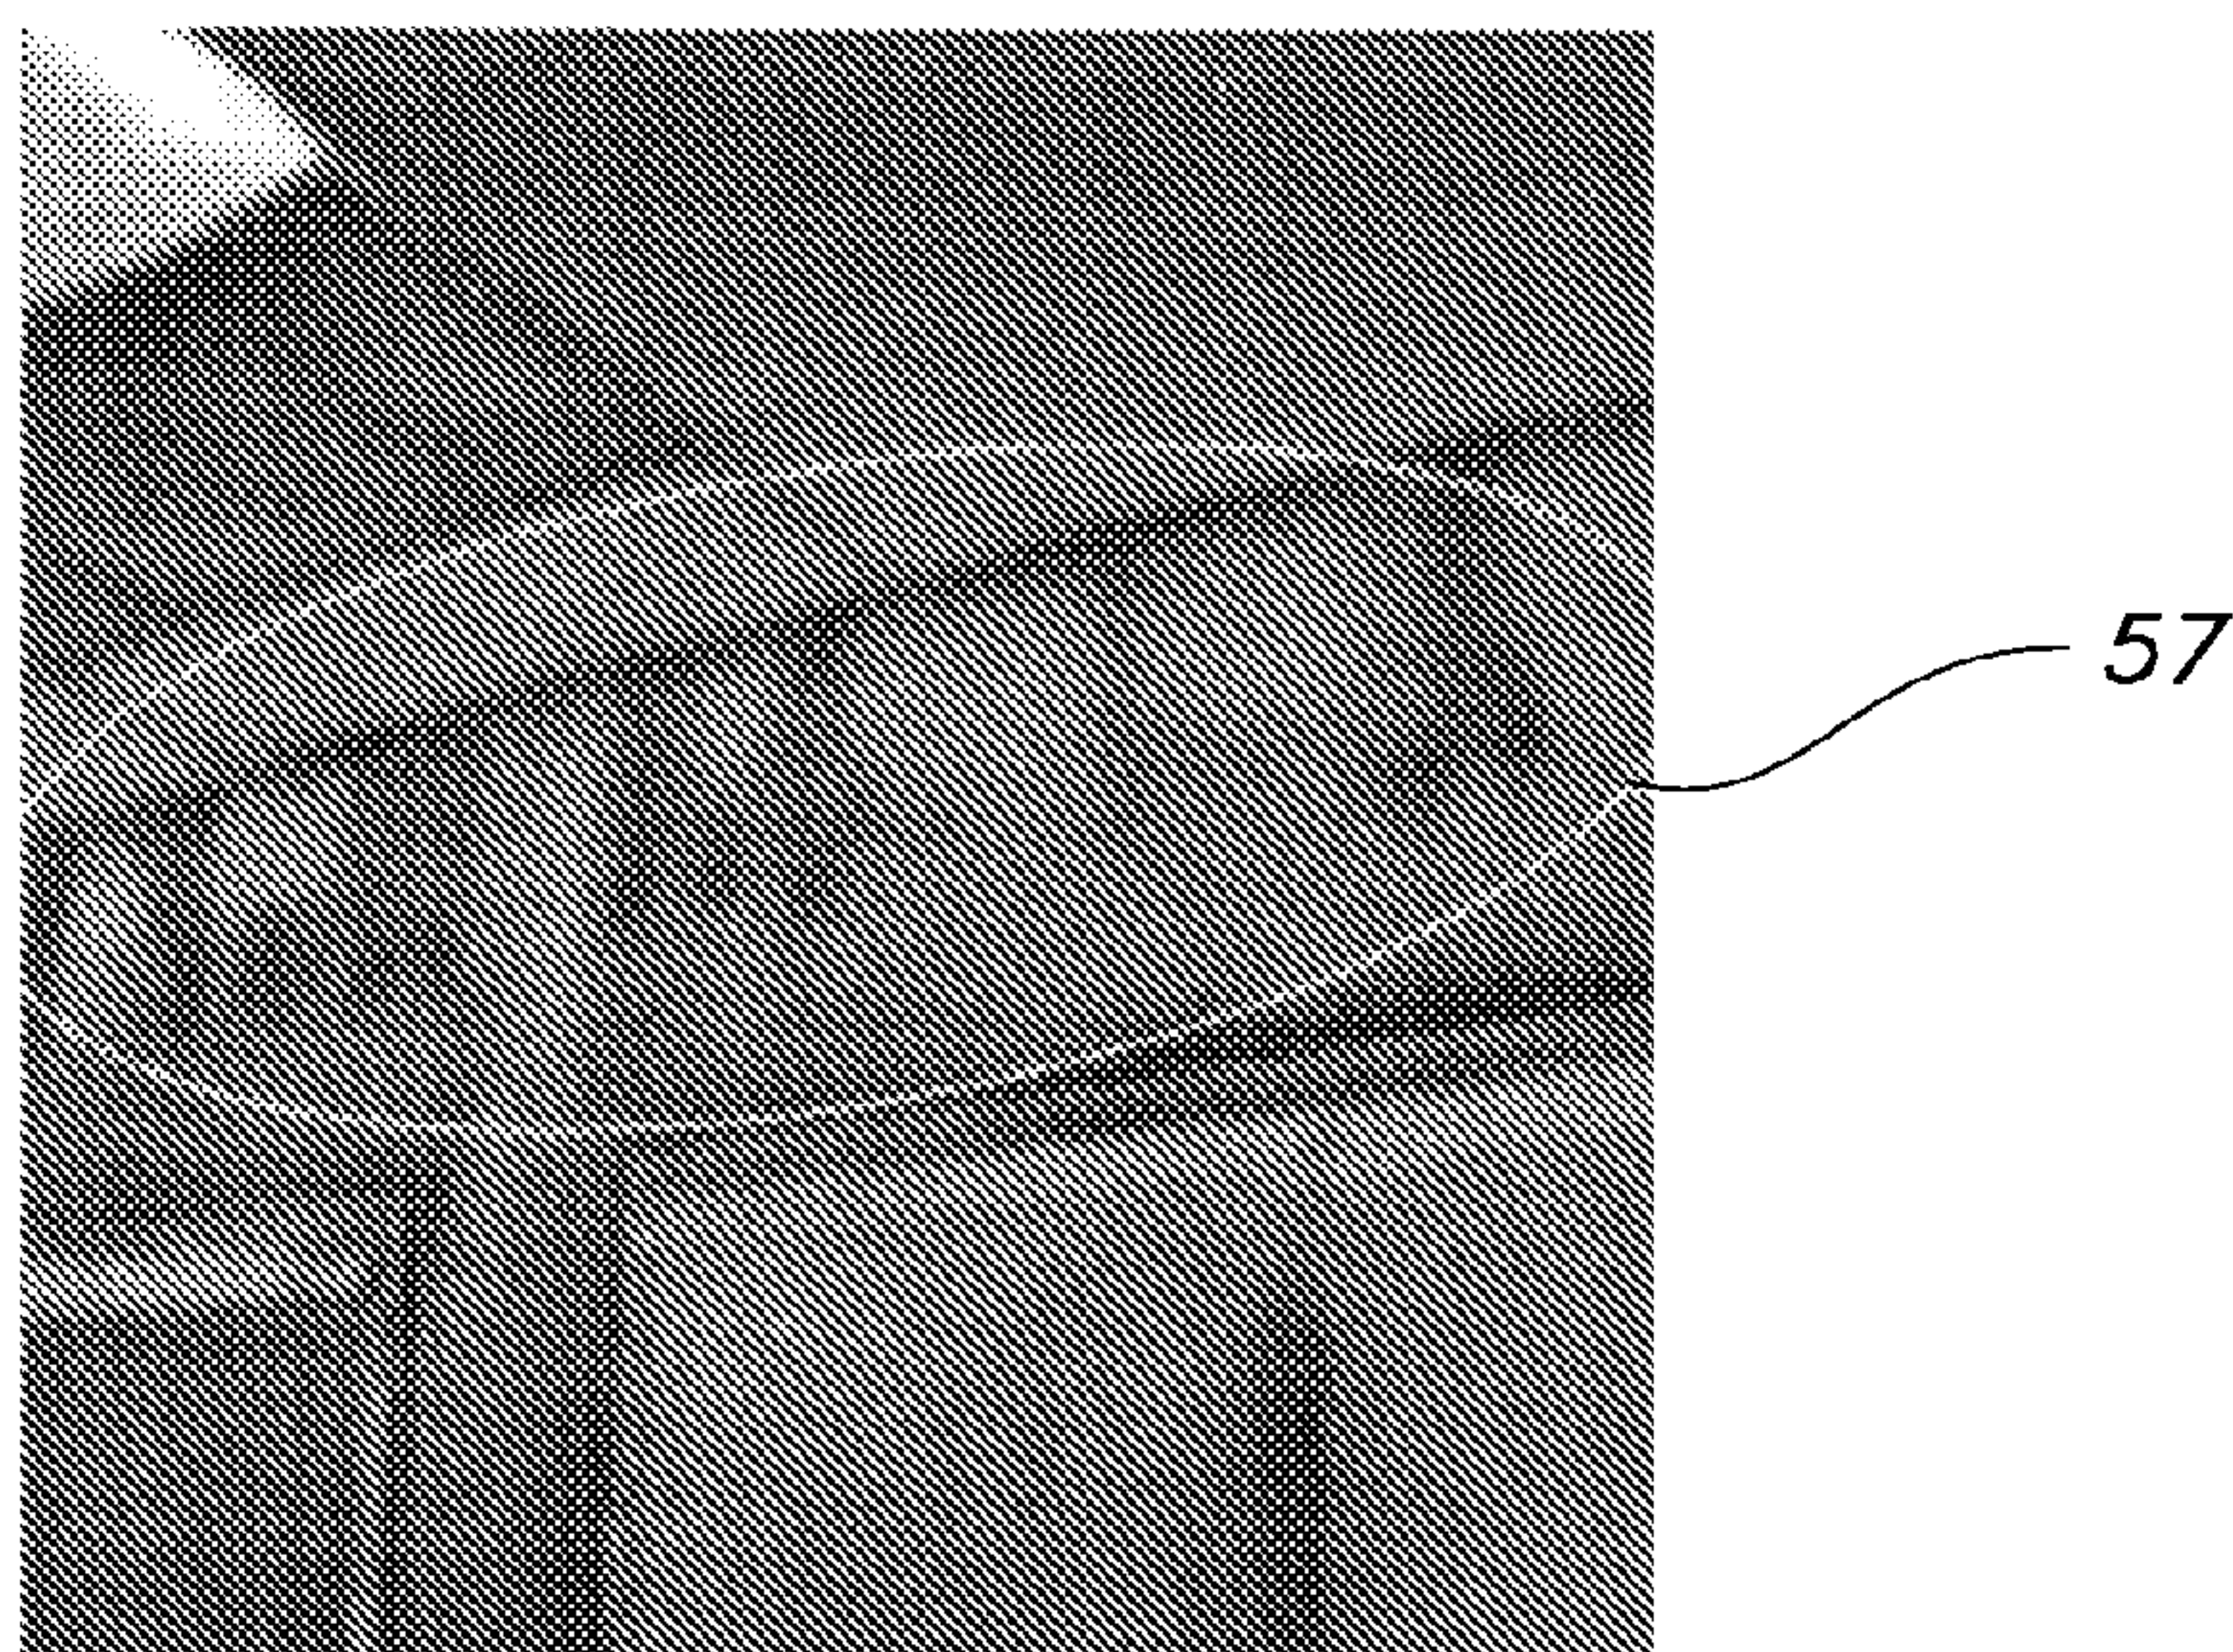
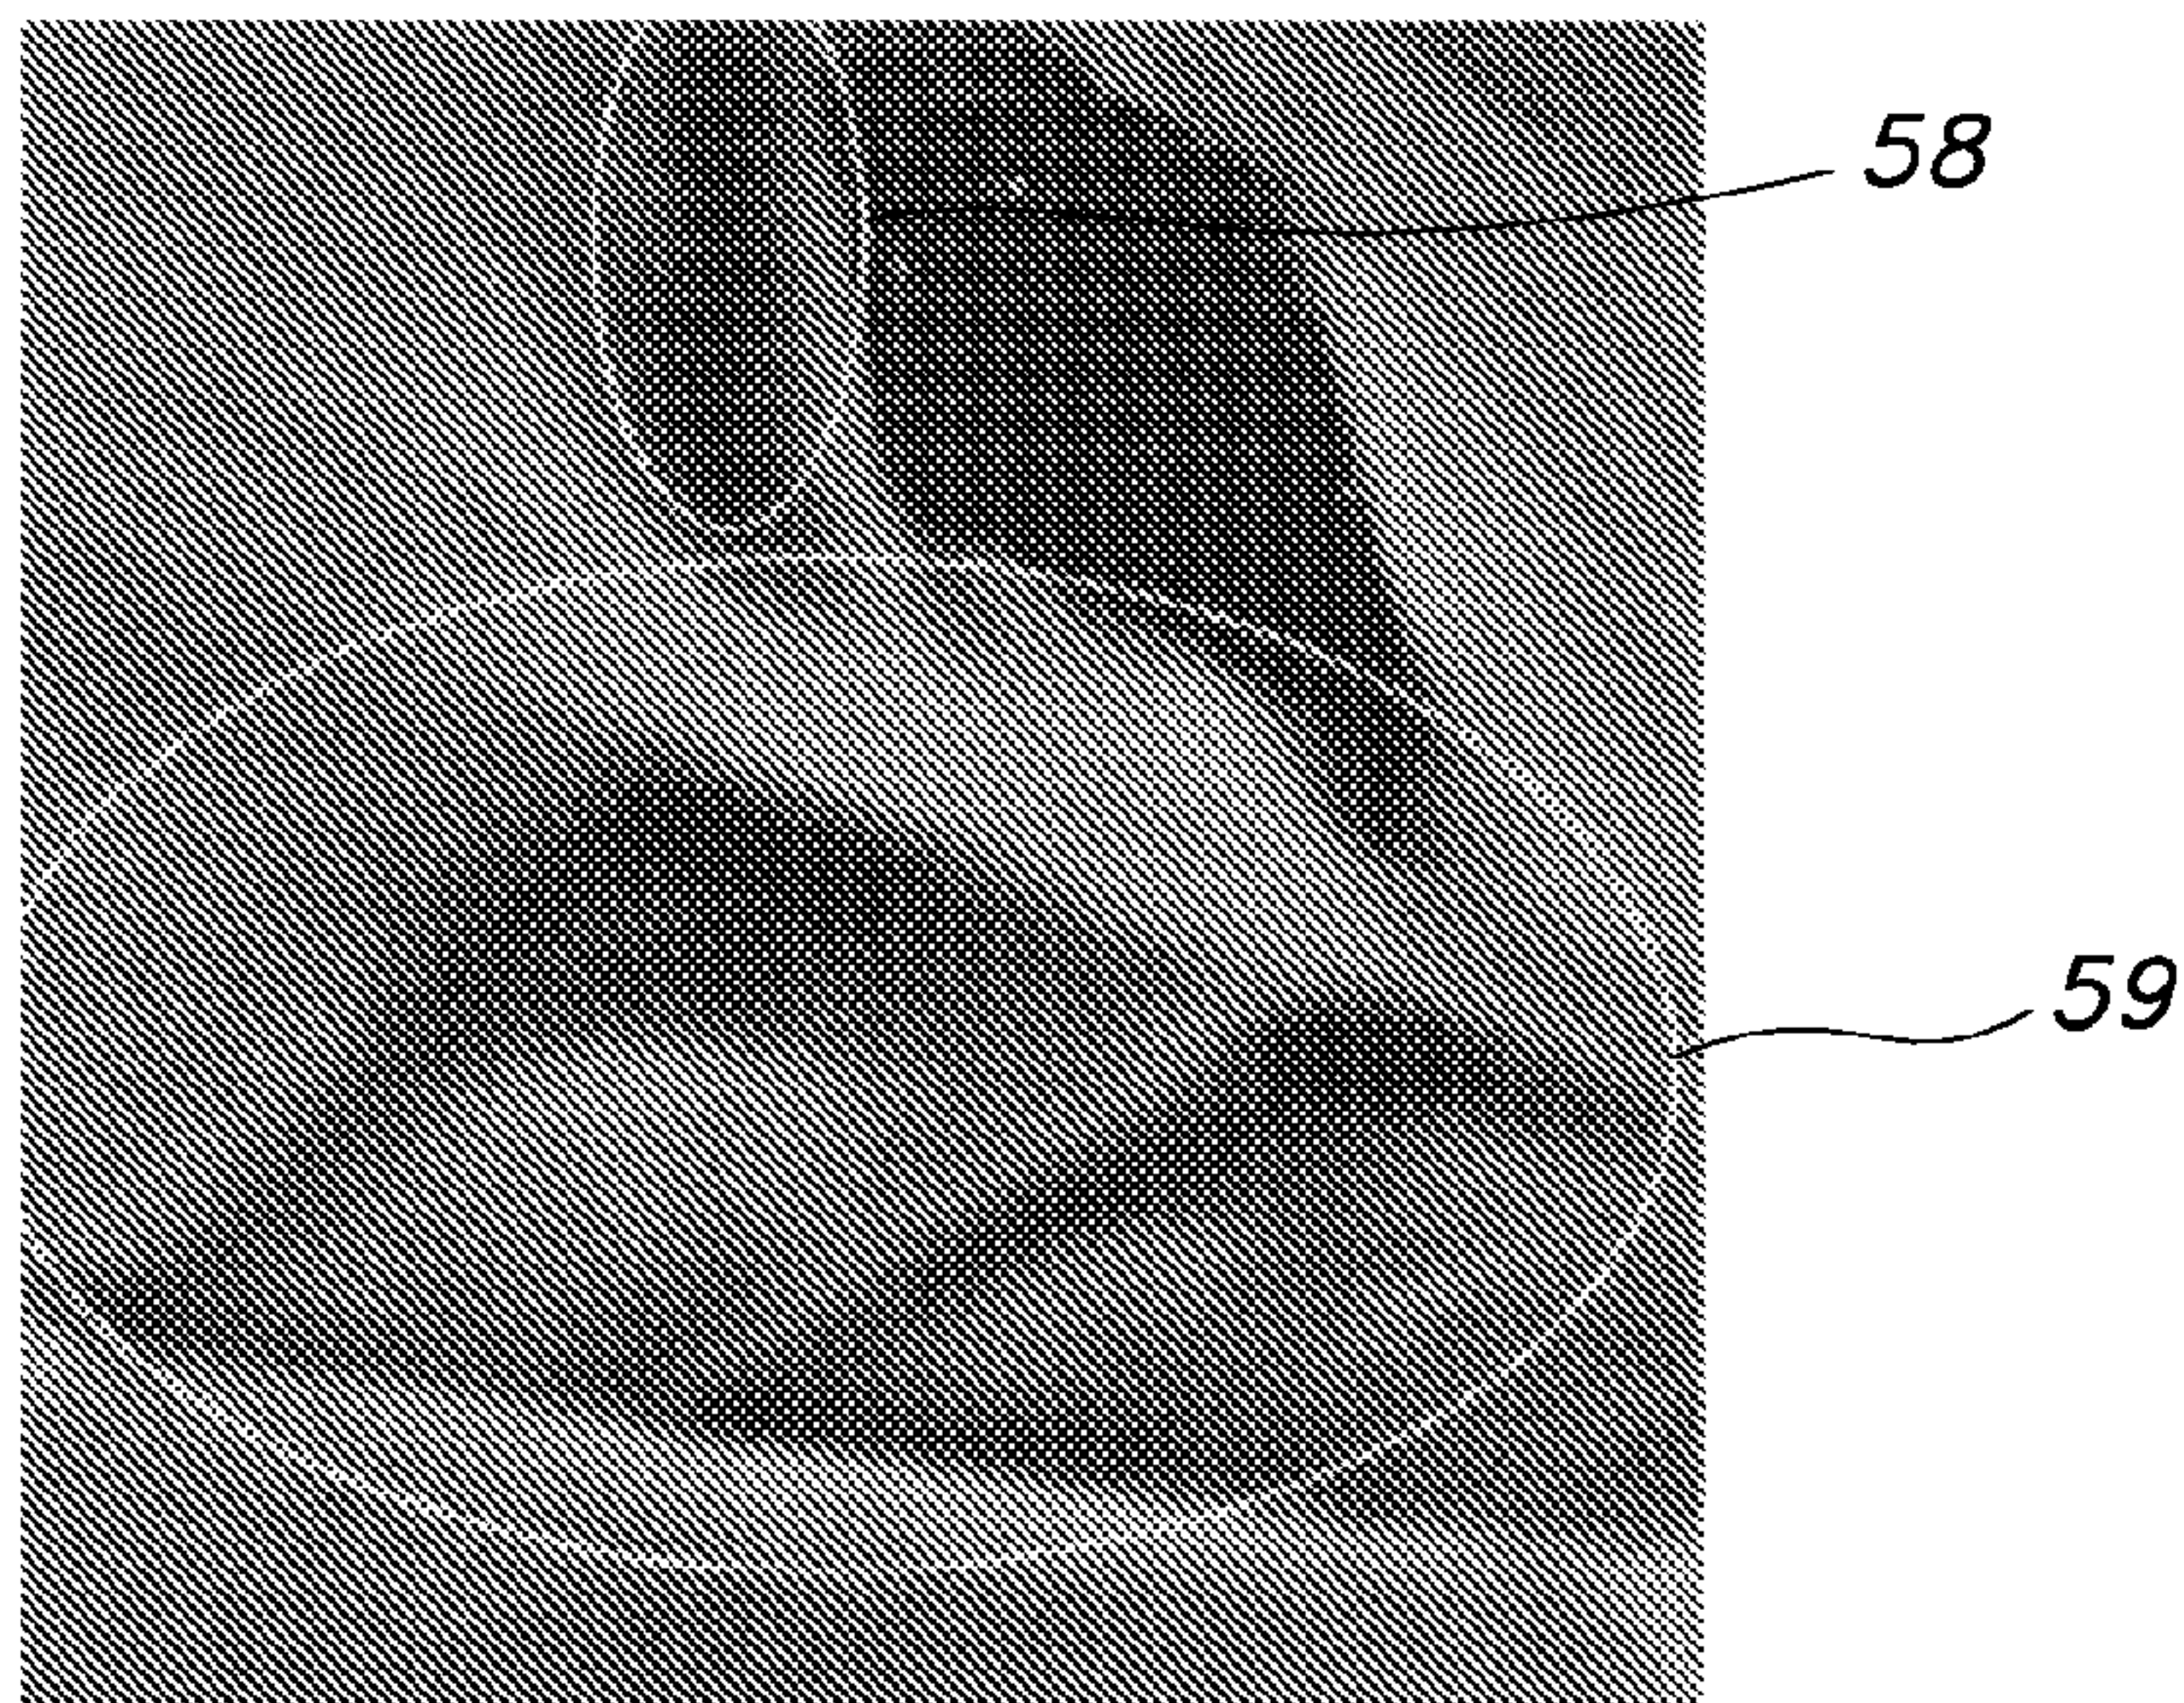
(9) Duct Leakage—FIGS. 28 and 29 show a temperature profile indicative of air duct leakage. In these temperature profiles, the anomalies 57, 58, 59 are indicative of air leaking out of an air duct. The black is cold air leakage in the summer (in the winter it would be opposite).
