(10) **Patent No.:** **US 8,764,285 B2**
(45) **Date of Patent:** **Jul. 1, 2014**

(54) **NONDESTRUCTIVE RESIDENTIAL INSPECTION METHOD AND APPARATUS**

(73) Assignee: **Homesafe Inspection, Inc.**, Oxford, MS (US)

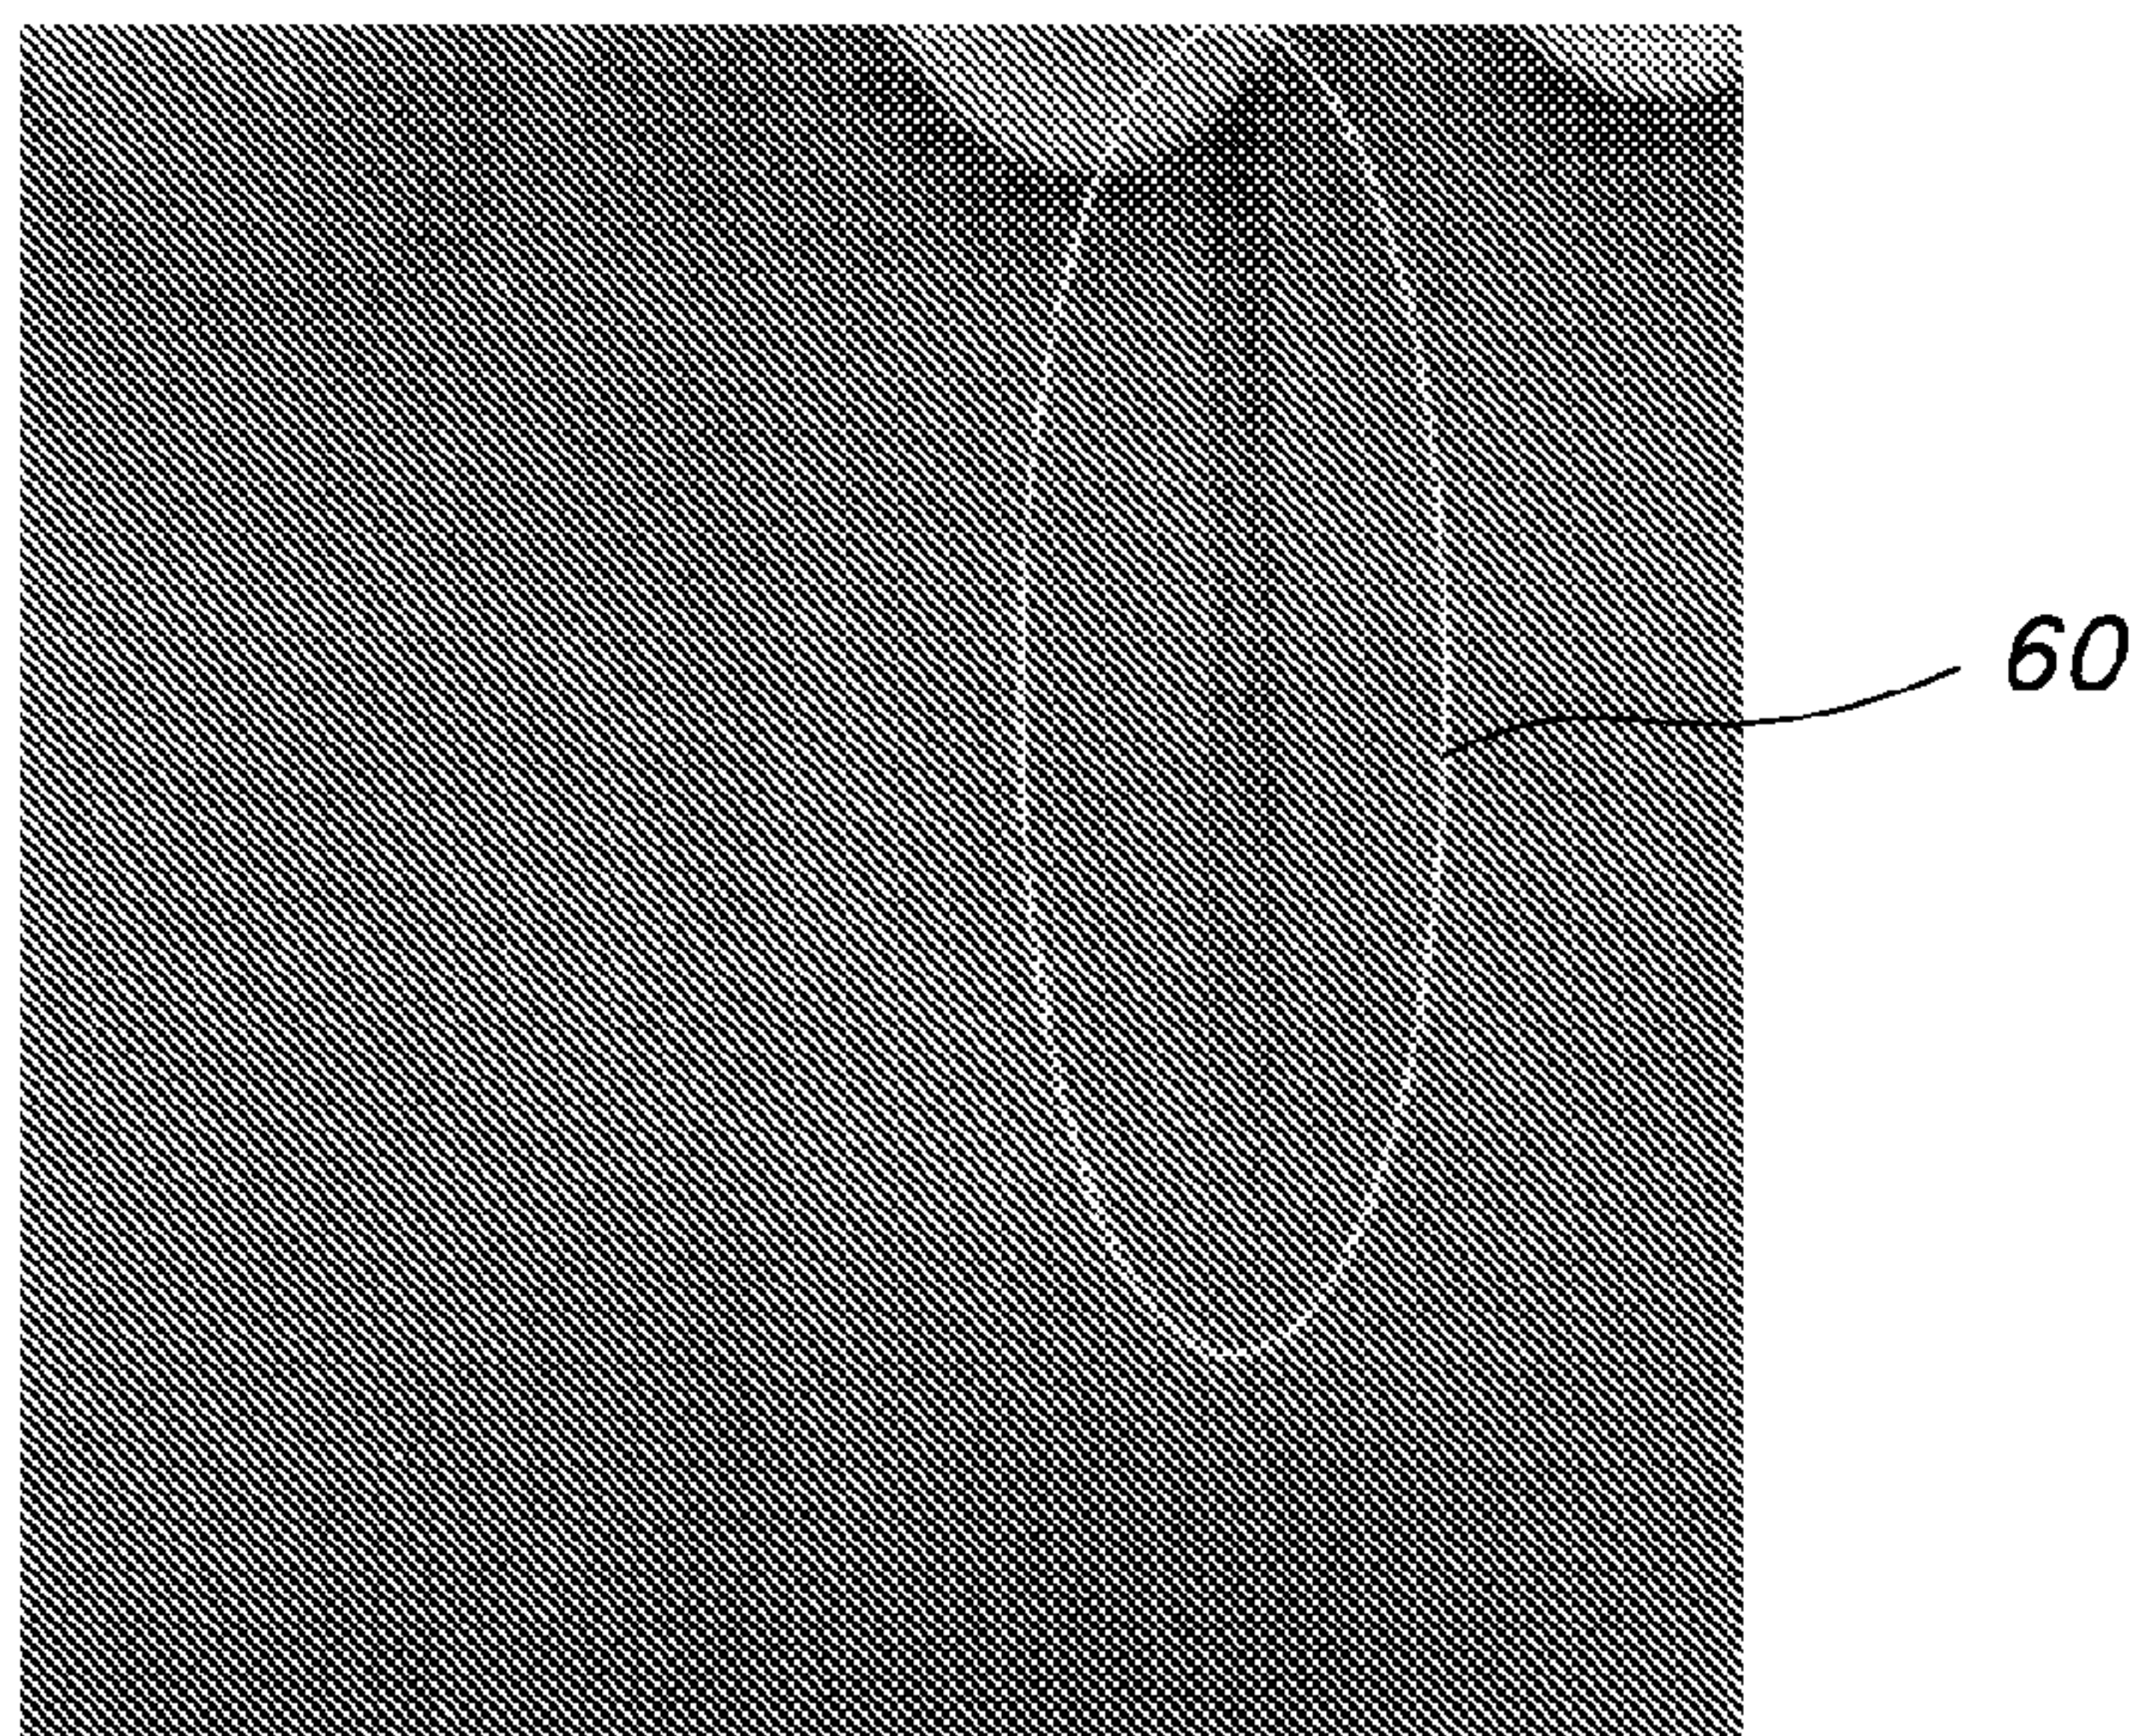
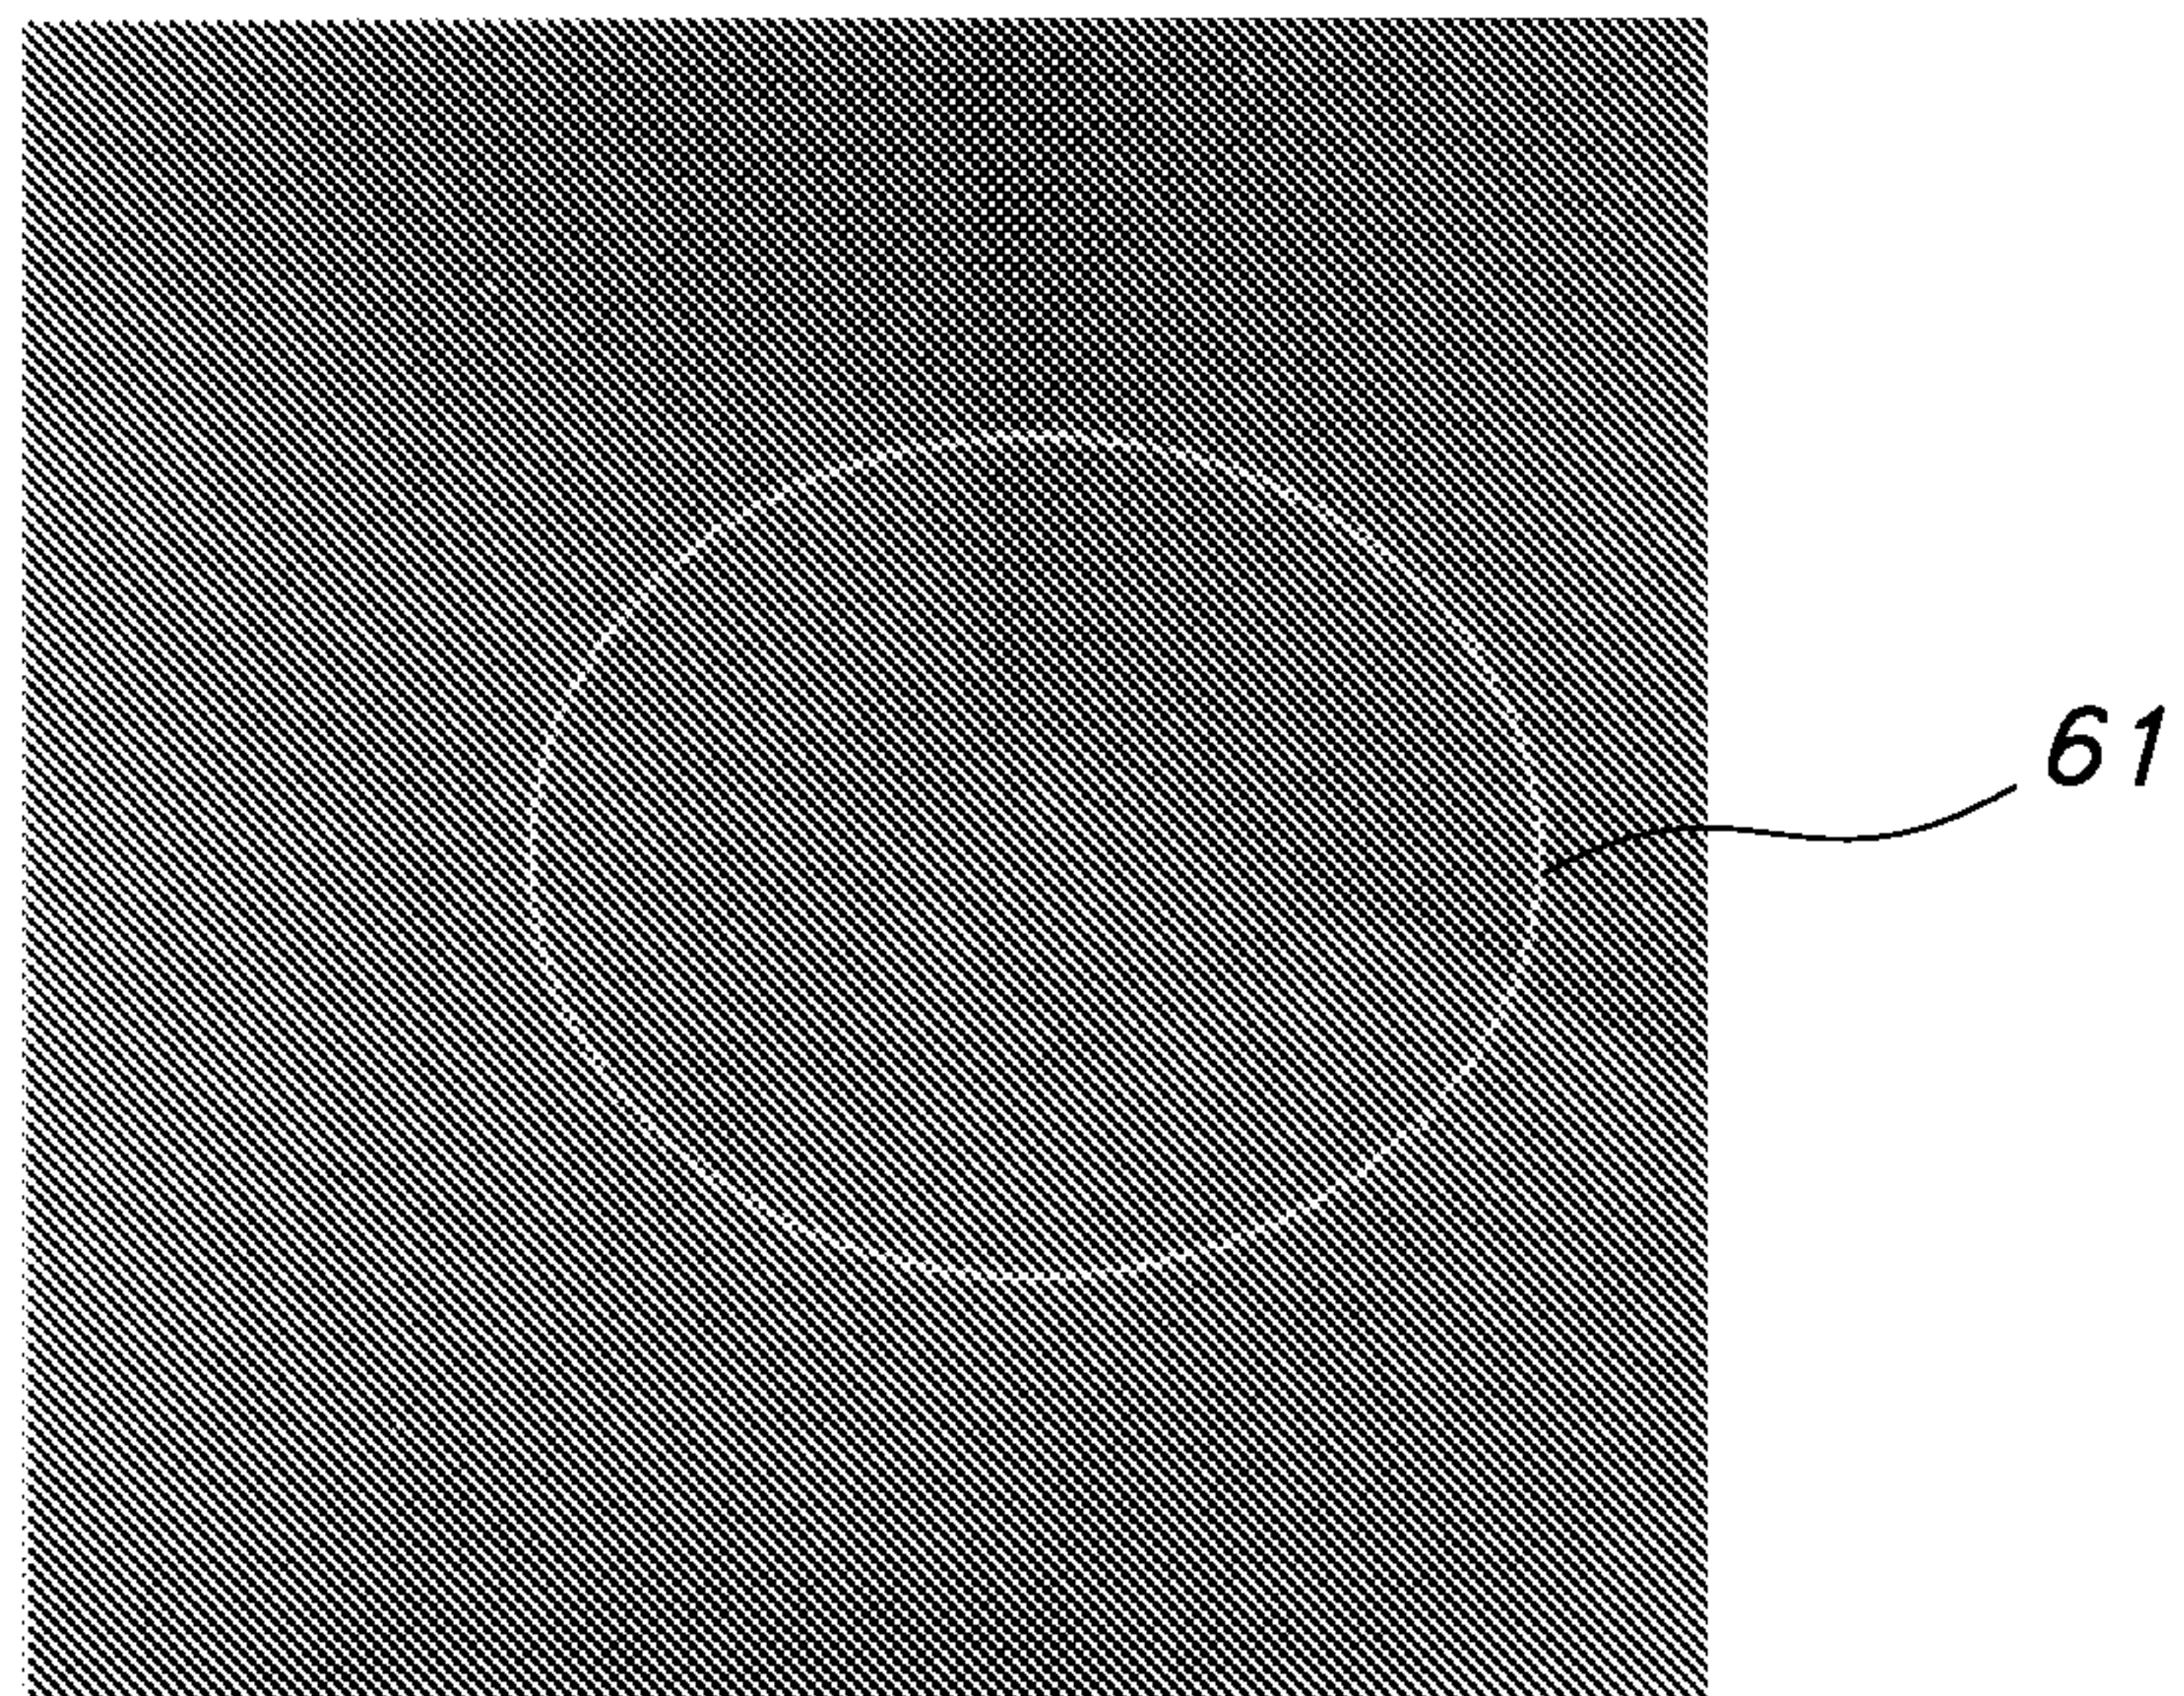
FIGS. 30 and 31 are temperature profiles indicative of moisture penetrating through cracks in a basement wall. More specifically, in FIGS. 30 and 31, anomalies 60 and 61 are indicative of moisture on a basement wall.
