(10) **Patent No.:** **US 9,920,694 B2**
(45) **Date of Patent:** **Mar. 20, 2018**

(54) **FIRESHIELD FASTENER HOOD**

FIRESHIELD FASTENER HOOD

The present disclosure relates to a fireshield, and more particularly to an aircraft nacelle fireshield.

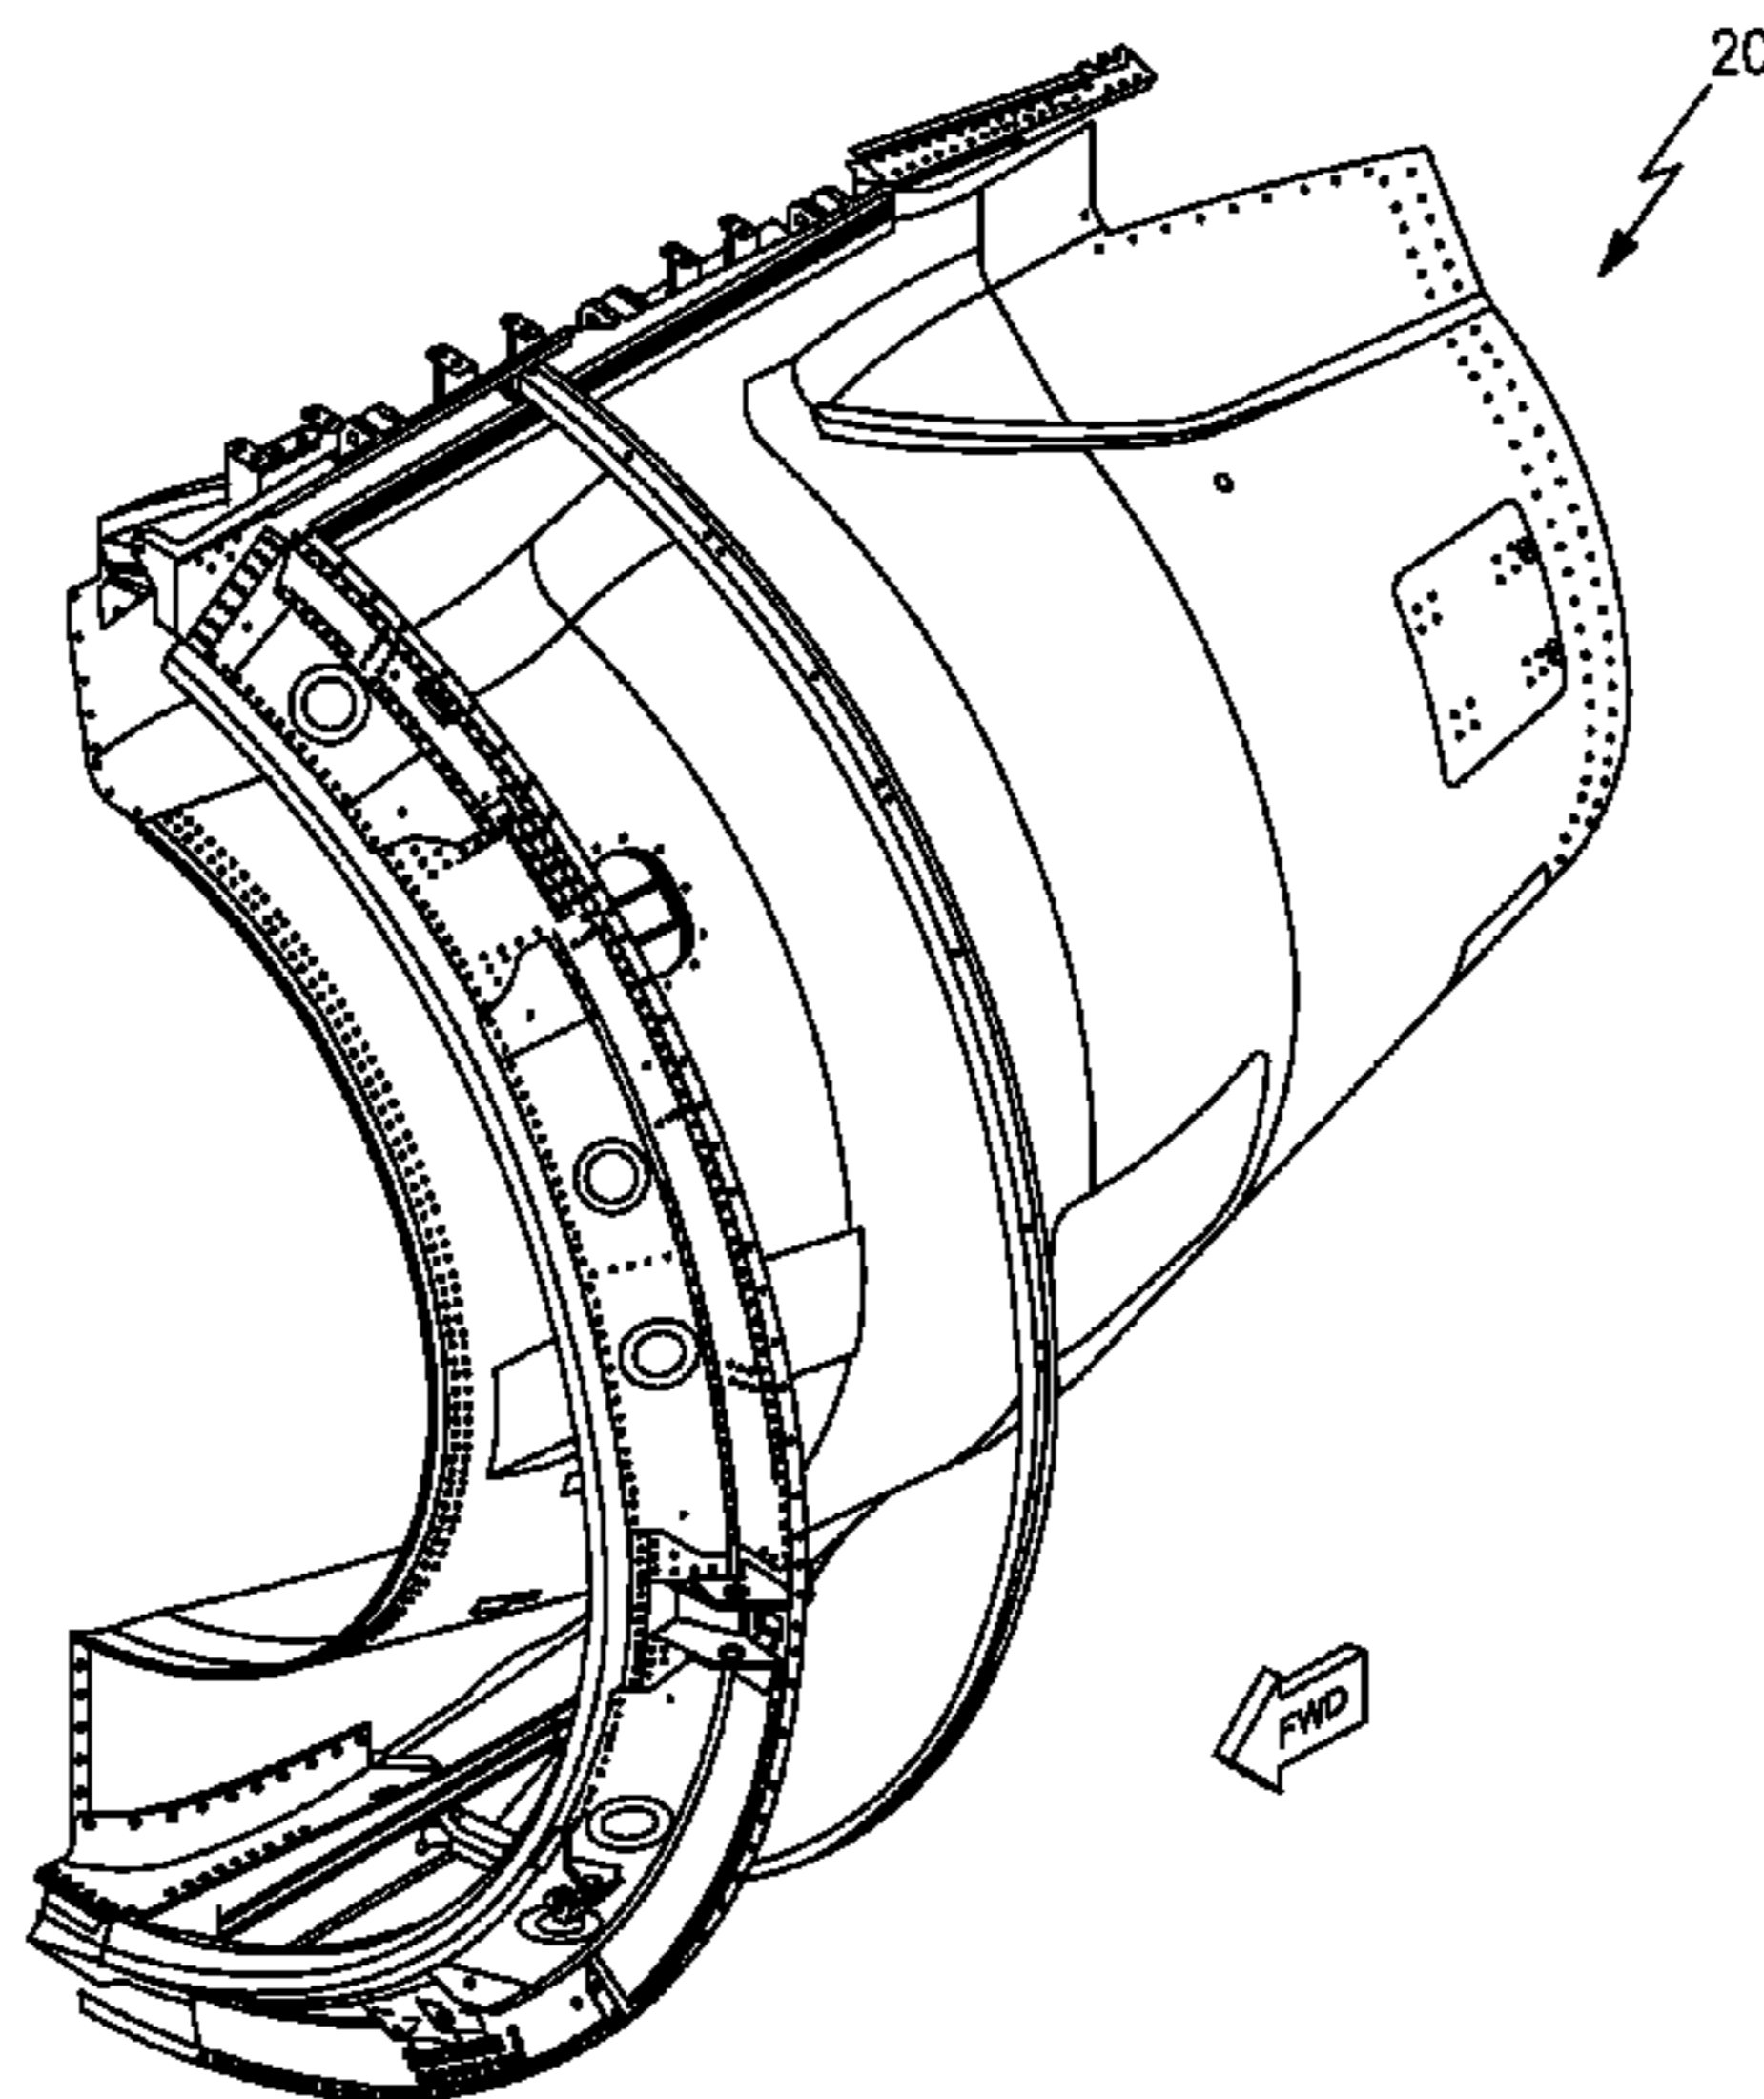
FIG. 1 is a general perspective view of part of a nacelle structure for a gas turbine engine embodiment for use with the present disclosure;

FIG. 1 illustrates a Thrust Reverser Core Cowl portion of a gas turbine engine nacelle structure 20. Although a nacelle structure 20 is illustrated in the disclosed non-limiting embodiment, it should be understood that various structures will benefit herefrom and the disclosure herein should not be limited only to such structures.

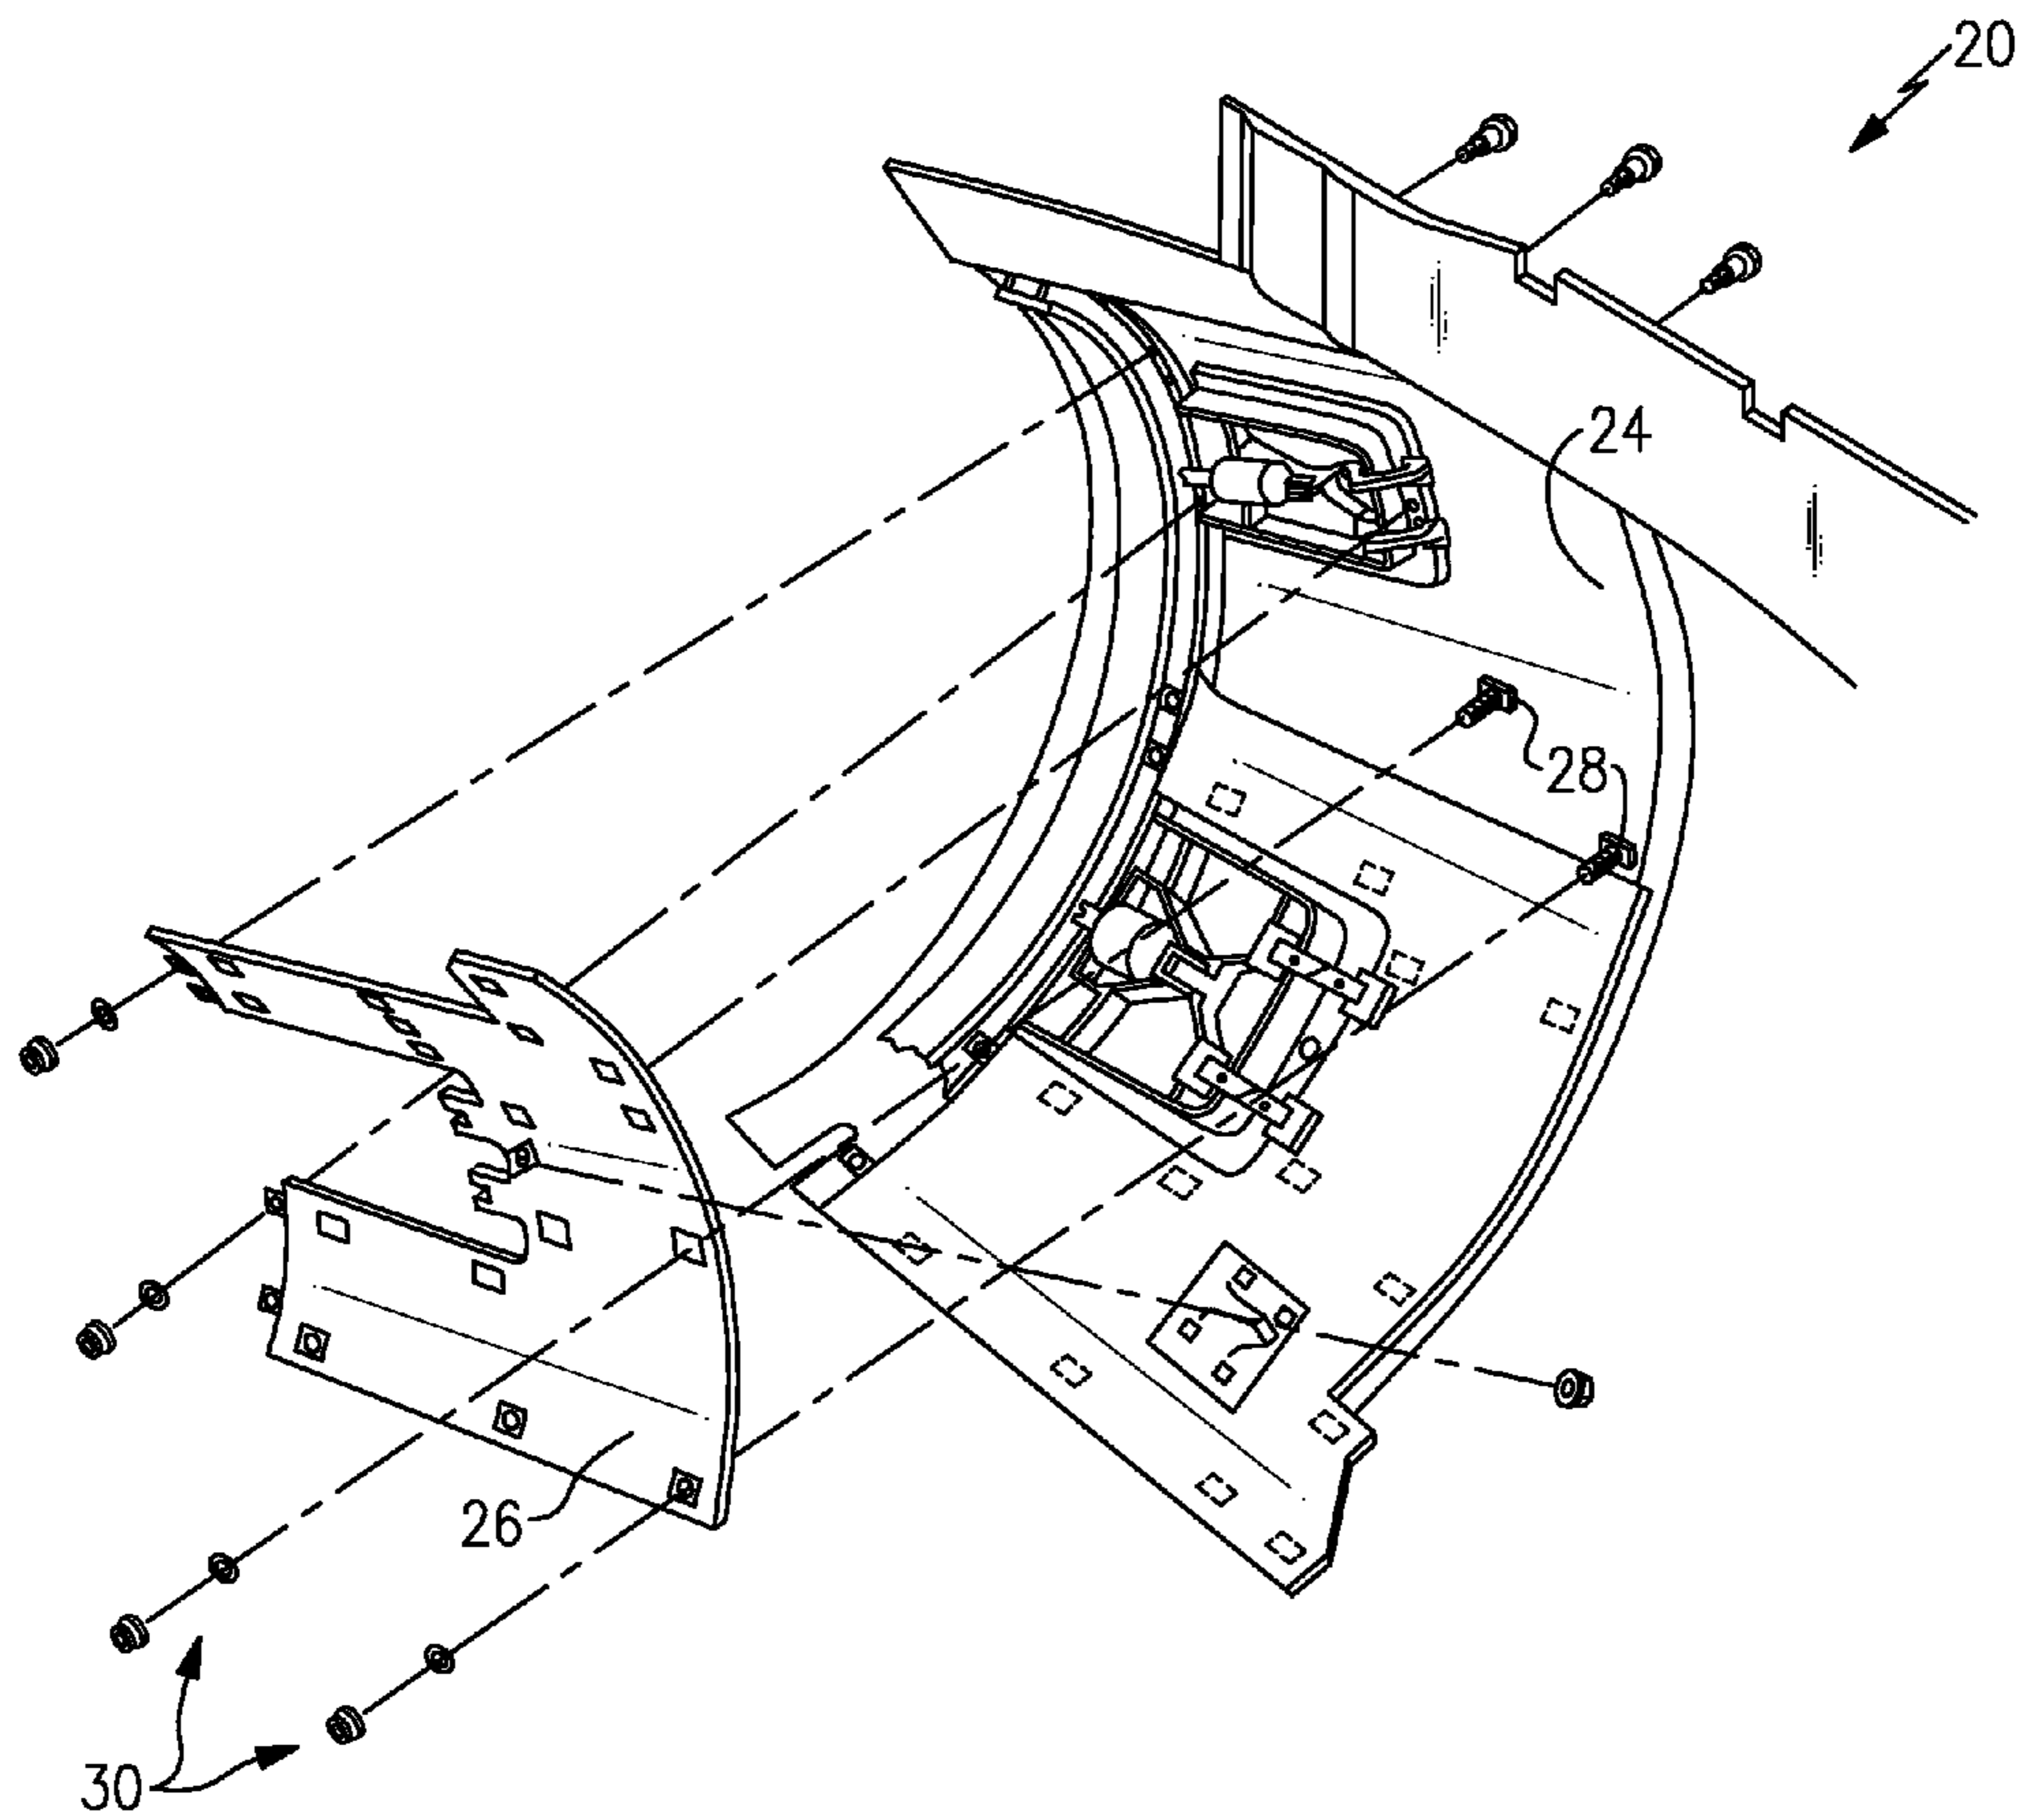
FIG.2

FIG. 2 is an exploded view of a fireshield of the nacelle structure of FIG. 1;

With reference to FIG. 2, the nacelle structure 20 generally includes an inner cowl section 24 onto which is mounted a fireshield 26. The cowl section 24 is typically manufactured from a carbon fiber or light weight metallic material such as an aluminum alloy which may require the thermal protection of the fireshield 26 during normal service or in the abnormal event of a fire in that compartment.

The fireshield 26 is mounted to a multiple of studs 28 which extend from the cowl section 24. The studs 28 extend through the fireshield 26 to receive a fastener 30 such as a nut to retain the fireshield 26 to the cowl section 24. The extended stud 28 and fastener 30 are protected by a movable fireshield fastener hood 32 (FIG. 3). Although a movable fireshield hood for a fastener is discussed in detail herein, it should be understood that other fireshield hoods such as that for a hinge 34 will also benefit herefrom.

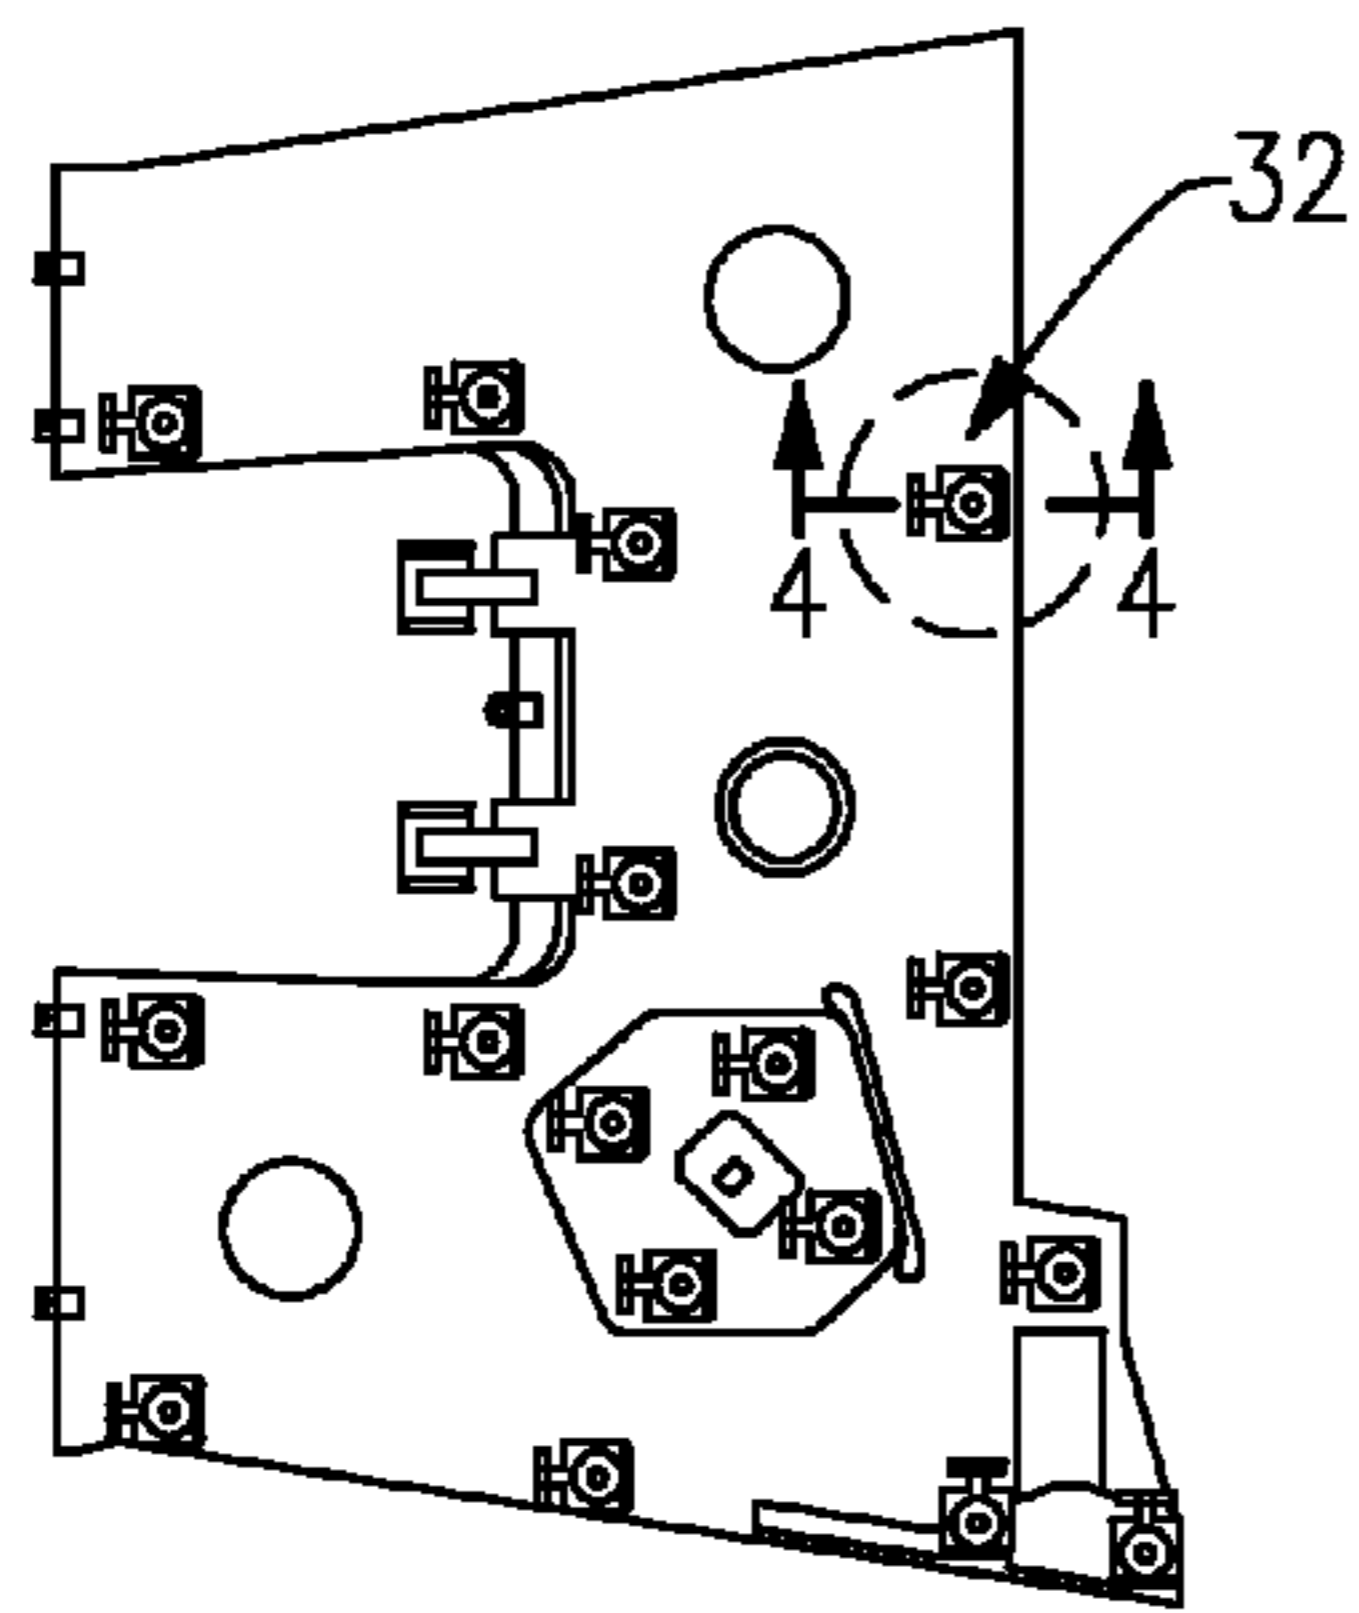
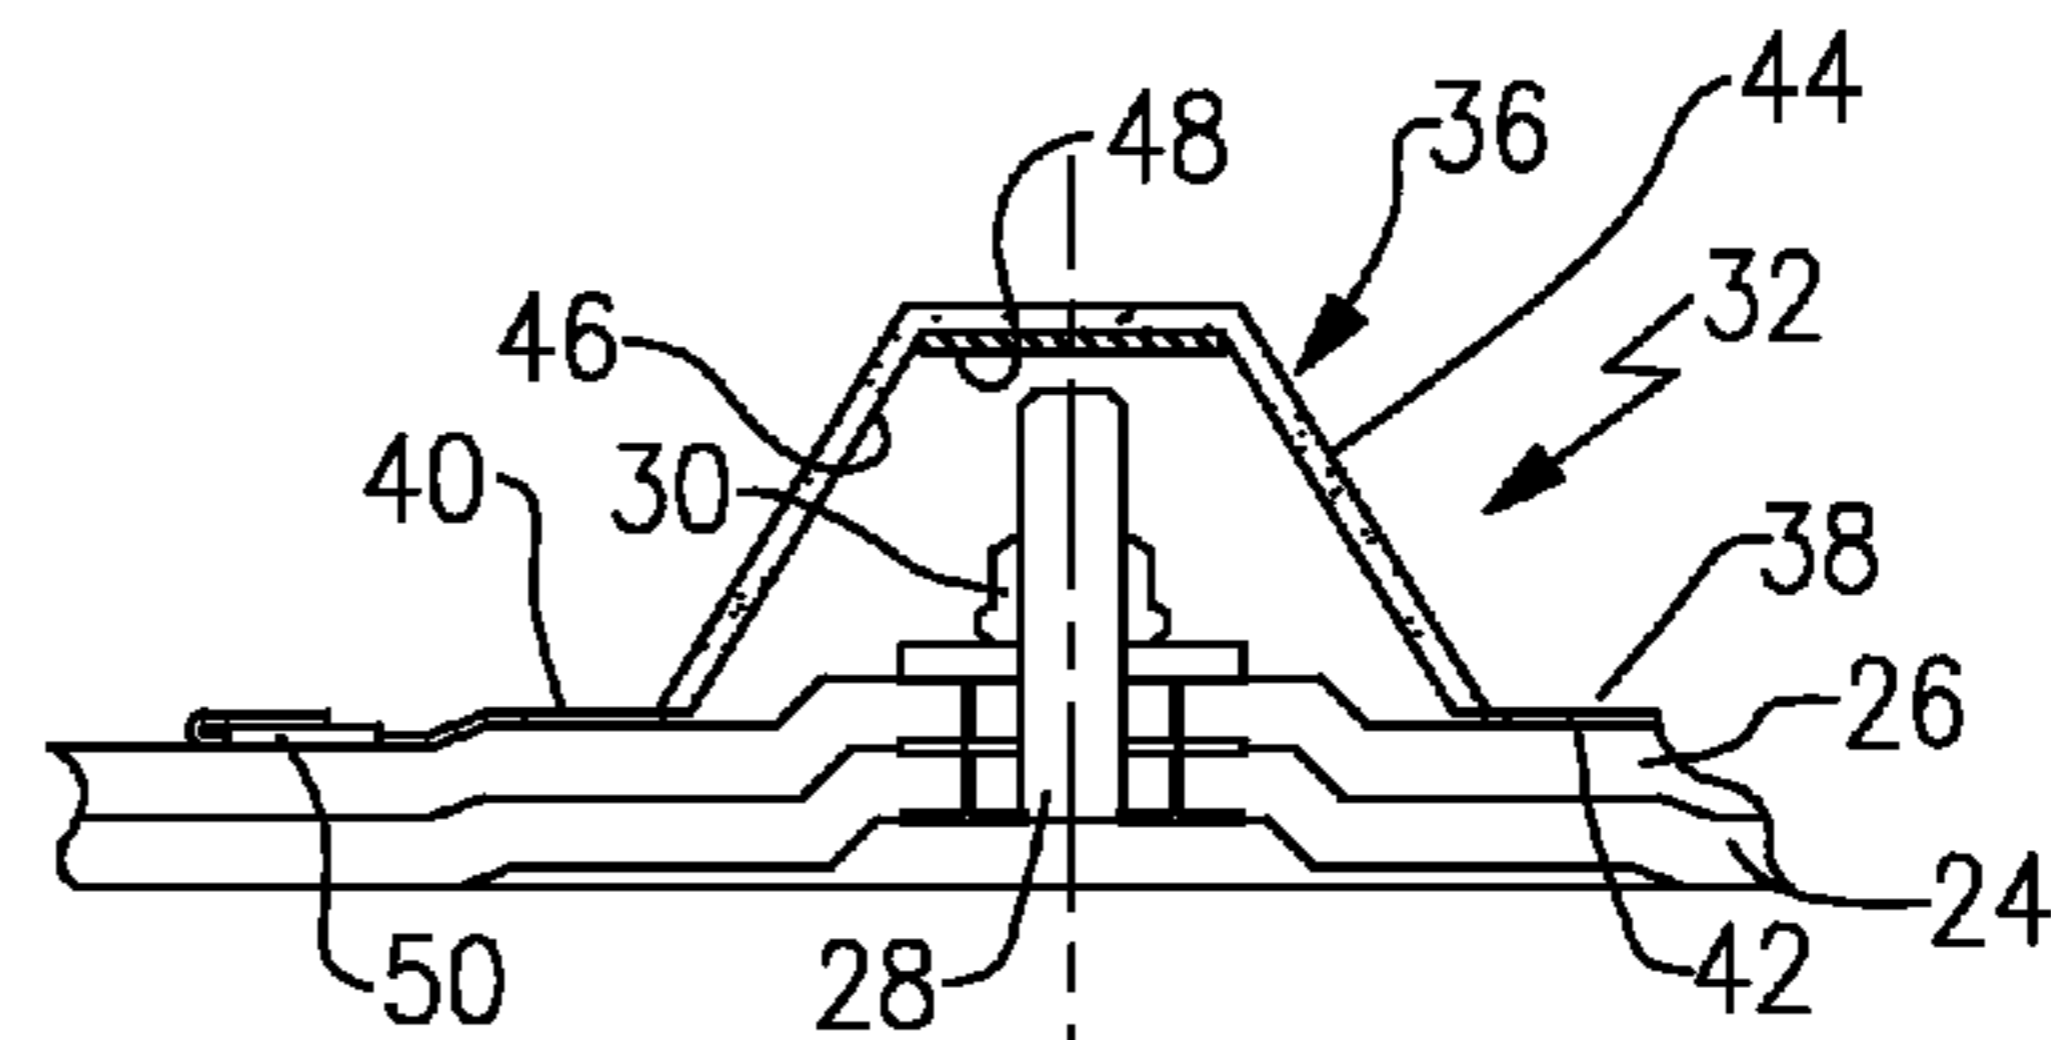
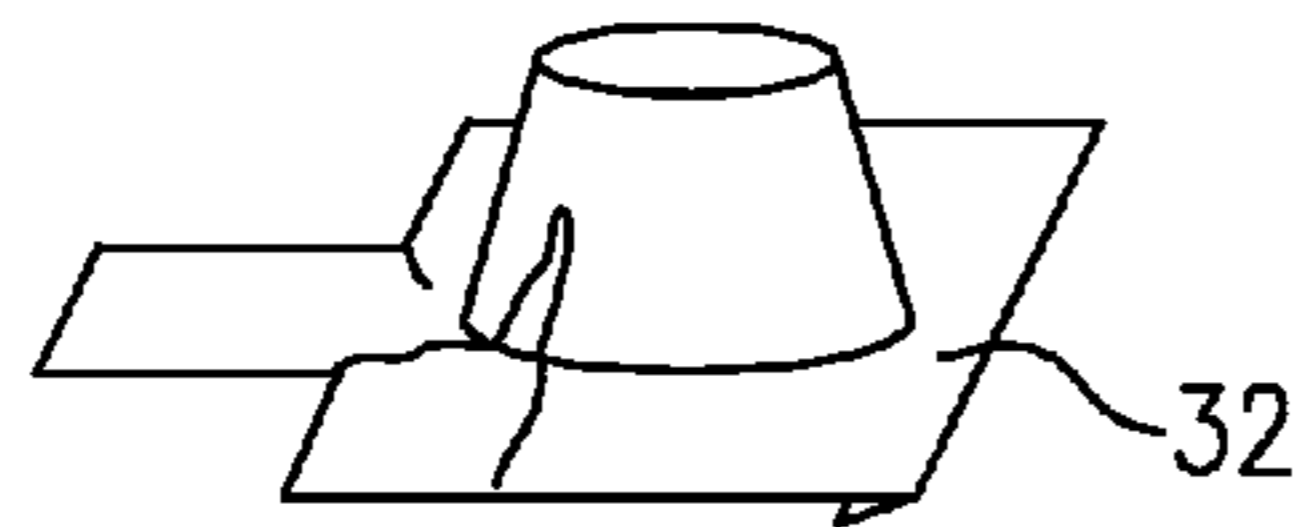
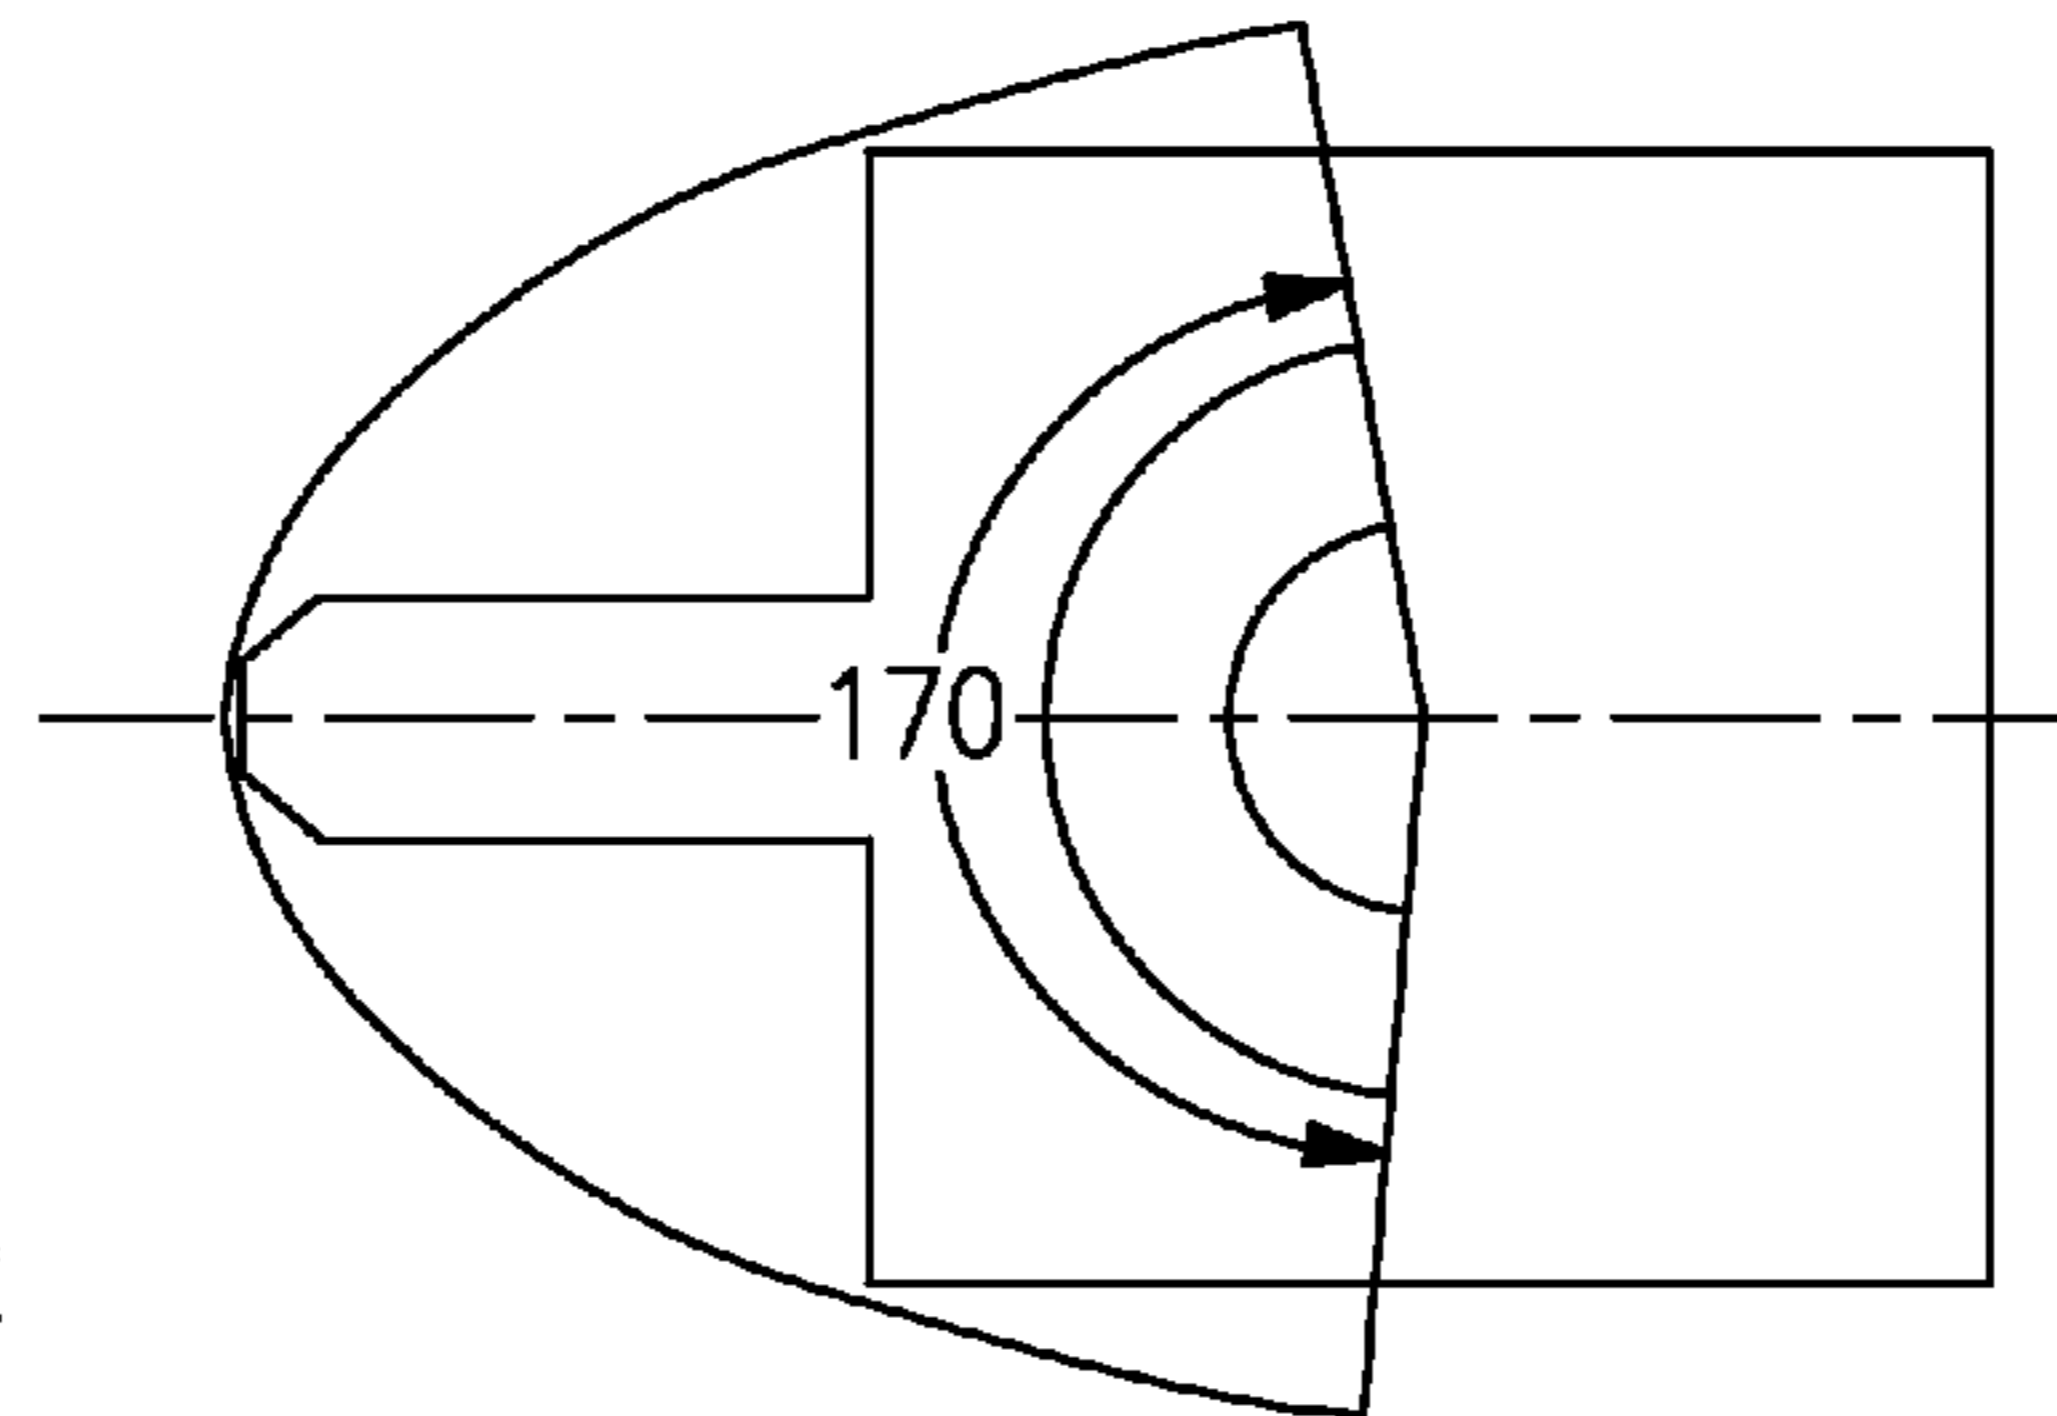
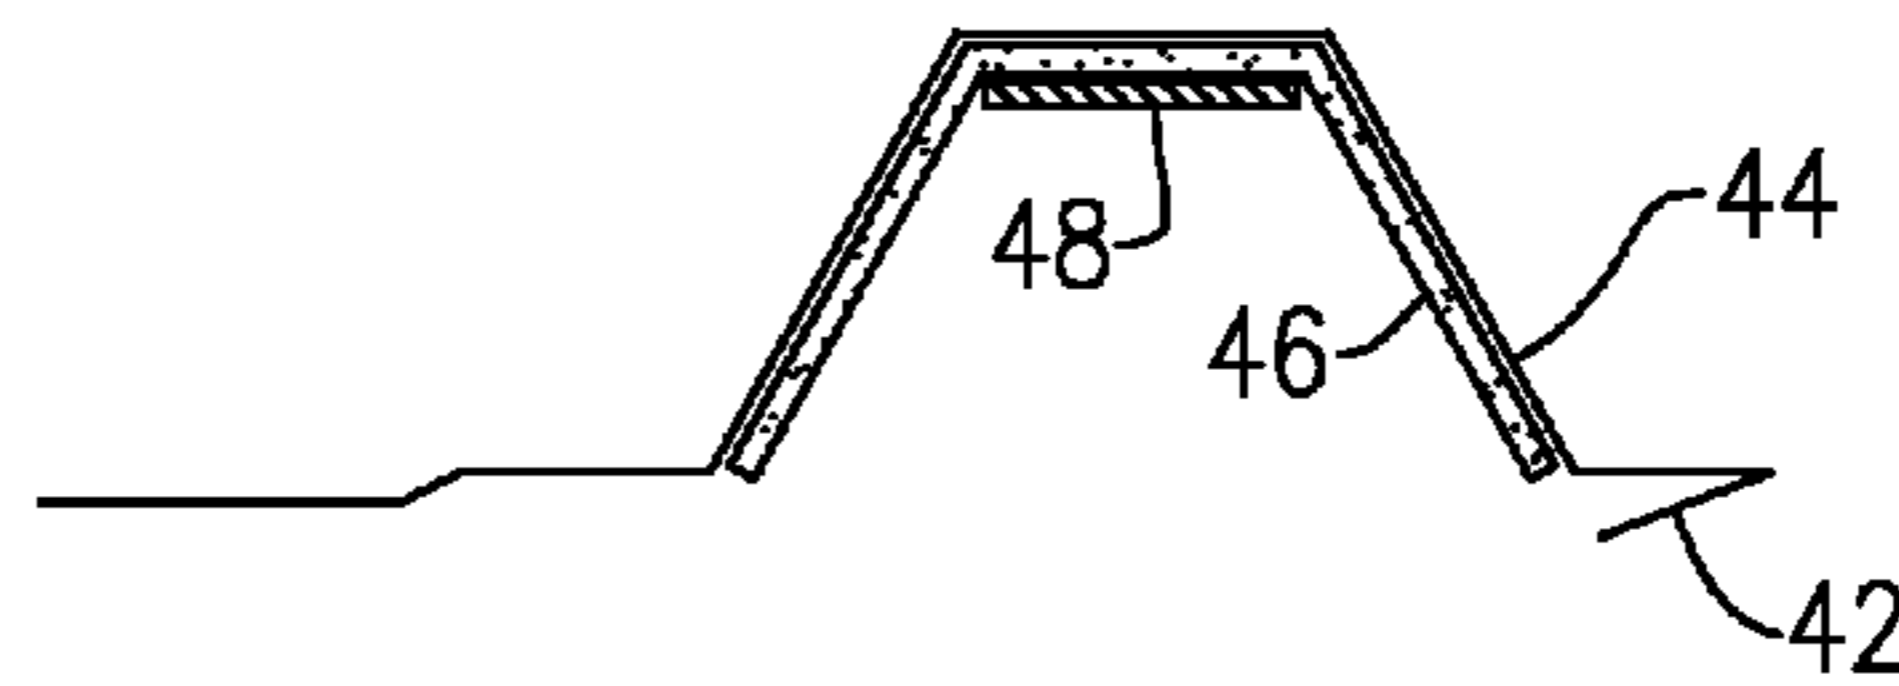
FIG. 3 is an inner view of the fireshield illustrating a fireshield fastener hood

FIG. 4 is a sectional view of the fireshield fastener hood attached to a fireshield mounted to the nacelle cowl;

FIG. 5 is a sectional view of the fireshield fastener hood;

FIG. 6 is a perspective view of the fireshield fastener hood;

FIG. 7 is a schematic view of an allowable crack area in the fireshield fastener hood for a repair thereof;

With reference to FIG. 4, the fireshield fastener hood 32 generally includes a frusto-conical hood 36 which extends from a generally planar platform 38 which includes a tab 40 and a bendable hinge 42 (also illustrated in FIG. 5). The hood 36, platform 38, tab 40 and hinge 42 may be manufactured of an AISI 300 Series Stainless Steel alloy substrate 44 which is approximately 0.003 inches (0.0762 mm) thick. A silicone layer 46 coats the interior of the hood 36 and a polytetrafluoroethylene disk 48 is mounted to the apex of the hood 36 to protect the silicone layer 46 should the relatively thin substrate 44 be over-compressed to make intimate contact with the stud 28. It should be understood that various other constructions may alternatively or additionally be provided and the fireshield fastener hood 32 may be of various geometries.

The hinge 42 is a folded section of the substrate 44 which may be tack welded to the fireshield 26 to permit the fireshield fastener hood 32 to move relative thereto. The tab 40 extends from the platform 38 for receipt into a retainer 50 in the fireshield 26 to close the fireshield fastener hood 32 over the stud 28 and fastener 30. To access the stud 28 and fastener 30, the tab 40 is slipped out from under the retainer 50 and the fireshield fastener hood 32 is pivoted upon the hinge 42.

Oftentimes the substrate 44 may crack, tear, or otherwise be damaged in a manner which is repairable by the method disclosed herein (FIG. 6). Typically, acceptable cracks may be located in an arc of approximately 170 degrees from the center of the hood 36 in an area adjacent to the tab 40 (FIG. 7). It should be understood that other crack locations may alternatively or additionally be allowable.

facilitates bonding and crack inspection. The repair to the fireshield fastener hood **32** may be performed while the fireshield fastener hood **32** is mounted to the fireshield **26** (FIG. 3).

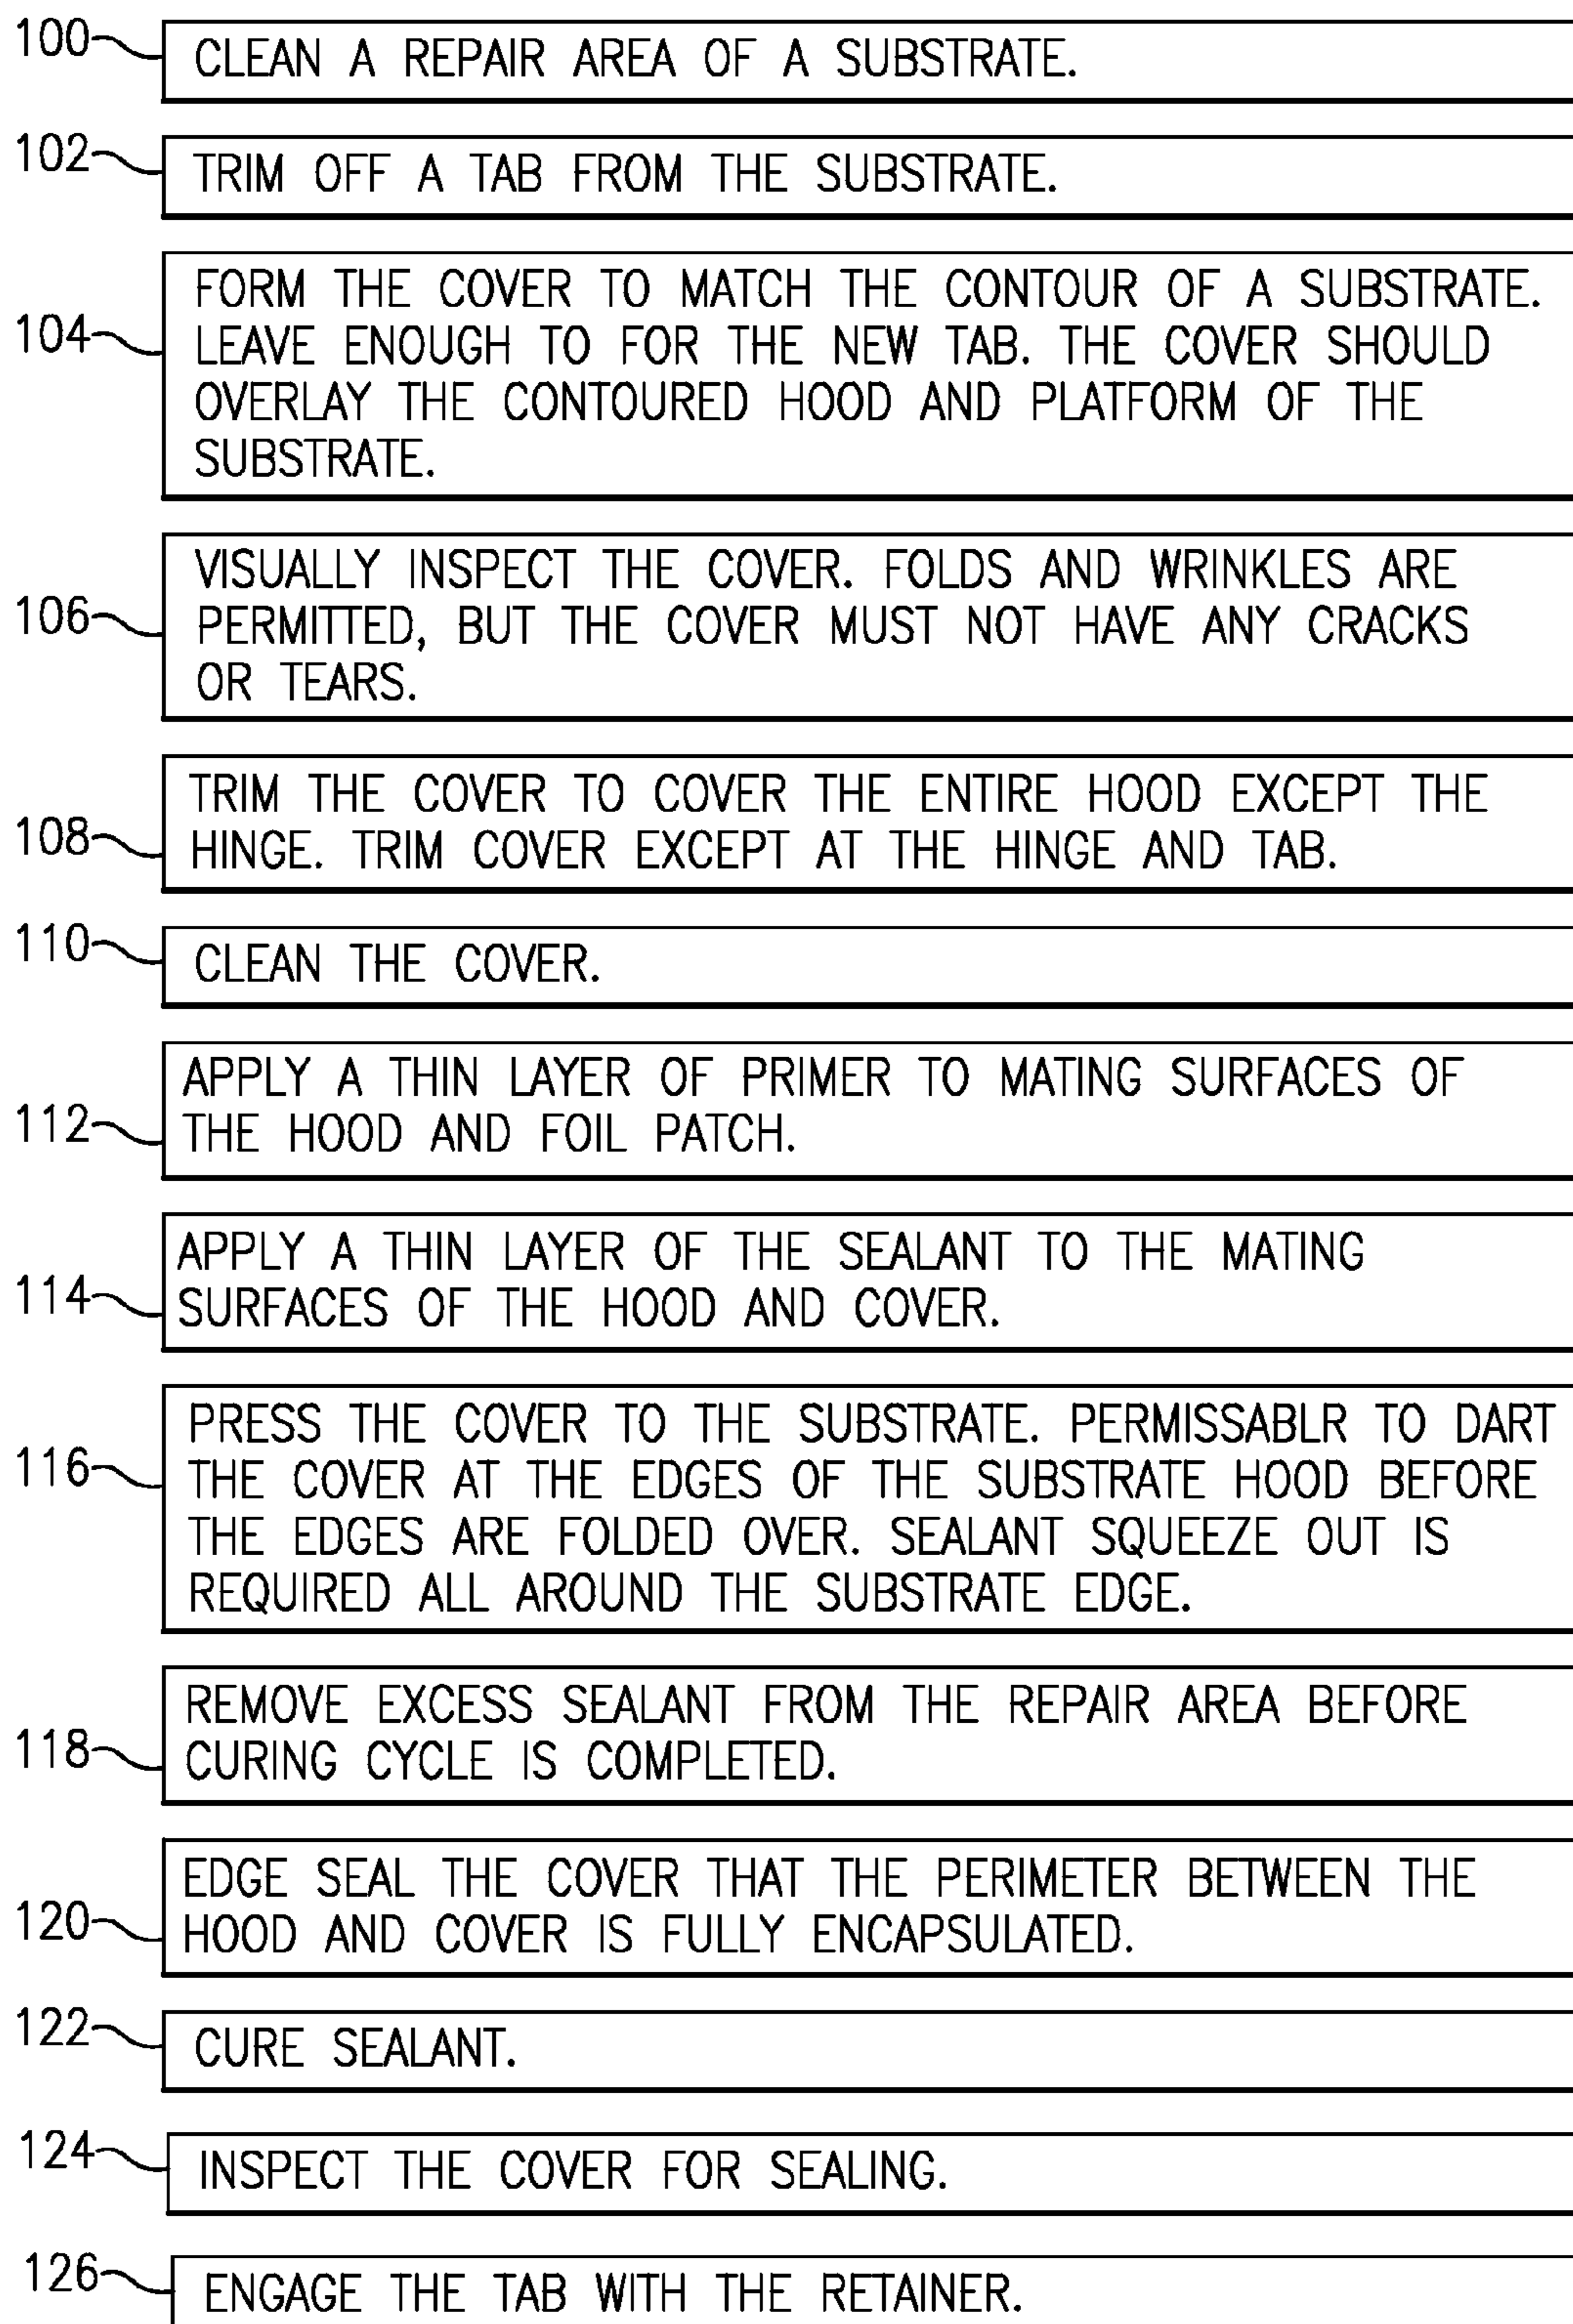
**FIG.8**

FIG. 8 is a method of repair steps for the fireshield fastener hood;

With Reference to FIG. 8, step 100 of a manufacture or repair to the fireshield fastener hood 32 includes cleaning the repair area of the fireshield fastener hood 32. The cleaning
