(10) **Patent No.:** **US 9,920,694 B2**
(45) **Date of Patent:** **Mar. 20, 2018**

(54) **FIRESHIELD FASTENER HOOD**

FIRESHIELD FASTENER HOOD

The present disclosure relates to a fireshield, and more particularly to an aircraft nacelle fireshield.

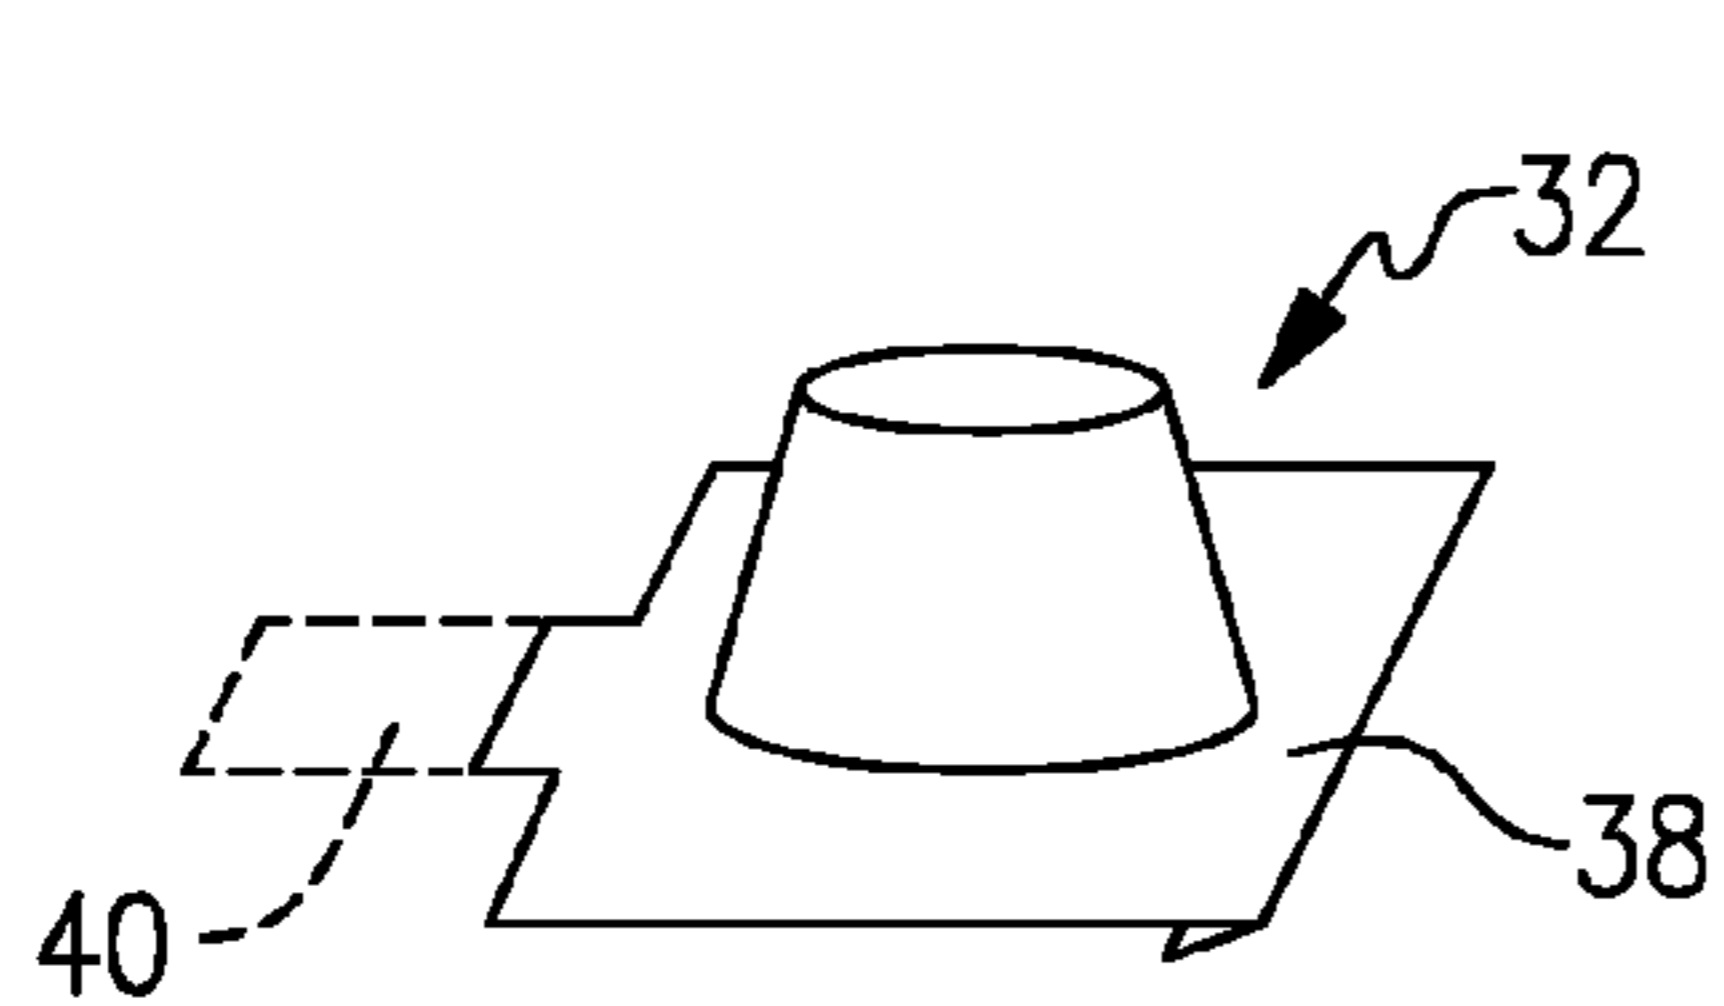
FIG. 9 is a perspective view of the fireshield fastener hood with a tab cut off;

Step **102** of the repair may include removal of the tab **40** (FIGS. 9 and 10). The tab **40** may be trimmed to be from 0 to 0.3 inches (0-8 mm) from the platform **38**. The tab removal may only be necessary where an extra thick tab **40** will not fit under retainer **50** or when tab **40** is damaged.

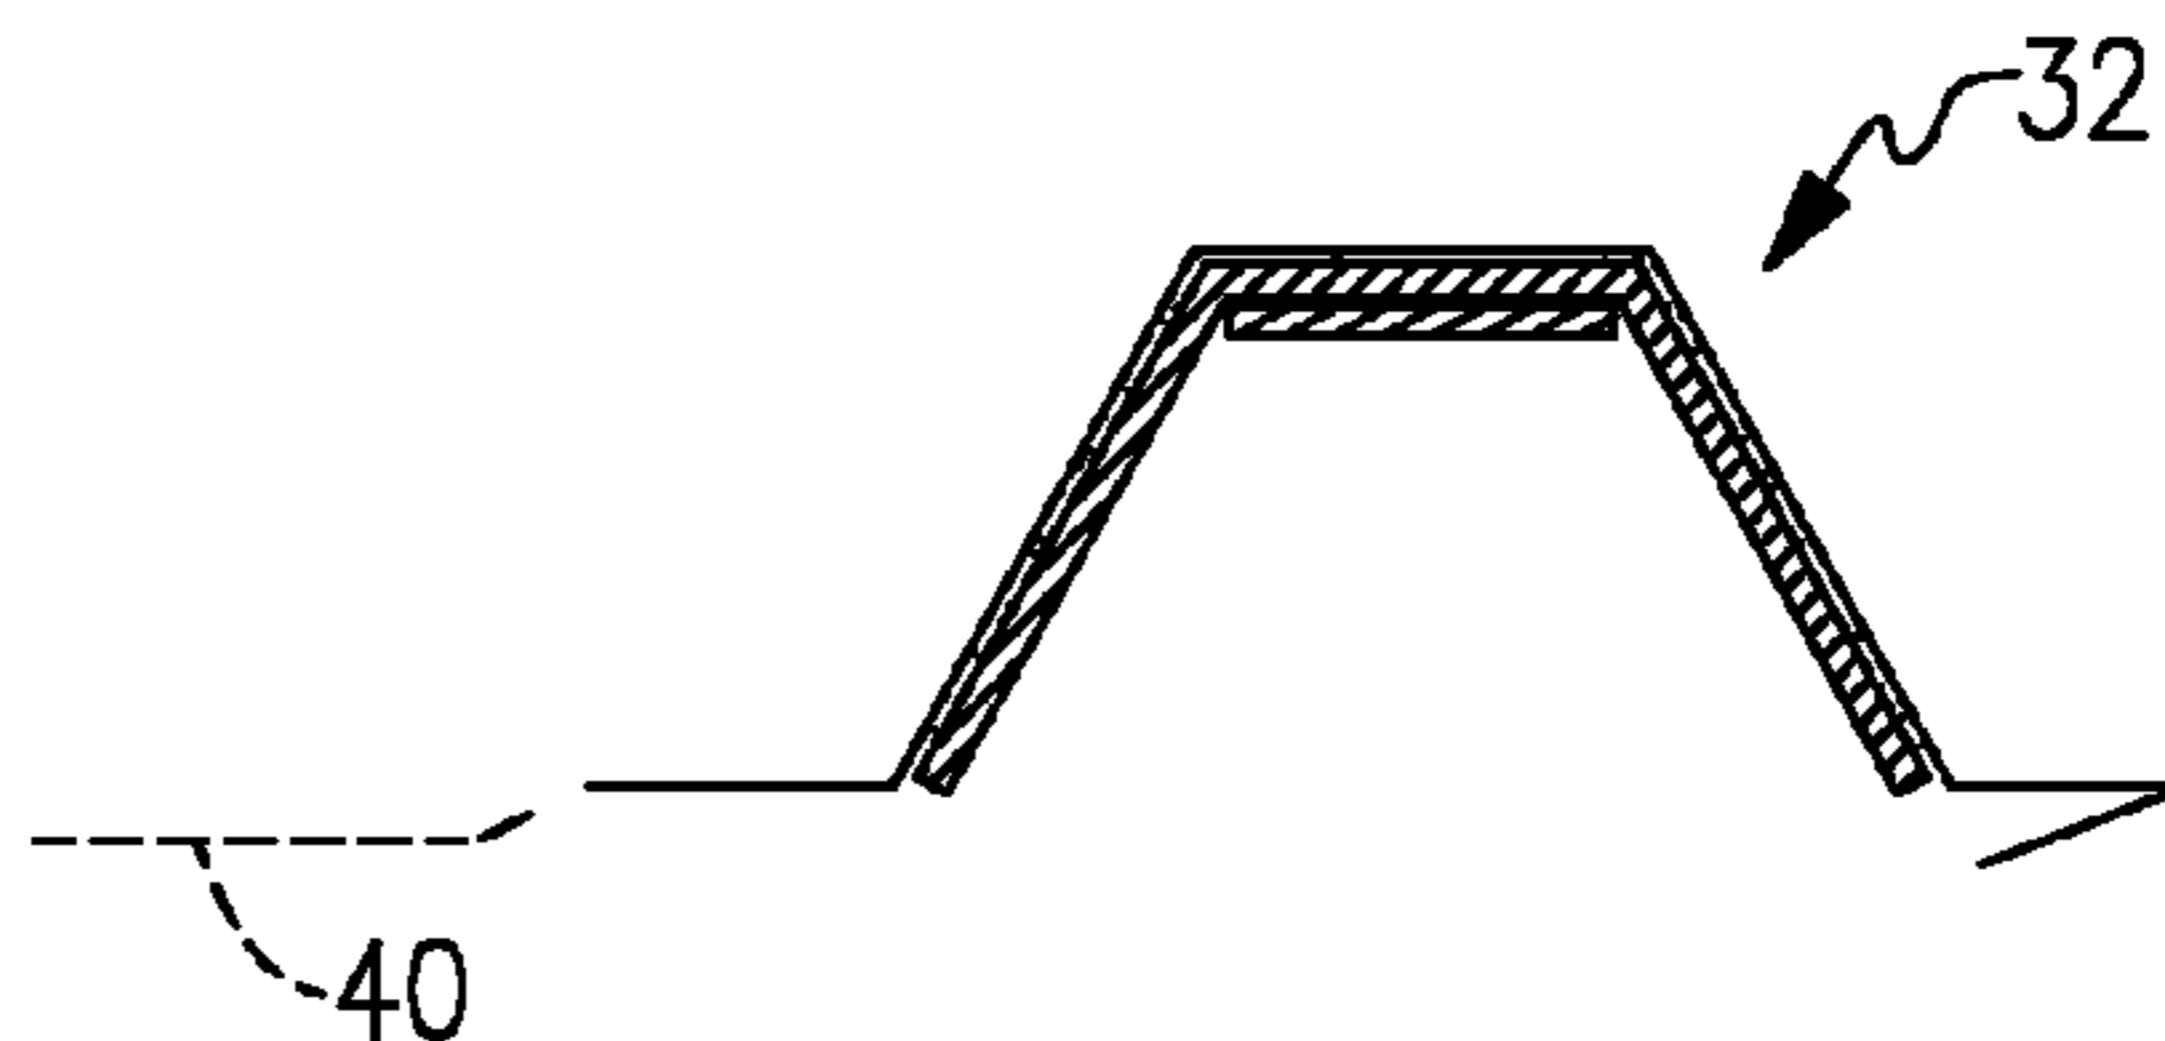
FIG. 10 is a sectional view of the fireshield fastener hood with the tab cut off;

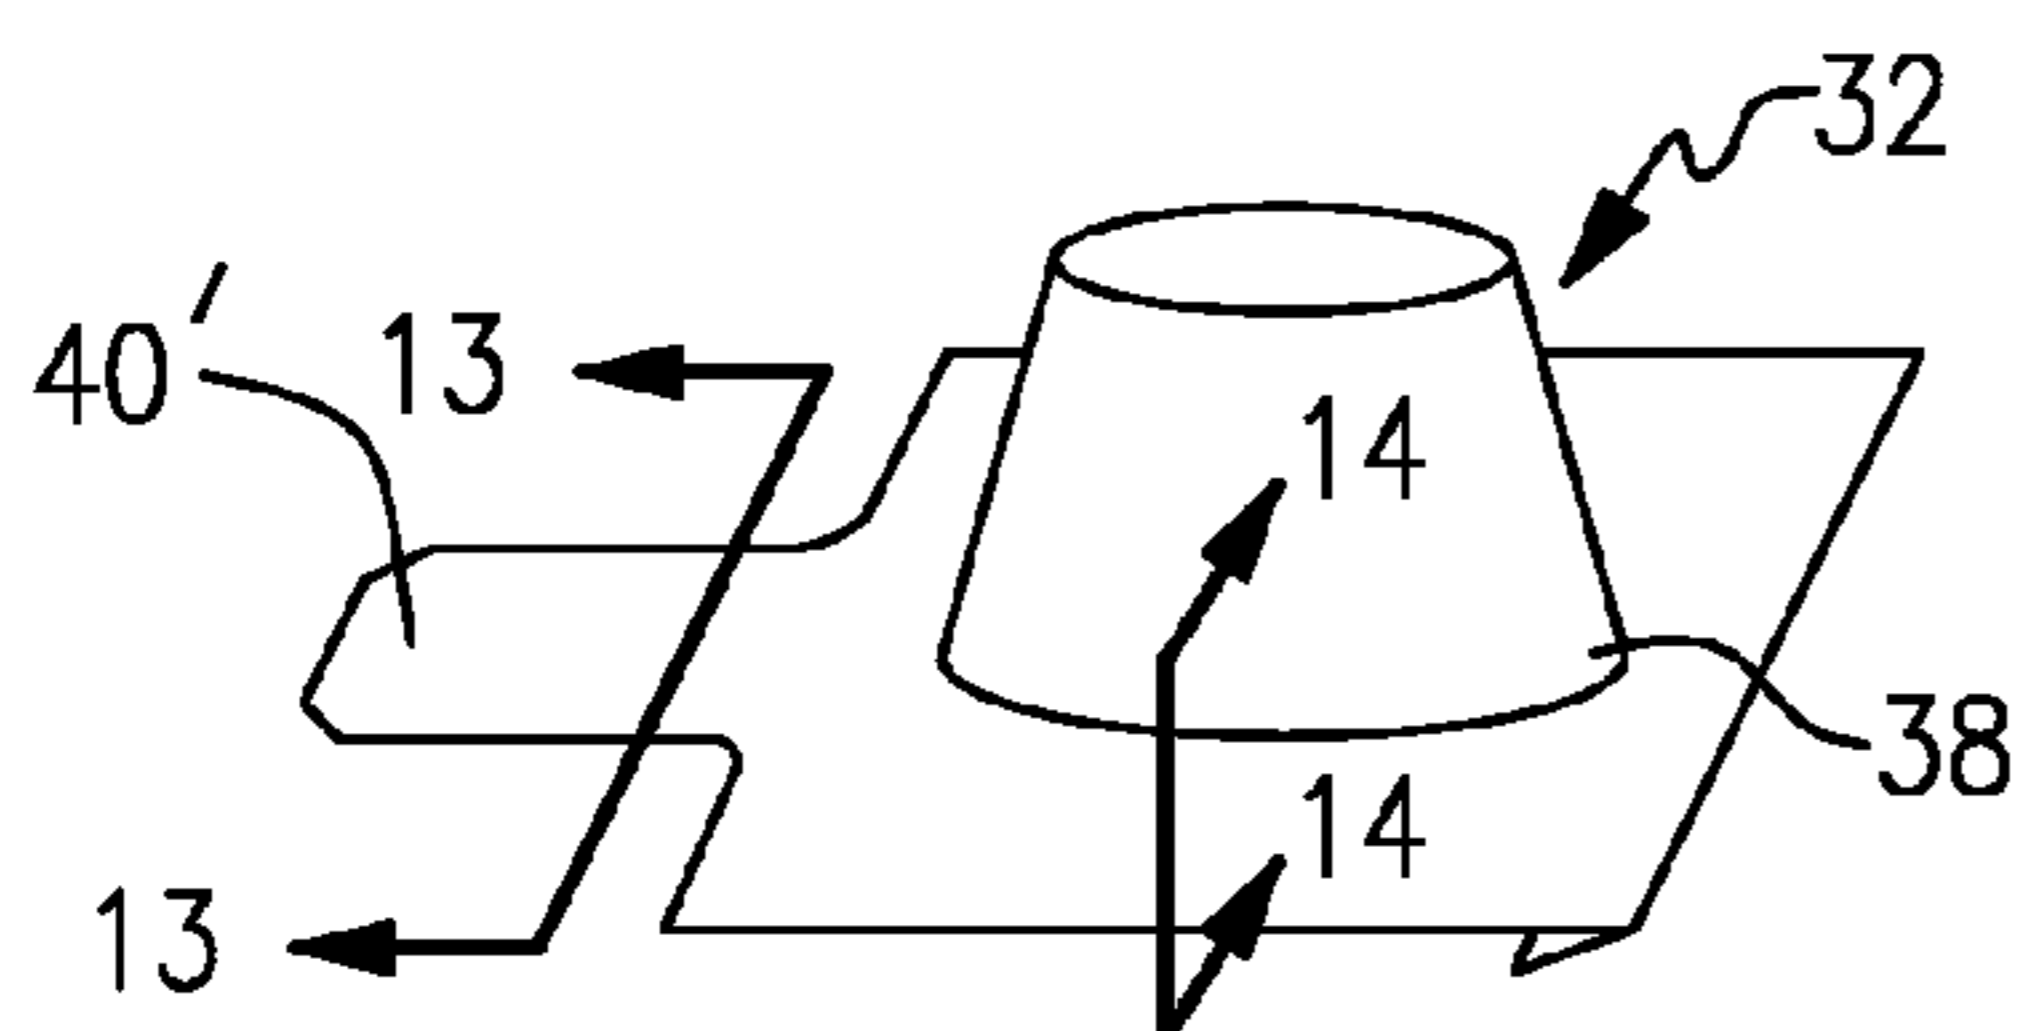
FIG. 11 is a perspective view of the fireshield fastener hood with a cover mounted thereon;

With Reference to FIG. 11, a cover **52** is formed to match the contour of the substrate **44**, hood **36** and platform **38** (Step **104**). The cover **52** may be formed over a rigid tool which is generally of the contour of the hood **36** and the platform **38**. It should be understood that a kit to perform the repair may include a preformed cover **52**. The cover **52** should cover the entire contoured hood surface with sufficient material to allow trim. Folds and wrinkles are permitted, but the cover **52** must not have any cracks or tears.

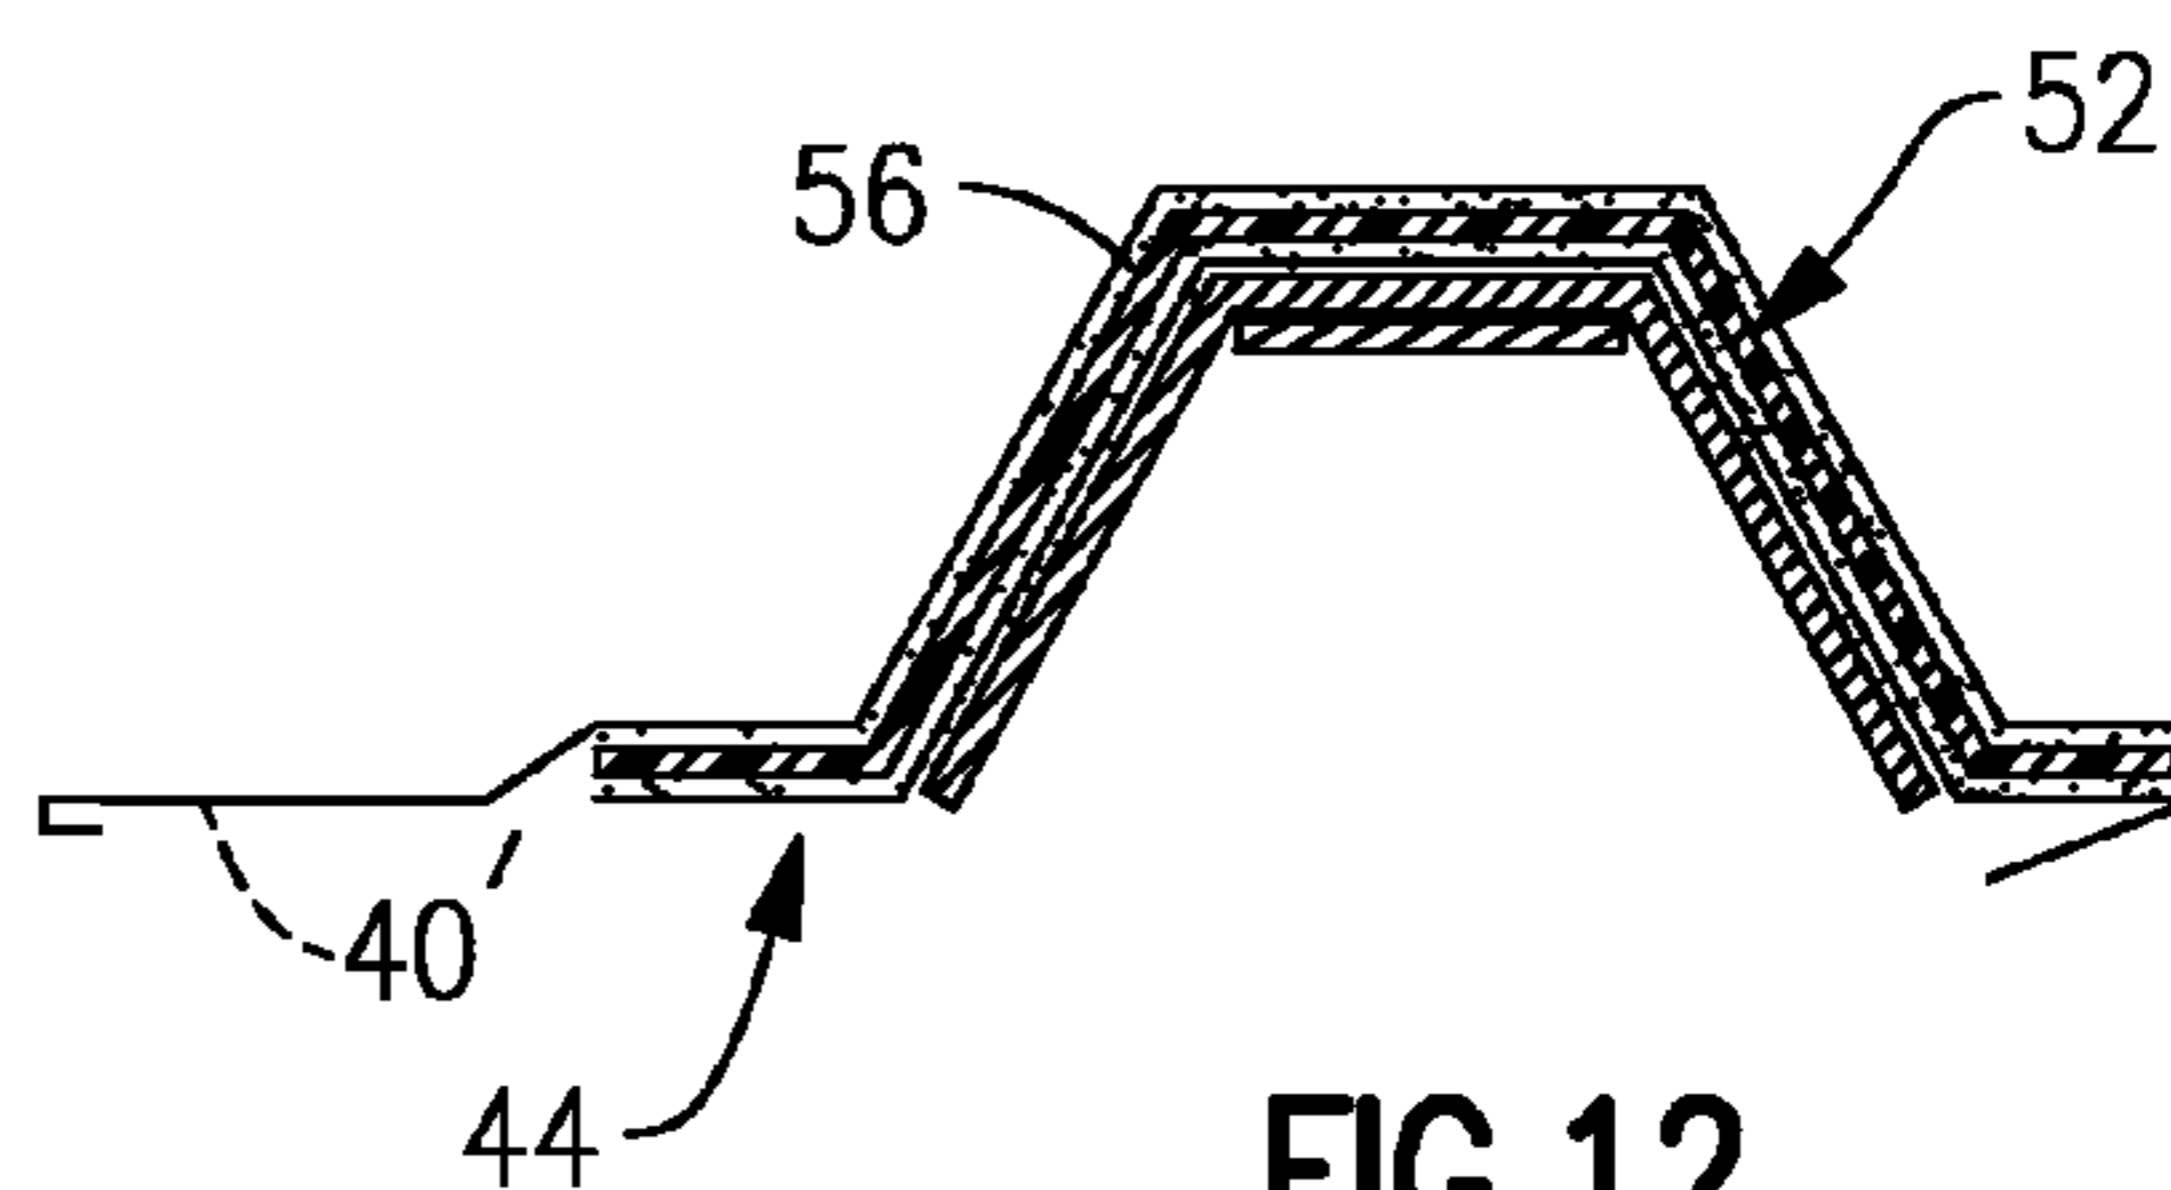
FIG. 12 is a sectional view of the fireshield fastener hood with a cover mounted thereon;

With reference to FIG. 12, in step **114**, a layer of sealant **56** is applied to the mating surface of the cover **52**, and the substrate **44**. The sealant **56** may be a thixotropic silicone paste firewall sealant such as DAPCO 18-4F manufactured by D Aircraft Products Inc. of California, USA.

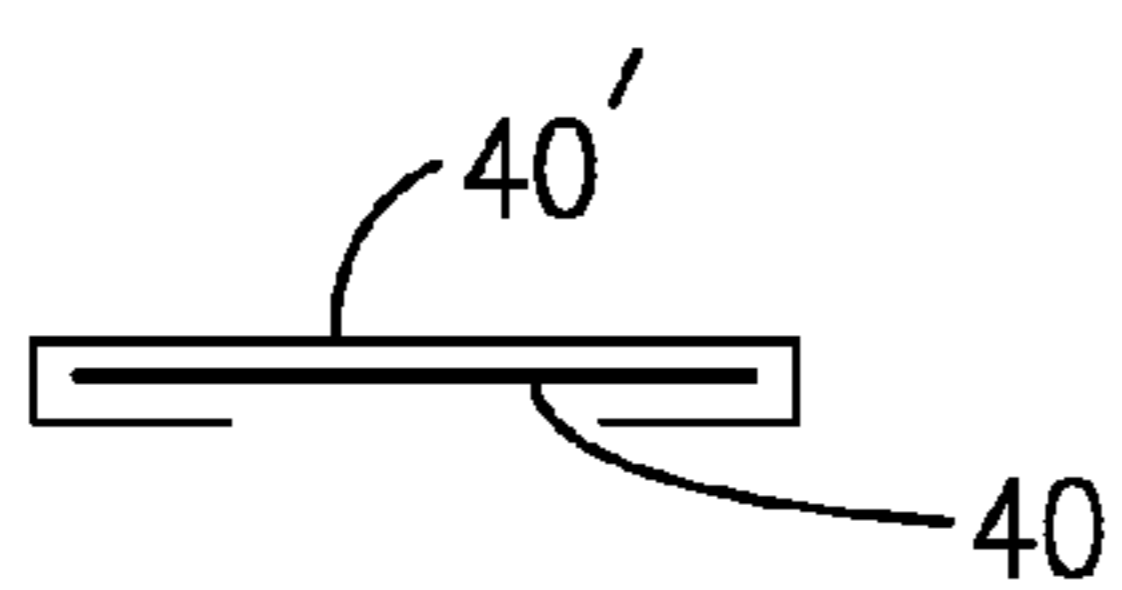
FIG. 13 is a sectional view of a replacement tab taken along line 13-13 in FIG. 11;

The cover **52** may be manufactured of an AISI 300 Series Stainless Steel alloy which is approximately the same thickness as the hood **32**. That is, the cover **52** may be manufactured from a similar material as the substrate **44**. The cover **52** may also form a replacement tab **40'**. That is, the cover **52** forms a double layer of material over the hood **36** and the platform **38** but a single layer to define the replacement tab **40'** as only a single layer thickness would fit within the retainer **50** (FIG. 12). The section of the cover **52** which forms the replacement tab **40'** should be doubled over a minimum of 0.08 inches (2 mm) along the length of the replacement tab **40** to increase the strength to the replacement tab **40'** (FIG. 13).

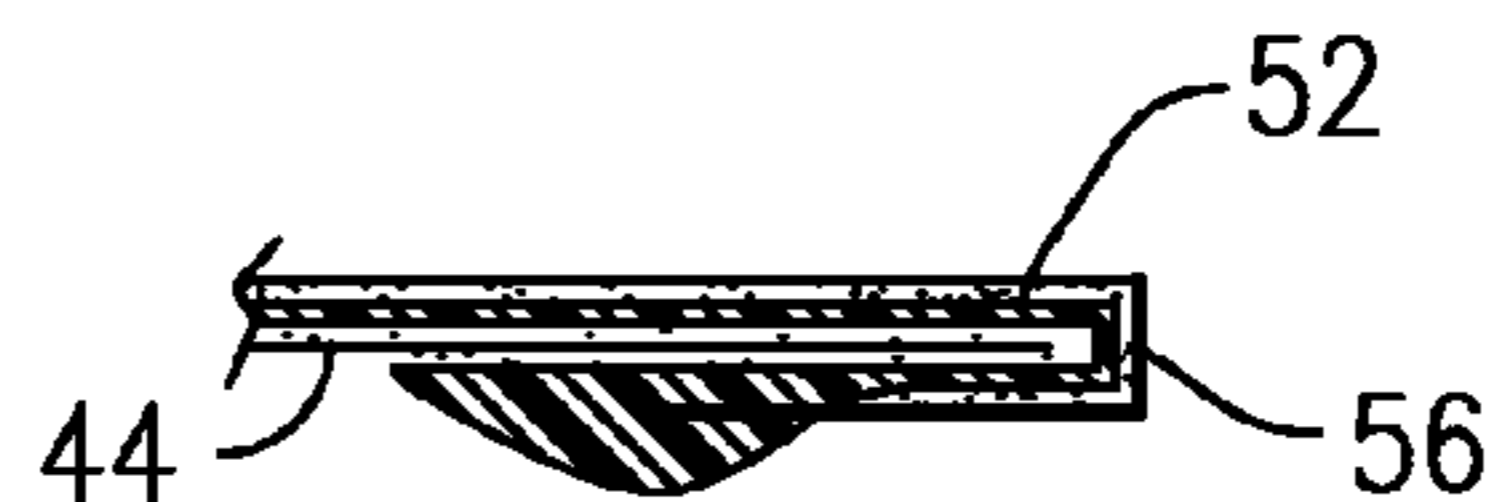
FIG. 14 is an edge view of the fireshield fastener hood with a cover along line 14-14 in FIG. 11; and

Step **108** of the repair includes trimming the cover **52** to cover the substrate except the hinge **42**. The trimming should include additional material to wrap around the edges. (FIG. 14). The cover **52** may be a maximum of 0.060 inches (10 mm) of the edge (FIG. 14). It is permissible to trim the replacement tab **40'** of the cover **52** to width and length after bonding.

In step **120**, the cover **52** is edge sealed (step **120**). Sealant squeeze out is required all around the cover **52** (FIG. 14). The cover **52** is wrapped around the edge to a minimum of 0.2 inches (5 mm) and edge sealed in the sealant **56** (FIG. 14). The perimeter is to be fully encapsulated.

In step **116**, the cover **52** is then pressed onto the layer of sealant **56** on the substrate **44**. The cover **52** is wrapped over the edges of the substrate **44** (FIG. 14). It is permissible to dart the cover **52** at the edges where the cover **52** extends beyond the hood **36** before the edges are folded over the platform **38**. A Radius of 0.06-0.25 inches (1.5-6.35 mm) may be formed between the platform **38** and the replacement tab **40'** (FIG. 15). The radius also minimizes stress concentrations.

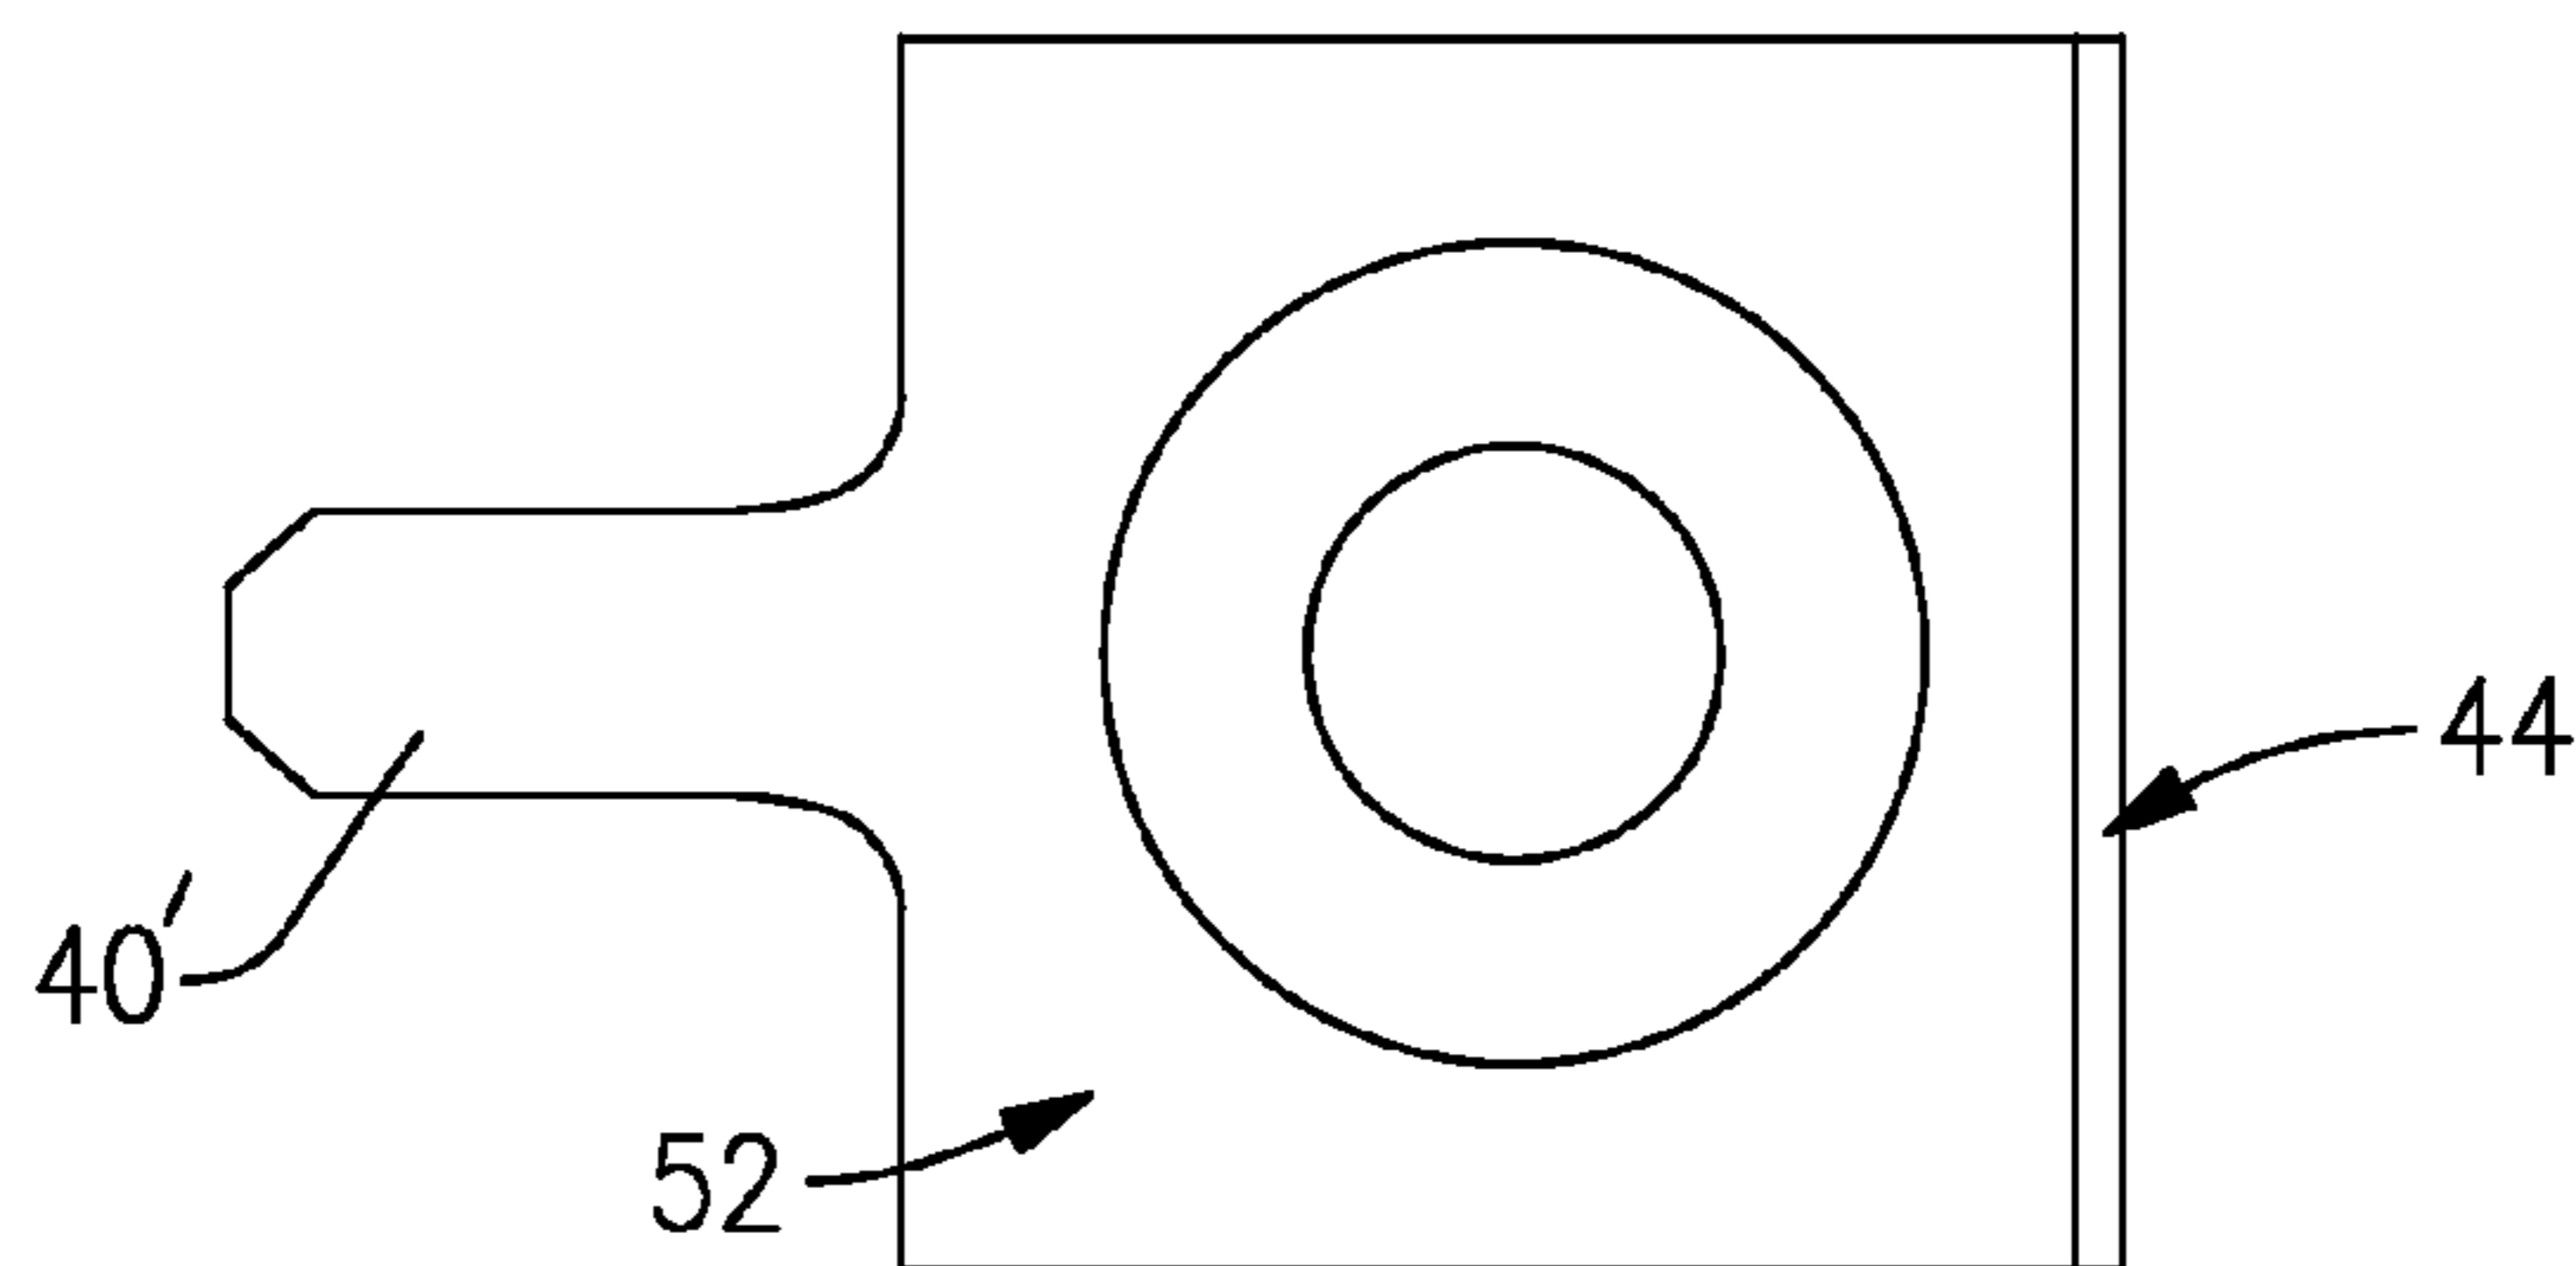
FIG. 15 is a top view of the fireshield fastener hood with the cover.
