(10) **Patent No.:** **US D632,634 S**

(54) **VEHICLE RACK**

(73) Assignee: **Softride, Inc.**, Bellingham, WA (US)

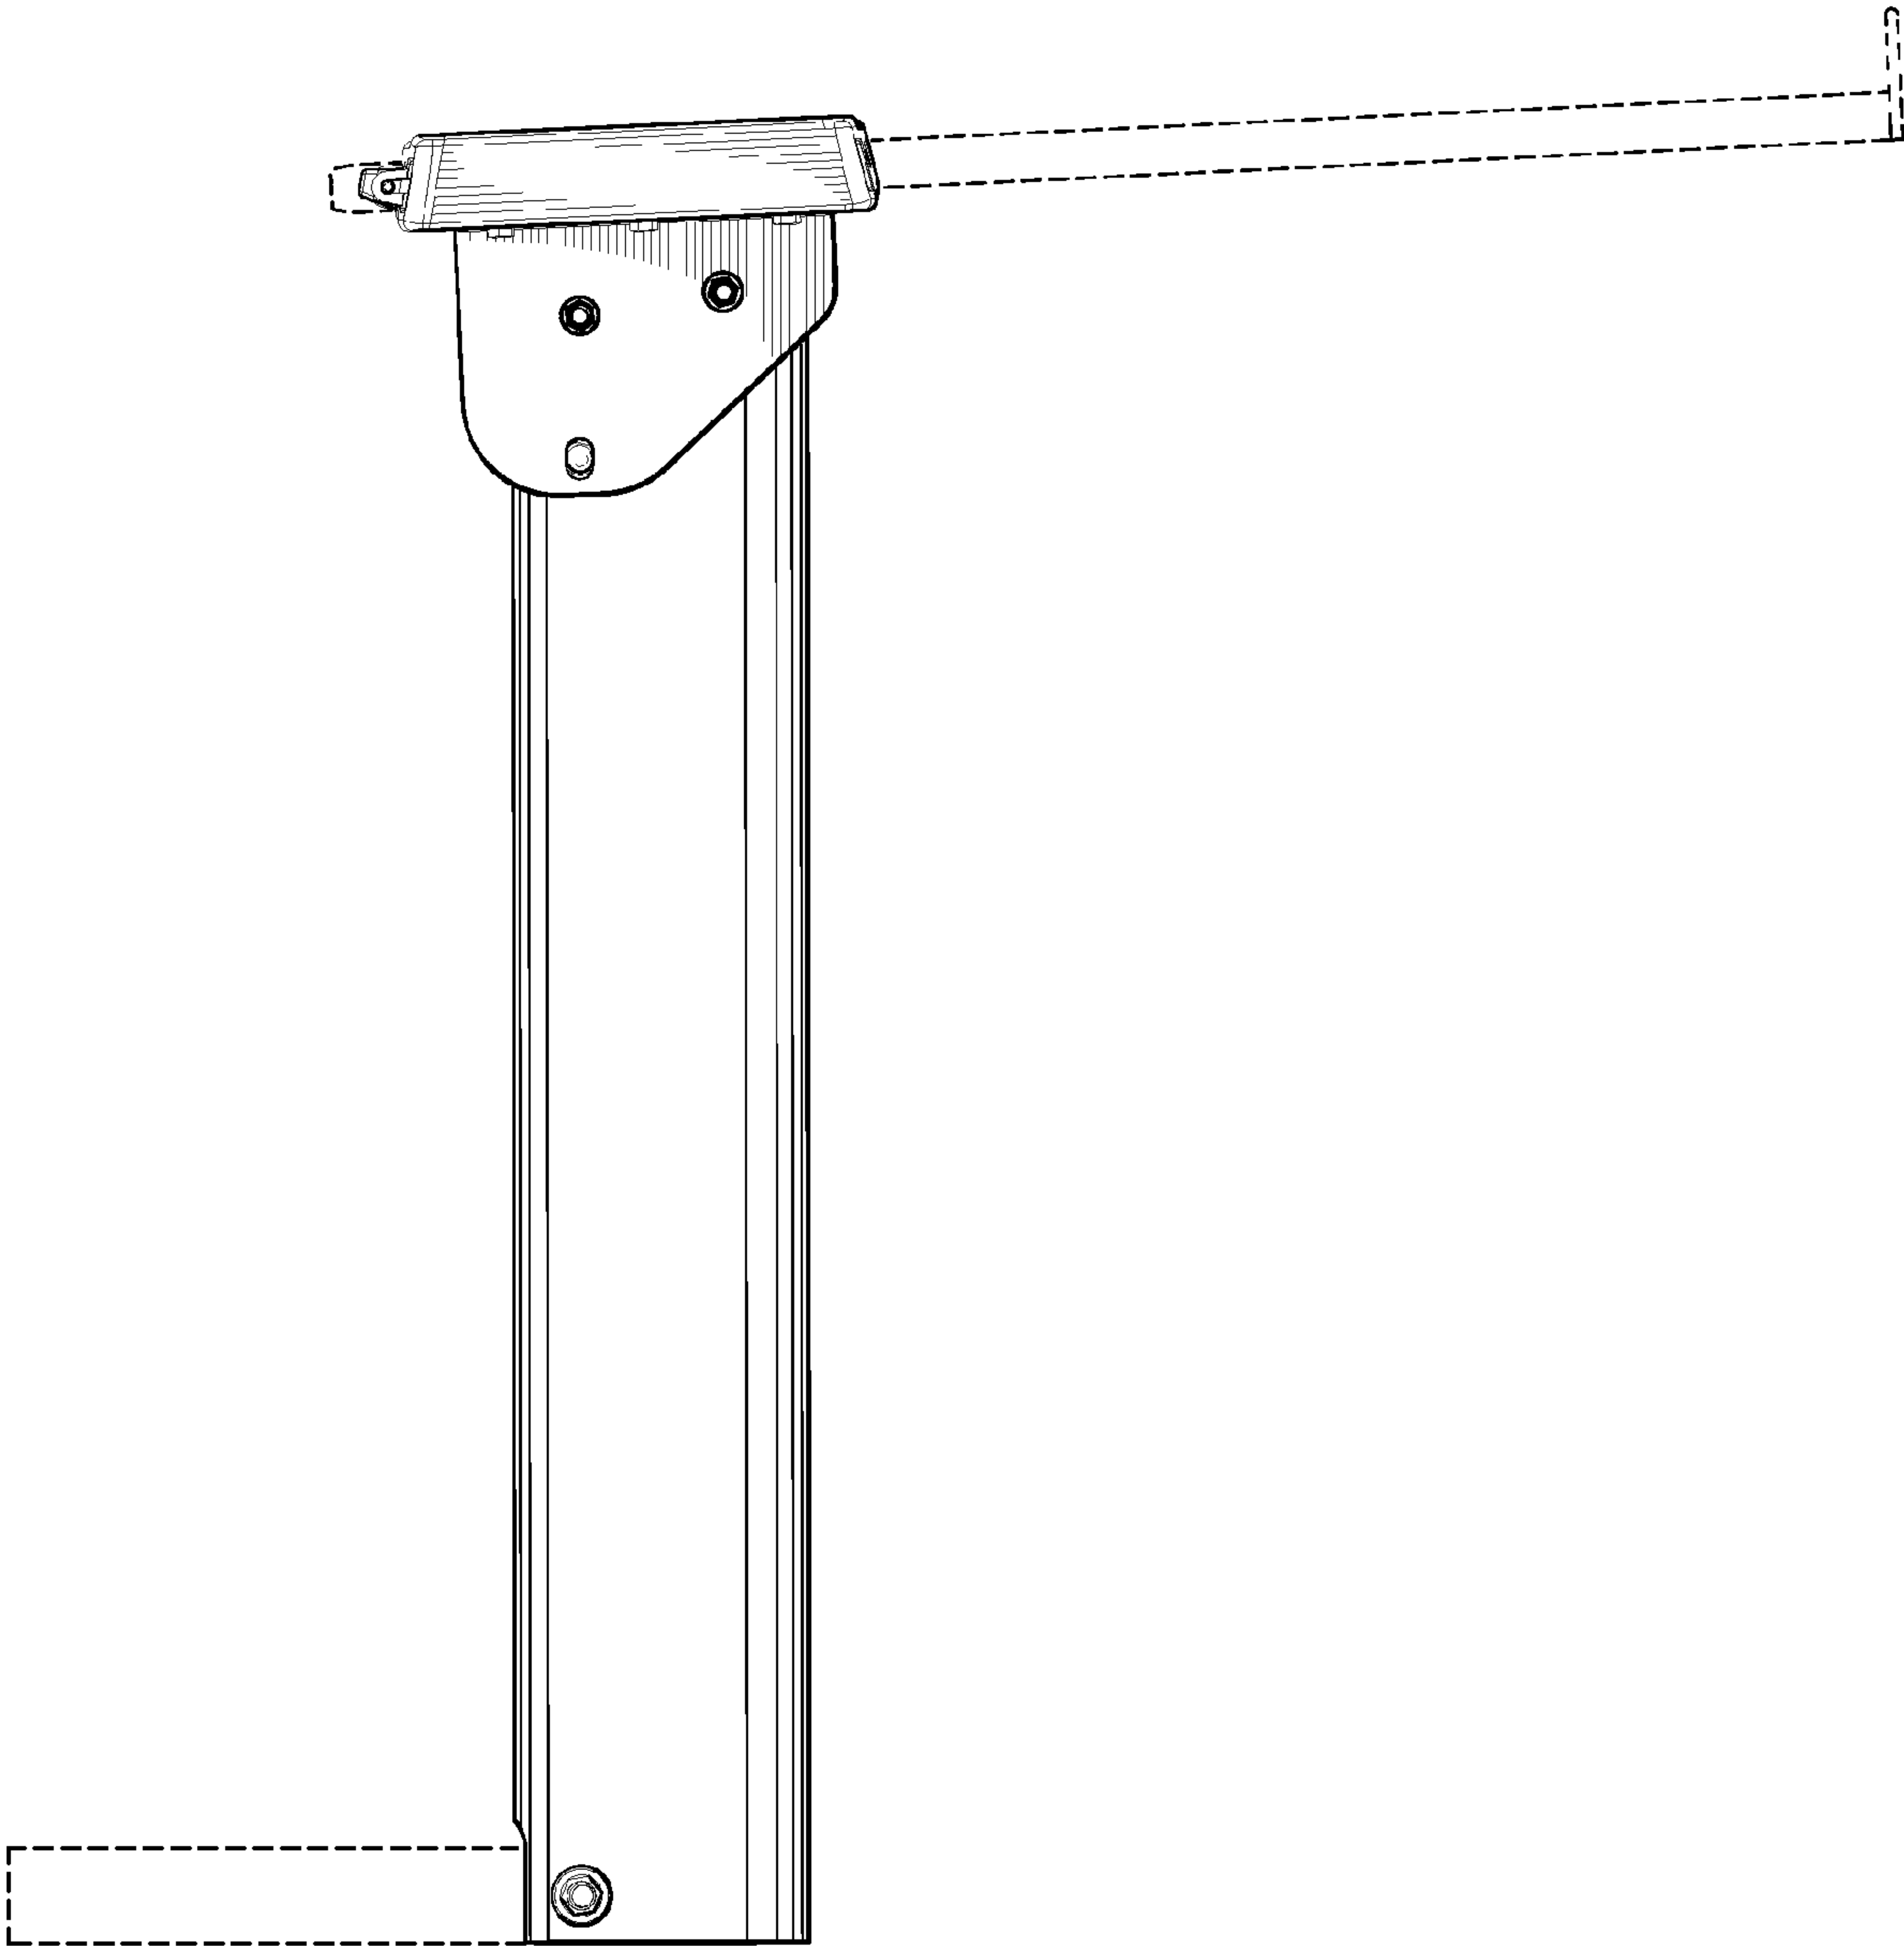
*Fig. 1.*

FIG. 1 is a right side elevation view of the vehicle rack showing our new invention;

In the drawings, the broken line showing of a hitch mount tube and support arms depicts environmental subject matter and forms no part of the claim.

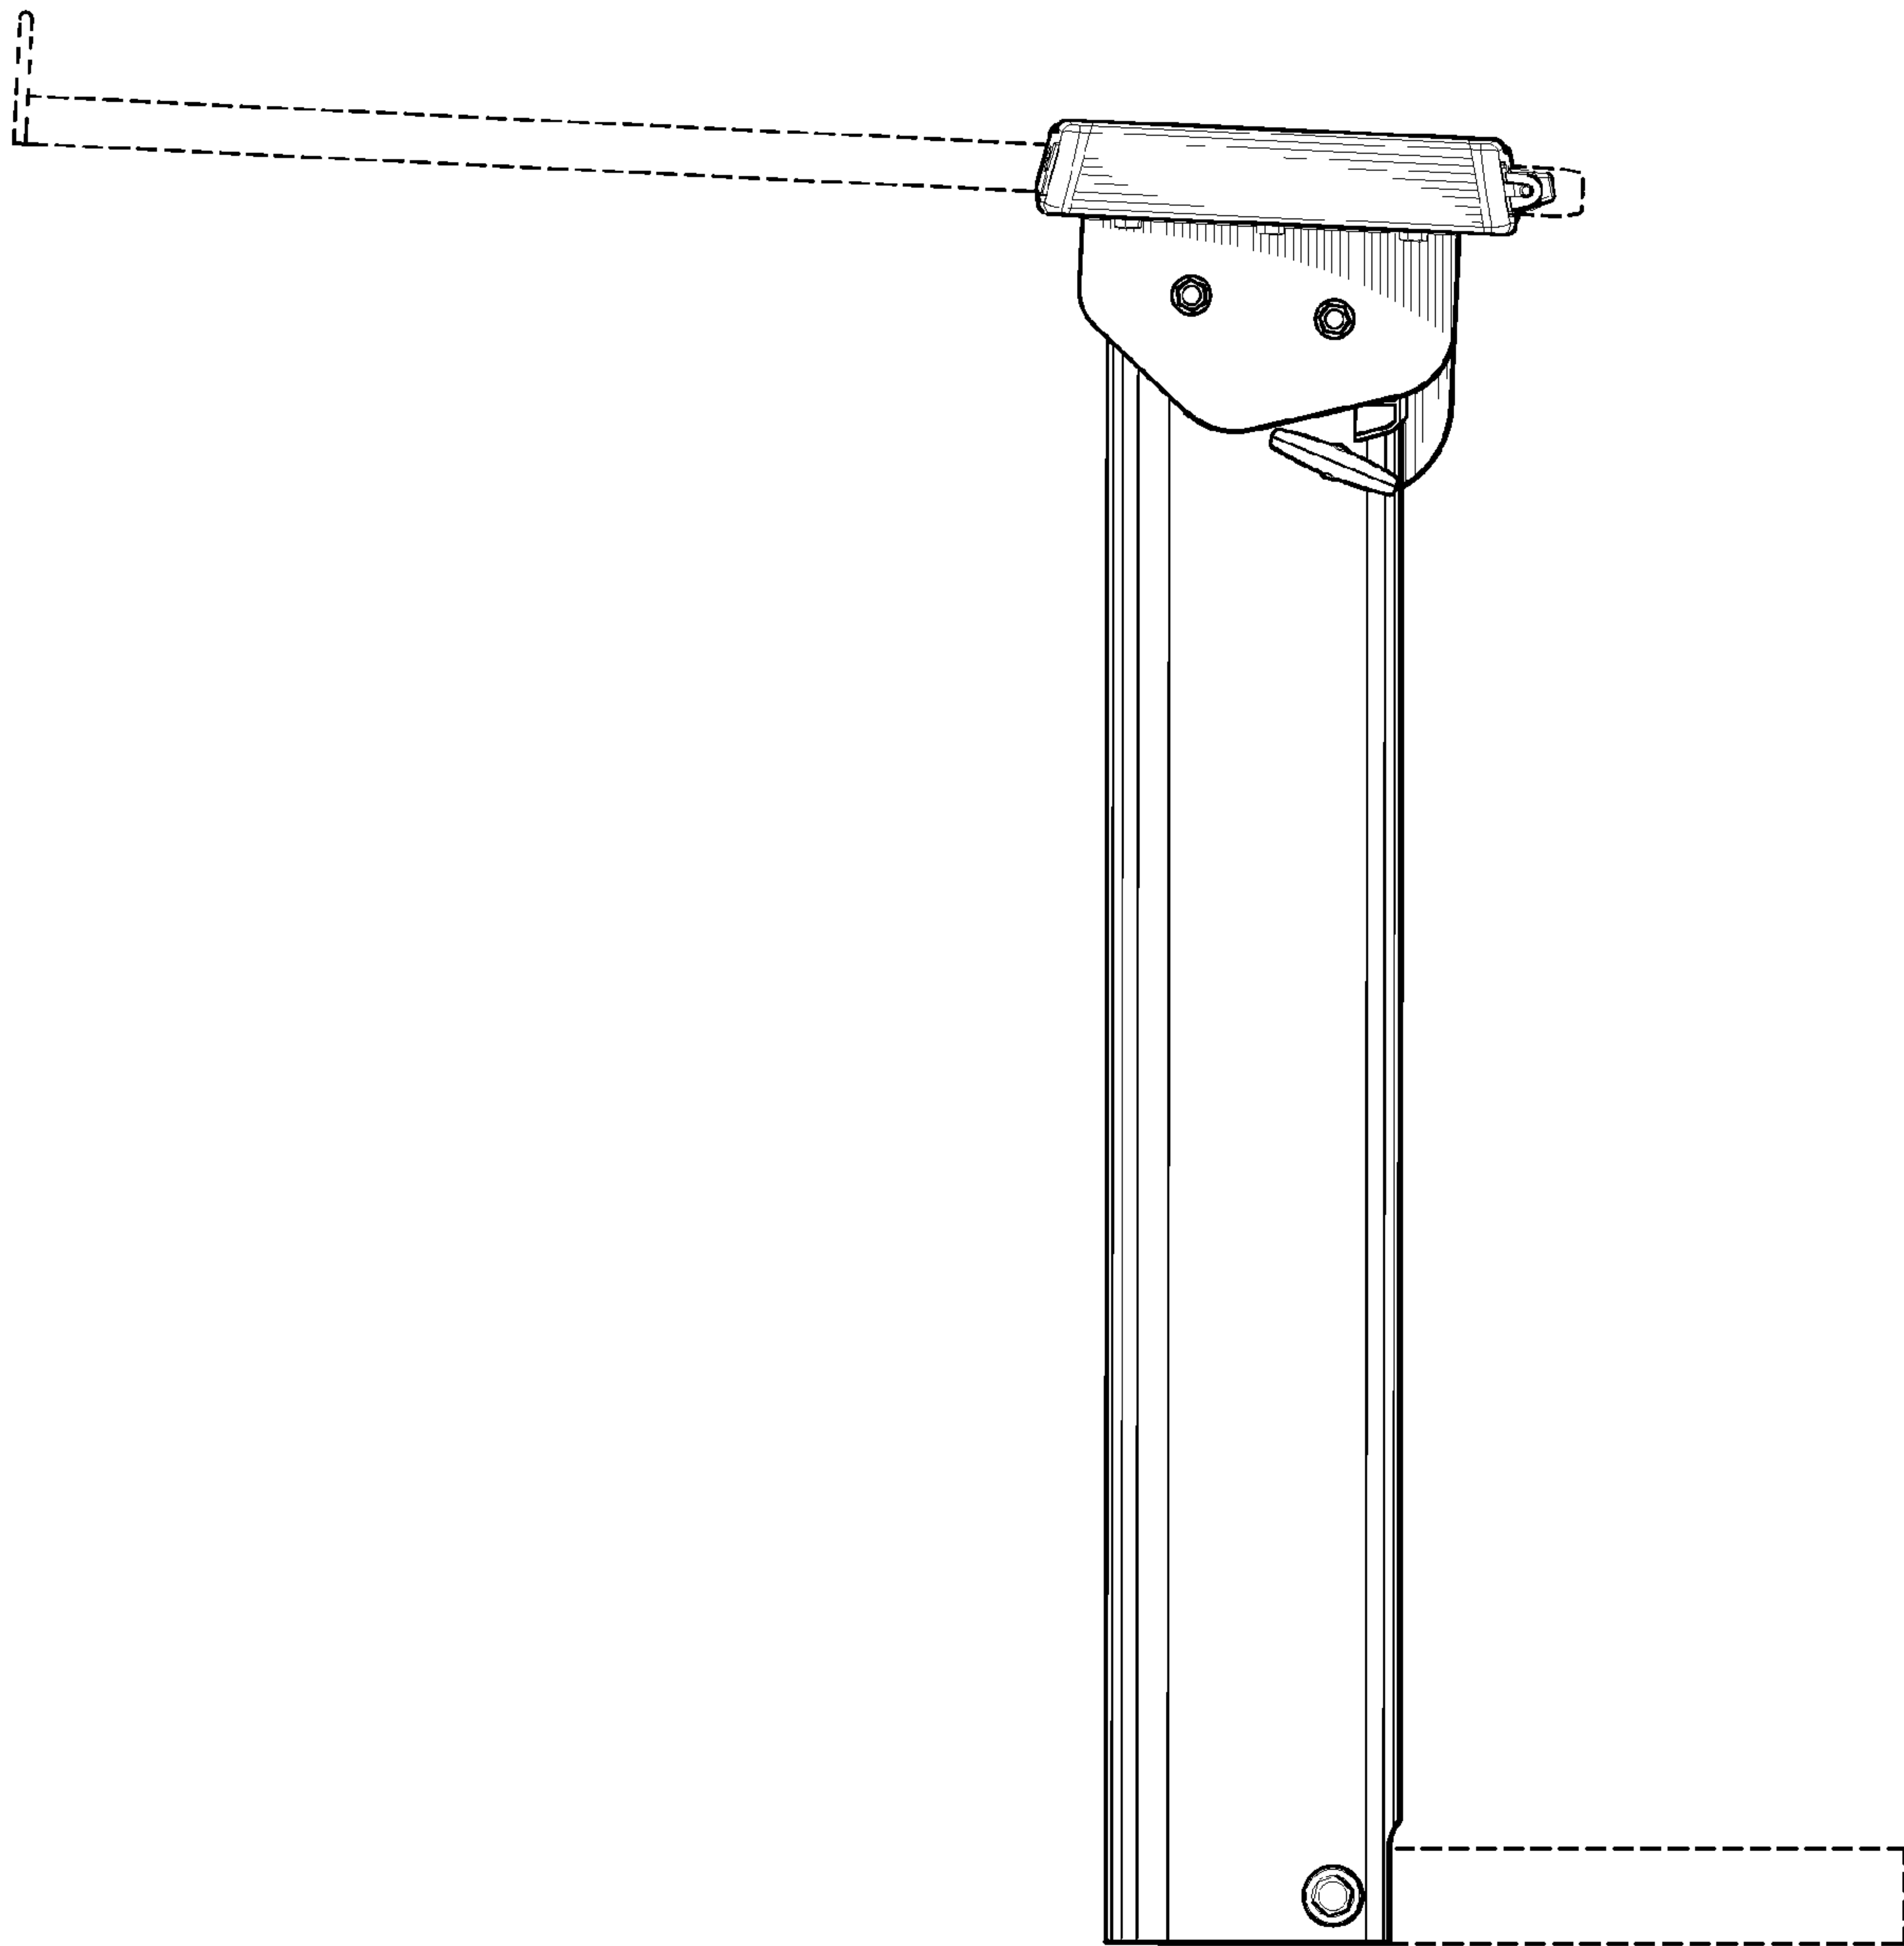
*Fig. 2.*

FIG. 2 is a left side elevation view of the vehicle rack of FIG. 1;

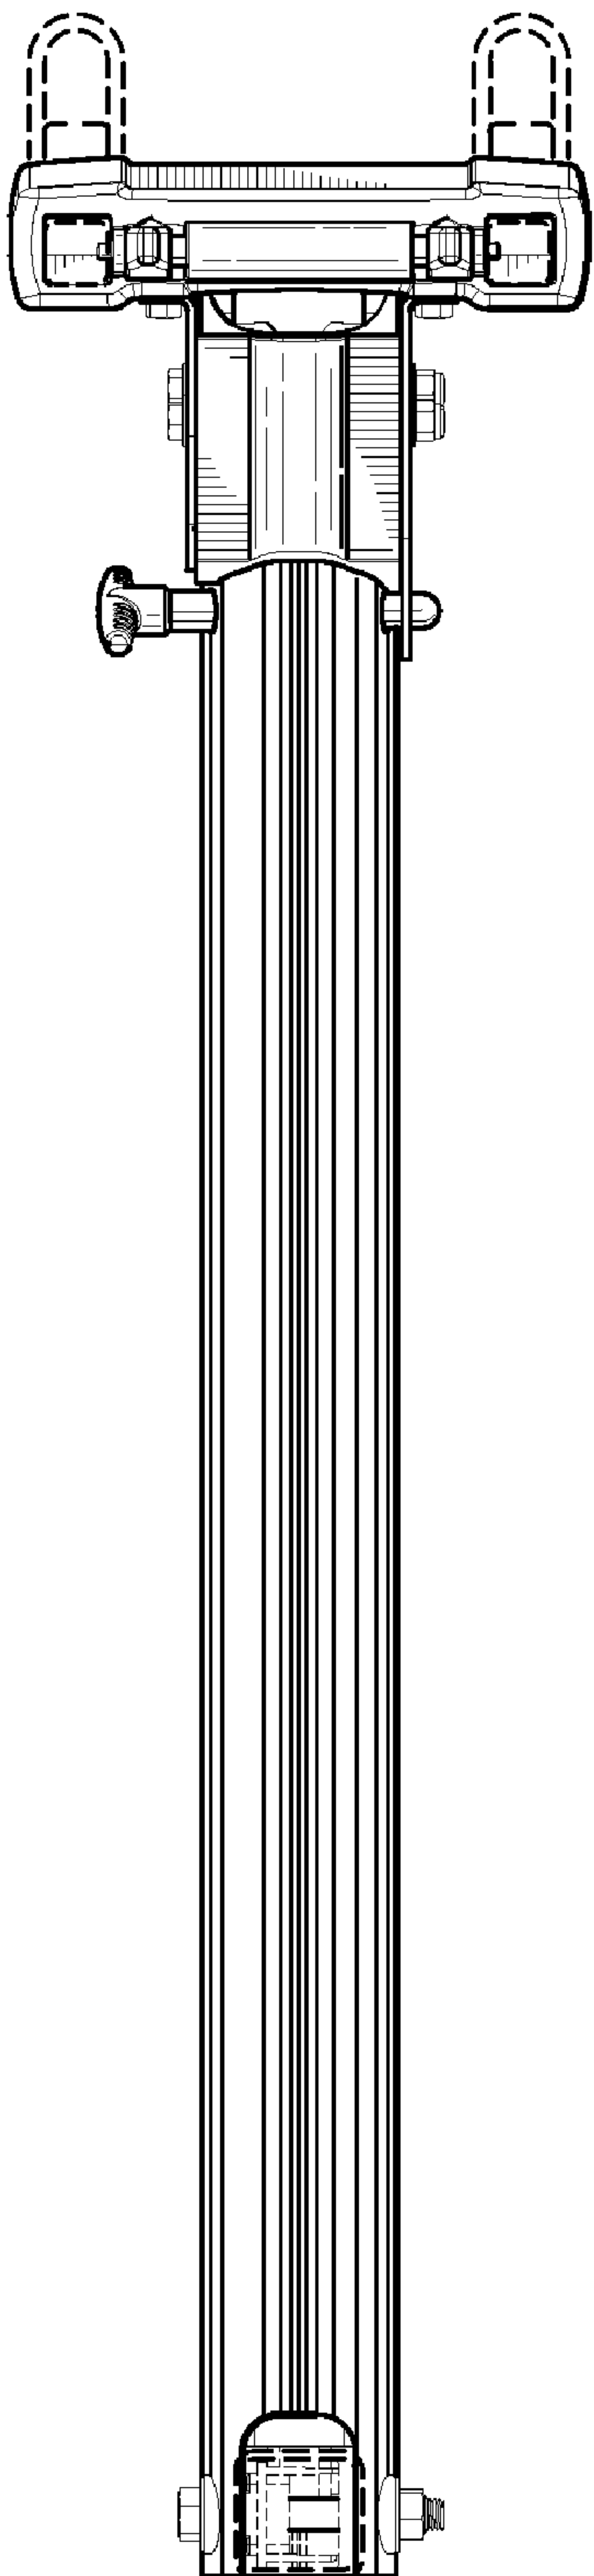
*Fig.3.*

FIG. 3 is a front elevation view of the vehicle rack of FIG. 1;

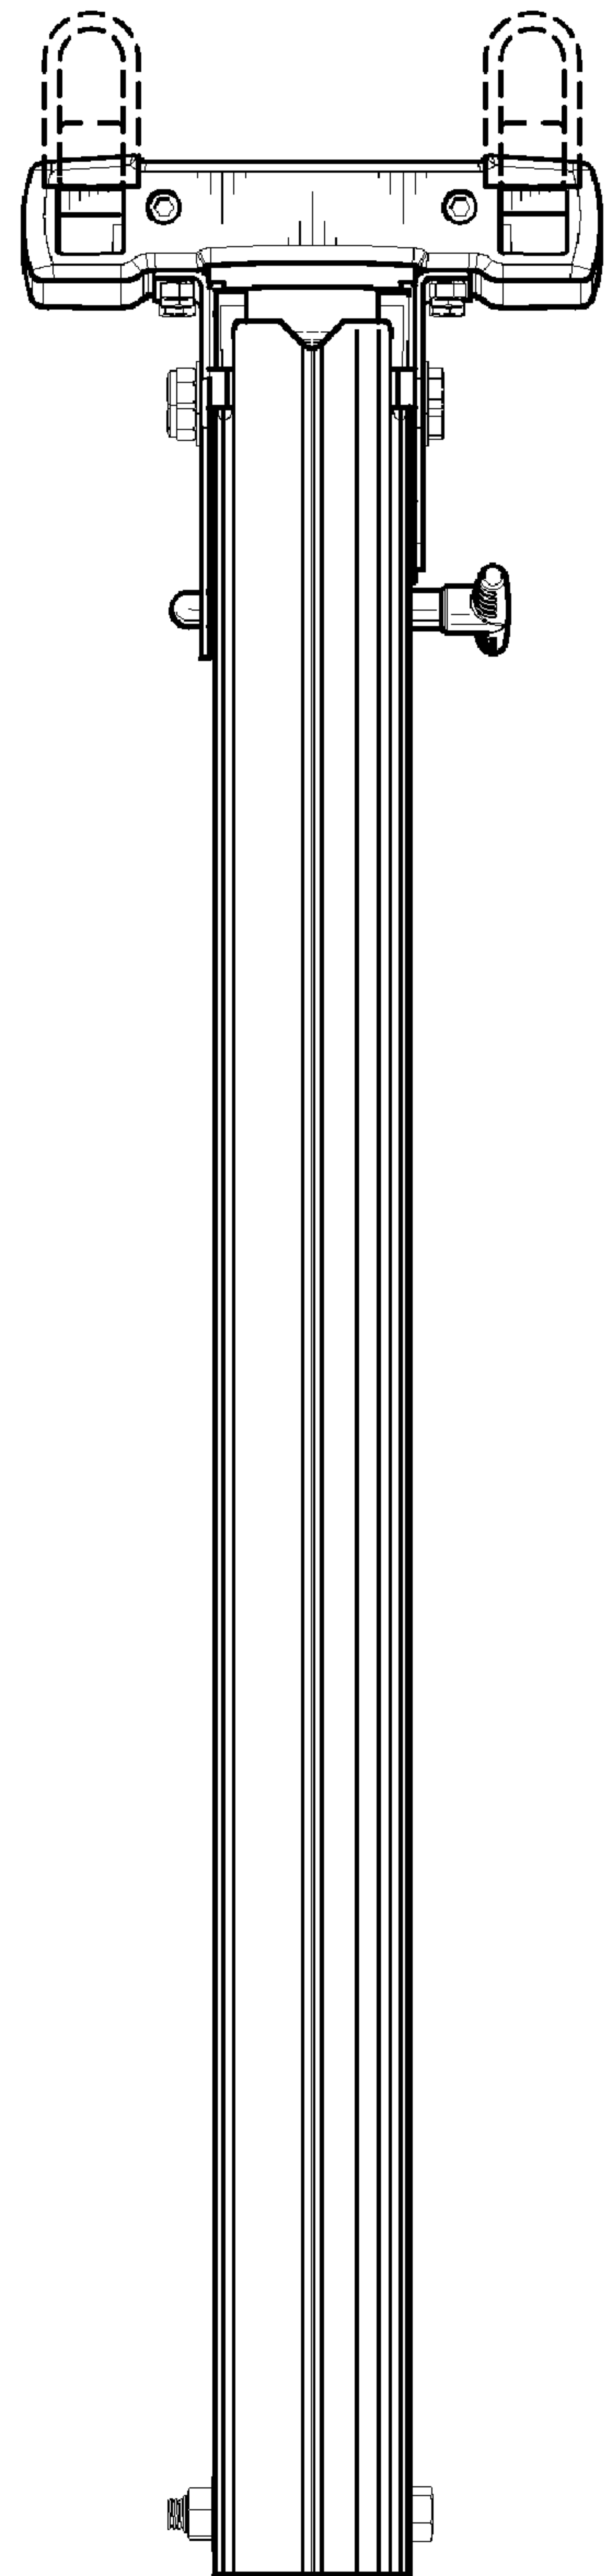
*Fig.4.*

FIG. 4 is a rear elevation view of the vehicle rack of FIG. 1;

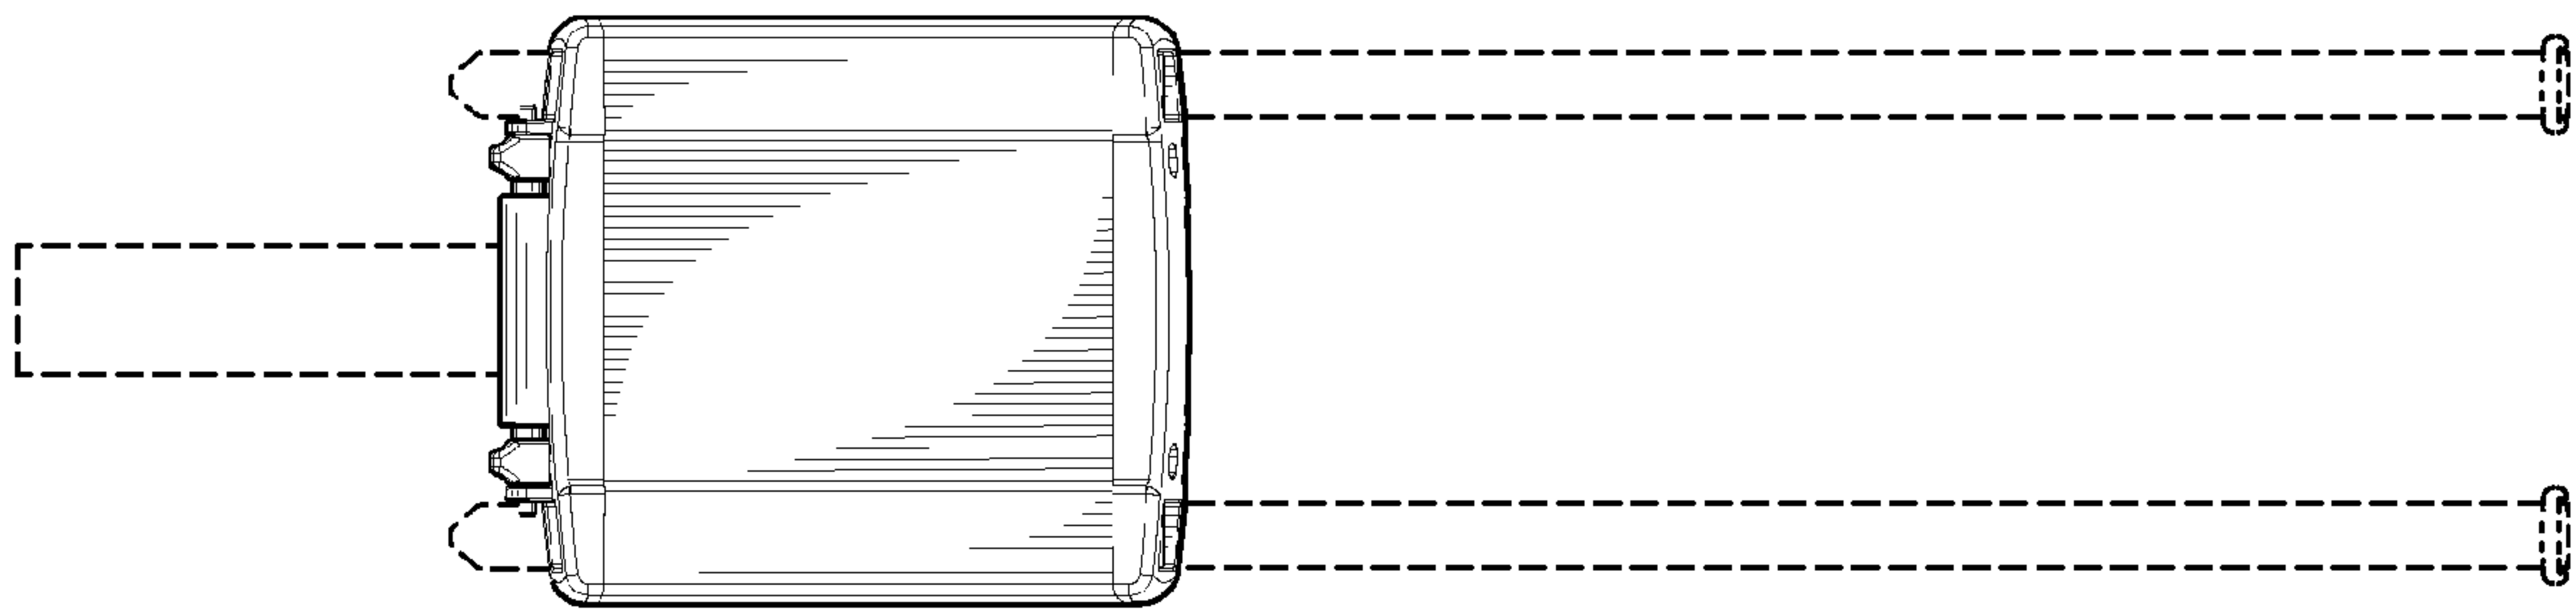
*Fig. 5.*

FIG. 5 is a top plan view of the vehicle rack of FIG. 1; and,

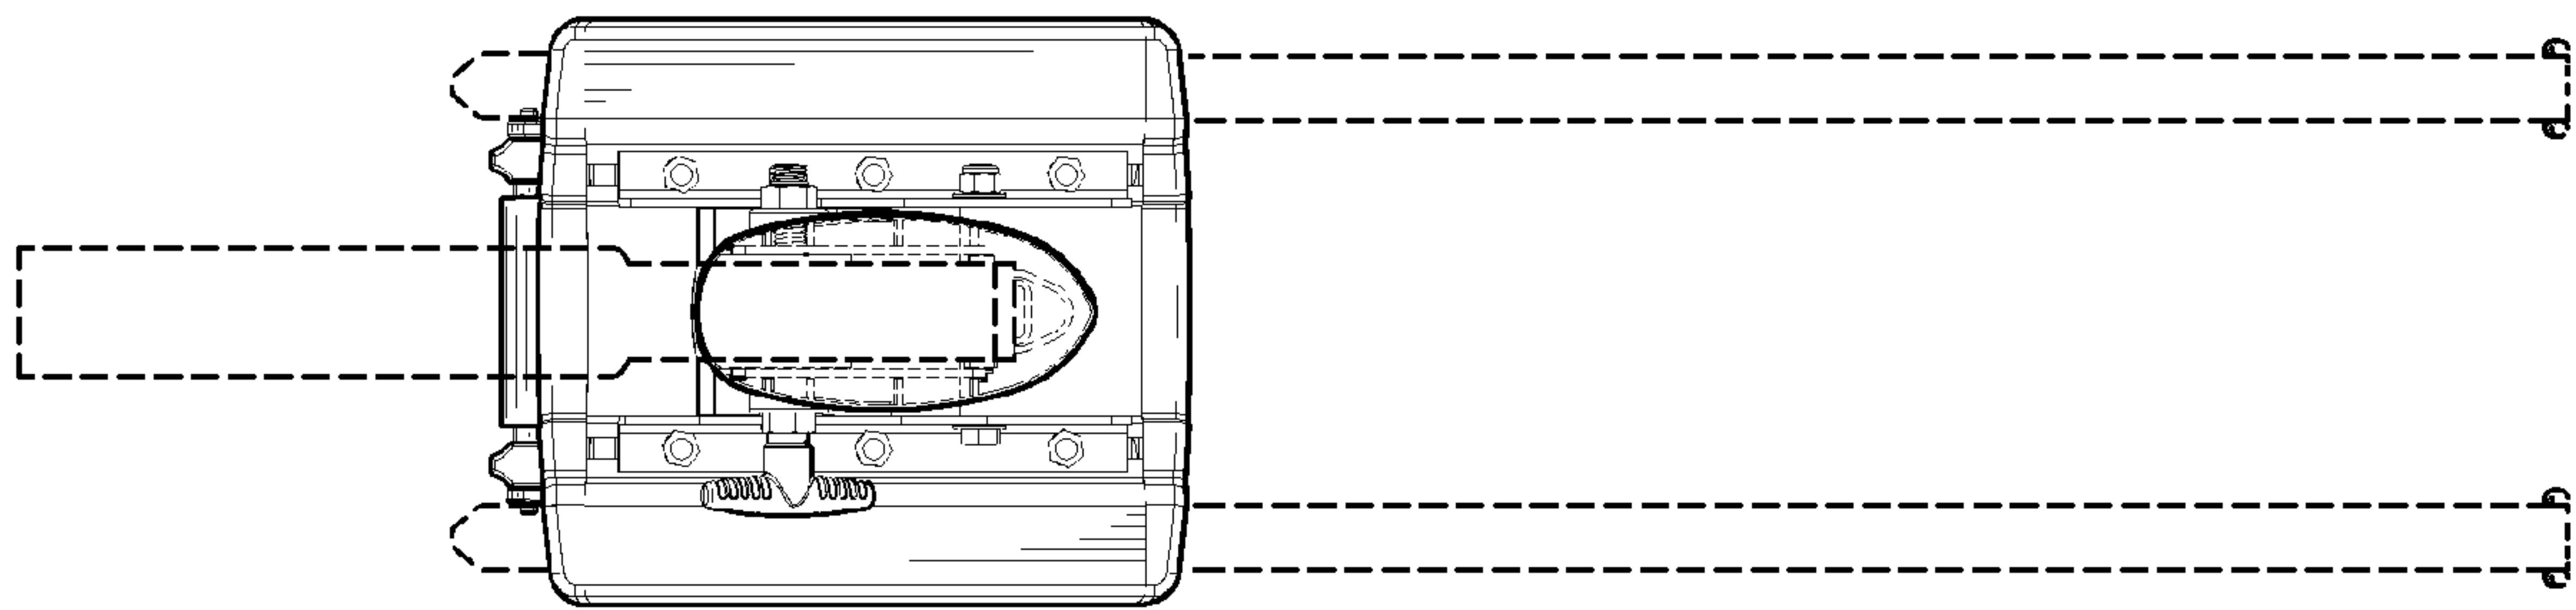
*Fig. 6.*

FIG. 6 is a bottom plan view of the vehicle rack of FIG. 1.
