(10) **Patent No.:** **US D705,908 S**  
(45) **Date of Patent:** **\*\* May 27, 2014**

(54) **AIRPLANE LAVATORY**

(71) Applicant: **The Yokohama Rubber Co., Ltd.**,  
Tokyo (JP)

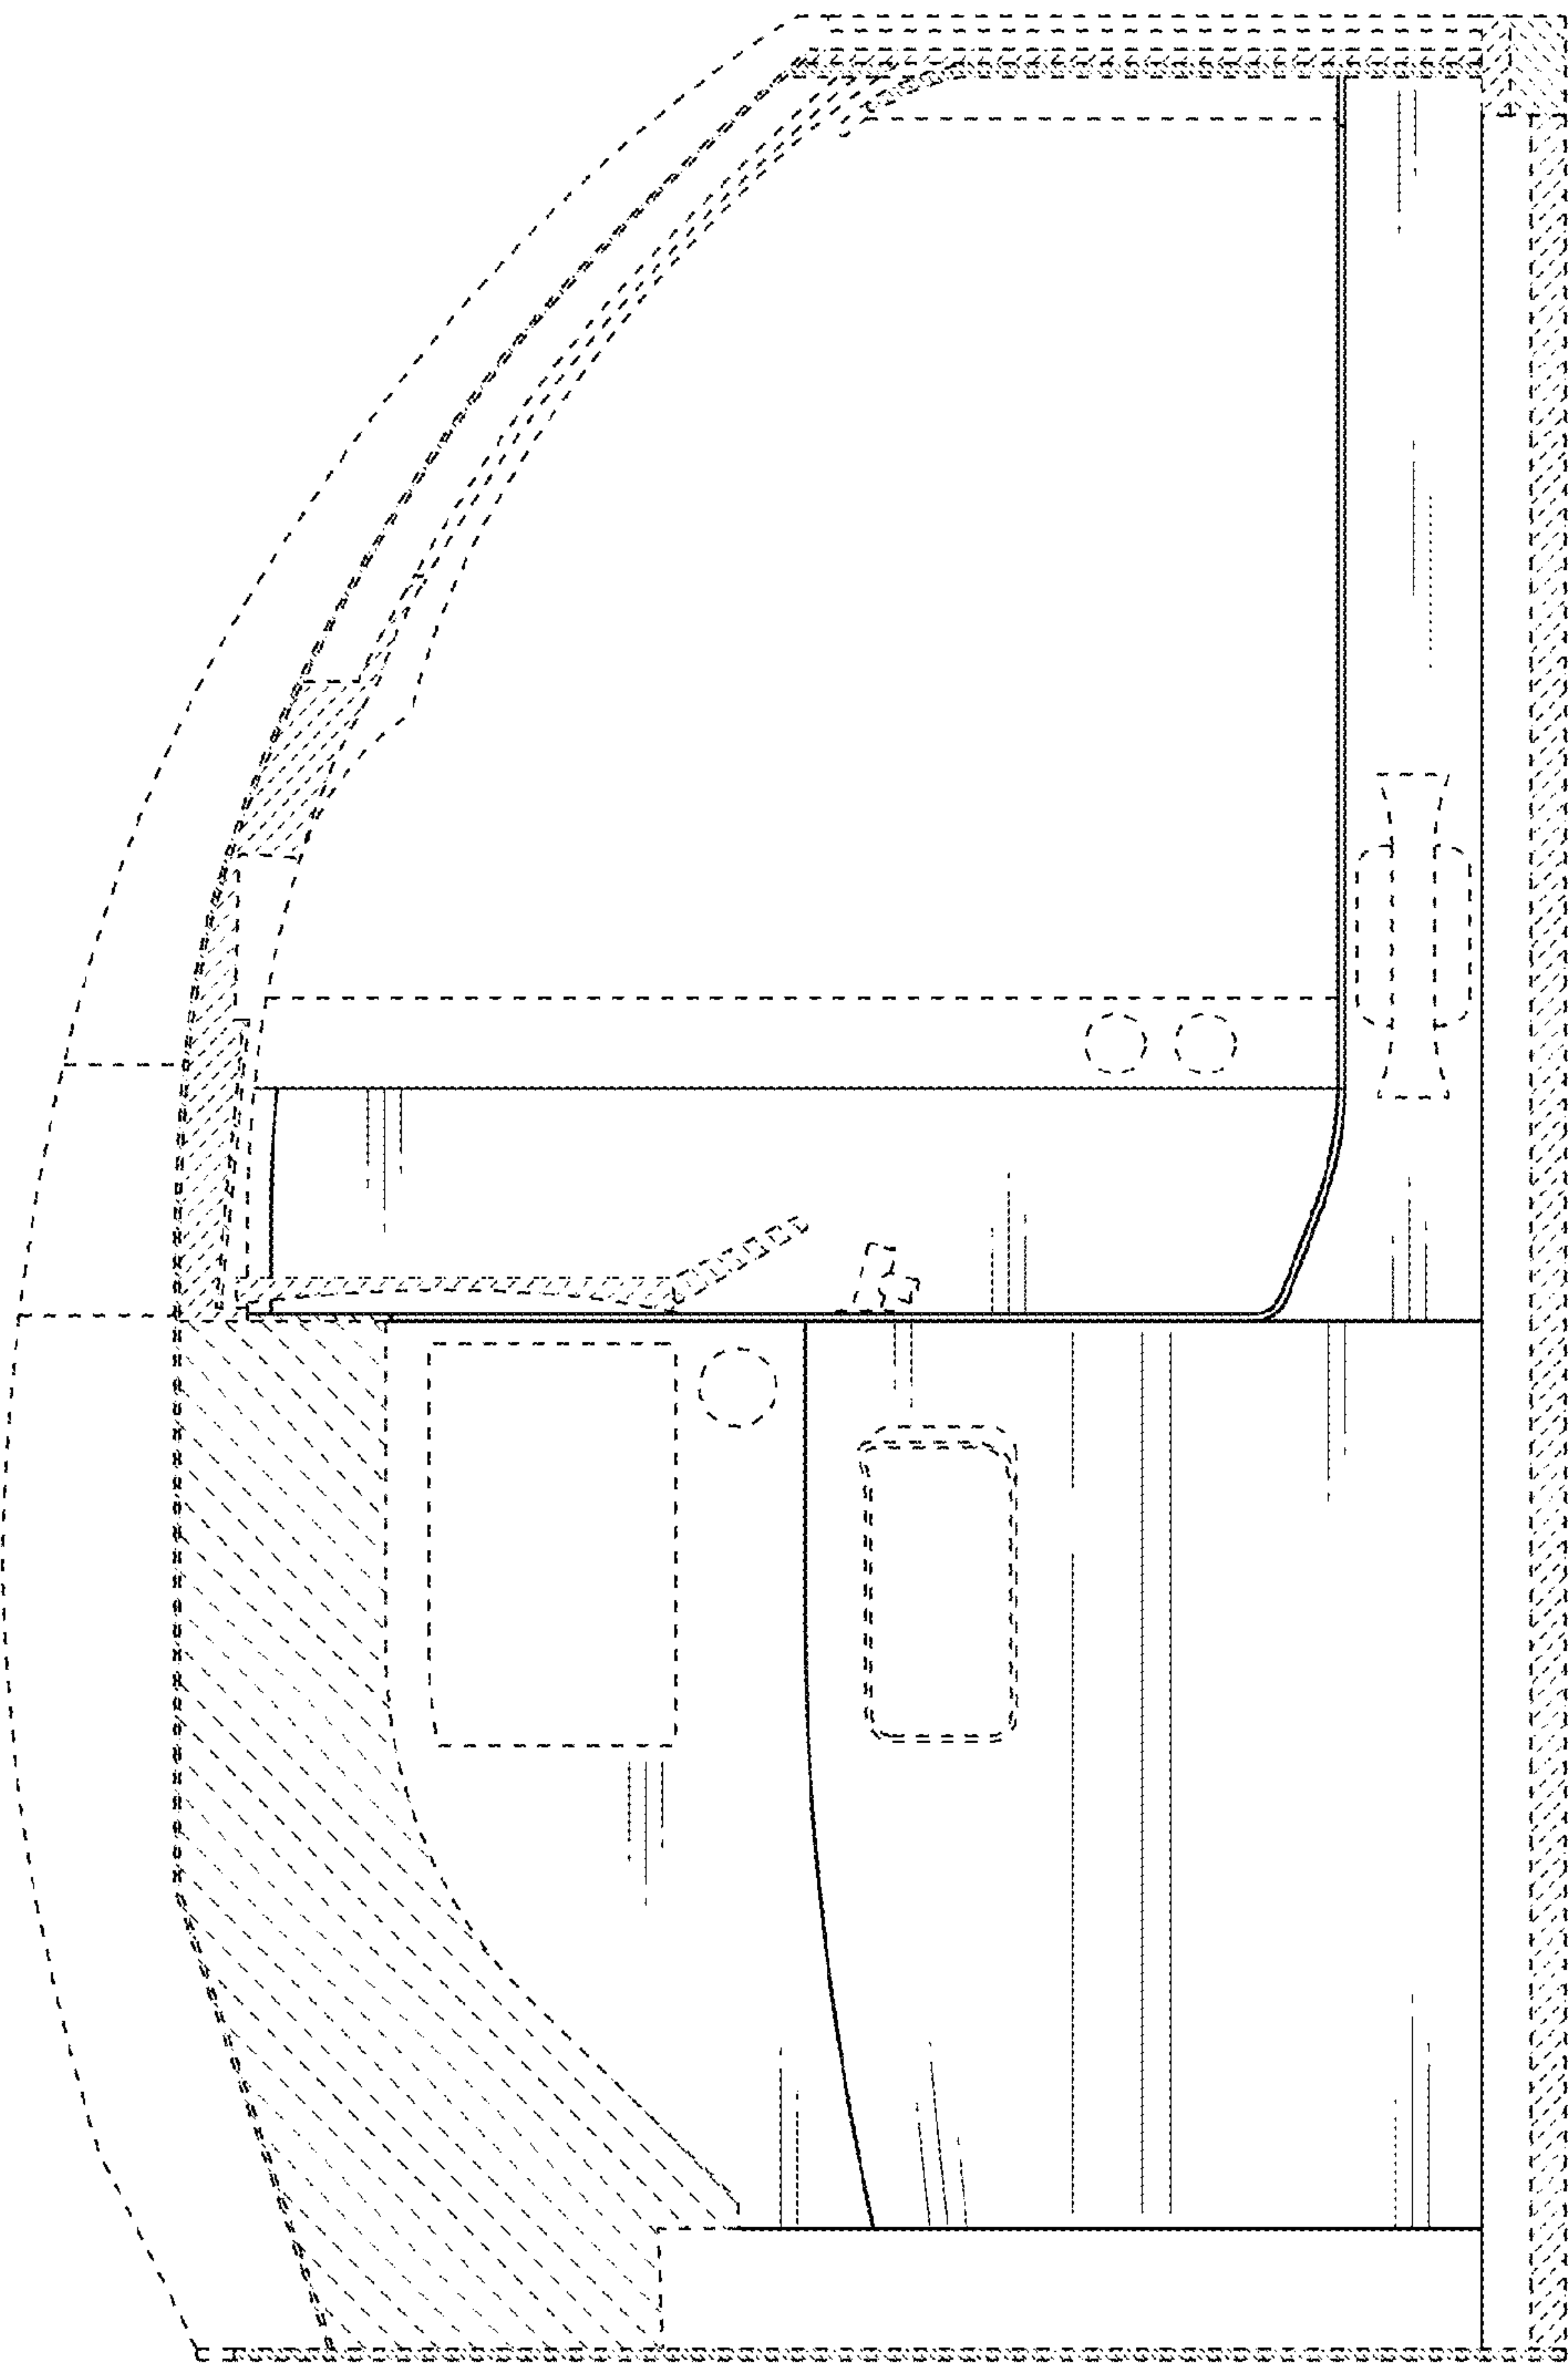
Fig. 14

FIG. 14 is a sectional view taken along lines 11-11 shown in FIG. 6 in a state where a folding shelf is unfolded.
