(54) TURBINE DISK FATIGUE REJUVENATION

A process for rejuvenating a turbine disk having a plurality of slots includes the steps of determining a depth of a damaged layer containing M23C6 carbide dissolution; and removing the damaged layer from the slots in accordance with the determined depth.

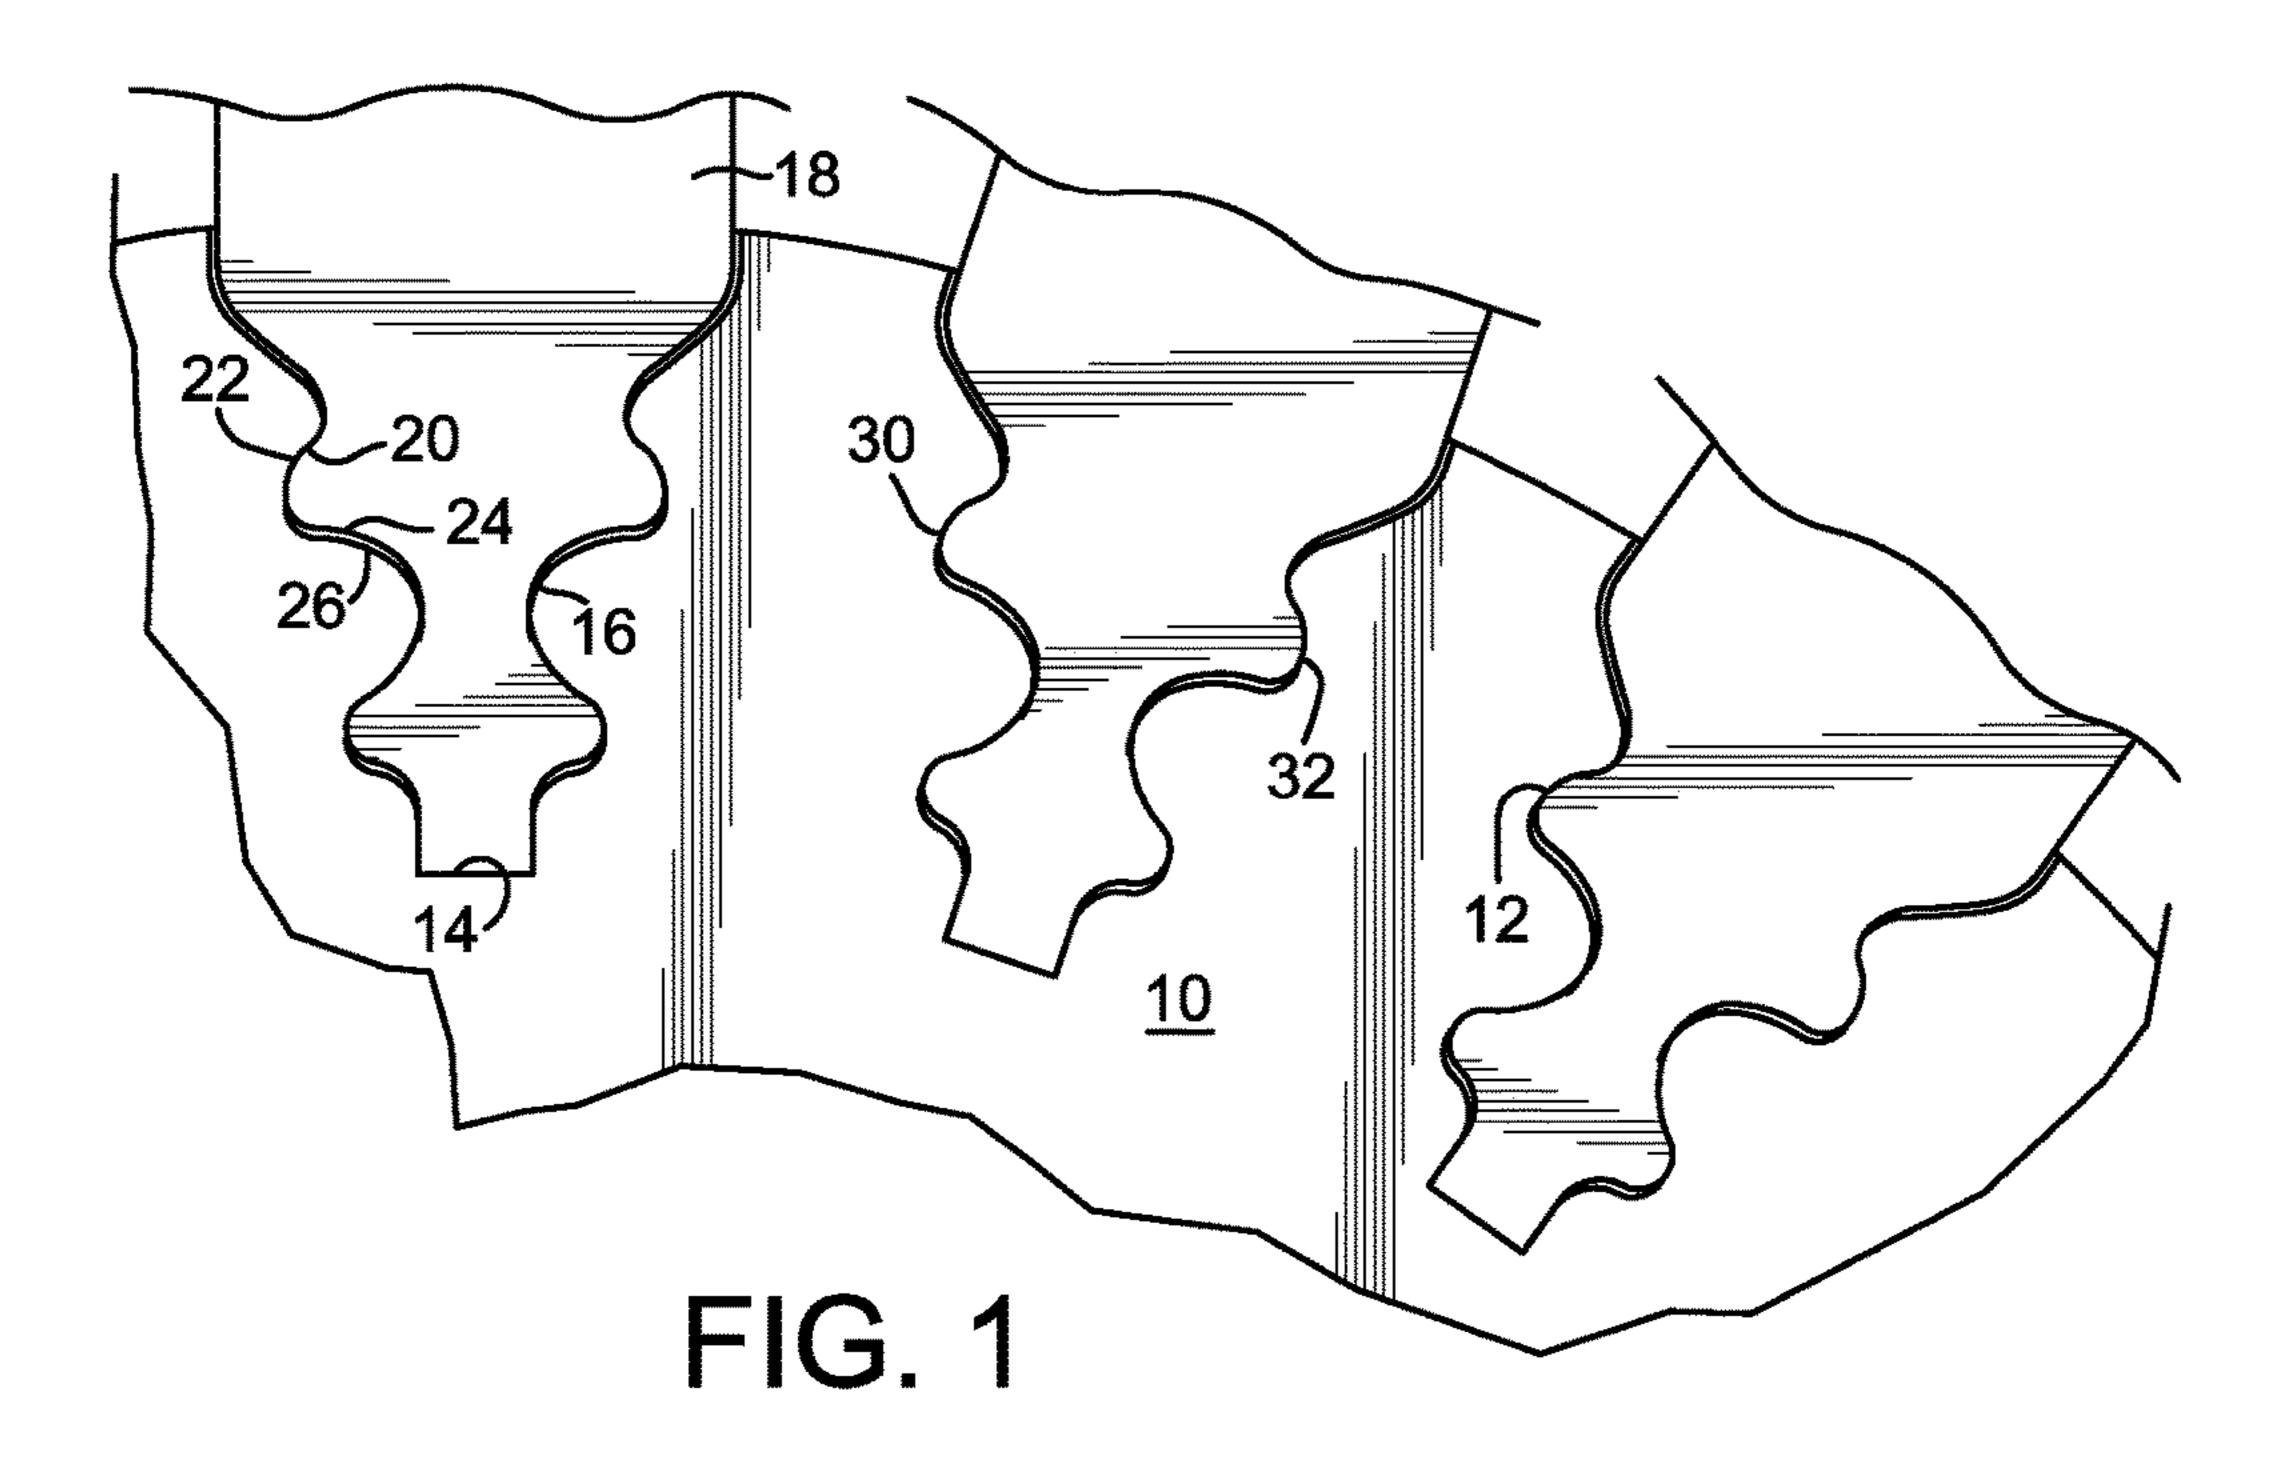
FIG. 1 is a schematic representation of a turbine disk; FIG. 2 is a flow chart showing the process for rejuvenating a turbine disk.

In step 106, once it is understood how much material must be removed from the turbine disk 10 to eliminate any region of M23C6 carbide dissolution, the disk slots 12, as well as other high temperature exposed surfaces, are remachined to eliminate the unwanted regions of M23C6 carbide dissolution. The other high temperature exposed surfaces could be the outer rim or front face of the turbine disk 12. The remachining step may be performed using super abrasive machining, wire EDM, broaching, grinding, milling, etc. to remove the damaged layer. During the remachining, the surfaces of the slots 12 are transformed by removing the determined damaged layer while retaining the dovetail configuration.
