(10) **Patent No.:** **US 10,024,162 B2**
(45) **Date of Patent:** **Jul. 17, 2018**

(54) **TURBINE DISK FATIGUE REJUVENATION**

(71) Applicant: **United Technologies Corporation**,
Hartford, CT (US)

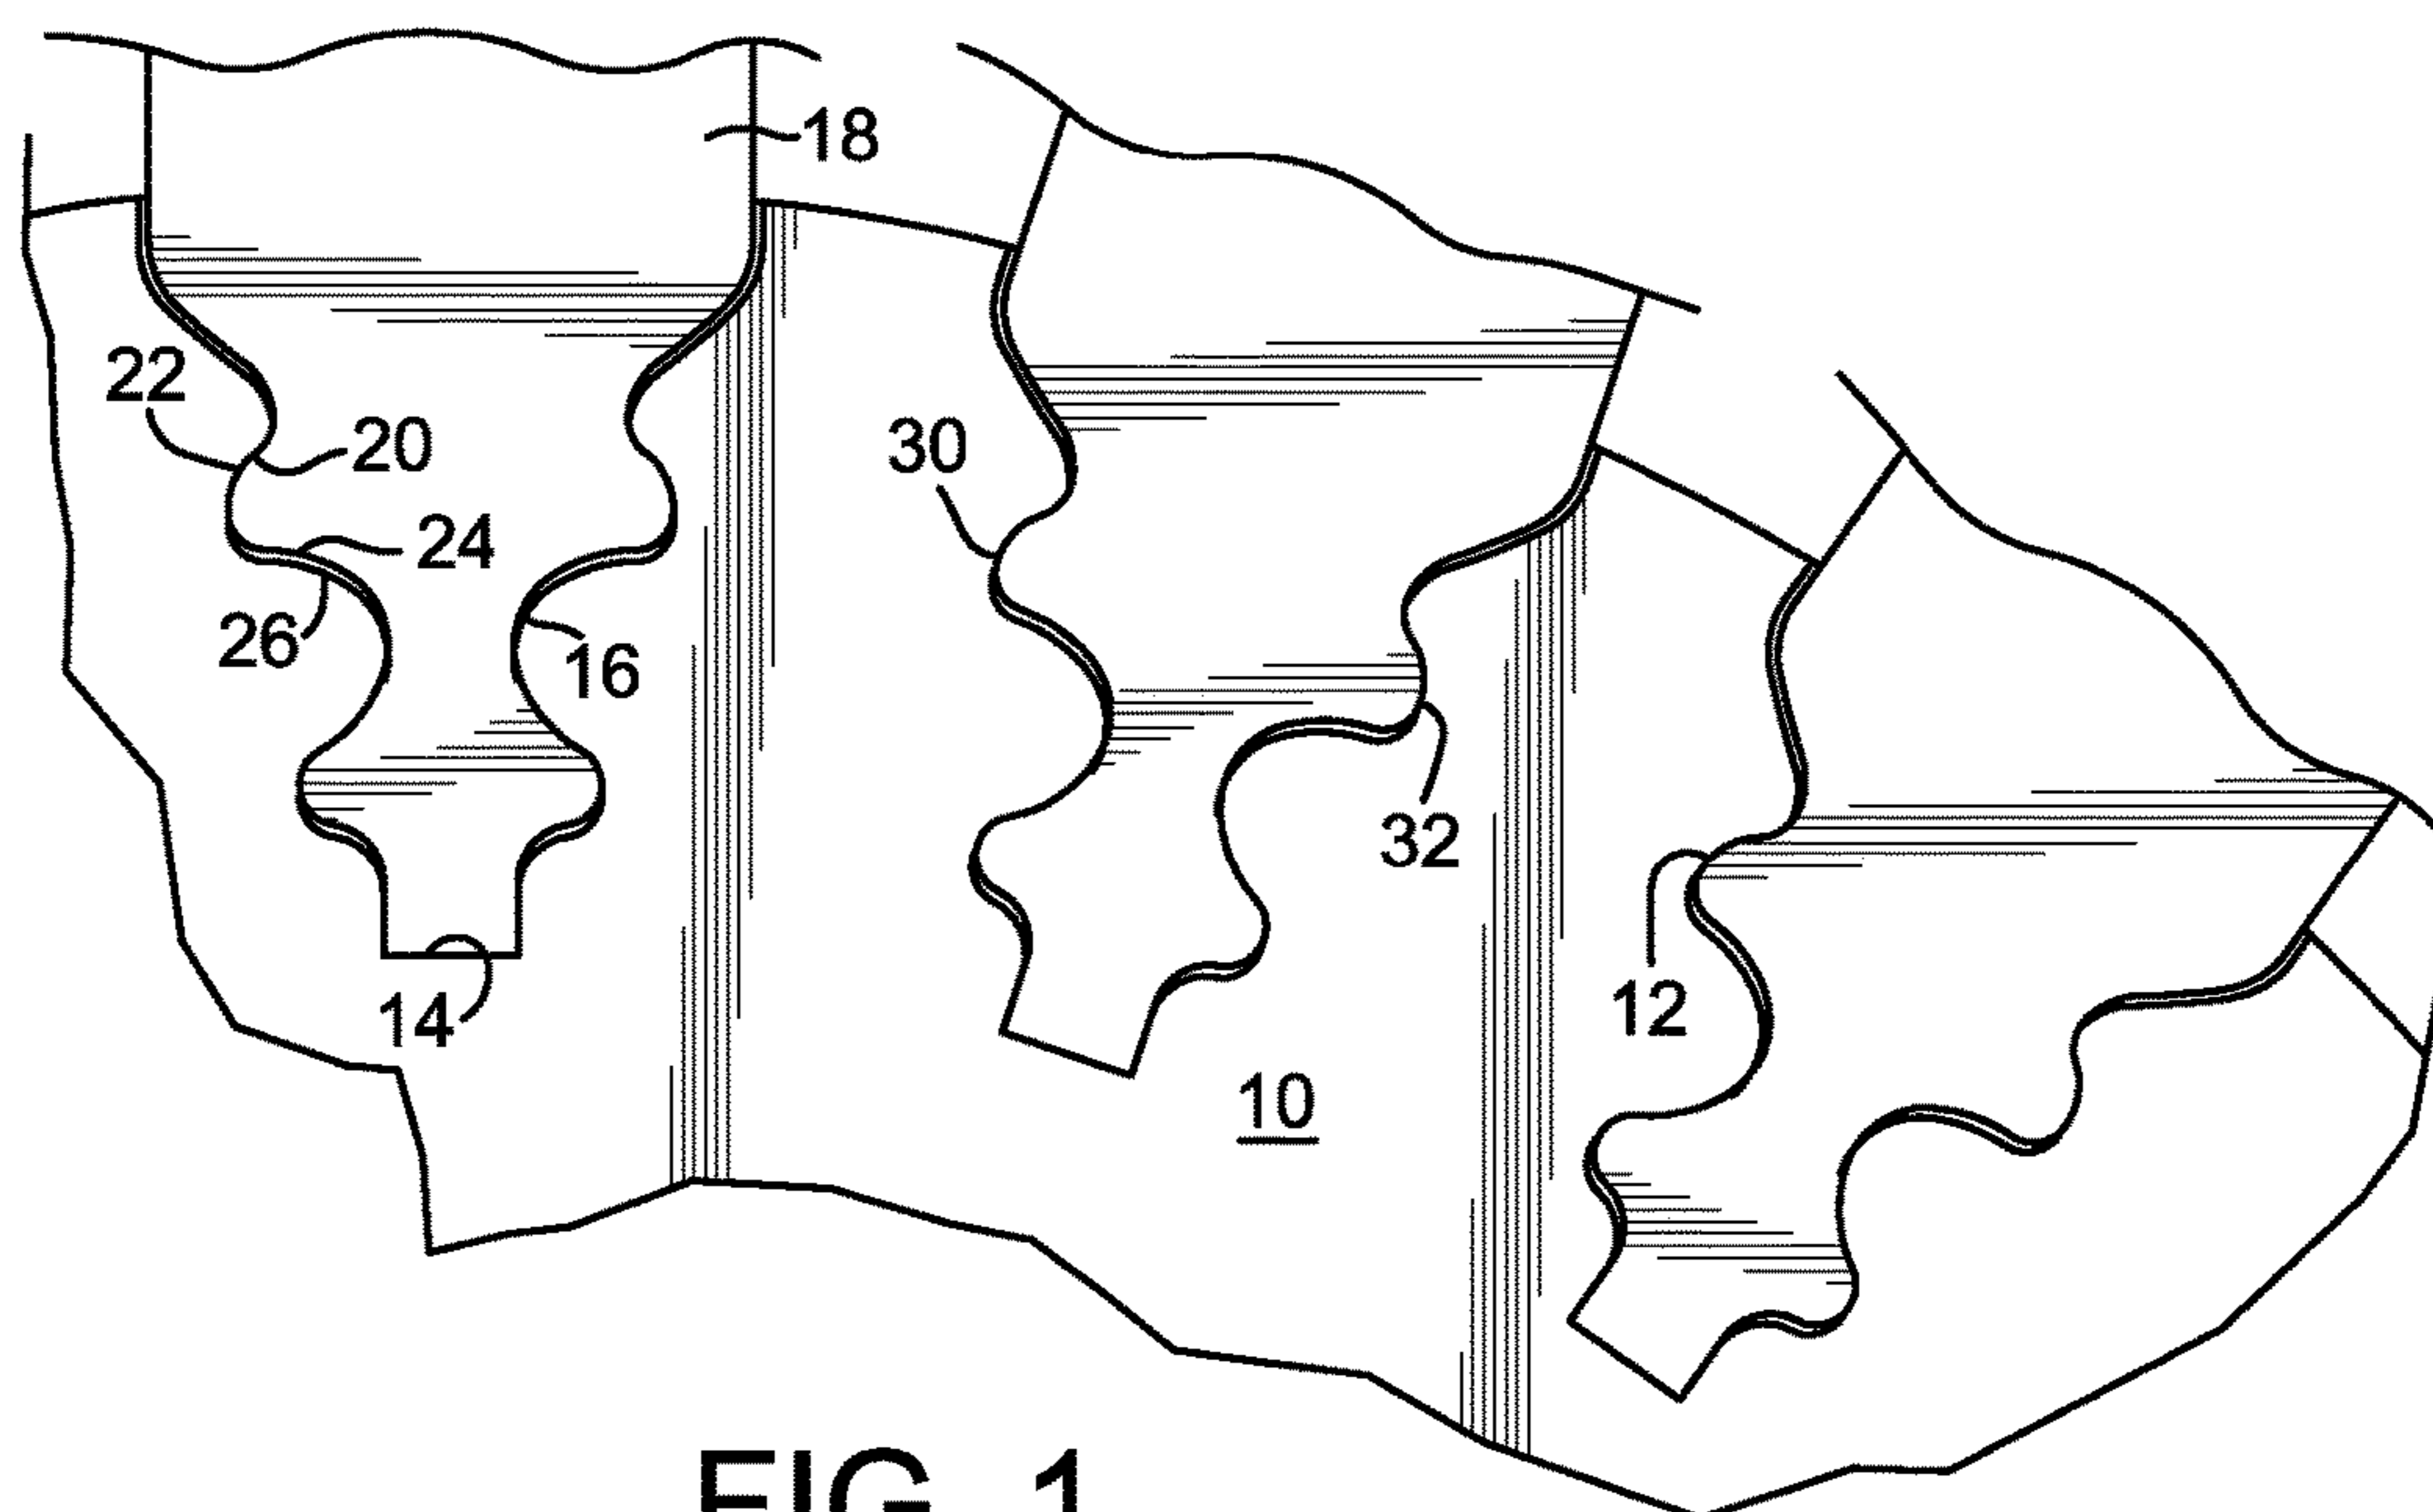
FIG. 1 is a schematic representation of a turbine disk;

Referring now to FIG. 1, there is shown a turbine disk **10** forming one of the disks of a gas or steam turbine. The turbine disk **10** may be formed from a nickel-based superalloy or an iron based alloy. The turbine disk **10** has a plurality of generally dovetail-shaped slots **12** spaced circumferentially one from the other about the periphery of the margin of the turbine disk **10**. As illustrated, each slot **12** includes a slot bottom **14** and a plurality of ribs **16** along opposite sides of the slot **12** and progressively spaced greater distances from one another from the bottom of the slot **14** radially outward to its outermost opening.
