(54) **GENERATOR ROTOR FRETTING FATIGUE CRACK REPAIR METHOD**

GENERATOR ROTOR FRETTING FATIGUE CRACK REPAIR METHOD

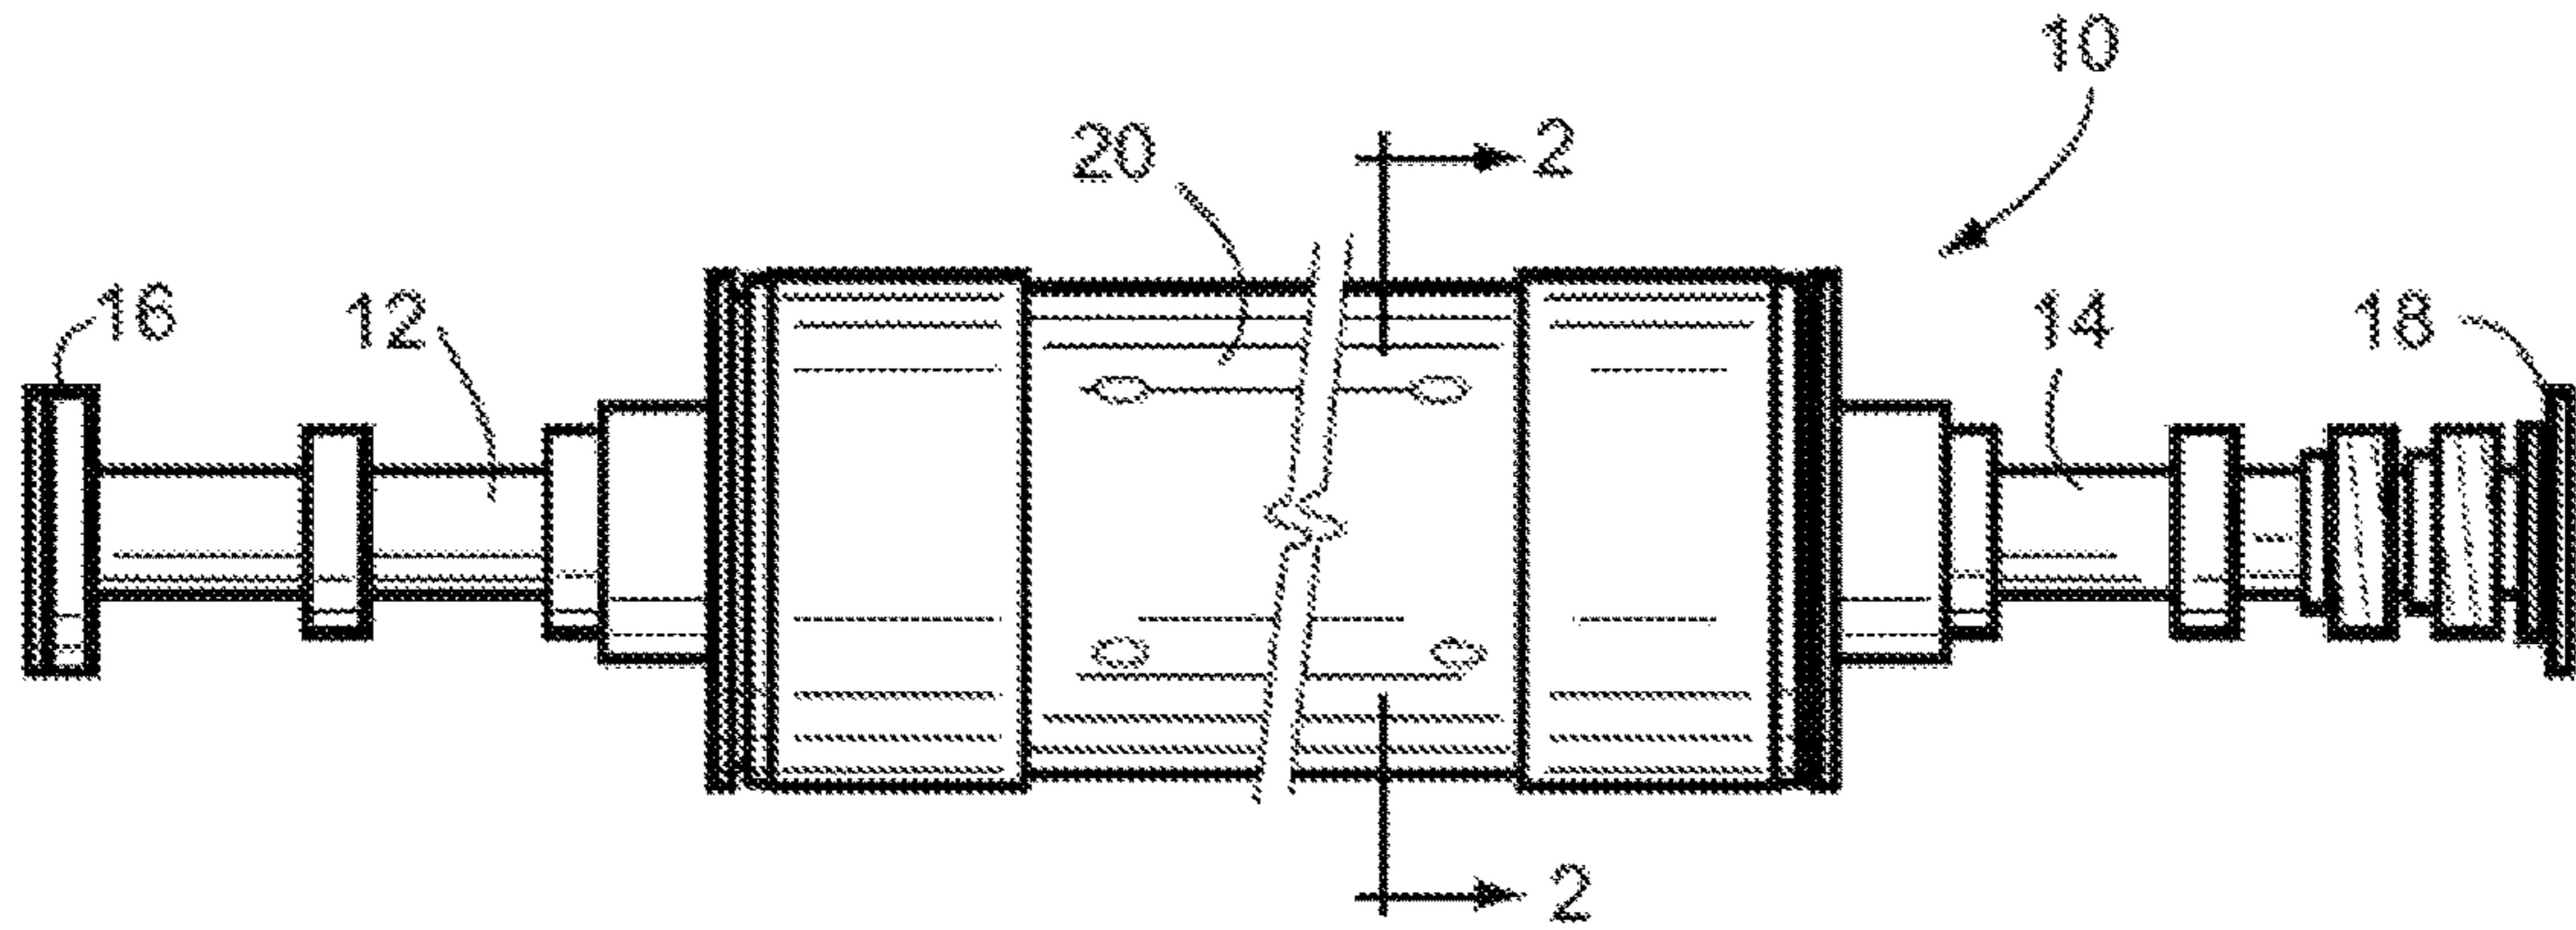
FIG. 1
(PRIOR ART)

FIG. 1 is a side elevation of a conventional generator rotor including radially oriented coil slots;

FIGS. 1 and 2 illustrate a typical rotor 10 for a dynamo-electric machine wherein the rotor includes conventional elements such as rotor end shaft portions 12, 14 and couplings 16, 18 for connection with a turbine or gear reduction unit. Of particular significance here are the axially oriented coil slots 20 arranged circumferentially about the mid-section of the rotor, that are used for holding the copper field windings or coils.

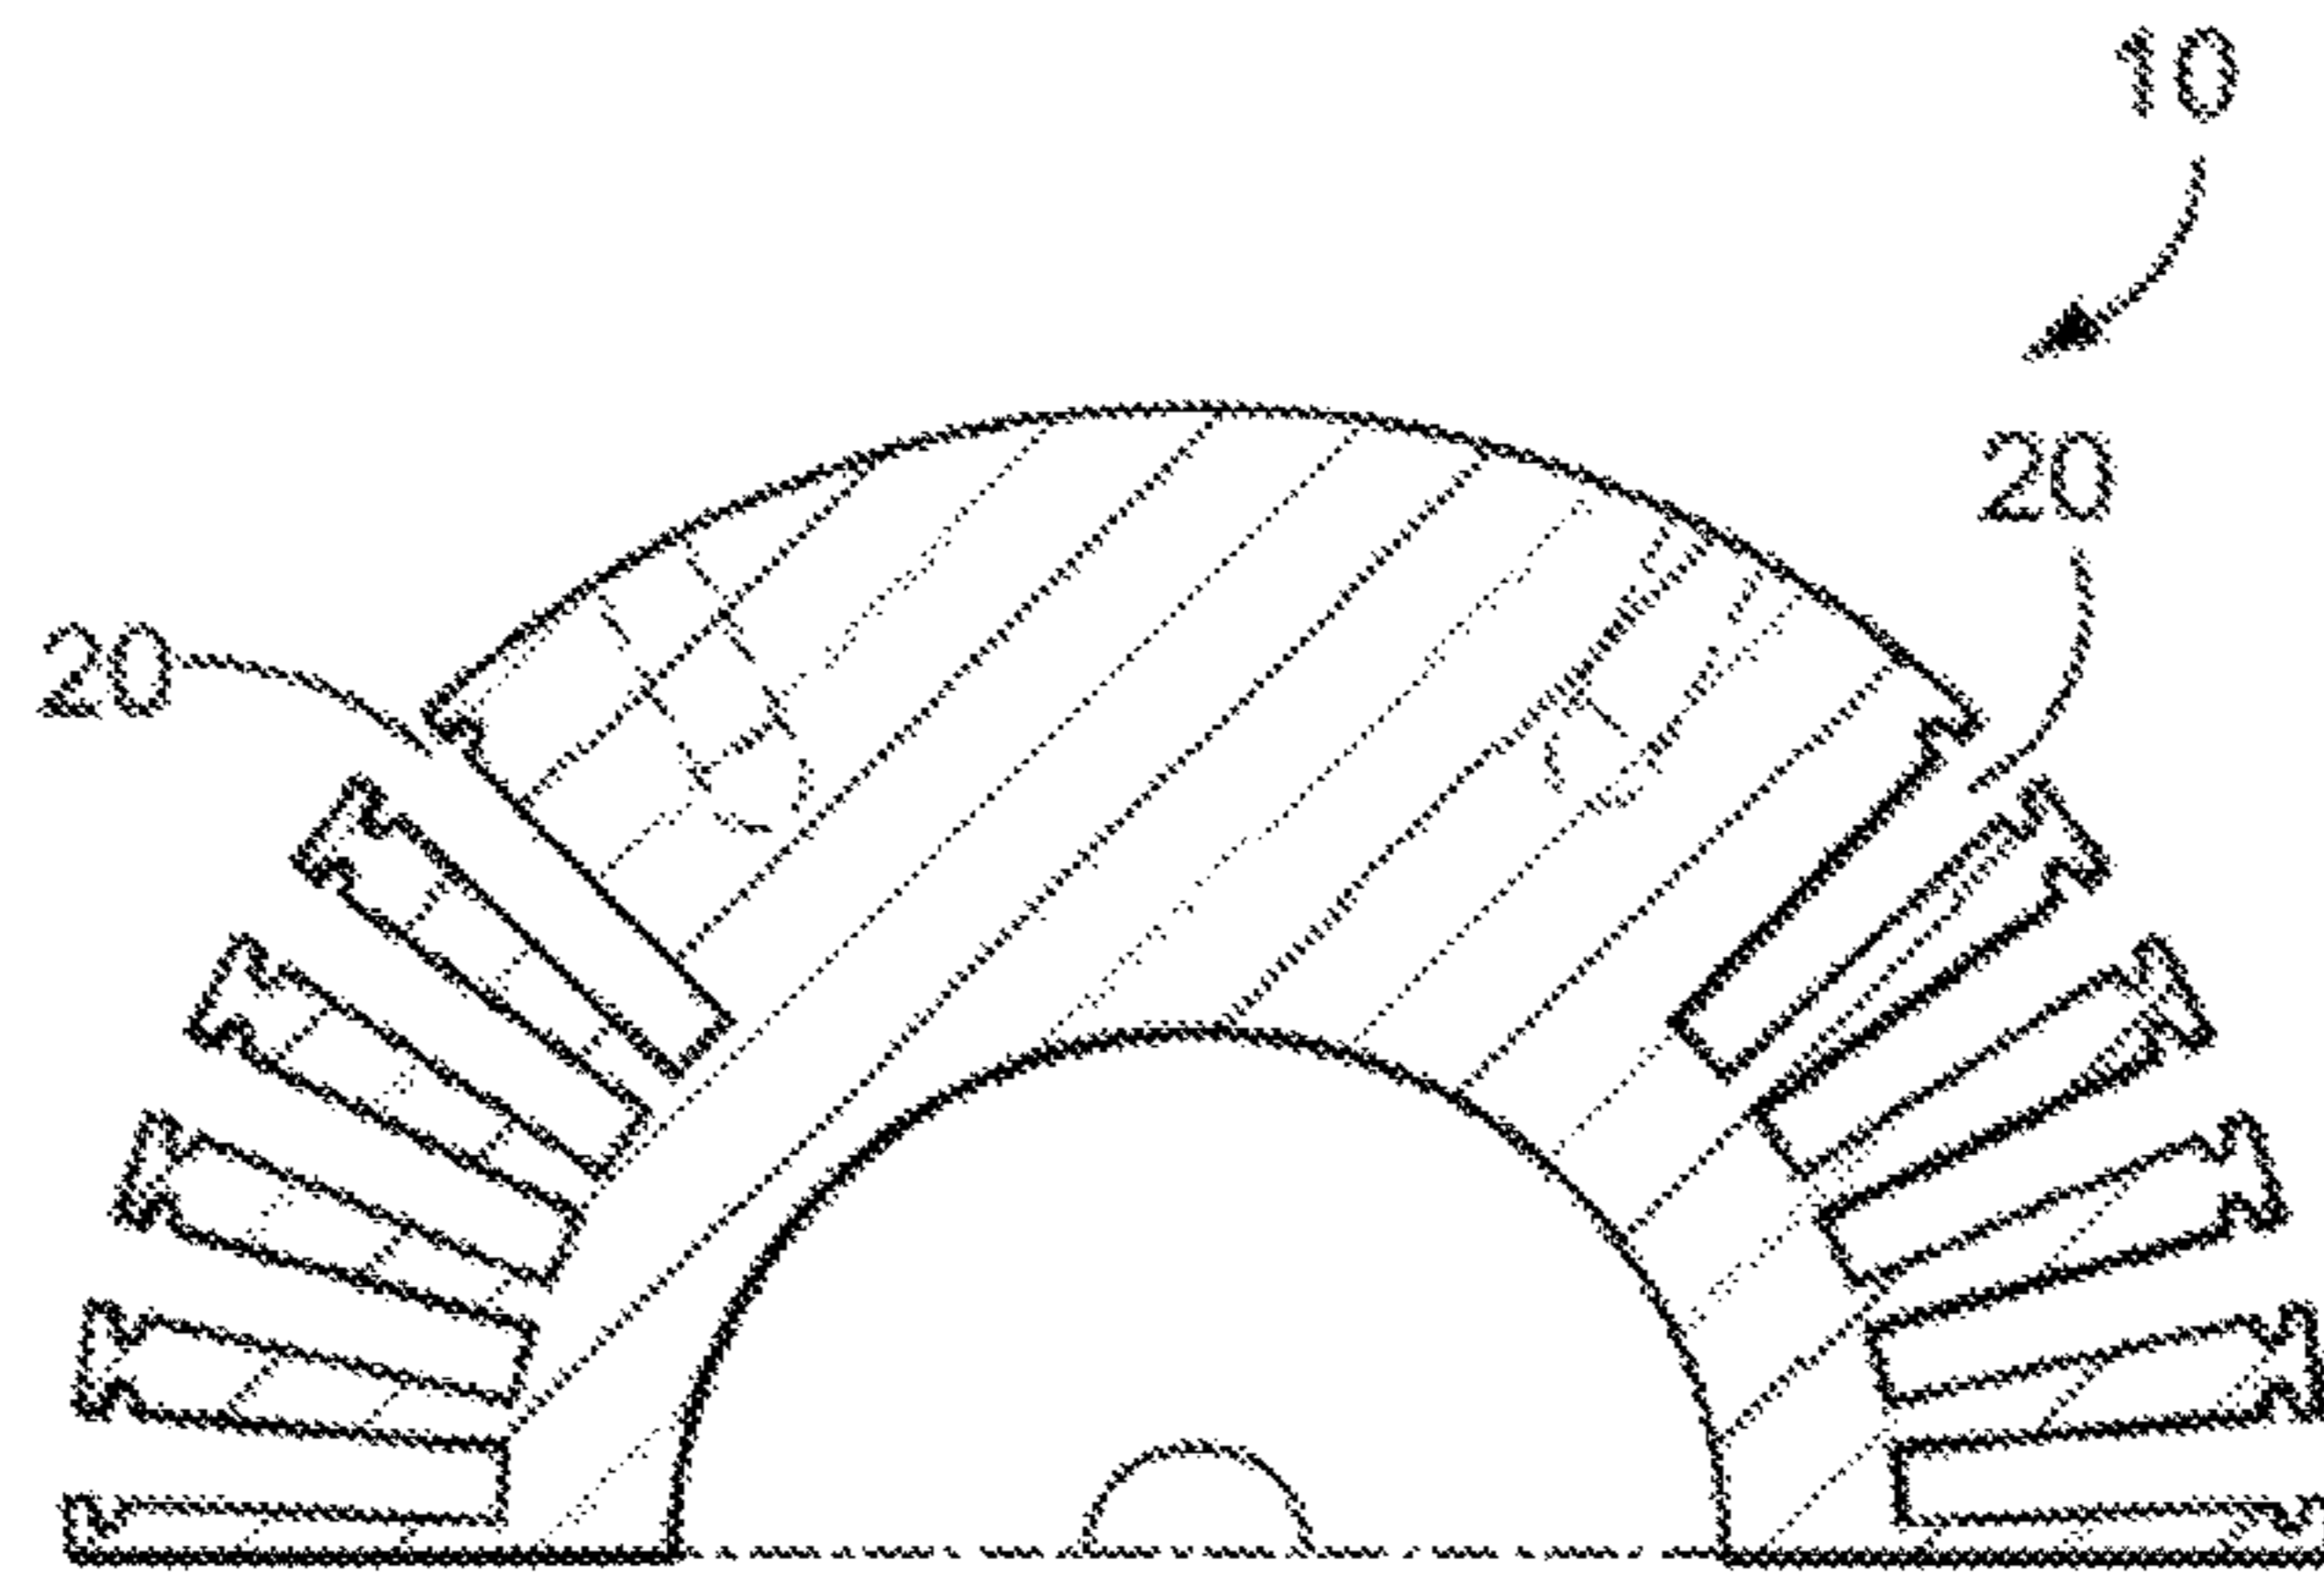
FIG. 2
(PRIOR ART)

FIG. 2 is a partial cross section of the rotor body taken along the lines 2-2 of FIG. 1;

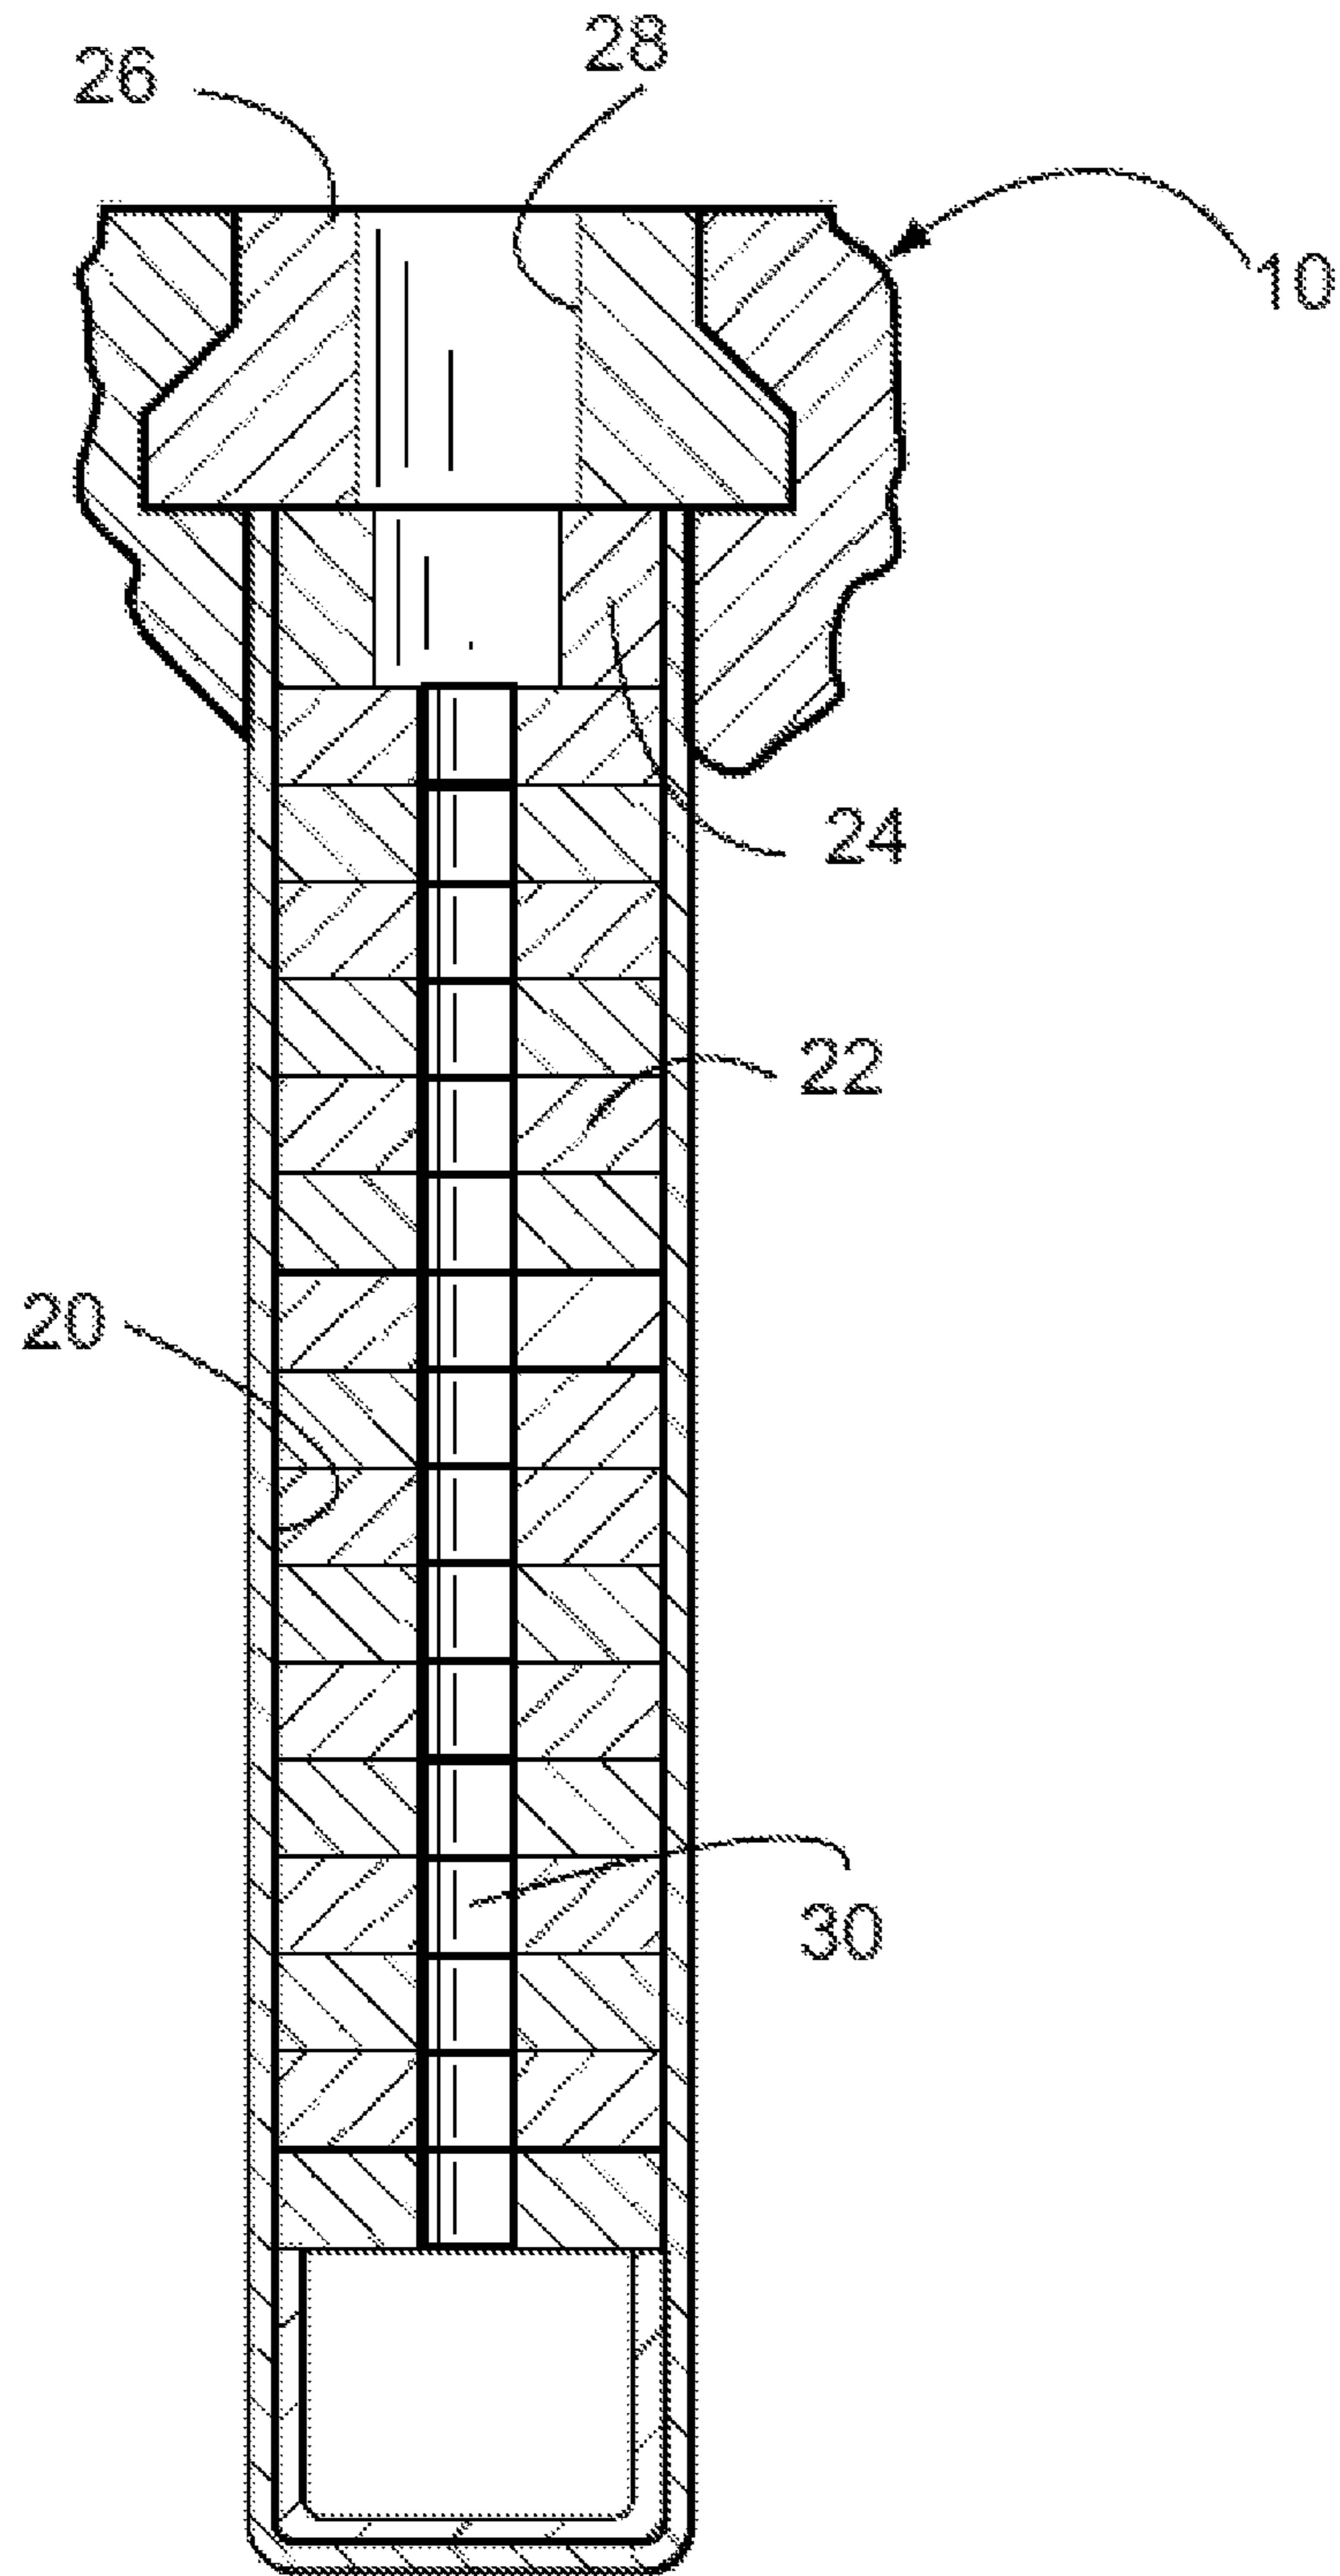
FIG. 3
(PRIOR ART)

FIG. 3 is a cross section through a typical coil slot and contents thereof;

With further reference to FIG. 3, the coil slots 20 are each radially directed and typically contain, in a radially outward sequence, insulated copper coils 22, a creepage block 24, and a plurality of axially aligned slot wedges 26. The wedges have a generally dovetail shape in cross section, and are located and arranged so as to maintain the copper coils 22 and creepage block 24 in place while the rotor is spinning. The slot wedges 26 may also contain ventilation holes 28 (one shown) which are in general alignment with ventilation channels 30 (one shown) which pass through the copper conductors or coils, as well as through the creepage block 24.

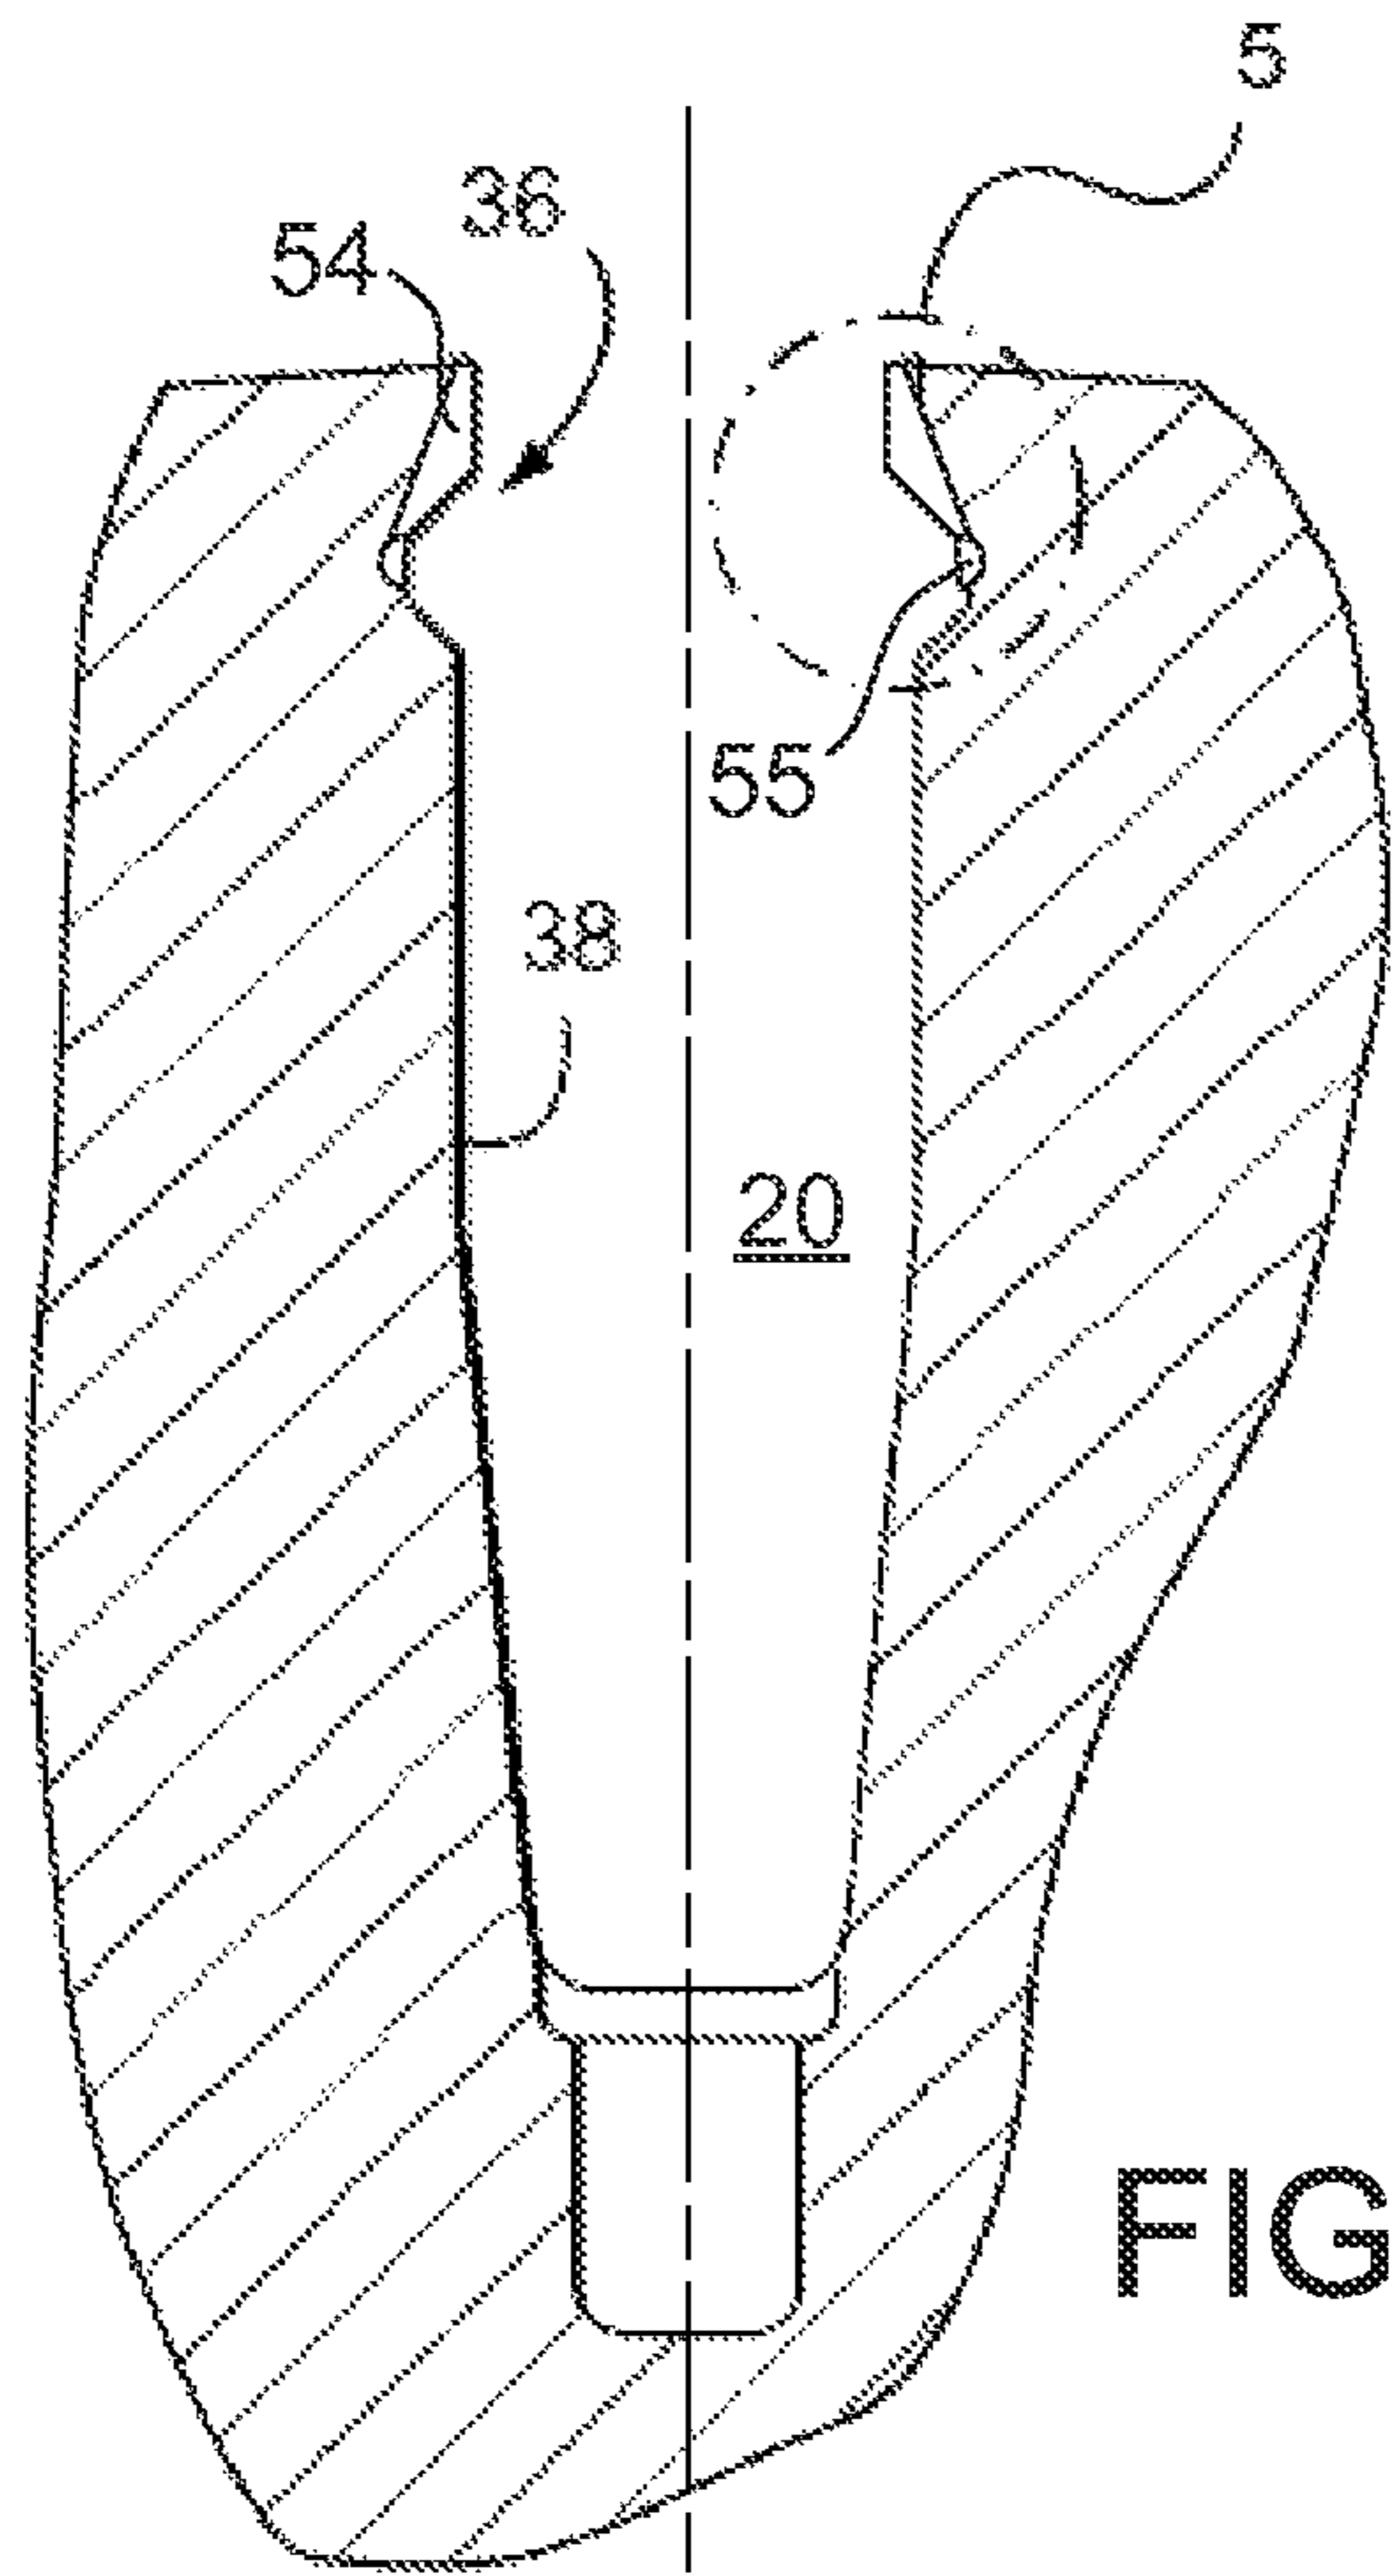
FIG. 4 is a cross section of a rotor slot with damaged areas machined away, according to an aspect of the present invention;

The present invention has two significant aspects in terms of repair of fretting cracks in rotor teeth. First, the damaged material is ground out of the rotor and a local stress field is altered near the repaired ends. With reference to FIGS. 4 and 5, the machined area is in the wedge-receiving dovetail portion 36 of the slot wail 38. As already noted, this is the area of the slot wail that is susceptible to fretting cracks, and particularly, at the interface of two abutting steel wedges. The outer rotor surface 50 forms an outer most portion of the rotor. The coil slots 20 include a radial entry surface 51, an inwardly tapered surface 52 and an intermediate radial surface 53. An opposing side of slot 20 will have the same surfaces, but in an opposing configuration. The radial entry surface 51 extends radially downward until it connects to the inwardly tapered surface 52. The inwardly tapered surface angles over and is connected to the intermediate radial surface 53.

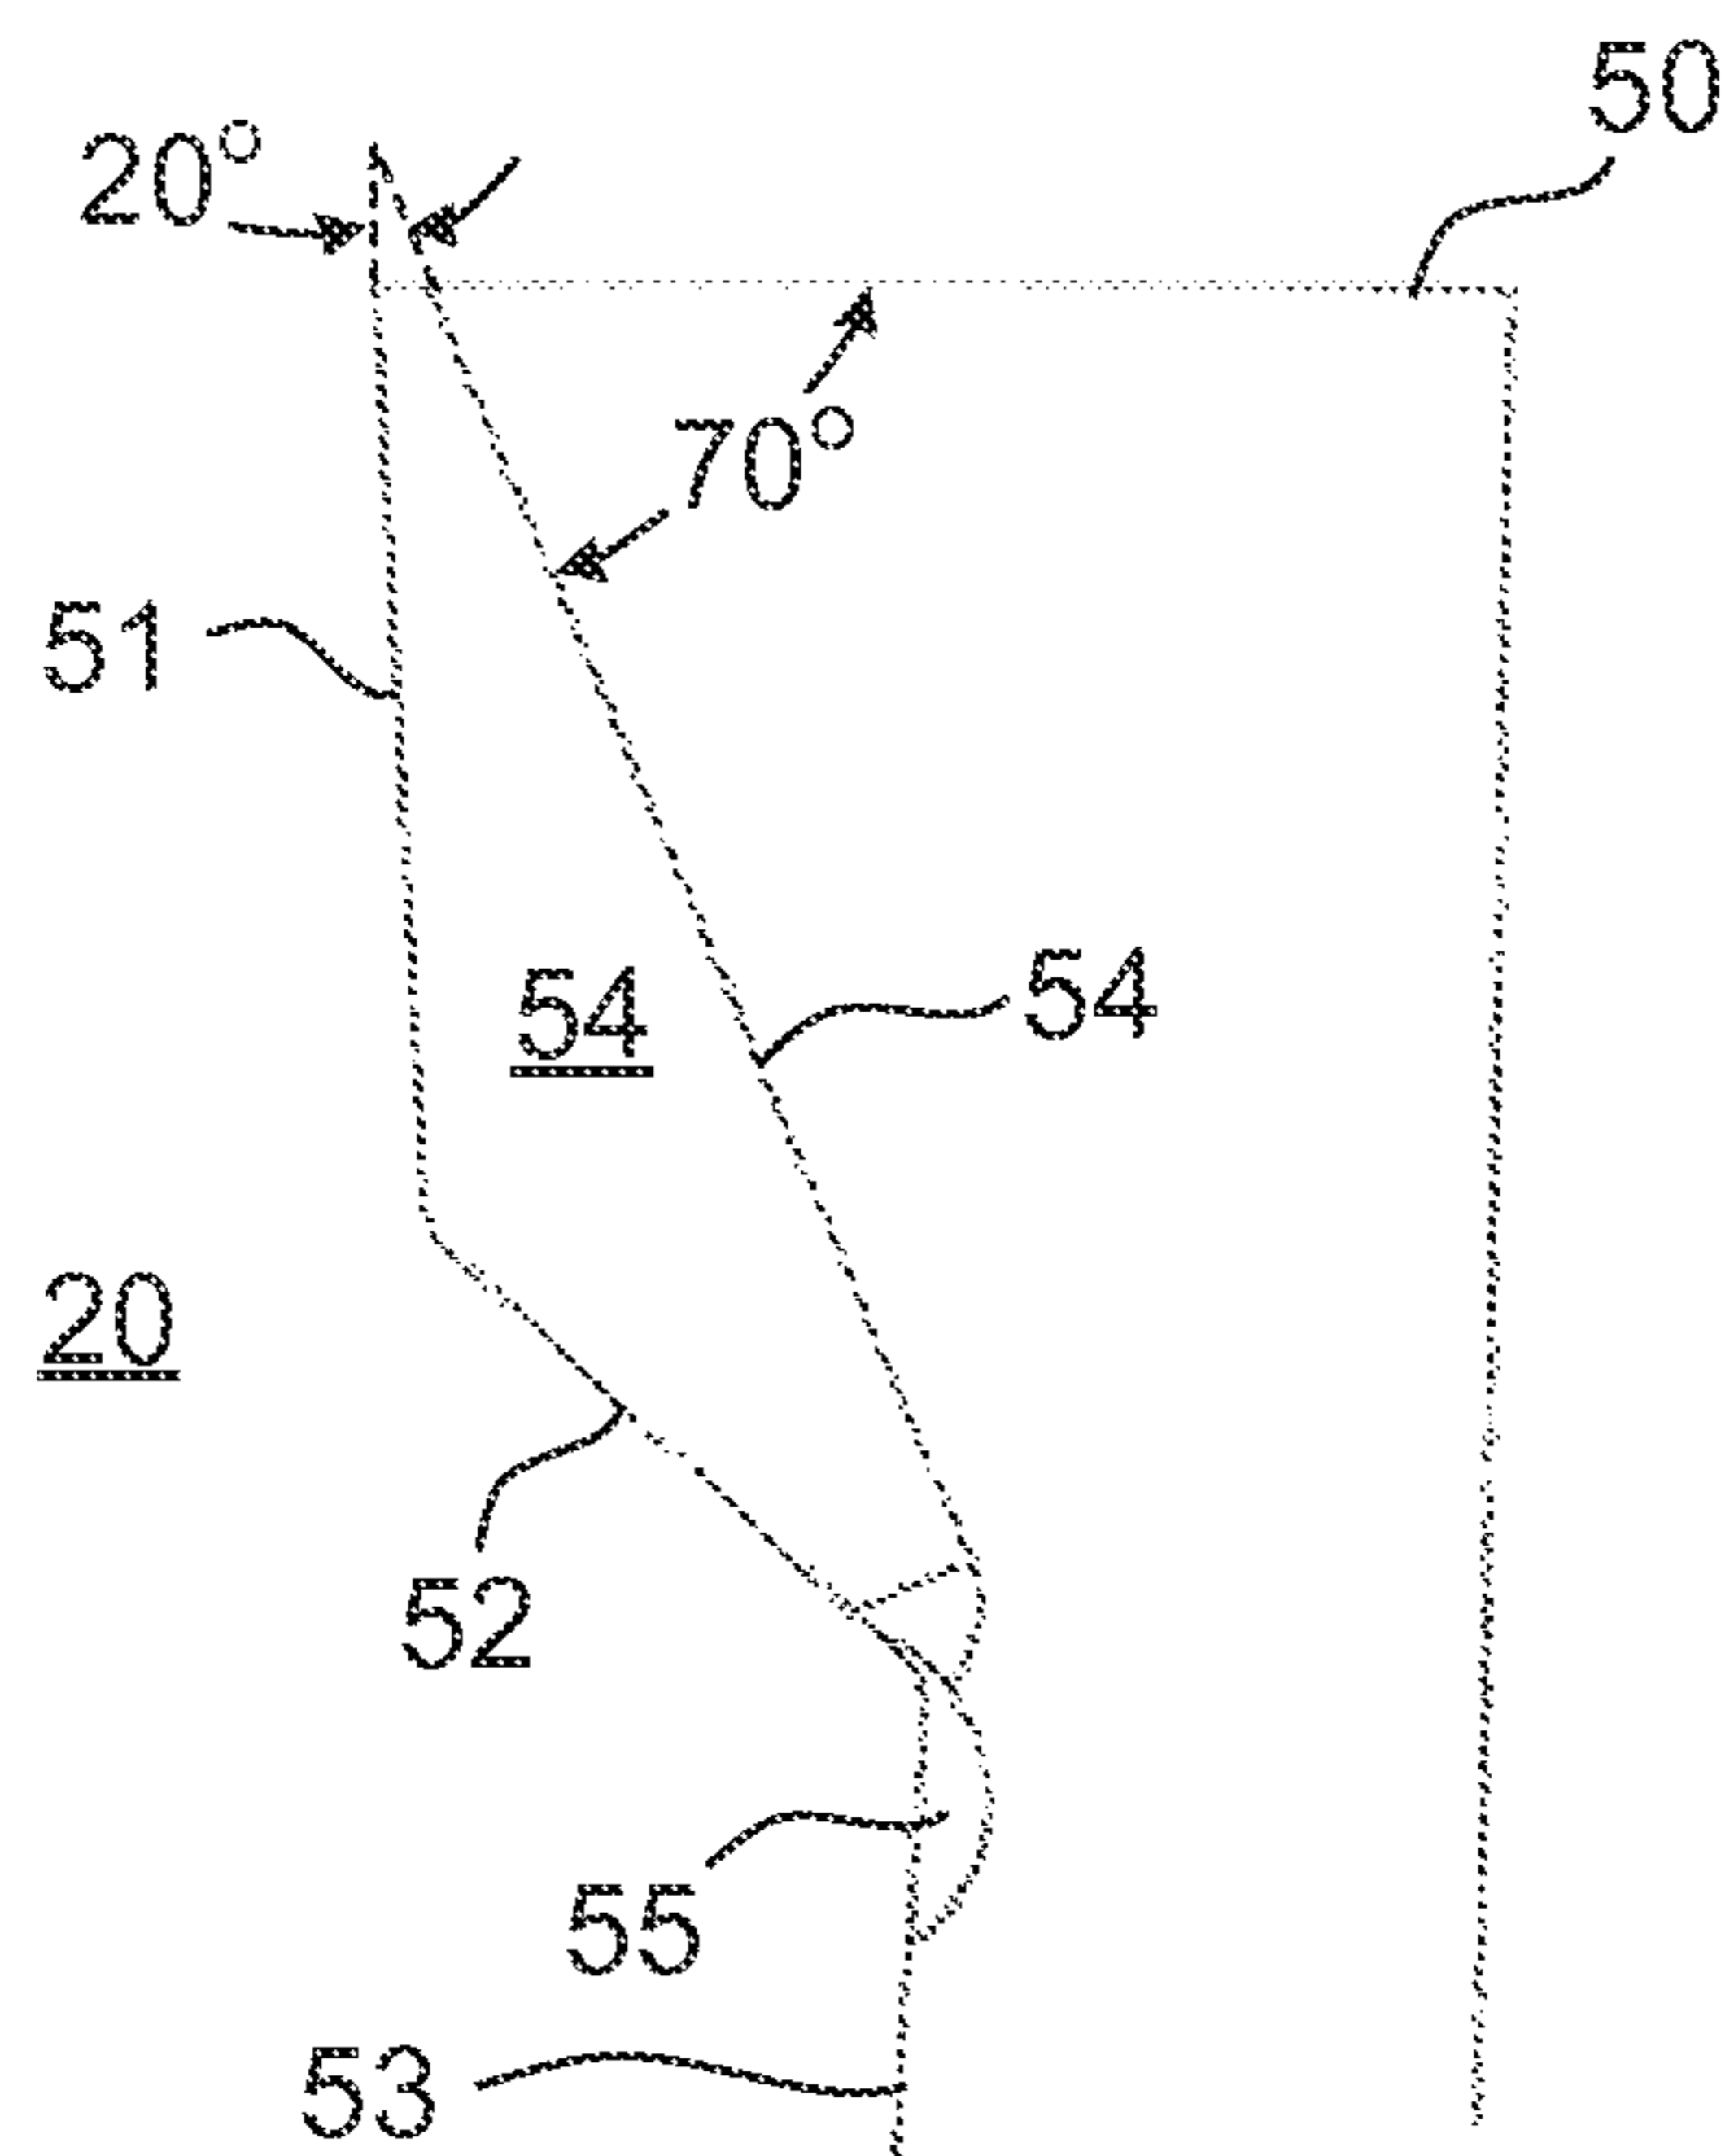
FIG. 5 is an enlarged detail taken from FIG. 4, according to an aspect of the present invention;

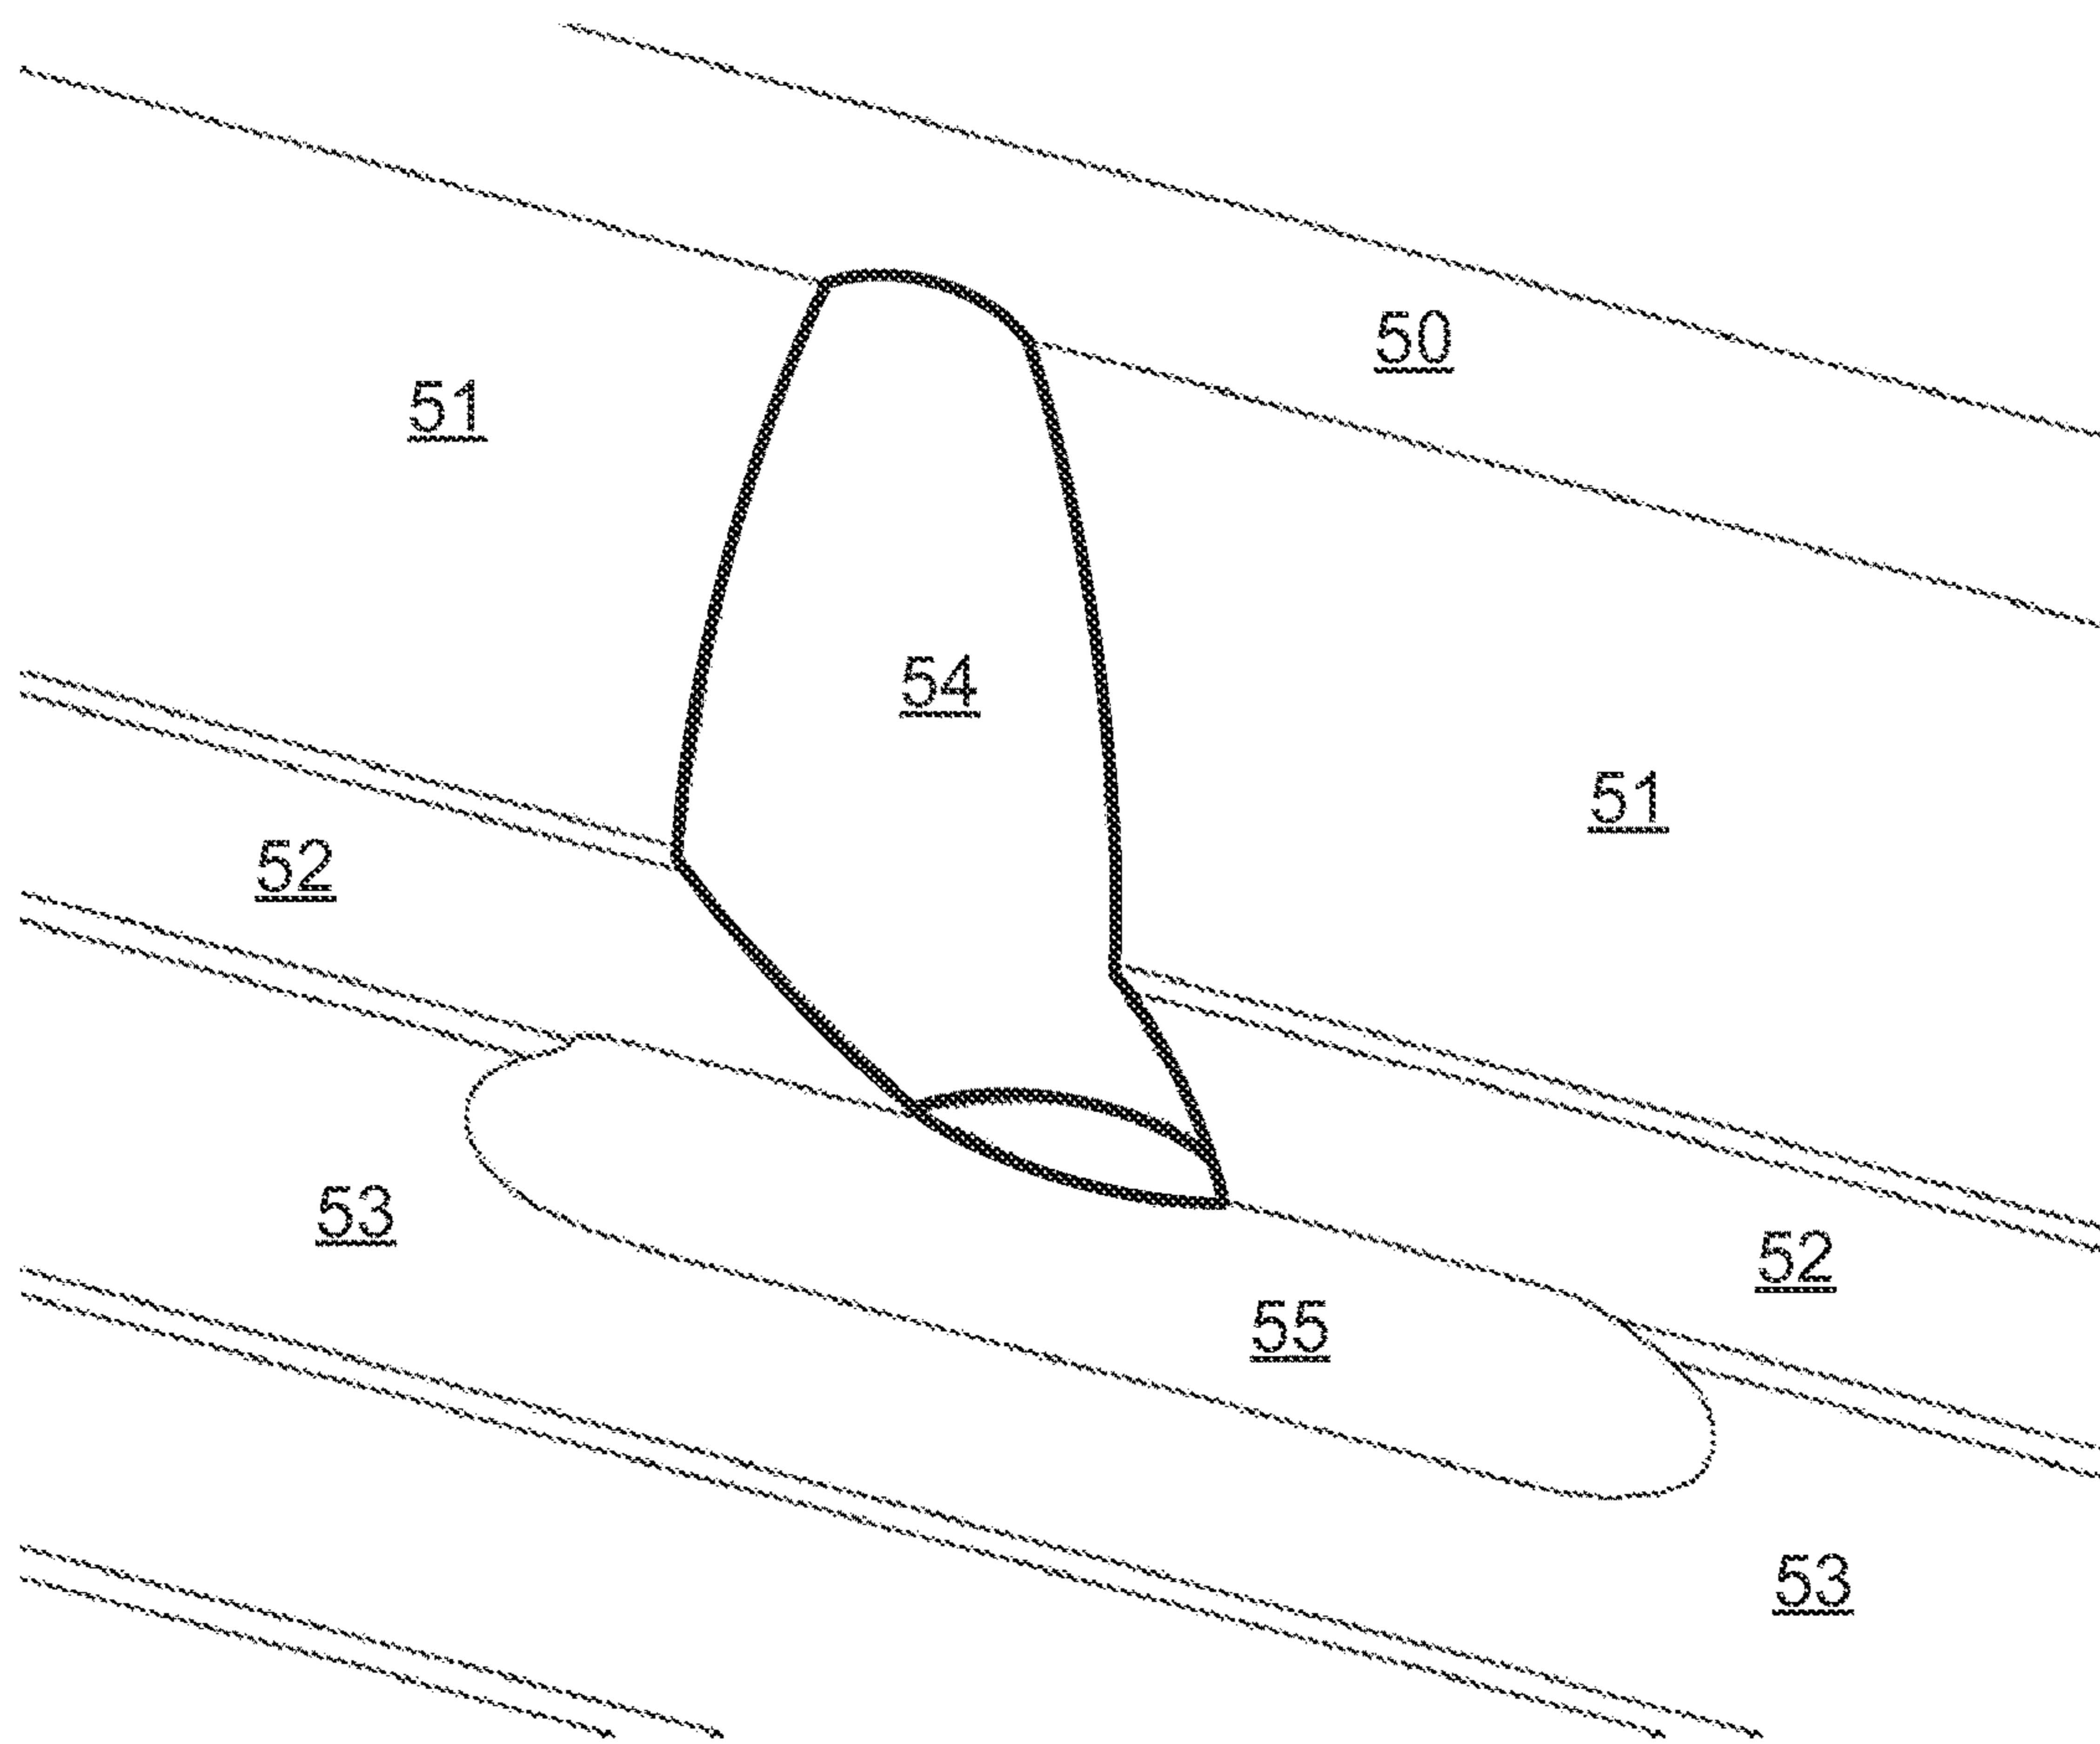
FIG. 6 is a perspective view of the rotor slot, showing damaged areas machined away from the slot wall, according to an aspect of the present invention;
