(54) **GENERATOR ROTOR FRETTING FATIGUE CRACK REPAIR METHOD**

GENERATOR ROTOR FRETTING FATIGUE CRACK REPAIR METHOD

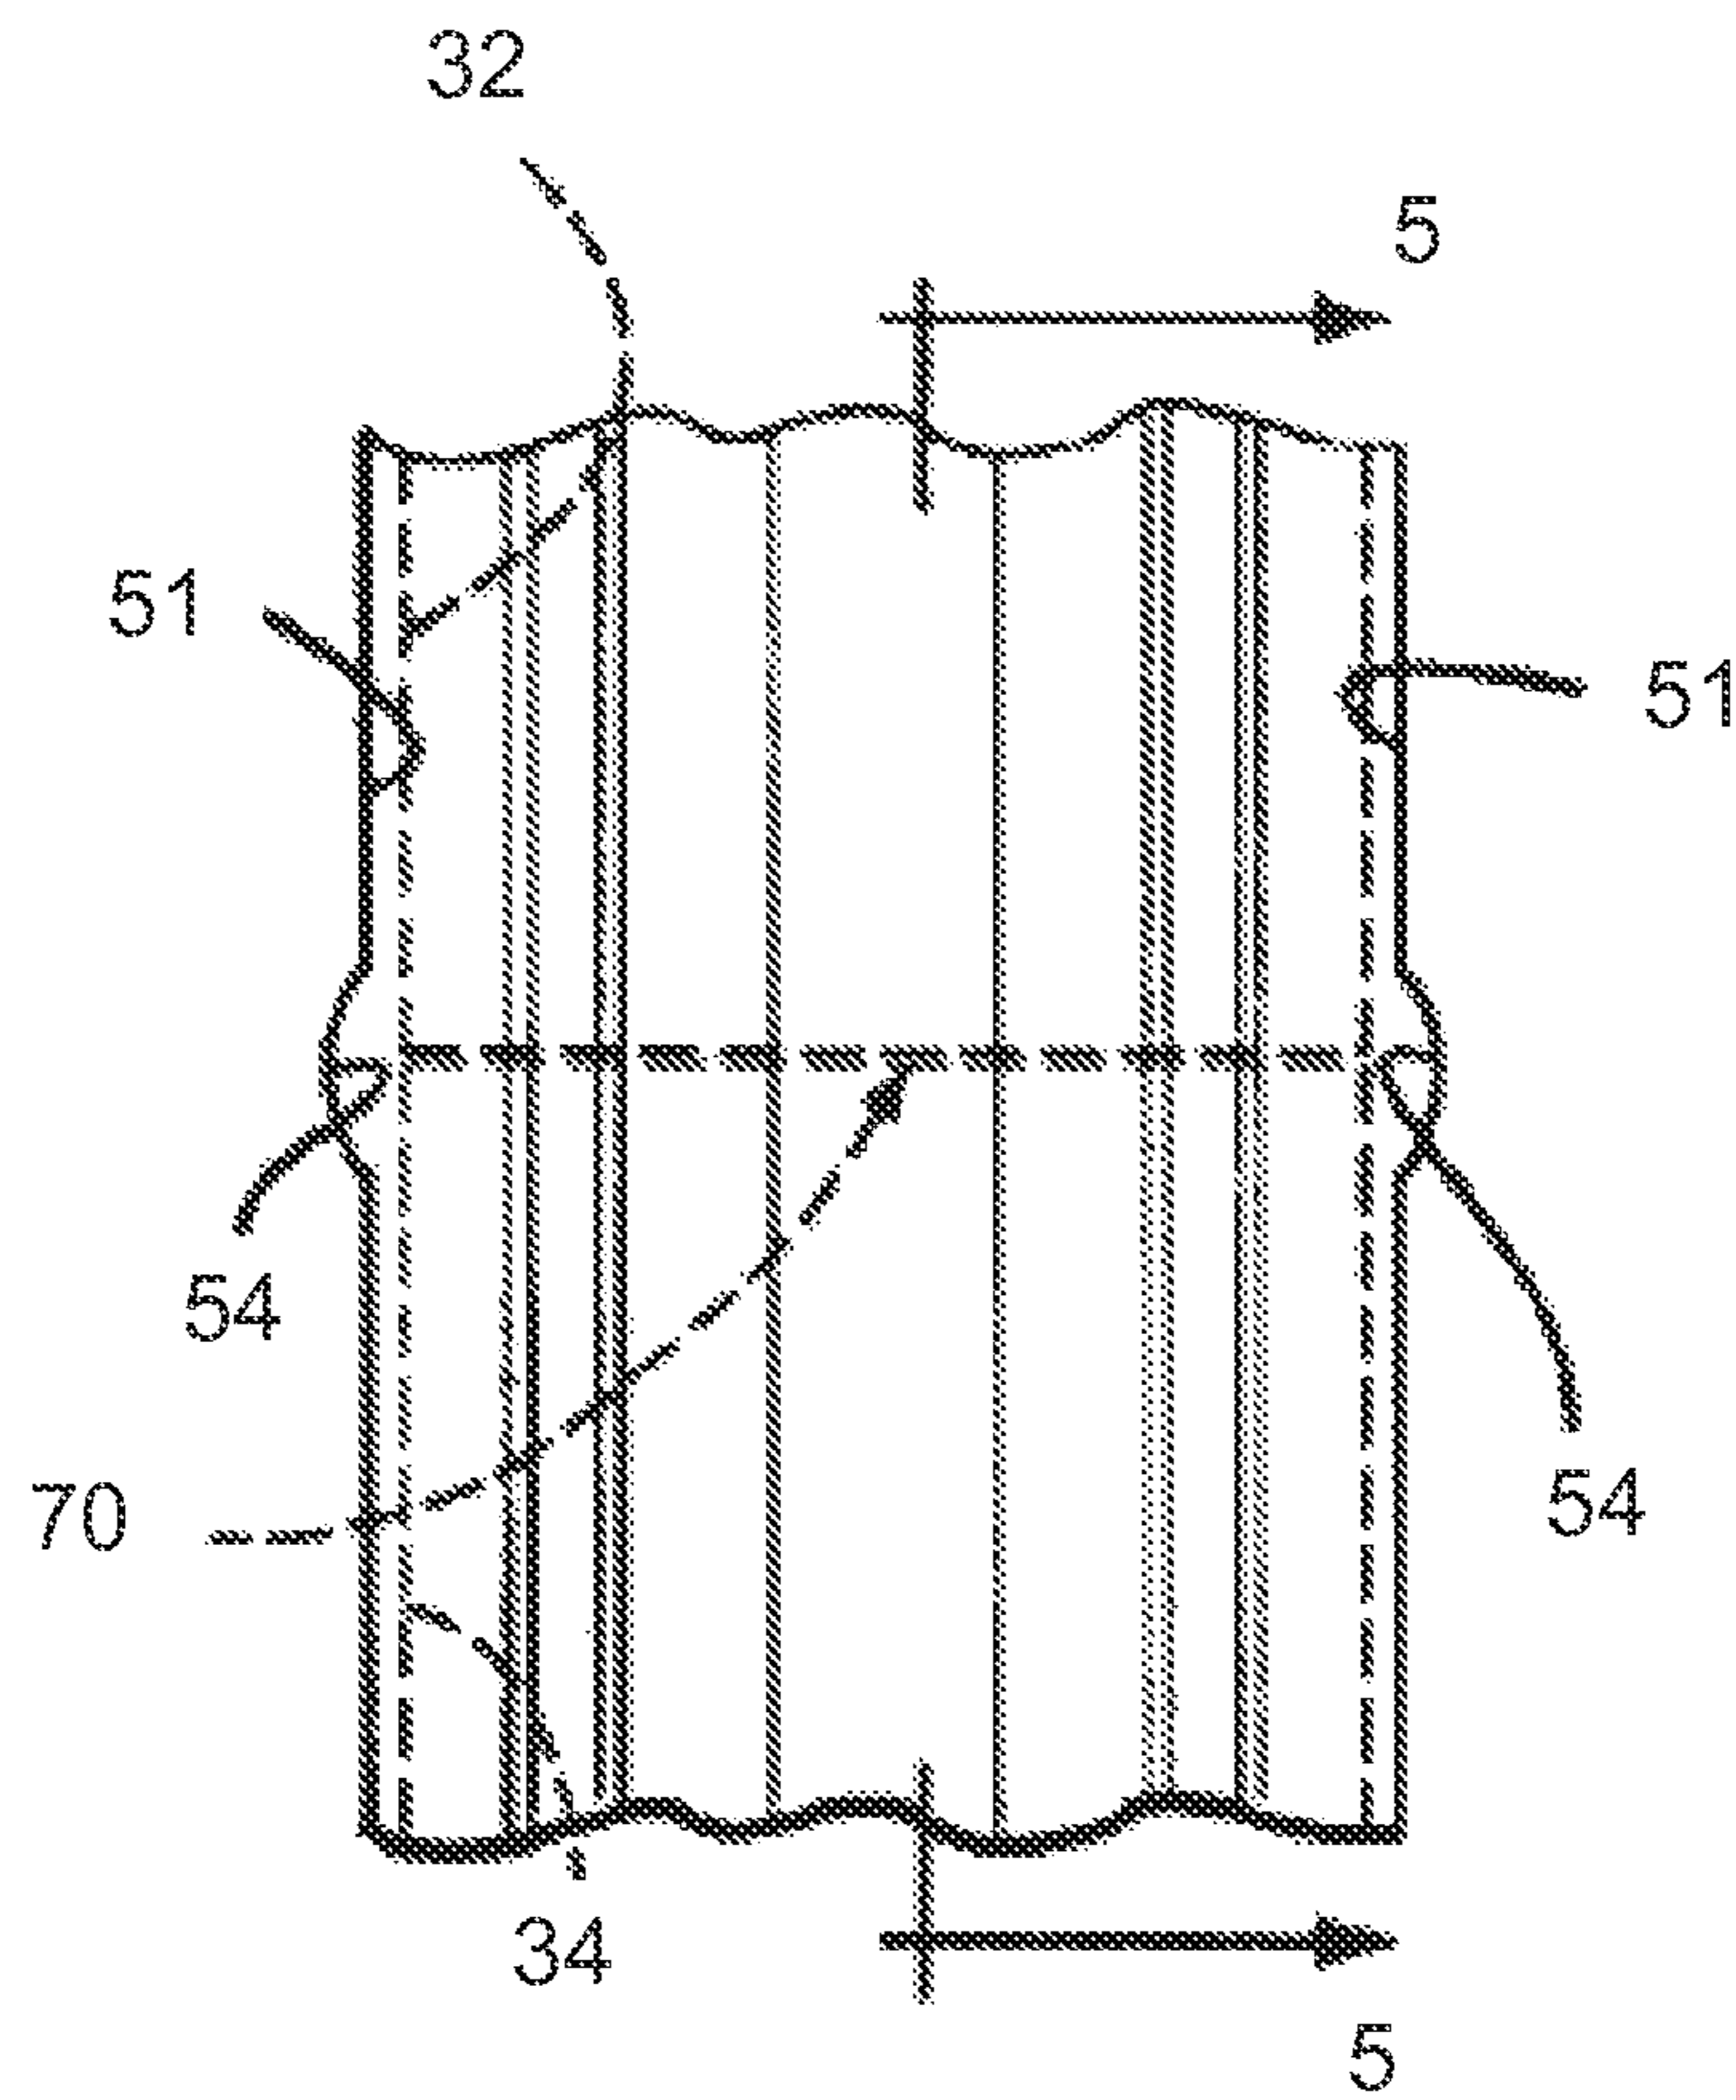
FIG. 7 is a plan view of the rotor slot shown in FIG. 6, with adjacent wedges shown in phantom, according to an aspect of the present invention; and

Fretting fatigue damage has occurred in the coil slots 20, specifically in the slot walls, at the butt joints of the axially adjacent steel rotor wedges 26 (a butt joint 70 between a pair of adjacent wedges 32, 34 is shown in phantom in FIG. 7). Fretting occurs whenever a junction between components is subjected to a cyclic load that leads to small tangential displacement over part of the interface. A two dimensional (radial-axial) finite element fretting model was developed to model the mechanics of contact between the rotor slot 20, and particularly the dovetail-shaped portion 36 of the slot wail 38 (see FIGS. 4 and 5) and the wedge 26, where fretting initiated cracks were observed in the rotor. The model provided a qualitative understanding of the fretting mechanism, and provided a basis for preliminary assessment of various wedge redesign options.

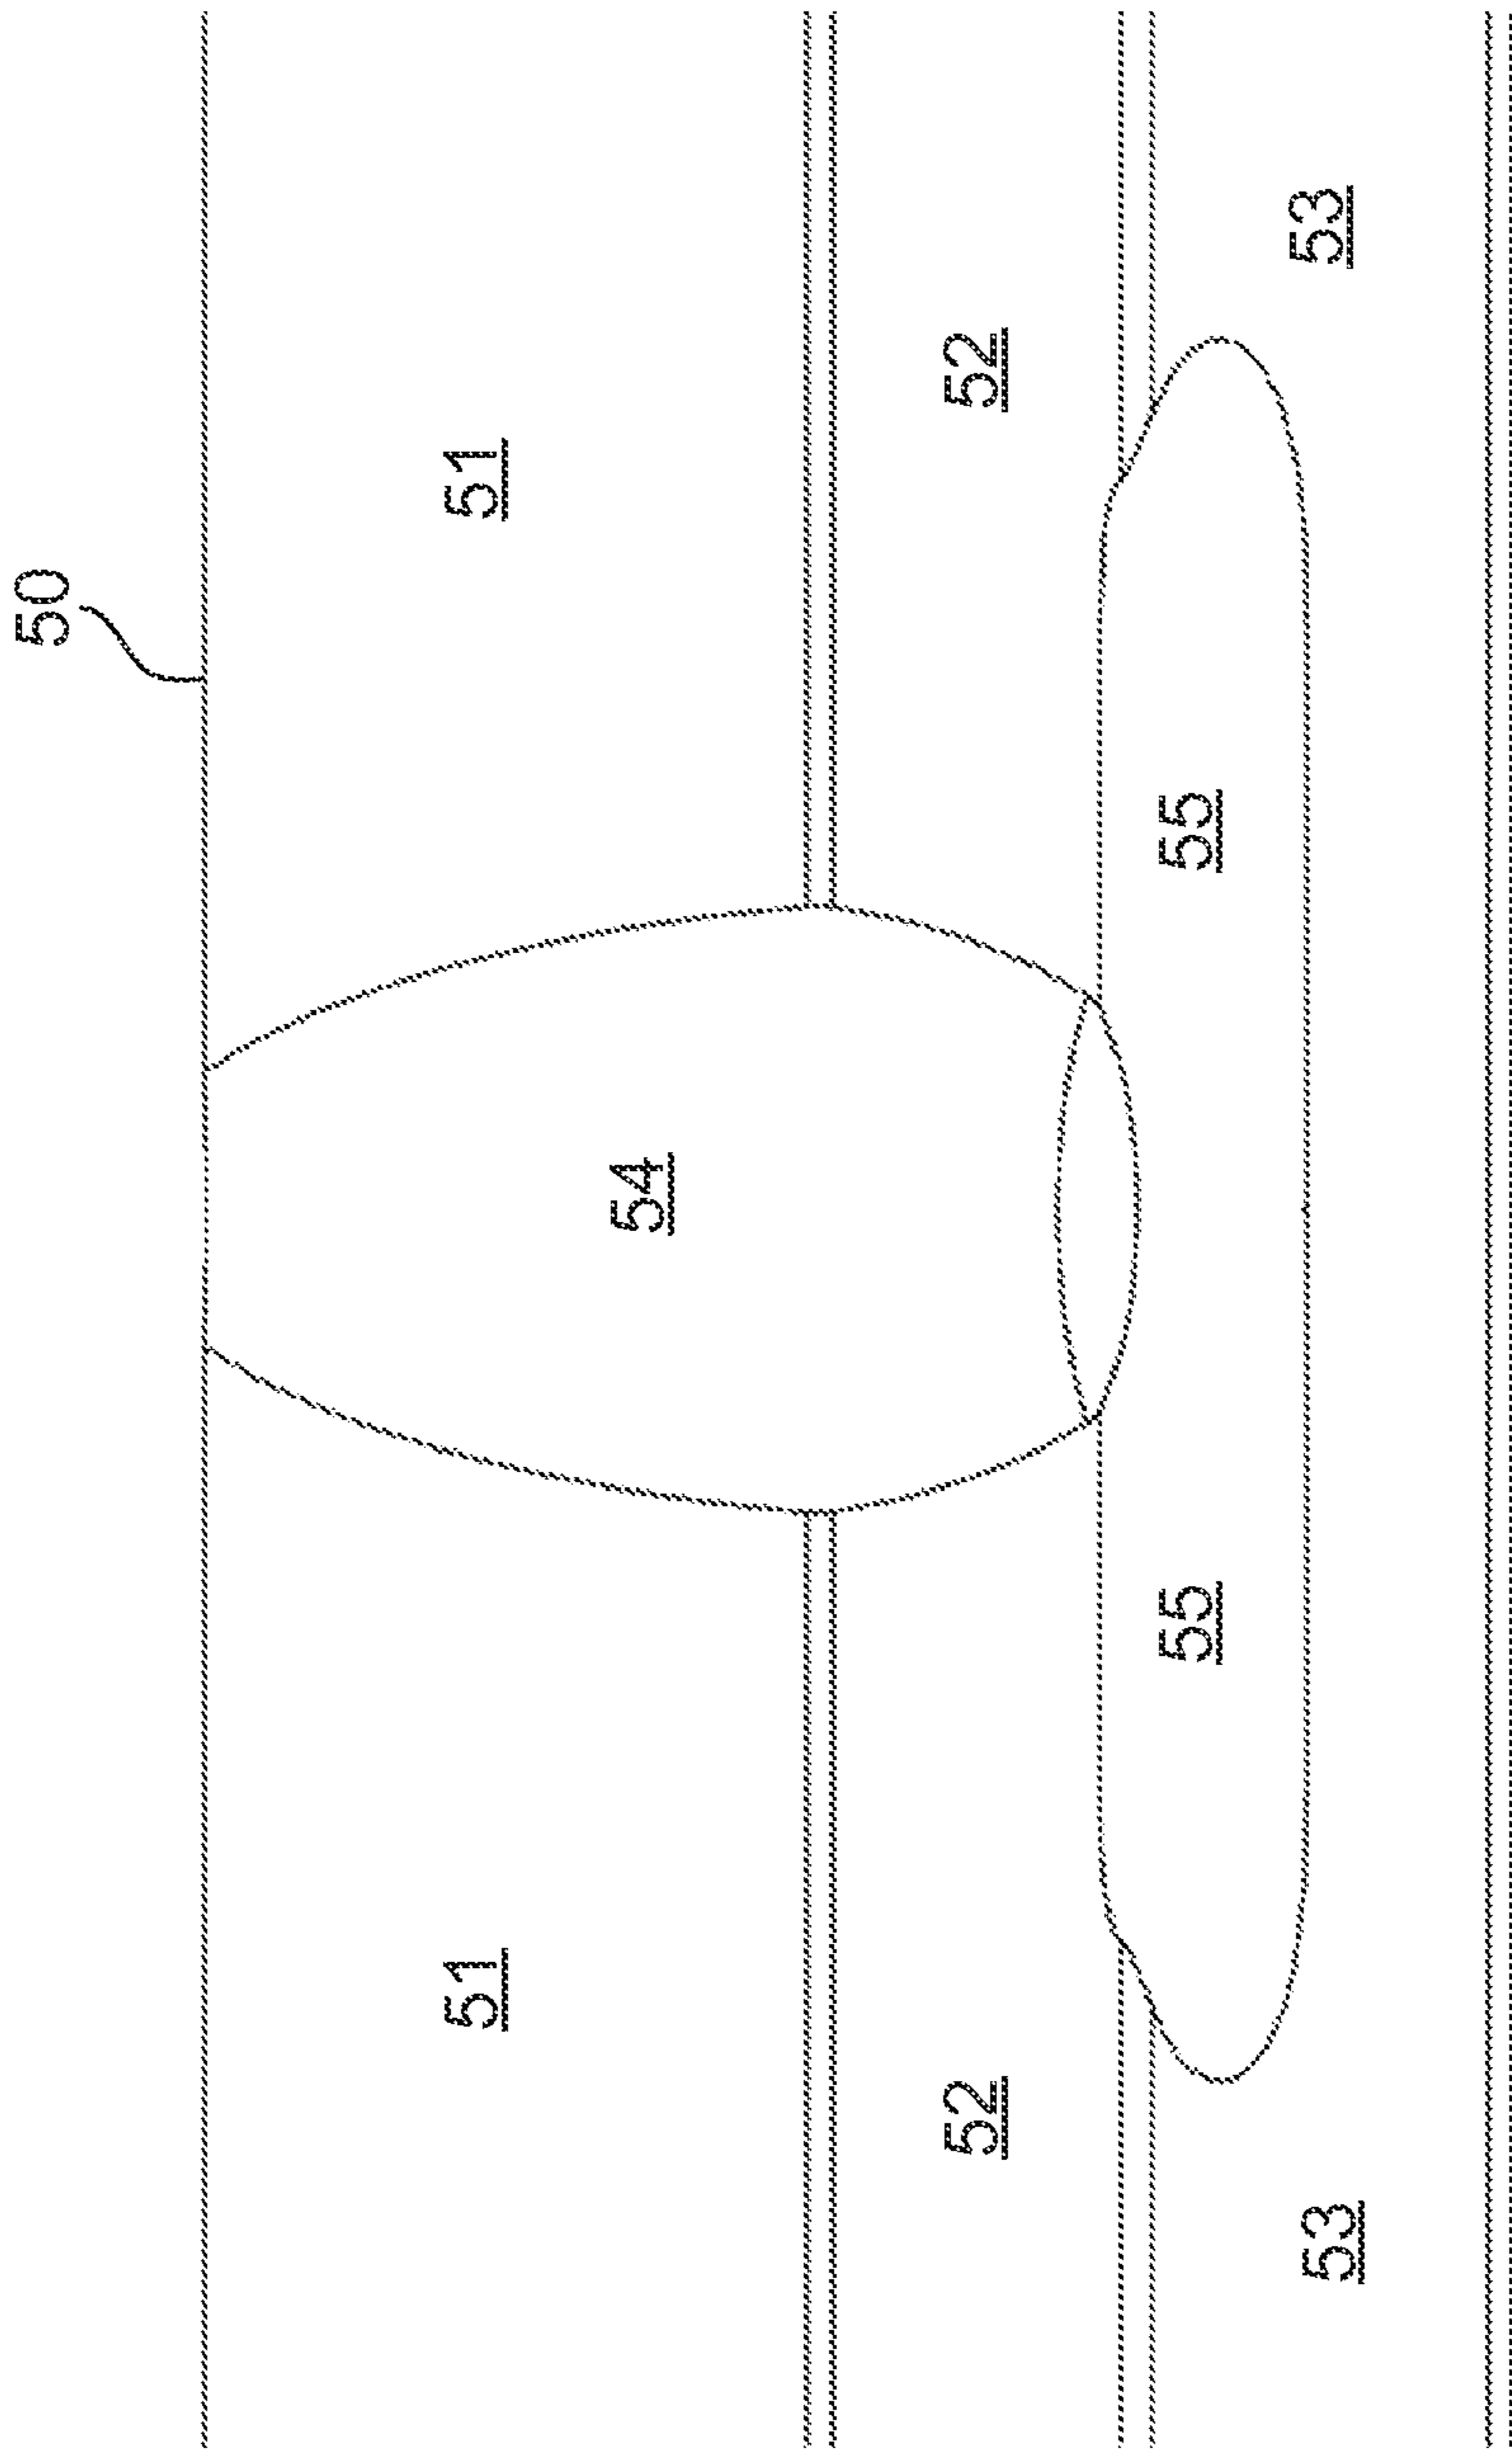
FIG. 8 is a side view of the rotor slot, showing the first and second grooves machined into the slot wall, according to an aspect of the present invention,

A second groove 55 may be machined in the intermediate radial surface 53. The second groove 55 is oriented in a substantially perpendicular direction with respect to the first groove 54. For example, the second groove 55 may be machined in an axial direction with respect to rotor 10. The second groove 55 may also be configured to contact a portion, of the first groove 54, as shown in FIG. 4. The first groove 54 and/or the second groove 55 are configured to remove damaged material (e.g., a crack) from the coil slot wail, and both grooves 54, 55 may act as a preventative measure against future damage to the coil slot wall. The machining work may create a first concave groove 54 and a second concave groove 55. Once the material is machined to form the grooved portions, the sharp edges along the boundaries of both portions may be radiused. Machining in this manner only minimally reduces the low and high cycle fatigue life of the rotor. Where appropriate (i.e., depending on the crack location and extent of the crack), the repair may be effected by forming the first groove 54 only. When the wedges are replaced, the butt joint between adjacent wedges may be centered on the machined regions (i.e., on the radial centerline through the groove 54. Alternatively, the wedge butt joint may be axially offset from the repaired area.
