(10) **Patent No.:** **US 10,107,101 B2**  
(45) **Date of Patent:** **Oct. 23, 2018**

(54) **METHOD TO REPAIR VARIABLE VANES**

(71) Applicant: **UNITED TECHNOLOGIES CORPORATION**, Hartford, CT (US)

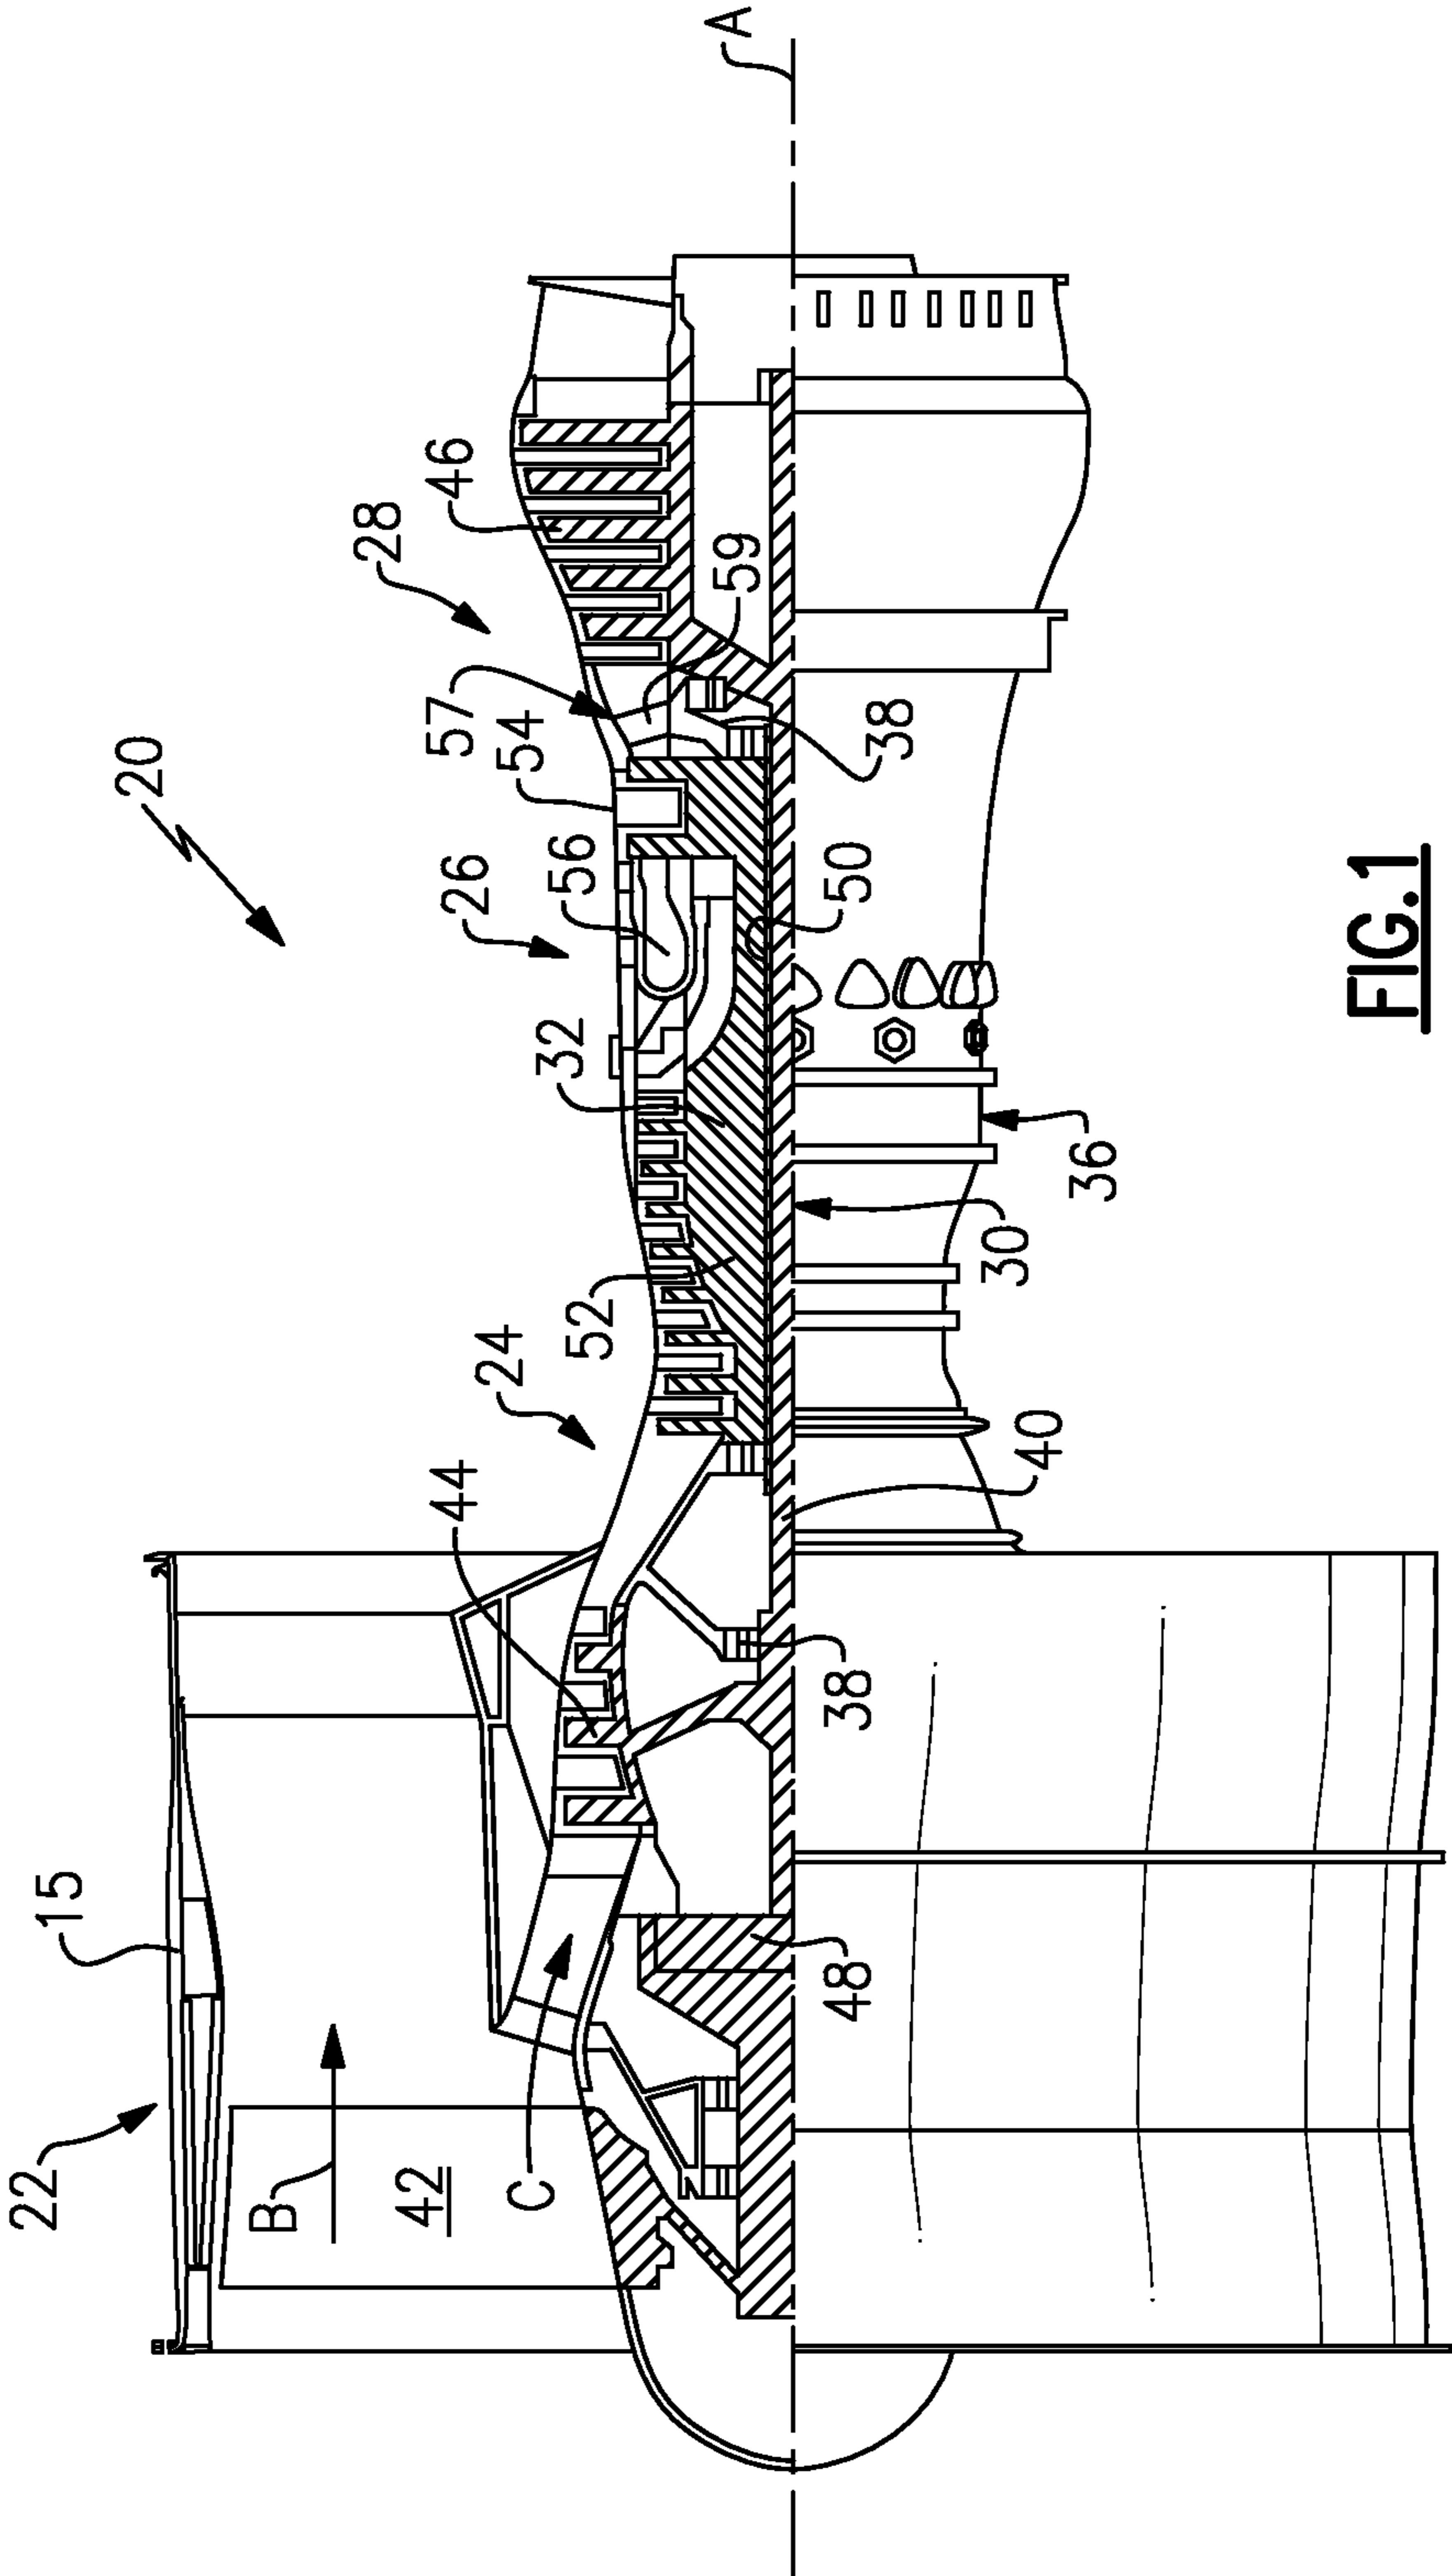
**FIG. 1**

FIG. 1 schematically shows a gas turbine engine.

FIG. 1 schematically illustrates a gas turbine engine 20. The gas turbine engine 20 is disclosed herein as a two-spool turbofan that generally incorporates a fan section 22, a compressor section 24, a combustor section 26 and a turbine section 28. Alternative engines might include an augmentor section (not shown) among other systems or features. The fan section 22 drives air along a bypass flow path B in a bypass duct defined within a nacelle 15, while the compressor section 24 drives air along a core flow path C for compression and communication into the combustor section 26 then expansion through the turbine section 28. Although depicted as a two-spool turbofan gas turbine engine in the disclosed non-limiting embodiment, it should be understood that the concepts described herein are not limited to use with two-spool turbofans as the teachings may be applied to other types of turbine engines including three-spool architectures.

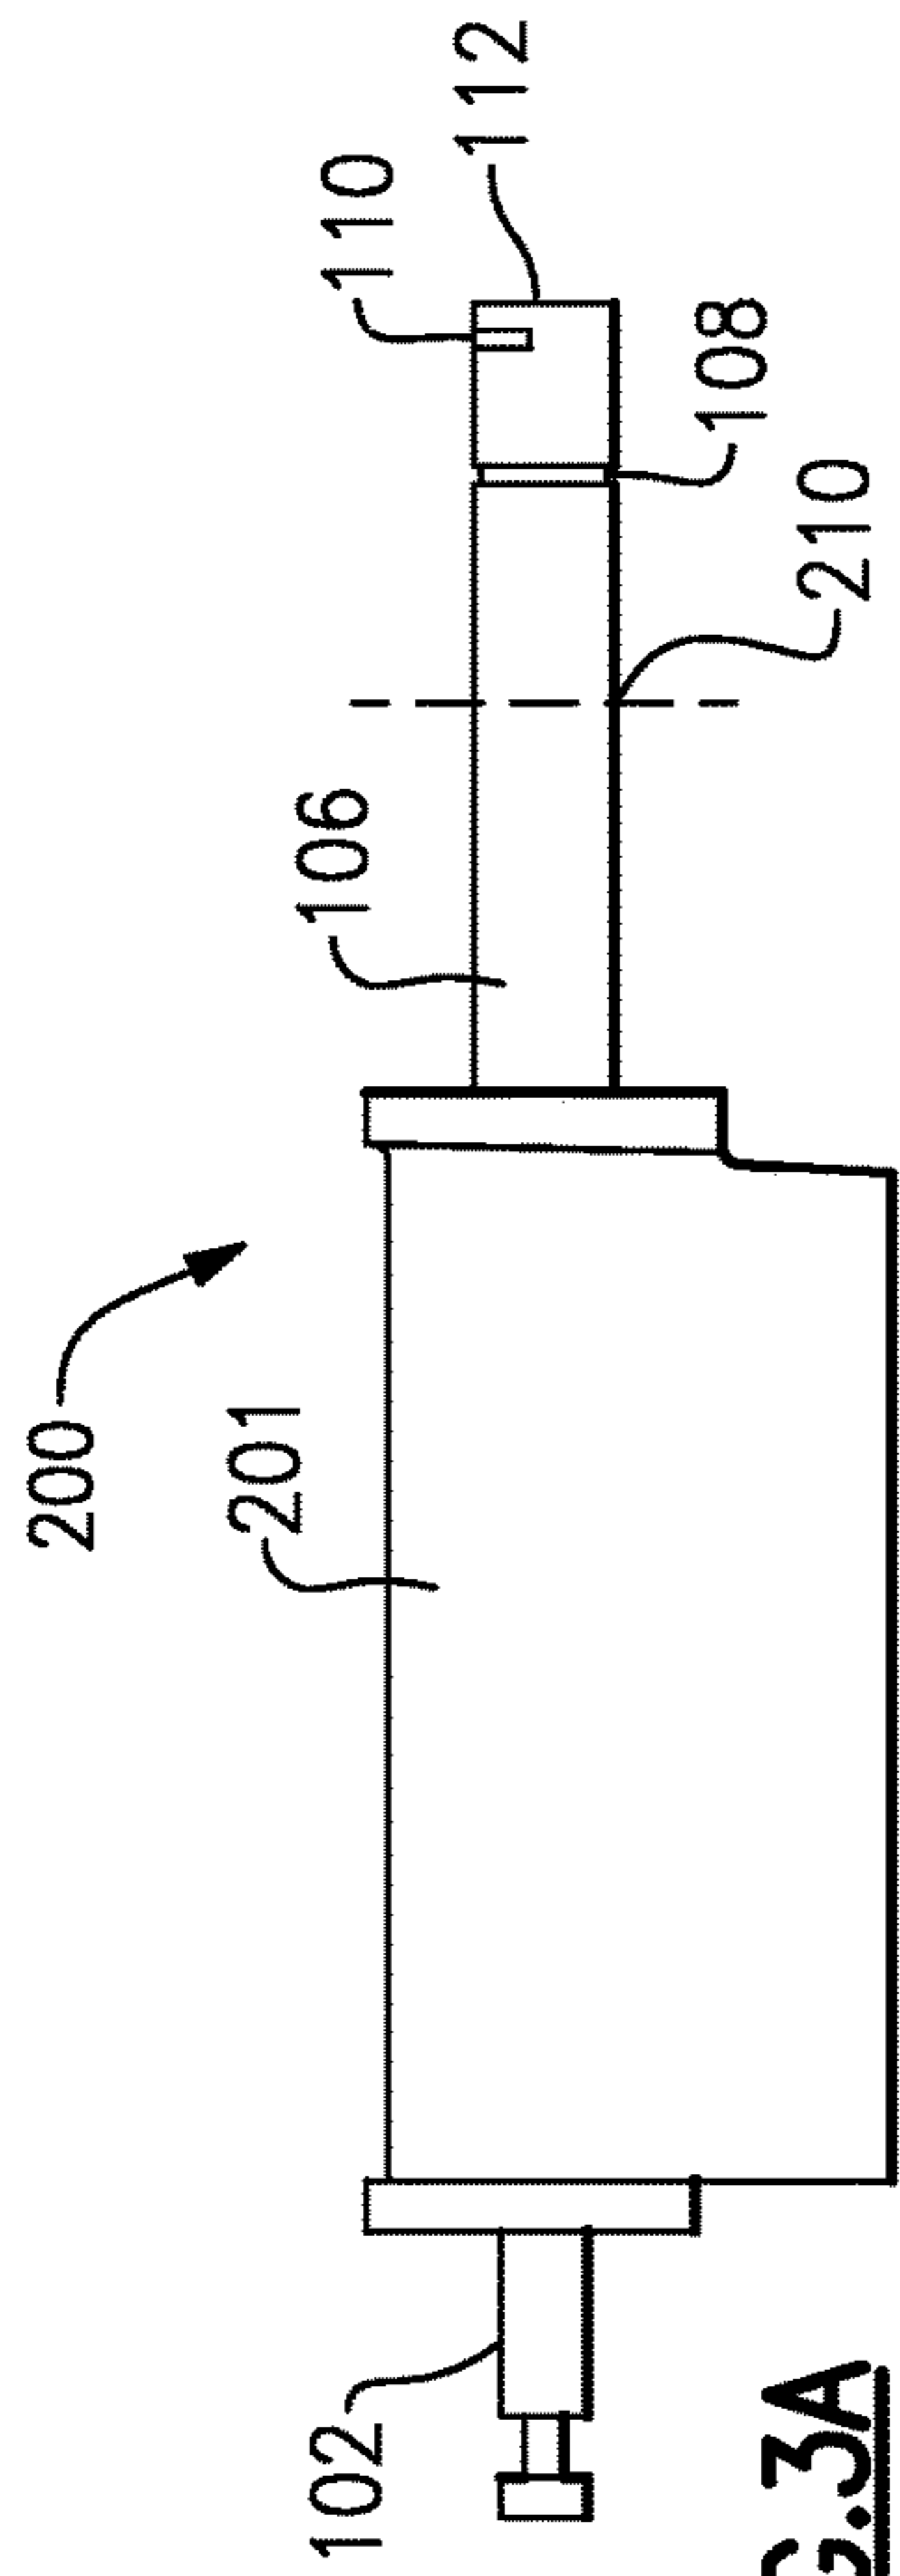
**FIG. 3A**

FIG. 3A shows a first repair step.
