(10) **Patent No.:** **US 10,118,366 B2**
(45) **Date of Patent:** **Nov. 6, 2018**

(54) **UNIT COMPRISING A FORMWORK BOARD INCLUDING A HOUSING AND A REPAIRING ELEMENT SUITABLE FOR BEING FIXED TO THE HOUSING, AND REPAIRING METHOD OF A FORMWORK BOARD**

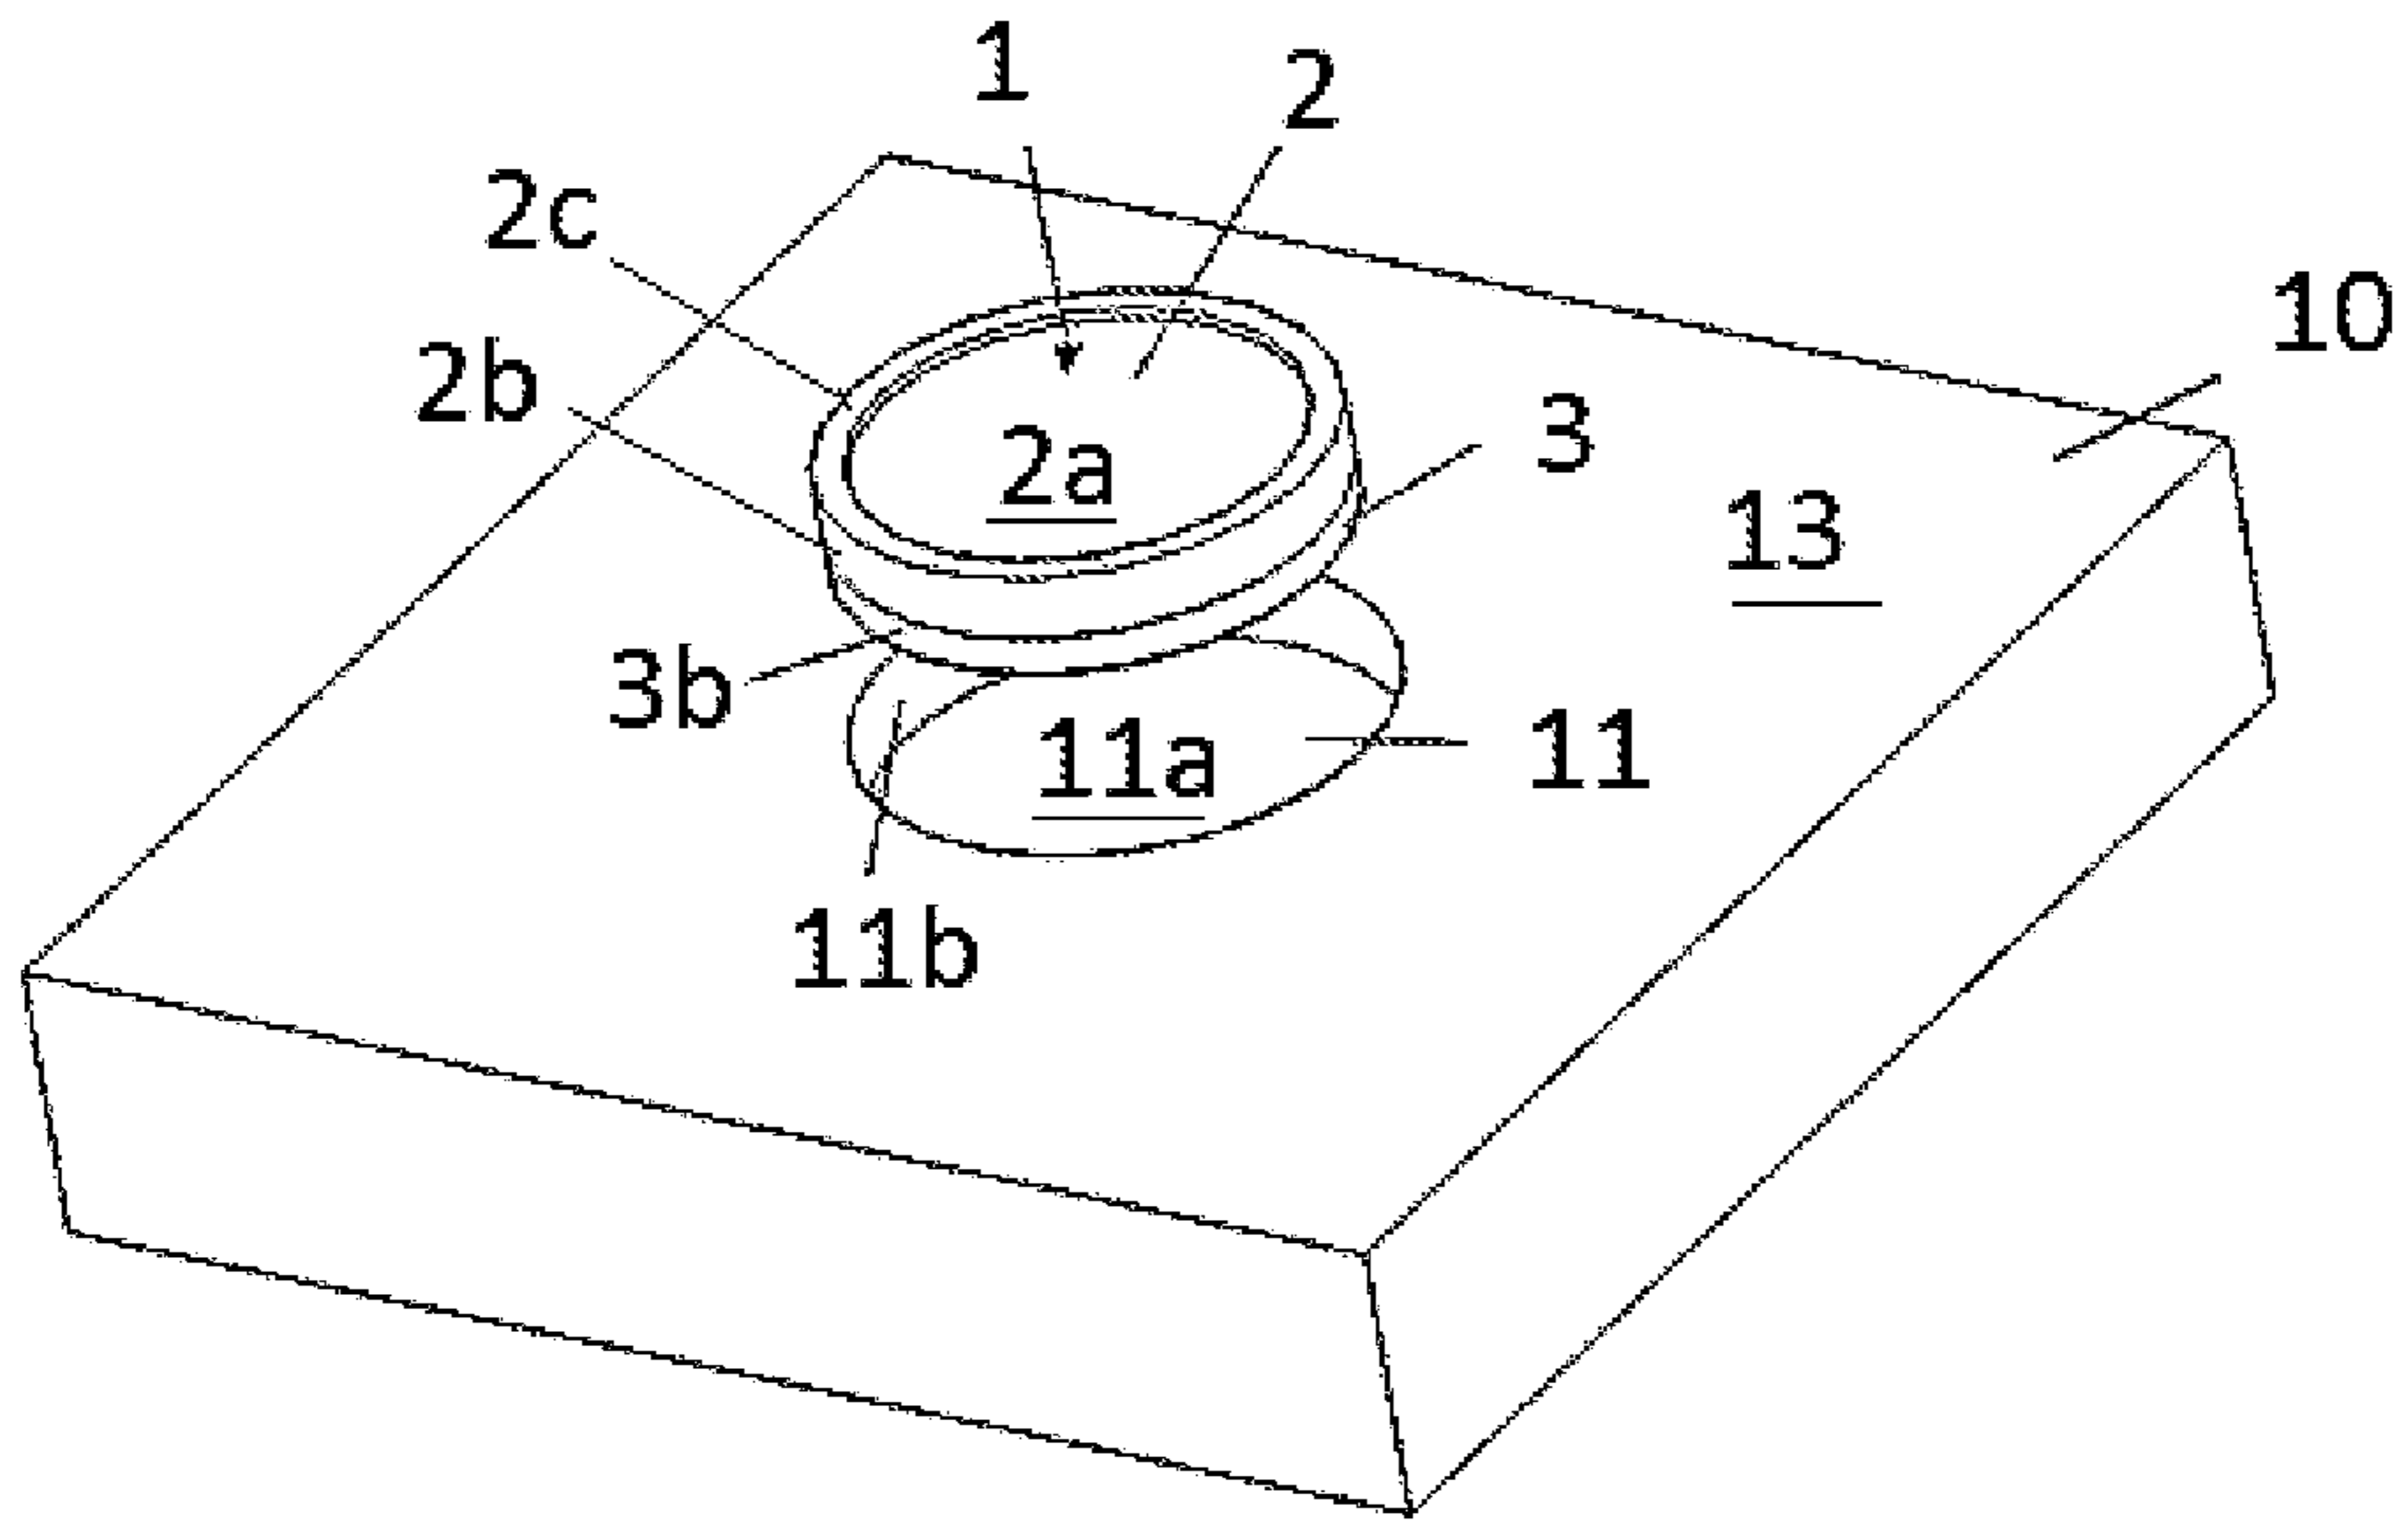
FIG. 1 shows a perspective view of a formwork board before being repaired.

FIGS. 1 to 3 show a repairing element 1 according to one implementation that is suitable for being fixed to a housing 11 of a formwork board 10. The repairing element 1 comprises a first member 2 made of thermoplastic material and a second member 3 made of porous material. The second member 3 acts as a support of the first member 2, the first member 2 being arranged on the second member 3. According to one implementation, the second member 3 is injection molded on the first member 2, the repairing element 1 being obtained.

According to one implementation the first member 2 further comprises an annular projection 2c extending from an outer surface 2a of the first member 2 as shown in FIGS. 1 to 3. Said annular projection 2c assures that there is enough material to completely fill the cavity 12.

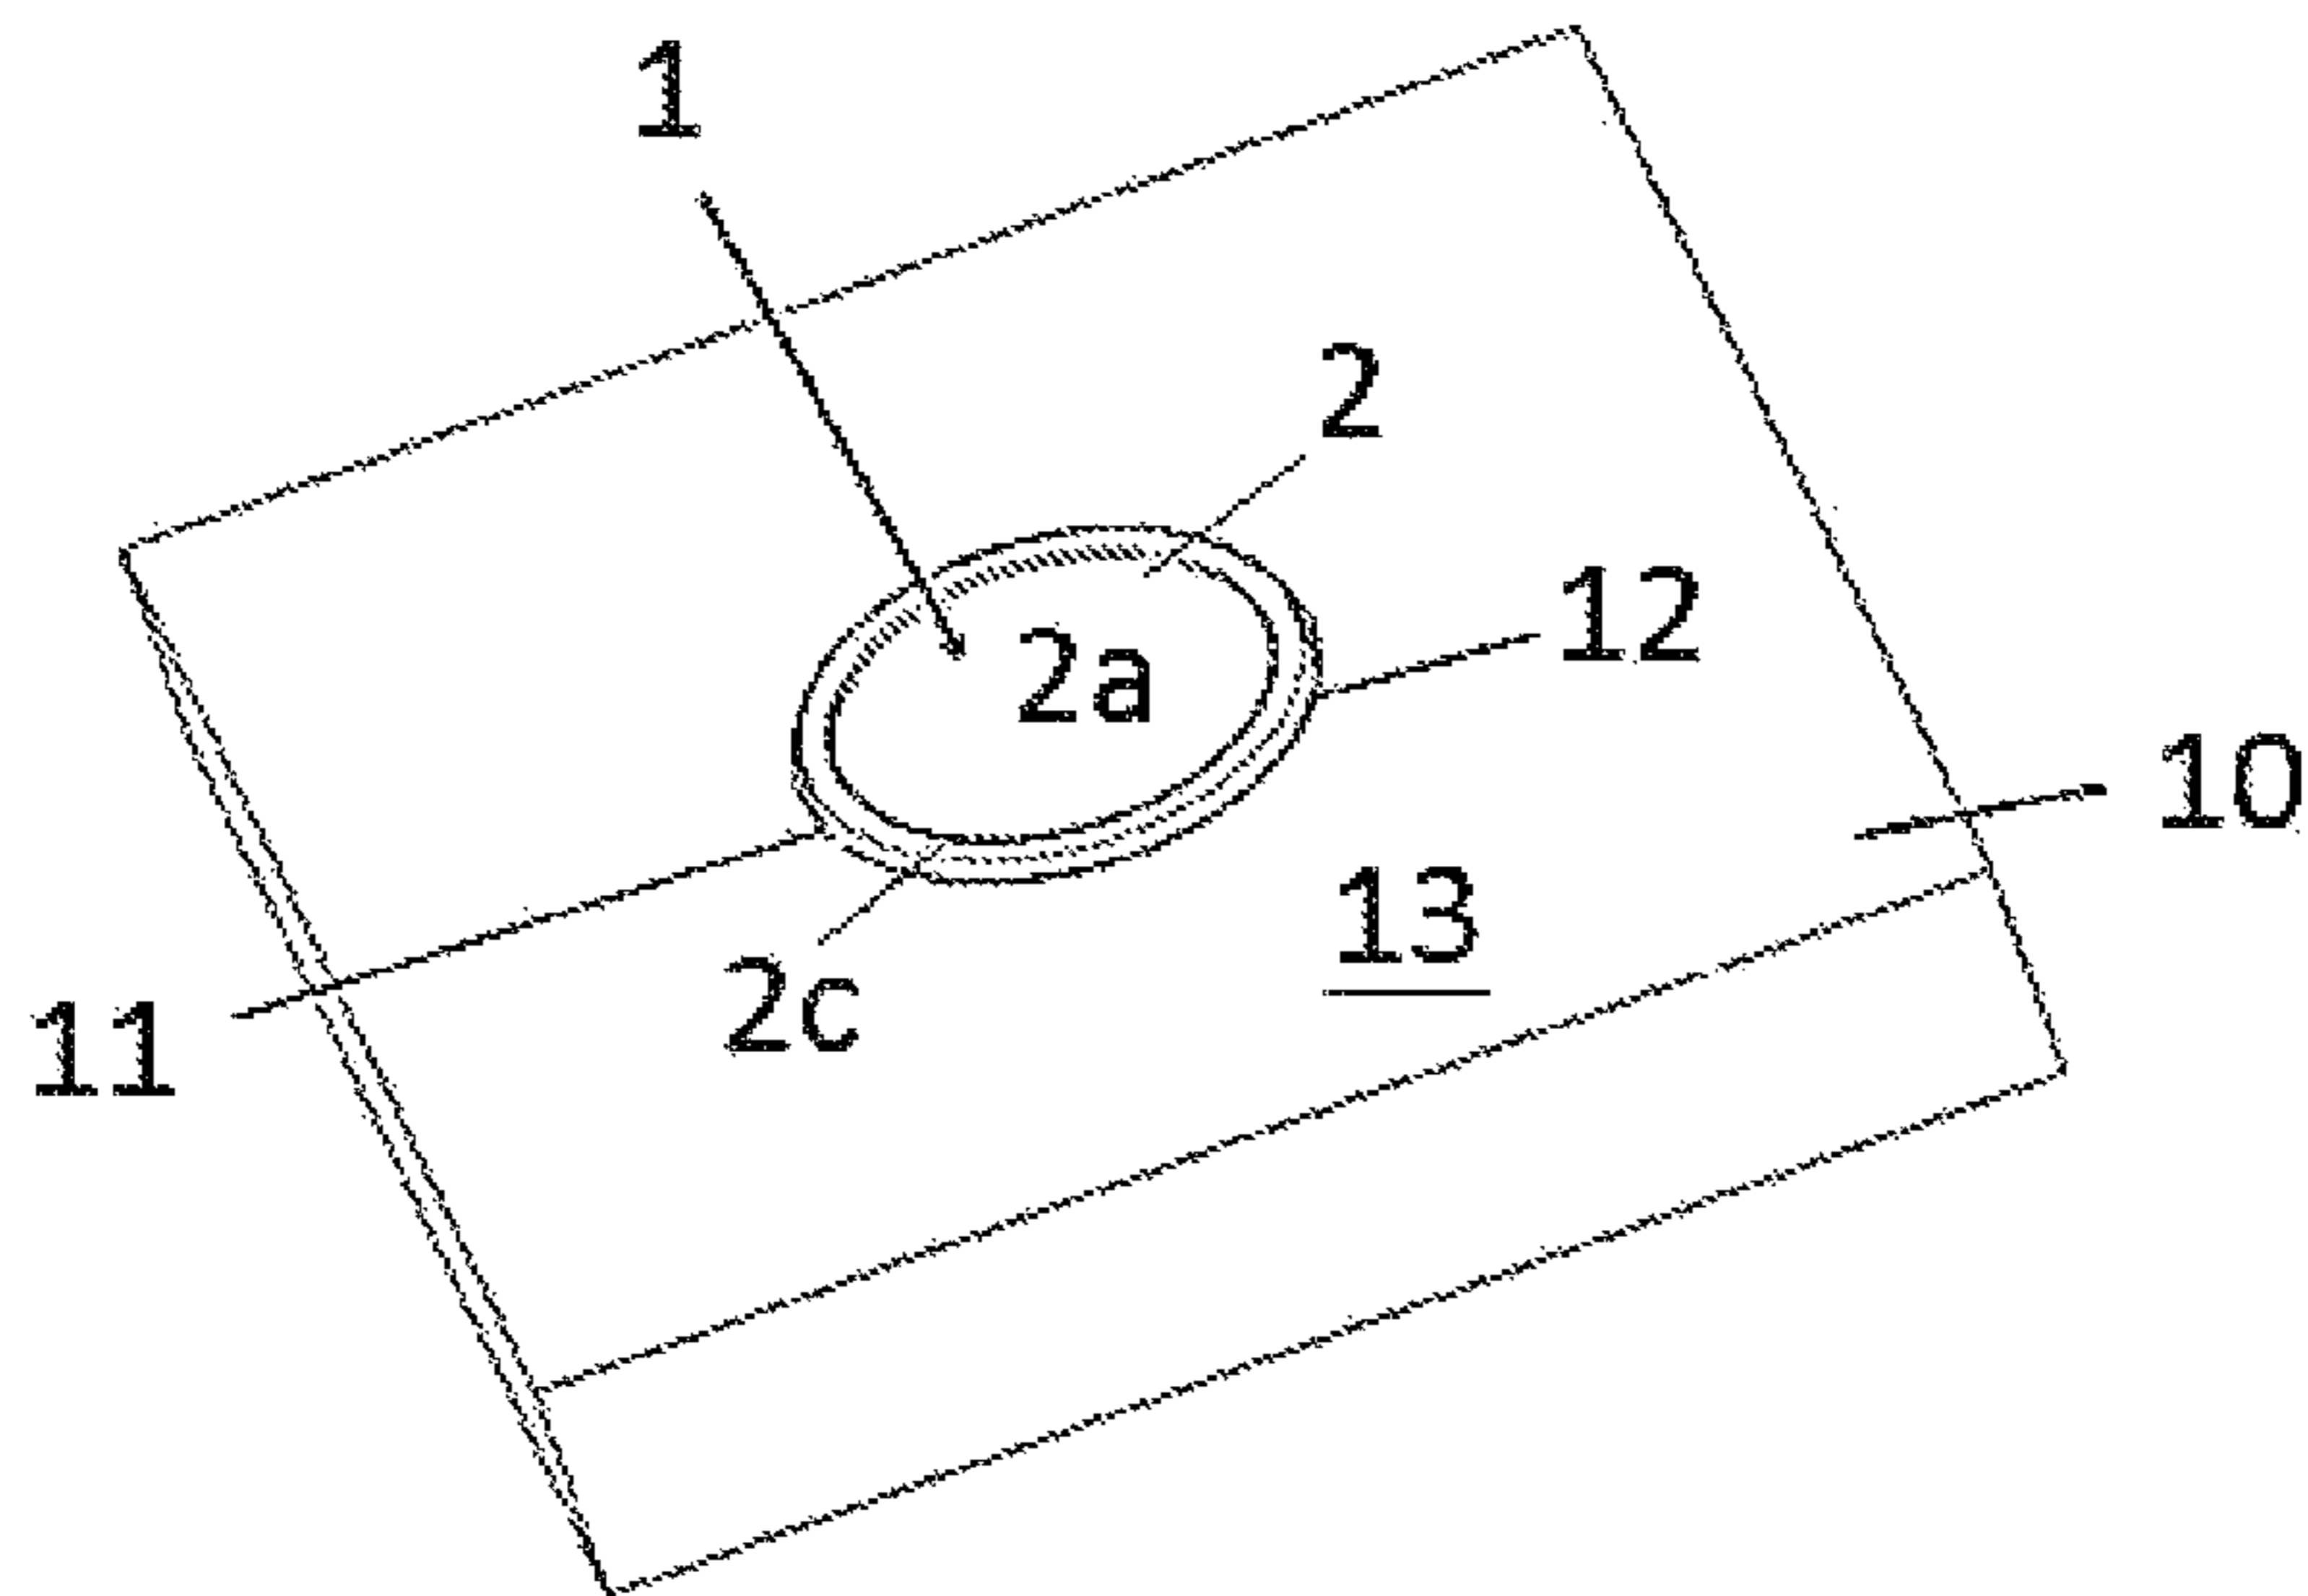
FIG. 2 shows a perspective view of the formwork board and the repairing element shown in FIG. 1, the repairing element being housed in the formwork board.

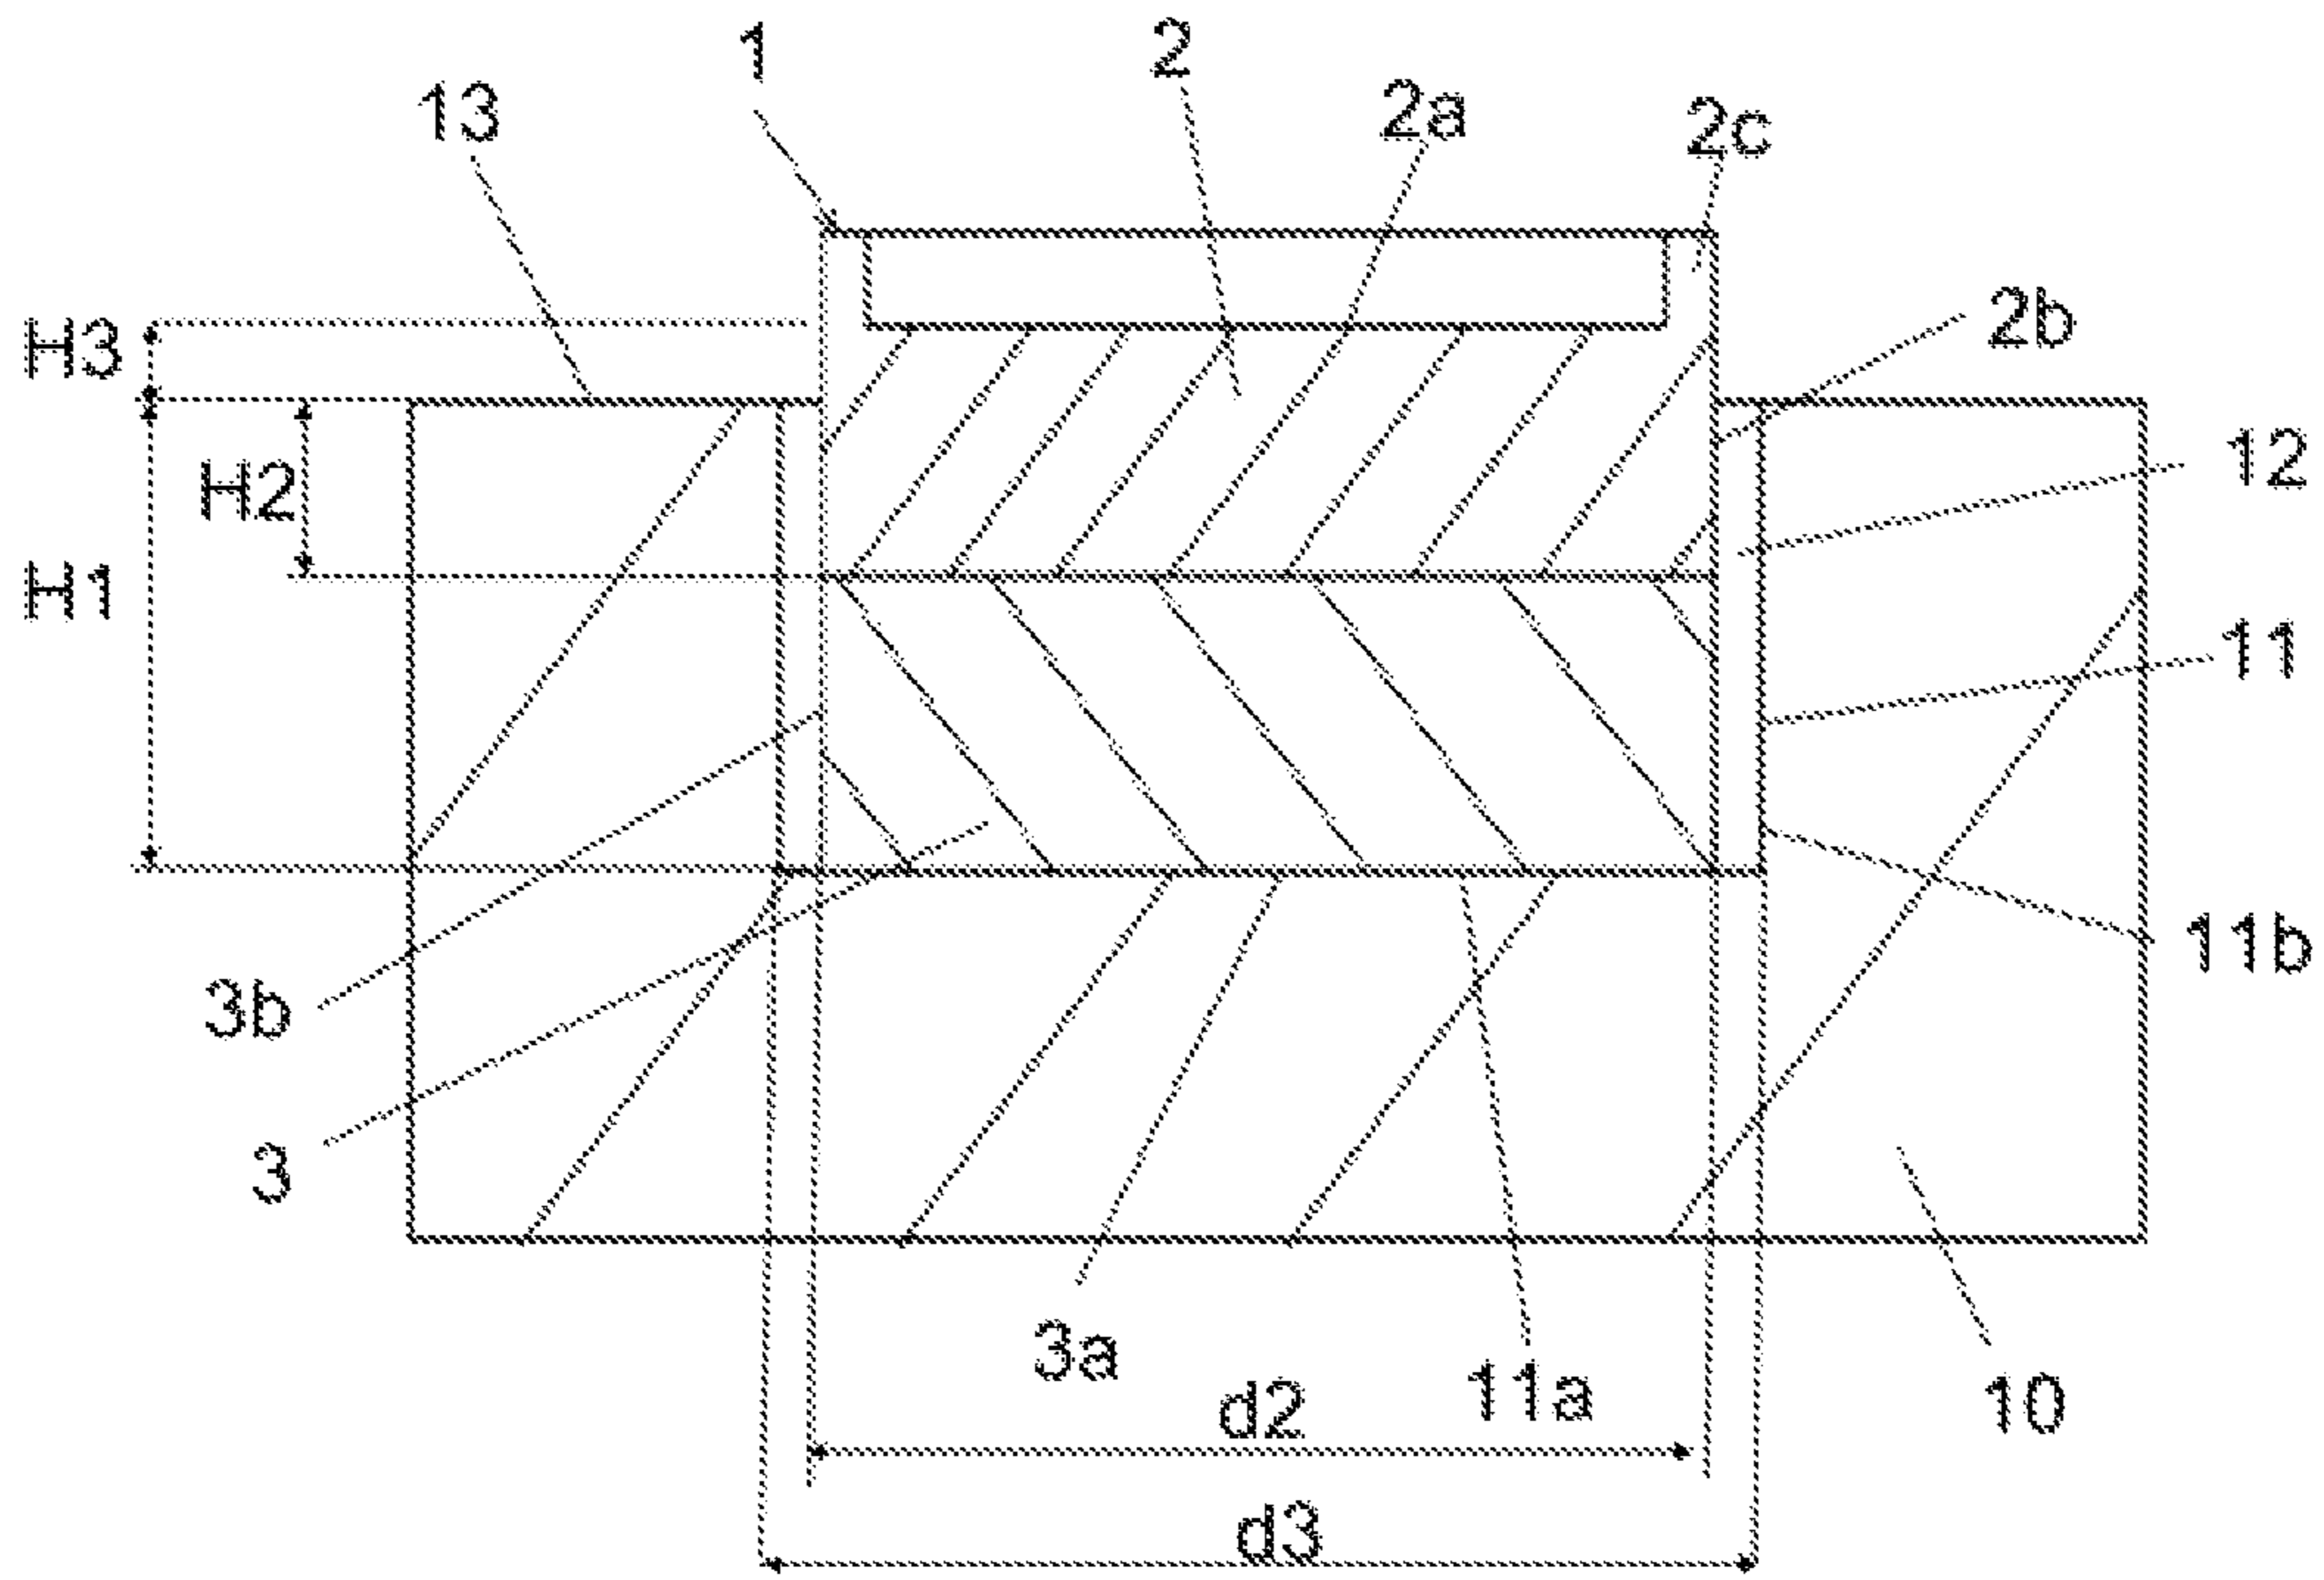
FIG. 3 shows a cross-section of the formwork board and the repairing element shown in FIG. 1 inserted in the housing of said board.

Since the base 3a of the second member 3 is fixed to the board 10, the repairing element 1 can be centered with respect to the housing 11, substantially concentric to said housing 11. Therefore, the material flows during the subsequent step of melting at least one part of the first member 2, filling the entire cavity 12, a substantially homogenous seal being formed along the entire perimeter of the repairing element 1 with respect to the housing 11. Once the material of the first melted member 2 has cooled, it completely seals said cavity 12. Finally, the material of the first member 2 which projects from the surface 13 of the board 10 is removed, the resulting repairing element 1 being level with the surface 13 of the board 10, as shown in FIG. 3.

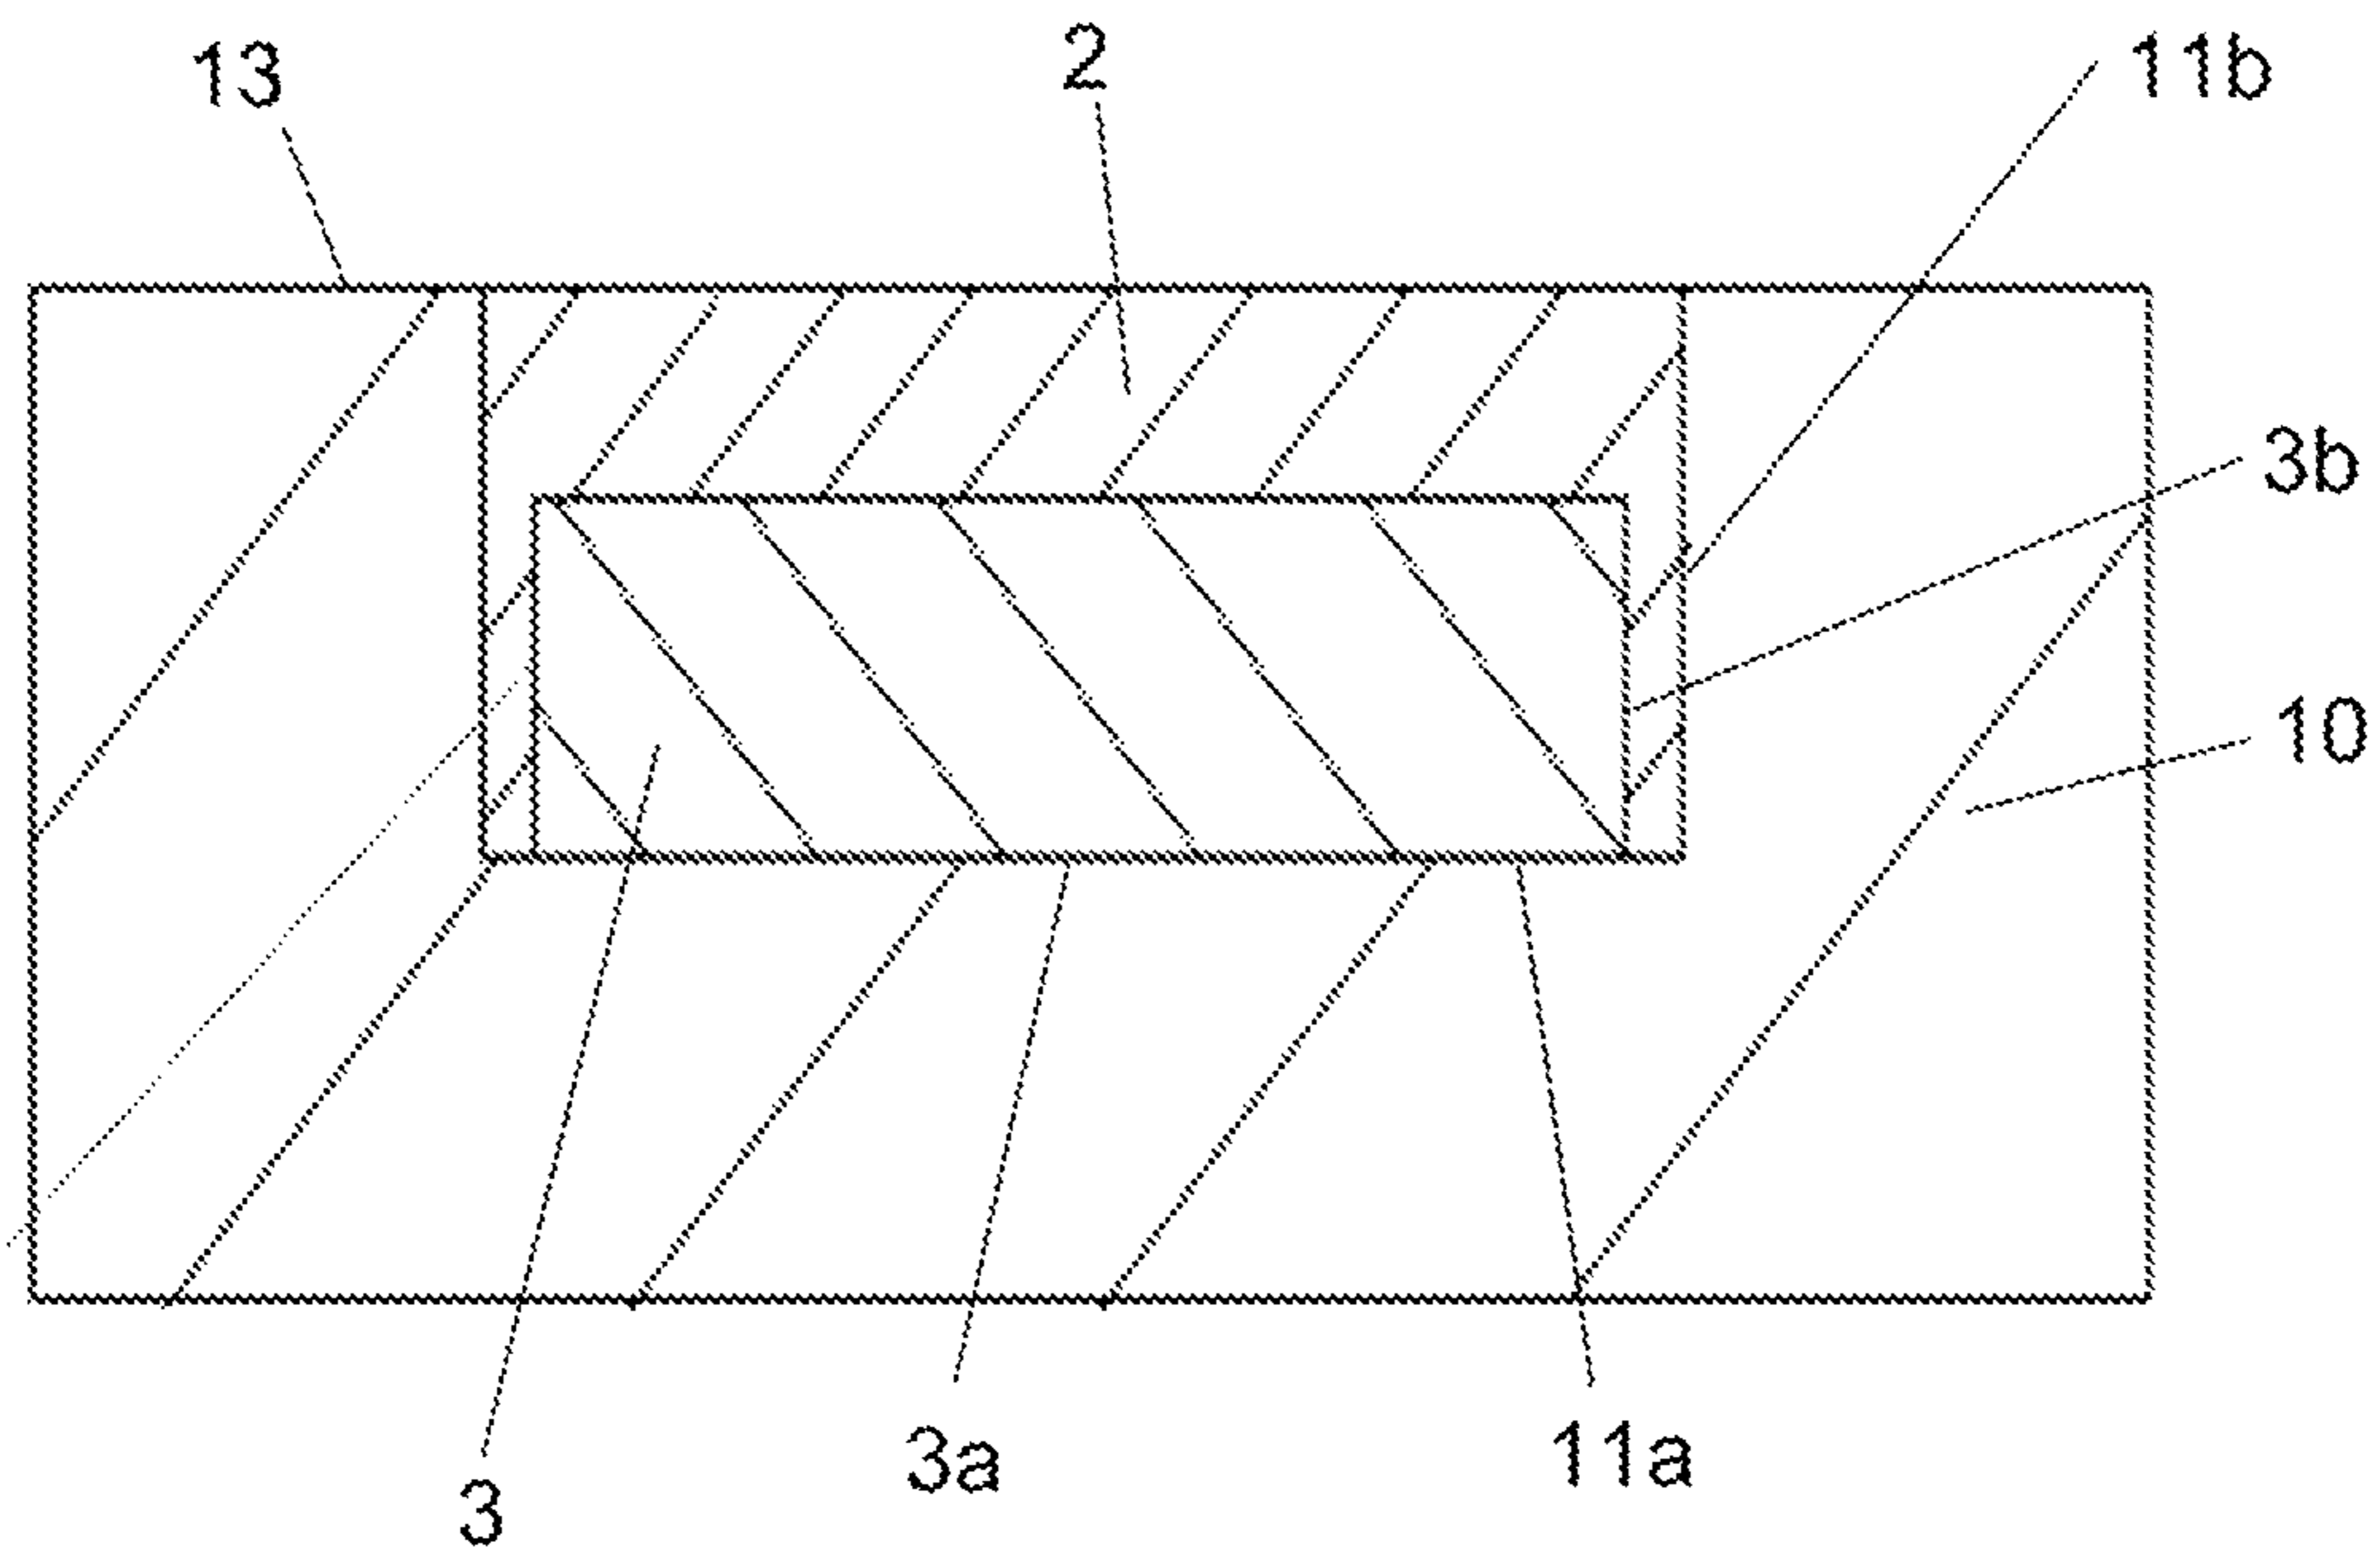
FIG. 4 shows a cross-section of the formwork board that has been repaired with the repairing element shown in FIG. 1.

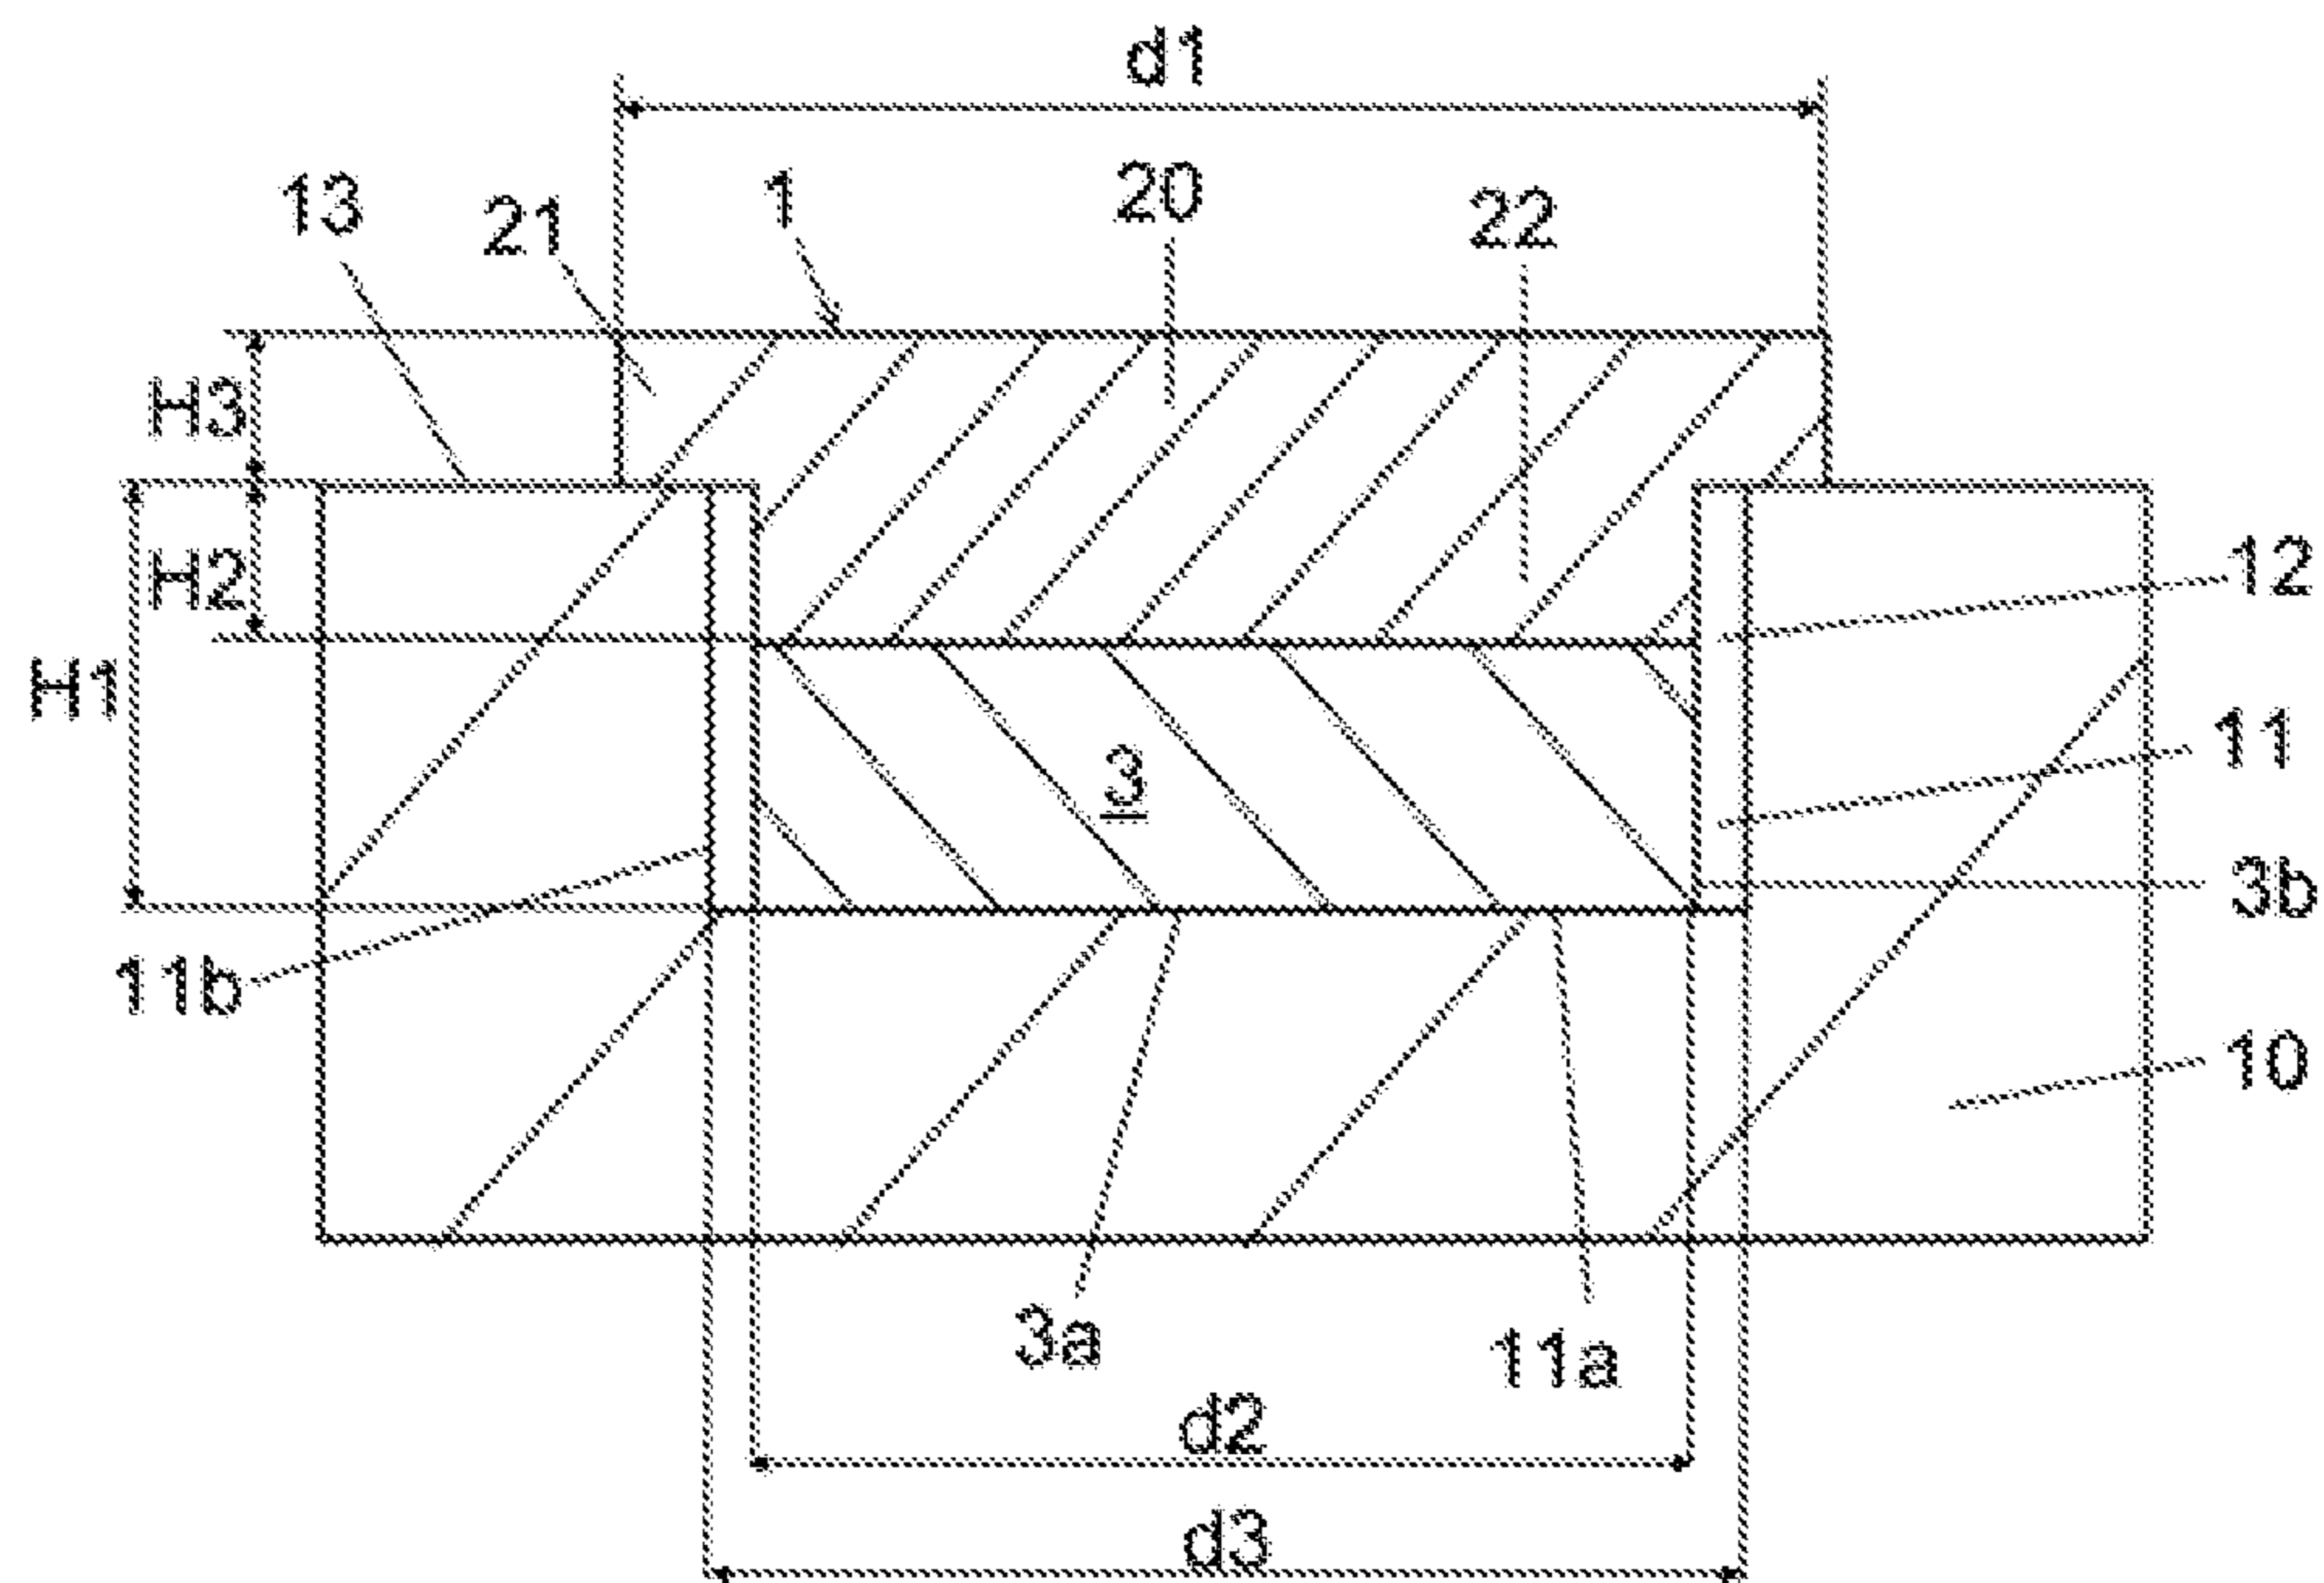
FIG. 5 shows a cross-section of another implementation with the repairing element inserted in the housing of a formwork board.

According to another implementation as shown in FIGS. 5 and 6, the repairing element 1 differs from the repairing element discussed above in conjunction with FIGS. 1 through 4 in that the geometry of the first member 20 is different, the remaining features as well as the repair process being similar, so it is not considered necessary to describe them again.

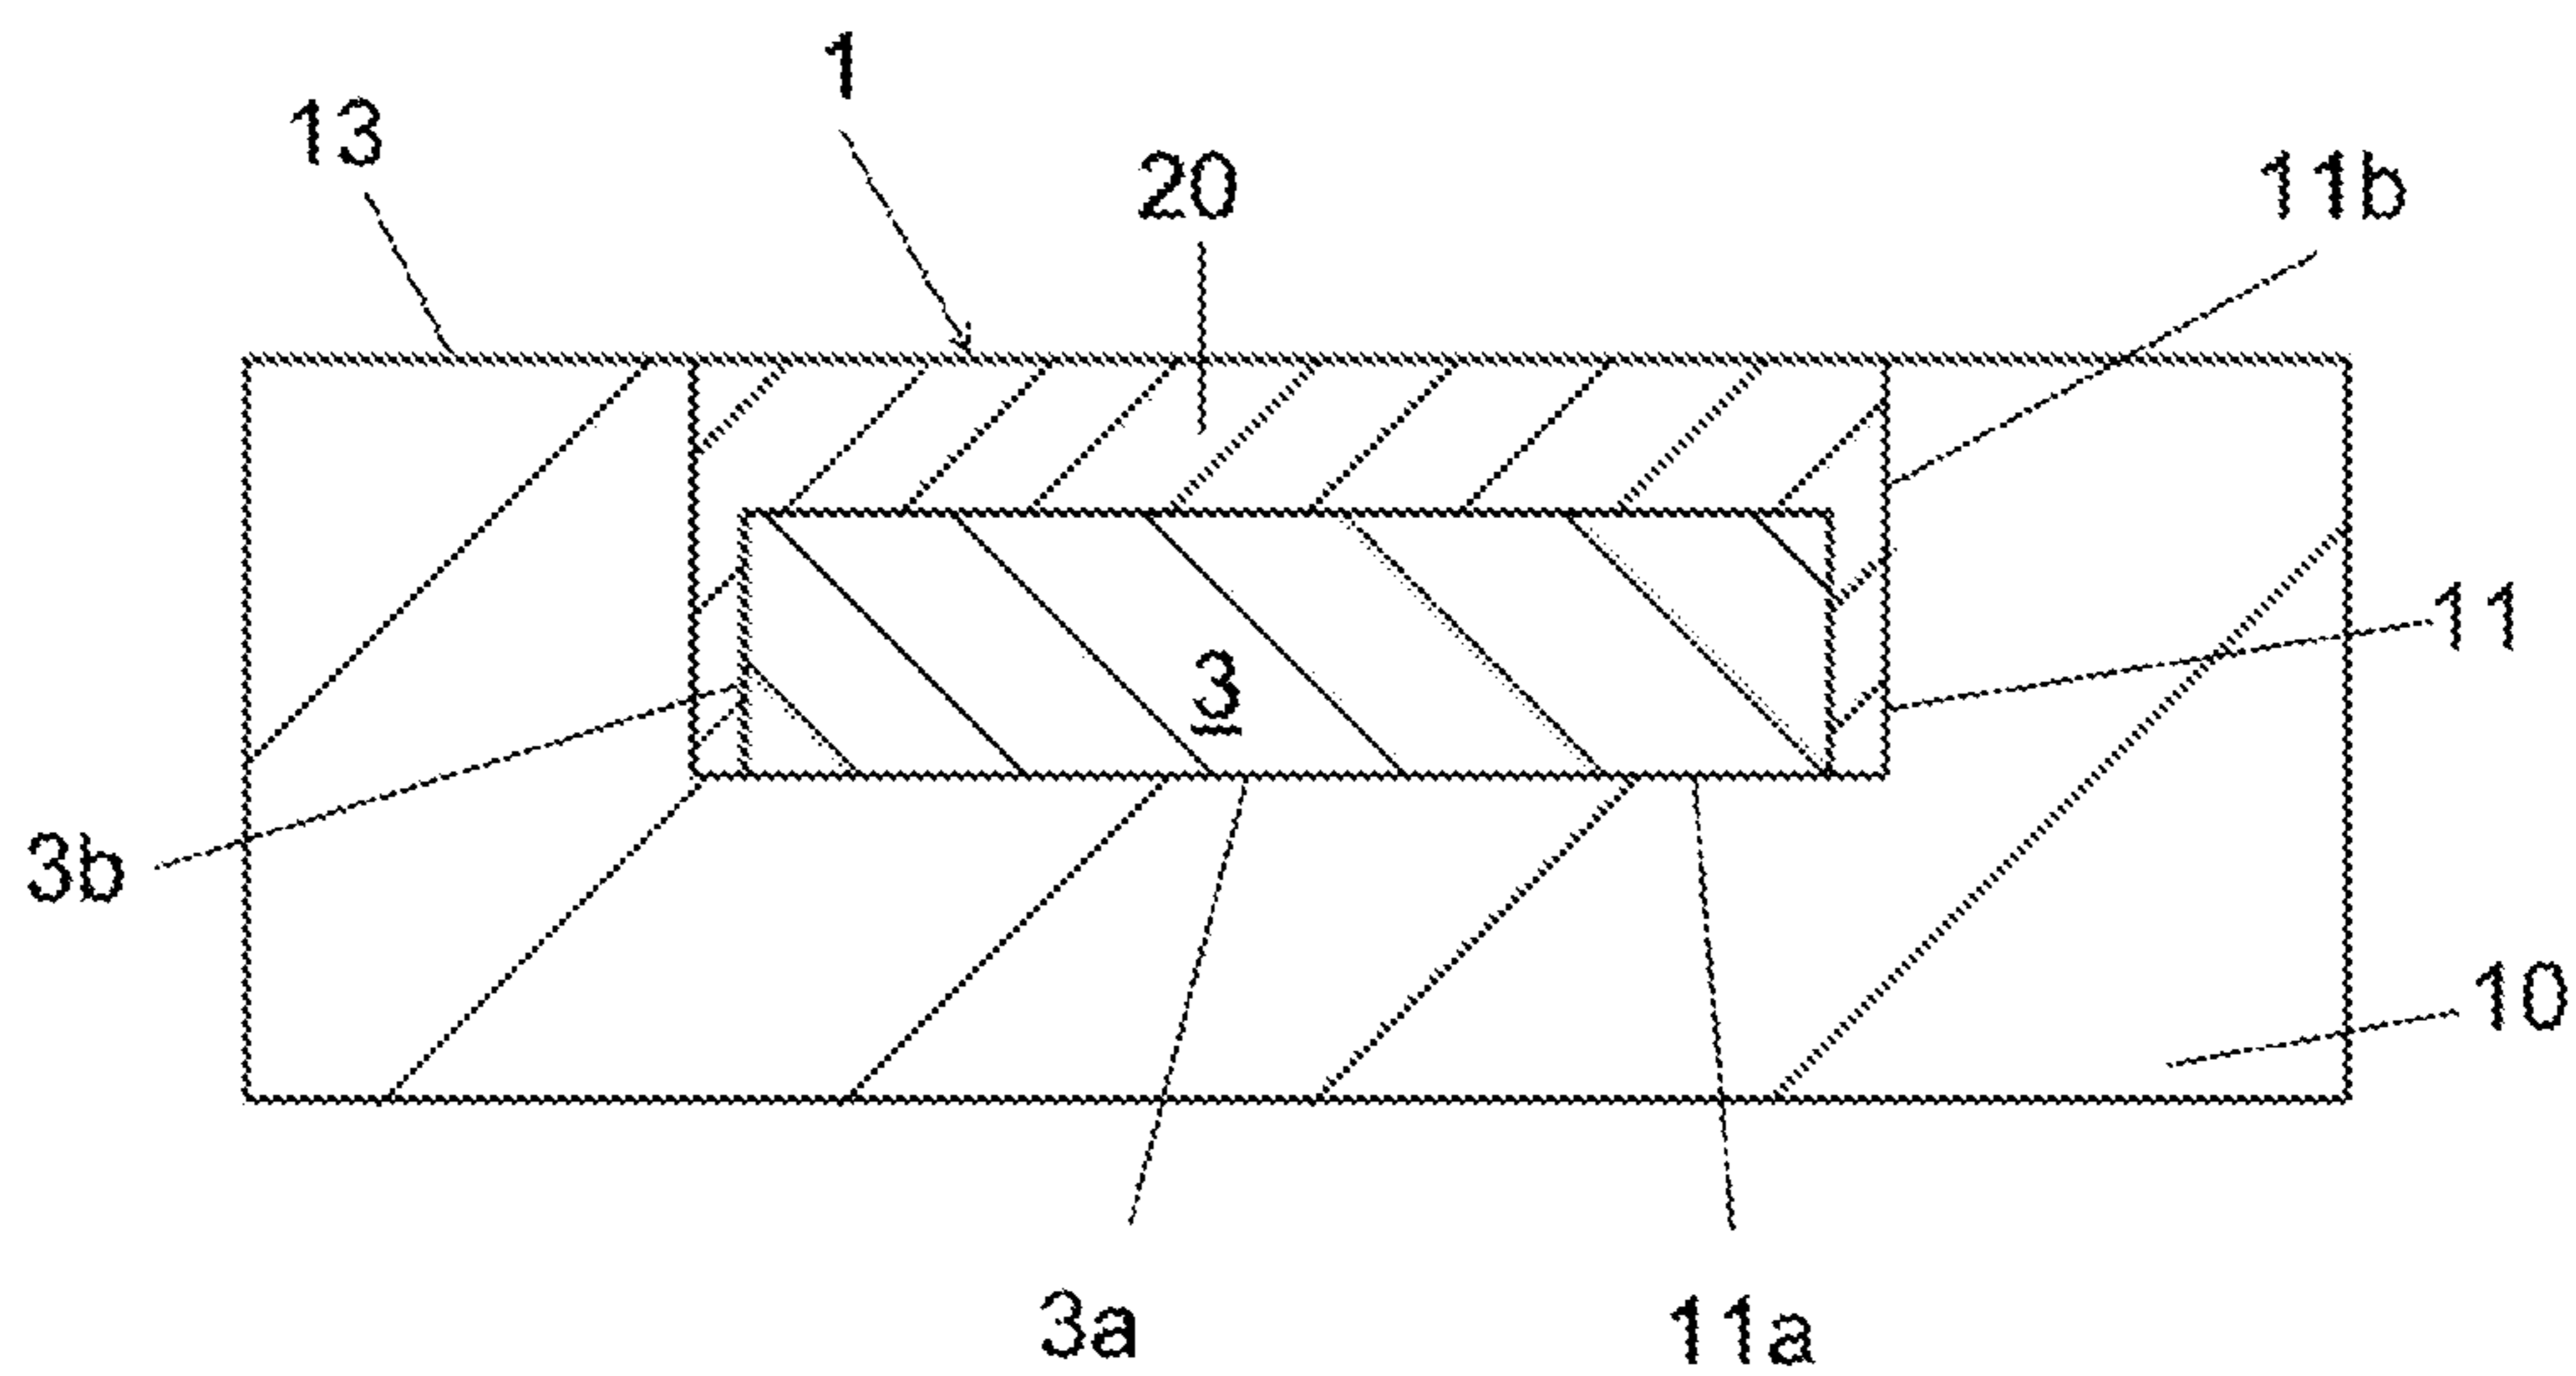
FIG. 6 shows a cross-section of the formwork board that has been repaired with the repairing element shown in FIG. 5.
