(10) **Patent No.:** **US 10,118,366 B2**
(45) **Date of Patent:** **Nov. 6, 2018**

(54) **UNIT COMPRISING A FORMWORK BOARD INCLUDING A HOUSING AND A REPAIRING ELEMENT SUITABLE FOR BEING FIXED TO THE HOUSING, AND REPAIRING METHOD OF A FORMWORK BOARD**

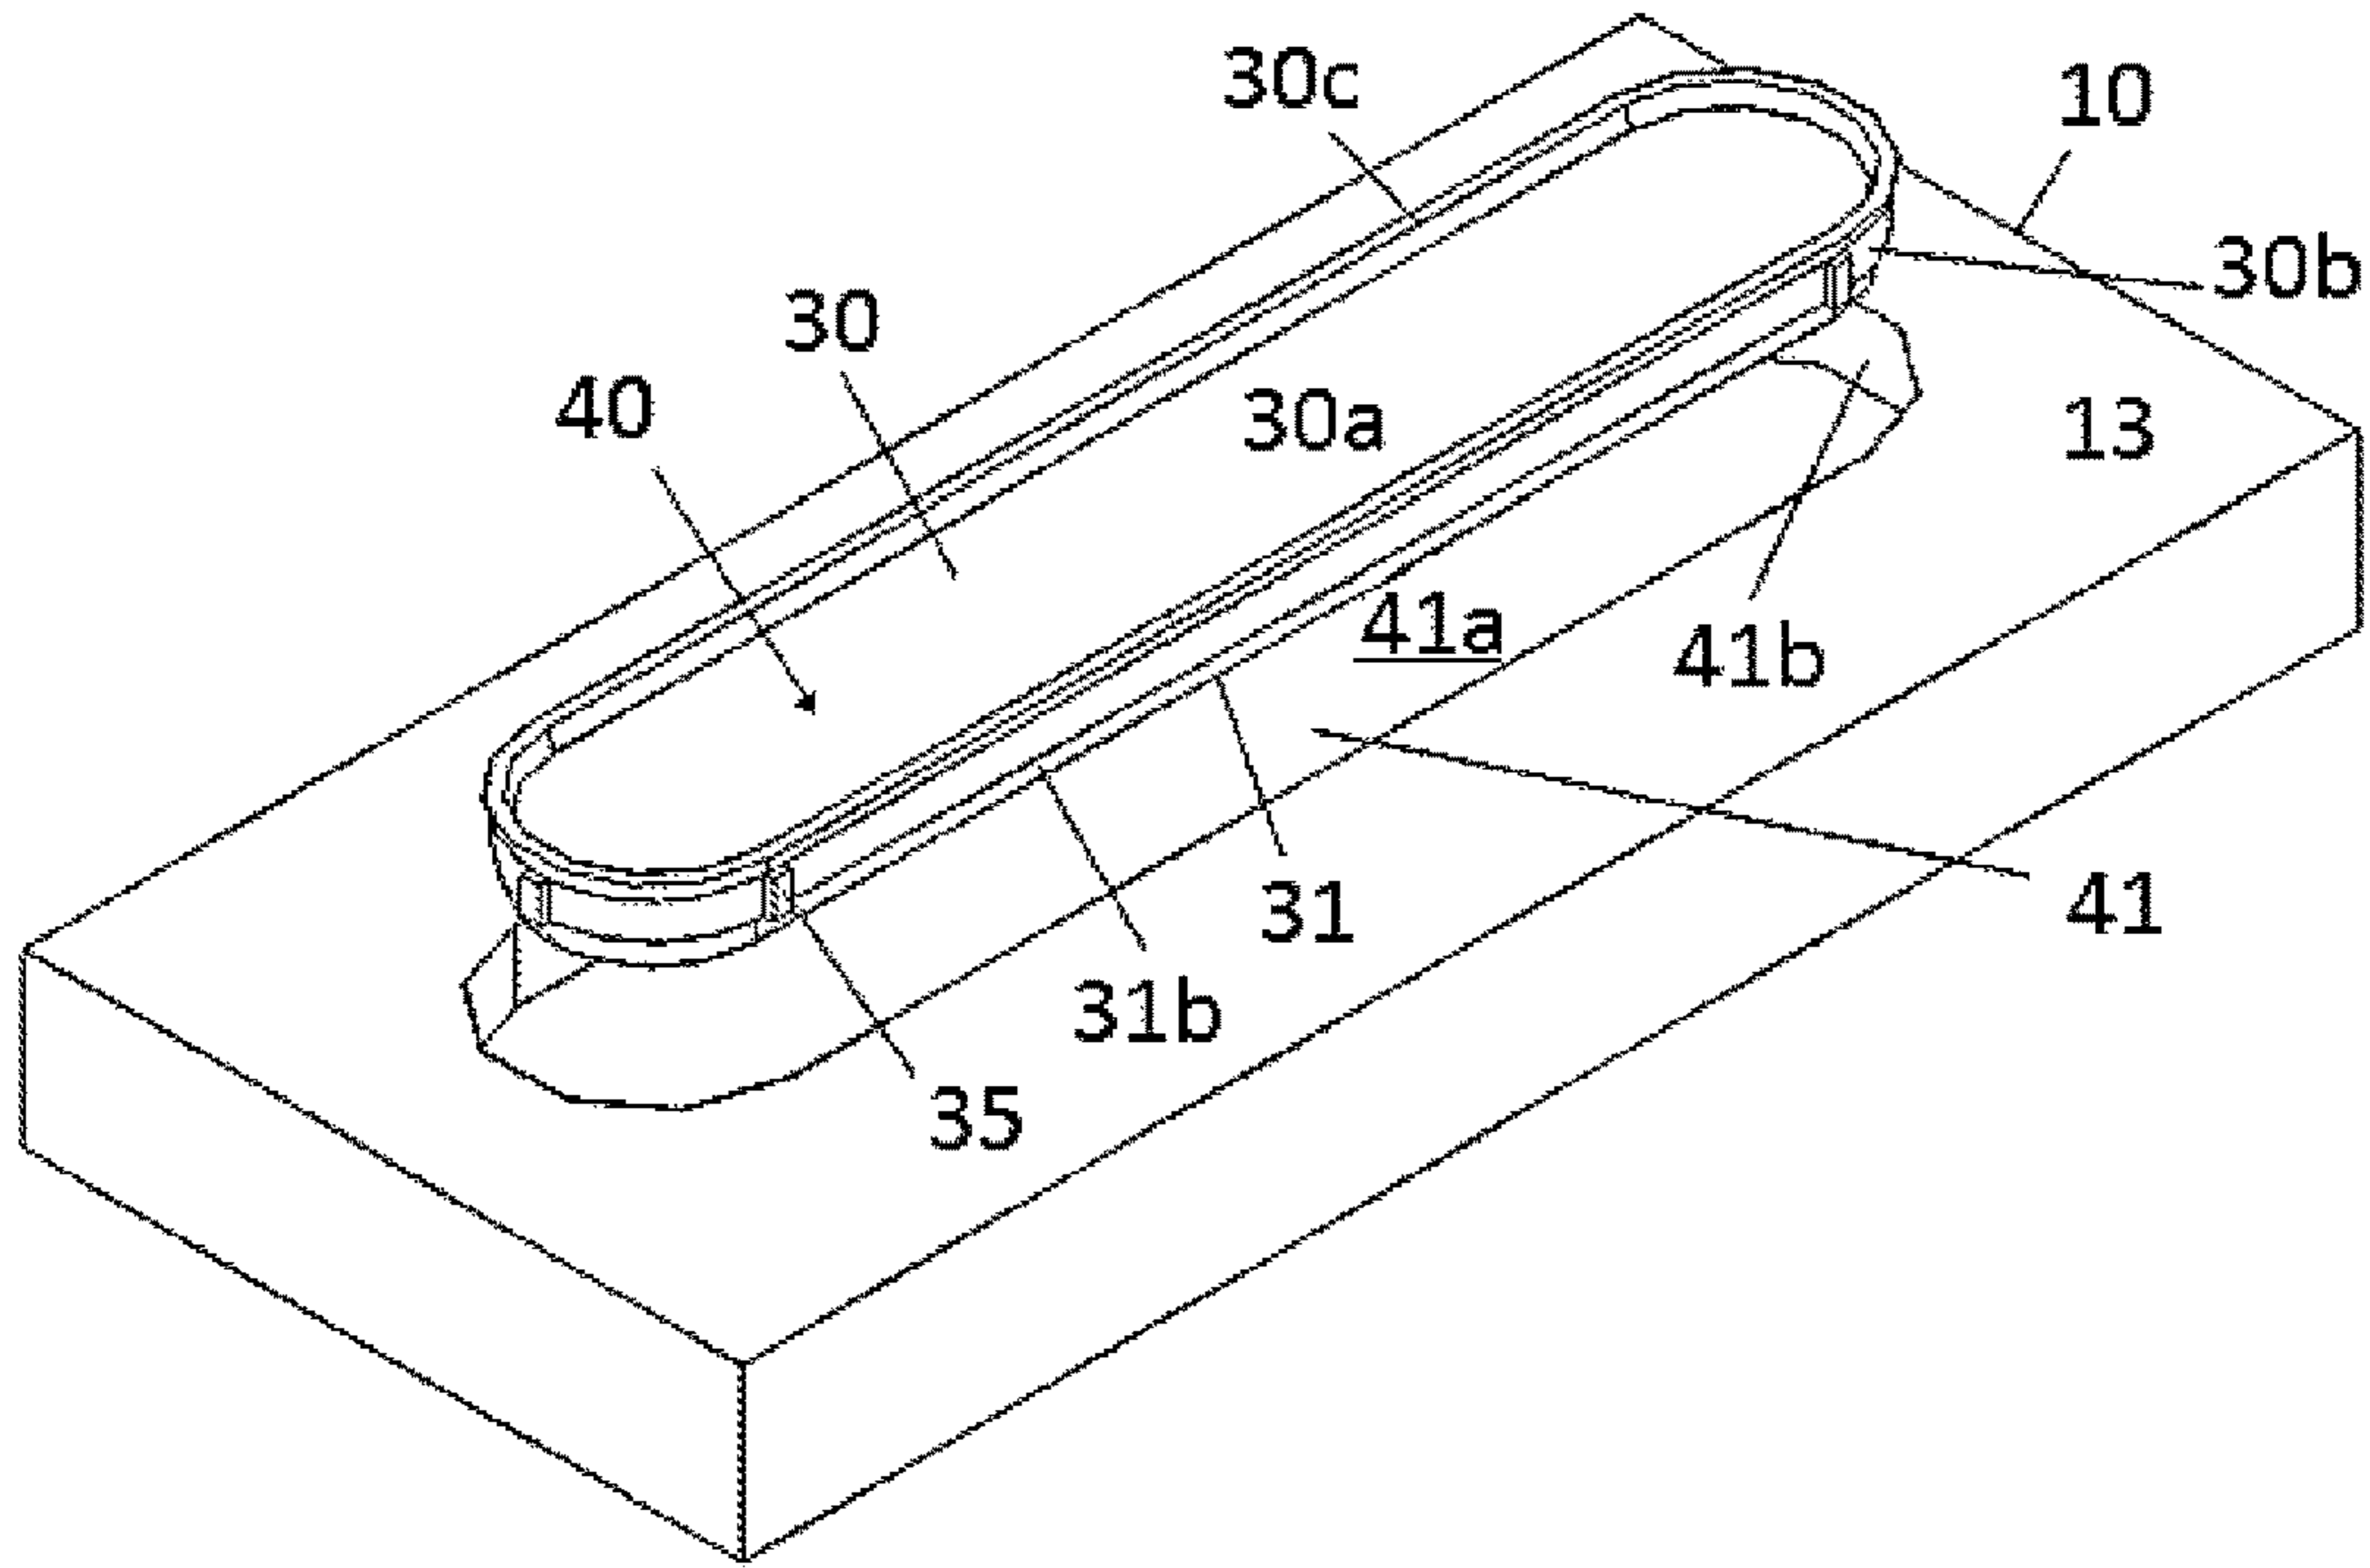
FIG. 7 shows a perspective view of a formwork board and repairing element according to another implementation.

FIGS. 7 to 9 show another implementation. The repairing element 40 differs from the repairing element of the preceding implementations in the geometry of the first member 30 and of the second member 31, the remaining features being similar, so it is not considered necessary to describe them again.

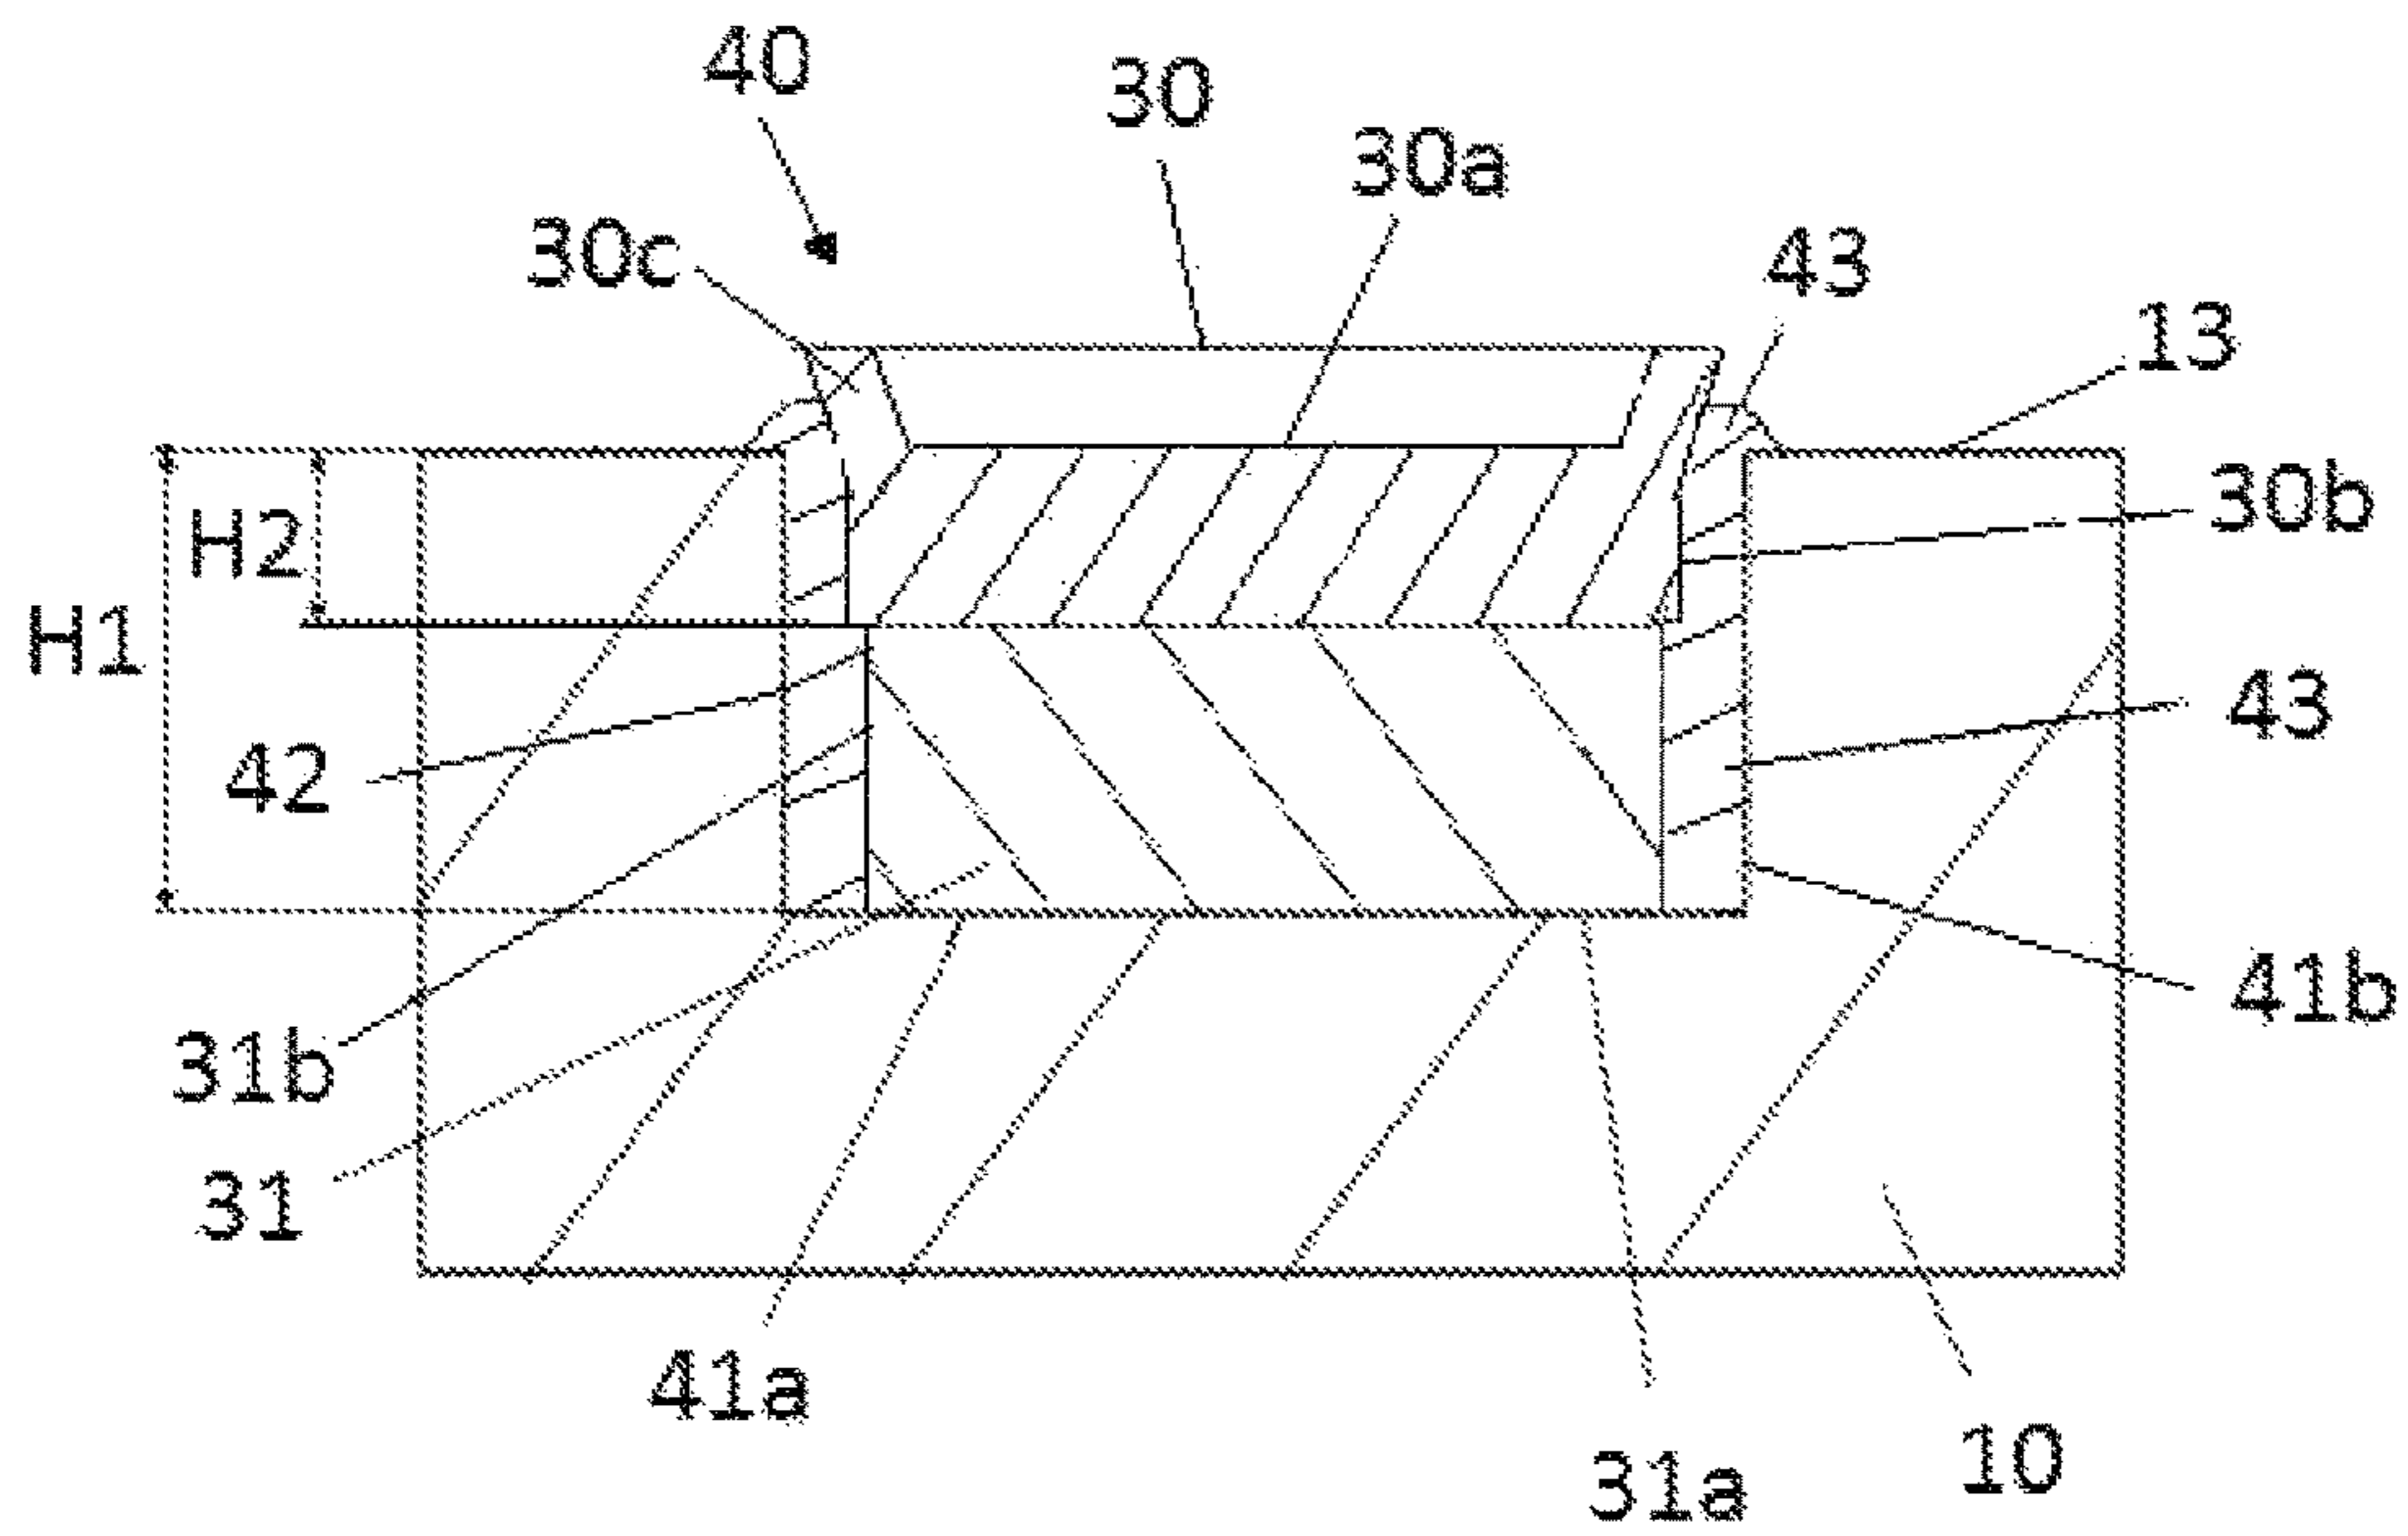
FIG. 8 shows a cross-section of the formwork board with the repairing element shown in FIG. 7 inserted in the housing of the formwork board.

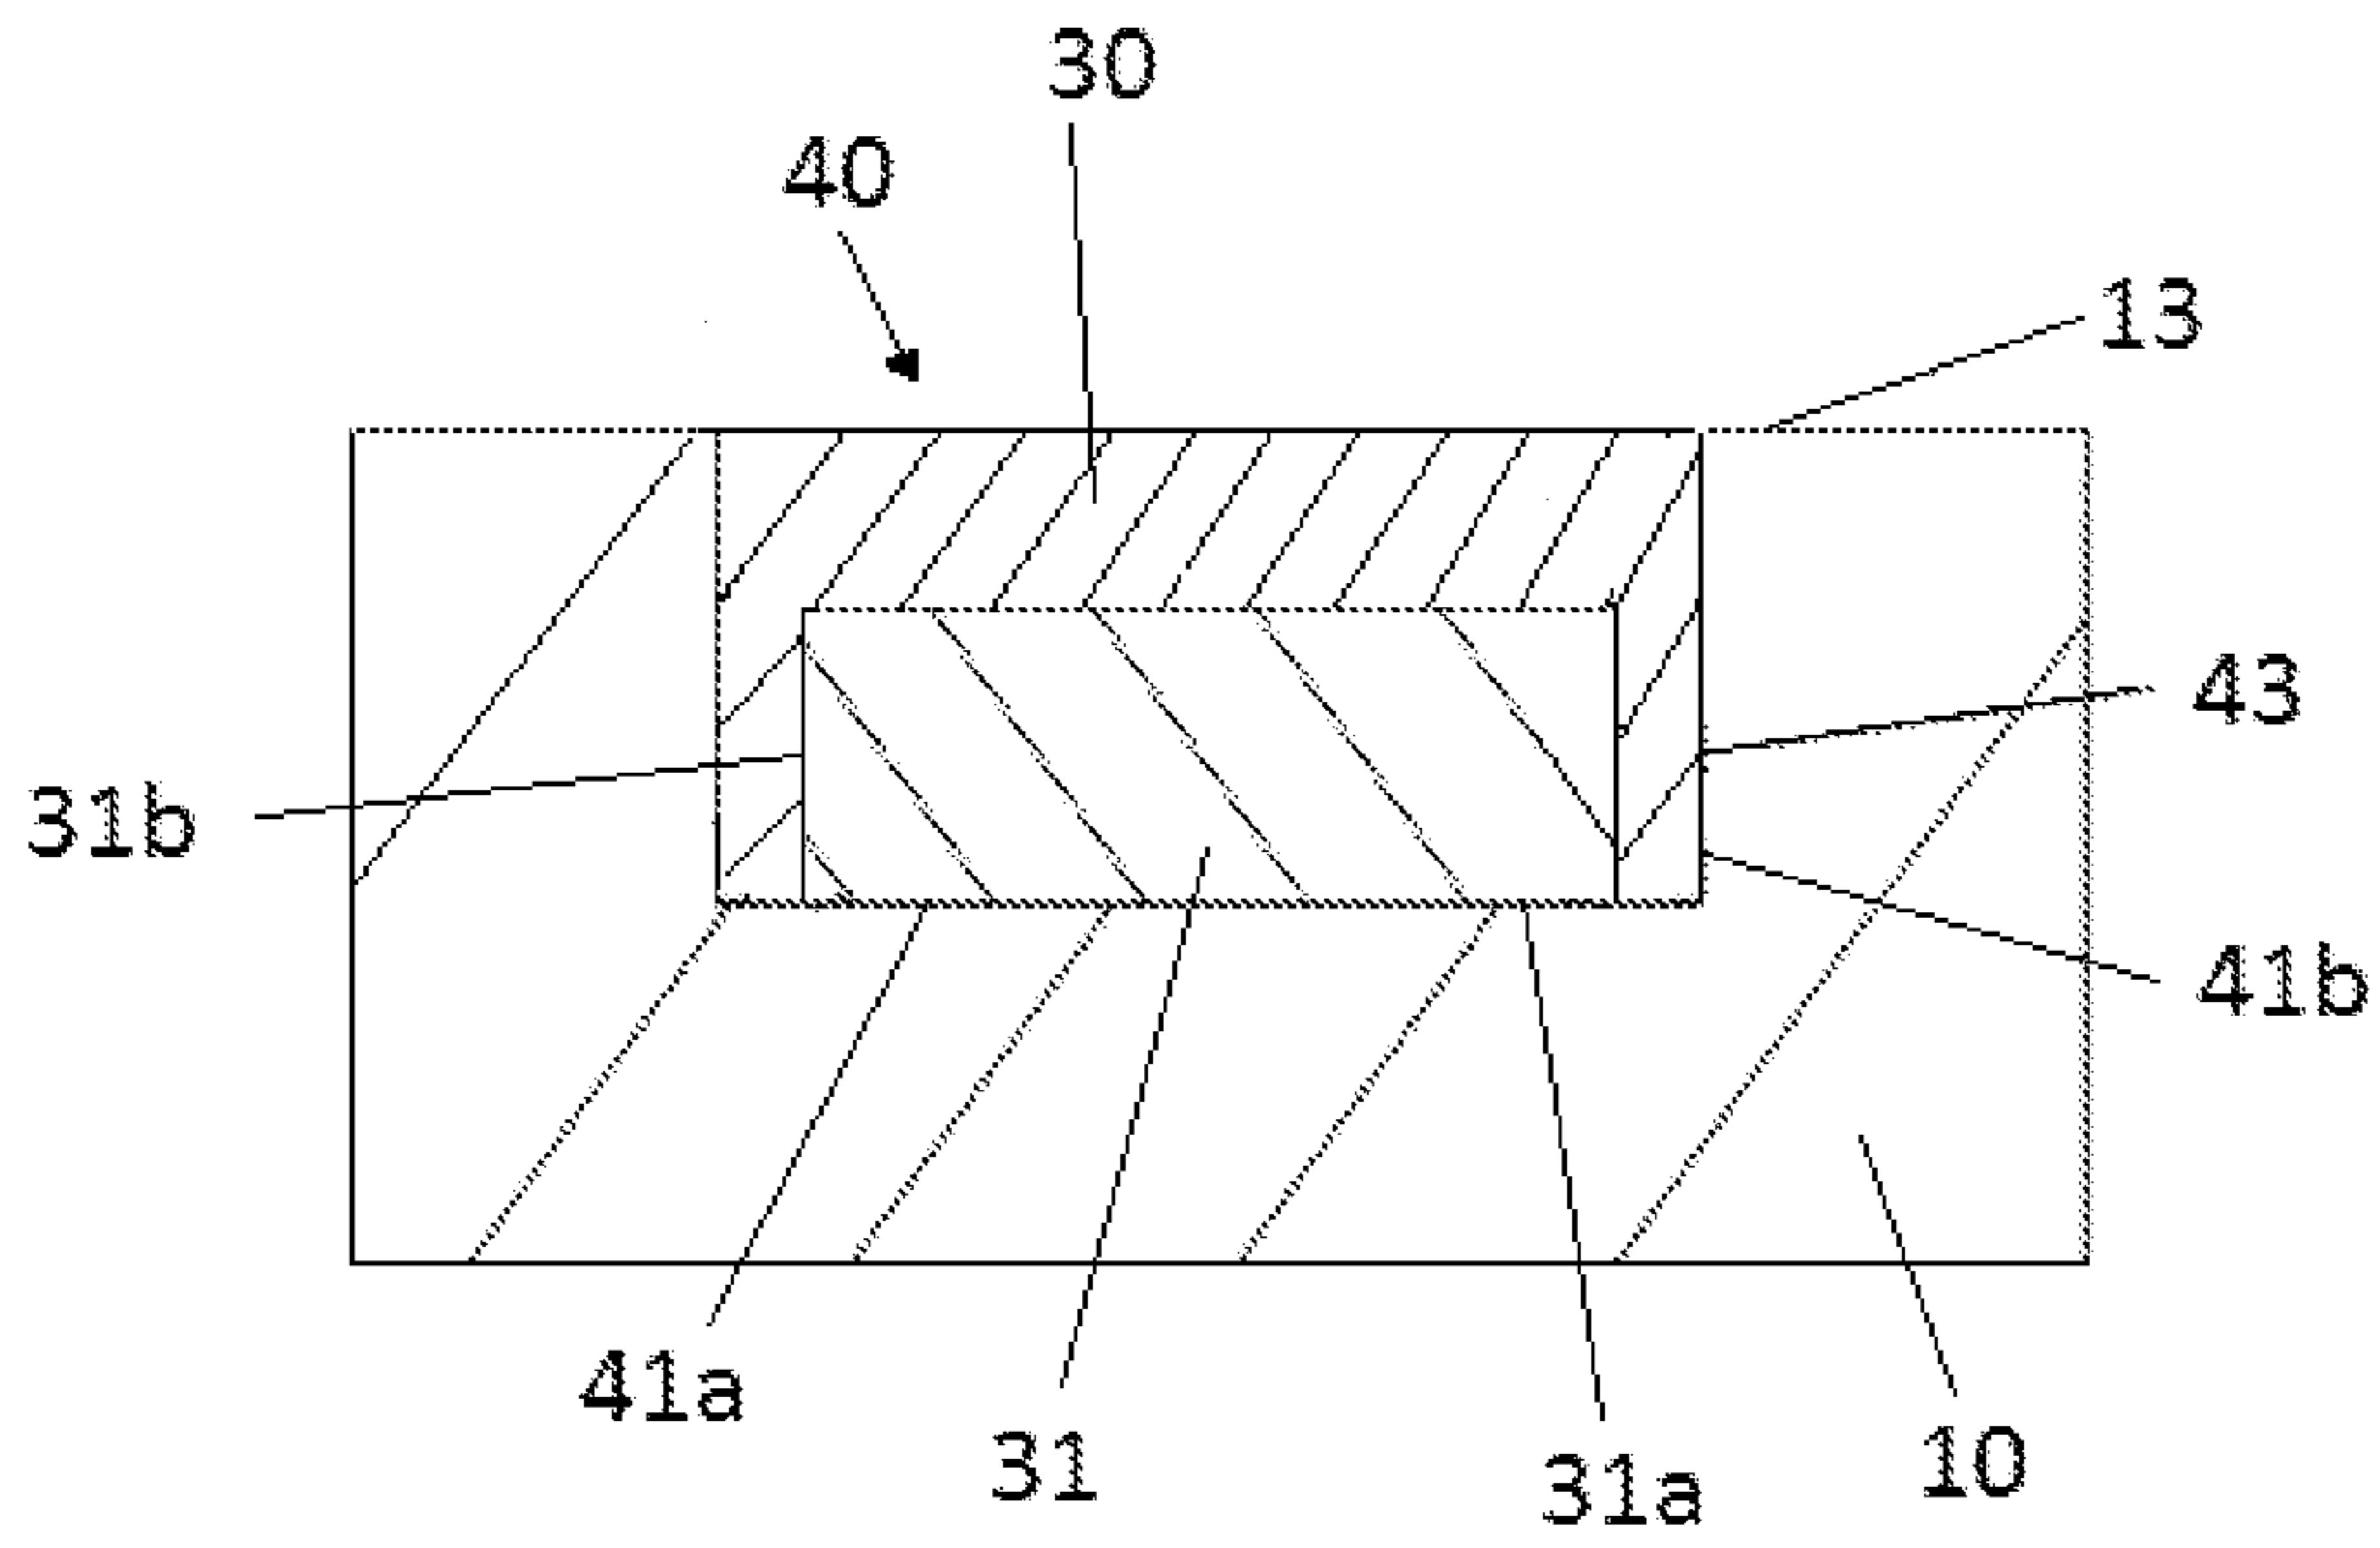
FIG. 9 shows a cross-section of the formwork board that has been repaired with the repairing element shown in FIG. 7.
