(54) LOW AND EXTRA LOW SULFUR ALLOYS FOR REPAIR

A method for repairing, refurbishing, or replacing a turbine engine component or sub-component includes the steps of providing a turbine engine component or sub-component having a site to be repaired, refurbished, or replaced providing a repair or replacement material having a sulfur content, which sulfur content is less than 10 ppm, and (Continued)

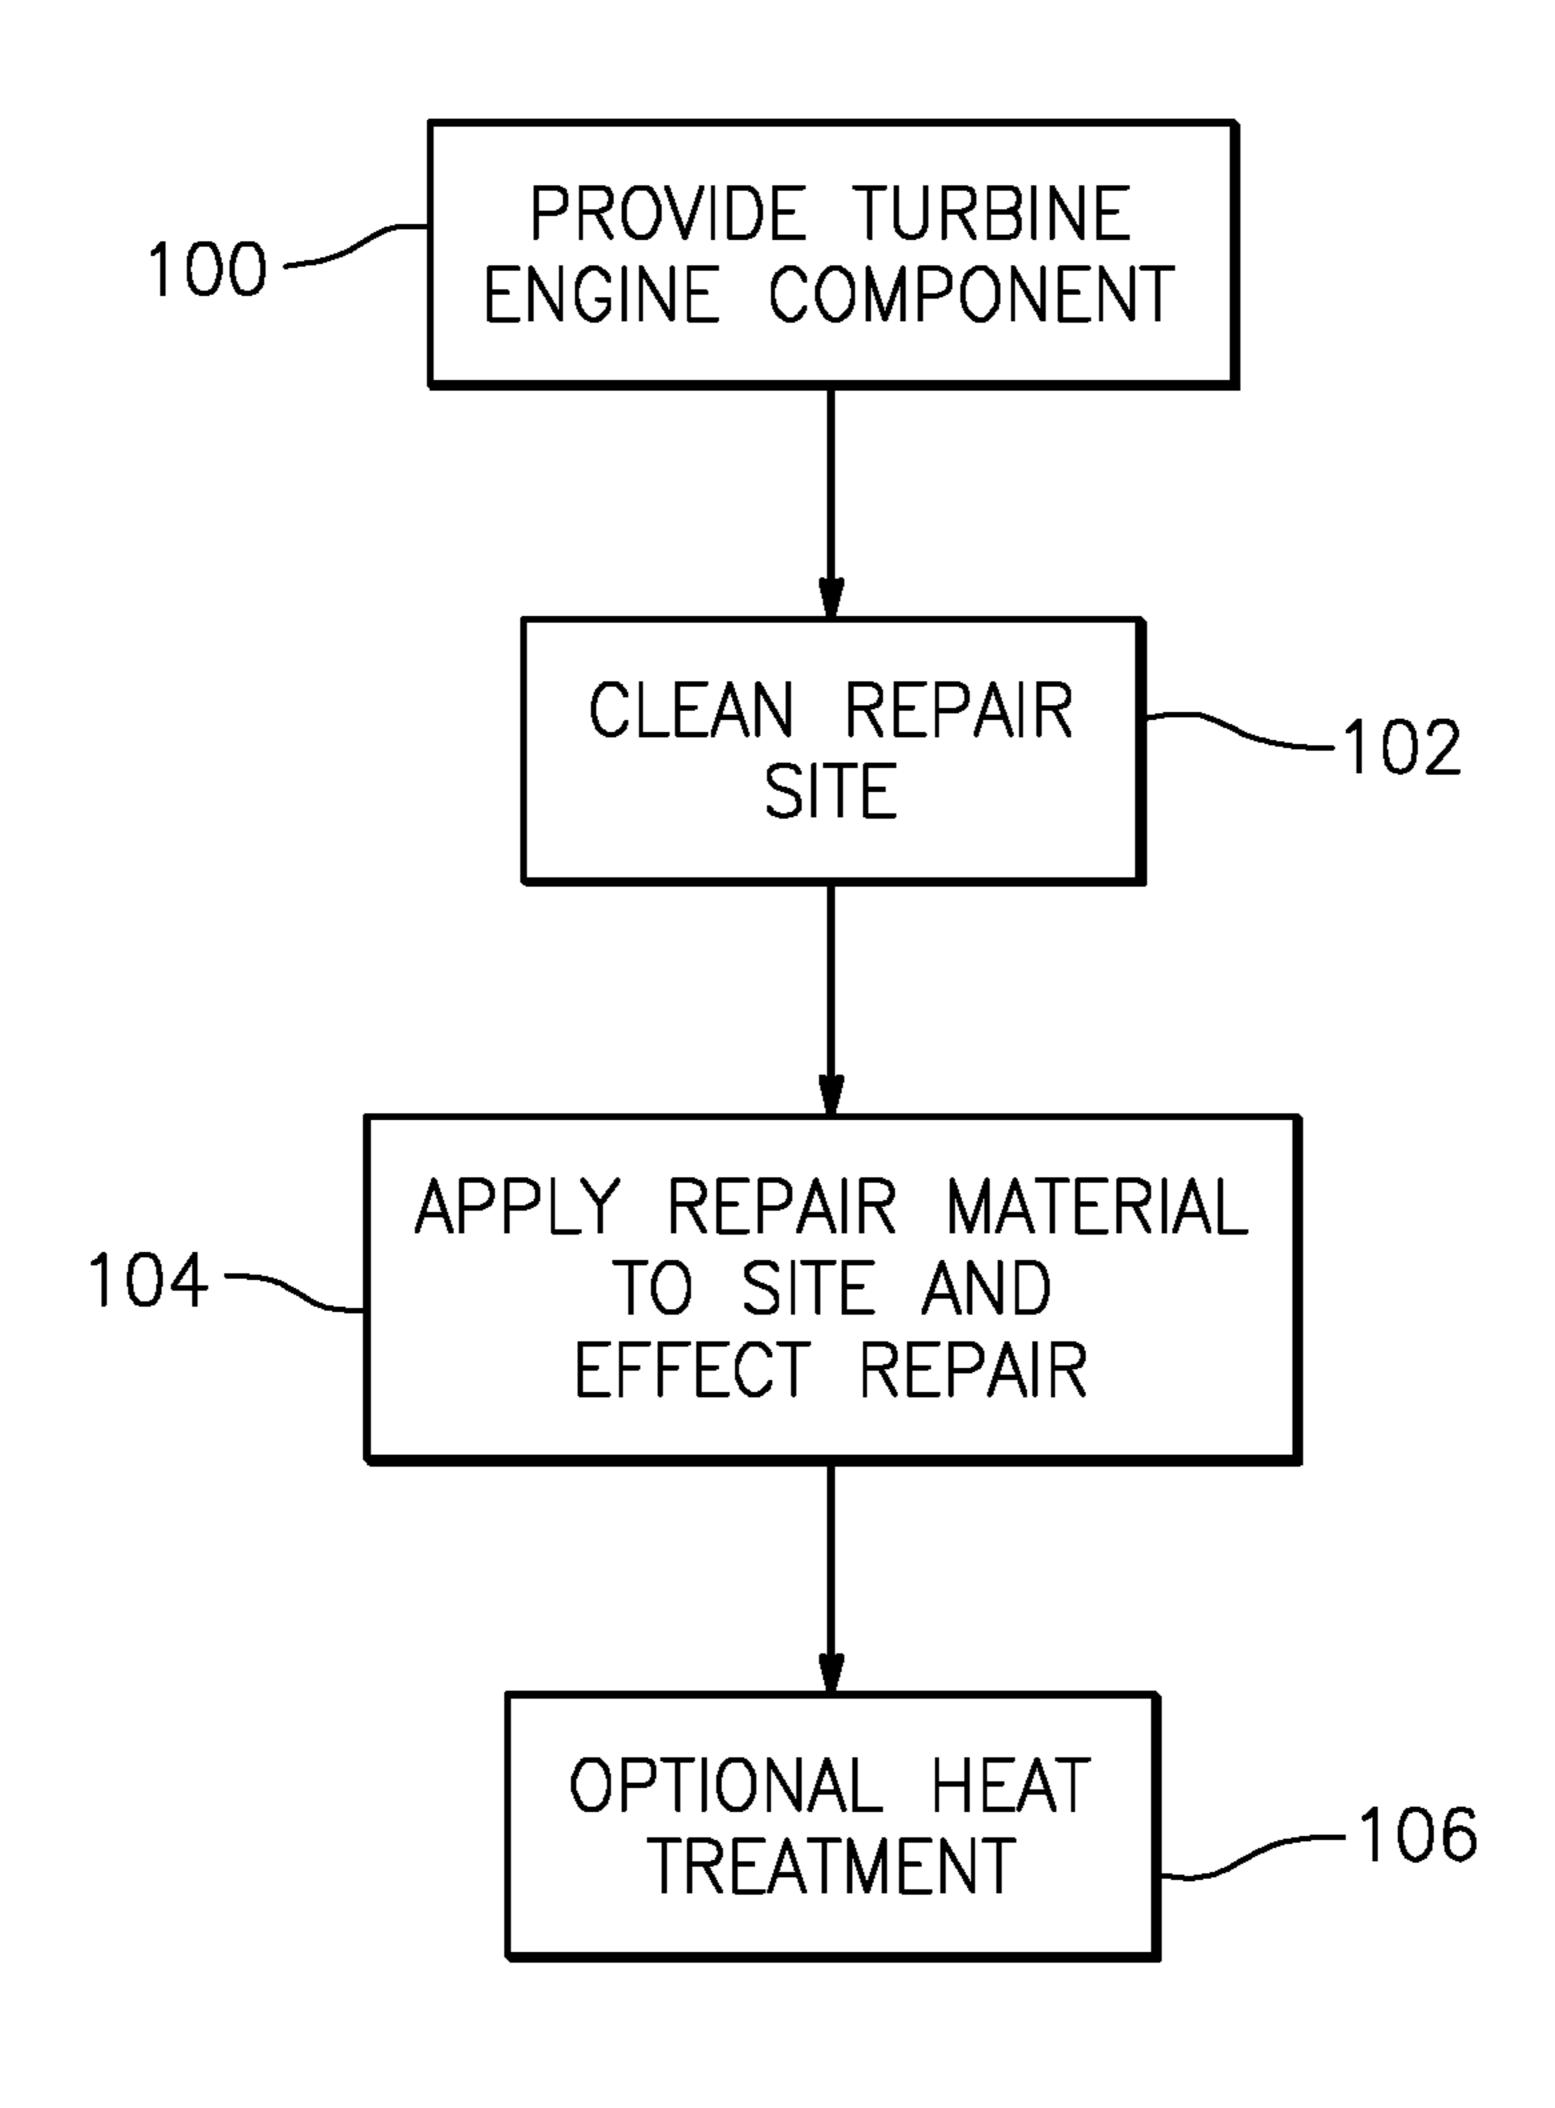
FIG. 1 is a flow chart showing a method for effecting a repair;

In accordance with the method of the present invention, and as shown in FIG. 1, a turbine engine component/sub-component to be repaired/replaced may be provided in step 100. Each site to be repaired/refurbished/replaced may be cleaned in step 102. Any suitable cleaning technique known in the art may be used to remove deleterious material from the site(s) to be repaired and/or clean the site(s).
