(54) **METHOD AND ASSEMBLY FOR INSPECTING A PARTIALLY CURED REPAIR PATCH PRIOR TO INSTALLATION**

(71) Applicant: **The Boeing Company**, Chicago, IL (US)  
(72) Inventors: **Jeffrey Reyner Kollgaard**, Seattle, WA (US); **John F. Spalding**, Tukwilla, WA (US)  
(73) Assignee: **THE BOEING COMPANY**, Chicago, IL (US)  
(\* ) Notice: Subject to any disclaimer, the term of this patent is extended or adjusted under 35 U.S.C. 154(b) by 316 days.

An example embodiment is directed to a method and assembly for inspecting a repair patch and, more particularly, to a method and assembly for inspecting a partially cured repair patch prior to installation.

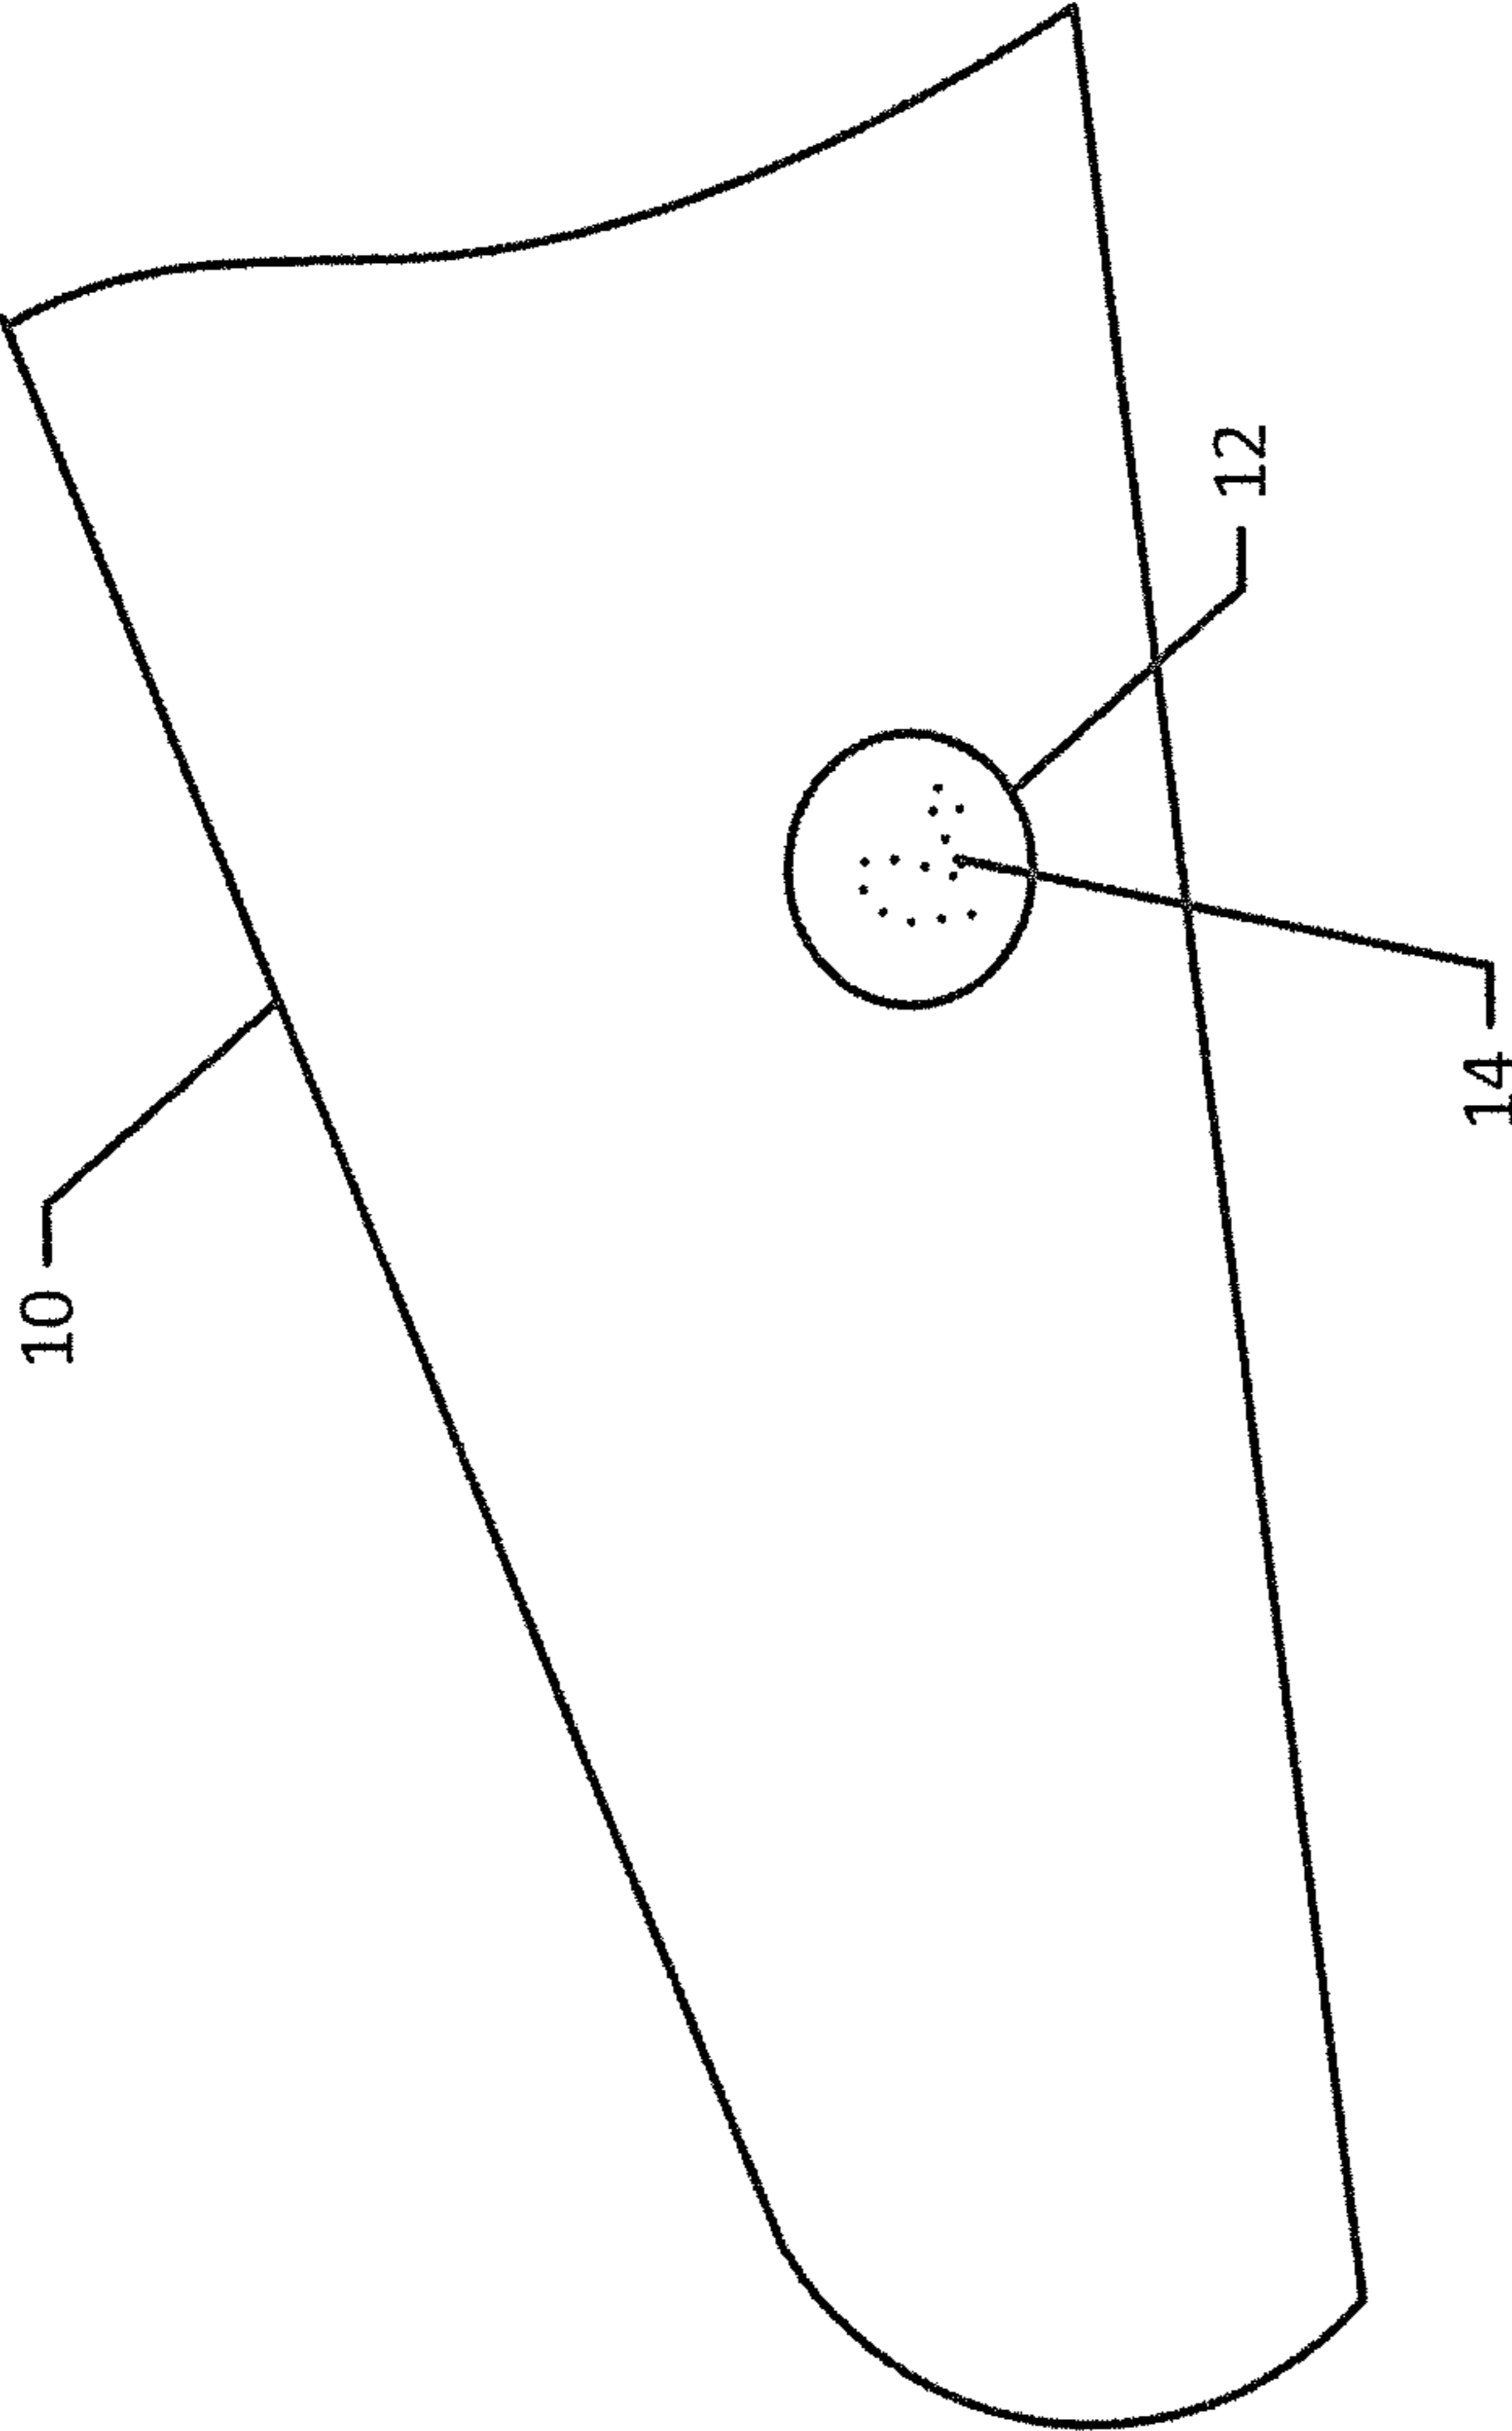
Figure 1

FIG. 1 is a perspective view of a portion of a wing of an aircraft having a repair patch installed thereupon;

An assembly for inspecting a repair patch and the associated method are provided in accordance with an example embodiment of the present disclosure. In this regard, the repair patch may be utilized in order to repair a variety of structures, such as vehicles, including aircraft, watercraft or the like, etc. By way of example, FIG. 1 depicts a portion of a wing **10** of an aircraft to which a repair patch **12** has been affixed, such as with an adhesive, in order to repair a defect **14** shown in dashed lines in the wing. By repairing struc-

tures, such as the aircraft wing 10 of FIG. 1, with repair patches 12, these structures may be repaired in the field so as to reduce the time, if any, that the structure is out of service.

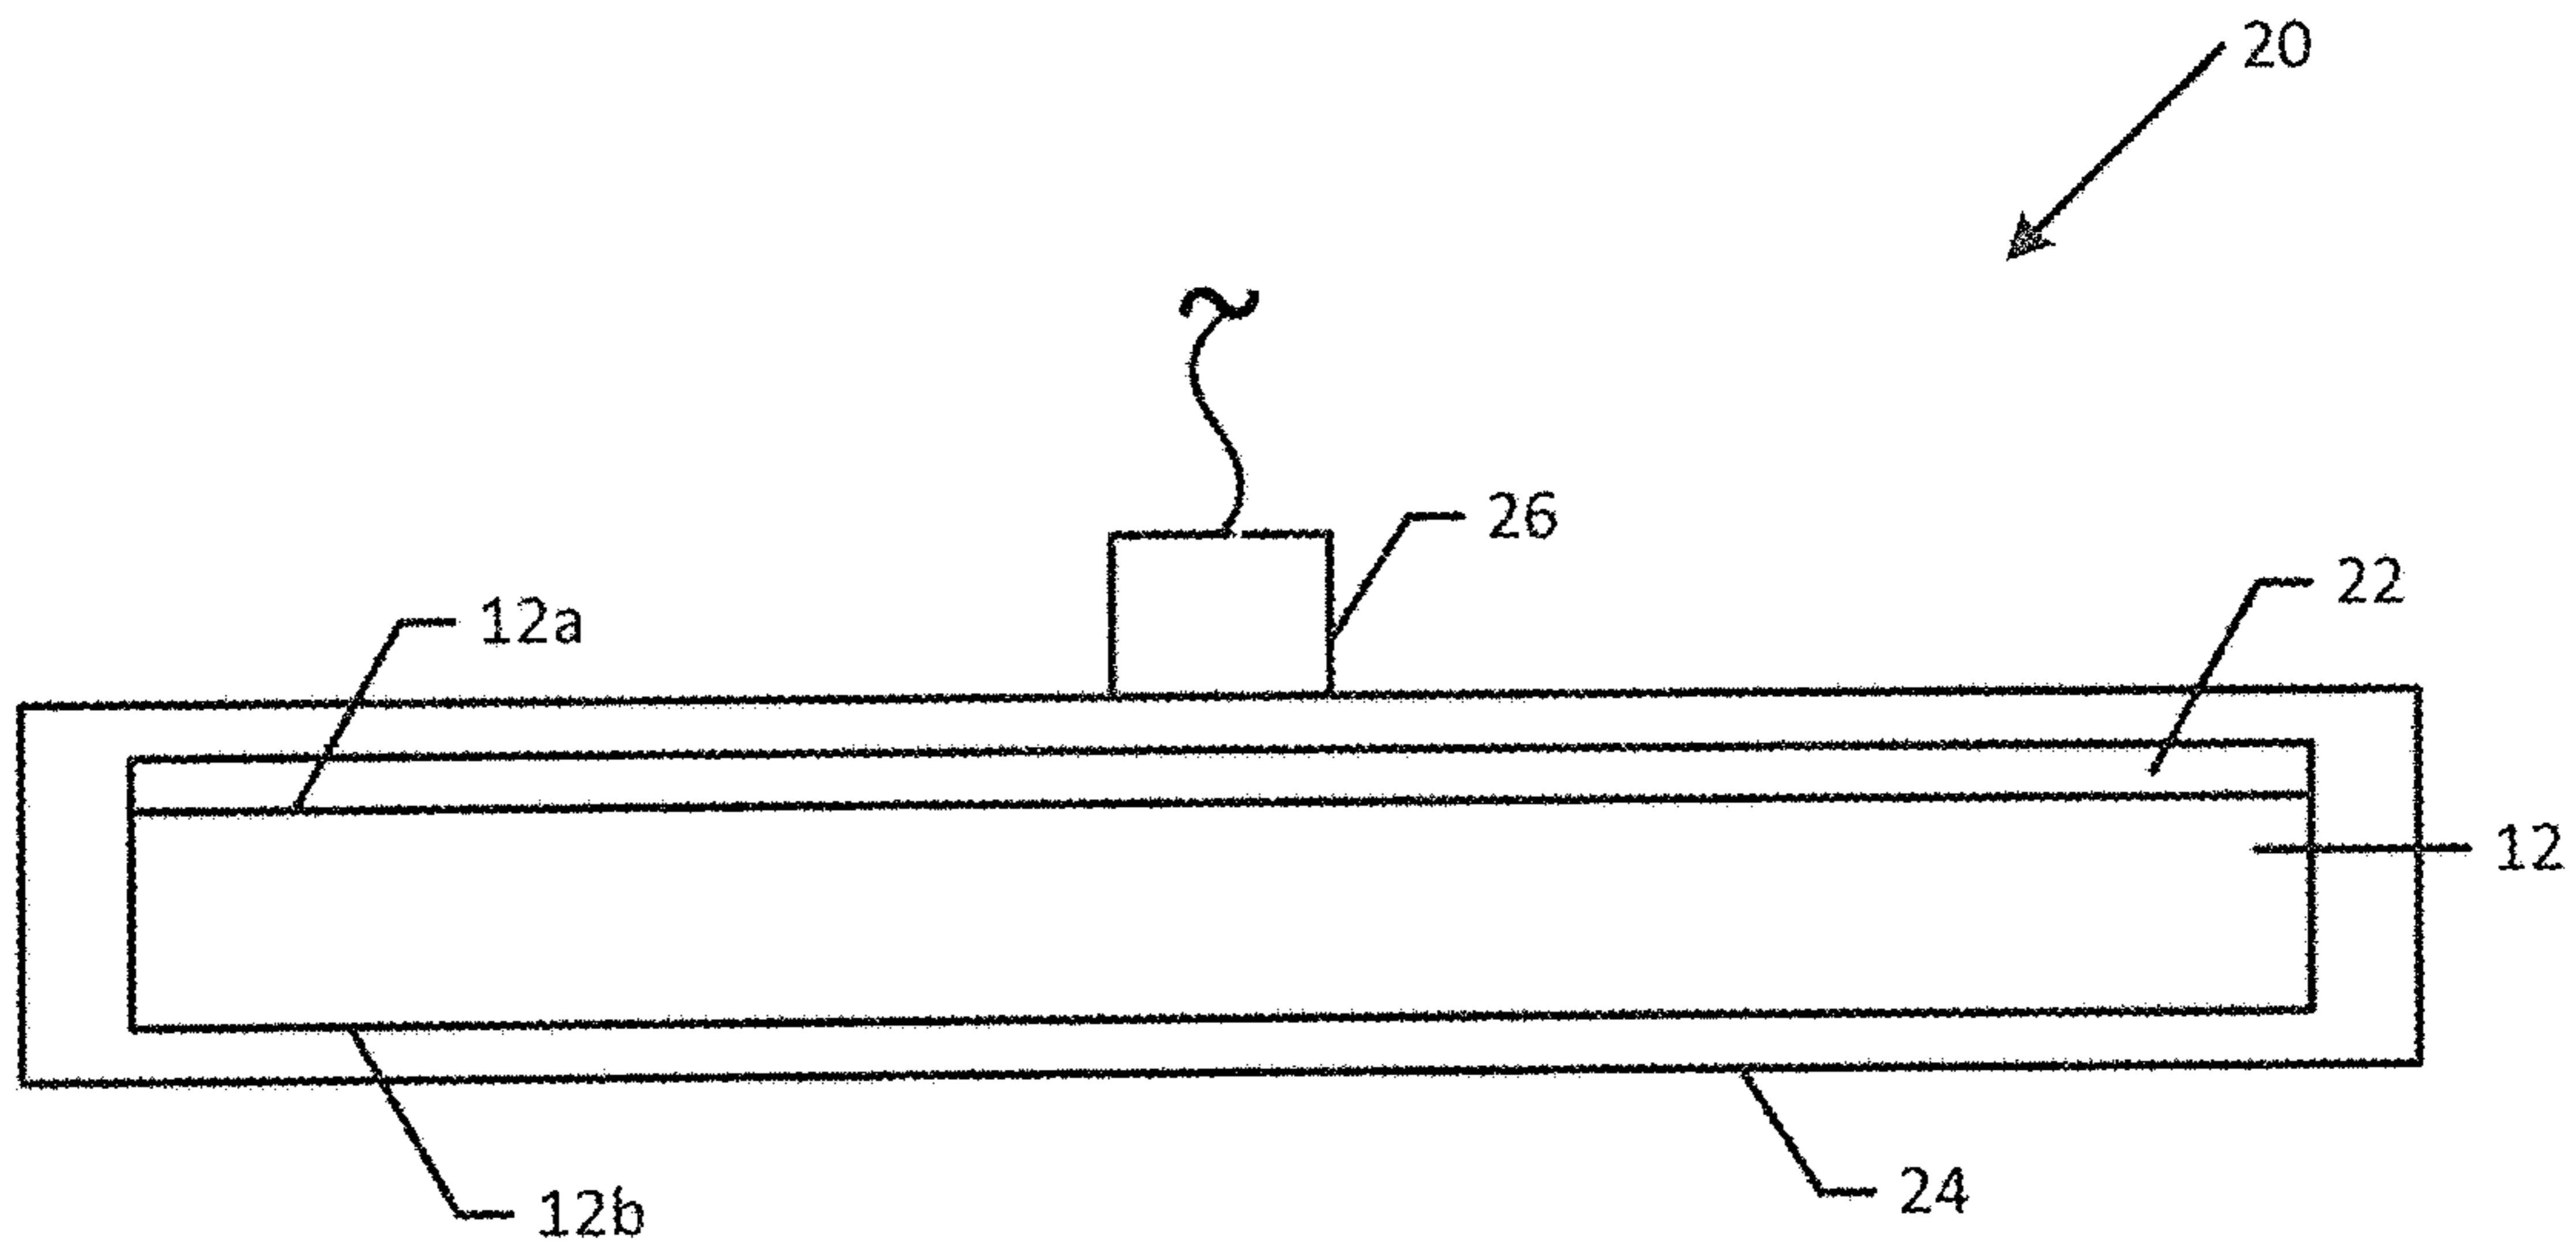
Figure 2

FIG. 2 is a cross-sectional view of a repair patch in accordance with an example embodiment of the present disclosure;

Referring now to FIG. 2, an assembly 20 for inspecting a repair patch 12 is illustrated in accordance with an example embodiment. The assembly 20 includes a partially cured repair patch 12 formed of a composite material. The assembly 20 of this example embodiment also includes an acoustic facilitation layer 22 proximate the surface of the repair patch 12 through which ultrasonic signals will be introduced, as described below. In this regard, the repair patch 12 of an example embodiment includes opposed first and second surfaces 12a, 12b with the ultrasonic signals being introduced via the first surface as described below. As such, the acoustic facilitation layer 22 may be disposed proximate the first surface 12a of the repair patch 12 and, in an example embodiment, may be disposed in contact with the first surface 12a of the repair patch 12 so as to extend across the entire first surface.

As shown in FIG. 2, the assembly 20 also includes a vacuum bag 24 surrounding the repair patch 12 and the acoustic facilitation layer 22 and configured to apply pressure thereto. The vacuum bag 24 may be formed of various materials, but is formed of nylon in an example embodiment.

As shown in FIG. 2, the assembly **20** of an example embodiment also includes an ultrasonic transducer **26** configured to introduce ultrasonic signals that propagate through the vacuum bag **24** and the acoustic facilitation layer **22** and then into the repair patch **12**. Although an embodiment that employs through transmission inspection of a repair patch **12** is contemplated as described below, the assembly **20** of FIG. 2 is configured to inspect the repair patch **12** via a single-sided inspection. As such, the ultrasonic transducer **26** is also configured to receive echo signals returning from the repair patch **12**.

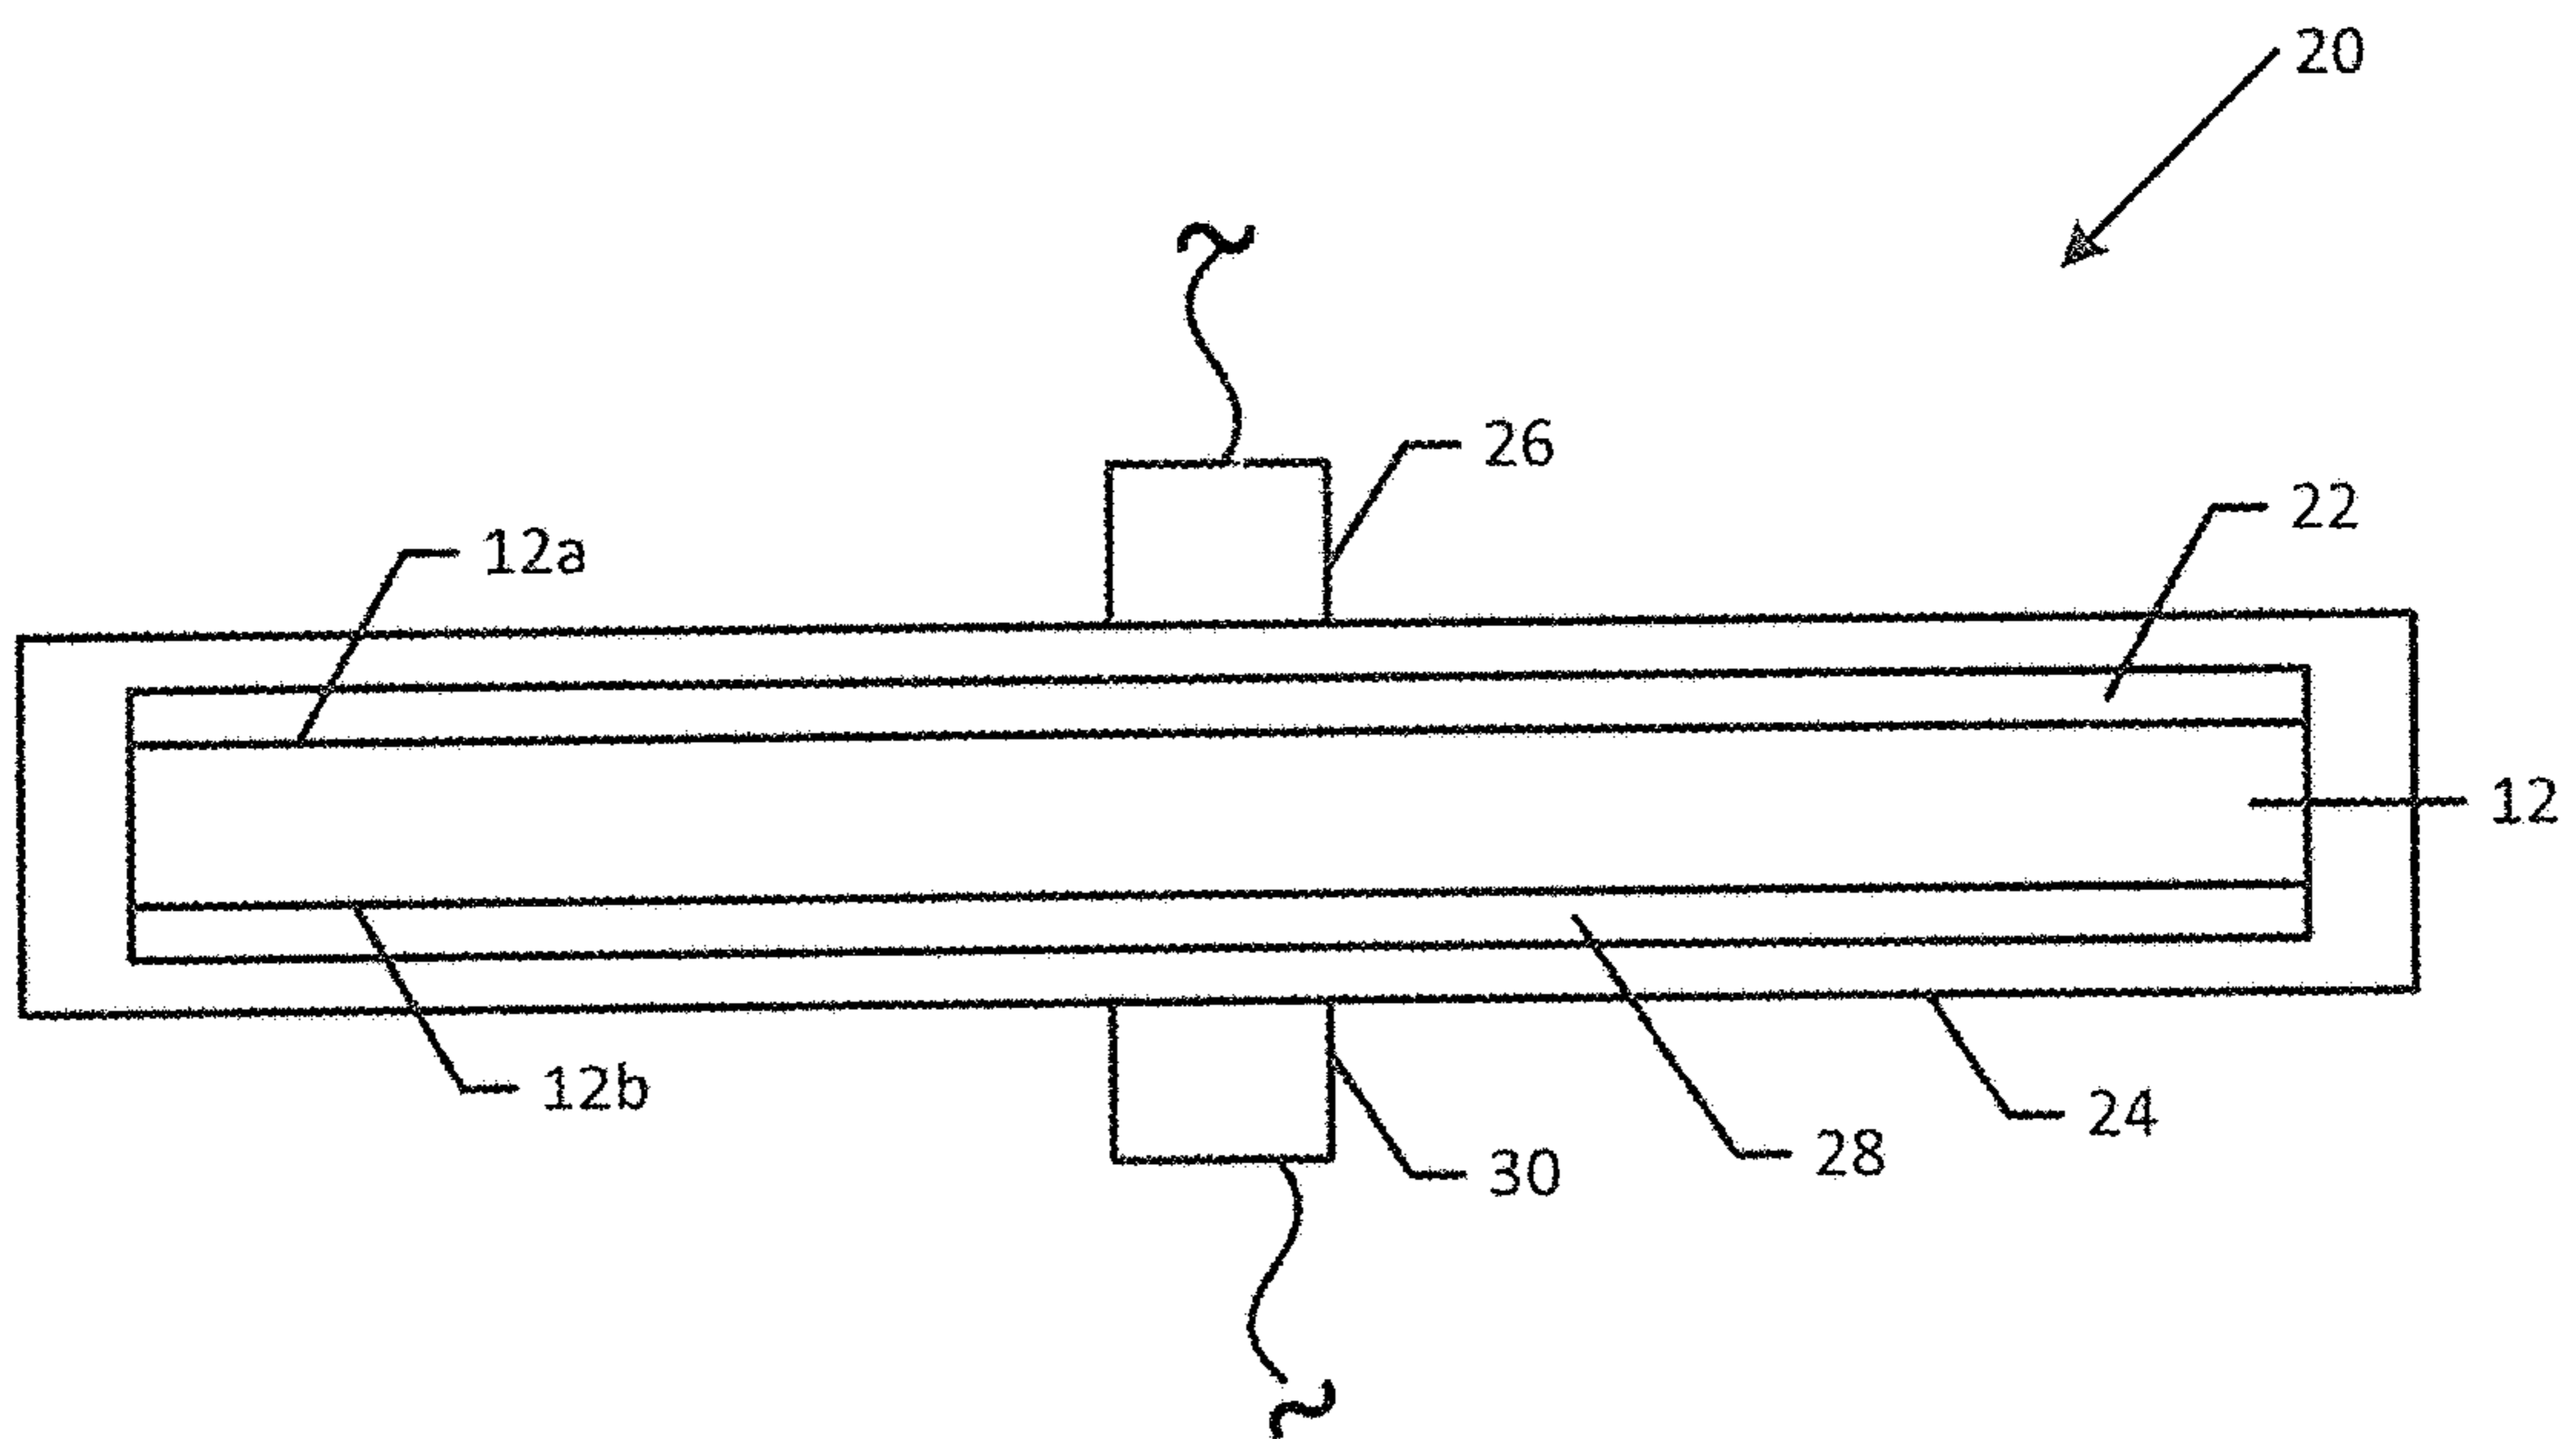
Figure 3

FIG. 3 is a cross-sectional view of a repair patch in accordance with another example embodiment of the present disclosure;

As noted above, and shown in FIG. 3, the assembly **20** of an example embodiment can alternatively provide for through transmission inspection of a repair patch **12** in which ultrasonic signals are introduced through the first side **12a** of the repair patch and the signals that exit through the second side **12b** of the repair patch are captured and analyzed. In this embodiment, the assembly **20** also includes a second acoustic facilitation layer **28** disposed proximate the second surface **12b** of the repair patch **12**, opposite the first surface **12a** of the repair patch through which the ultrasonic signals will be introduced. The first and second acoustic facilitation layers **22**, **28** may be comprised of the same material. Alternatively, the first and second acoustic facilitation layers **22**, **28** may be formed of different materials. In this example embodiment, the assembly **20** also include an ultrasonic receiver **30** configured to receive ultrasonic signals that exit the repair path **12** from the second side of the assembly, opposite the first side via which the ultrasonic transducer **26** introduces the ultrasonic signals. In this regard, ultrasonic signals introduced via the first surface **12a** of the repair patch **12** by the ultrasonic transducer **26** are received upon exit from the second surface **12b** of the repair path with the ultrasonic receiver **30**. As such, the repair patch **12** can be subjected to a through transmission inspection, such as while the assembly **20** is held in a rack or submerged in a tank.

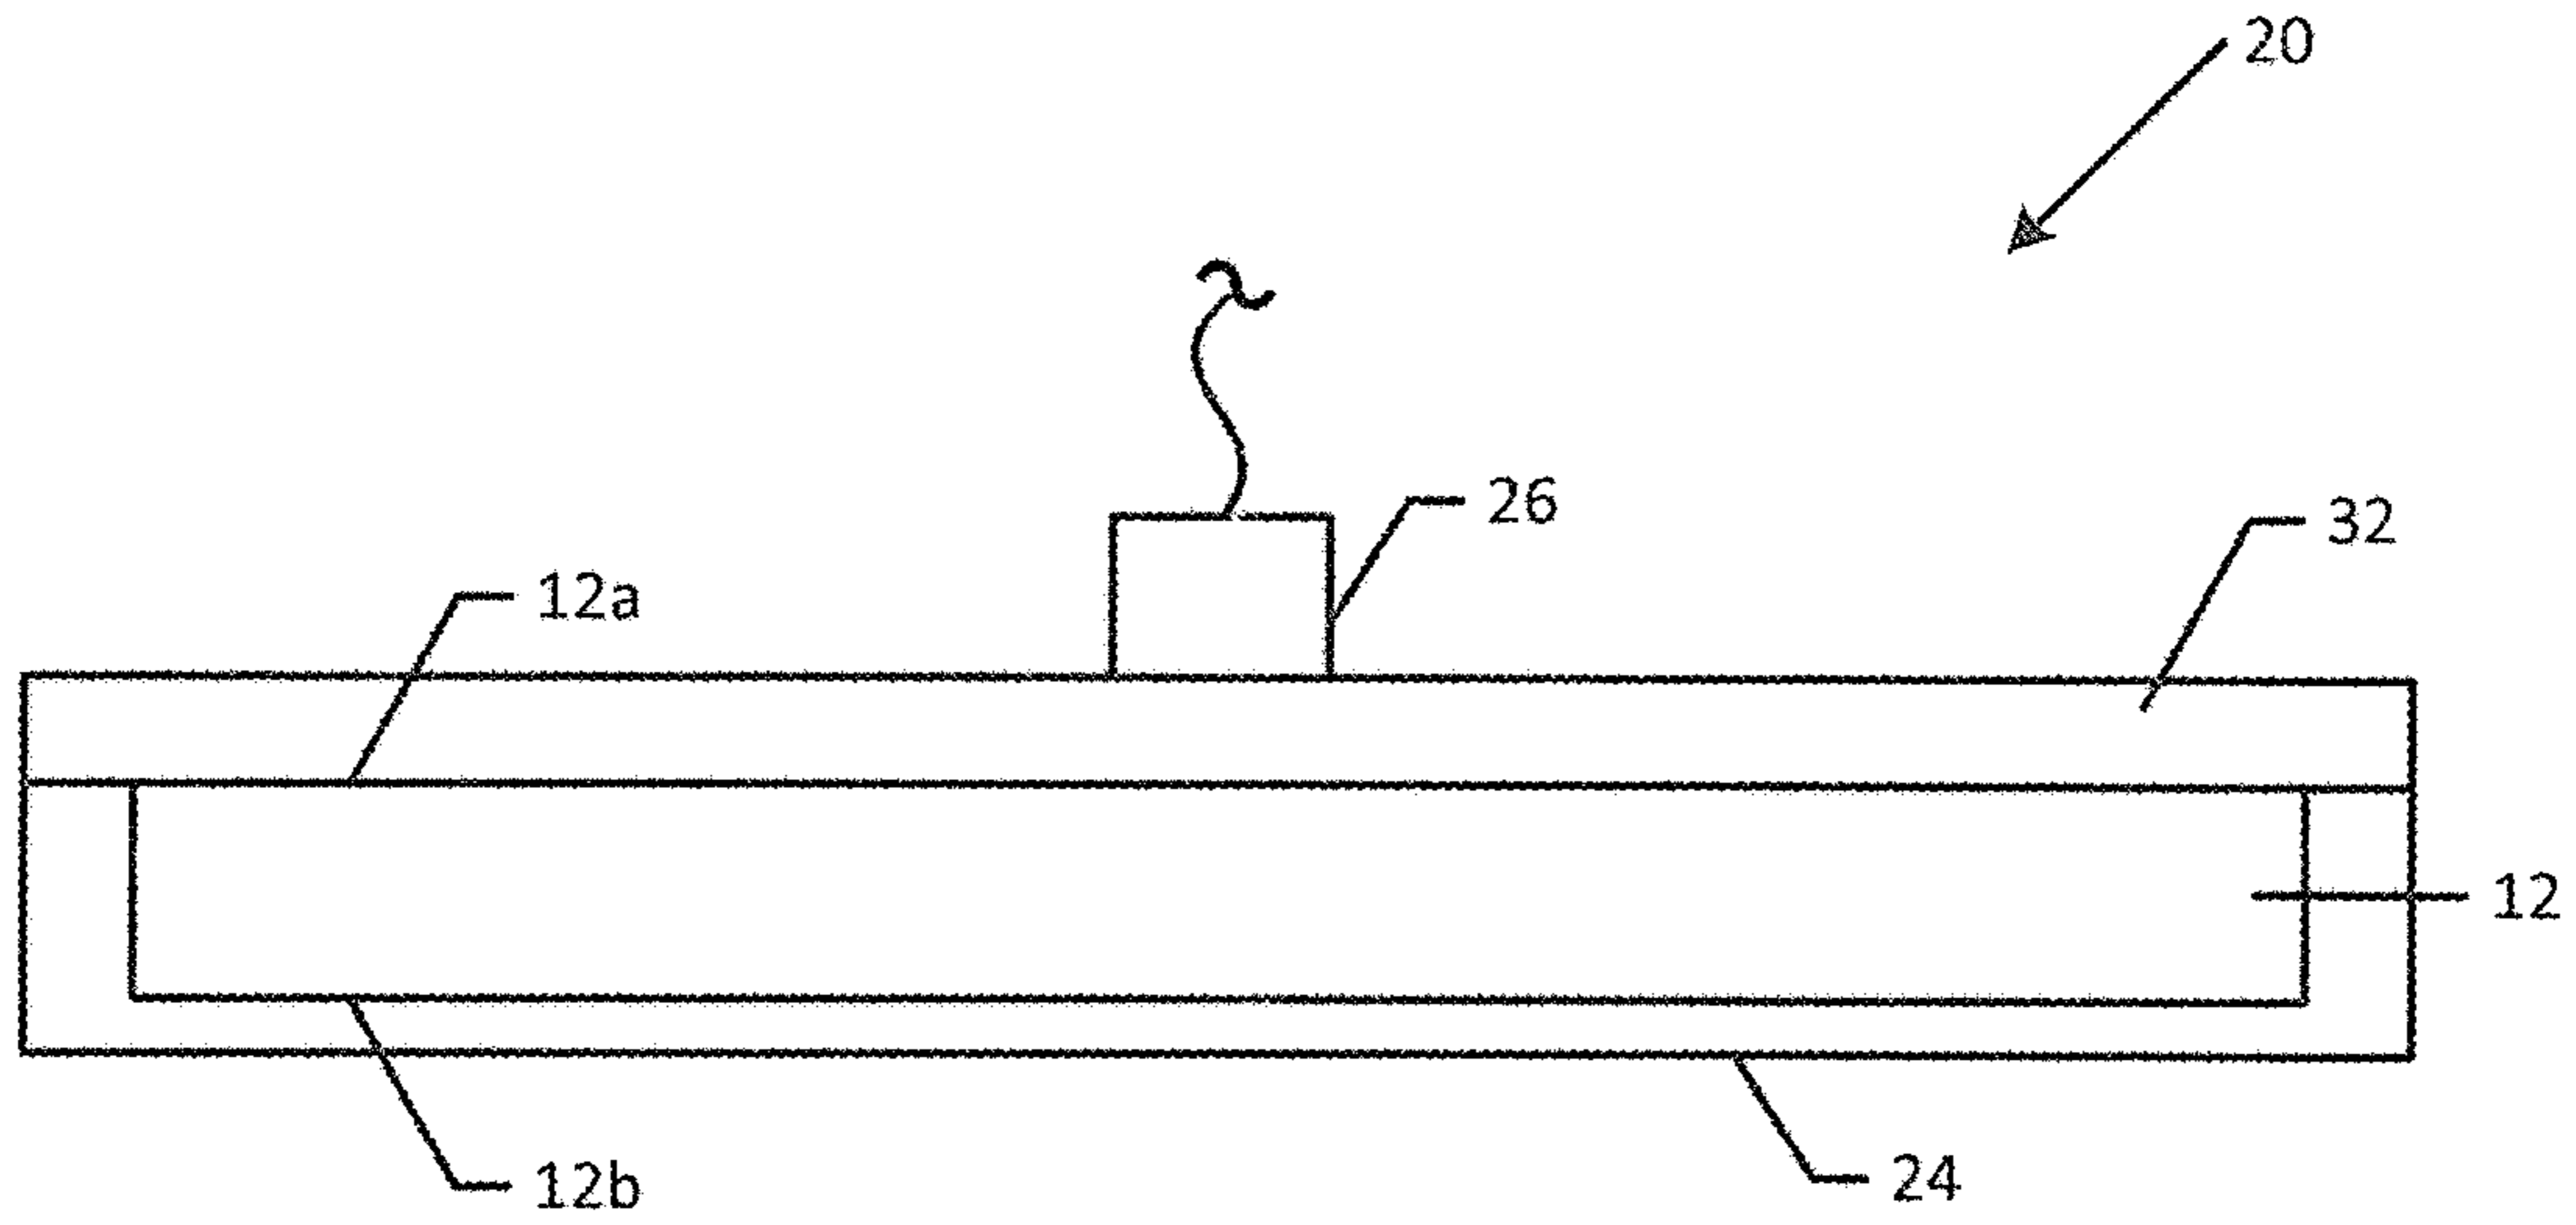
Figure 4

FIG. 4 is a cross-sectional view of a repair patch in accordance with a further example embodiment of the present disclosure;

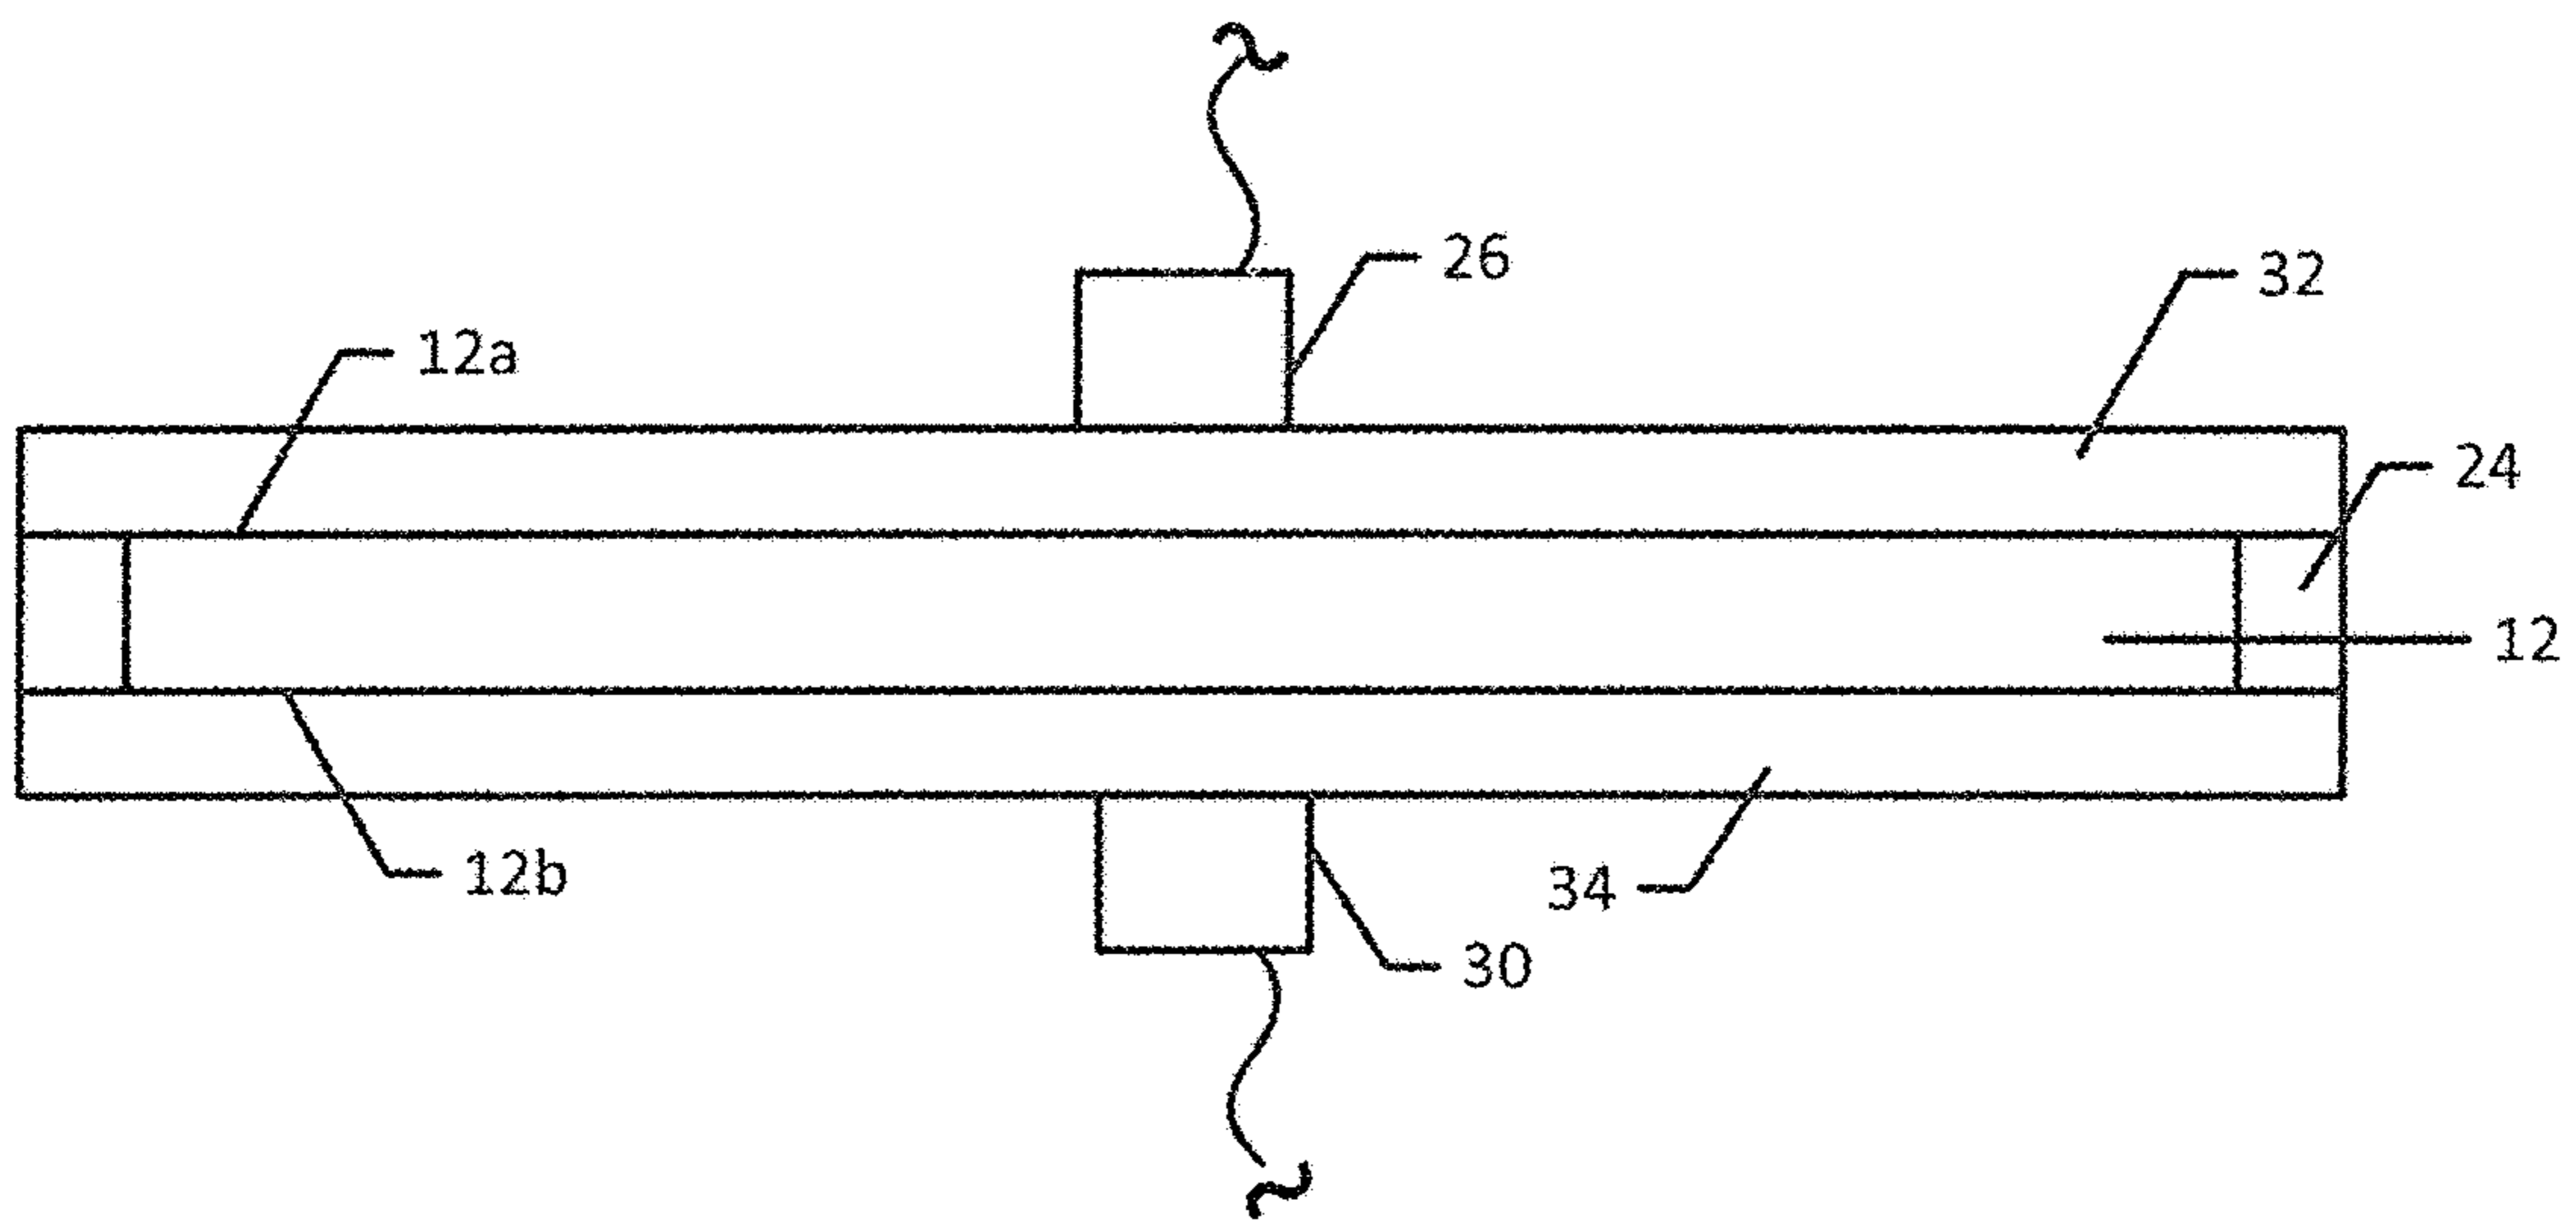
Figure 5

FIG. 5 is a cross-sectional view of a repair patch in accordance with yet another example embodiment of the present disclosure; and

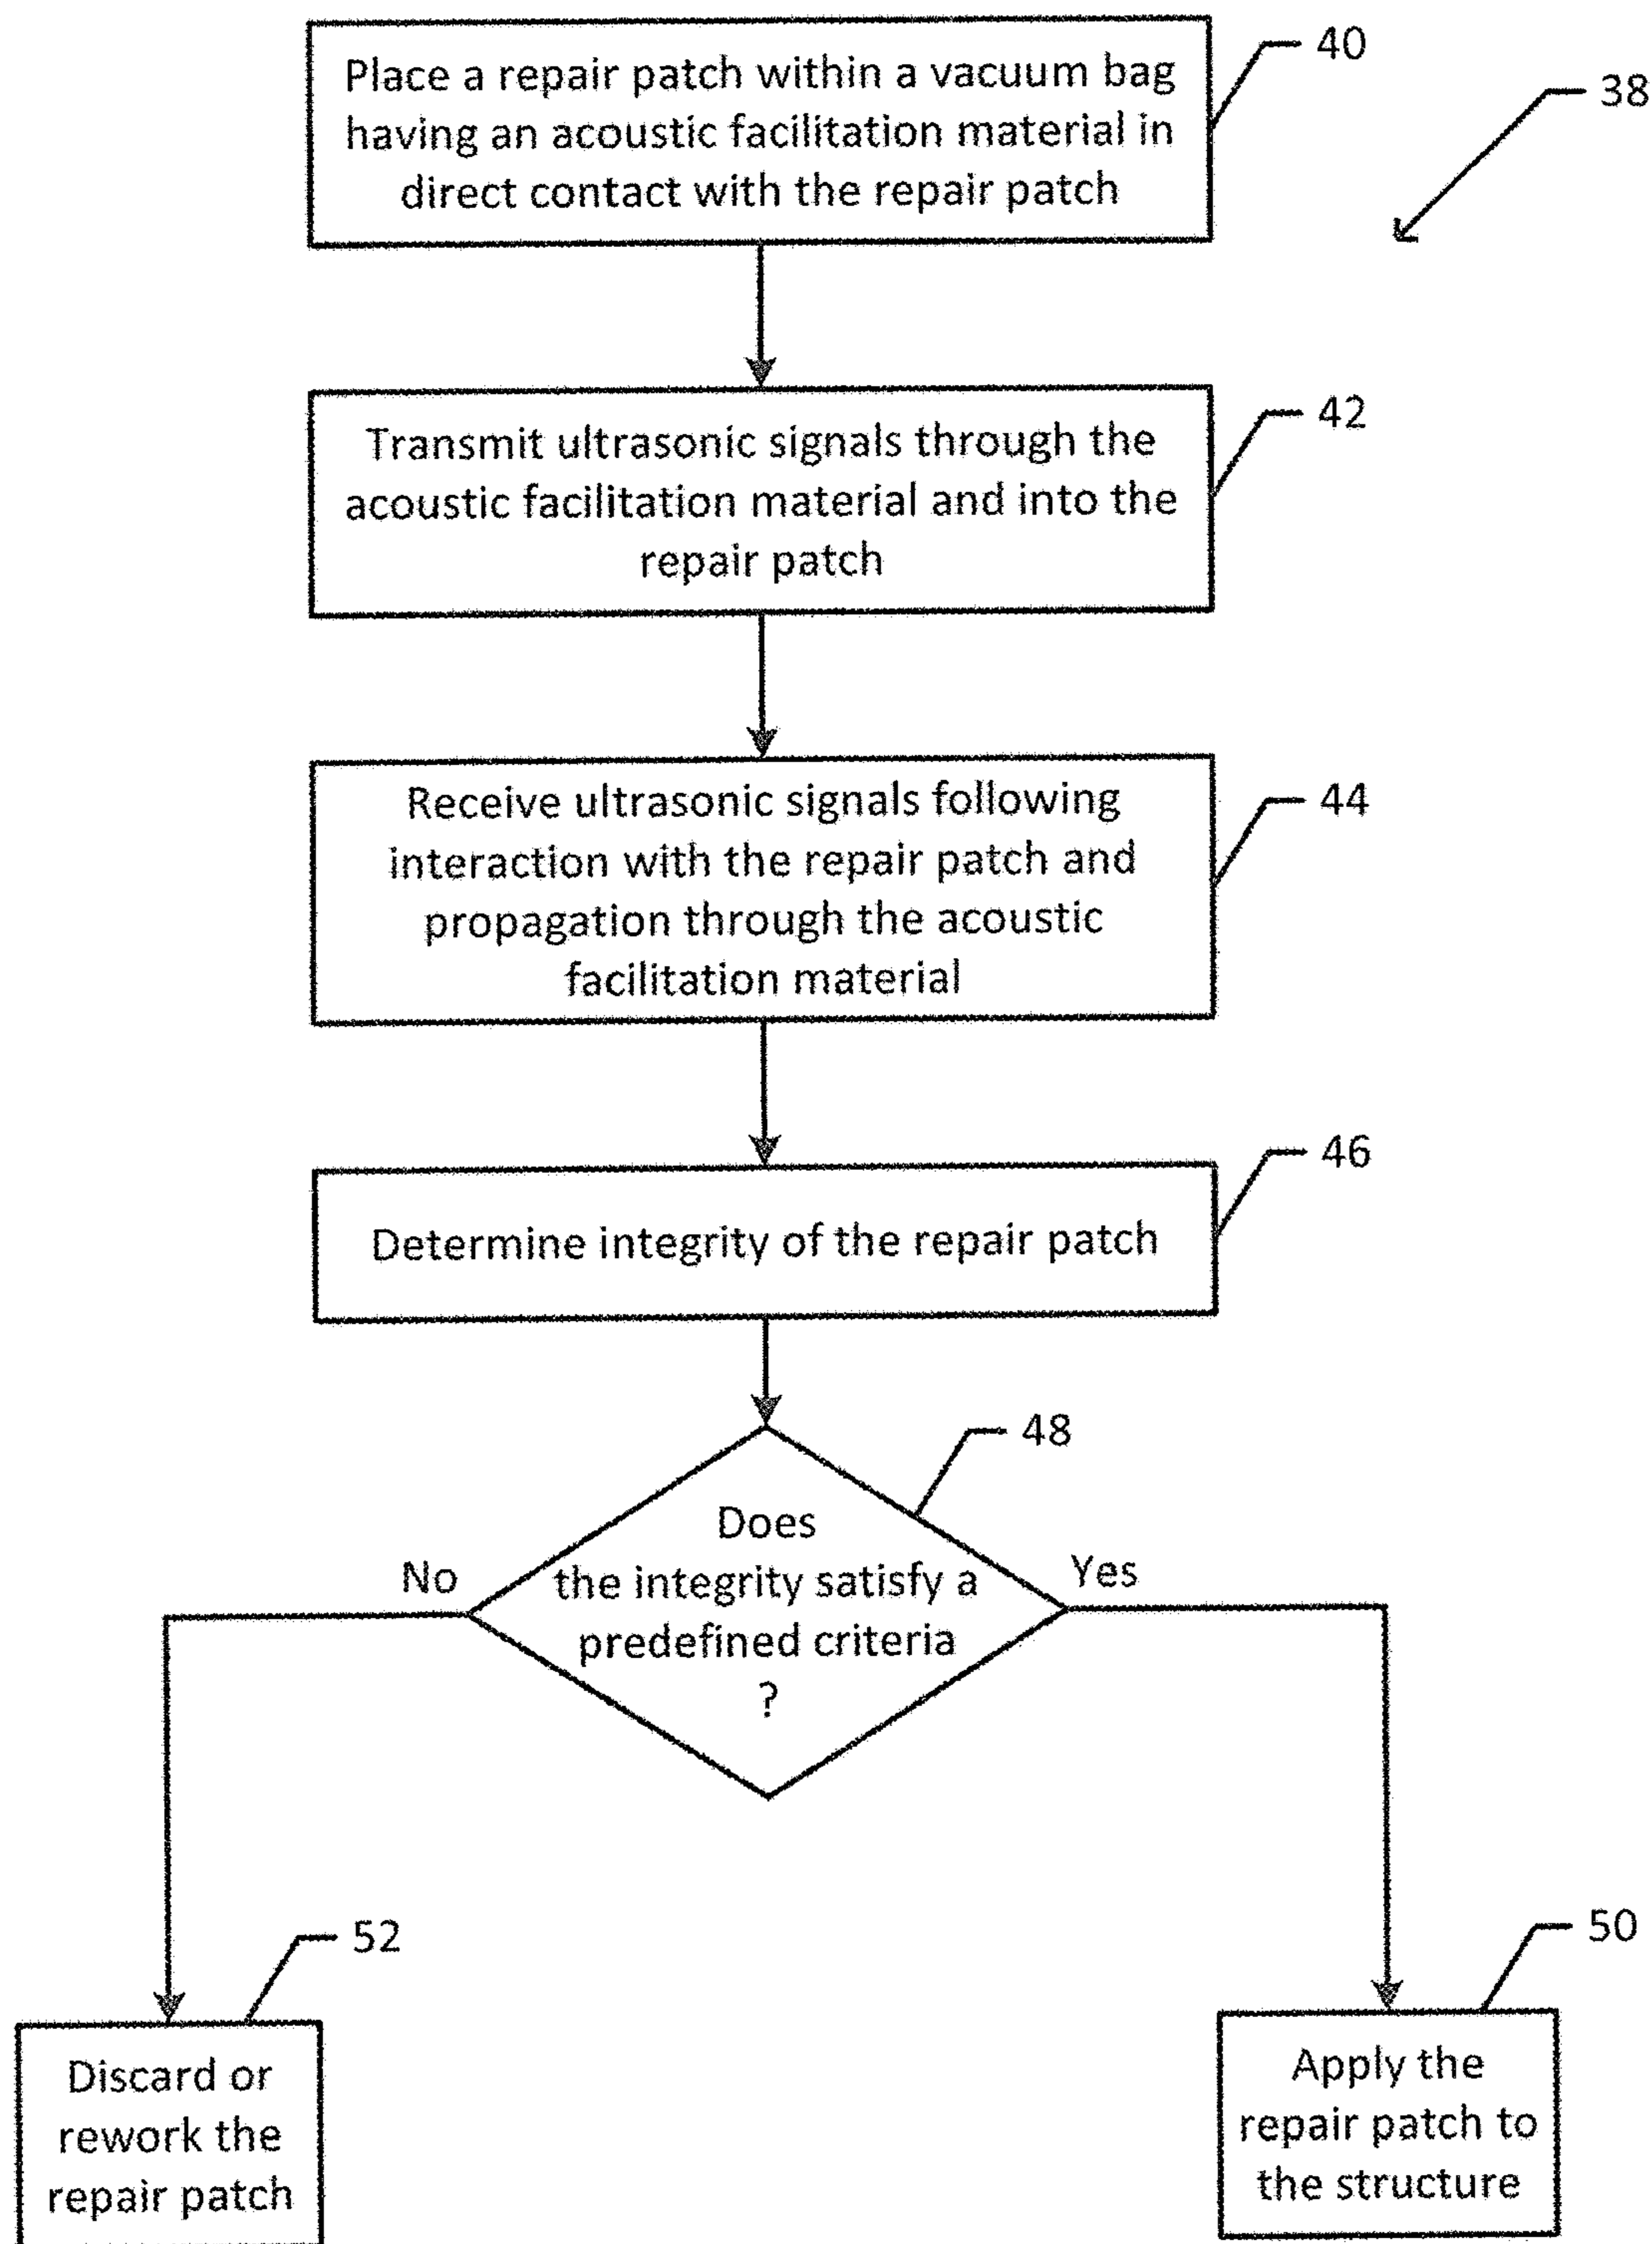
Figure 6

FIG. 6 is a flowchart illustrating operations performed in accordance with an example embodiment of the present disclosure.
