US010233780B2

(54) **FLANGE PARTIAL SECTION  
REPLACEMENT REPAIR**

A method of repairing a casing for a gas turbine engine, wherein the casing has a wall extending generally axially, and between at least one radially extending flange, the radially extending flange being formed with a plurality of bolt holes, includes the steps of removing a portion of the flange including at least one bolt hole. The removed portion is associated with a defect and a remaining portion of the flange includes at least one non-removed bolt hole. A replacement portion is obtained to replace the removed portion. The replacement portion is secured in an opening left in the flange by the removed portion. A repaired gas turbine engine casing is also disclosed.

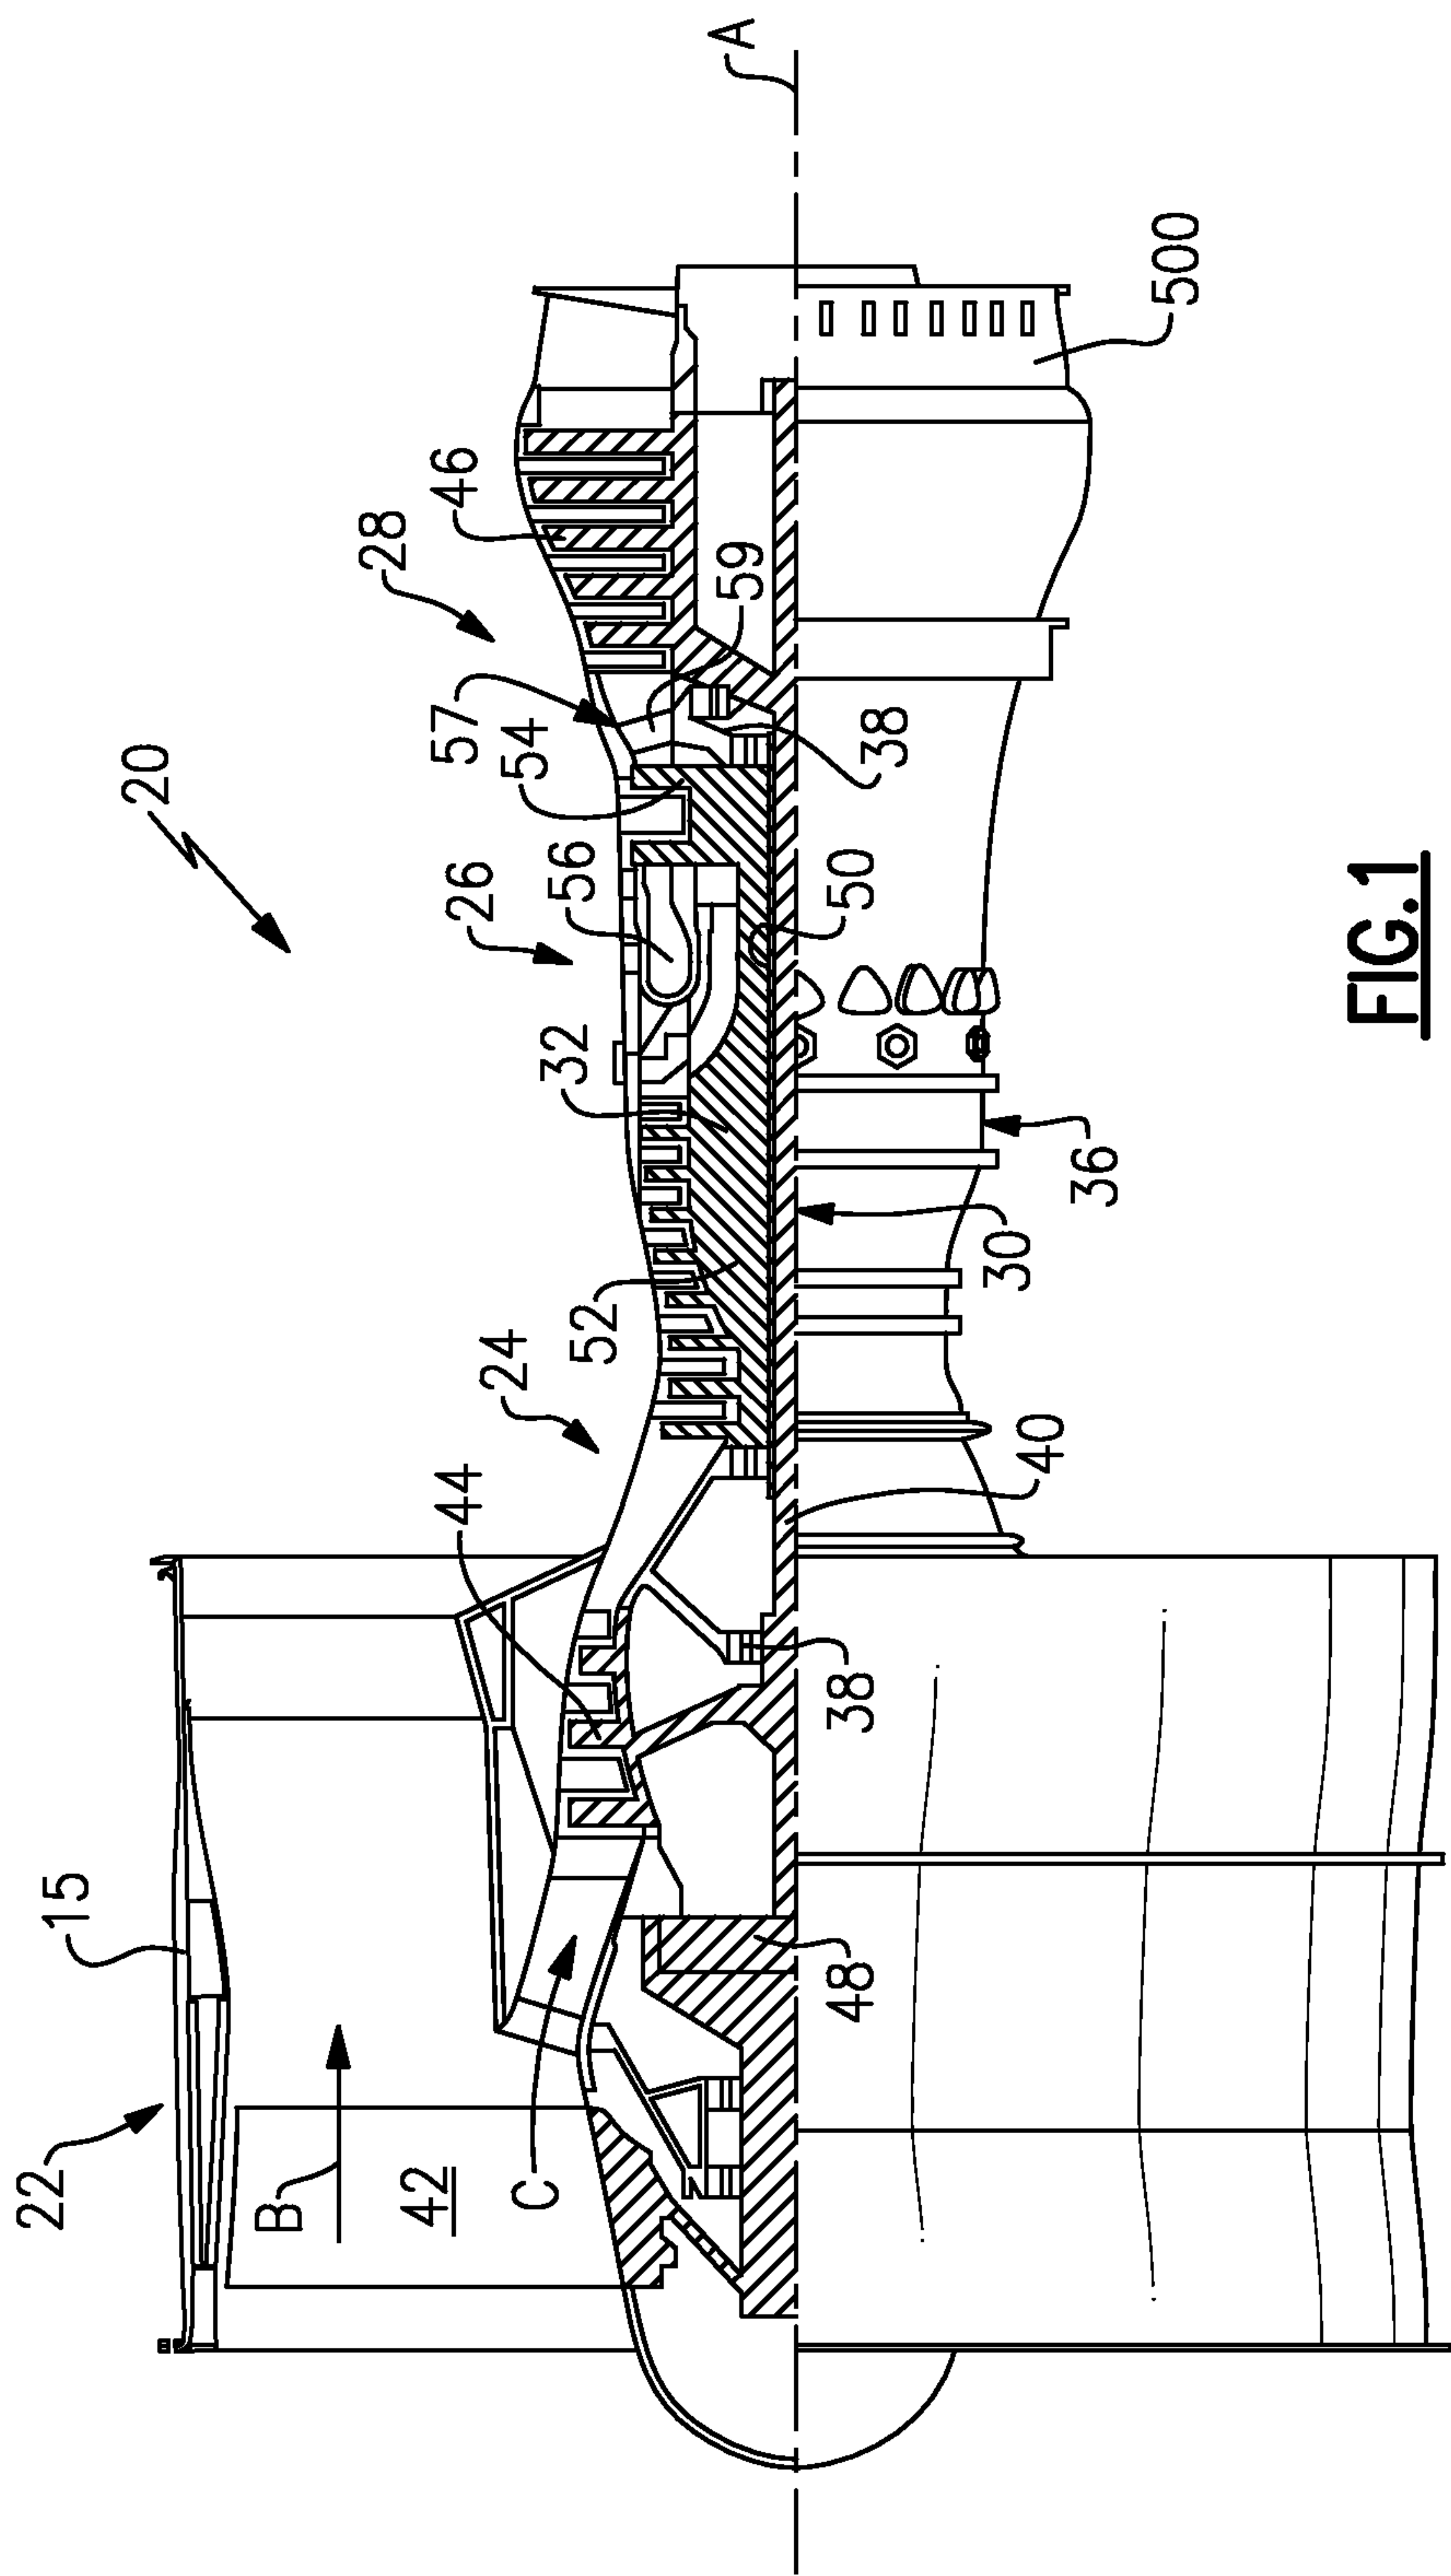
FIG.1

FIG. 1 is a schematic view of a gas turbine engine.

FIG. 1 schematically illustrates a gas turbine engine 20. The gas turbine engine 20 is disclosed herein as a two-spool turbofan that generally incorporates a fan section 22, a compressor section 24, a combustor section 26 and a turbine section 28. Alternative engines might include an augmentor section (not shown) among other systems or features. The fan section 22 drives air along a bypass flow path B in a bypass duct defined within a fan case 15, while the compressor section 24 drives air along a core flow path C for compression and communication into the combustor section 26 then expansion through the turbine section 28. Although depicted as a two-spool turbofan gas turbine engine in the disclosed non-limiting embodiment, it should be understood that the concepts described herein are not limited to use with two-spool turbofans as the teachings may be applied to other types of turbine engines including three-spool architectures.

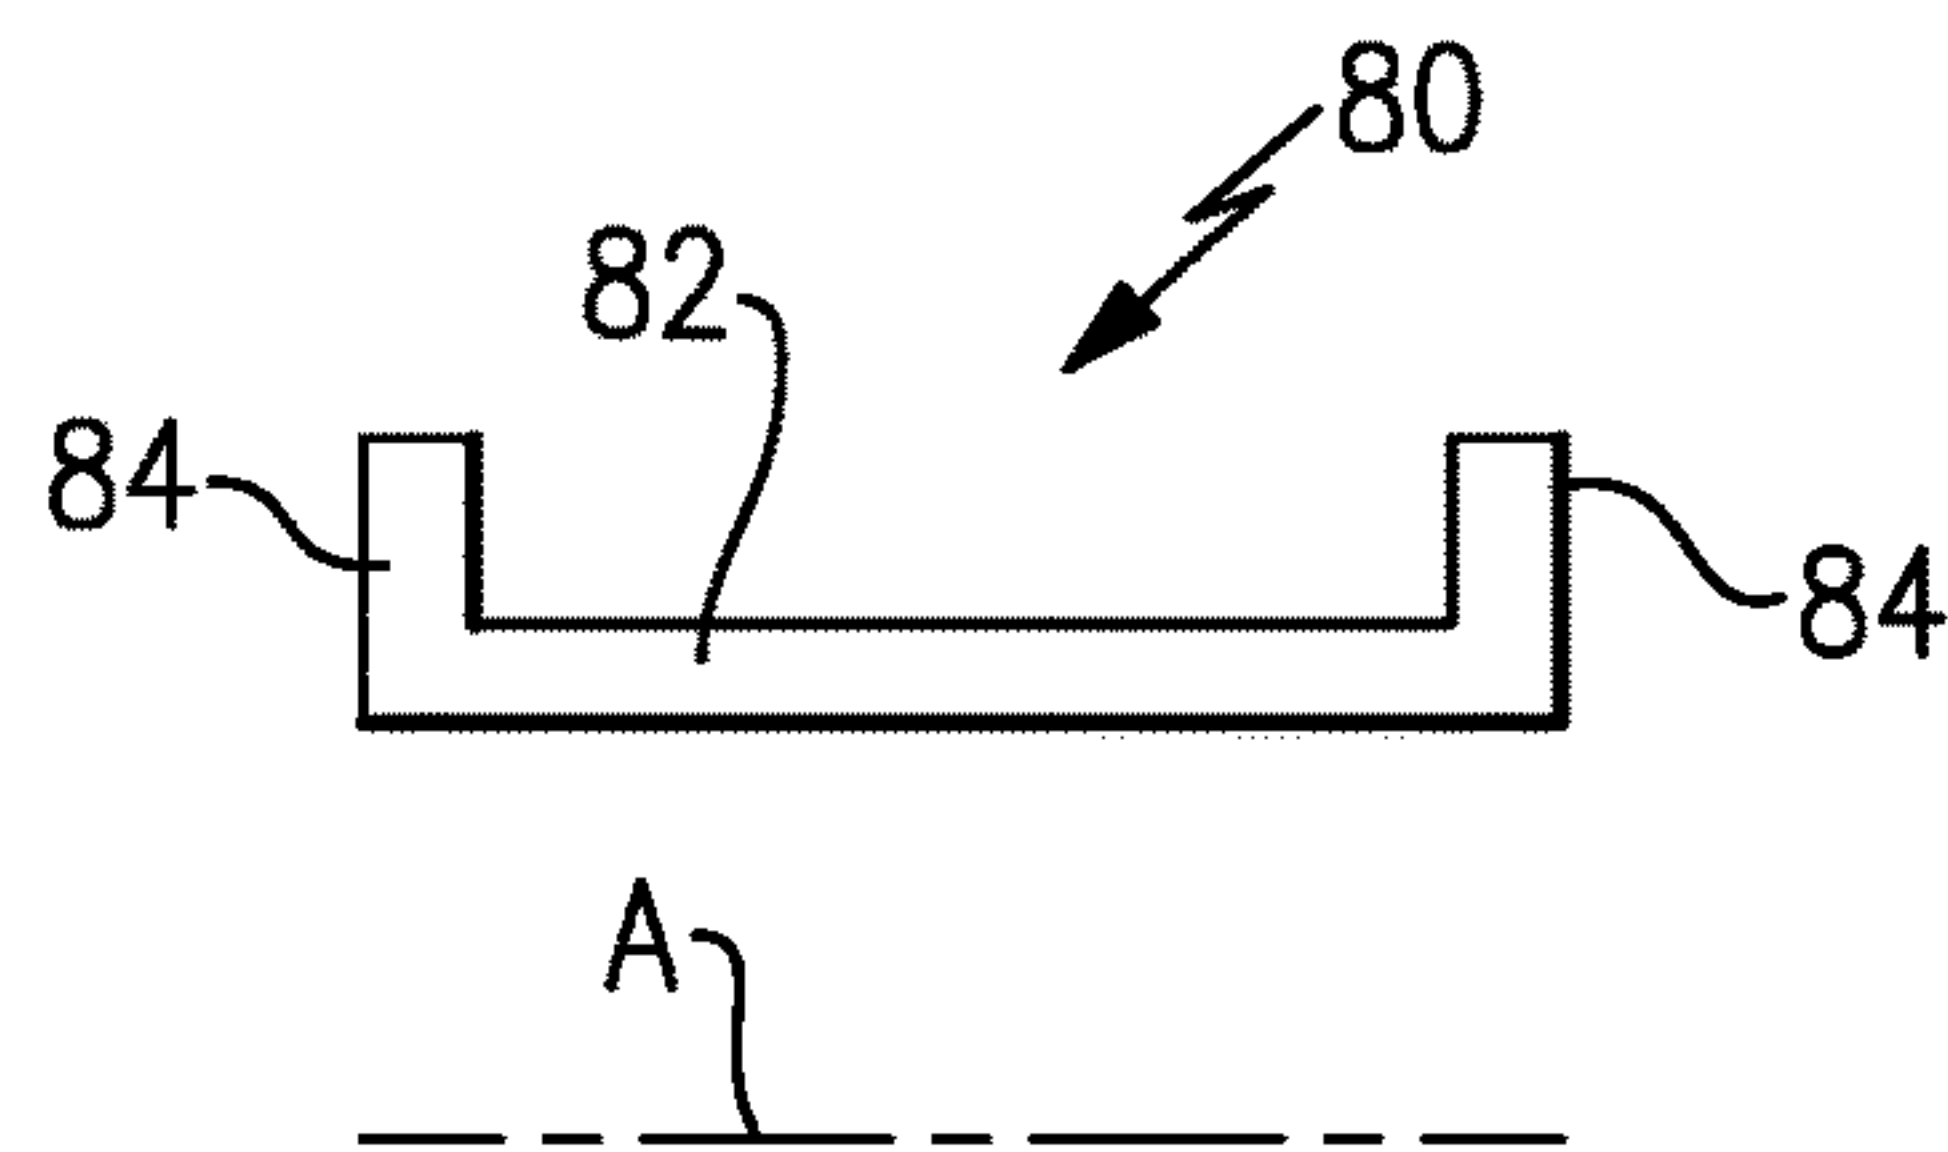
**FIG. 2A**

FIG. 2A shows a casing that may be incorporated into the FIG. 1 gas turbine engine.

FIG. 2A shows a casing 80 which may be utilized to enclose any number of parts of the gas turbine engine 20 of FIG. 1. The casing 80 is generally cylindrical and extends for 360 degrees about a center axis A (see also FIG. 1). As shown, a case wall 82 extends between radially outwardly extending flanges 84.

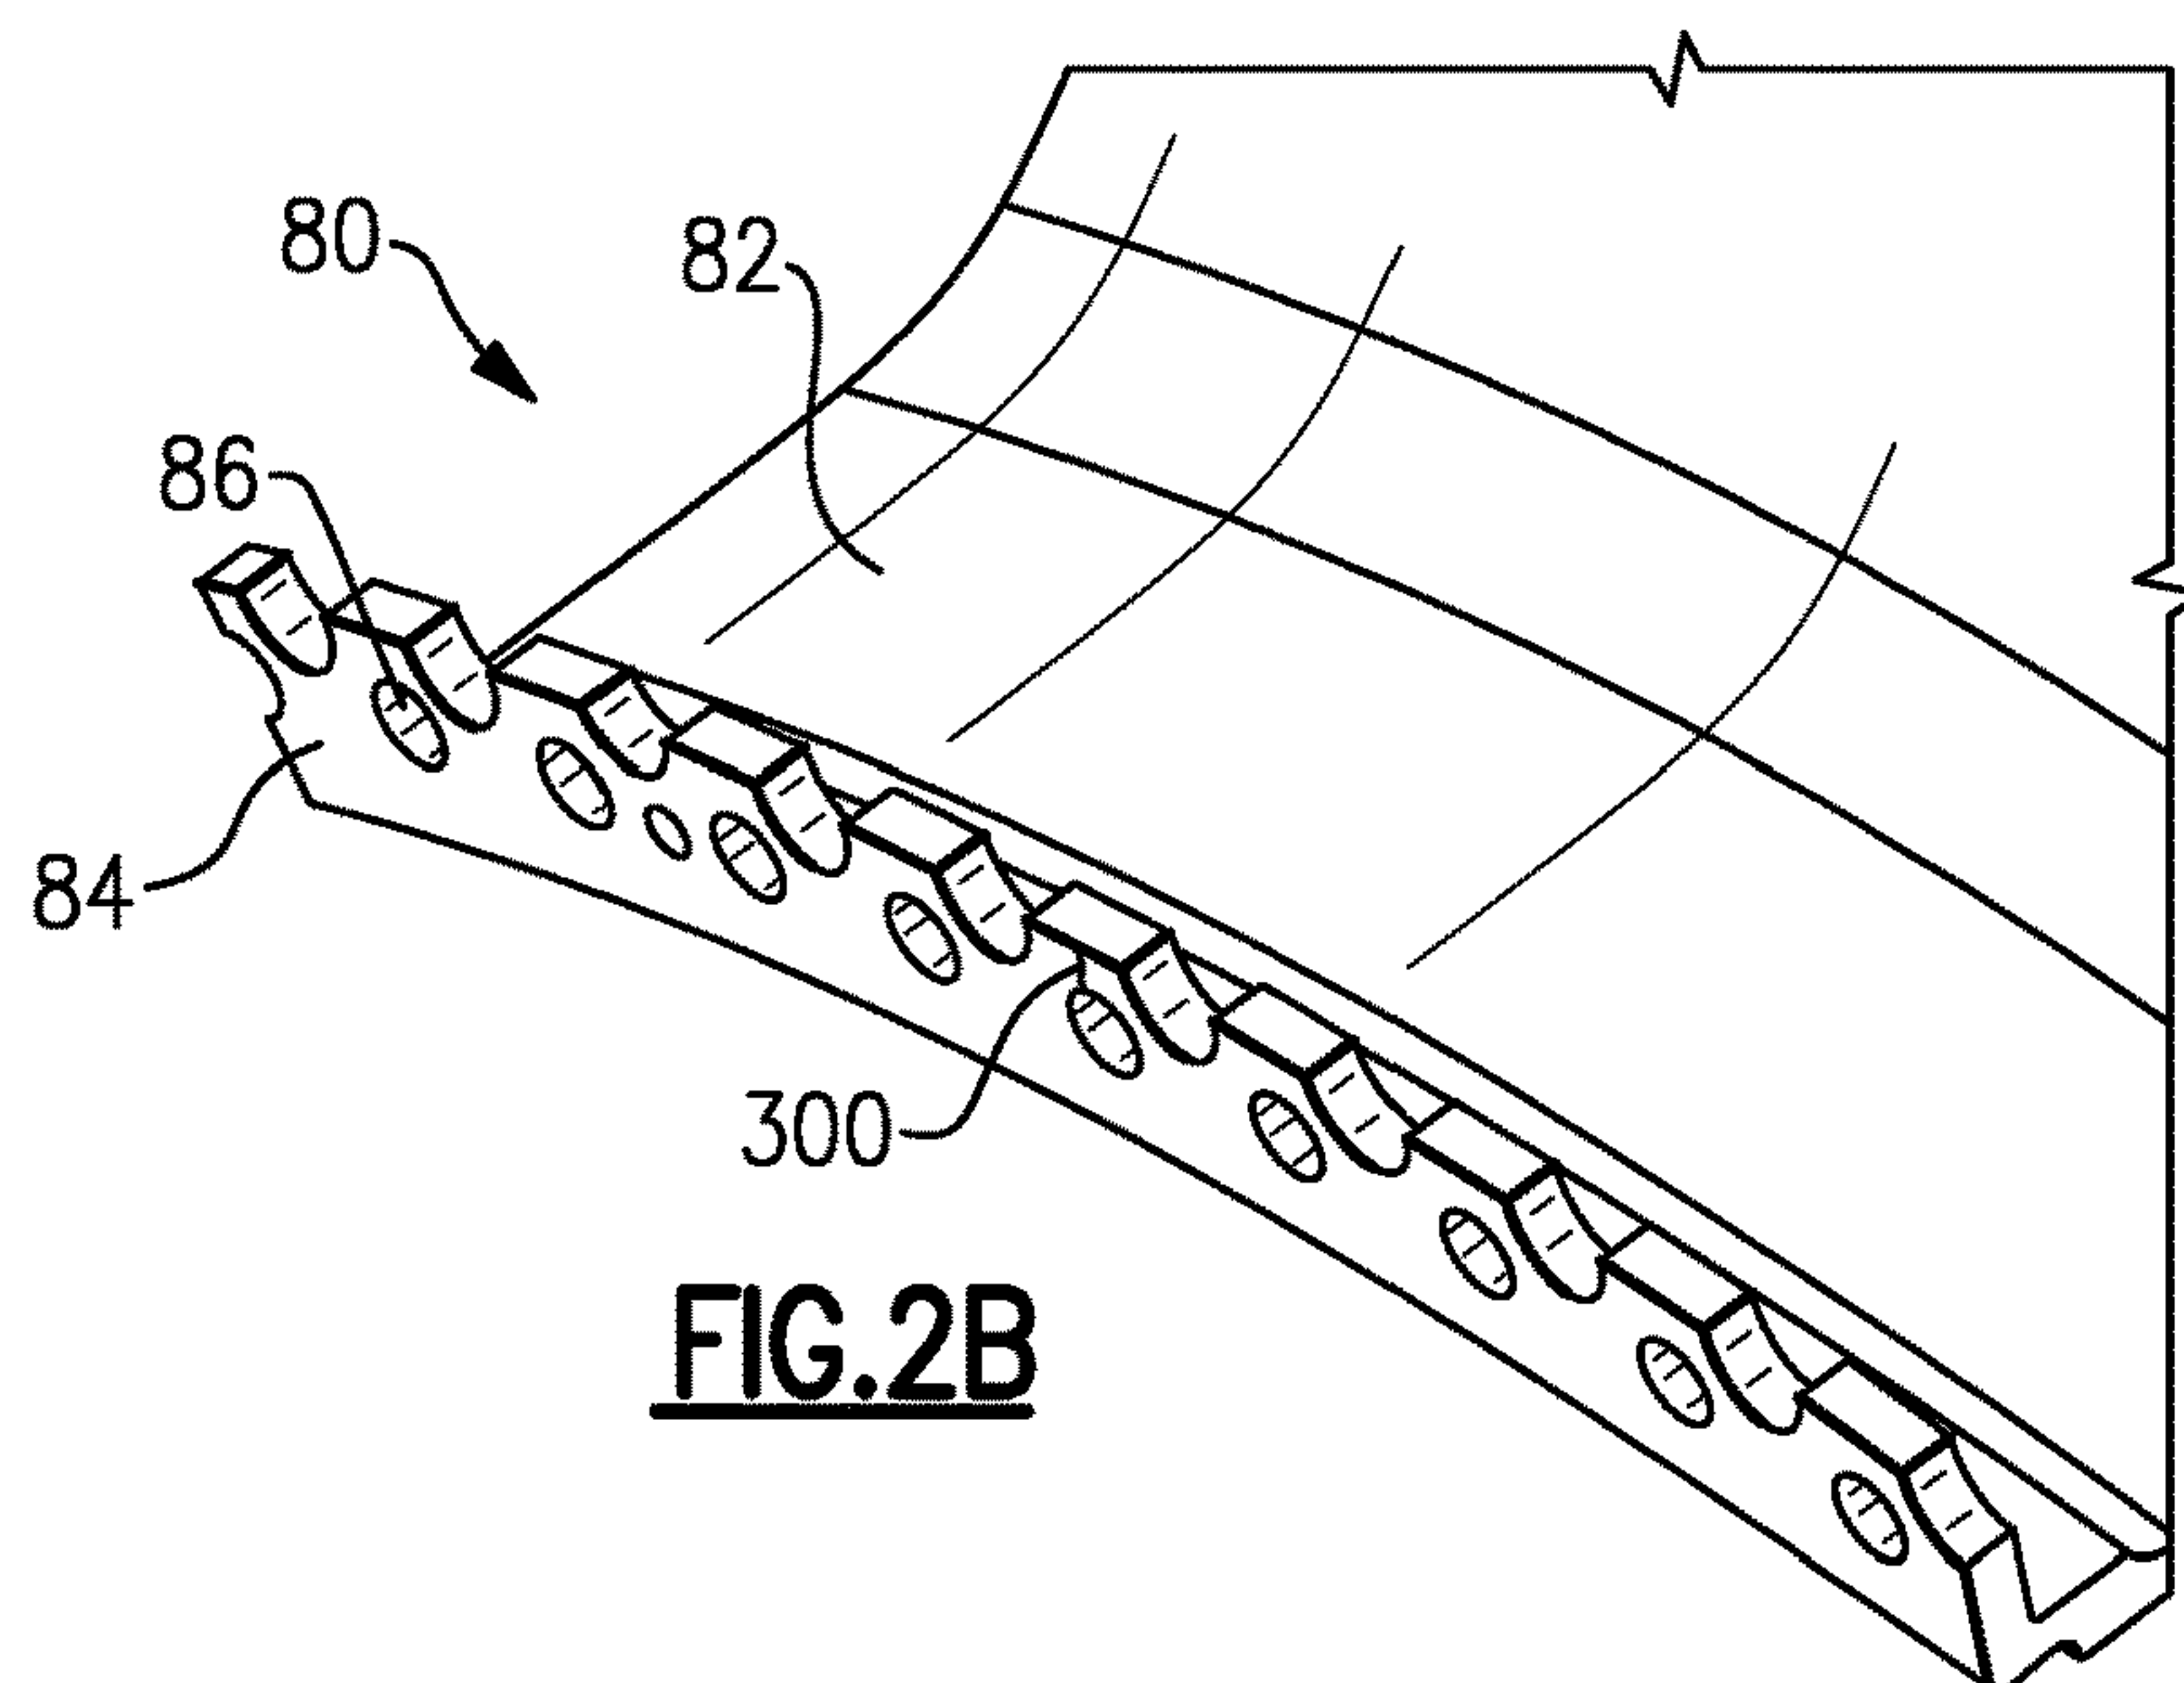
**FIG. 2B**

FIG. 2B shows a detail of the FIG. 2A casing.

FIG. 2B shows a detail of the flange 84 and, namely, a plurality of bolt holes 86. As can be appreciated, the flange 84 extends radially from the wall 82 and the bolt holes 86 are formed in the flange 84. A crack 300 extends radially

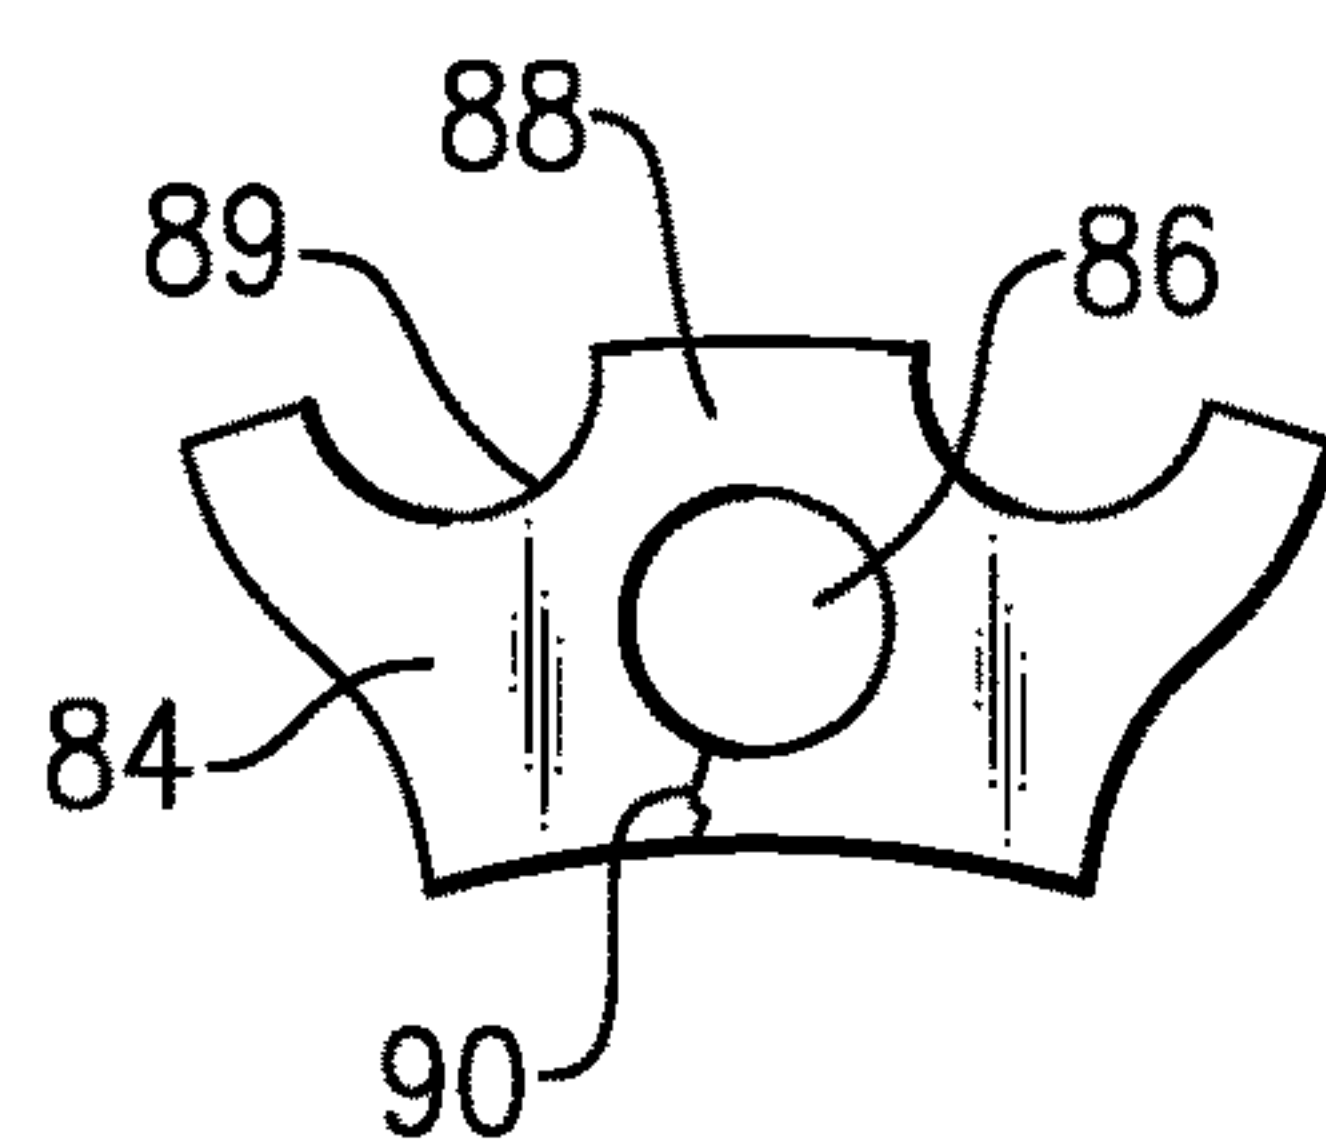
**FIG. 2C**

FIG. 2C shows a defect in the FIG. 2A casing.

As shown in FIG. 2C, a crack **90** is propagated from a bolt hole **86** toward the surface of the flange **84** which is connected to the wall **82**. As mentioned above, it is somewhat unsatisfactory to repair such a crack with existing welding techniques. As can be seen in FIG. 2C, the flange **84** has an outer portion **88** generally circumferentially aligned with the bolt hole **86**, and scalloped portions **89** which are intermediate adjacent bolt holes **86**.

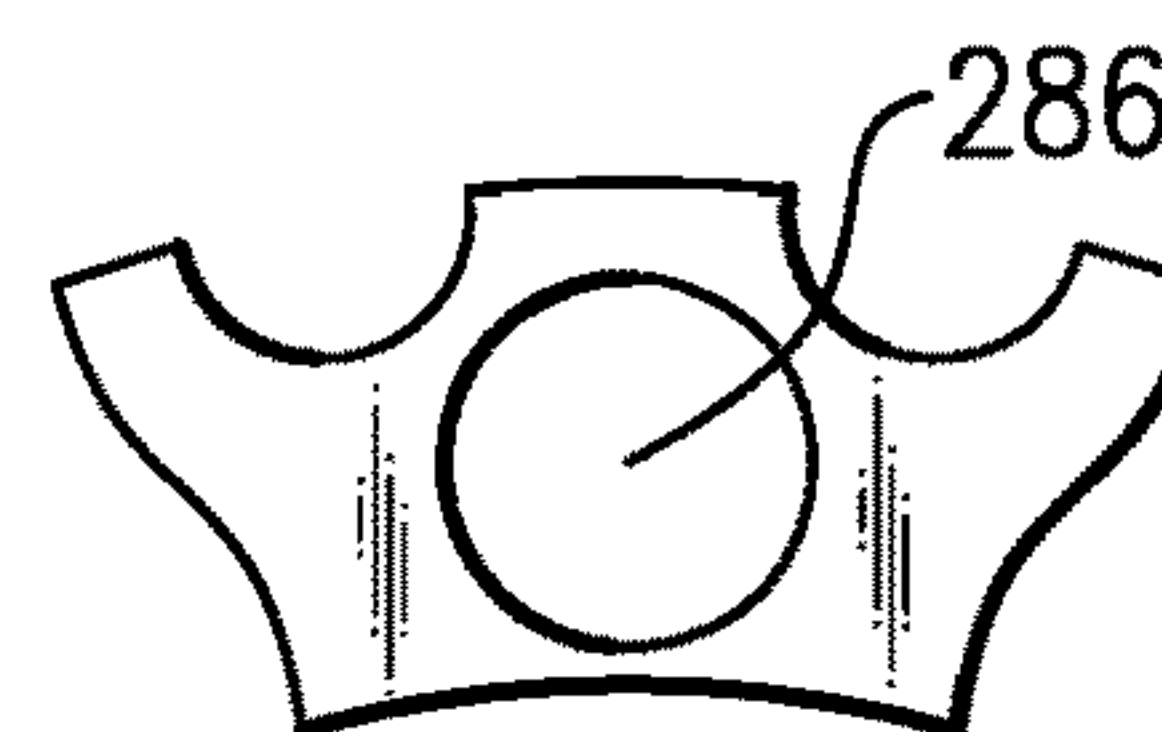
**FIG. 3D**

FIG. 3D shows an alternative to FIG. 2C.

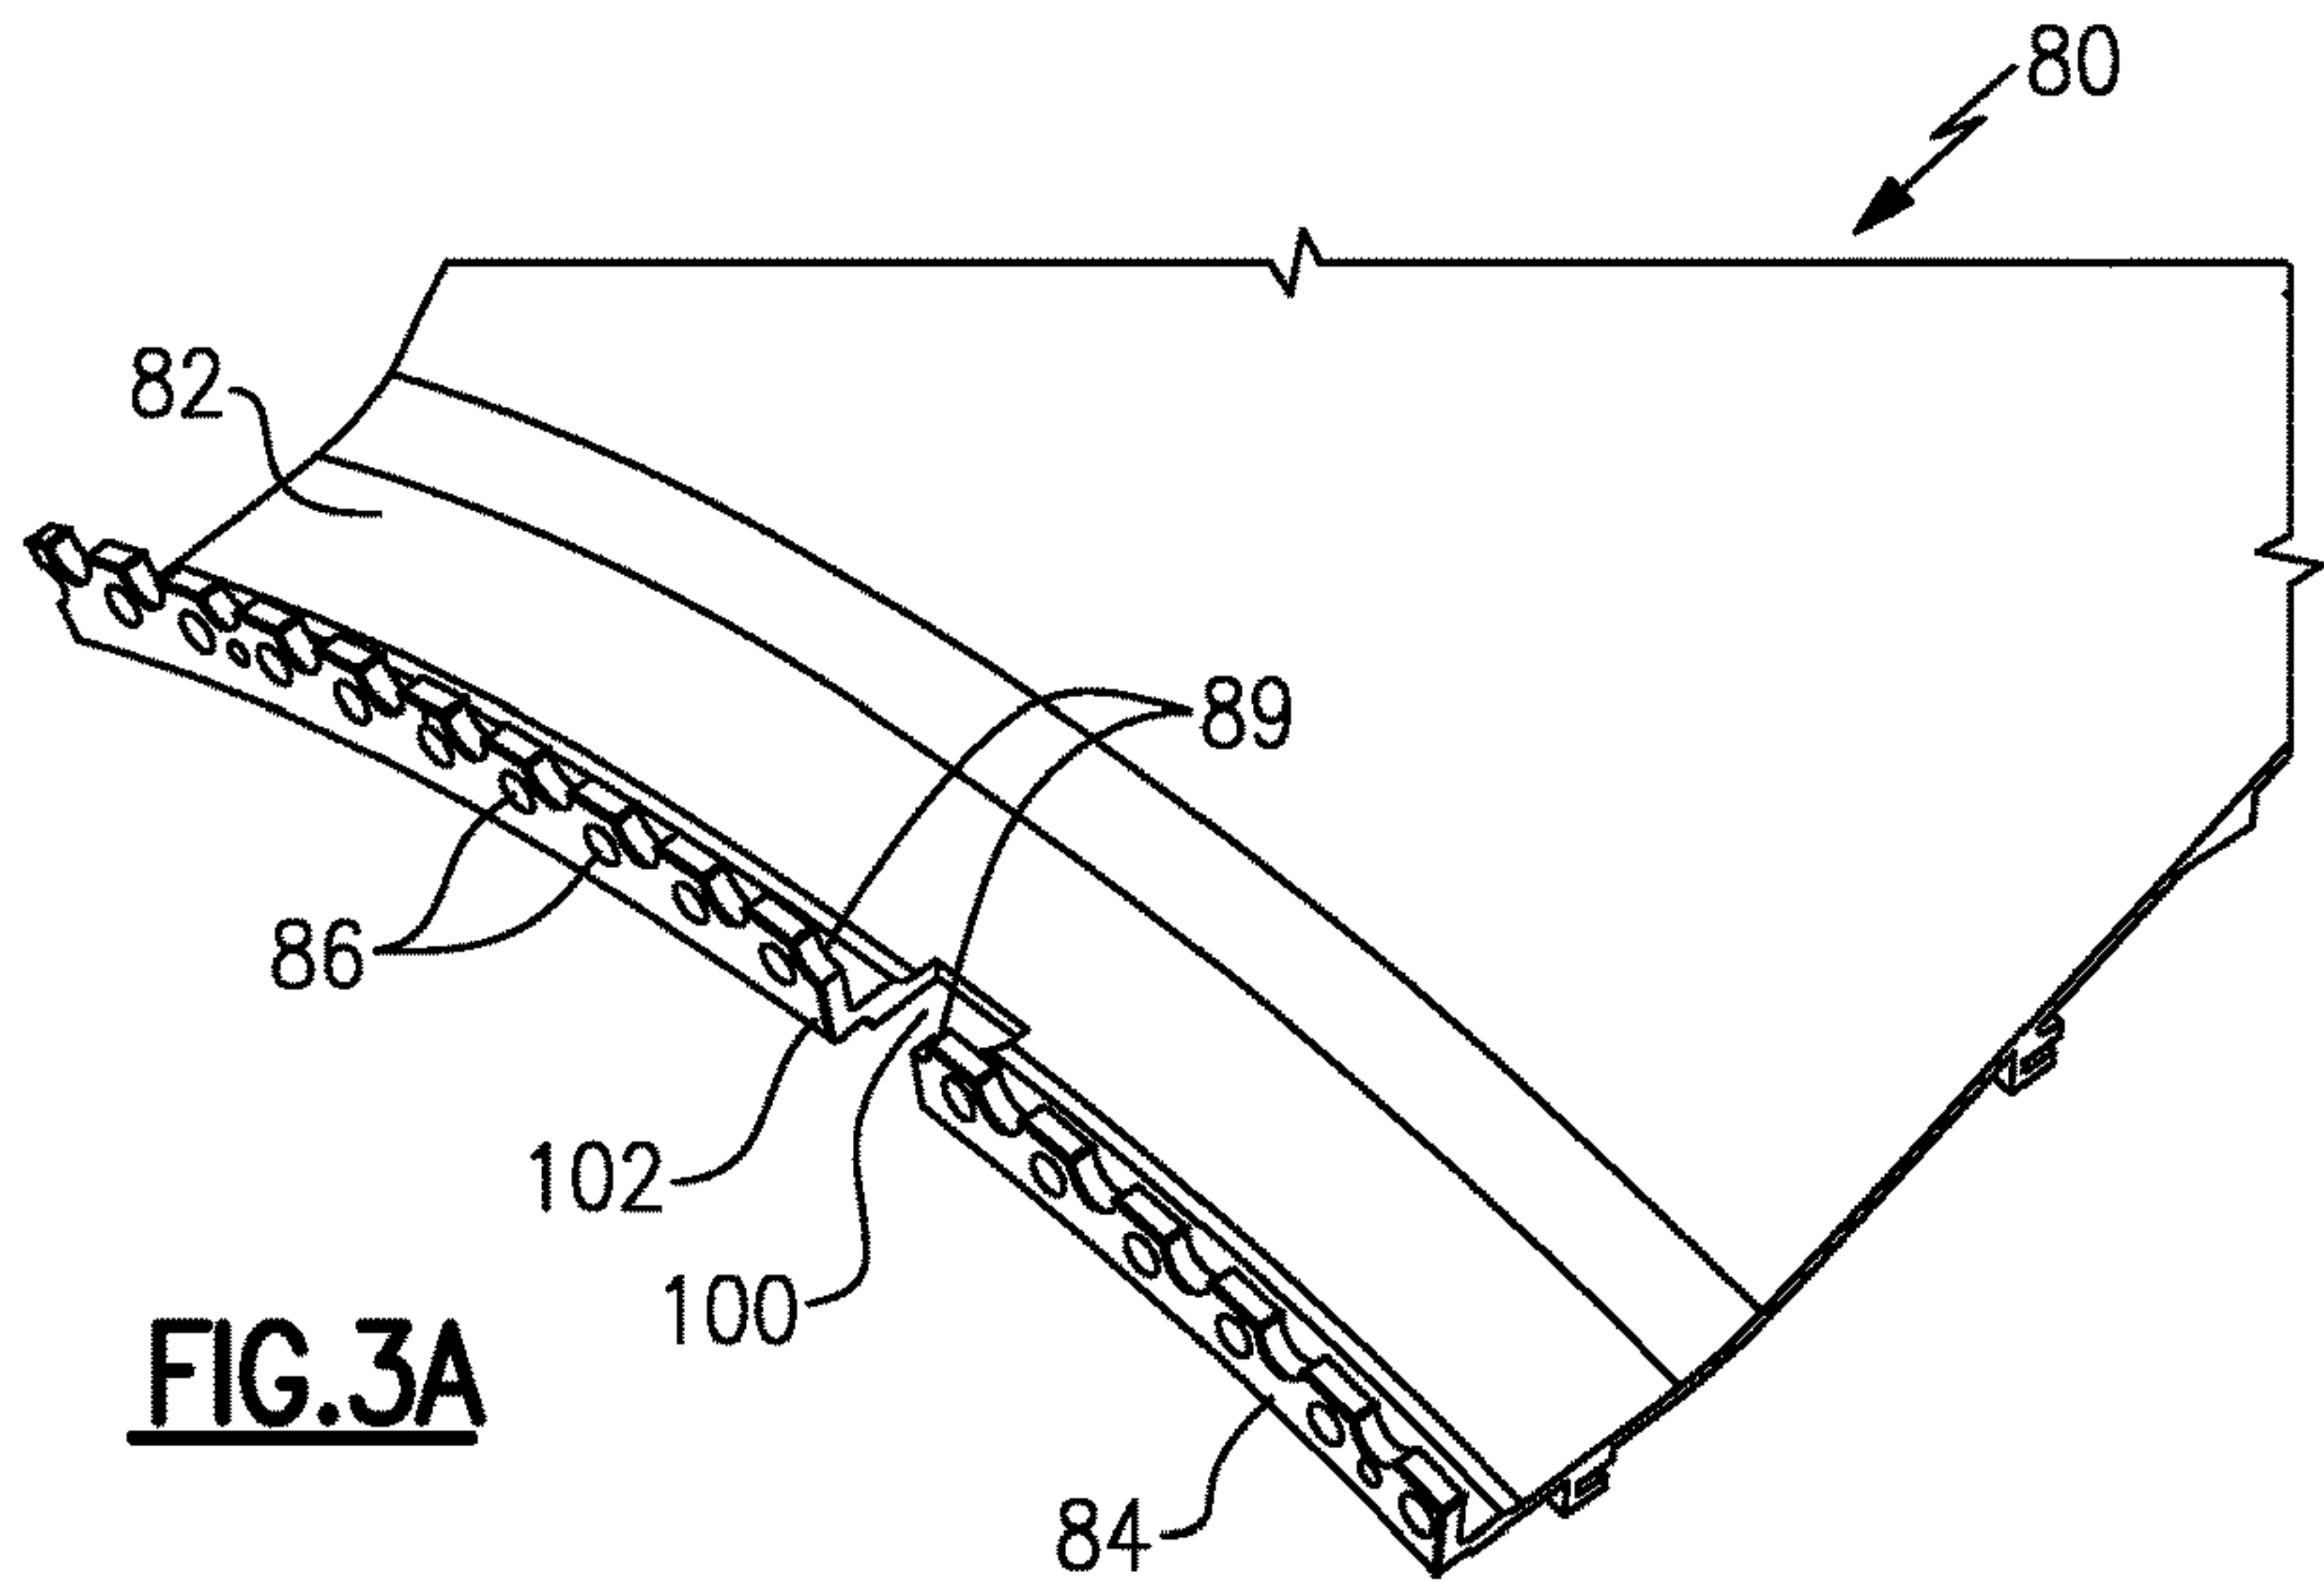
FIG. 3A shows a first repair step.

FIG. 3A shows a first step in repairing the casing **80**. When the crack **90** is identified, the following repair process is initiated. A section **100** of the wall **82** and a section **102** of the flange is removed. This would be the section associated with the hole **86** with the crack **90**. While a single bolt hole portion has been removed, a worker of ordinary skill in the art would recognize that more than one bolt hole could be removed. Notably, a plurality of other bolt holes **86** and their respective flange portions do remain. As can be seen, the removed portion may be intermediate to portions of two scallops **89** in the remainder of the flange **84**. Of course, the scallops are optional, and the teachings of this application would extend to casings not having such scallops.

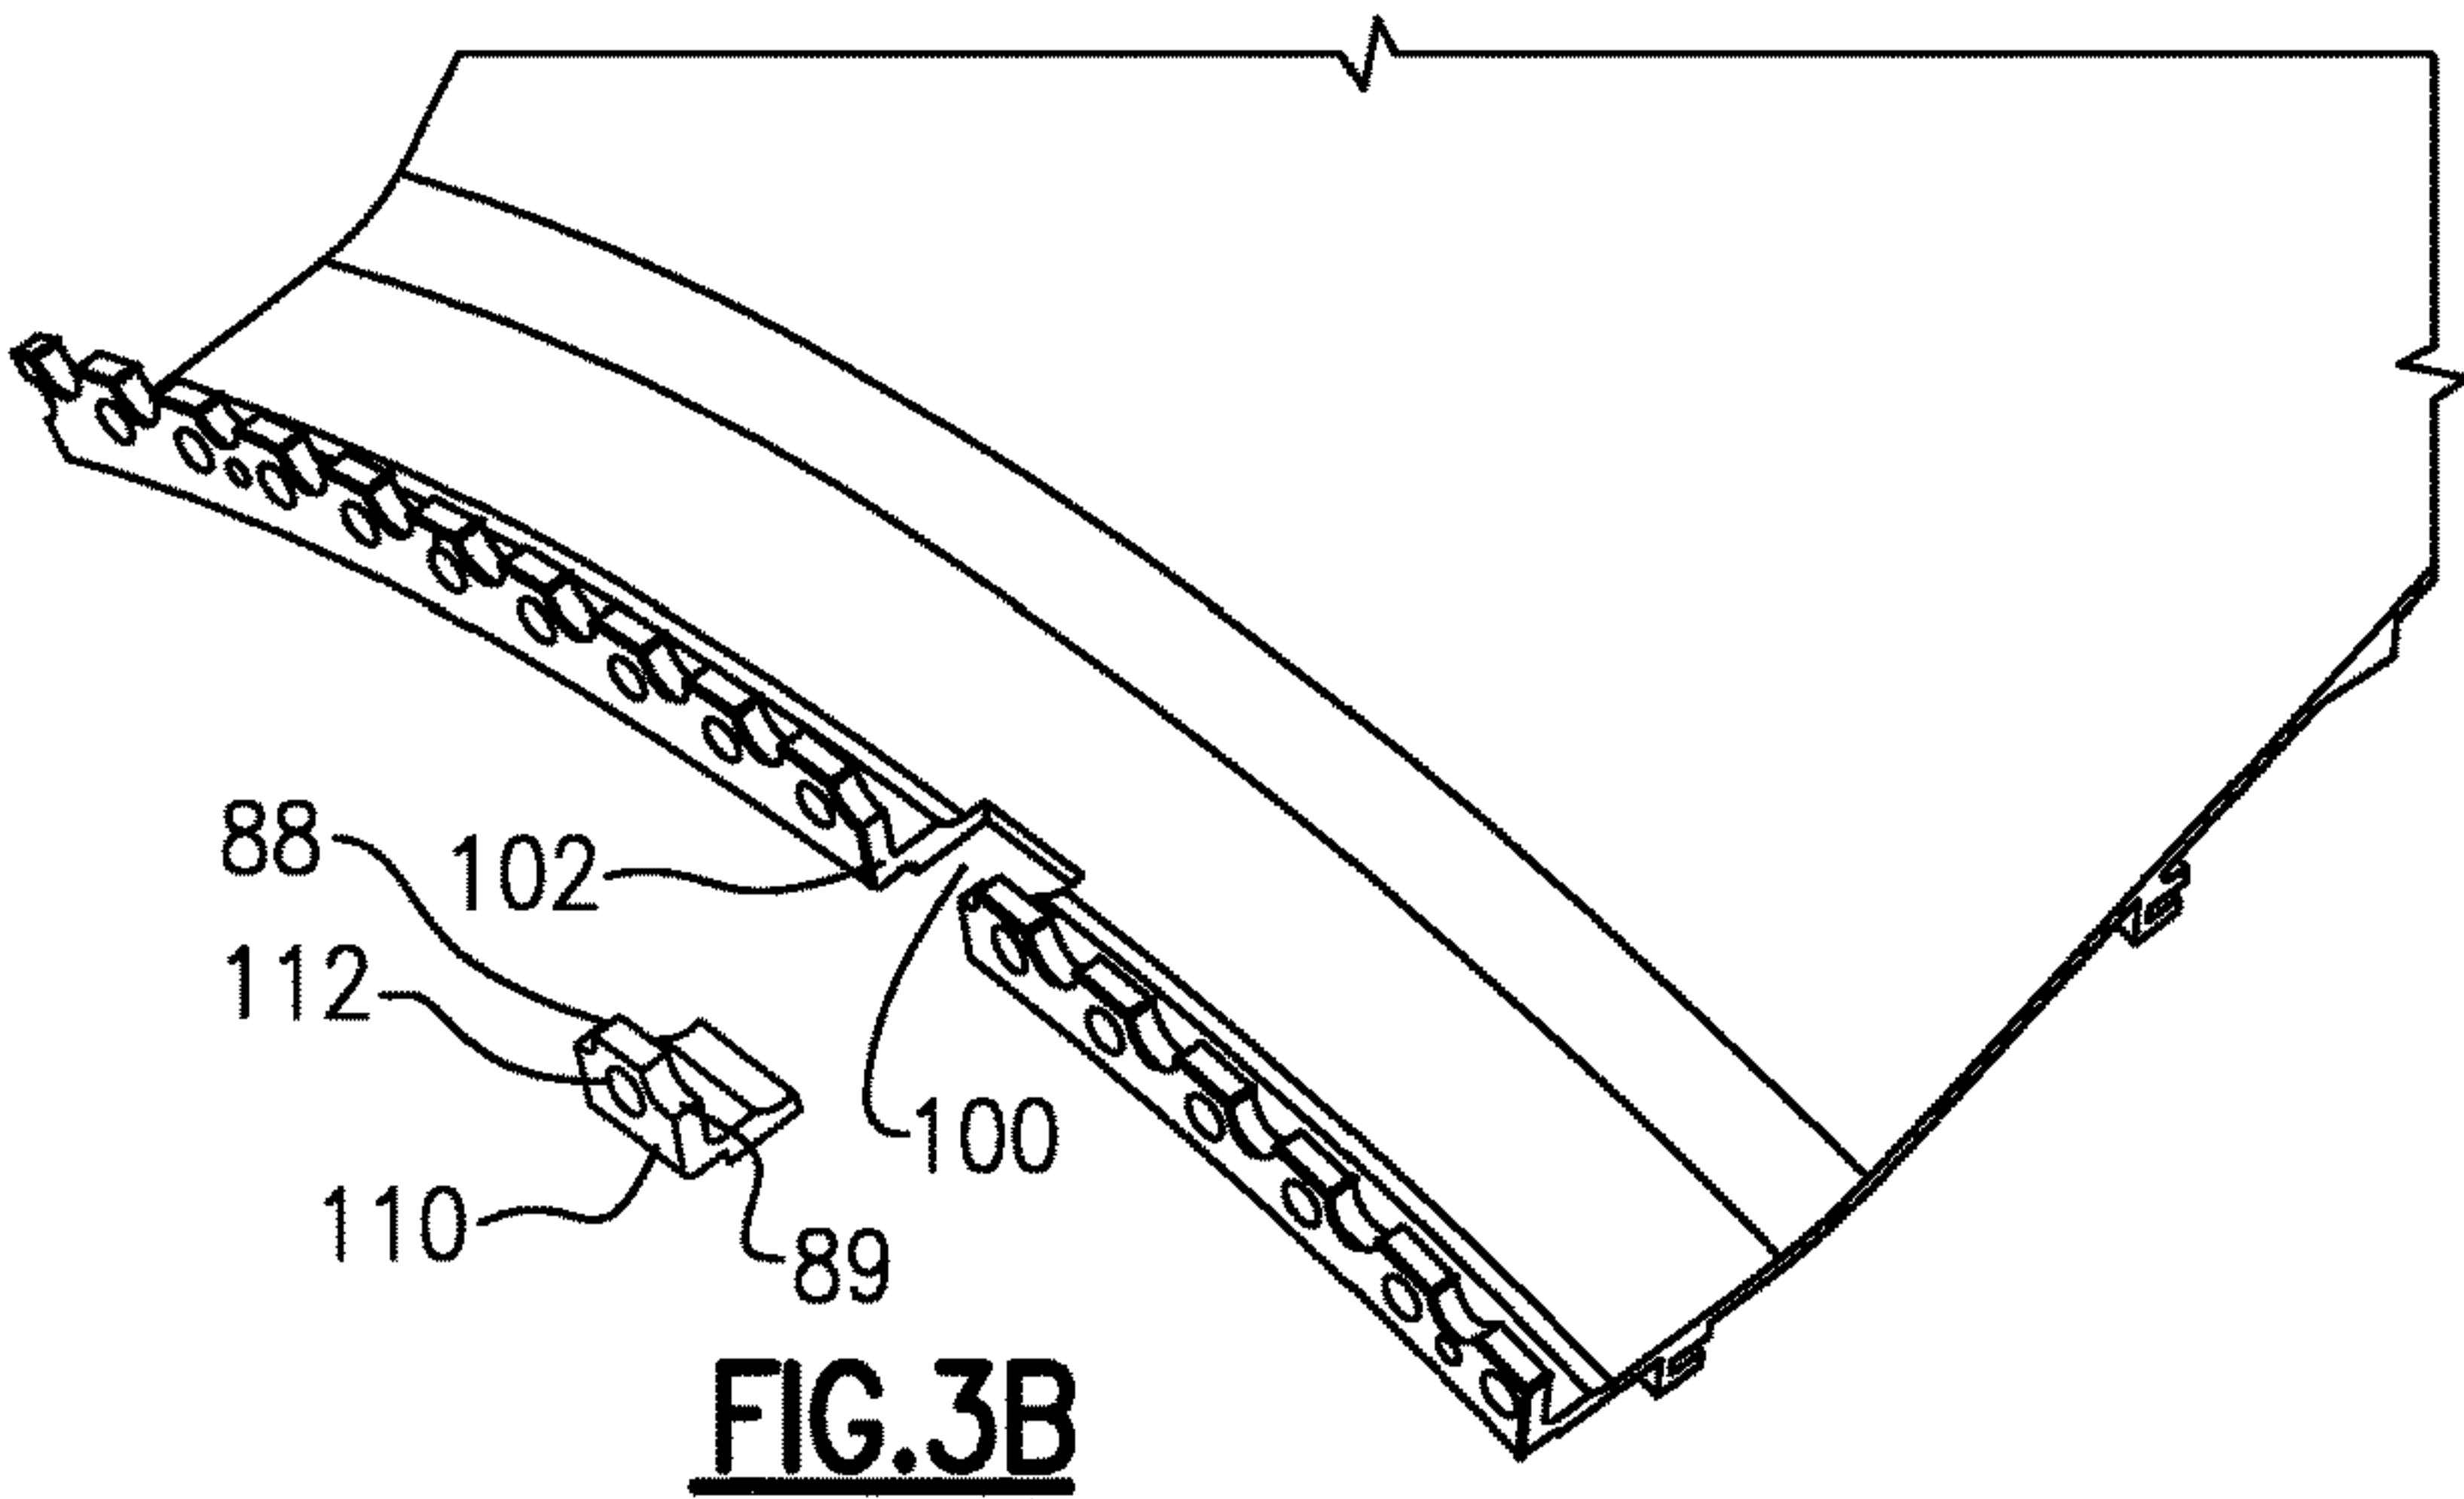
FIG. 3B shows a subsequent step.

FIG. 3B shows a subsequent step. Namely, a replacement part **110** is obtained and includes a hole **112**. As can be seen, there may be scallop portions **89** on the replacement part **110**. In one embodiment, the replacement part **110** may be fabricated from a pre-machined section or block of a material similar or identical to the material of the flange **84**. In one aspect, the pre-machined section also includes a pre-machined bolt hole **86**. In one aspect, the removed section **100** is sized to include the bolt and the crack as described above, while also being sized to match the pre-machined section. That is, the pre-machined section may be of a standard size. In this aspect, the pre-machined section may not require additional fabrication. In another aspect, the pre-machined section is machined onsite to match the dimensions of the removed section **100**, removed from the flange **84**.
