US010233780B2

(54) **FLANGE PARTIAL SECTION  
REPLACEMENT REPAIR**

A method of repairing a casing for a gas turbine engine, wherein the casing has a wall extending generally axially, and between at least one radially extending flange, the radially extending flange being formed with a plurality of bolt holes, includes the steps of removing a portion of the flange including at least one bolt hole. The removed portion is associated with a defect and a remaining portion of the flange includes at least one non-removed bolt hole. A replacement portion is obtained to replace the removed portion. The replacement portion is secured in an opening left in the flange by the removed portion. A repaired gas turbine engine casing is also disclosed.

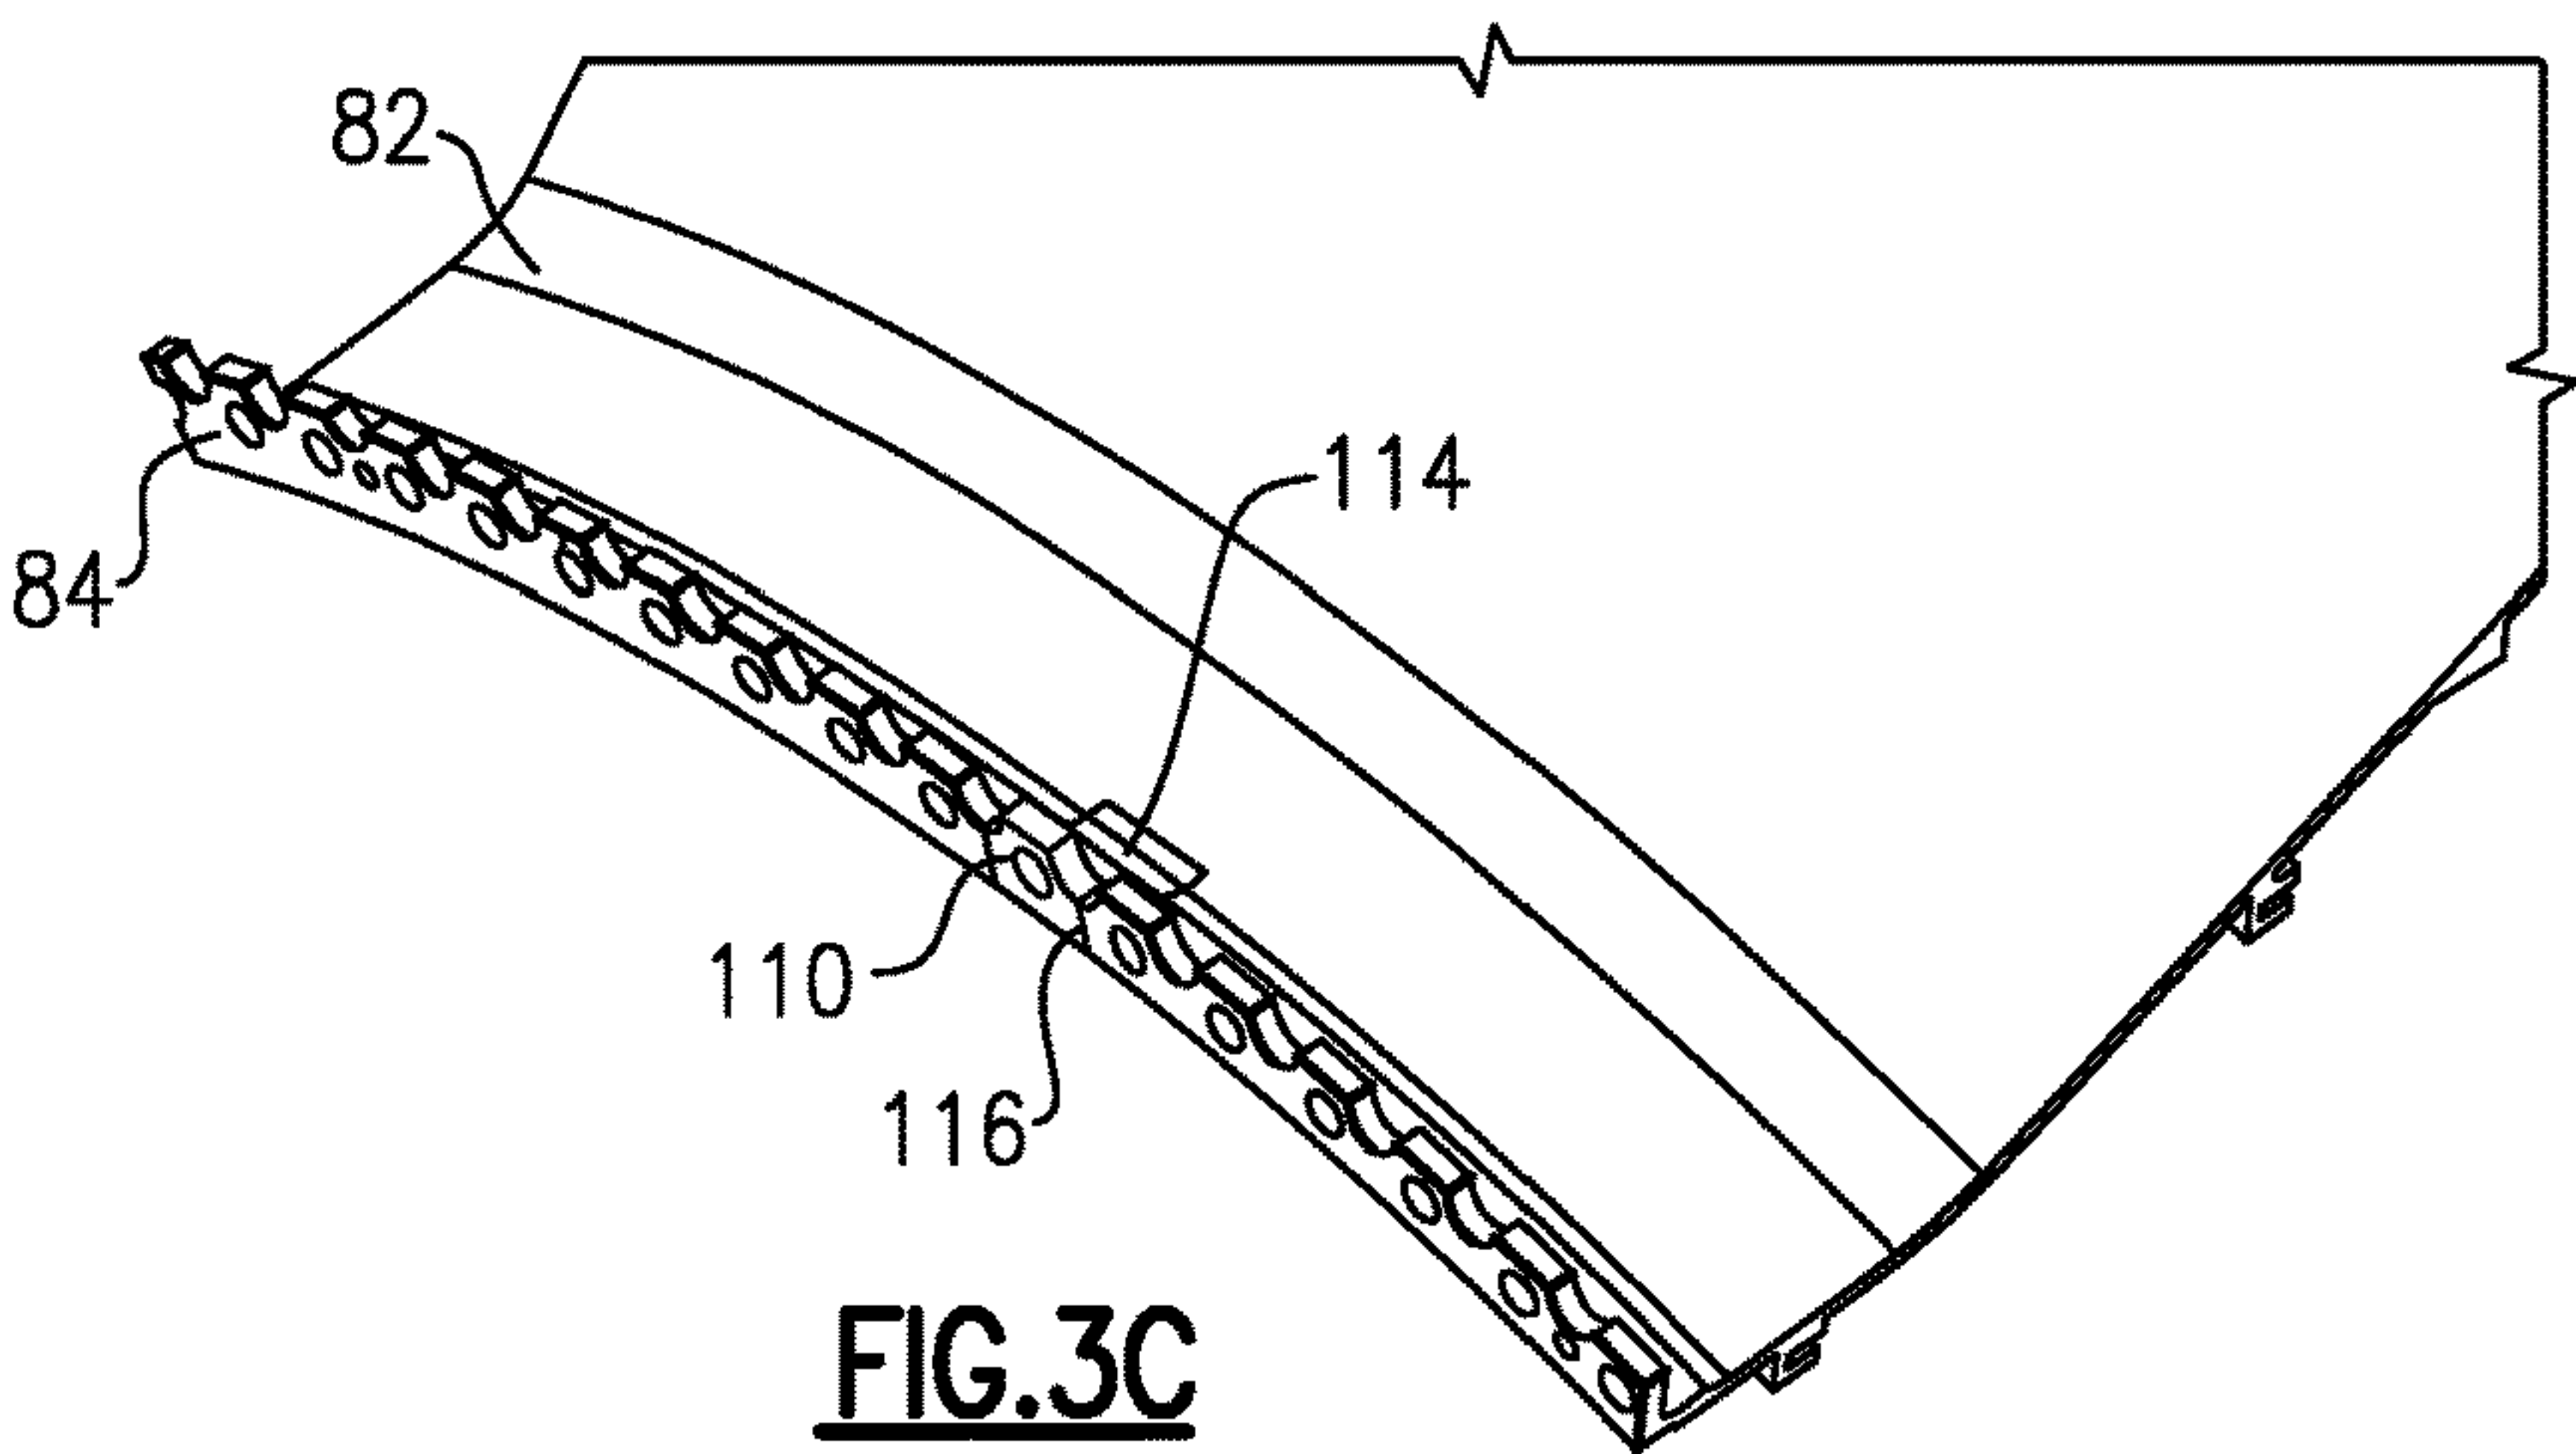
FIG. 3C shows a fully repaired casing.

As shown in FIG. 3C, the replacement part **110** has now been inserted into the prior opening **100** and **102**. The replacement portion **110** is welded at **114** to the wall **82**, and welded at **116** to circumferentially adjacent portions of the flange **84**. While welding is described, other methods of securing the replacement portion **110** may be utilized. Now, a relatively simple method of repairing a bolt hole flange having a crack has been developed that does not require complete replacement of the bolt hole flange.
