US010265915B2

(54) **COMPOSITE BONDED REPAIR METHOD**

(71) Applicant: **Sikorsky Aircraft Corporation**,  
Stratford, CT (US)

A composite bonded repair method for an aircraft is provided. The method includes generating a doubling patch of a portion of the aircraft from topographic data, filling damage at the portion of the aircraft with filler material, applying adhesive to the portion of the aircraft and the filler material and adhering the doubling patch to the adhesive.

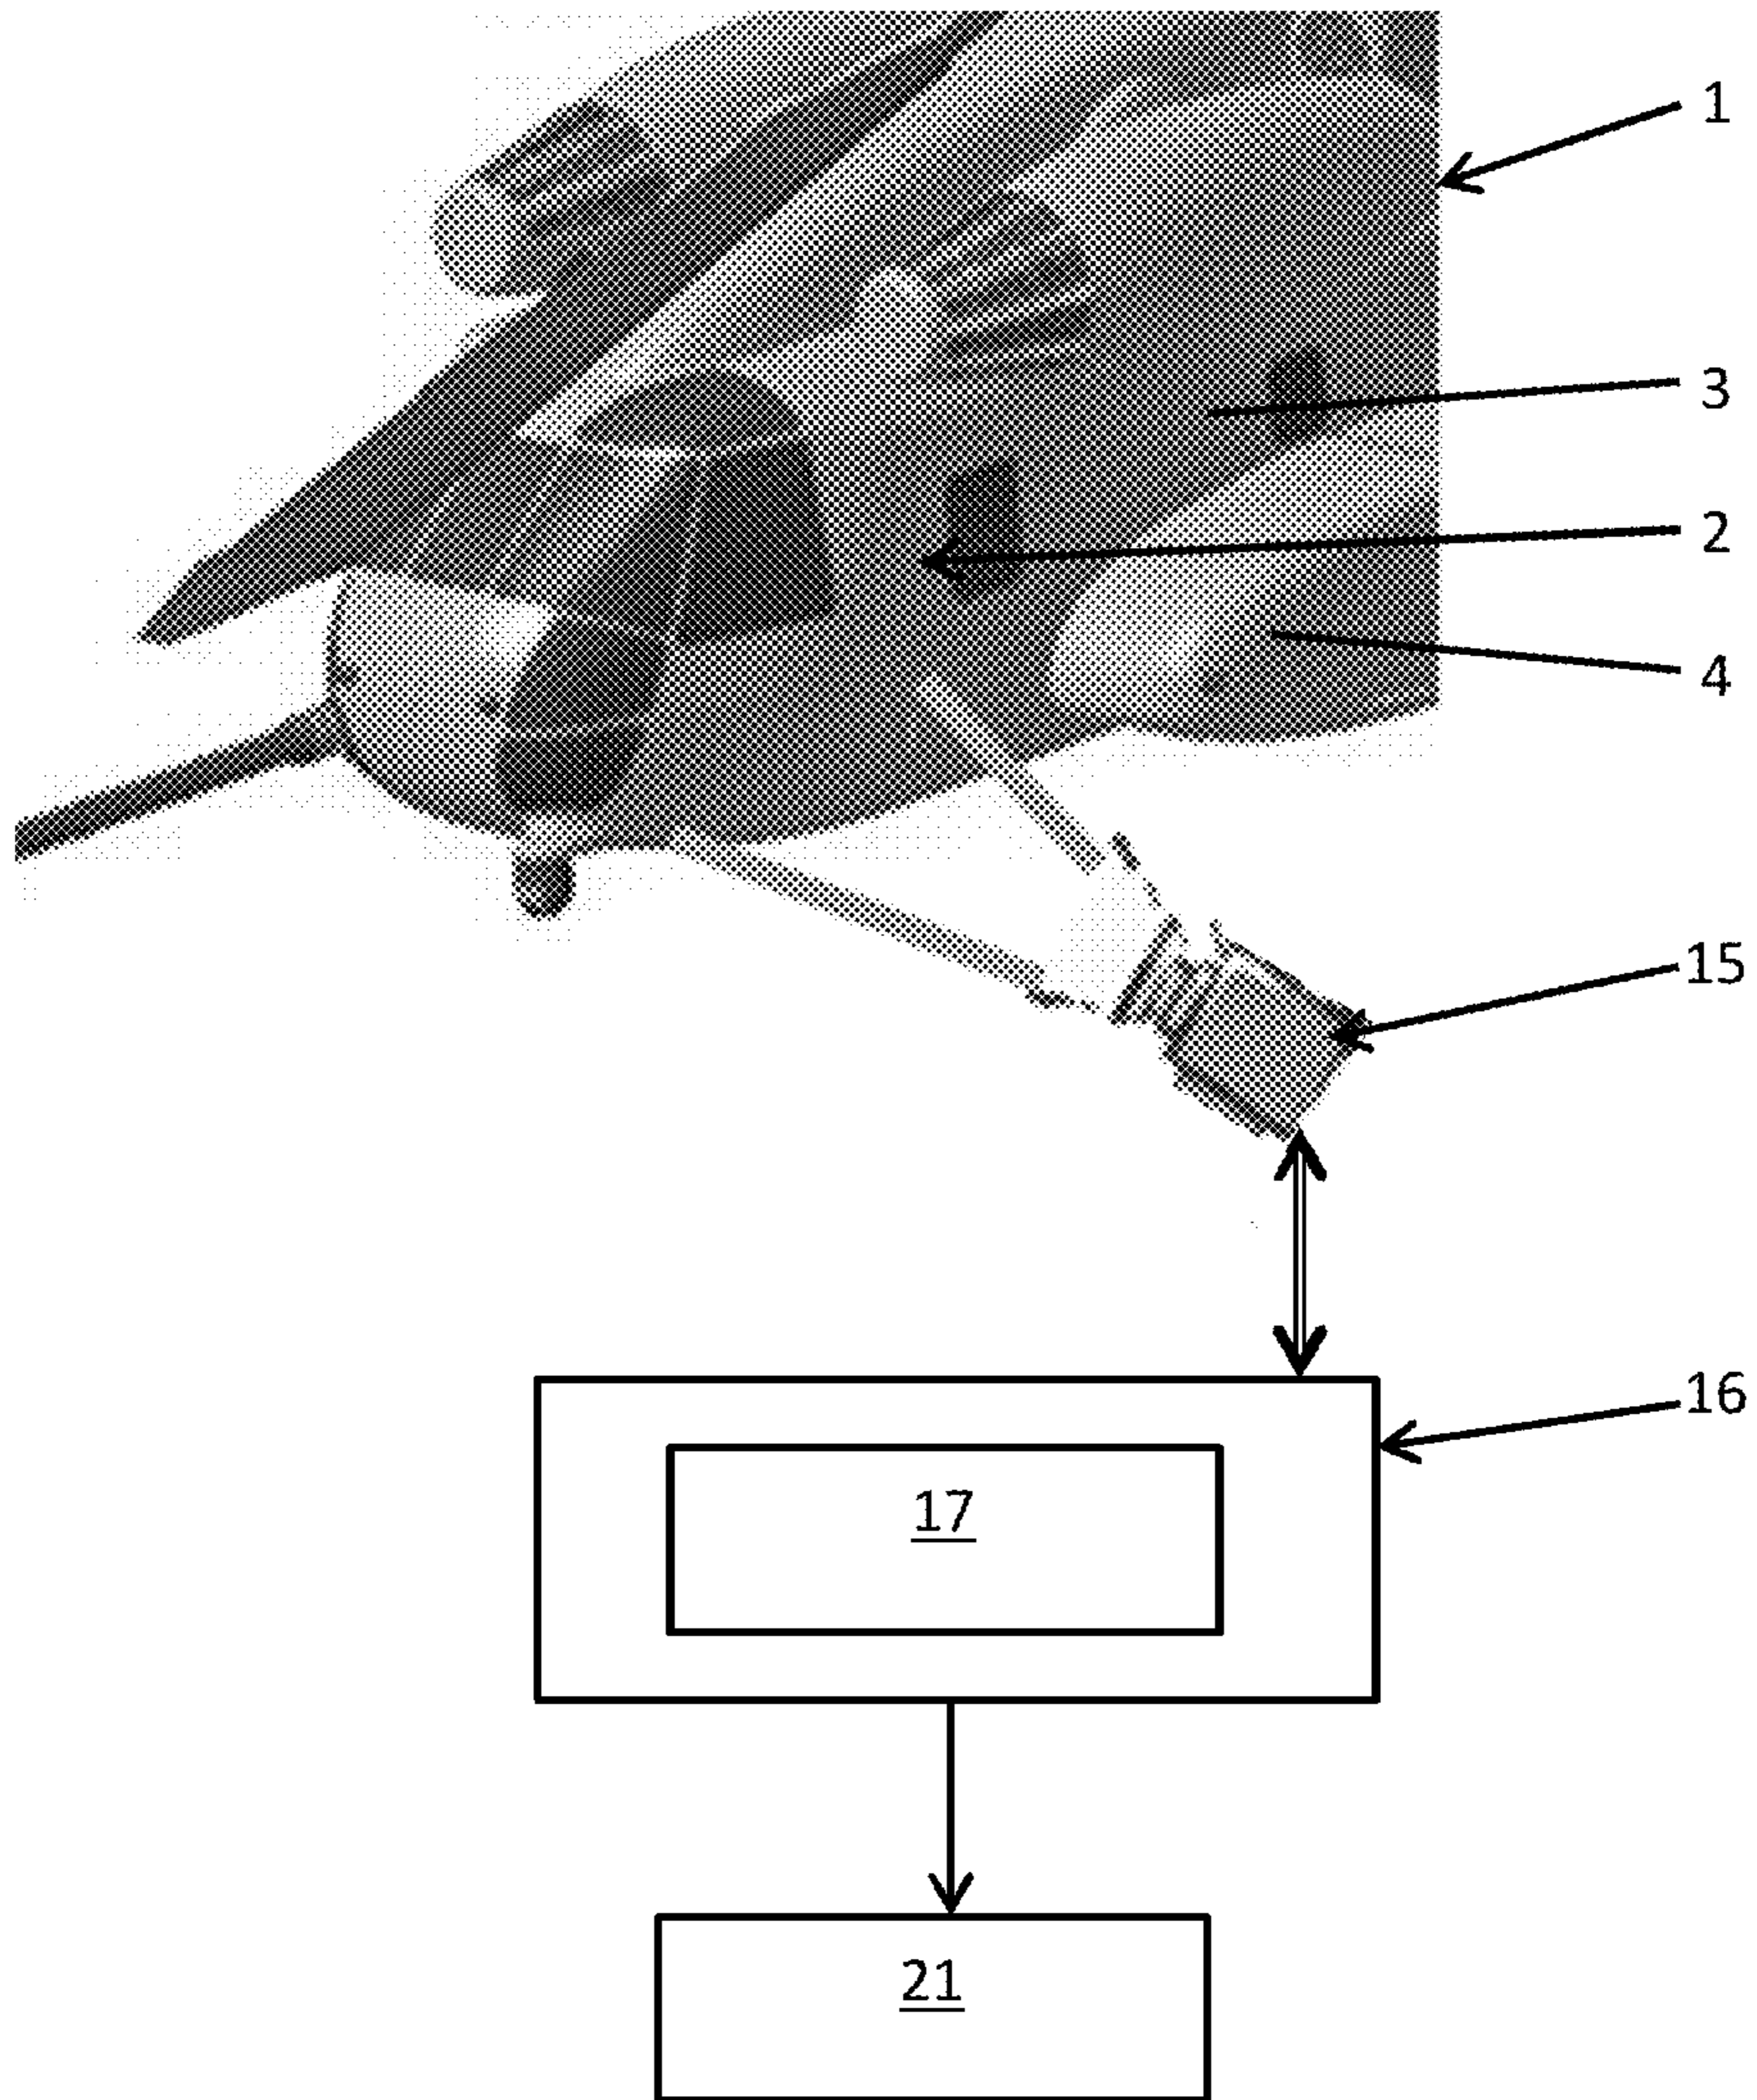
FIG. 1 is a perspective view of an aircraft;

With reference to FIG. 1, an aircraft 1 is provided and may be a helicopter, an airplane or any other similar device. The aircraft 1 includes an outer skin 2 and the outer skin 2 includes fuselage sections 3 and aerodynamic elements 4. The fuselage sections 3 define an interior of the aircraft in which navigational components are housed and, in the case of manned aircraft, the pilot and passengers sit. The aerodynamic elements 4 include wings and other similar features. In accordance with aspects as will be discussed below, damage to the outer skin 2 may be caused by transport of the aircraft 1, maintenance of the aircraft 1 and or impacts during flight. Such damage may be repaired by filler material being disposed in the damaged sections such that the damaged sections are filled, adhesive being applied to the outer skin 2 around the damaged sections and a doubling patch being adhered to the adhesive where the doubling patch is formed from topographic data of the outer skin 2.

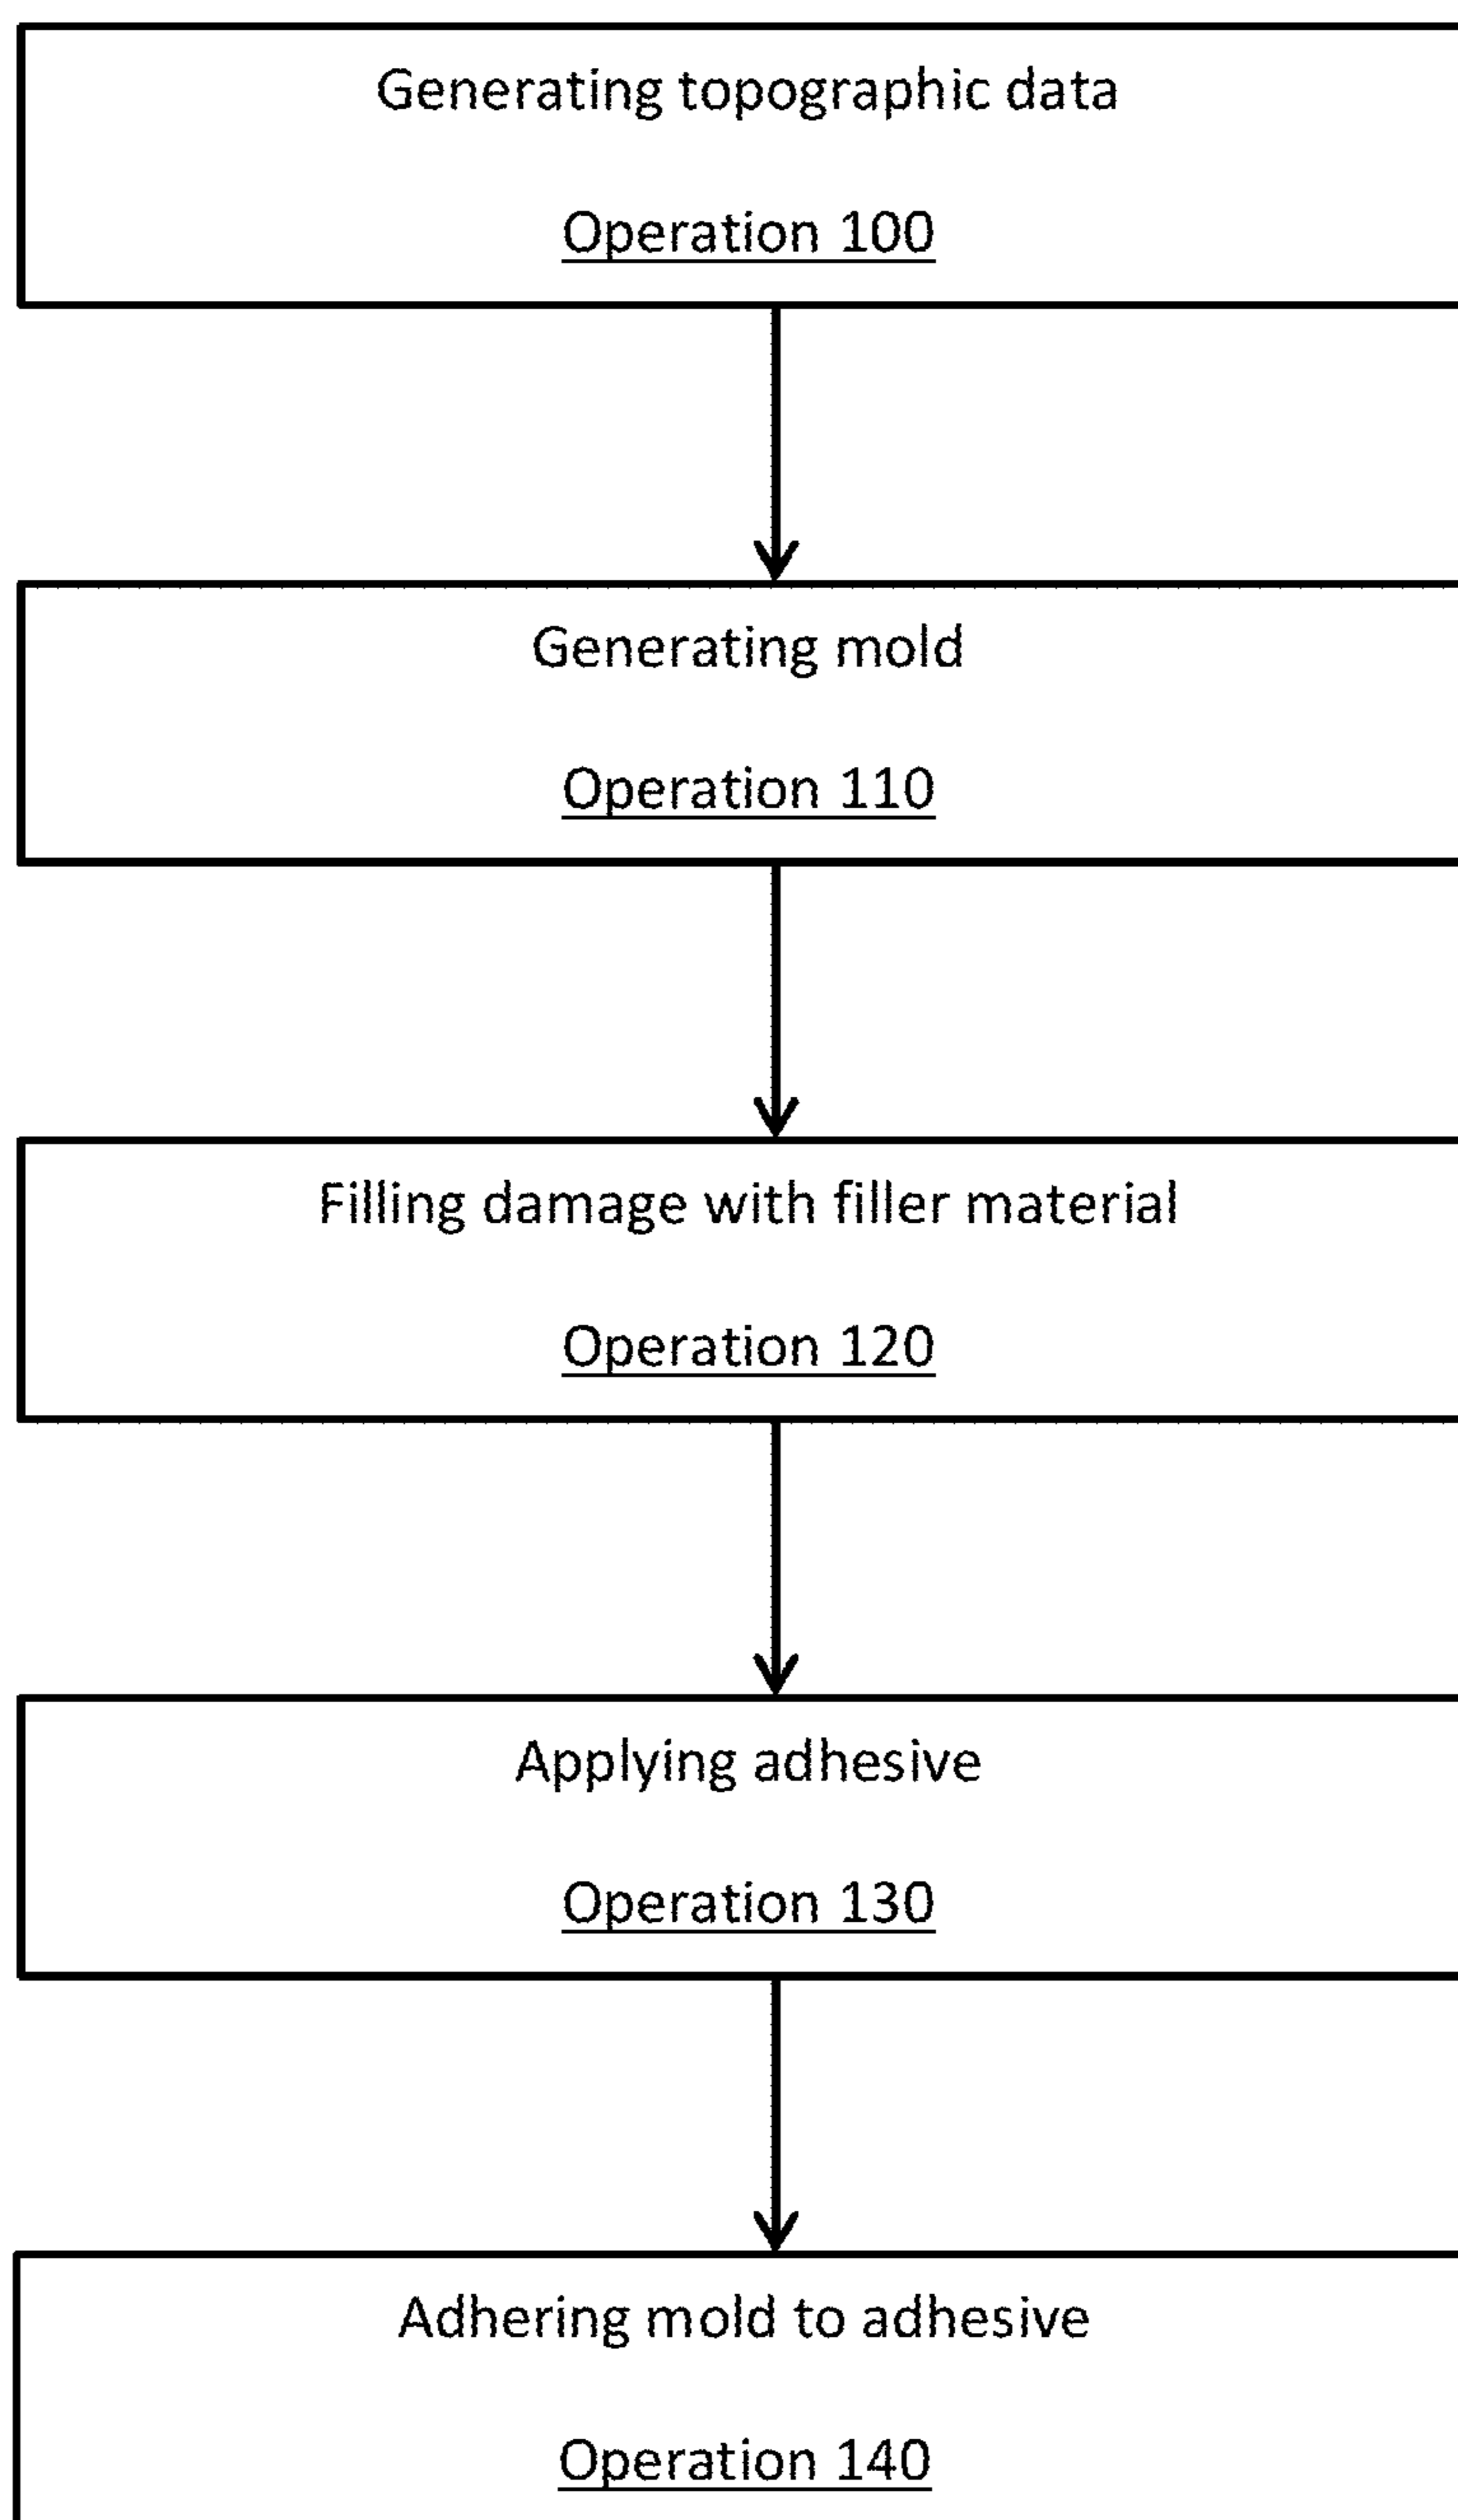
FIG. 2 is a flow diagram illustrating a composite bonded repair method for use with the aircraft in accordance with embodiments;

With reference to FIGS. 2-4, a composite bonded repair method for an aircraft, such as the aircraft 1 of FIG. 1, is provided. The method includes generating topographic data of a portion 11 of an outer skin 12 of an aircraft where the portion 11 is defined to surround damage 13 formed in the outer skin 12 (operation 100). The generating of the topographic data may include at least one of scanning the portion 11 of the outer skin 12 of the aircraft with a scanning unit 15 (see FIG. 1) coupled to a computing device 16 (see FIG. 1) and deriving data from a model of the aircraft stored in memory units or storage 17 (see FIG. 1) of the computing device 16.

The method further includes generating a doubling patch 20 of the portion 11 of the outer skin 12 of the aircraft from the topographic data (operation 110). The generating of the doubling patch 20 may be accomplished by three-dimensional (3-D) printing processes executed by a 3-D printing element 21 (see FIG. 1) or by forming on a mold through similar three-dimensional (3-D) printing processes. The doubling patch 20 and/or the mold may be formed of non-metallic material, such as graphite or fiberglass cloth. As shown in FIG. 3, the doubling patch 20 includes body 201 having an inner surface 202 and an outer surface 203, which is opposite the inner surface 202. The inner surface 202, in particular, has a shape that corresponds to a shape of the portion 11 of the outer skin 12 of the aircraft. That is, where the portion 11 of the outer skin 12 has a continuously variable external contour with curvature C1, the inner surface 202 may have a similarly continuously variable external

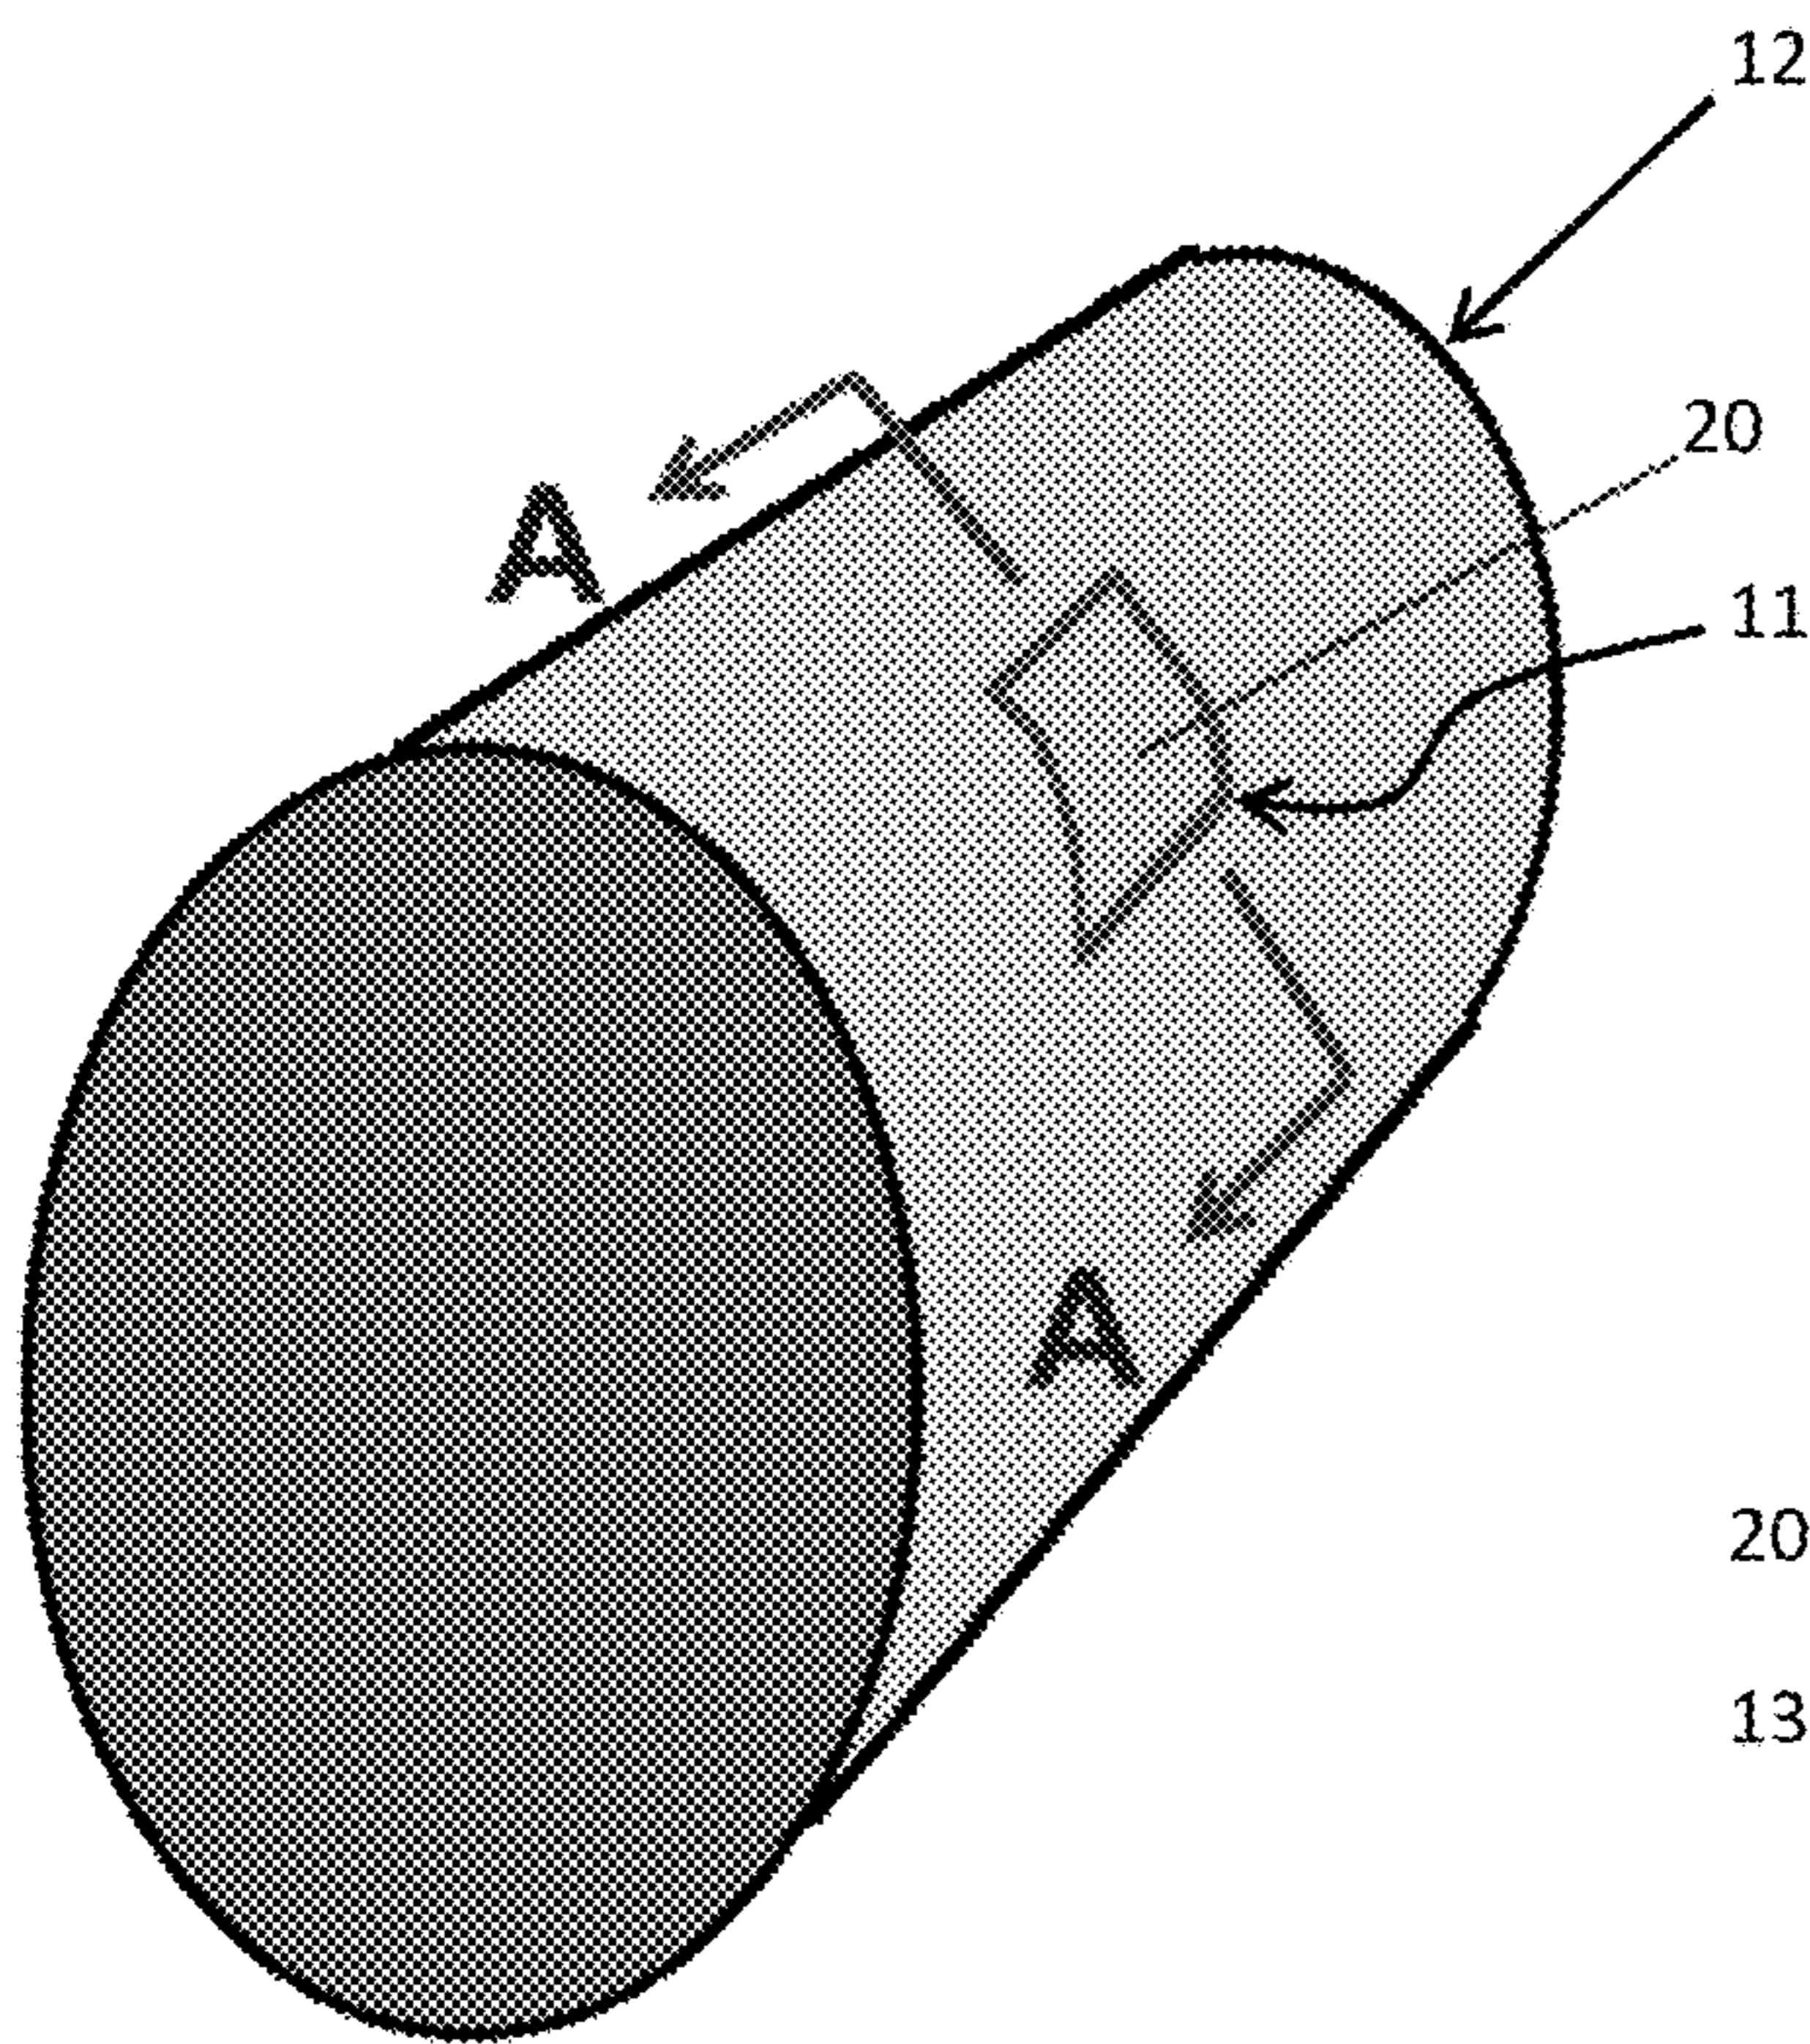
FIG. 3 is a perspective view of a repaired portion of an aircraft in accordance with embodiments; and

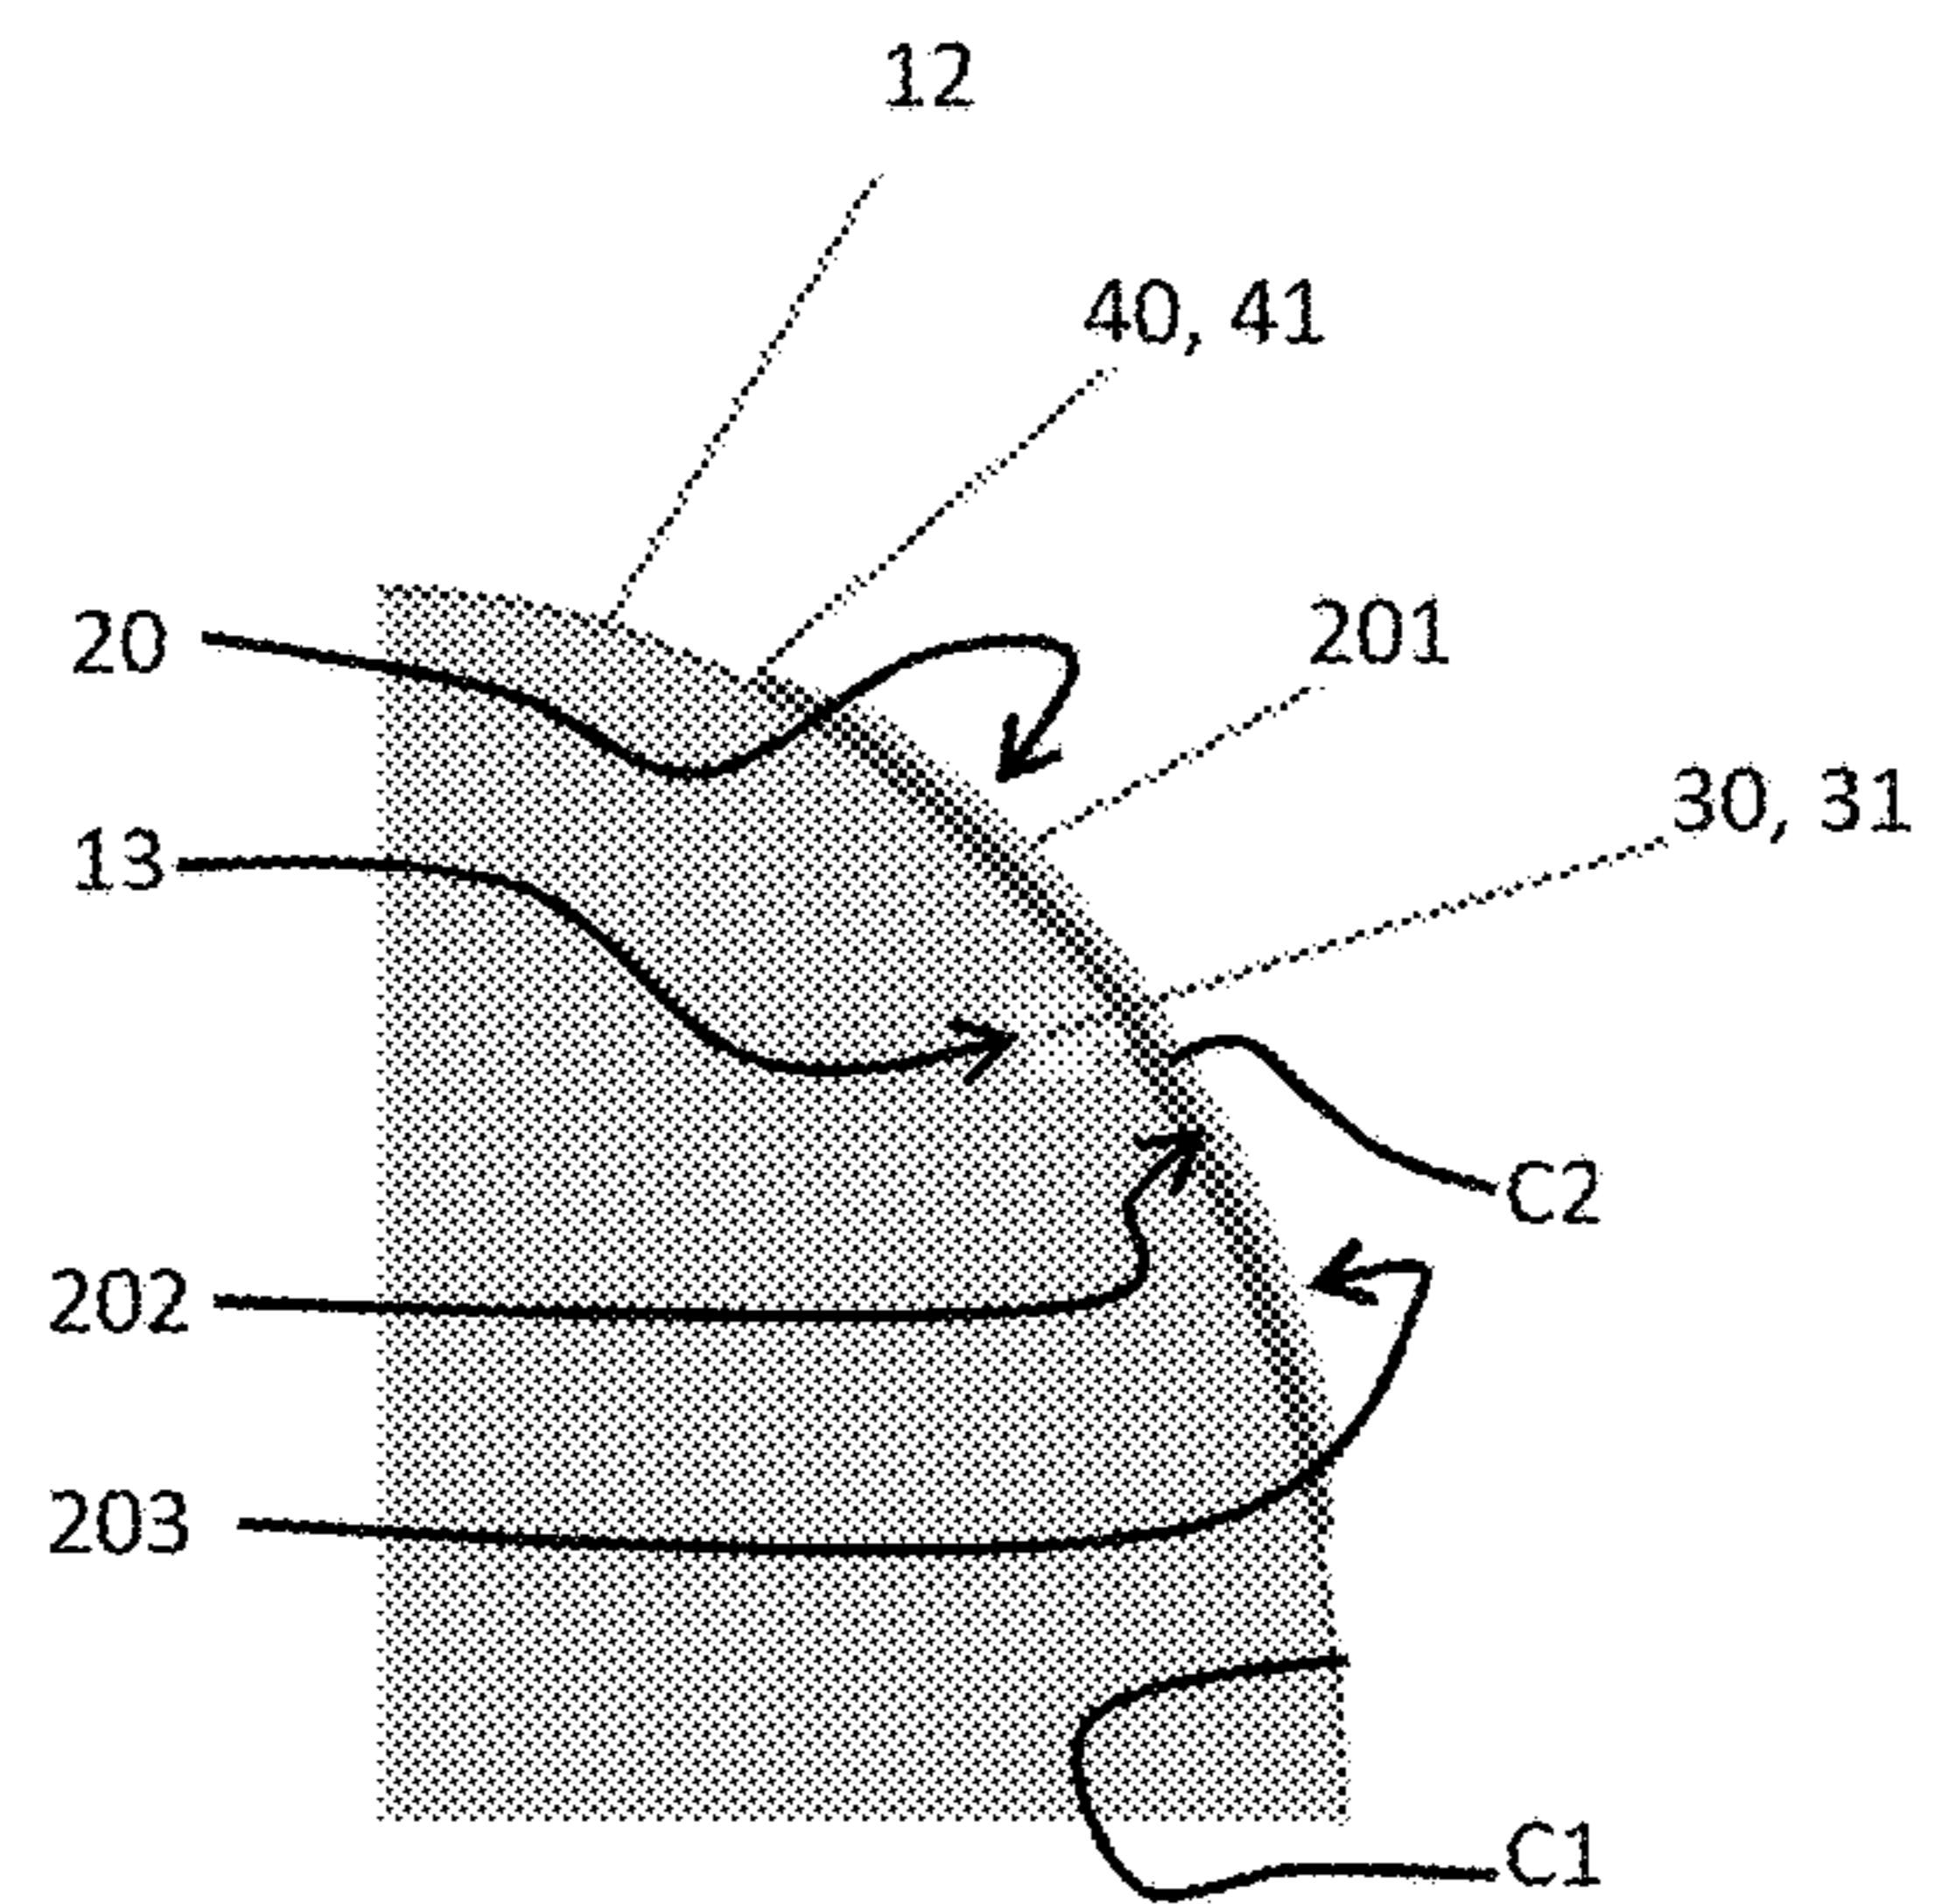
FIG. 4 is a side view of the repaired portion taken along line A-A of FIG. 3.
