(12) **United States Patent**
Urban

(54) **COMPOSITE BONDED REPAIR METHOD**

A composite bonded repair method for an aircraft is provided. The method includes generating a doubling patch of a portion of the aircraft from topographic data, filling damage at the portion of the aircraft with filler material, applying adhesive to the portion of the aircraft and the filler material and adhering the doubling patch to the adhesive.

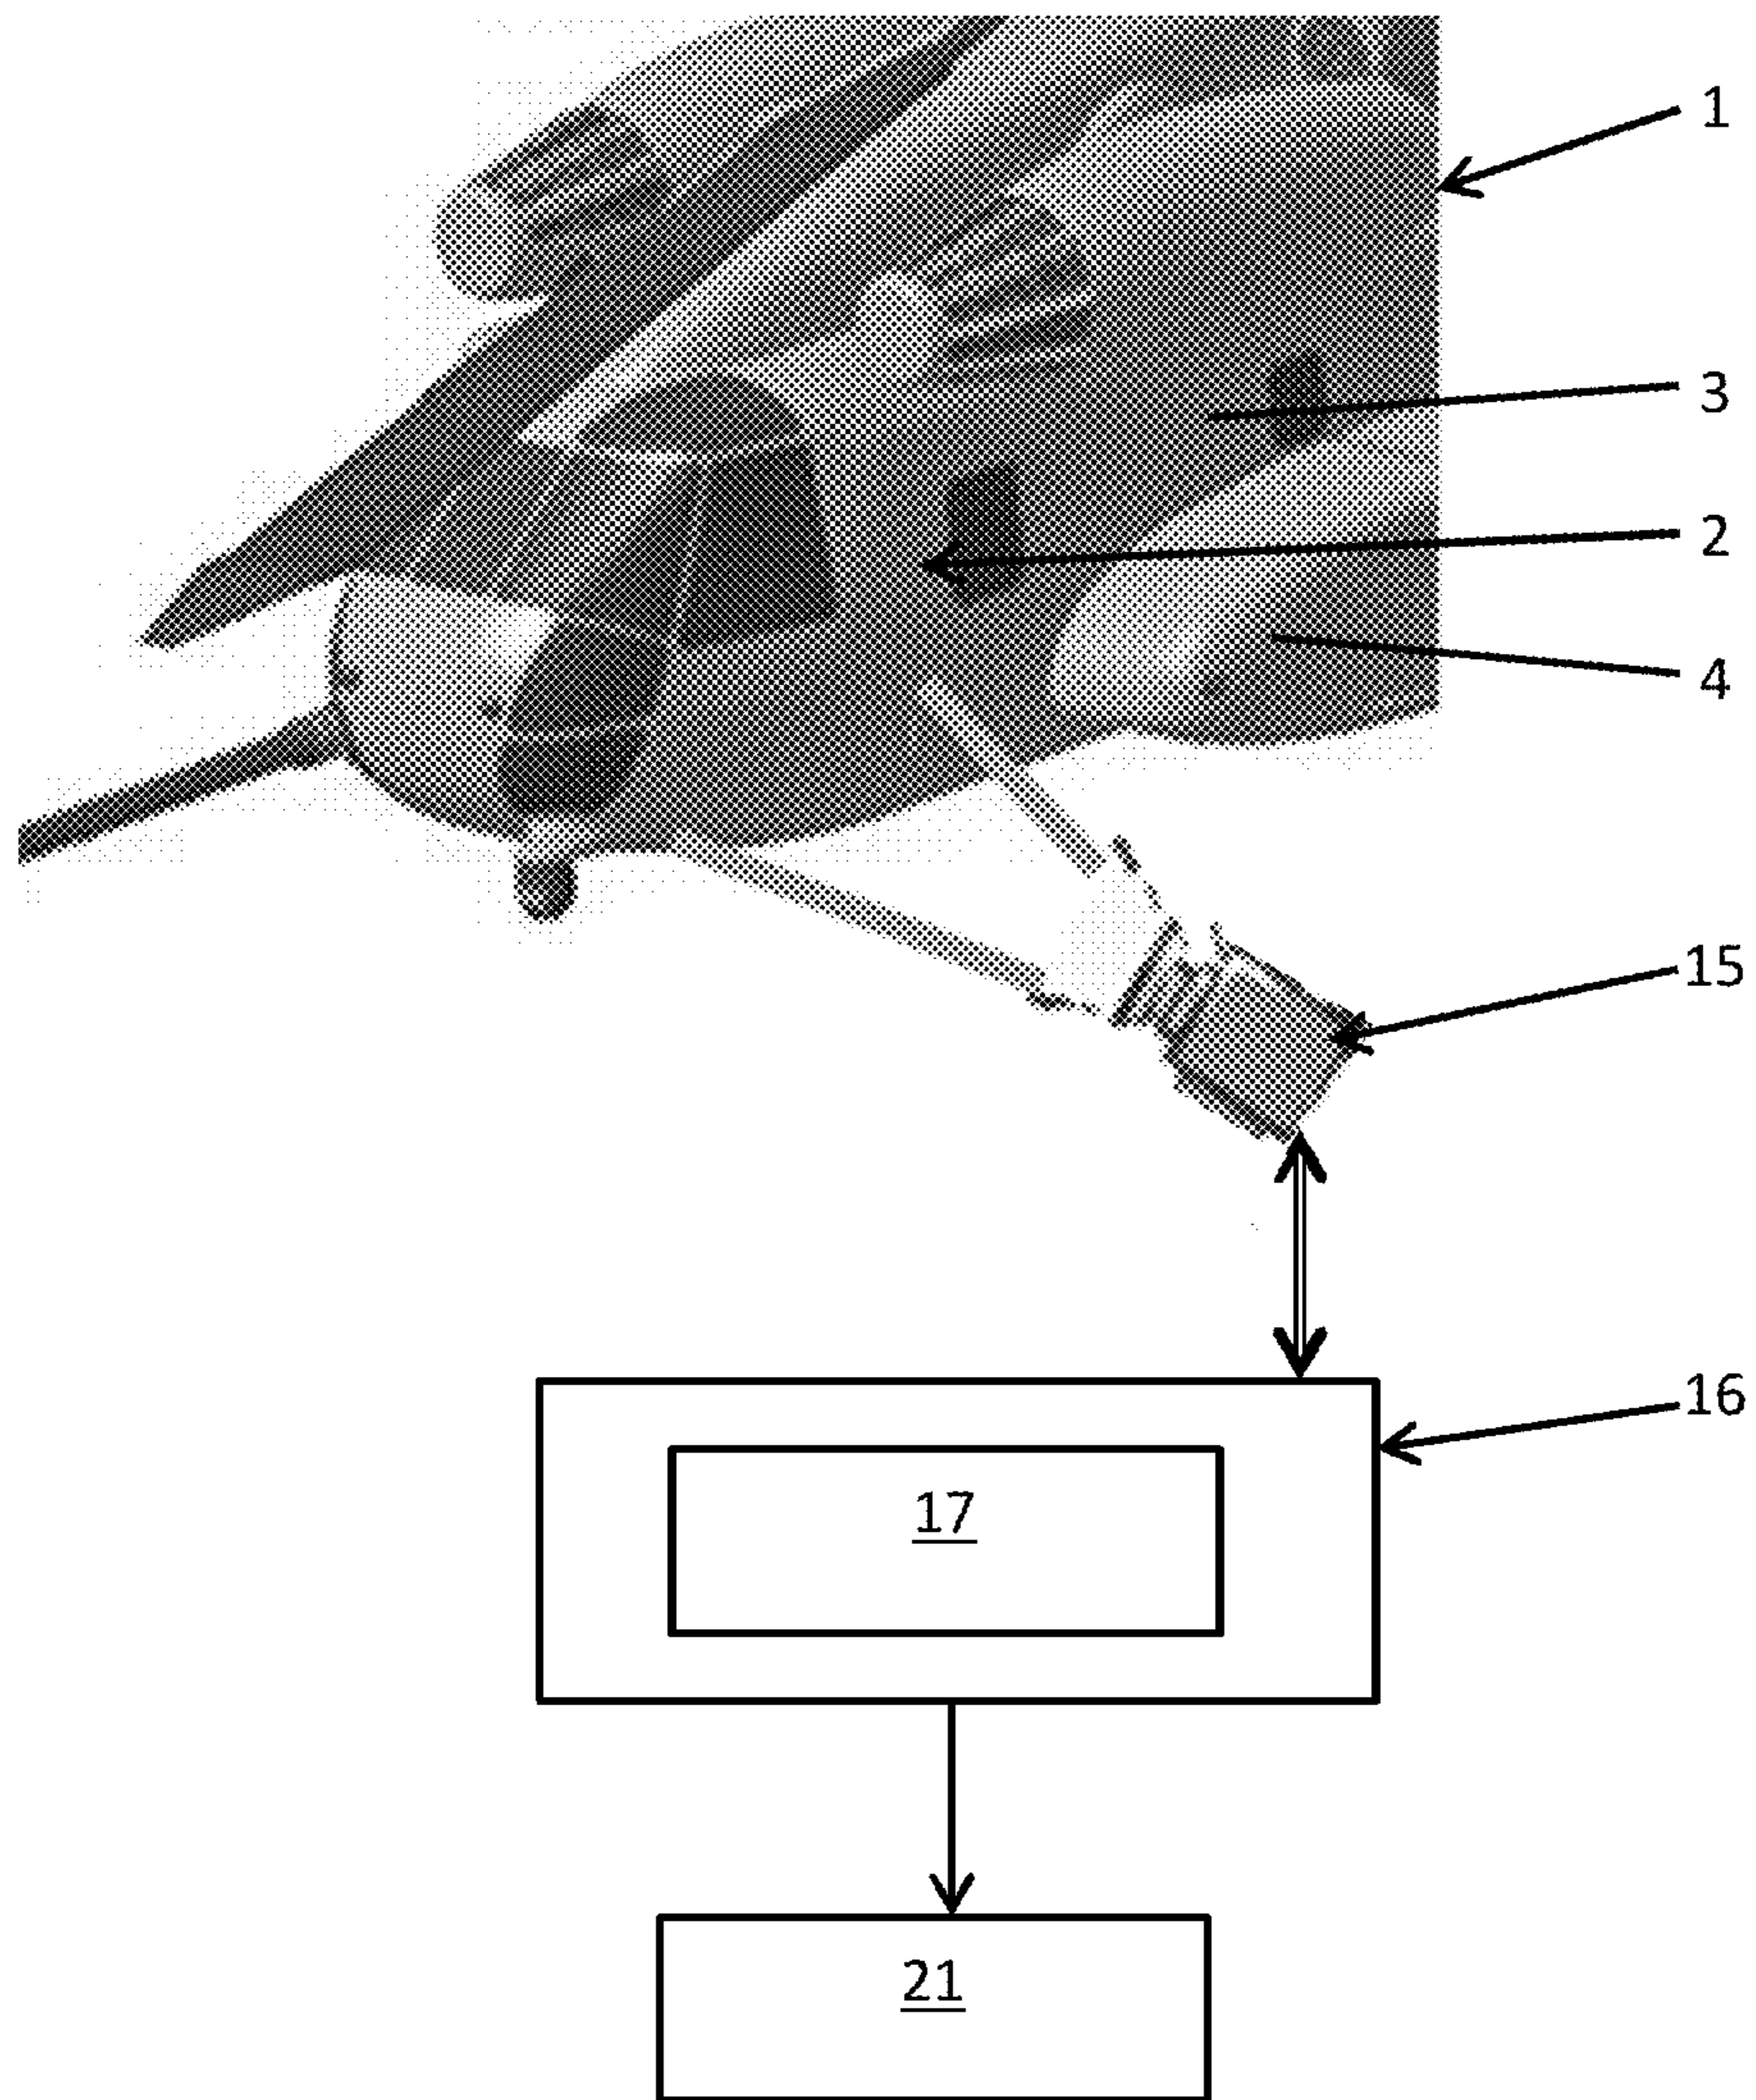
FIG. 1 is a perspective view of an aircraft;

With reference to FIG. 1, an aircraft 1 is provided and may be a helicopter, an airplane or any other similar device. The aircraft 1 includes an outer skin 2 and the outer skin 2 includes fuselage sections 3 and aerodynamic elements 4. The fuselage sections 3 define an interior of the aircraft in which navigational components are housed and, in the case of manned aircraft, the pilot and passengers sit. The aerodynamic elements 4 include wings and other similar features. In accordance with aspects as will be discussed below, damage to the outer skin 2 may be caused by transport of the aircraft 1, maintenance of the aircraft 1 and or impacts during flight. Such damage may be repaired by filler material being disposed in the damaged sections such that the damaged sections are filled, adhesive being applied to the outer skin 2 around the damaged sections and a doubling patch being adhered to the adhesive where the doubling patch is formed from topographic data of the outer skin 2.
