(54) **METHOD FOR REPAIRING TURBINE COMPONENTS**

(57) **ABSTRACT**  
A method is disclosed for repairing a precision casted turbine blade having a squealer and at least one letterbox which was closed by brazing during new-part manufacturing, wherein the letterbox area was damaged during operation in the first life cycle of the blade.

The present invention relates to the technology of gas turbines. It refers to a method for repairing turbine components, especially turbine blades, by welding.

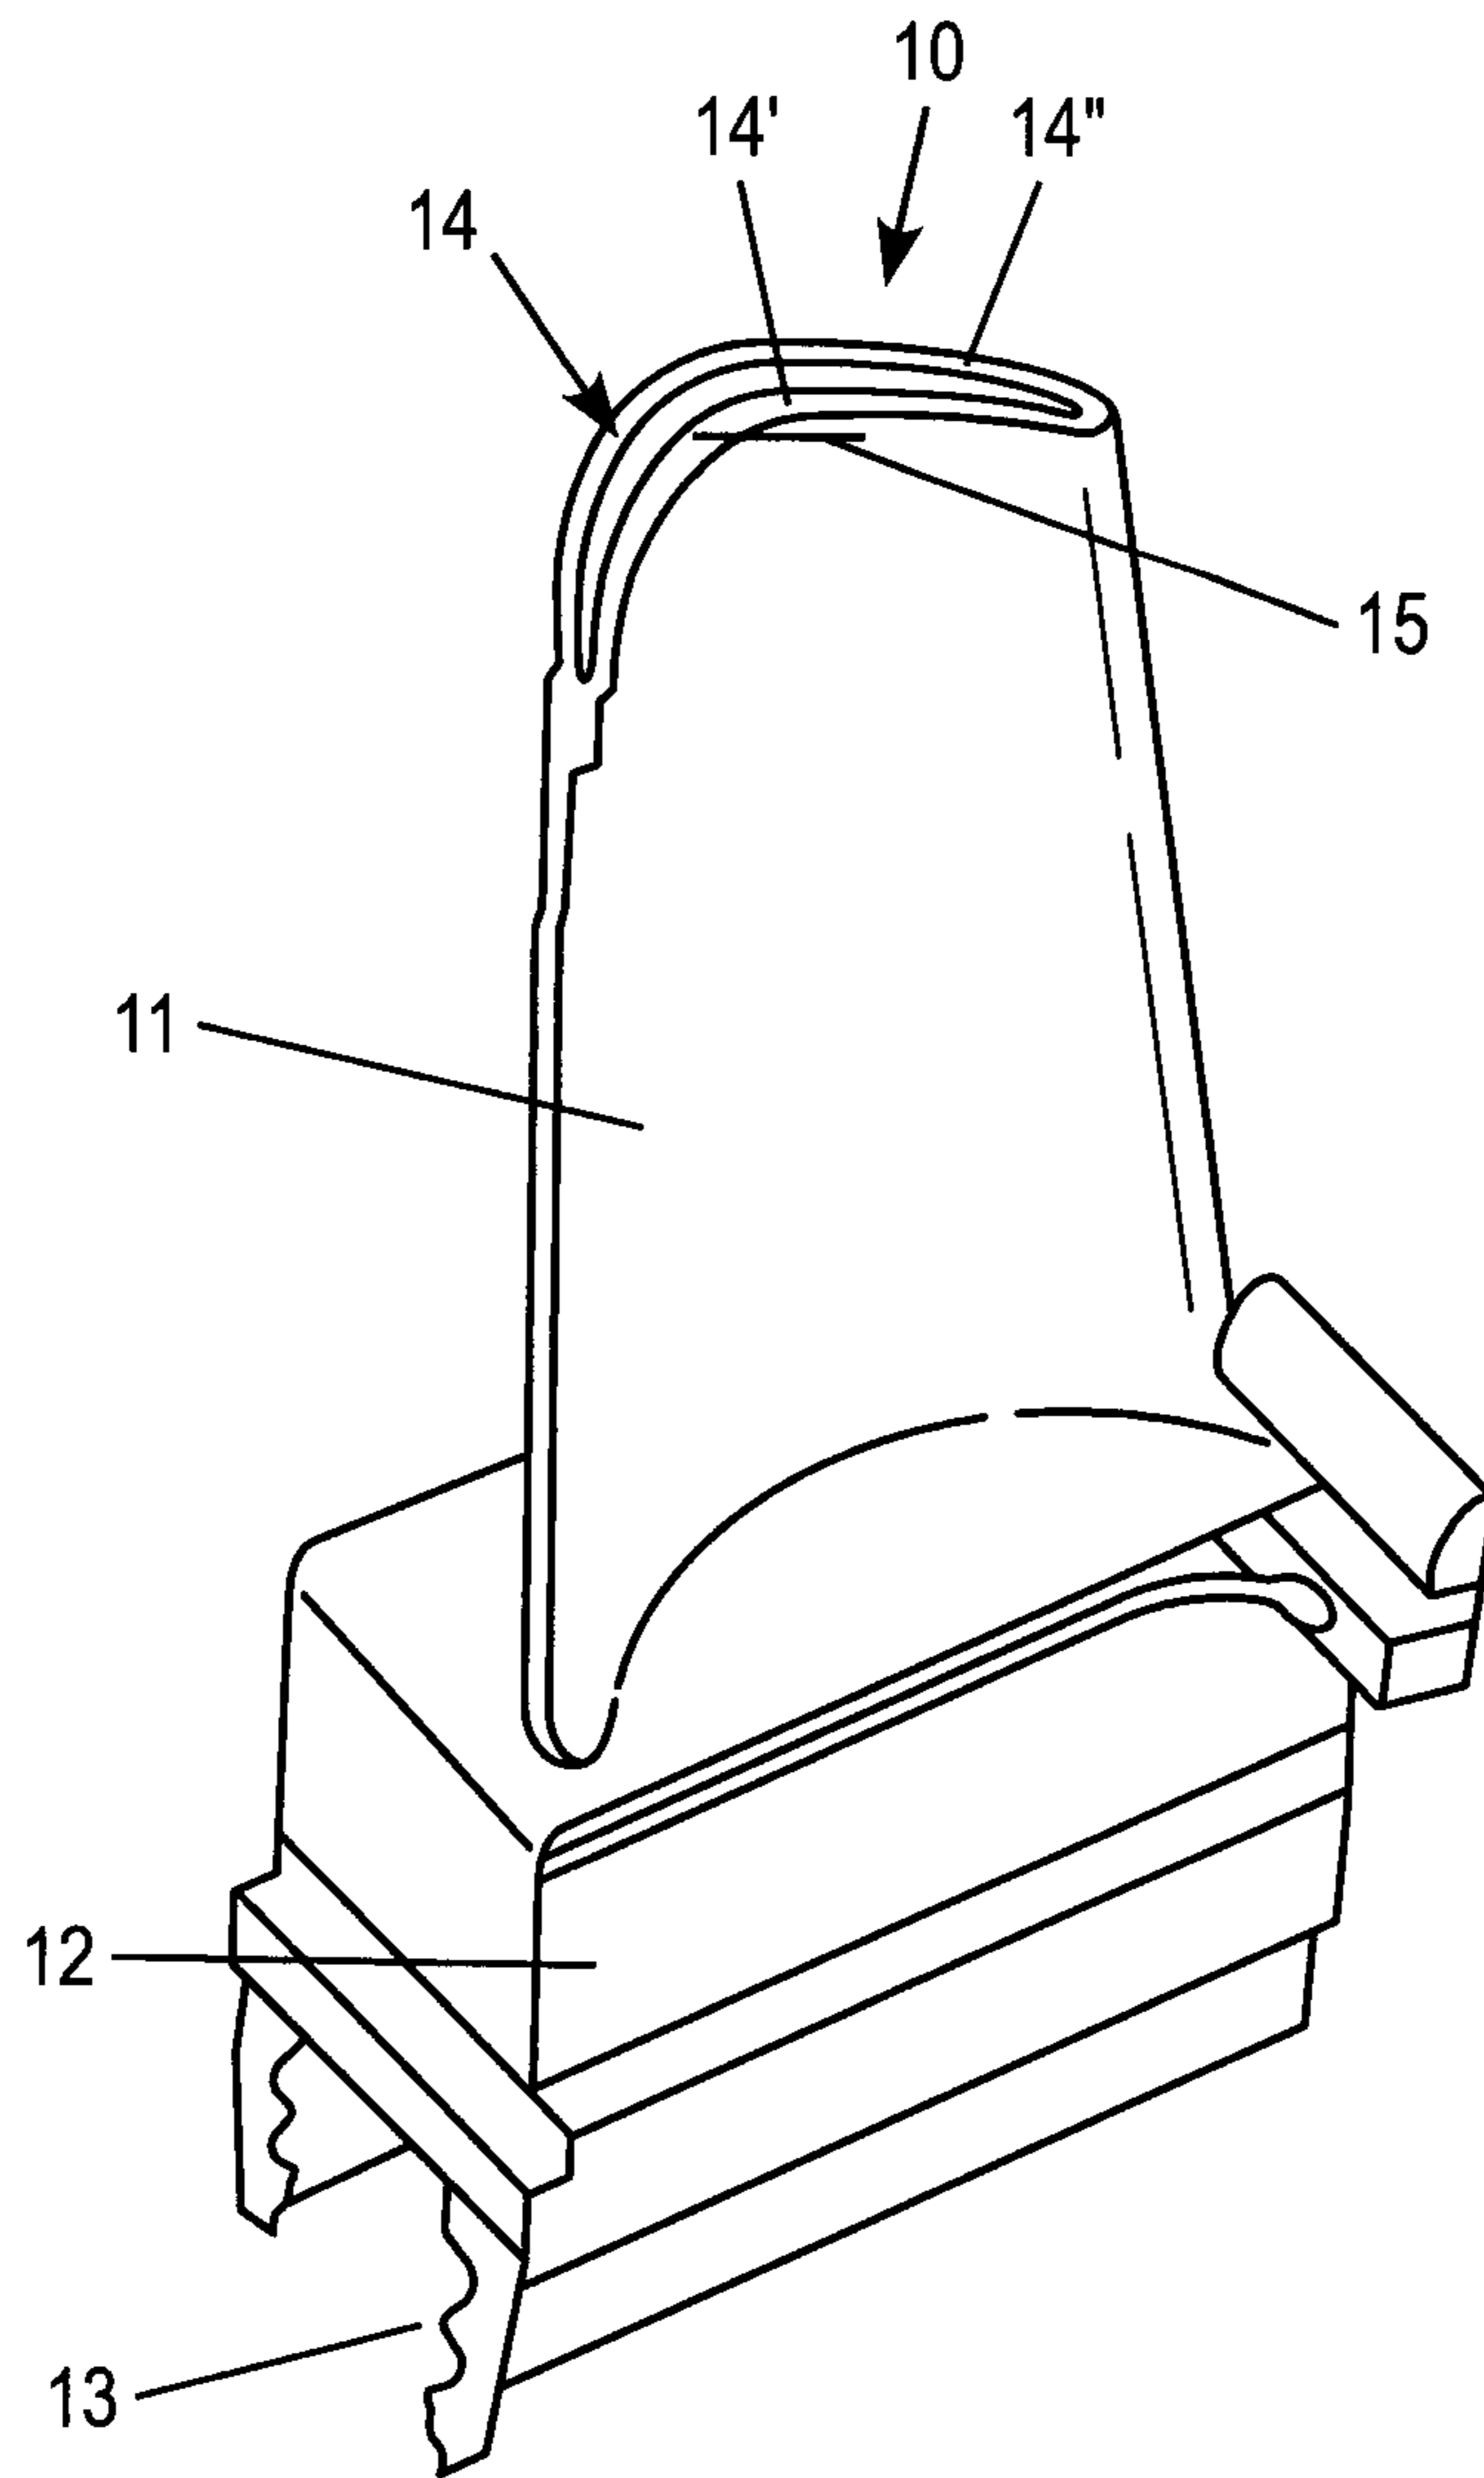
FIG. 1 shows a photograph of a typical gas turbine blade in a perspective view;

Typical gas turbine blades, an example of such a blade **10** is illustrated in FIG. **1**, comprise an airfoil **11**, which extends in radial direction from a shaft **12** and ends with a blade tip **14**. Below the shaft **12** is a root section **13** (foot of the blade) for mounting the blade **10** in a respective groove of the rotor (not shown). Part of the blade tip **14** is a crown with a crown plate **14'** and a rim (squealer **14''**). Those tip features are often referred as squealer tips and are designed to minimize the tip leakage flow, protect the blade tip from the full impact of high temperature leakage gases, when the tip cavity is used as a cooling system and protect the blade against incidental rubs. An additional feature of the blade tip **14** is a so called letterbox **15** (details see below).

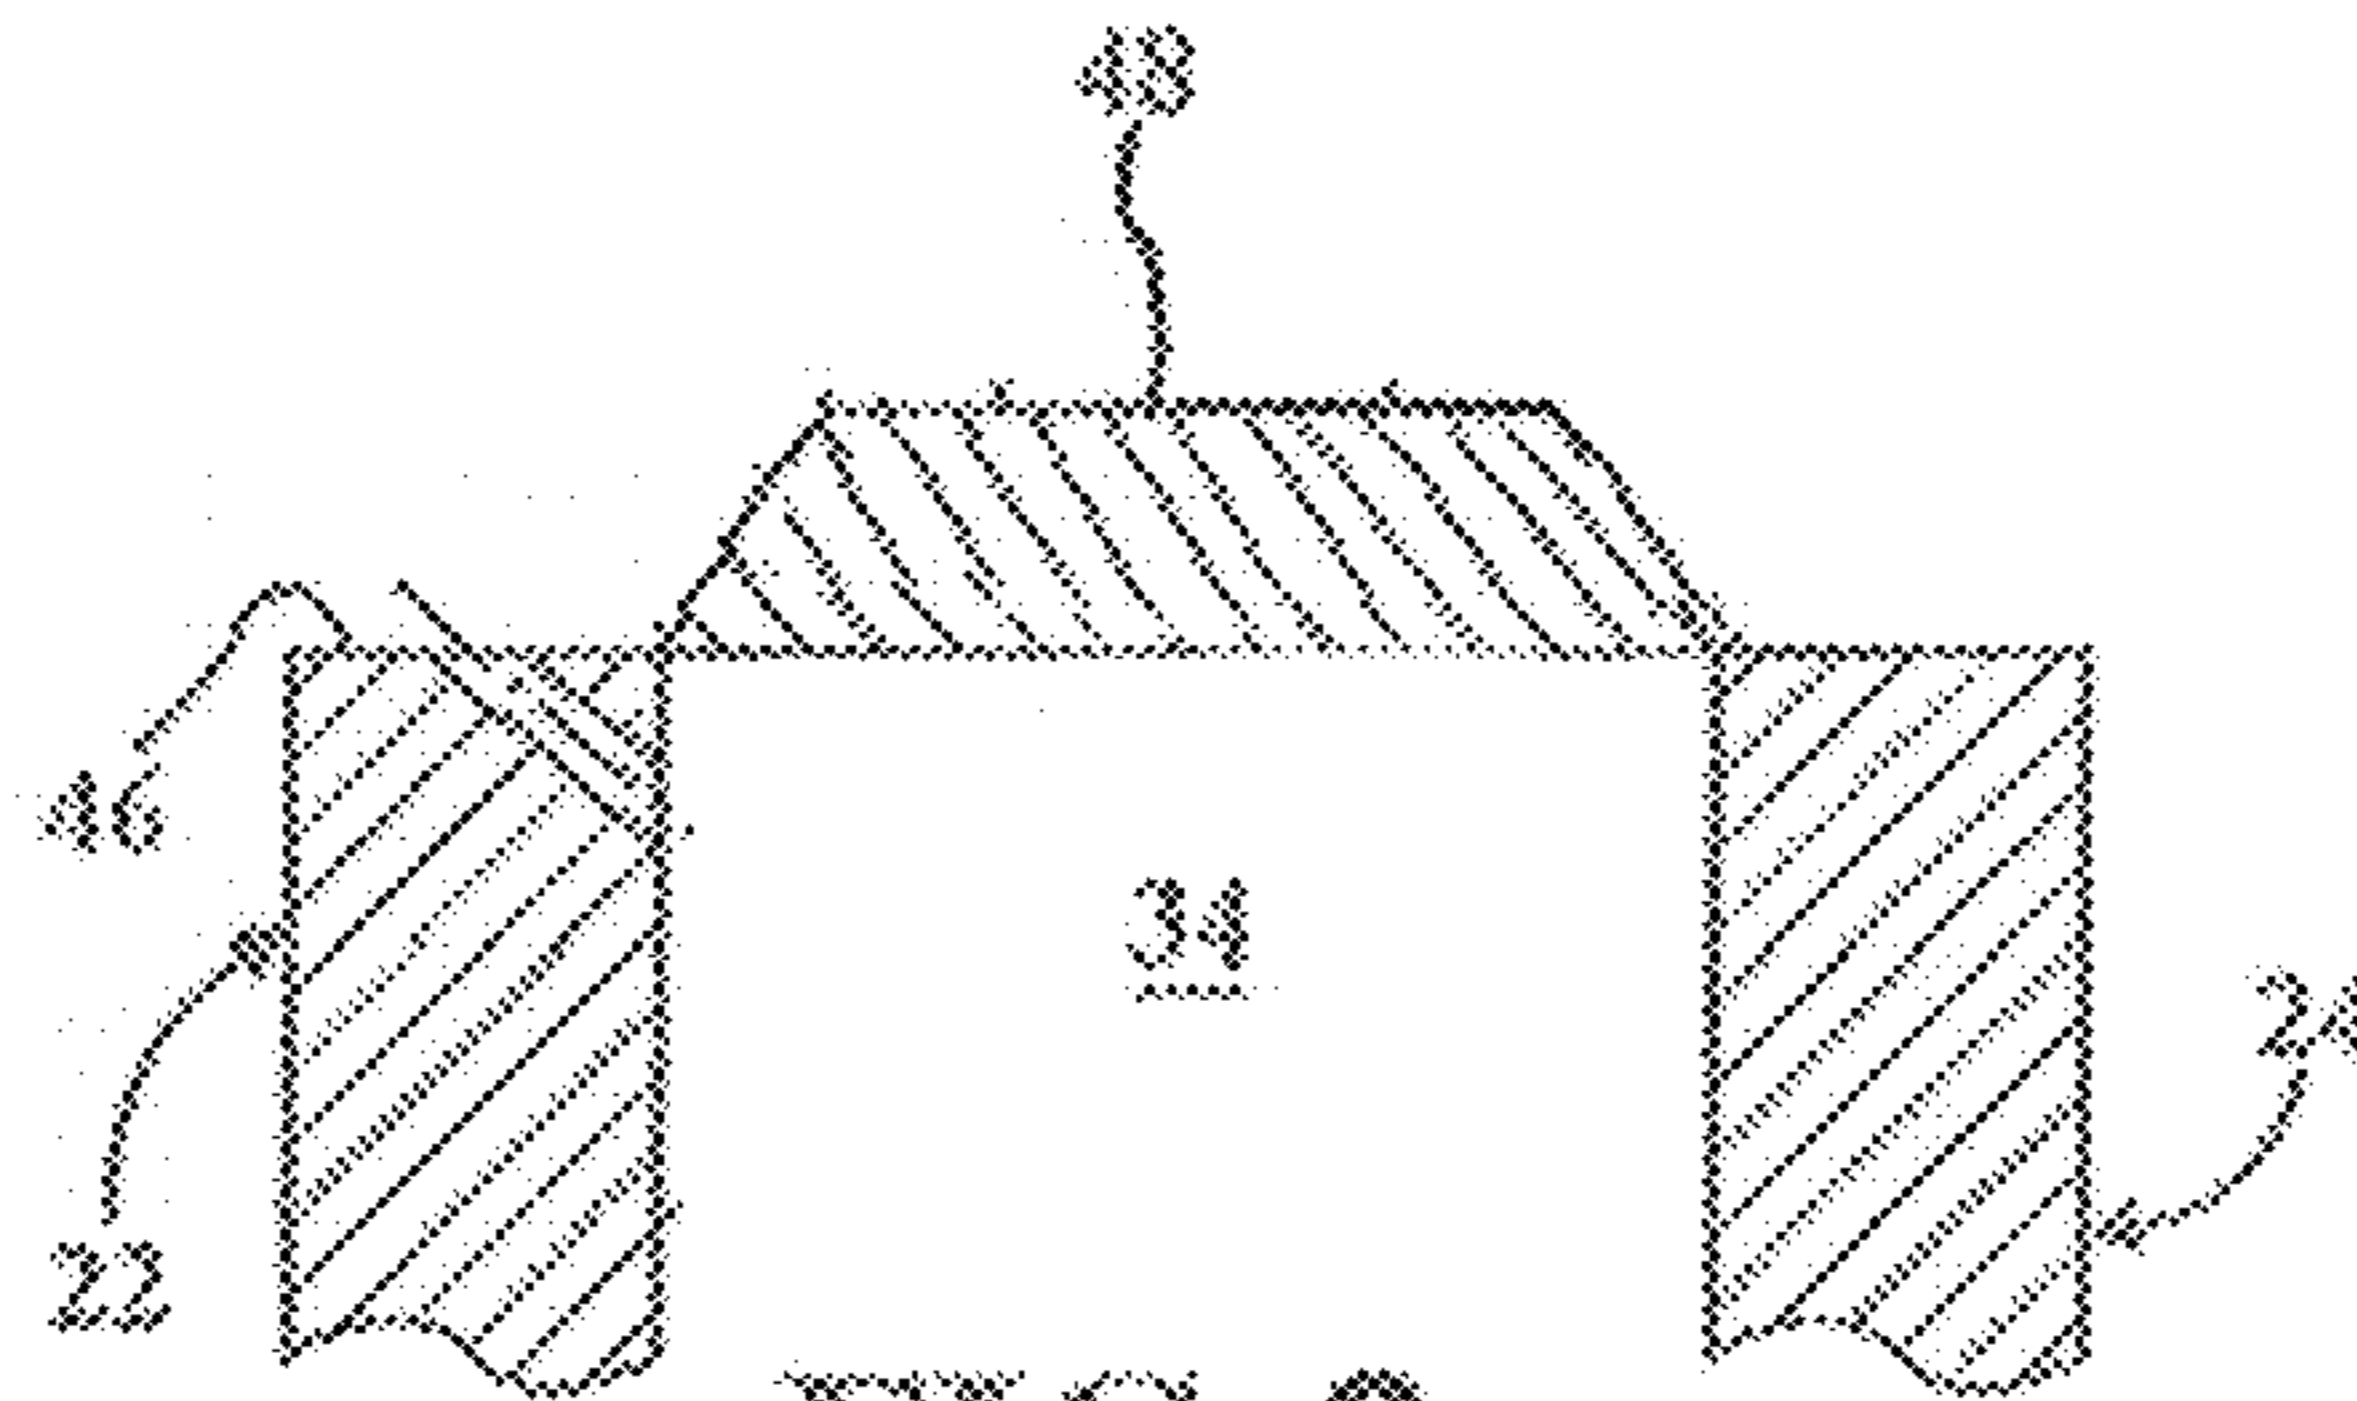
FIG. 2a

FIG. 2a-c show several steps for closing of the blade tip according to the prior art (tip cap welding);

A new closure plate or tip cap **48** is placed above a previously grinded or machined (repair surface **46**) blade tip (FIG. **2a**) and welded in place (FIG. **2b**), e.g. with different weld fillers. The closure of the blade resp. internal cavity **34** is realized by the closure plate/tip cap **48** itself. The finished assembly structure consists according to FIG. **2c** of the blade itself with pressure and suction side walls **22**, **24**, the new tip cap **48** and one or several welded elements, e.g. weld joint **54**, peripheral portion **56** and replacement squealer tip **62**. This is the typical repair approach for the case, where a blade tip requires a complete or partial opening into its internal cavity **34** (cooling air side).

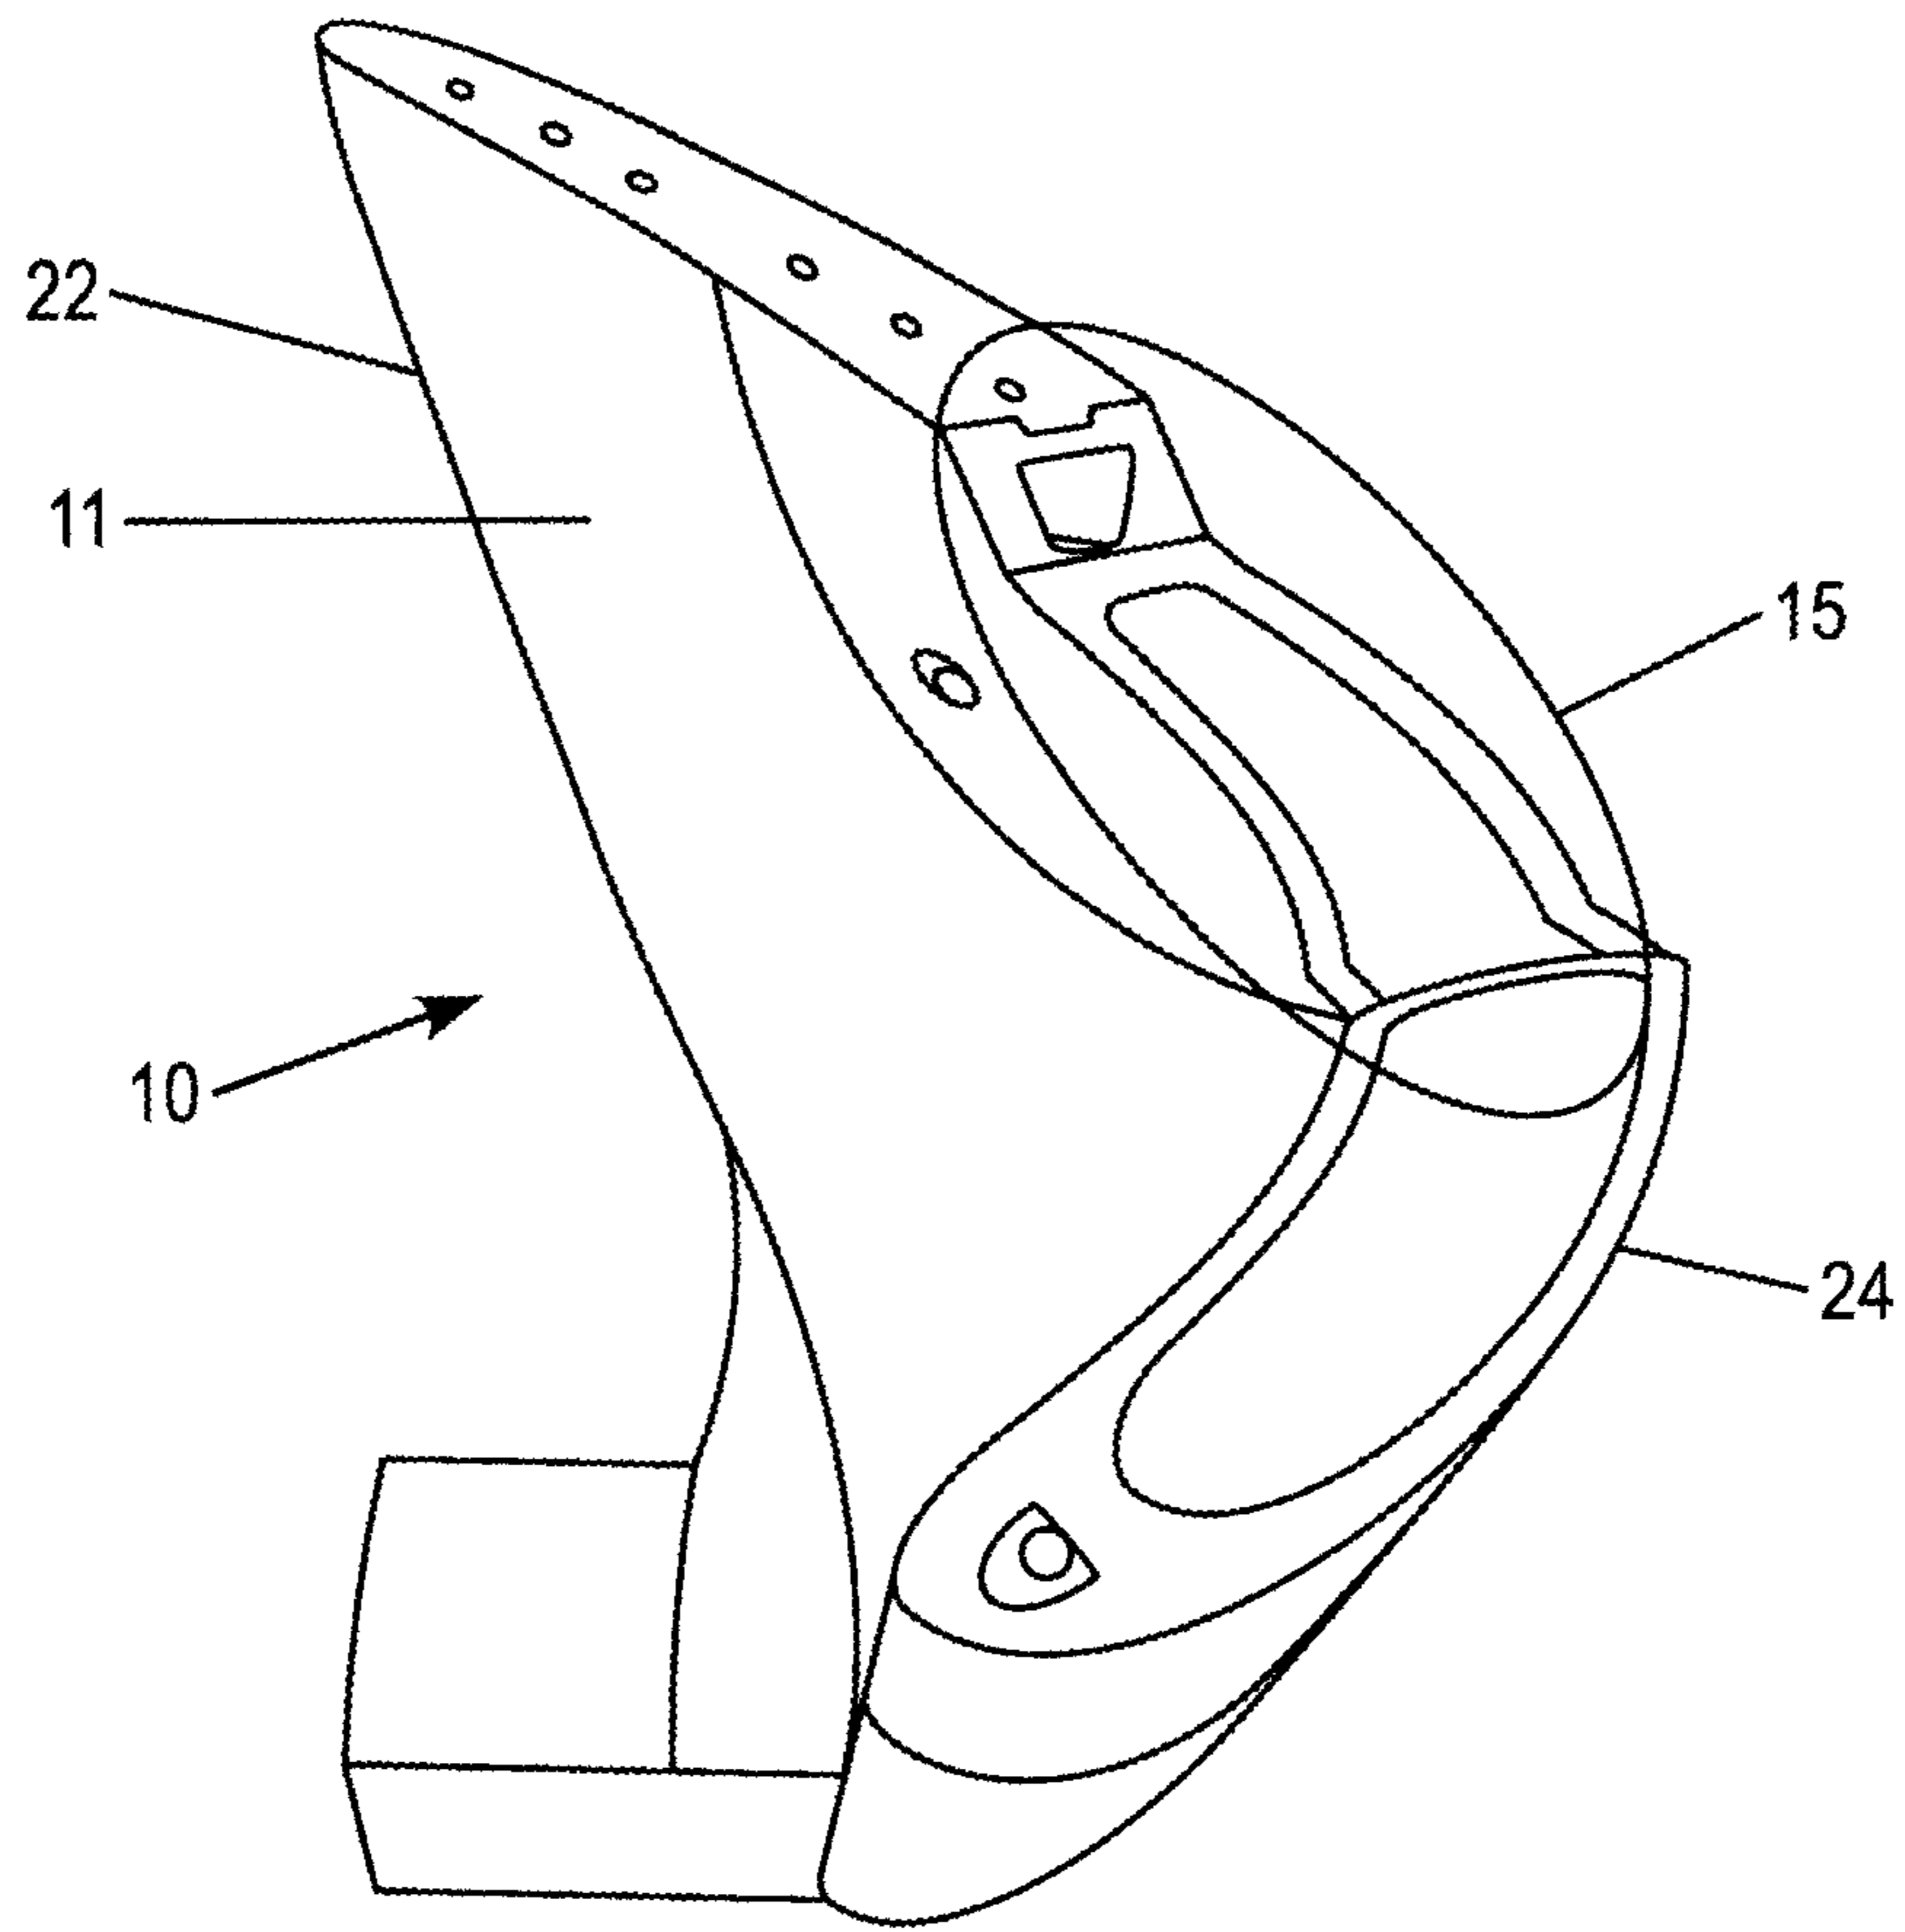
FIG. 3 shows a photograph of an ex-service gas turbine blade with removed letterbox and surrounded material (identified by the circle in the figure) after step a) of the present invention;

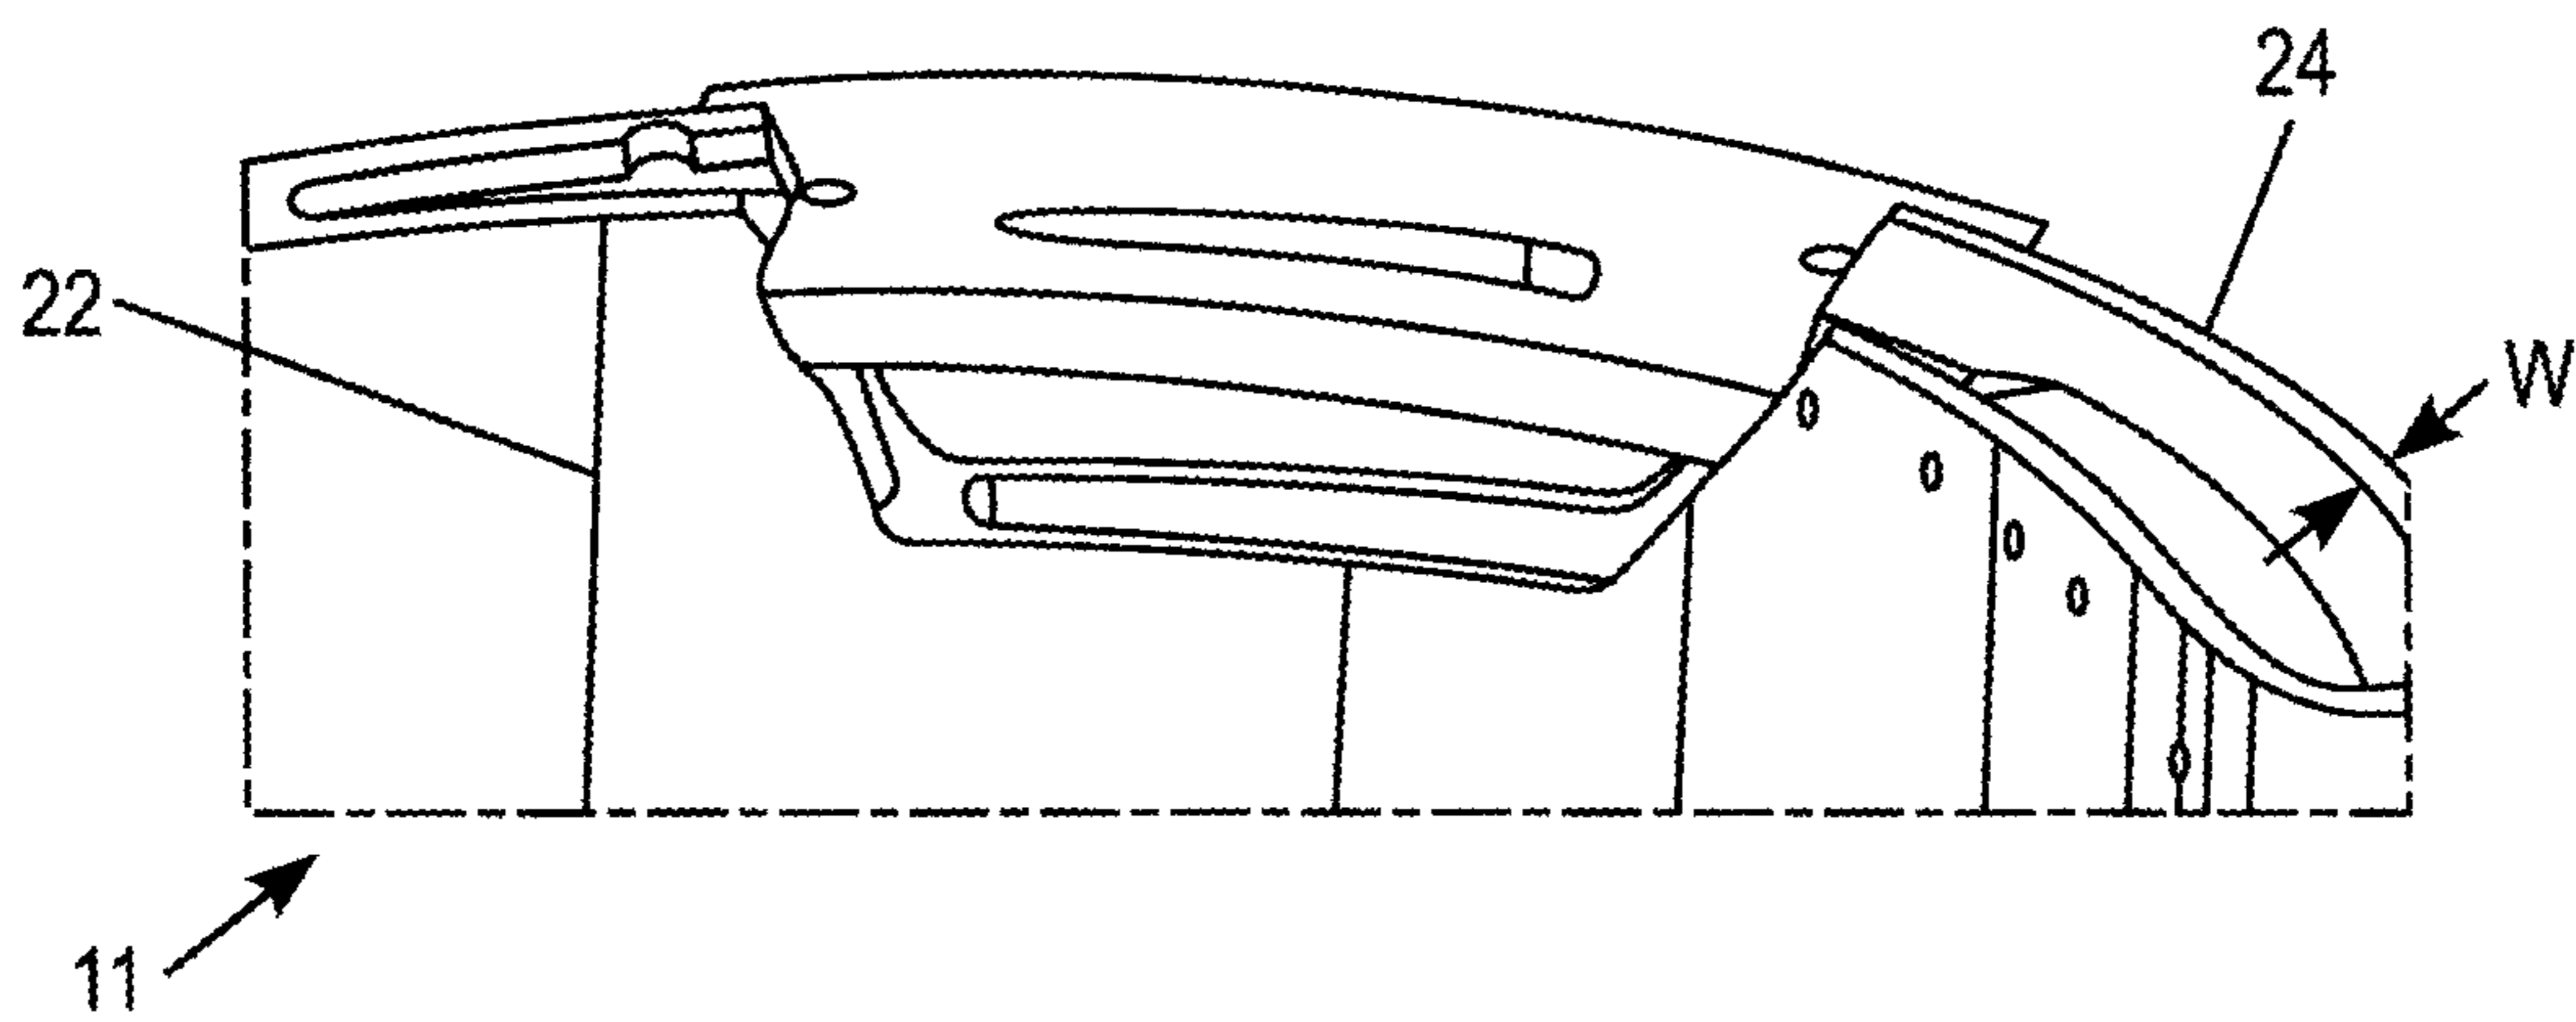
FIG. 4 shows schematically the tip of the blade with a gauge designed for better control of the inner contour of welding;

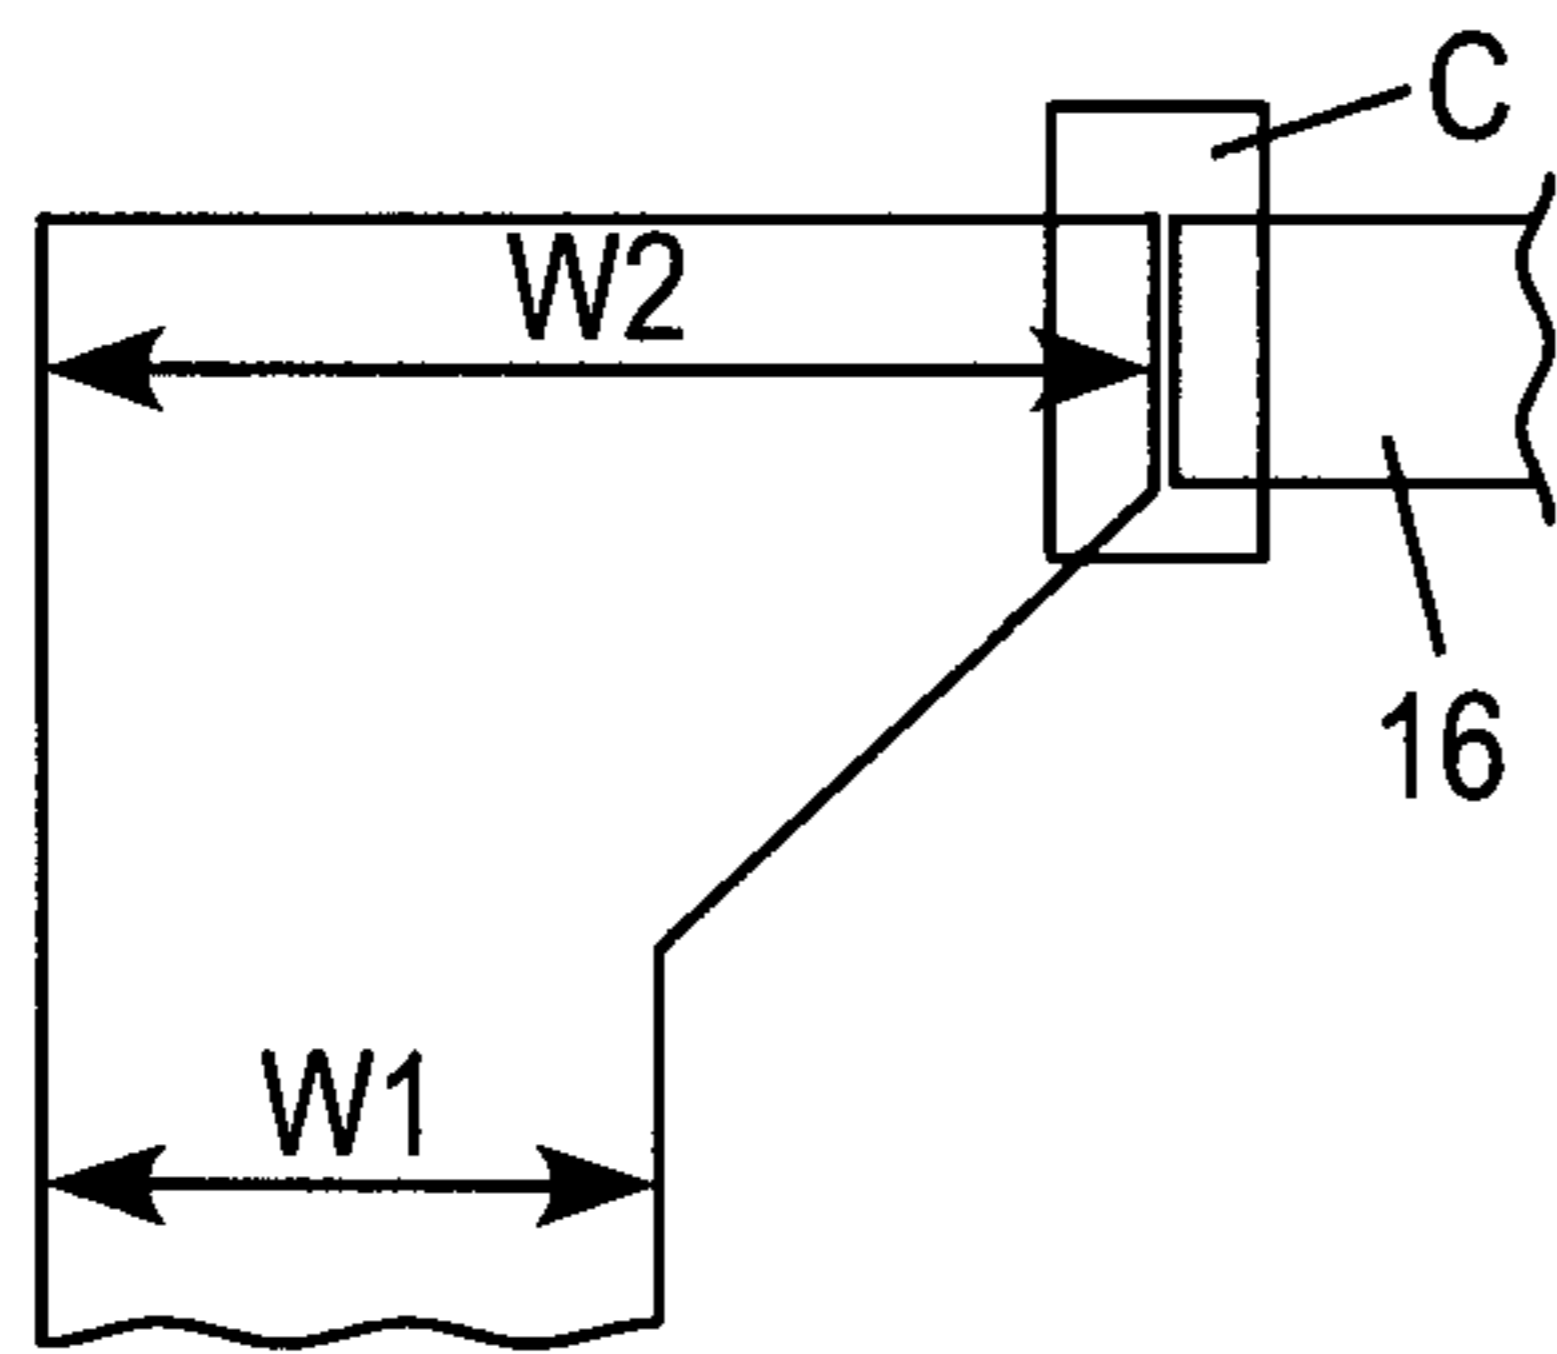
FIG. 5a)

FIG. 5a-b show schematically embodiments of the building-up of one of the airfoil sides walls by welding with an increase of the wall thickness after step b) of the present invention;

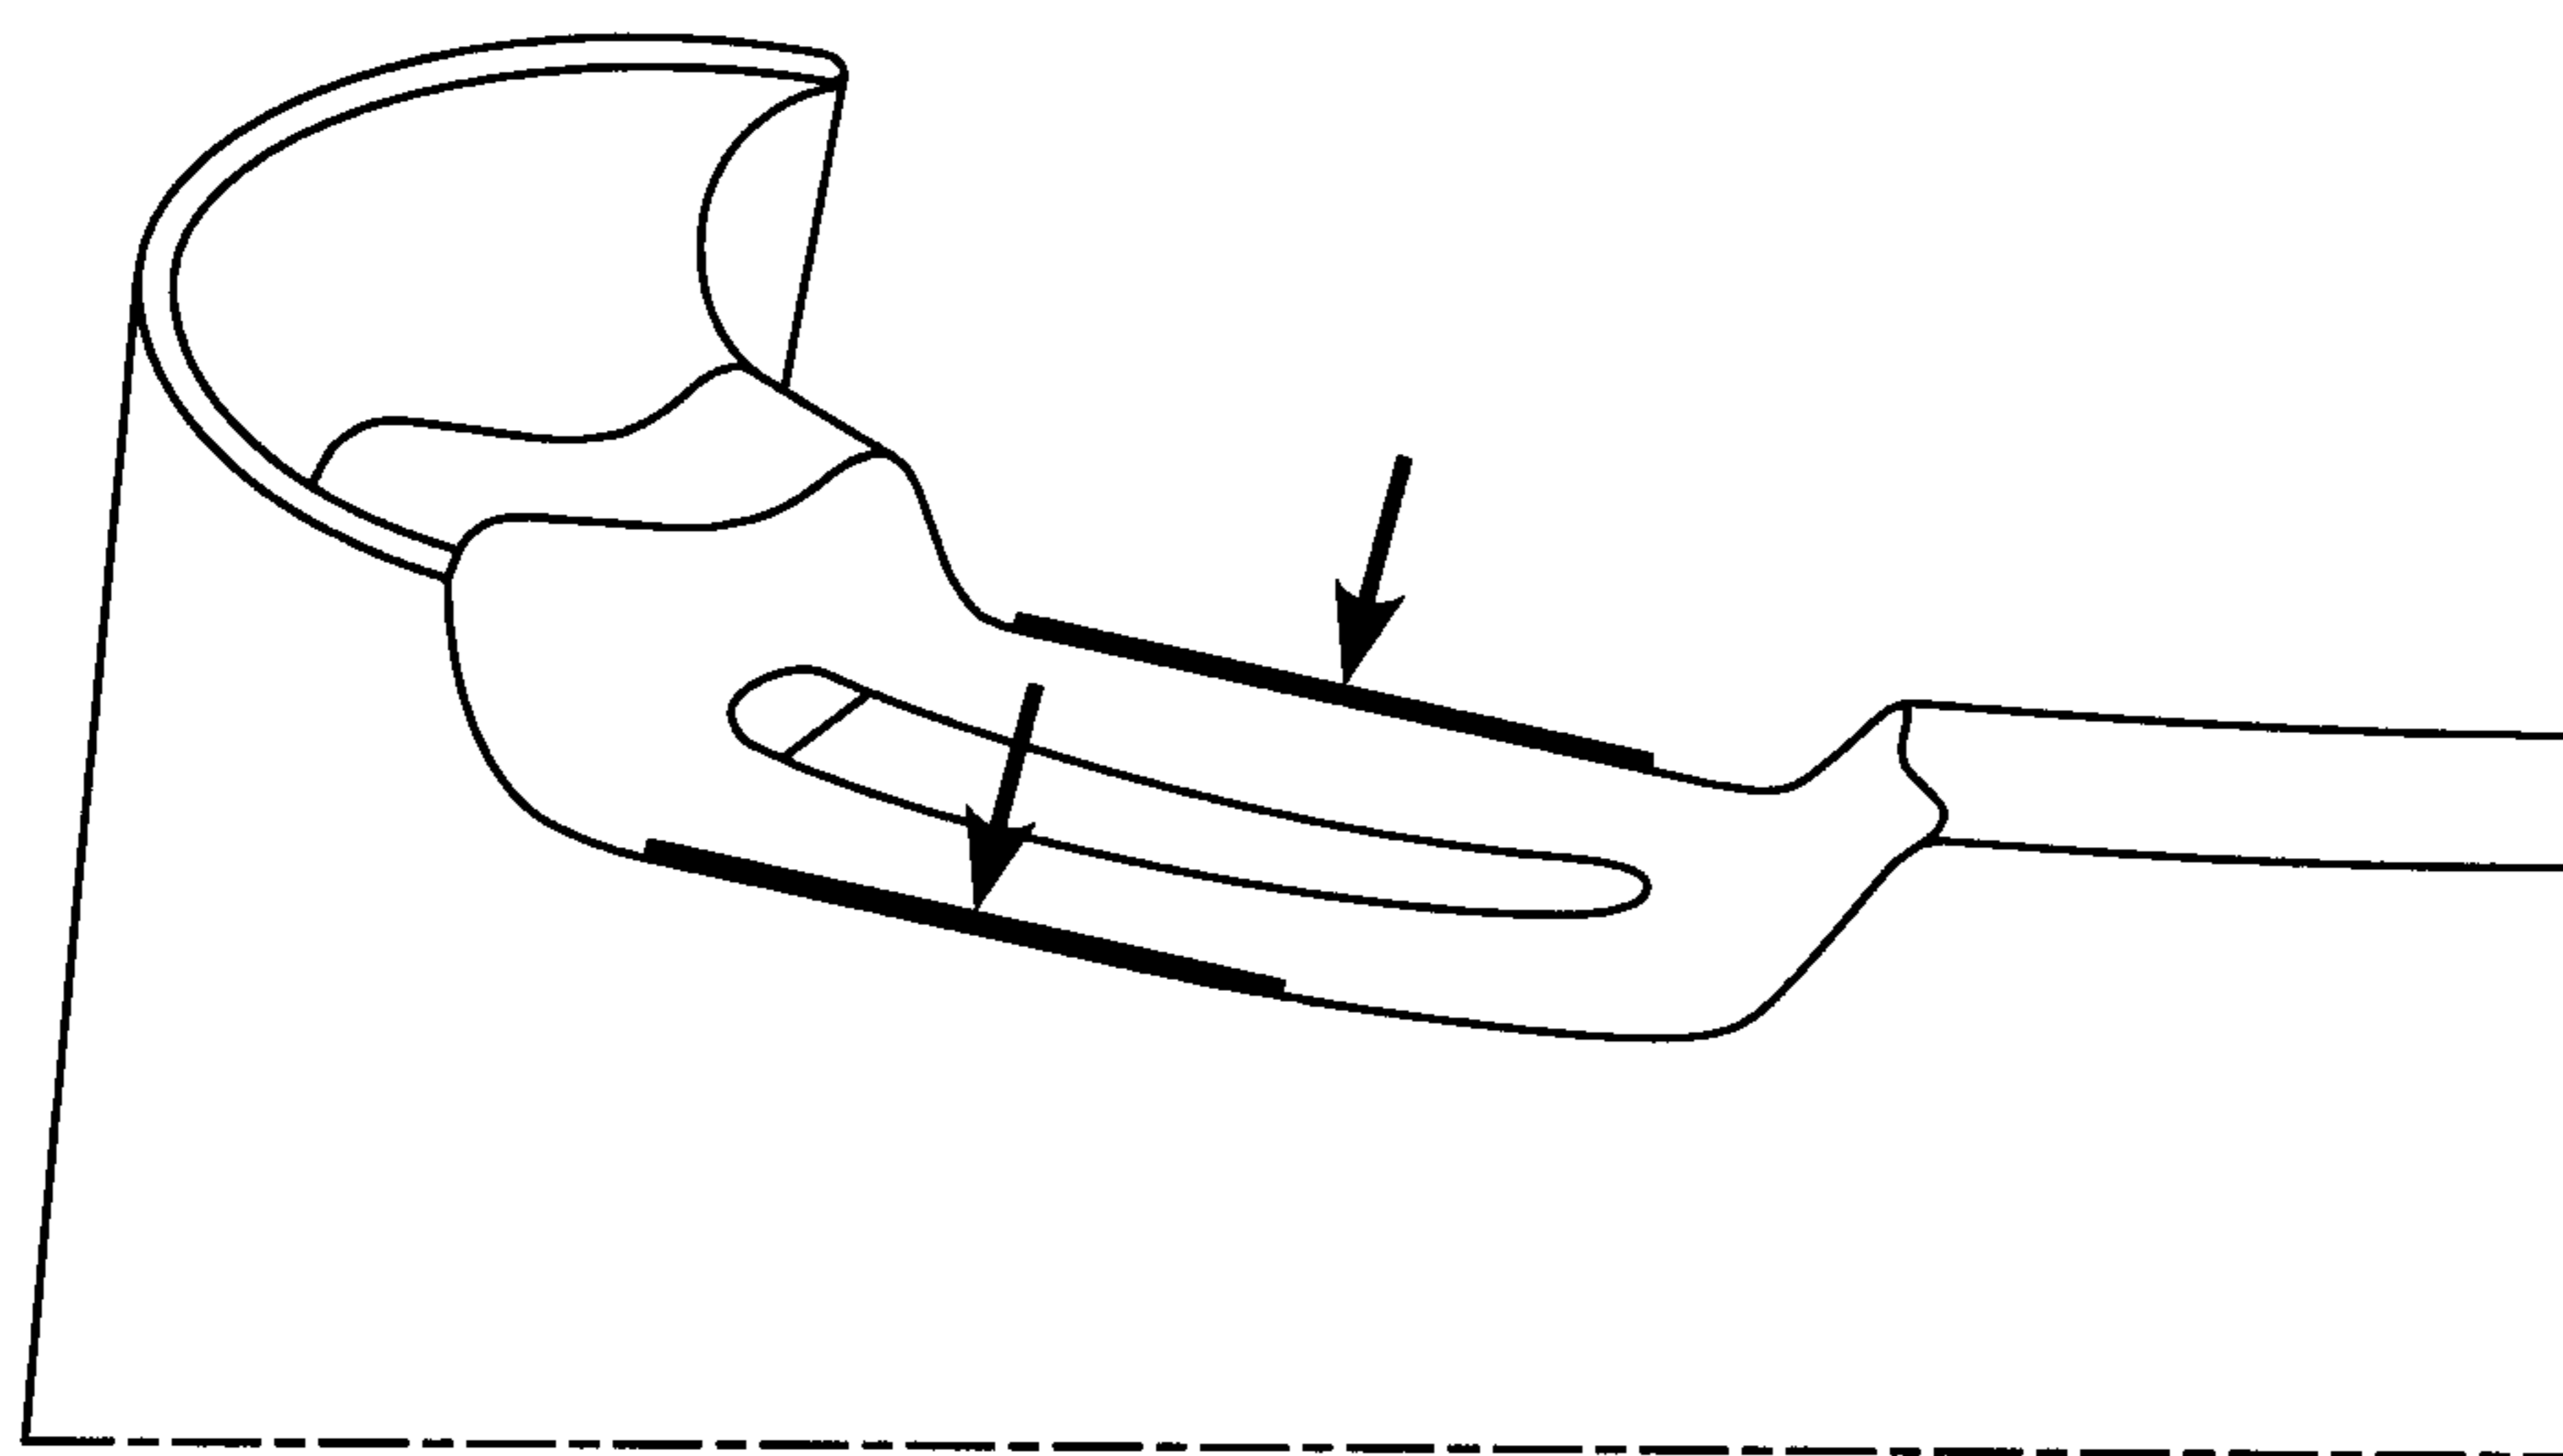
FIG. 6 shows a photograph of the airfoil after step c) of the present invention;
