(54) **METHOD FOR REPAIRING TURBINE COMPONENTS**

(57) **ABSTRACT**  
A method is disclosed for repairing a precision casted turbine blade having a squealer and at least one letterbox which was closed by brazing during new-part manufacturing, wherein the letterbox area was damaged during operation in the first life cycle of the blade.

The present invention relates to the technology of gas turbines. It refers to a method for repairing turbine components, especially turbine blades, by welding.

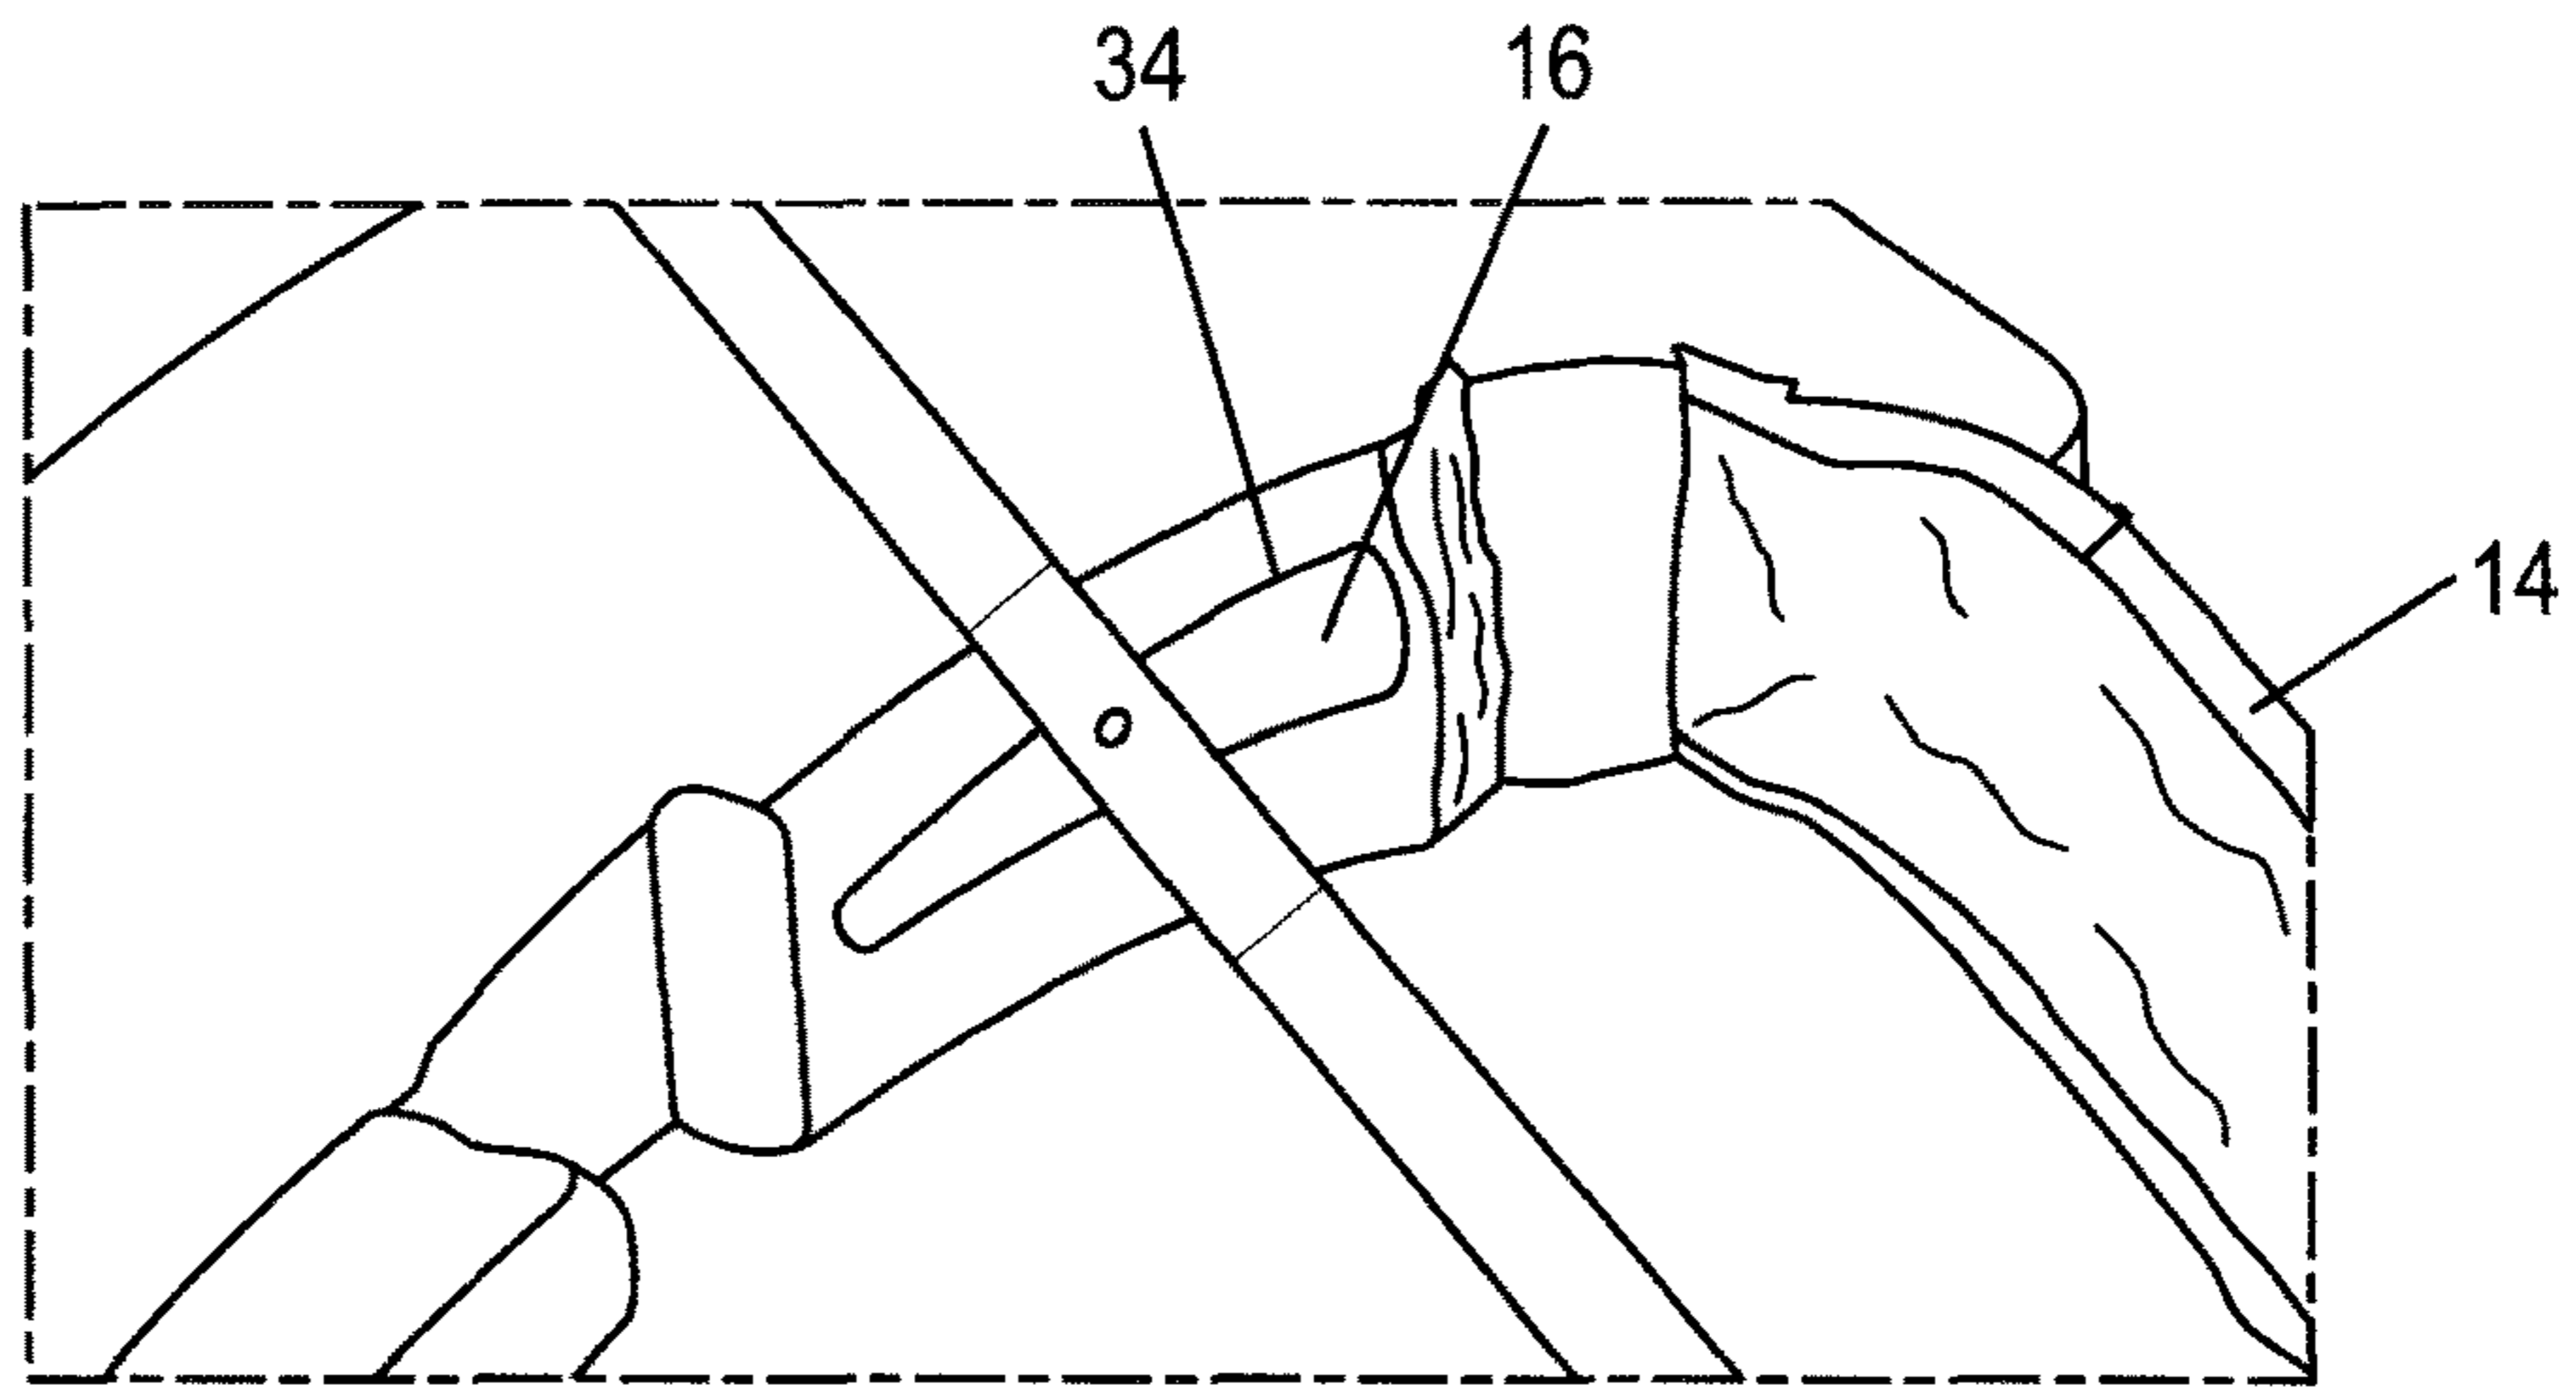
FIG. 7a)

FIG. 7a-c show photographs with several steps for closing the cavity with an inserted exactly fitting closure plate, the spot welded plate and completely over welded plate (after steps e) and f) of the present invention.
