- (54) **PIPING INSPECTION APPARATUS** 5,251,487 A * 10/1993 Marshall G01H 5/00
73/644
- (71) Applicant: **Hitachi, Ltd.**, Tokyo (JP) 6,138,514 A 10/2000 Iwamoto et al.
7,474,092 B1 * 1/2009 Kwun G01N 29/043
324/238
- (72) Inventors: **Masahiro Miki**, Tokyo (JP); **Yuki Oshima**, Tokyo (JP); **Naoyuki Kono**, Tokyo (JP); **Toshimi Kimura**, Tokyo (JP) 7,799,139 B2 * 9/2010 Keating C11D 7/263
134/1.3
9,404,903 B2 * 8/2016 Batzinger G01N 33/00
2002/0134161 A1 * 9/2002 Chinn G01N 29/07
73/622
- (73) Assignee: **Hitachi, Ltd.**, Tokyo (JP) 2011/0072905 A1 * 3/2011 Lam G01N 29/221
73/622
- (*) Notice: Subject to any disclaimer, the term of this patent is extended or adjusted under 35 U.S.C. 154(b) by 217 days. 2014/0102201 A1 4/2014 Brignac et al.

An ultrasonic transmission probe is arranged such that an ultrasonic wave transmitted from the ultrasonic transmission probe toward a pipe propagates in a thick part of the pipe, is at least reflected on the outer peripheral face of the pipe, and travels toward an inspection site on the pipe, and an ultrasonic reception probe is arranged to be symmetrical to the ultrasonic transmission probe with reference to the xz plane including the insp

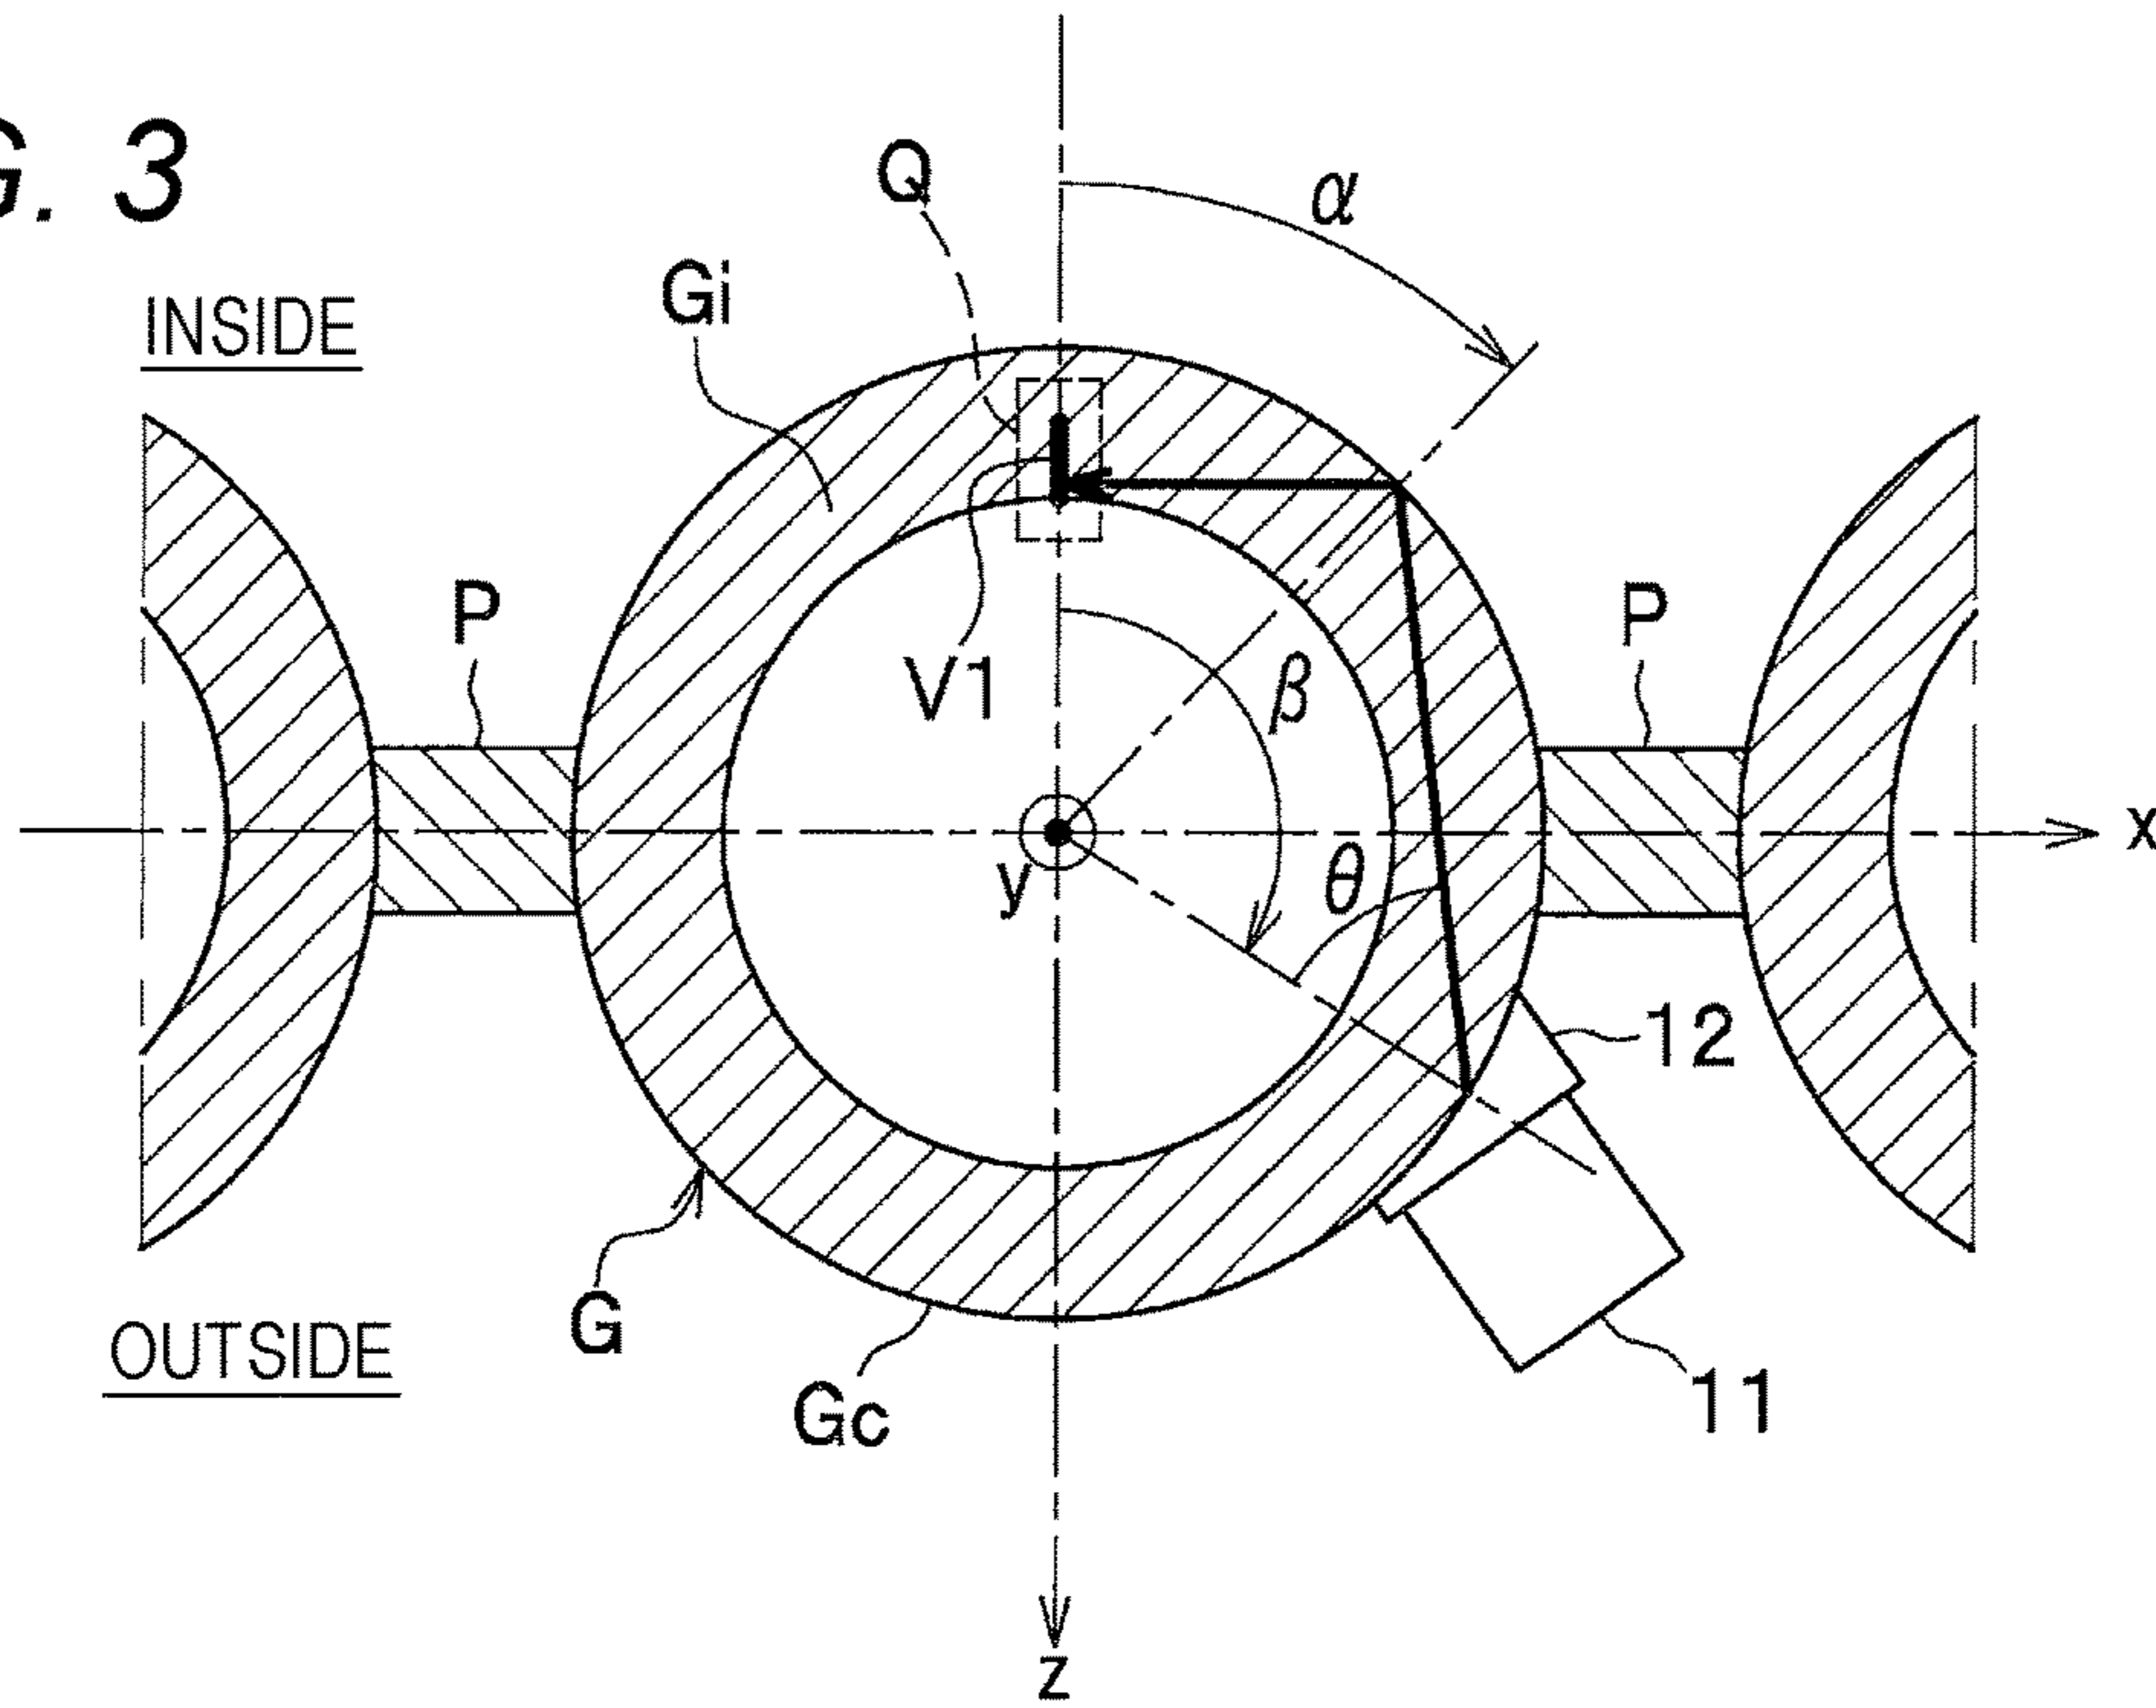
FIG. 4 is an explanatory diagram of a pipe, an ultrasonic transmission probe, an ultrasonic reception probe, and the like in the piping inspection apparatus according to the first embodiment of the present invention viewed in the negative x-axis direction;

FIG. 4 is an explanatory diagram of the pipe G, the ultrasonic transmission probe 11, the ultrasonic reception probe 21, and the like viewed in the negative x-axis direction. The film plate P (see FIG. 3) is not illustrated in FIG. 4.

The wedge 22 illustrated in FIG. 4 is a member present between the ultrasonic reception probe 21 and the pipe G, and is fixed on the ultrasonic reception probe 21 by metal part or screw. An ultrasonic wave is incident into each oscillator 21a (see FIG. 2) of the ultrasonic reception probe 21 via the wedge 22.

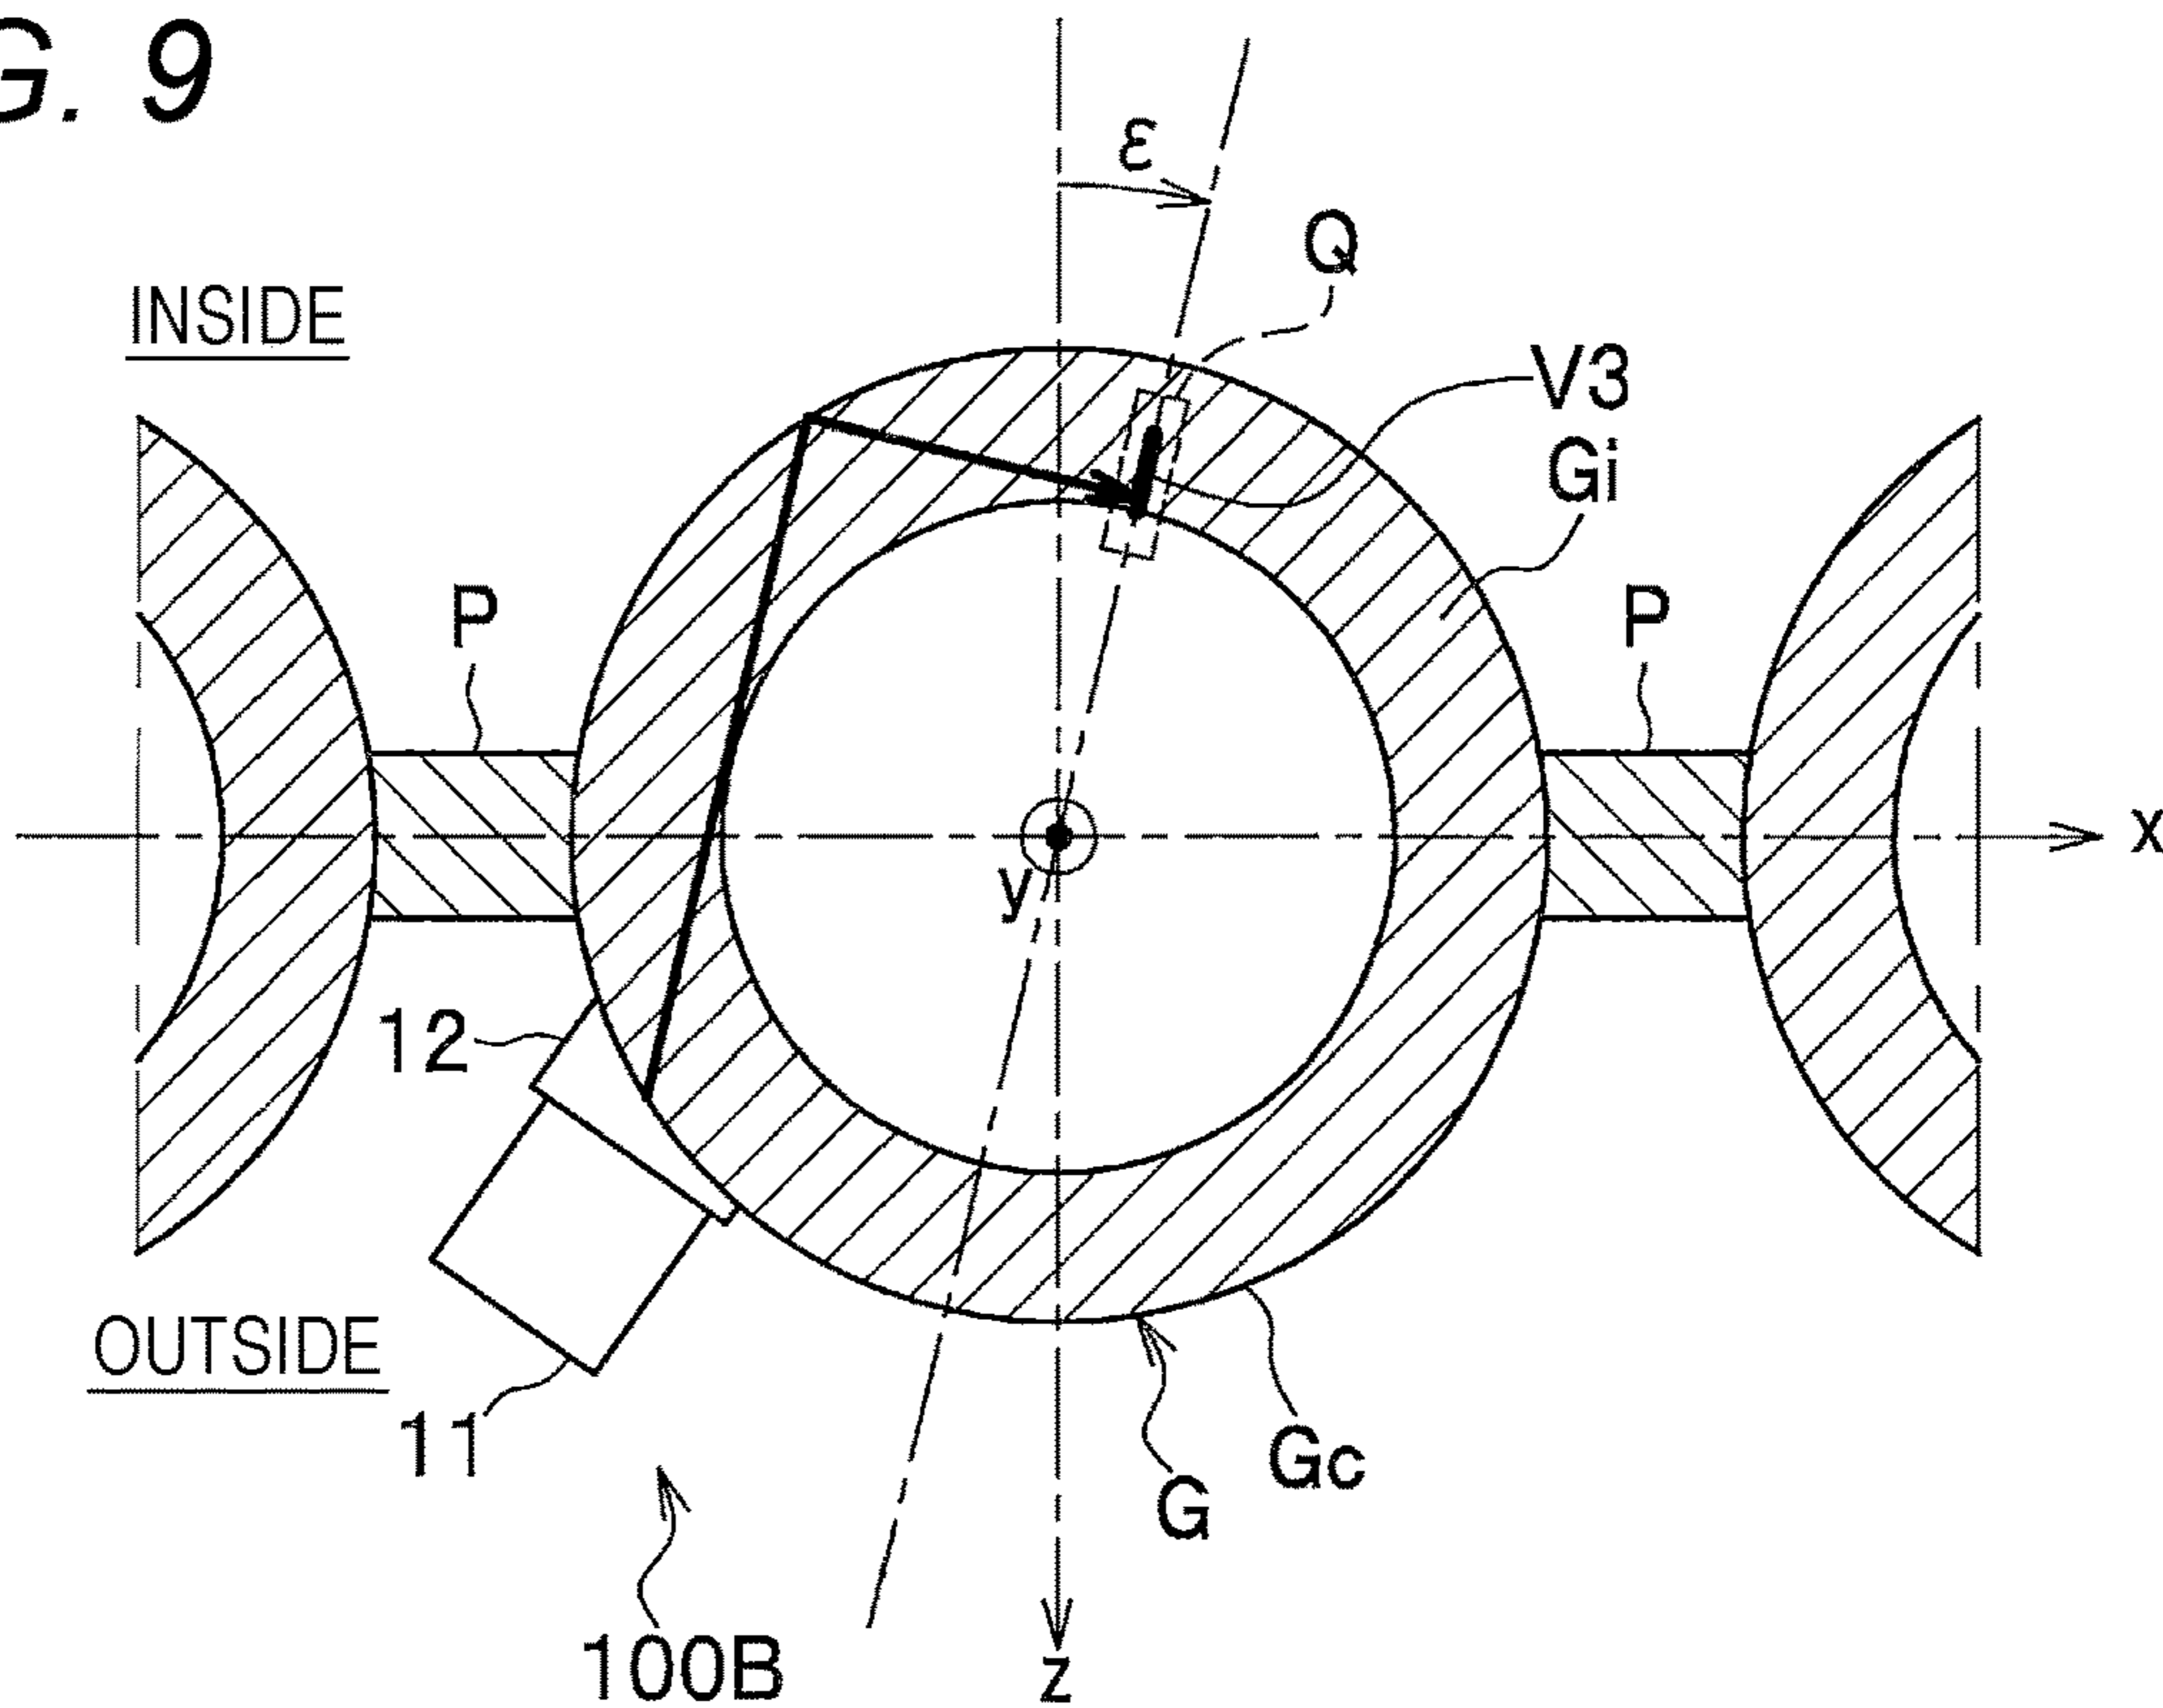
FIG. 10 is a transverse cross-section view including an ultrasonic transmission probe and an ultrasonic reception probe in a piping inspection apparatus according to a fourth embodiment of the present invention;

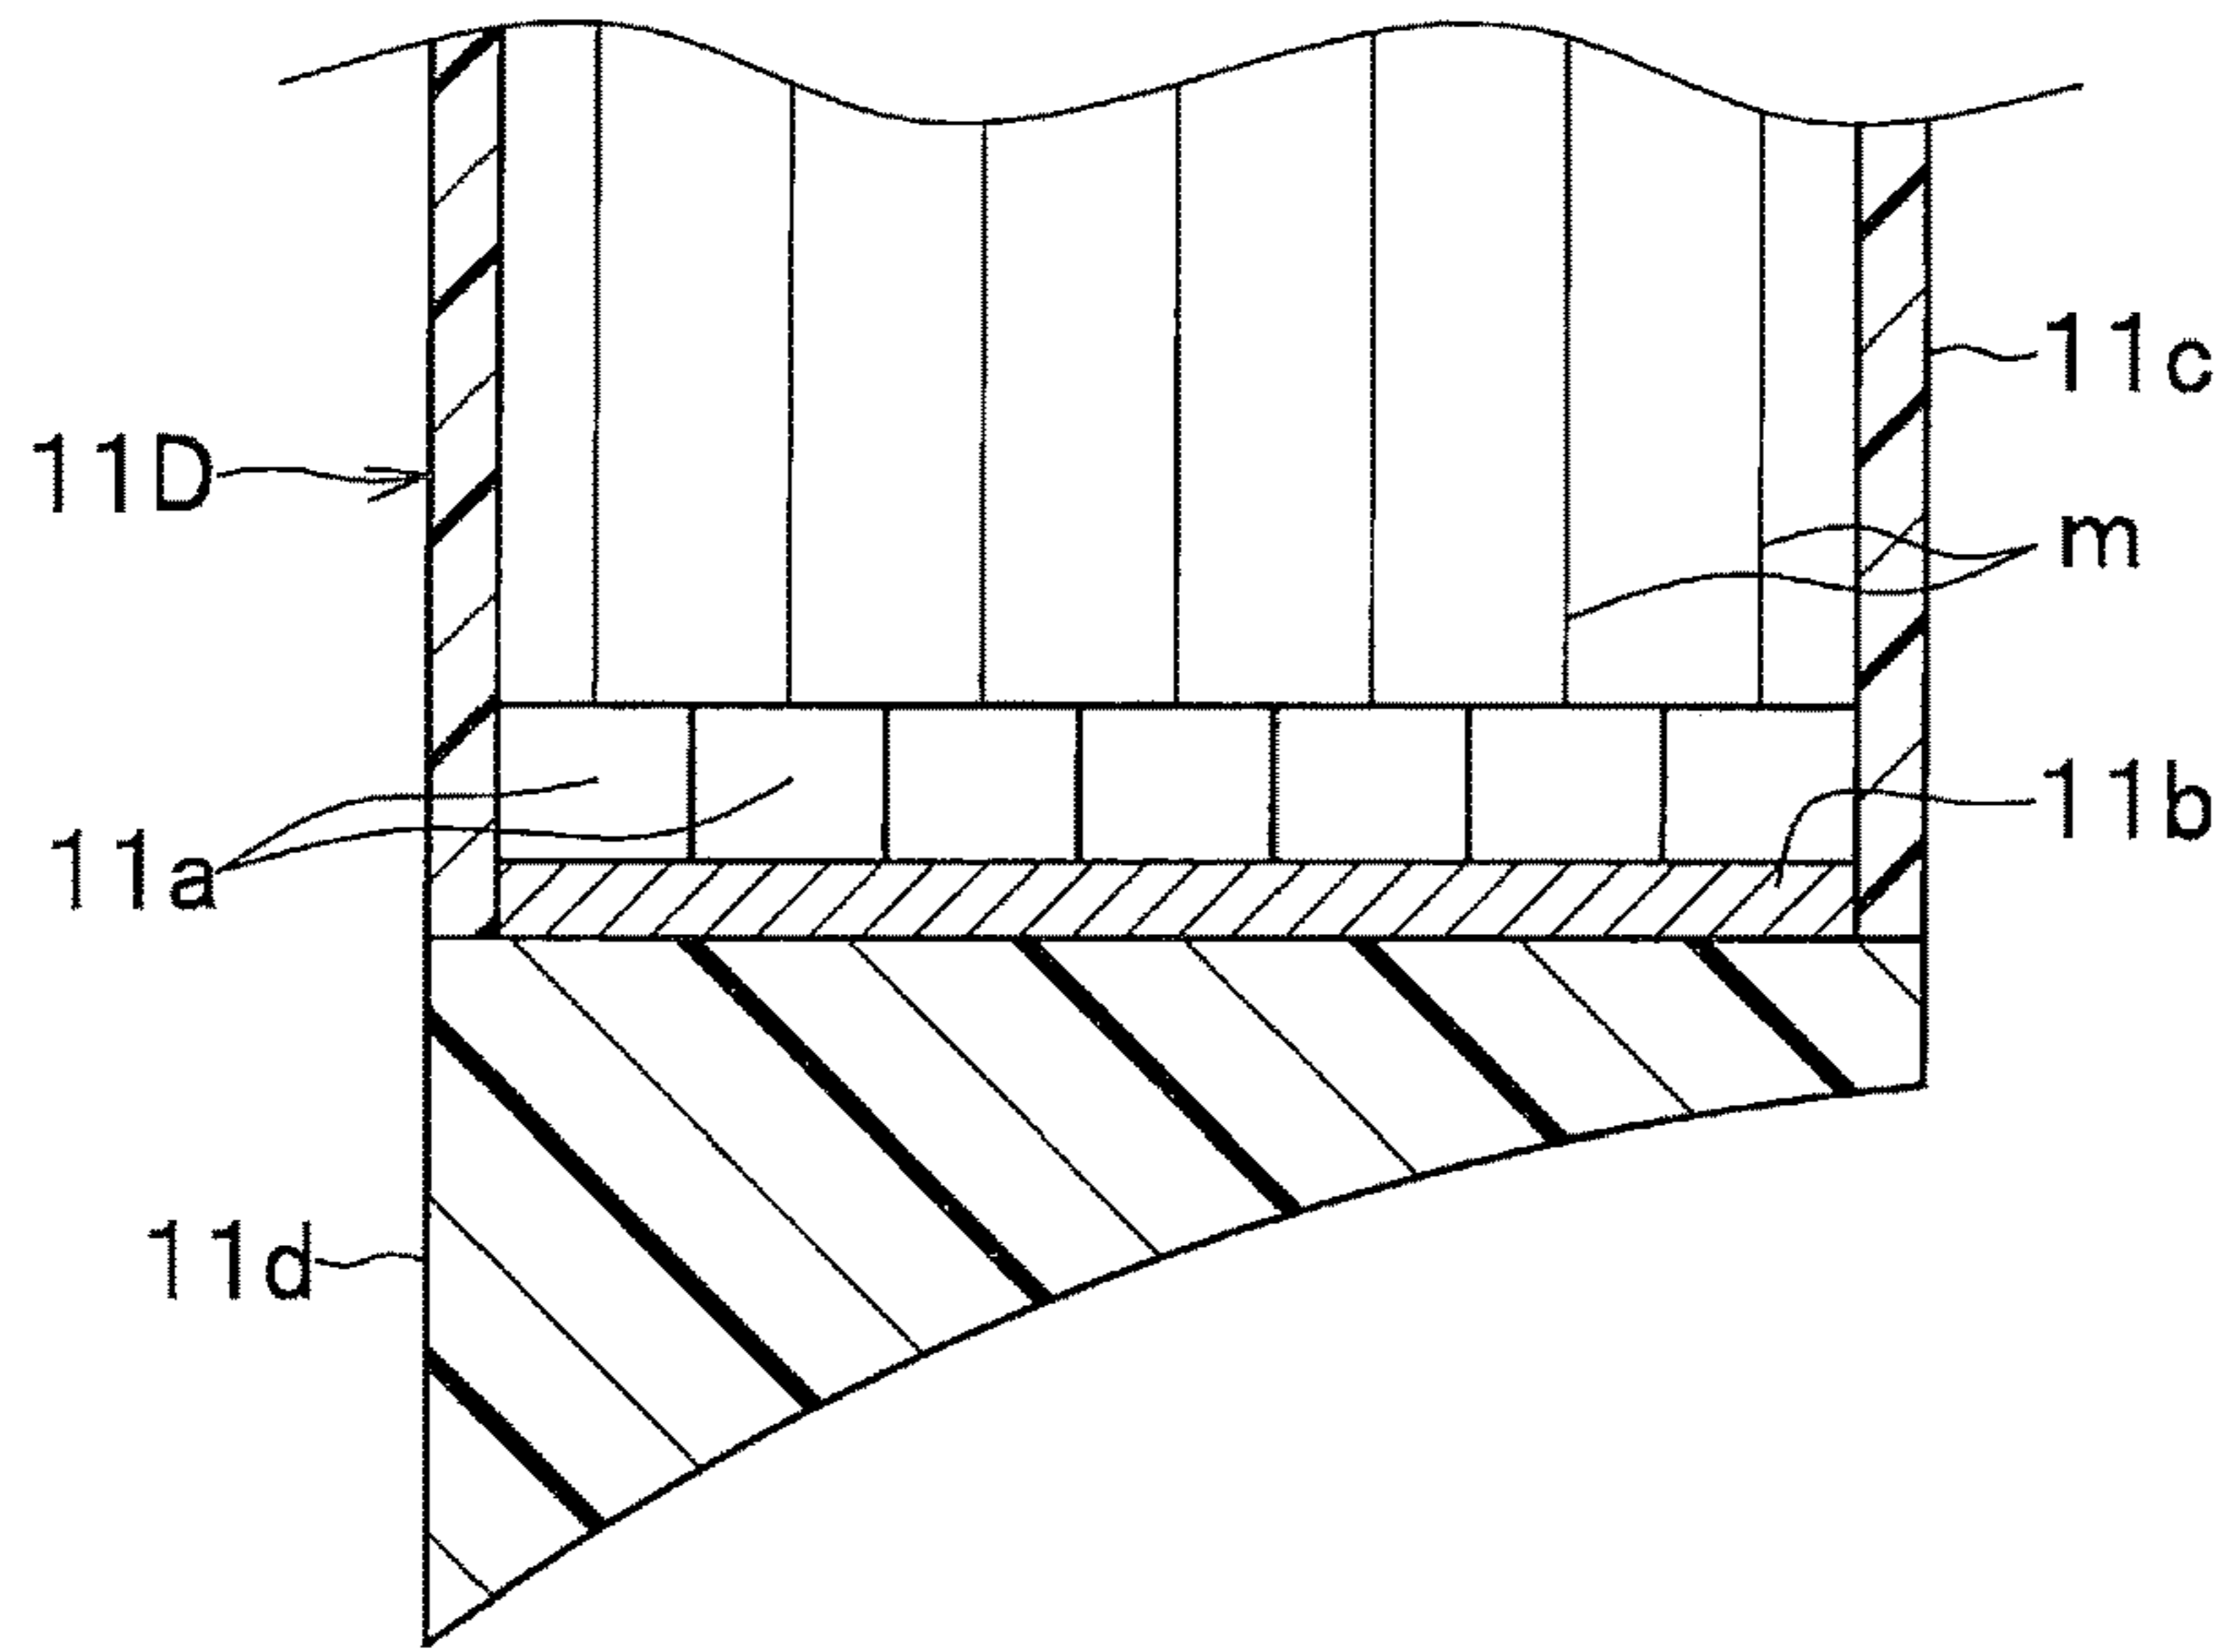
FIG. 14 is a transverse cross-section view illustrating a route of an ultrasonic wave transmitted from an ultrasonic transmission probe in a piping inspection apparatus according to another variant of the present invention.
