(12) **United States Patent**
Koketsu et al.

(54) **MEMBER INSPECTION DEVICE AND MEMBER REPAIRING METHOD**

(71) Applicant: **MITSUBISHI HEAVY INDUSTRIES, LTD.**, Tokyo (JP)

In a member inspection device and a member repairing method, an irradiation device irradiates a surface of a member to be inspected with light, an image pickup device picks up an image of a surface portion irradiated with the light, a failure detection device detects a failure area on the basis of a photographed image picked up by the image pickup device, and a determining device classifies the shape of the failure area detected by the failure detection device.

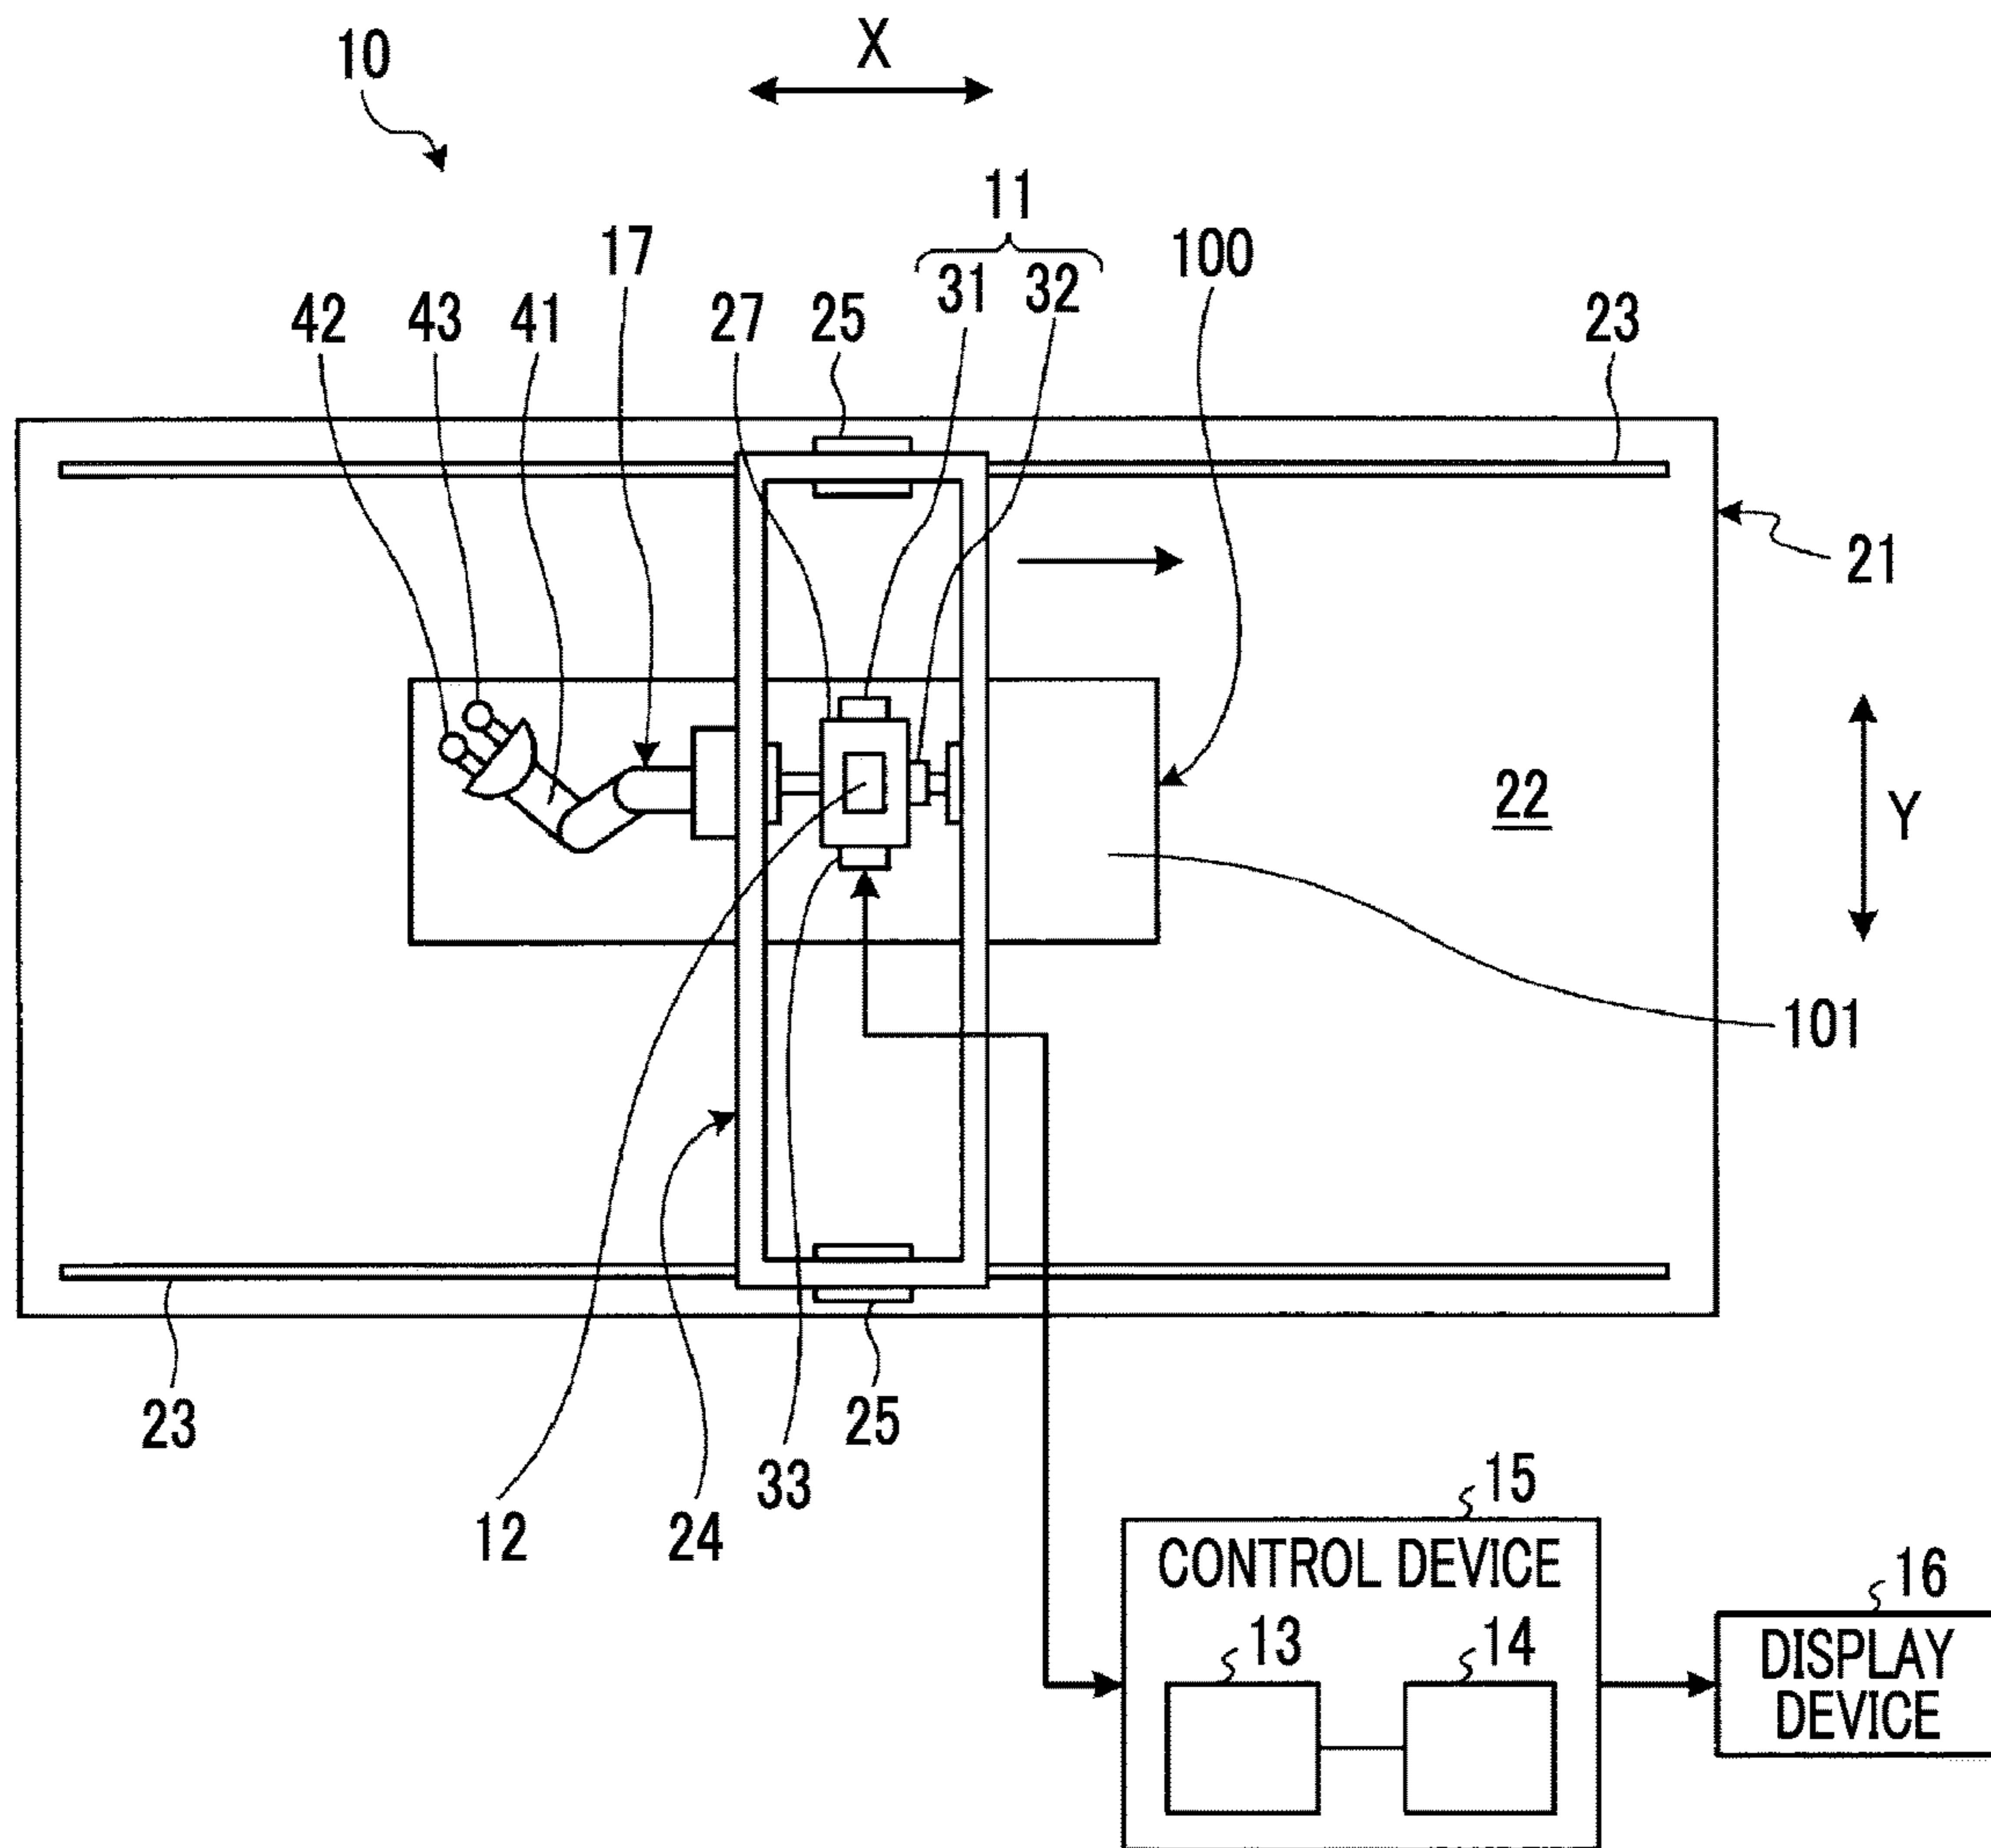
FIG. 1 is a plan view illustrating a member inspection device of the present embodiment.

FIG. 1 is a plan view illustrating a member inspection device of the present embodiment, and FIG. 2 is a front view illustrating the member inspection device.

In the present embodiment, a member inspection device **10** is a device that inspects a failure area on a surface to be inspected (surface) **101** of a member **100** as illustrated in FIG. 1 and FIG. 2. The member **100** is turned into a product by providing an underlying coating on the surface and then providing a primary coating thereon. The member inspection device **10** of the present embodiment detects a failure area on the surface of the member **100** on which underlying coating has been provided. The member inspection device **10** includes an irradiation device **11**, an image pickup device **12**, a control device **15** having a failure detection device **13** and a determining device **14**, a display device **16**, and a multi-jointed robot **17**.

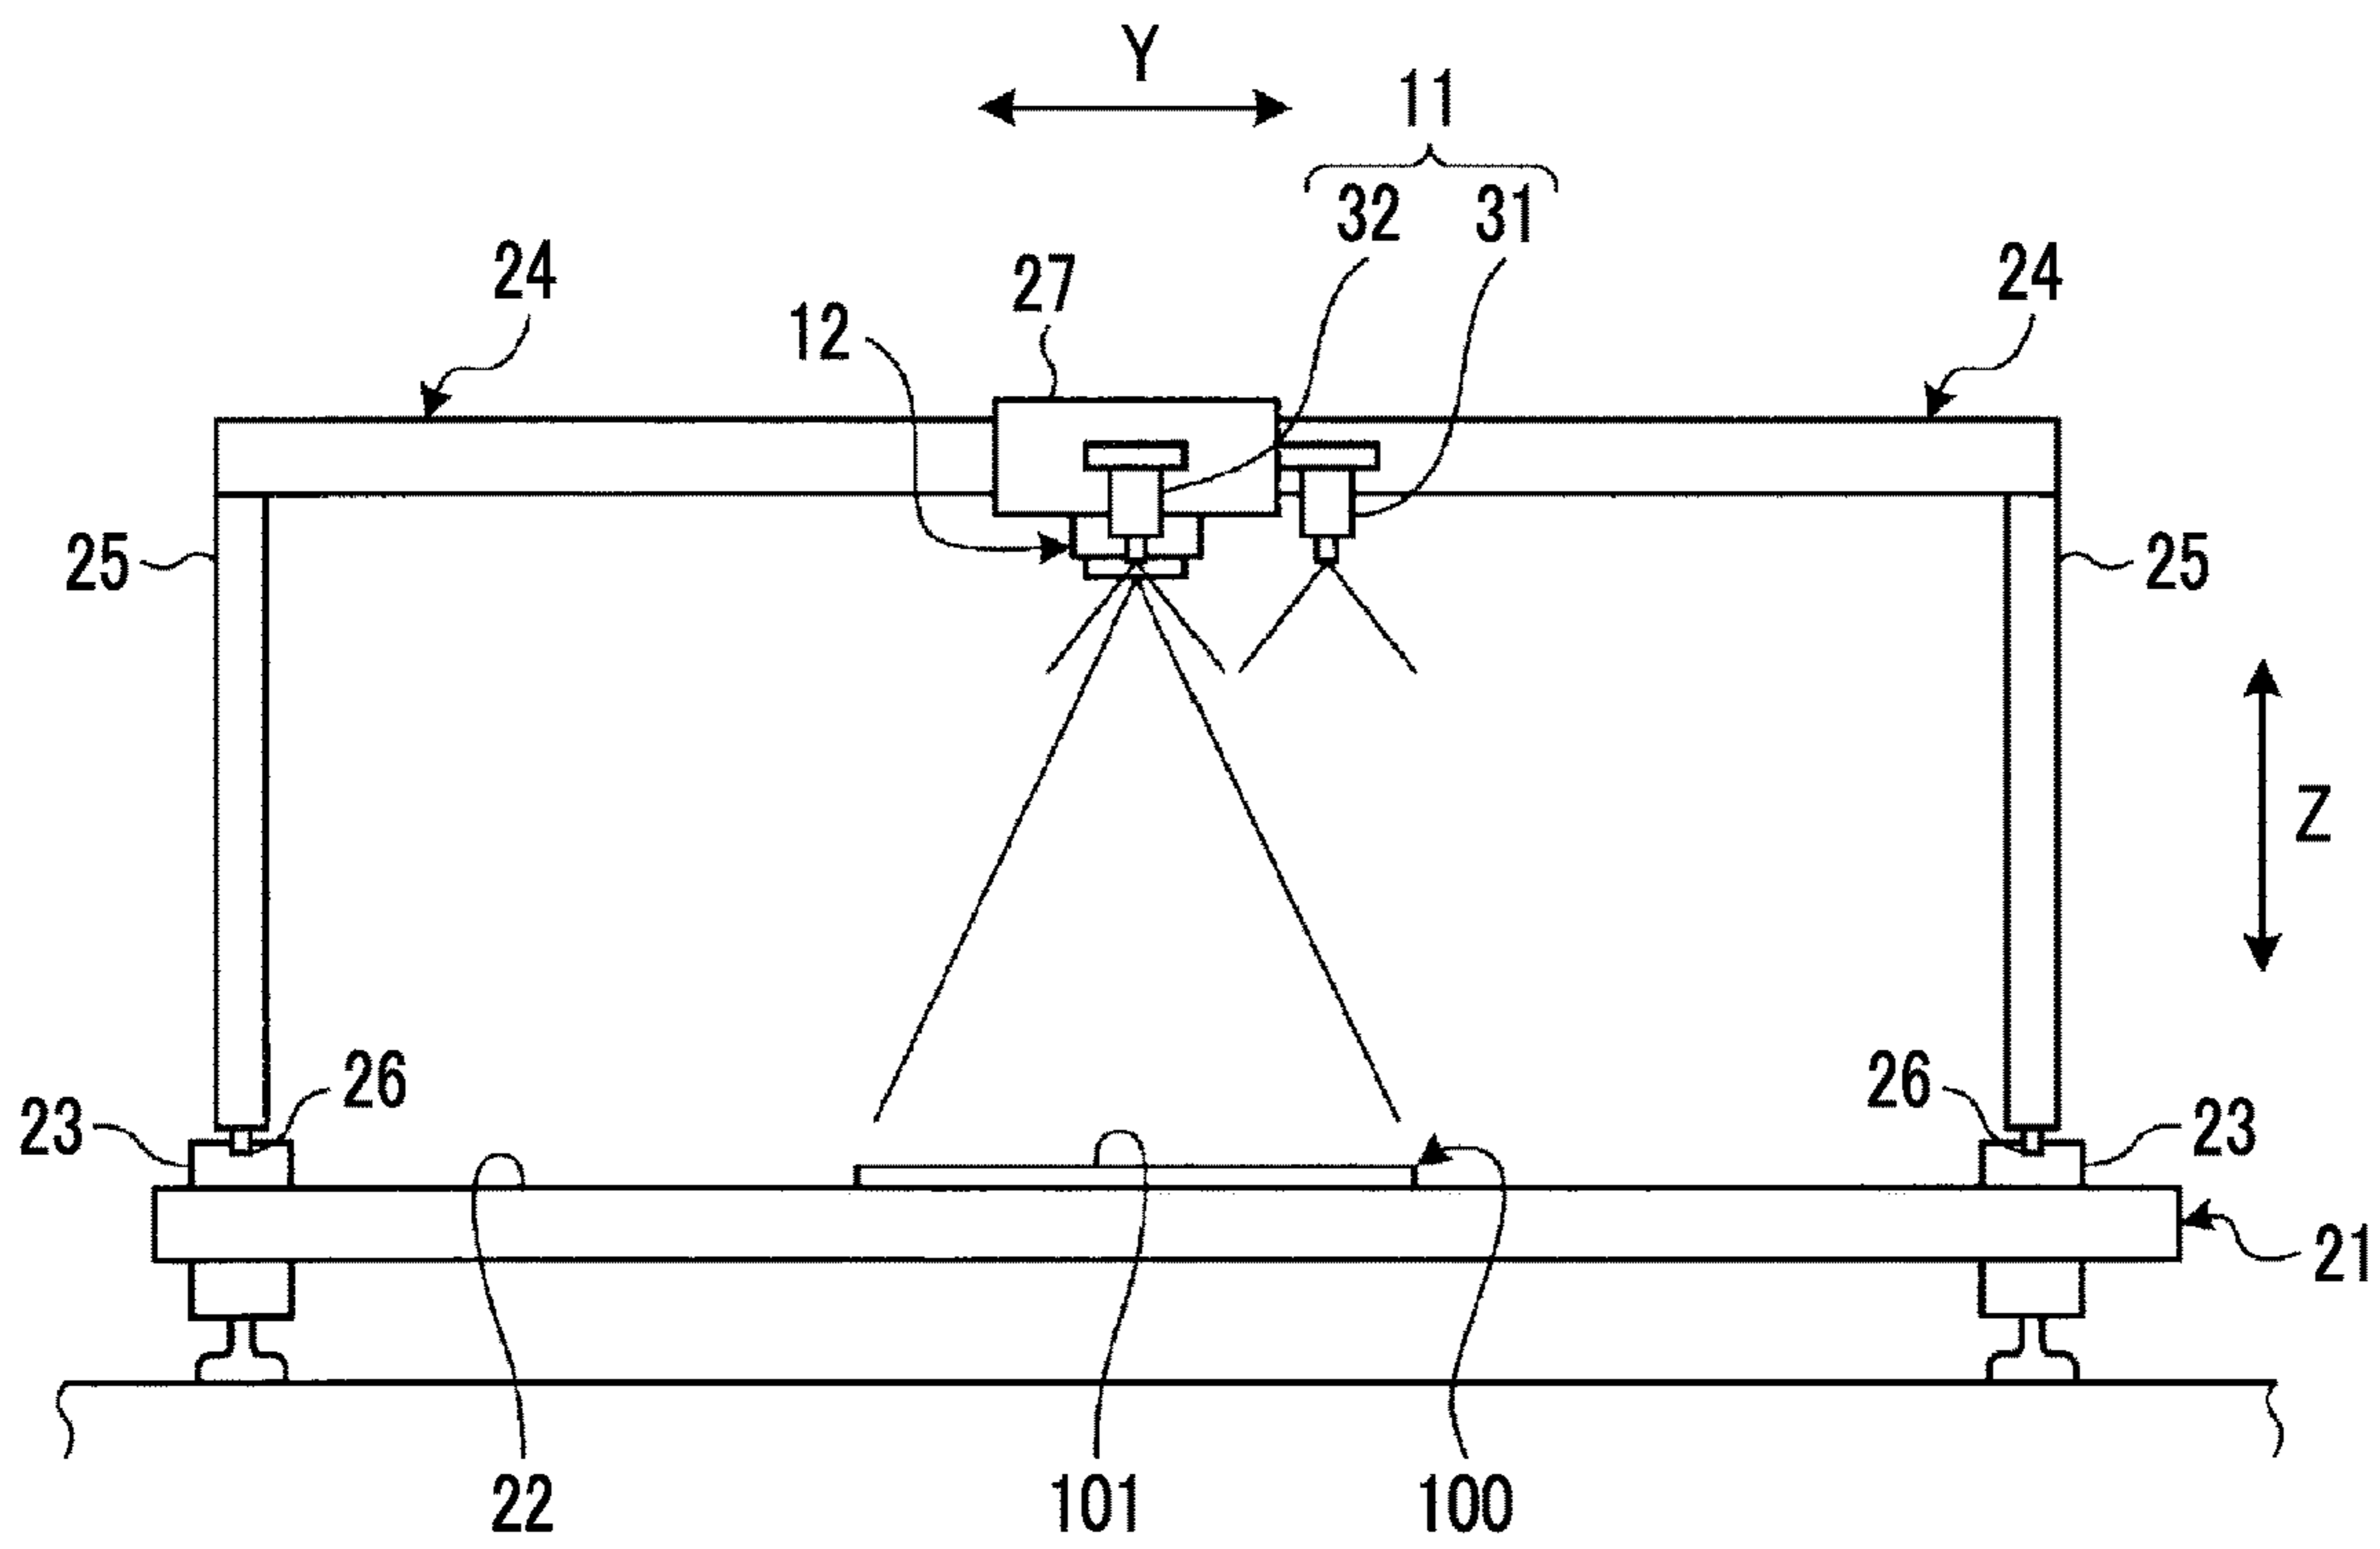
FIG. 2 is a front view illustrating the member inspection device.

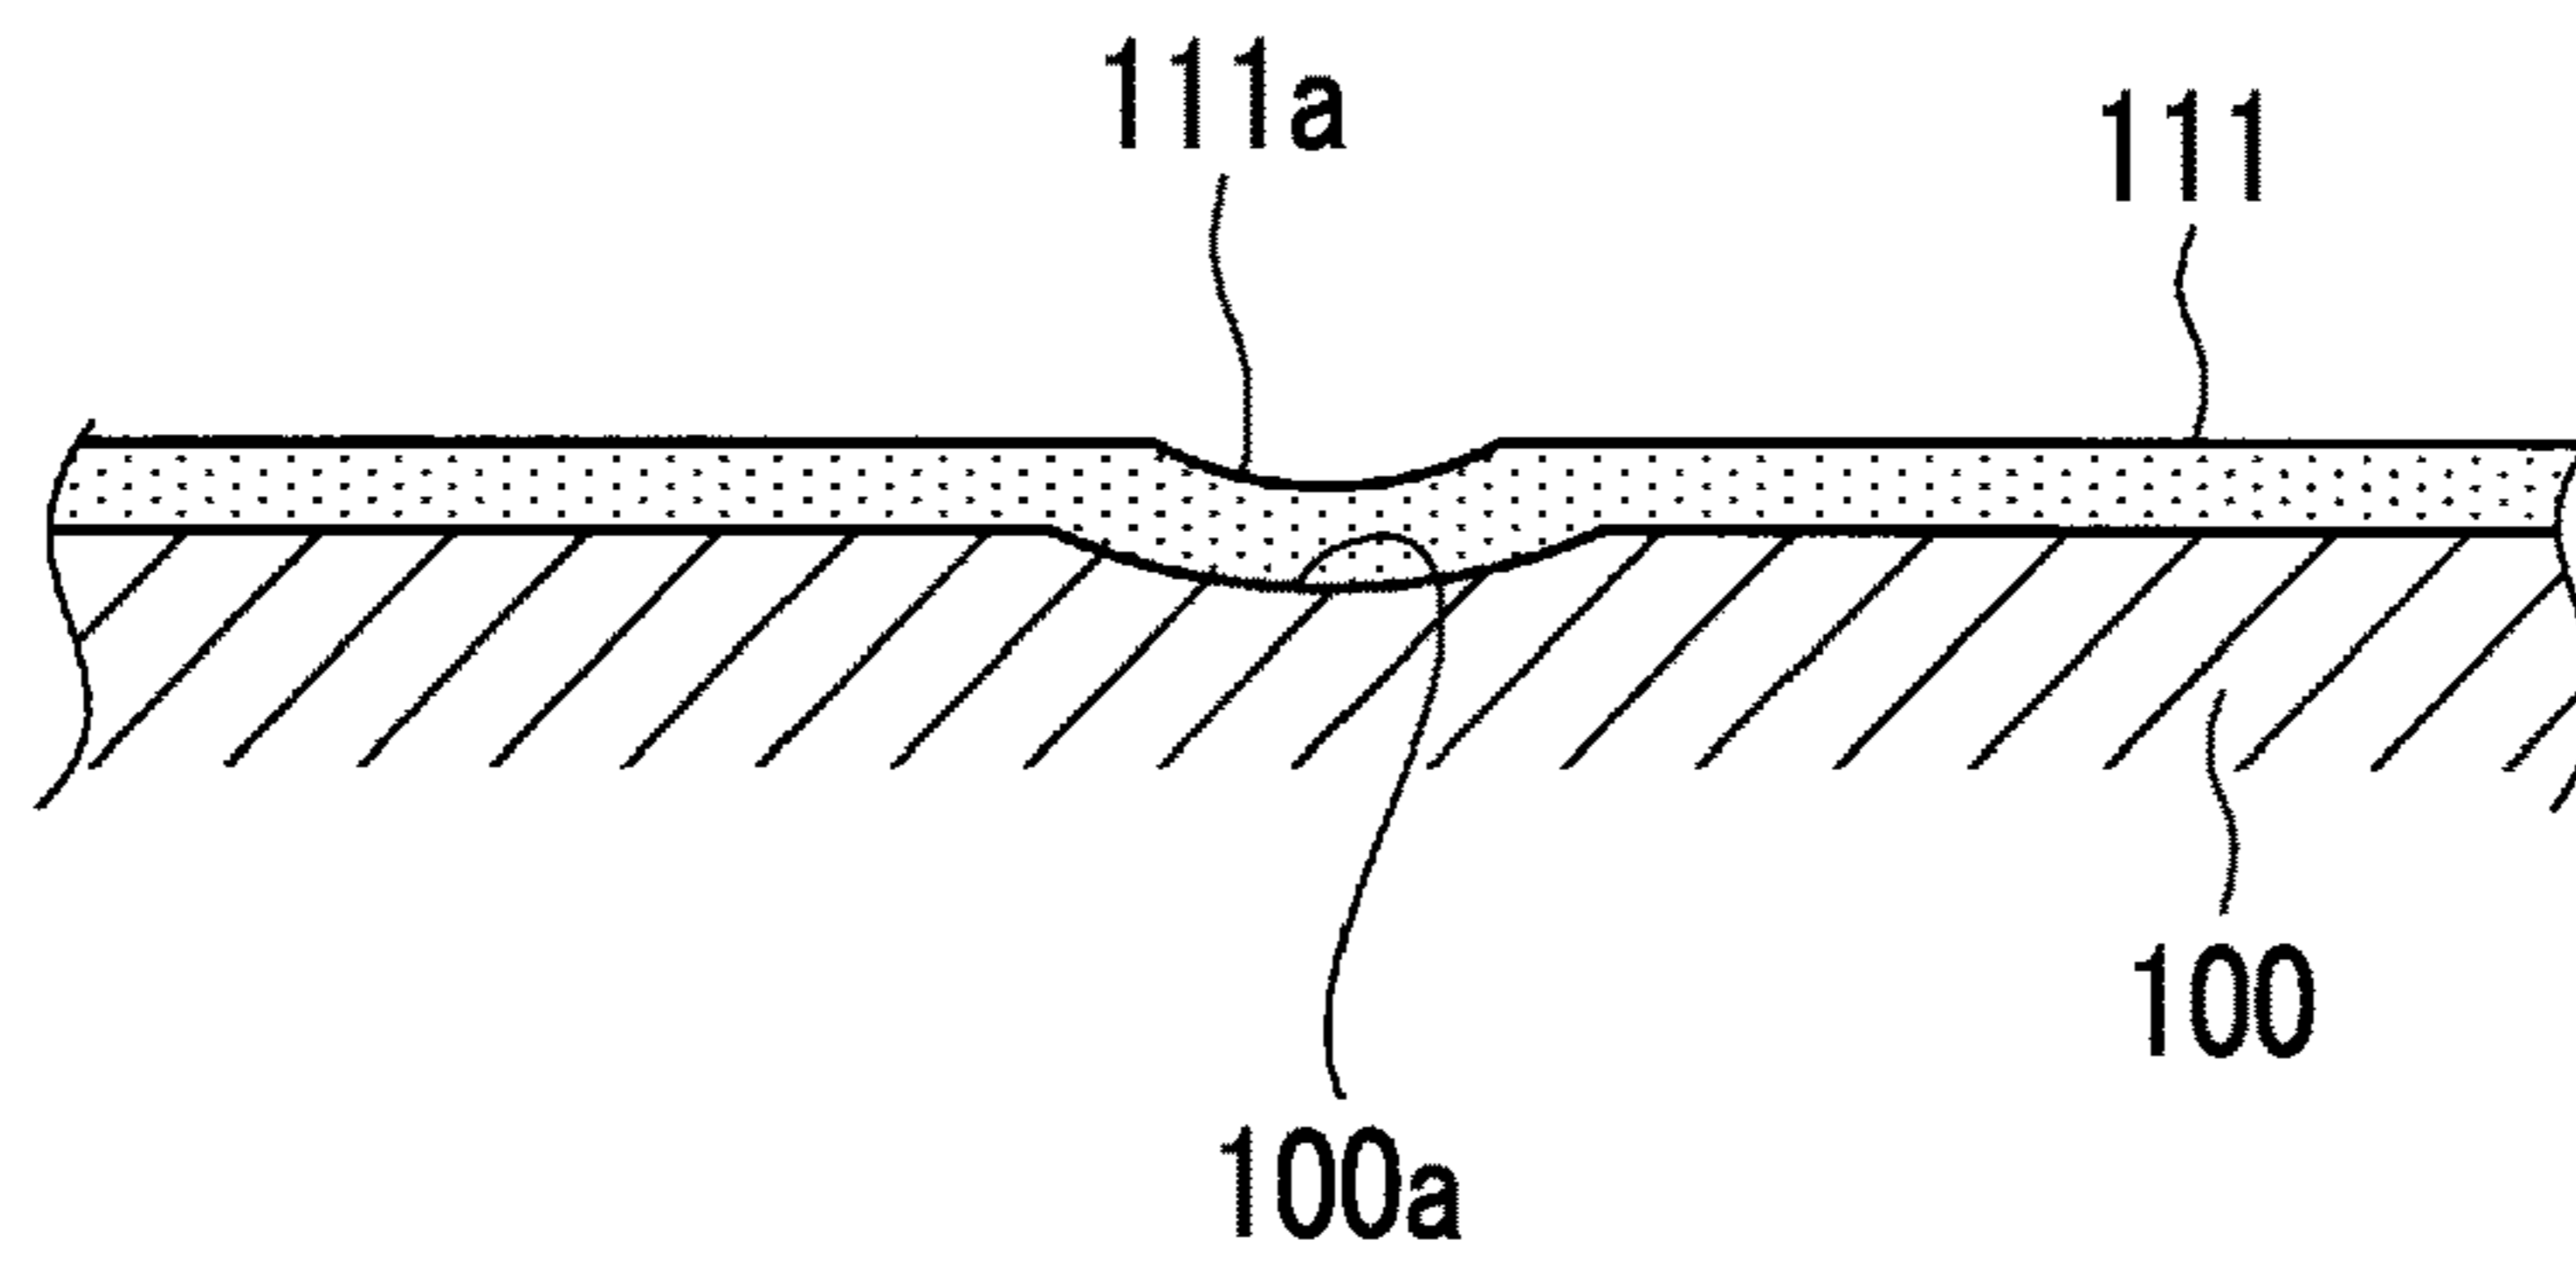
FIG. 4A is a schematic view illustrating a failure shape of a member.

FIG. 4A to FIG. 4C are schematic views illustrating failure shapes of the member. As failure areas that are formed on the surface to be inspected **101** of the member **100**, a recessed portion, a protrusion, and a coating failure can be considered. When a recessed portion **100a** is formed on the surface of the member **100** as illustrated in FIG. 4A, a recessed portion **111a** is still shown on the surface even after an underlying coating **111** of a certain thickness is provided. In addition, when a protrusion **100b** is formed on the surface of the member **100** as illustrated in FIG. 4B, a protrusion **111b** is still shown on the surface even after the underlying coating **111** of a certain thickness is provided. Furthermore, when the surface of the member **100** is flat as illustrated in FIG. 4C, if the underlying coating **111** of a certain thickness is not provided, a fine protrusion and recessed portion **111c** is shown on the surface.

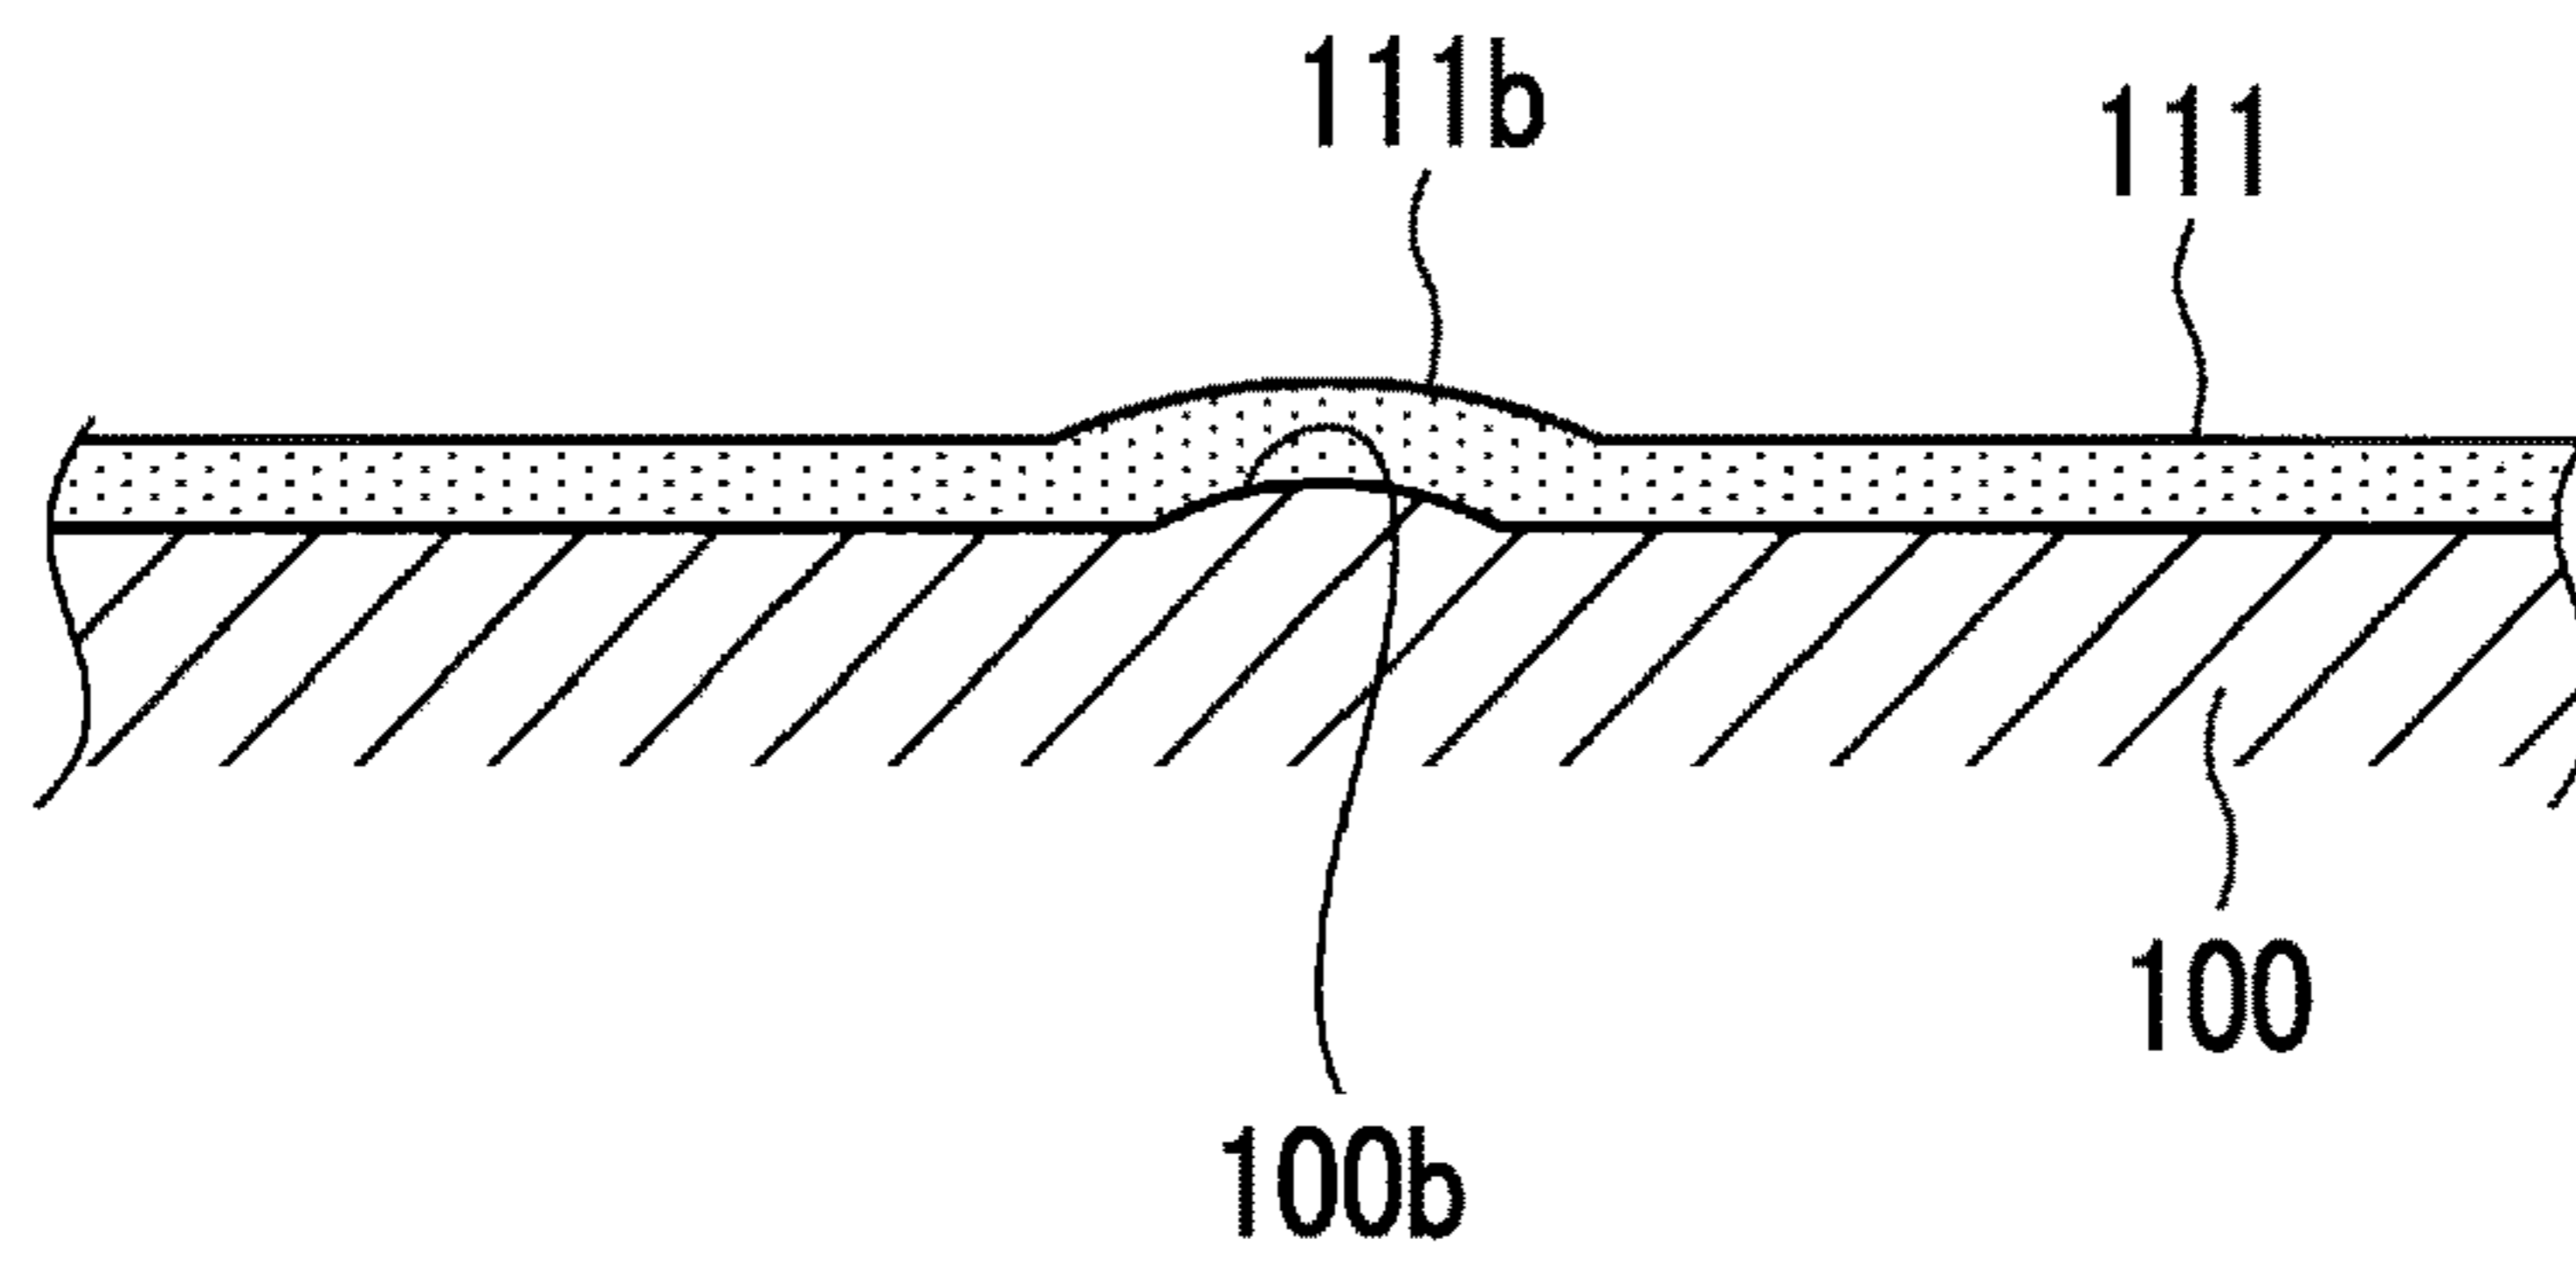
FIG. 4B is a schematic view illustrating a failure shape of the member.

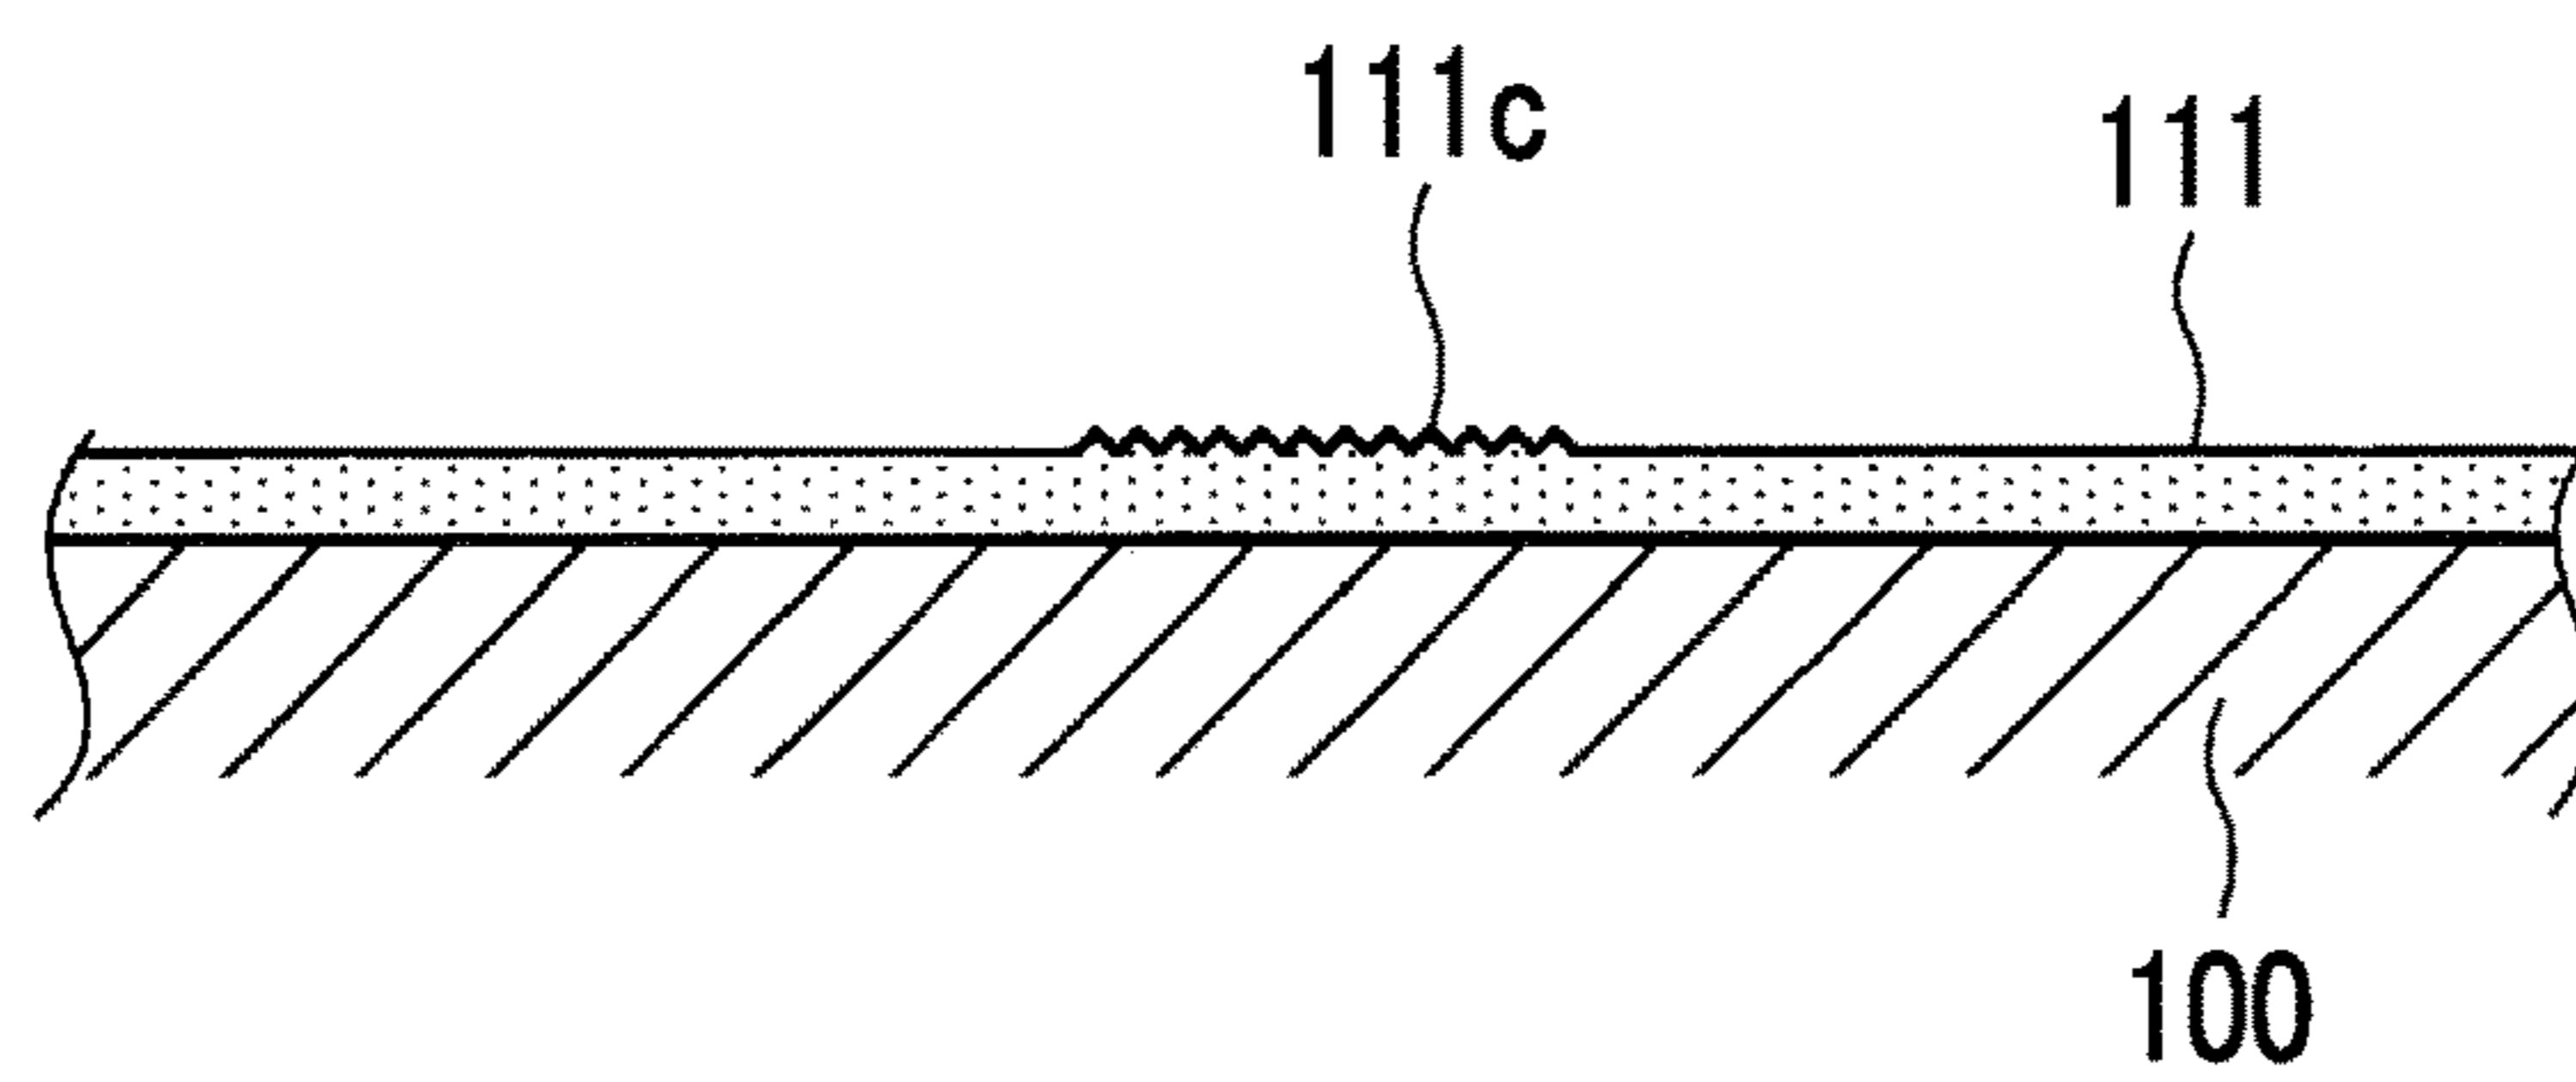
FIG. 4C is a schematic view illustrating a failure shape of the member.

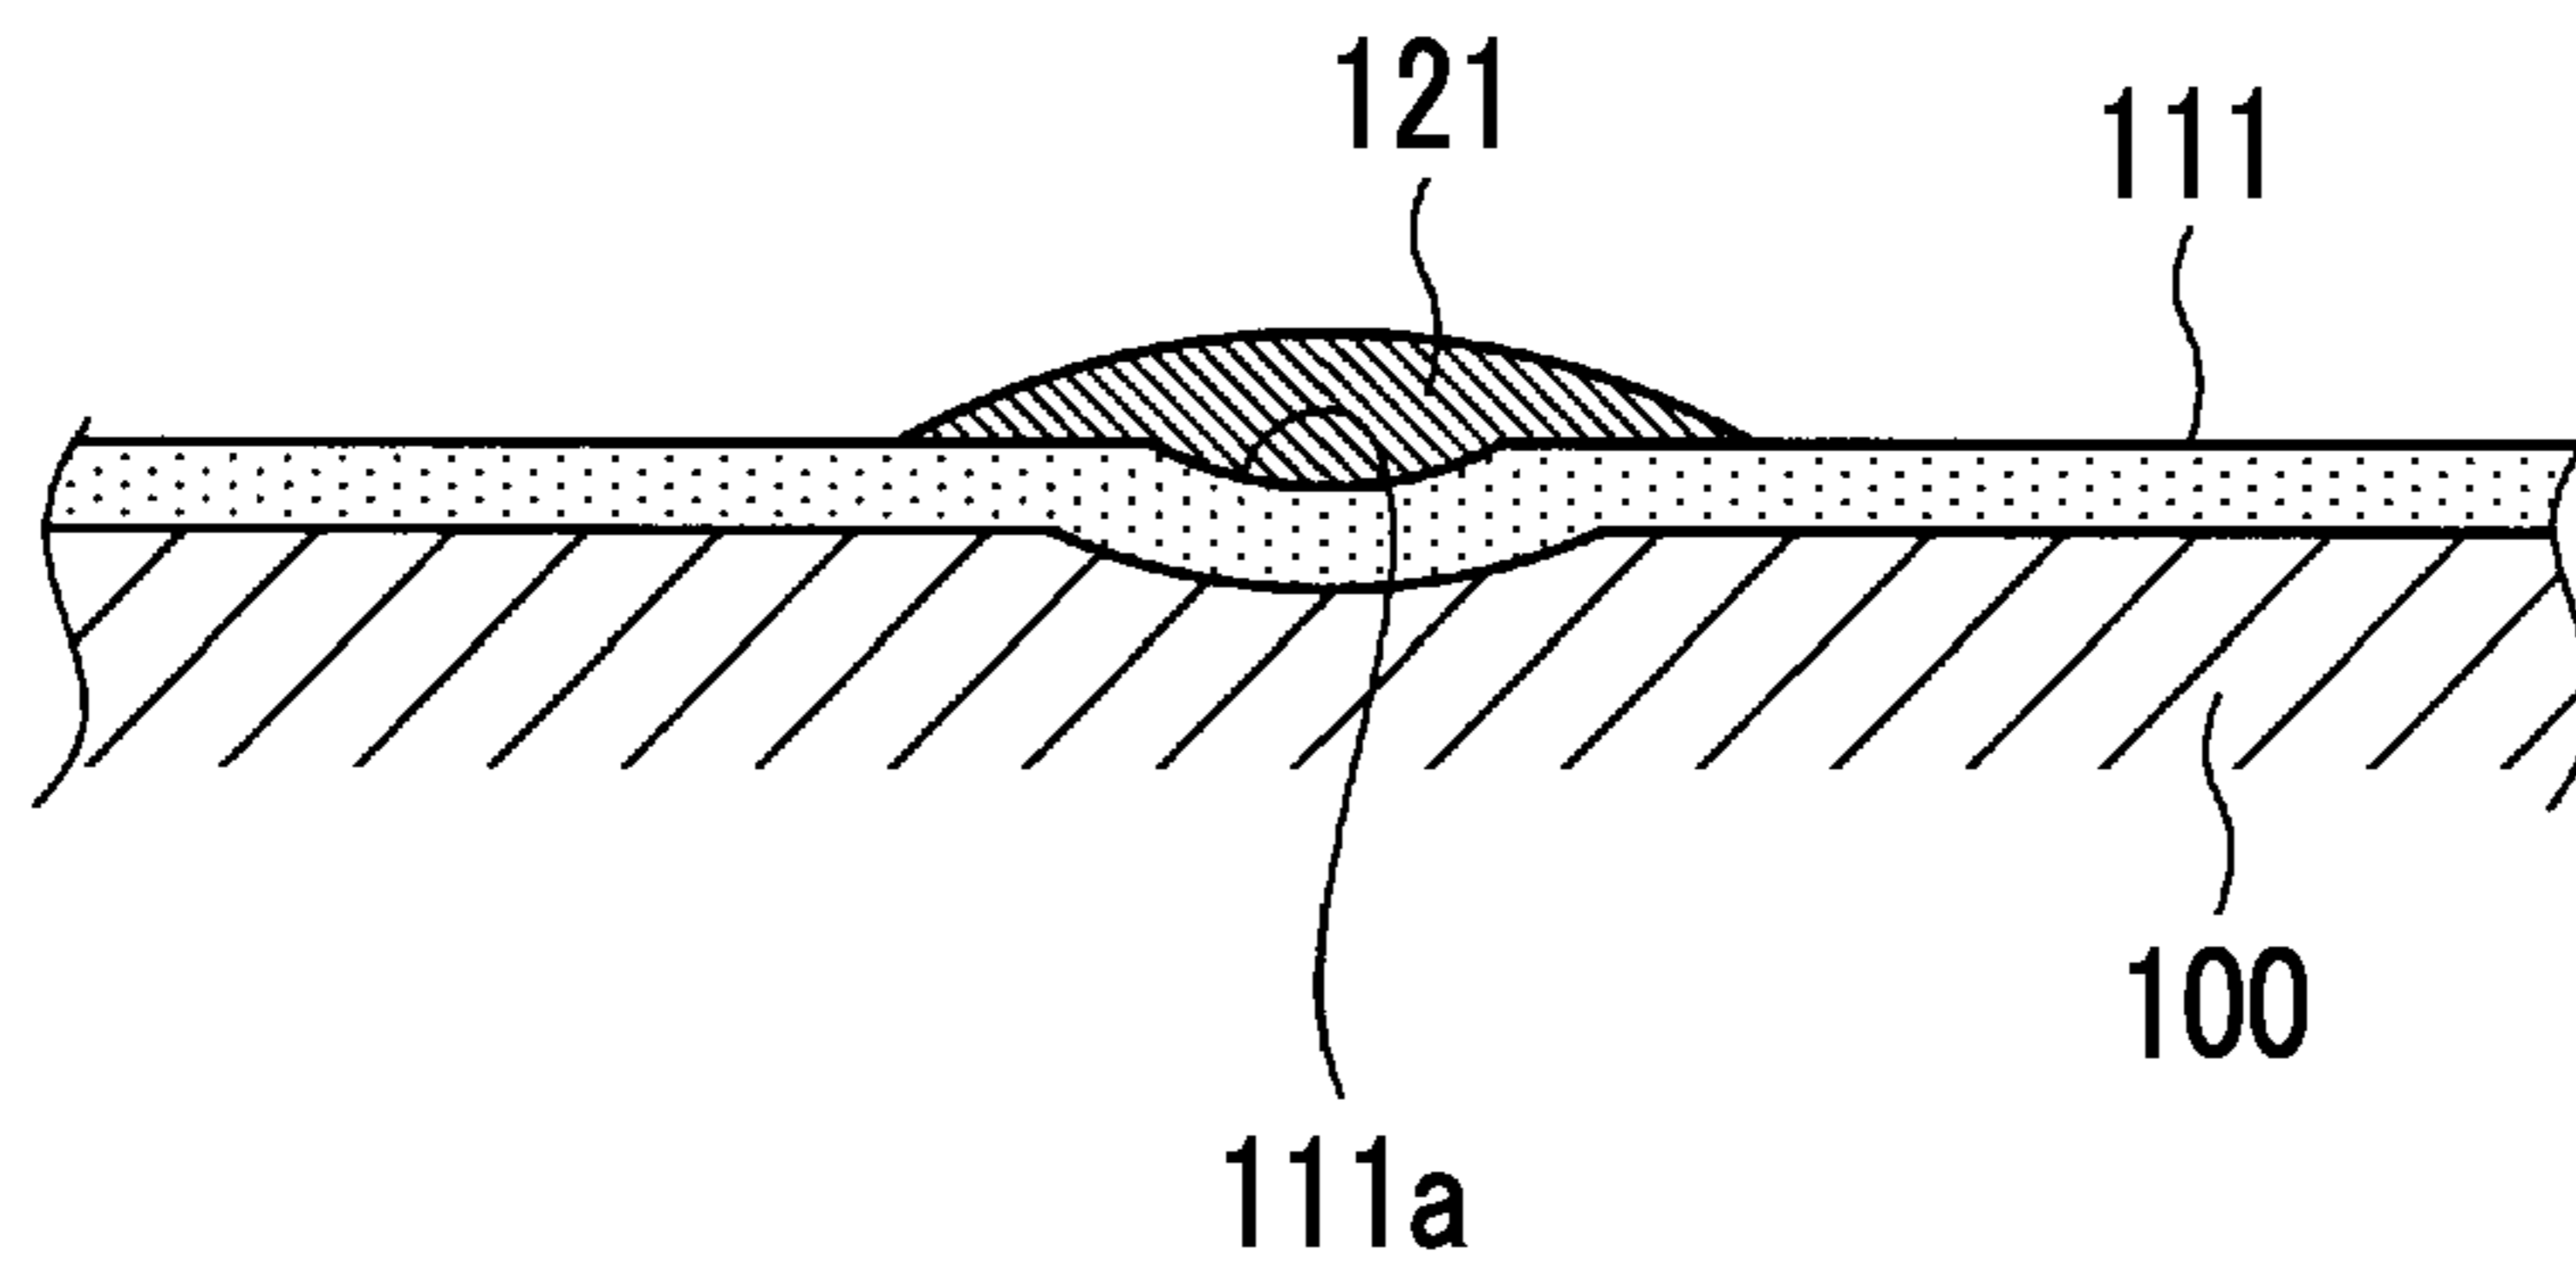
FIG. 5A is a schematic view illustrating a member repairing work.

Here, a member repairing method of the present embodiment will be described using a flowchart of FIG. 3. FIG. 3 is a flowchart illustrating the member inspection method, and FIG. 5A and FIG. 5B are schematic views illustrating a member repairing work.

That is, as illustrated in FIG. 5A, the repairing material supply gun **42** sprays an underlying coating material toward the recessed portion **111a**, whereby an underlying coating material **121** fills the inside of the recessed portion **111a**, and the recessed portion falls in a heaped state. In addition, in Step S15, a surface processing treatment of the surface to be inspected **101** of the member **100** is carried out, whereby the underlying coating material **121** protruding from the recessed portion **111a** is removed, and a surface **121a** of the underlying coating material **121** becomes equal to the surface of the member **100** as illustrated in FIG. 5B.
