(12) **United States Patent**
Koketsu et al.

(54) **MEMBER INSPECTION DEVICE AND MEMBER REPAIRING METHOD**

(71) Applicant: **MITSUBISHI HEAVY INDUSTRIES, LTD.**, Tokyo (JP)

In a member inspection device and a member repairing method, an irradiation device irradiates a surface of a member to be inspected with light, an image pickup device picks up an image of a surface portion irradiated with the light, a failure detection device detects a failure area on the basis of a photographed image picked up by the image pickup device, and a determining device classifies the shape of the failure area detected by the failure detection device.

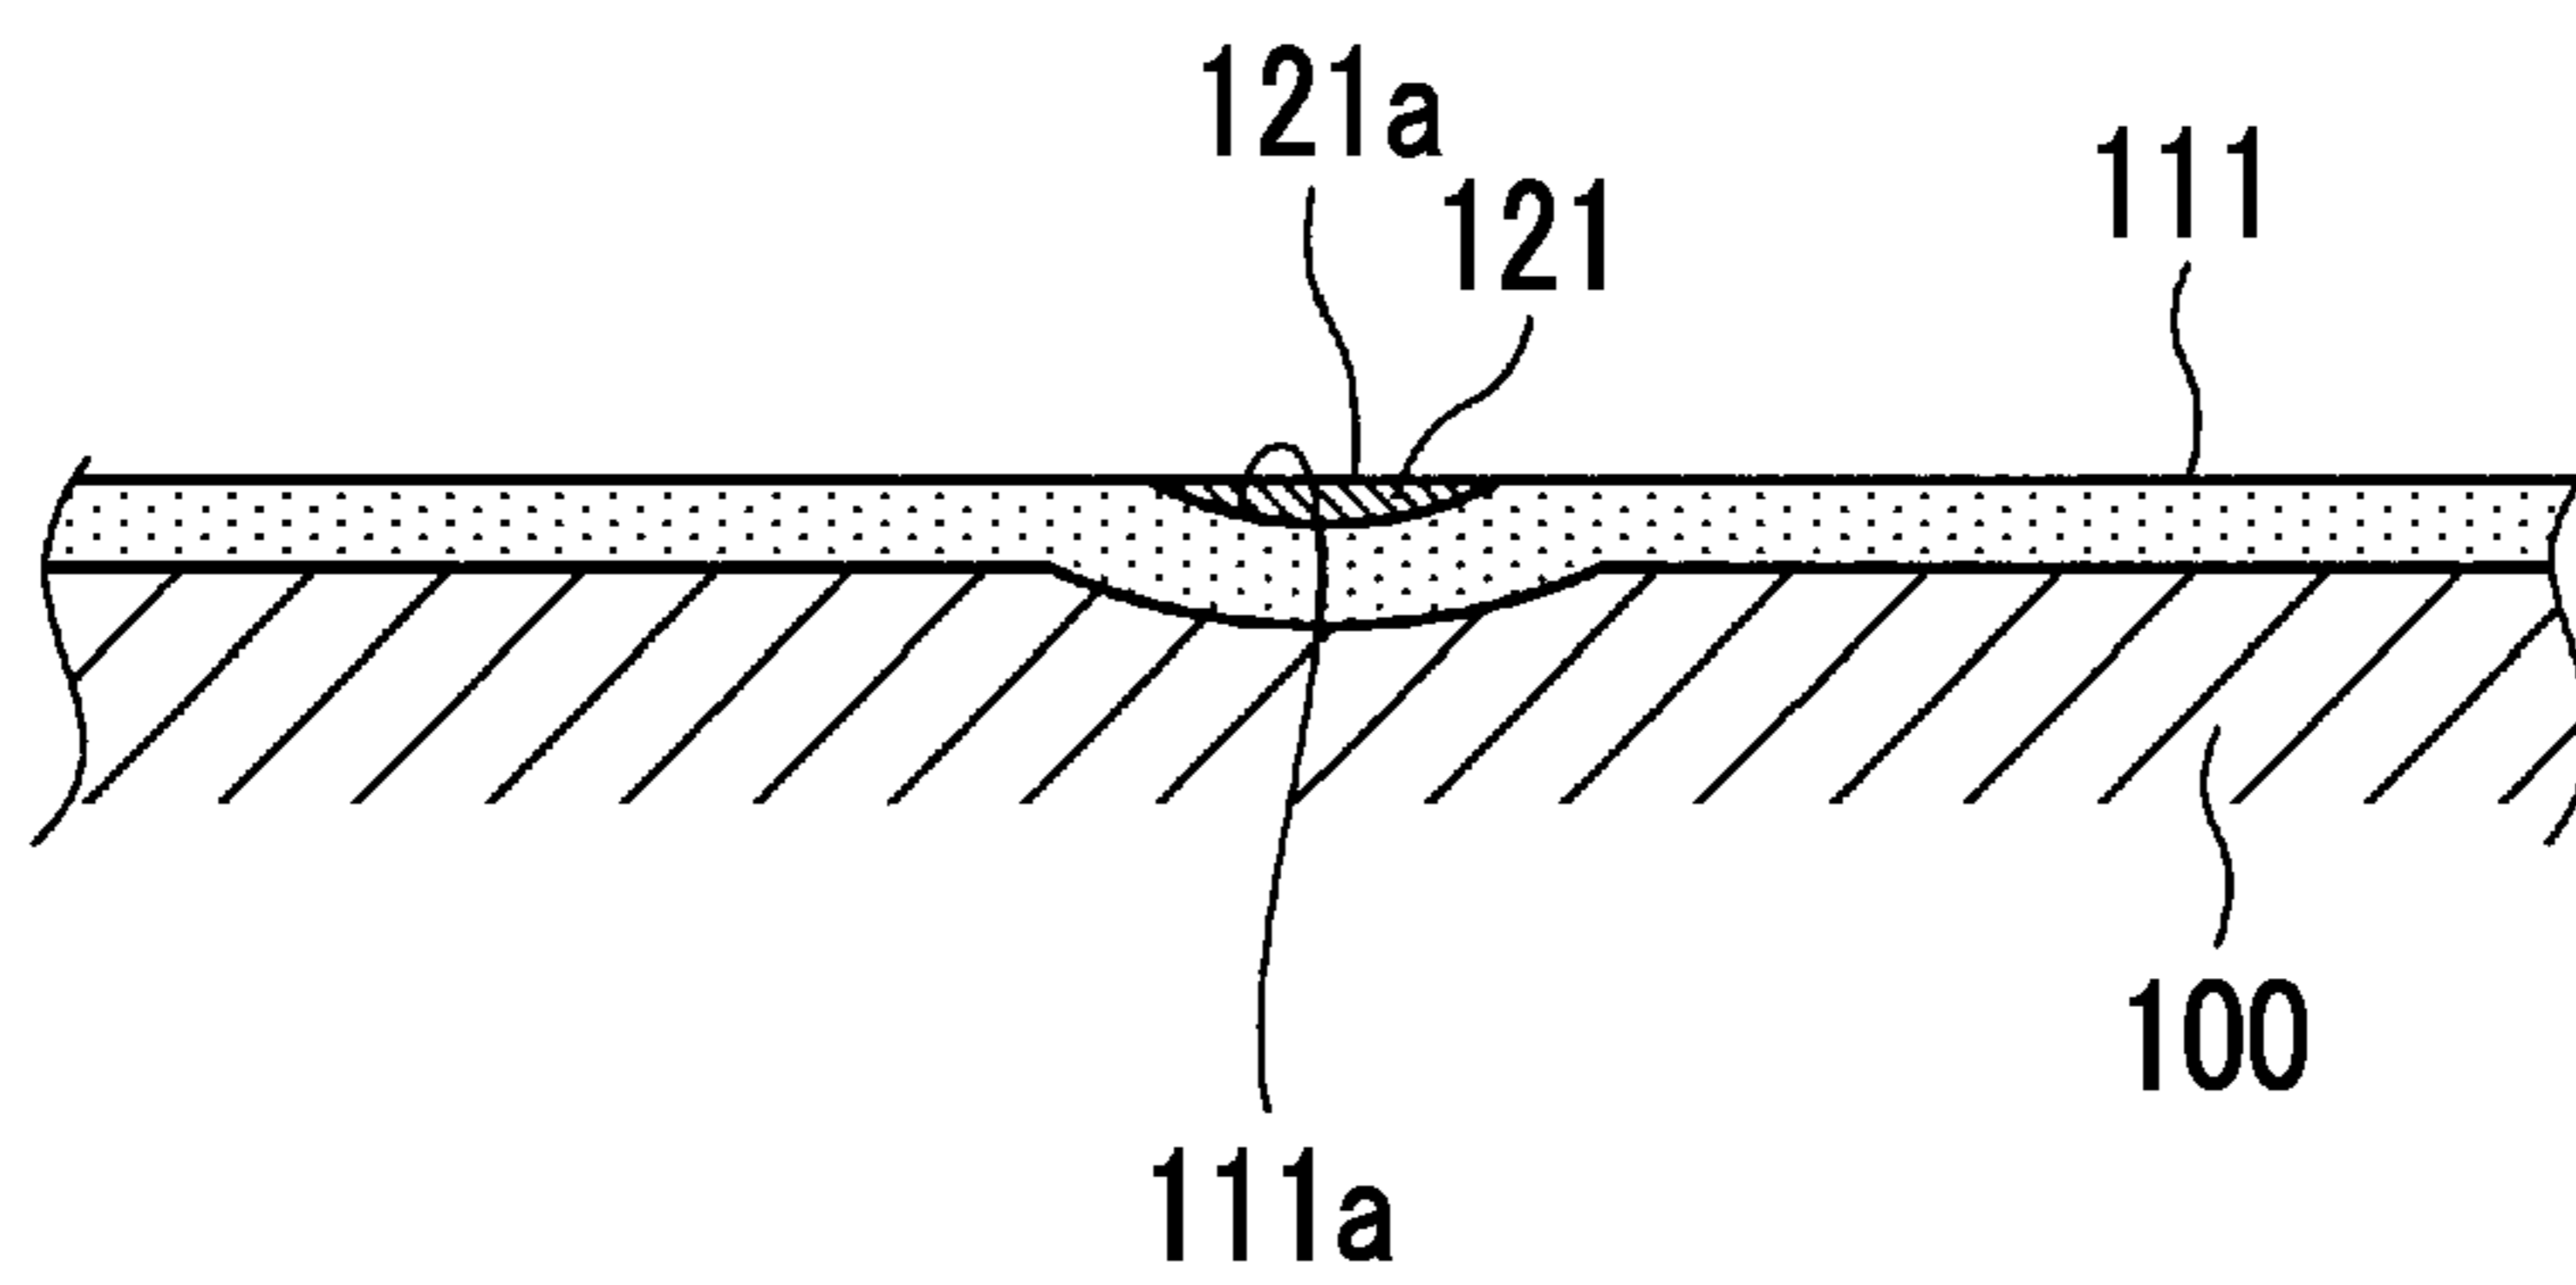
FIG. 5B is a schematic view illustrating a member repairing work.

Here, a member repairing method of the present embodiment will be described using a flowchart of FIG. 3. FIG. 3 is a flowchart illustrating the member inspection method, and FIG. 5A and FIG. 5B are schematic views illustrating a member repairing work.

That is, as illustrated in FIG. 5A, the repairing material supply gun **42** sprays an underlying coating material toward the recessed portion **111a**, whereby an underlying coating material **121** fills the inside of the recessed portion **111a**, and the recessed portion falls in a heaped state. In addition, in Step S15, a surface processing treatment of the surface to be inspected **101** of the member **100** is carried out, whereby the underlying coating material **121** protruding from the recessed portion **111a** is removed, and a surface **121a** of the underlying coating material **121** becomes equal to the surface of the member **100** as illustrated in FIG. 5B.
