(12) **United States Patent**
Walker et al.

(10) **Patent No.: US 10,563,533 B2**
(45) **Date of Patent: Feb. 18, 2020**

(54) **REPAIR OR REMANUFACTURE OF BLADE
OUTER AIR SEALS FOR A GAS TURBINE
ENGINE**

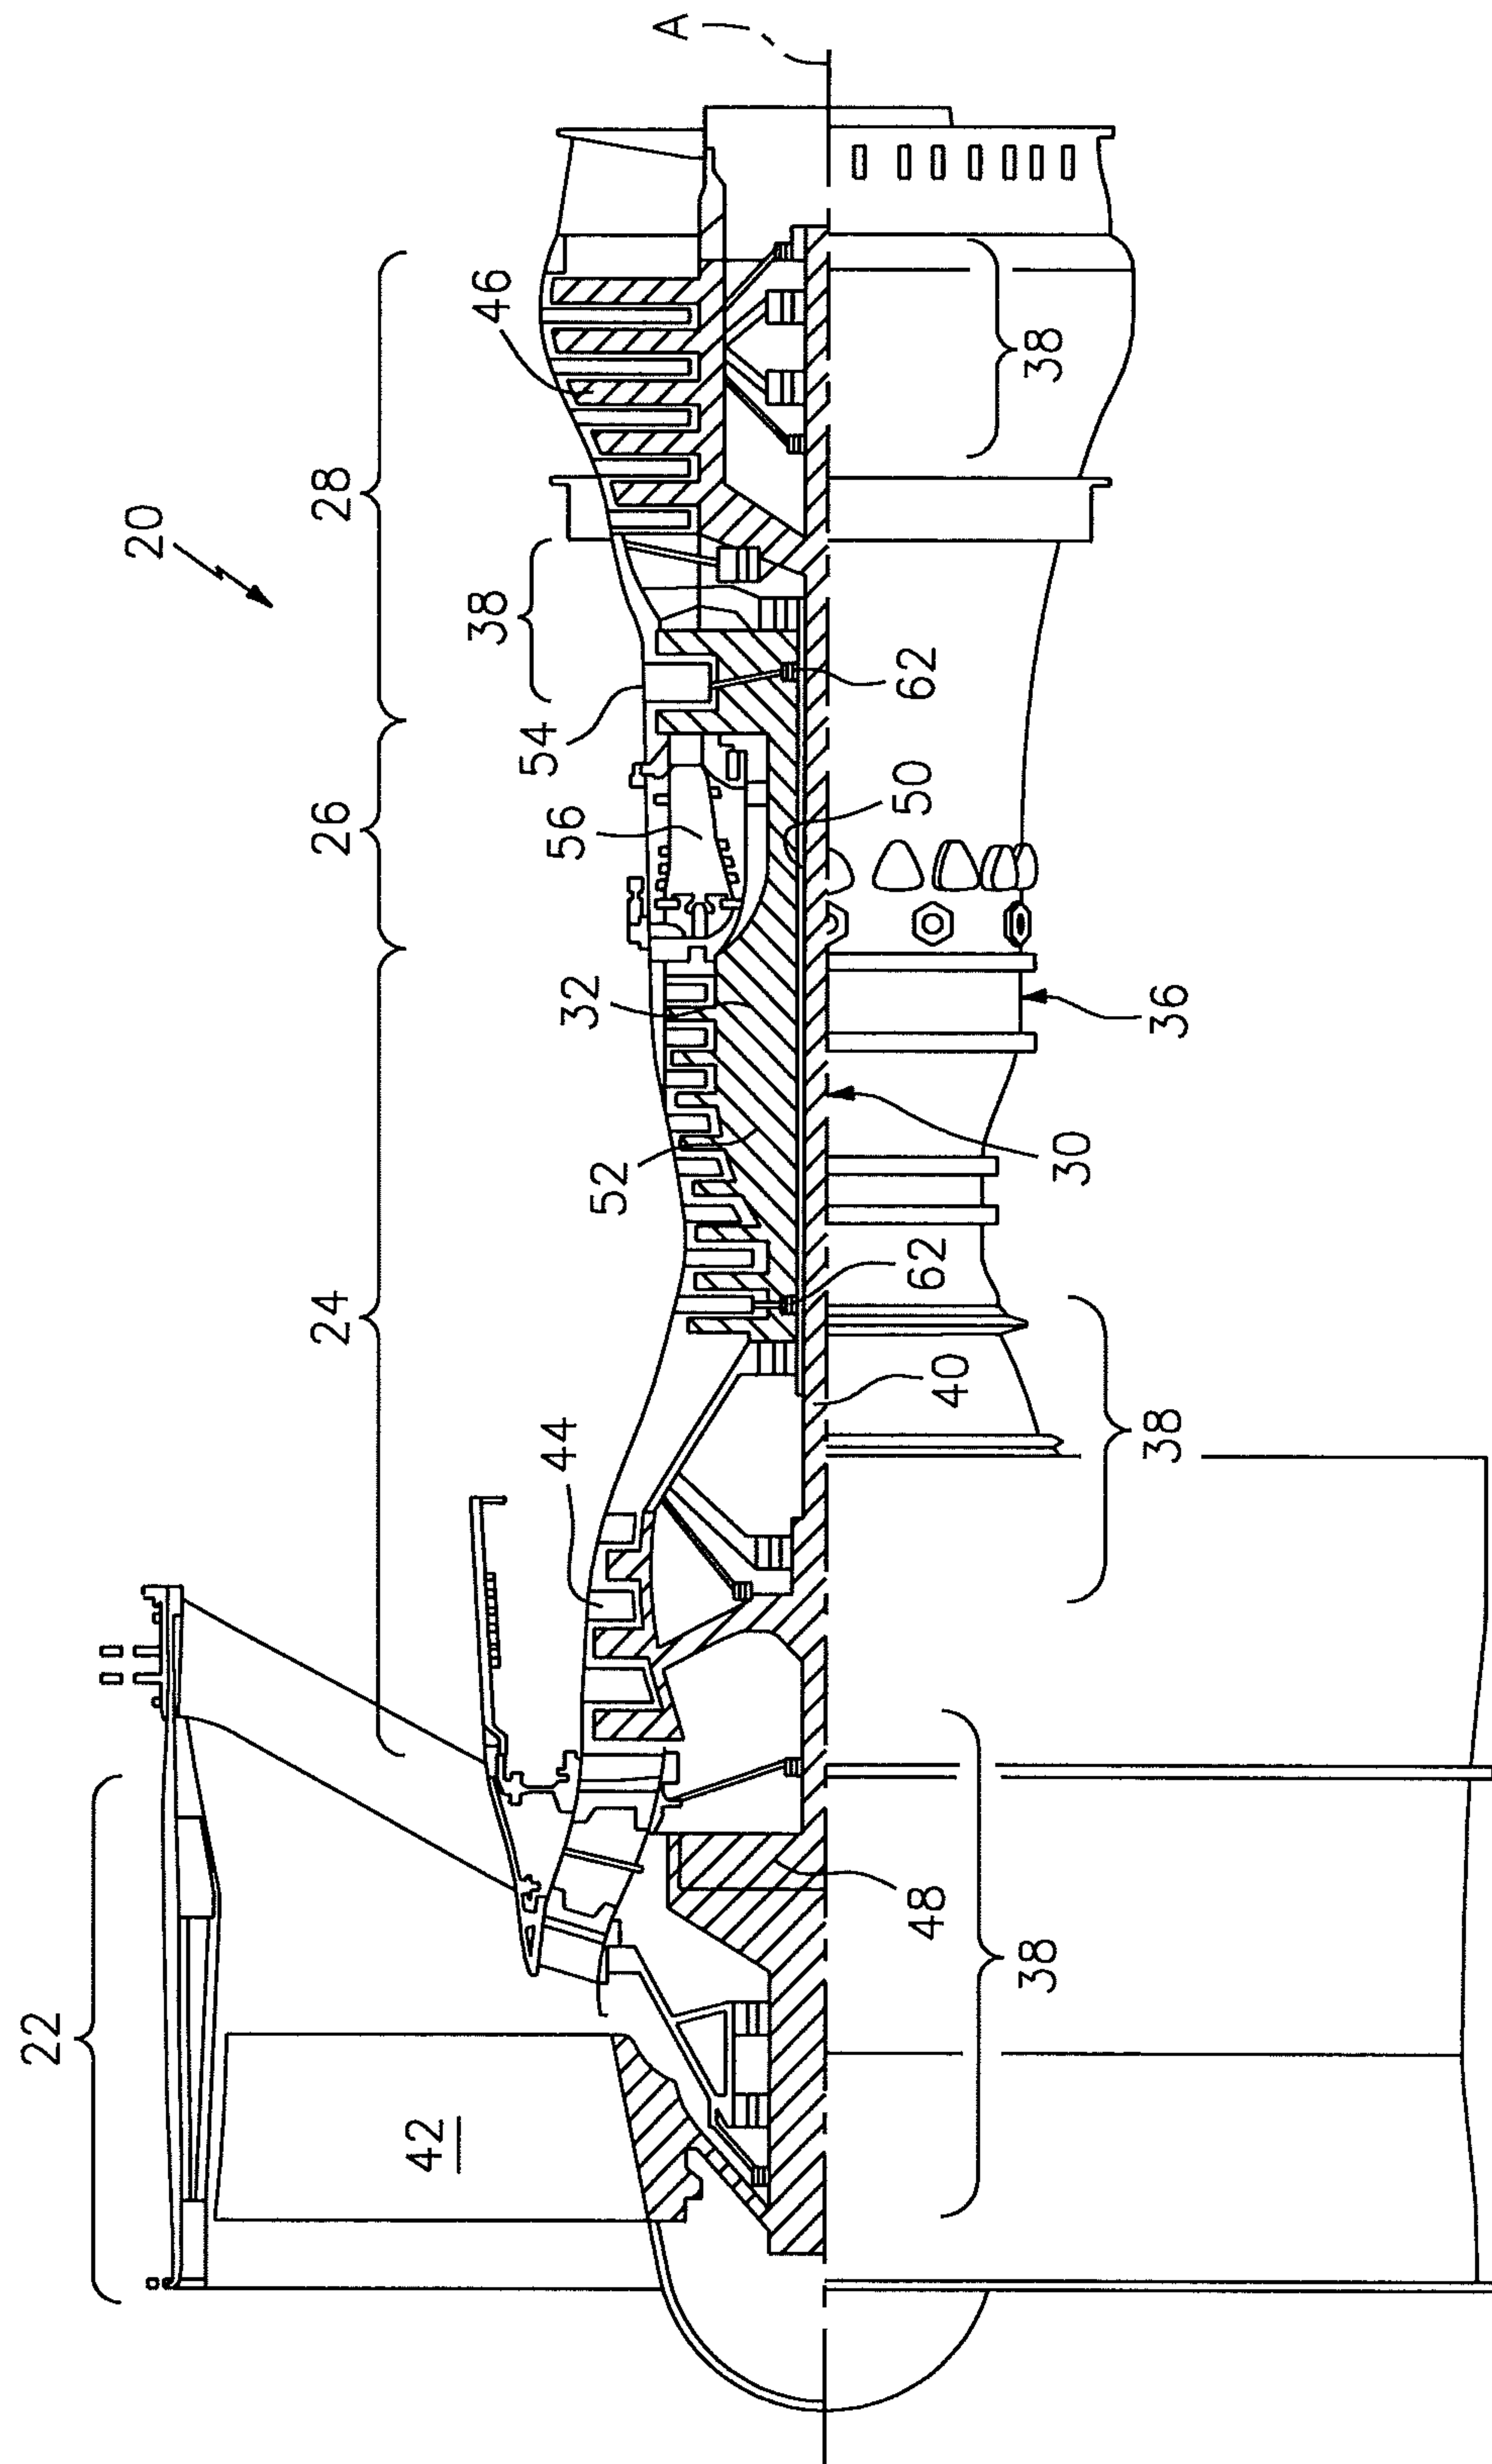
FIG. 1 is a schematic cross-section of one example gas turbine engine;

FIG. 1 schematically illustrates a gas turbine engine 20. The gas turbine engine 20 is disclosed herein as a two-spool turbo fan that generally incorporates a fan section 22, a compressor section 24, a combustor section 26 and a turbine section 28. Alternative engines might include an augmentor section (not shown) among other systems or features. Although depicted as a turbofan in the disclosed non-limiting embodiment, it should be appreciated that the concepts described herein are not limited to use with turbofans as the teachings may also be applied to other types of turbine engines such as turbojets, turboshafts, industrial gas turbines, and three-spool (plus fan) turbofans with an intermediate spool.

The engine 20 generally includes a low spool 30 and a high spool 32 mounted for rotation about an engine central longitudinal axis A relative to an engine case structure 36 via several bearing structures 38. The low spool 30 generally includes an inner shaft 40 that interconnects a fan 42, a low pressure compressor ("LPC") 44 and a low pressure turbine ("LPT") 46. The inner shaft 40 may drive the fan 42 directly or through a geared architecture 48 (see FIG. 1) to drive the fan 42 at a lower speed than the low spool 30. An exemplary reduction transmission is an epicyclic transmission, namely a planetary or star gear system.

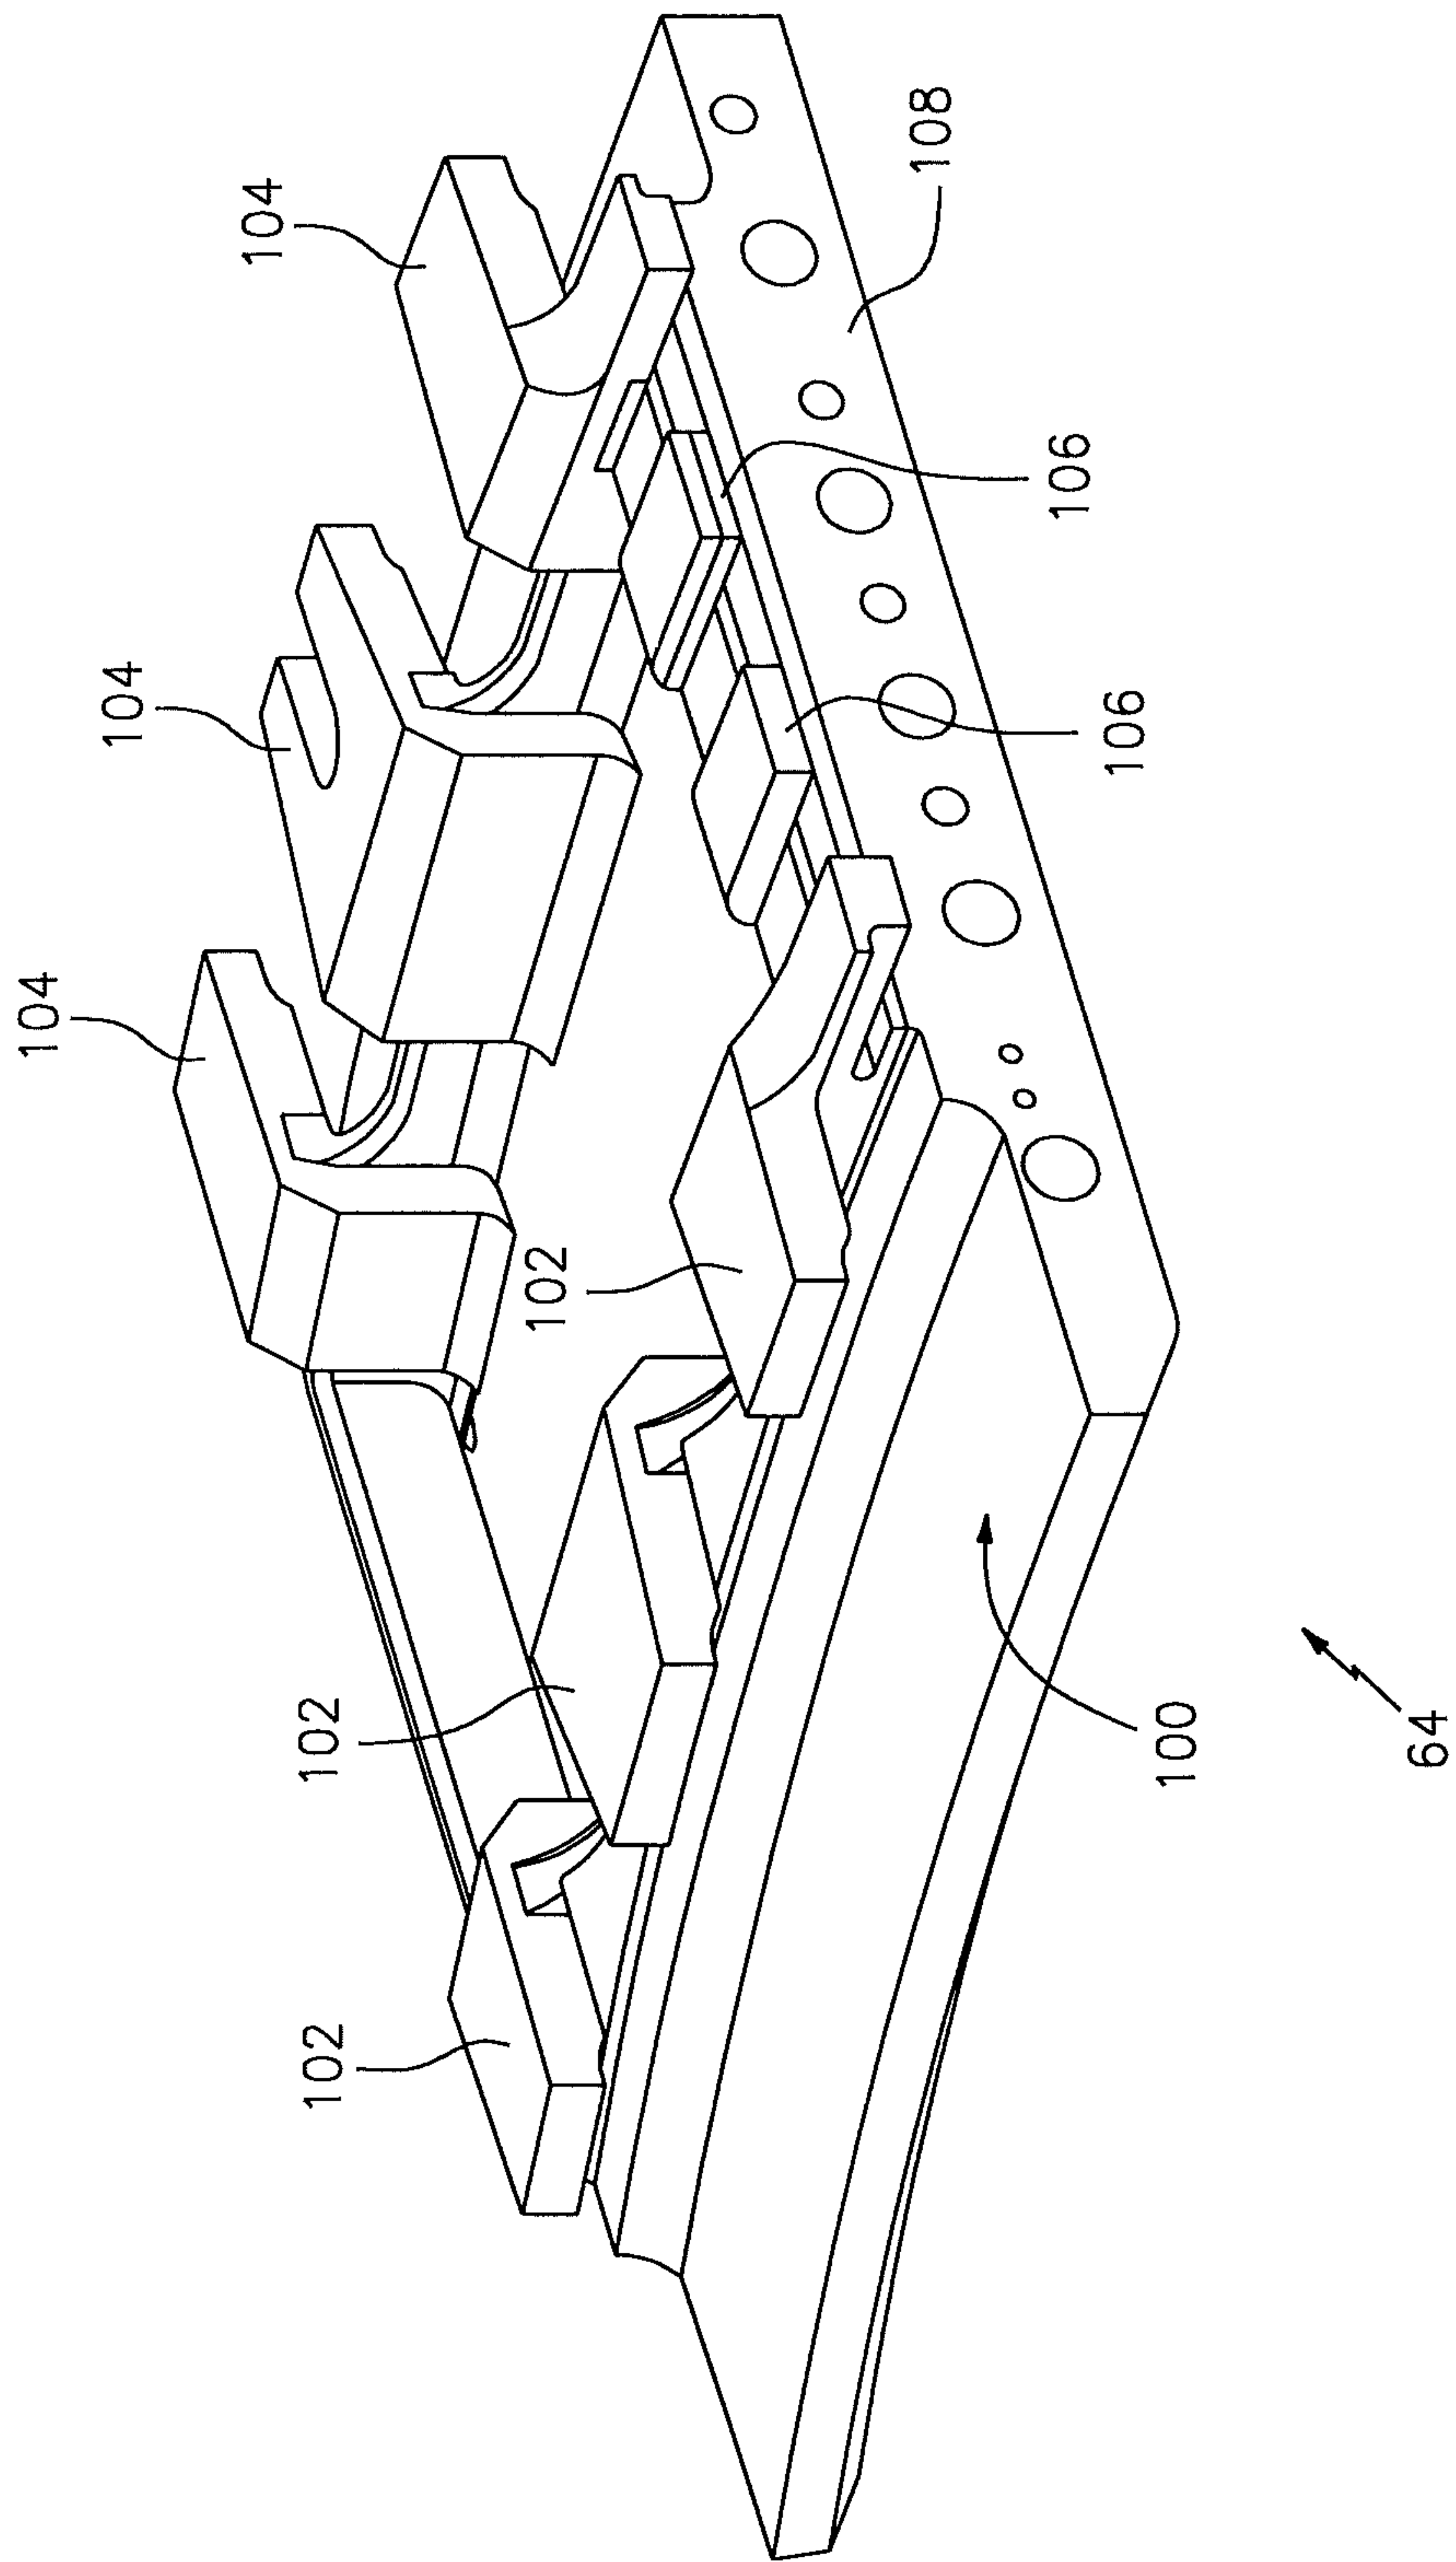
FIG. 3 is a perspective view of one BOAS;

With reference to FIG. 3, each BOAS 64 includes a body 100, a multiple of forward lugs 102 (three shown), a multiple of aft lugs 104 (three shown) and a multiple of shiplap tabs 106 transverse to the lugs 102, 104 (two shown). The BOAS 64 is typically manufactured of, for example, a Nickel Alloy.

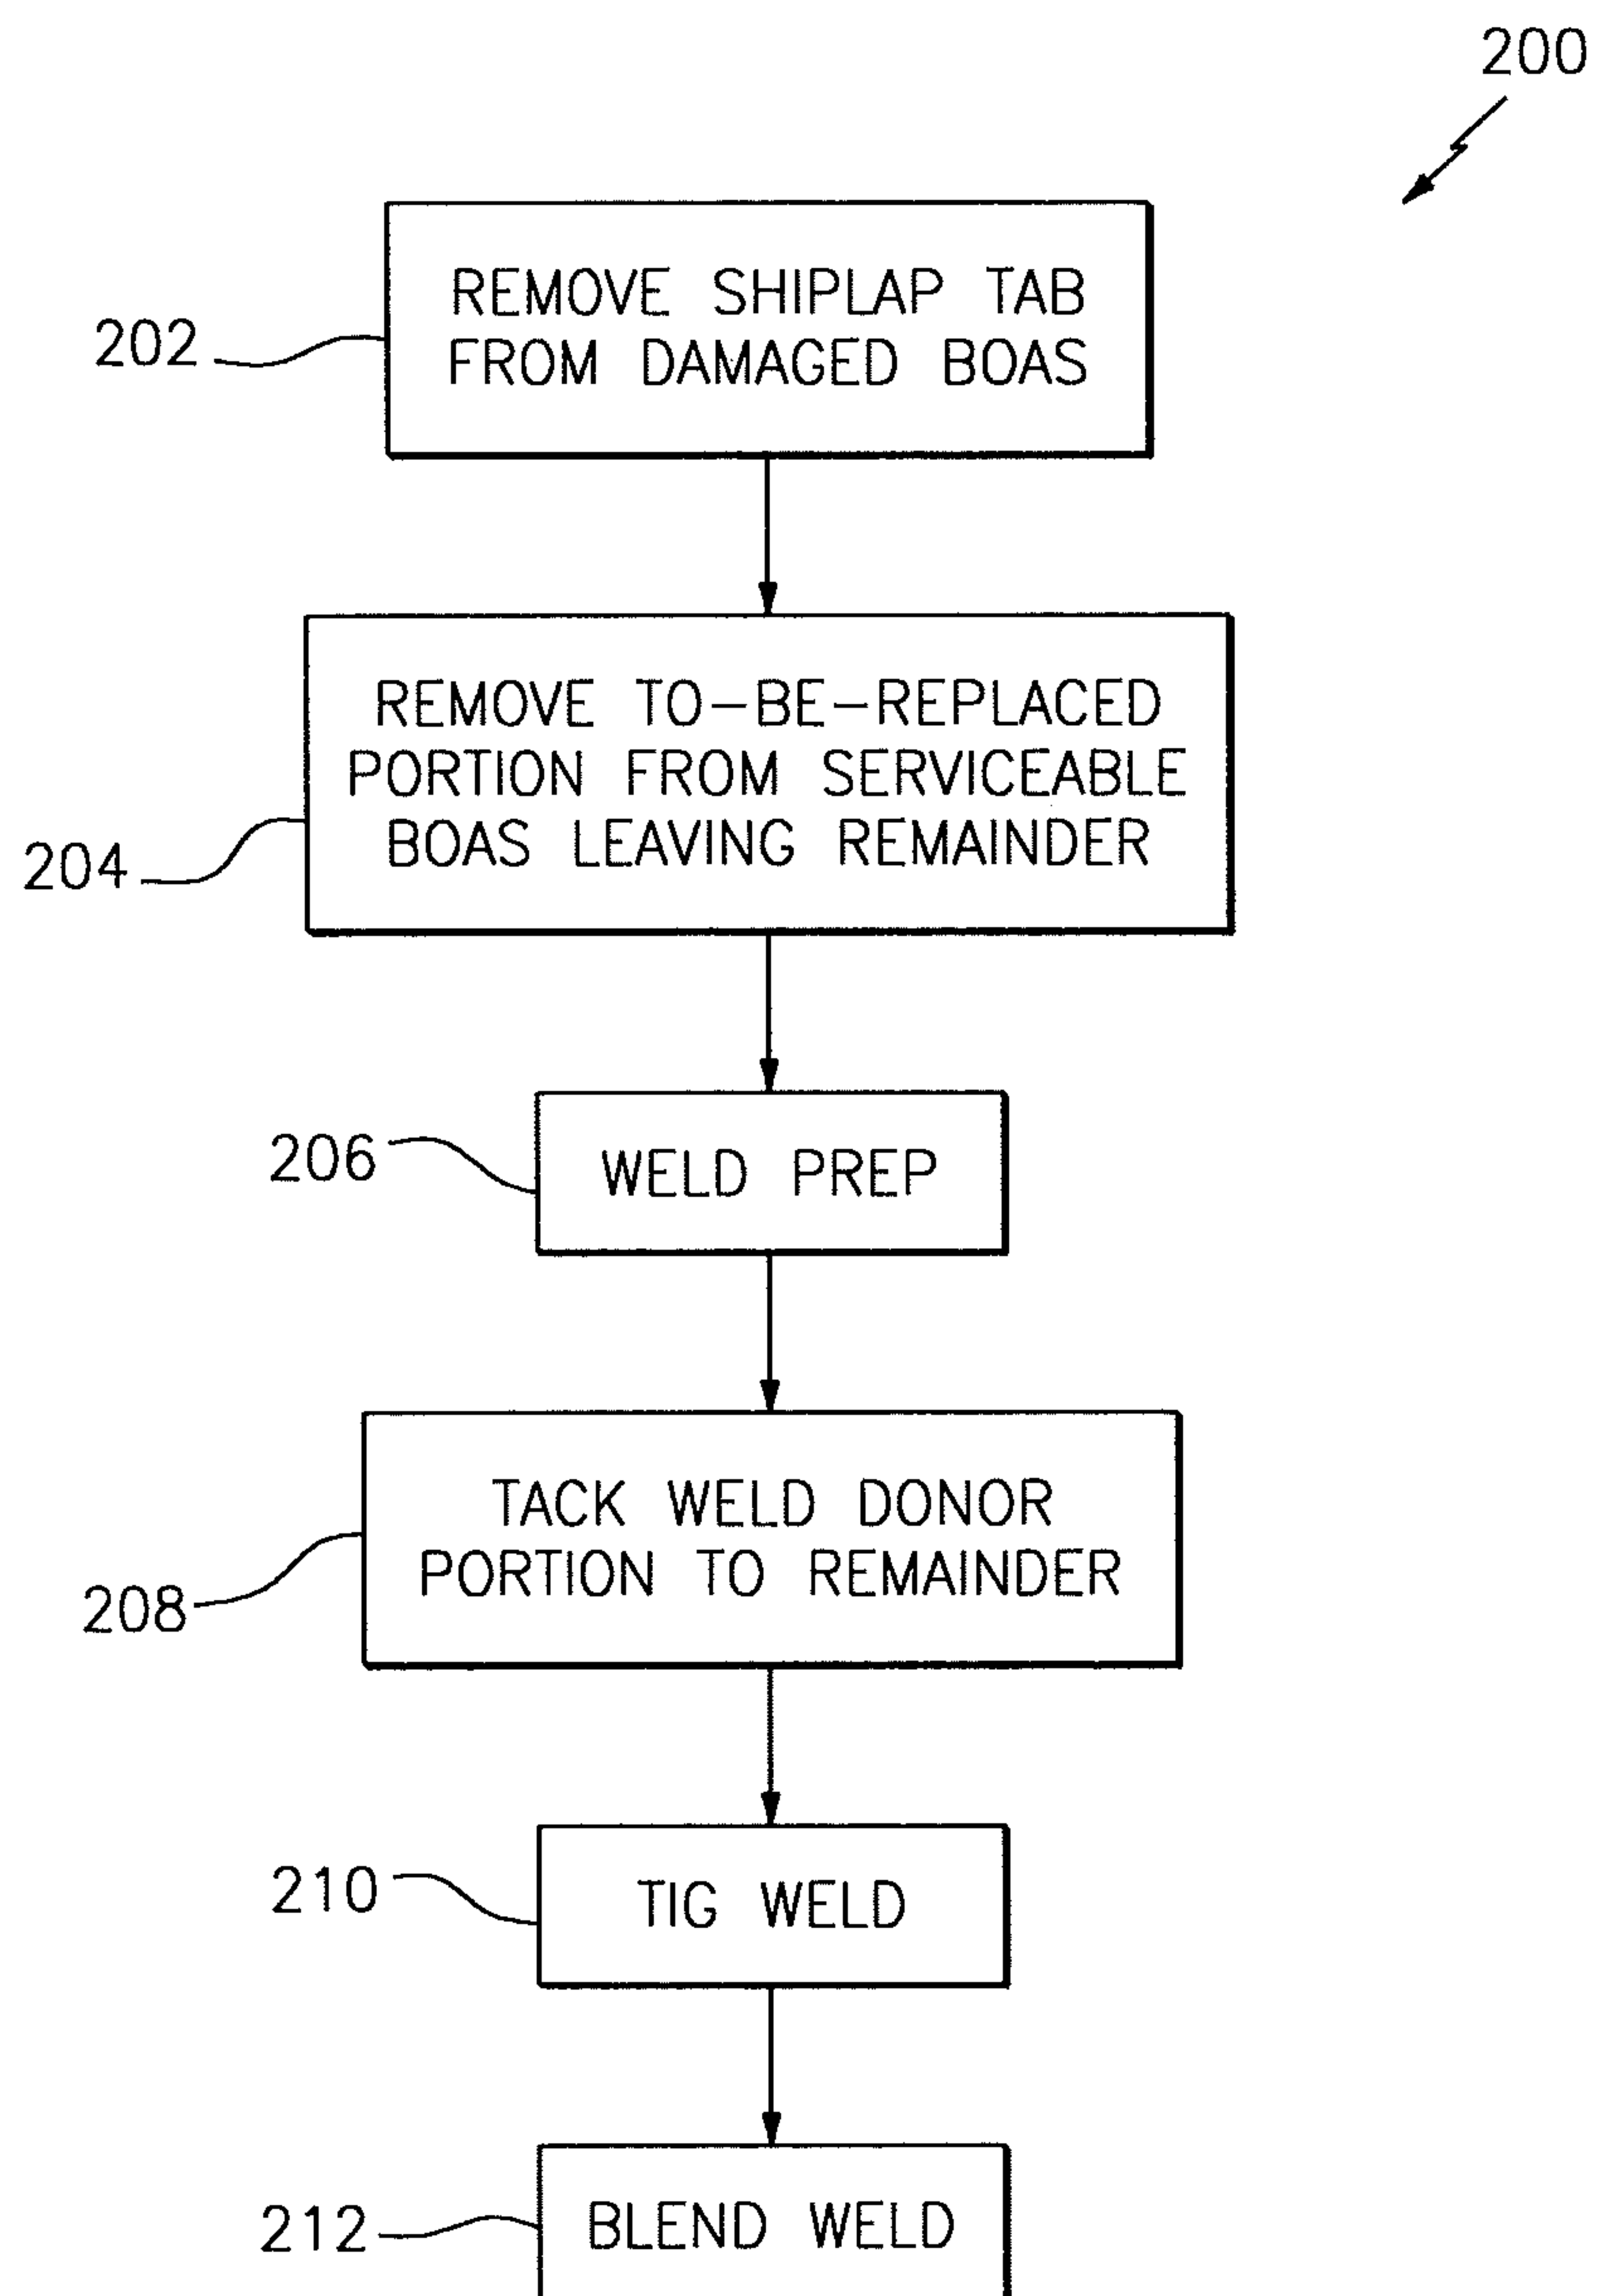
*FIG. 4*

FIG. 4 is a flowchart illustrating a method to repair/remanufacture a BOAS;

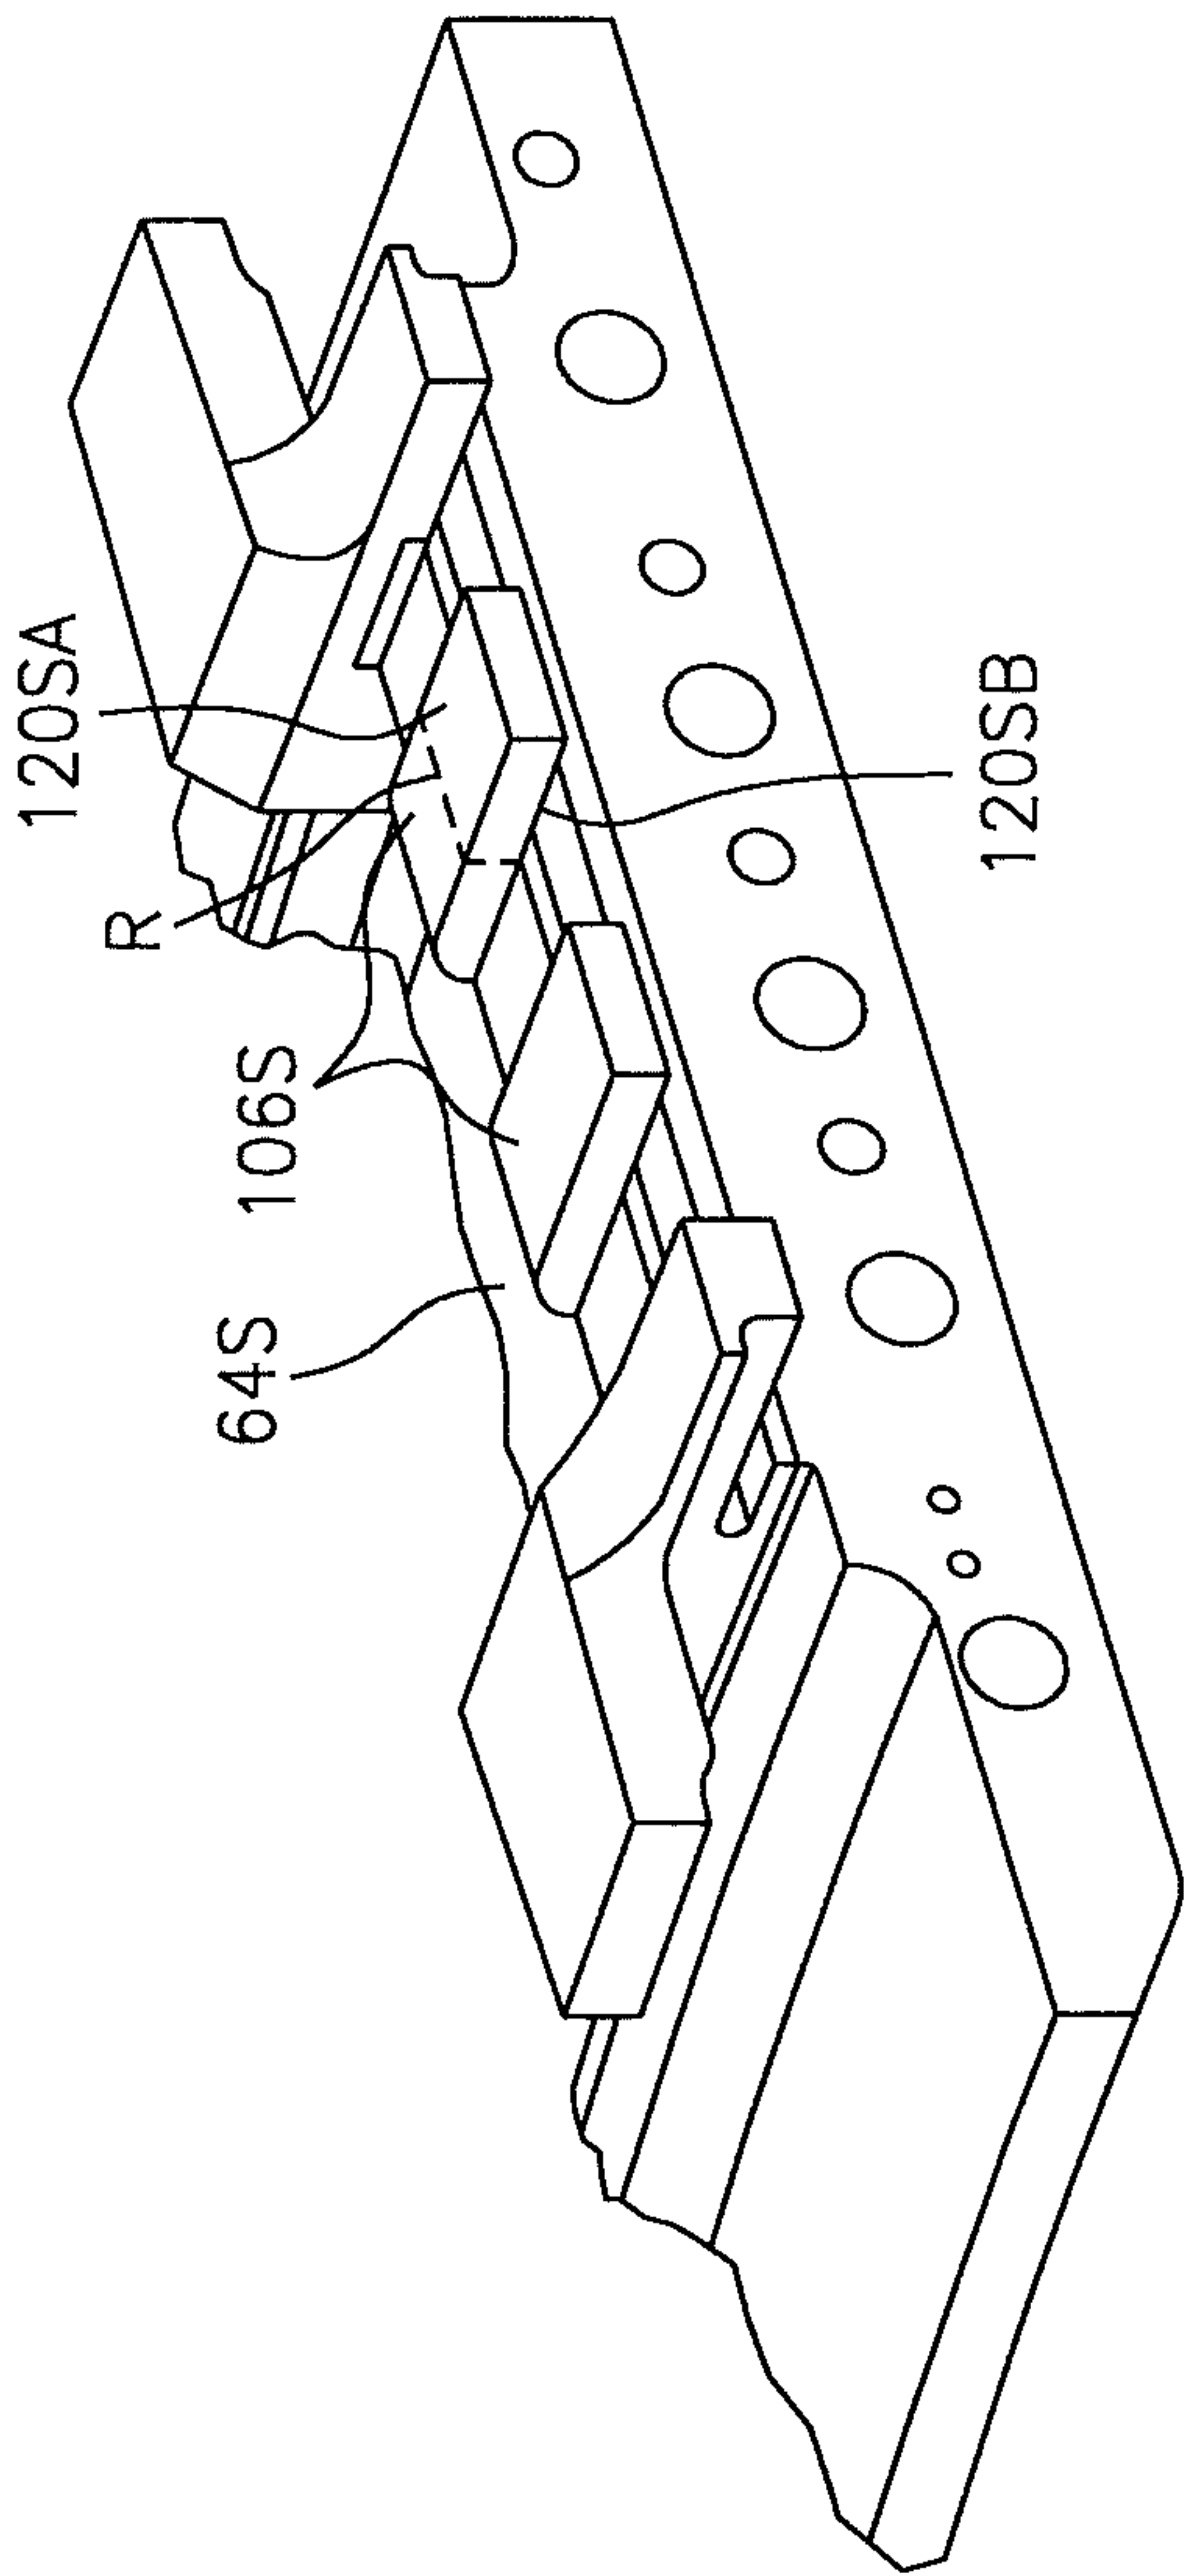
FIG. 5 is a perspective view of an unserviceable BOAS which provides an example donor portion according to one step of the method to repair/remanufacture illustrated in FIG. 4;

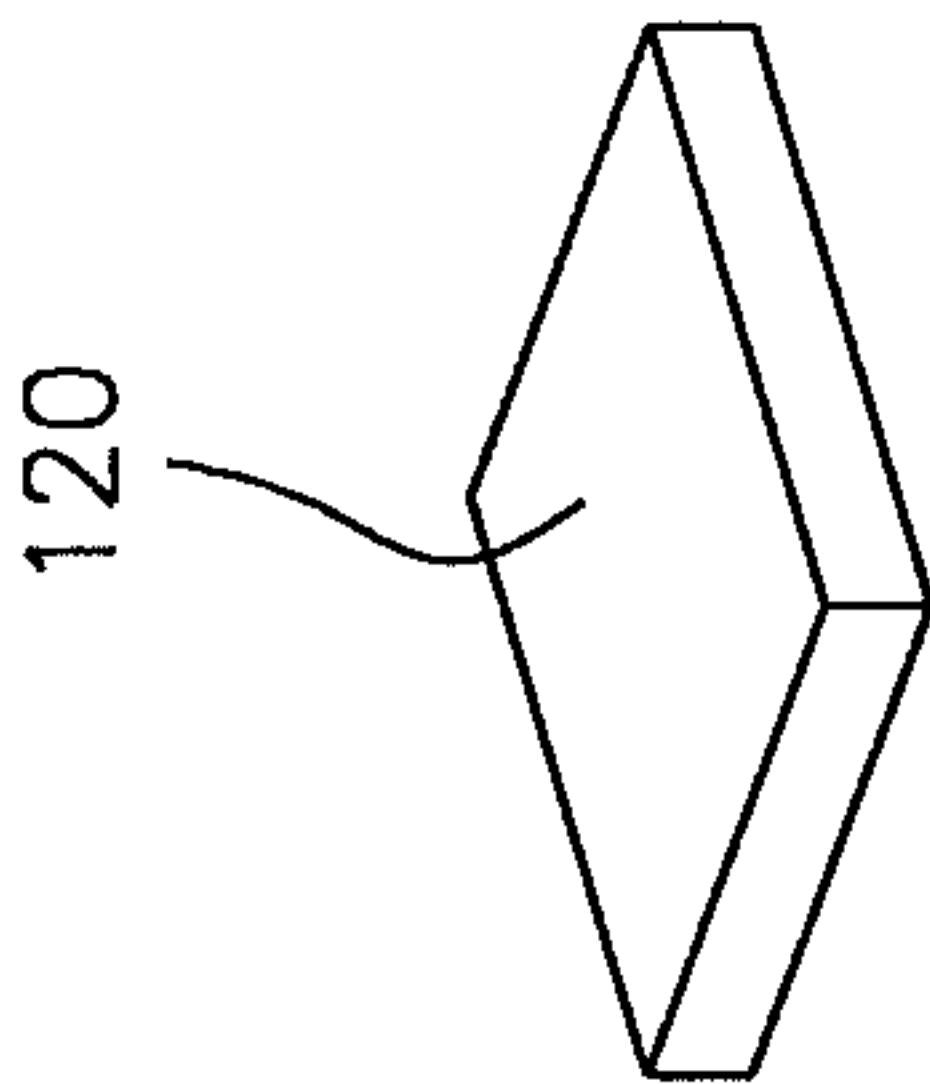
FIG. 6 is a perspective view of the example donor portion;

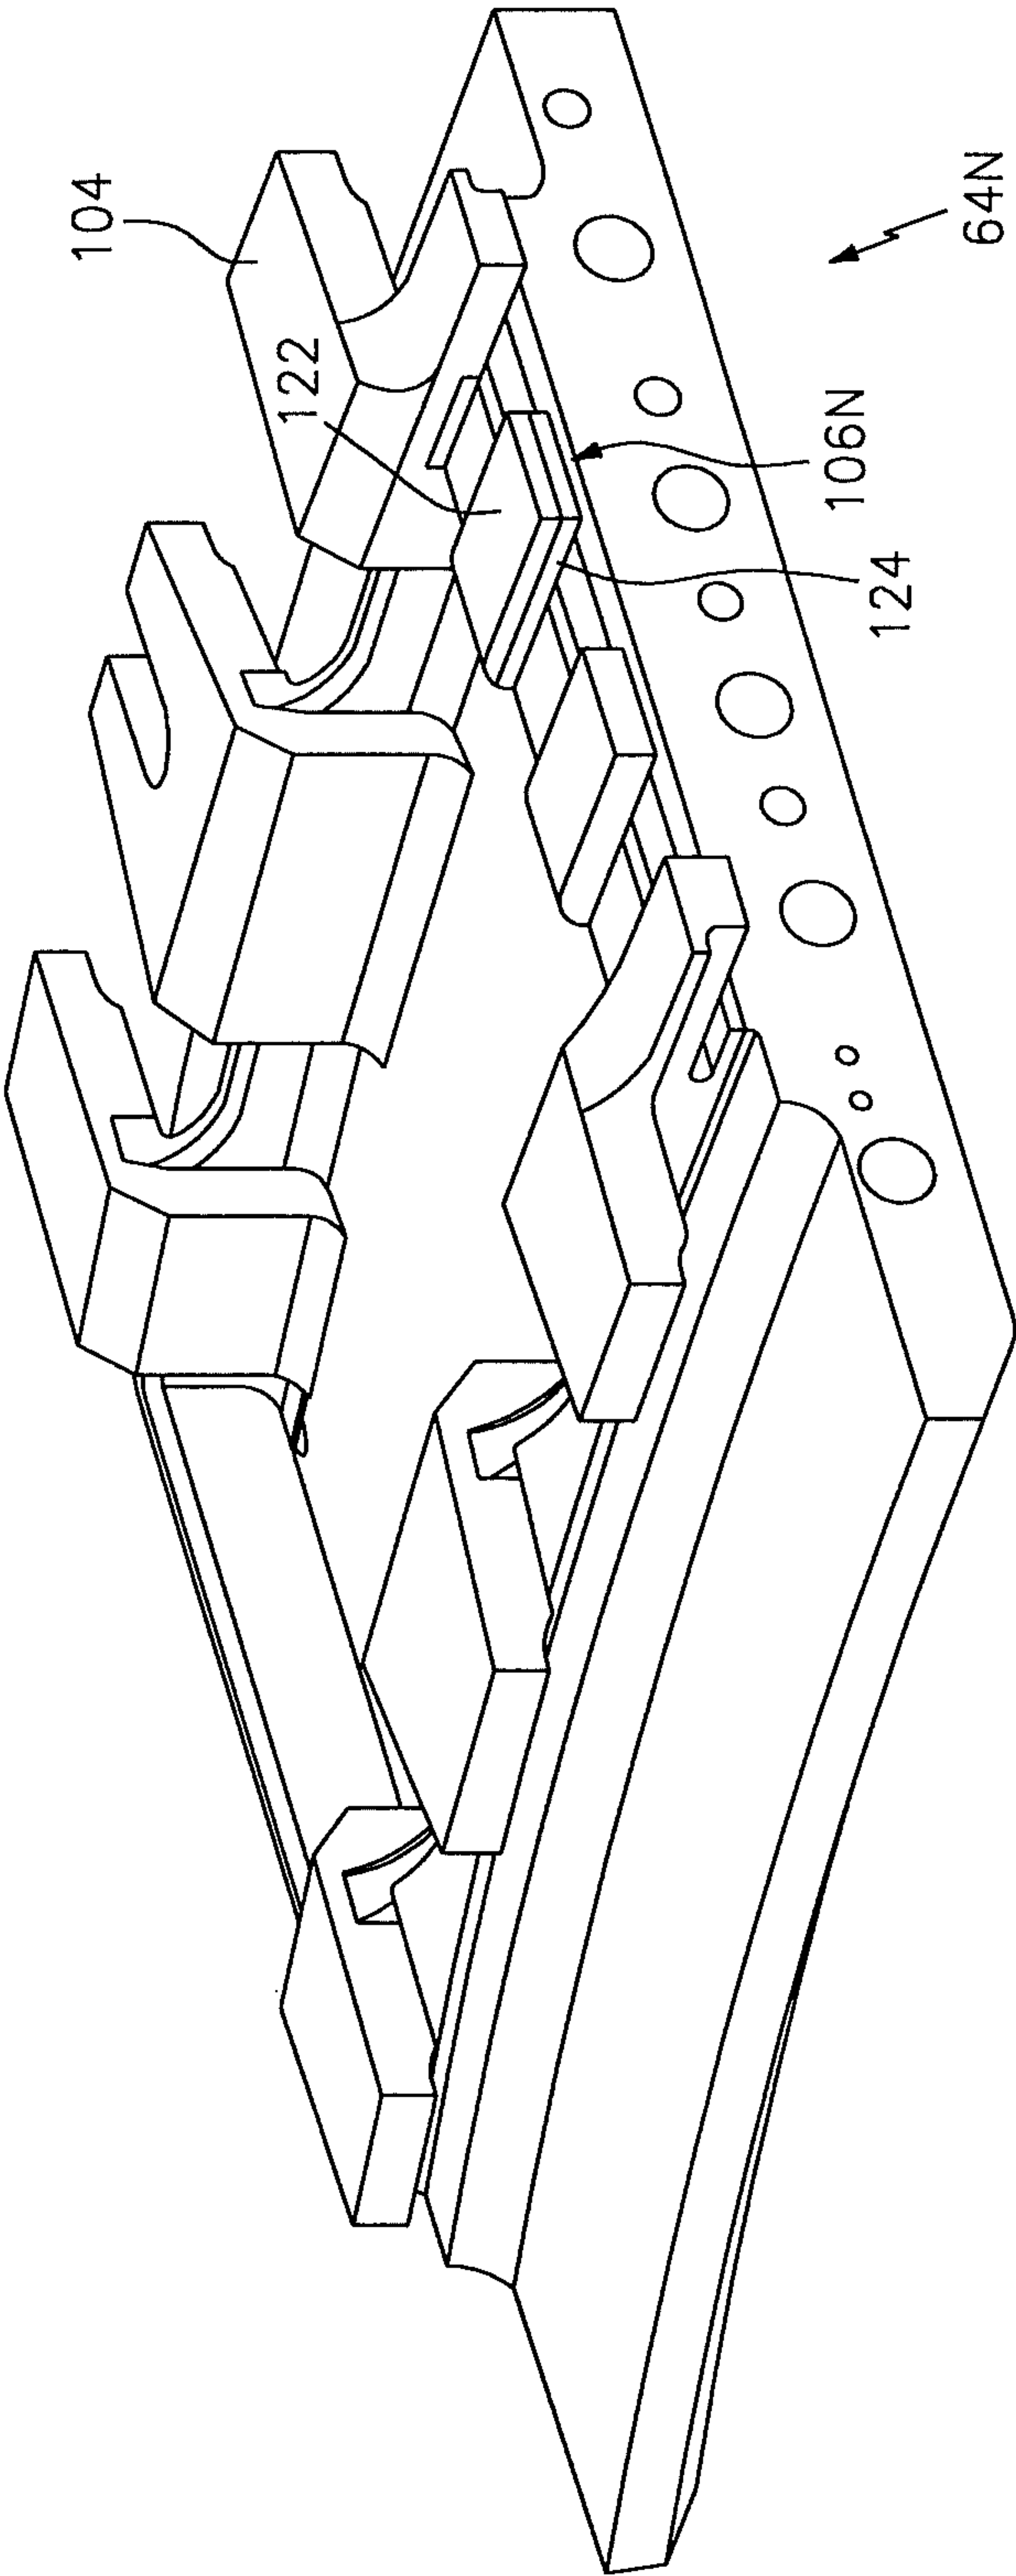
FIG. 7 is a perspective view of a serviceable BOAS which receives the example donor portion according to one step of the method to repair/remanufacture illustrated in FIG. 4;

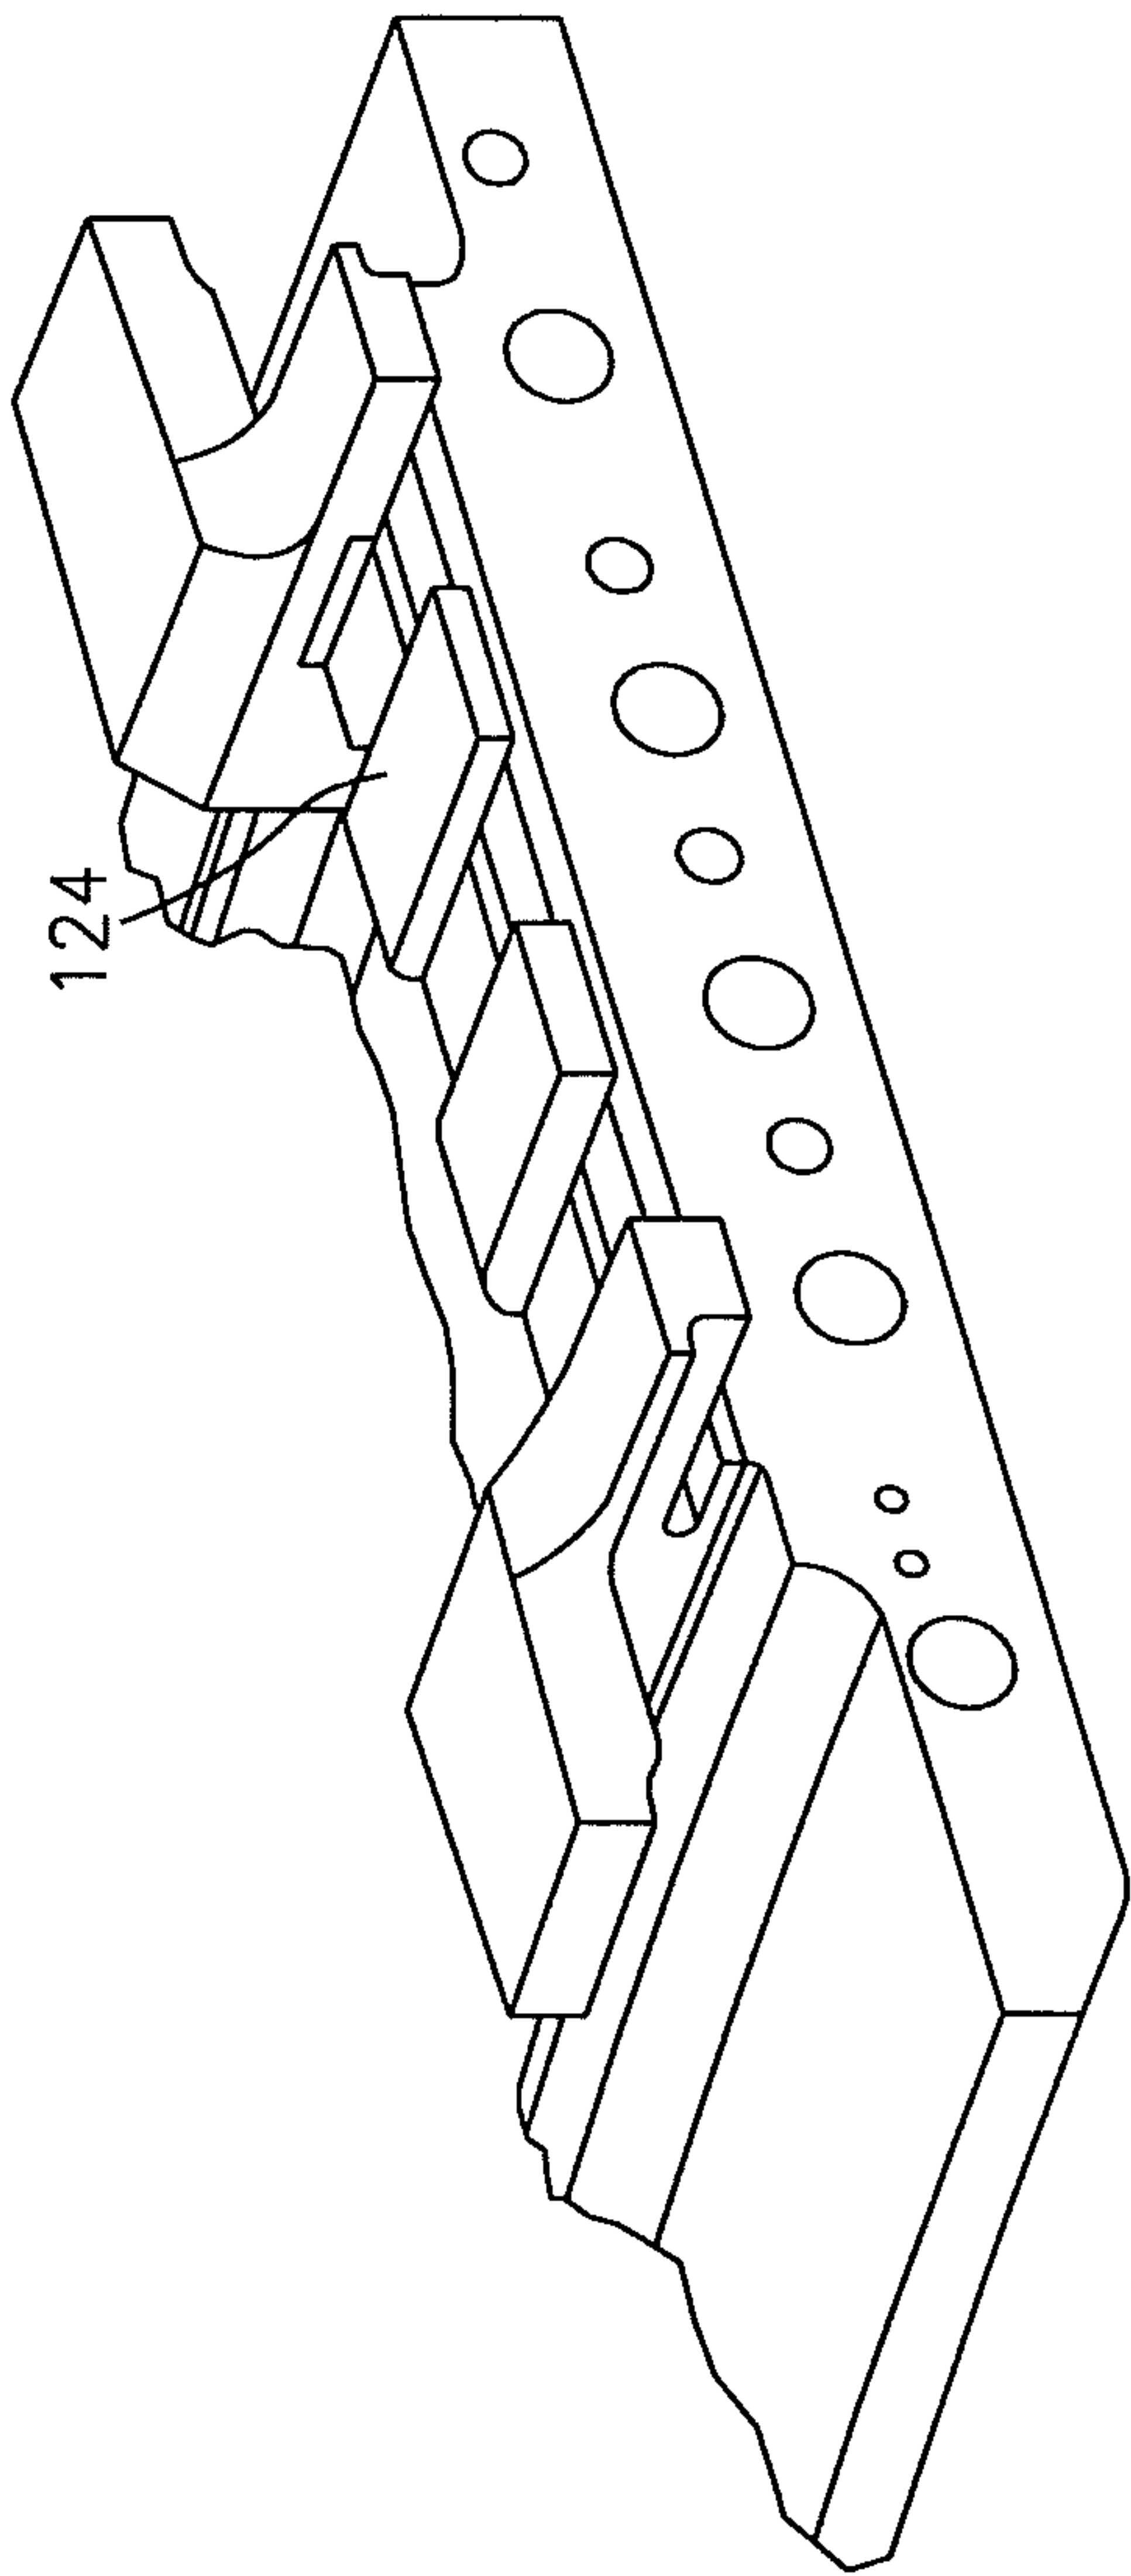
FIG. 8 is a perspective view of the serviceable BOAS with a remainder to receive the example donor portion according to one step of the method to repair/remanufacture illustrated in FIG. 4;
