(12) **United States Patent**
Walker et al.

(10) **Patent No.: US 10,563,533 B2**
(45) **Date of Patent: Feb. 18, 2020**

(54) **REPAIR OR REMANUFACTURE OF BLADE
OUTER AIR SEALS FOR A GAS TURBINE
ENGINE**

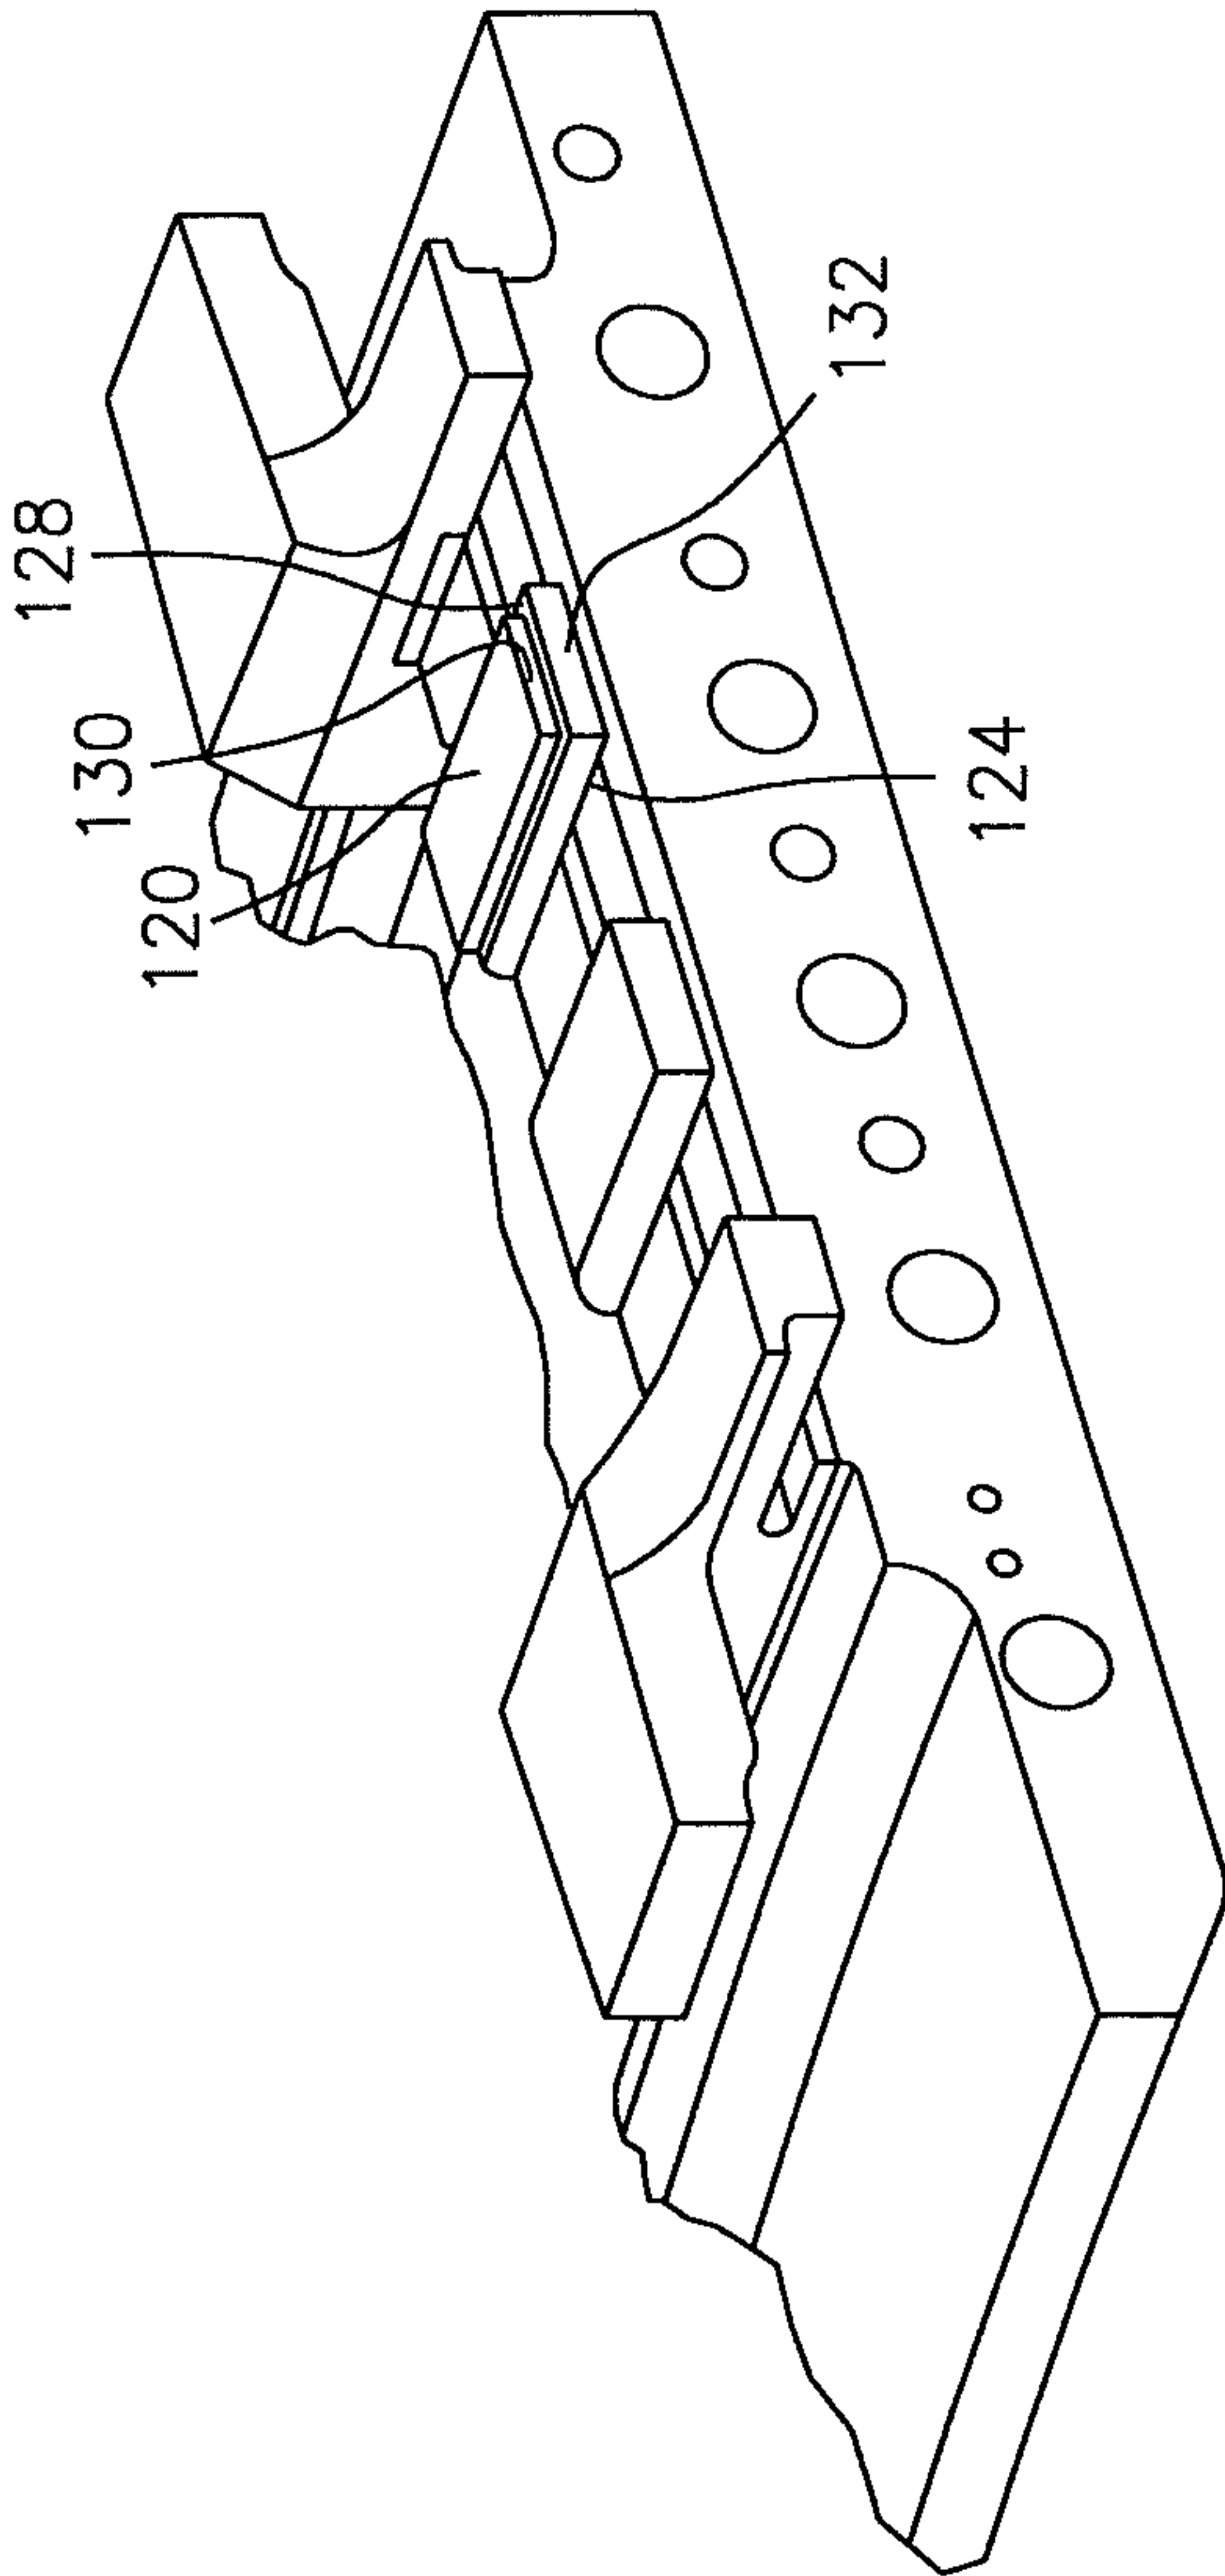
FIG. 9 is a perspective view of the serviceable BOAS with the example donor portion tack welded to the remainder according to one step of the method to repair/remanufacture illustrated in FIG. 4;

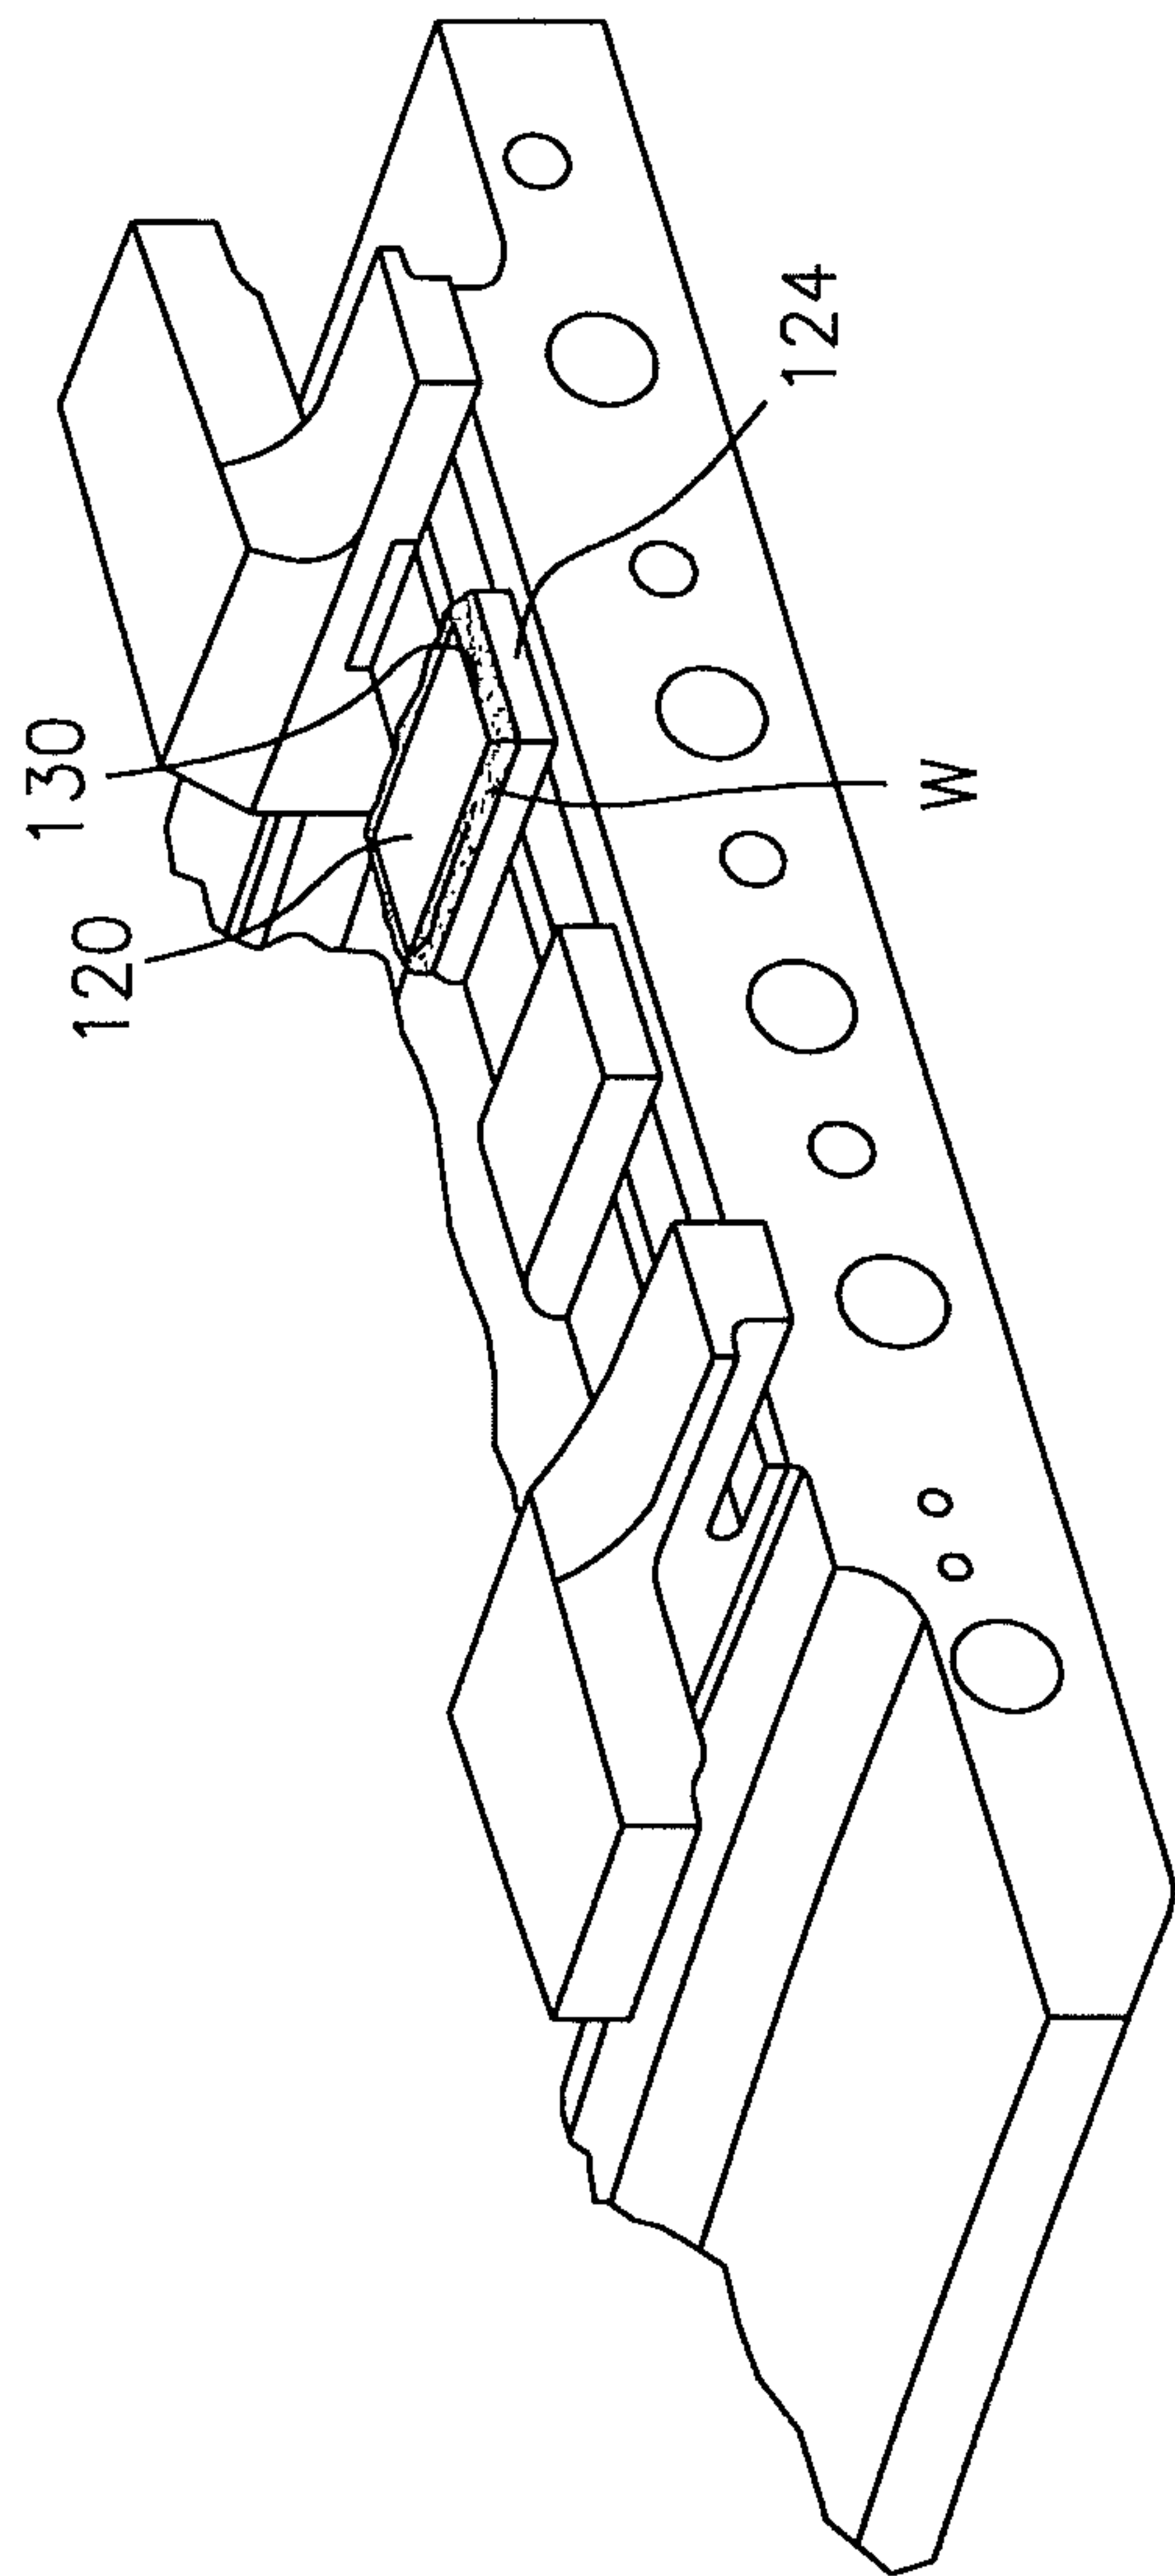
FIG. 10 is a perspective view of the serviceable BOAS with the example donor portion welded around a perimeter thereof to the remainder according to one step of the method to repair/remanufacture illustrated in FIG. 4; and

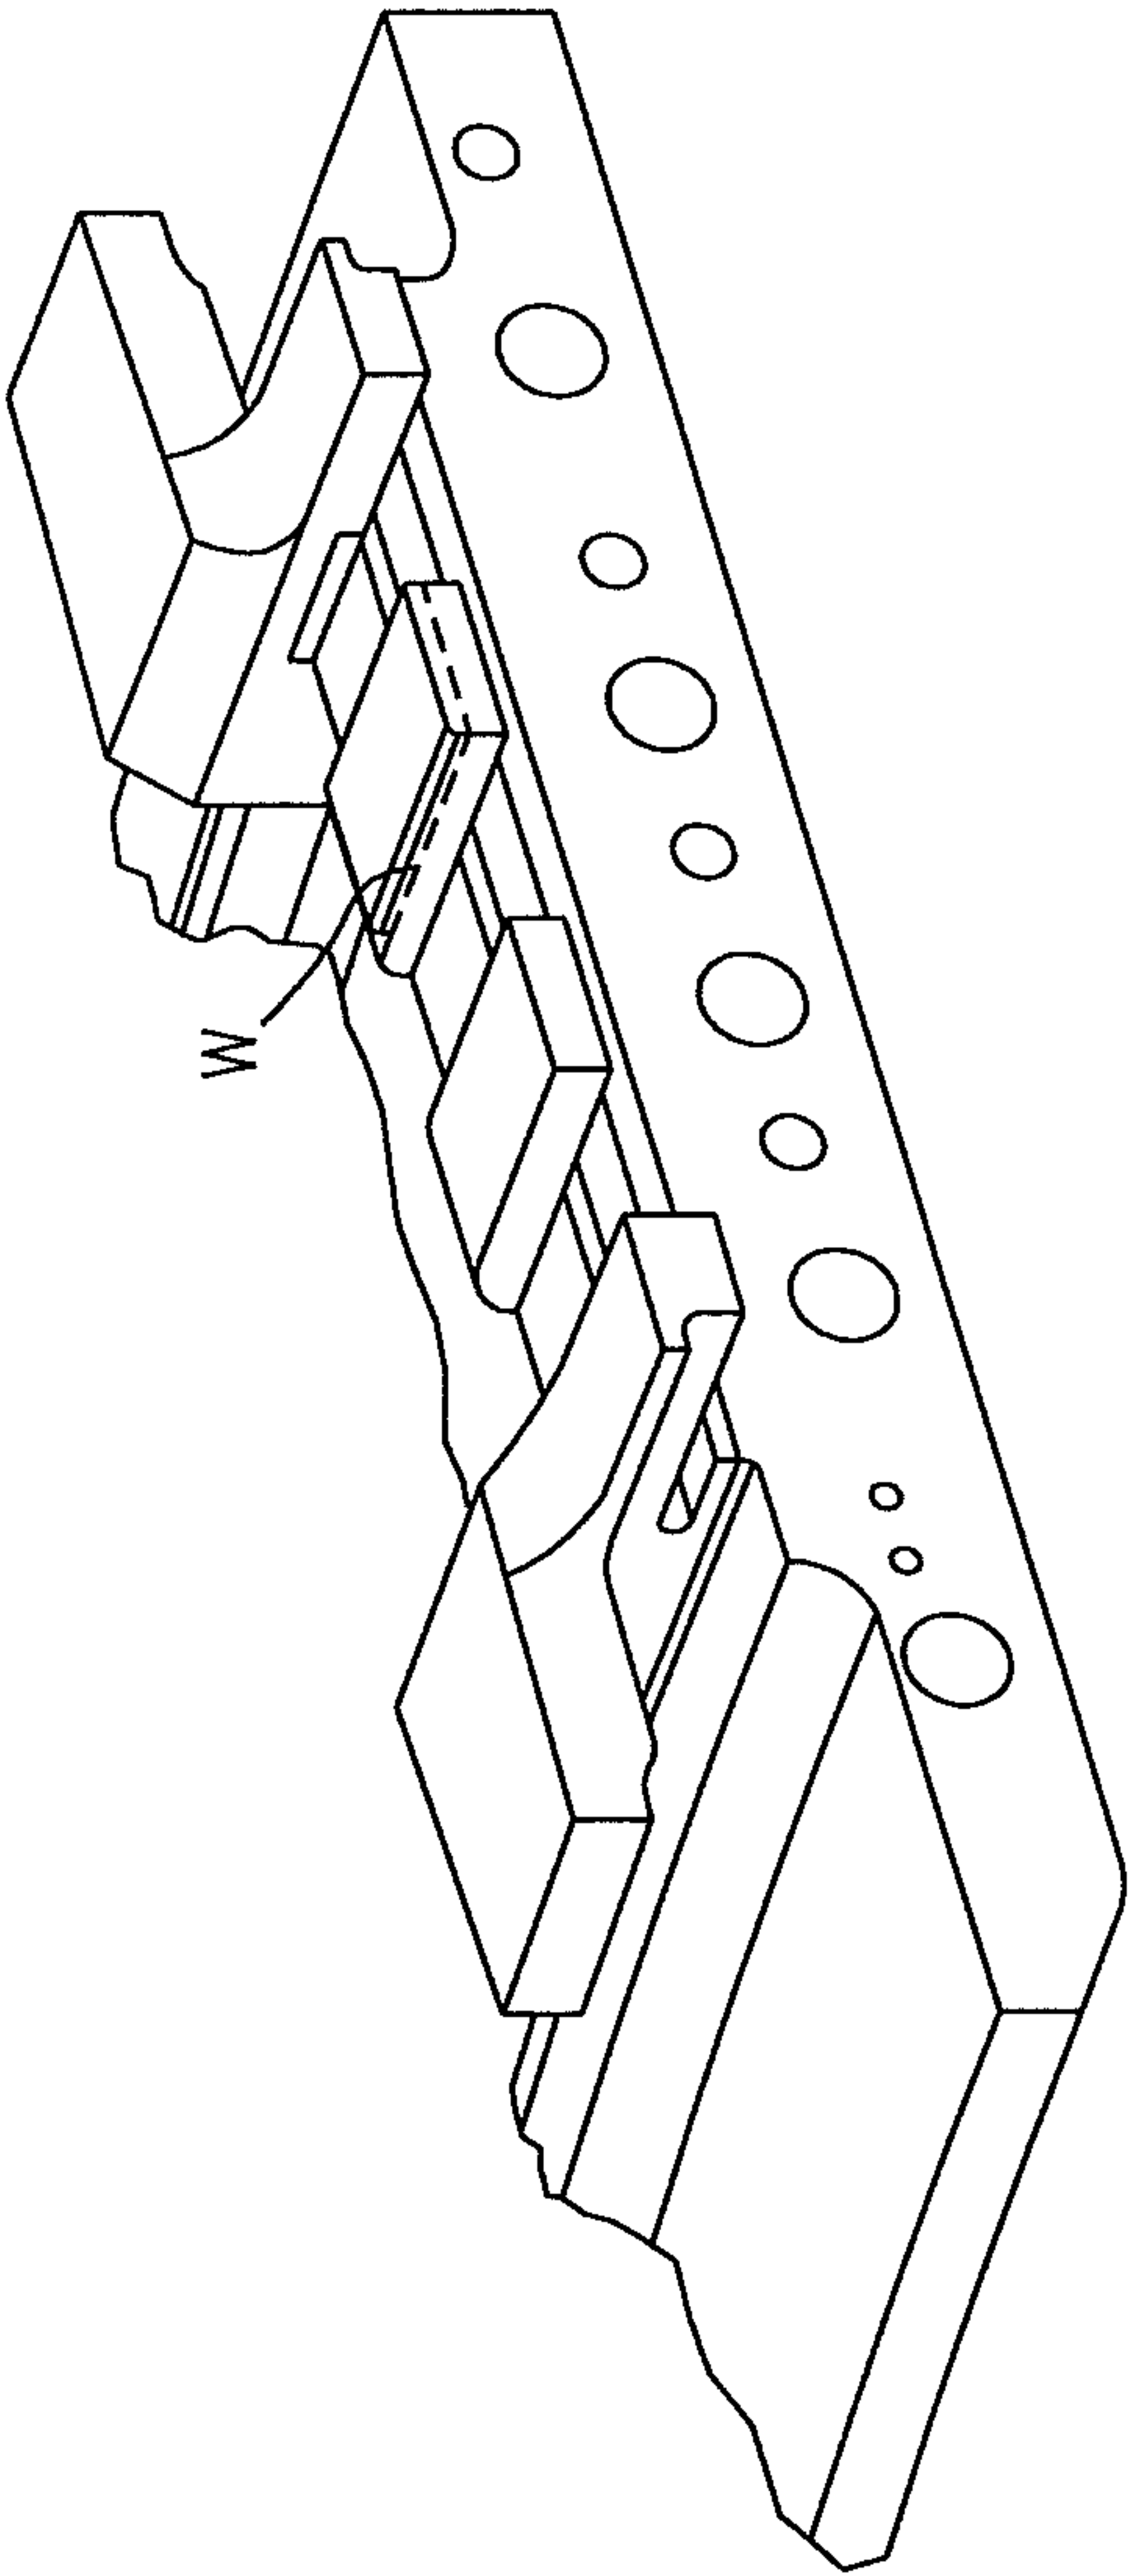
FIG. 11 is a perspective view of the serviceable BOAS with the example donor portion blended to the remainder according to one step of the method to repair/remanufacture illustrated in FIG. 4.
