(54) **THERMOGRAPHY INSPECTION FOR NEAR-SURFACE INCONSISTENCIES OF COMPOSITE STRUCTURES**

(71) Applicant: **The Boeing Company**, Chicago, IL (US)

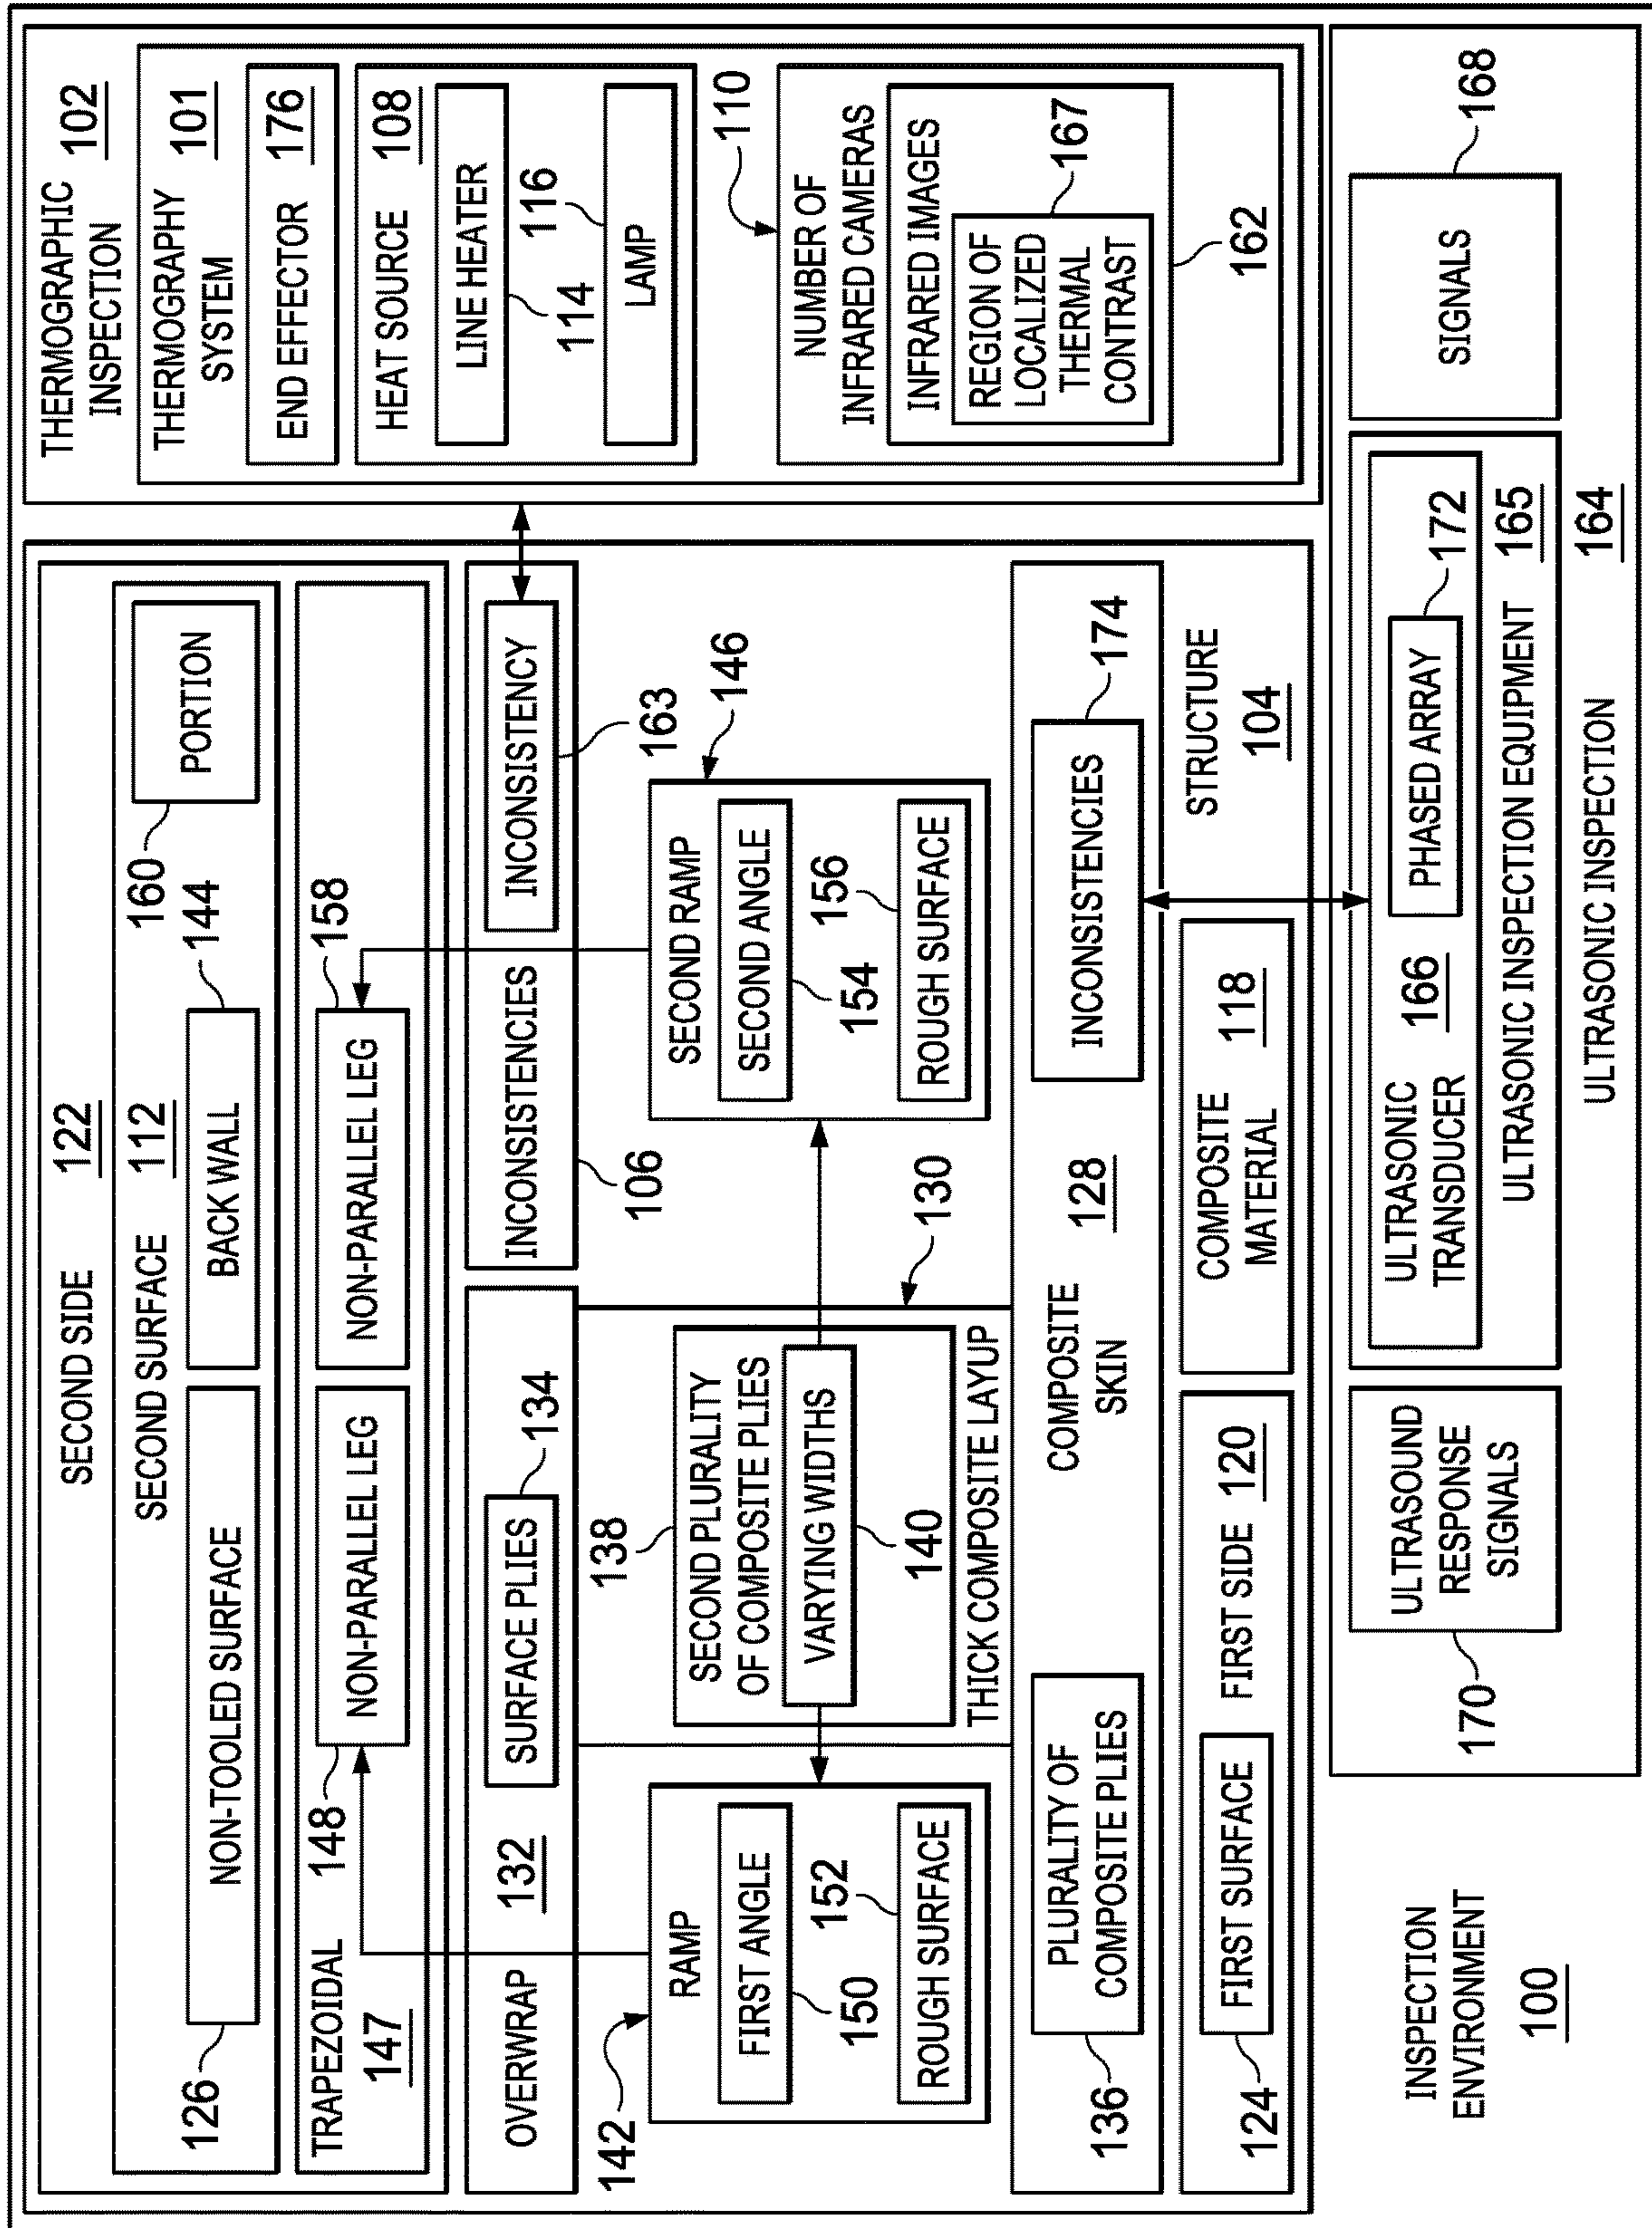
FIG. 1 is an illustration of a block diagram of an environment in which a composite structure is inspected using ultrasonic techniques in accordance with an illustrative embodiment;

Referring now to the figures and, in particular, with reference to FIG. 1, an illustration of a block diagram of an environment in which a composite structure is inspected using ultrasonic techniques is depicted in accordance with an illustrative embodiment. Inspection environment 100 includes thermography system 101 to perform thermographic inspection 102 on structure 104. Thermographic inspection 102 detects inconsistencies 106 in structure 104.

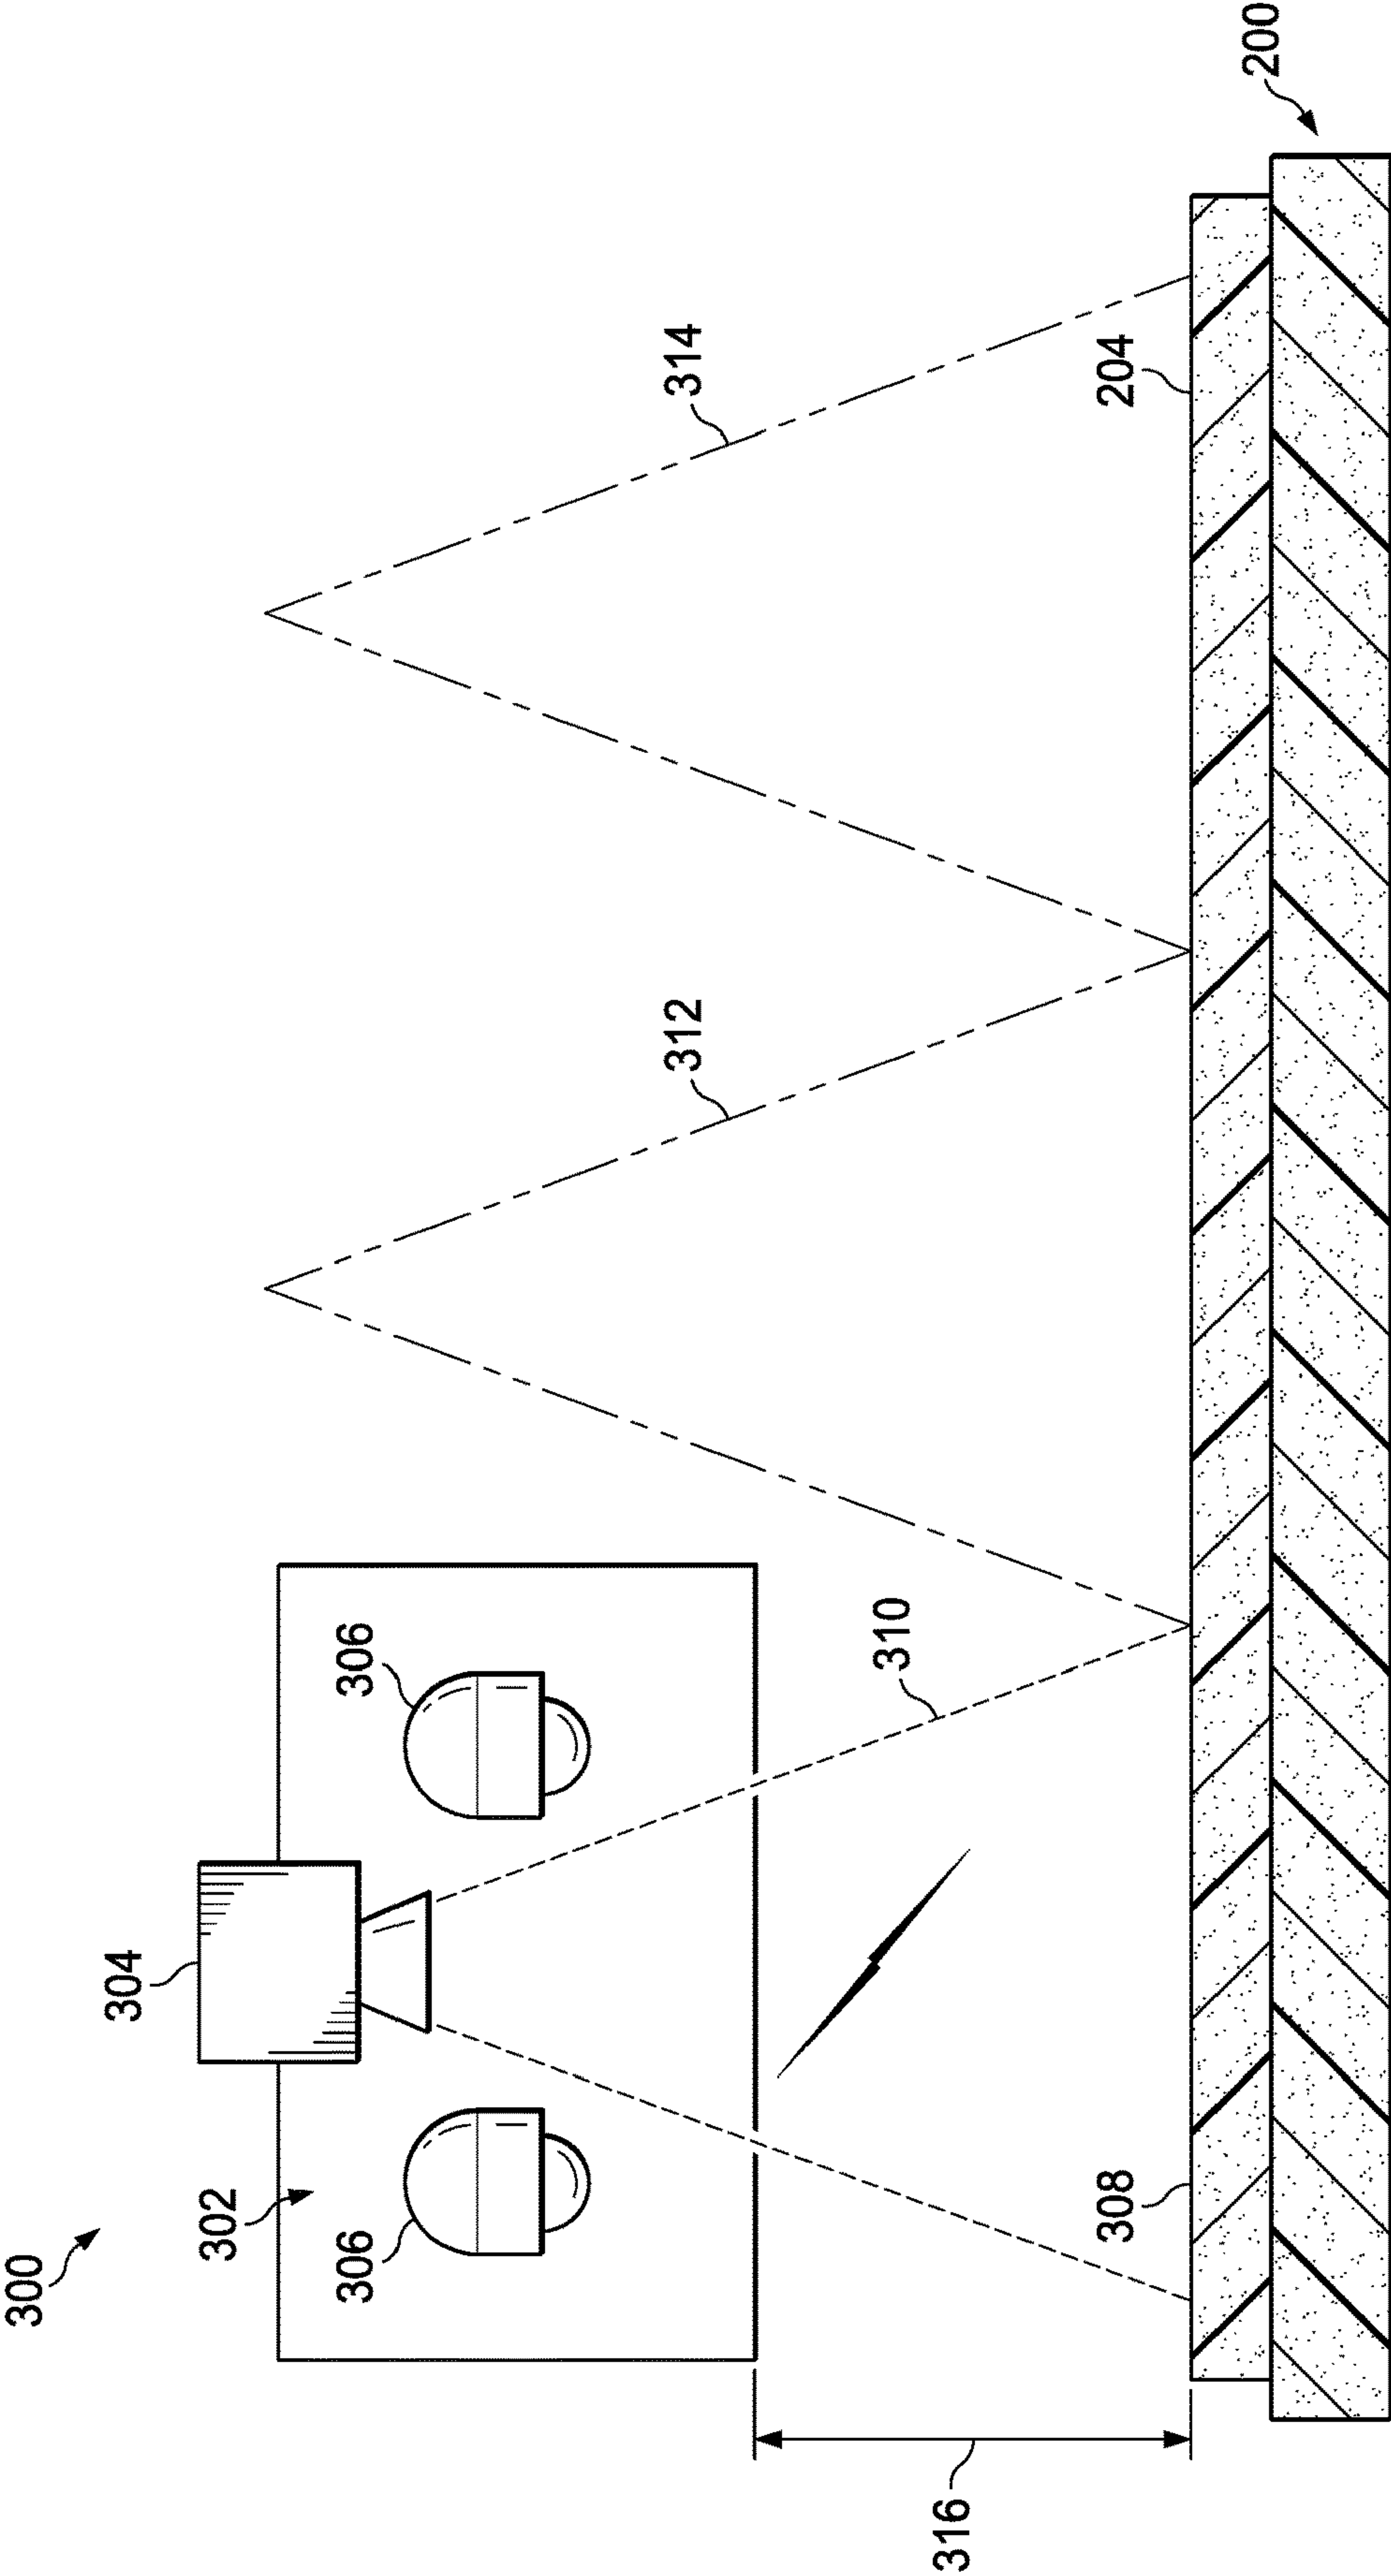
FIG. 3 is an illustration of a cross-sectional view of inspecting a composite structure using a thermography system in accordance with an illustrative embodiment;

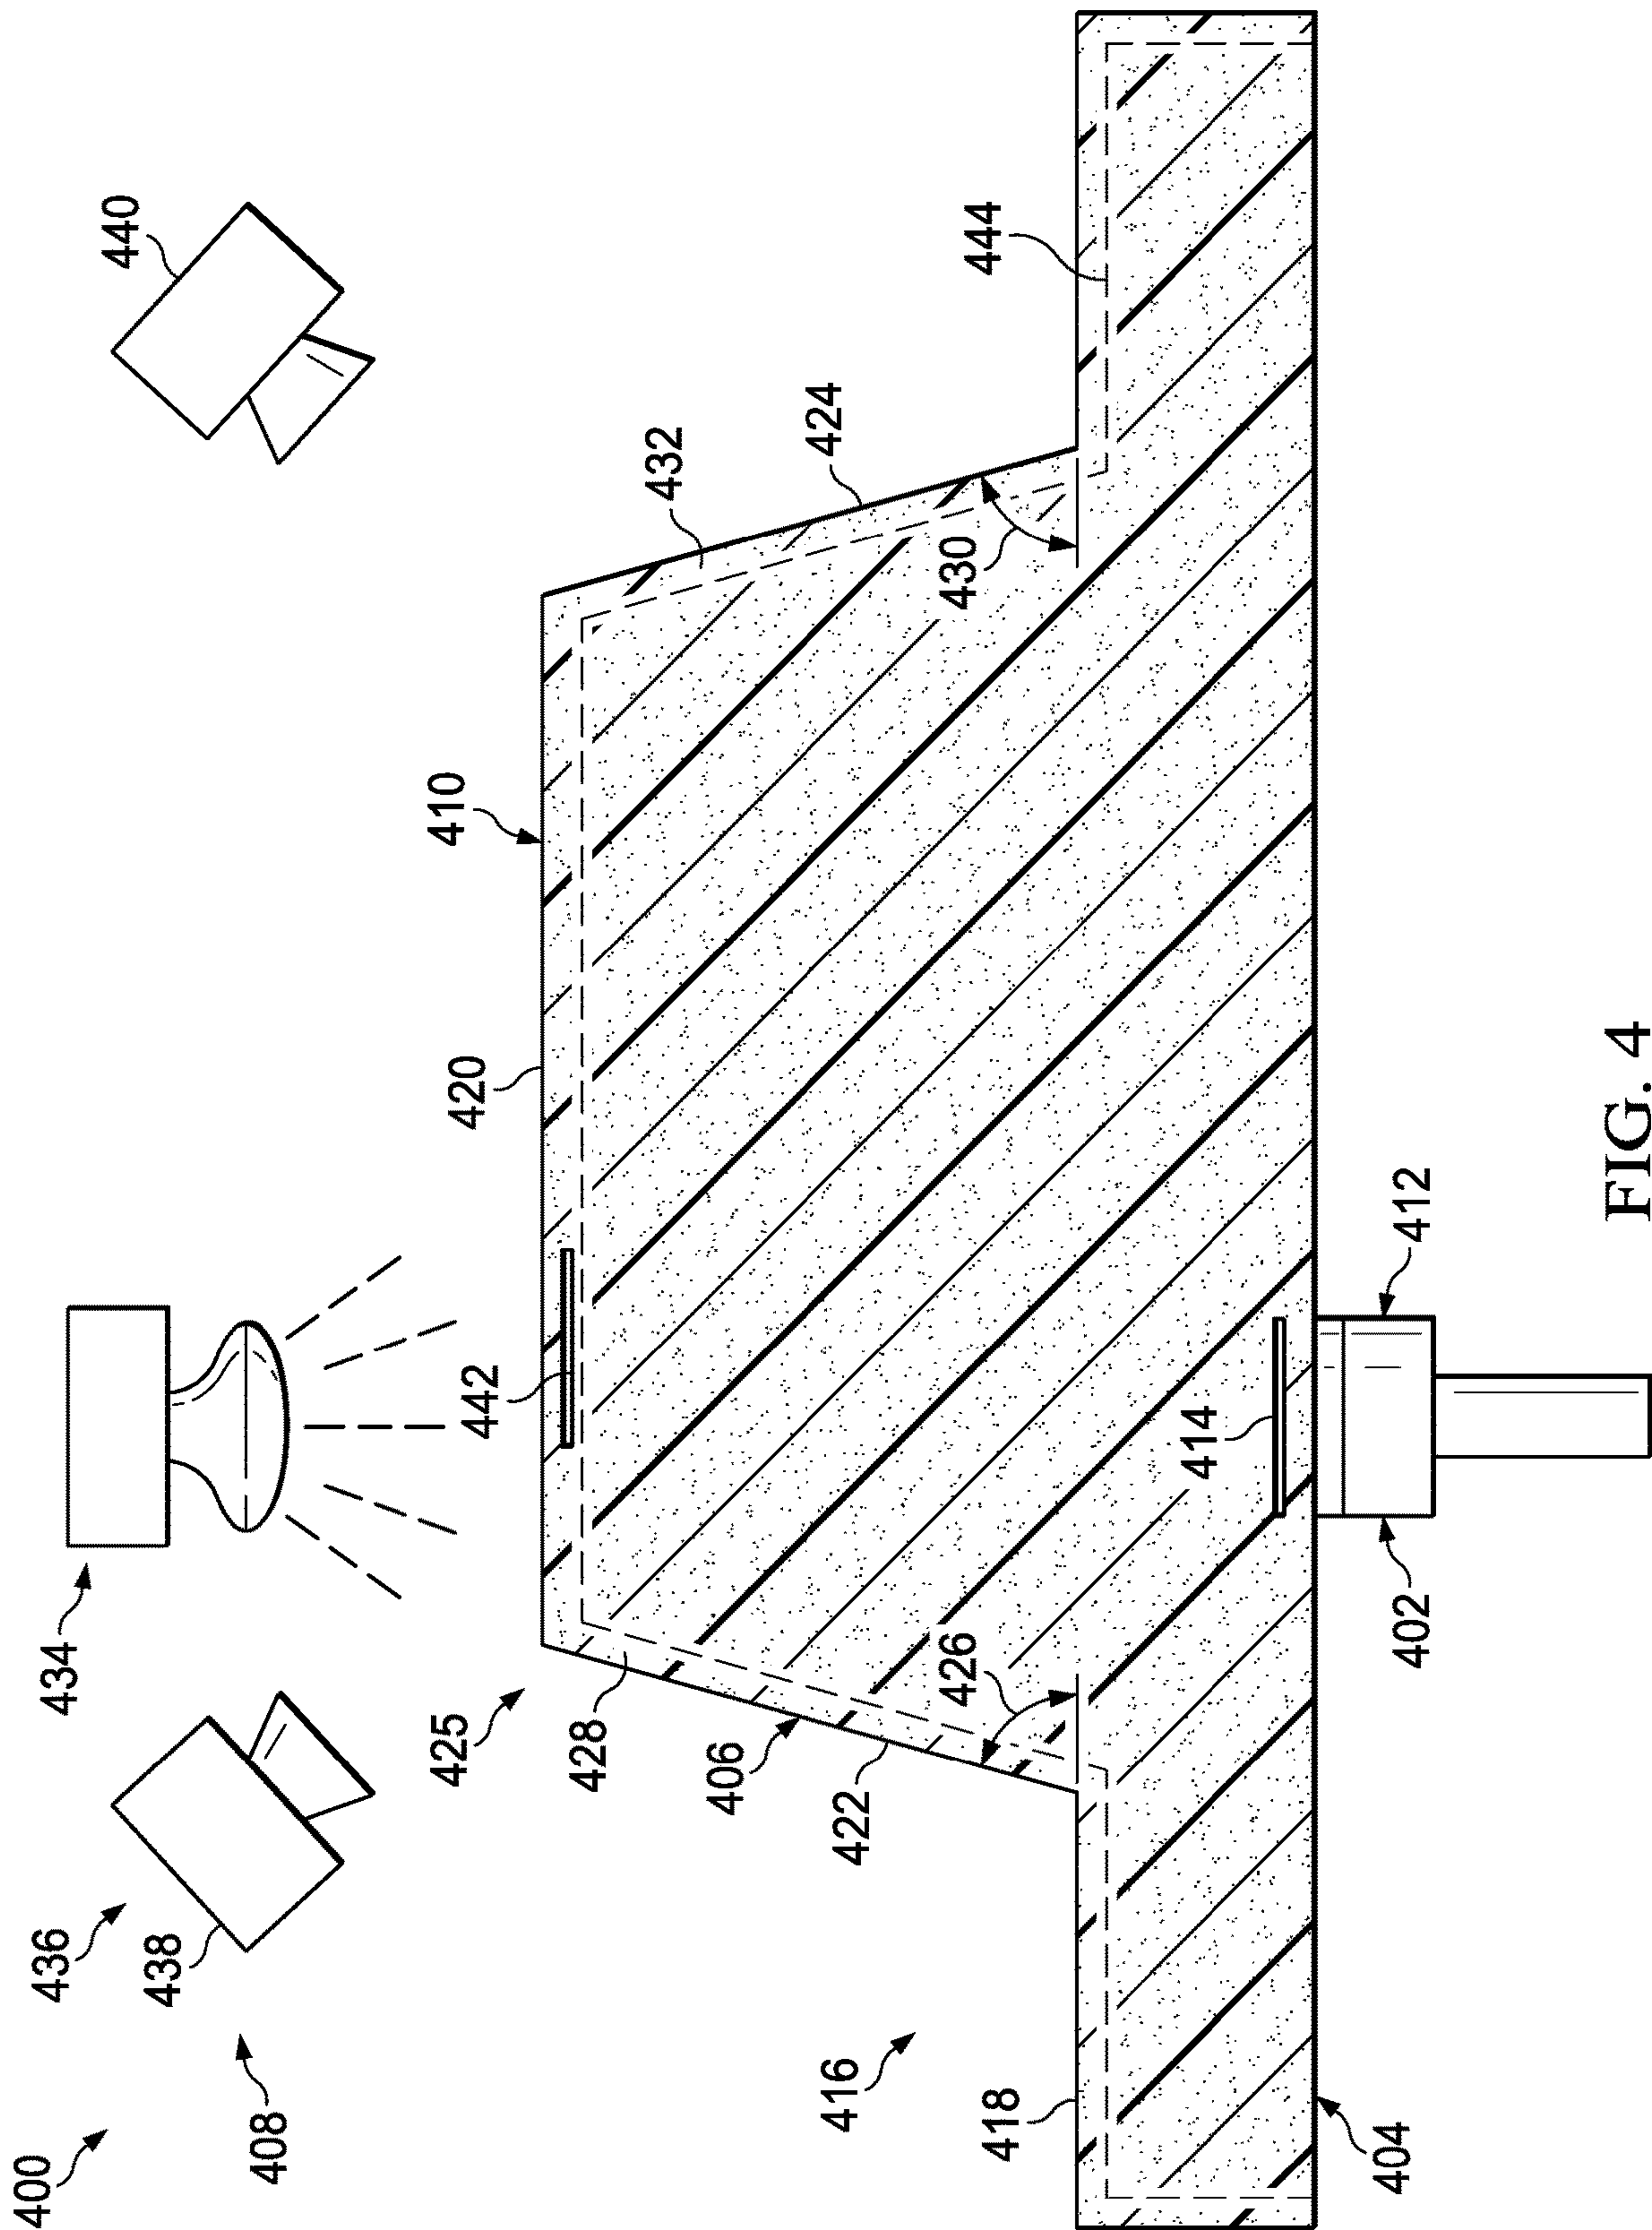
FIG. 4 is an illustration of a cross-sectional view of a simultaneous ultrasonic inspection and infrared inspection of a composite structure in accordance with an illustrative embodiment;

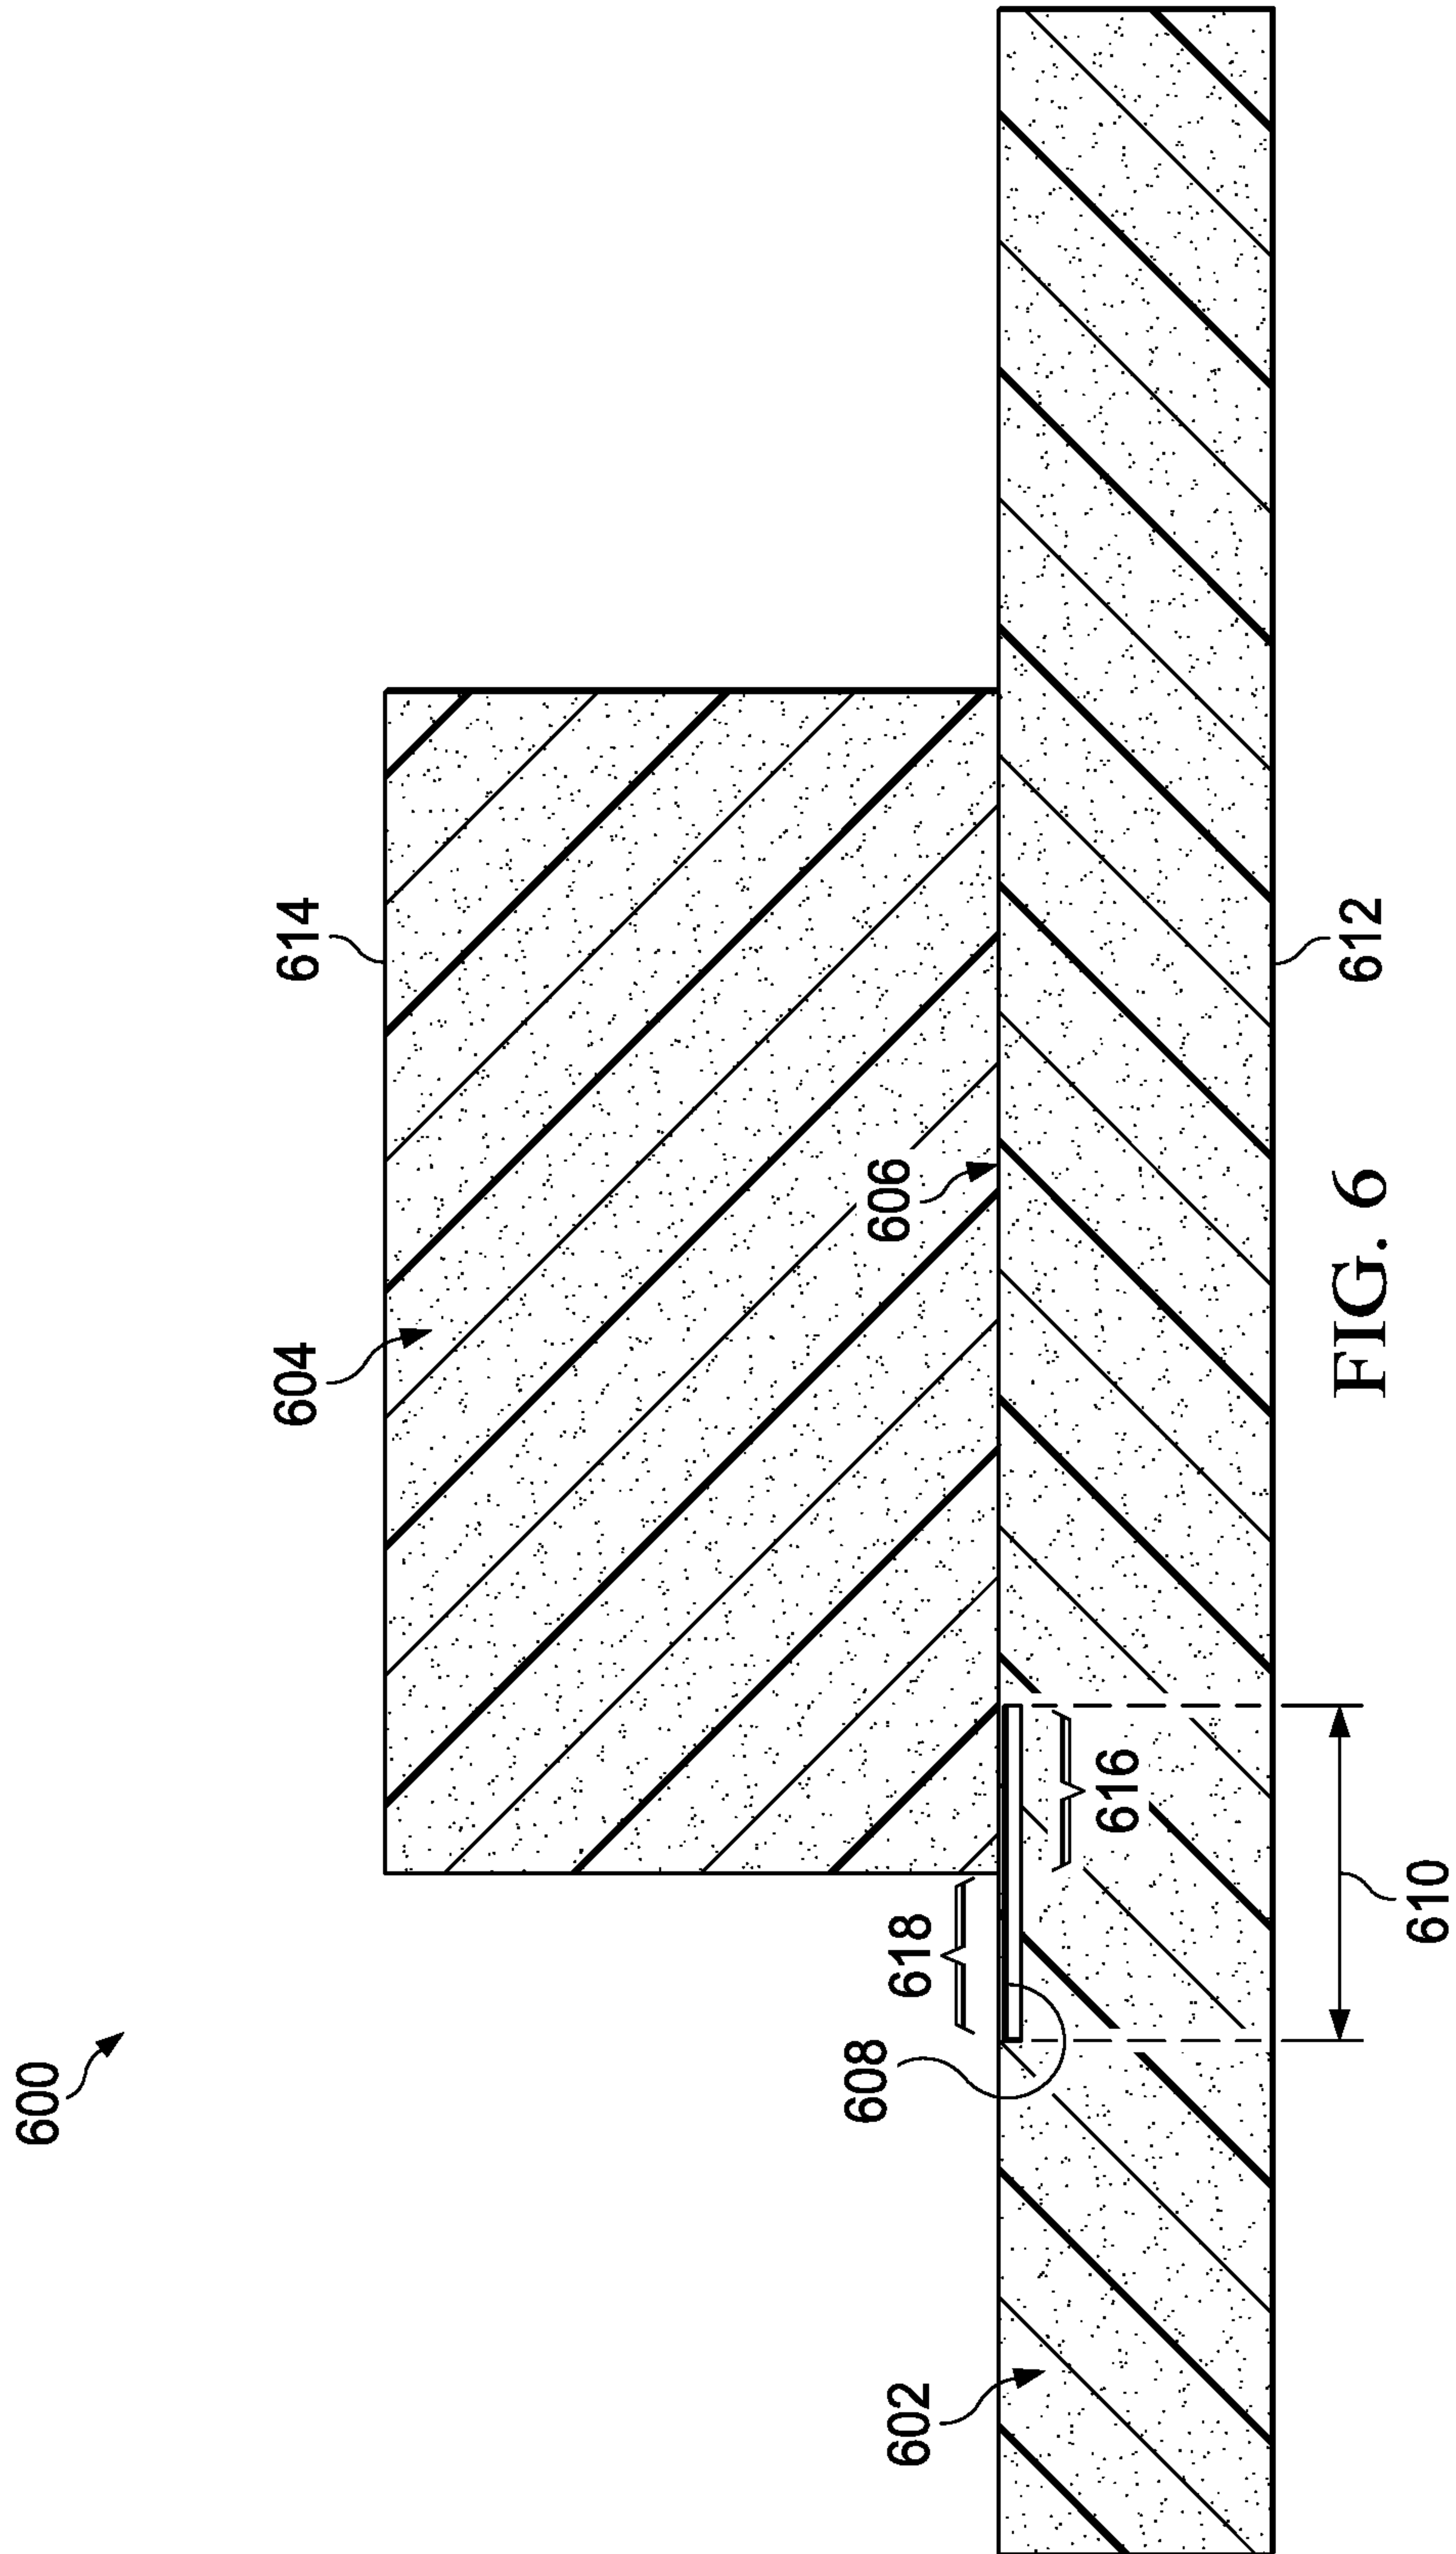
FIG. 6 is an illustration of a cross-sectional view of an inconsistency positioned in an interface of a composite structure in accordance with an illustrative embodiment;

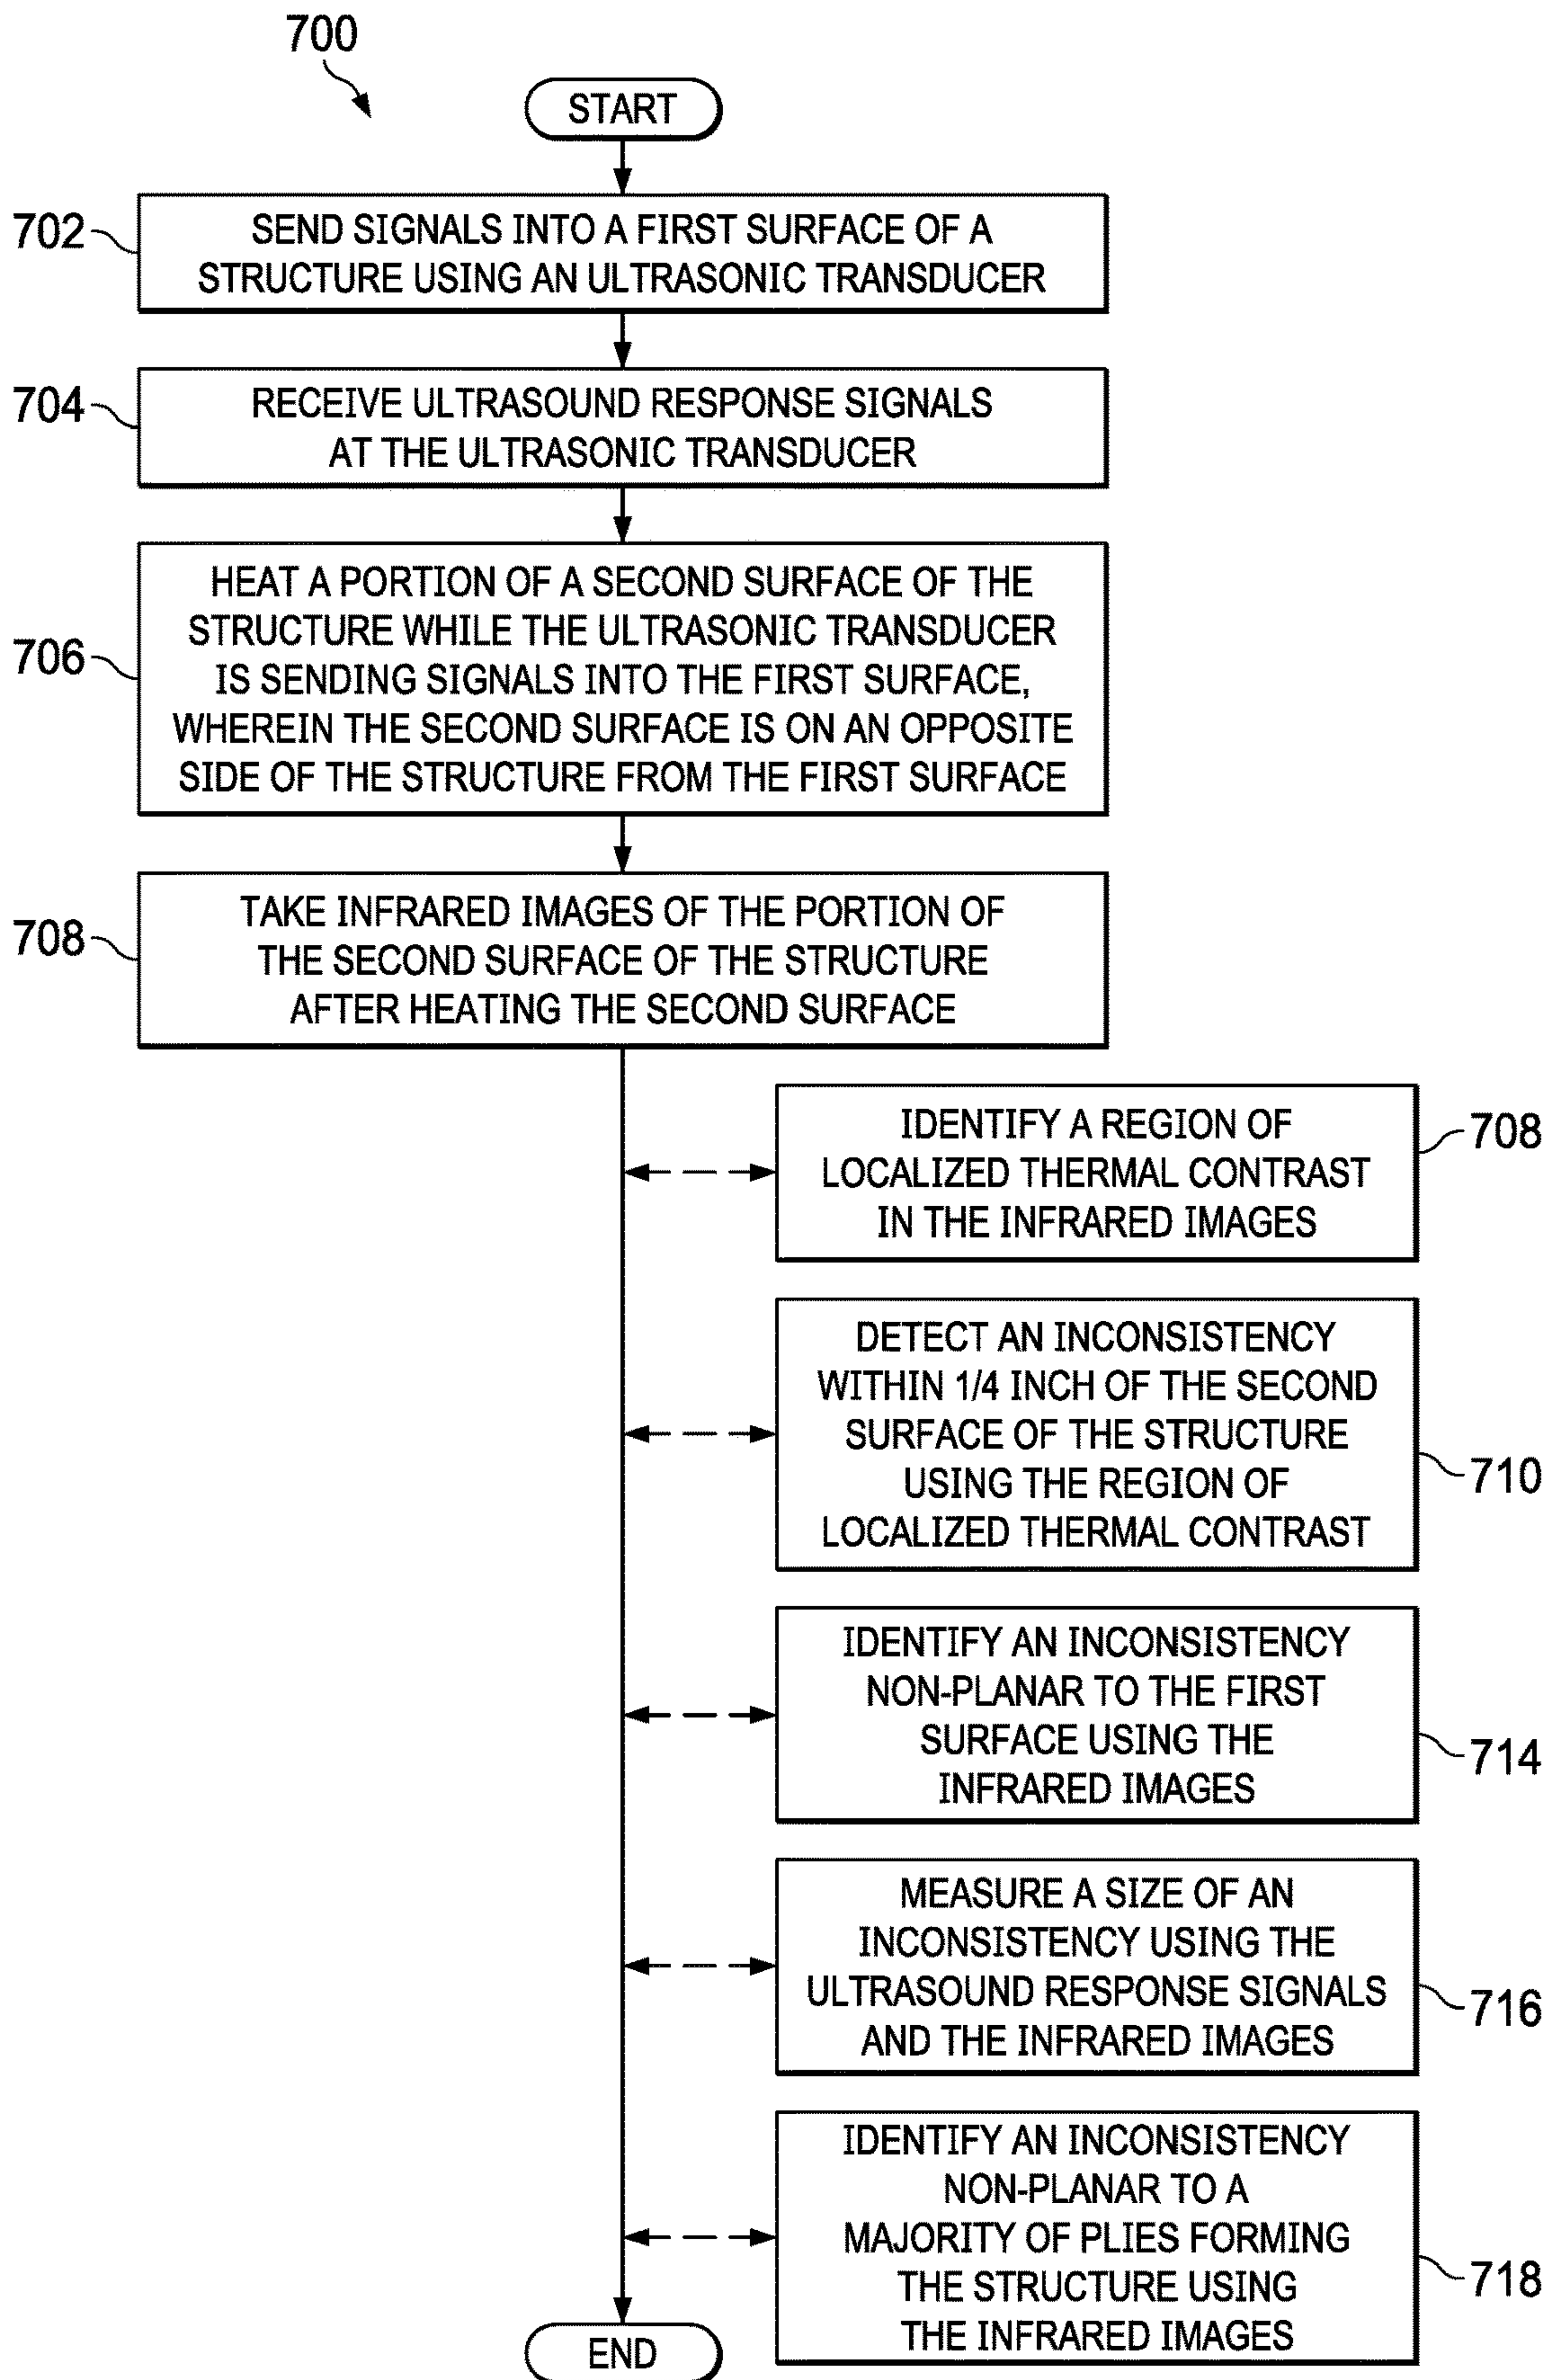
FIG. 7 is an illustration of a flowchart of a method for inspecting a composite structure in accordance with an illustrative embodiment;

Turning now to FIG. 7, an illustration of a flowchart of a method for inspecting a composite structure is depicted in accordance with an illustrative embodiment. Method 700 may be implemented in inspection environment 100 to perform ultrasonic inspection 164 and thermographic inspection 102 of FIG. 1. Method 700 may use thermography system 208 of FIG. 2 or thermography system 300 of FIG. 3. Method 700 may be performed on any of structure 406 of FIG. 4, structure 500 of FIG. 5, or structure 600 of FIG. 6.

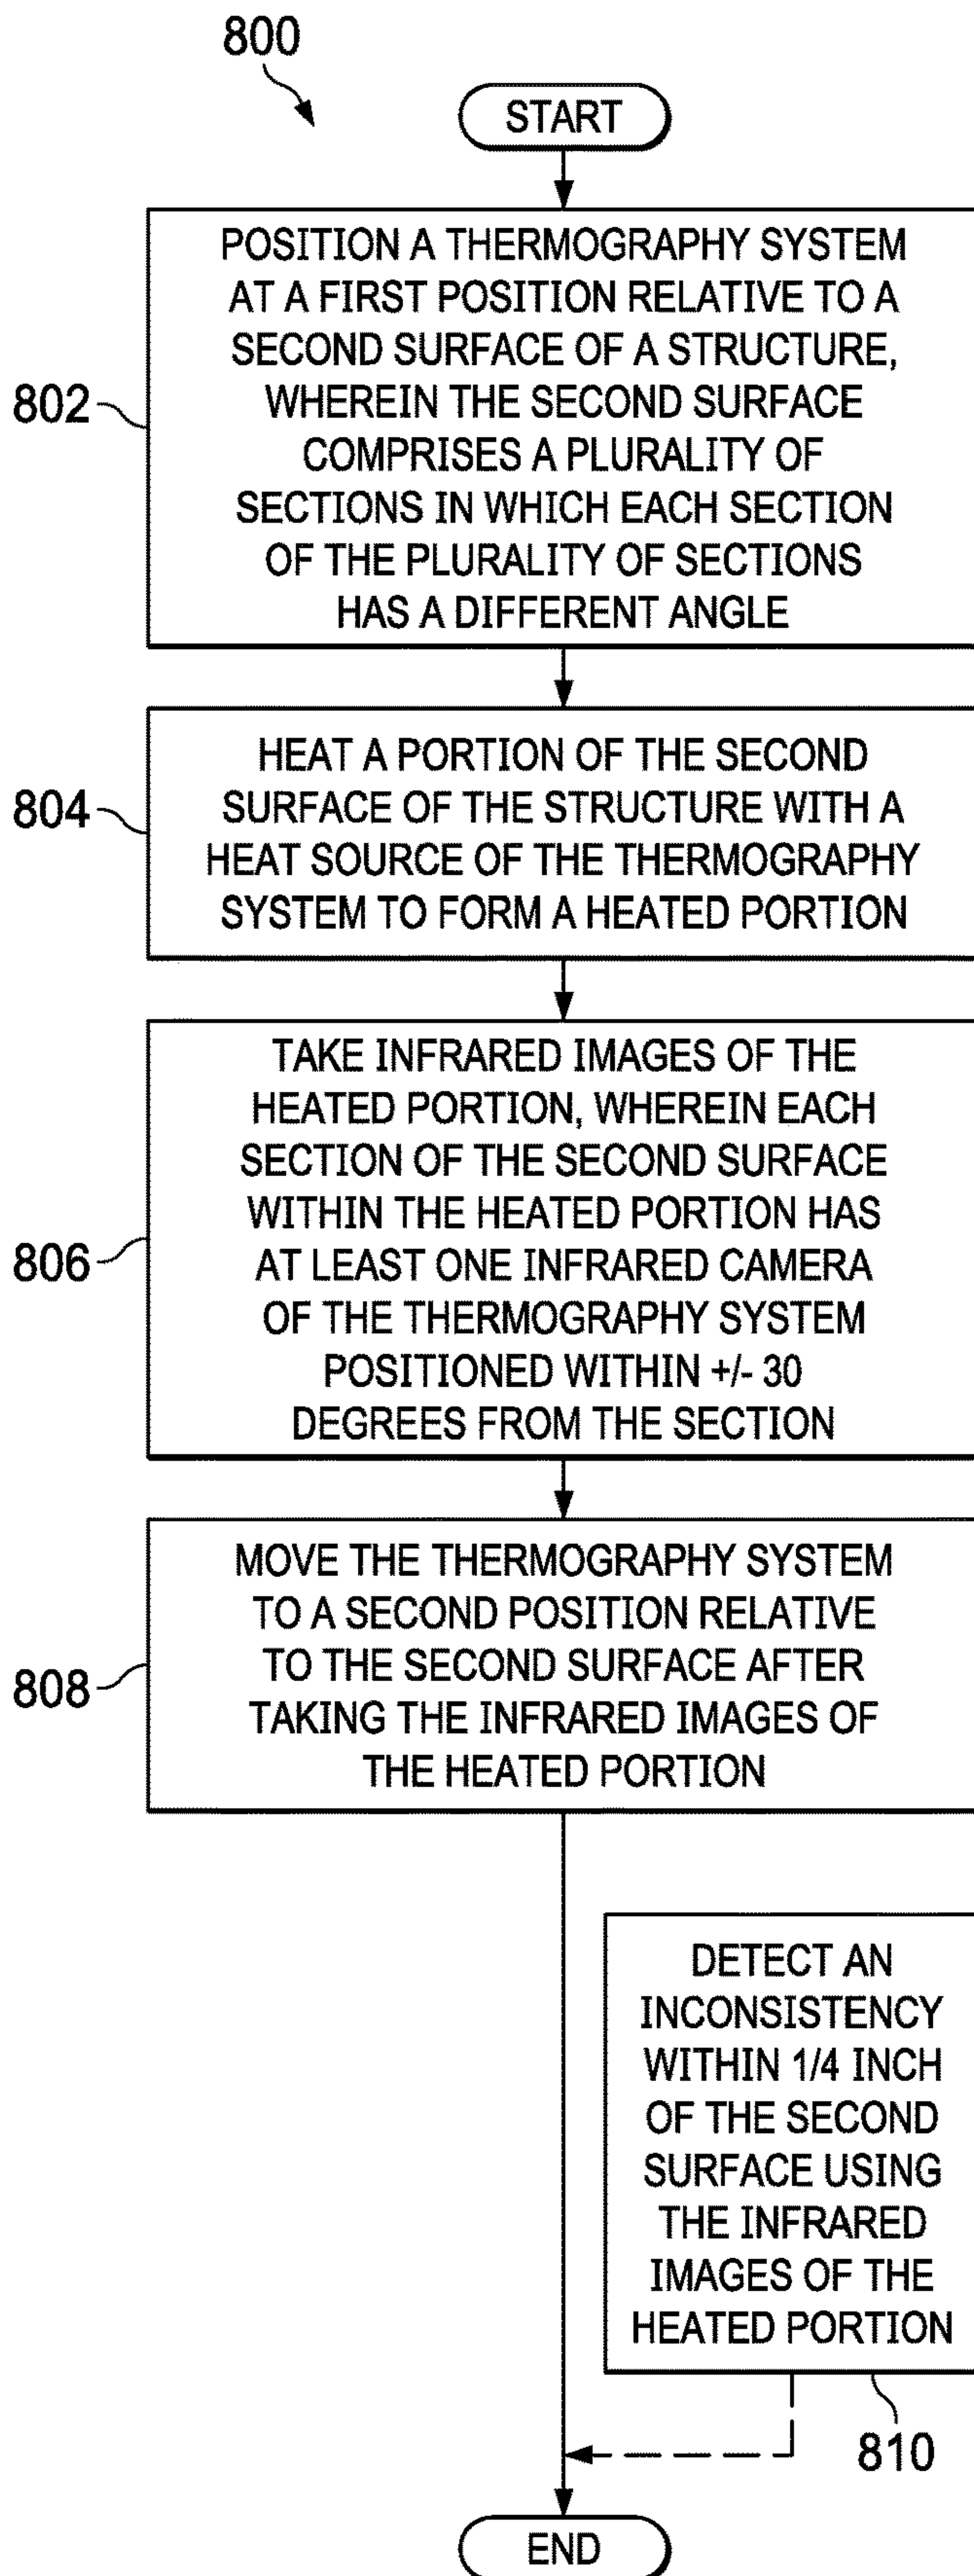
FIG. 8 is an illustration of a flowchart of a method for inspecting a composite structure in accordance with an illustrative embodiment; and

Turning now to FIG. 8, an illustration of a flowchart of a method for inspecting a composite structure is depicted in accordance with an illustrative embodiment. Method 800 may be implemented in inspection environment 100 to

perform ultrasonic inspection 164 and thermographic inspection 102 of FIG. 1. Method 800 may use thermography system 208 of FIG. 2 or thermography system 300 of FIG. 3. Method 800 may be performed on any of structure 406 of FIG. 4, structure 500 of FIG. 5, or structure 600 of FIG. 6.
