(54) **THERMOGRAPHY INSPECTION FOR NEAR-SURFACE INCONSISTENCIES OF COMPOSITE STRUCTURES**

(71) Applicant: **The Boeing Company**, Chicago, IL (US)

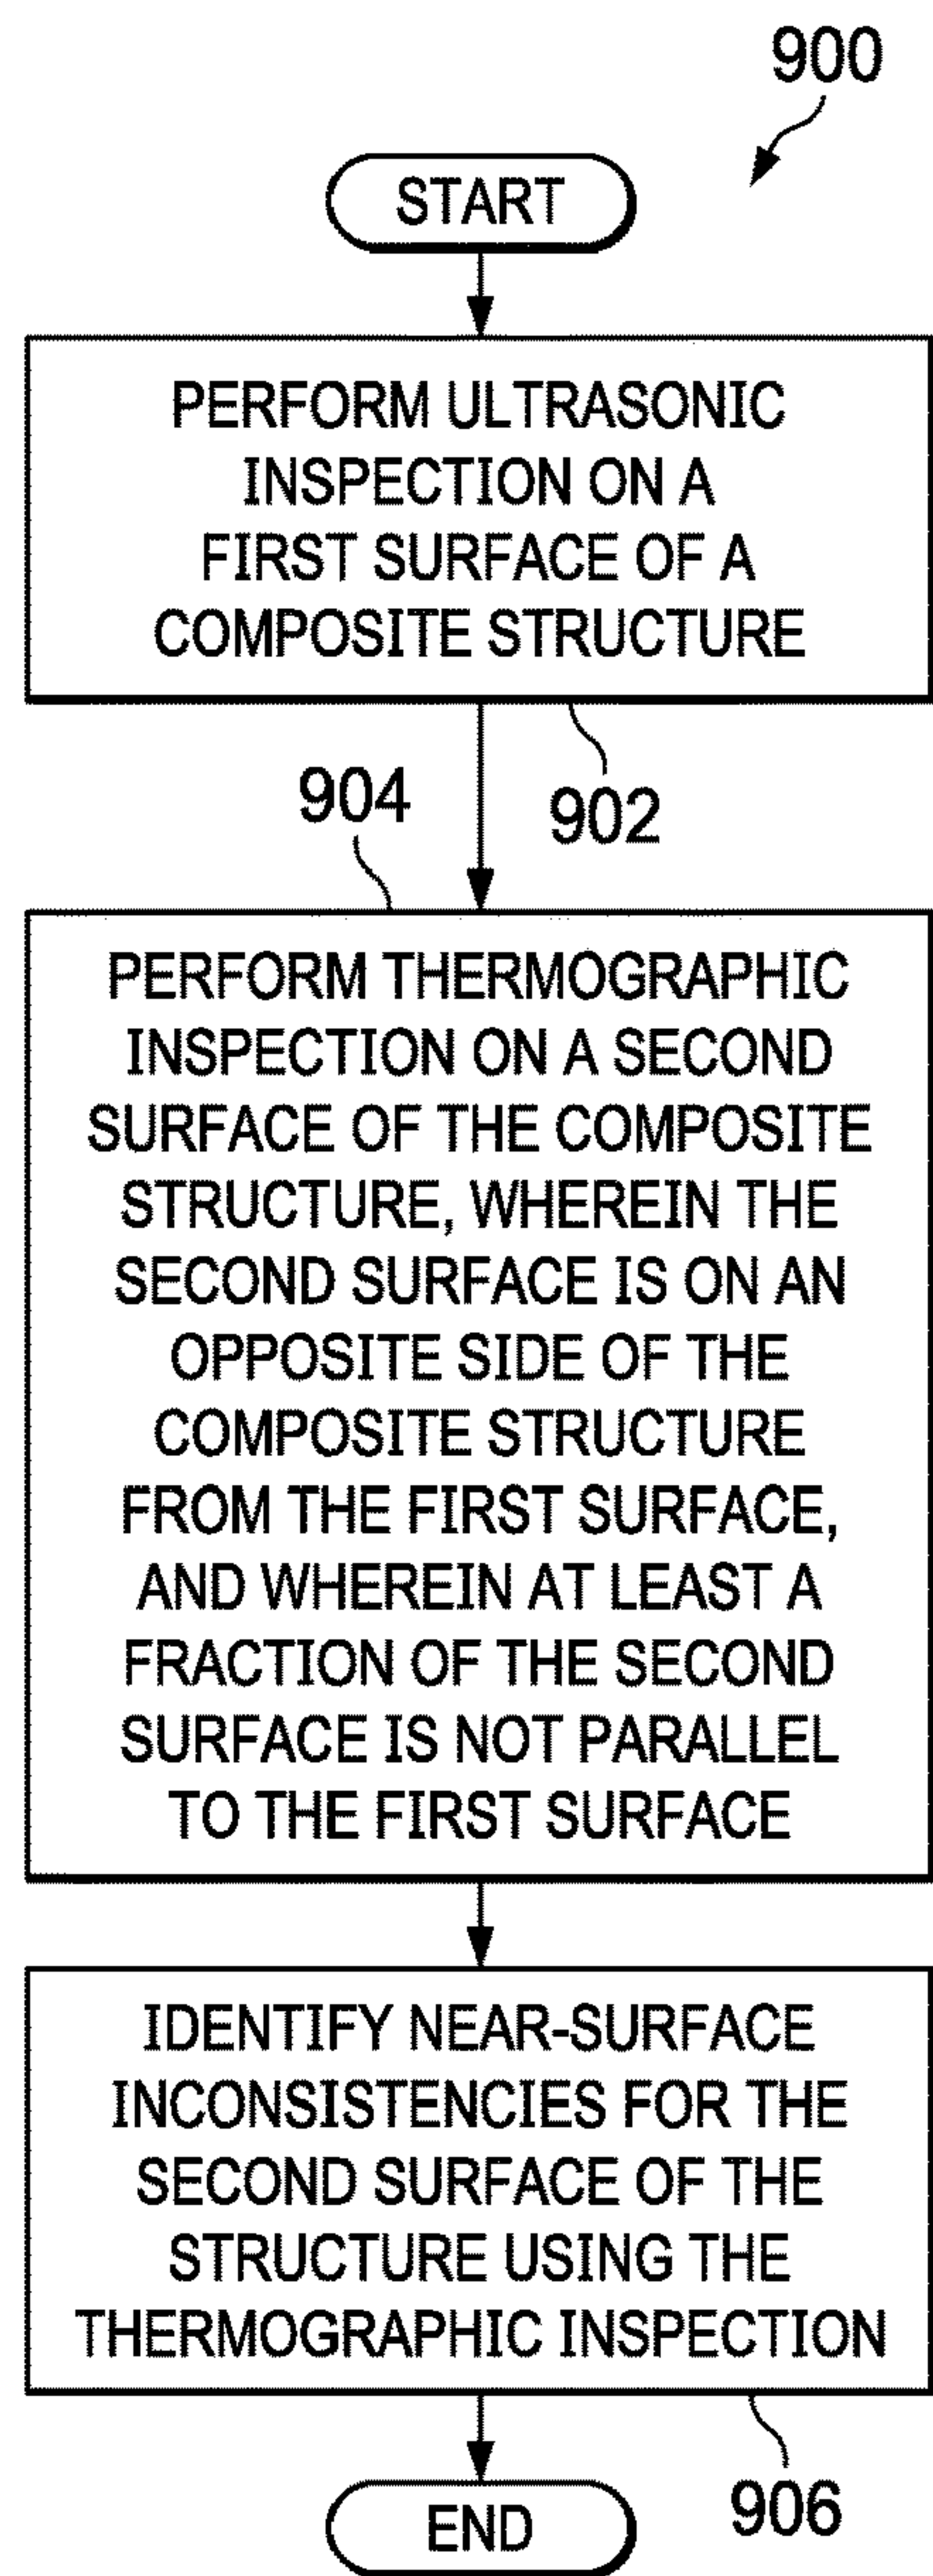
FIG. 9 is an illustration of a flowchart of a method for inspecting a composite structure in accordance with an illustrative embodiment.

Turning now to FIG. 9, an illustration of a flowchart of a method for inspecting a composite structure is depicted in accordance with an illustrative embodiment. Method 900 may be implemented in inspection environment 100 to perform ultrasonic inspection 164 and thermographic inspection 102 of FIG. 1. Method 900 may use thermography system 208 of FIG. 2 or thermography system 300 of FIG. 3. Method 900 may be performed on any of structure 406 of FIG. 4, structure 500 of FIG. 5, or structure 600 of FIG. 6.
