(54) **ACOUSTIC PANEL REPAIR WITH  
RETENTION OF ACOUSTIC PROPERTIES**

An acoustic panel (200) for an aircraft nacelle (100) may comprise a perforated first skin (220), a second skin (230), and a core (210) sandwiched between them. A damaged portion of the perforated first skin may be removed. A fiberglass ply (510) may be coupled to the acoustic panel. A pressure differential may cause the fiberglass ply to form dimples (515) within the perforations (325) of the first skin. The fiberglass ply may be used as a template to drill holes in a replacement patch (400).

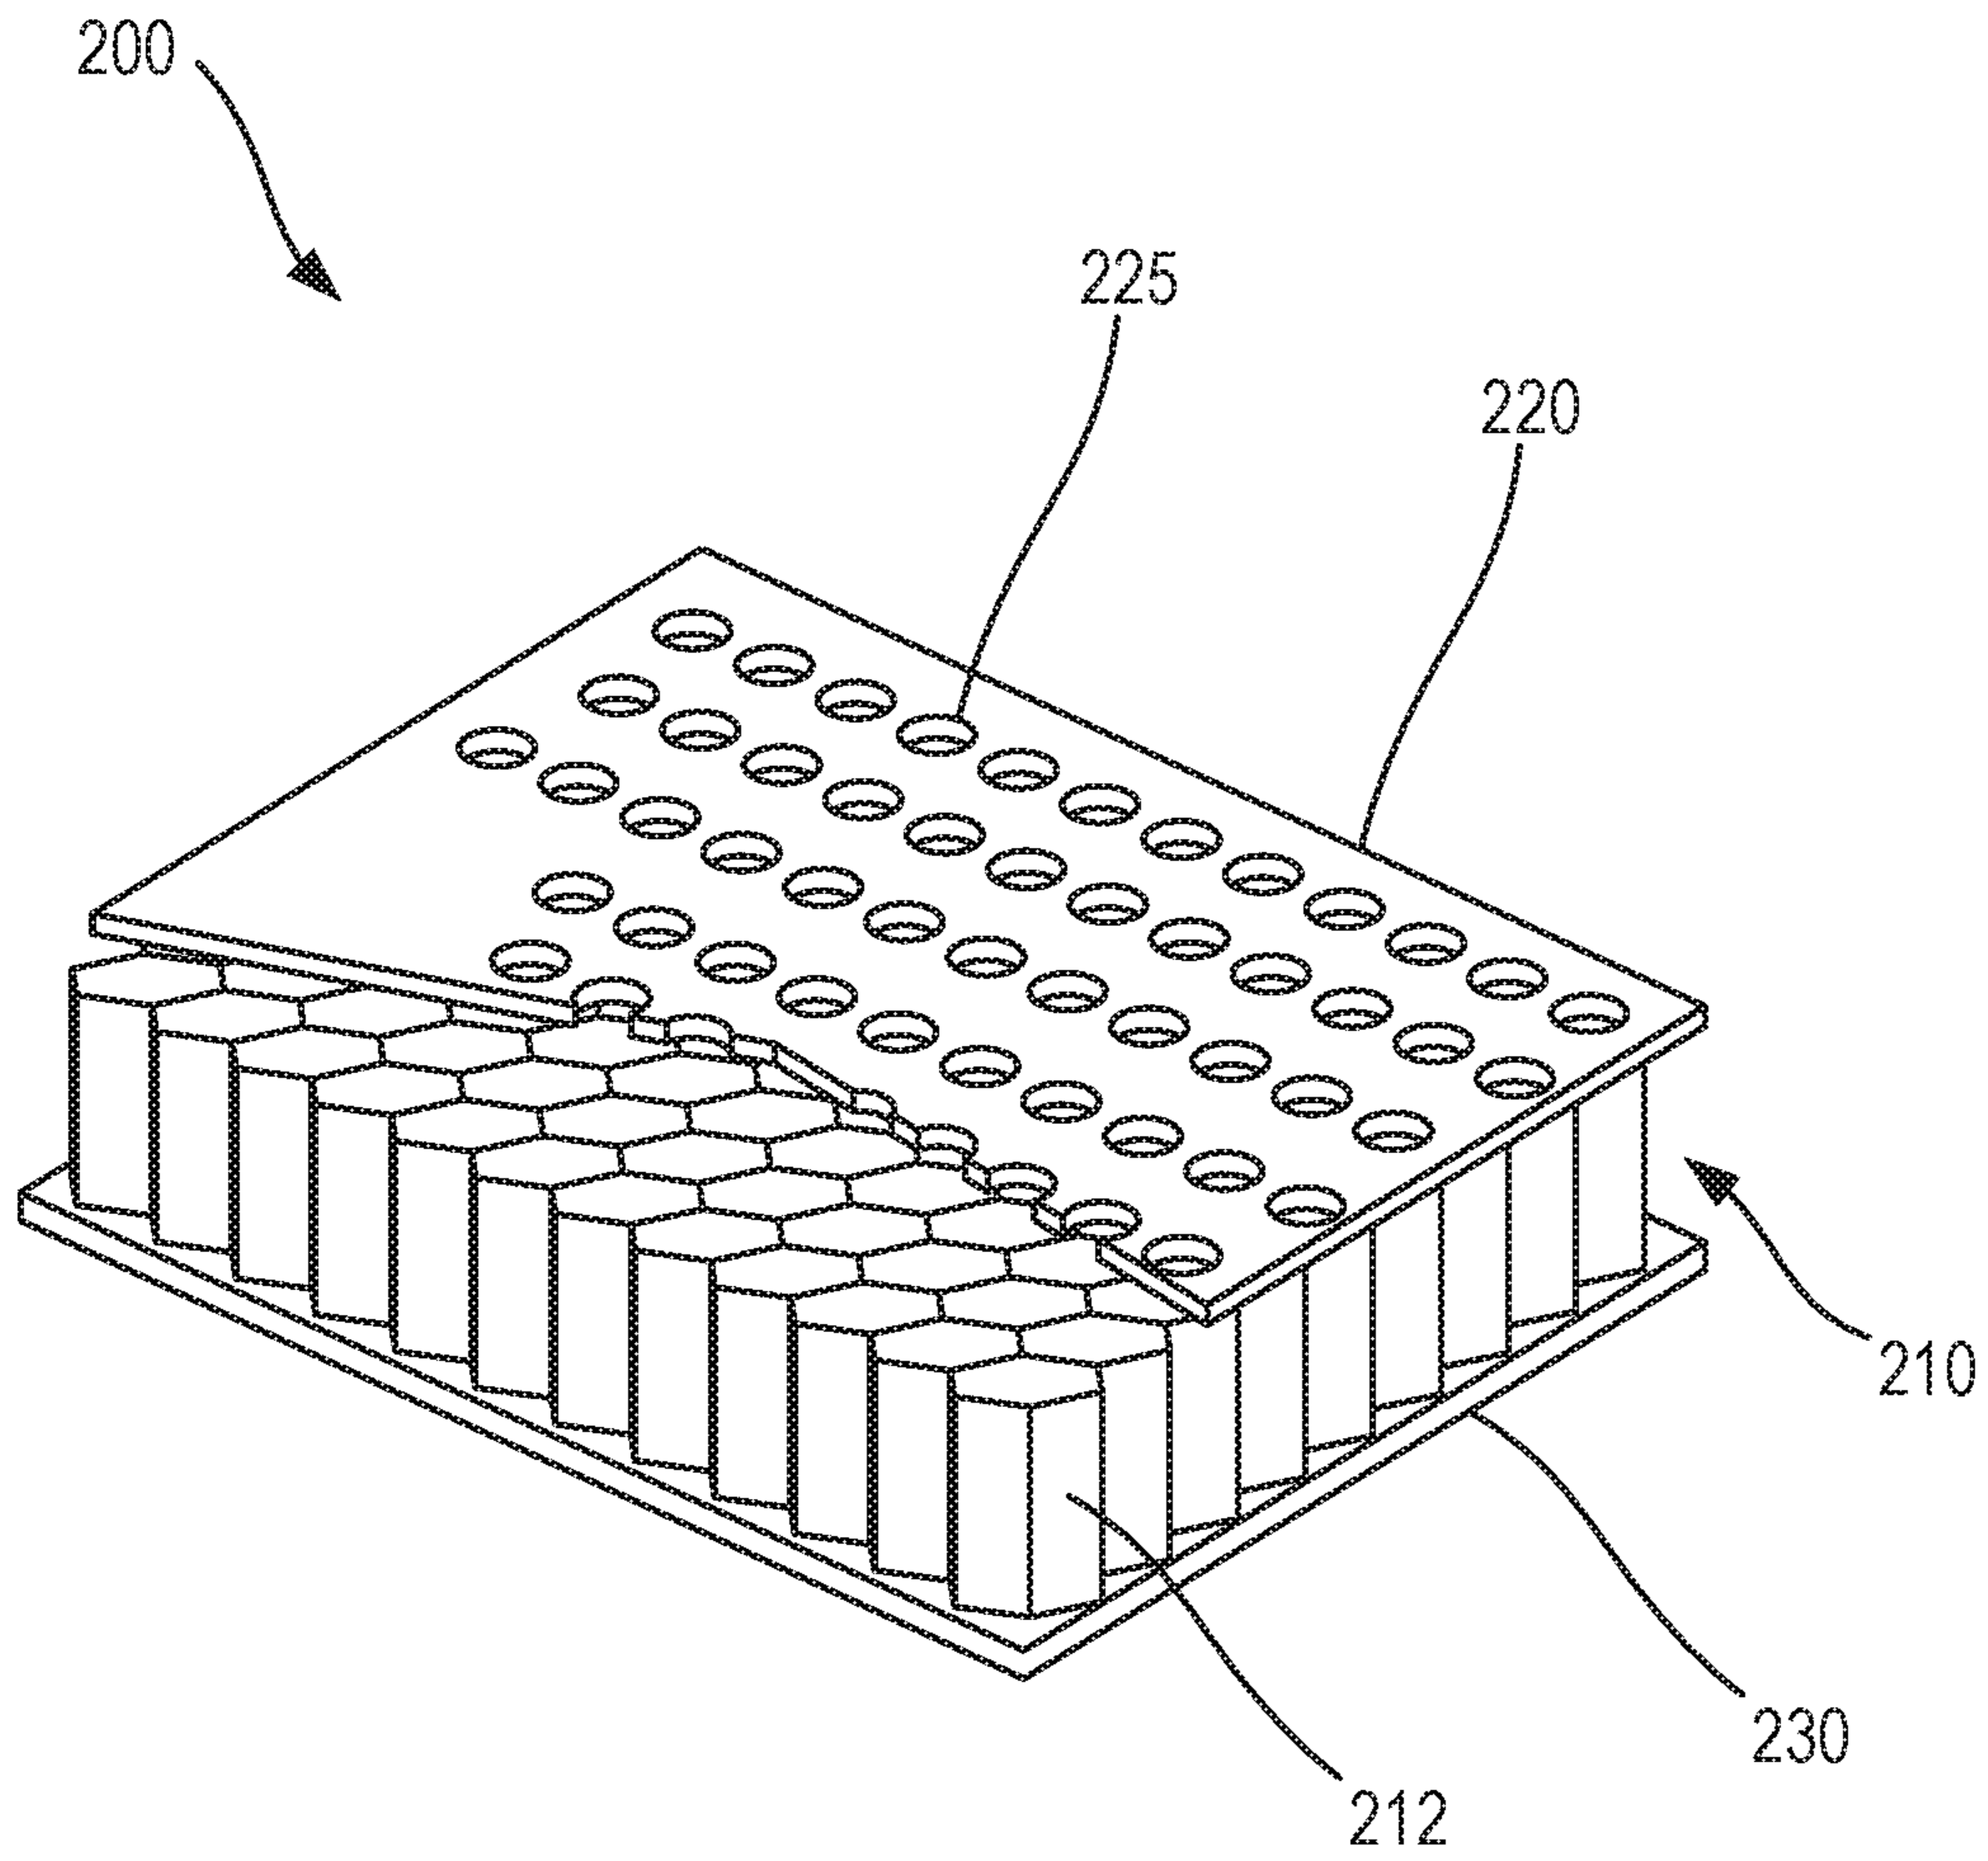
FIG. 2 illustrates a perspective view of an acoustic panel in accordance with various embodiments;

Referring to FIG. 2, an acoustic panel 200 is illustrated according to various embodiments. The acoustic panel 200 may comprise perforations 225, and could be used to form portions of a nacelle for an aircraft engine, as described above. The acoustic panel 200 may comprise a core 210, positioned between a first skin 220 and a second skin 230. The core 210 may have walls extending generally in a normal direction from the first skin to the second skin that form a plurality of cells 212. The cells 212 may be hexagonal in shape and are then commonly referred to as honeycomb core. In various embodiments, however, the cells 212 could have any of a number of different geometries. Core walls could be made from various metals such as titanium or aluminum, or composites, or hardened paper or other plastics, according to the particular application and material properties. Adjacent core walls may be bonded to each other with glue or may be welded, or other methods may be used to join core walls together to form the cellular structure. The first skin 220, core 210, and second skin 230 combine to form closed cells that may become resonator chambers when

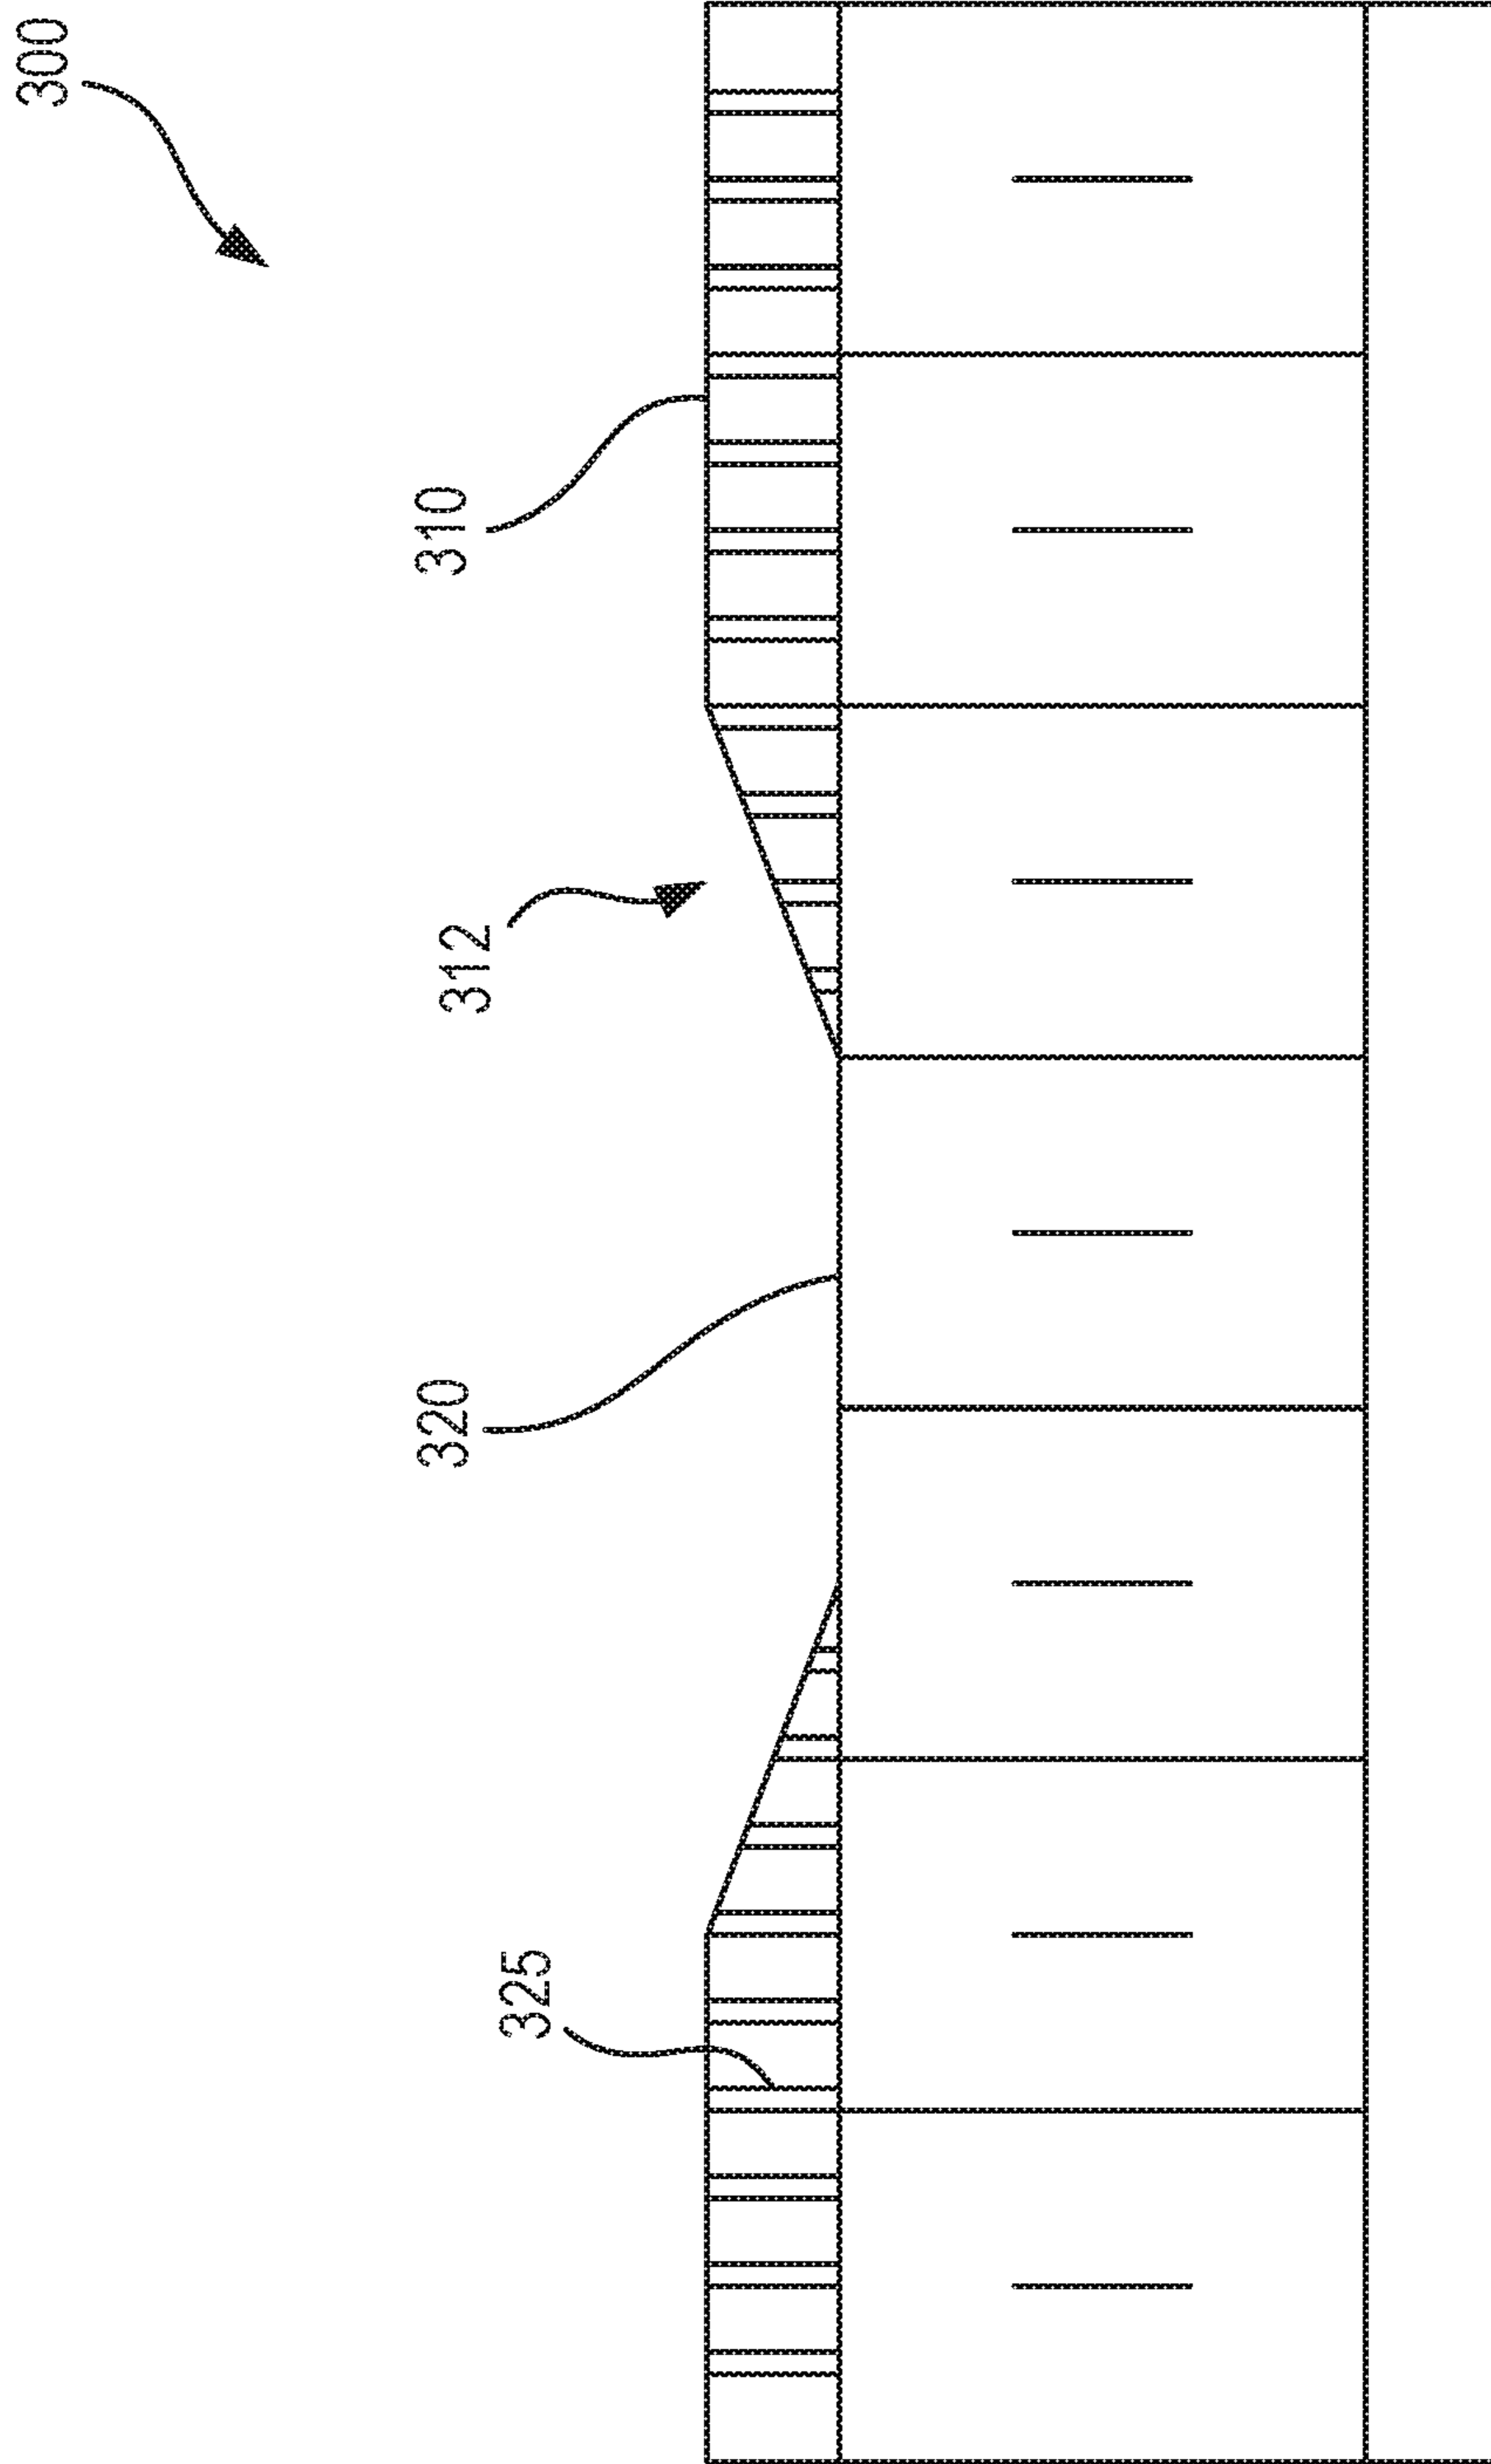
FIG. 3 illustrates a schematic cross-section view of an acoustic panel with a damaged portion of a perforated top skin removed in accordance with various embodiments;

Referring to FIG. 3, a schematic cross-section view of an acoustic panel 300 with a damaged portion of a perforated top skin 310 removed is illustrated according to various embodiments. The damaged portion may be cut with a continuously sloped ramp portion 312 between the top of the top skin 310 and the core section 320 where the top skin 310 is completely removed. However, in various embodiments, the damaged portion may be cut with a stepped profile. In various embodiments, the acoustic panel 300 may be curved in two or three dimensions. The curved shape may make it difficult to align perforations 325 between the remaining top skin and a replacement patch.

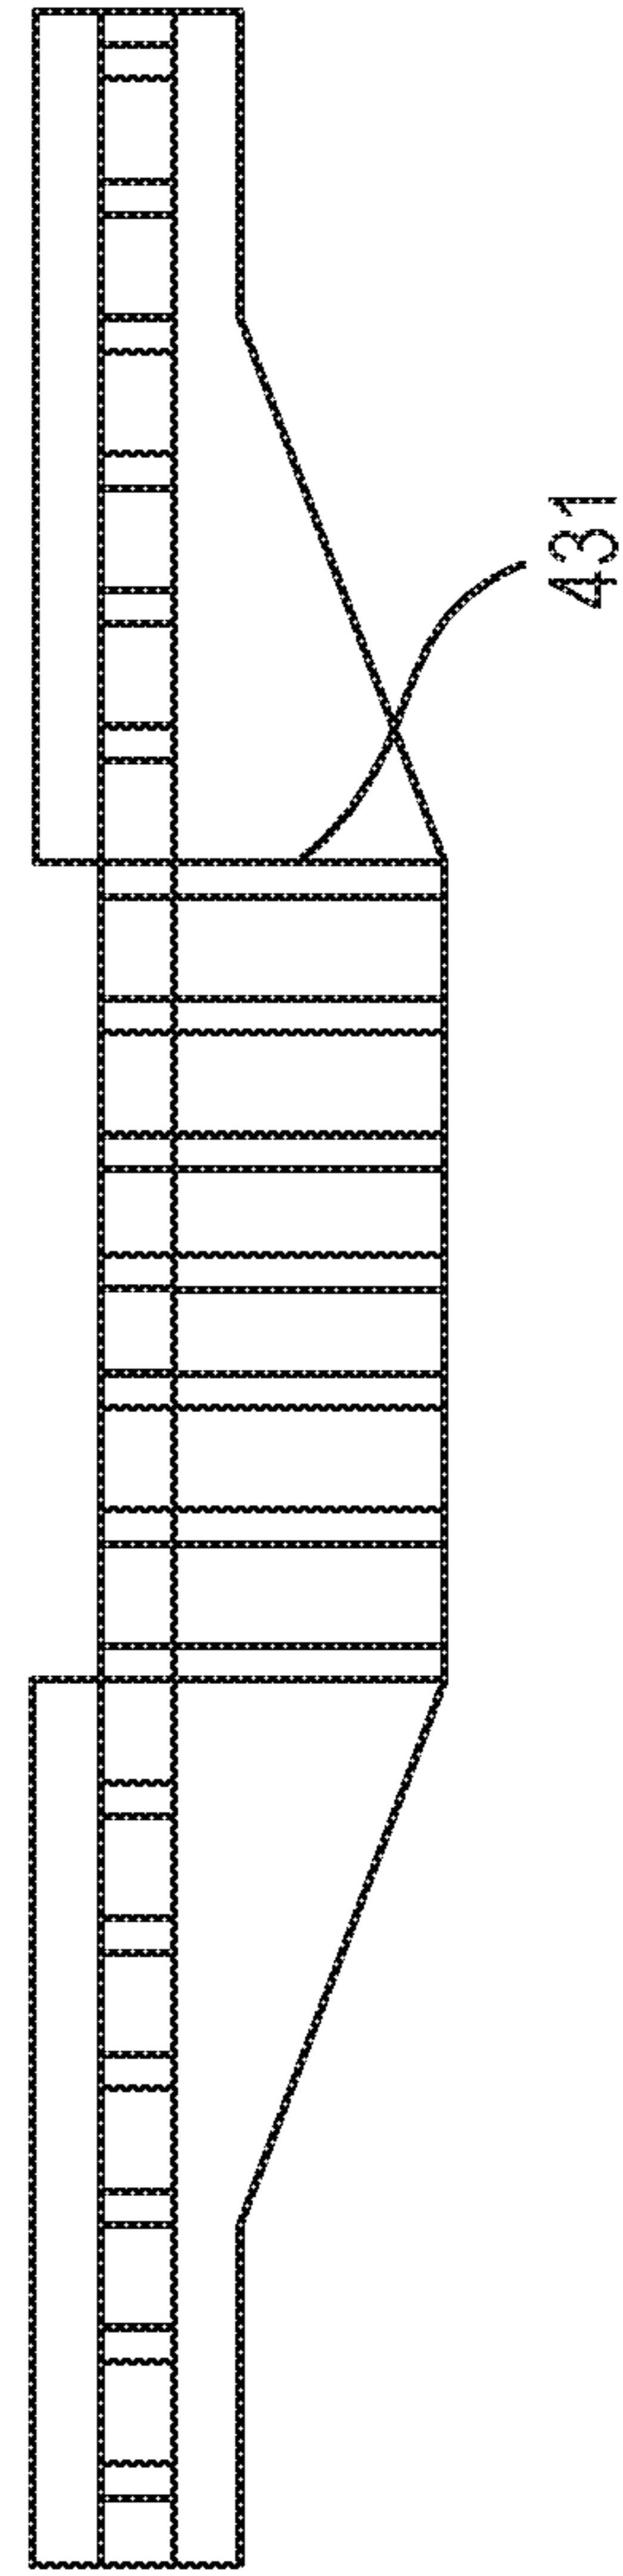
FIG. 4C illustrates a schematic cross-section view of a replacement patch with perforations in a core portion in accordance with various embodiments

Referring to FIGS. 4A-4C, a schematic cross-section view of a replacement patch 400 is illustrated according to various embodiments. The replacement patch 400 may comprise a plurality of composite plies. The plies may be laid up on a bond tool which matches the shape of the component which is being repaired. The replacement patch 400 may comprise a core portion 401 which is configured to be placed directly over the core of an acoustic panel where the original top skin is completely removed. The replacement patch 400 may comprise a ramp portion 402 which is configured to be placed where the original top skin is partially removed. The replacement patch 400 may comprise an overlap portion 403 which is configured to be placed over the original top skin.

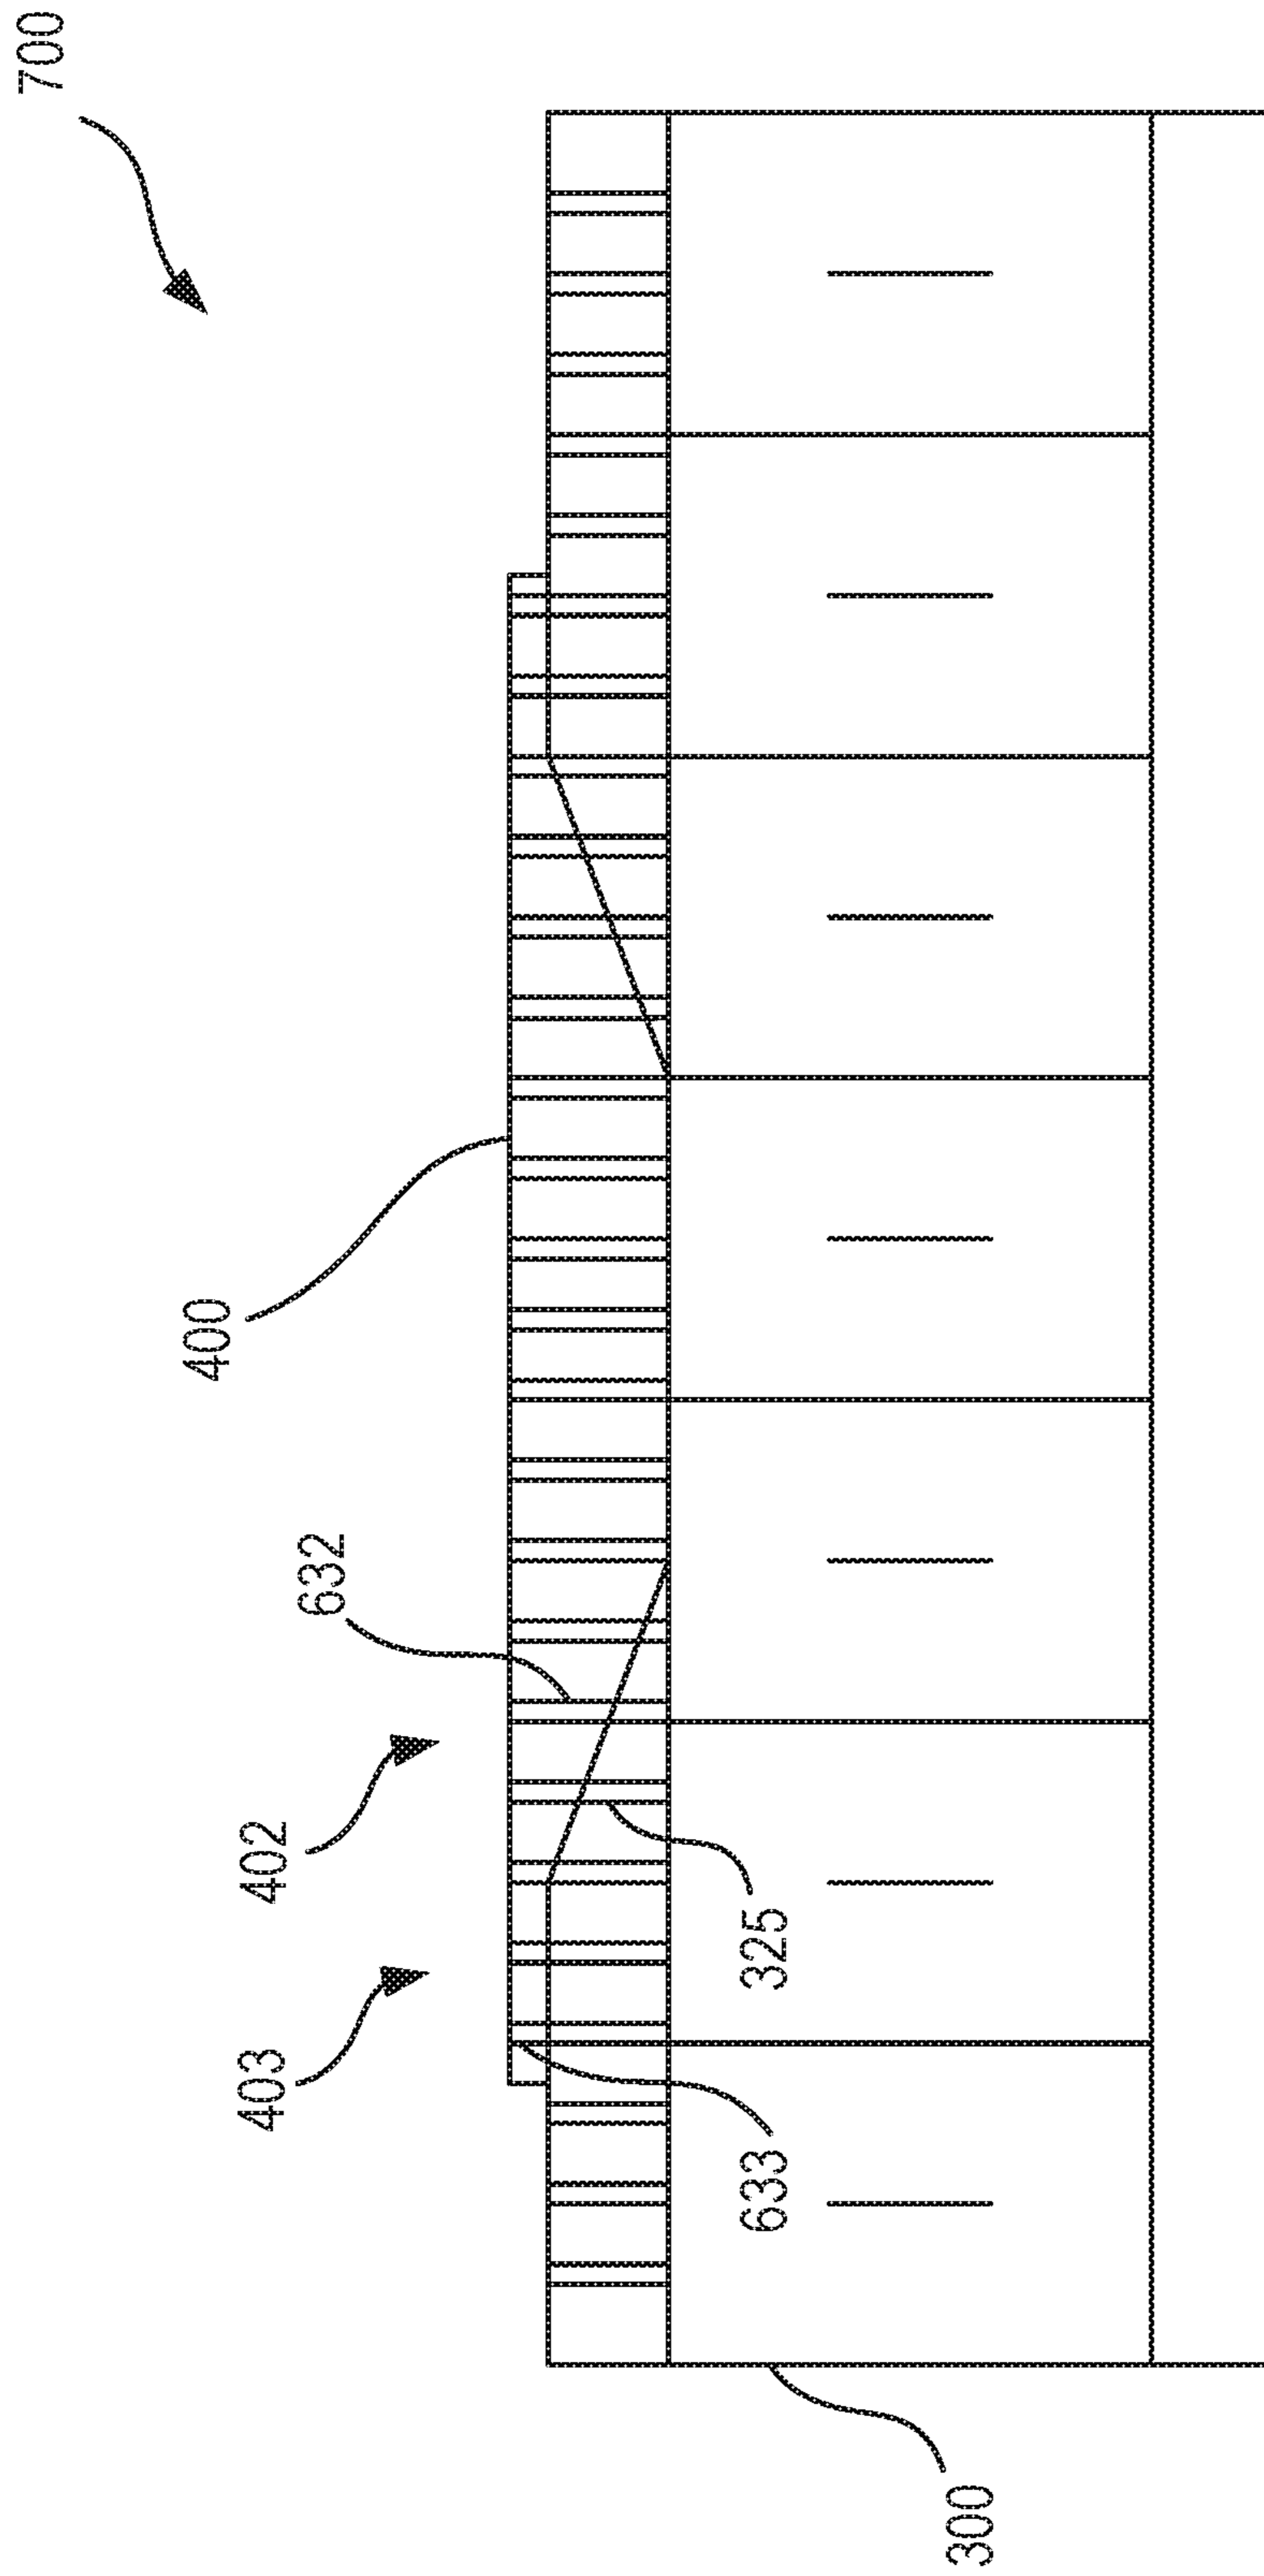
FIG. 7 illustrates a repaired acoustic panel, in accordance with various embodiments; and
