(54) **ACOUSTIC PANEL REPAIR WITH
RETENTION OF ACOUSTIC PROPERTIES**

An acoustic panel (200) for an aircraft nacelle (100) may comprise a perforated first skin (220), a second skin (230), and a core (210) sandwiched between them. A damaged portion of the perforated first skin may be removed. A fiberglass ply (510) may be coupled to the acoustic panel. A pressure differential may cause the fiberglass ply to form dimples (515) within the perforations (325) of the first skin. The fiberglass ply may be used as a template to drill holes in a replacement patch (400).

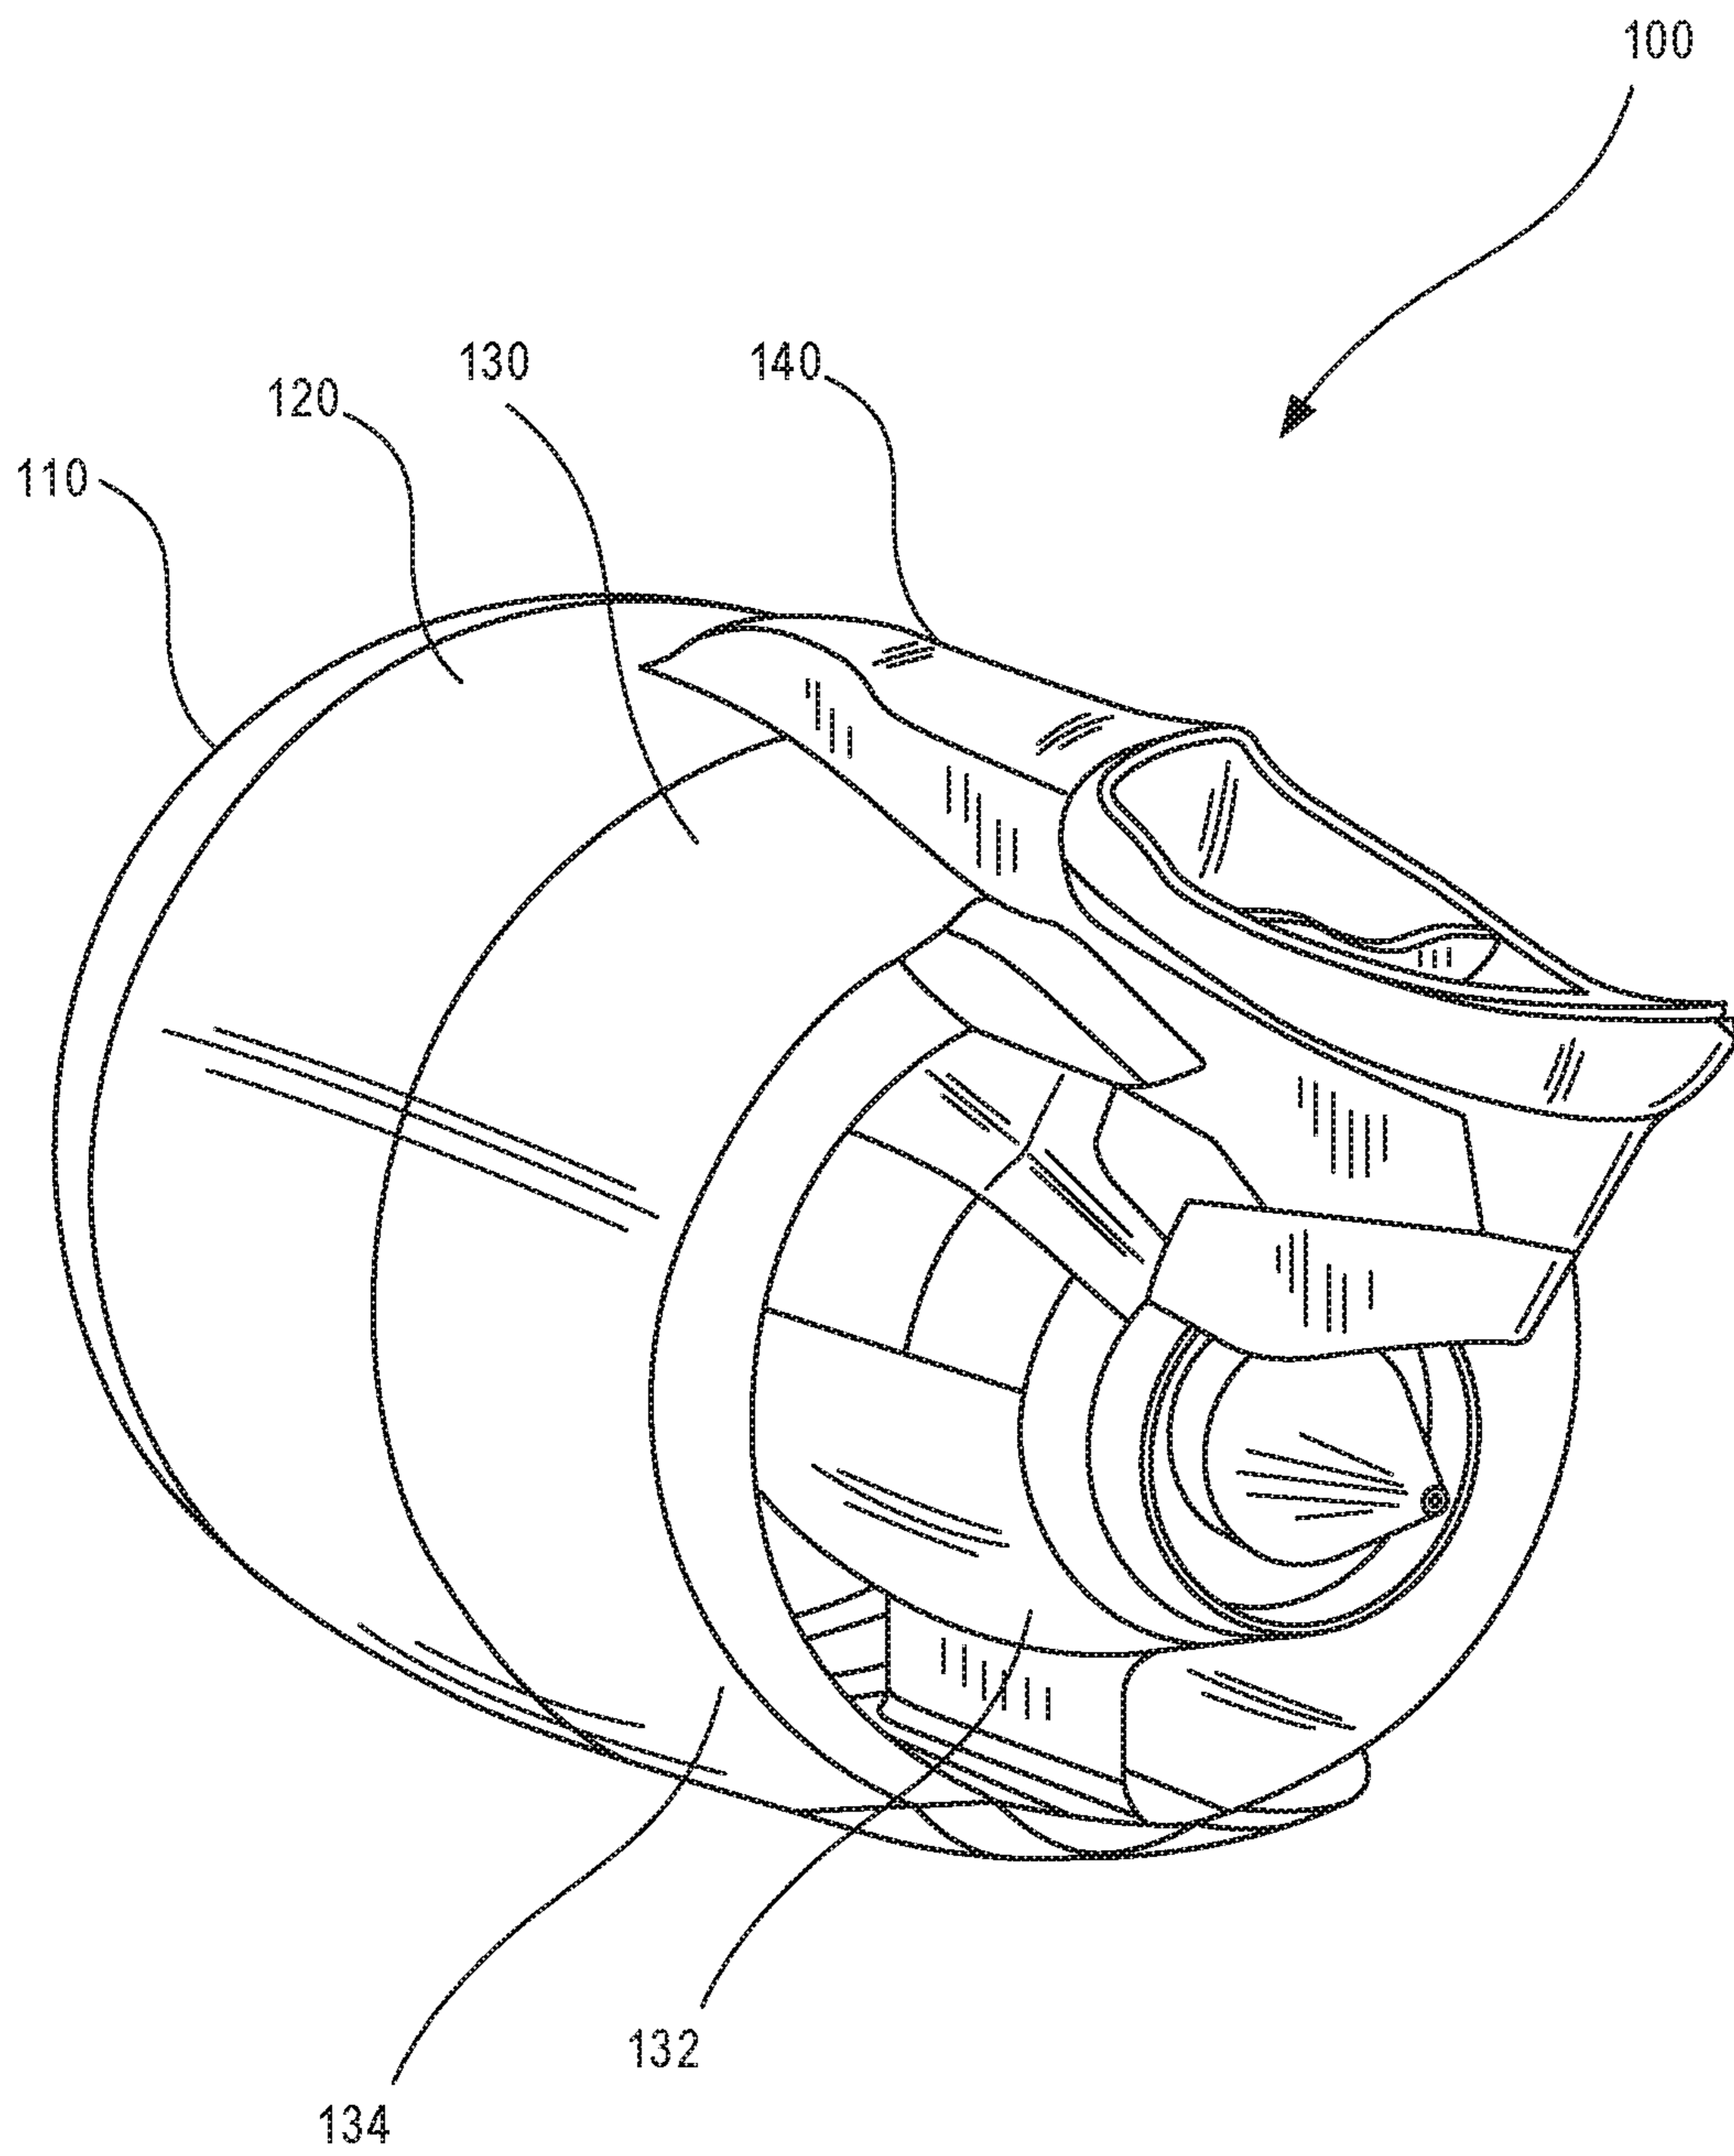
FIG. 1 illustrates a perspective view of a nacelle for an aircraft in accordance with various embodiments;

Referring to FIG. 1, a nacelle 100 for a gas turbine engine is illustrated according to various embodiments. Nacelle 100 may comprise an inlet 110, a fan cowl 120, and a thrust reverser 130. Nacelle 100 may be coupled to a pylon 140, which may mount the nacelle 100 to an aircraft wing or aircraft body. Thrust reverser 130 may comprise an inner fixed structure (“IFS”) 132, an outer fixed structure (“OFS”), and a translating sleeve 134. Bypass air from an engine fan may flow in a generally annular bypass air duct defined between the IFS 132 and the translating sleeve 134. Portions of the inner fixed structure 132, the translating sleeve 134, and the inlet 110 may be commonly formed using acoustic panels.

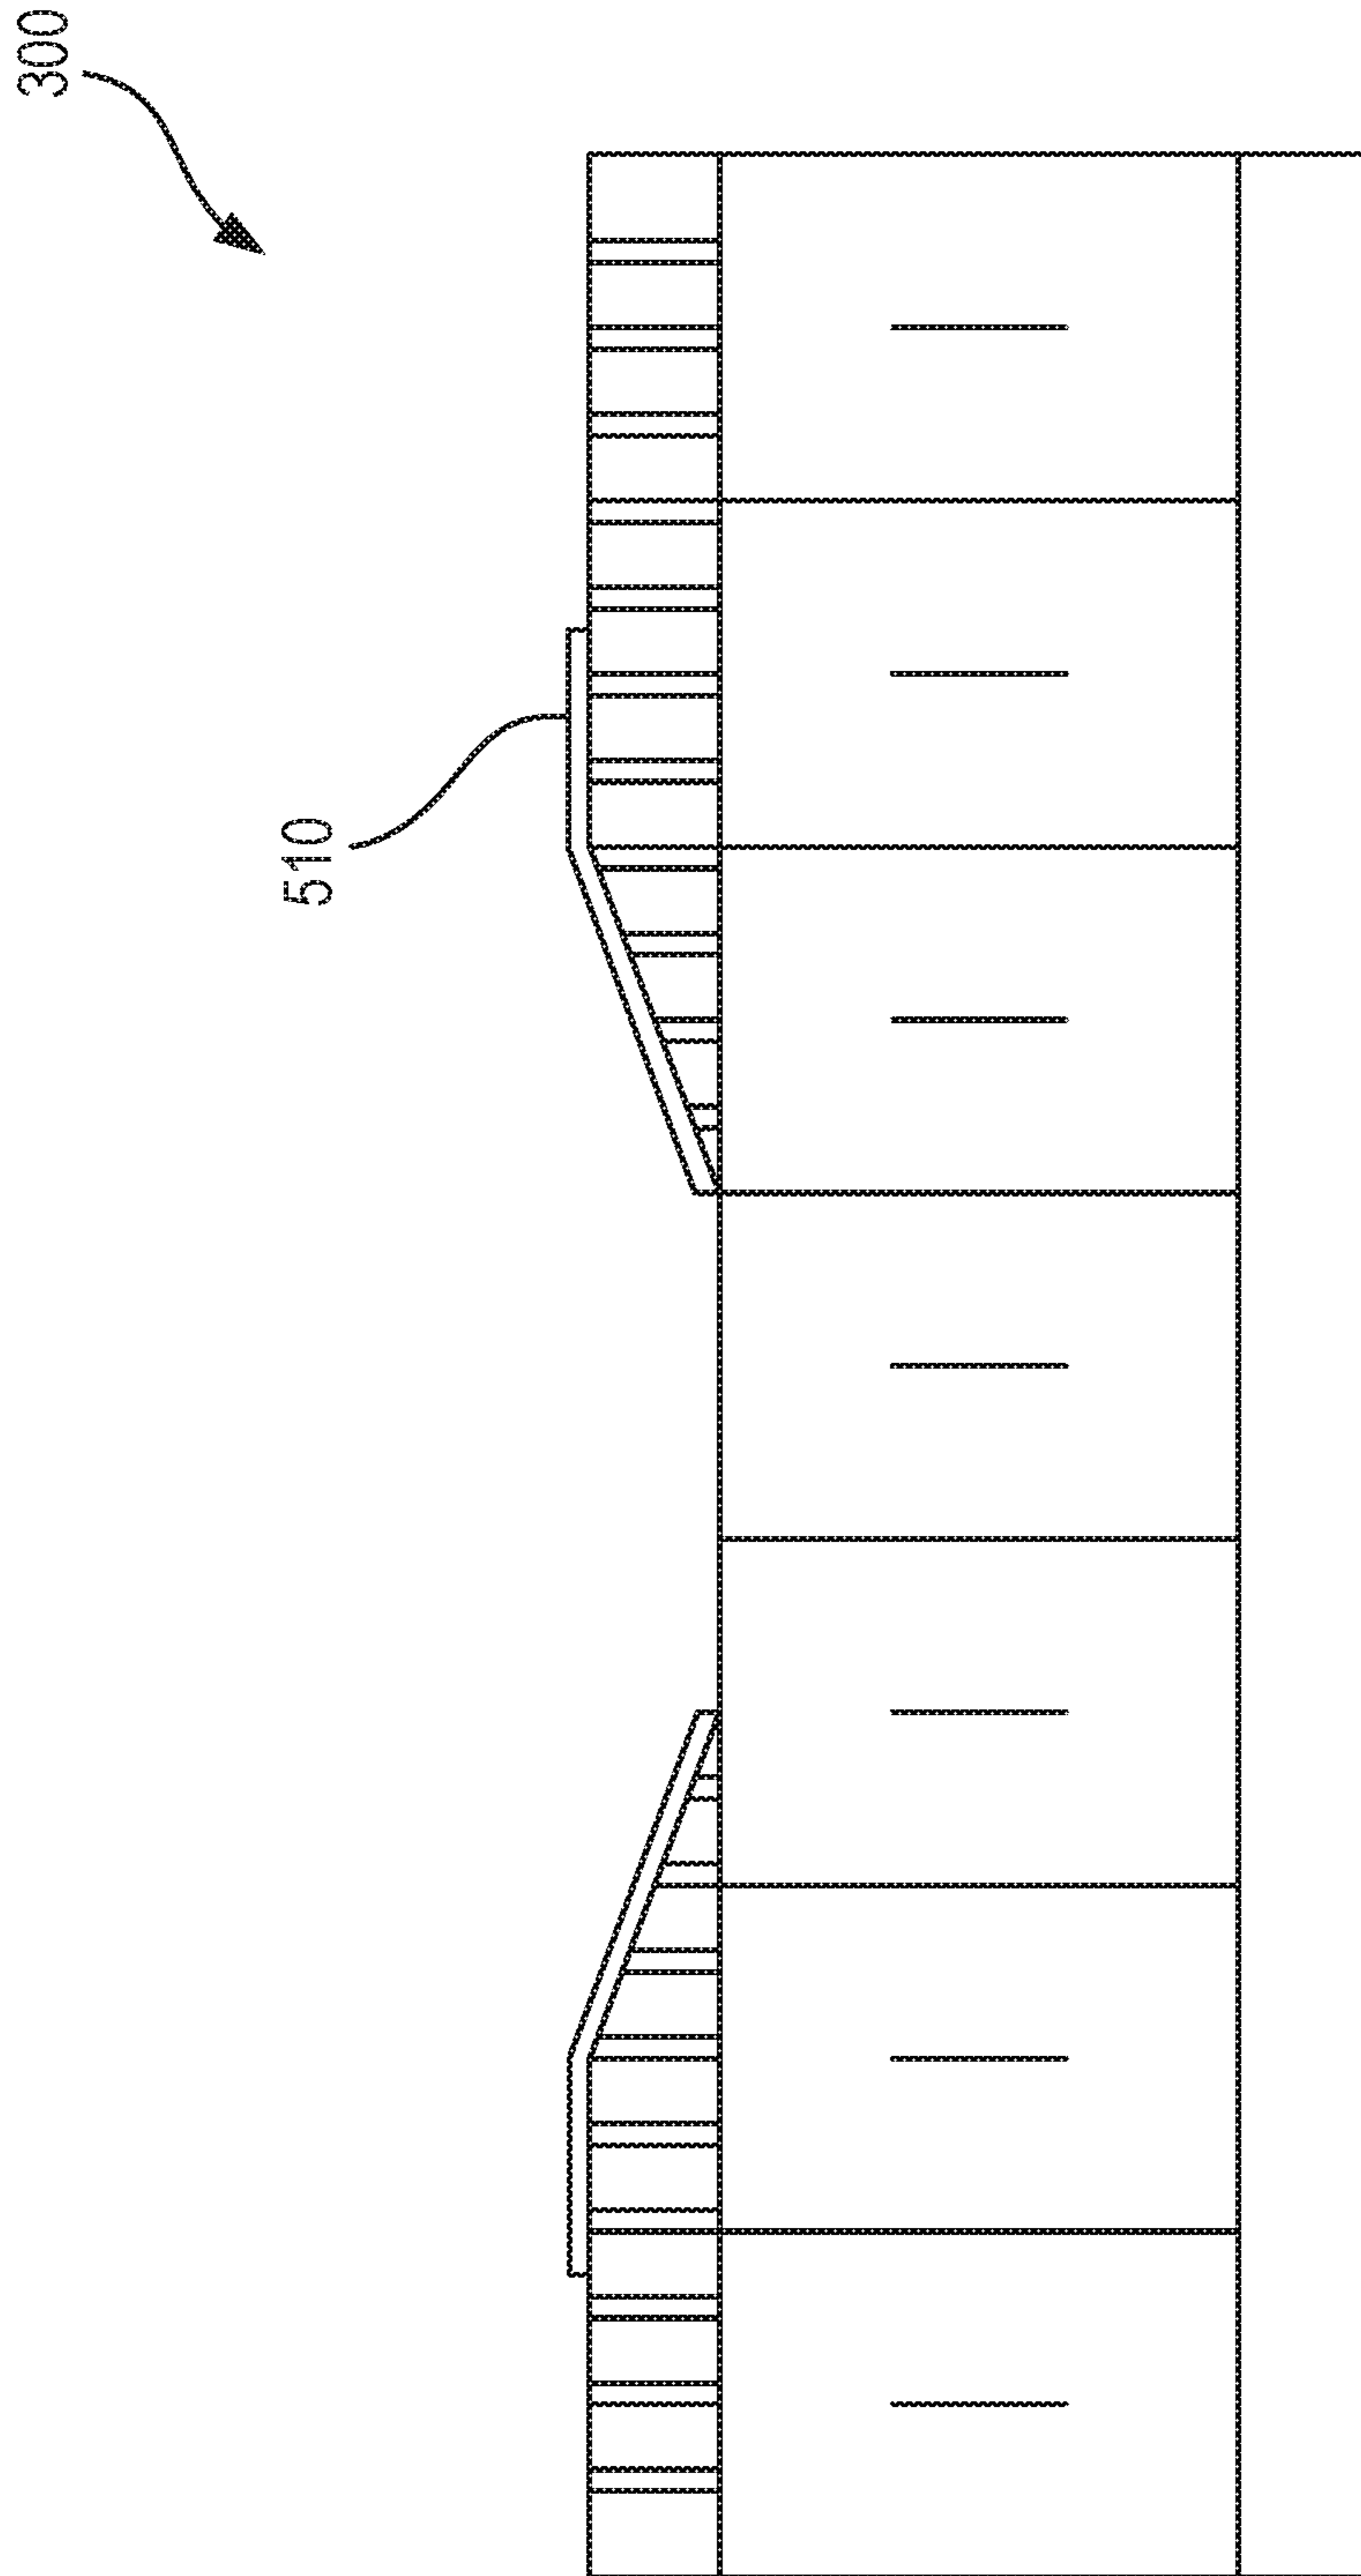
FIG. 5A illustrates a schematic cross-section view of an acoustic panel with an uncured fiberglass ply in accordance with various embodiments;

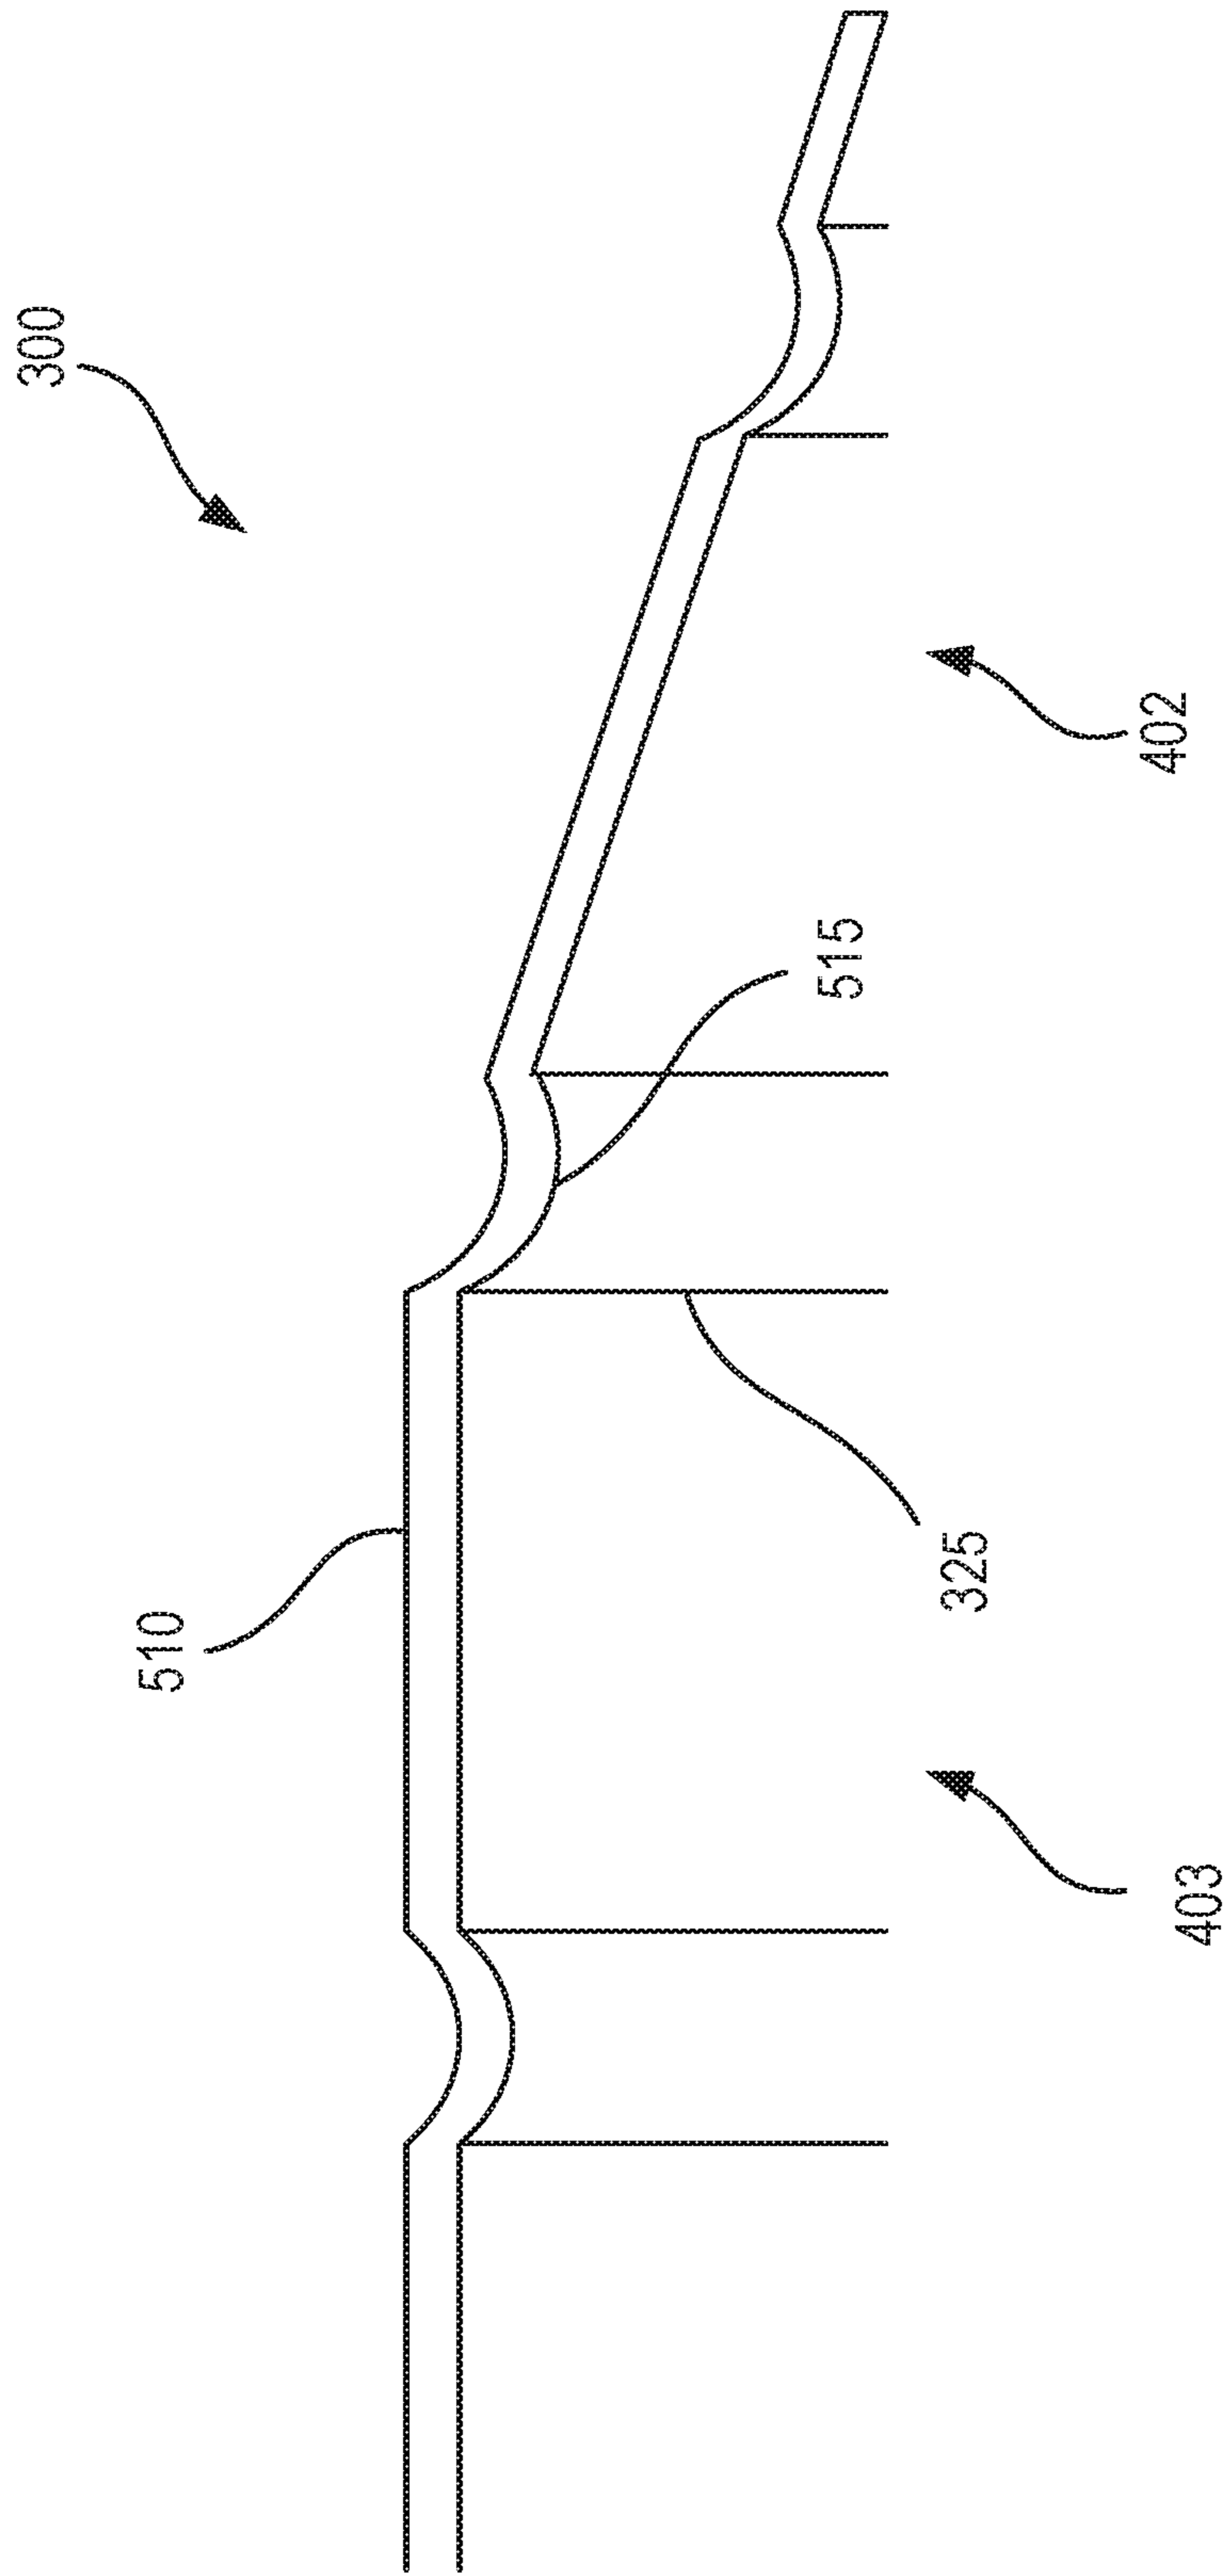
FIG. 5B illustrates a schematic cross-section view of an acoustic panel with a fiberglass ply with dimples in accordance with various embodiments
