US010828667B1

(54) **REMOVAL OF EPOXIES FROM METAL SUBSTRATES**

A method of repairing a defectively manufactured multi-layer component having a substrate material and a primer layer includes applying, to the primer layer, a solvent that causes the primer layer to swell to form a swelled primer layer. The method also includes abrading away the swelled primer layer from the multi-layer component and rebuilding the multi-layer component by forming a new primer layer on the substrate material.

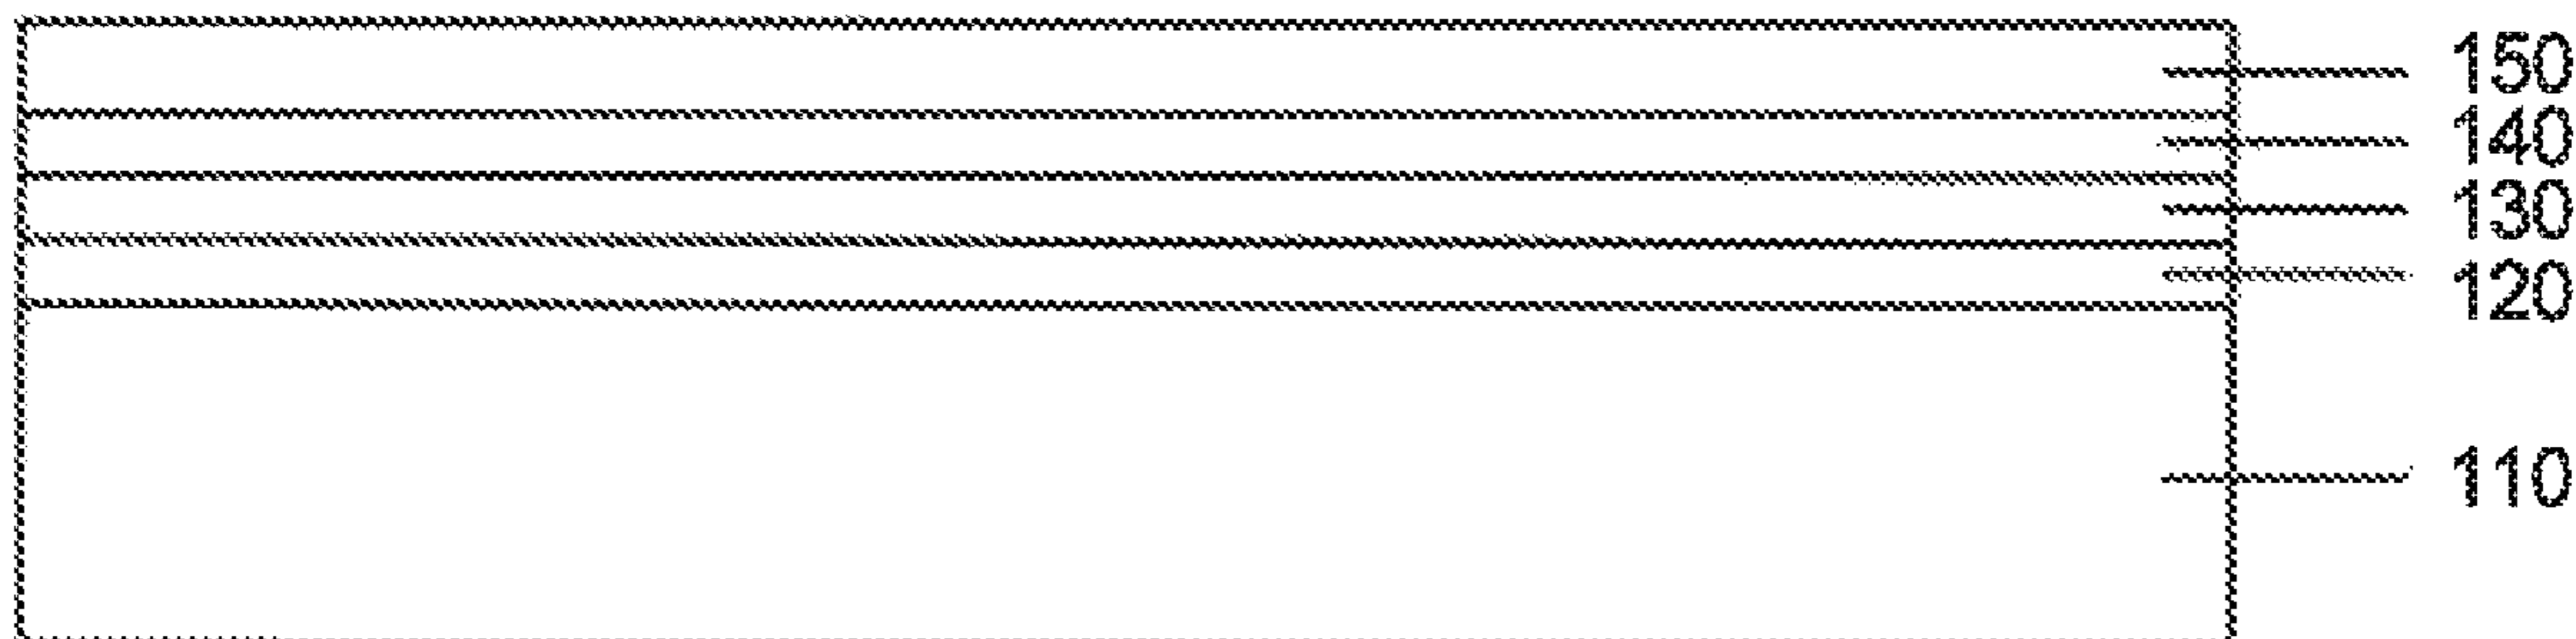
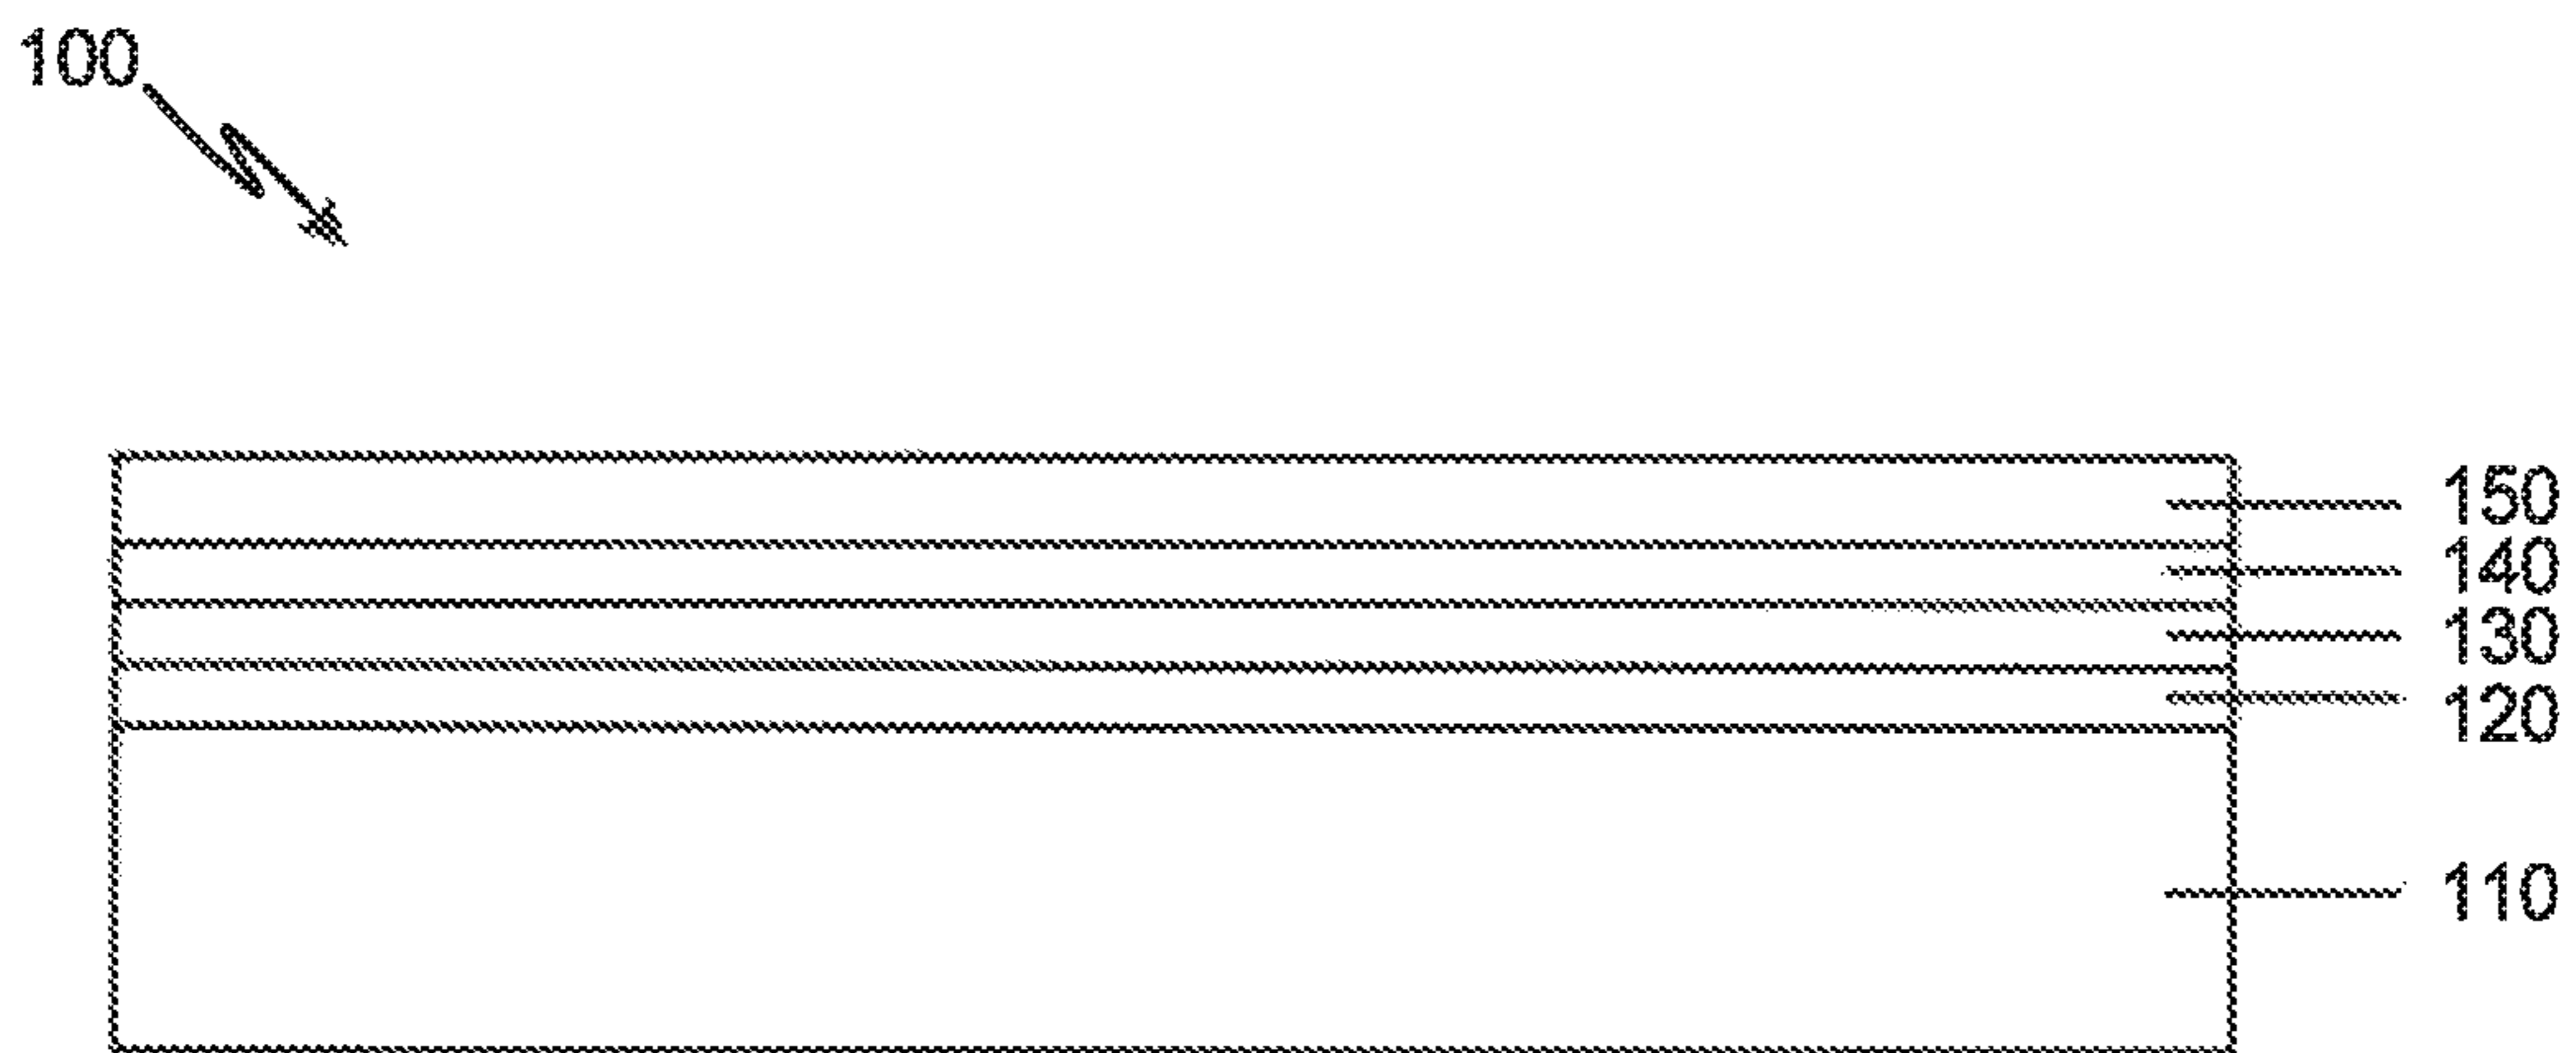
Fig. 1

FIG. 1 is a cross-sectional view of a multi-layer component.

FIG. 1 is a cross-sectional view of a multi-layer component. FIG. 1 shows component 100 including substrate material 110, anodized layer 120, primer layer 130, structural adhesive 140, and coating 150. Component 100 can be, for example, a compressor blade, turbofan blade, a turbo-prop propeller blade, tilt rotor prop, vane strut, or other component with a toughened epoxy layer.
