(54) **CESSNA TAIL-CONE REINFORCEMENT ANGLE SPLICE, INSTALLATION KIT, AND METHOD FOR INSTALLATION THEREOF**

A tail-cone reinforcement angle of a Cessna 180-185 series aircraft is repaired by the removal of an aft most section of that tail-cone reinforcement angle and its replacement with an elongated splice body. The elongated splice body is attached to the remainder of the tail-cone reinforcement angle and to the tail-cone portion of the fuselage of the aircraft. The aft section of the original tail-cone reinforcement angle is subject to the development and propagation of cracks in the area of the rear pivot shaft receiving bore, which cracks render the aircraft unfit for use. The invention includes the provision of a suitable elongated splice body, a method for its installation, and a tool kit which is usable in accomplishing the removal and replacement of the aft section of the tail-cone reinforcement angle.

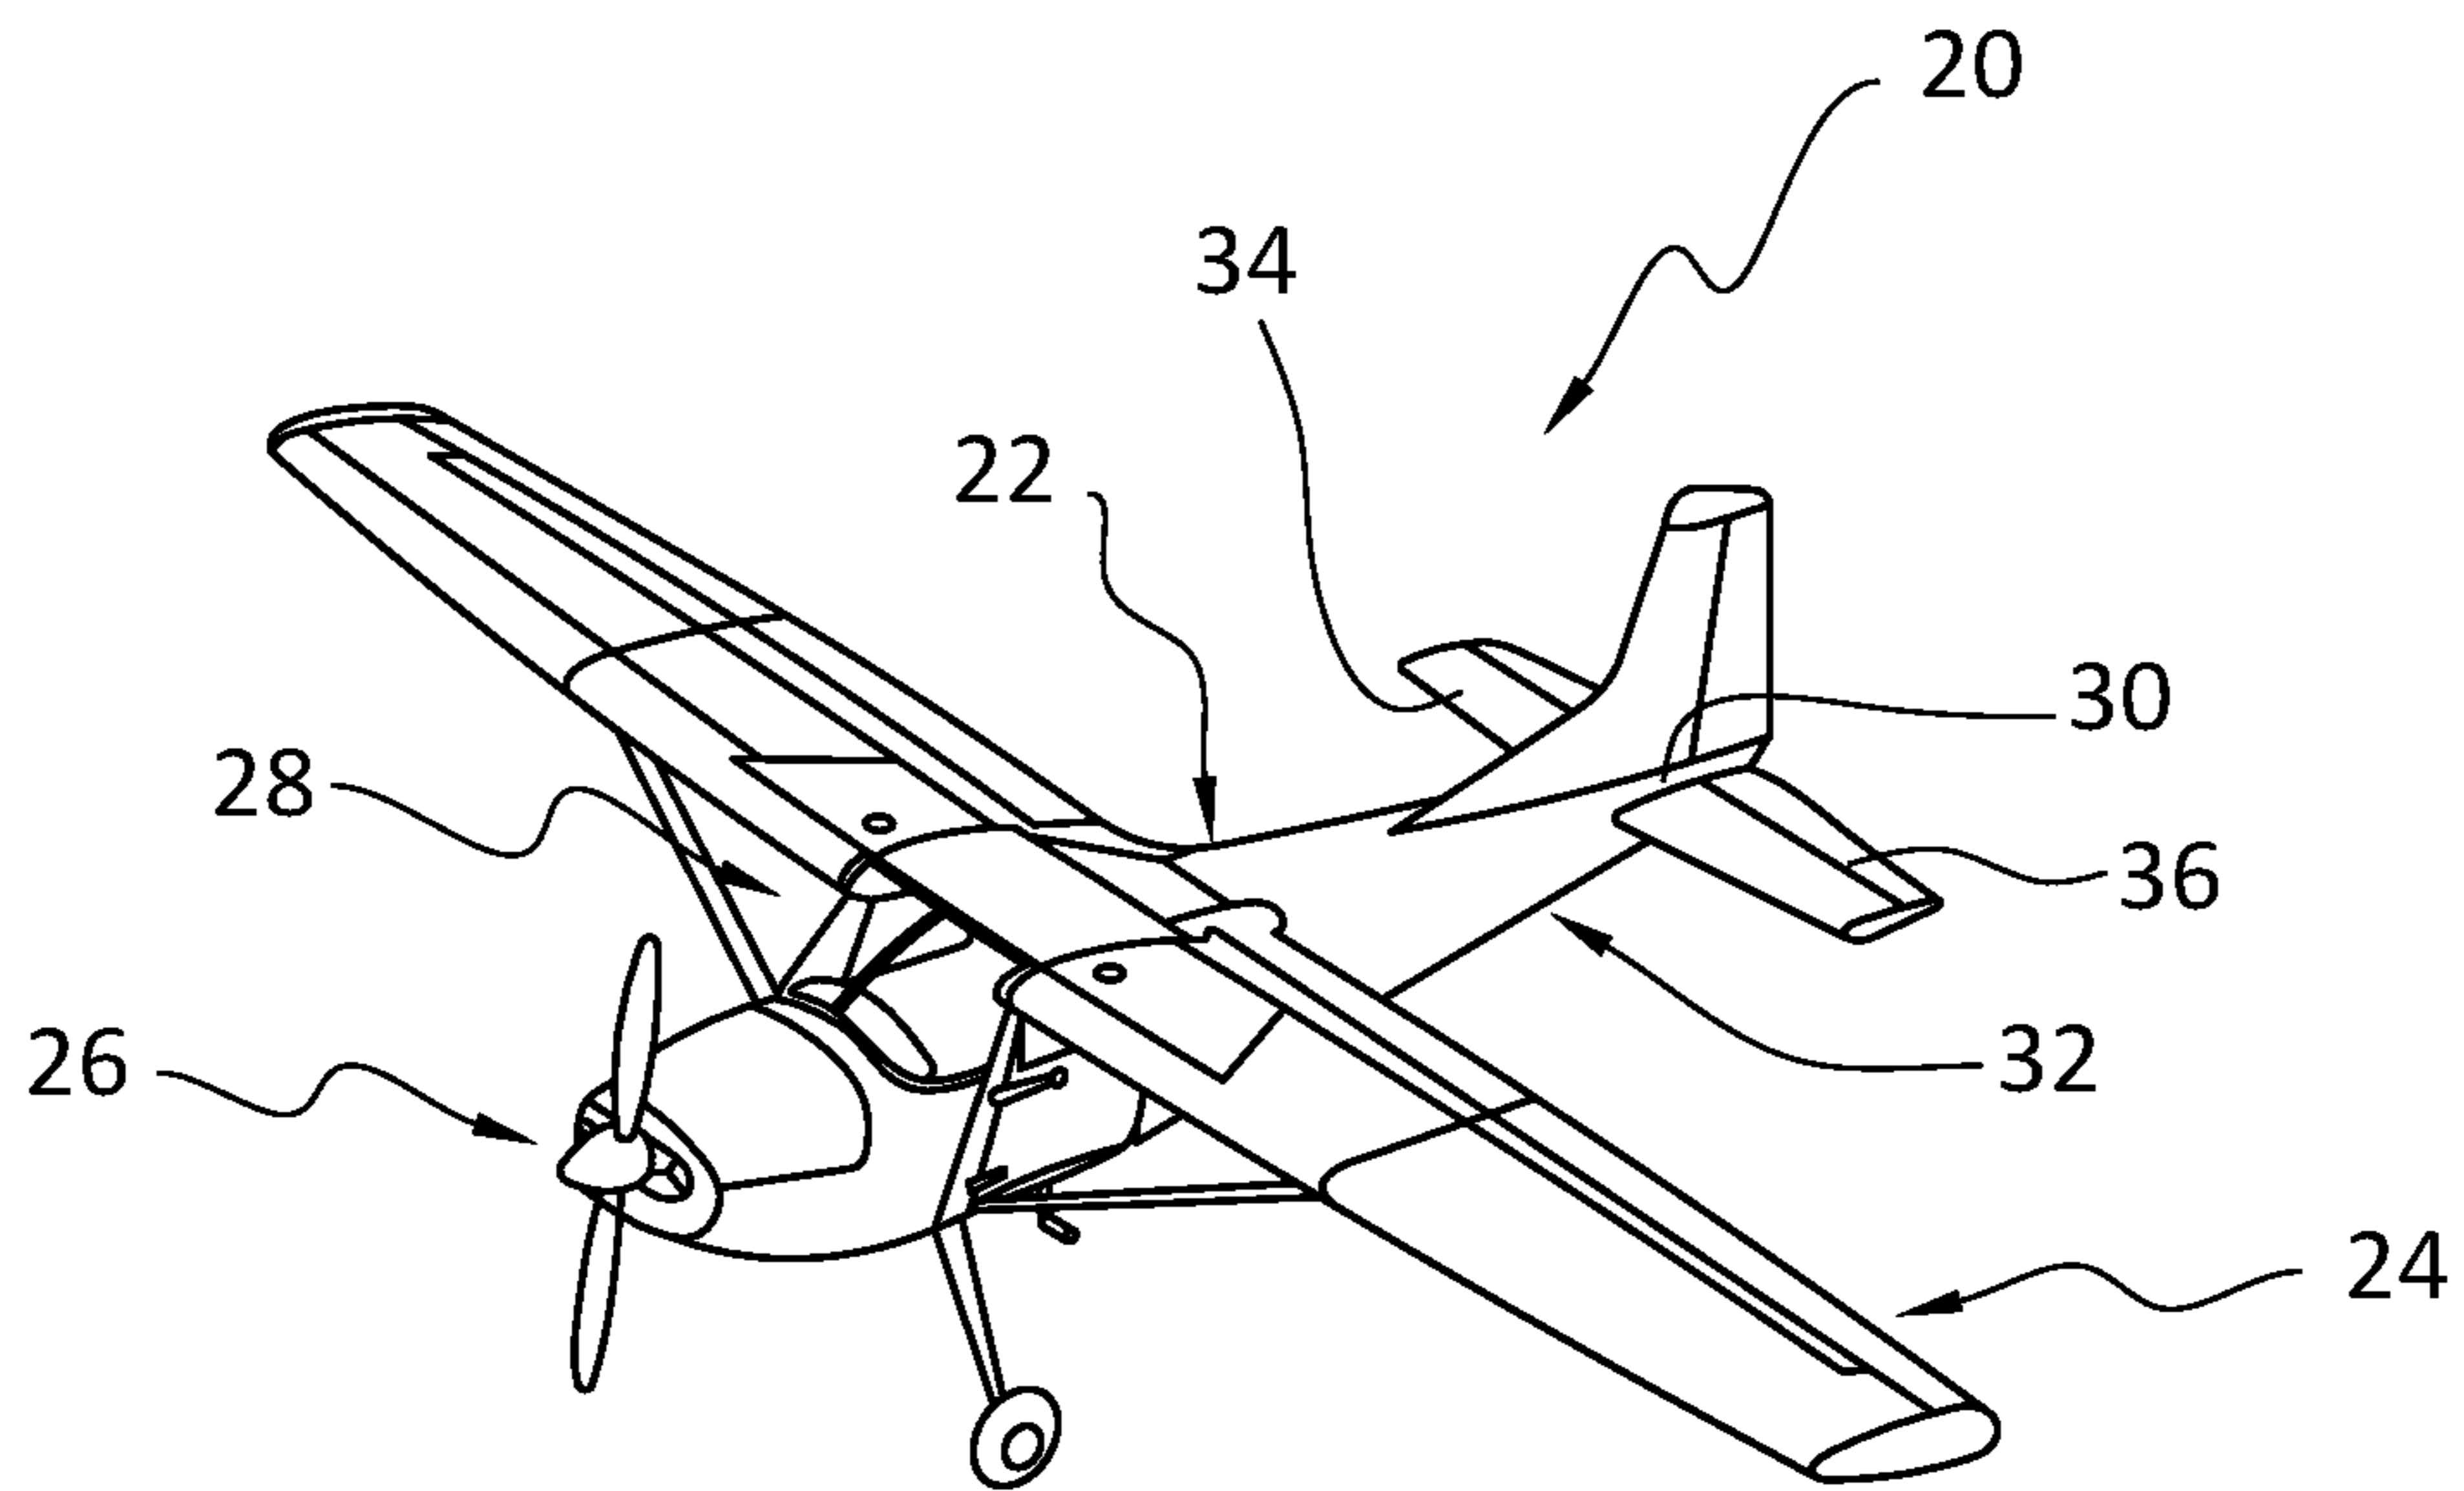
FIG. 1 is a schematic depiction of a Cessna series 180-185 series aircraft with which the pertinent invention is intended for use;

Referring initially to FIG. 1 of the patent drawings filed in the subject U.S. patent application, there may be seen, generally at **20**, a typical Cessna 180-185 series aircraft with which the tail-cone reinforcement angle splice, in accordance with the present invention, finds particular usage. Aircraft **20**, as is well known to one familiar with such aircraft, includes a fuselage, generally at **22**, forward upper mounted wings **24**, an engine and propeller assembly **26**, a cockpit **28** and a rear elevator and stabilizer assembly generally at **30**. The rear elevator and stabilizer assembly generally at **30**, is attached to a rear portion of the fuselage **22**, in an area that fuselage known as the tail-cone **32**, which tail-cone area **32** is seen somewhat schematically in FIG. 2. The rear stabilizer and elevator assembly, generally at **30**, includes a pivotally mounted horizontal stabilizer **34** and a pair of elevators **36**. The horizontal stabilizer **34** is attached to the tail-cone, generally at **32**, in an aft portion **38** of the tail cone **32**. The attachment of the horizontal stabilizer **34** is accomplished by providing pivot shafts which are located in the trailing portion of the horizontal stabilizer **34**, which pivot shafts are well known, are not illustrated, and which form no part of the present invention. The horizontal stabilizer is attached to the tail-cone aft portion **38**, of the aircraft's fuselage **22**, through the provision of horizontal stabilizer pivot shaft receiving apertures or bores **40** which

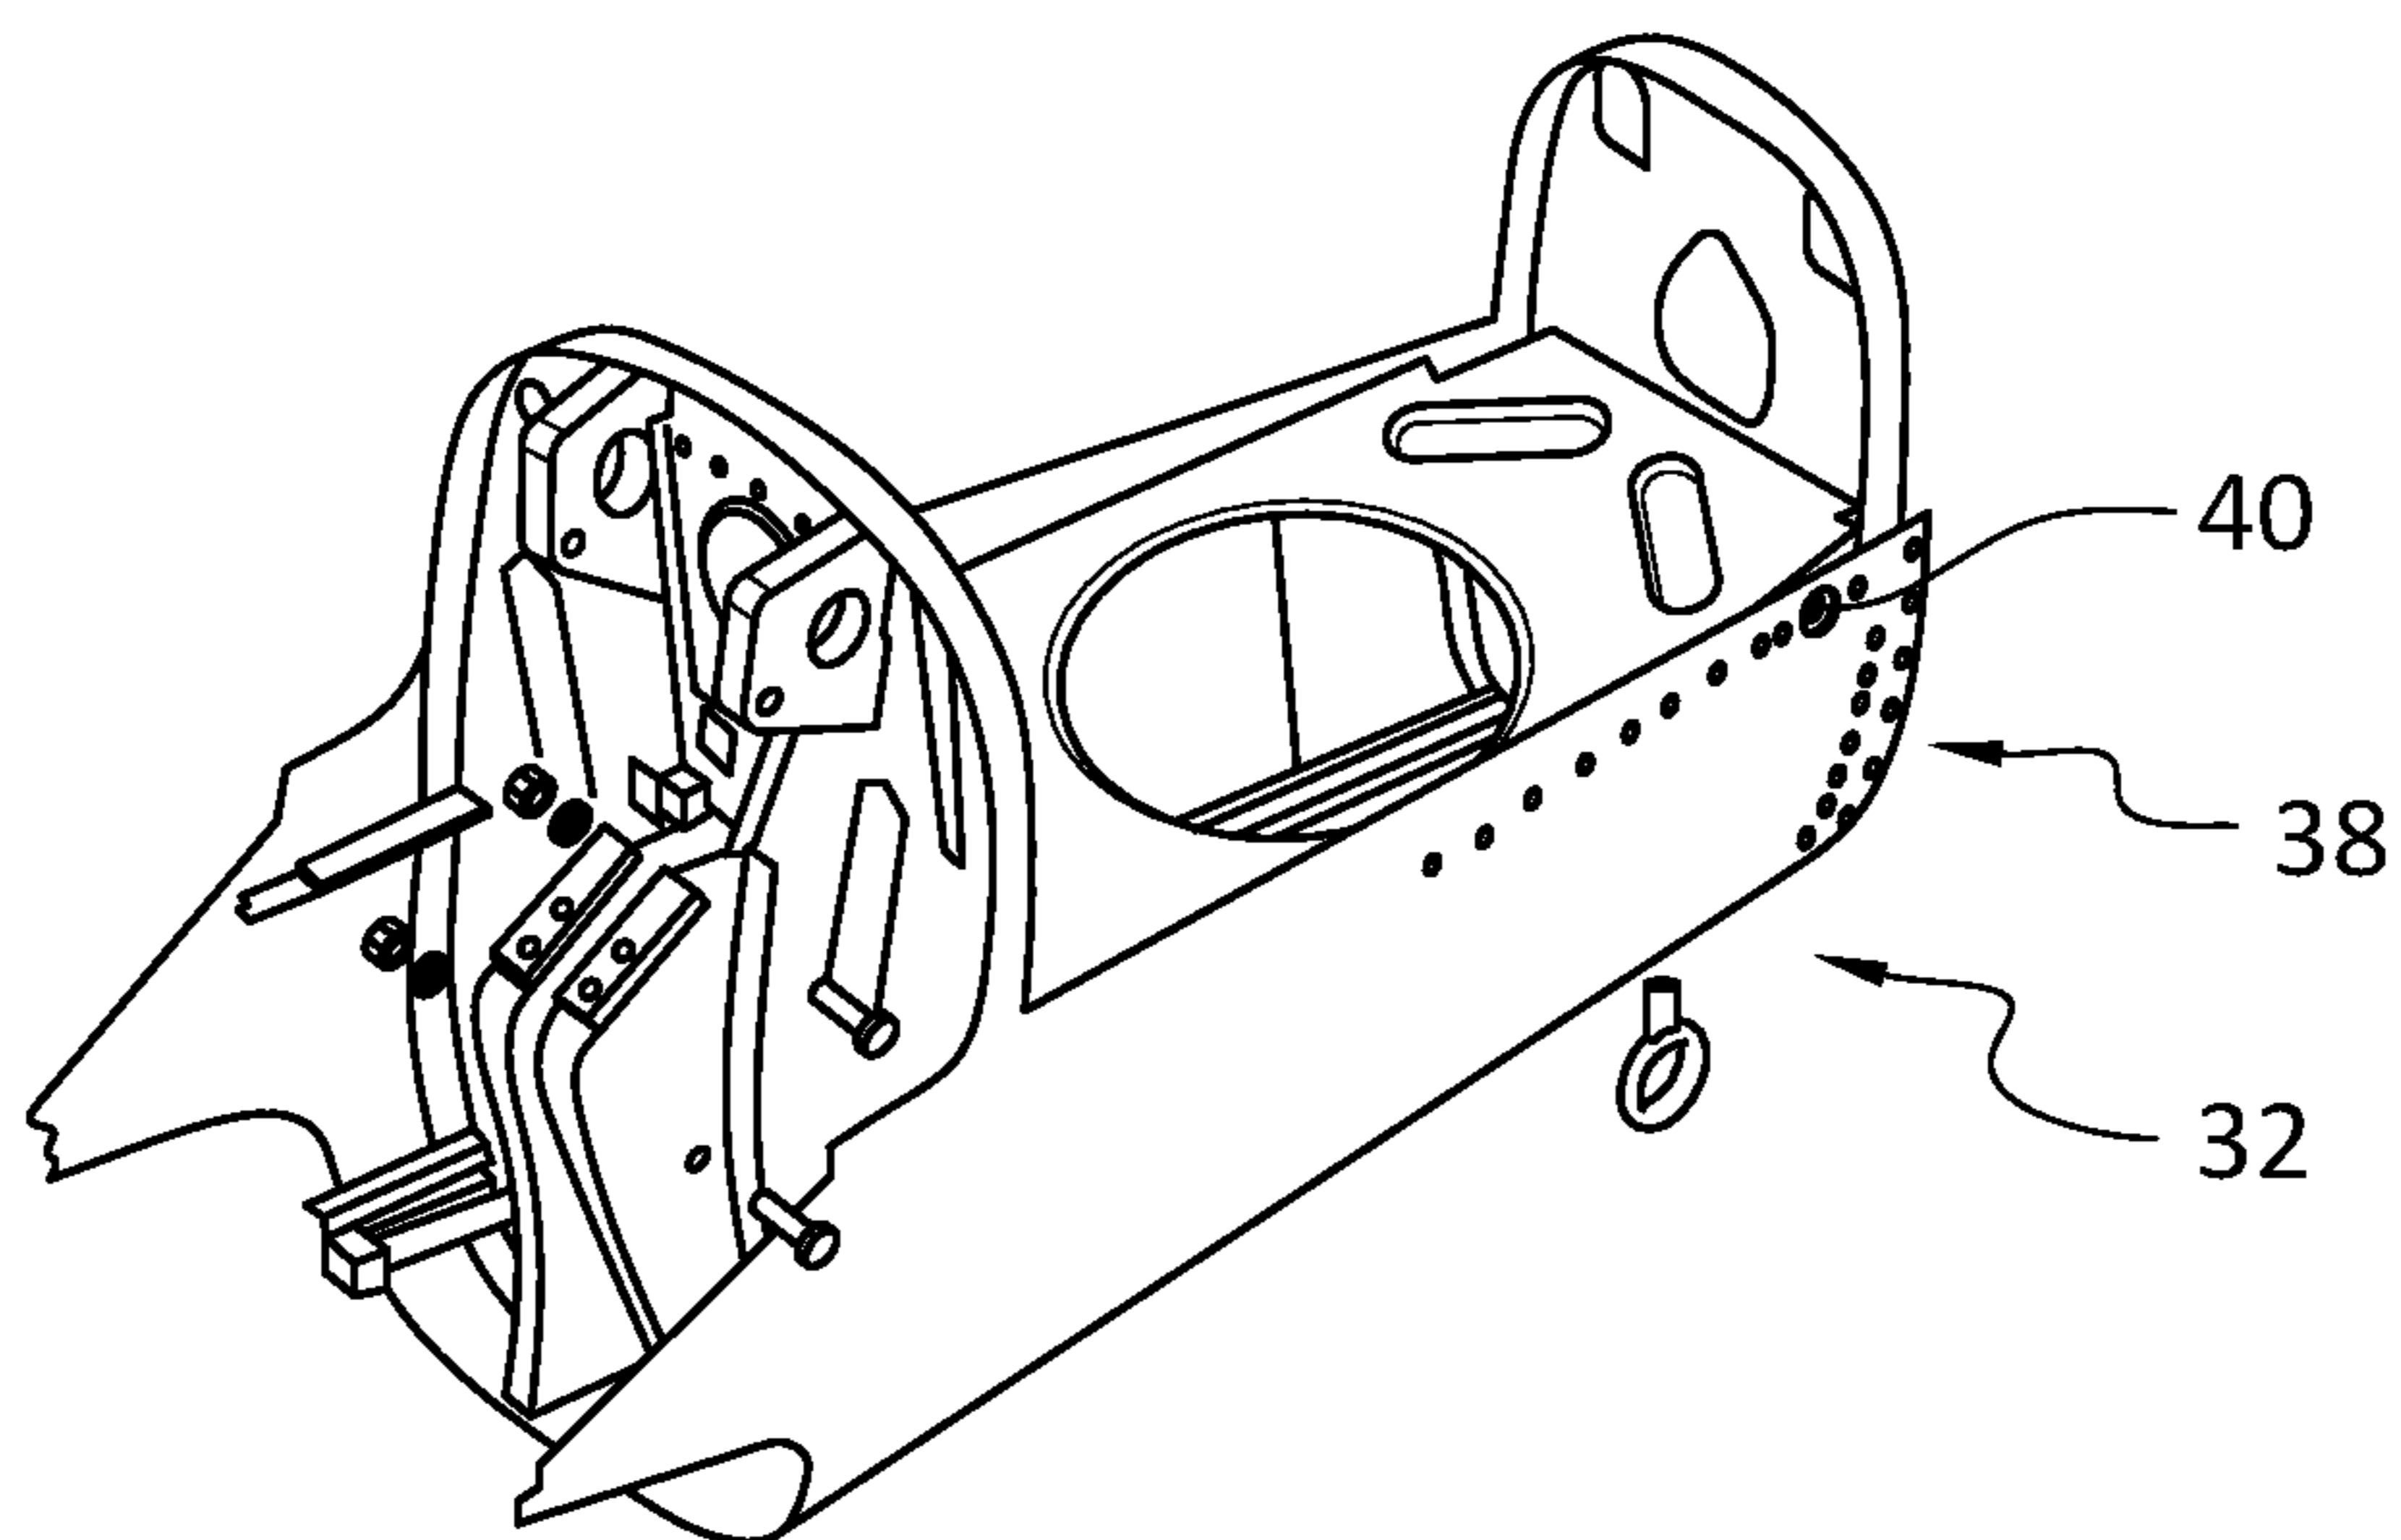
FIG. 2 is a schematic depiction of a tail-cone area of the Cessna 180-185 series aircraft depicted in FIG. 1, and with the horizontal stabilizer, elevator, tail, tail wheel and stinger removed;

Once the tail of the Cessna 180-185 series aircraft has been disassembled, to render the tail-cone assembly as it is depicted in FIG. 2, the installation process may commence. The initial step is to use a suitable reamer, which is supplied in a kit that is provided by the manufacturer of the subject invention, and which is supplied together with, and including the subject tail-cone reinforcement angle splice, as will be discussed subsequently, to ream out both the horizontal stabilizer rear pivot aperture 40 in the tail cone of the fuselage and the underlying bore 44 in the original far aft portion of the now defective tail-cone reinforcement angle. Once this has been accomplished, four aft flush rivets 82, in the tail cone portion 32 of the fuselage 22 and in the underlying blade portion 42 of the tail-cone reinforcement angle, are drilled out. This is depicted in FIG. 9 of the drawings accompanying the application. The holes in the web of the blade portion of the tail-cone reinforcement angle, which result from the drilling out of these four flush rivets 82, will align with the rivet receiving holes 68 in the forward or overlap section 62 of the splice 54.

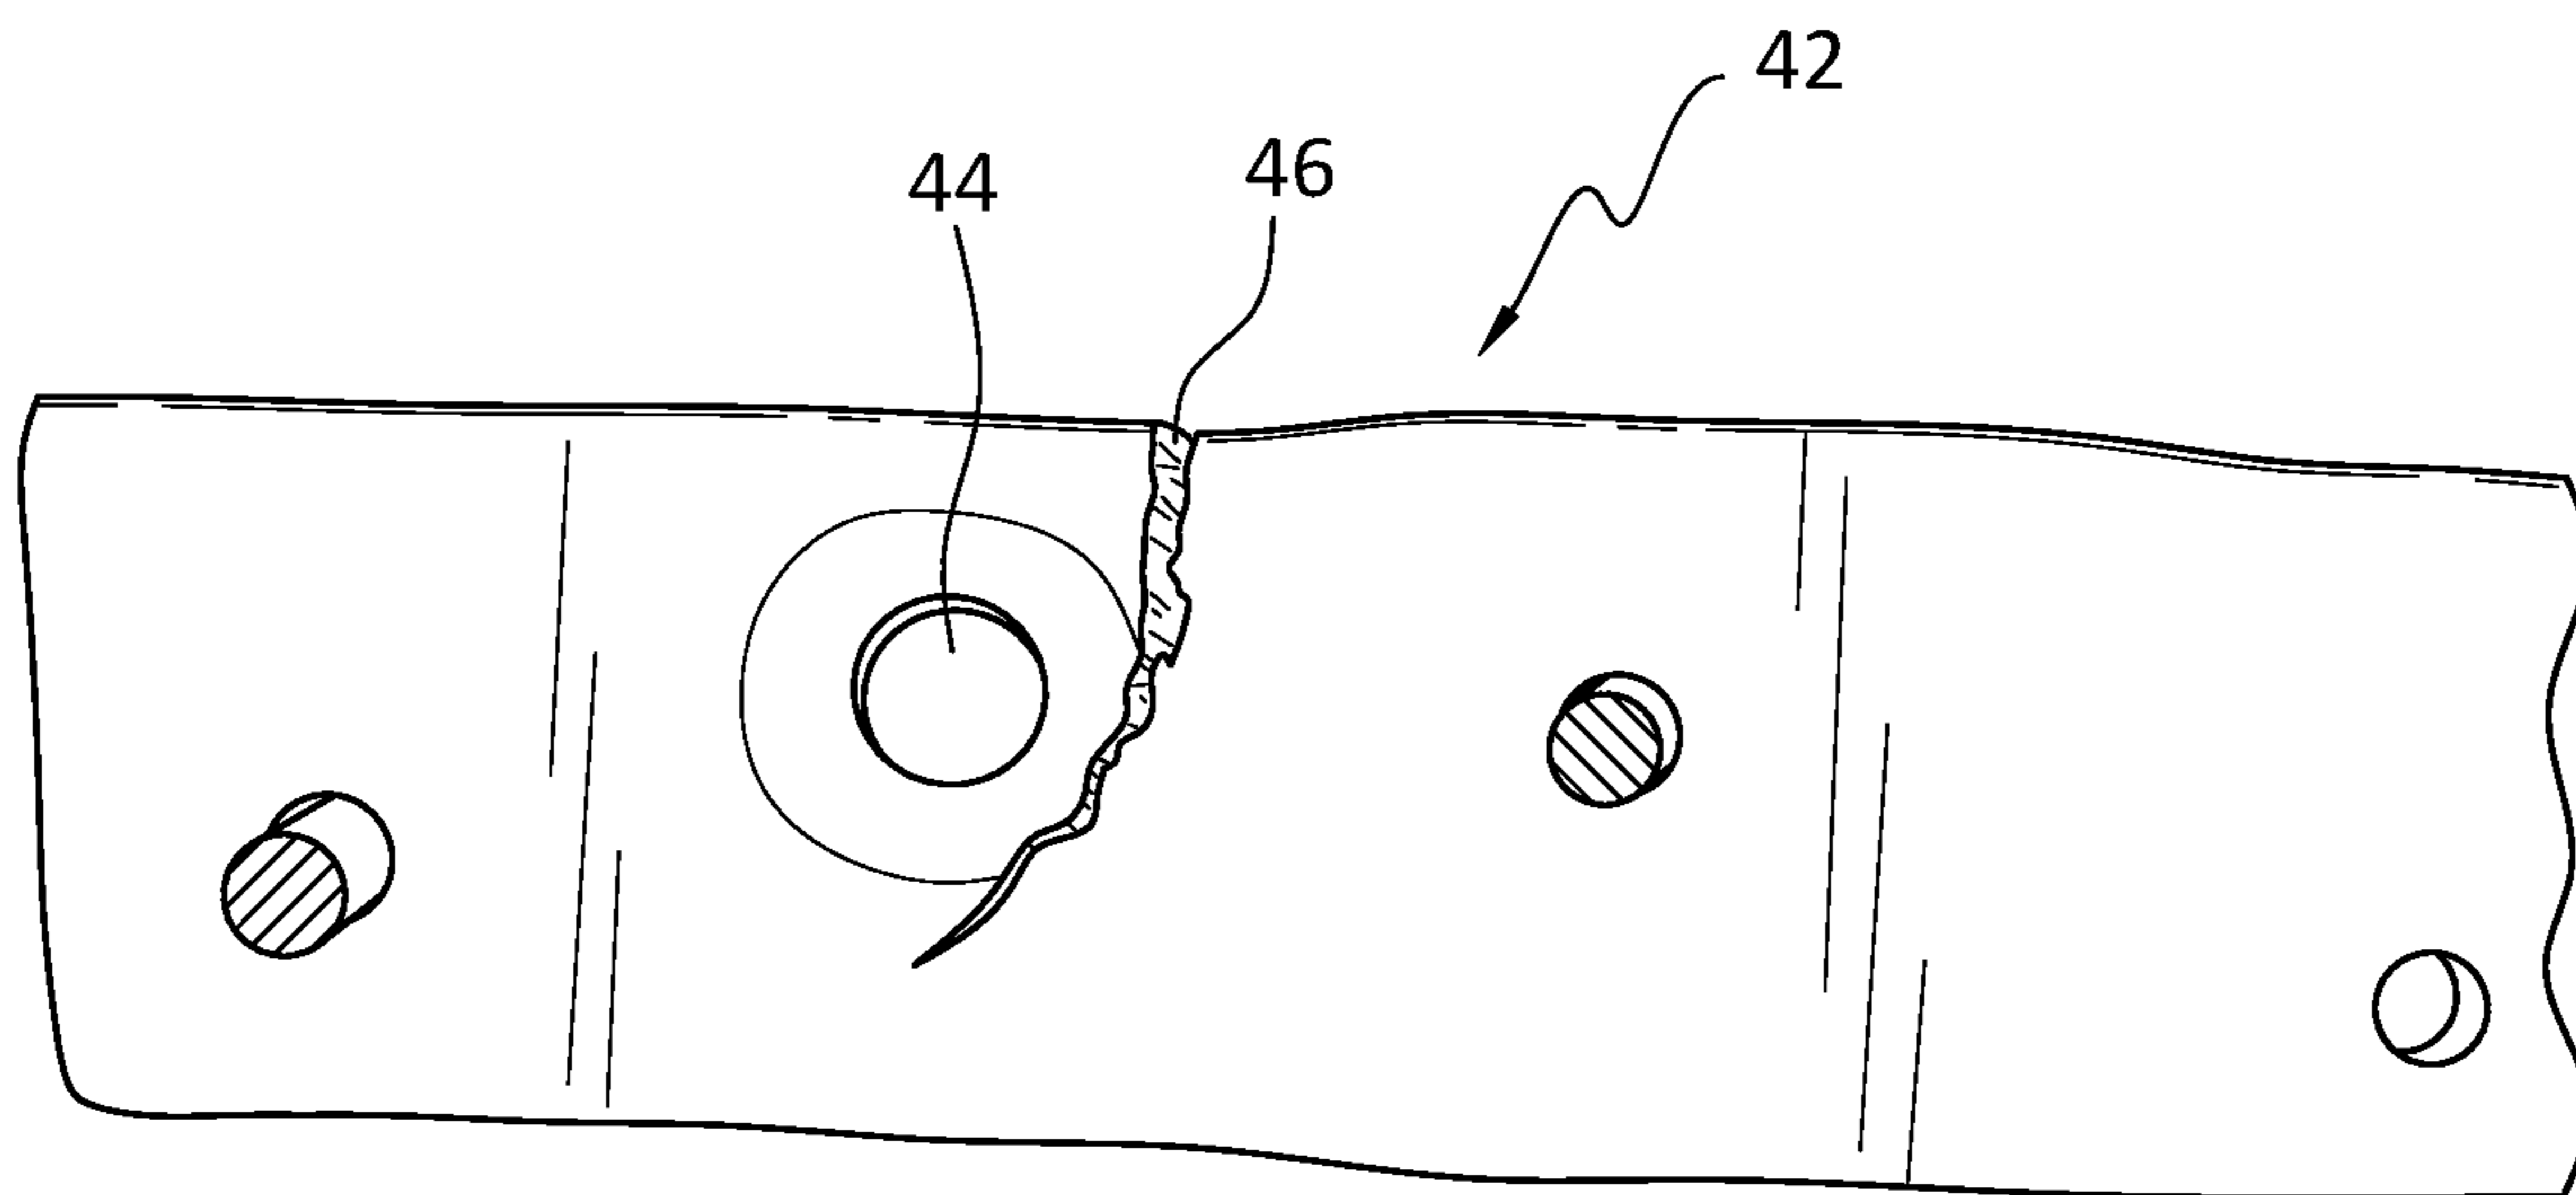
FIG. 3 is a photograph of an aft portion of a tail-cone reinforcement angle showing a typical failure in the horizontal stabilizer pivot shaft receiving bore of tail-cone reinforcement angle;

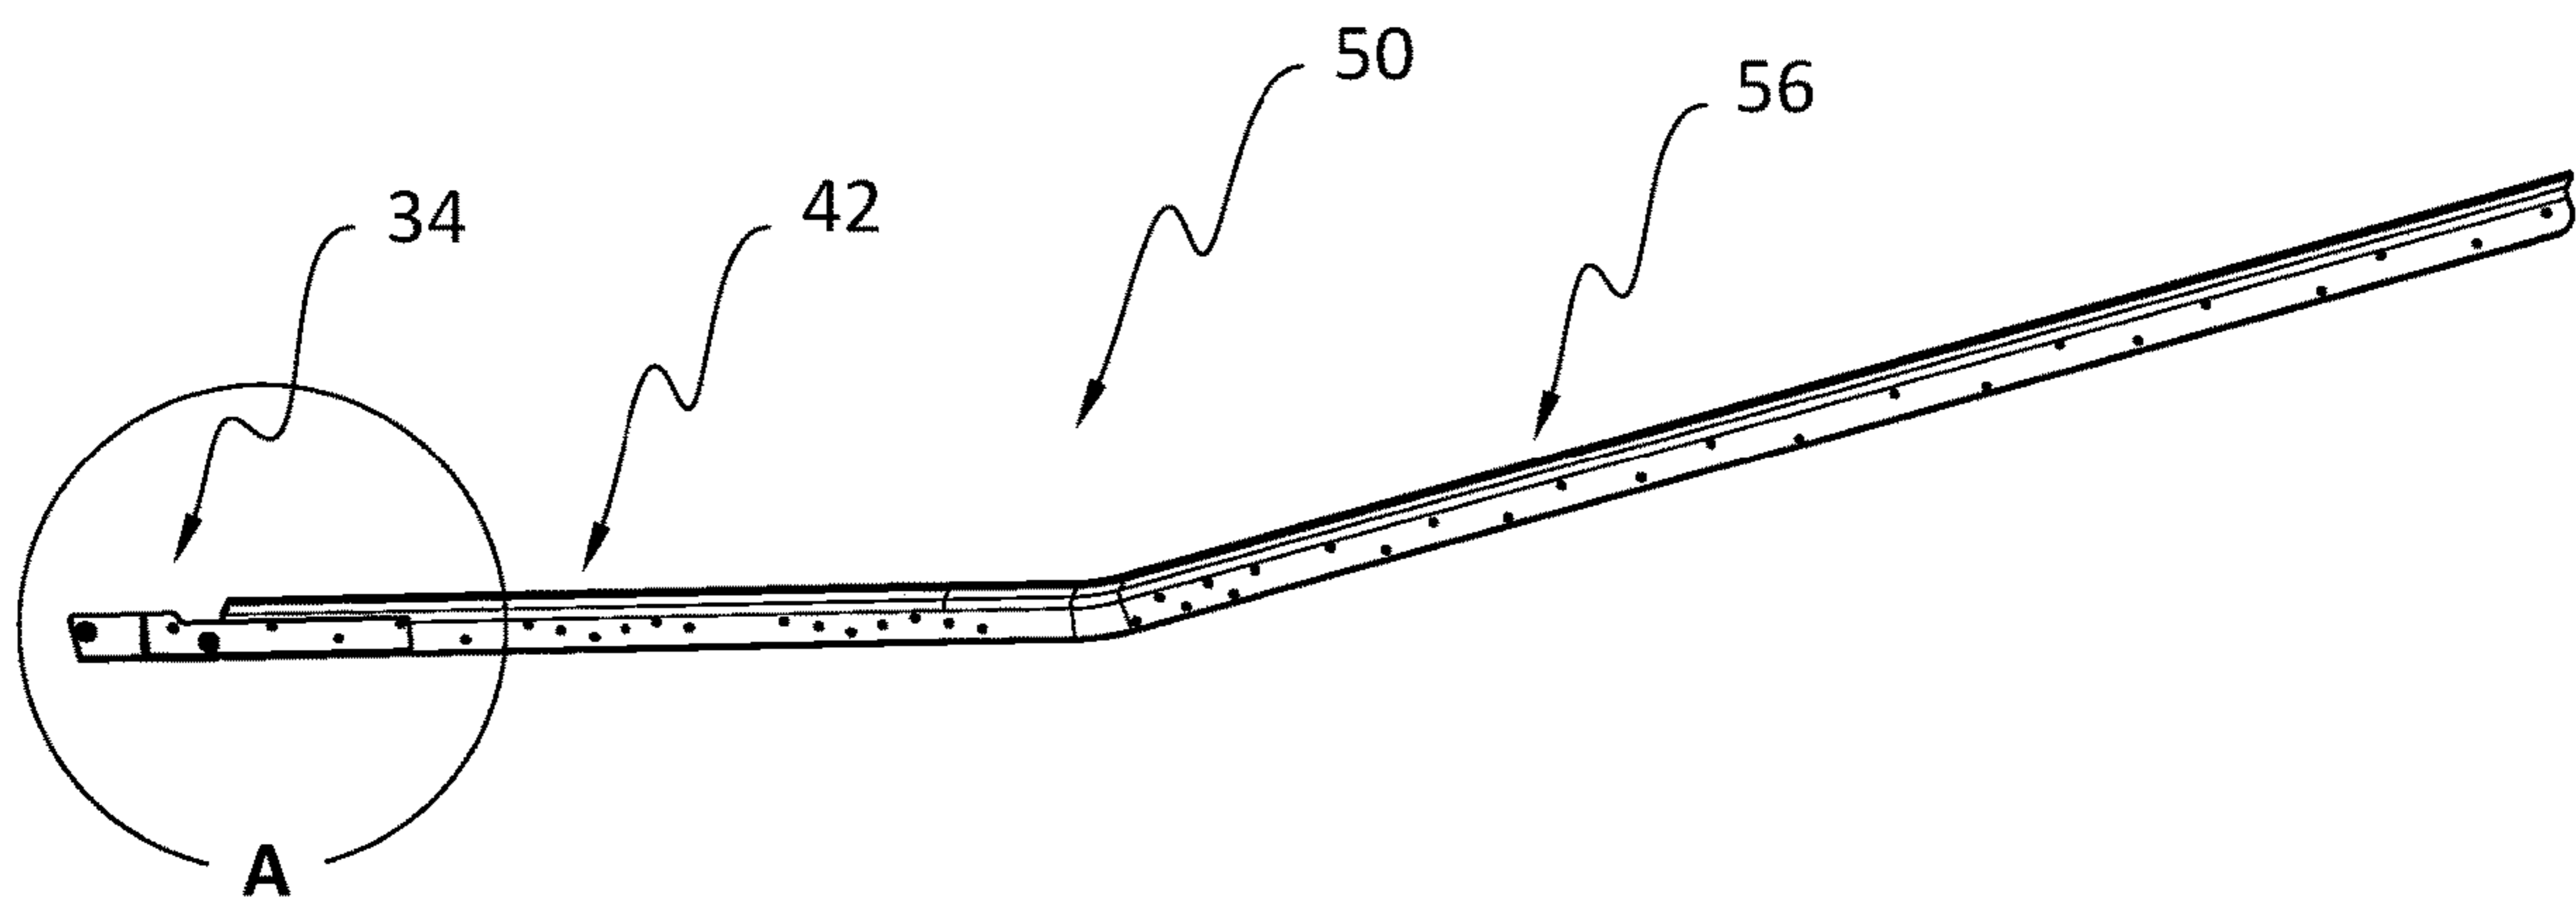
FIG. 4 is a perspective view of a left side tail-cone reinforcement angle including a left side tail-cone reinforcement angle splice, in accordance with the present invention;

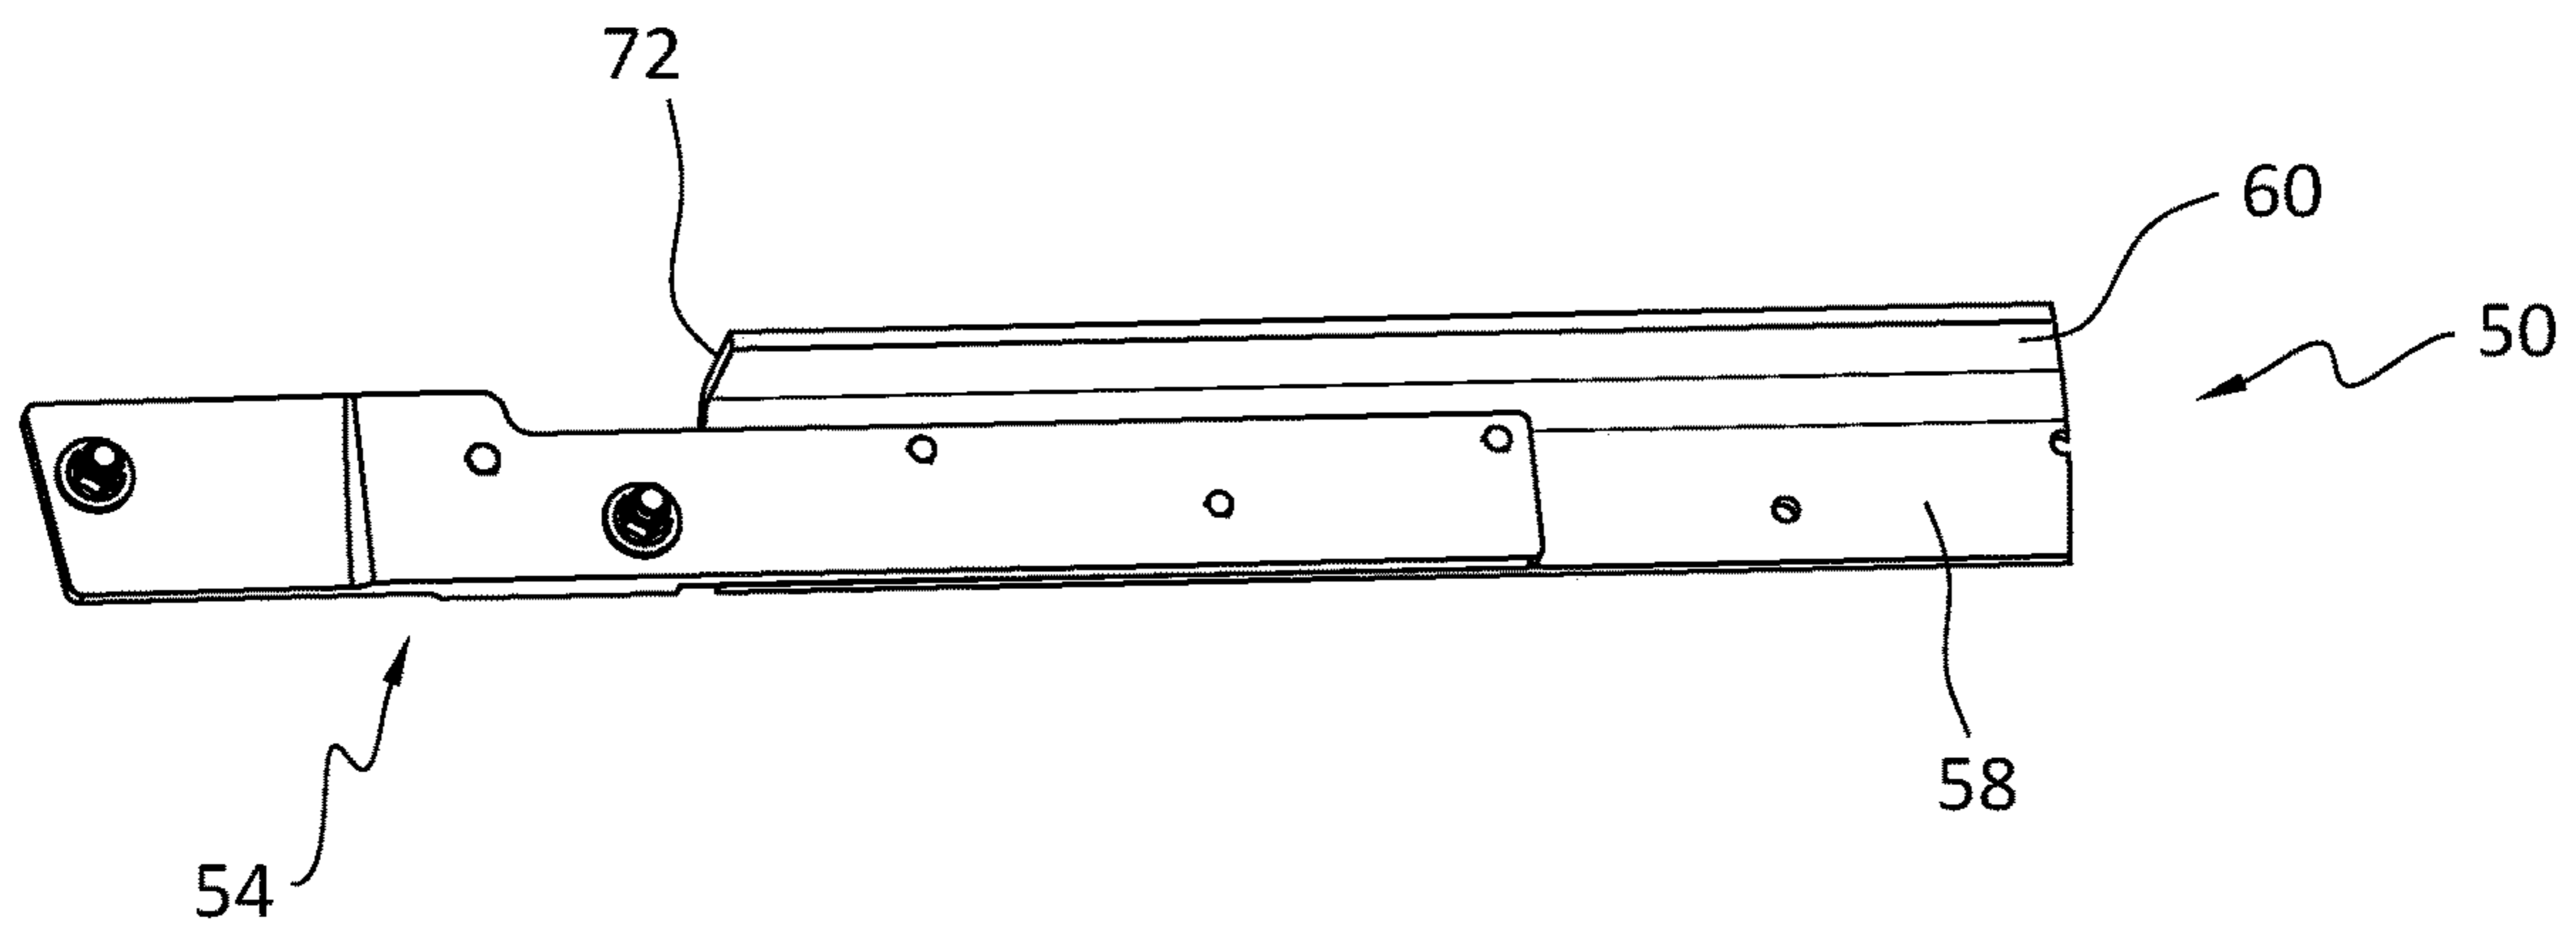
FIG. 5 is a side elevation view of an aft portion of the left side tail-cone reinforcement angle, encircled at A in FIG. 4, with the tail-cone reinforcement angle splice, in accordance with the present invention, in place;

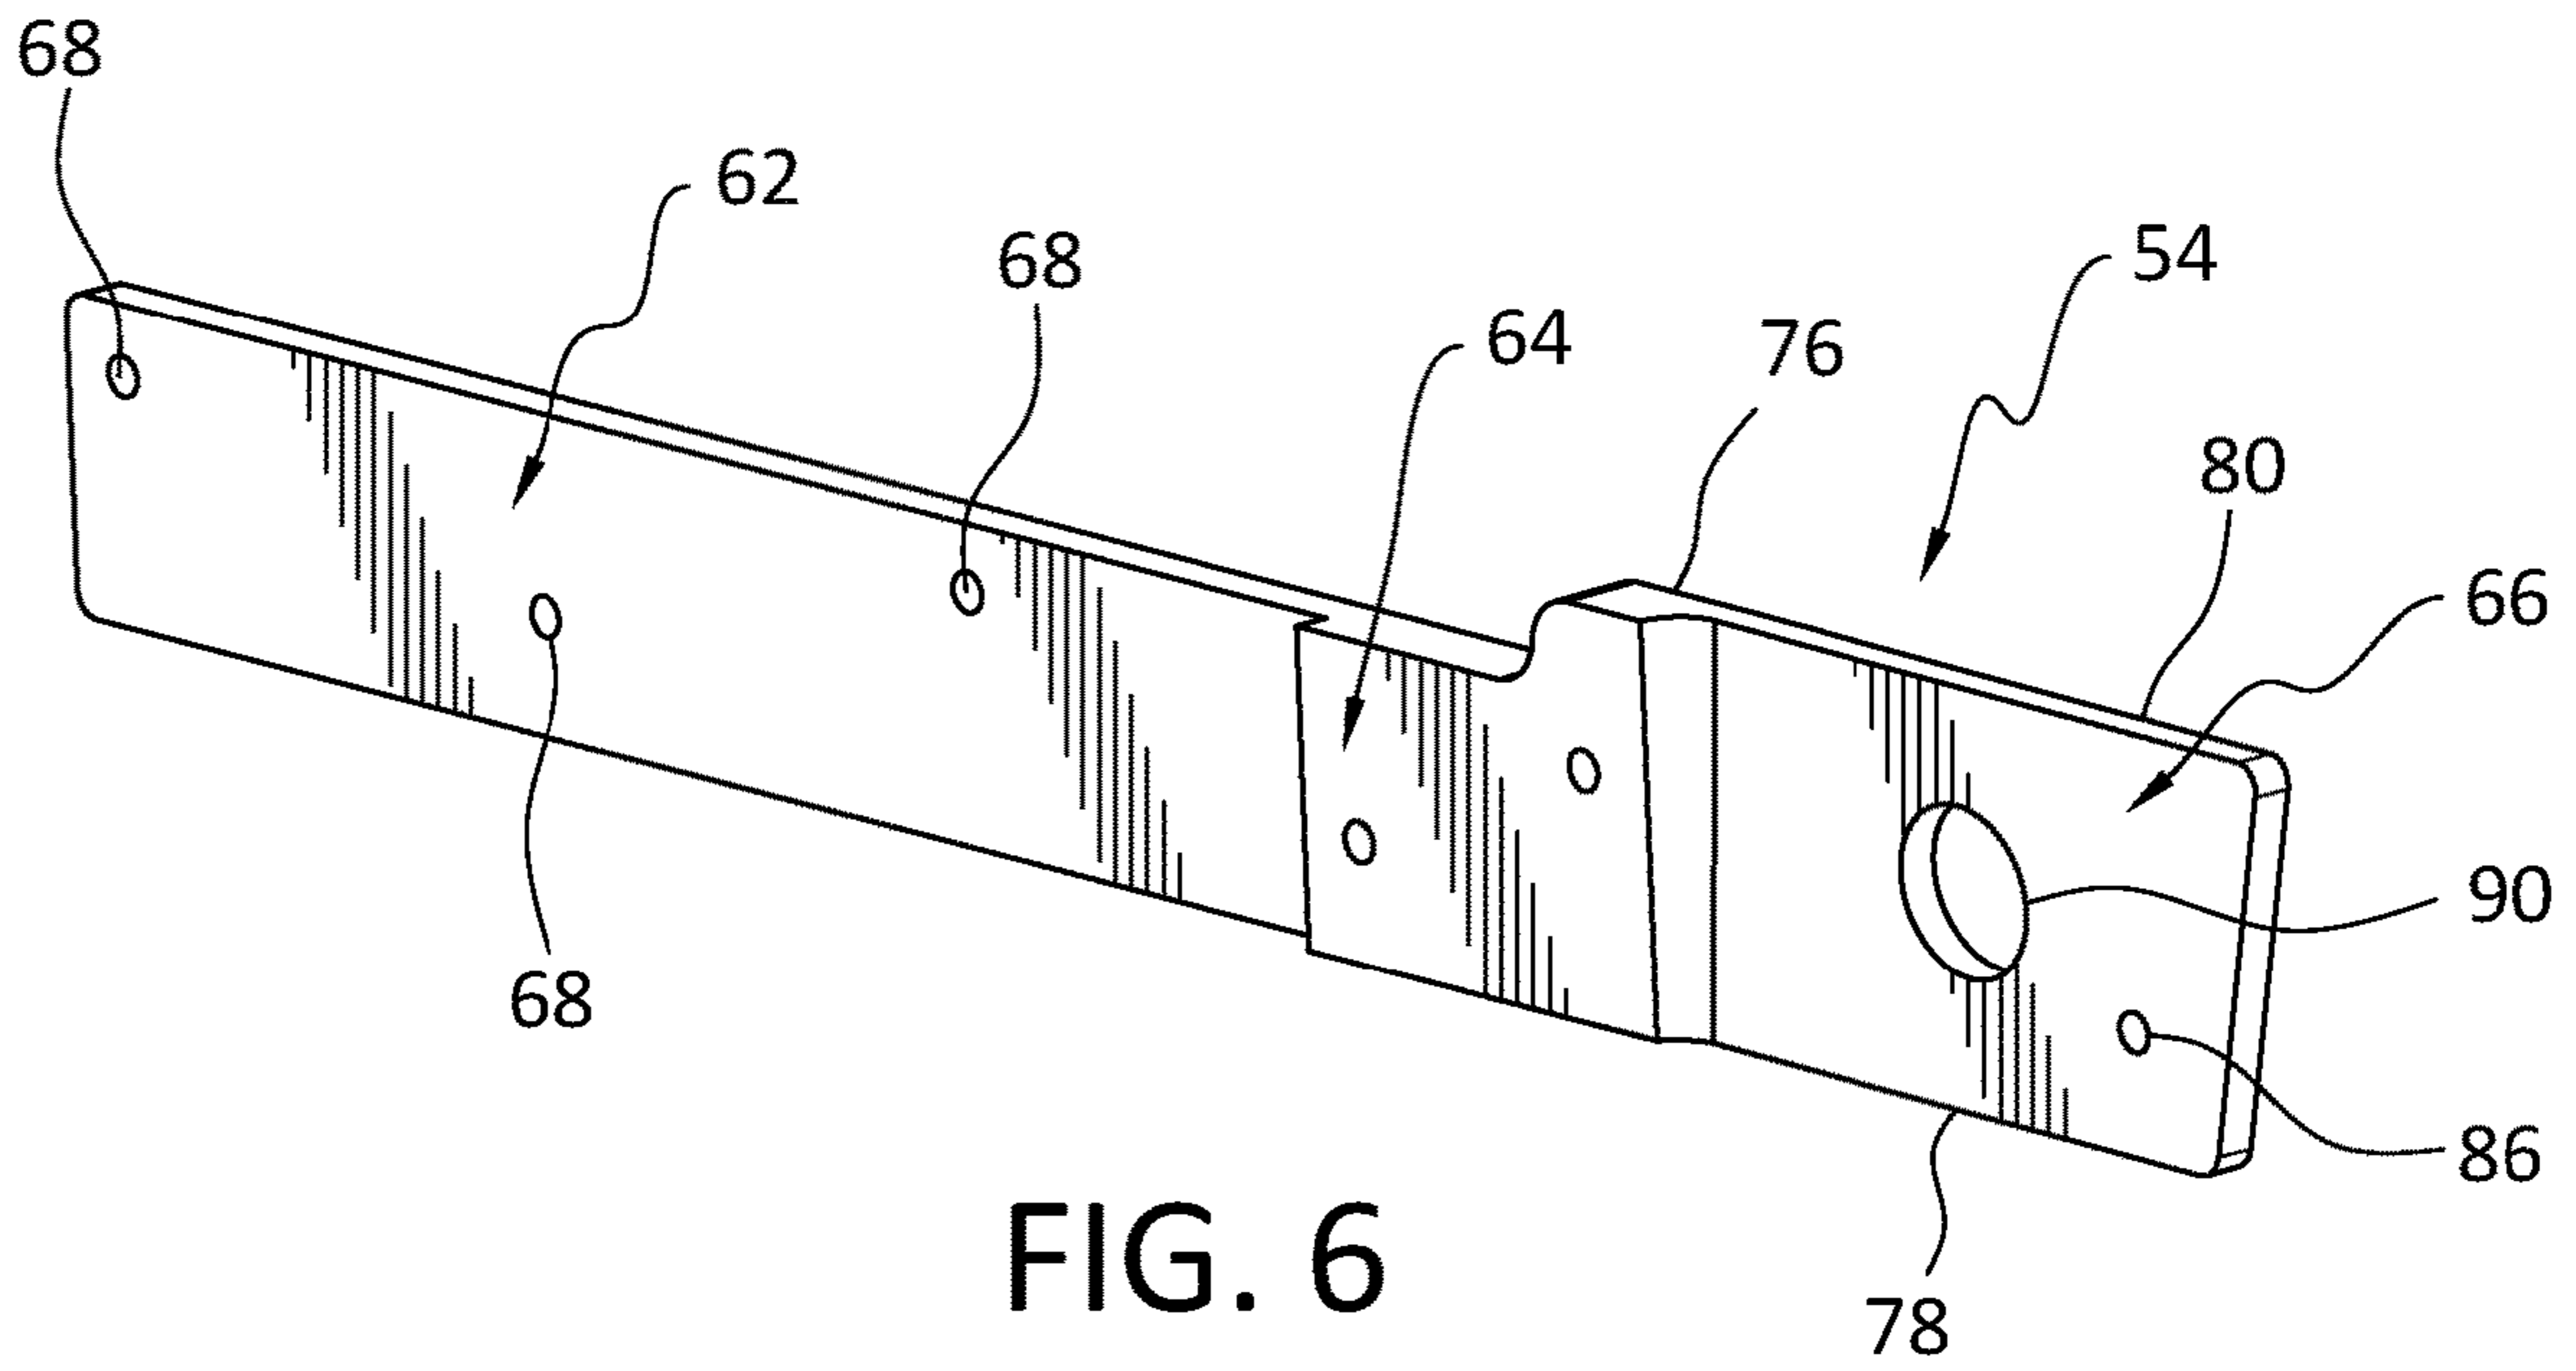
FIG. 6 is a perspective view of a left side tail-cone reinforcement angle splice prior to installation;

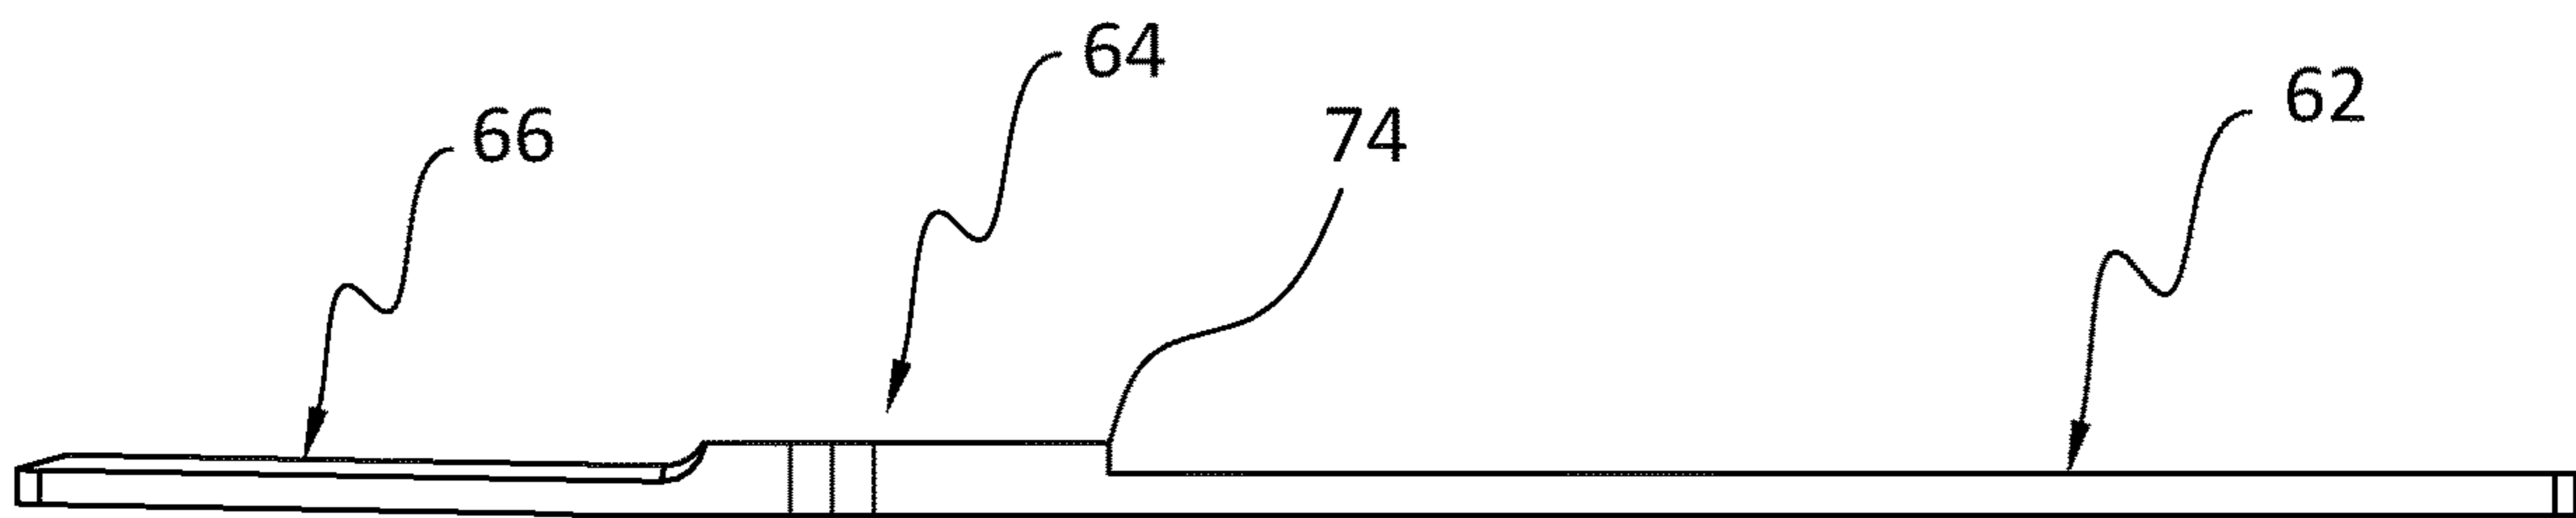
FIG. 7 is a top-plan view of the reinforcement angle splice depicted in FIG. 6;
