(54) **CESSNA TAIL-CONE REINFORCEMENT ANGLE SPLICE, INSTALLATION KIT, AND METHOD FOR INSTALLATION THEREOF**

A tail-cone reinforcement angle of a Cessna 180-185 series aircraft is repaired by the removal of an aft most section of that tail-cone reinforcement angle and its replacement with an elongated splice body. The elongated splice body is attached to the remainder of the tail-cone reinforcement angle and to the tail-cone portion of the fuselage of the aircraft. The aft section of the original tail-cone reinforcement angle is subject to the development and propagation of cracks in the area of the rear pivot shaft receiving bore, which cracks render the aircraft unfit for use. The invention includes the provision of a suitable elongated splice body, a method for its installation, and a tool kit which is usable in accomplishing the removal and replacement of the aft section of the tail-cone reinforcement angle.

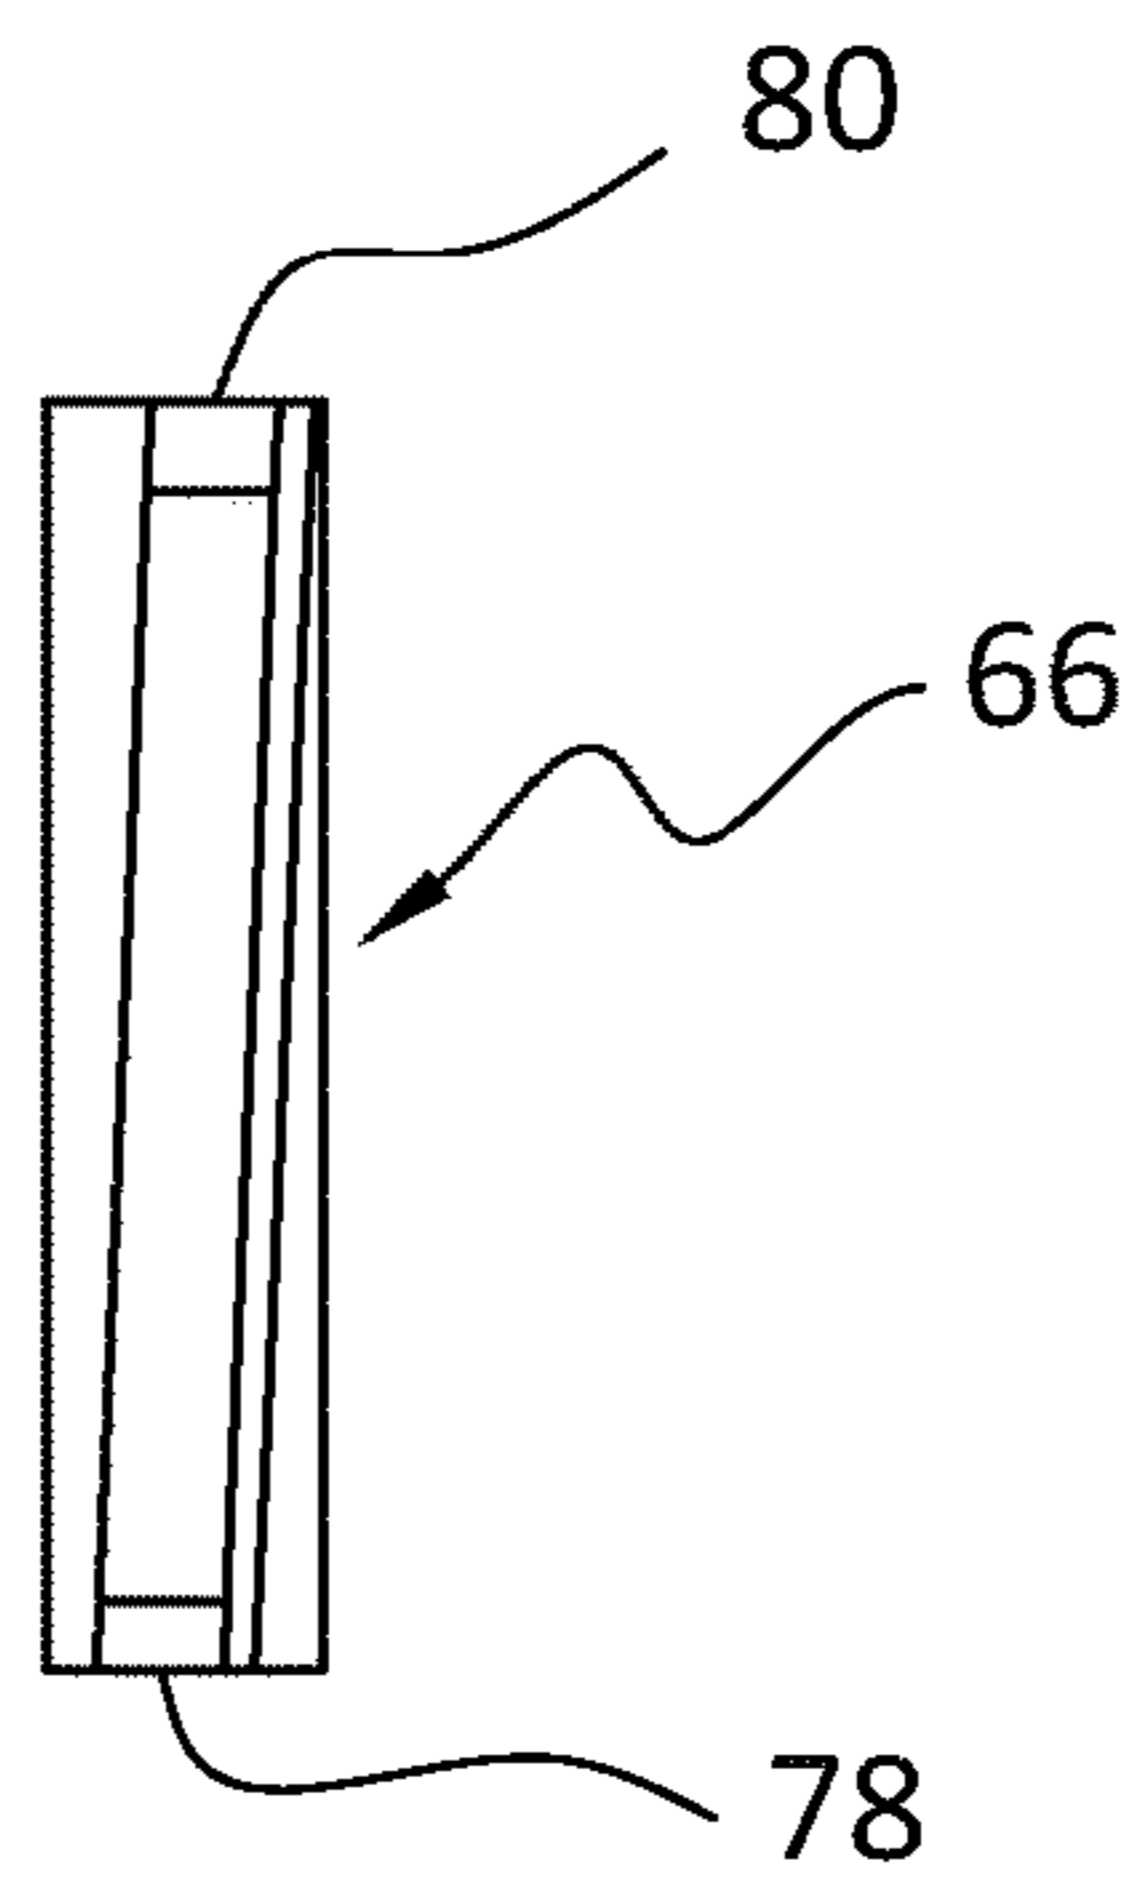
FIG. 8 is an aft end view of the reinforcement angle splice depicted in FIGS. 6 and 7 and taken from the right as seen in FIG. 6 and from the left as seen in FIG. 7;

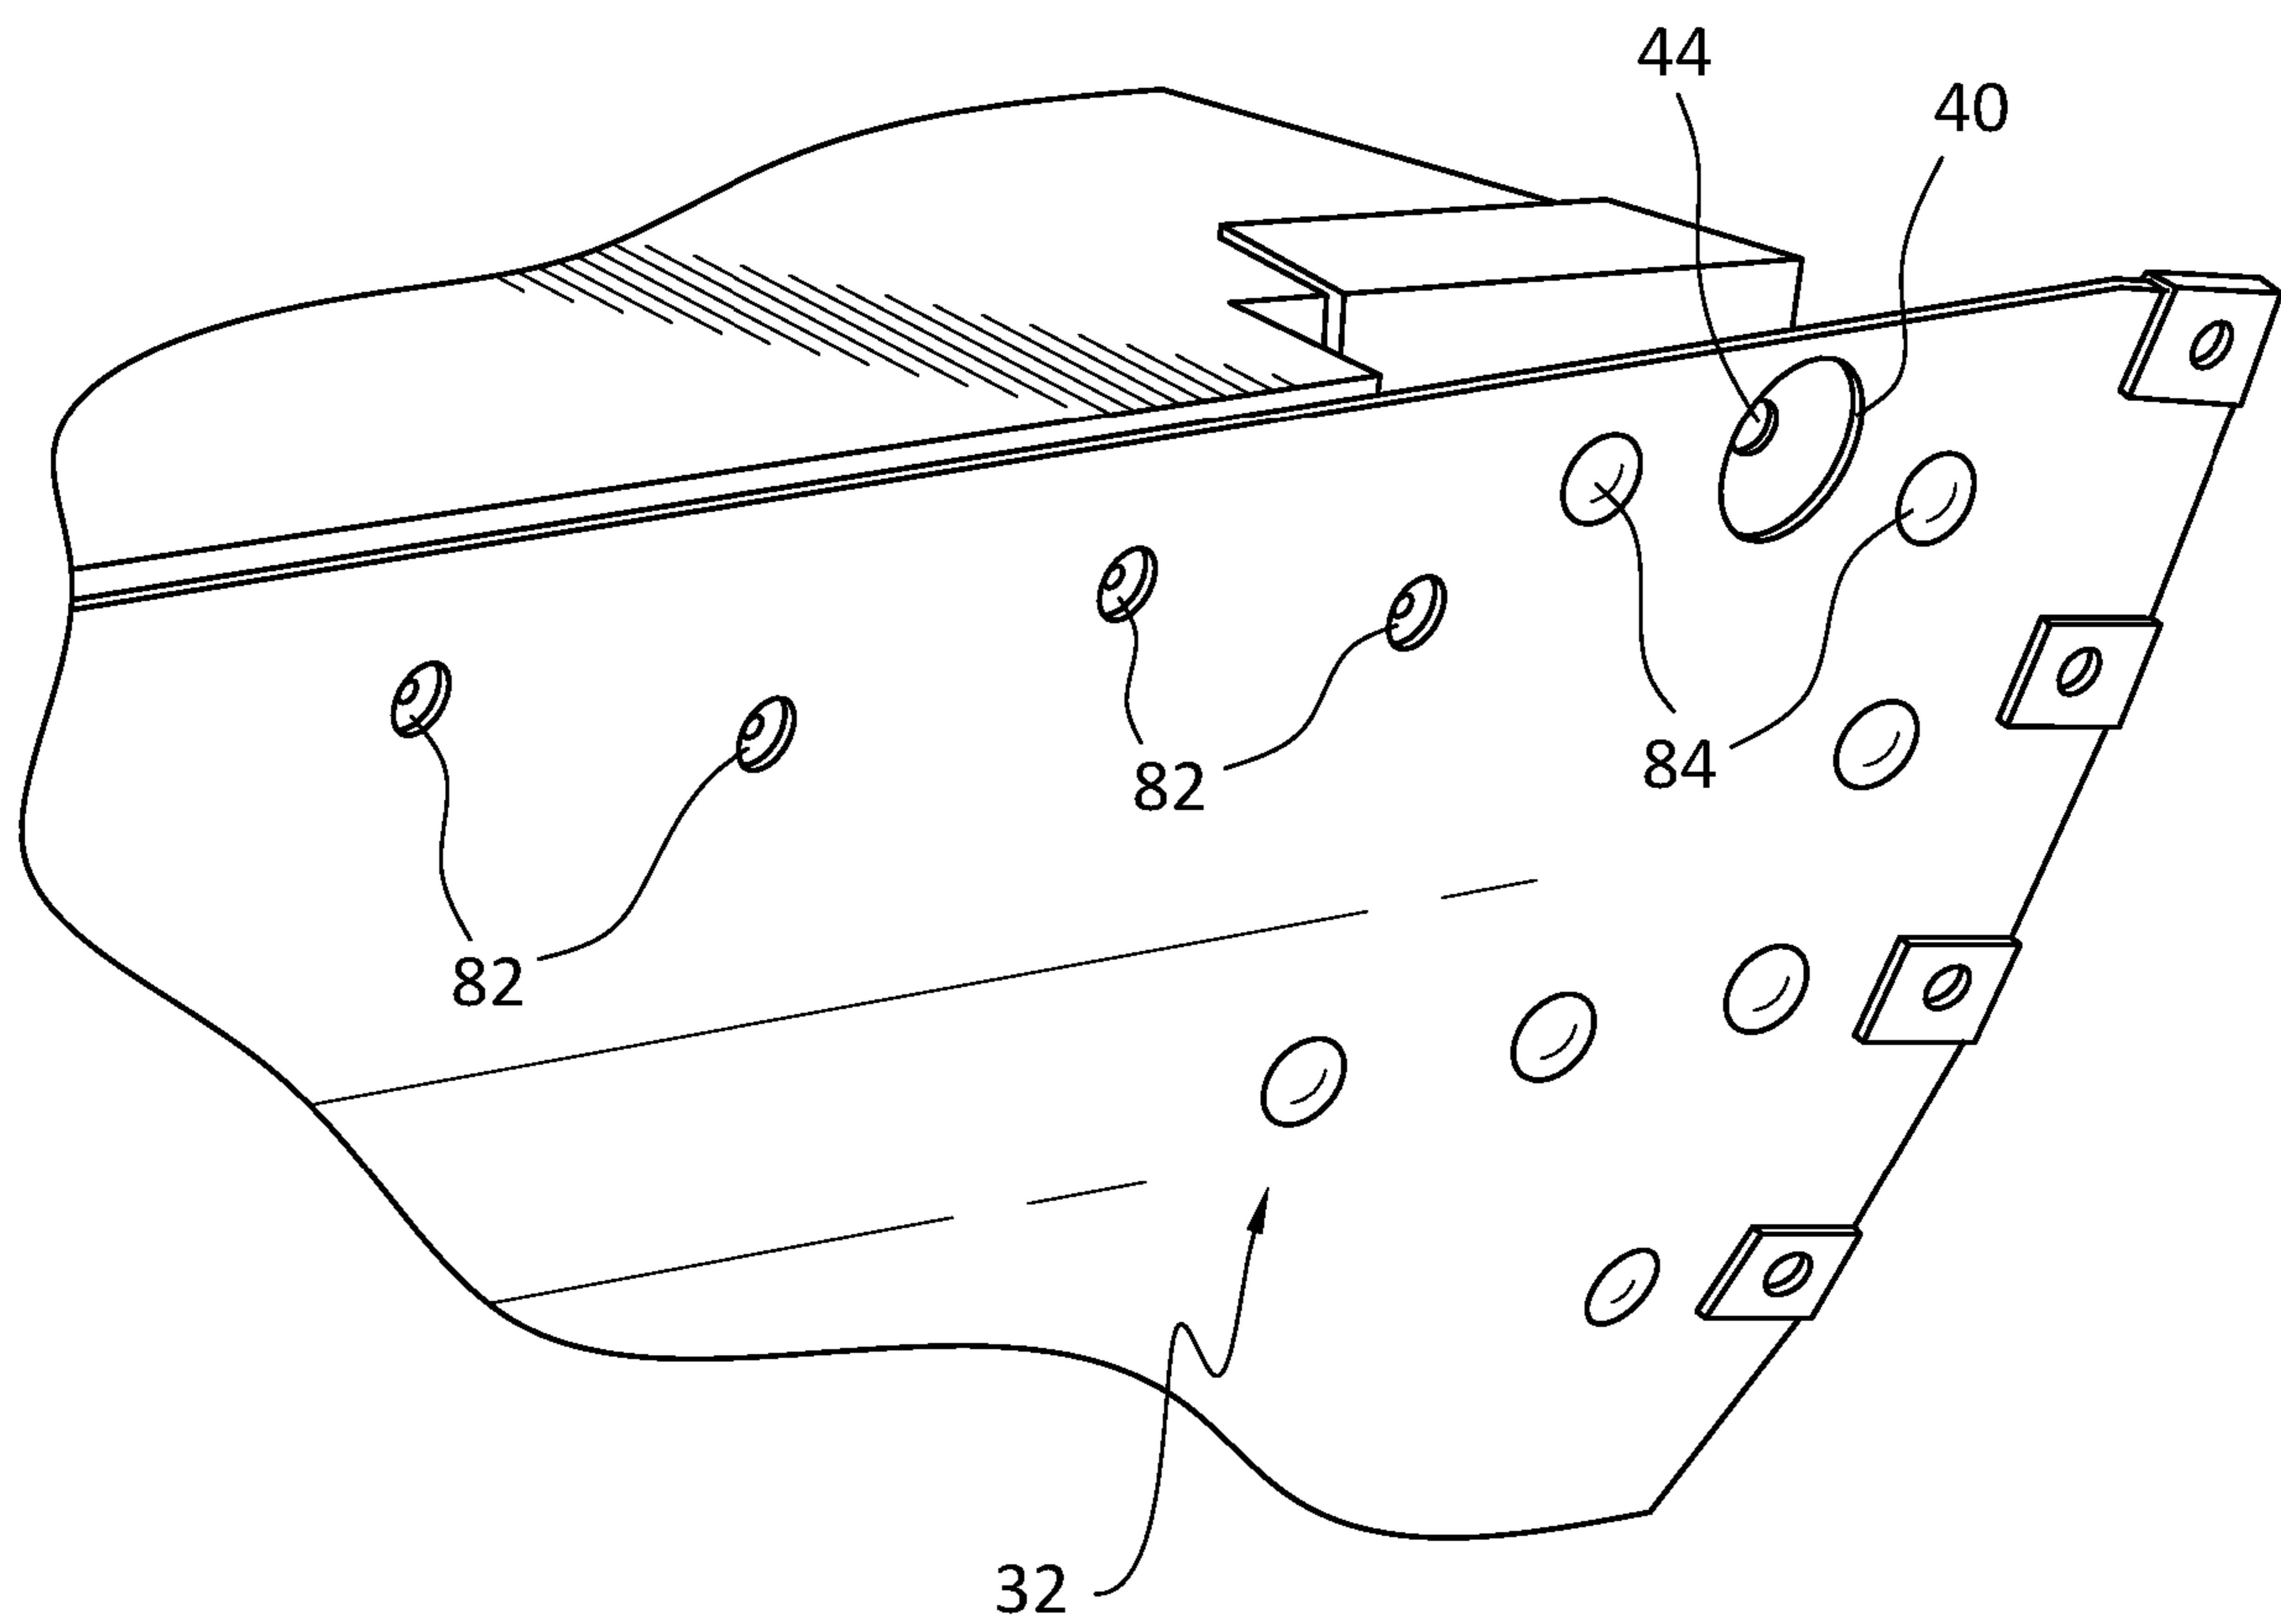
FIG. 9 is a view of an aft portion of the tail cone and showing the removal of four rivets;

In the next step of the repair and reconstruction process, two universal head rivets 84, as is also seen in FIG. 9, will be drilled out. This is accomplished using number 40 and number 30 drill bits that are included in the kit which is supplied by the manufacturer and which accompanies the splice 54. These number 40 and number 30 drill bits were also previously used in the removal of the four flush rivets 82. The reaming of the pivot aperture 40 and bore 44, together with the removal of the four flush head rivets 82 and the two universal head rivets 44, will free the defective portion of the blade section of the original tail-cone reinforcement angle from the tail cone portion of the fuselage of the aircraft.

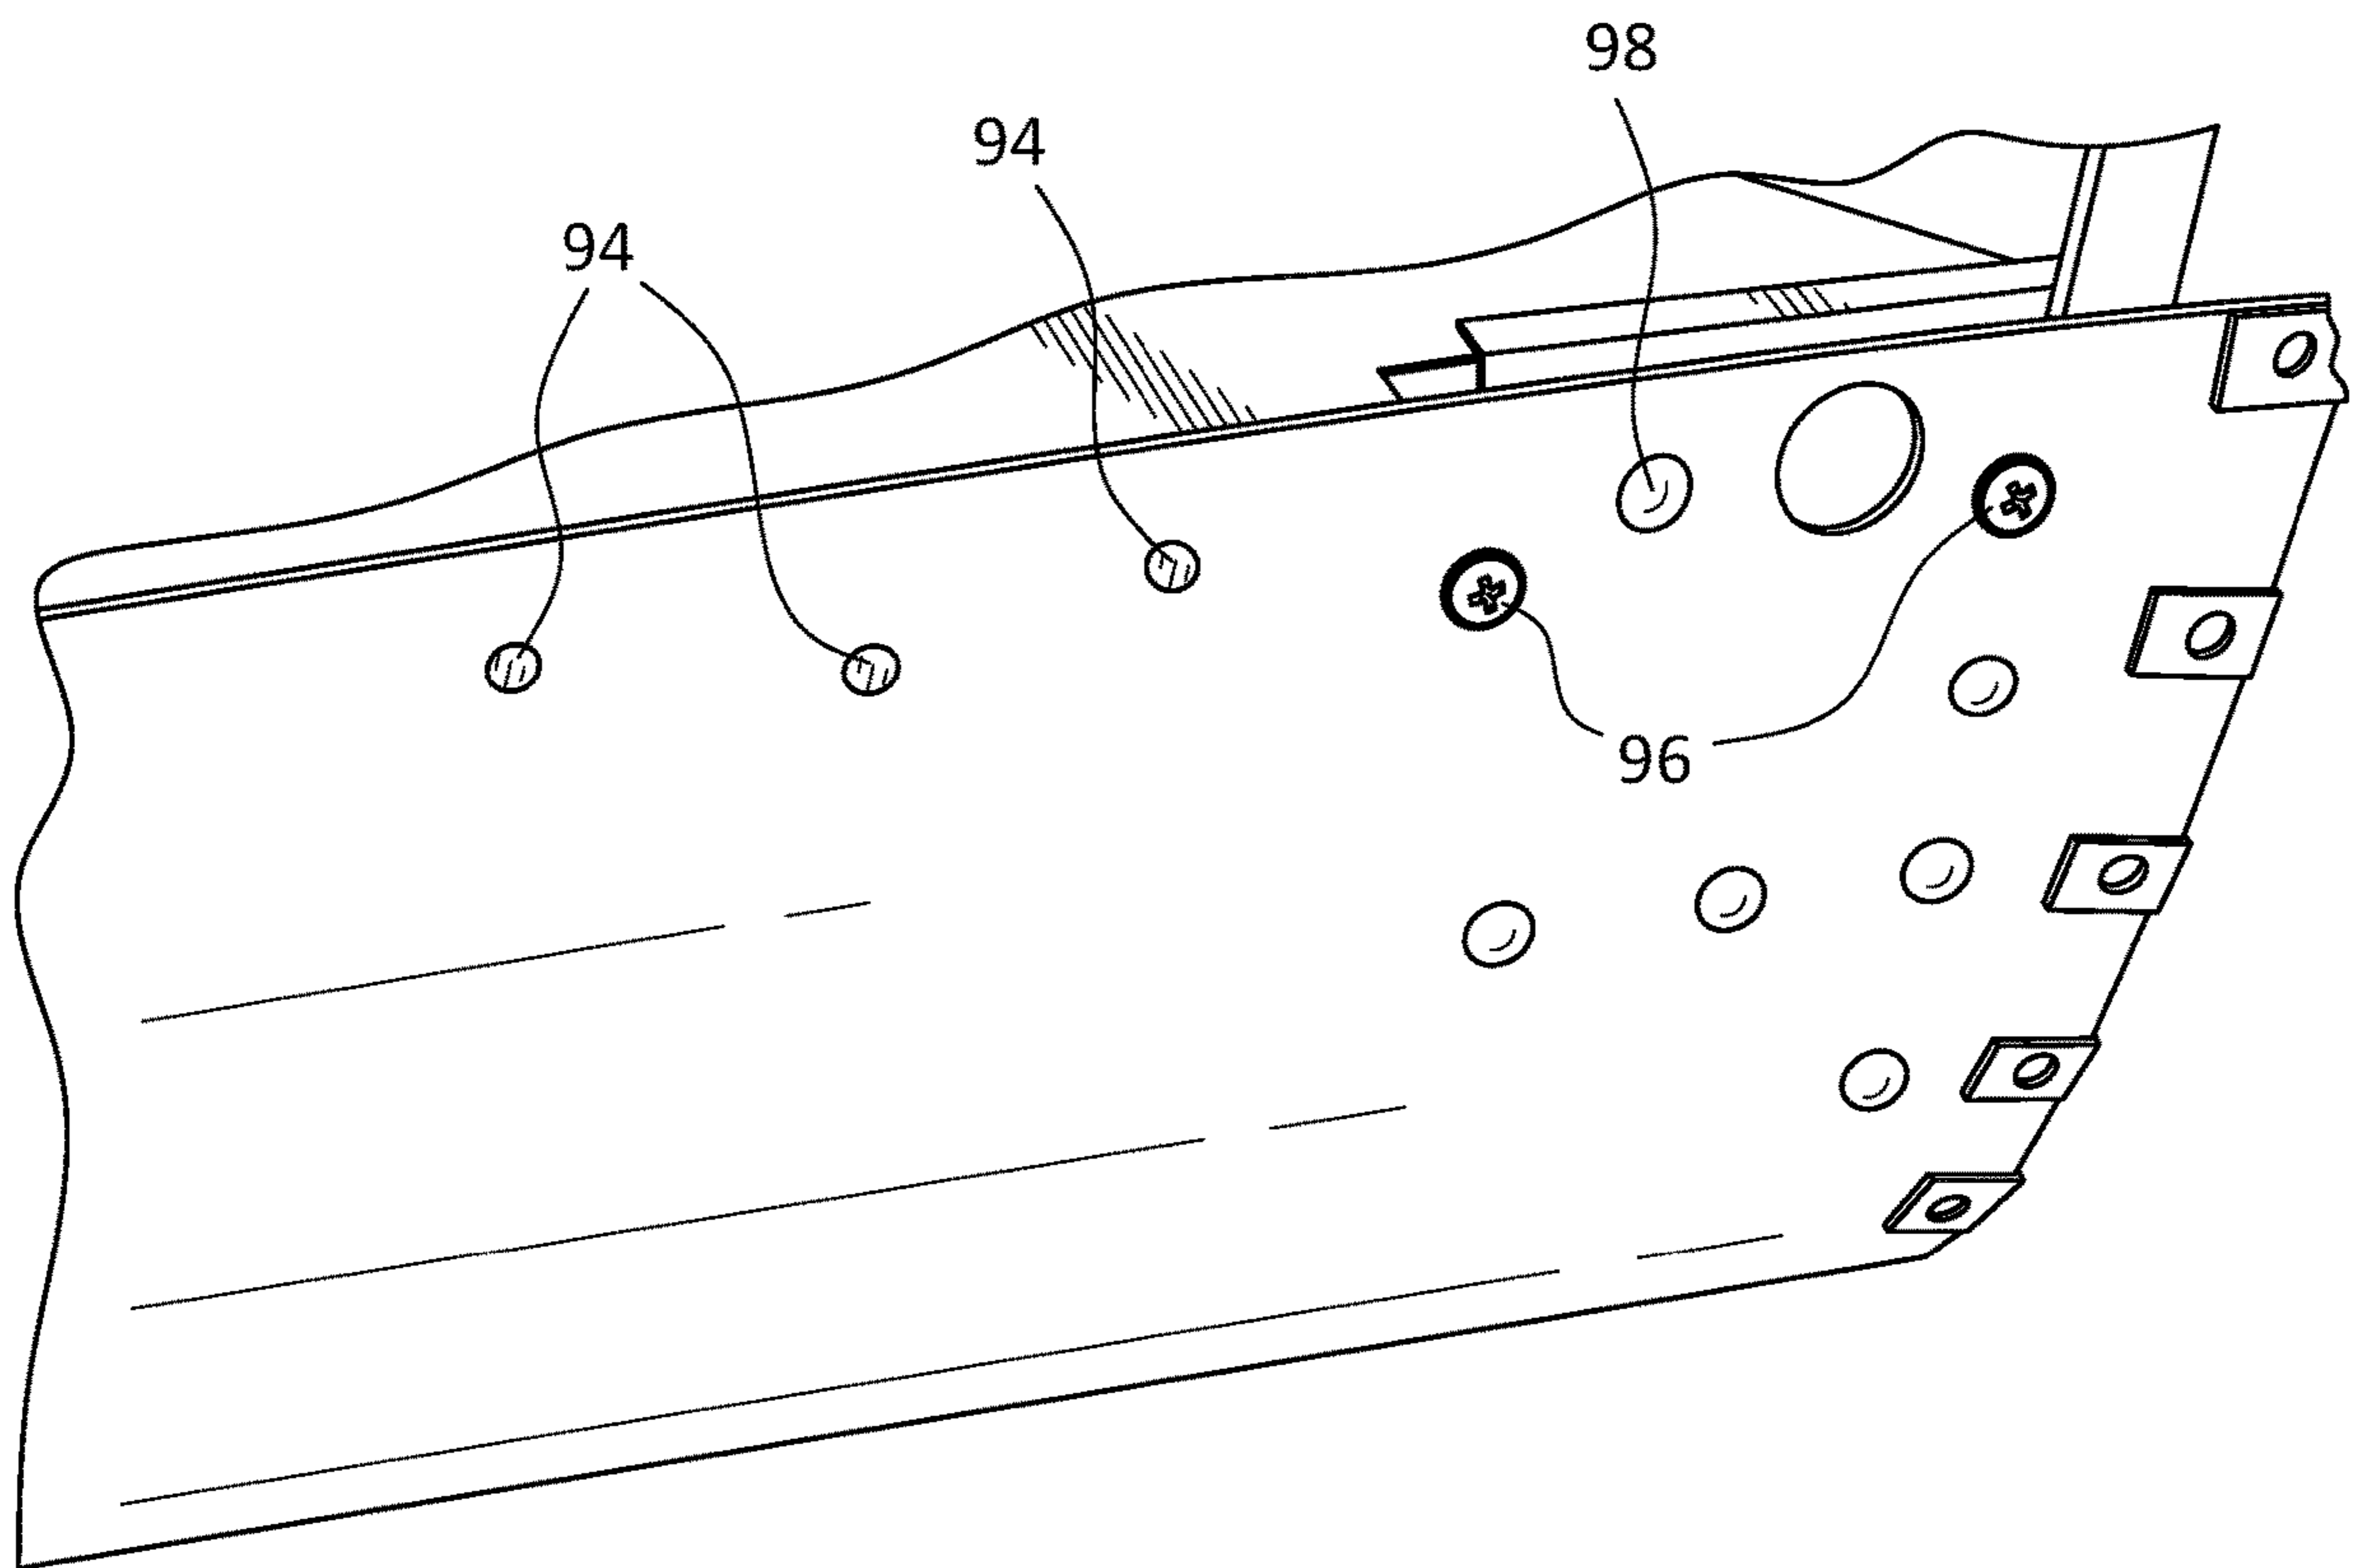
FIG. 10 is a view similar to FIG. 9 with the tail-cone reinforcement angle splice installed and secured in place;

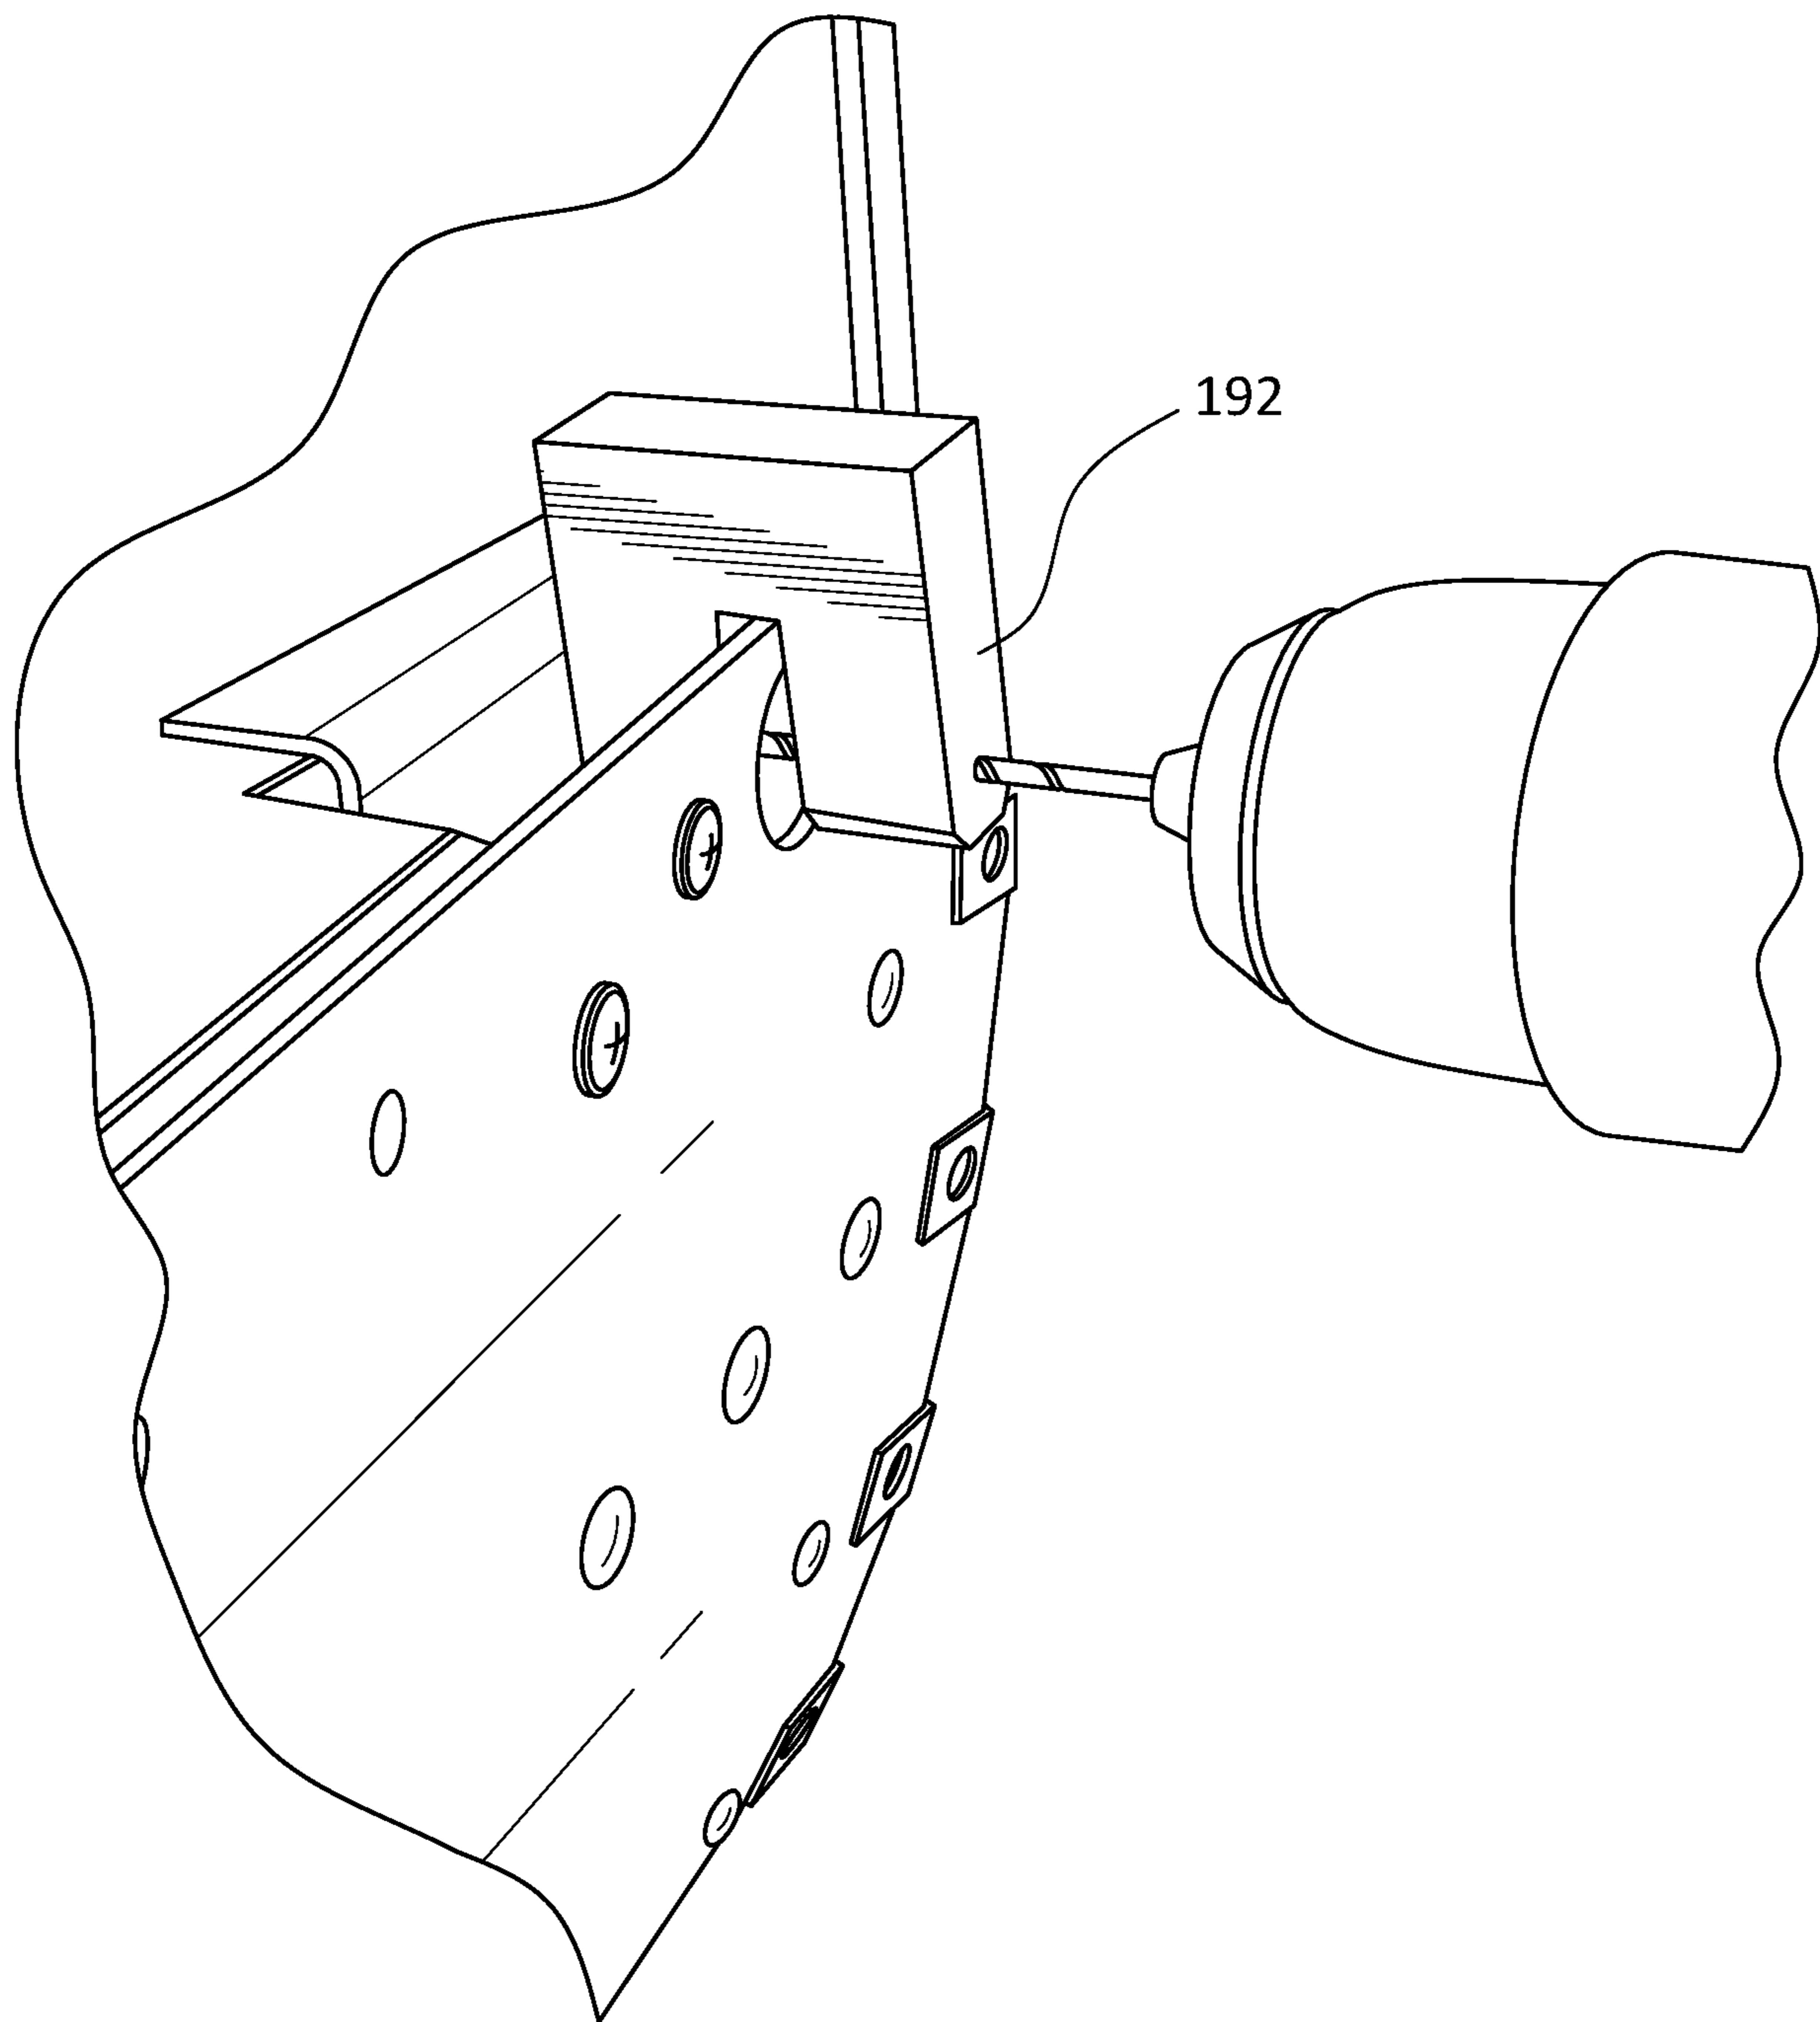
FIG. 11 is a view of the aft section of the tail cone and showing the forming of the horizontal stabilizer shaft receiving bore in the tail-cone reinforcement angle splice;

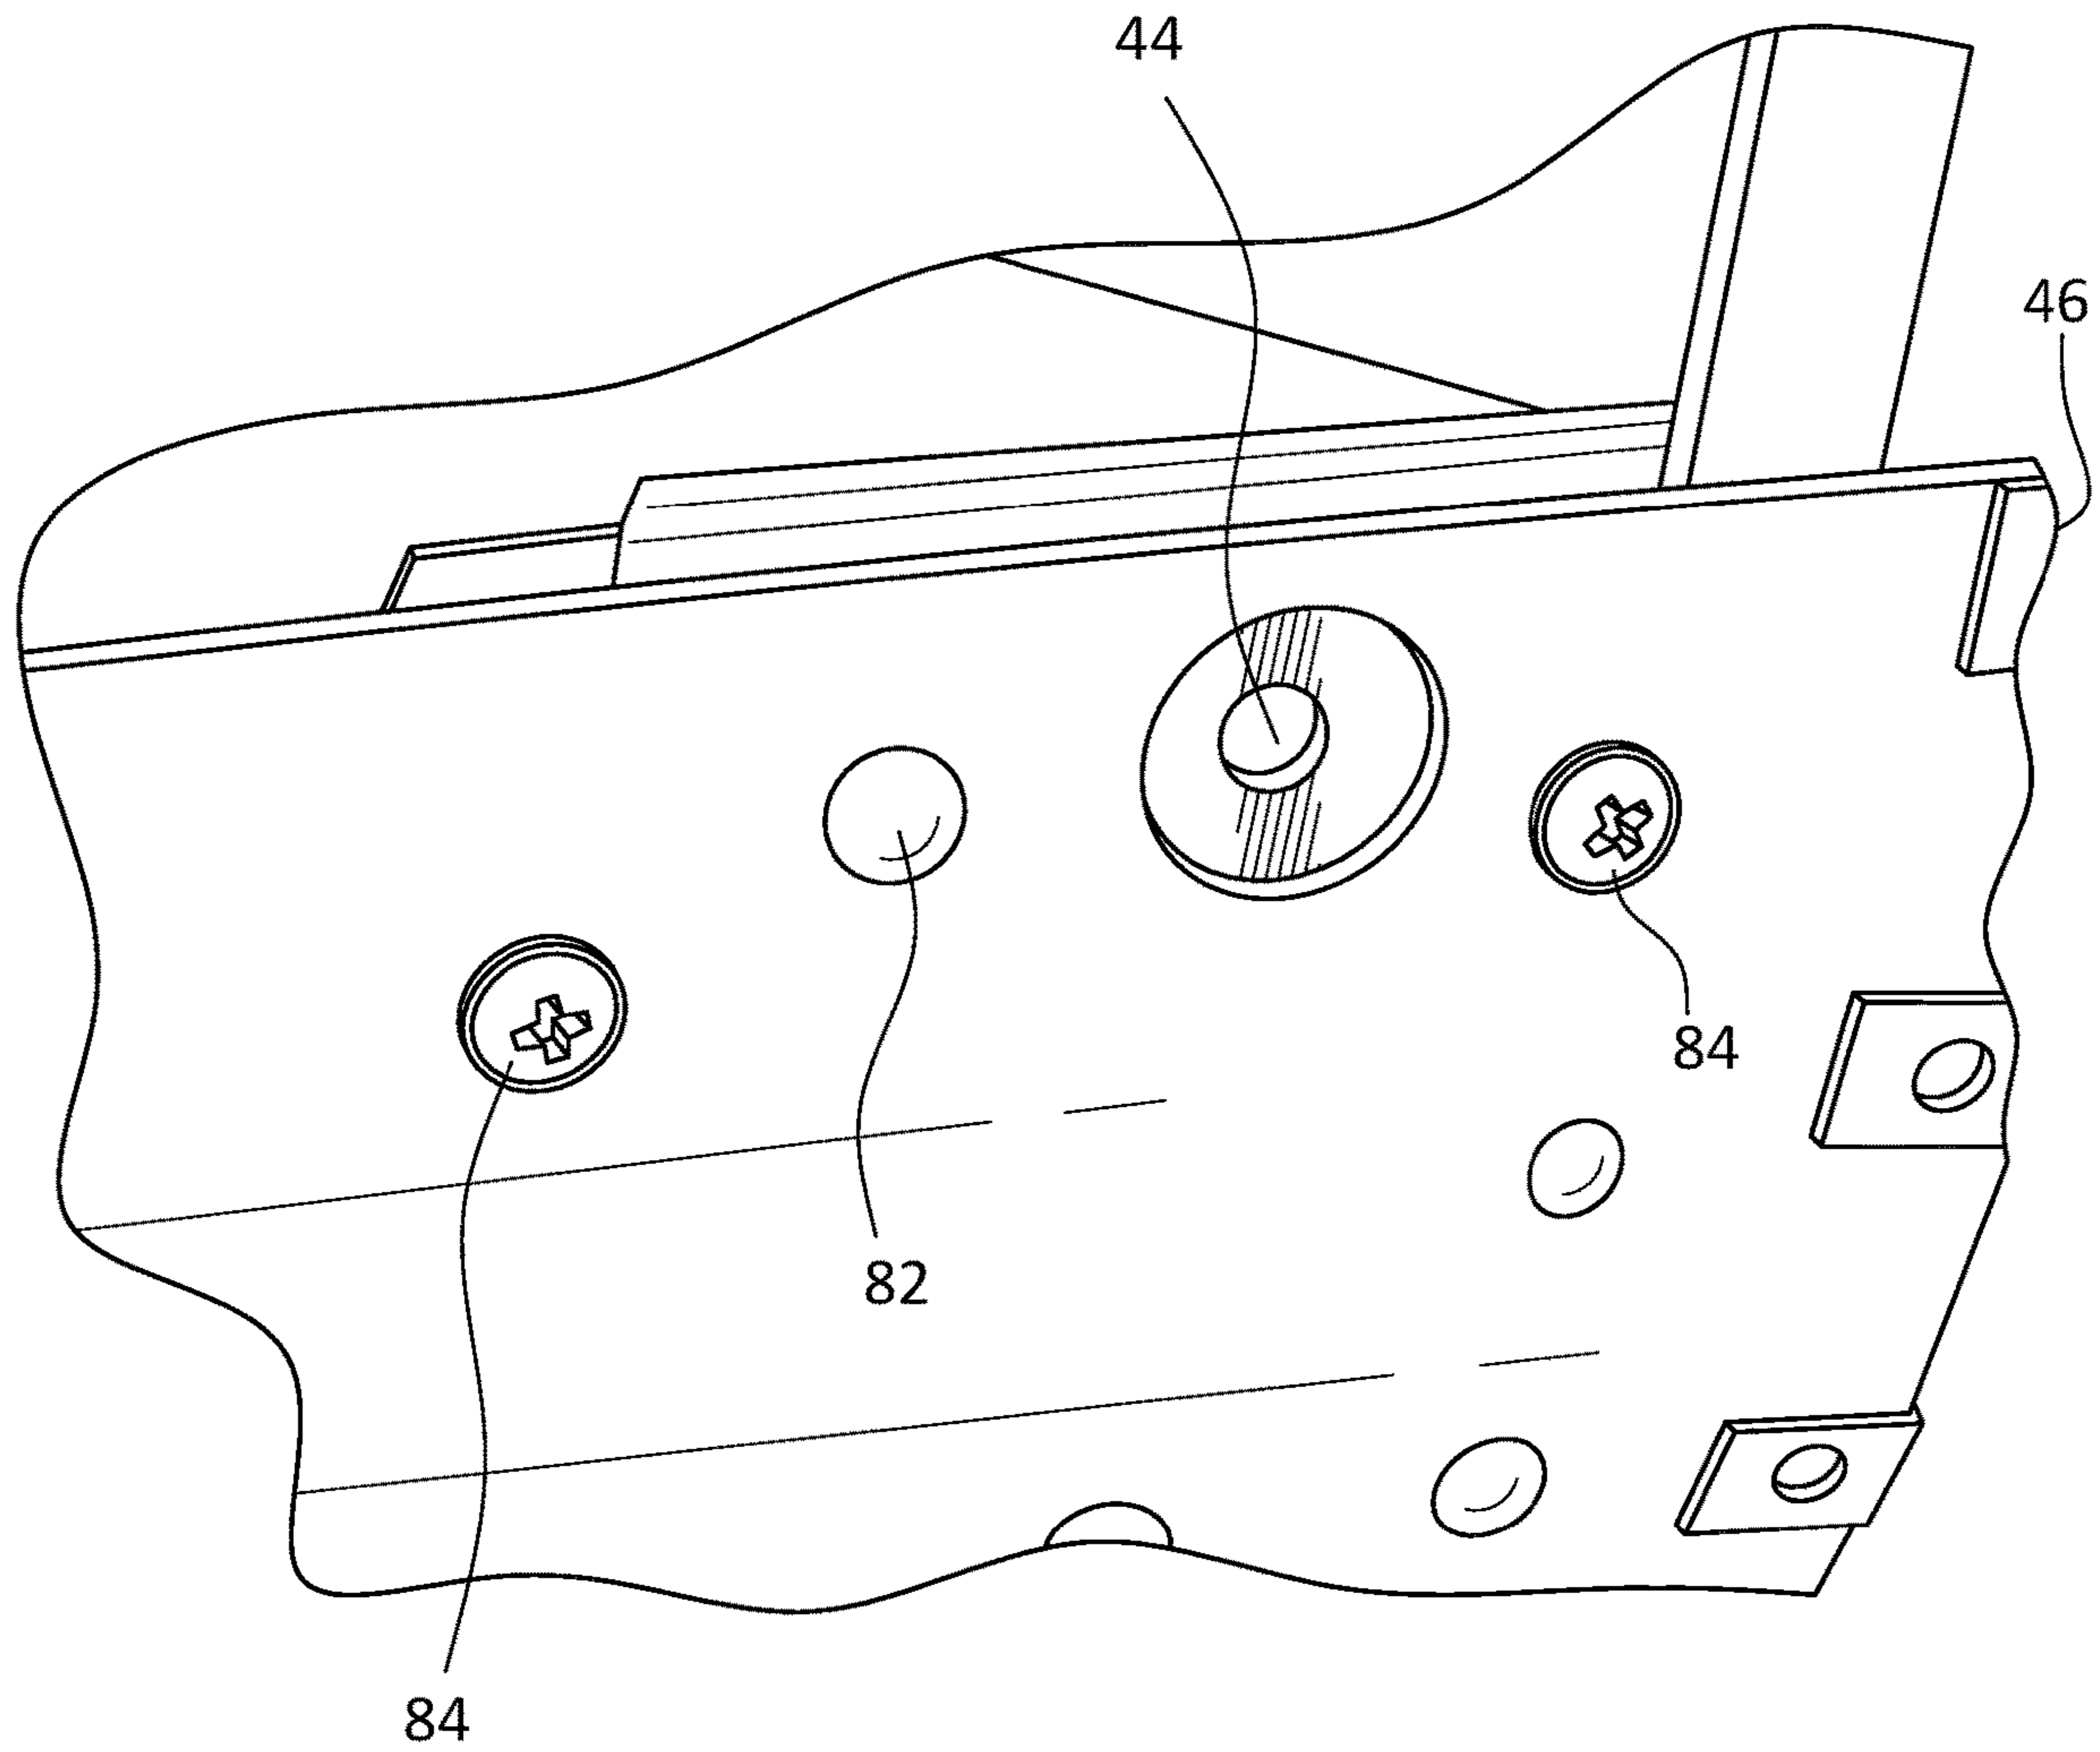
FIG. 12 is a view of the aft section of the tail cone and showing the completed horizontal stabilizer pivot shaft receiving bore formed in the tail-cone reinforcement angle splice; and
