(10) **Patent No.:** **US 10,910,926 B2**  
(45) **Date of Patent:** **Feb. 2, 2021**

(54) **METHOD FOR REPAIRING GENERATOR STATOR CORE**

(71) Applicant: **Siemens Energy, Inc.**, Orlando, FL (US)  
(72) Inventors: **Shane Bell**, Chuluota, FL (US); **Randy Edward Whitener**, Chuluota, FL (US); **Alejandro Felix**, Oviedo, FL (US)

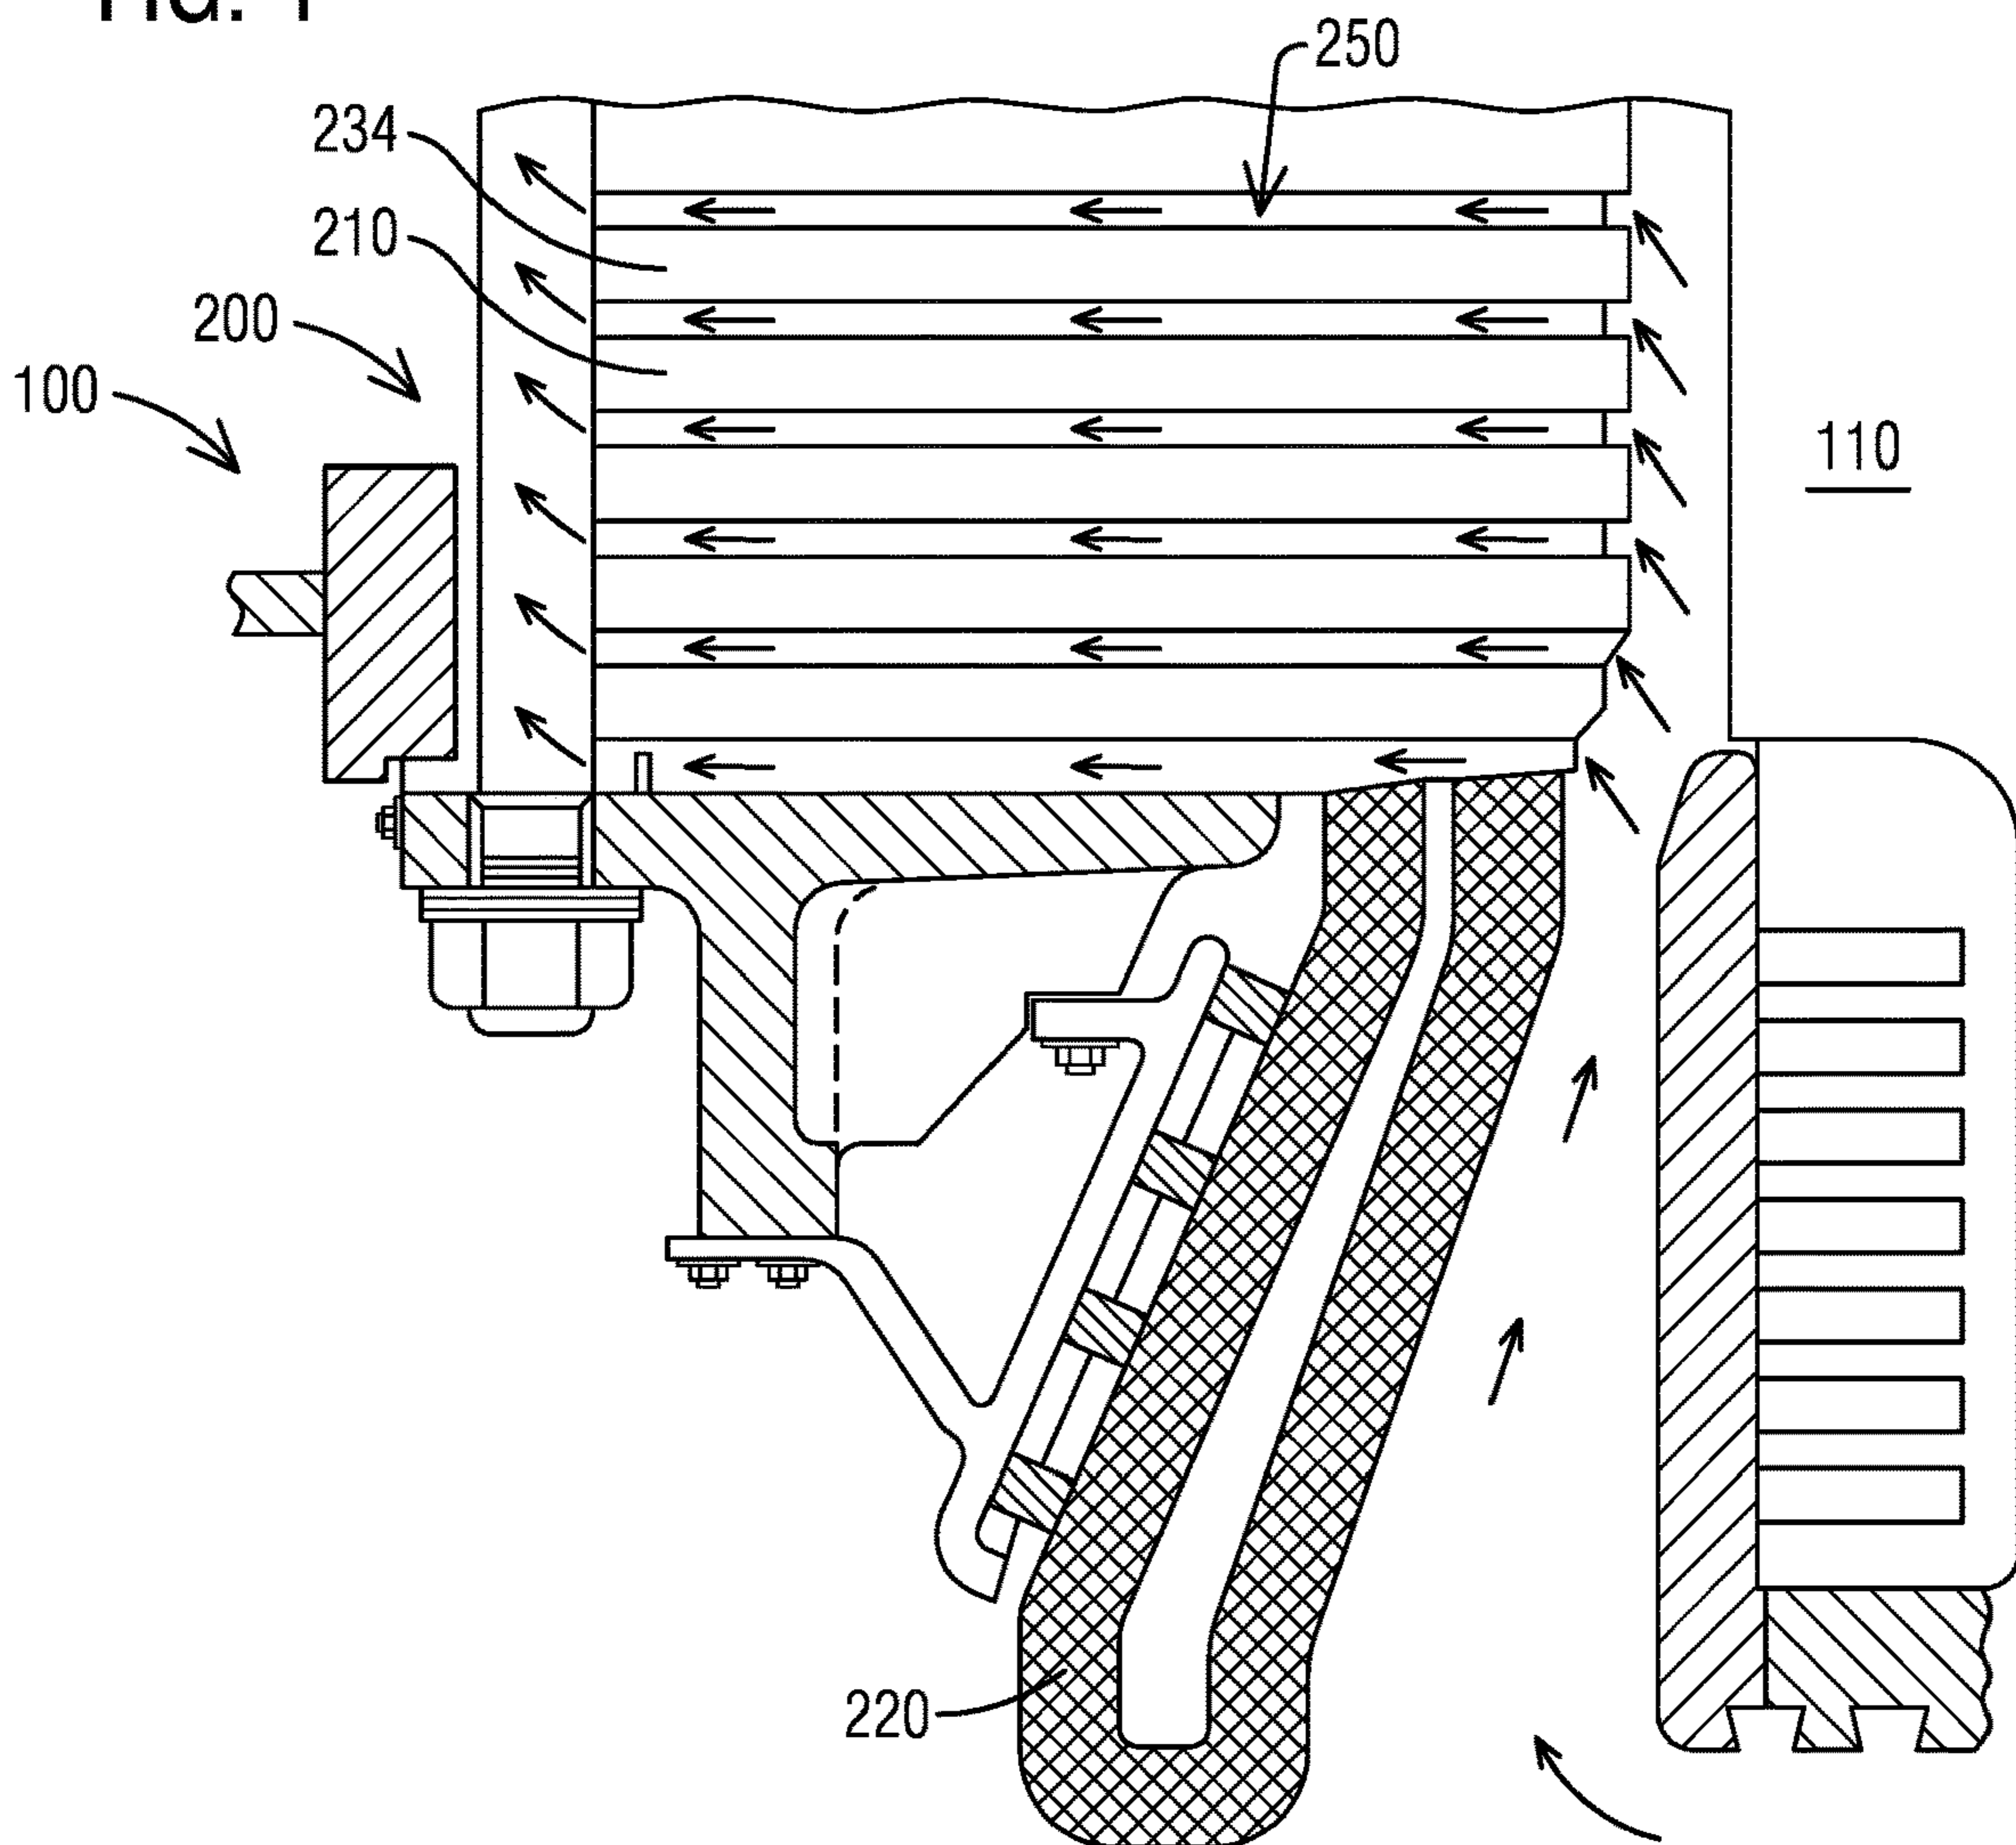
FIG. 1 illustrates a schematic partial cross section view of a generator in which embodiments of the present invention may be implemented;

FIG. 1 illustrates a schematic partial cross section view of a generator 100. The generator 100 includes a rotor 110 and a stator 200. The stator 200 has a stator core 210. The rotor 110 is installed within the stator core 210. A stator winding 220 may be arranged within the stator core 210.

The stator core 210 may be comprised of a plurality of packs 234 of stacked thin metal laminations 230. Each pack 234 includes multiple laminations 230 which are shown in more detail in FIG. 2. The stator core 200 may be cooled by a plurality of ventilation ducts 250 radially oriented between adjacent packs 234. The ventilation ducts 250 may be formed by ventilation spacers 260 which are shown in more detail in FIG. 3. The ventilation spacers 260 are disposed on the last lamination 230 in each pack 234 and are in contact with a surface of a lamination 230 in an adjacent pack 234 facing to the ventilation ducts 250. The ventilation spacers 260 may be secured to the lamination 230 to prevent the ventilation spacers 260 from moving. The ventilation spacers 260 may be secured to the lamination 230 by any suitable manners, such as by being spot welded to the lamination 230, by being pressed into holes in the lamination 230, or by being nailed to the lamination 230. The ventilation spacers 260 may tighten and provide support to the laminations 230 in adjacent packs 234 to prevent vibration of the laminations 230. The ventilation spacers 260 may include any suitable materials, such as metals, carbon steel, etc.

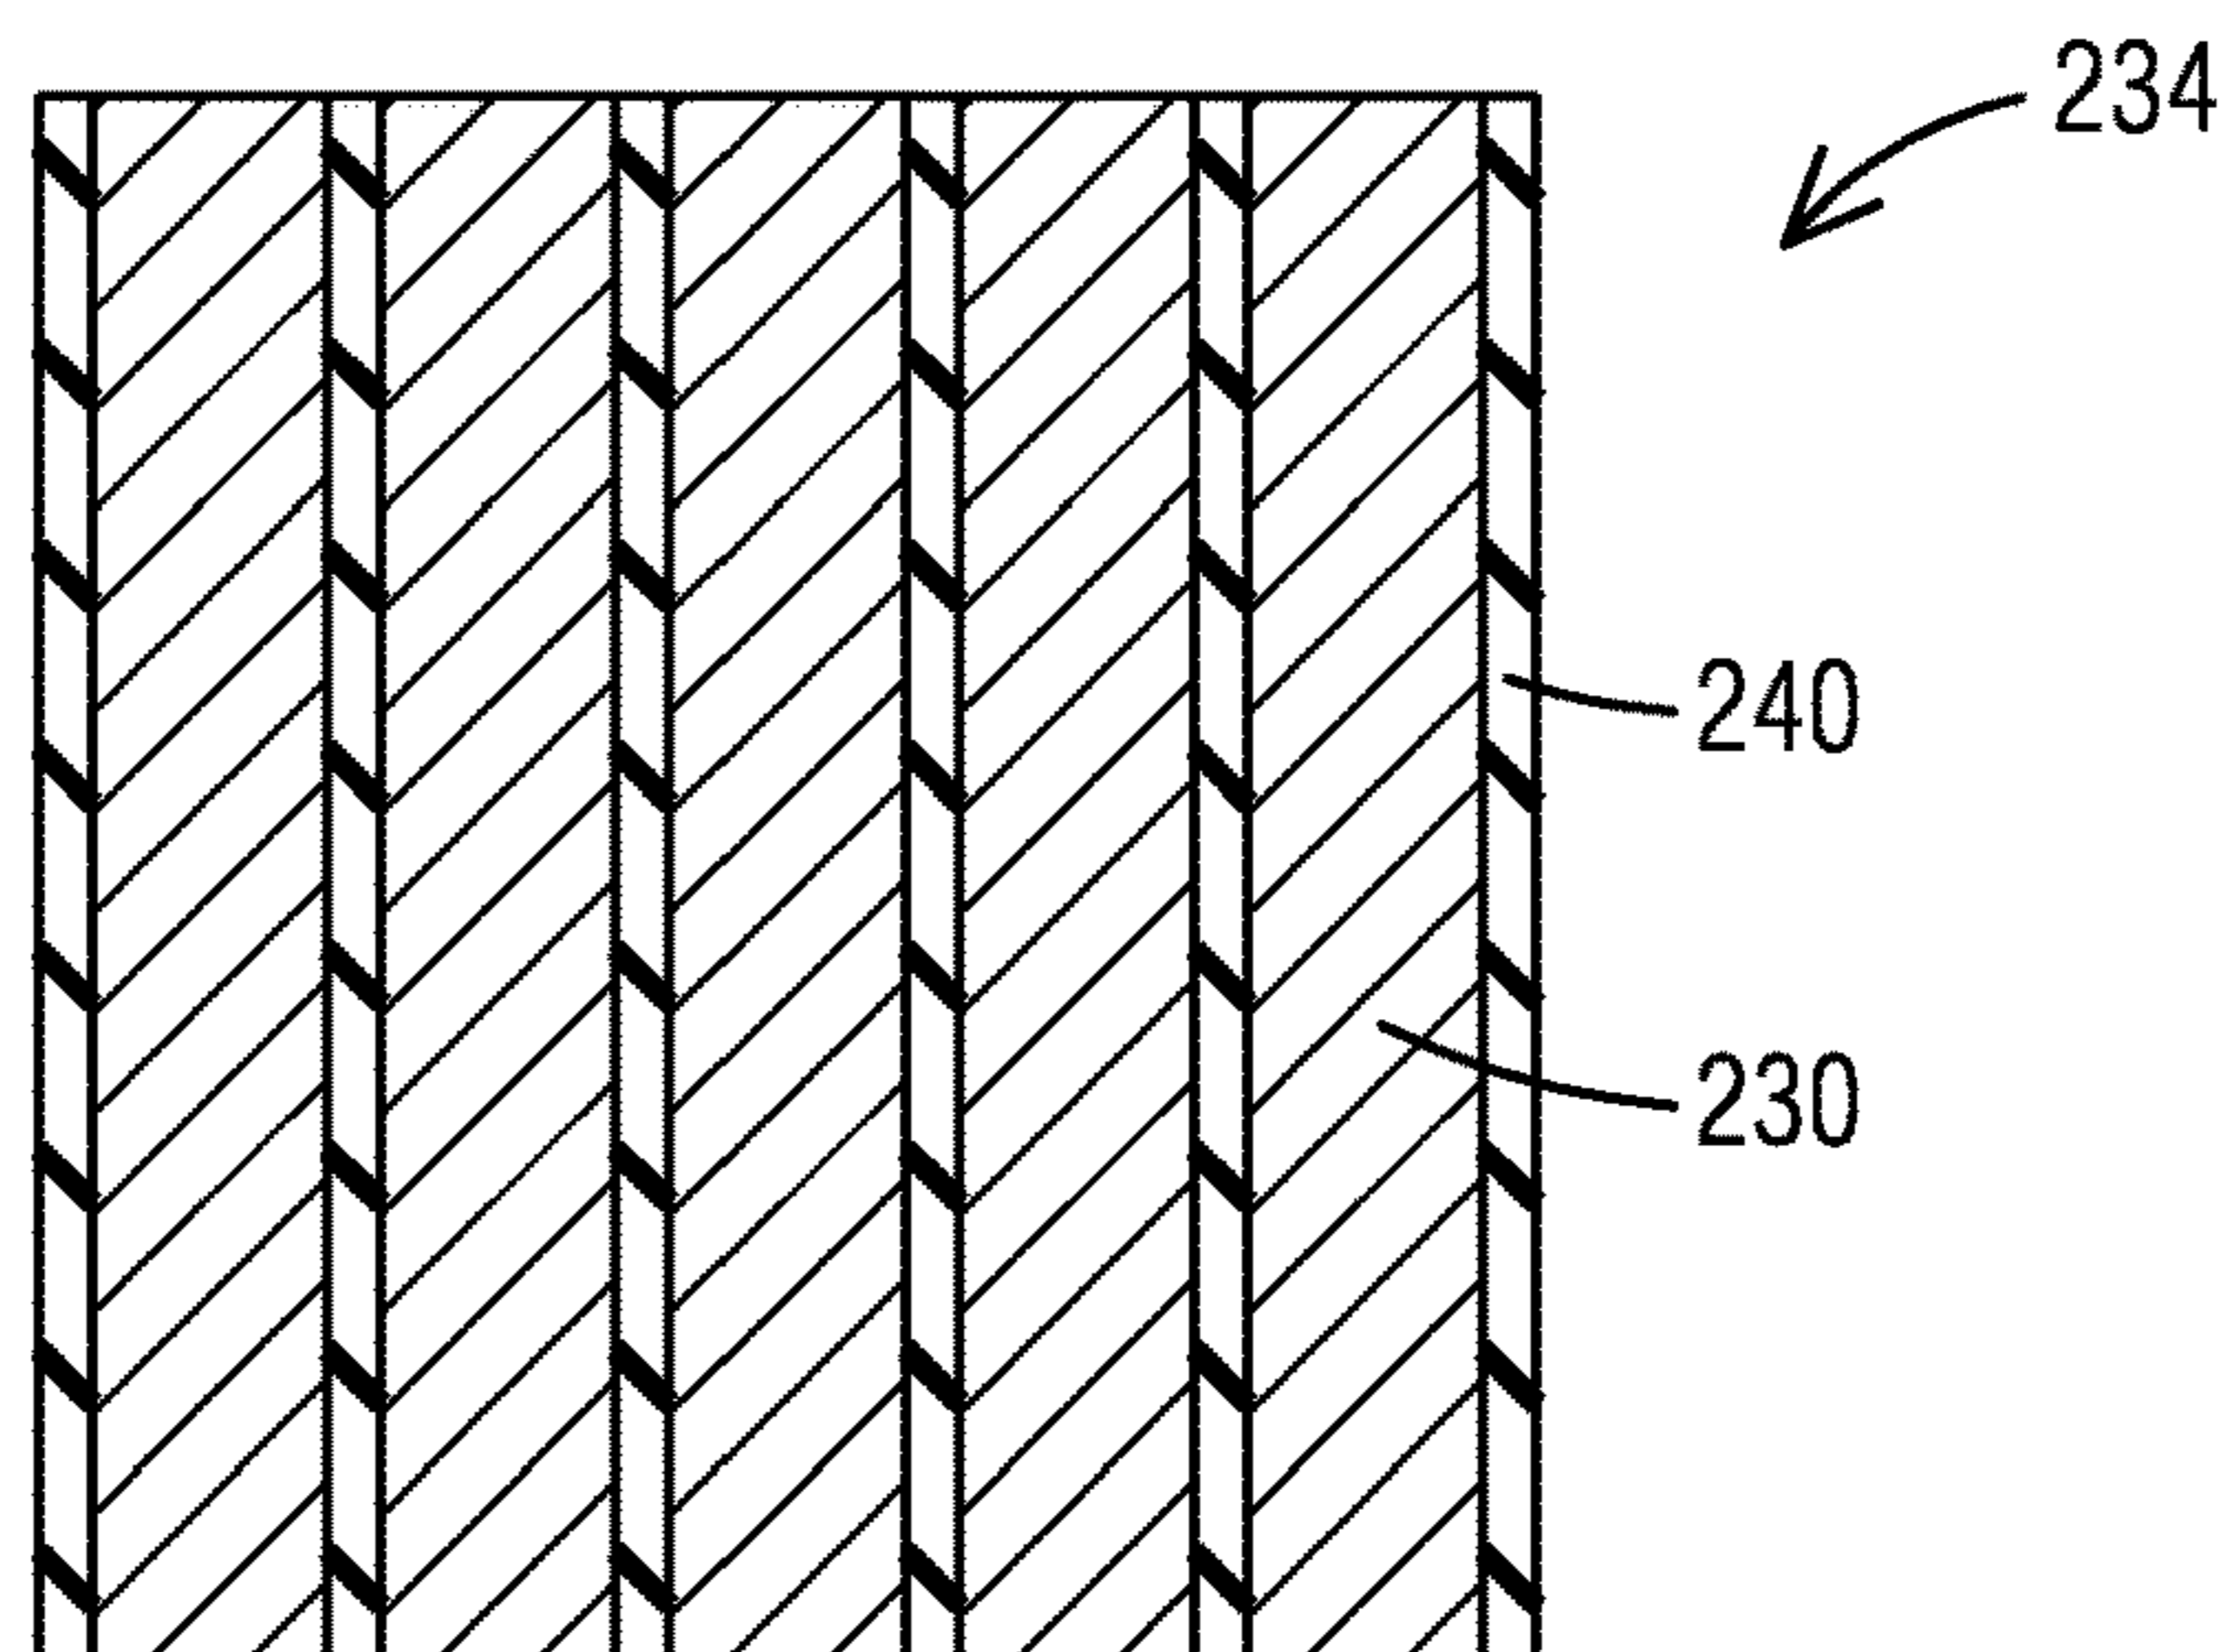
FIG. 2 illustrates a schematic cross section view of a lamination pack in which embodiments of the present invention may be implemented;

FIG. 2 illustrates a schematic cross section view of a pack 234 having a plurality of laminations 230. As shown in FIG. 2, the laminations 230 are separated from each other by an insulation layer 240. The insulation layer 240 may include any suitable materials, such as insulation paper, fiber glasses, etc. The insulation layer 240 is much thinner than the lamination 230. For example, the lamination 230 may have a thickness in an order of millimeters. The insulation layer 240 may have a thickness in an order of micrometers.

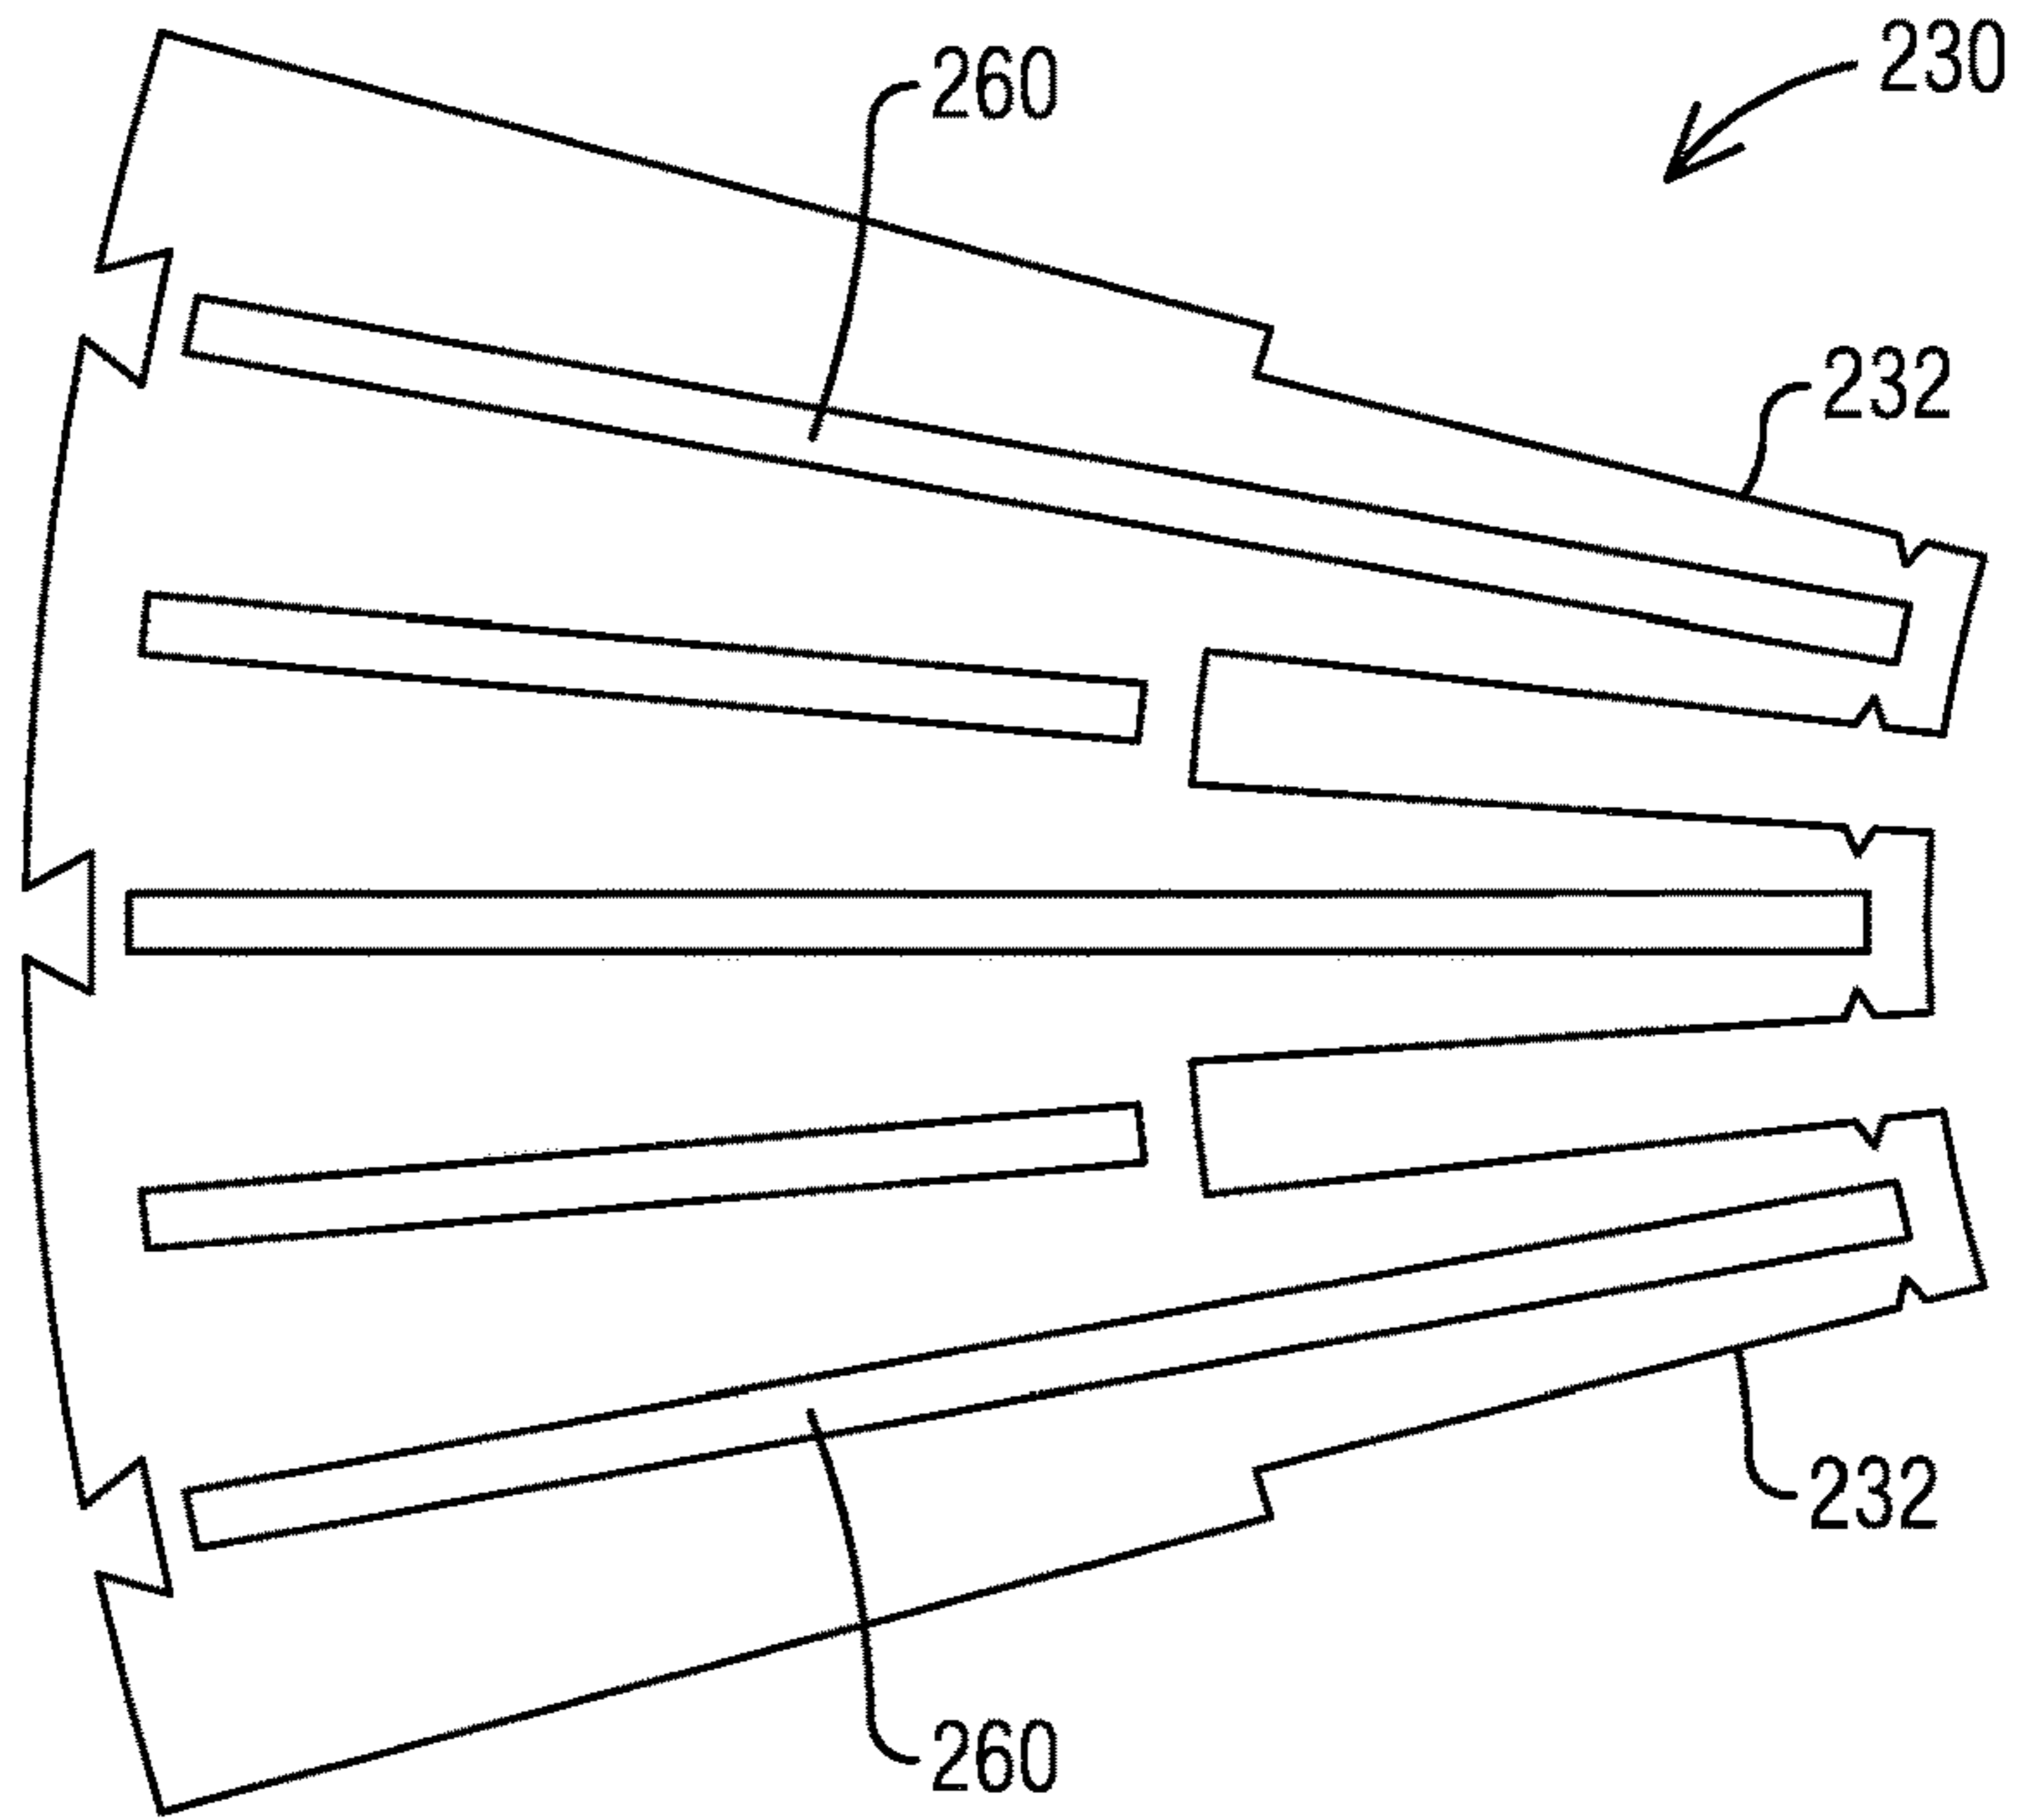
FIG. 3 illustrates a schematic plan view of a lamination having ventilation spacers of which embodiments of the present invention may be implemented;

FIG. 3 illustrates a schematic plan view of a last lamination 230 in a pack 234. As shown in FIG. 3, an inner portion of the lamination 230 has a tooth shape comprised of a plurality of tooth 232. Typically, damage of the insulation layers 240 occurs near the tooth 232 of the laminations 230. The ventilation spacers 260 are disposed on a surface of the lamination 230 facing to the ventilation duct 250. The ventilation spacers 260 may have a block rail shape and are radially oriented. The ventilation spacers 260 are in contact with a surface of a lamination 230 of an adjacent pack 234 facing to the ventilation duct 250. The ventilation spacers 260 may tighten the laminations 230 in the adjacent packs 234. Removal of the ventilation spacers 260 may locally loosen the laminations 230 in the adjacent packs 234 so that damaged insulation layers 240 between the laminations 230 in the adjacent packs 234 may be repaired. The repair may include reapplying insulation layers 240 between the lami-

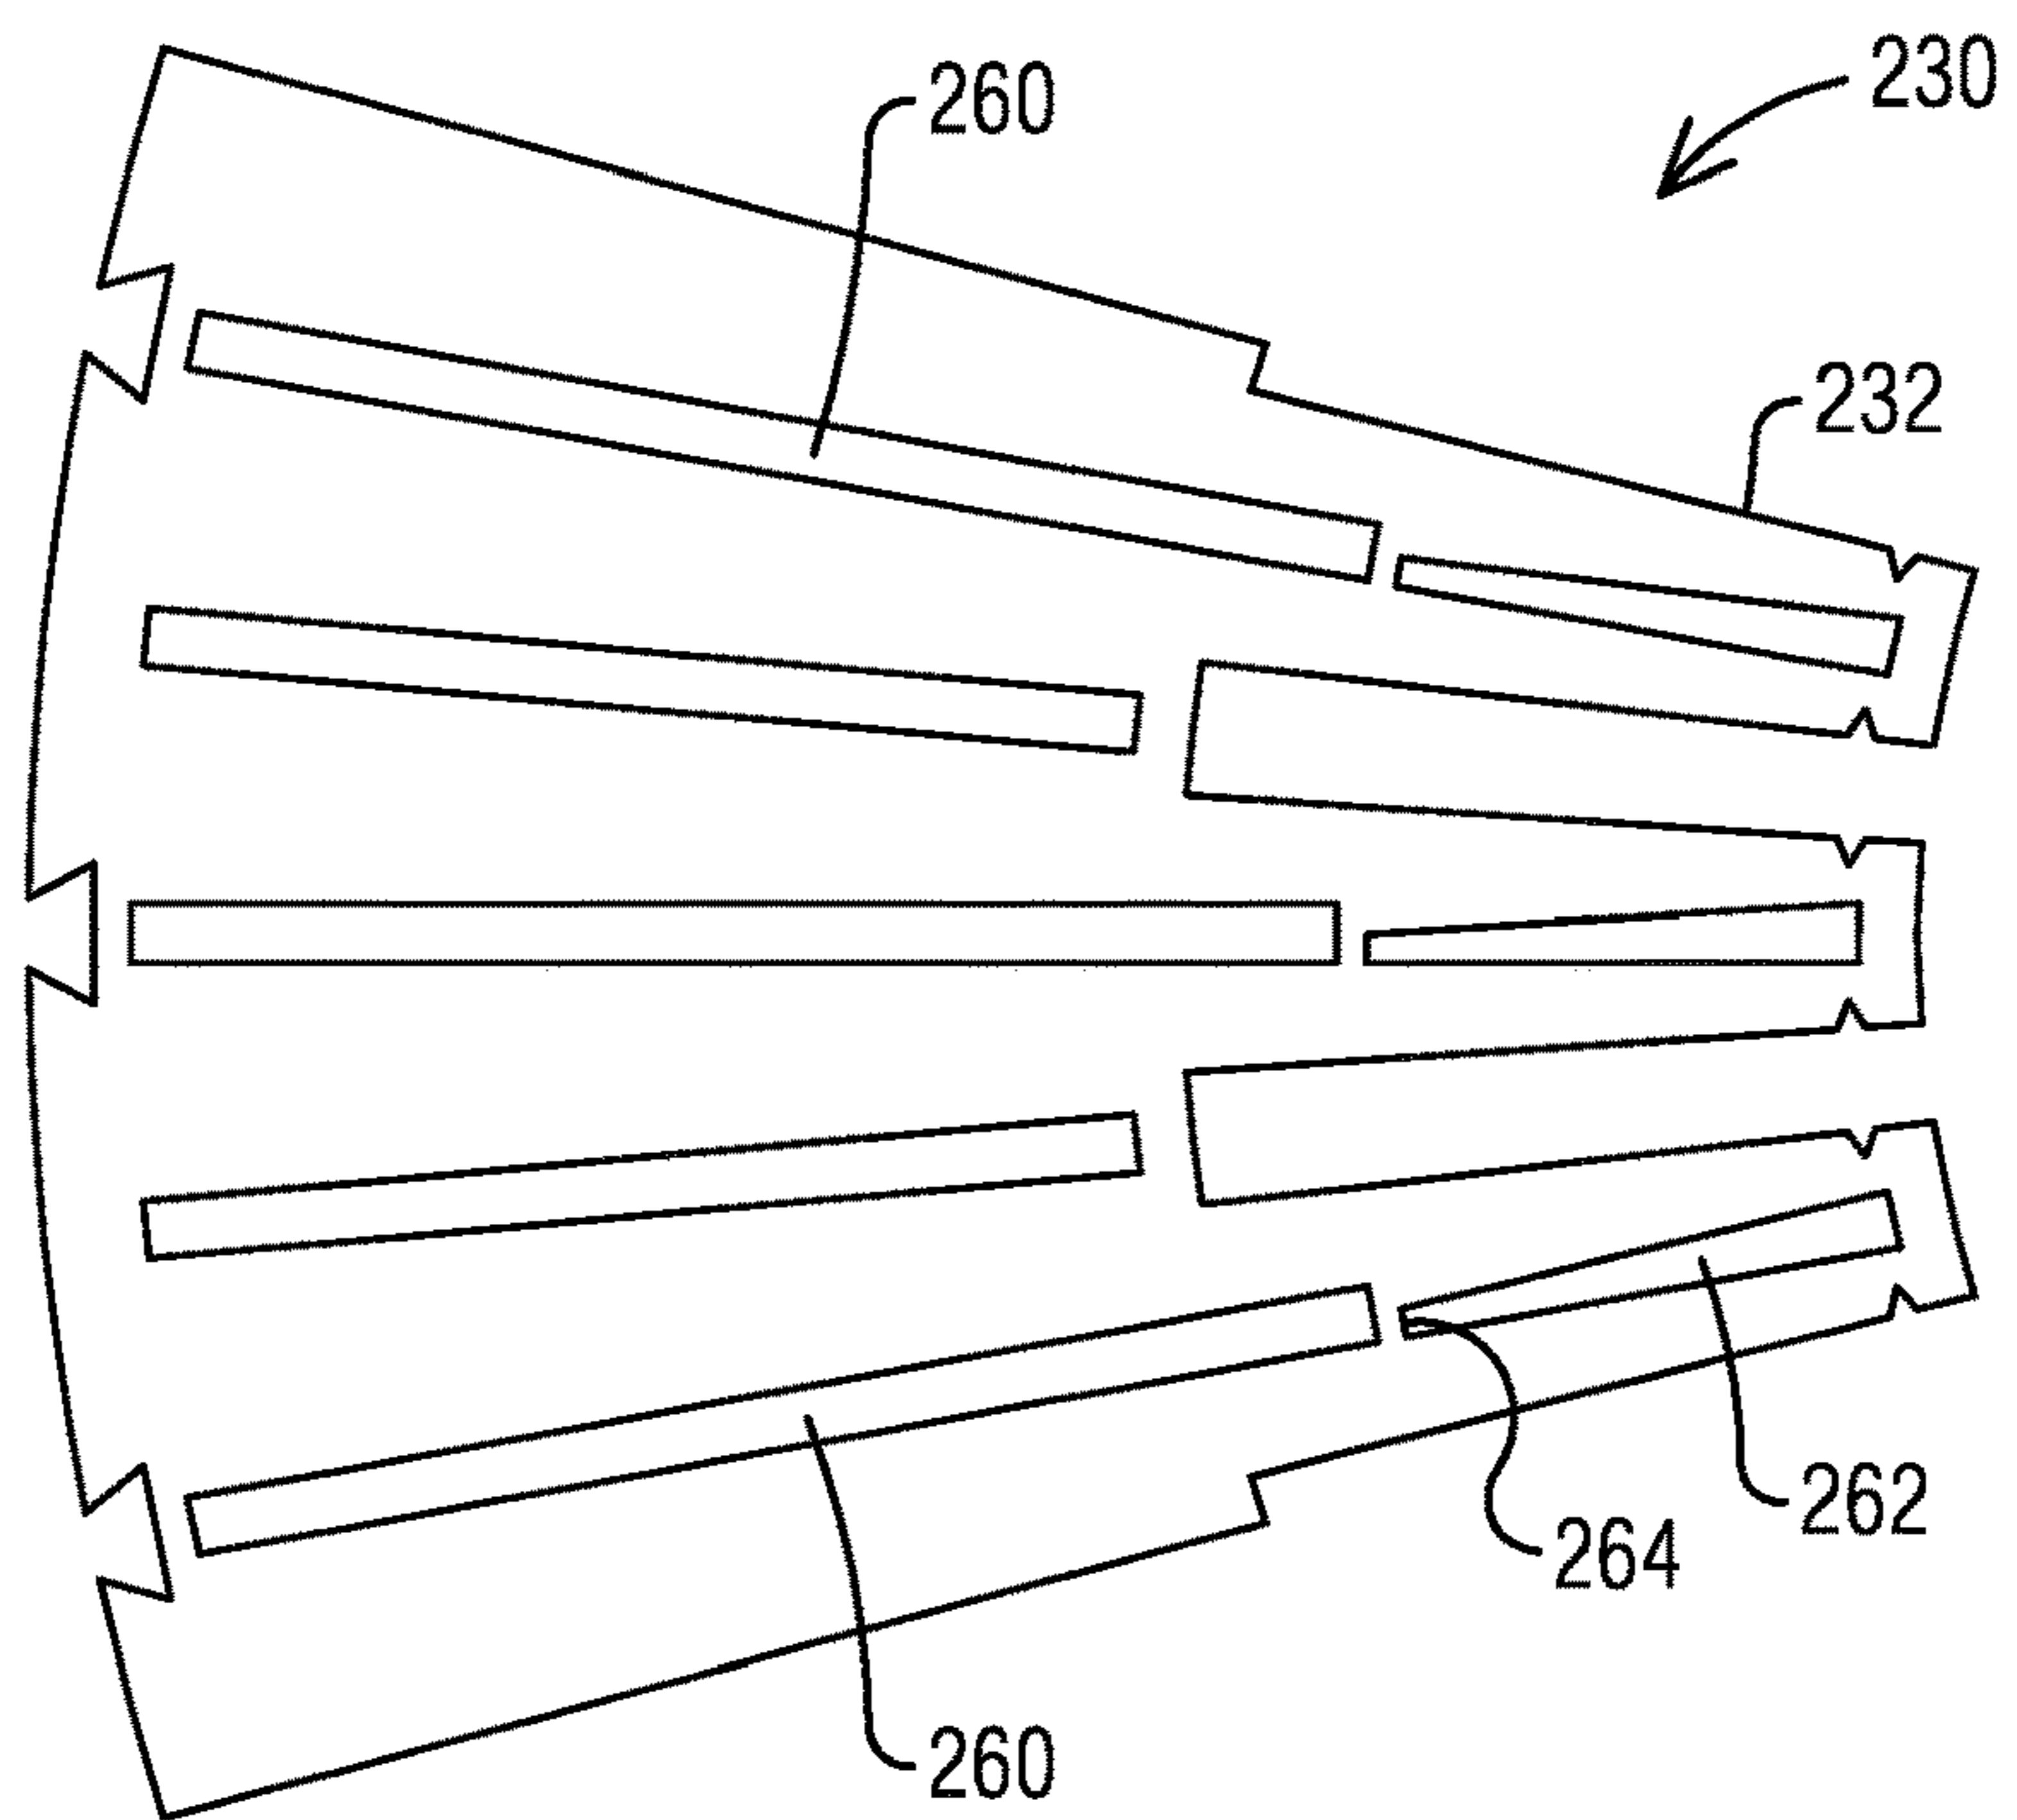
FIG. 4 illustrates a schematic plan view of a lamination having new ventilation spacers according to an embodiment of the present invention; and

After completion of the repair, new ventilation spacers 262 are reinstalled back to areas where the ventilation spacers 260 are removed. FIG. 4 illustrates a schematic plan view of a last lamination 230 having reinstalled new ventilation spacers 262. As shown in FIG. 4, a portion of ventilation spacers 260 are removed prior to repair. New ventilation spacers 262 are reinstalled between adjacent packs 234 back to areas where the ventilation spacers 260 are removed after completion of the repair. The reinstalled new ventilation spacers 262 retighten the loosen laminations 230 in the adjacent packs 234. The new ventilation spacers 262 may have a block rail shape. The new ventilation spacers 262 may have a tapered shape for easy reinstallation. Tapered tips 264 of the new ventilation spacers 262 are inserted toward to the remaining portion of the ventilation spacers 260. A radial length of the new ventilation spacers 262 may be equal to or less than a radial length of the ventilation spacers 260 being removed. For illustration purpose as shown in FIG. 4, a radial length of the new ventilation spacers 262 is less than a radial length of the ventilation spacers 260 being removed so that the tapered tips 264 of the new ventilation spacers 262 are not in contact with the remaining portion of the ventilation spacers 260. It is understood that a radial length of the new ventilation spacers 262 may be equal to a radial length of the ventilation spacers 260 being removed so that the tapered tips 264 of the new ventilation spacers 262 are in contact with the remaining portion of the ventilation spacers 260. It is also understood that tapered tips 264 of some of the new ventilation spacers 262 may be in contact with the remaining portion of the ventilation spacers 260 and tapered tips 264 of some of the new ventilation spacers 262 may be not in contact with the remaining portion of the ventilation spacer 260. The new ventilation spacers 262 may include polymer plastic materials, epoxy composite resins, such as G-11 fiber glass. The new ventilation spacers 262 may be adhesively secured between the adjacent packs 234. For example, the new ventilation spacers 262 may be coated with glue prior to reinstallation. Alternatively, areas between the adjacent packs 234 where the ventilation spacers 260 being removed are coated with glue prior to reinstalling the new ventilation spacers 262. The glue may include any suitable glue materials, such as Dacron™, or Nomex™.
