(54) **METHOD FOR REPAIRING GENERATOR STATOR CORE**

A method for repairing a stator core of a generator is presented. The stator core includes laminations grouped into packs. A ventilation spacer is disposed between adjacent packs. Laminations are separated from each other by insulation layers. The ventilation spacer is removed between adjacent packs having a damaged insulation layer between the laminations to locally loosen the laminations in the adjacent packs which allows the damaged insulation layer between the laminations to be repaired. A new ventilation spacer is reinstalled between the adjacent packs where the ventilation spacer being removed to retighten the laminations in the adjacent packs after completion of the repair. The new ventilation spacer is adhesively secured between the adjacent packs.

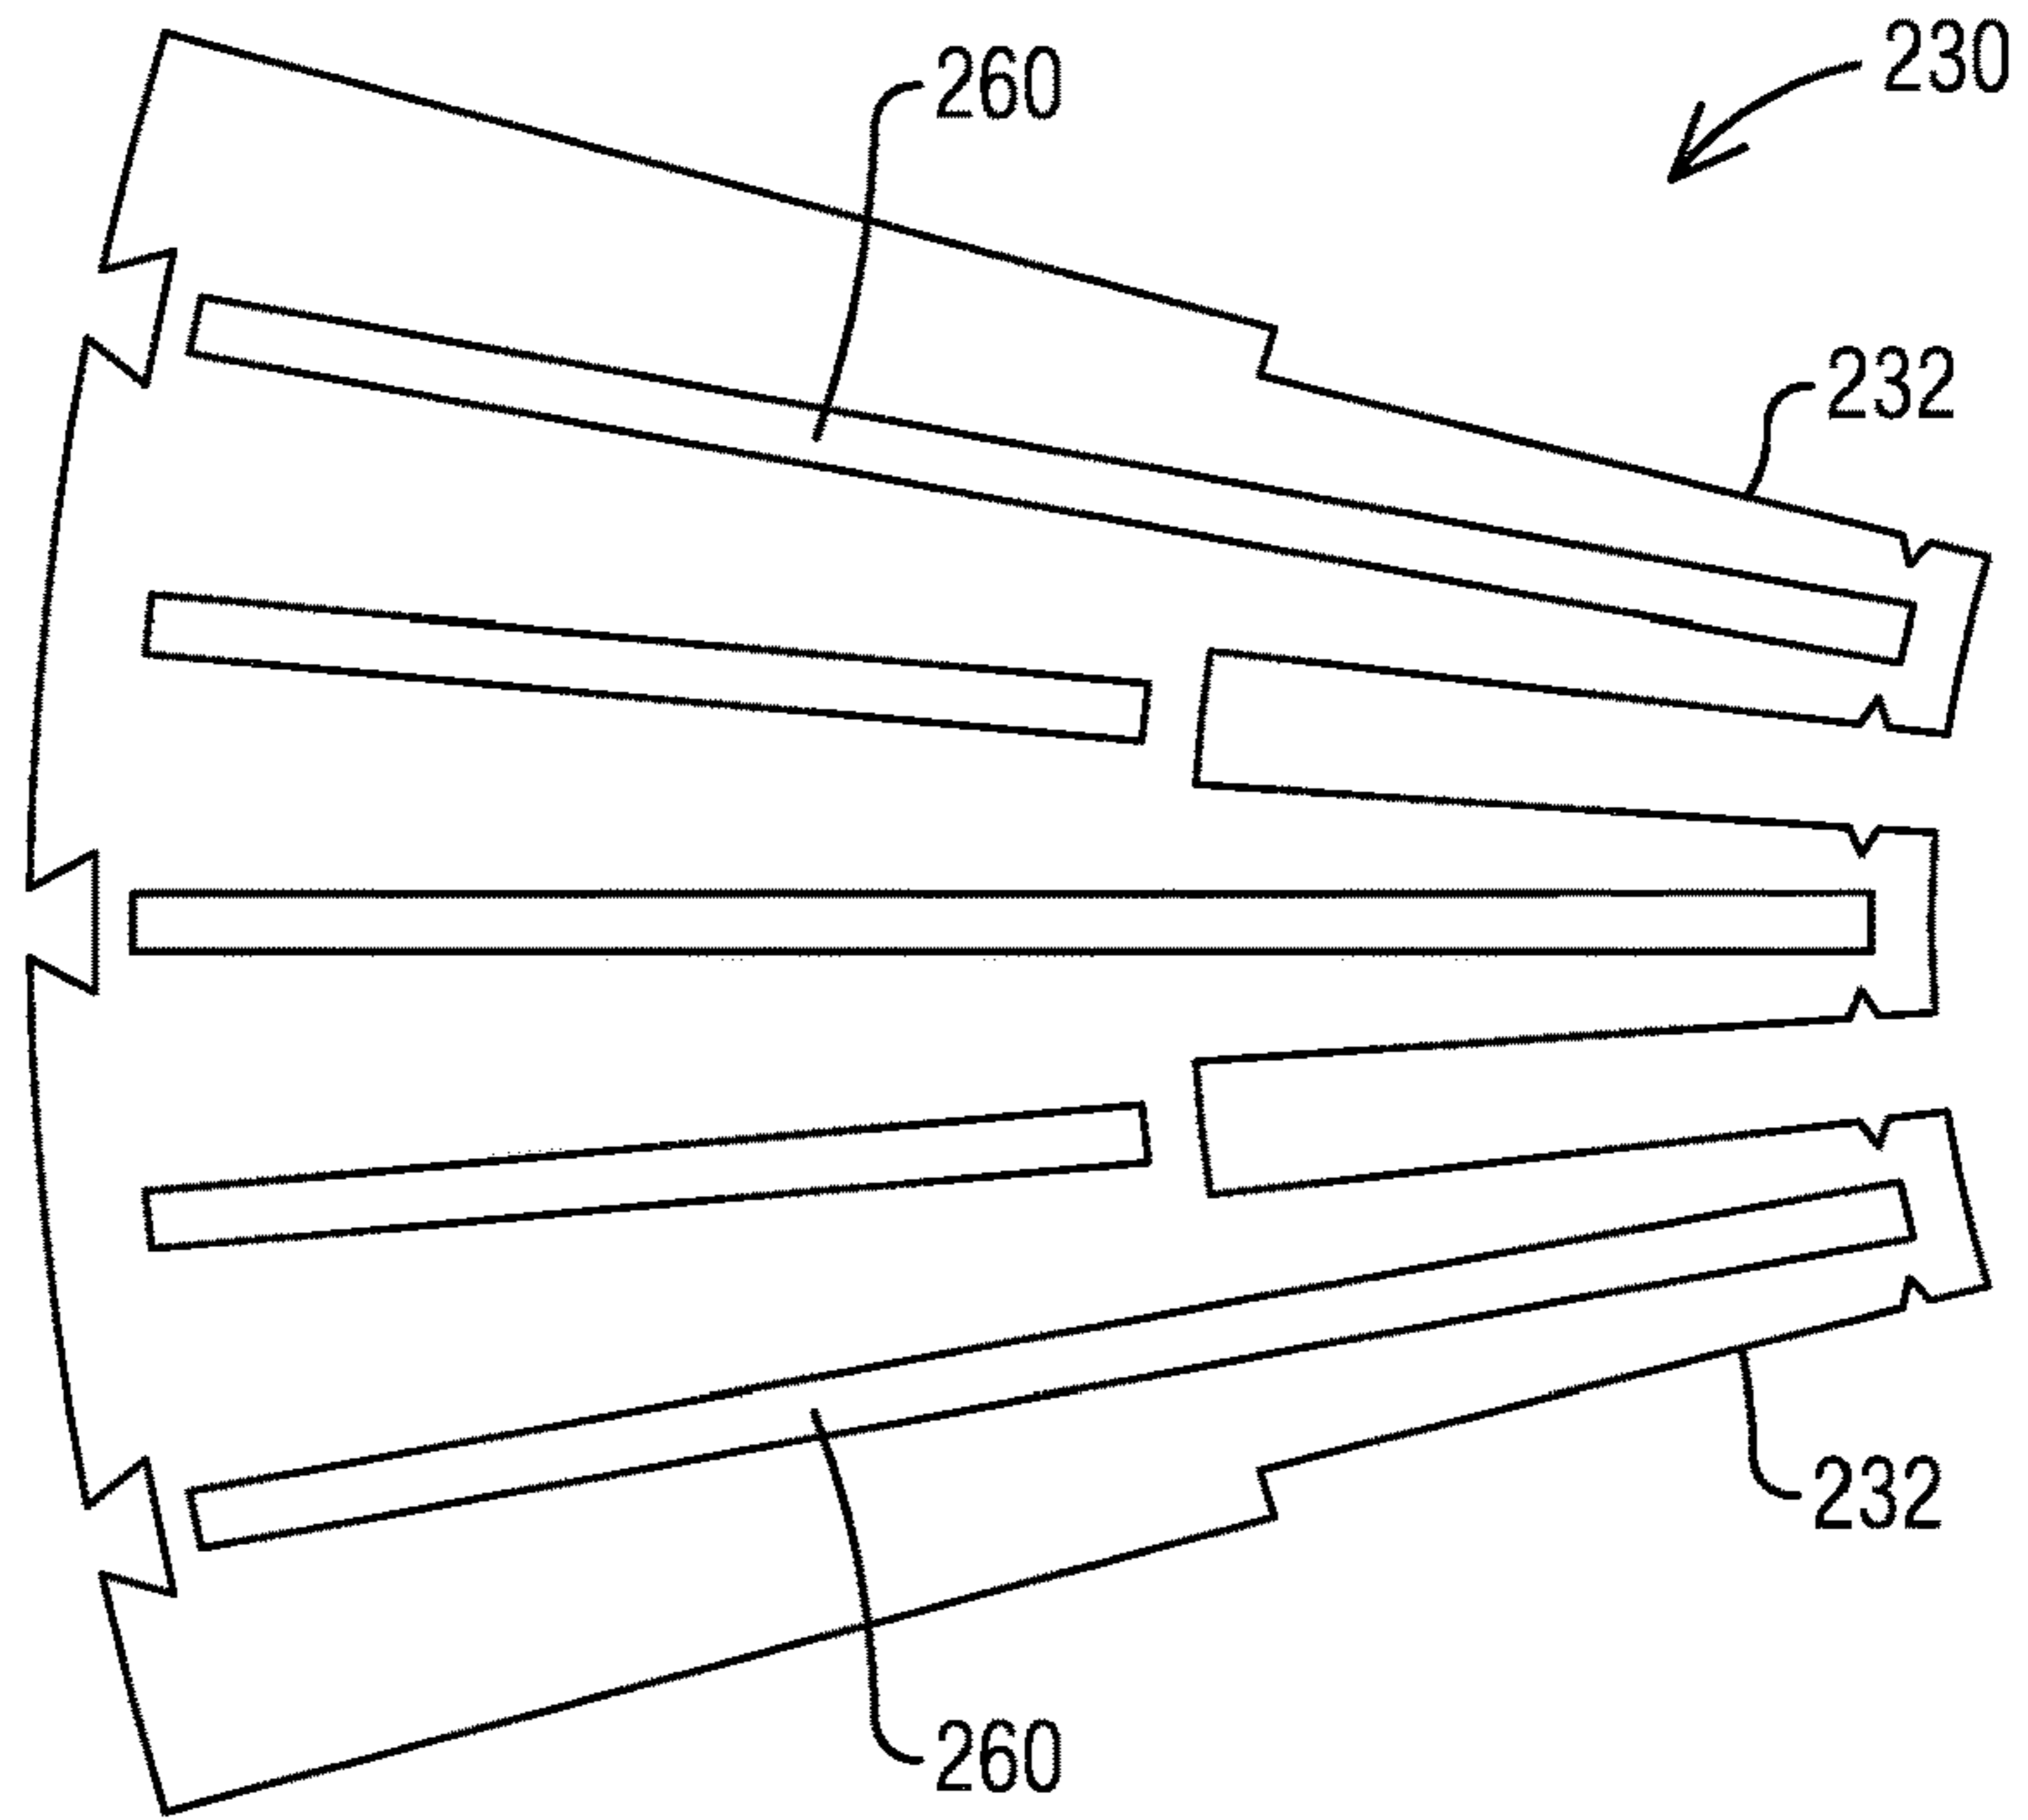
FIG. 3 illustrates a schematic plan view of a lamination having ventilation spacers of which embodiments of the present invention may be implemented;

FIG. 3 illustrates a schematic plan view of a last lamination 230 in a pack 234. As shown in FIG. 3, an inner portion of the lamination 230 has a tooth shape comprised of a plurality of tooth 232. Typically, damage of the insulation layers 240 occurs near the tooth 232 of the laminations 230. The ventilation spacers 260 are disposed on a surface of the lamination 230 facing to the ventilation duct 250. The ventilation spacers 260 may have a block rail shape and are radially oriented. The ventilation spacers 260 are in contact with a surface of a lamination 230 of an adjacent pack 234 facing to the ventilation duct 250. The ventilation spacers 260 may tighten the laminations 230 in the adjacent packs 234. Removal of the ventilation spacers 260 may locally loosen the laminations 230 in the adjacent packs 234 so that damaged insulation layers 240 between the laminations 230 in the adjacent packs 234 may be repaired. The repair may include reapplying insulation layers 240 between the lami-
