US010954822B2

(54) **REPAIR MEMBER FOR A VANE ASSEMBLY OF A GAS TURBINE AND METHOD FOR REPAIRING A DAMAGED VANE OF A VANE ASSEMBLY OF A GAS TURBINE**

(71) Applicant: **Nuovo Pignone Tecnologie Srl**,  
Florence (IT)

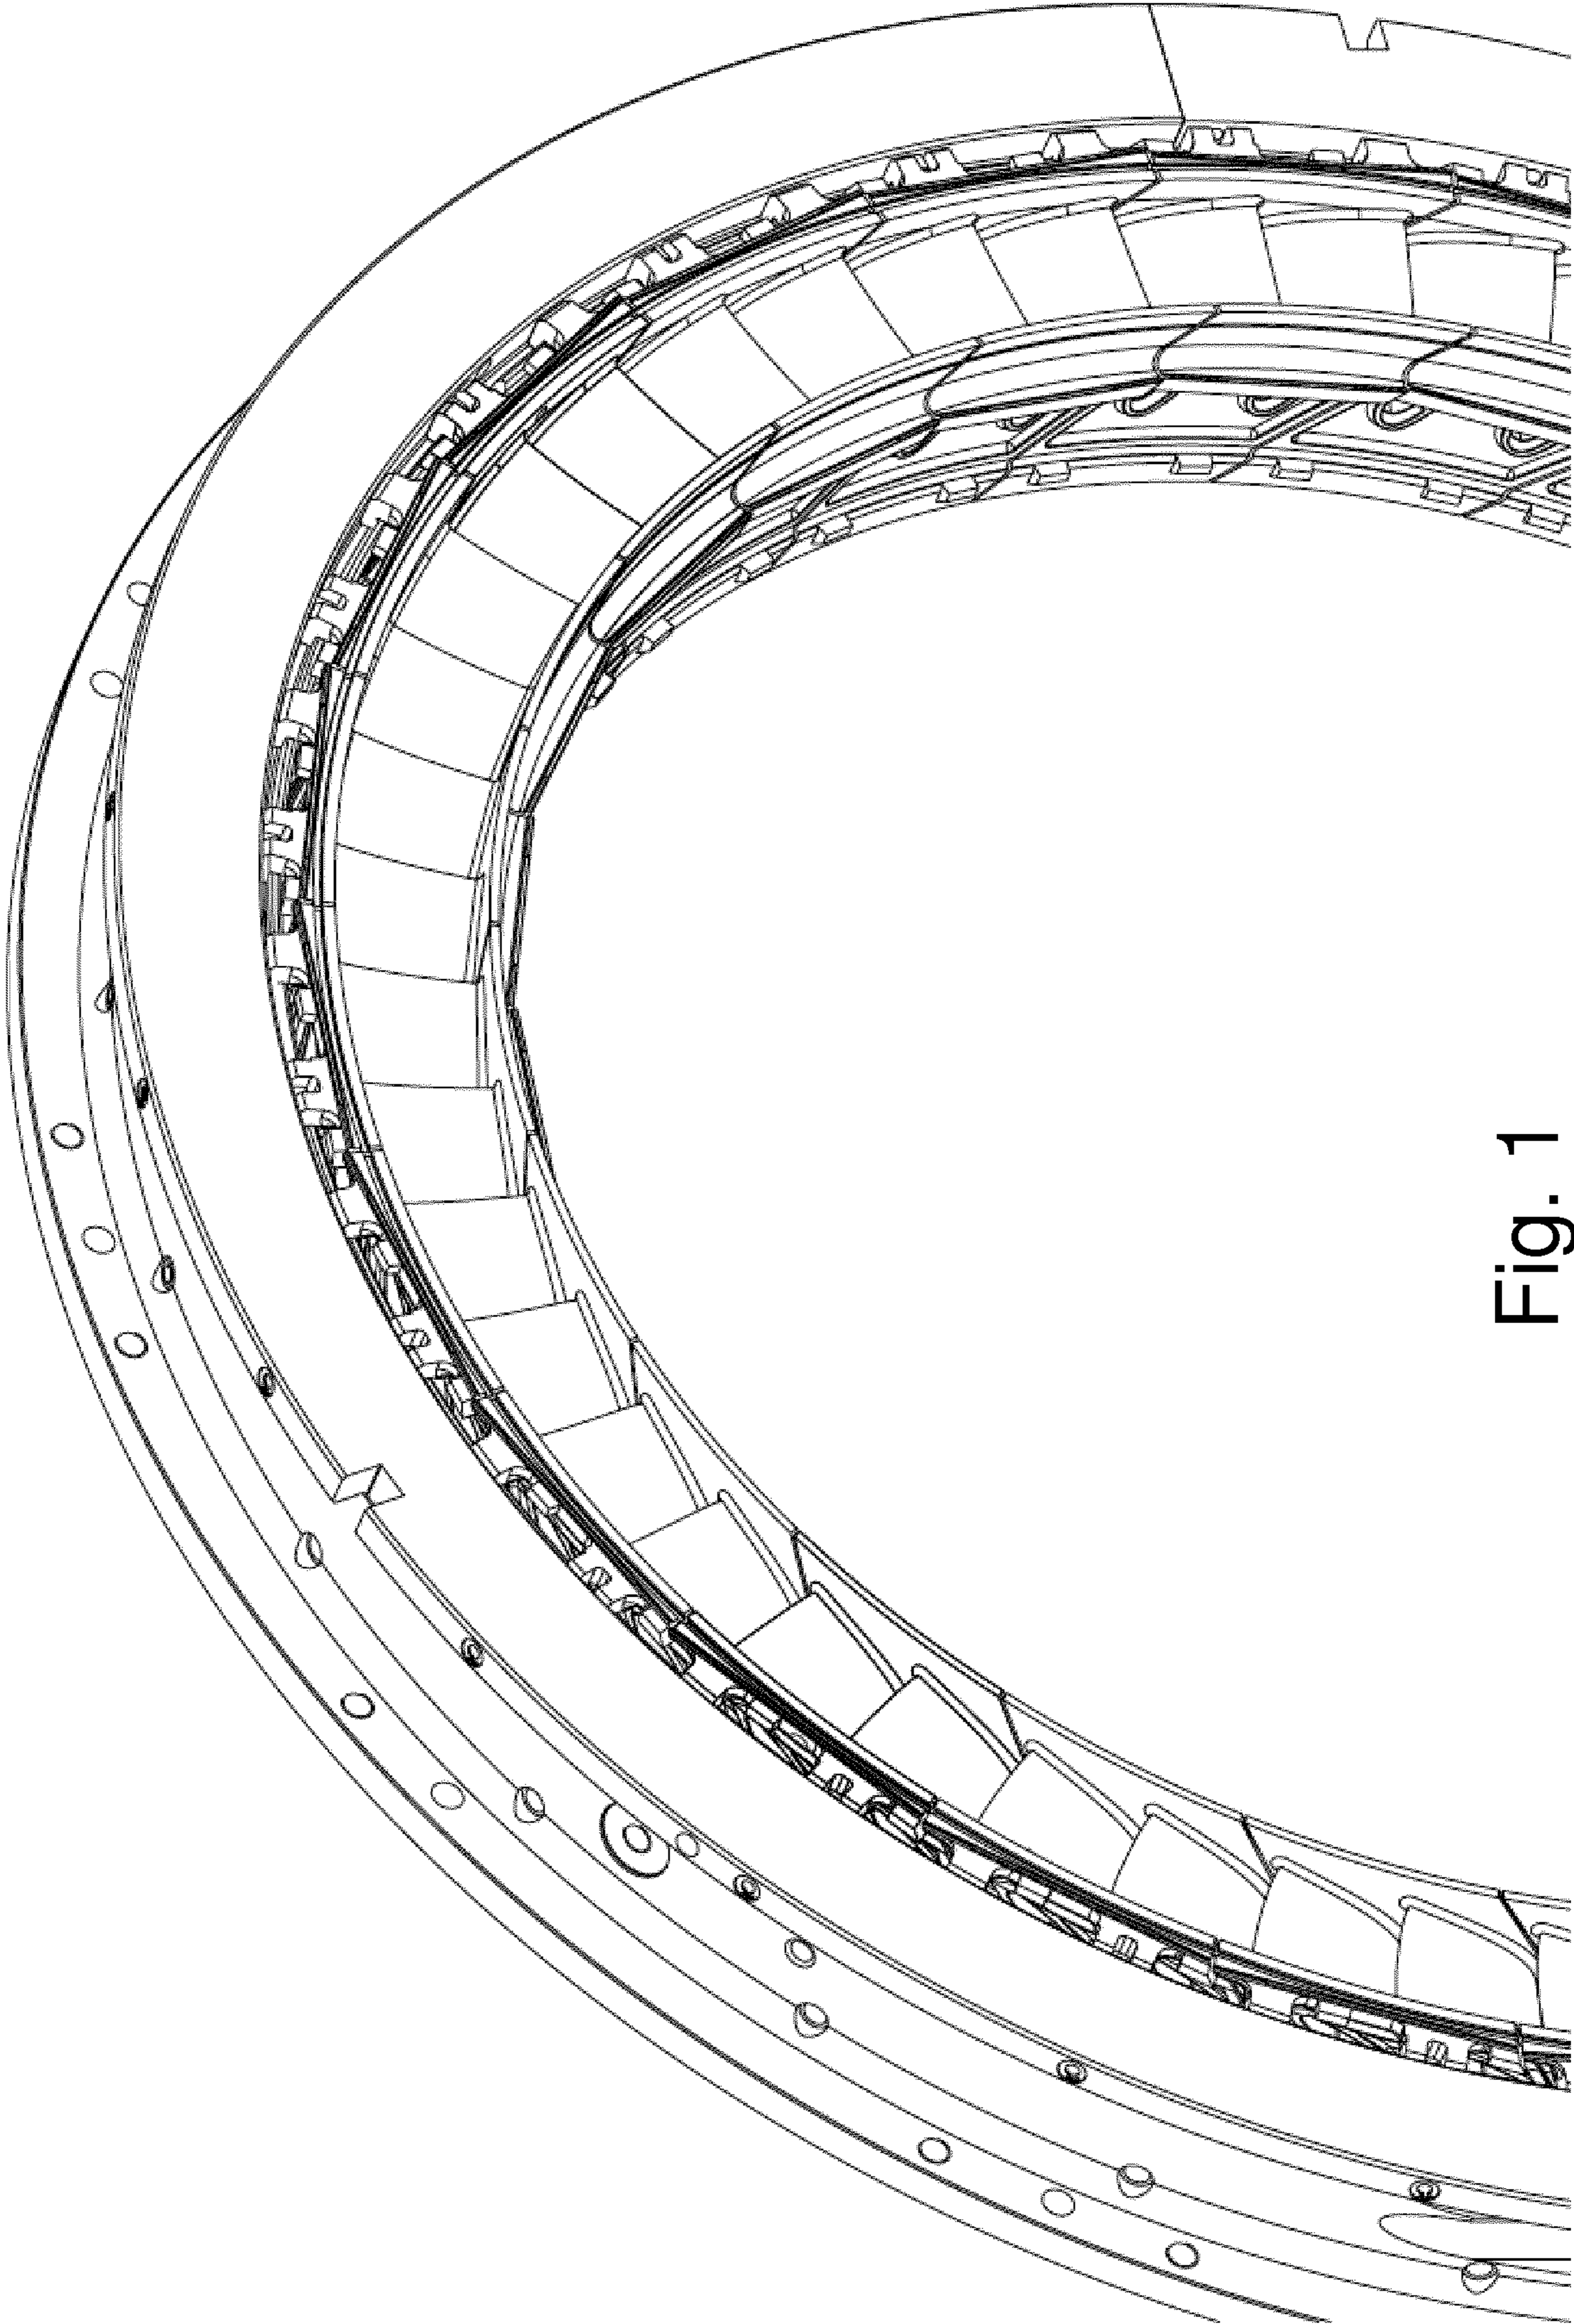
Fig. 1

FIG. 1 shows a partial three-dimensional view of the front of a ring-shaped vane assembly (i.e. showing the leading edges of the vanes),

FIG. 1 shows the front of a ring-shaped vane assembly and the leading edges of the vanes may be seen. FIG. 1 is a three-dimensional view.

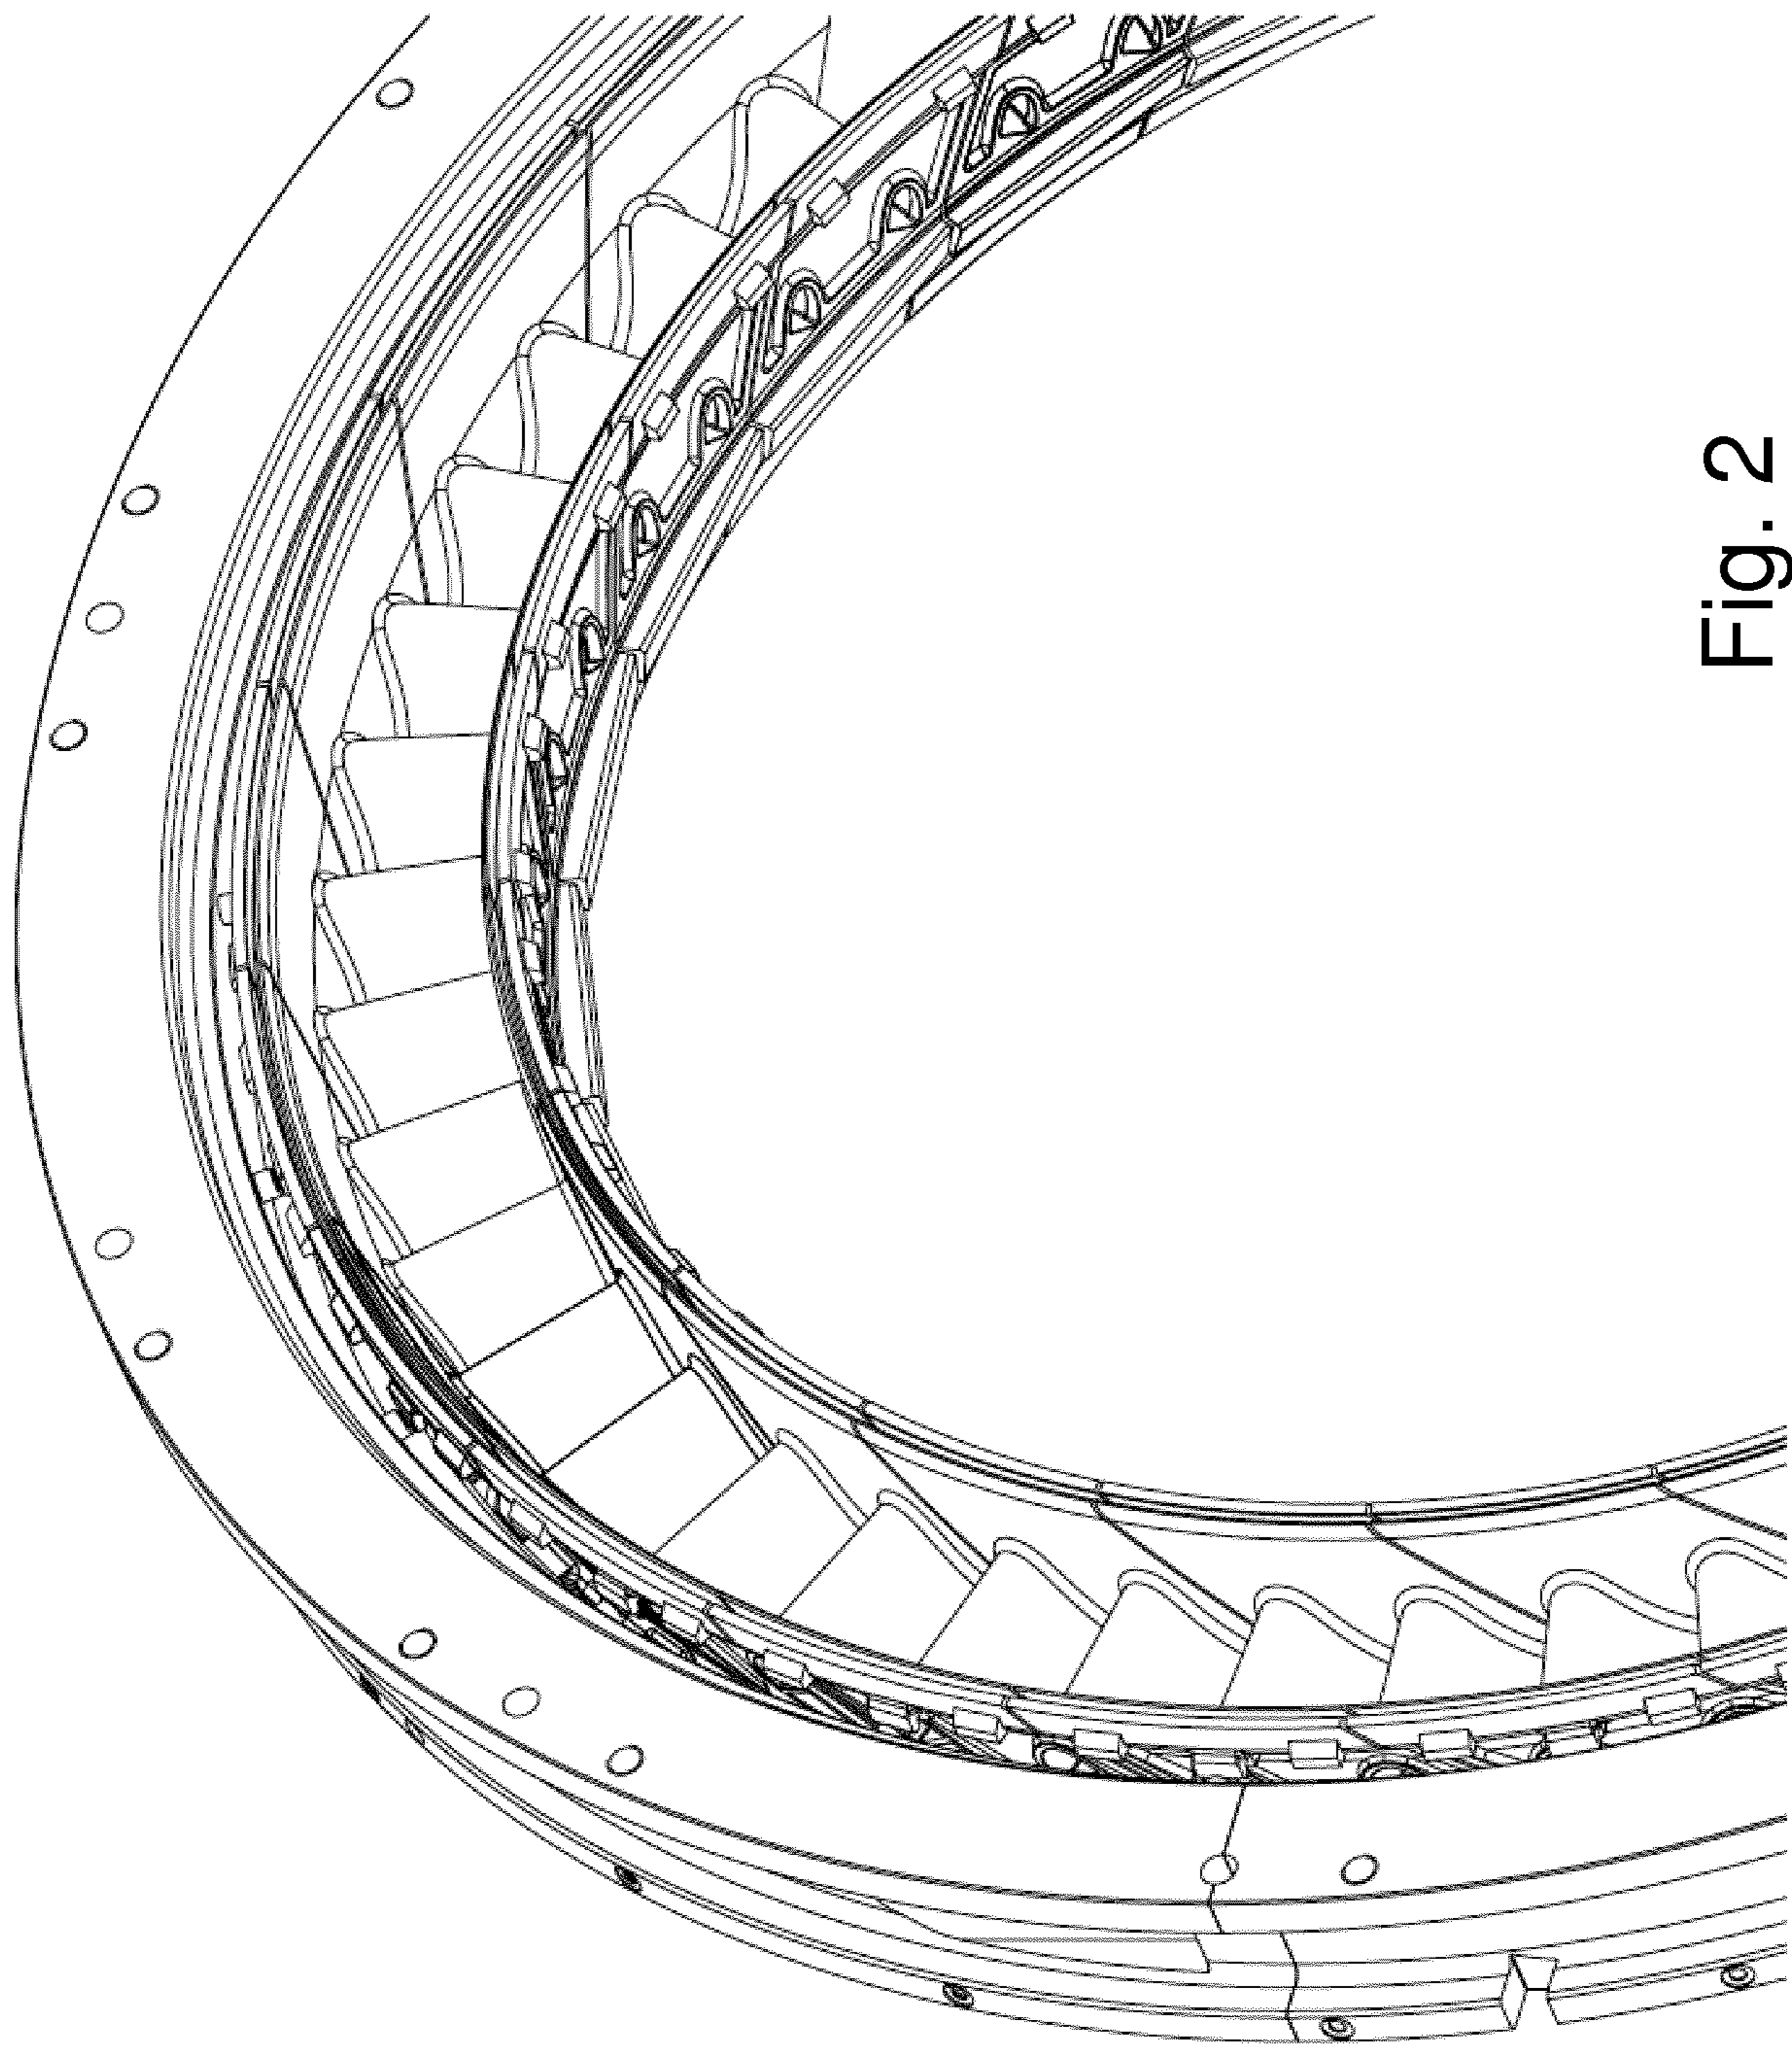
Fig. 2

FIG. 2 shows a partial three-dimensional view of the rear of a sector-ring-shaped vane assembly (i.e. showing the trailing edges of the vanes),

FIG. 2 shows the rear of a ring-shaped vane assembly and the trailing edges of the vanes may be seen. FIG. 2 is a three-dimensional view.

According to this solution, the blades are presumably comprised in a blade assembly (not shown in the figures); the bases of the blades are used for fixing the blades while the tips of the blades are loose. As it is apparent from the figures, in particular FIG. 2, the repair member does not comprise any platform portion of the assembly either at the base region of the blade and, even less, at the tip region of the blade; the repair member simply consists in an airfoil portion (see FIG. 2). Furthermore, the repair member may be taken to the blade to be repaired along any direction;

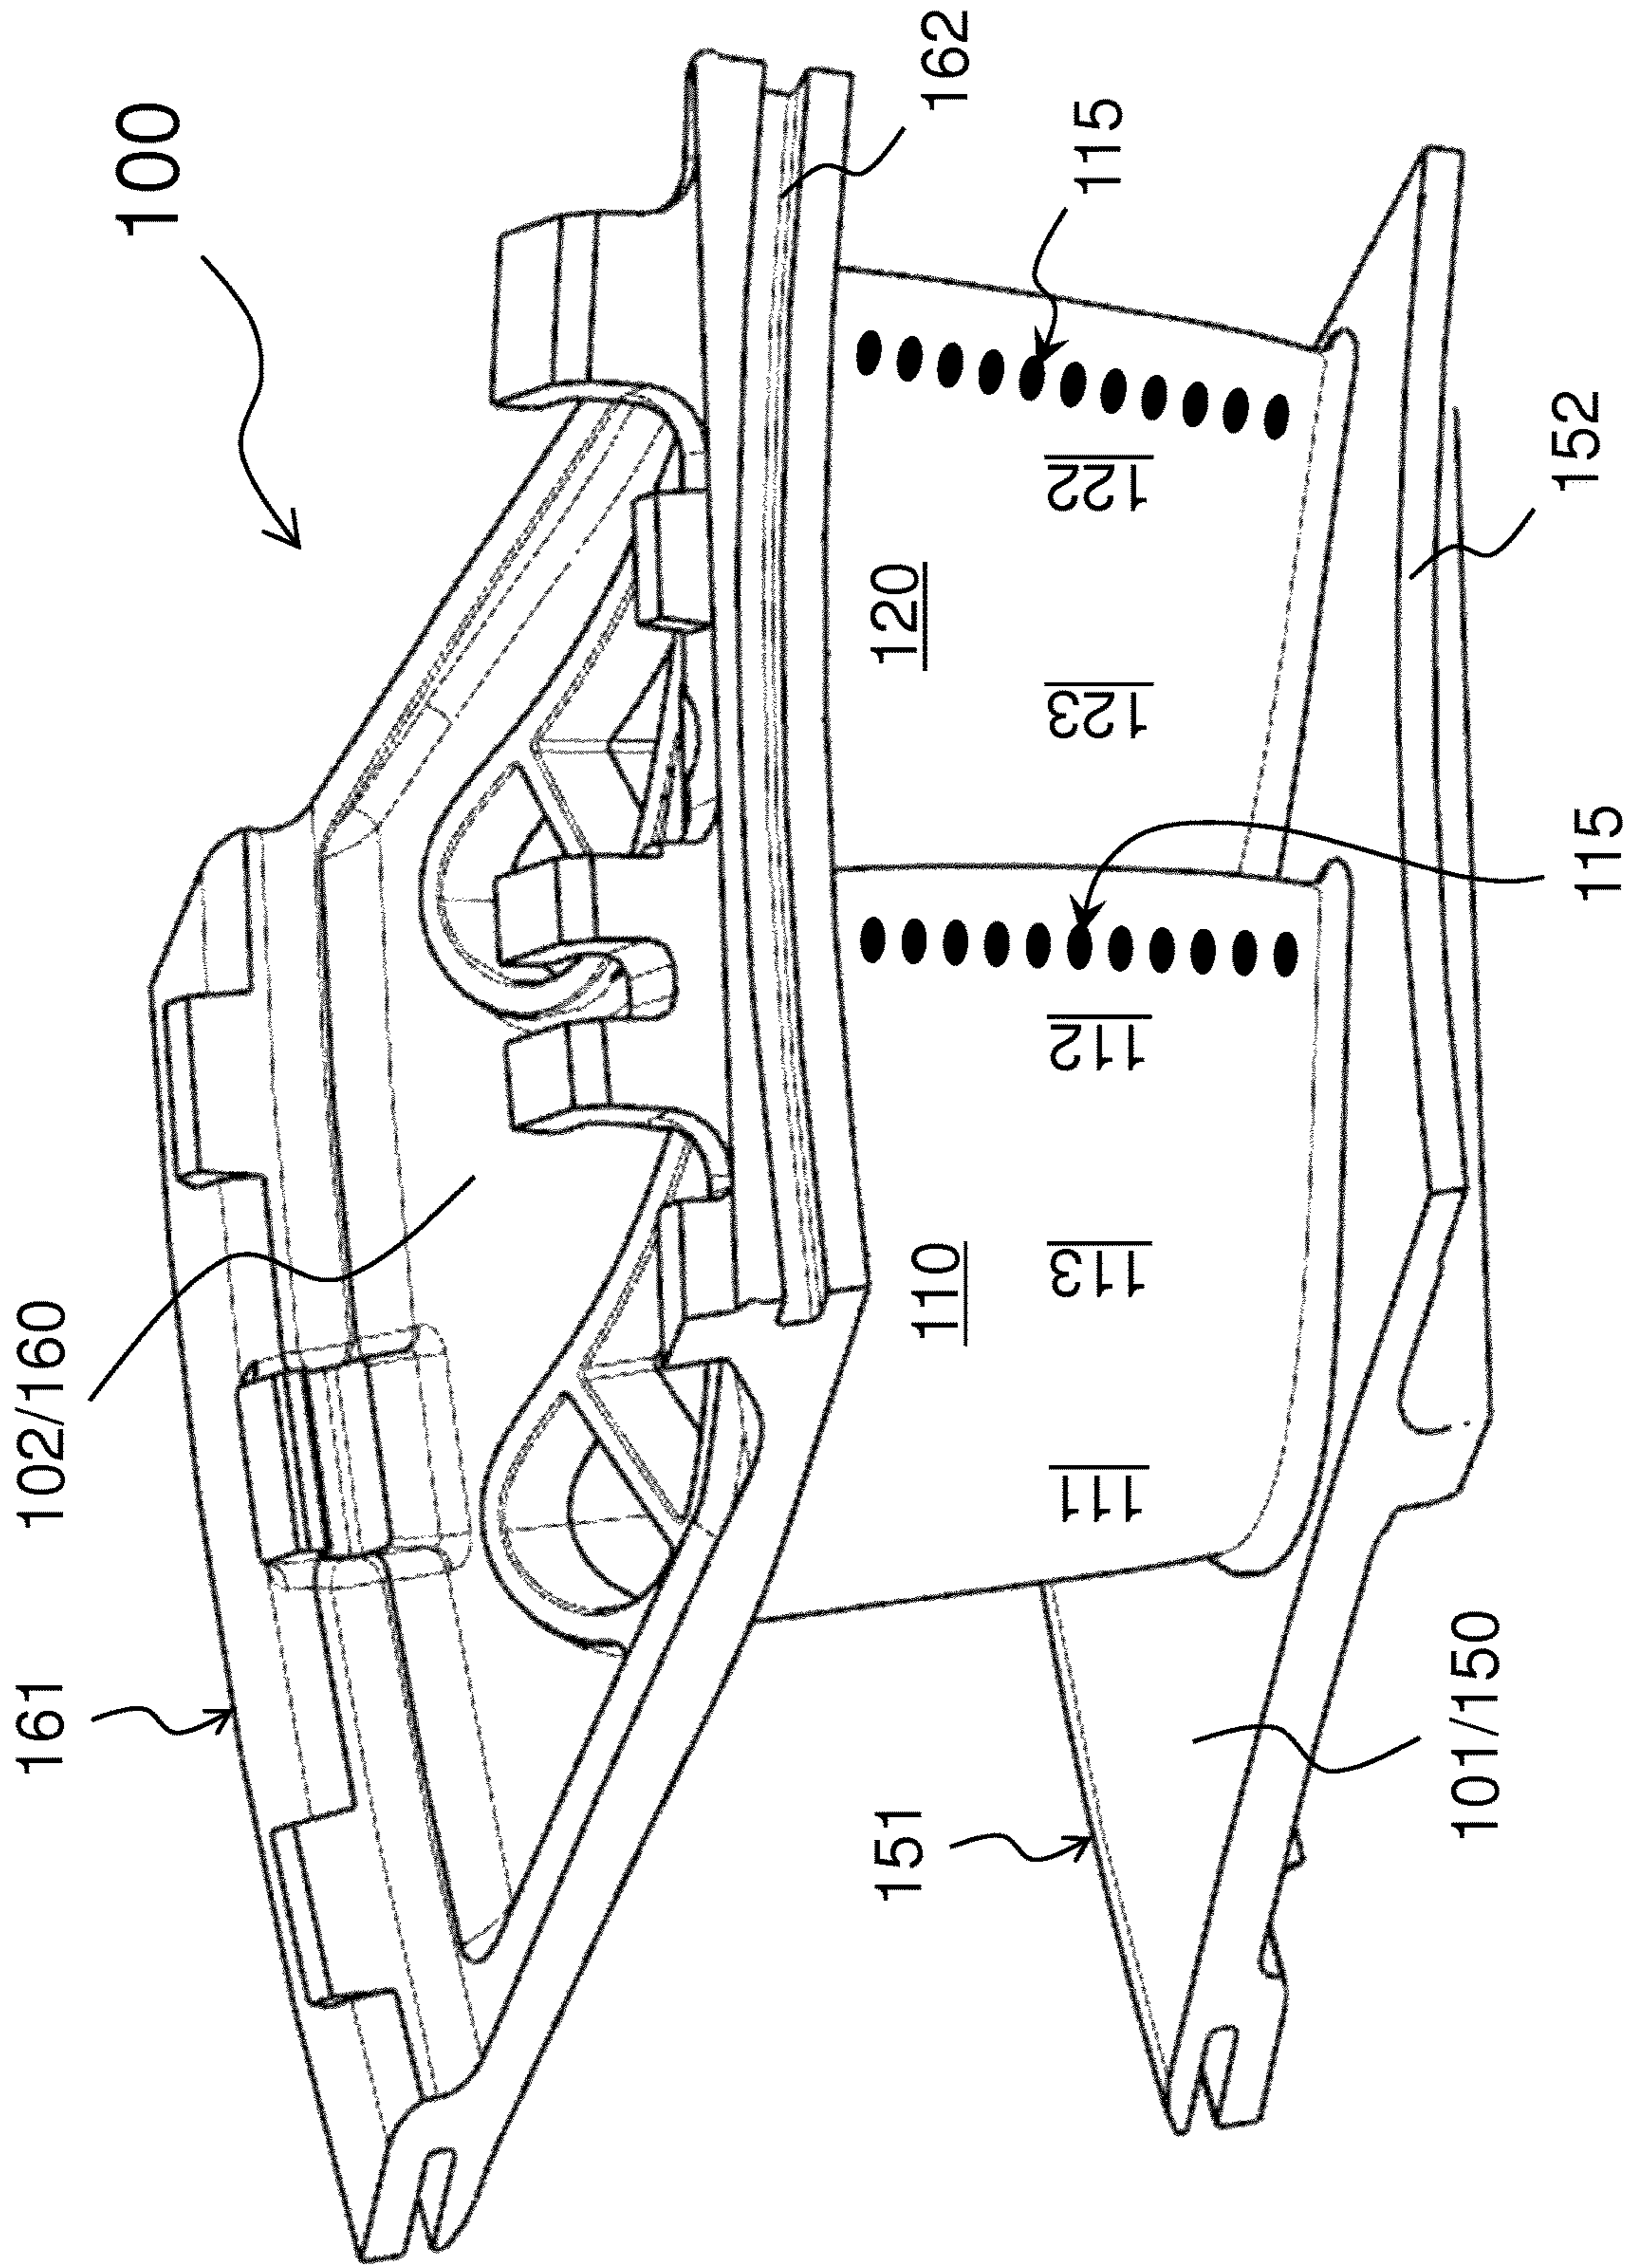
Fig. 3

Each of the vanes 110 and 120 consists of a leading edge portion 111 and 121 (not shown in FIG. 3), a trailing edge portion 112 and 122, and a body portion 113 and 123. As can be seen from e.g. FIG. 3 and FIG. 8A, each of the vanes 110 and 120 is hollow and has a set of (e.g. cooling) holes 115 at its trailing edge portion.

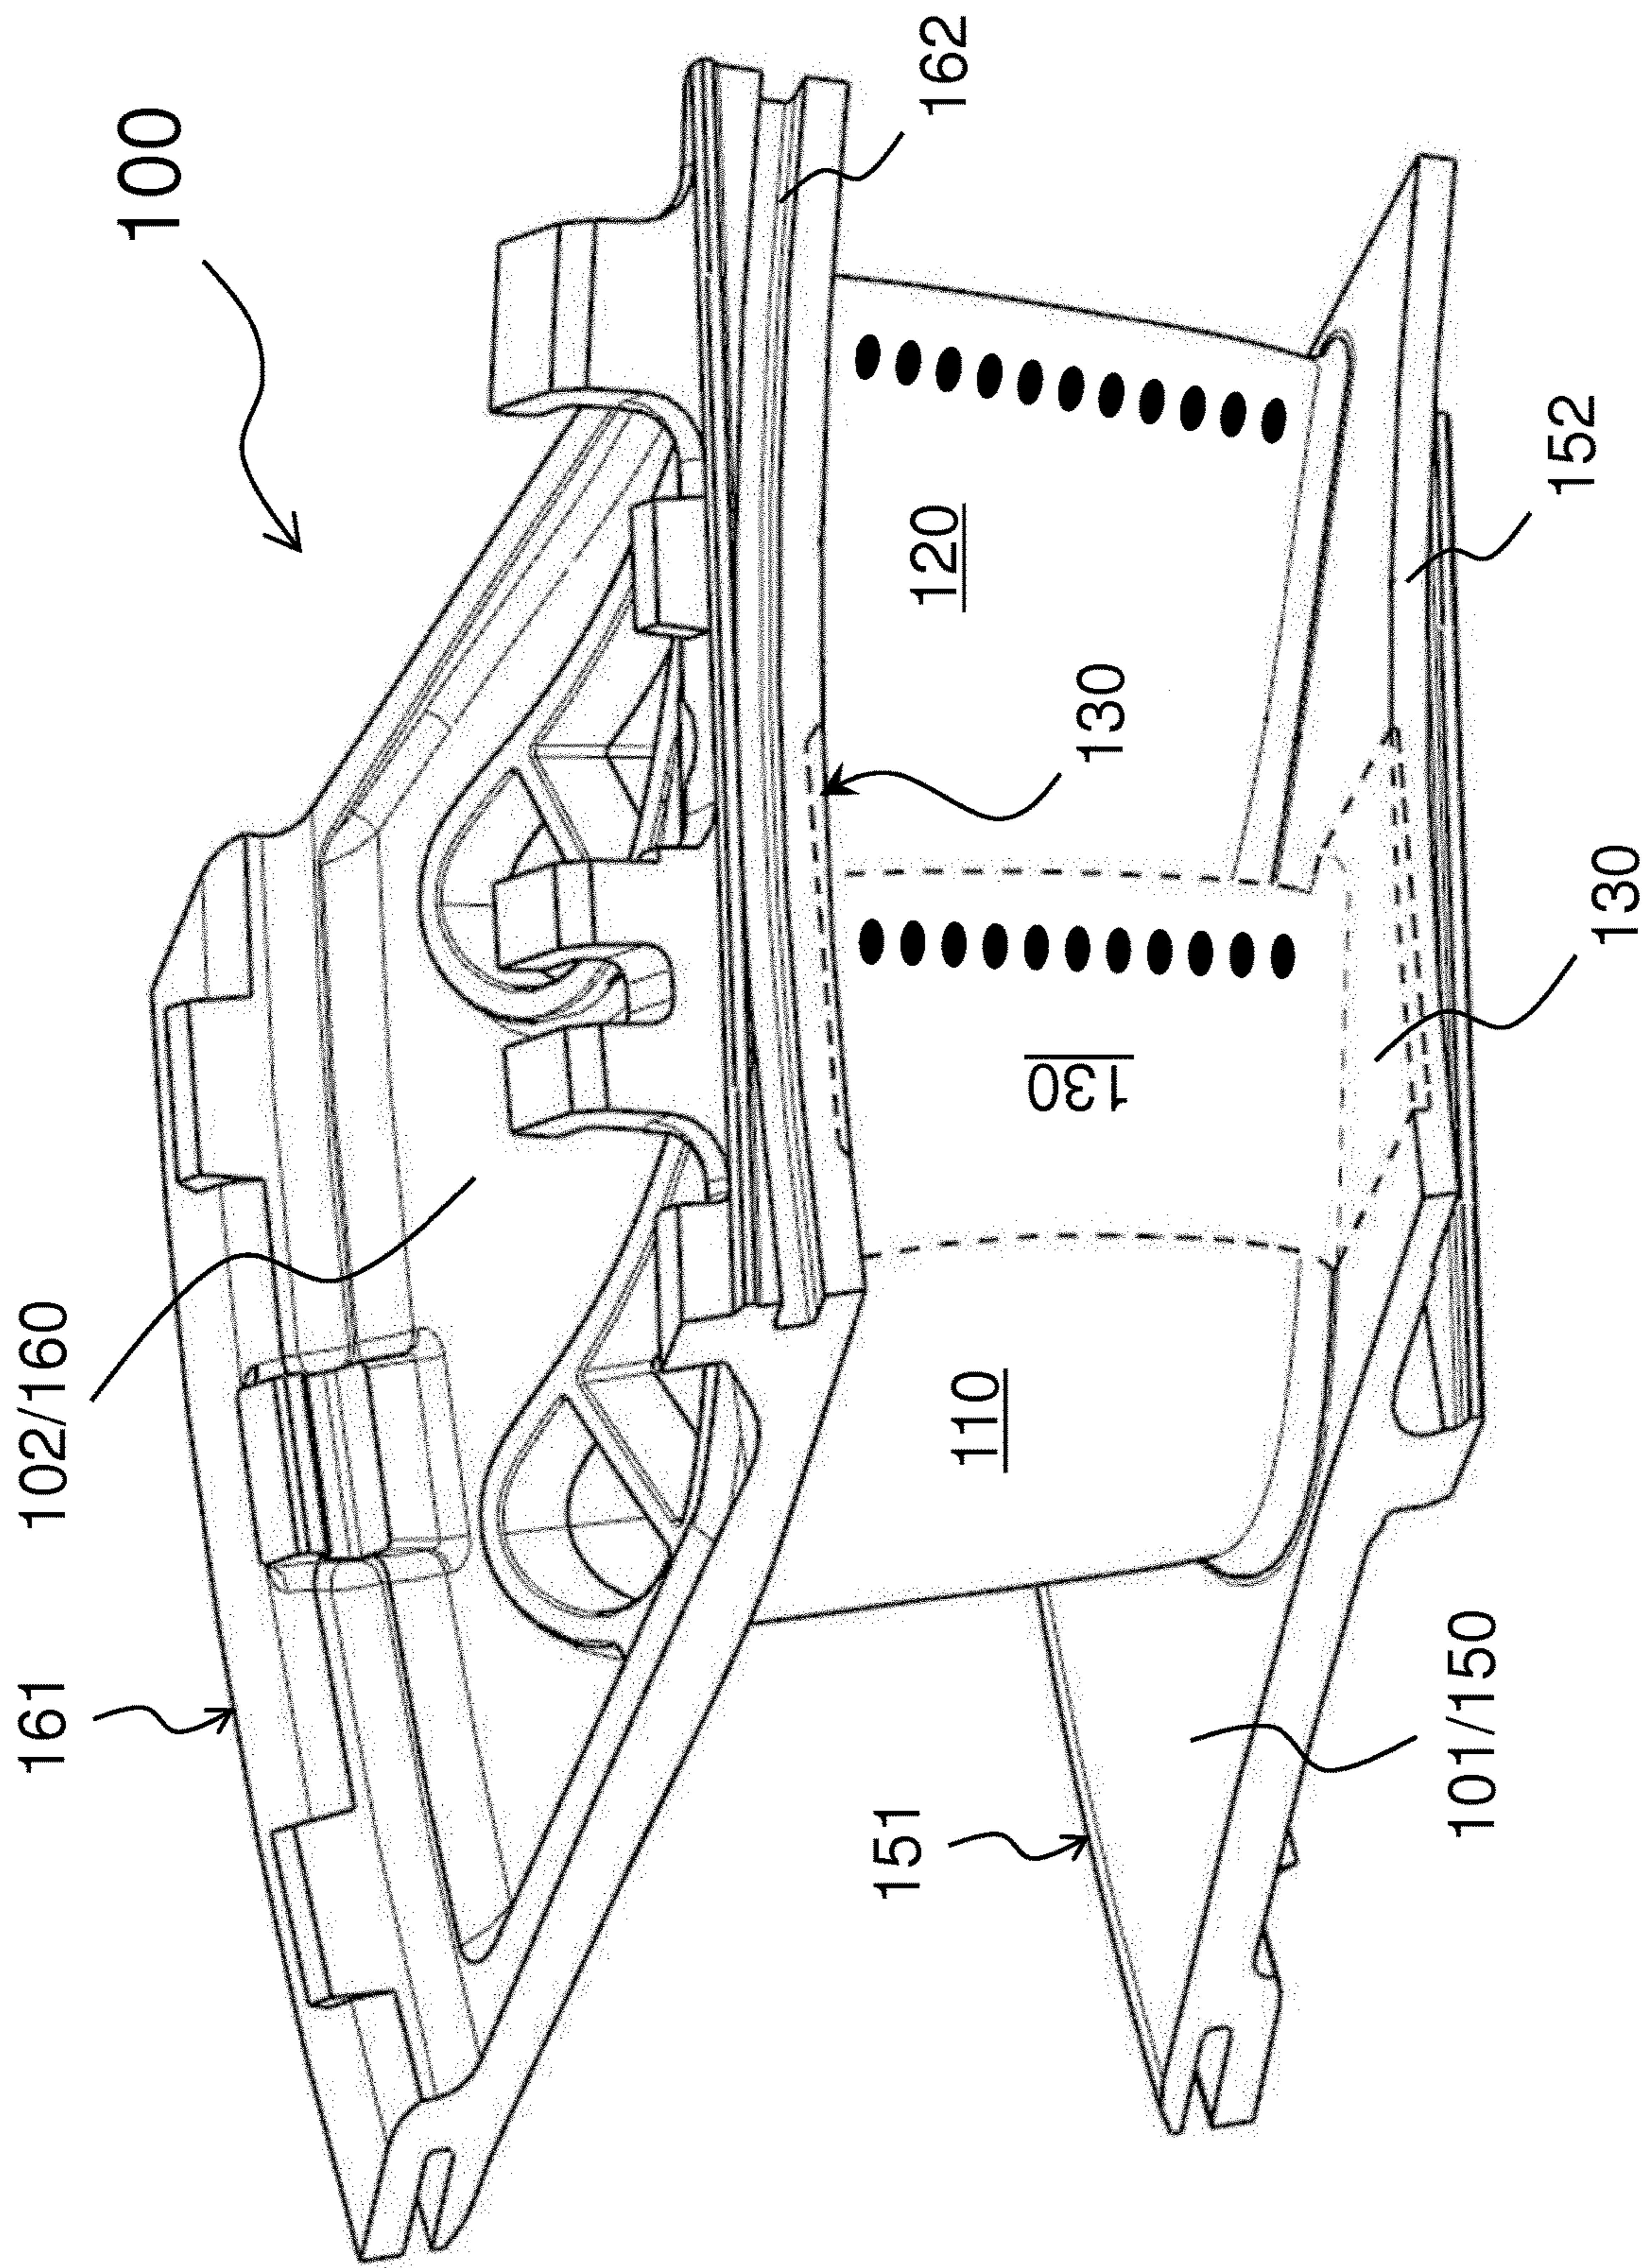
Fig. 4

FIG. 4 shows the vane assembly of FIG. 3 wherein one vane region to be removed is highlighted,

FIG. 4 shows the vane assembly of FIG. 3 wherein one vane region of the vane 110 to be removed is highlighted (see dashed lines); the region is to be removed as there damages (not shown either in FIG. 3 or in FIG. 4) in it.

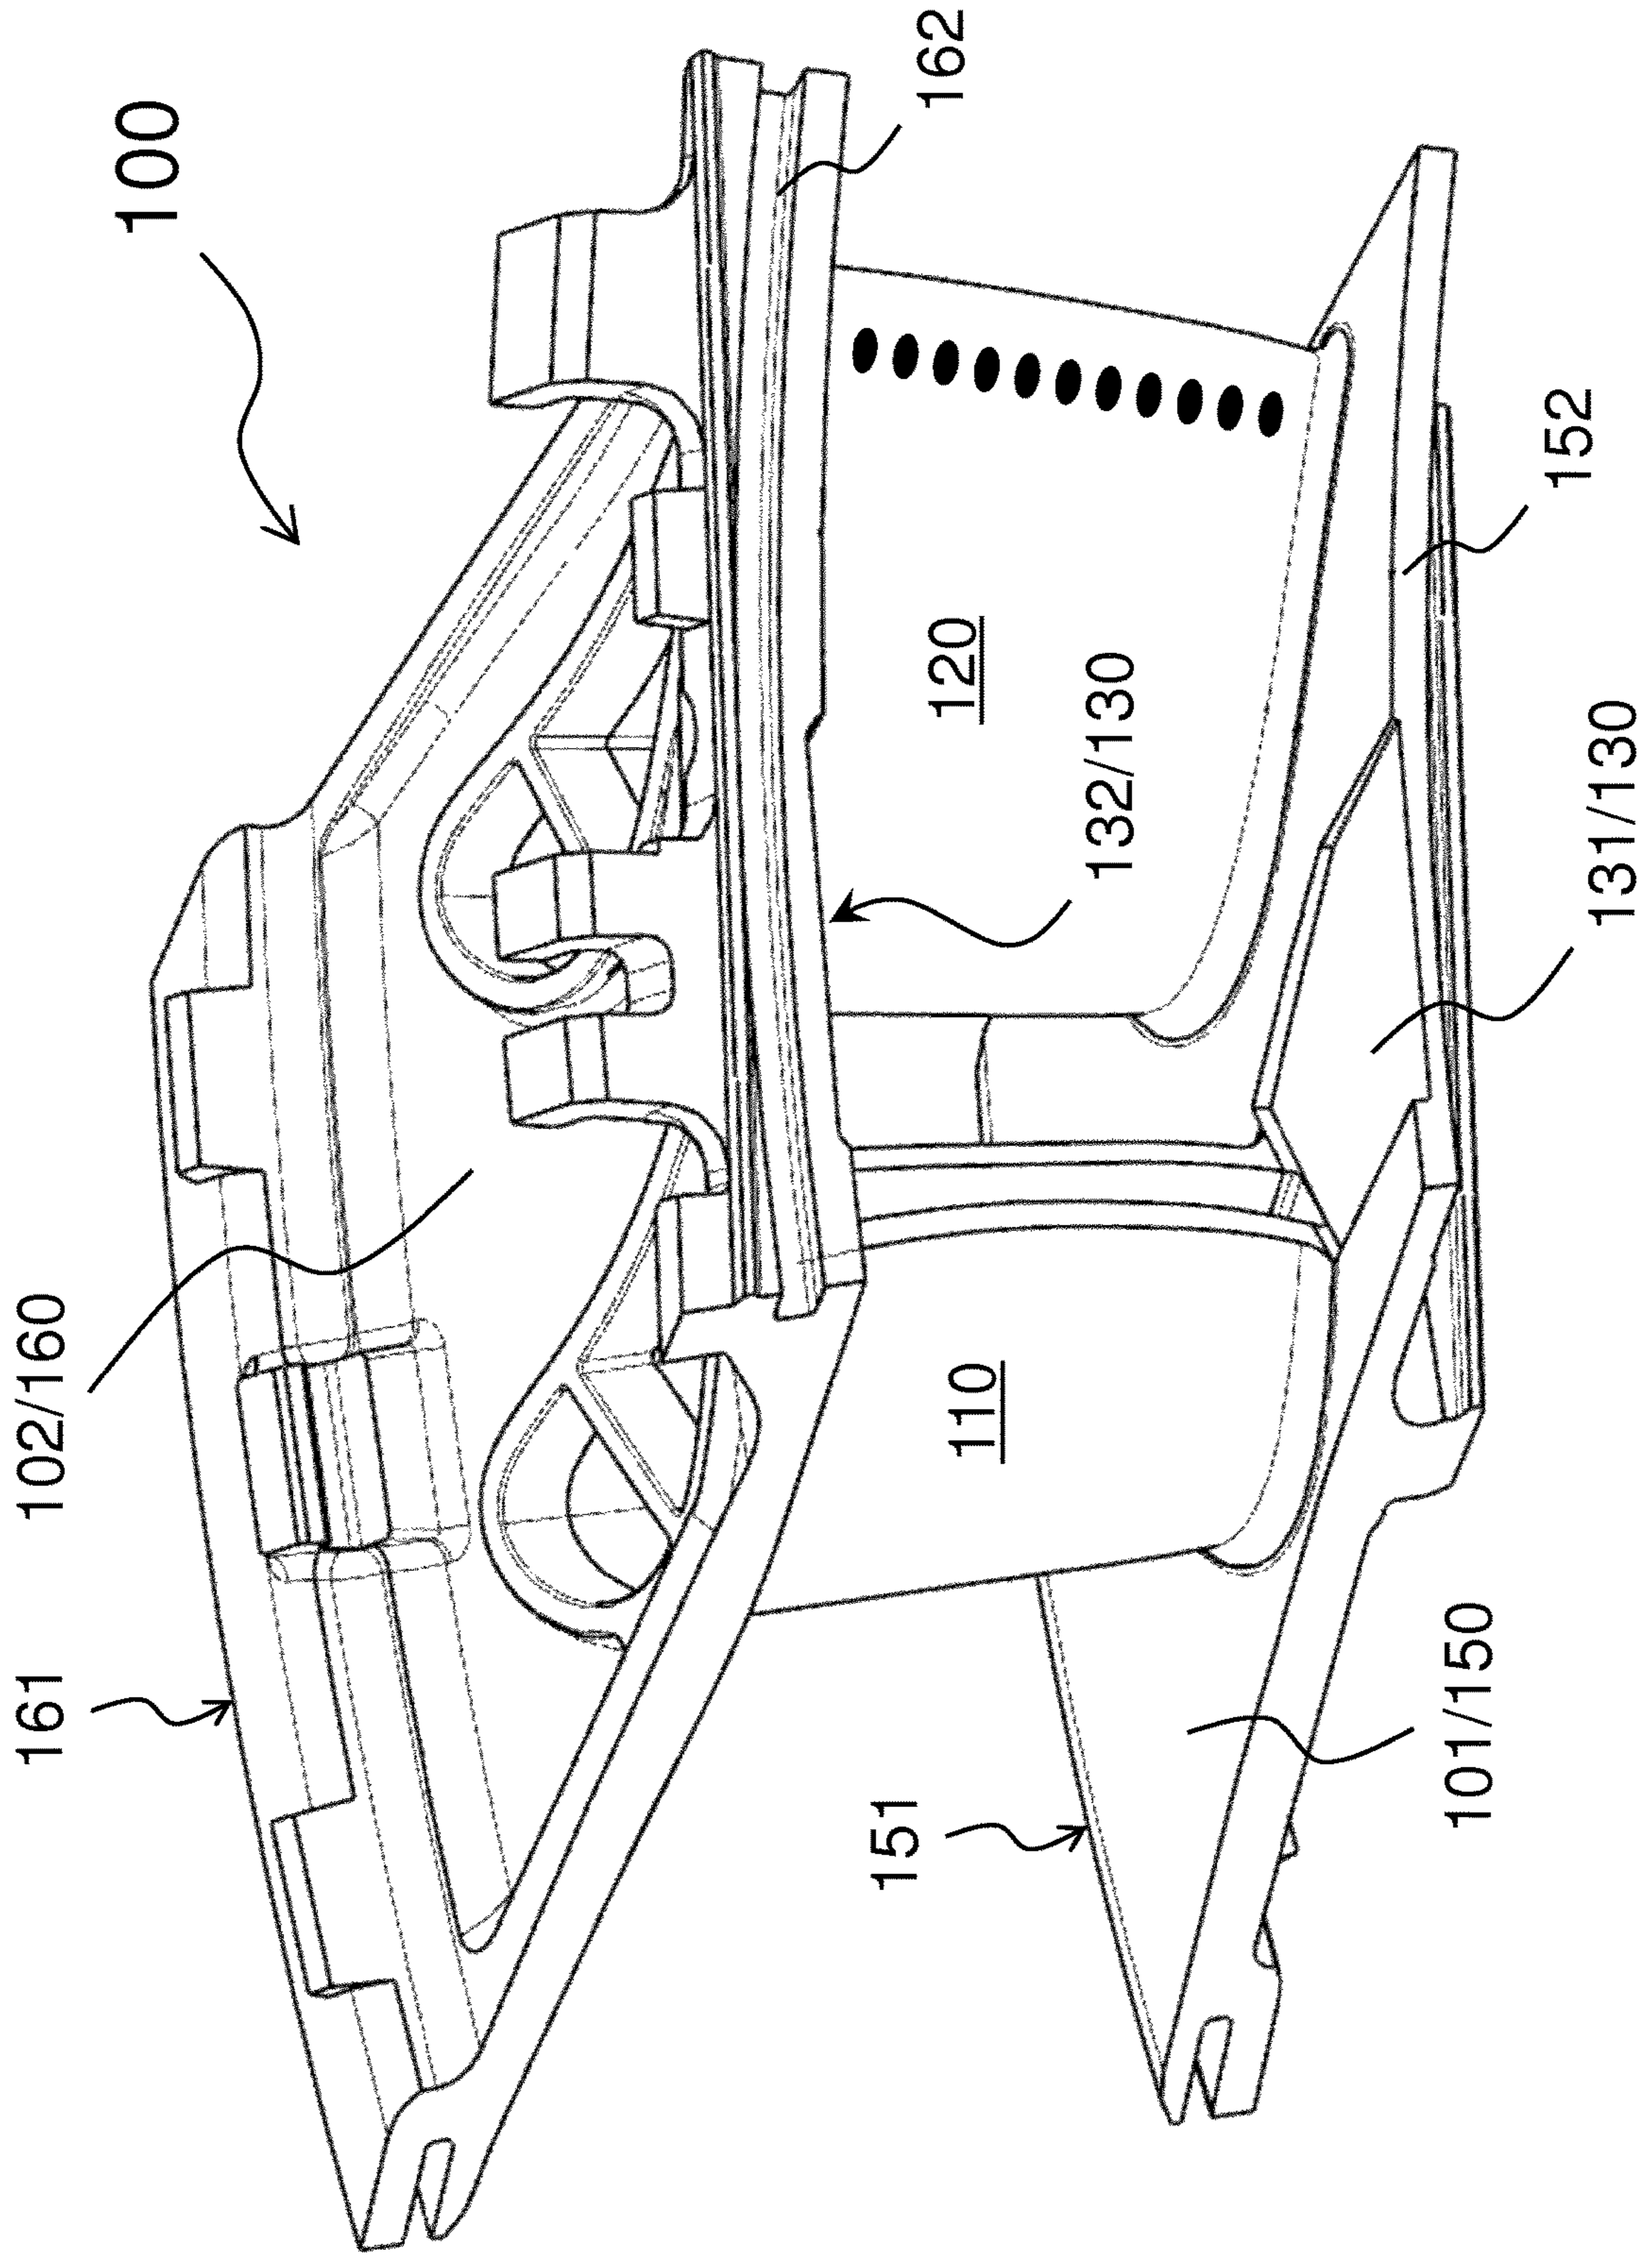
Fig. 5

FIG. 5 shows the vane assembly of FIG. 3 wherein one vane region is removed,

FIG. 5 shows the vane assembly 100 of FIG. 3 after removing the vane region of the damaged vane 110 where damages are present. The removed vane region is at the trailing edge of the vane 110, and comprises an inner platform region, an outer platform region and an airfoil region. Reference number 130 in the figures refers to the space occupied by the removed region of the inner platform 101, the removed region of the outer platform 102 and the removed region of the airfoil of the vane 110; as it will be clear in the following, the space occupied by the removed region of the inner platform 101 defines an inner guide 131, and the space occupied by the removed region of the outer platform 102 defines an outer guide 132.

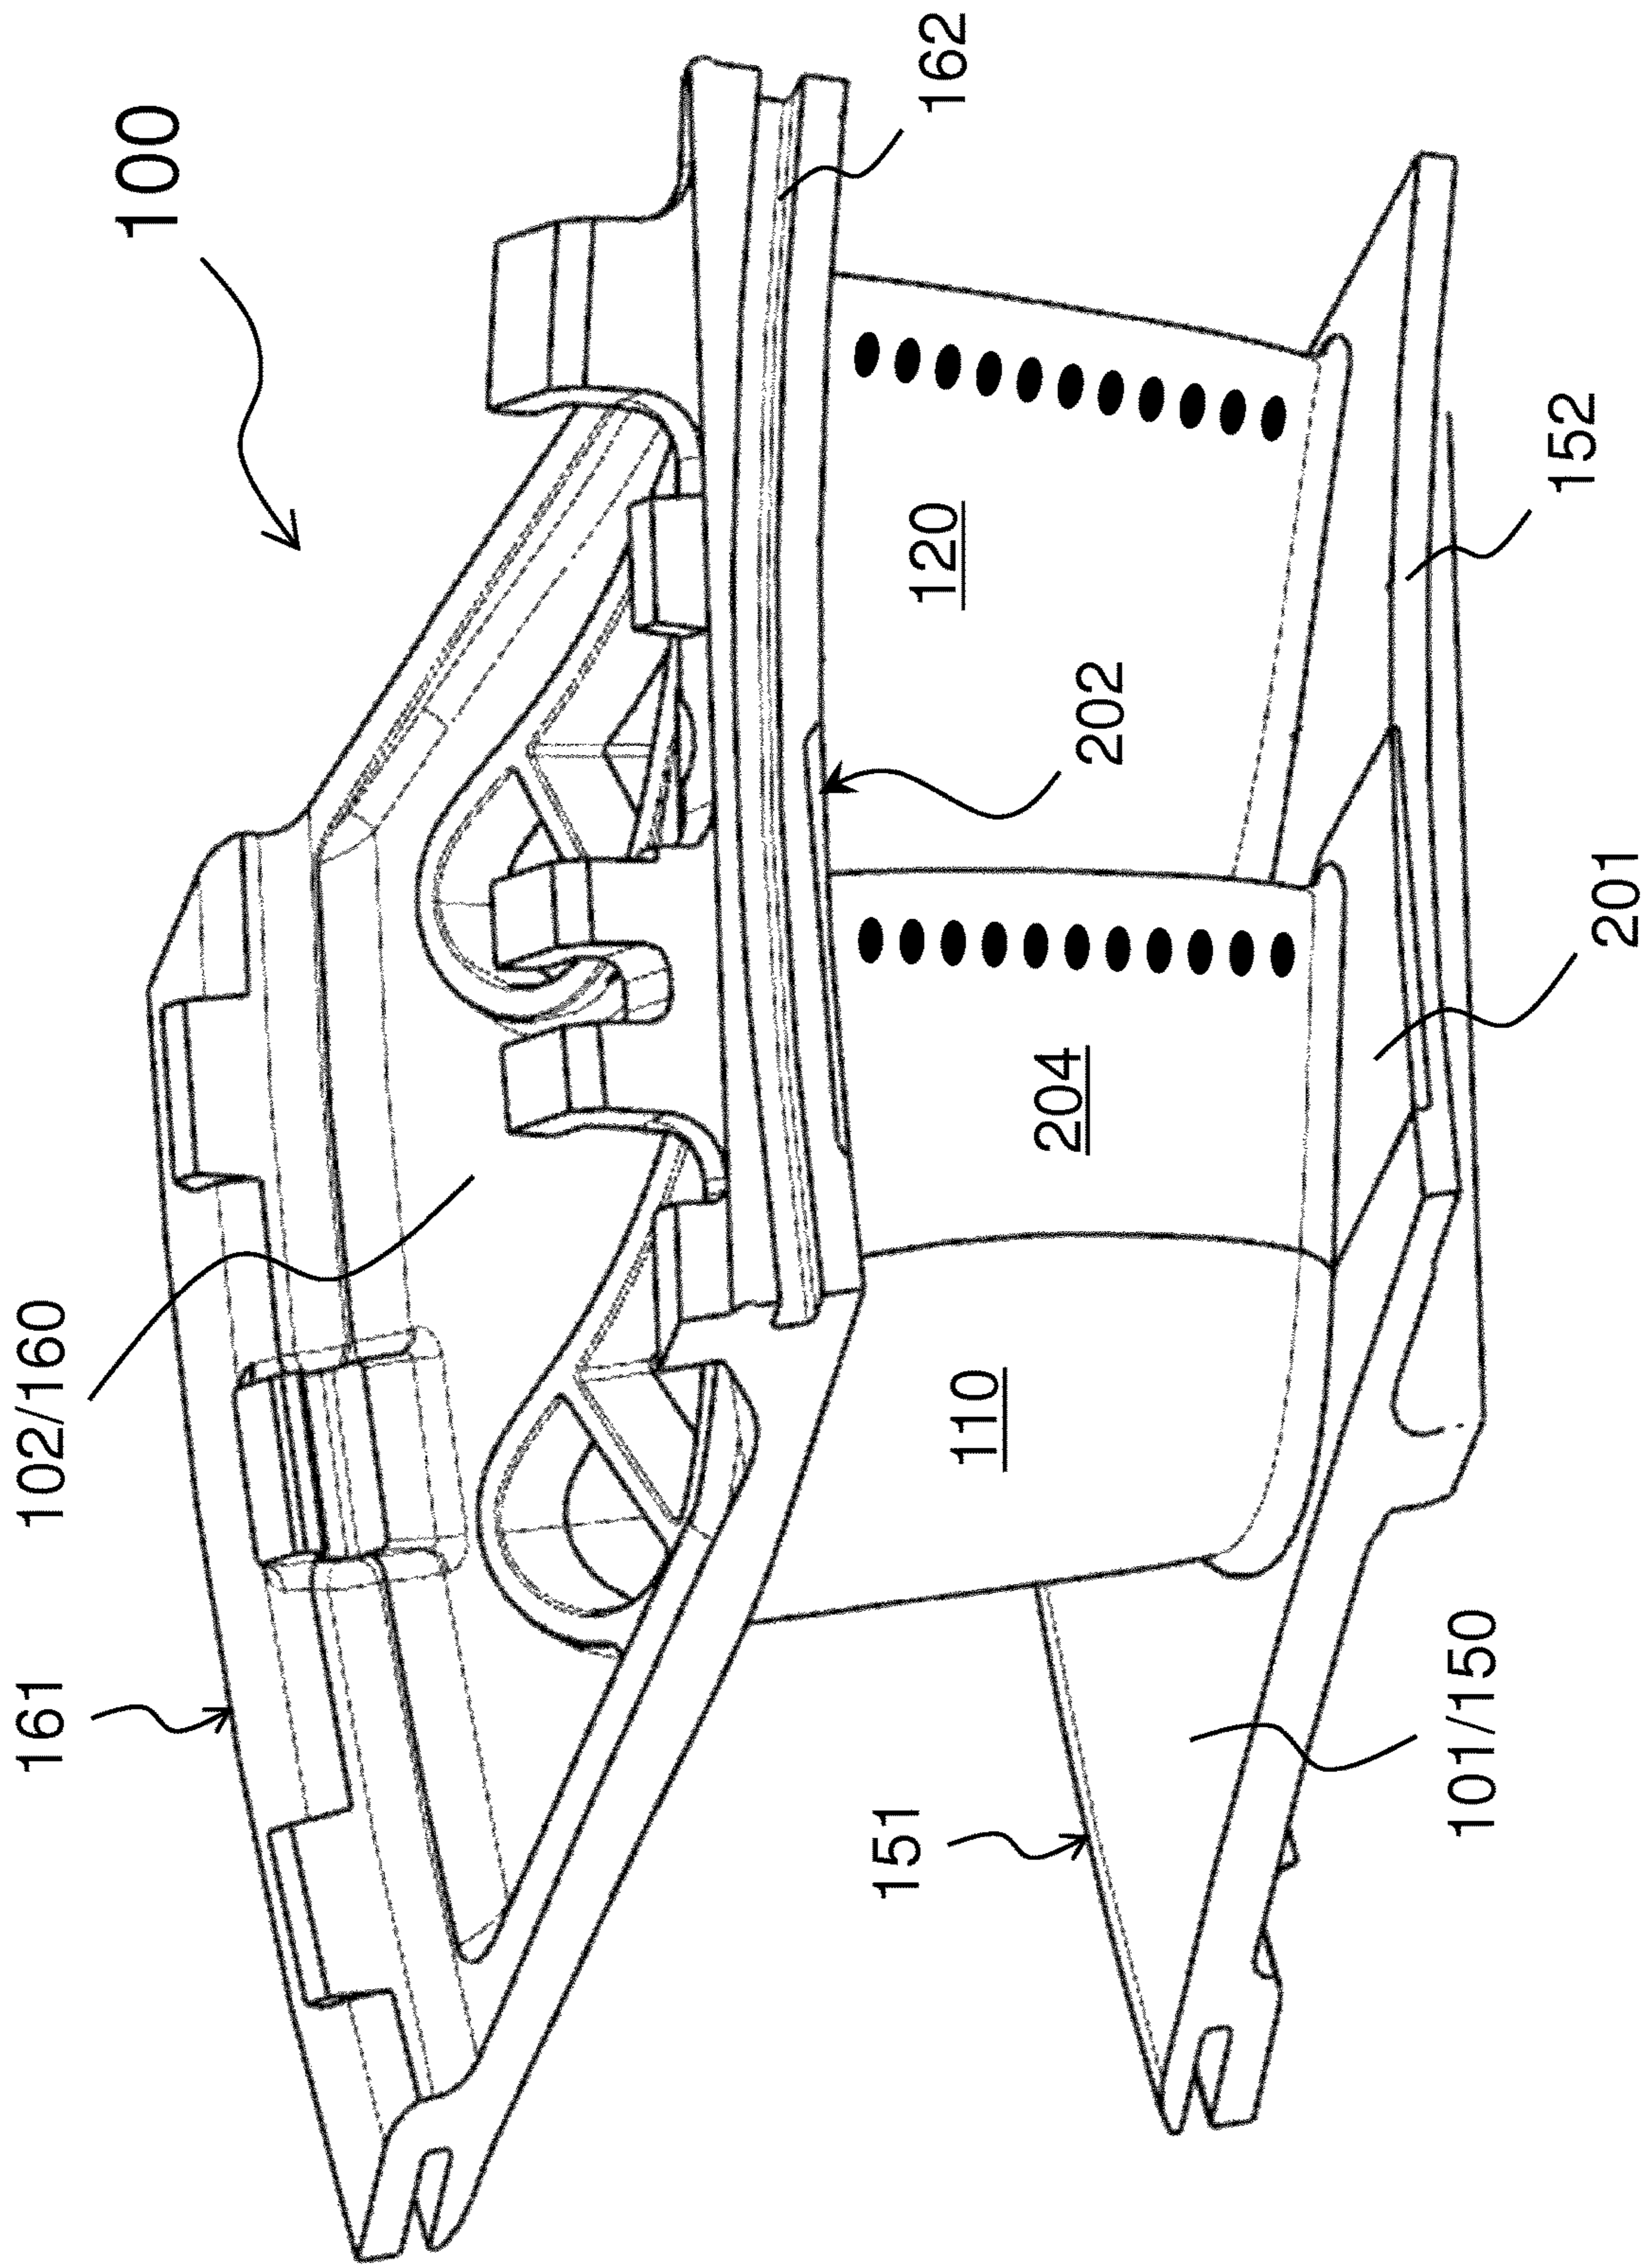
Fig. 6

FIG. 6 shows the vane assembly of FIG. 3 wherein one vane region is repaired,

FIG. 6 shows the vane assembly of FIG. 3 wherein one vane region of the vane 110 is repaired through a repair member 200 comprising three portions 201, 202 and 204.
