US010954822B2

(54) **REPAIR MEMBER FOR A VANE ASSEMBLY OF A GAS TURBINE AND METHOD FOR REPAIRING A DAMAGED VANE OF A VANE ASSEMBLY OF A GAS TURBINE**

(71) Applicant: **Nuovo Pignone Tecnologie Srl**,  
Florence (IT)

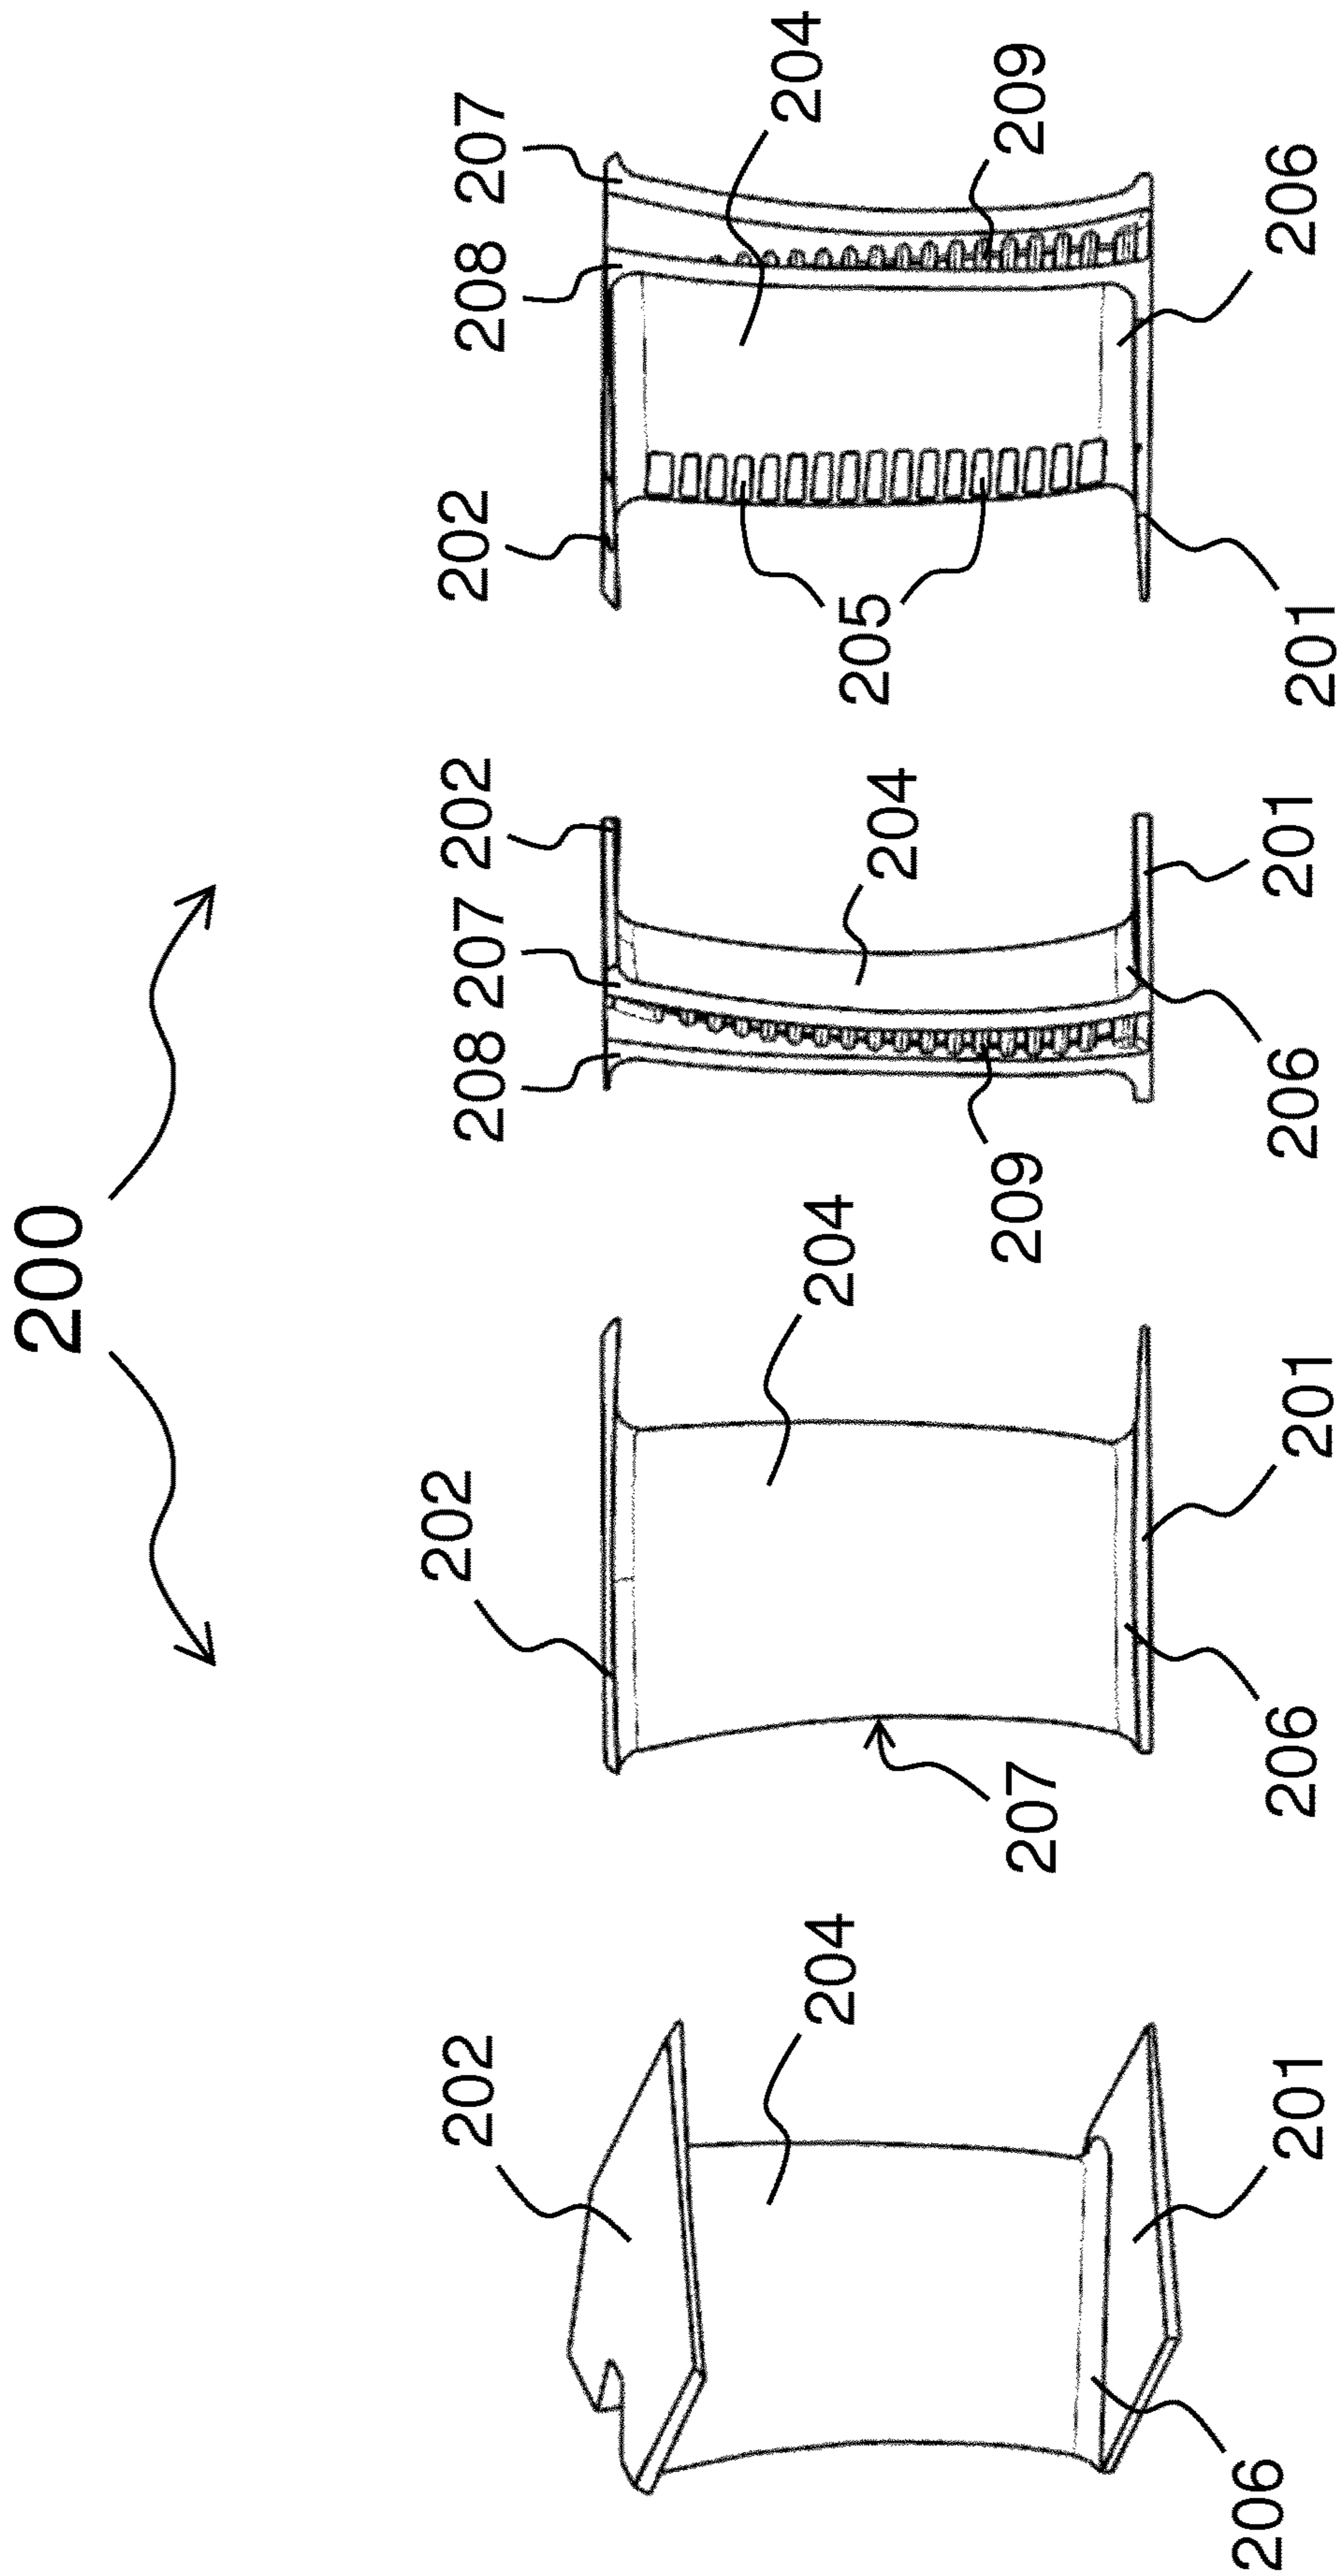
Fig. 7

FIG. 7 shows an embodiment of a repair member for repairing the vane assembly of FIG. 3,

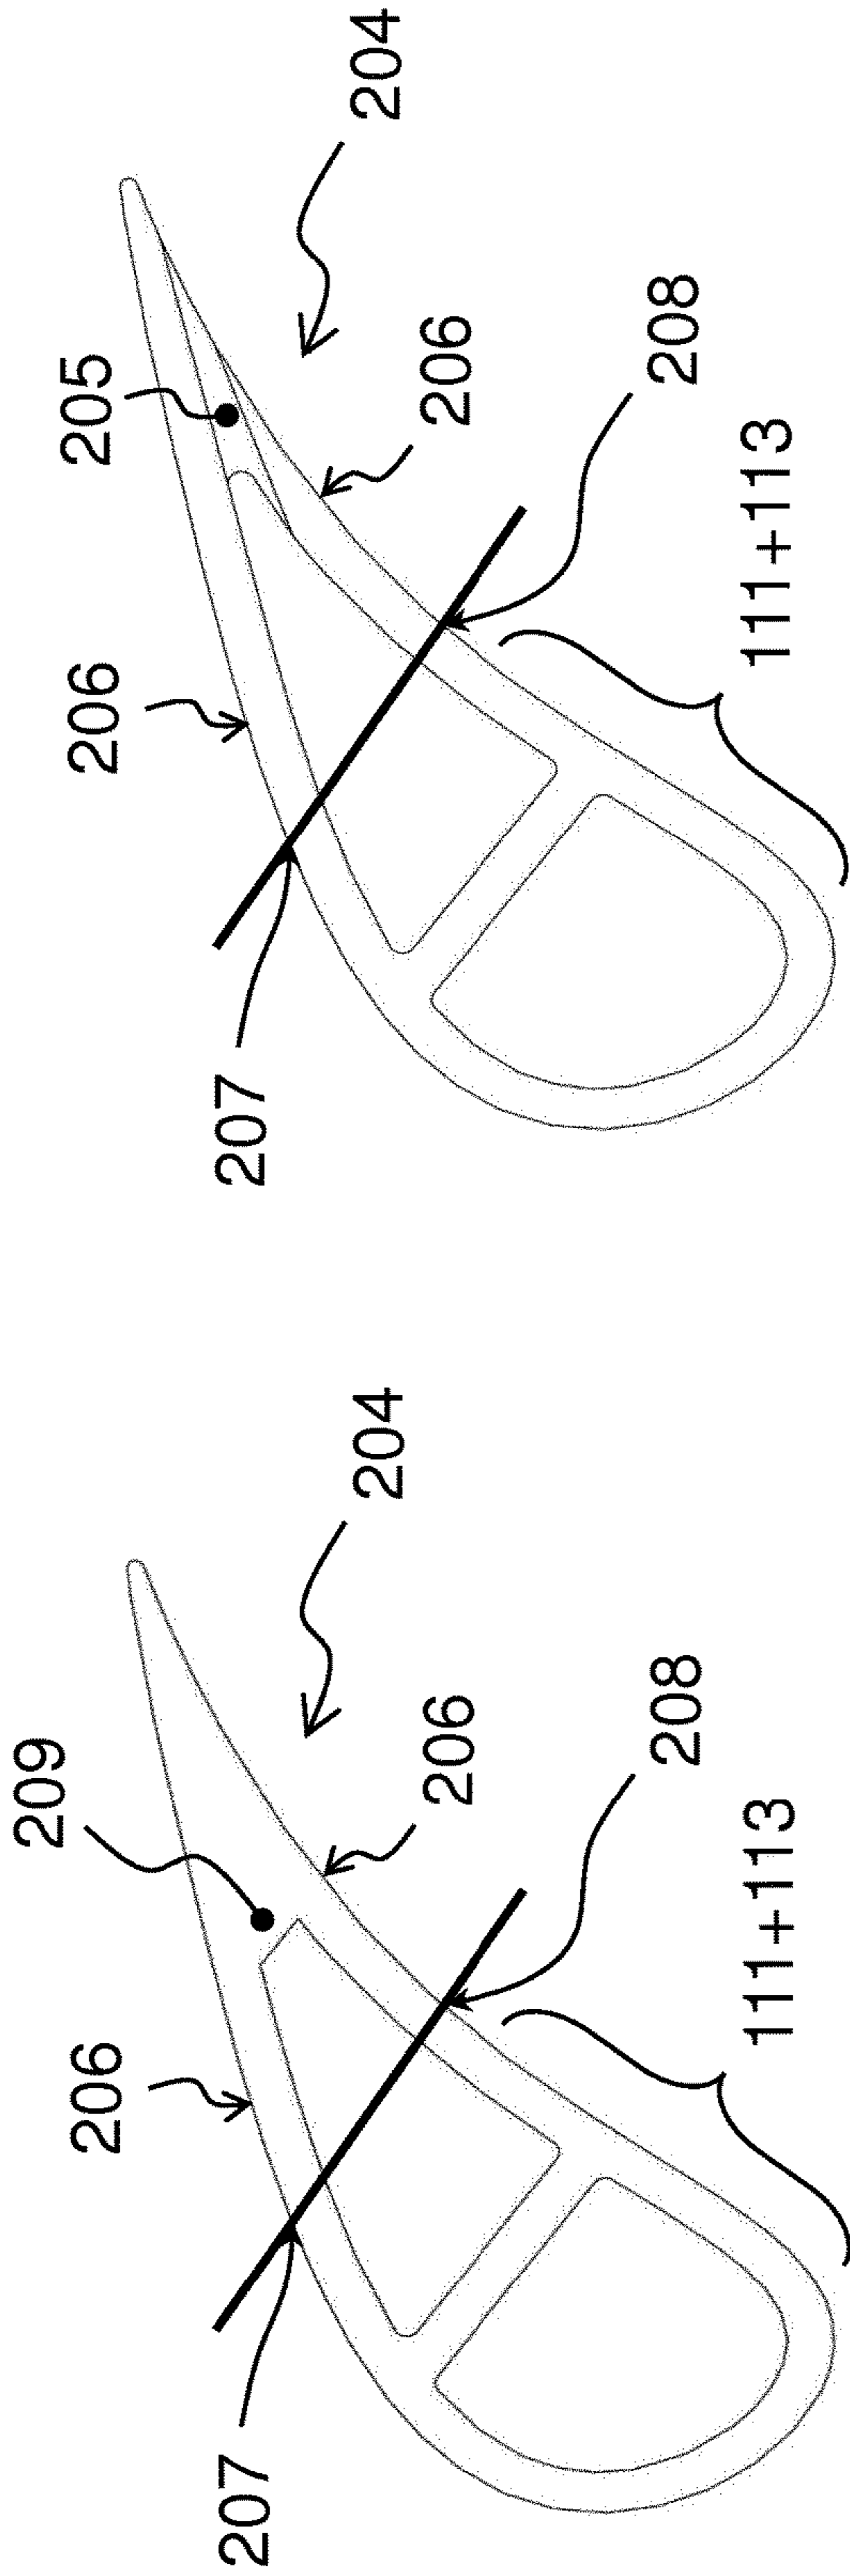
Fig. 8C

FIG. 8 comprising FIG. 8A, FIG. 8B and FIG. 8C shows a cross-section view of a vane of an embodiment of a vane assembly to be repaired, and two cross-sections (at two different levels) of an embodiment of a repaired vane of an embodiment of a vane assembly,

FIG. 8B and FIG. 8C show the repair member 200 in repair place, i.e. the airfoil portion 204 of the repair member 200 is perfectly adjacent to the body portion 113 of the damaged vane 110.

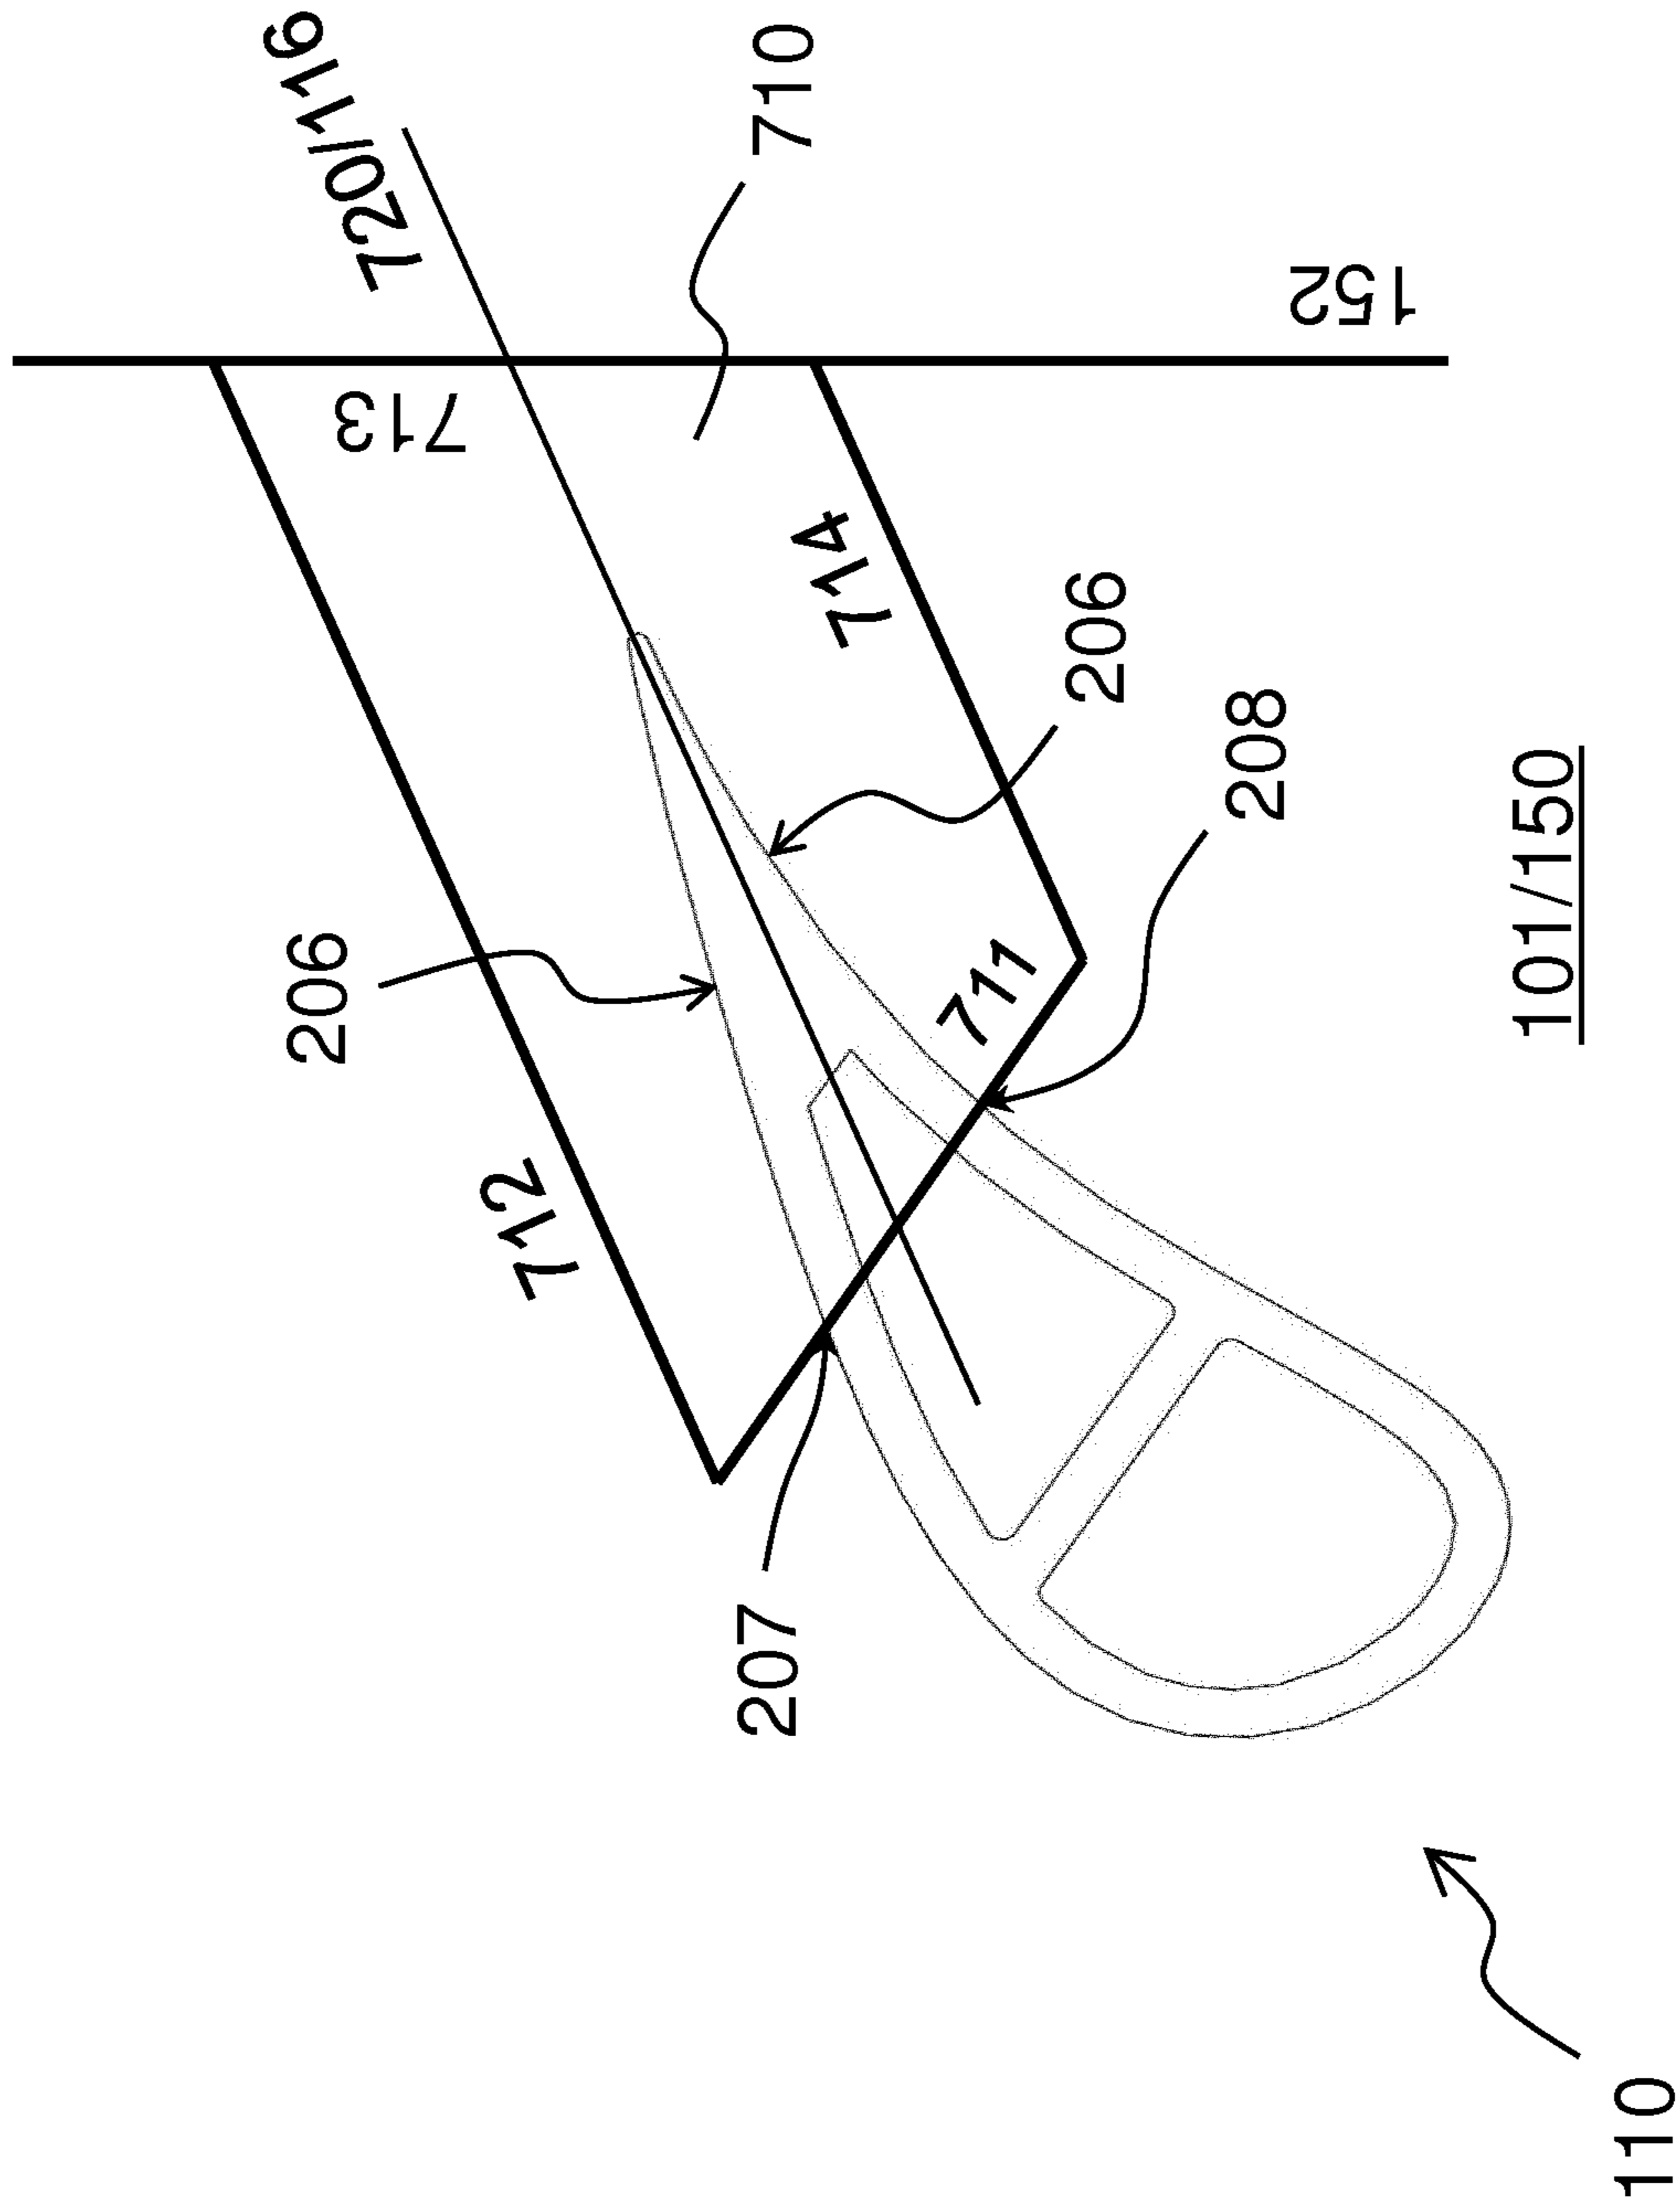
Fig. 9

FIG. 9 shows a cross-section view of a first embodiment of a repaired vane,

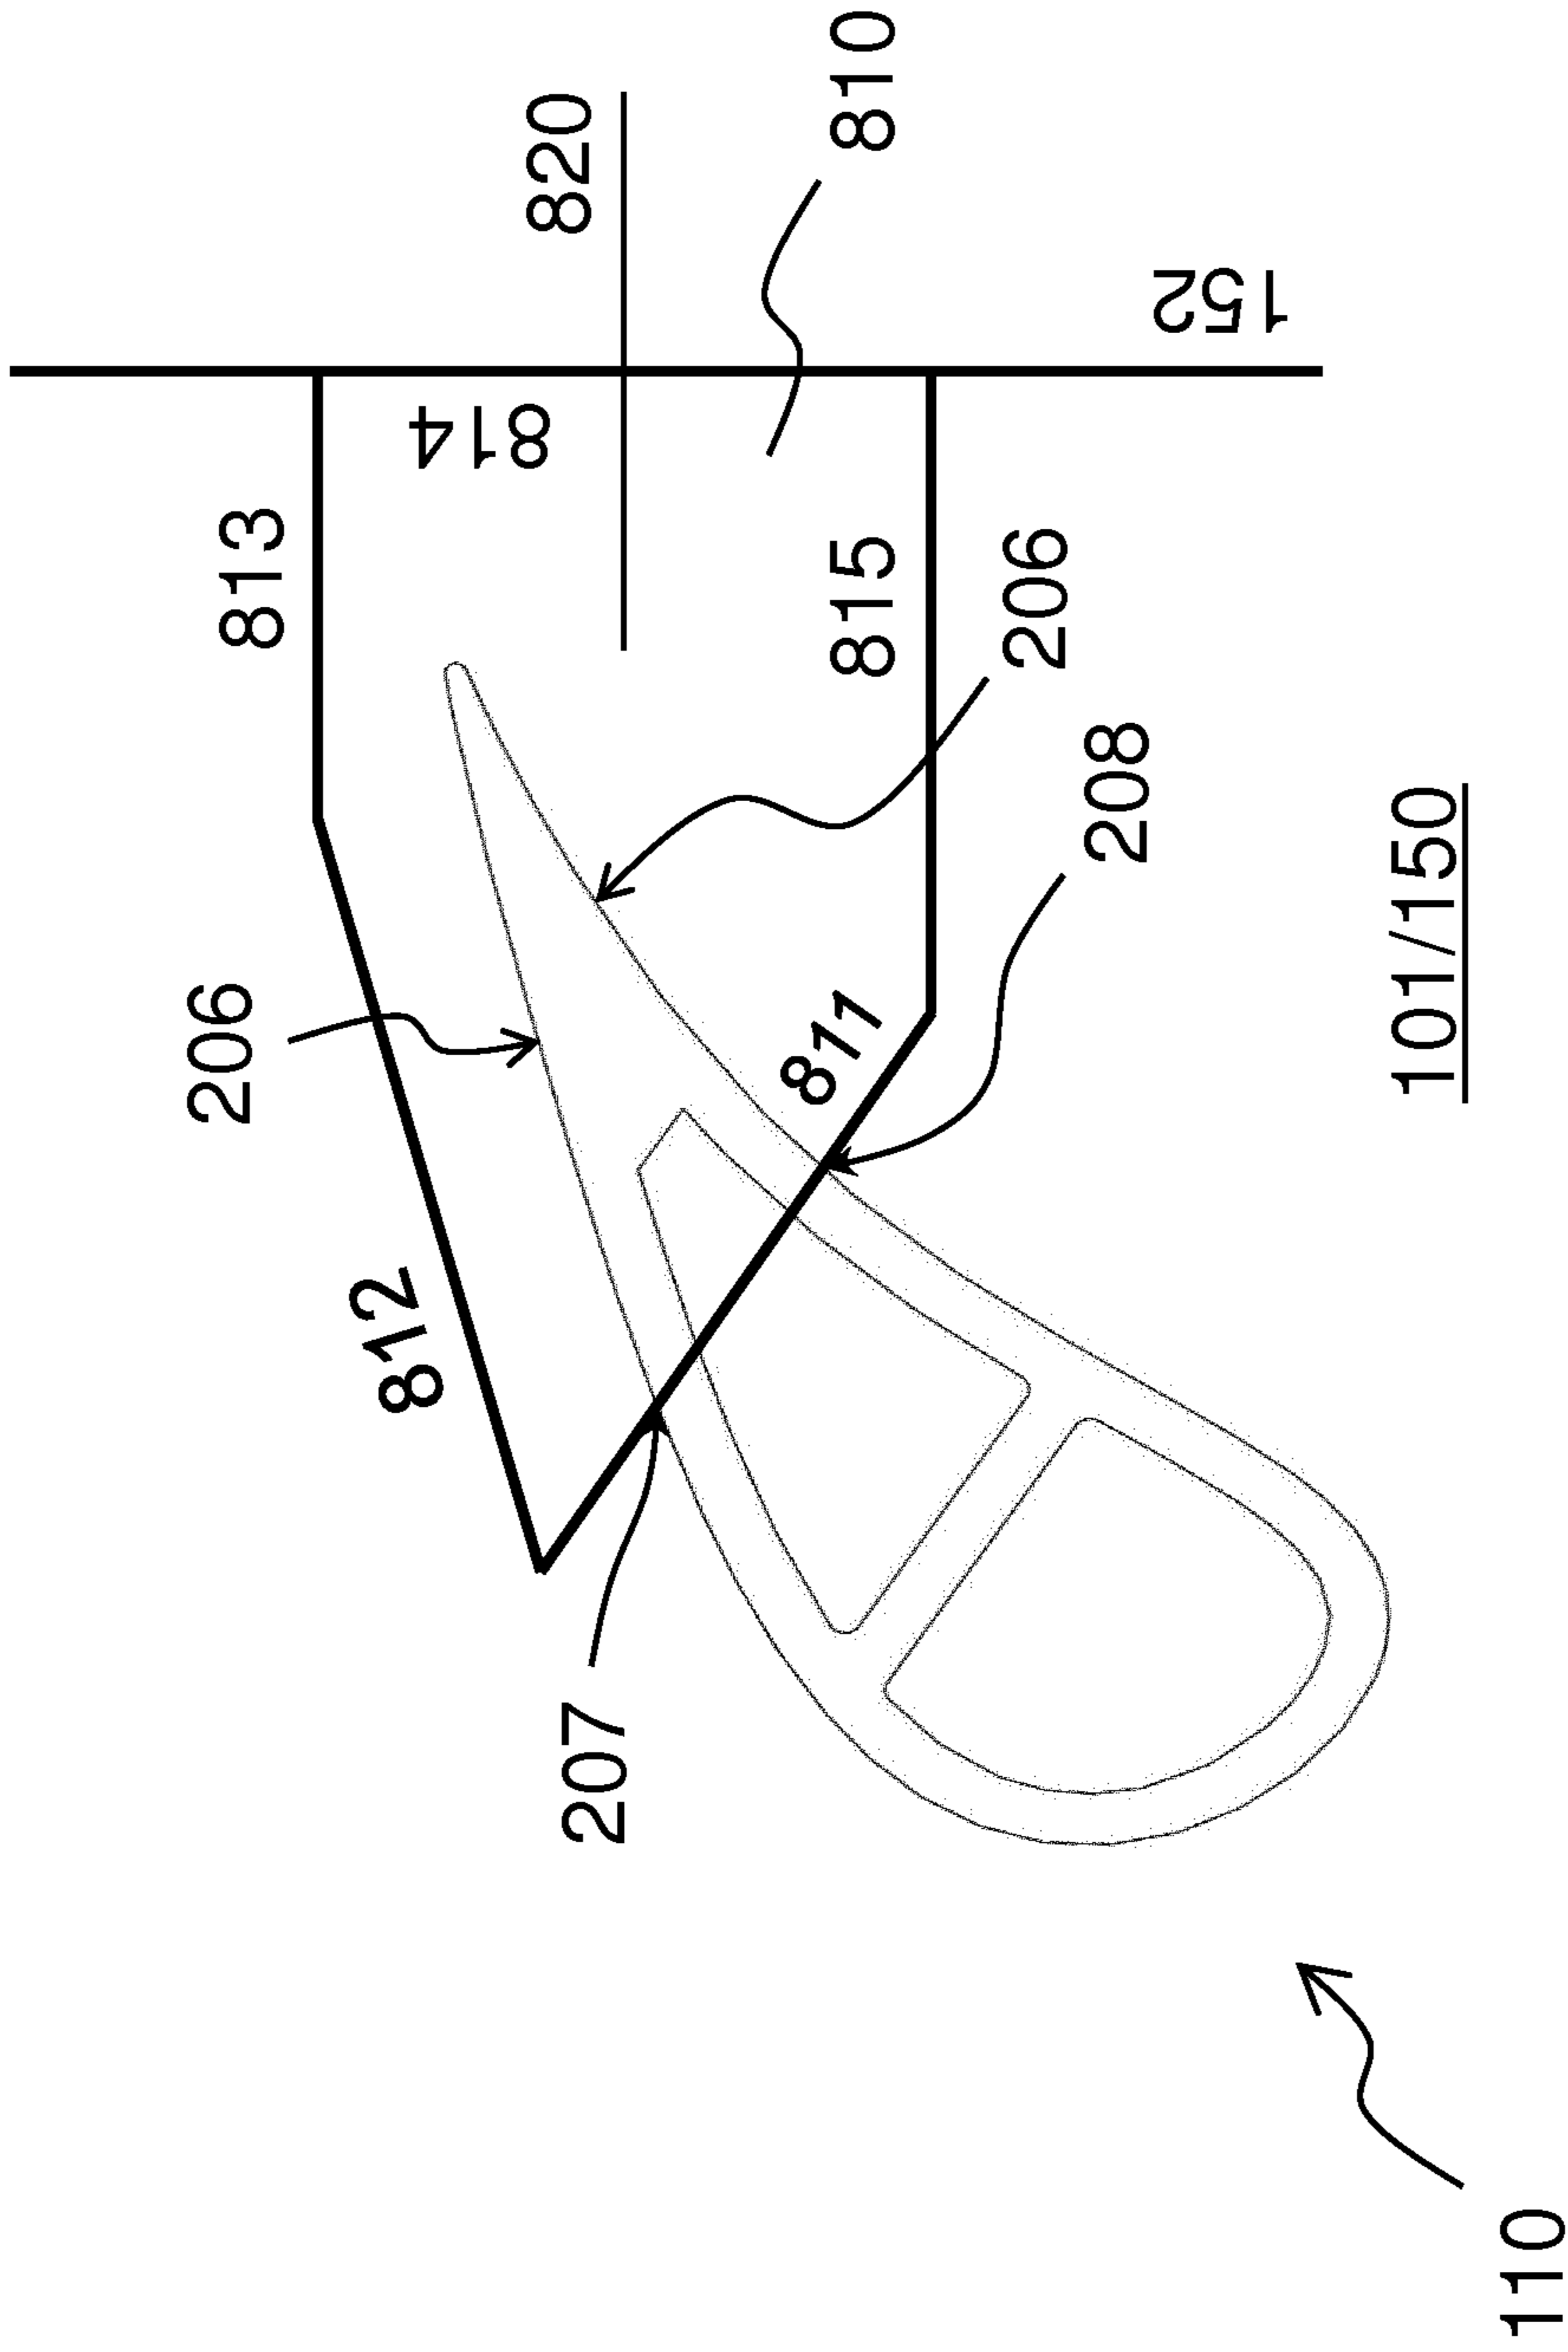
Fig. 10

FIG. 10 shows a cross-section view of a second embodiment of a repaired vane, and

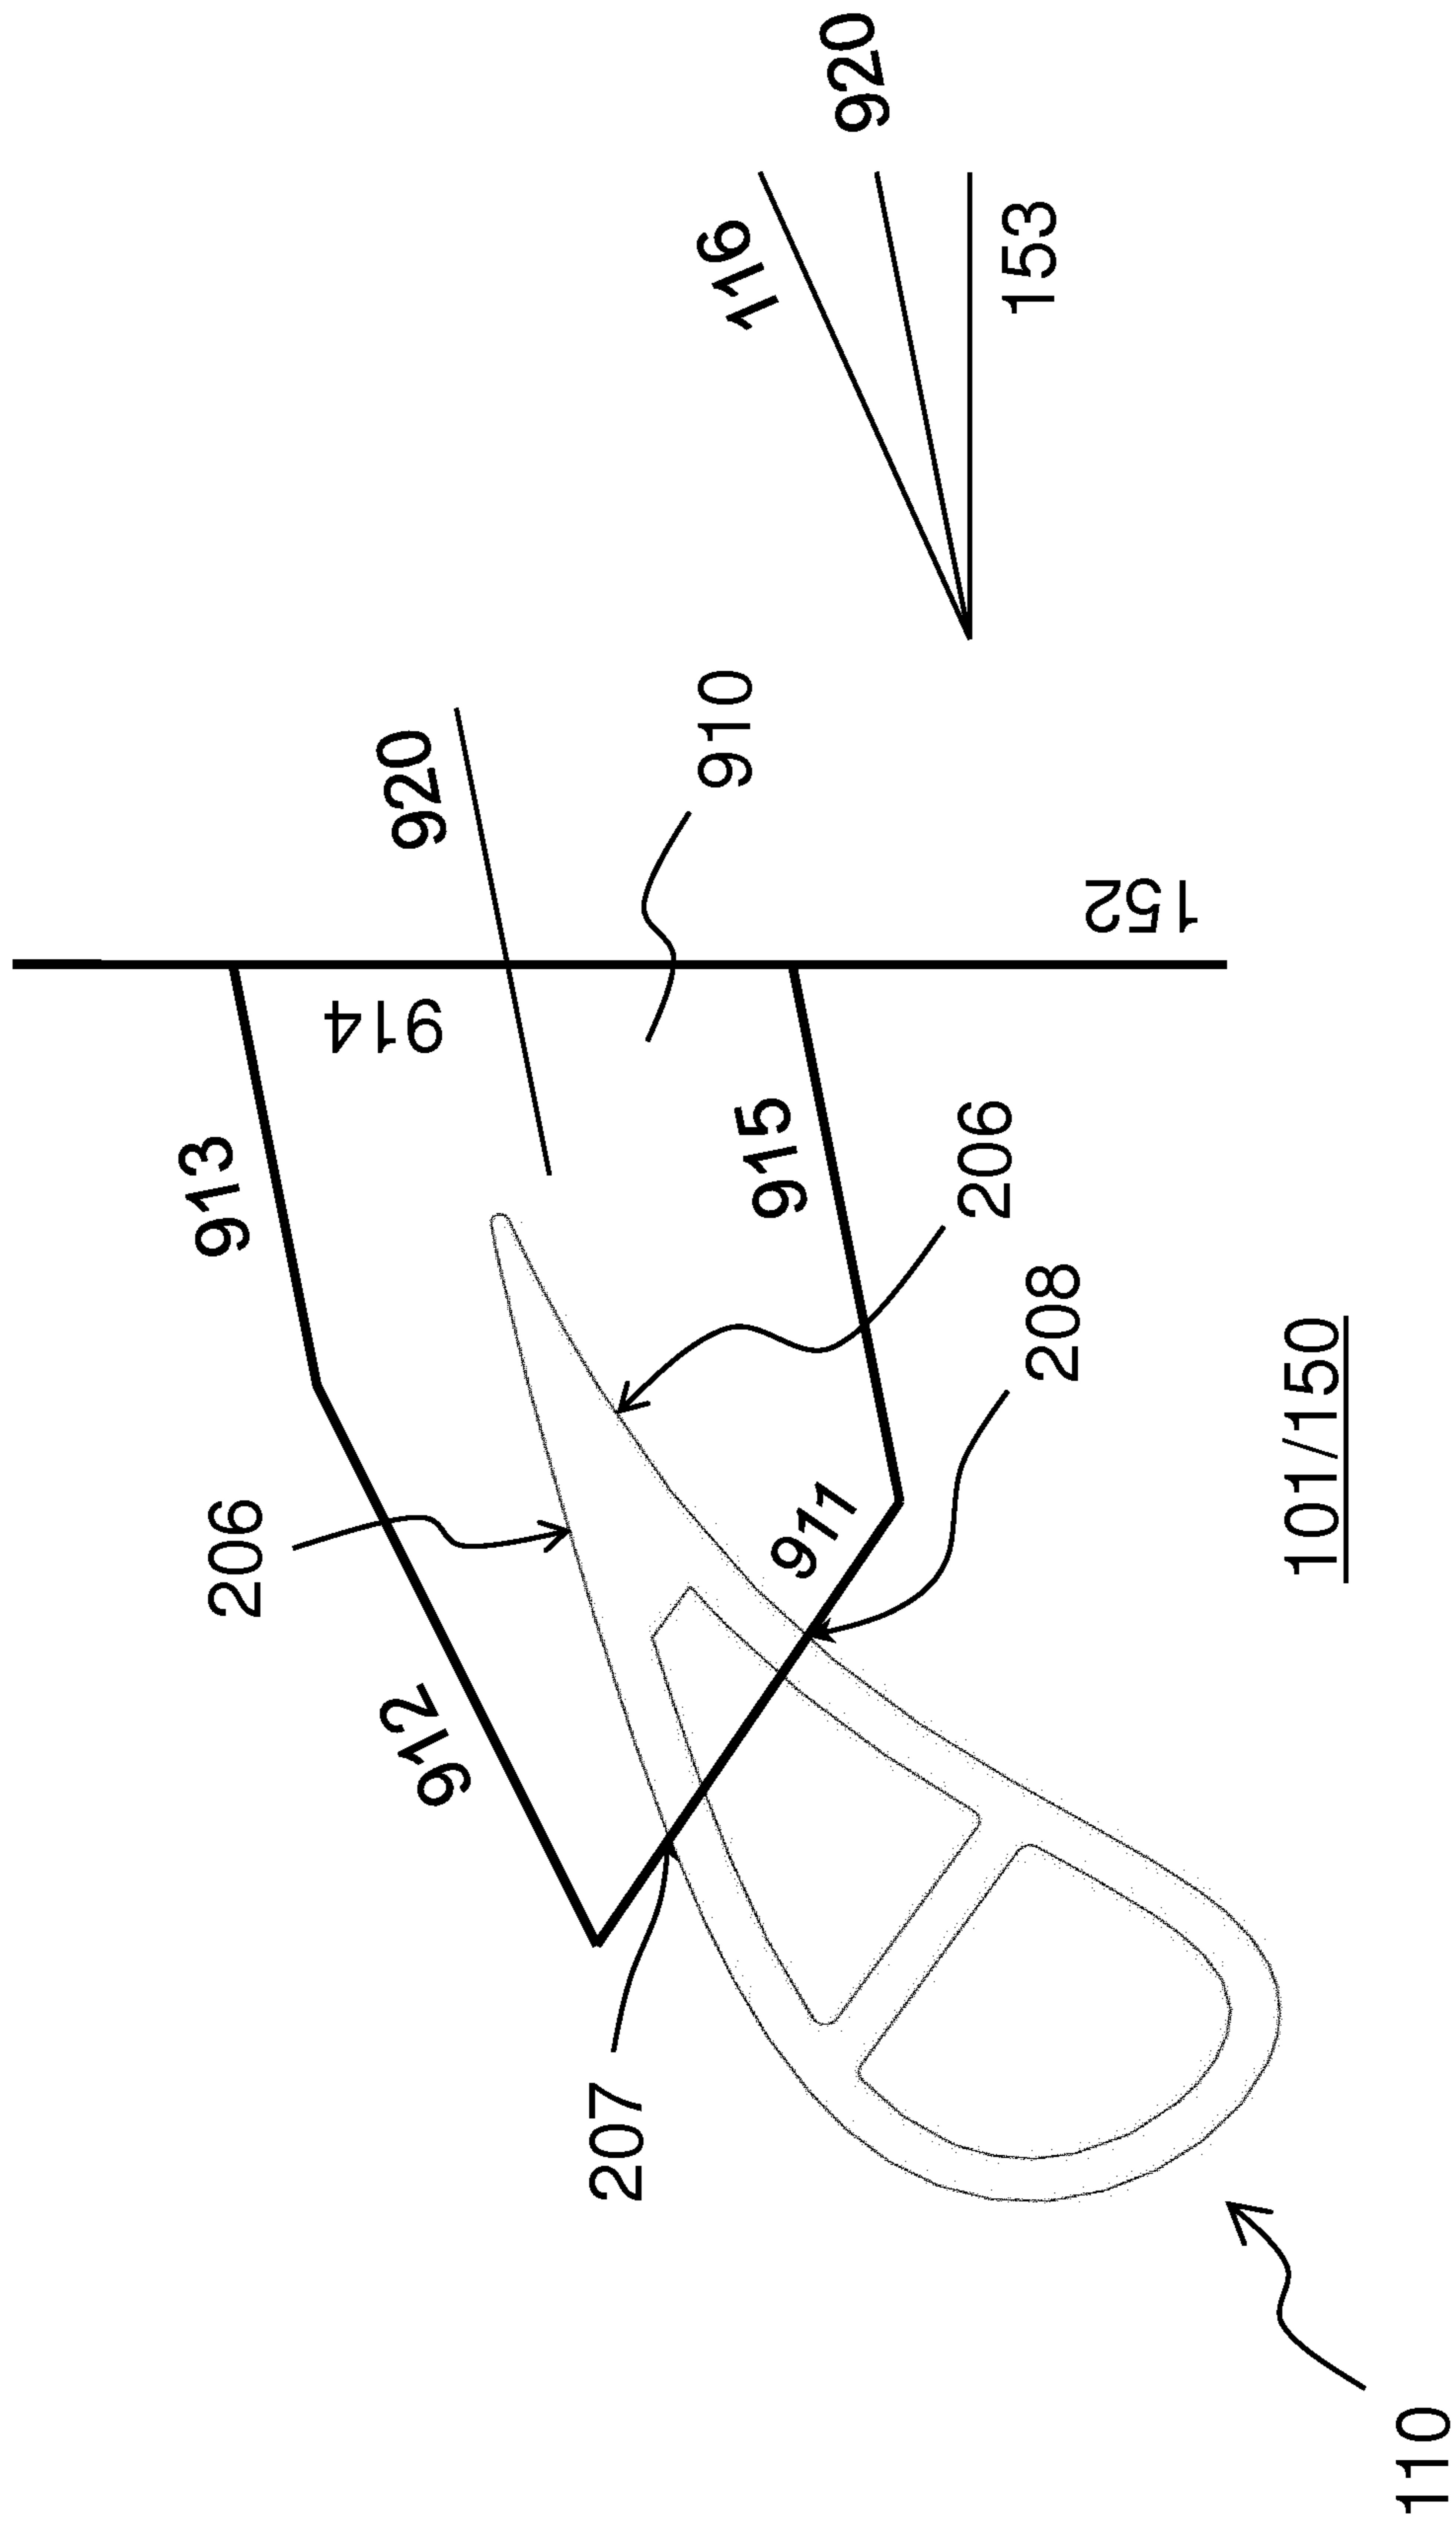
Fig. 11

FIG. 11 shows a cross-section view of a third embodiment of a repaired vane.
