US010967989B2

(54) **CESSNA TAIL-CONE REINFORCEMENT ANGLE SPLICE, INSTALLATION KIT, AND METHOD FOR INSTALLATION THEREOF**

(71) Applicant: **QMI, Inc.**, Joseph, OR (US)

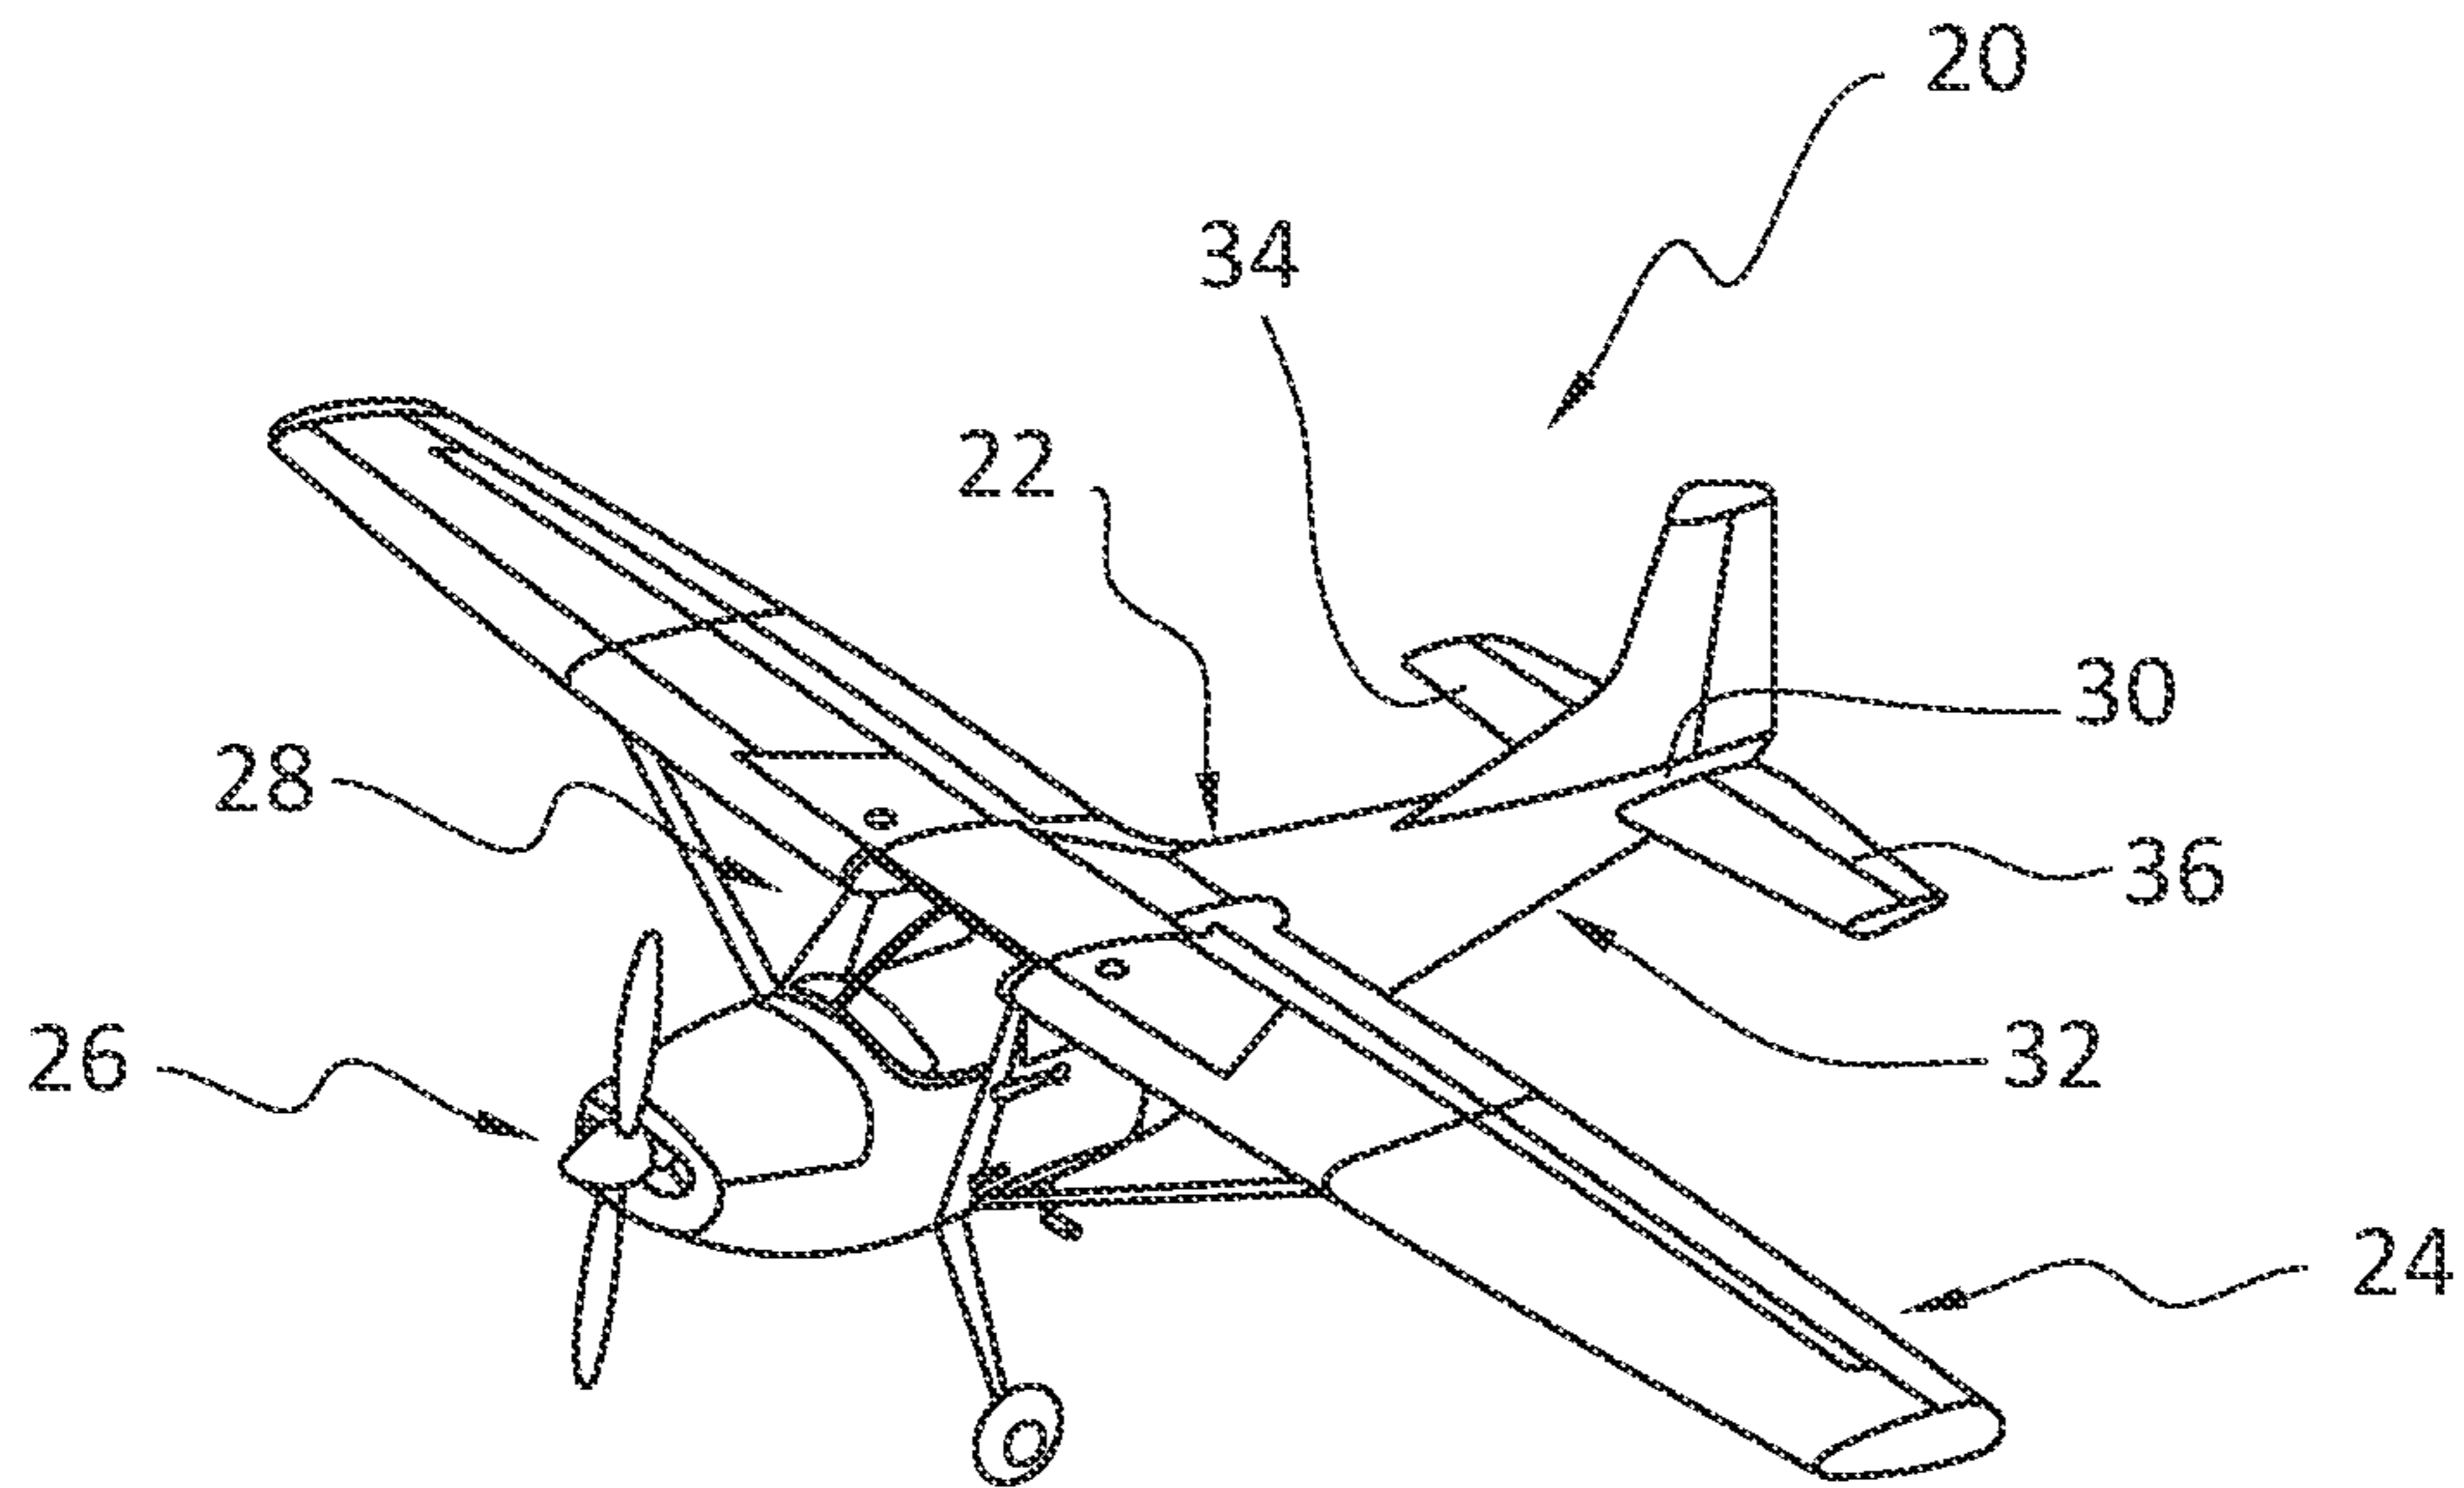
FIG. 1 is a schematic depiction of a Cessna series 180-185 series aircraft with which the pertinent invention is intended for use;

Referring initially to FIG. 1 of the patent drawings filed in the subject U.S. patent application, there may be seen, generally at 20, a typical Cessna 180-185 series aircraft with which the tail-cone reinforcement angle splice, in accordance with the present invention, finds particular usage. Aircraft 20, as is well known to one familiar with such aircraft, includes a fuselage, generally at 22, forward upper mounted wings 24, an engine and propeller assembly 26, a cockpit 28 and a rear elevator and stabilizer assembly generally at 30. The rear elevator and stabilizer assembly generally at 30, is attached to a rear portion of the fuselage 22, in an area that fuselage known as the tail-cone 32, which tail-cone area 32 is seen somewhat schematically in FIG. 2. The rear stabilizer and elevator assembly, generally at 30, includes a pivotally mounted horizontal stabilizer 34 and a pair of elevators 36. The horizontal stabilizer 34 is attached to the tail-cone, generally at 32, in an aft portion 38 of the tail cone 32. The attachment of the horizontal stabilizer 34 is accomplished by providing pivot shafts which are located in the trailing portion of the horizontal stabilizer 34, which pivot shafts are well known, are not illustrated, and which form no part of the present invention. The horizontal stabi-

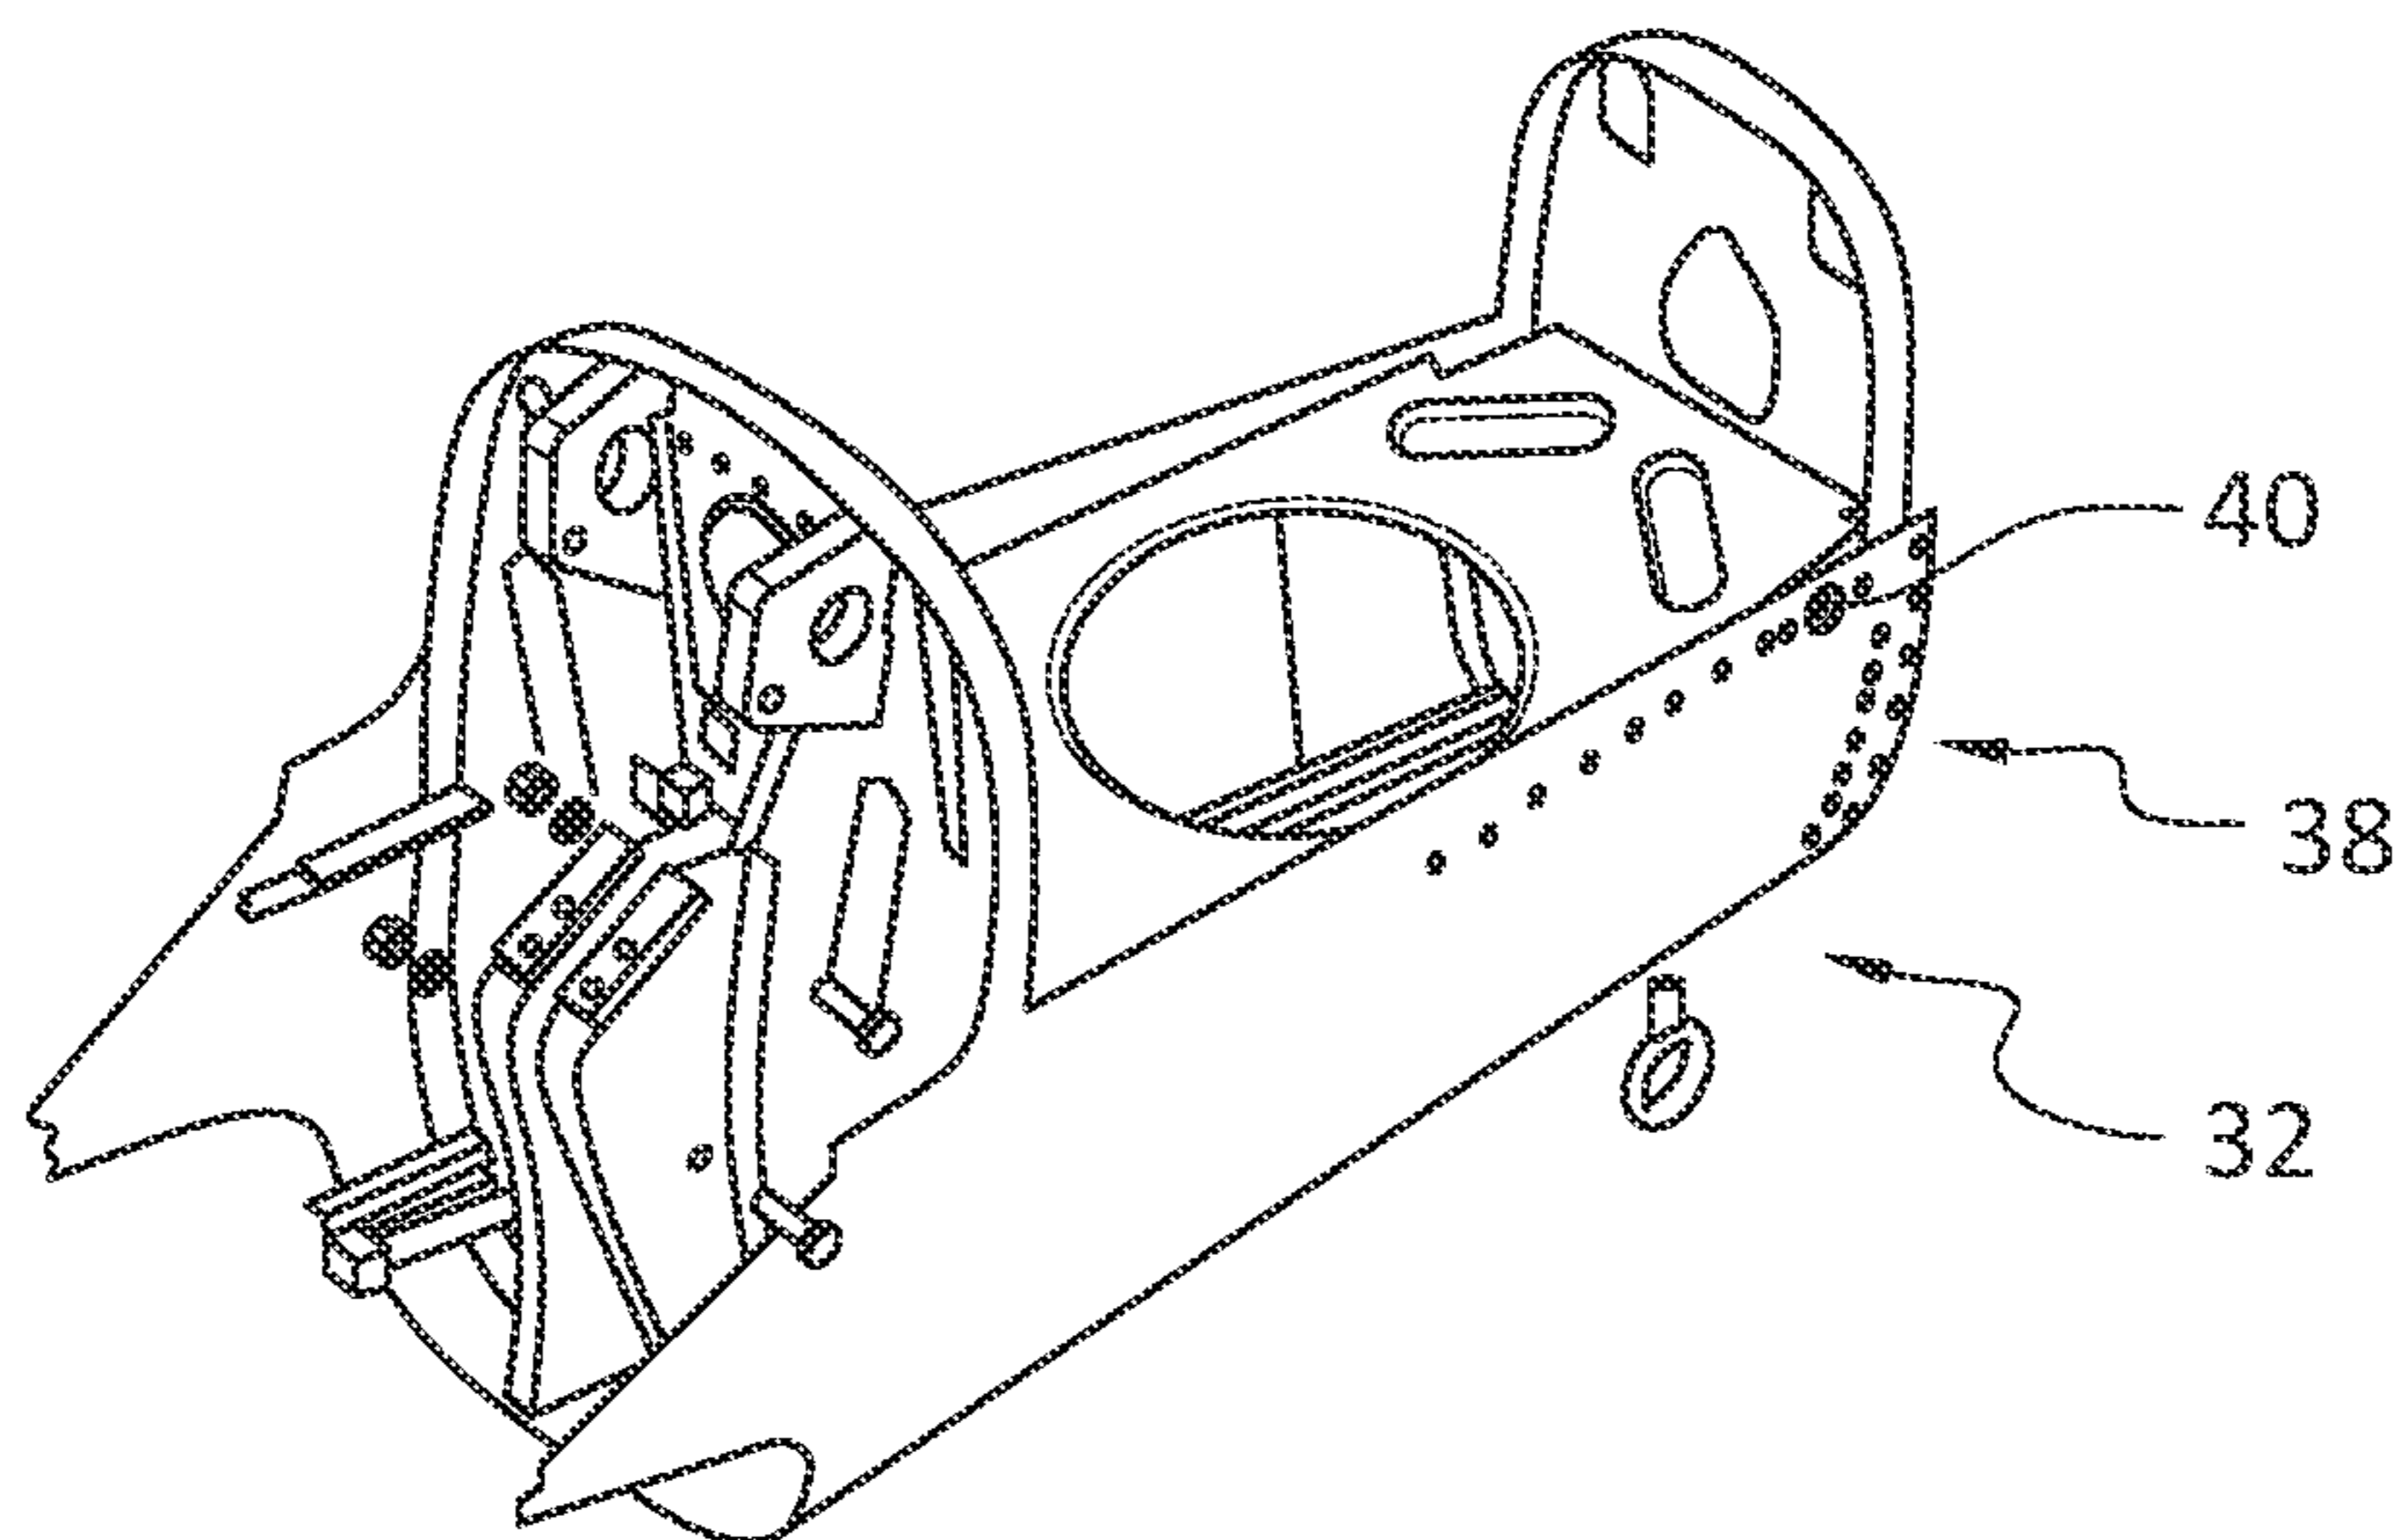
FIG. 2 is a schematic depiction of a tail-cone area of the Cessna 180-185 series aircraft depicted in FIG. 1, and with the horizontal stabilizer, elevator, tail, tail wheel and stinger removed;

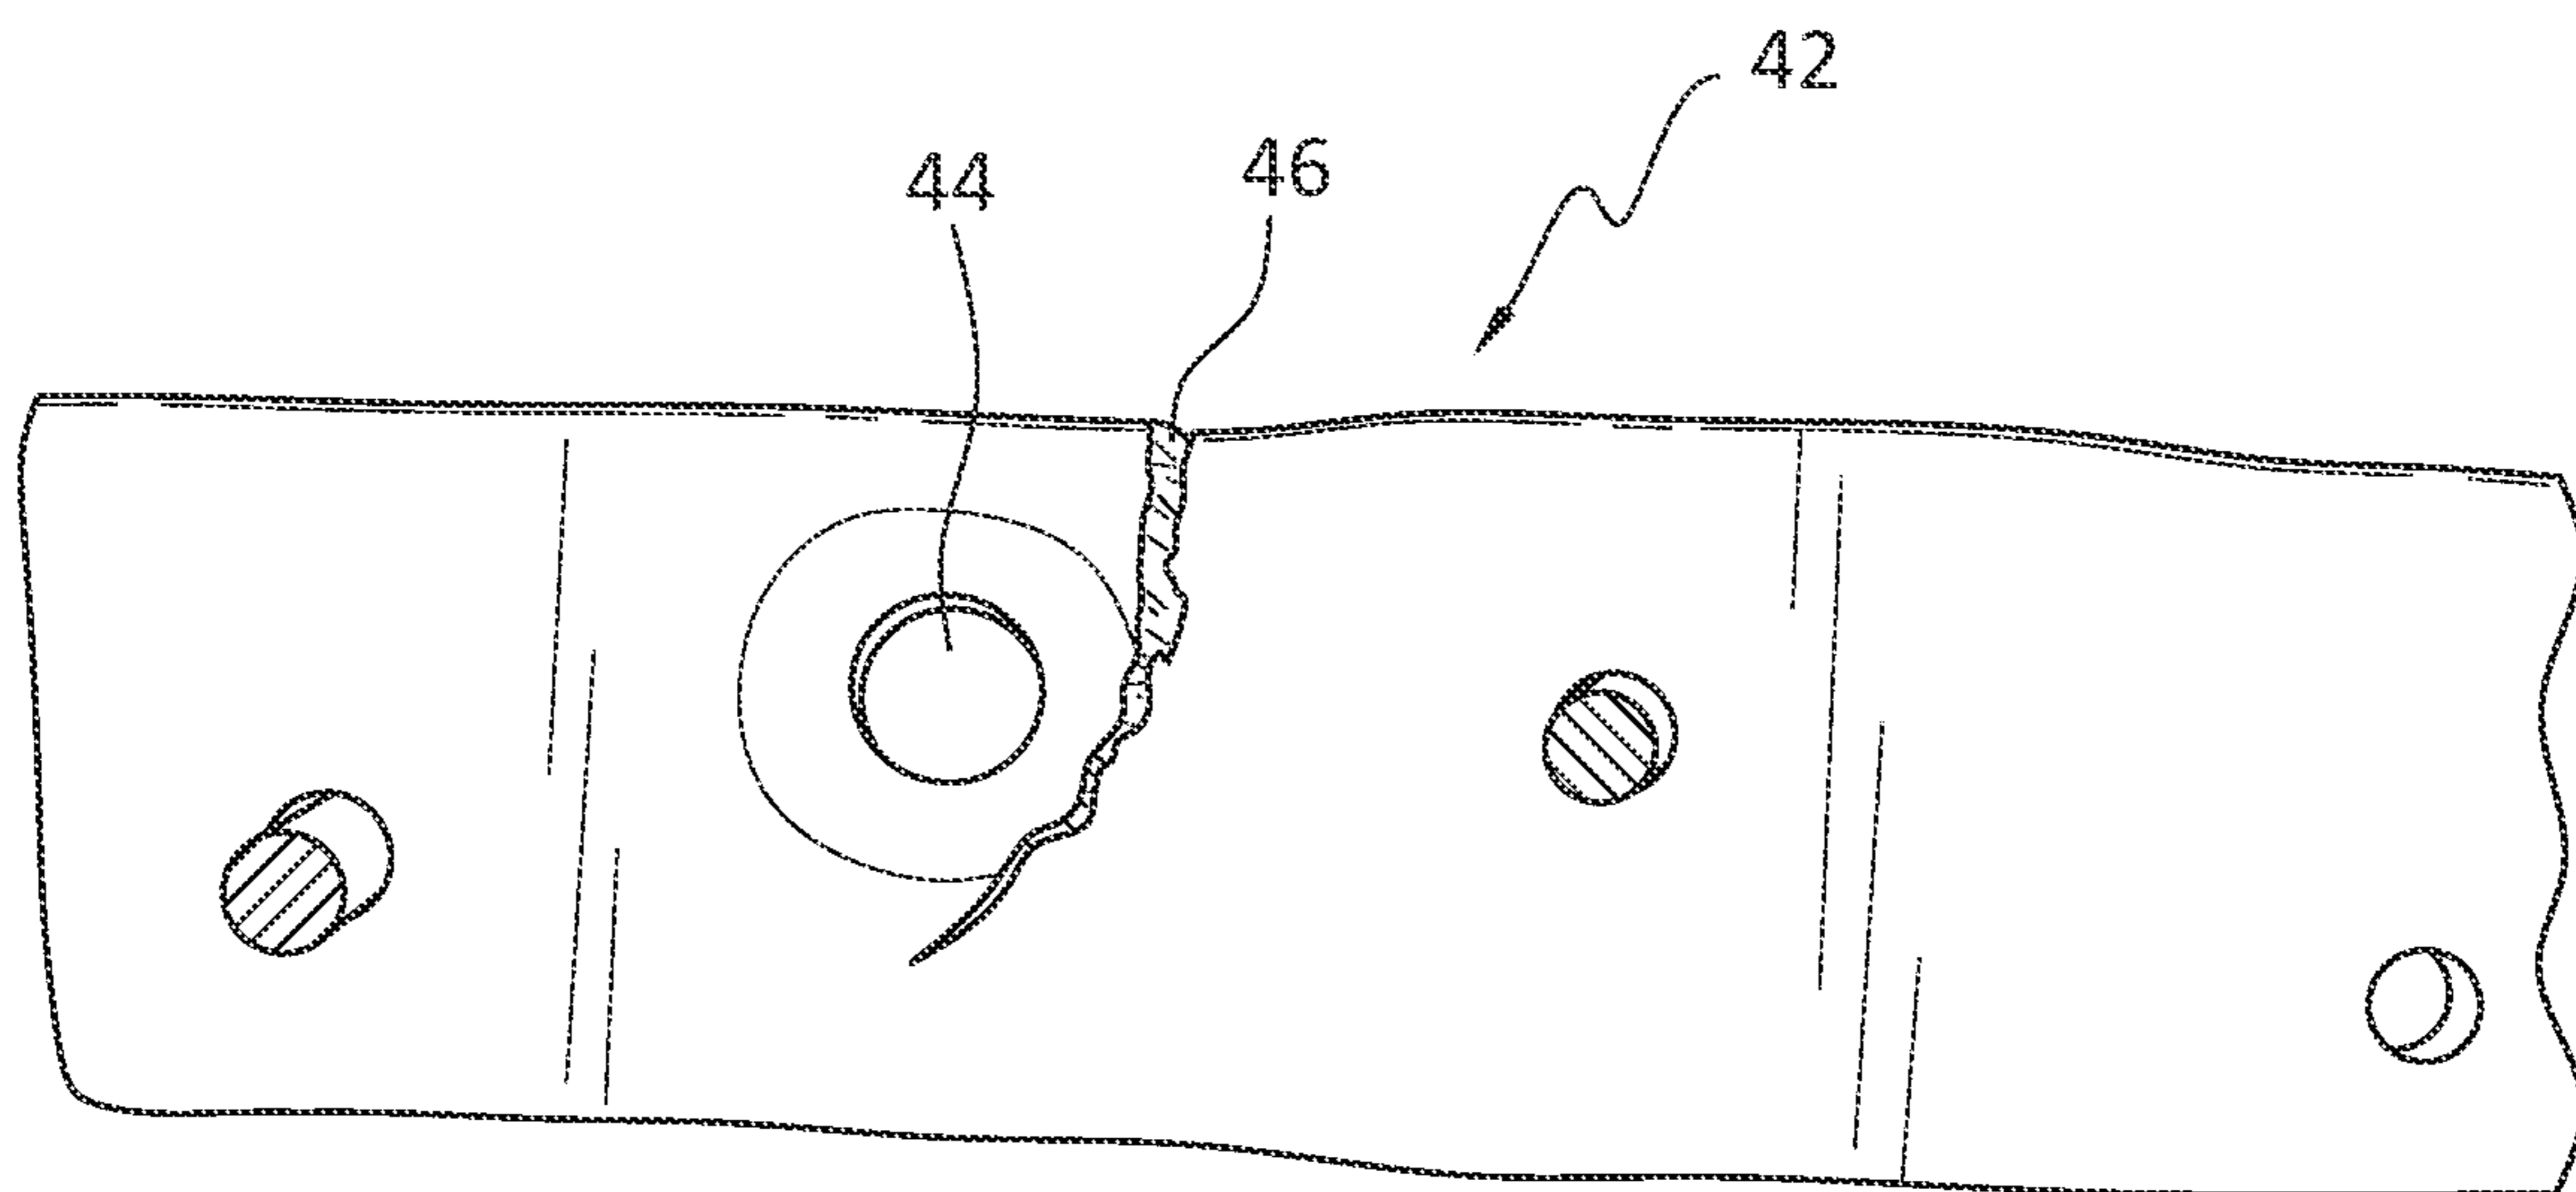
FIG. 3 is a photograph of an aft portion of a tail-cone reinforcement angle showing a typical failure in the horizontal stabilizer pivot shaft receiving bore of tail-cone reinforcement angle;

A rear "blade" portion 42 of each such tail-cone reinforcement angle 50, as seen at 42 in FIG. 3, is provided with a horizontal stabilizer pivot shaft receiving bore, indicated at 44, again in FIG. 3. Bore 44 is aligned with the horizontal stabilizer pivot shaft receiving apertures 40 in the aft portion 38 of the tail cone 32. These tail cone fuselage apertures 40 and their aligned tail-cone reinforcement angle blade bores 44 are aligned and form the mounting points for the horizontal stabilizer 34, as is known in the art.

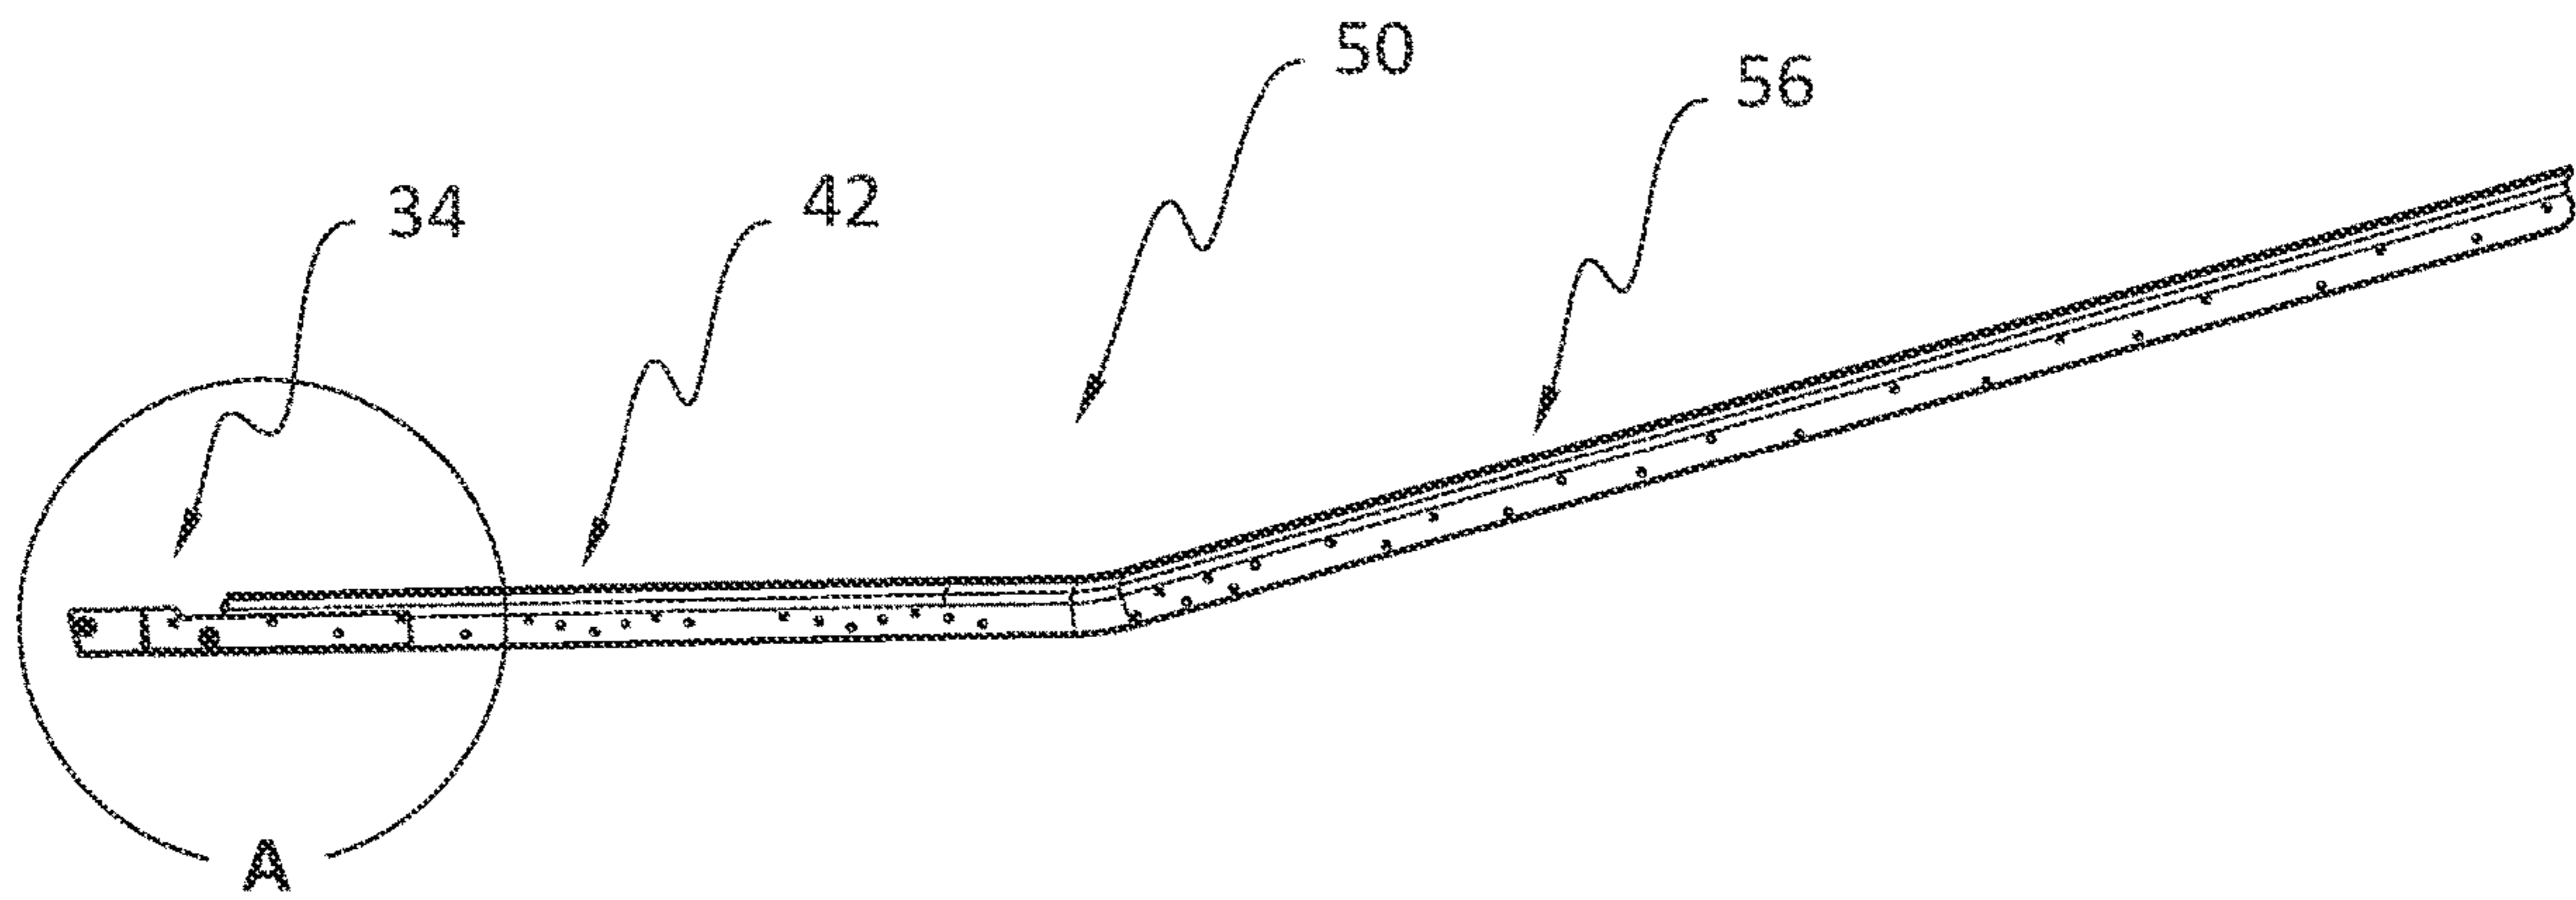
FIG. 4 is a perspective view of a left side tail-cone reinforcement angle including a left side tail-cone reinforcement angle splice, in accordance with the present invention;

As is also well known to those familiar with the Cessna 180-185 series aircraft, the rear fuselages of such aircraft are typically reinforced by tail-cone reinforcement angles, often referred to as "hockey sticks" because of their shape, which somewhat resemble a typical hockey stick. These tail-cone reinforcement angles are attached to interior right and left portions of the rear section of the aircraft's fuselage. These tail-cone reinforcement angles are intended to provide structural rigidity to the aircraft's fuselage 22 and are intended to prevent inward deflection of that portion of the fuselage if lateral exterior pressure were to be applied to the fuselage, typically as a result of physical pressure being applied to the fuselage while the plane is being handling on the ground. A typical tail-cone reinforcement angle is depicted generally at 50 in FIGS. 4 and 5.

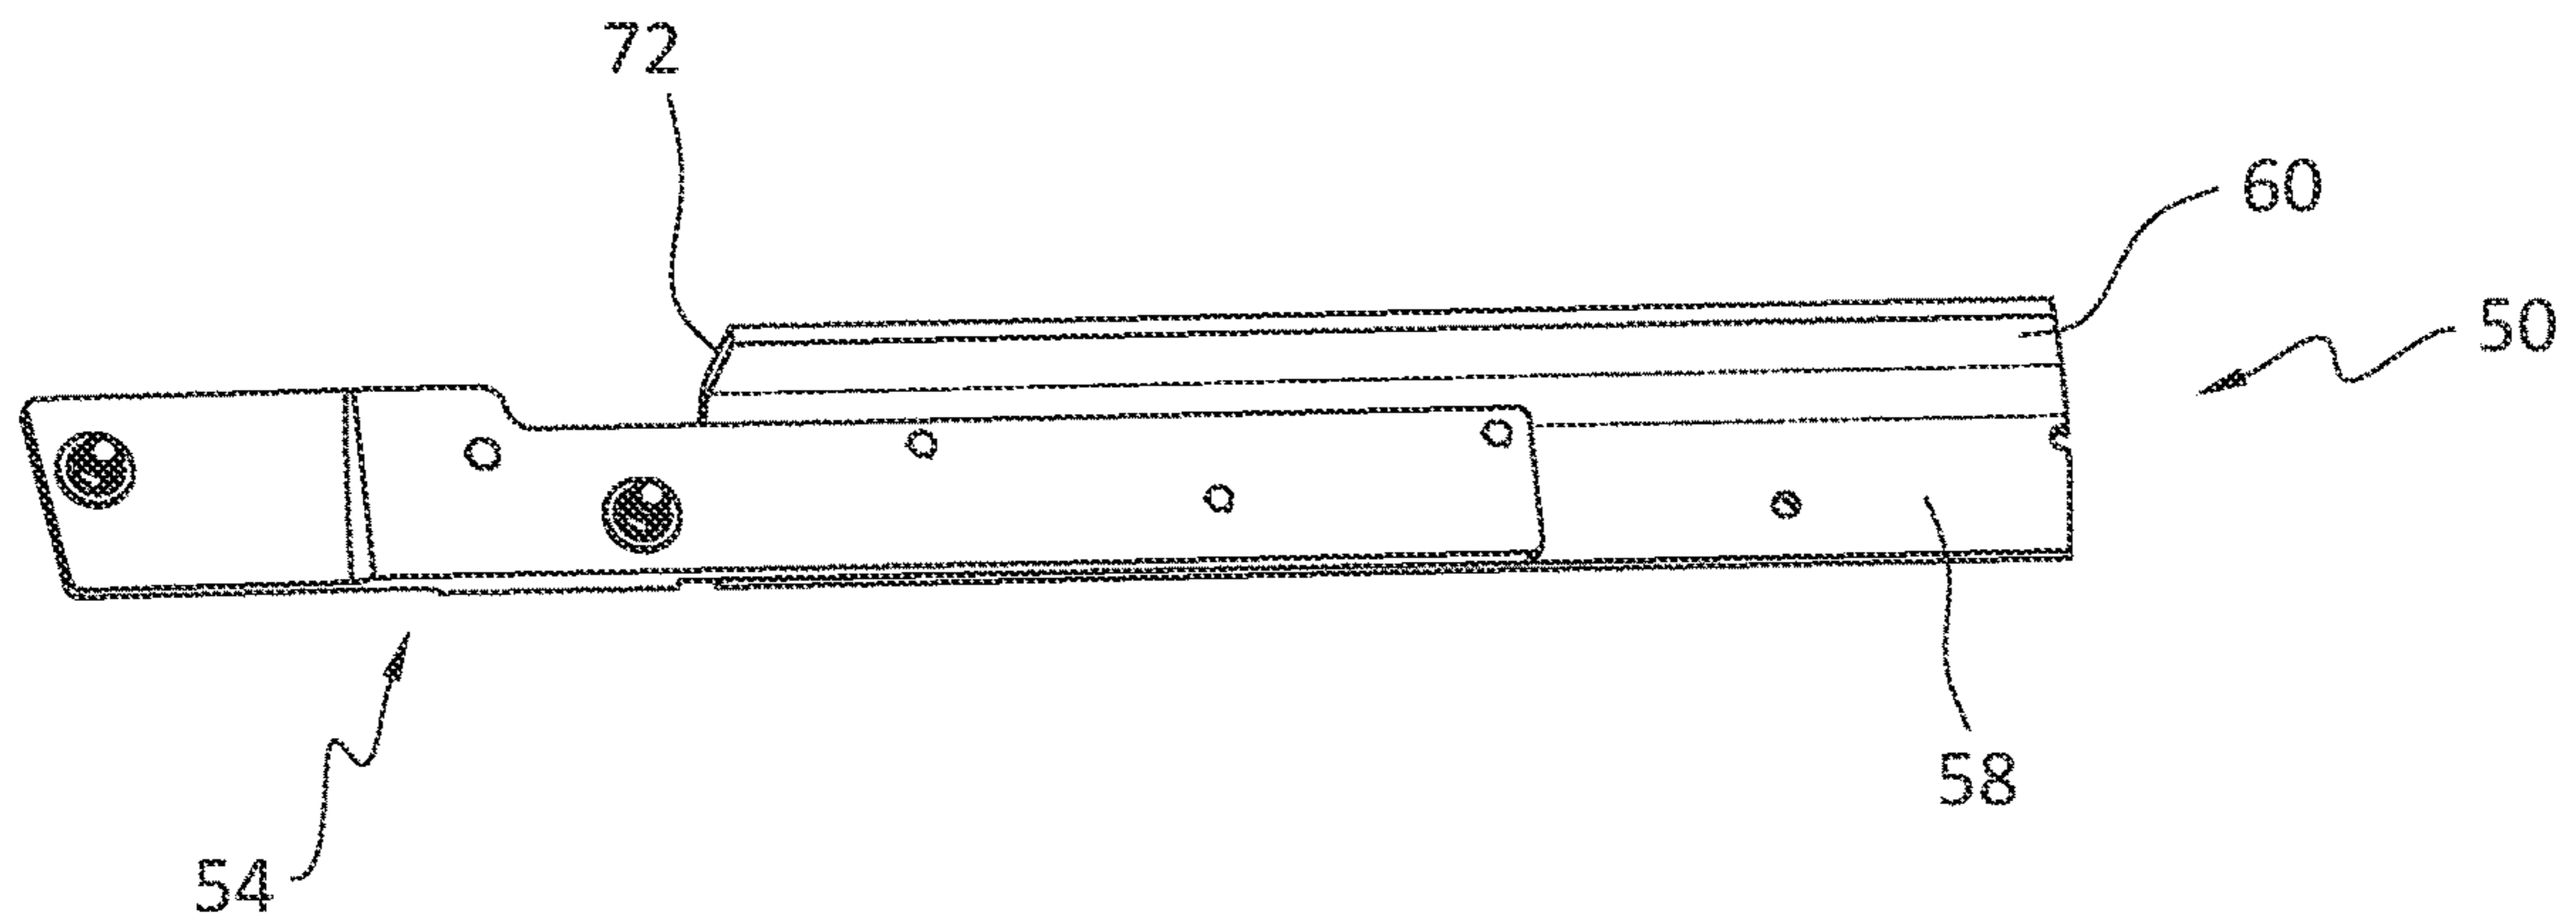
FIG. 5 is a side elevation view of an aft portion of the left side tail-cone reinforcement angle, encircled at A in FIG. 4, with the tail-cone reinforcement angle splice, in accordance with the present invention, in place;

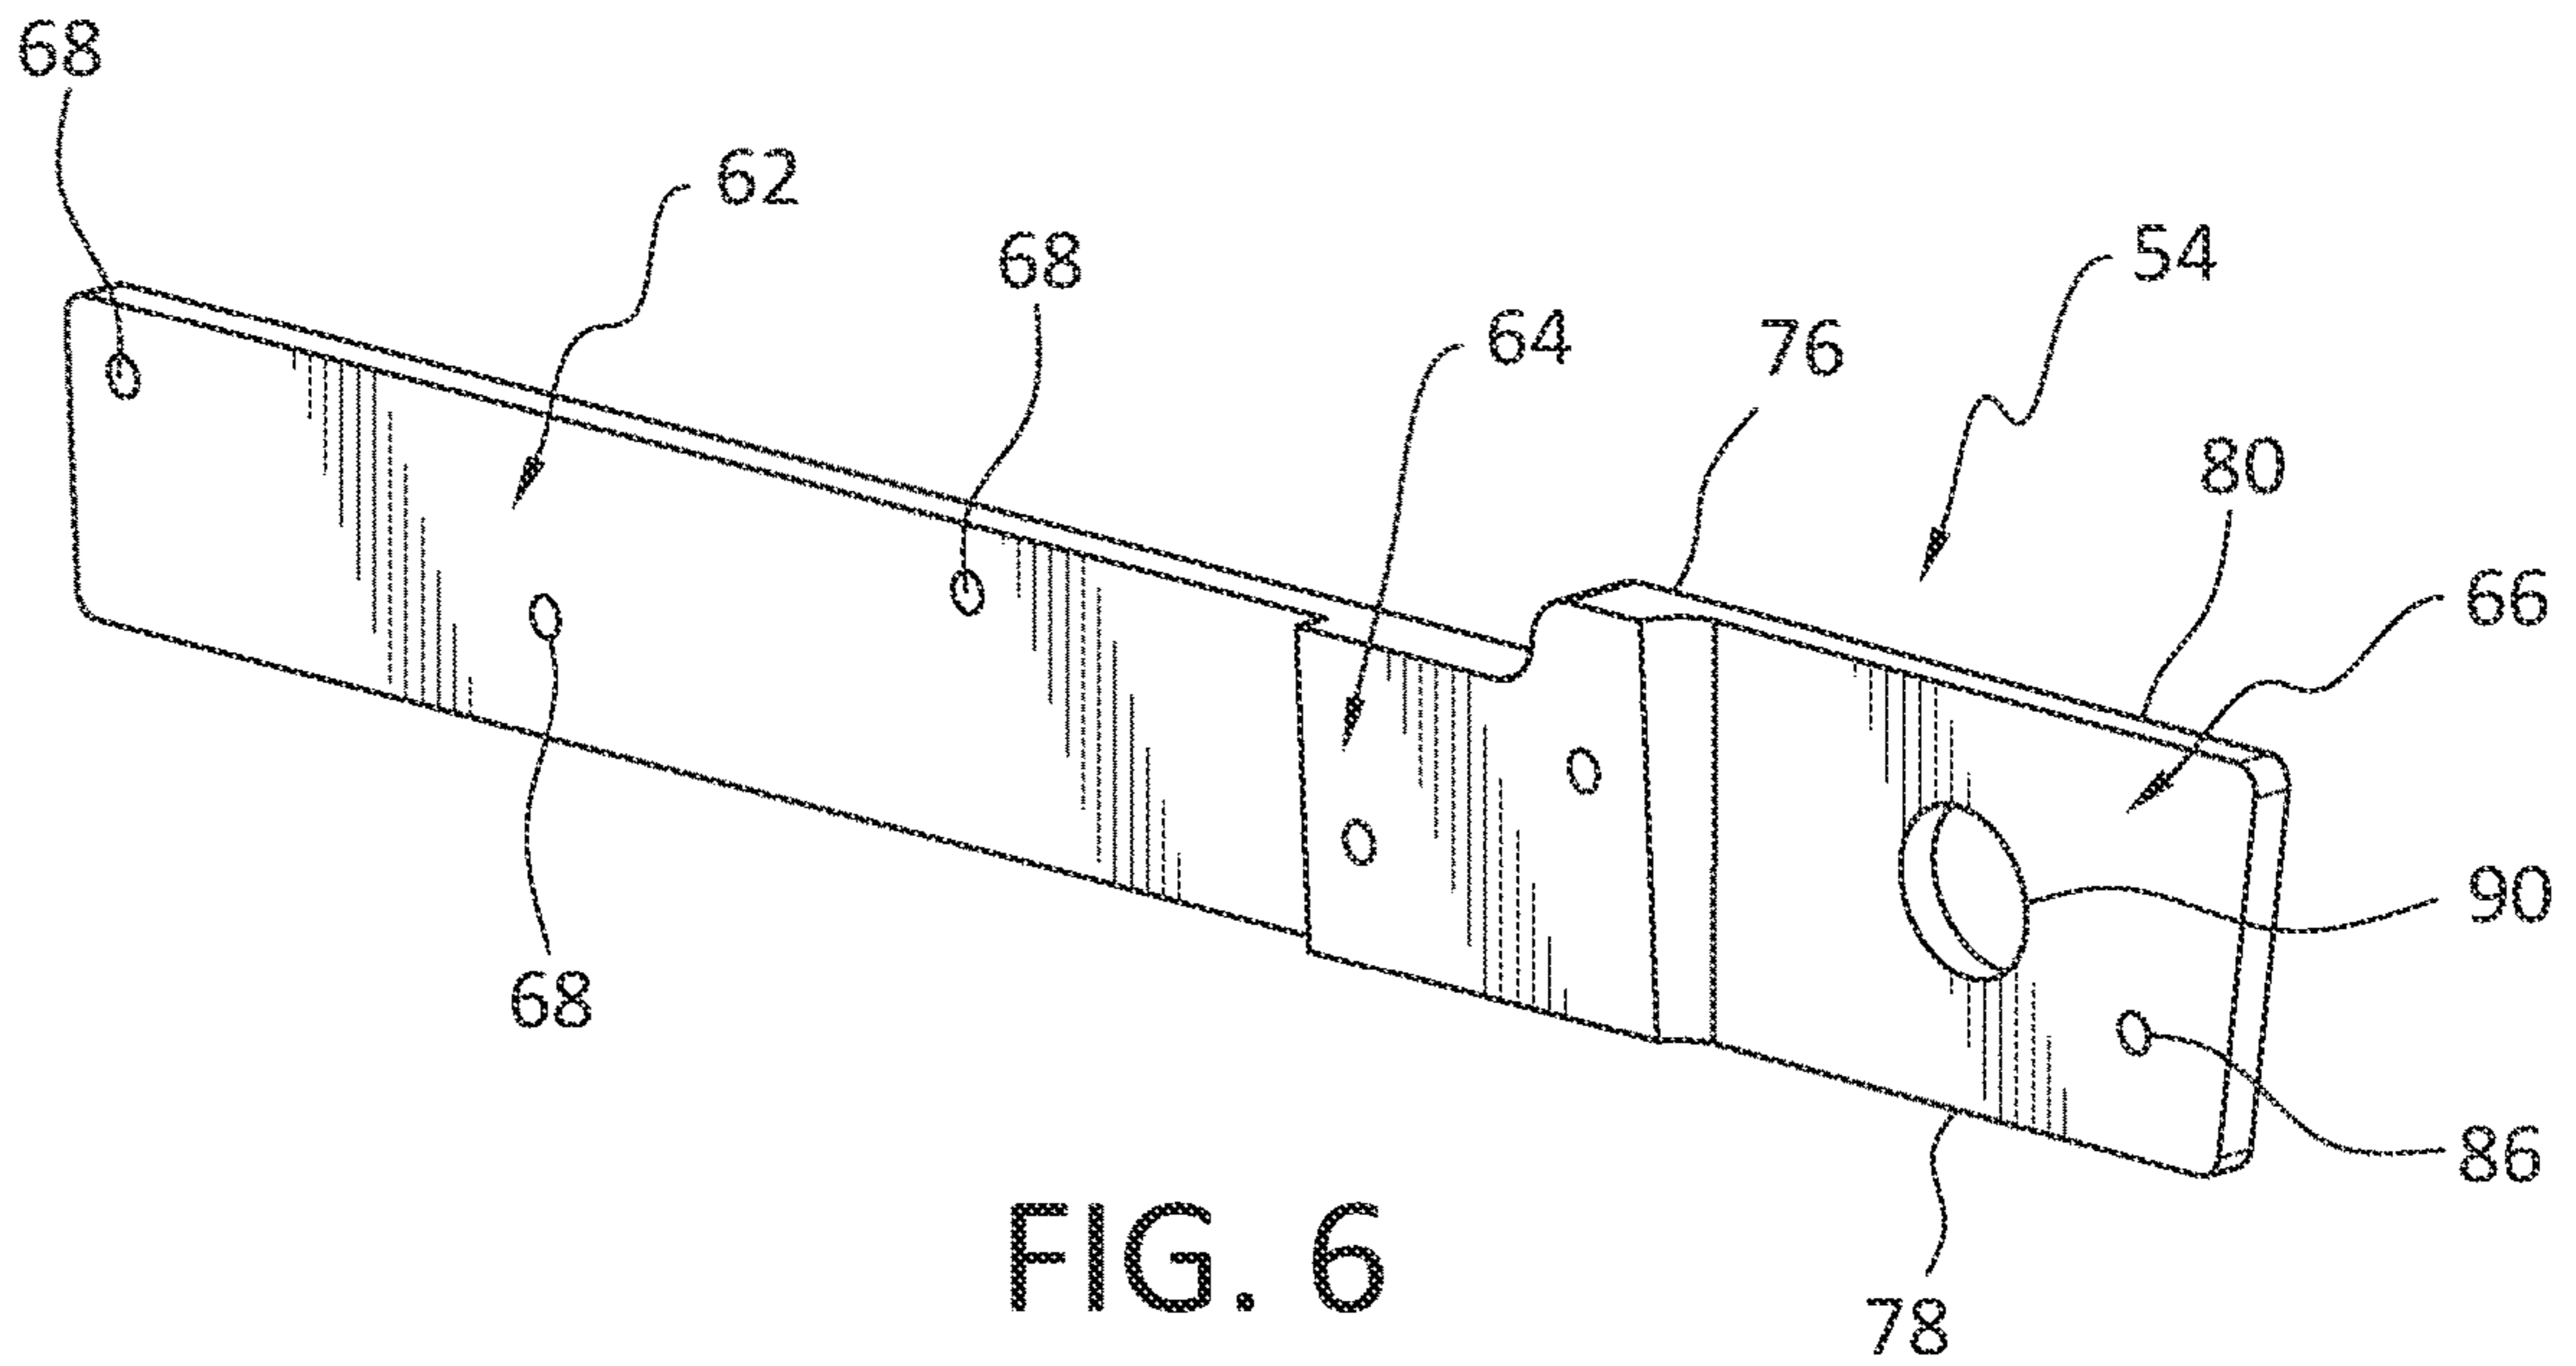
FIG. 6 is a perspective view of a left side tail-cone reinforcement angle splice prior to installation;

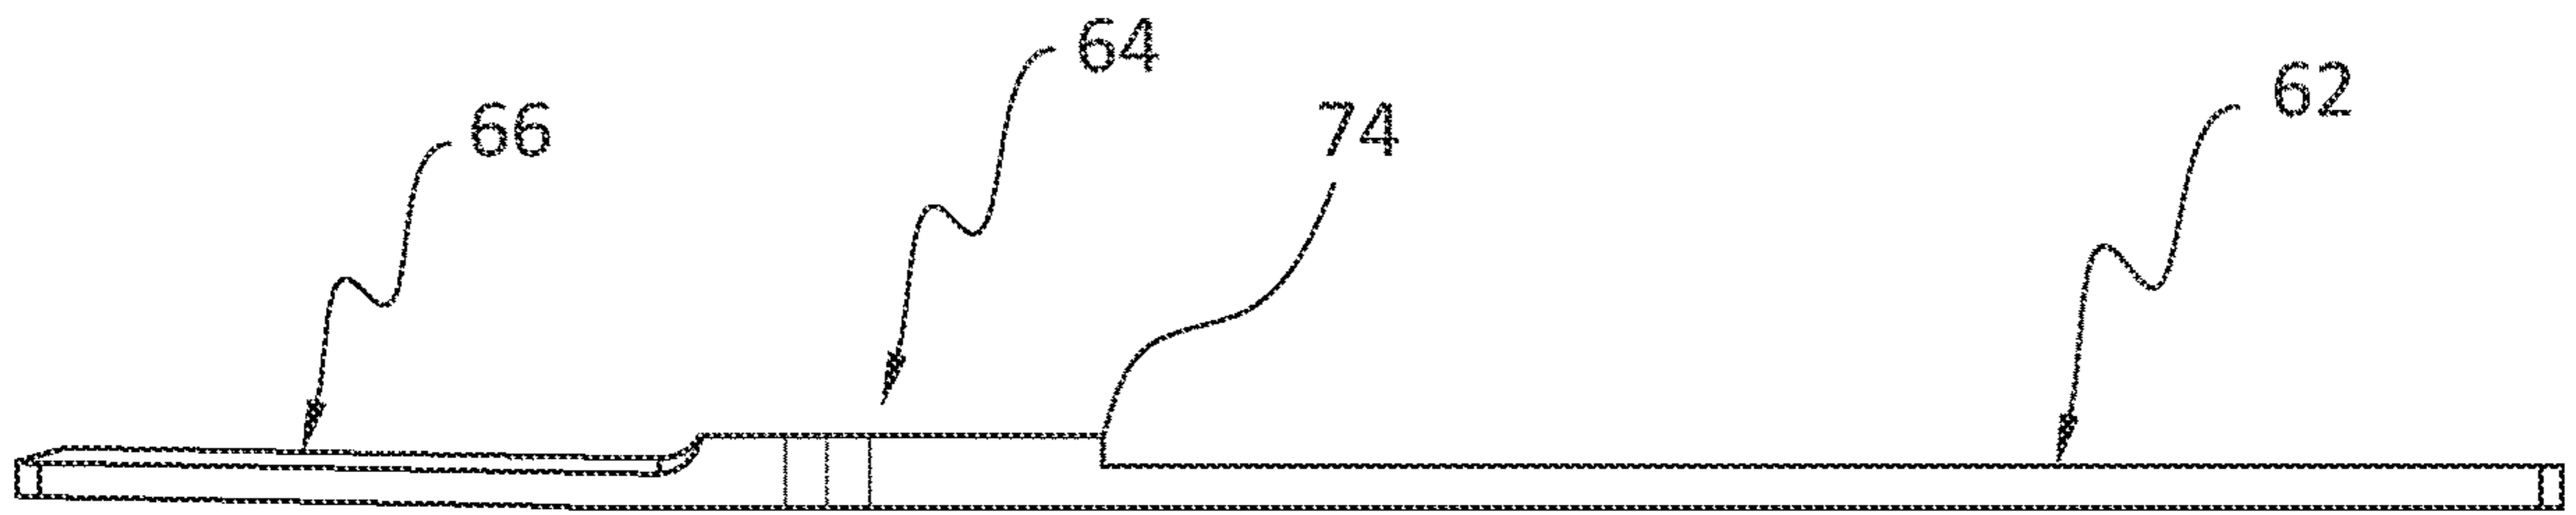
FIG. 7 is a top-plan view of the reinforcement angle splice depicted in FIG. 6;
